ESTUARINE WETLAND RESTORATION

Lessons Learned so far from the
Winchester Tidelands Restoration Project

South Slough NERR
Coos Bay, OR

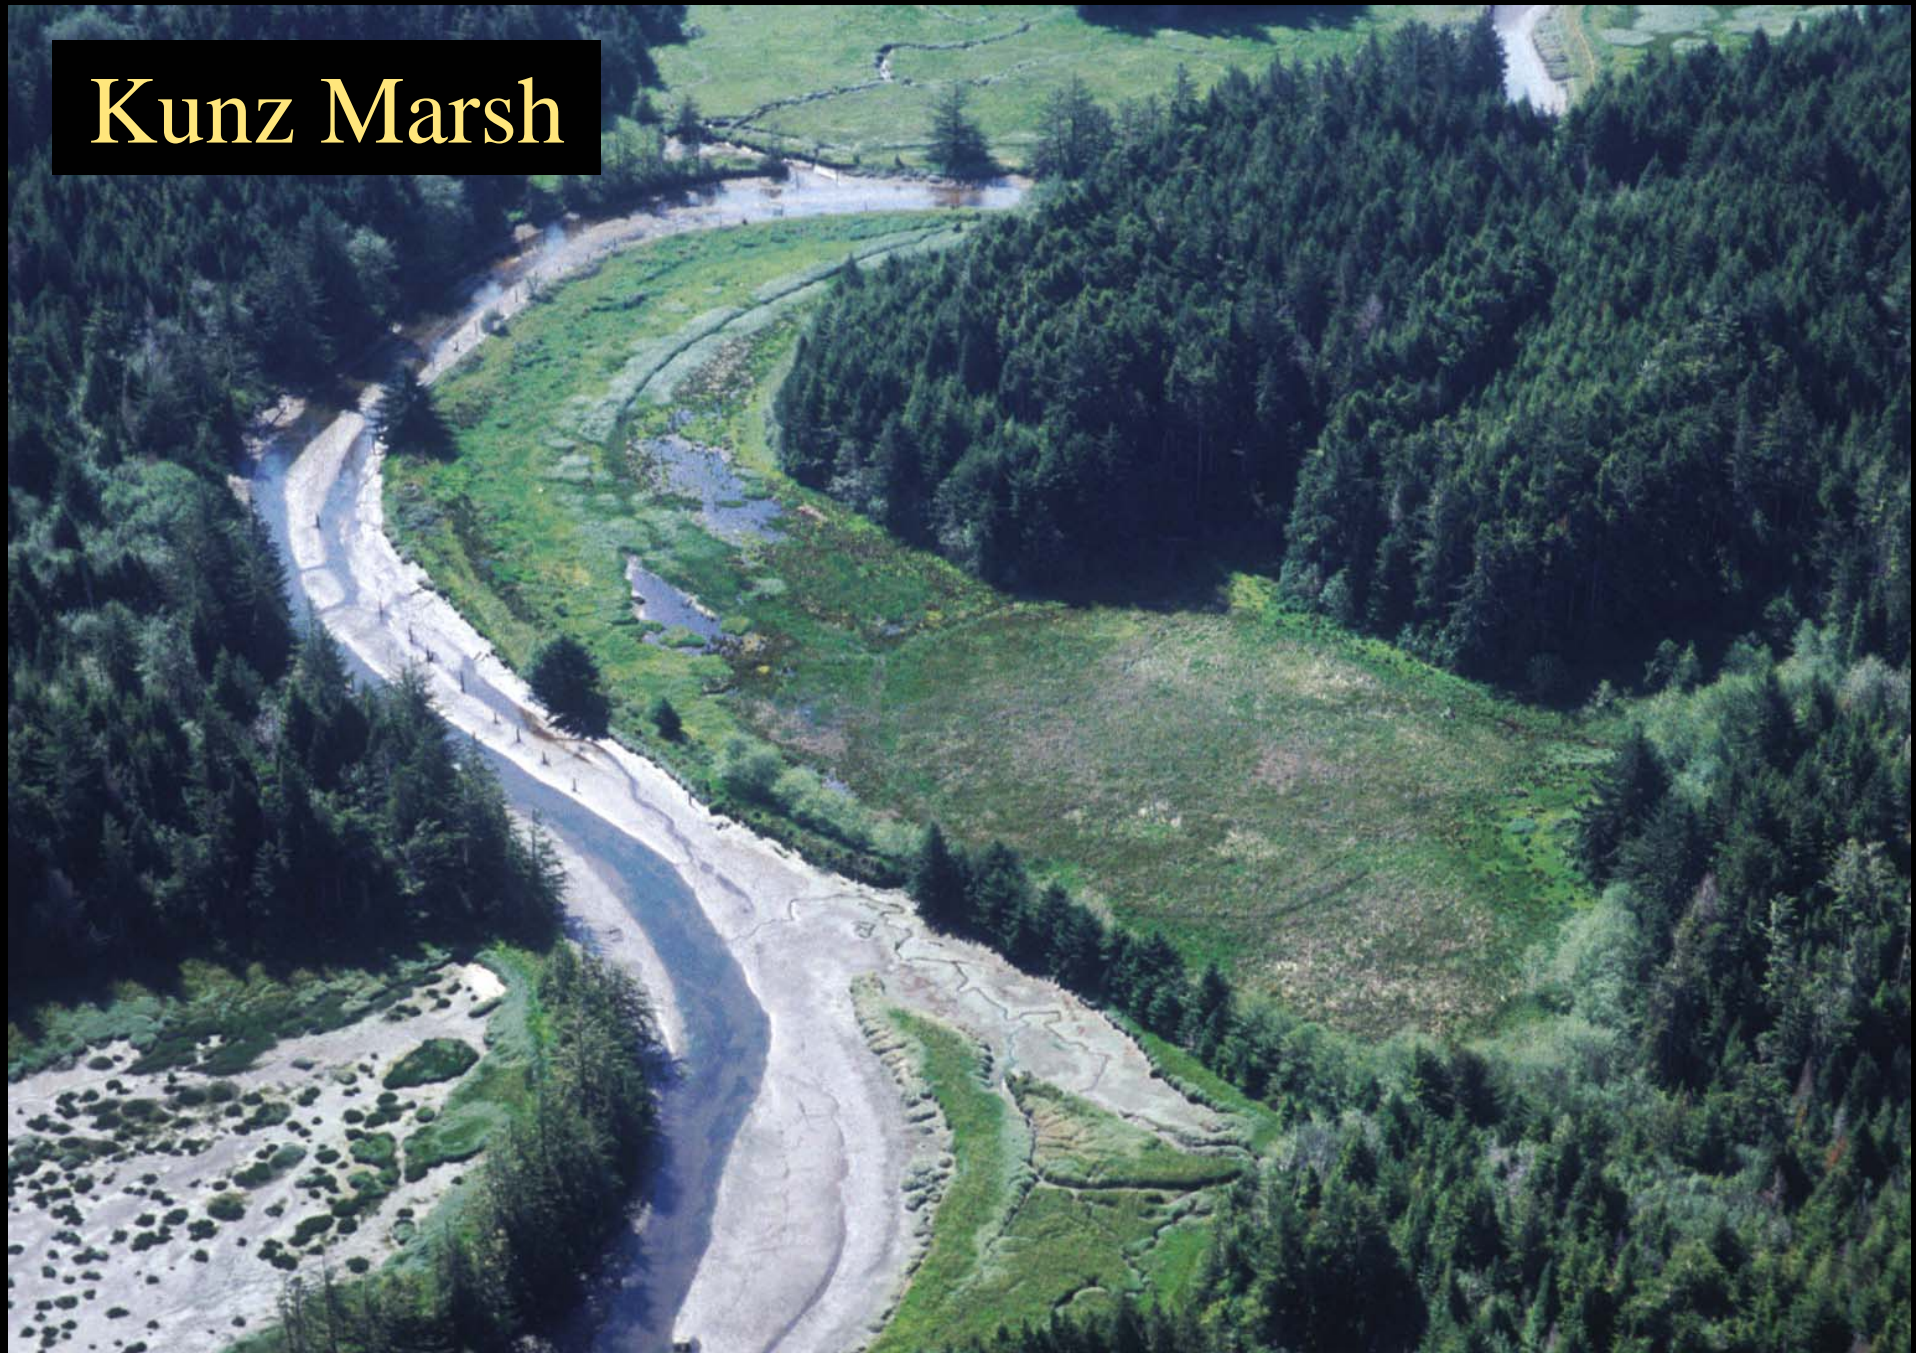
Kunz Marsh

Earth levee

Ditches

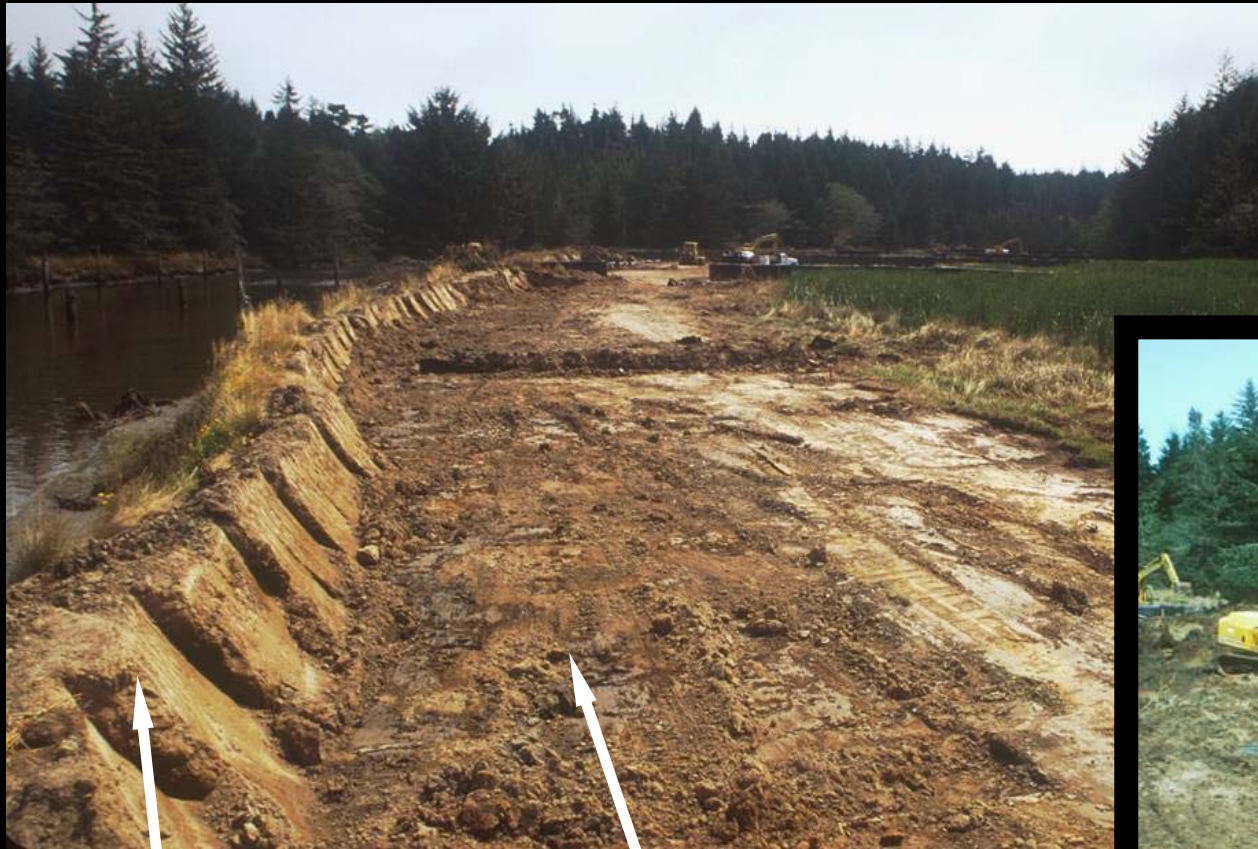
**Dike remnant
removed when cells
fully graded**

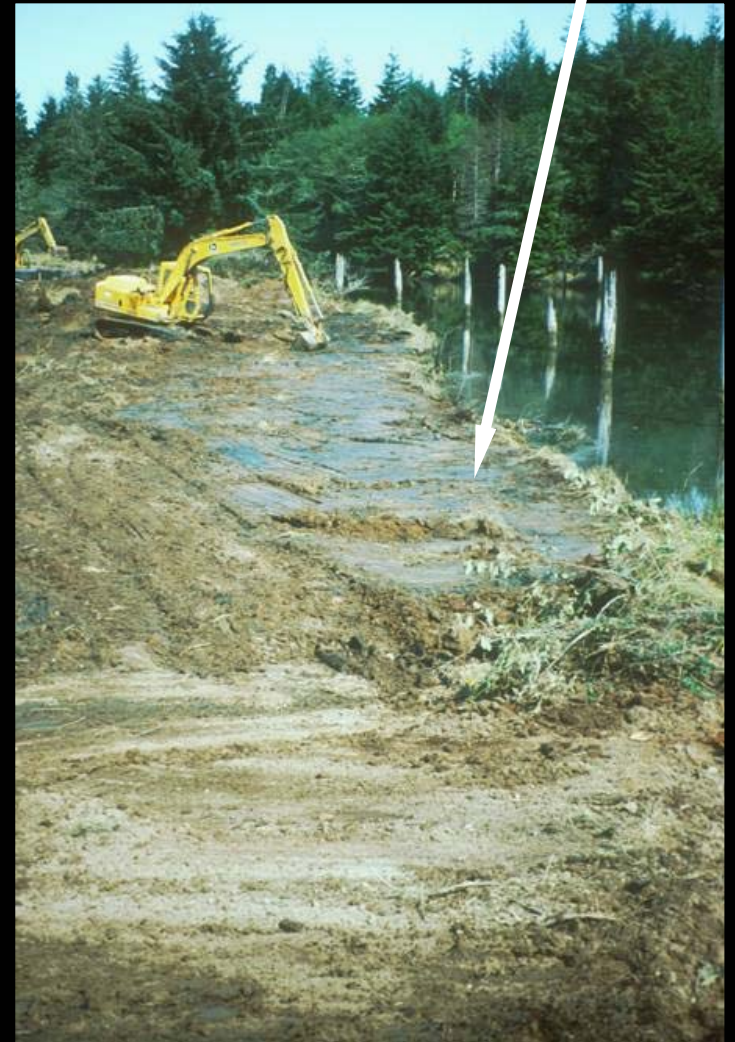
**Dike material moved to
create cells**

**Dike remnant to prevent
premature flooding**

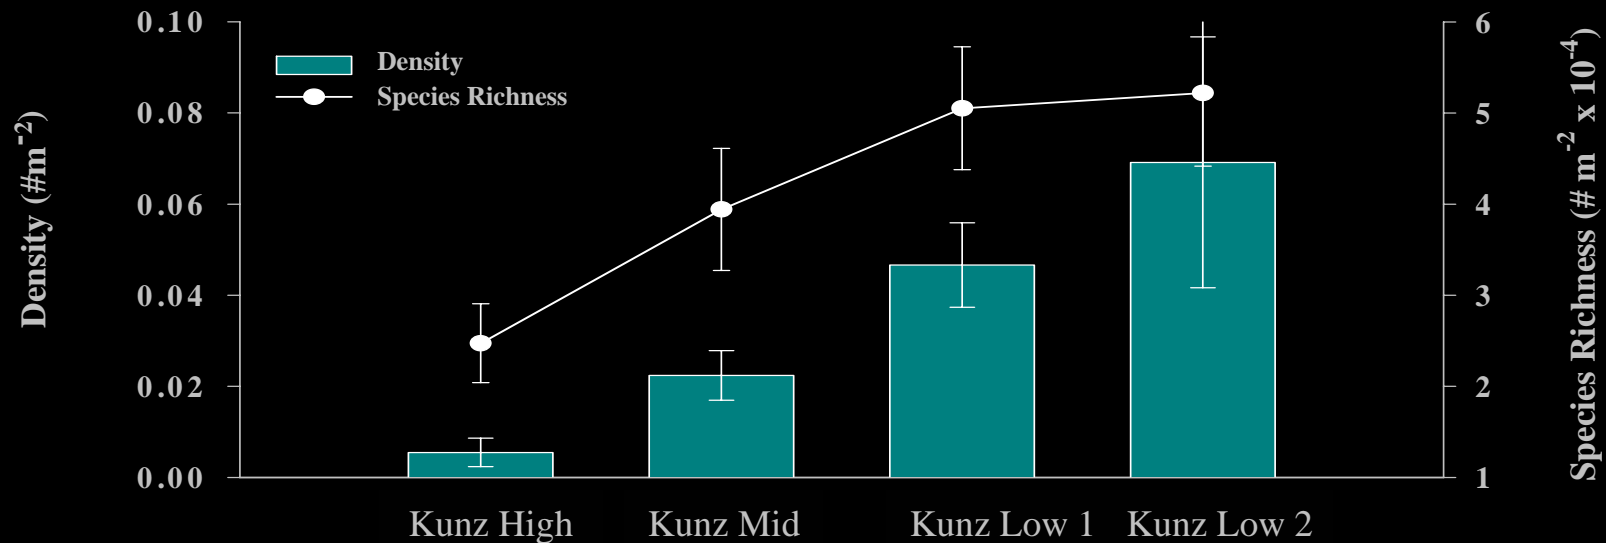
Mean Total Density and Species Richness- 11/98-3/99

Greater numbers of fish and higher diversity of fish species used the lower cells as compared with the upper cells

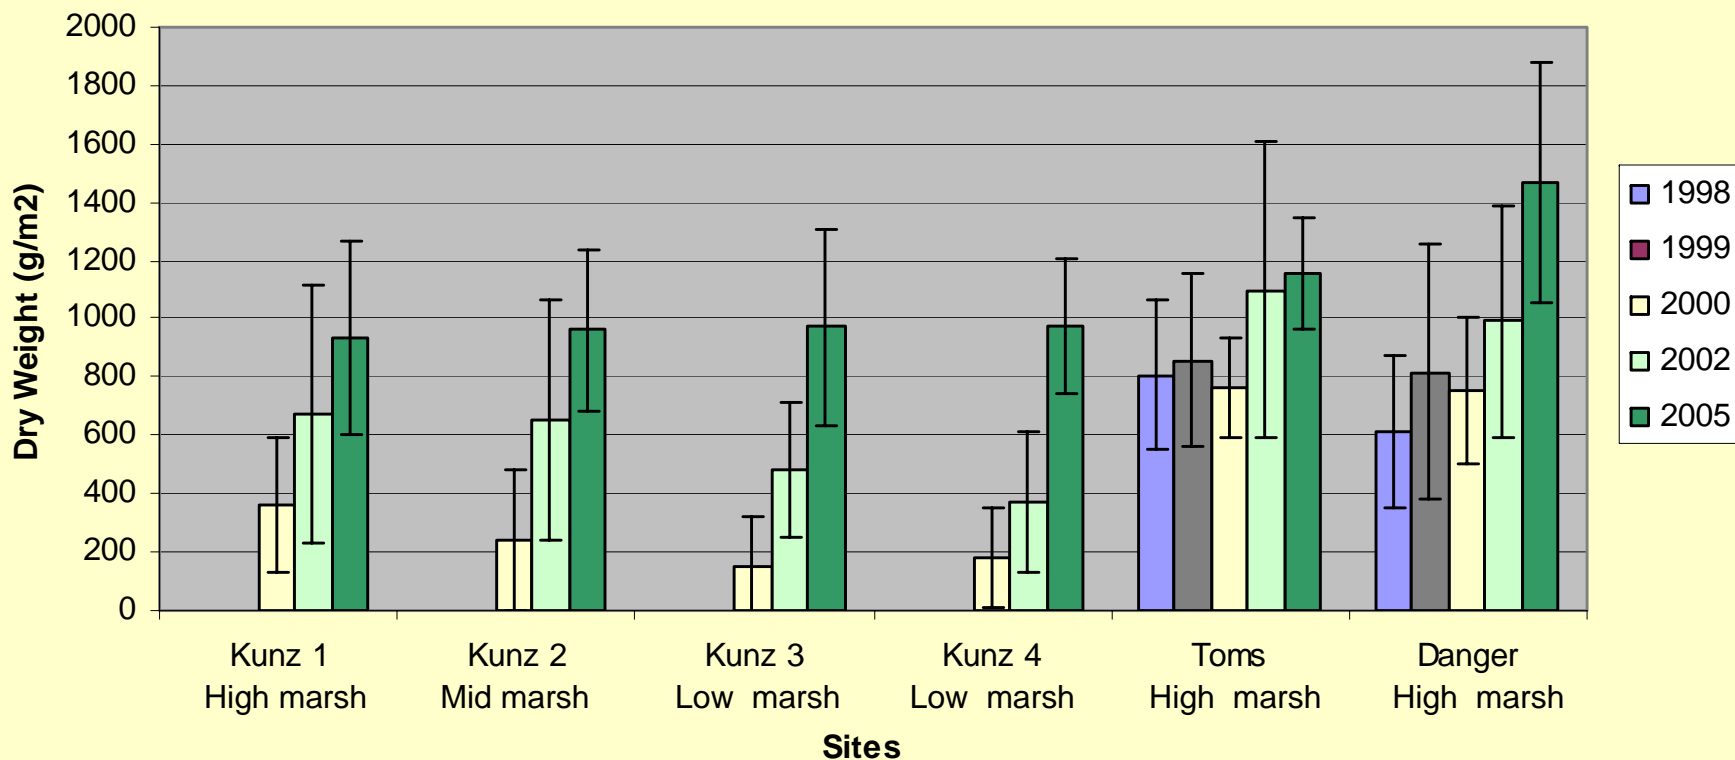
Above Ground Biomass 1998-2005

1998-2005 Above-Ground Biomass

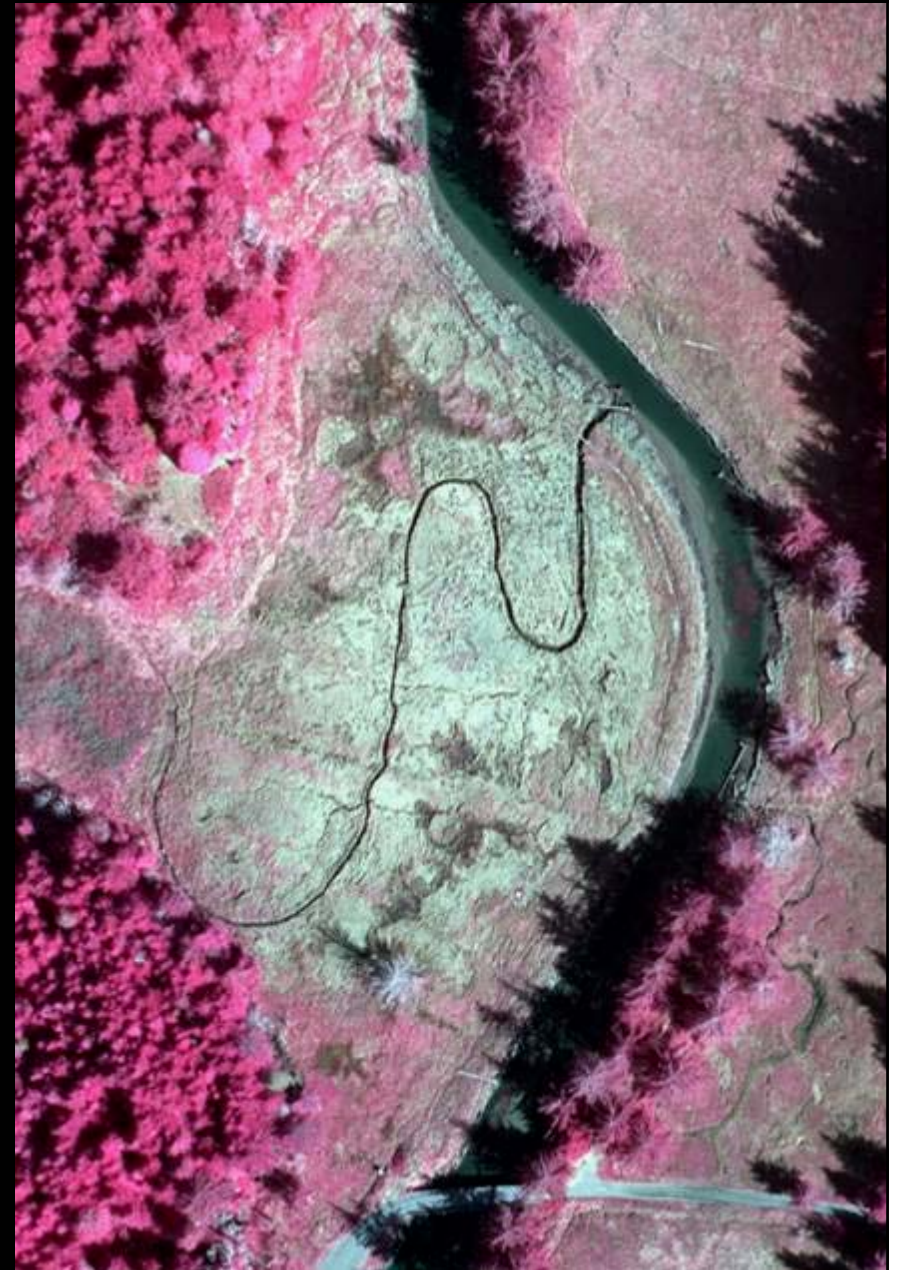
2005

Ditch length: 125 m
Pilot channel length: 400 m

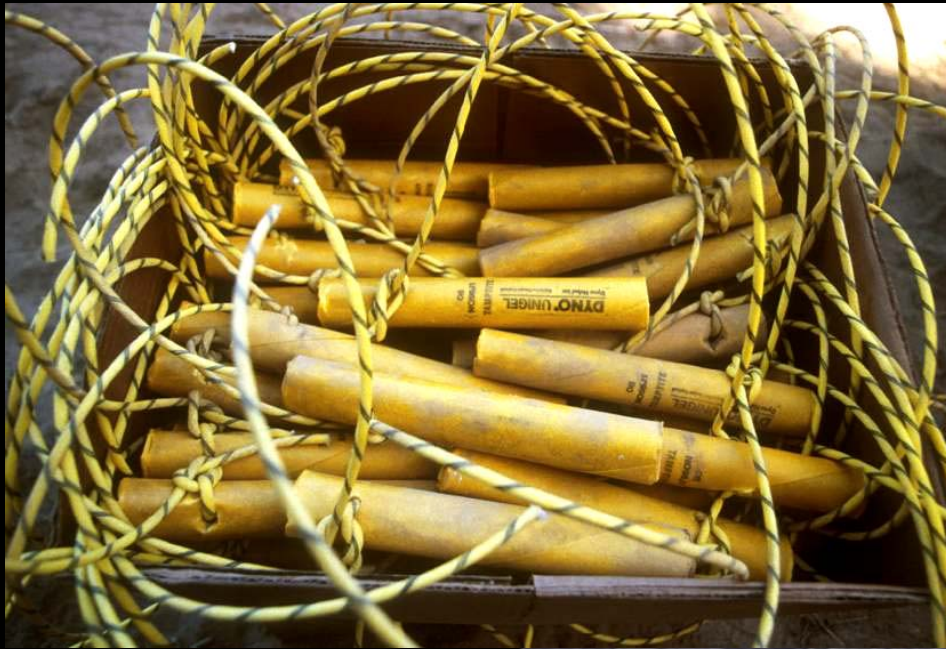
Use of explosives for tidal channel construction

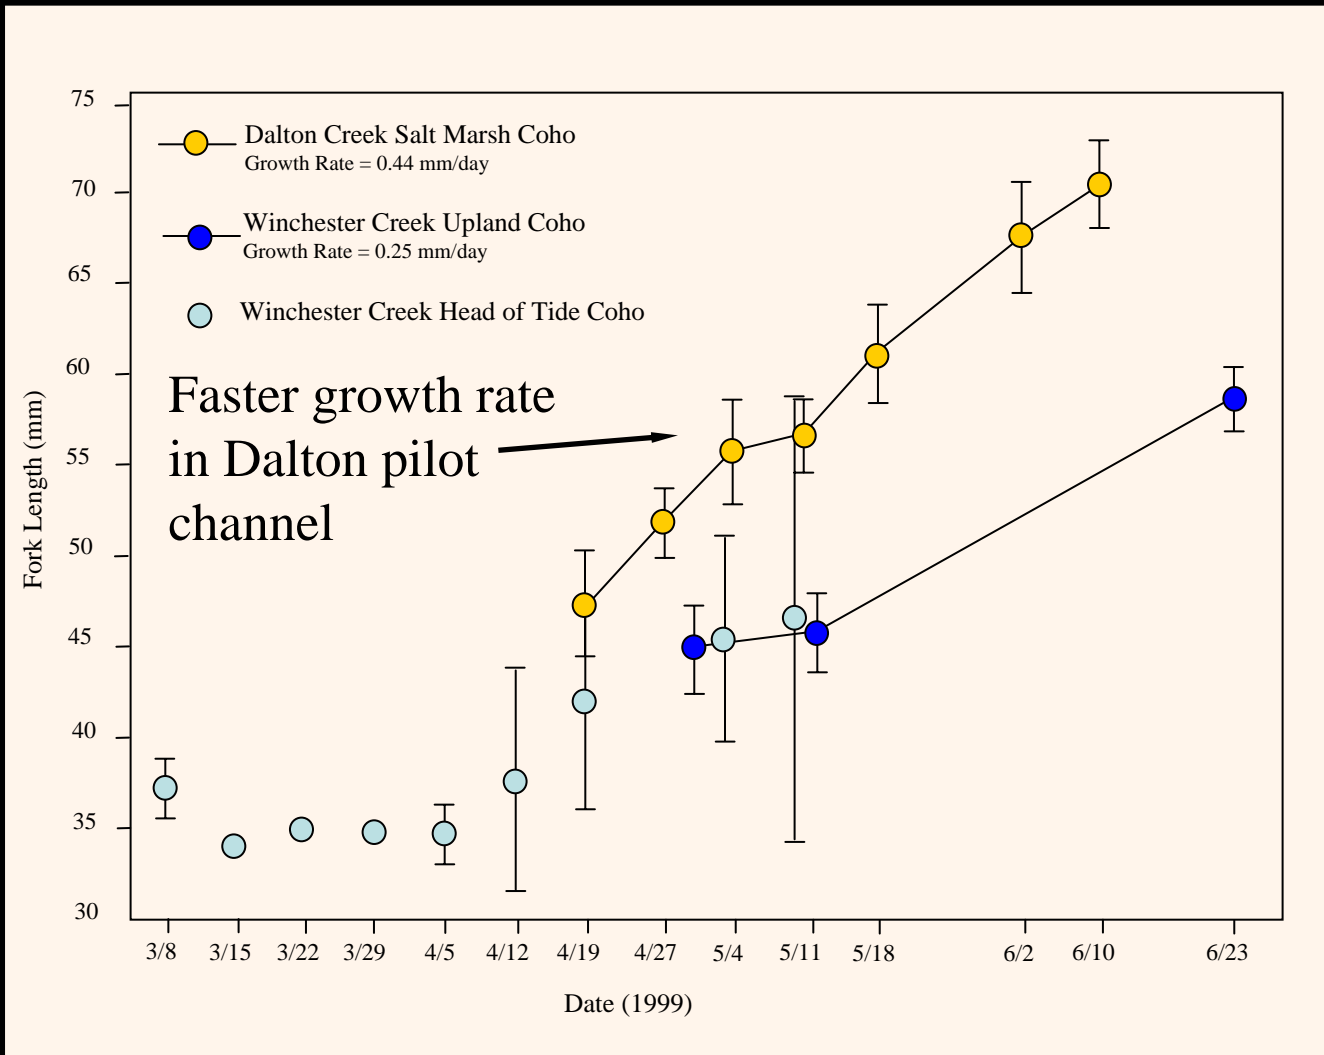
Growth of 0+ coho salmon populations in Dalton Creek pilot channel and freshwater stream environments in 1999

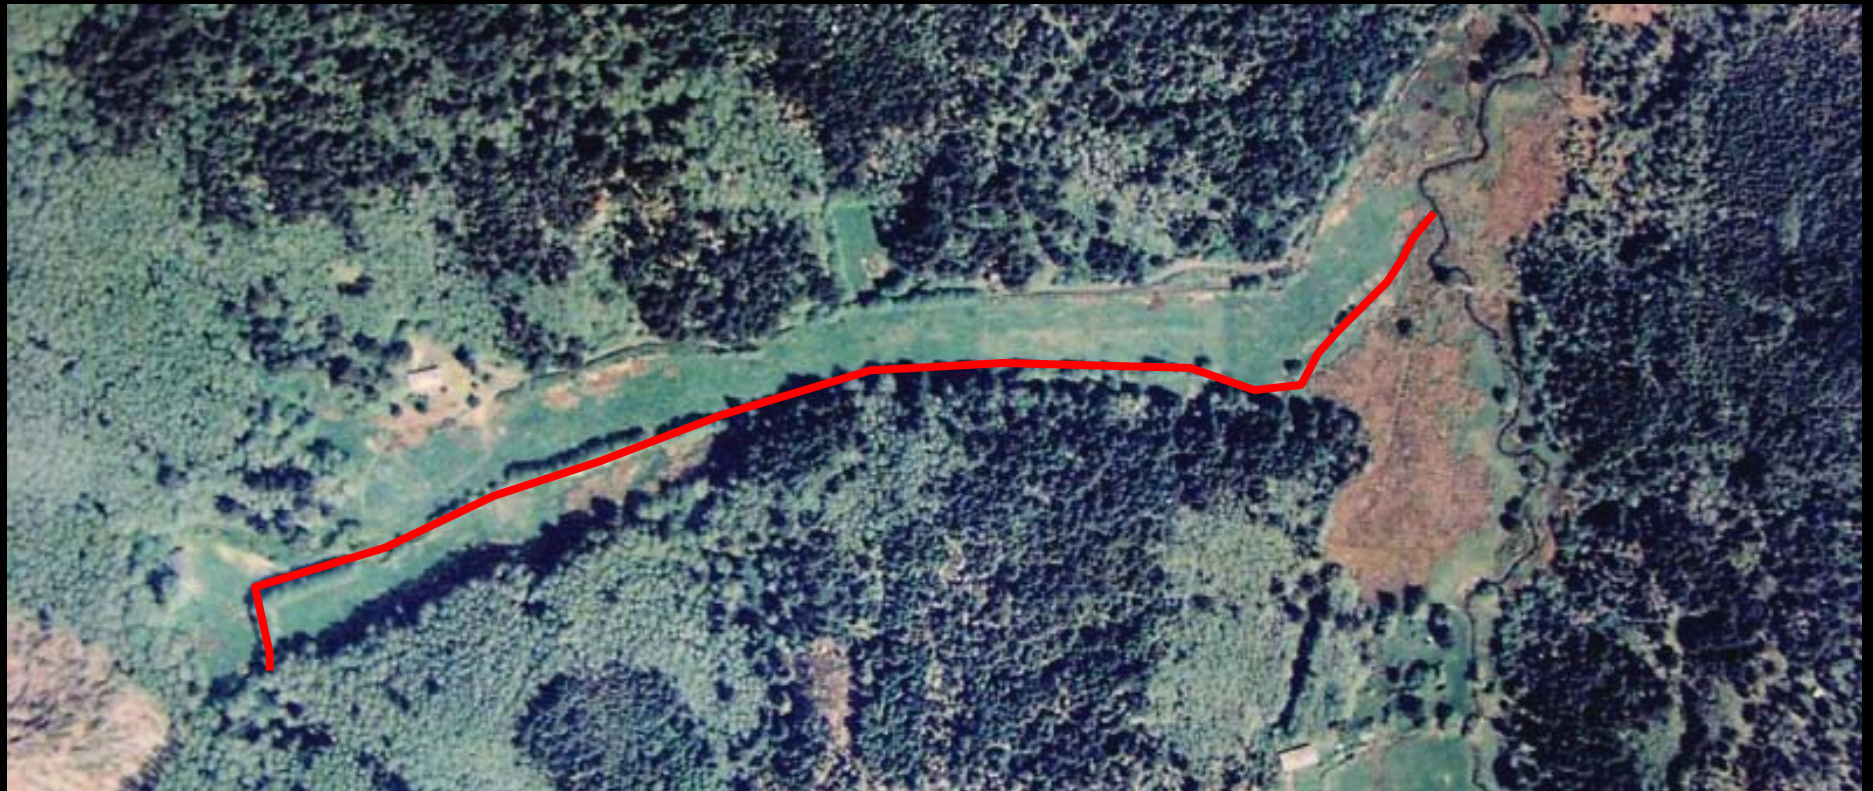
Anderson Creek Marsh 1991

Ditch length: 850 m
Pilot channel length: 1,160 m

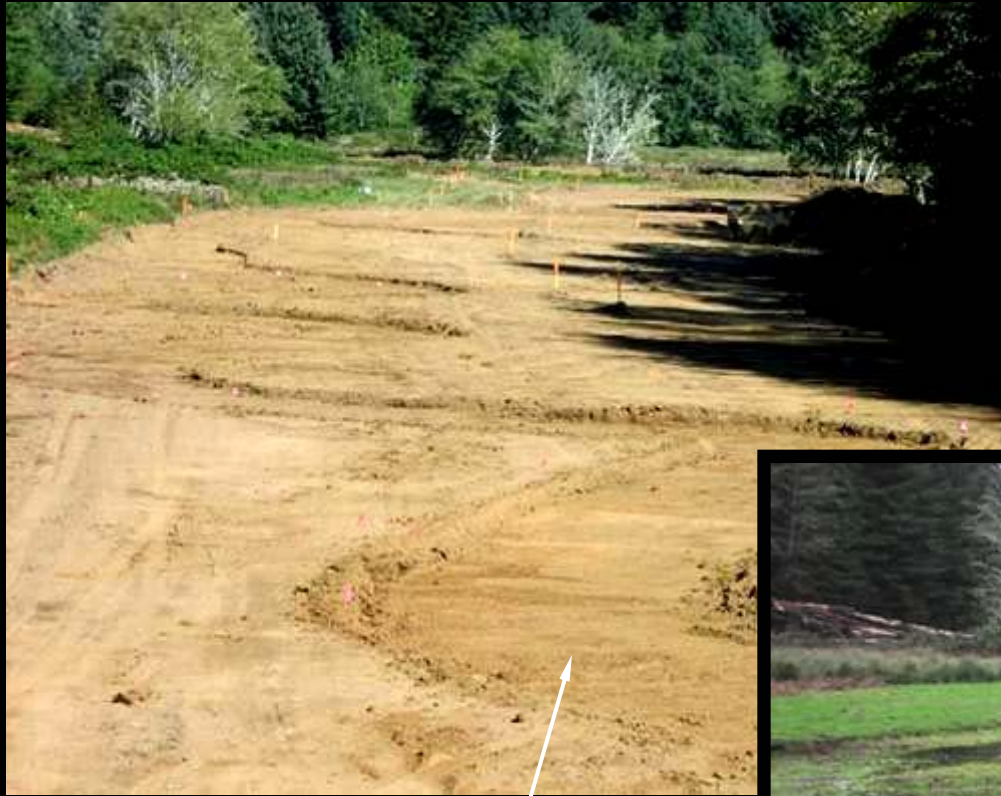
Low flow channel under construction

High flow channel under construction

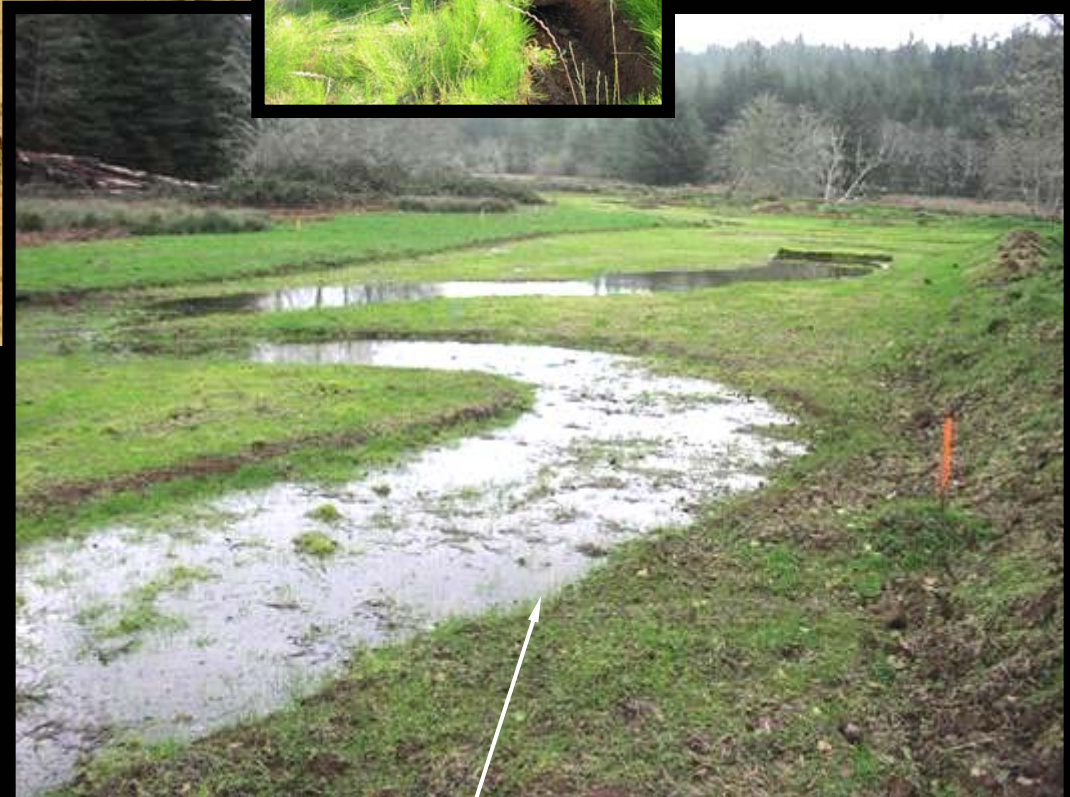
High flow channel "overwintering"

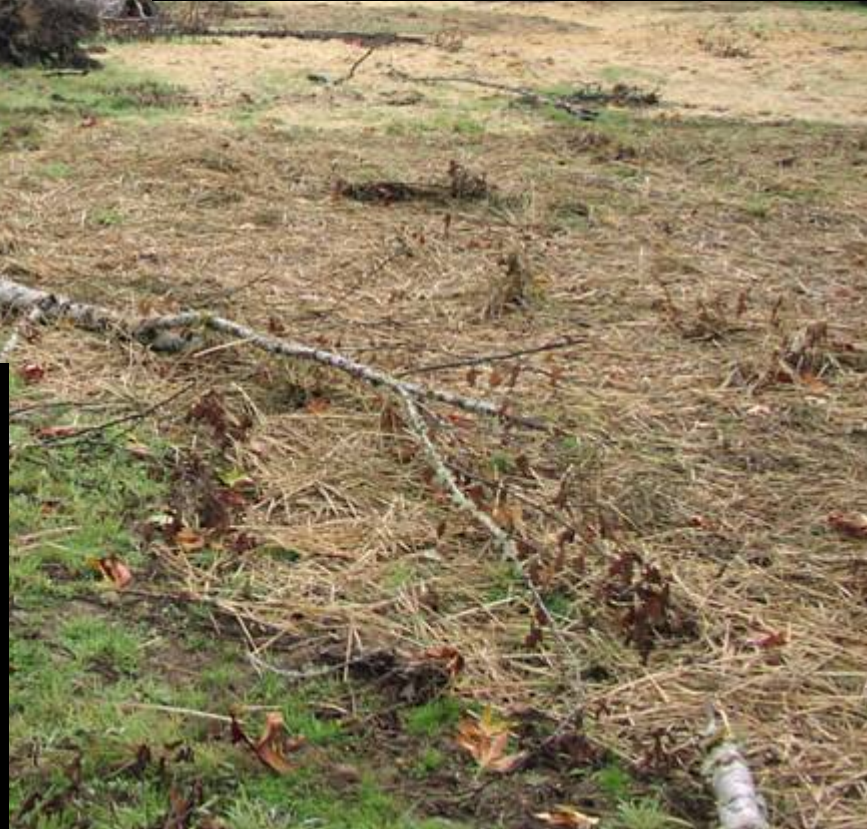
Slough Sedge (*Carex obnupta*) hay, baled at an adjacent site, used as mulch
