Salmon River Estuary  
Restoration Continues...

# Salmon River Estuary Continues...

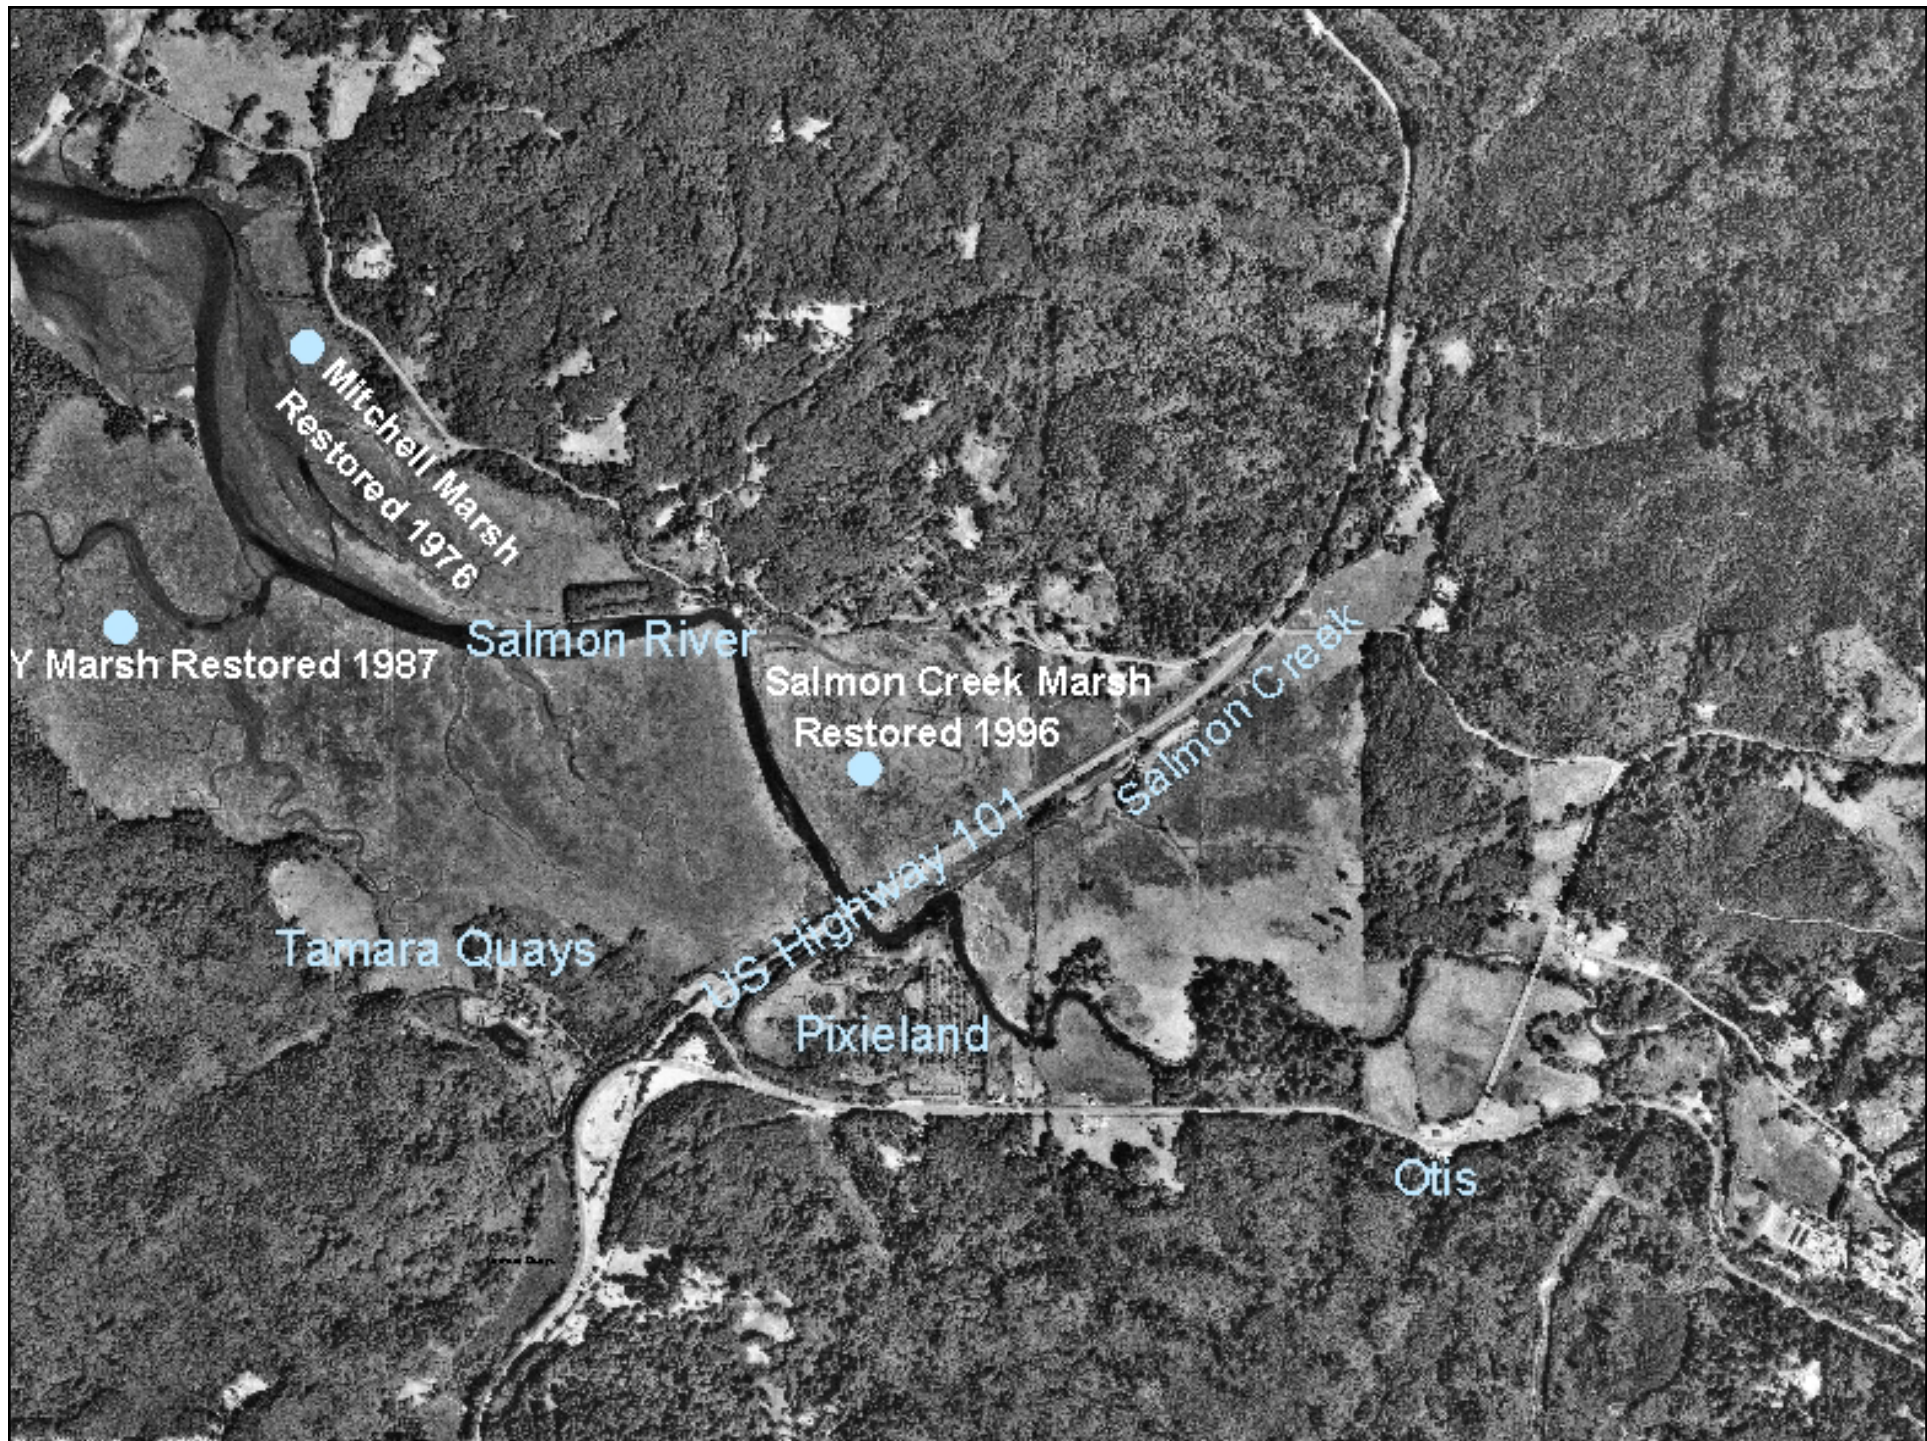
Mitchell Marsh  
Restored 1976

Y Marsh Restored 1987

Salmon Creek Marsh  
Restored 1996

- o Land Acquisition - Westwind
- o Forest Service Land Acquisitions
- o Mitchell Marsh 1976
- o Y Marsh 1987
- o Salmon Creek 1996
- o Gnos Dike 1996-to present
- o Tamara Quays 2003  
(final land acquisition)

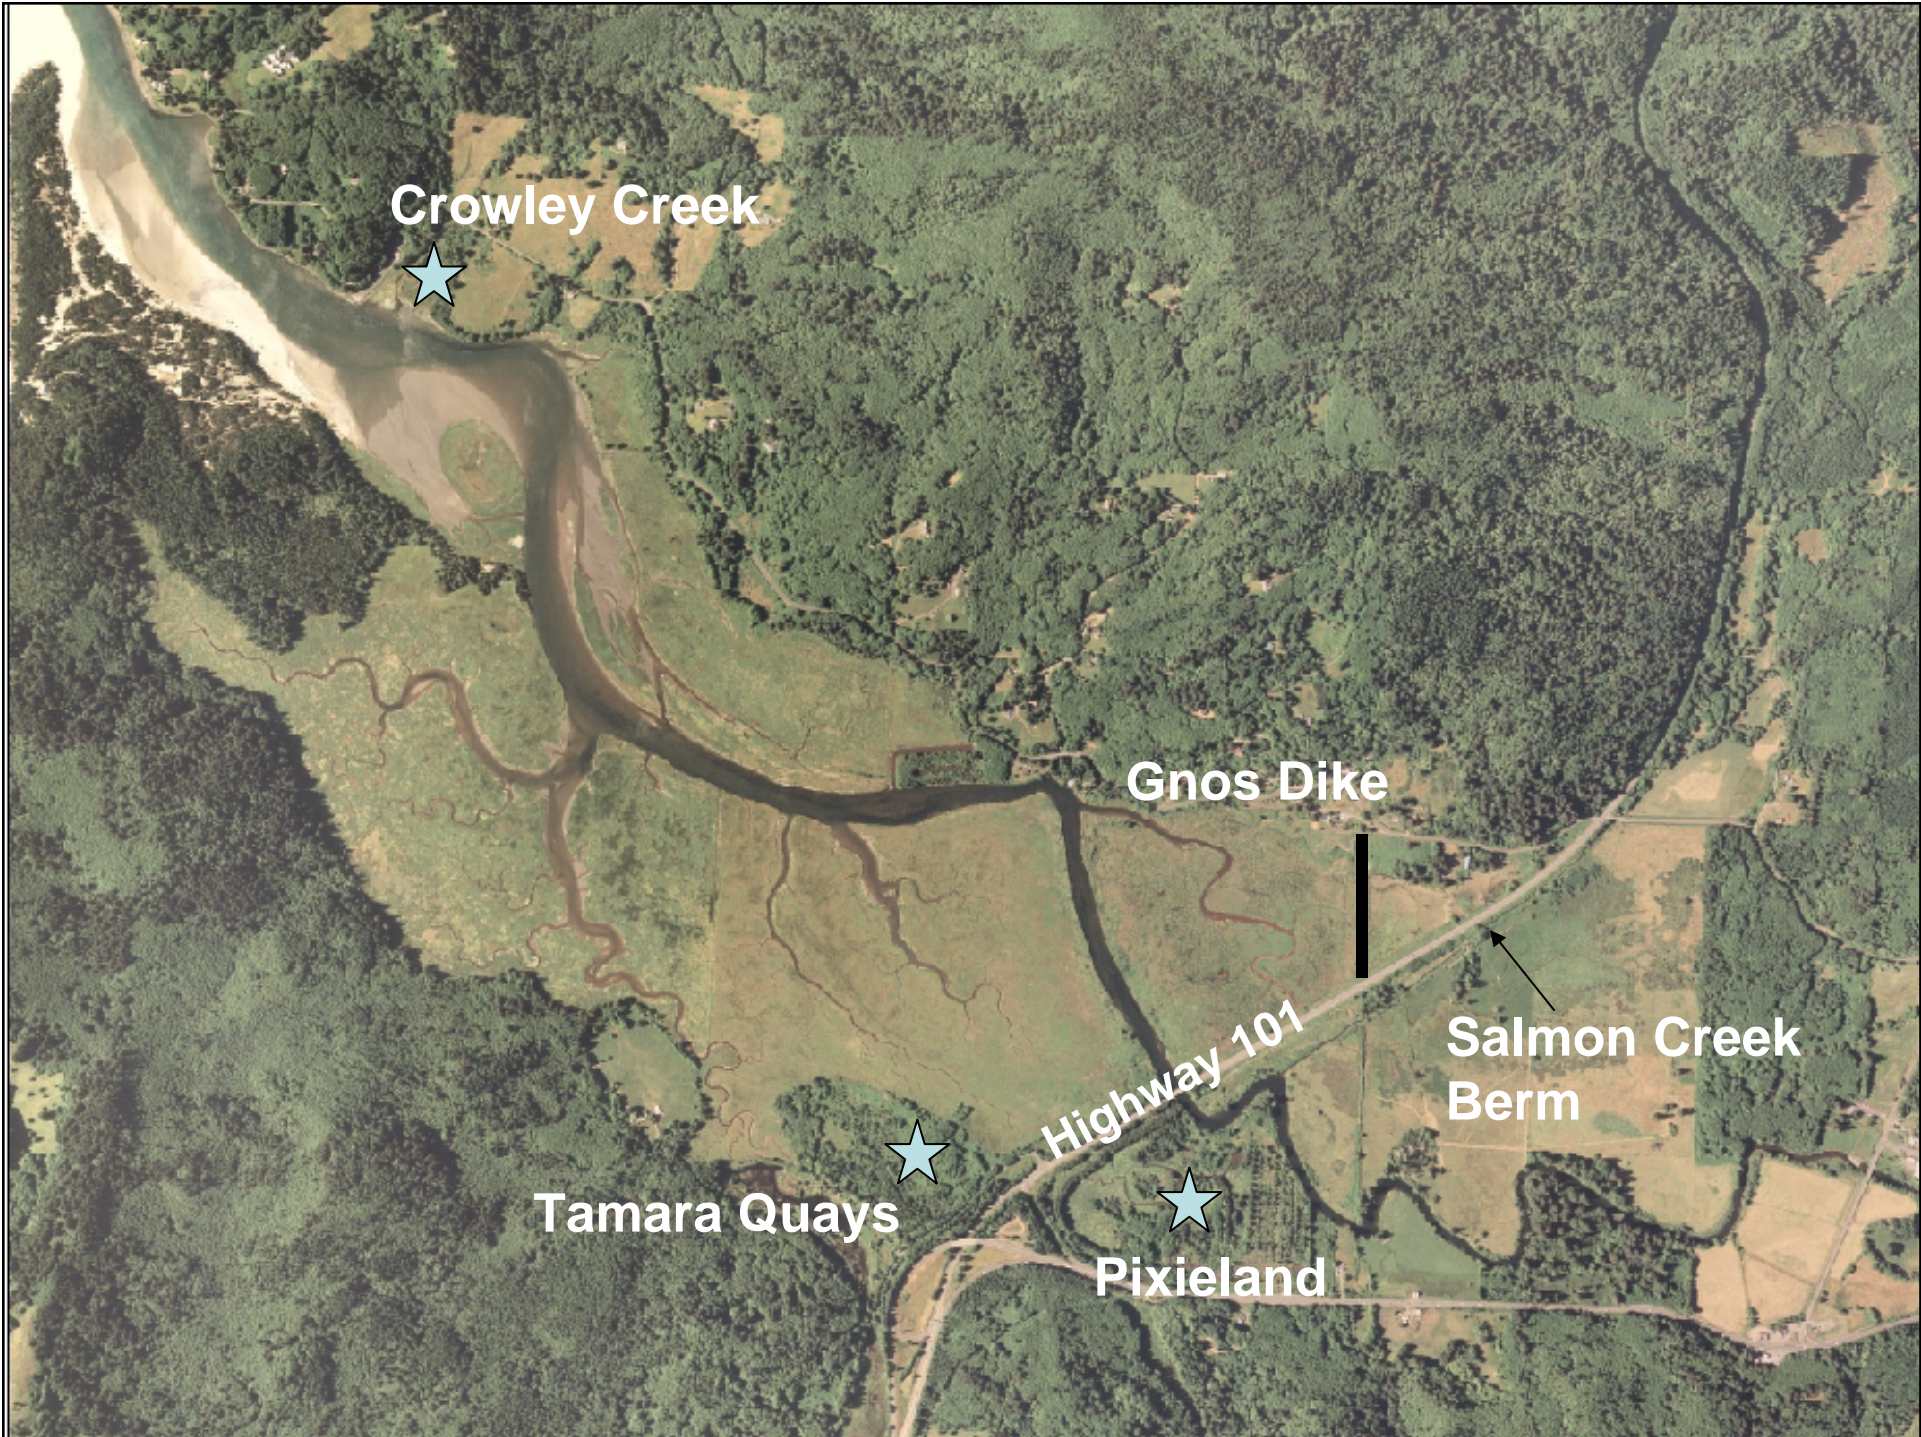
- o Gnos Dike
  - Repair dike (2008)
- o Crowley Creek
  - Remove dike across from Knight Park (2008)
- o Tamara Quays
  - Restore hydrology and native vegetation (2007 - 2008)
- o Pixieland
  - Asphalt and noxious weed removal, restore native vegetation (2007)
  - Restore hydrology and continue native vegetation restoration (2008)
- o Highway 101 – Salmon & Fraser Creeks
  - Restore stream and tidal flows

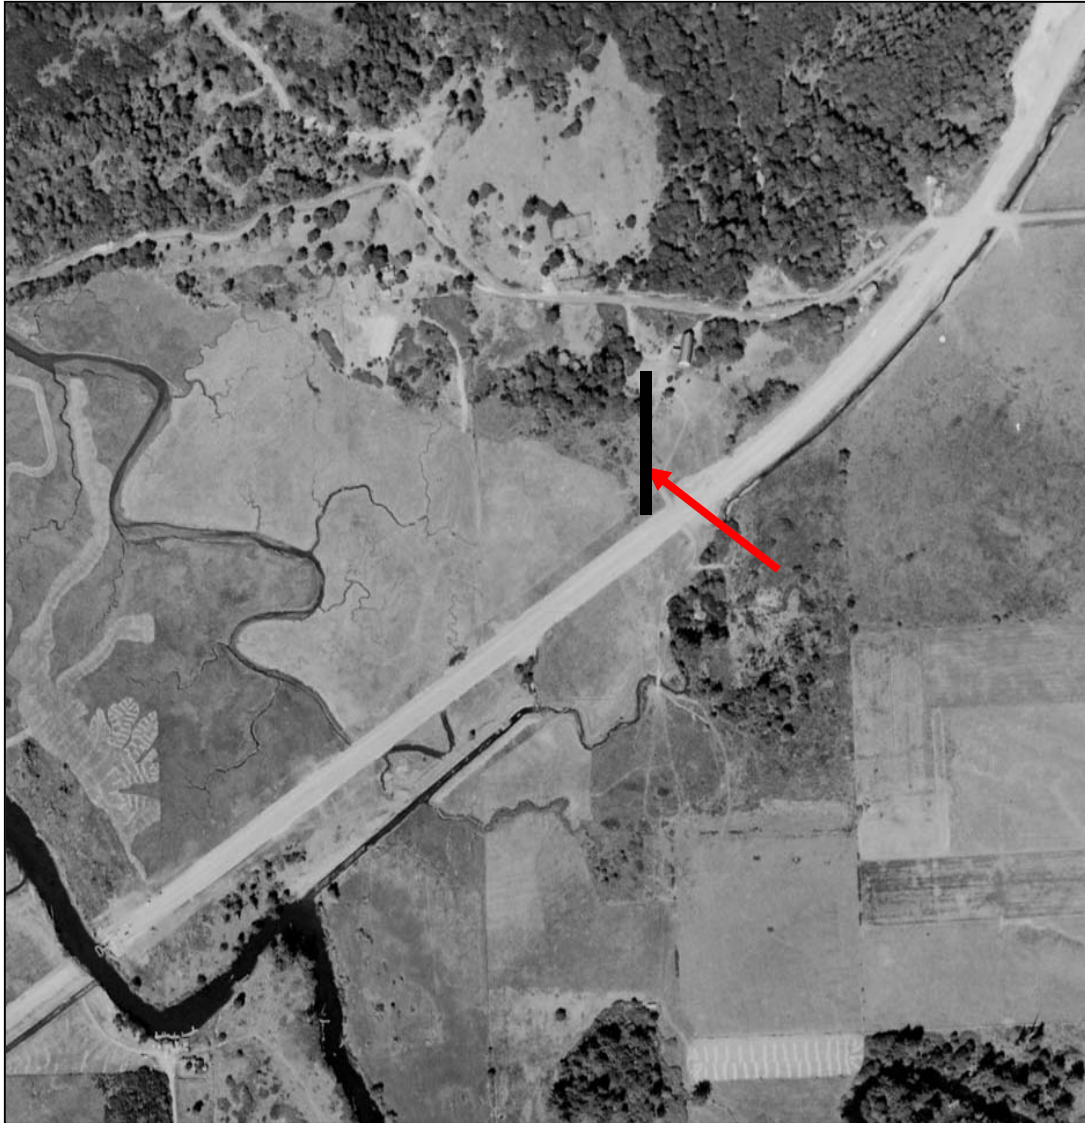
Failure to protect private land when the Salmon Creek tidegate was removed in 1996.

1961 photo shows condition of pasture land that was maintained throughout the area prior to saline introduction.

2-foot berm was built in 1996-Improper material was used.

Berm was initially not allowed to touch Hwy 101-Later corrected with coarse pit run rock in 45-foot swath.

3-4 attempts to correct situation, always without the proper funds, materials or support.

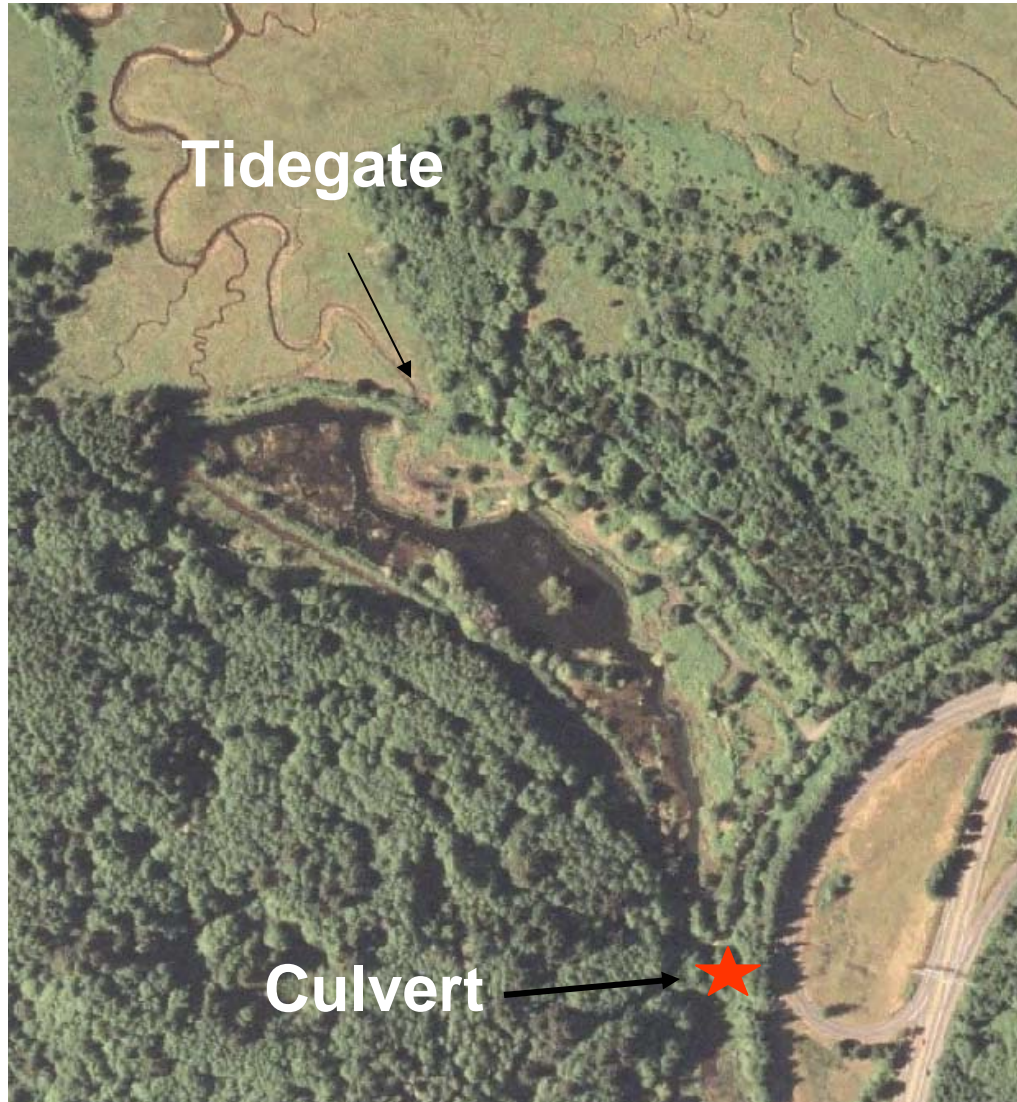
2005 photo-Tamara Quays, Kingfisher Lake and dikes

Remove dikes, tidegates, and Kingfisher Lake.

Restore Rowdy Creek channel complexity.

Fill ditches and replace culvert with fish-passage culvert.

Restore native vegetation.

Properly decommission septic system.

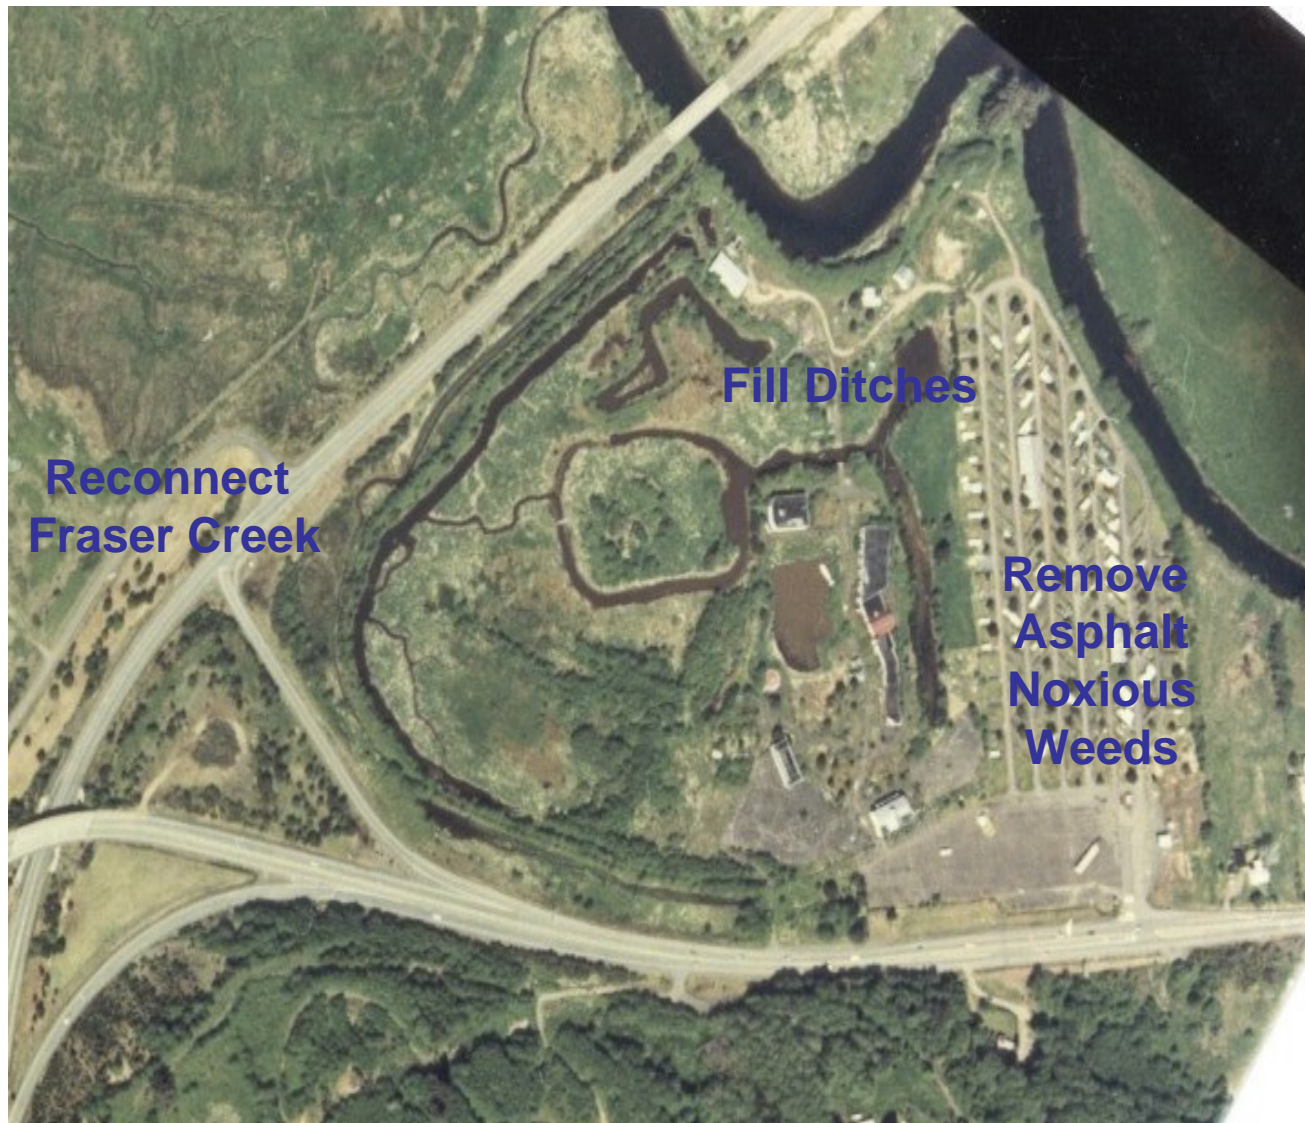
Remove dike, concrete and asphalt.

Fill ditches and pond.

Restore native vegetation.

Possible fishing access site.

Restore Fraser Creek.

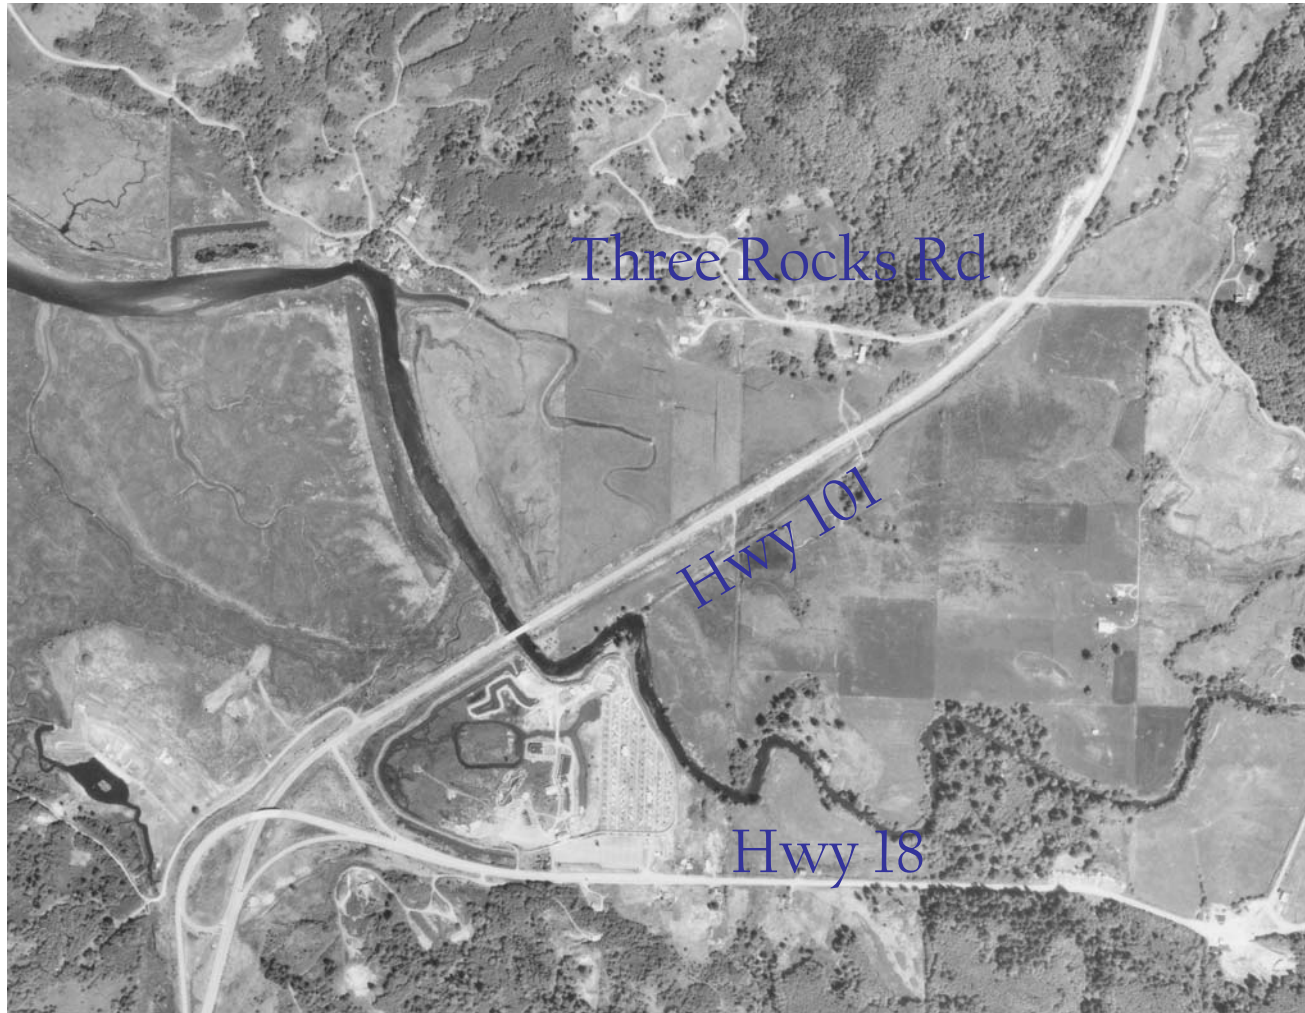
Hwy 101 is the last major dike through estuary.

Restore hydrologic connection between Salmon Creek and Fraser Creek.

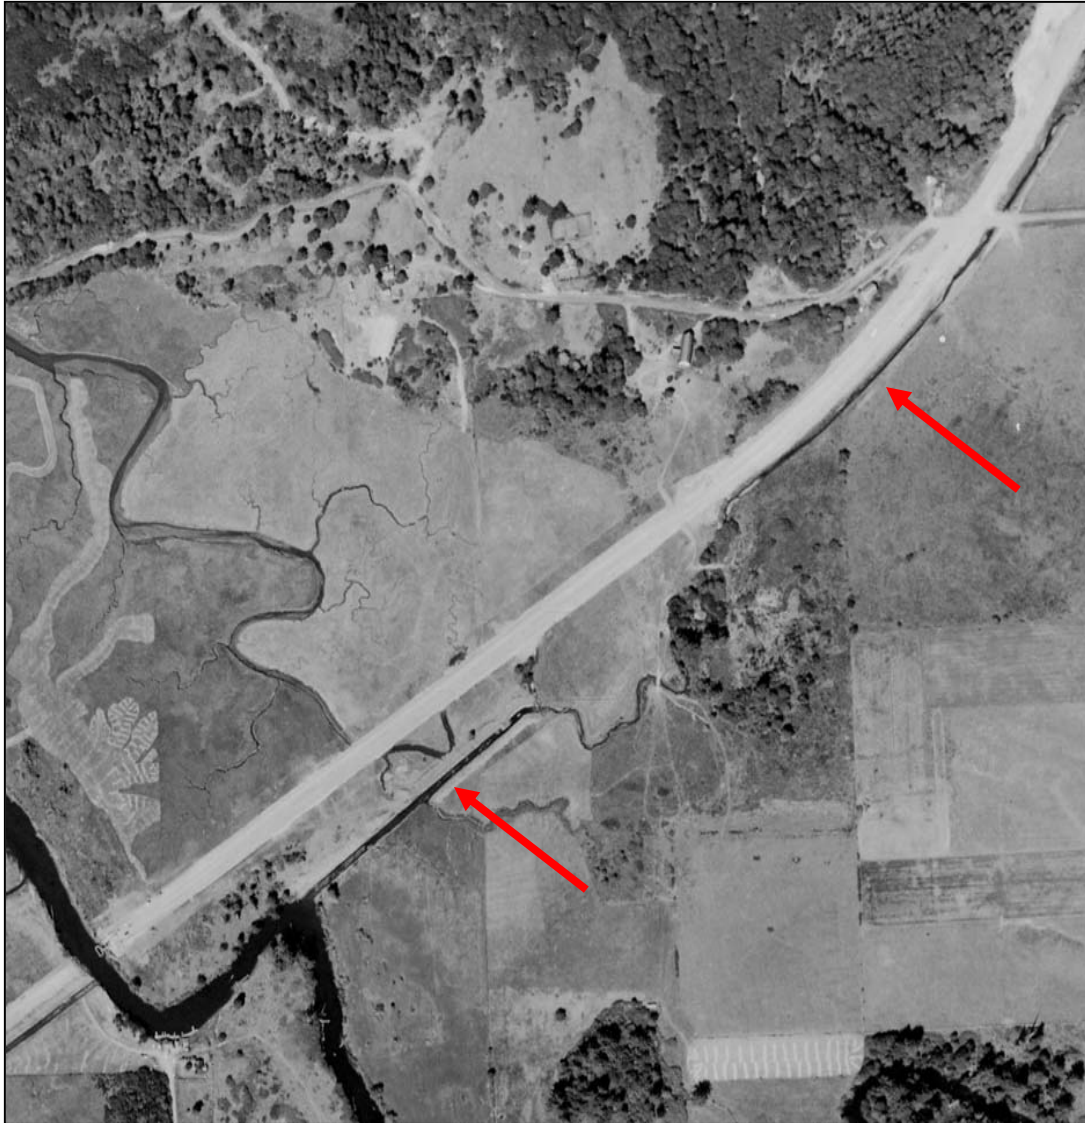
Trenching of Salmon Creek when Hwy 101 was built.

1961 photo shows Salmon Creek stream channel prior to Hwy 101.

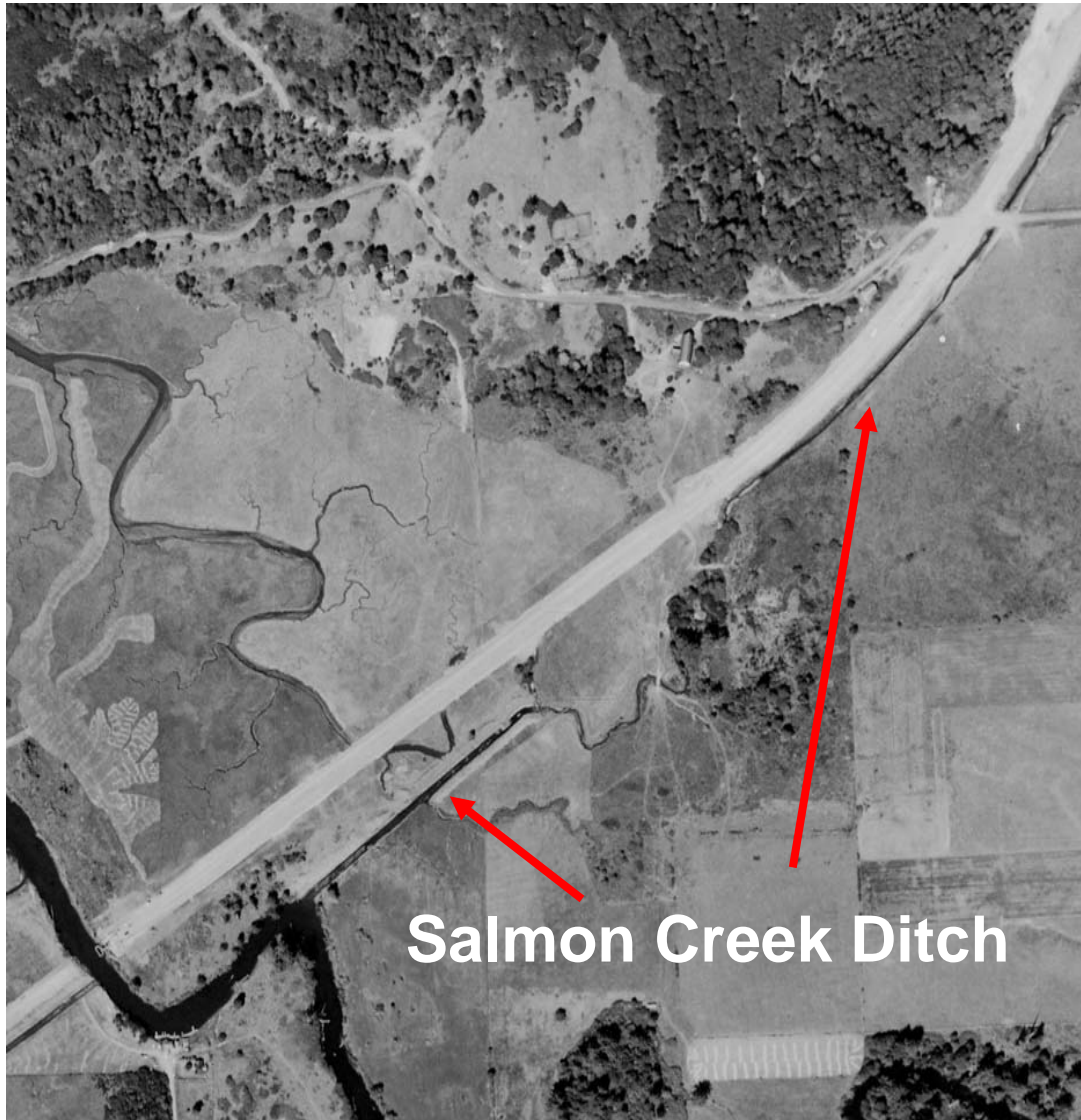
1961 photo

Salmon Creek Ditch

Short-term repair to prevent juvenile Coho fatalities in pastures.

Long-term goal to work with landowner on stream restoration.

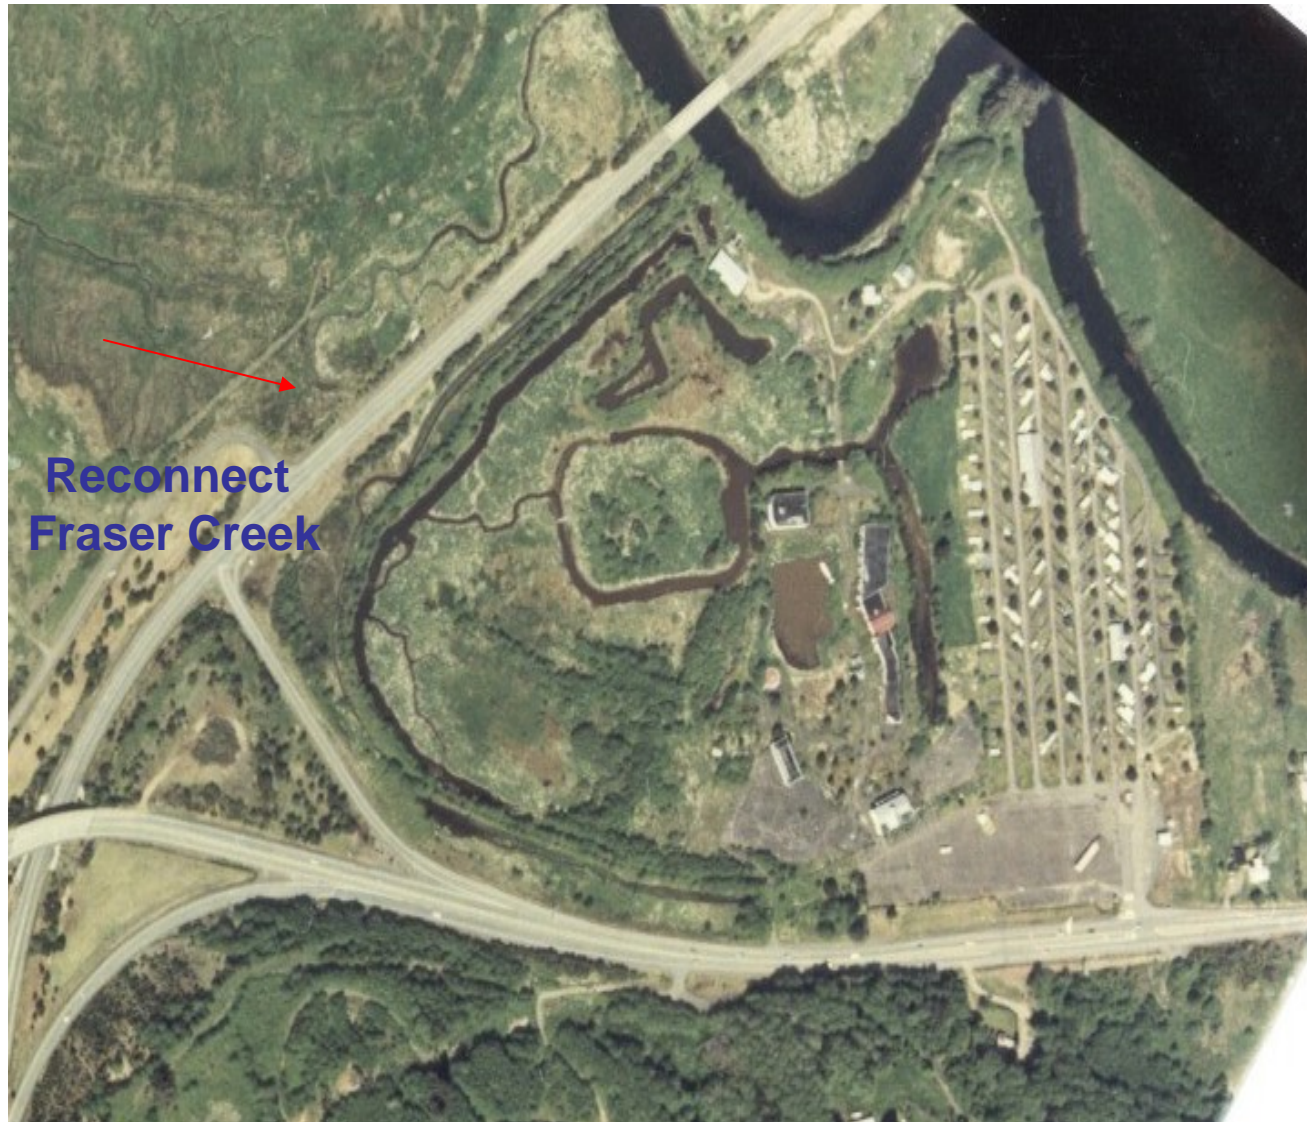
Reconnect  
Fraser Creek

Restore Fraser  
Creek channel  
and connection  
from Estuary to  
headwaters.
