**Public Health Service**  
**DEPARTMENT OF HEALTH & HUMAN SERVICES**  
**Centers for Disease Control and Prevention (CDC)**

**Subject:** **Environmental Health Assessment for Epi-Aid 2004-076: Outbreak of gastroenteritis with multiple etiologies among resort island visitors and residents—Ohio, 2004.**

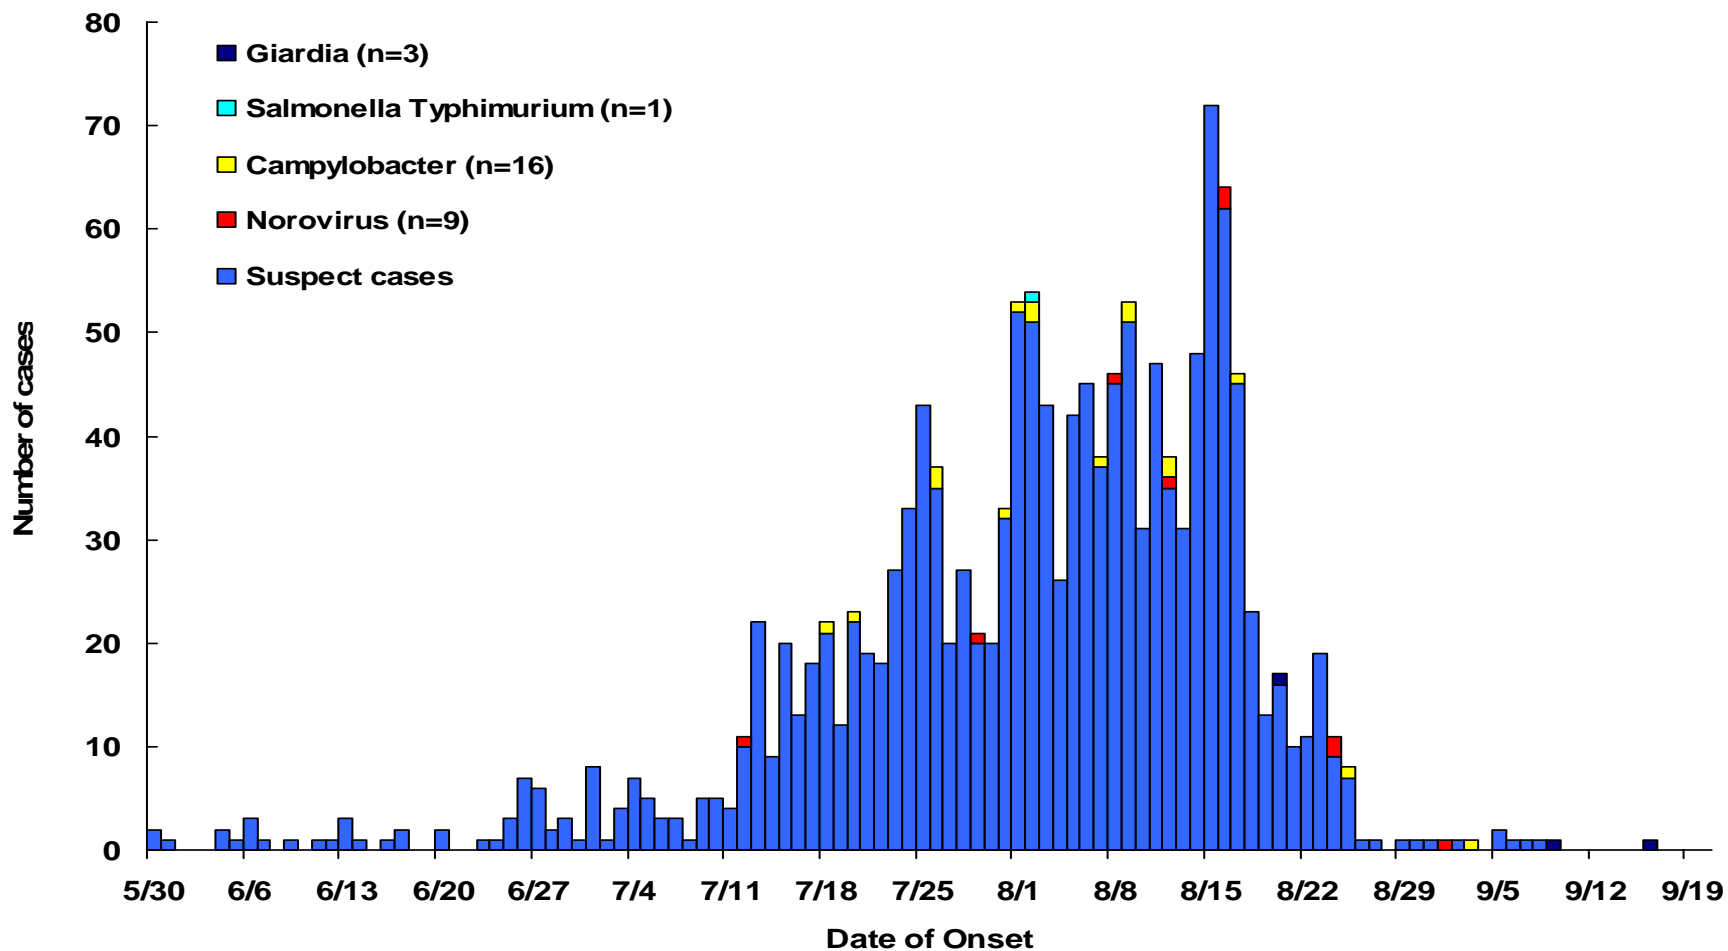
**ATTACHMENT 1. Cases of gastroenteritis by date of onset and etiology, South Bass Island, Ohio, May 30–September 12, 2004 (N = 1,450)**

residents of Lake Erie's South Bass Island (see Attachment 1). Pathogenic agents isolated from 19 stool samples submitted by ill persons included: *Campylobacter* (14); norovirus (3); *Salmonella* Group B (1); and *Giardia* (1). The fecal-oral route is the usual means of transmission for these enteric pathogens. Epidemiological evidence collected by the multiagency outbreak response team implicated drinking water consumed on South Bass Island as the vehicle of this outbreak. Before the NCEH team arrived, the local outbreak response team began to collect information on the various South Bass Island water sources and systems and sewage management practices and procedures.

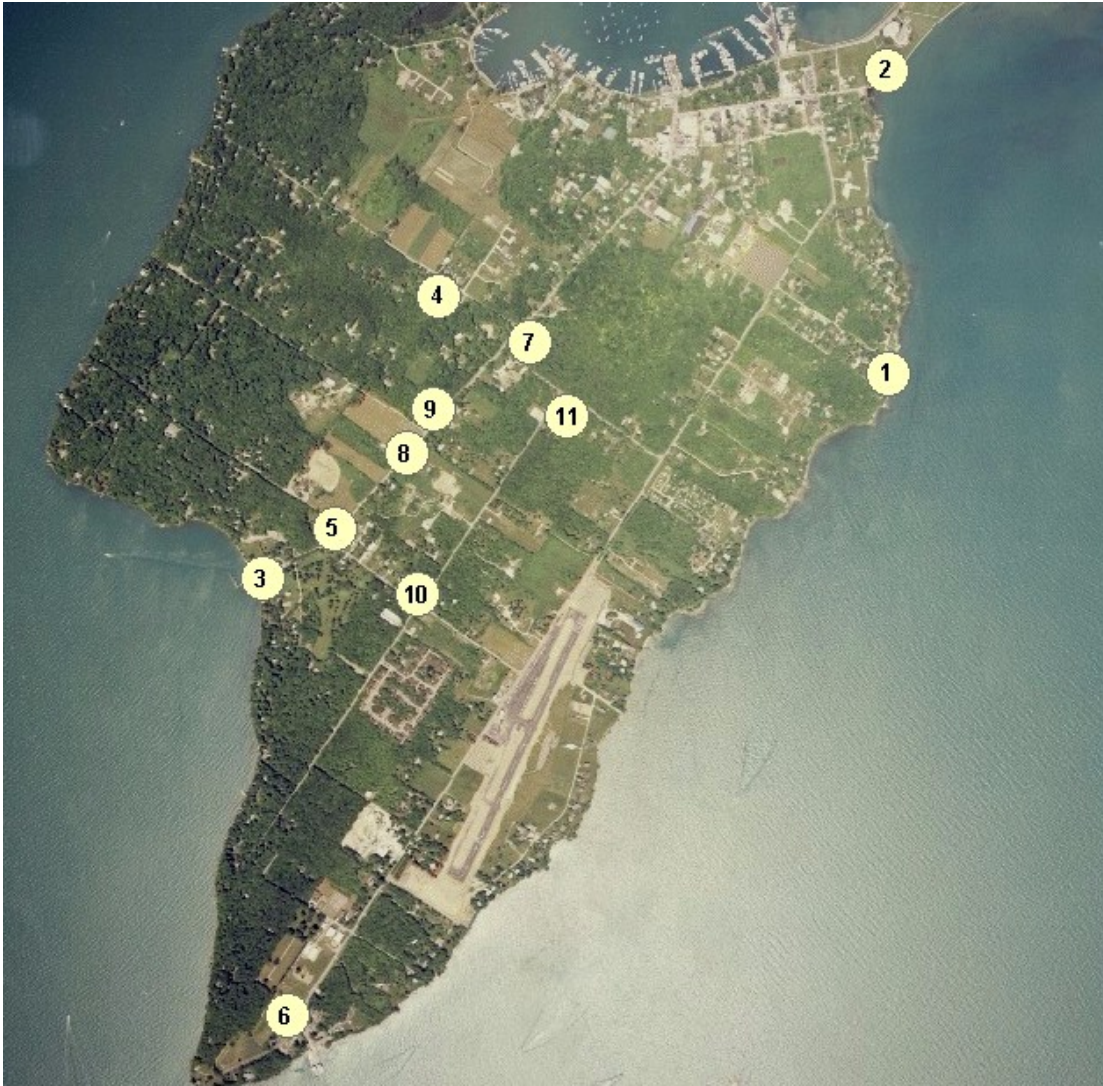
**ATTACHMENT 3.**

**Aerial photograph identifying 11 NCEH water sample collection locations, South Bass Island, Ohio, August 30–September 2, 2004.**

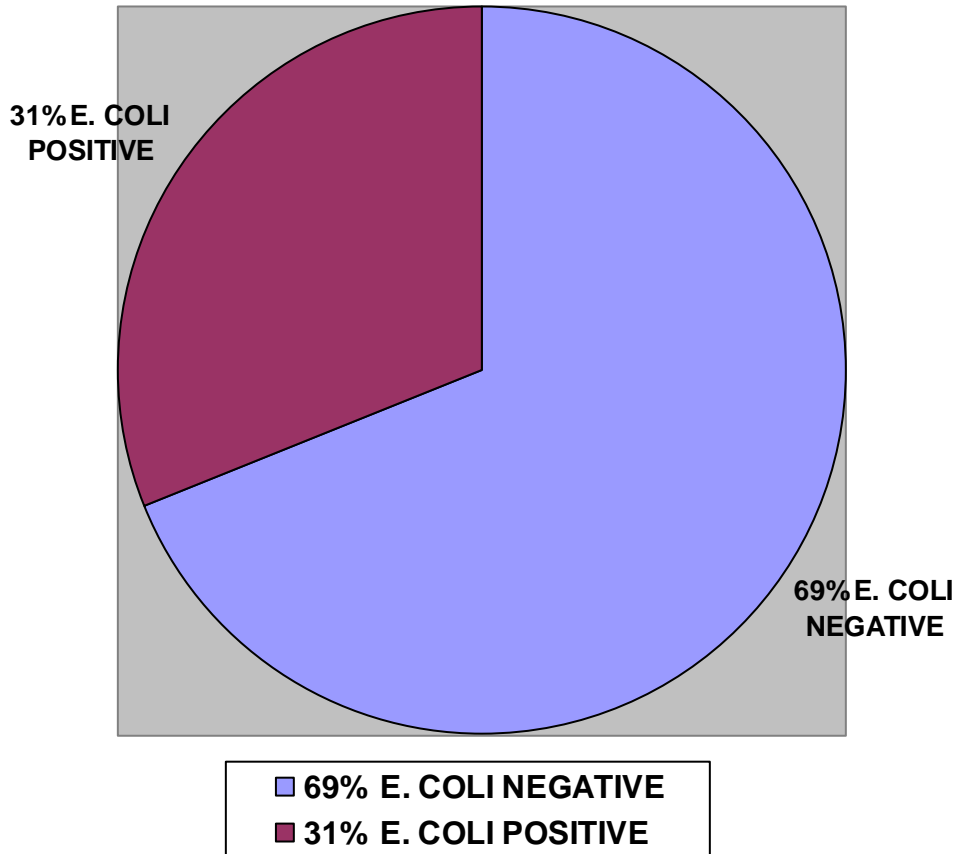
***E. coli* Analysis Results  
Groundwater Samples Collected on South Bass Island, Ohio  
September 2004**

**E. COLI POSITIVE RESULTS  
n = 77**

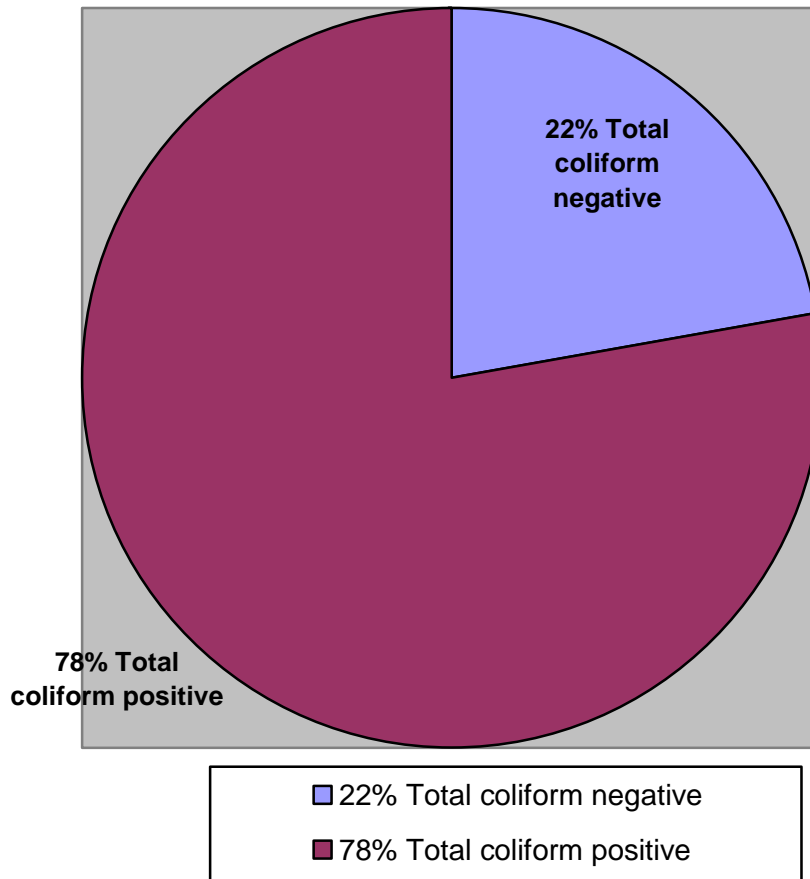
**Total Coliform Analysis Results  
Groundwater Samples Collected on South Bass Island, Ohio  
September 2004**

**TOTAL COLIFORM POSITIVE RESULTS**  
n = 77
