Maintenance Guides for the Treatment of Historic Properties

Petrified Forest National Park

Andrew Gorski and Michael Lovato

June 2005

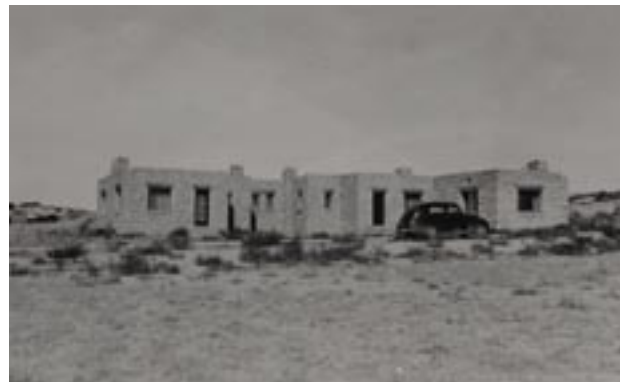
Rainbow Forest #52A-C viewed from the east. Note the texture of the rough faced stone used to construct walls and the smaller projections used to break up the building mass. *PEFO Photo Archive #15678*

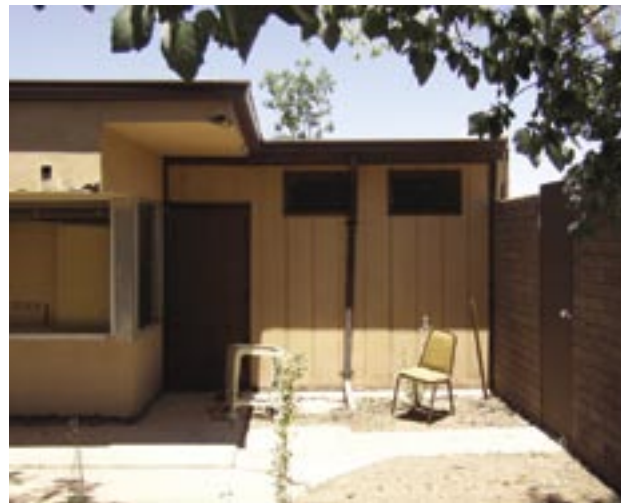
Painted Desert Residential Unit 208. At this scale, it is possible to see how materials come together, like the aluminum windows and roof overhang and the contrast between the smooth stucco walls and brown concrete blocks. *Photo by author*

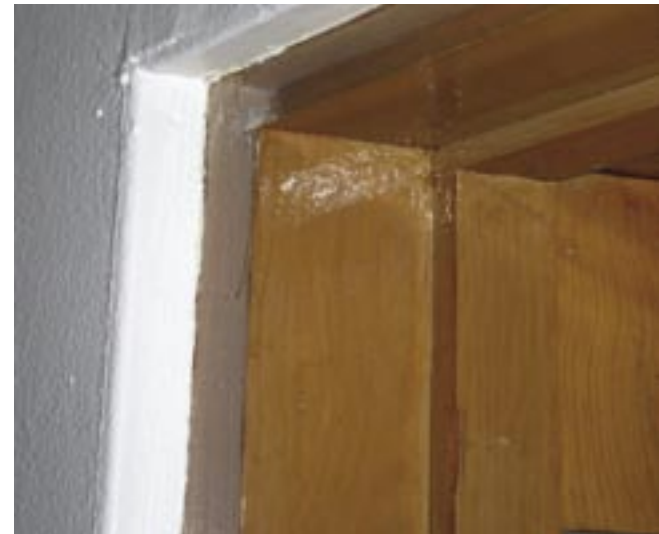
Painted Desert Community Complex detail at interior door jamb. This detail shows the how interior door jamb's are recessed from the drywall surface of interior walls. It also shows Neutra's attention to how a frame is constructed and how his use of materials created a very light and natural feeling on the interior. *Photo by author*

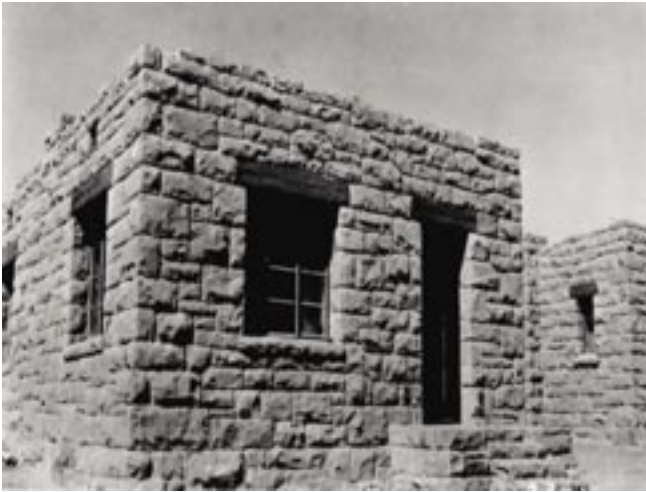
The regularly shaped sandstones and solid stone lintels were used to create a rustic design aesthetic throughout the Rainbow Forest Historic District. Windows were steel casements, recessed from the surface of the wall, creating deep shadow lines reminiscent of Puebloan structures. *PEFO Photo Archive #15750*

Rustic Design and Construction includes the use of native sandstone, dressed to a roughly rectangular shape, and placed randomly in box like structures showing influences of Ancestral Puebloan structures found throughout the region. Stone lintels were used in the earliest buildings to span openings, while later construction includes poured-in-place concrete lintels.

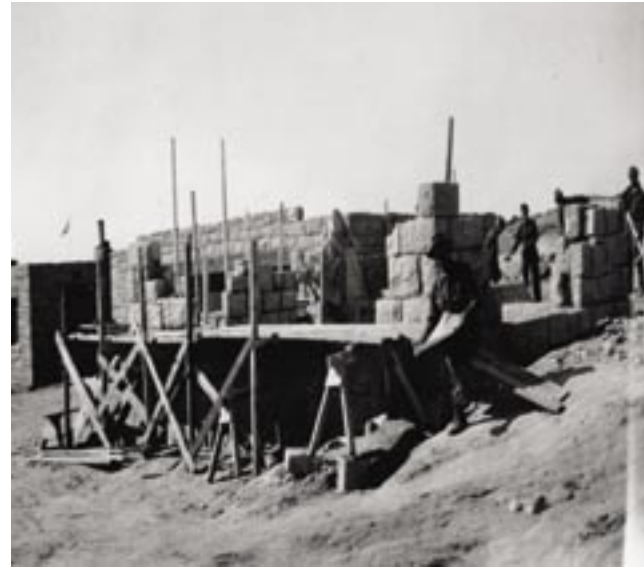
Construction photo of Rainbow Forest buildings showing sandstone masonry construction. *PEFO Photo Archive #15867*

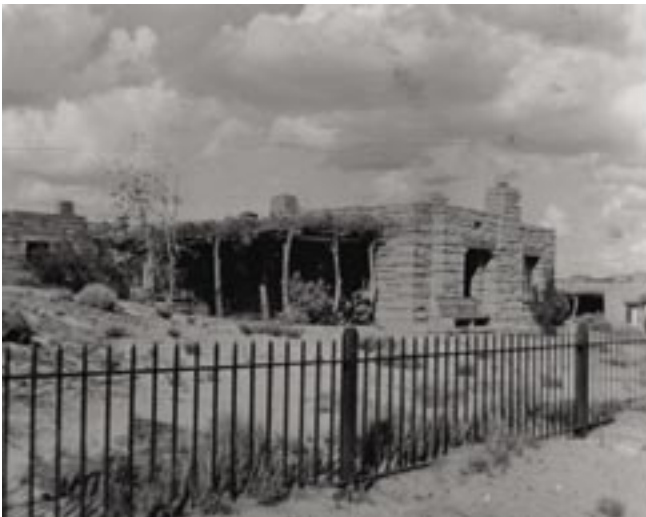
Small-scale landscape elements, such as the historic wrought iron fencing shown above, helps separate the public from the private areas while maintaining the visual connection through the landscape. *PEFO Photo Archive #15693*

Small scale features, including wrought-iron fencing and sandstone curbing carry the rustic design aesthetic to landscape elements and help to integrate the buildings into the landscape.

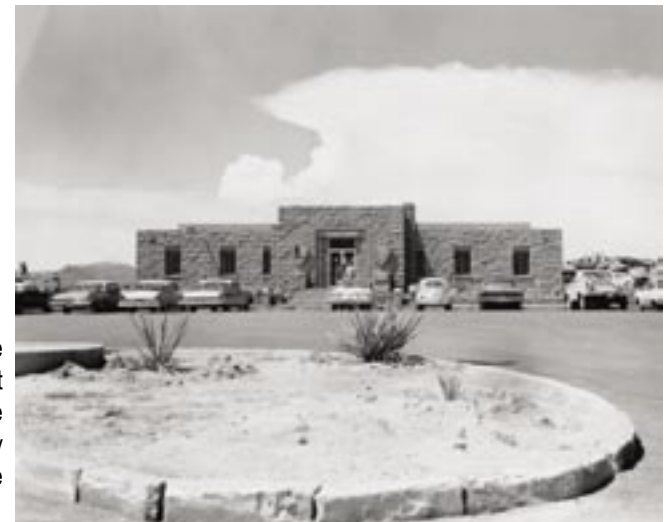
This photo from 1963 shows the small scale features, like sandstone curbing and how it harmonizes with the prominent RF Museum. The almost total absence of vegetation, especially at the entrance to the RF museum, should be noted. *PEFO Photo Archive #15728*

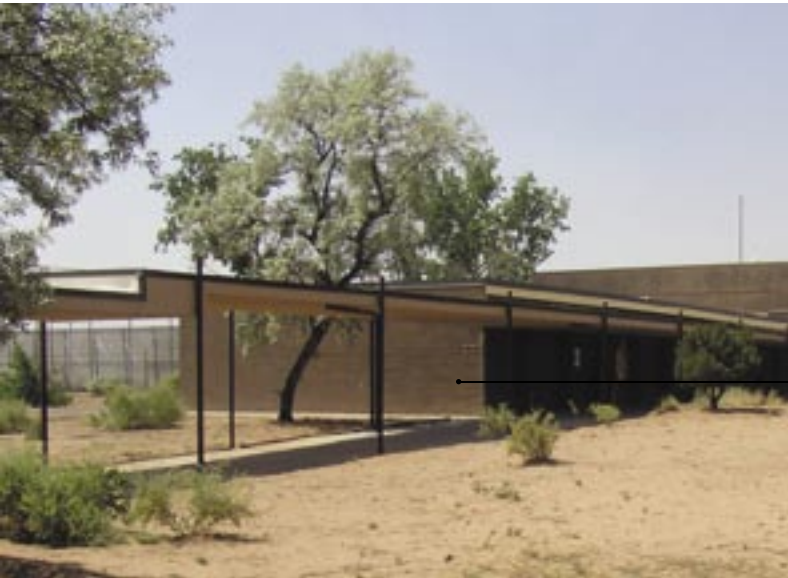
Covered Walkway and School Building looking south-east 2004 Photo by author

③ Covered walkways provide a shaded transition between visitor areas and more private residential areas

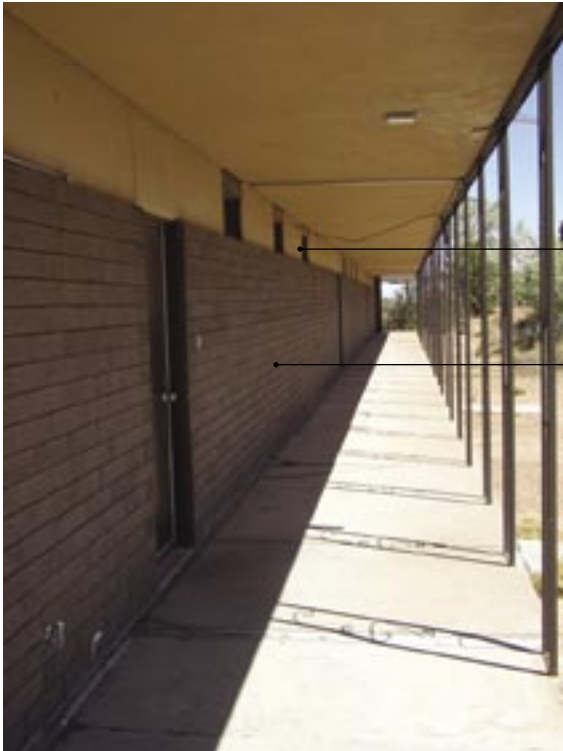
Residences Block A south facade 2004 *Photo by author*

⑩ These structural steel “spider legs” were once a major architectural feature

⑩ Plaster is used to accentuate the horizontal facade

⑨ This brown, pumice aggregate, 8” x 4” x 16” concrete masonry unit is the basic building block for the entire PDCCHD

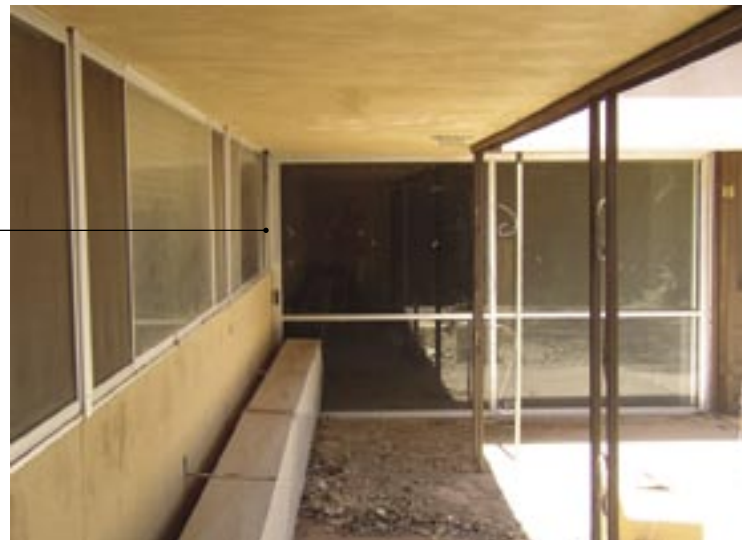
Residence 208 sliding wall 2004 *Photo by author*

⑨ The sliding glass wall that still remains in residence PD 208 is one of the best examples of how new building technologies were used to help blur the barrier between “inside and outside”

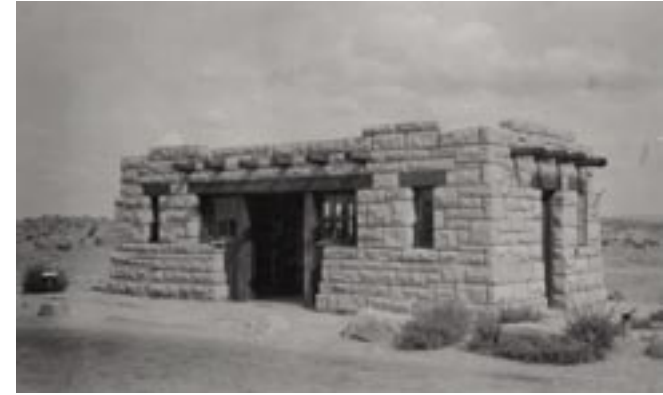
The Puerco checking station (now used as a comfort station) had a glazed central area which allowed views through to the landscape beyond. *PEFO Photo Archive*

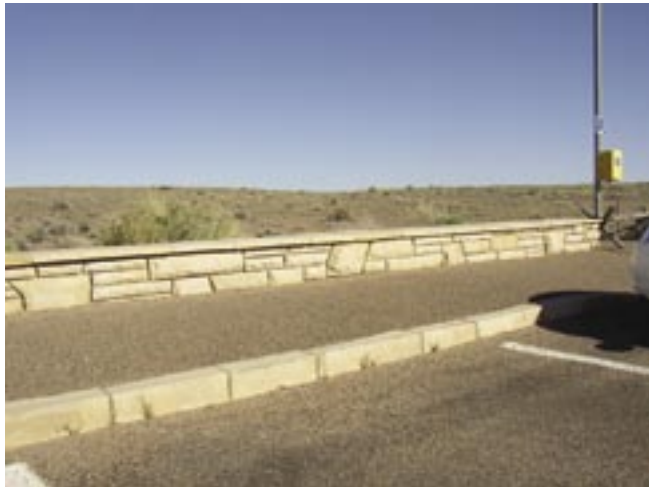
Stonework was used for the curbs and landscape walls at early park landscape features, such as the area around Puerco Pueblo, shown above. *Photo by author*

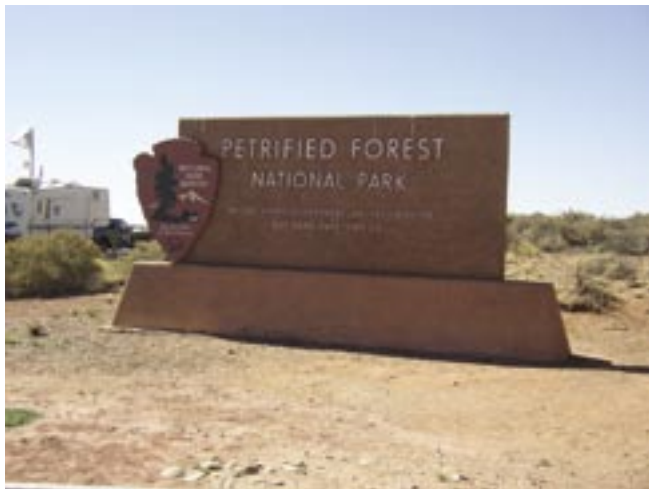
Exposed aggregate concrete and poured in place concrete were used during the construction of landscape features built in conjunction with the development of the Painted Desert Community Complex. Pictured above is the entrance sign located at the north end of the park. *Photo by author*

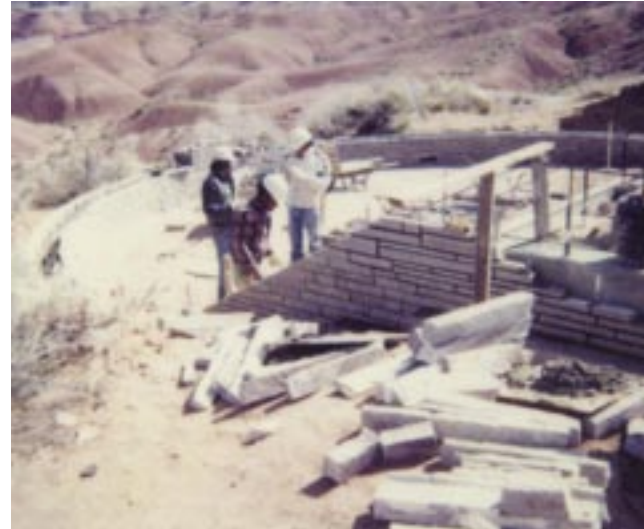
This construction photo from Tiponi Point shows stone being used as a veneer over a concrete wall. This construction system is still widely used throughout the park and is appropriate for new construction. *PEFO Photo Archive*

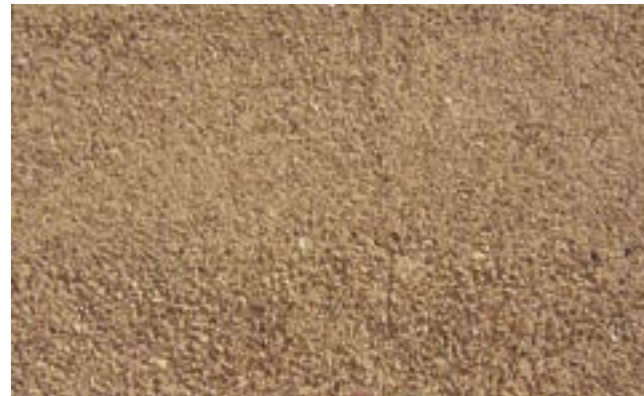
The color and texture of materials used in landscape elements is an important characteristic and should be considered when introducing new materials. The earthy clay hue and coarse pebble finish of the entry sign at the north end of park results in a unique design element that should be maintained. *Photo by Author*

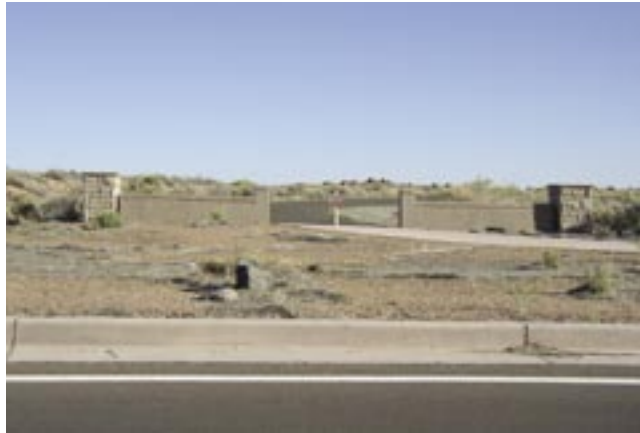
The entrance to the Long Logs trail head reveals the challenge of modifying existing landscape elements. The addition of unadorned concrete walls contrasts sharply with the older stone piers that remain from the entrance to a vehicular road since abandoned. While the use of concrete in this situation is not an unworkable solution, it does illustrate the need for more careful consideration of its visual qualities and how they react with more rustic materials. *Photo by author*

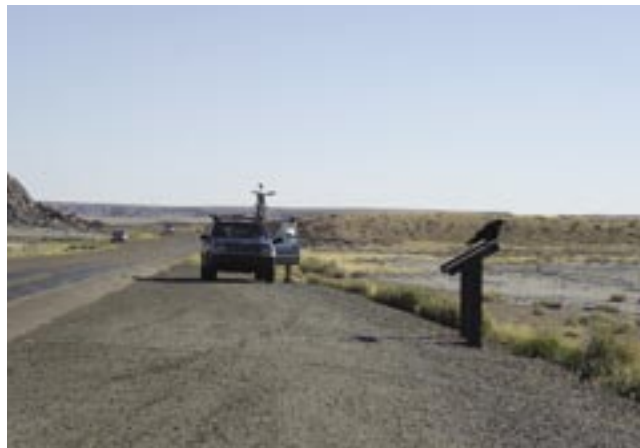
Underdeveloped pullouts, such as this one located adjacent to The Tepees will require a careful design solution that responds to other features along the road. *Photo by author*

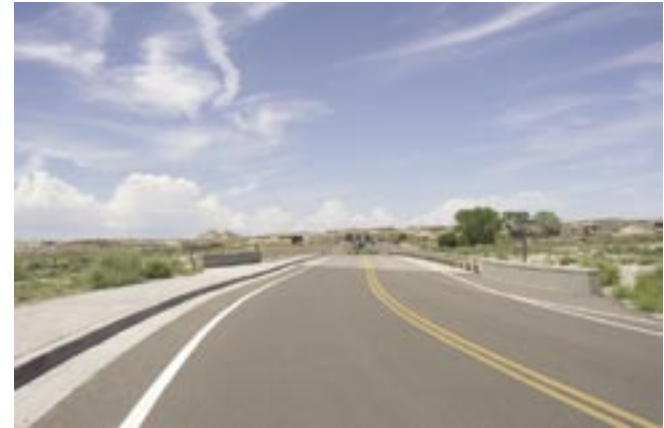
Landscape features built in recent years often overwhelm the natural landscape and lack the natural aesthetic of earlier features. In responding to current transportation regulations that require wider lanes, the Jim Camp Wash Bridge completed in 2002, became a more significant element in the landscape. Also, of note, is the use of monolithic concrete walls that lack the texture and color of earlier features found in the adjacent Rainbow Forest Historic District. *Photo by author*

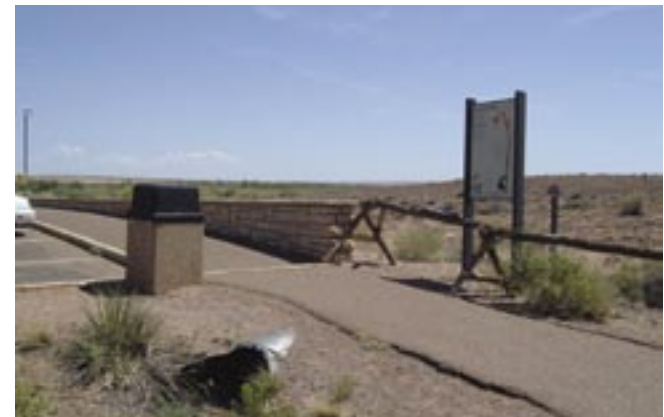
Rio Puerco Parking Area, 2004. This photo shows the wide variety of materials and objects found at many viewpoints. A more integrated design could vastly improve the visual qualities of these areas in the park. *Photo by author*

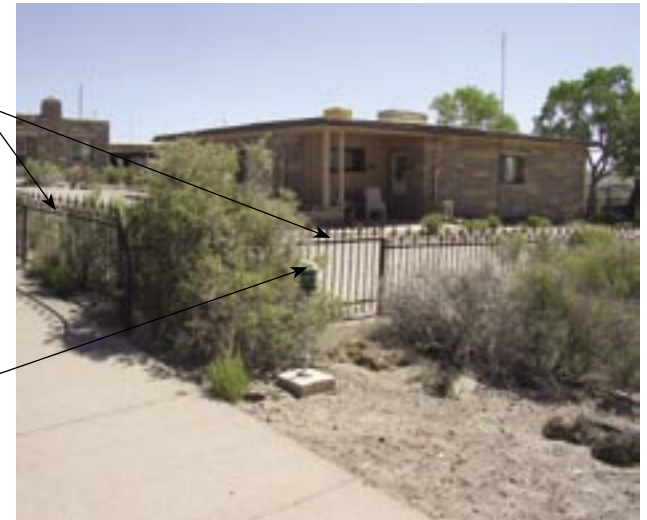
Non-historic cemetery fencing and obtrusive lighting should be removed. Photo by author

① Remove non-historic cemetery fencing

② Remove obtrusive site lighting

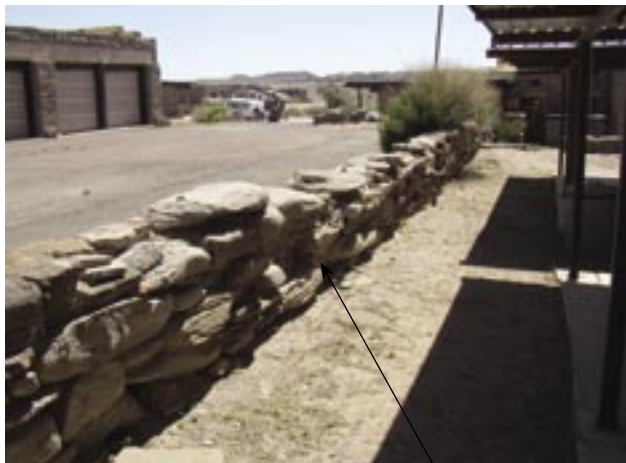
Repair or rebuild historic site walls
Photo by author

Many of the walls, especially along the residential plaza are damaged and need to be restored.

③ Repair rubble stone walls near existing picnic area

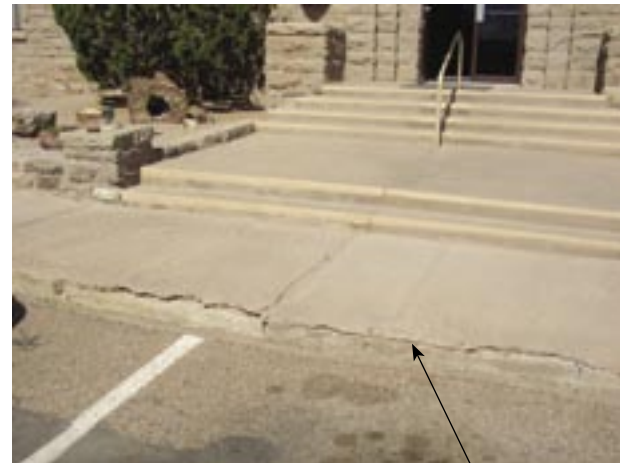
Repair concrete walks and sandstone curbs
Photo by author

③ Repair Damaged Curbs and Walks. Historic curbing should be maintained and new concrete walks shall align with the top of curb.

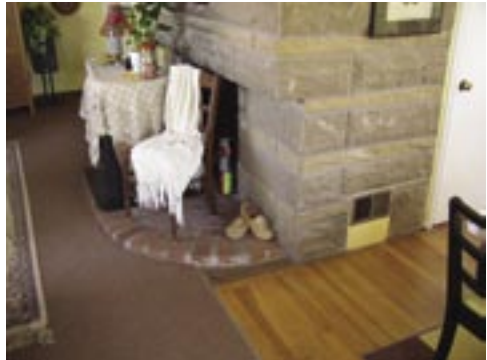
Employee Residence #50 has many of its original historic furnishings intact, including wood flooring and an unpainted sandstone masonry fireplace. The brick hearth and carpet have been added.
Photo by author.

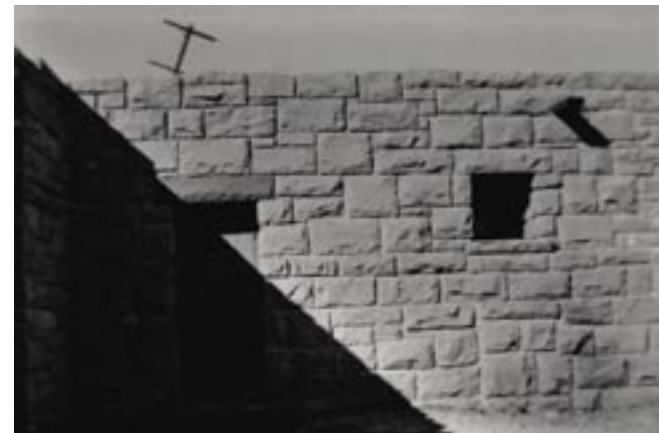
Deep recesses and strong shadow lines are important design features at Rainbow Forest. PEFO Photo Archive #15697

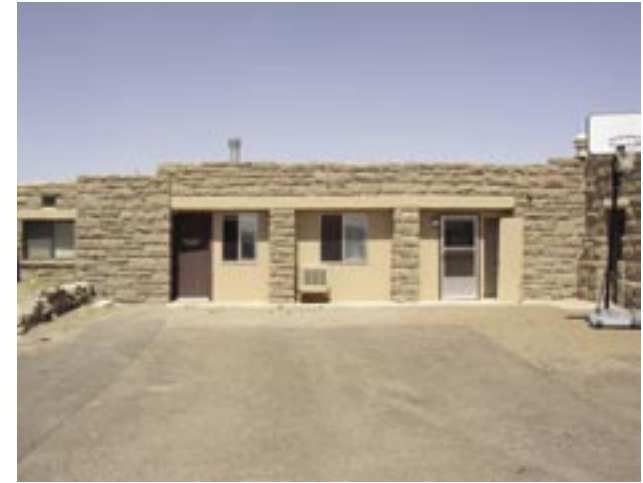
East Elevation of Rainbow Forest Seasonal Employee Residence #51B taken in July, 2004. Note the irregular arrangement of windows and doors that distract from the simplicity of the three original bays. Photo by author

and access into the seasonal residence. While the garage doors at Unit #51-E maintain the solid / void relationship at the exterior of the building, they could also be replaced with units that are more historic in character.

Non-historic windows should be replaced with more authentic looking double glazed casement units. A number of the original steel windows still exist at buildings #51-C, #51-D and #51-E and maintenance should be performed on these windows to keep them in good condition.

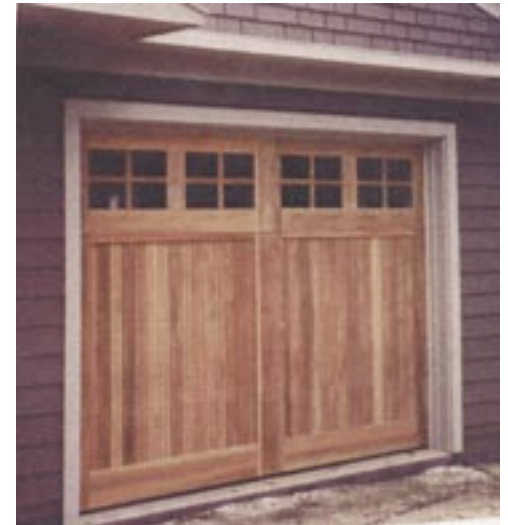
These doors with their western red cedar exterior would be a good choice for infill at RF #51-E.
Source: Red Lake Custom Doors

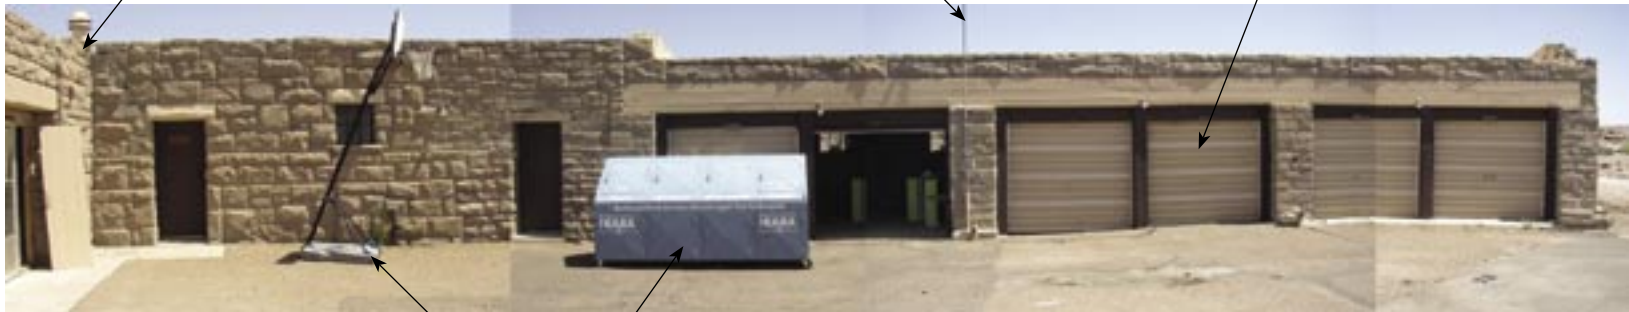
Existing South Elevation

④ Repair masonry at separation in parapet.

③ Remove conduit and communications devices.

① Provide more historic looking garage doors.

⑤ Remove Items From Around Buildings.

Separation of the masonry between buildings is a concern and a consistent treatment should be developed to protect these separations from moisture.

Exterior pole lighting should be removed from Unit #51-E. Any extraneous conduit, communications equipment or surface wiring should also be removed.

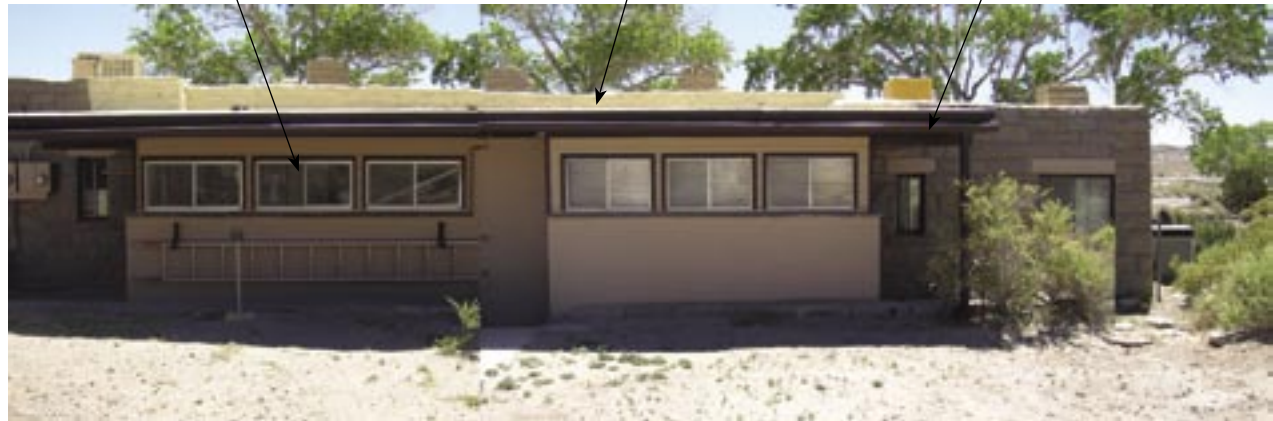
Partial Existing West Elevation

Remove foam roofing from masonry parapets

Roof overhangs are inappropriate at Rainbow Forest

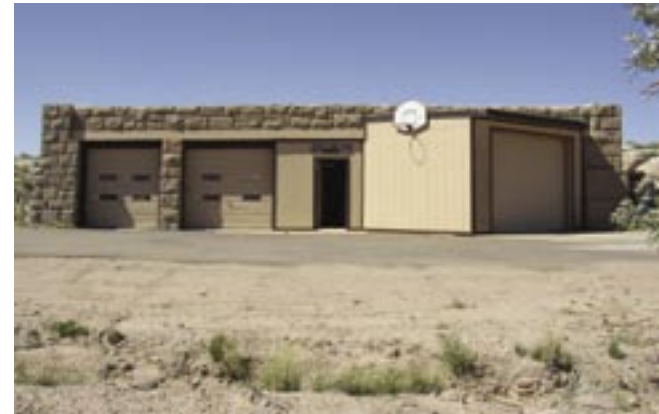
Rainbow Forest Warehouse and Shop with V-Shaped addition, 2004. *Photo by author*

Building #100 has suffered structural damage as a result of the major changes undertaken by the v-shaped addition in 1992. In particular, a large crack has developed in the southeast corner of the parapet, possibly from the removal and replacement of masonry piers with steel columns. Stabilizing and repairing damage to the masonry should be completed in conjunction with removing the v-shaped addition and restoring the south elevation.

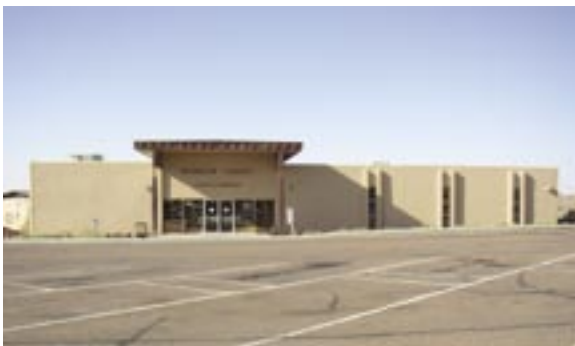
South elevation of Rainbow Forest Lodge, 2004
Photo by author

In the 1960s, attention began shifting away from the Rainbow Forest District with the opening of the Painted Desert Community Complex. At the same time, with visitation increasing, the park could support major visitor services at both ends of the park. The transformation of Rainbow Forest Lodge from an outpost to a significant visitor amenity was completed in 1963 with a large addition and redesign of the building's exterior. The addition was constructed primarily of concrete block and stucco with large laminated wood beams being used to support the raised entry canopy. Clerestory windows, facing south, brought natural light into the gift shop. The large addition added to the west featured an expanded kitchen and lunchroom. Since 1963, there have been a few minor changes to the building: Interior spaces have been reoriented to address visitation needs and the clerestory windows are no longer visible. A drop ceiling has been installed throughout most of the interior public spaces.

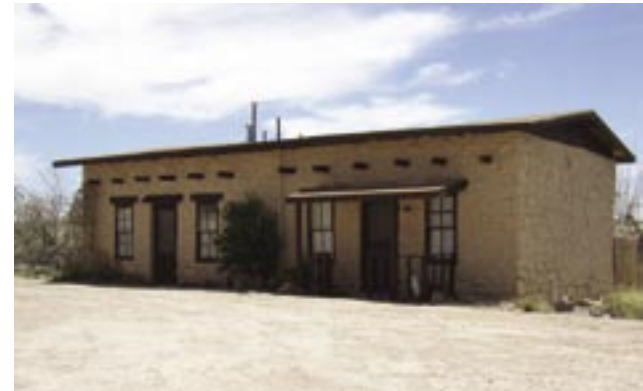
Rainbow Forest Cabins, 2004. *Photo by author*

Rainbow Forest Cabins is a small, one story stone structure dating to 1930. It is sited to the southeast of the Rainbow Forest Lodge. Photos dating from the 1940s show the building with a flat roof. The flat roof has been covered over with a gable roof and a small wood porch has been attached to the entry elevation. The interior originally consisted of two small studio apartments with kitchenettes, however it was remodeled into one apartment in the 1990's. The recommended management treatment is preservation / adaptive use. The building is considered contributing to the Rainbow Forest Historic District.

The gable roof should be removed to restore the historic character of the building.

The small entry porch should be removed to restore the west facade to its original appearance.

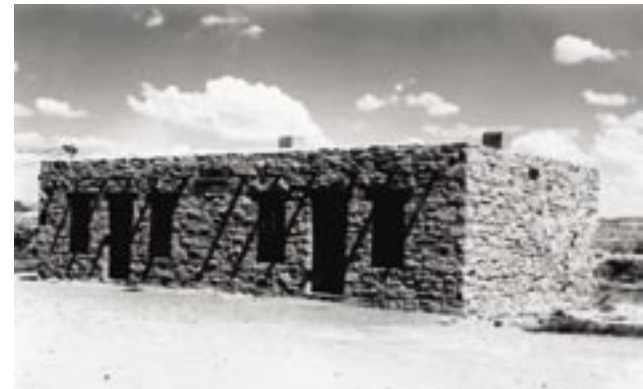
Rainbow Forest Cabins from the 1940s. *PEFO Photo Archive #15745*

The Rainbow Forest Cabins are one of the first buildings visitors see when approaching the Rainbow Forest Historic District along the park road from the north. While the building is in good condition, there is an assortment of items that could be cleaned up on the exterior of the building. If possible, the evaporative cooler and ductwork should be screened. Any unused conduit or wiring should be removed from the exterior of the building.

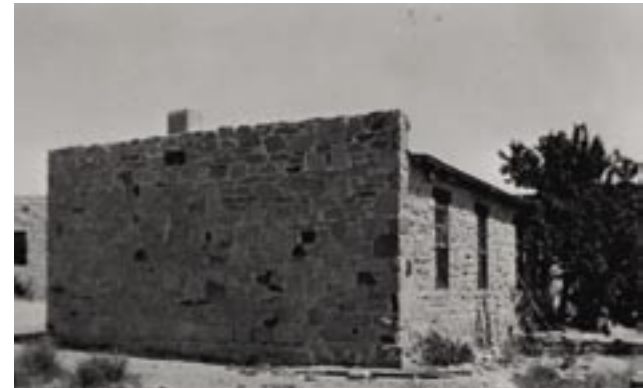
Rainbow Forest Cabins, looking north 1949. Note flat roof with parapets. *PEFO Photo Archive #15743*

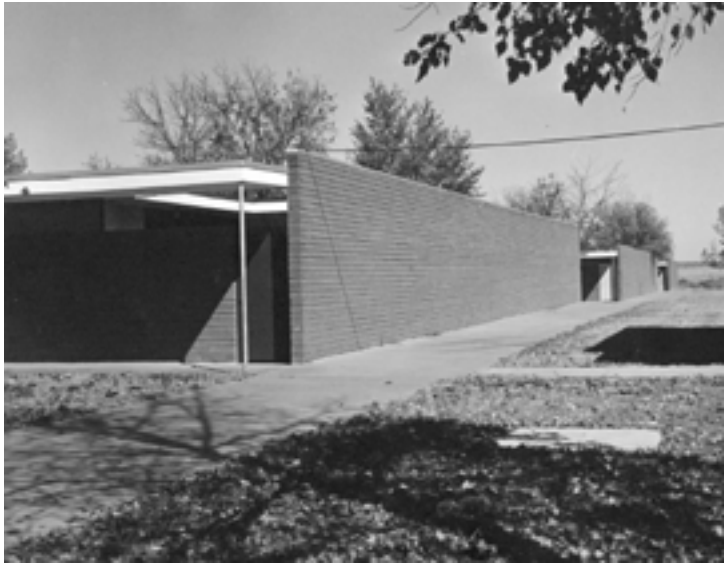
This photo, likely taken in sometime between the late 1960s and the mid 1970s, displays the original service yard configurations for the Cf plan units. The support column holding up the cantilever is also a good example of an appropriate support column. *PEFO Photo Archives photo by Stitt*

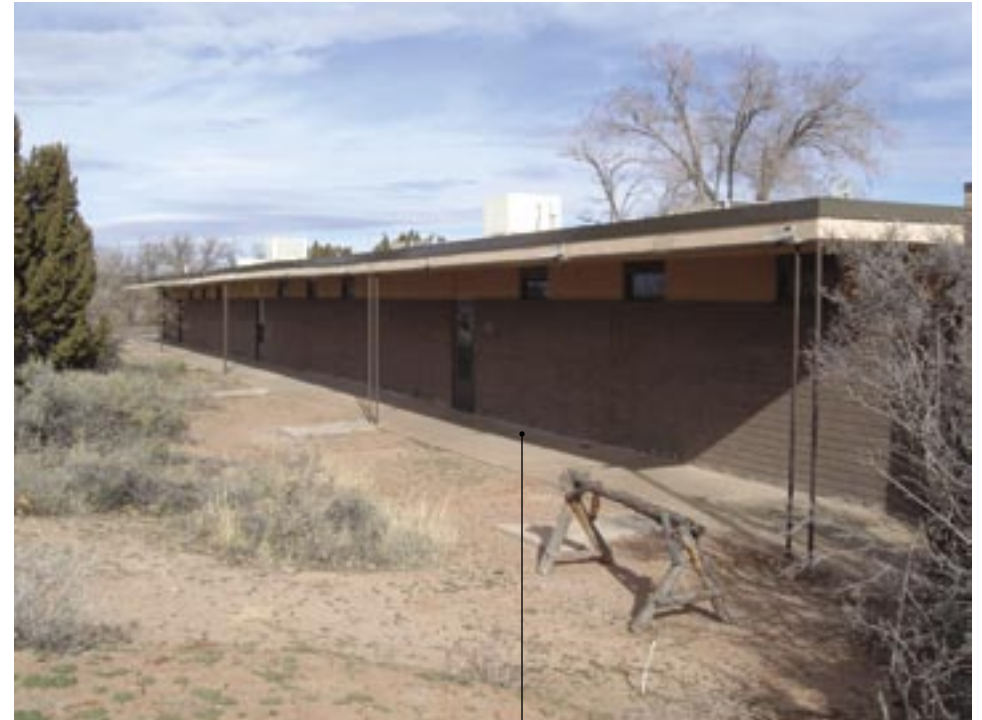
PD Residence Block A 2004 *2005 Photo by author*

② This photograph from the PEFO Archives shows the result of alterations made to provide more lighting to the Cf plan residences. The photograph shows the wall as one could expect to find it if the board and batten siding that currently clads the south facades of blocks B-D was removed.

② This design option illustrates the possibility of removing the board and batten siding and repairing the masonry underneath. Areas where block has been removed would be reconstructed, but the large window would remain. The stucco band that historically ran across the entire length of the facade would be reestablished. This design option seeks to restore the facade as closely as possible, while preserving the added natural light provided by the large windows. Eventually it would be desirable to replace the lar

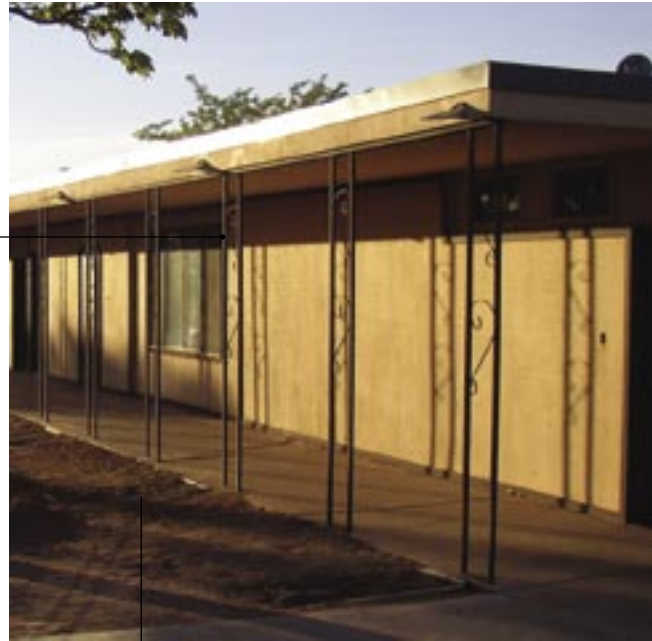
⑤ inappropriate column style

Residence Block B 2004 2004 Photo by author

⑤ Supports, if needed, should help to preserve sense of “floating” cantilever by not being placed directly at a corner.

⑦ evaluate current roof drainage collection system, apply uniformly to all PD residences

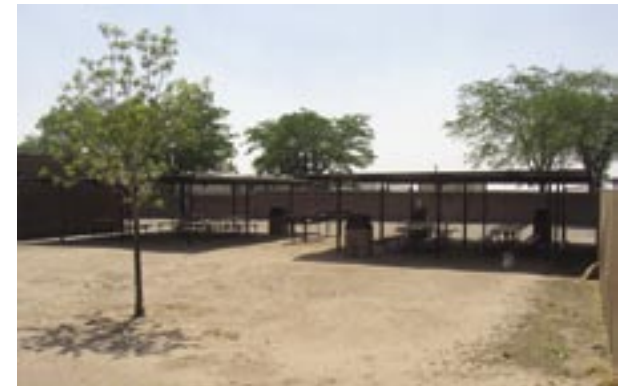
The picnic shelters remain in good condition and have undergone no alterations since their construction. They should be preserved and maintained as they are.

Picnic shelters looking northwest 2004 Photo by author

Charcoal grills should be cleaned regularly to keep them free from bird droppings and other grime.

In order to make this picnic area more useful to residents of the PDCCHD, electrical outlets and light controls should be more accessible to them. A motion detecting system that controlled both lighting and the availability of electricity would be an appropriate solution.

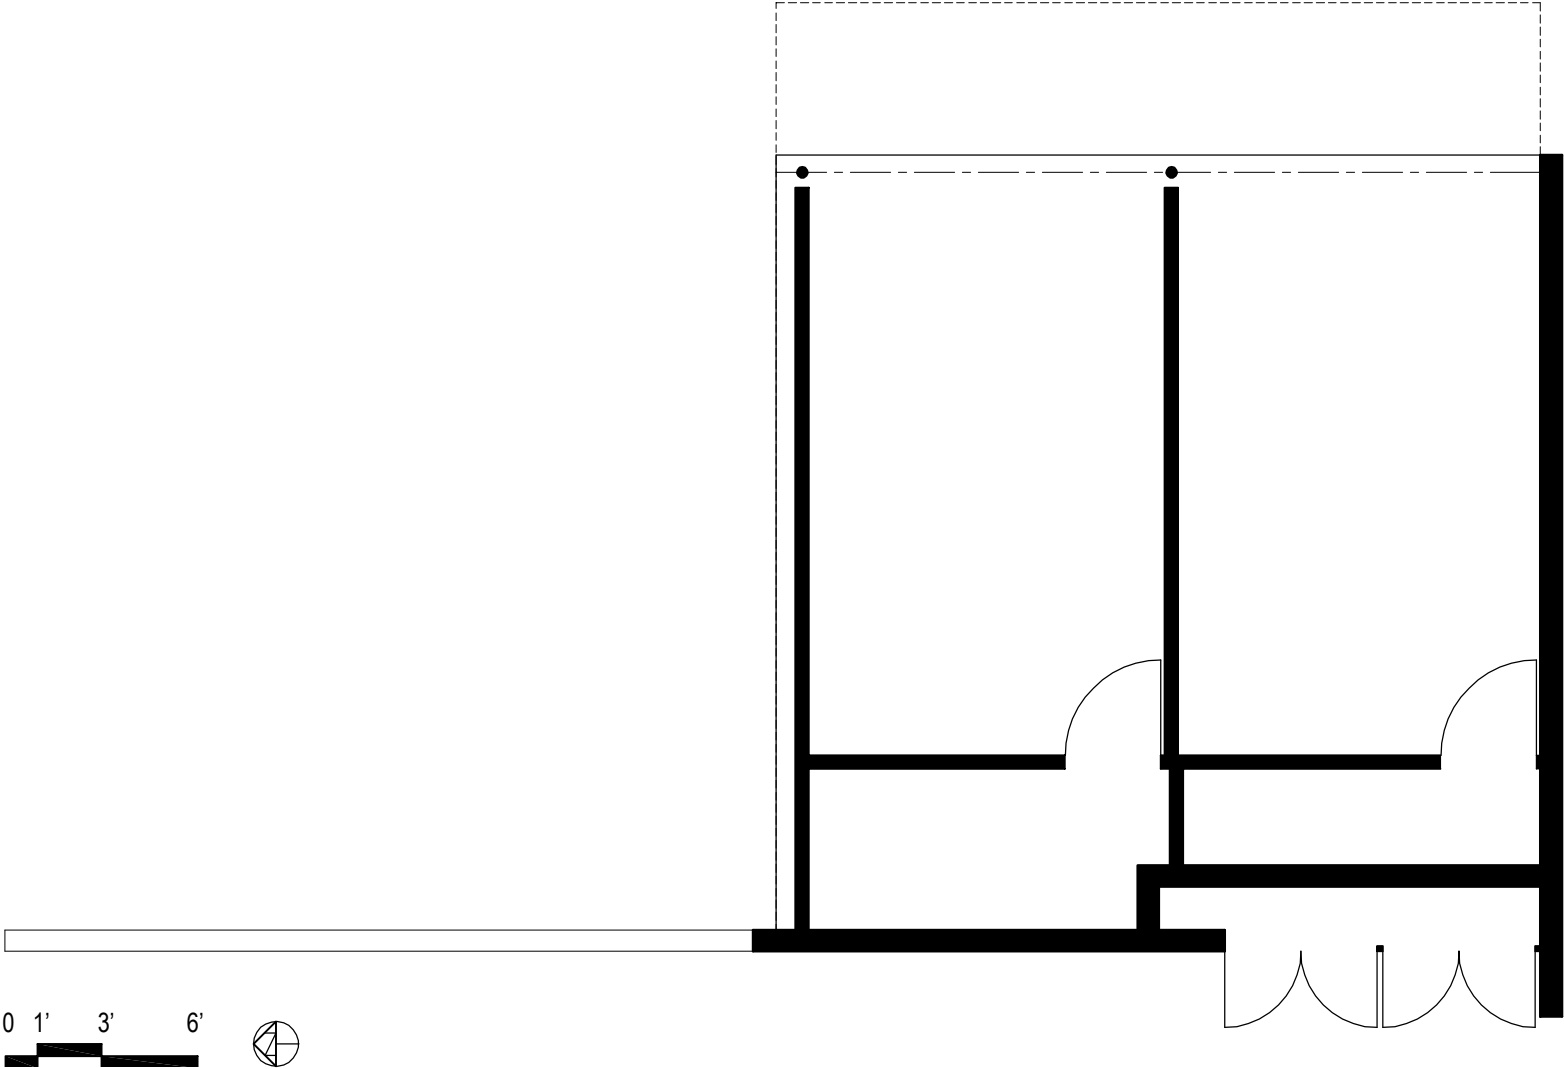
PD 220-222 Design Goals Illustrated

- ① remove east facades
- ② remove wood paneling and replace with stucco or plaster
- ③ replace flashing with more appropriate flashing
- ④ replace obtrusive outdoor lighting
- ⑤ replace roof and scuppers
- ⑥ relocate ladder storage
- ⑦ add vertical flashing on unit PD222
- ⑧ lower impact of exterior conduit

Exterior lighting on the east walls of units PD221 and PD222 is obtrusive and should be replaced with lighting similar to that of PD220

The current foam roof should be replaced with a single-ply membrane roof. Roof drainage should be handled in a manner similar to that of other PD buildings with single-ply membrane roofs. Scuppers simple and durable.

Ladder storage and ladder storage hardware should be removed from units PD220 and PD222, repairing holes created in block from removal.

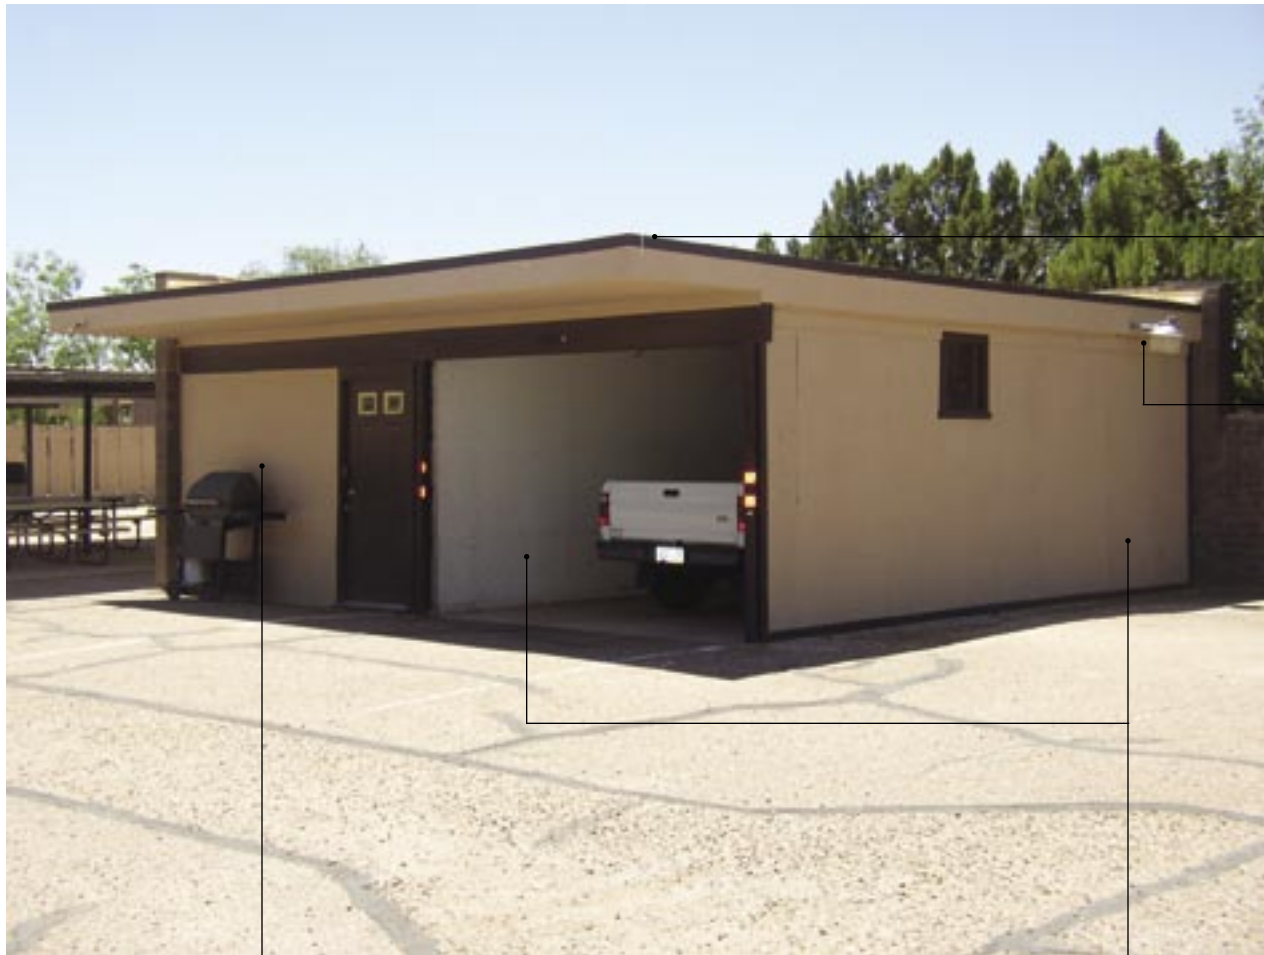
PD220 looking south-west 2004 Photo by author

Exterior lighting on the east walls of units PD221 and PD222 is obtrusive and should be replaced with lighting similar to that of PD220 or by suggestions made in the Exterior Lighting Cut Sheet.

The current foam roof should be replaced with a single-ply membrane roof. Roof drainage should be handled in a manner similar to that of other PD buildings with single-ply membrane roofs. The possibility of water harvesting should be investigated. Scuppers should be simple and durable.

Ladder storage and ladder storage hardware should be removed from units PD220 and PD222, repairing holes created in block from removal.

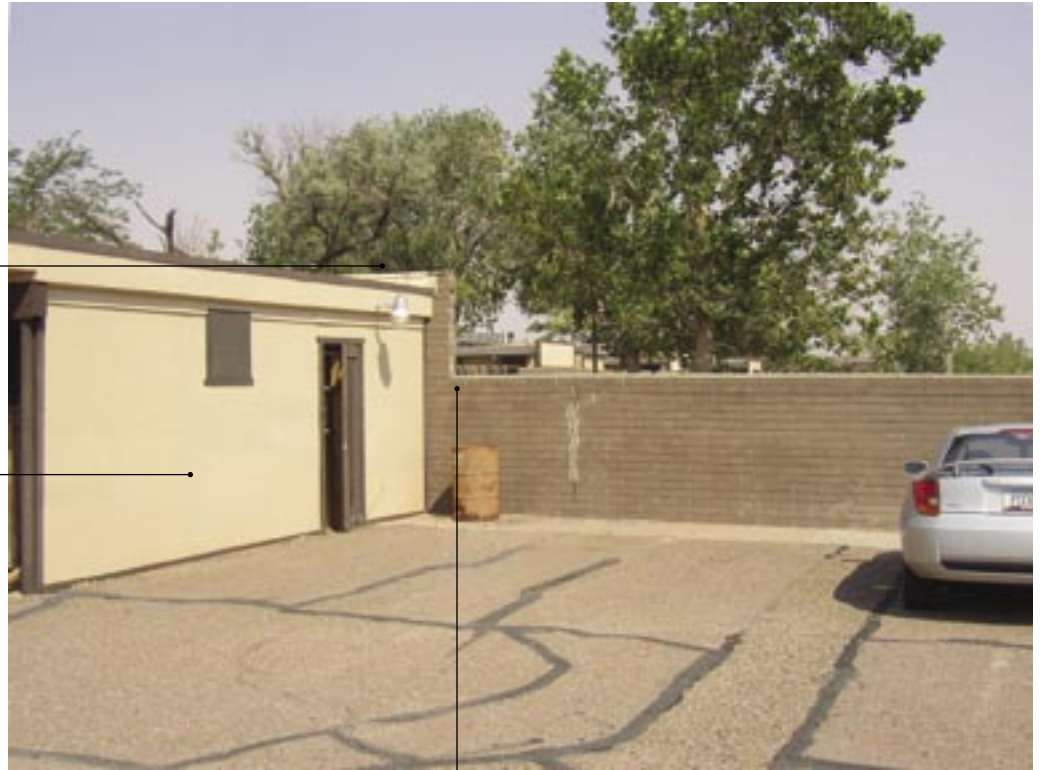
PD 222 looking west 2004 Photo by author

⑤ Replace foam roofs with single-ply membrane. Remove foam from parapets

② If north infill cannot be removed, accents should be removed or painted, including doors, trim and flashing

⑦ Apply vertical coping to exposed block ends on PD222, as done on PD220

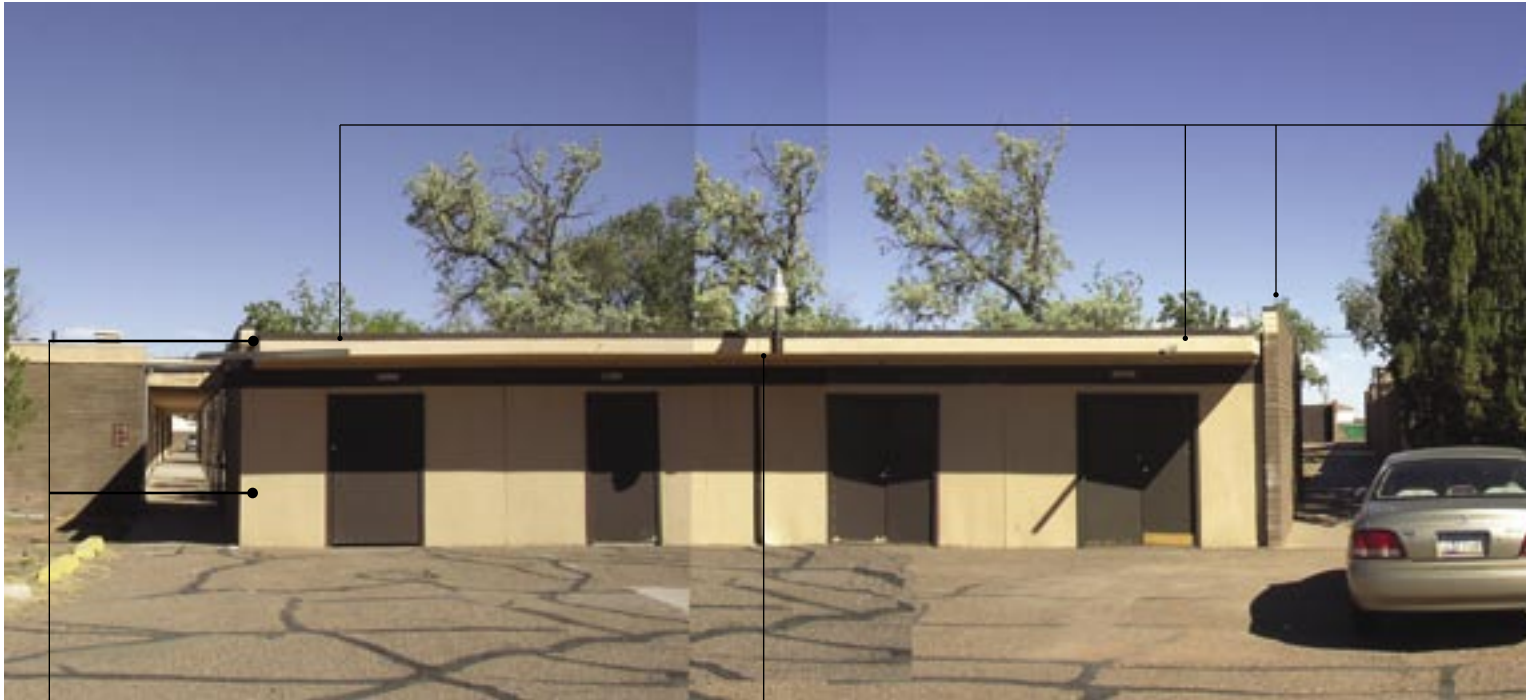
PD225 west facade 2004 Photo by author

The current foam roof should be replaced with a single-ply membrane roof. Roof drainage should be handled in a manner similar to that of other PD buildings with single-ply membrane roofs. The possibility of water harvesting should be investigated. Scuppers should be simple and durable. Any gutters should be removed.

① ② ③ Remove west facade and interior partitions, flashing should blend with fascia

④ Exterior lighting should be less obtrusive, should be smaller and attached to the fascia or soffit

② Replace foam roof with single-ply membrane roof, remove oversize scuppers replace with smaller scupper, remove gutter, remove foam from parapet

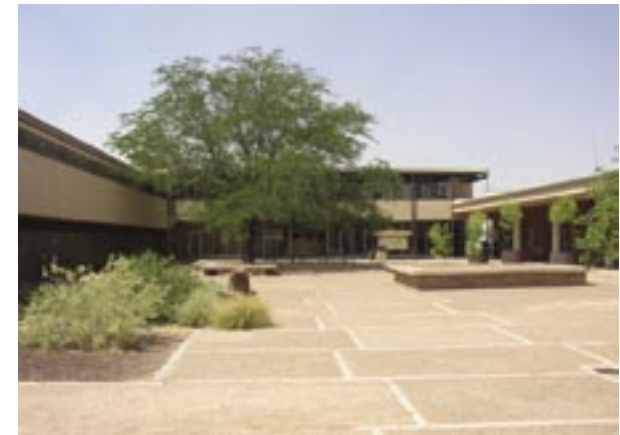
Central plaza looking south 2004 Photo by author

Currently, the central plaza serves as little more than a curiosity to park visitors. There is little to engage them in the plaza and it lacks adequate shading and seating. This lack of public use stems from the lack of any compelling reason for the visitor to be in the space, and is independent from the plaza's current state of deterioration. Efforts should be made to make this area more attractive for public use. The natural area with walking paths to the north that is currently being developed should help achieve this. Frequent ranger programs conducted in this area would also help. Impermanent outdoor seating for the Fred Harvey restaurant could also help activate the plaza. The idea of adding temporary yet attractive shade structures should also be entertained. This would help to make the space more inviting until the trees that have been recently planted are able to provide adequate shade. If adequately shaded seating is provided it will be used.

Repairs should be made to the patterned concrete work in the plaza. Concrete work should be carefully restored with attention given to original pattern, texture and color.

The block cap that tops the southern sandstone masonry planter should be replaced due to the inconsistency of previous repairs. Block and mortar similar to the original block and mortar should be used. Work should be completed with the highest standards of craft.

The gabled information board located near the entrance to the visitor center should be replaced with an information board more sympathetic to Modern design principles. A simple vertical information tree similar in design to the one located at the entrance to Puerco Pueblo would be appropriate. The orientation of the board should be turned ninety degrees so it doesn't block views of the plaza from the visitor center and so it can be viewed, and serve as a welcoming element, upon entrance to the plaza from the Visitor Center or the parking lot. It could also be placed near the entrance to the natural area north of the central plaza to help draw people through the plaza

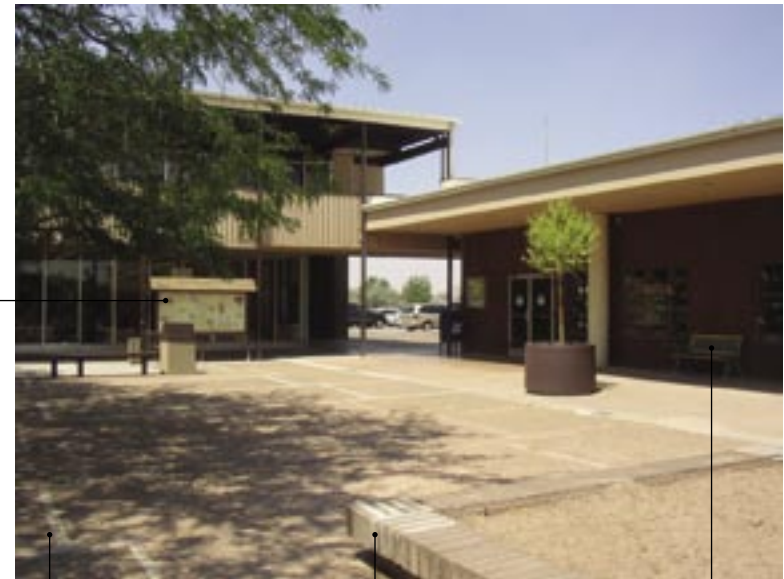
Central plaza 2004 Photo by author

The original drainage system in the plaza is obsolete because of the incompatibility of the drainage systems of newer roofs on the surrounding buildings. Drainage should be evaluated in depth for the entire plaza and the old drainage system should be replaced or repaired in respect to the findings of that study.

③ Replace and re-orient information board and move trash can to a less conspicuous location, restore bench to original configuration

① Repairs to concrete should match original in pattern, color and texture

② reconstruct block cap on sandstone planter
