Maintenance Guides for the Treatment of Historic Properties

Petrified Forest National Park

Andrew Gorski and Michael Lovato

June 2005

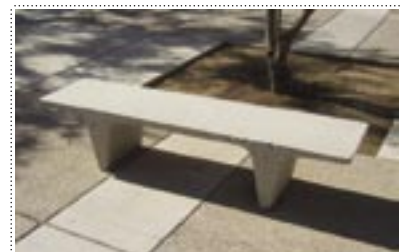
Appropriate bench Photo by Author

Replace decorative benches that line the Fred Harvey building with benches more consistent with the character defining features of the PDCCHD. Monolithic cast concrete benches would be cheapest, easiest, and most appropriate. Concrete of similar color should be used for benches as was used in patterned concrete work.

④ replace benches with more appropriate benches, poured in place concrete is an appropriate replacement

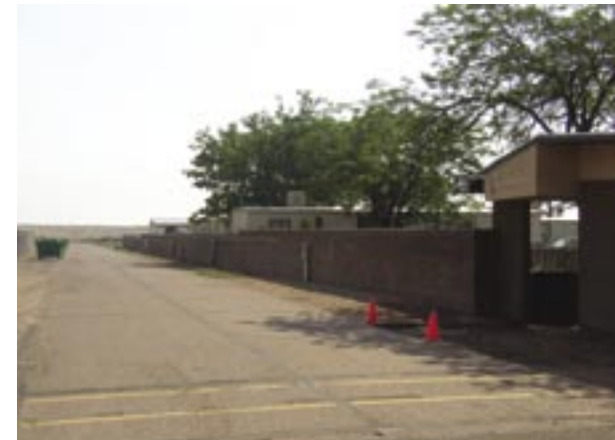
An interesting aspect of the trailer court is that the large expanses of block walls remain in good condition when compared to some of the other non-load bearing walls in the complex. The construction of these walls should be studied in order to determine what makes them less susceptible to damage than other walls within the complex.

Trailer court looking north 2004 Photo by author

The area enclosed by planters on the southern end of the trailer courts should be restored and used as an outdoor gathering area for residents of the trailer court.

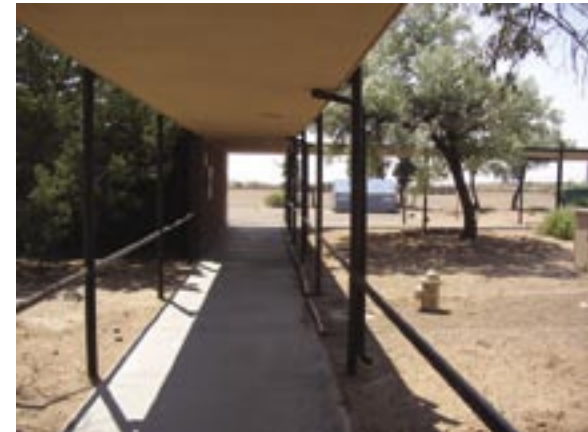
Covered walkway looking east 2004 Photo by author

The covered walkways remain in good condition and should be preserved and maintained as they are. A comprehensive study should be done on drainage issues for the entire PDCCHD. In this study the drainage from the walkways should be examined. The possibility of the columnar supports performing double duty as downspouts should be examined, as the current method is visually awkward. The possibility of water harvesting should be studied.

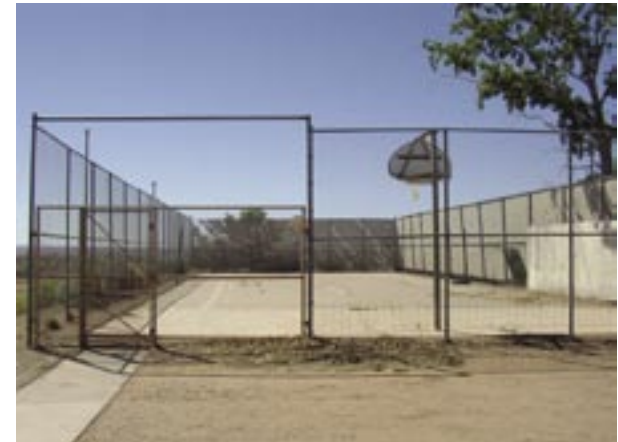
The PD Tennis Court is still functional, but in need of maintenance. The pavement is cracked in many places and may need to be entirely replaced. The fence surrounding the courts serves primarily to block the wind, which it does fairly well on the east side of the court. However, this system too is in need of repairs and it might be favorable to examine different wind blocking/ shading techniques that are more attractive than the current chain link fence.

Tennis court looking east 2004 Photo by author

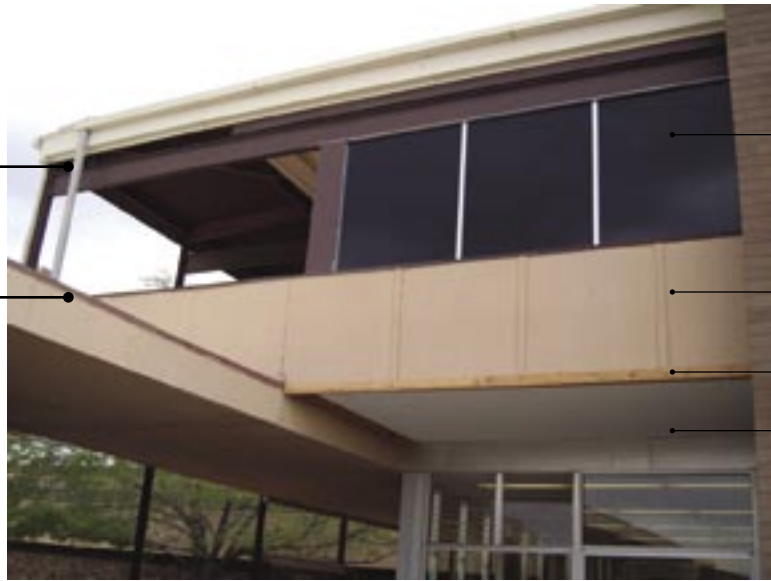
Intersection of PD Oasis and Administration Buildings 2004 Photo by author

②④ Move unsightly downspout to less conspicuous location. Paint to match adjacent material

④ De-emphasize flashing

④ Remove tint from windows

④ Remove all extraneous wood trim

④ Paint soffit same color as facade above

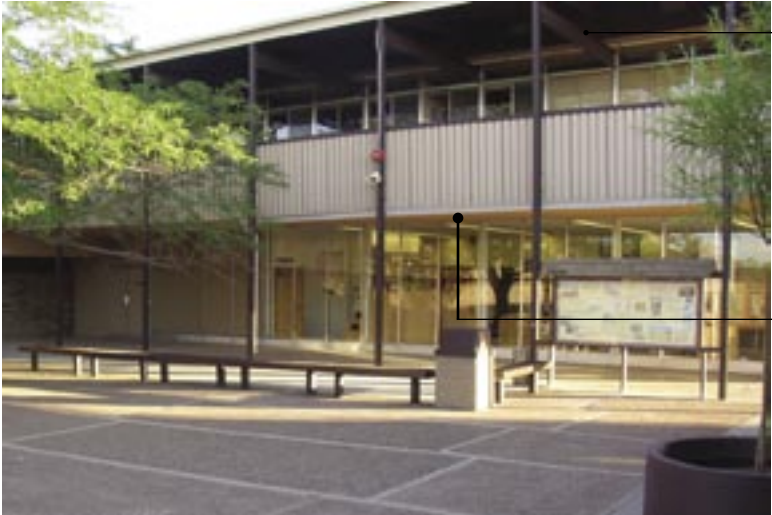
North terrace 2004 Photo by author

① Eventually, pitched roof should be removed, once again exposing the spider leg outrigging

② Remove unnecessary gutters and downspouts

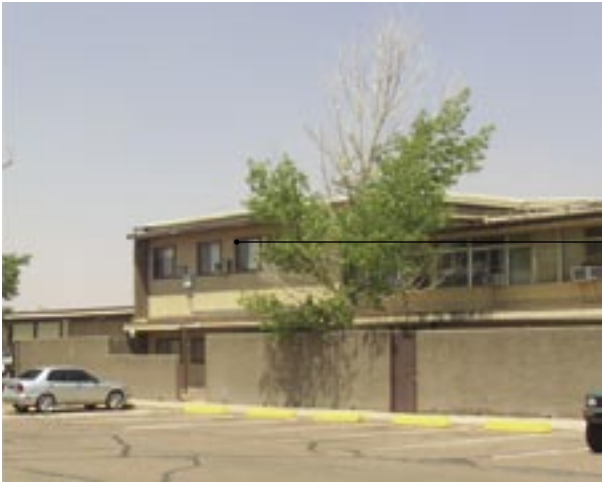
Former east terrace location 2004 Photo by author

③ Area that was once east terrace should be restored. If a complete restoration is impossible, T1-11 siding should be removed and a facade design that expresses the existence of the spider leg outrigging should be developed. I.e., a design where cladding is placed between flanges of I-beams, so they are still visible.

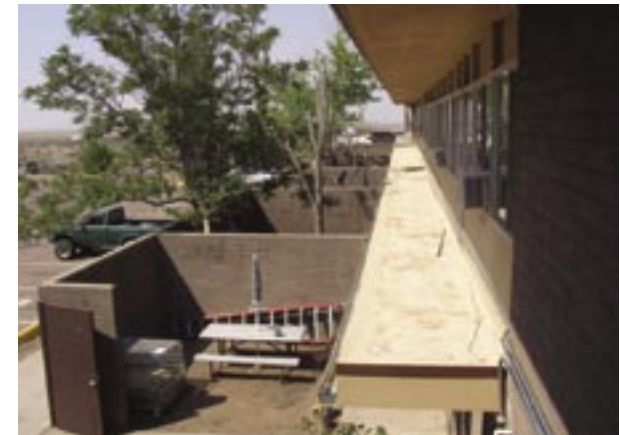
Apartment building looking south 2004 Photo by author

The door at the north end of the second story hall should be removed or detailed so that the open edge with insulation exposed isn't directly visible in the courtyard.

The corrugated fiberglass panel in the north stairway should be removed.

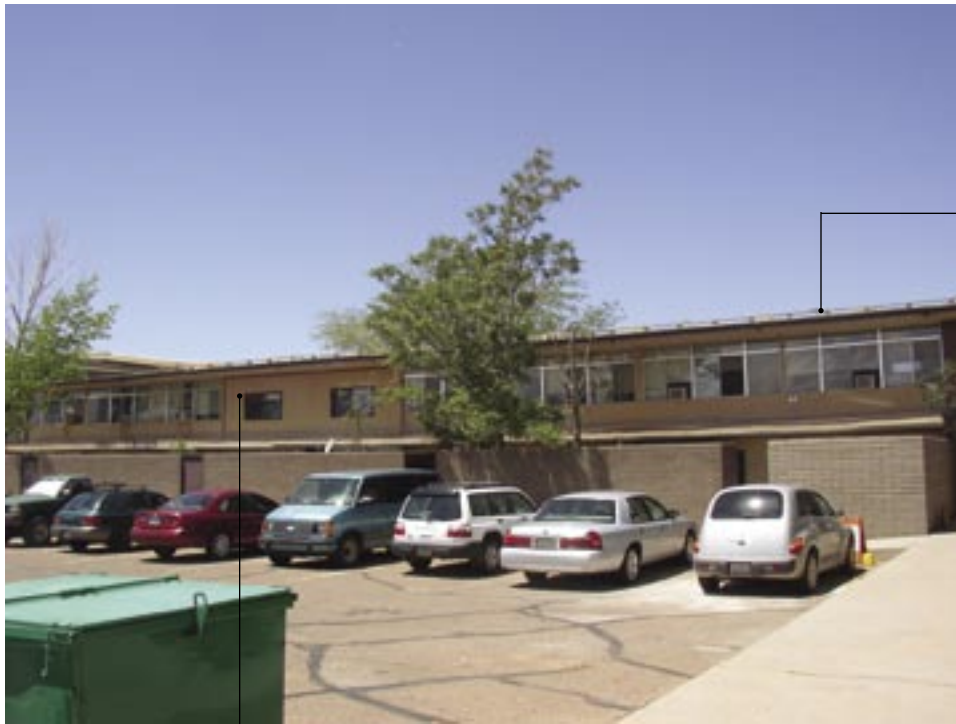
Apartments east facade 2004 Photo by author

The most evident modifications that have been made to the apartment building have been the removal of the original windows in several apartment units along the east facade. The most visible of these being the modifications done to apartment F. All T1-11 siding should be removed from east facade of the apartment building. Due to its visibility the exterior restoration of unit F should be a priority. It may be possible to remove the windows currently in unit B to replace the windows in unit F. Since the facade of all the lower level apartments is obscured by courtyard walls, the restoration of these windows isn't as urgent. If the windows from B and F were switched and all the windows along the lower story were replaced with appropriate aluminum sliding sash windows, then each stories windows would be from the same era, and would wear relatively evenly.

② Restore altered second story facade. Windows from apartment below could be sacrificed for use in more visible upper story

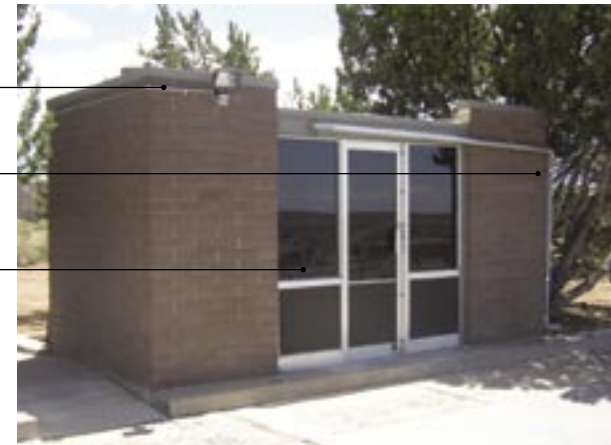
Gatehouse looking south-east 2004 Photo by author

- ② move conduit
- ① remove gutter
- ④ remove tinting

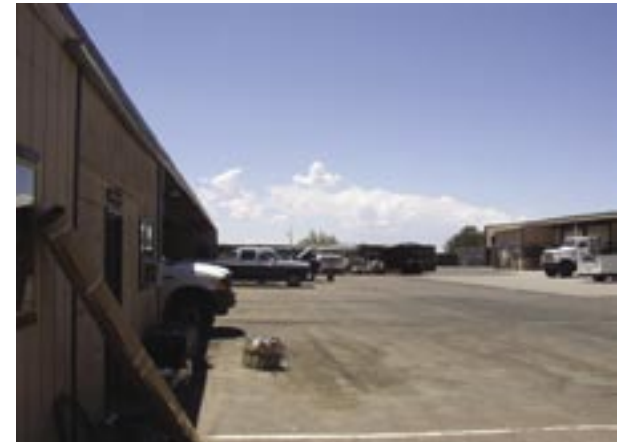
Maintenance and Fire Cache, Vehicle Storage interior yard looking south 2004 Photo by author

The southernmost portion of the maintenance building wall, used as exterior storage, is failing structurally and should be replaced. It should be executed using block as similar to the original block as possible.

All unnecessary conduit, gutters and utility meters should be removed. If they are determined necessary they should be concealed as well as possible.

Drainage issues should be looked at in respect to the entire complex and handled similarly throughout. The possibility of water harvesting should be studied.

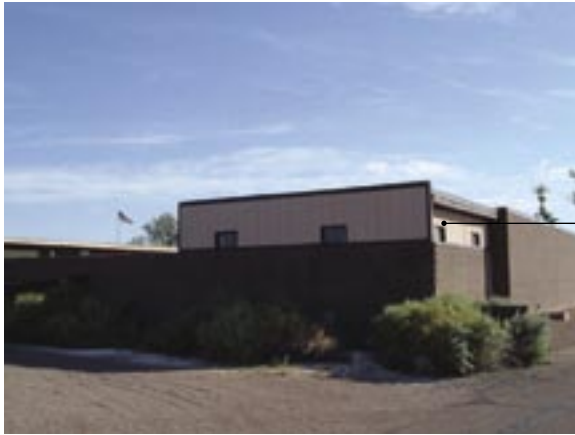
PD254 south facade 2004 Photo by author

① All additions visible from outside of the maintenance yard should be removed. If nothing else, the T1-11 siding should be replaced with stucco.

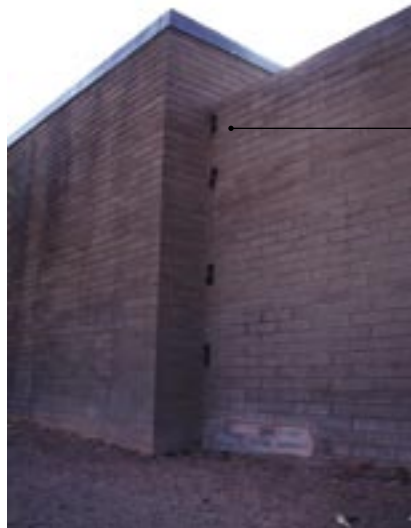
PD 255 west facade 2004 Photo by author

② The south service yard wall is failing and should be reconstructed. It should be executed according to the Secretary of Interior Standards for reconstruction.

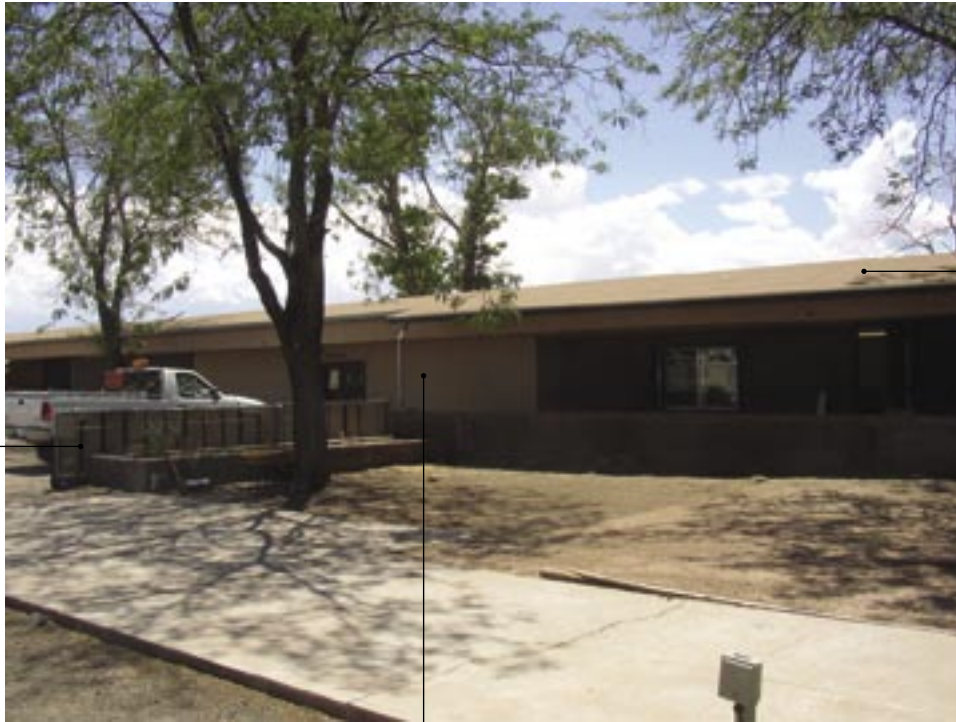
Trailer court building 2004 Photo by author

⑤ Remove fence

① remove gabled roof

① Remove T1-11 siding. Originally this space was an open courtyard. If it is not going to be returned to a courtyard space, the siding should be replaced with glass. This would help to reestablish the massing of the building.

Any T1-11 siding should be removed from the exterior. It should be either replaced with stucco, or in the area that was once the courtyard, should be replaced with windows to regain the openness that the space once possessed.

Chain link fences should be removed from the area around the trailer court building.

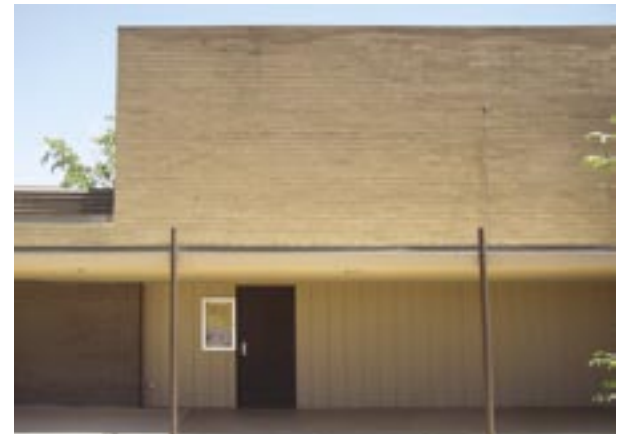
Community building before renovations 2004 Photo by author

However, despite the thorough renovation that the community building has recently undergone, it still lacks natural light on the west end. The clerestory windows on the upper north facade should be restored and outfitted with an electronic shutter system that allows them to be open or closed, based on the desired light level required in the building.

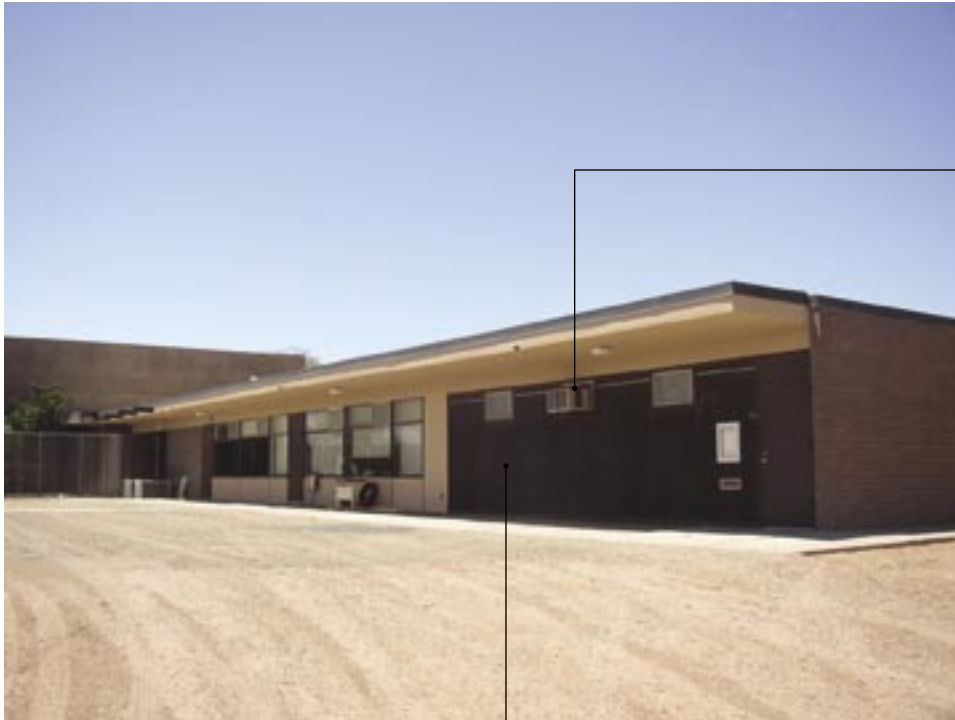
School building east facade 2004 Photo by author

③ An HVAC system should implement in the building. All AC window units should be removed.

② The north end of the east facade should be restored to match the south end. If it is not to be restore, it should be stuccoed, and windows should be added in a similar pattern to those on the south end

An HVAC system should be implemented in order to free the east facade of individual air conditioning units. The system should be inserted as inconspicuously as possible.

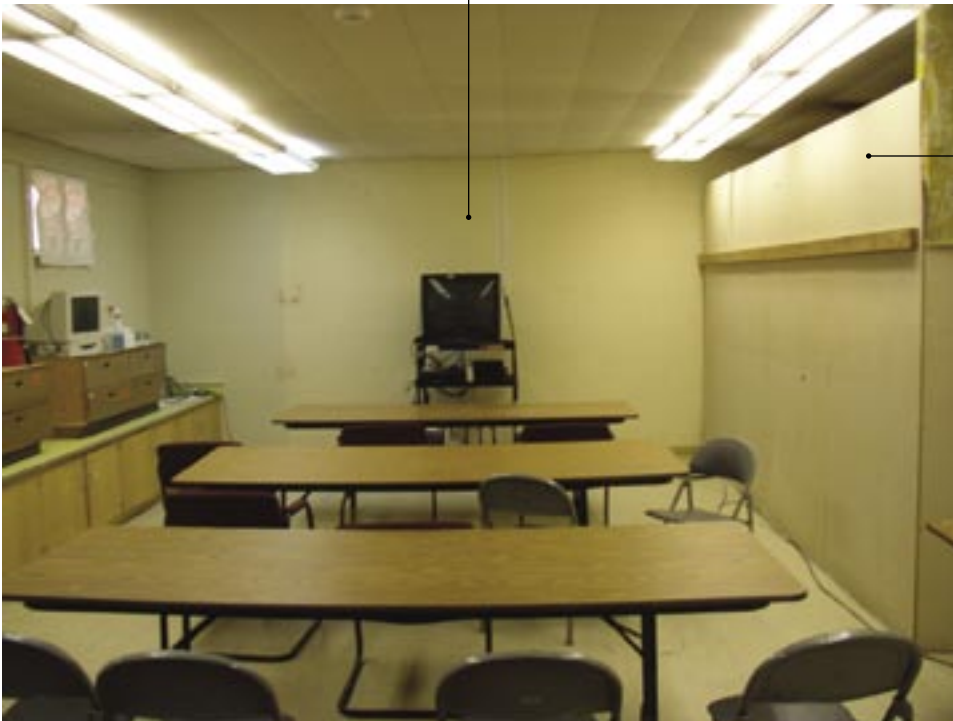
School building north classroom looking south 2004 Photo by author

②③ Middle wall should either be restored to a movable partition, as it once was, or finished.

②③ The post office should either be moved to a different location or its walls should be finished

An attempt should be made to unify the finishes of the north and south classrooms, i.e., flooring, trim, and

fixtures. The south classroom had green accents as indicated by the partitions and the counter tops. The north classroom had yellow accents, as demonstrated by the counter tops. These color themes should be respected with any changes to the finishes that might occur.

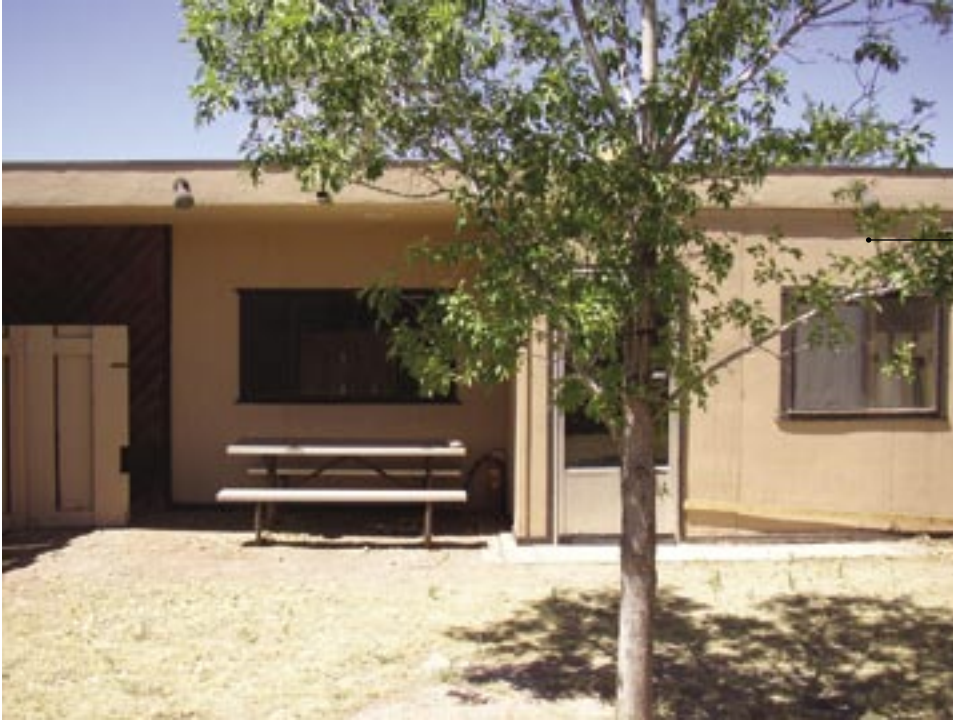
Apartment K north facade 2004 Photo by author

① Apartment K bumpout should be removed. If it can not be removed, it should be stuccoed. Whether or not it is removed, access from the yard should be by a large sliding glass door. Restoring this will help to reestablish the relationship that once existed between interior and exterior space.

Large sliding doors should be replaced in the north wall of the living areas in each apartment. This will help to re-establish the intended relationship between interior and exterior spaces.

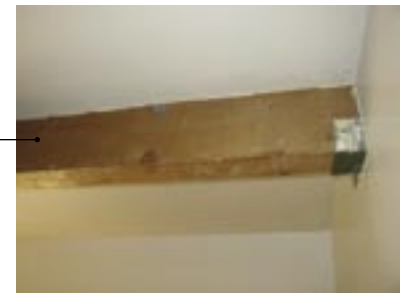
Apartment K exposed beam Photo by author

① If the bumpout is not removed, and the original wall is not restored, this beam should be clad in gypsum board and painted.

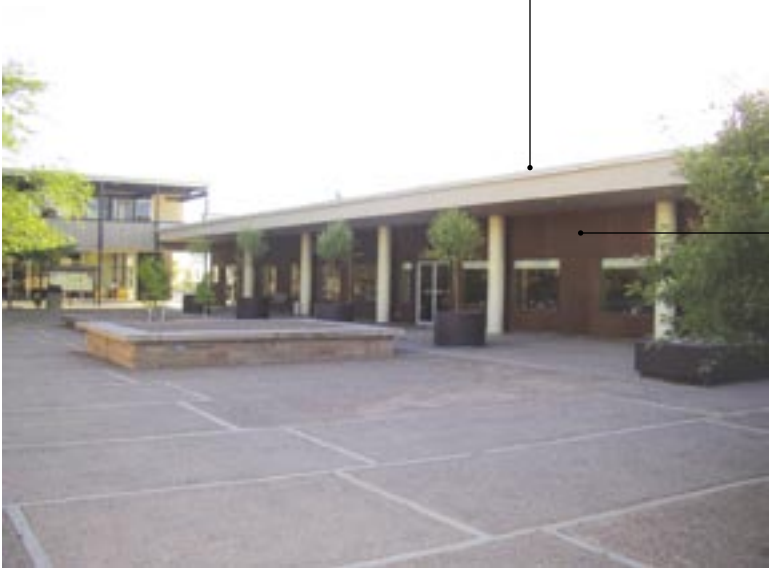
PD Oasis building east facade 2004 Photo by author

① Pitched metal roof should eventually be replaced with flat single ply membrane

② Full east facade windows should be restored

Eventually the flat roof should be restored in order to restore the buildings horizontality, this can happen when the current roof needs replacement.

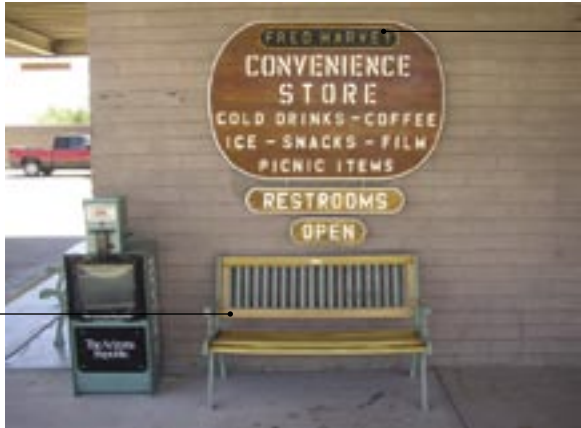
Service station 2004 Photo by author

④ Decorative wood benches are inappropriate to style of architecture. They should be replaced with benches more consistent with the aesthetics of the complex. A poured in place concrete bench might be more appropriate.

⑤ Decorative wood signs are inappropriate to the aesthetics of the PD complex. Signage should be brushed aluminum

The decorative wood benches that line the east and south facades should be replaced with benches more consistent with the character defining characteristics of the PDCCHD. Cast concrete benches would be an appropriate alternative

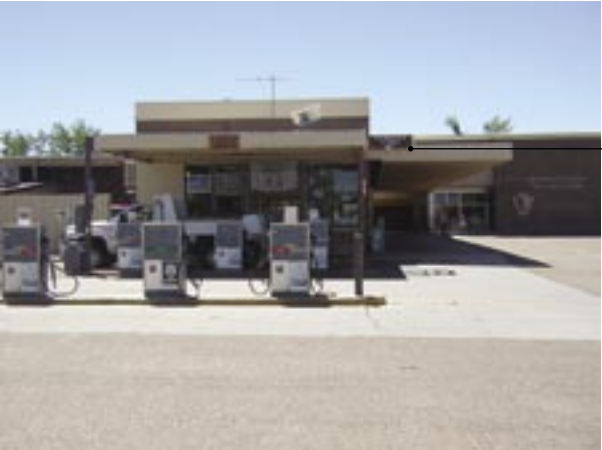
Service station 2004 Photo by author

⑥ The canopy over the gas pumps should be reconnected with the cantilever that runs along the south facade of the PD Oasis Building.

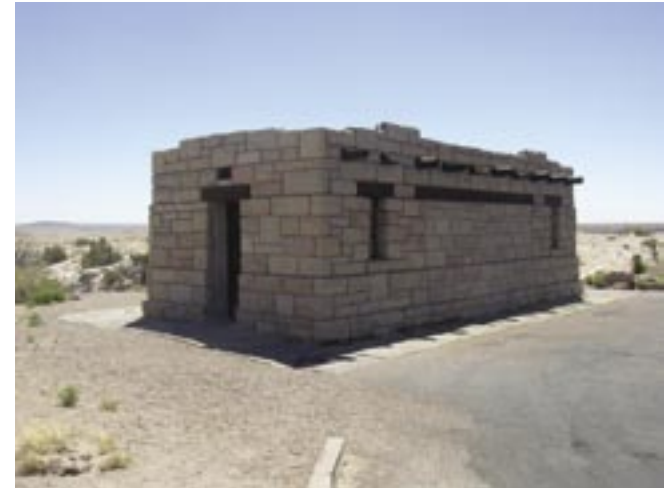
The roof appears to be in poor condition and should be replaced with a single-ply membrane system. Wood vigas should be inspected and maintained. Stone masonry should be inspected and repointed as required.

Agate Bridge Comfort Station viewed from the northeast in 2004.
Photo by author

Reestablishing the breezeway between the two restrooms would return much of the historic character to the building. While this would make the restroom situation uncertain, it would open up space for additional interpretive materials within the breezeway. Opening the center of the building would also provide a better visual link from the parking area to agate bridge.

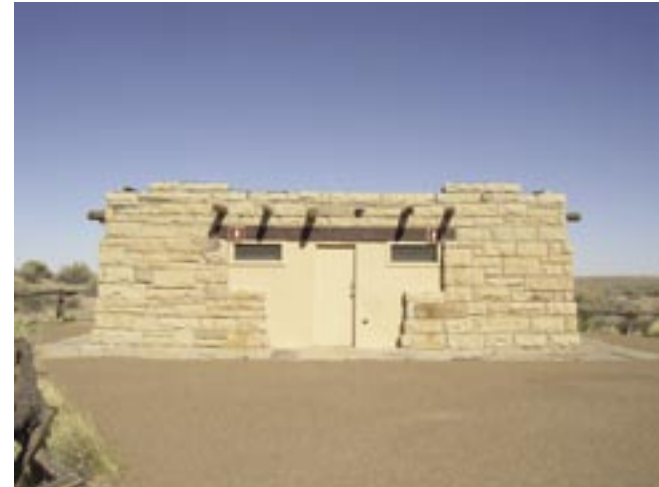
The roof appears to be in poor condition and should be replaced with a single-ply membrane system. Wood vigas should be inspected and maintained. Stone masonry should be inspected and repointed as required.

Rio Puerco Comfort Station viewed from the east in 2004.

The current plan is to restore this structure to its interpretive mission and to construct a new comfort station adjacent to the emergency phone in the existing parking area. Providing a space for more permanent exhibits could be established. Incorporating removal panels, as were provided for in the original design would make the structure flexible for use under variable weather conditions.

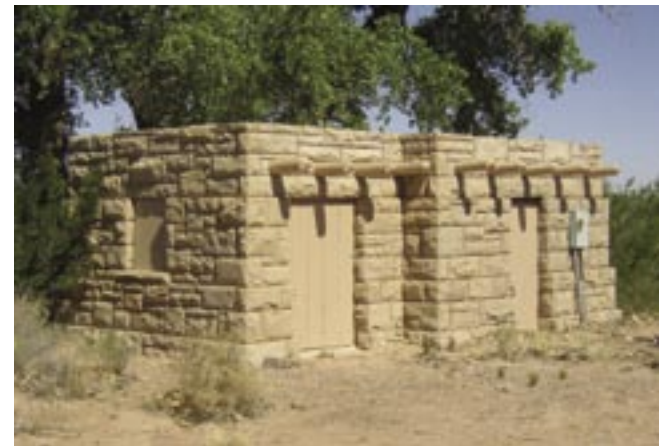
Rio Puerco Pump House, 2004. Photo by author

Beyond conducting long-term maintenance on the exterior features of the pump house to preserve the condition of the structure, little maintenance is necessary. Protecting the steel casement windows with wood coverings should be continued until a new use is determined for the structure. The roof appears to be in fair condition and should be replaced with a single-ply membrane system. Wood vigas, including those with integrated canales, should be maintained. Stone masonry should be inspected and repointed as necessary. Vegetation that has encroached on the building should be cleared to prevent damage from falling branches, insects and animals.

It would be beneficial to return a new use to this relatively isolated structure, as it may be easy to forget about it when scheduling cyclical maintenance. Furthermore, its location along the Puerco River* offers the opportunities for unique visitor and interpretive experiences.

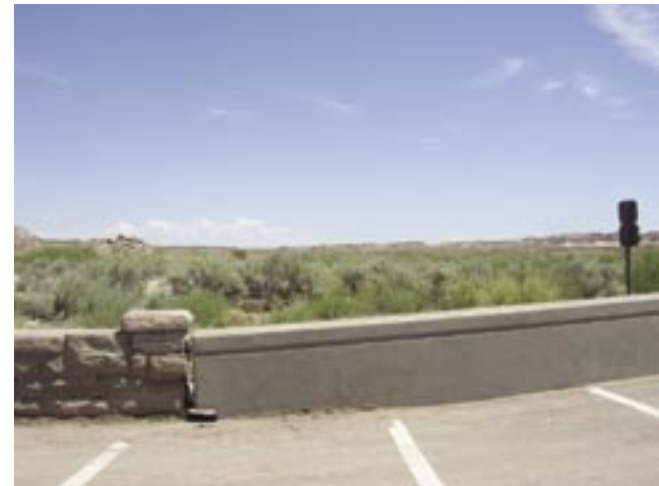
A gap between new construction and the existing structure is a preferred detail. *Photo by author*

For several reasons, it is desirable to physically separate new walls from existing features. In most cases, leaving approximately 2-4" between new and existing walls would be appropriate. From a historic preservation perspective, it is important to distinguish between eras of construction. Although it may be possible to match the look of an existing wall, it is important to acknowledge the different construction techniques of today. Secondly, if in the future it is determined that older portions of the landscape walls are historic, the designation will be clearer. From a construction perspective, a gap provides a place for expansion and contraction to occur in the new wall. Tying new walls into existing construction could cause cracking to occur to the existing walls as the new walls move and settle. The design opportunities presented by a gap include the option of changing materials and some flexibility to how well horizontal lines align.

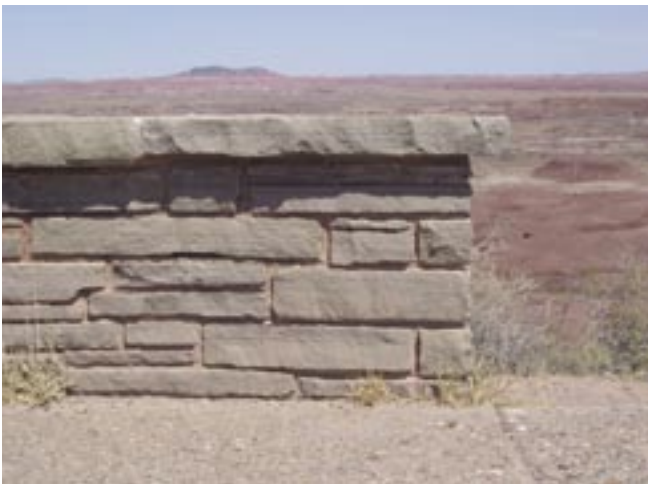
A stone cap provides a distinct shadow line. *Photo by author*

An existing feature that should be maintained in the design of new walls is the use of a wall cap. Approximately 4" in height and overhanging the lower wall surface by 2", the cap provides a clean termination to the wall while giving the wall a distinct horizontal shadow line.

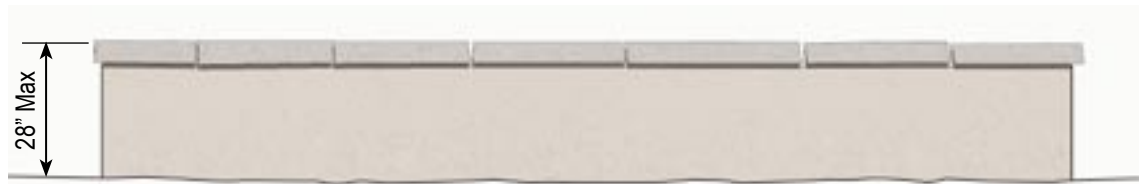
CMU wall with stucco finish (with stone cap or CMU cap)

- Wall cap creates shadow line. Wall should be under 24". Stone provides transition to natural areas beyond

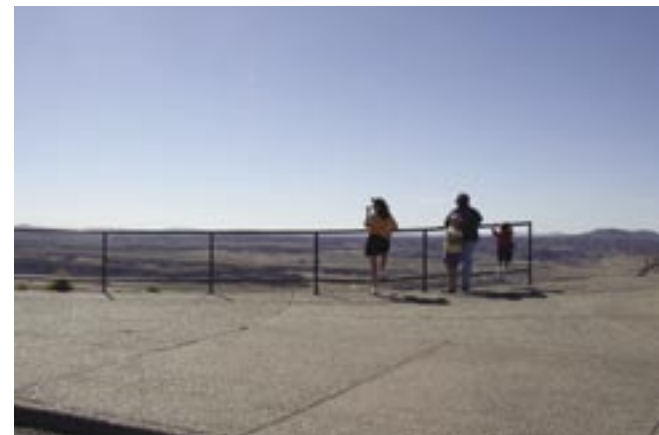
This railing along the parking area at Pintado Point is susceptible to damage by vehicles and visitors and could be replaced with a low stone wall. *Photo by author*

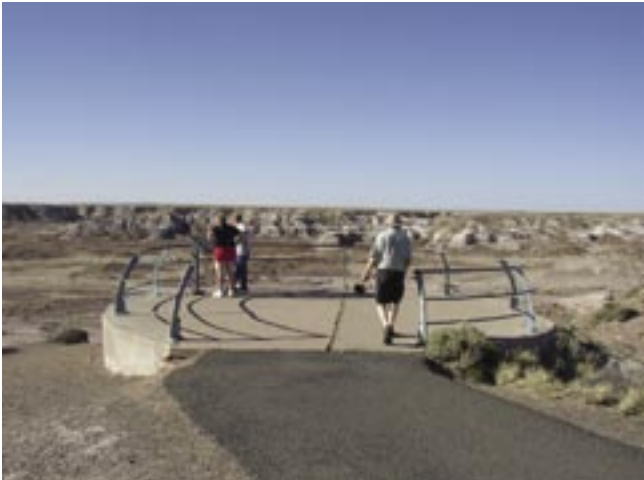
One of the more unusual railings in the park is found at Jasper Forest. Too many different designs could be problematic to repair and maintain. *Photo by author*

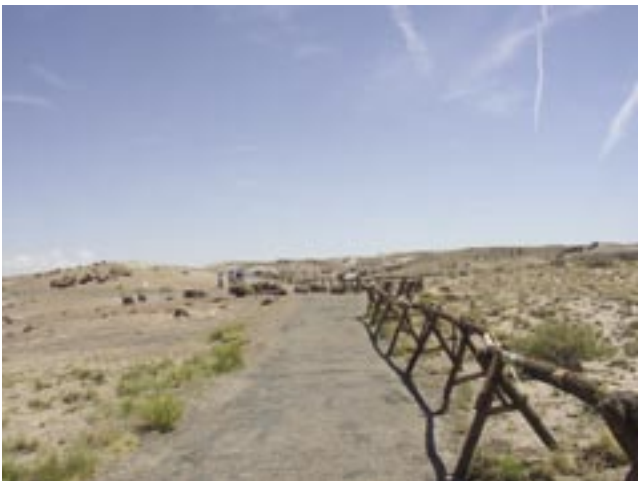
The use of pine pole barricades should be limited to temporary installations. *Photo by author*

The use of pine-pole barricades are widely distributed throughout the park. The merits of the pine-pole barricades include their portability, ease of construction and inexpensive cost. They can be quickly and easily located at “hot-spots” along the park road to keep visitors away from sensitive areas. When used as a temporary measure to block a road or to keep visitors outside an area, they are effective and should be used. However, the use of the pine-pole barricade has become ever-present in the park, especially along trails at popular pullouts, such as at Puerco Pueblo and Crystal Forest. Used in large numbers to discourage visitors from entering areas with petrified wood or from tramping through areas that contain sensitive artifacts, the pine pole barricades have become a dominant feature on the landscape.

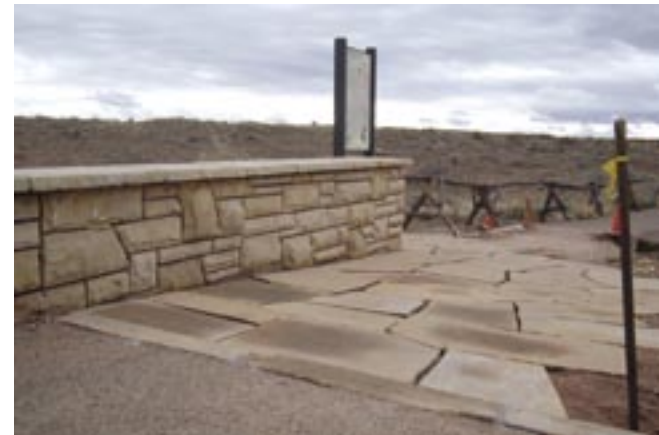
An effective transition area between the parking lot and pueblo site was created by introducing sandstone paving at Puerco Pueblo.
Photo by author

When used sparingly, more expensive materials such as native sandstone and precast concrete pavers can be attractive options. Using native stone to surround an entryway or important interpretive sign is a good idea and helps to create areas with more appeal. The recent addition of sandstone paving to create a different ground plane for the entry to Puerco Pueblo helps create a more unified and distinct entry experience. By being more fully integrated with the adjacent sandstone wall and of richer texture and quality, this small area of sandstone makes a positive impression on the visitor. The limited use of sandstone is also effectively used around the Puerco Pueblo and Agate Bridge Comfort Stations.

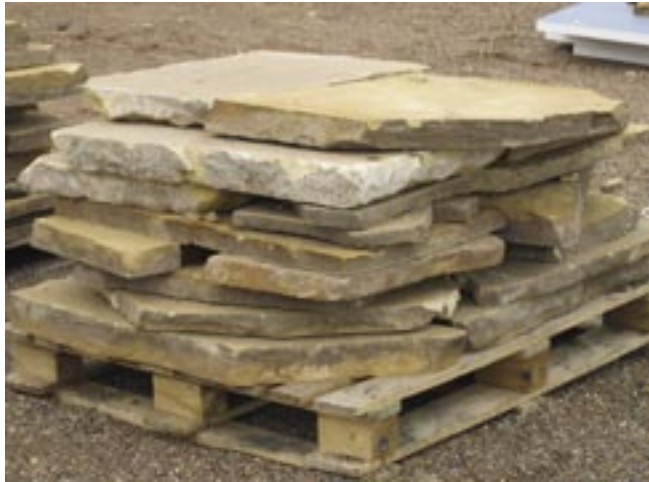
Natural material, such as this sandstone recently removed from the patio at the Painted Desert Inn, should be reused. *Photo from park*

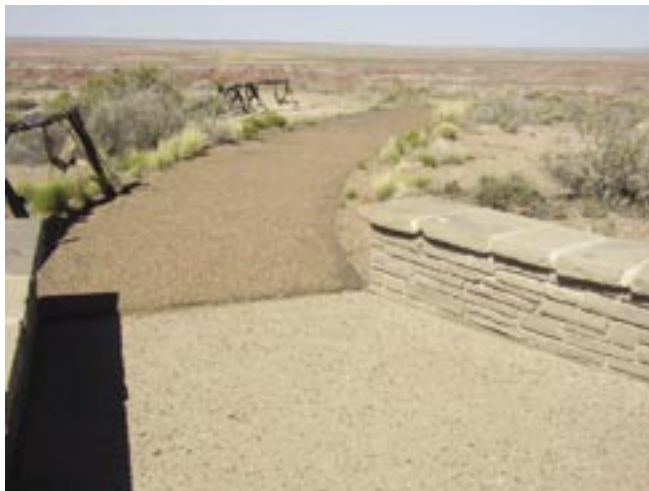
A smooth transition at a change in materials. In this example from Tawa Point, the edge of the exposed aggregate concrete walk aligns with the end of the low wall. *Photo by author*

Another technique that can be effective to integrating different materials into the landscape is to make transition points where other design features are being resolved. For example, changes in paving materials can easily be accommodated where landscape walls are terminating or where the trail approaches or leaves an important physical feature in the landscape.

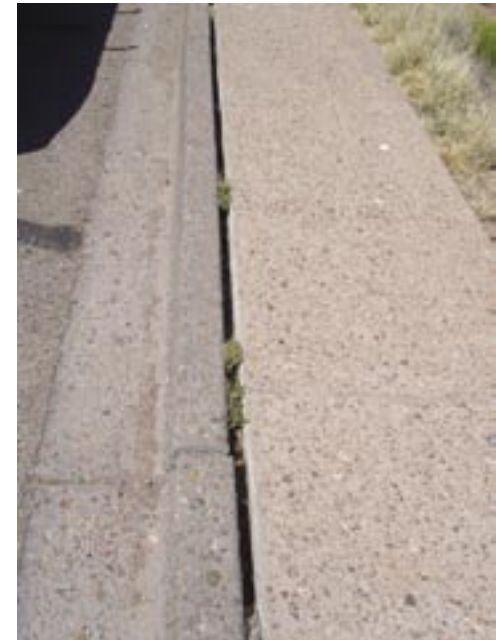
Exposed aggregate curb and gutter at Whipple Point. Note how use of exposed aggregate concrete for the curb relates to the adjacent walk. *Photo by author*

Curbing provides a transition between surfaces that are separated by a minor change in elevation. Curbing can be integrated with an adjacent paving surface, as is the case with many concrete curb and gutter systems, or constructed separately.

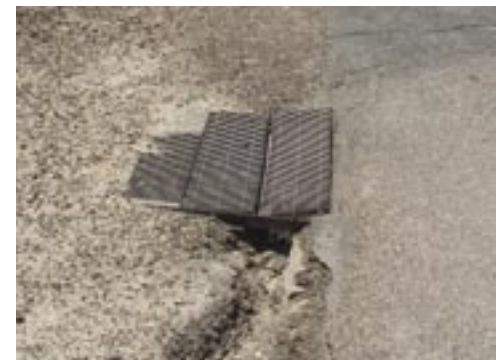
Tripping hazards, such as this drainage grate, should be properly maintained. *Photo by author*

Drainage devices, such as grating and culverts should be properly installed and maintained to eliminate tripping and so as not to detract from the quality of trail. Depressions should be carefully constructed to avoid areas where erosion and potholes could develop.

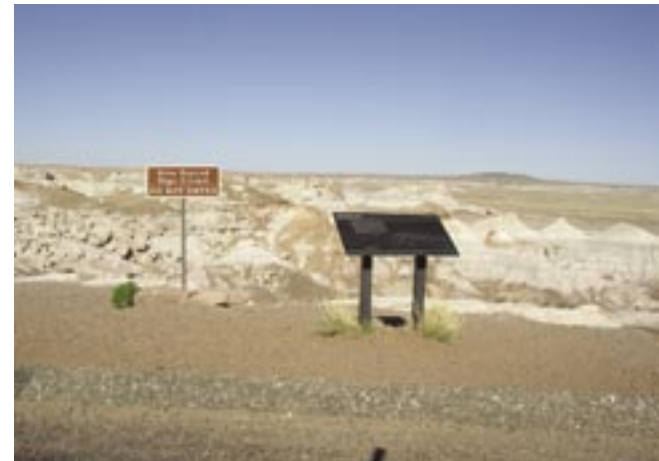
The brown “Do Not Enter” sign appears more important than the interpretive sign at this overlook at Blue Mesa. The warning sign should be smaller and the content edited to be more minimal.

More problematic, however, are regulatory signs that, more often than not, are ill conceived and dominate the signscape of the park. Regulatory signs typically warn visitors of prohibited activities, such as the removal of petrified wood or of restricted access to certain areas of the park. More often than not, these signs are large and prominently placed, appearing to the visitor as the most important information to be gathered while visiting the park. In addition to being out of scale with respect to the information being presented, these signs should be reworded to address visitors in a more positive way.

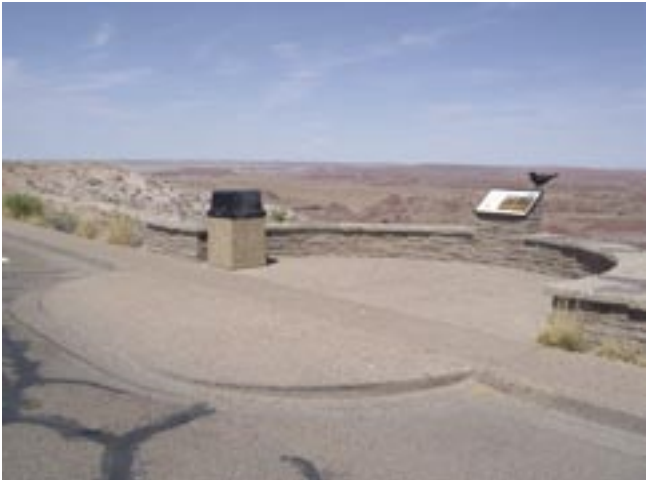
The interpretive sign at Lacey Point is effectively integrated into the landscape walls. *Photo by author*

Along with deciding upon the hierarchy of signs at each pullout and overlook, it is important to consider the sign's placement, including the possibility of integrating it into adjacent landscape features. In many areas, this has been effectively done through the construction of a raised platform within the landscape walls. In several cases, especially where pullouts are only partially developed, interpretive signage should be integrated with any future walls added at these locations.

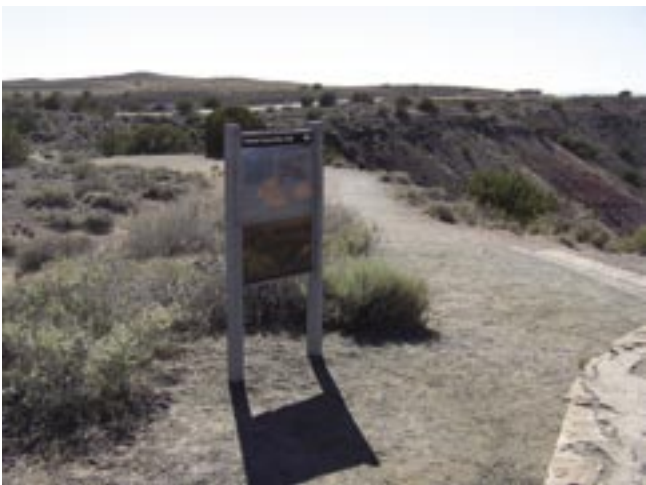
When signage cannot be integrated into other landscape features, it should be as unobtrusive as possible. While this sign along the rim trail may be a little too large, its placement away from major views is appropriate. *Photo by author*

When signs are placed away from developed pullouts and viewpoints, they should be as minimal as possible. Placing numerous large signs along trails should be avoided. The use of small, ground level signs is an attractive option and should be included in other areas of the park.

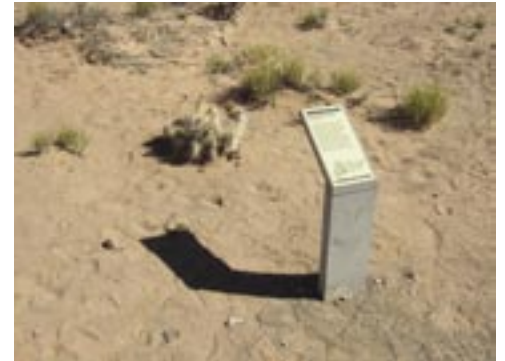
This small interpretive trail sign, located along the rim trail, is appropriate for the information it is presenting. *Photo by author*

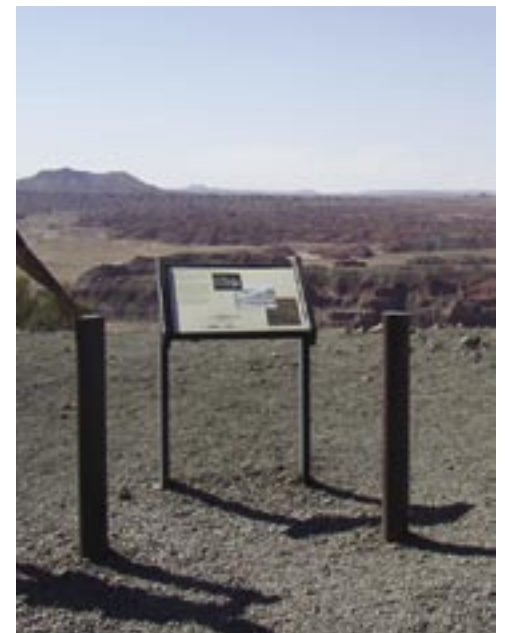
This interpretive sign at Chinde Point should be incorporated into a new landscape feature. *Photo by author*

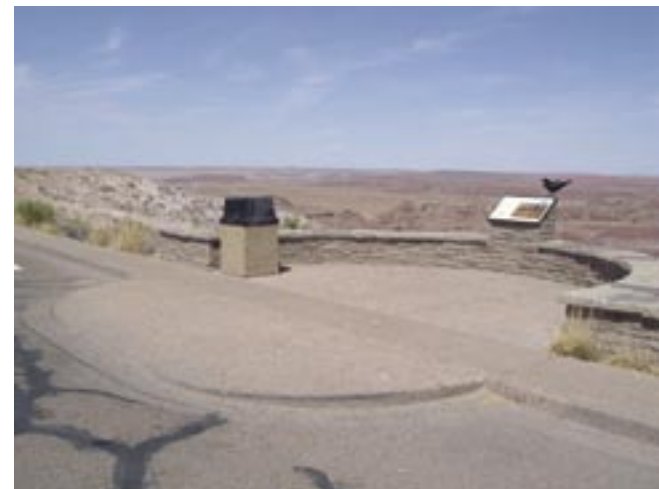
The difficulty of incorporating trash enclosures into existing walls is seen at Lacey Point. *Photo by author*

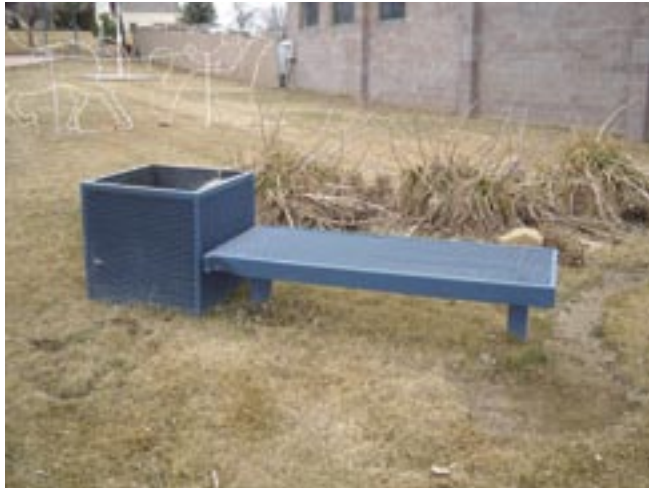
While this bench and trash receptacle would not be compatible with rustic elements in the park, it does show how several objects can be grouped together to create more harmony in the landscape.

Likewise, it may be possible to combine several functions into one well designed object. For example, it may be possible to combine a seating element with a trash receptacle and / or interpretive sign. Concentrating several elements together could be an effective way to plan for future visitor amenities and to bring disparate objects together to create a more unified whole.

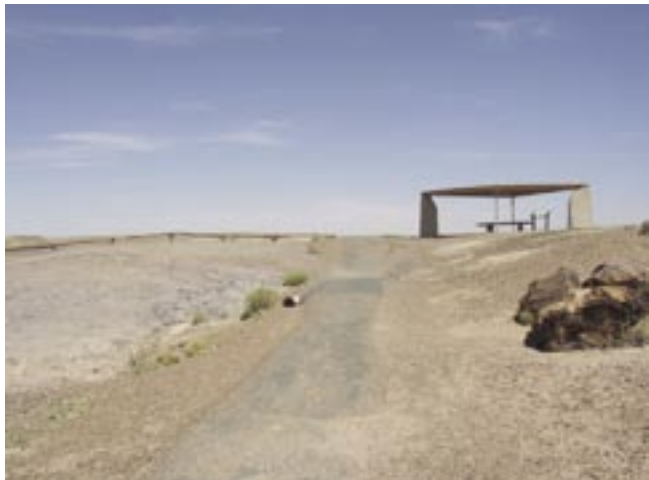
Shelter at Crystal Forest could be relocated to a less prominent location in the landscape. *Photo by author*

Besides the smaller objects found at turnouts and trailheads, there are several larger shelters that could be relocated or redesigned to be less obtrusive. In particular, the shelter at Crystal Forest is objectionable because of its placement above the parking area on a ridge. While having

visitors hike to this prominent location to take in the view is desirable, the placement of a large landscape element tends to dominate this area, drawing the visitor away from the wonderful features of the natural landscape in this location.

In lieu of moving the shelter, it may be possible to redesign the shelter to be less monumental. Constructing the shelter of lightweight and translucent materials could help ameliorate the condition of placing the shelter high on the landscape. Providing visitors a place with shade at Crystal Forest is of obvious benefit and the abandonment of a shelter should be replaced with some area that provides refuge from the summer sun.

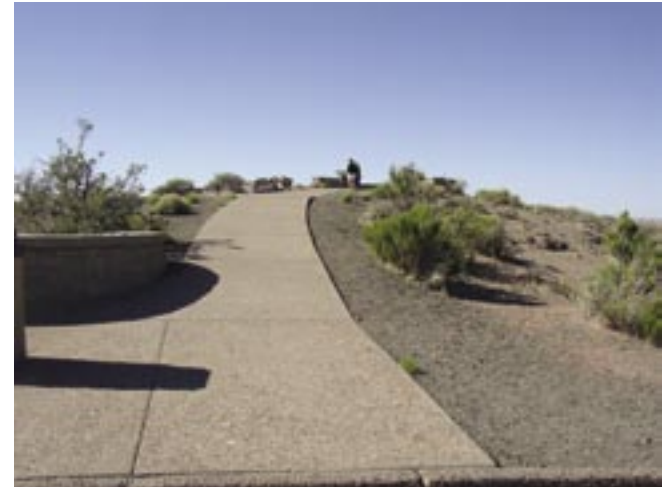
Draining water away from landscape walls and towards parking lots where it can be moved towards the natural landscape is a successful drainage strategy. *Photo by author*

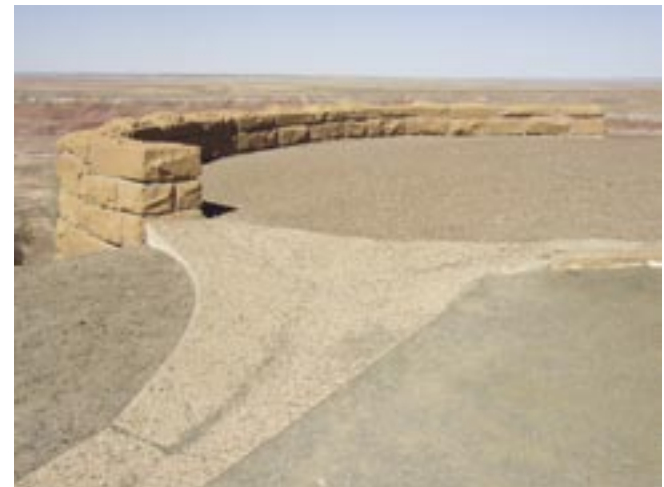
This simple drainage channel at Tawa Point is integrated into the paving material and moves water away from landscape walls. It is also visually pleasing and compliments the color and texture of the wall and paving. *Photo by author*

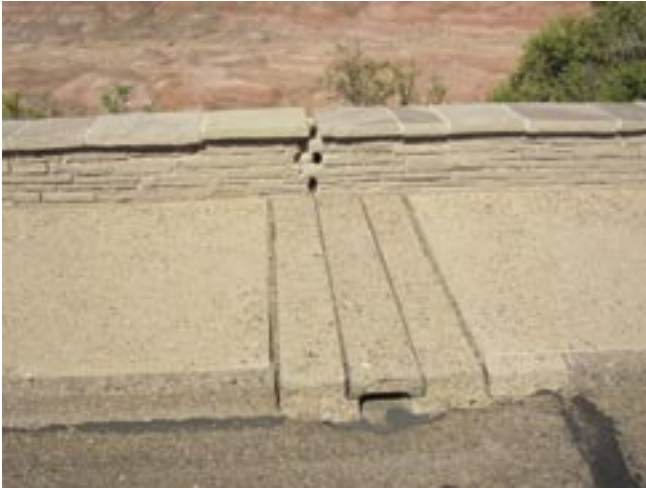
Draining water under this landscape wall at the “no-name” turnout likely caused the crack in the wall to develop from movement in the soil. *Photo by author*

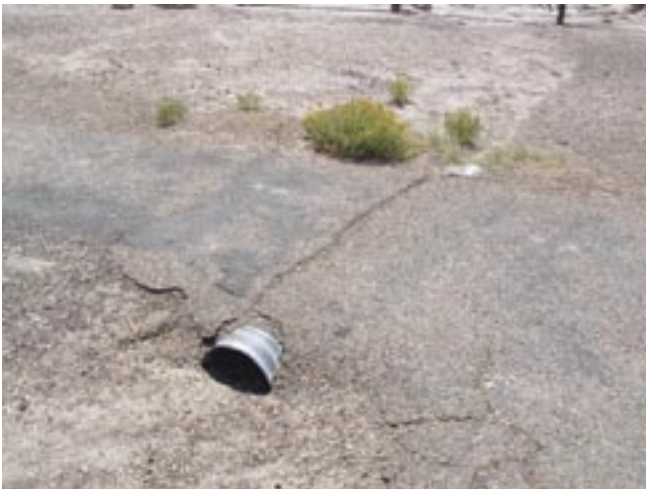
Culverts should be integrated into trails with installation appropriate to prevent tripping and provide aesthetic appeal. This exposed ends of this culvert make it more obtrusive than necessary. *Photo by author*

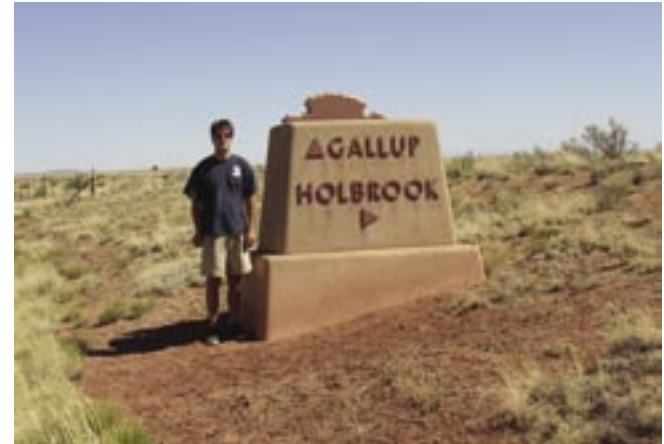
This roadside sign directing visitors to Interstate 40 near the Painted Desert Community Complex is simple with bold forms and graphics. *Photo by author*

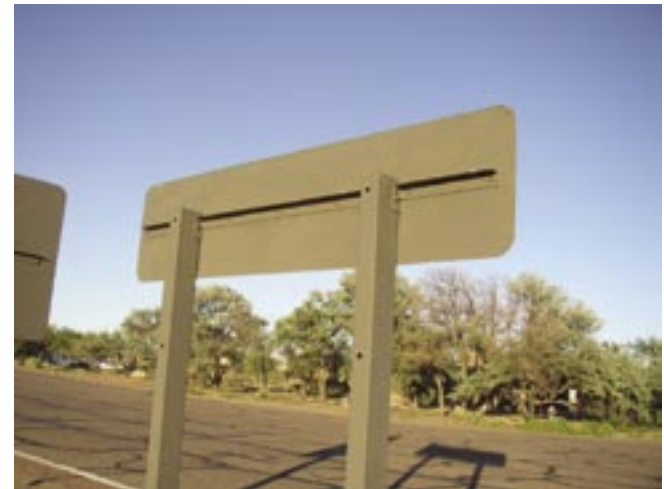
Standard roadside signage should follow NPS standards. The back of roadside signs should be painted to blend with the natural environment. *Photo by author*
