Maintenance Guides for the Treatment of Historic Properties

Petrified Forest National Park

Andrew Gorski and Michael Lovato

June 2005

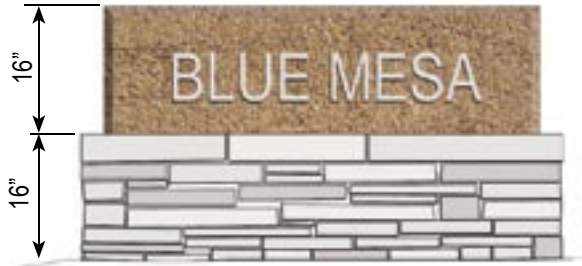
Stone base / exposed aggregate concrete top with painted alum. letters

- Combines existing elements of the park roadside landscape

The designs found on the proceeding page suggest a few appropriate designs for turnout signs in the park. The forms and materials of these signs are based on existing signs and landscape elements found in the park. While it may be desirable to use one sign design throughout the park, the variety of materials and landscapes in the park could support a combination of sign types if the overall format and execution of the signs was consistent.

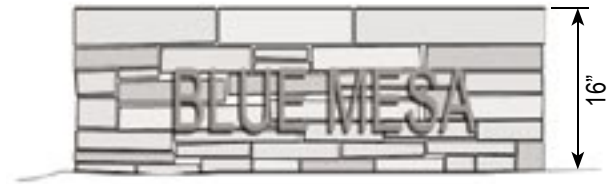
Stacked stone sign with painted aluminum letters

- Appropriate where stone is the predominant landscape element along the park road

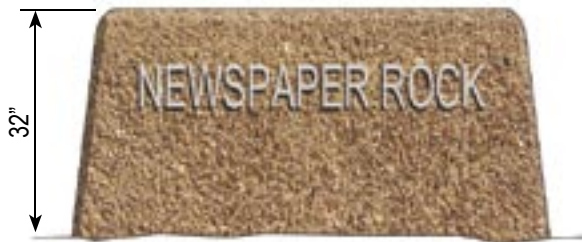
Exposed aggregate concrete sign with painted aluminum letters

- Compliments elements found in the signs at the north end of the park

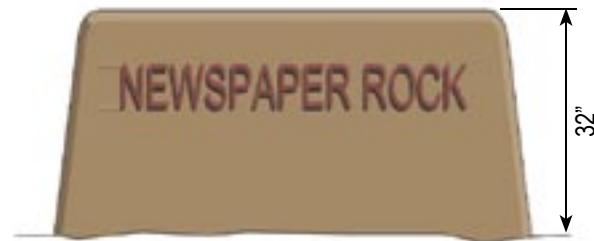
CMU sign with stucco finish with painted aluminum letters

- Simple and cost effective sign compliments existing signage and natural features in the park

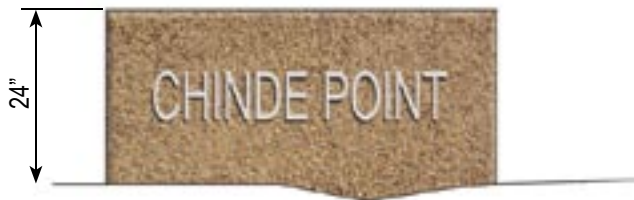
Exposed aggregate concrete sign with painted aluminum letters

- Compliments elements found in the signs at the north end of the park

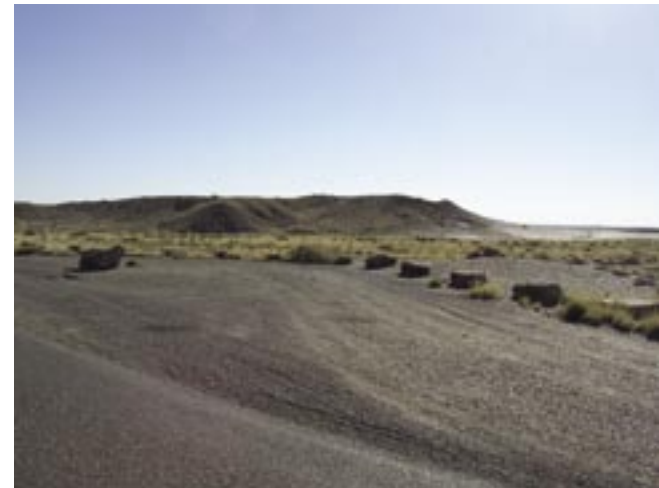
Using large objects, like petrified wood, to keep vehicles from leaving park roads has been used successfully in the park. While the use of petrified wood is no longer possible due to management guidelines restricting its movement the use of boulders may be a possible alternative. *Photo by author*

The use of large objects that sit low to the ground, such as boulders, should be explored as a means of protecting sensitive areas from vehicular access. While it is possible that many visitors will simply run over a stone barrier, there is probably no solution, short of constructing guardrails, that will keep areas completely protected from vehicles.

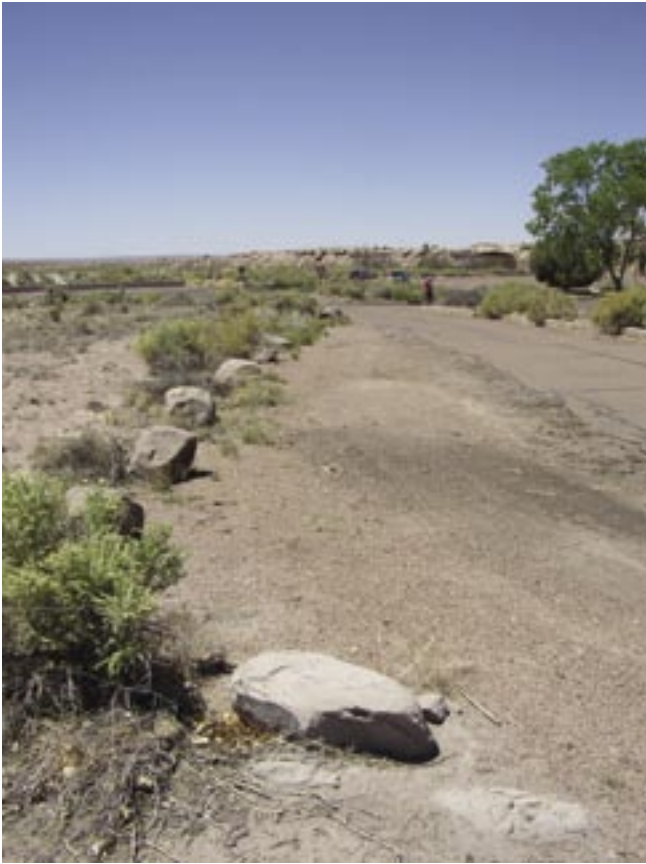
This barricade created from boulders is one possible means of preventing vehicle access to sensitive areas. *Photo by author*

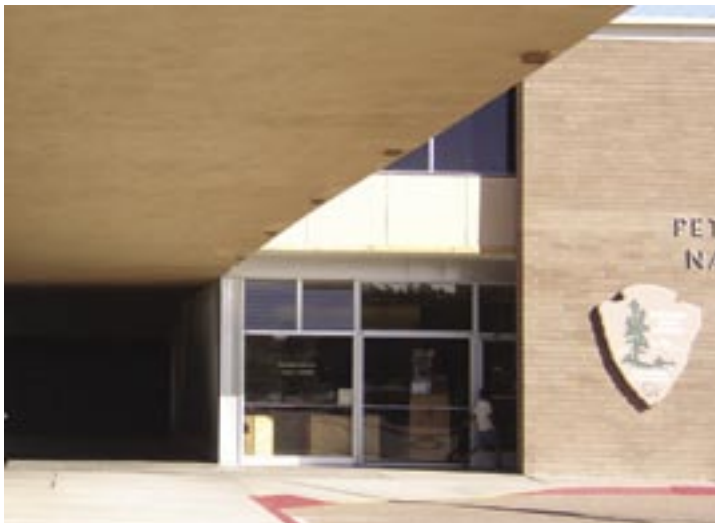
Aluminum storefront systems hold up very well with proper maintenance and cleaning. 2004 Photo by author

Regular cleaning will help to prolong the service life of aluminum by retarding corrosion. Mild cleaners, such as soaps, detergents, solvents, and emulsions can be used to remove loose grime. More aggressive soaps and detergents can be used to remove grime where milder cleaners are not successful. Heavily soiled aluminum may be cleaned with abrasive cleaners, polishes, or etching chemical cleaners at a risk of damaging surface treatments. Strong alkaline and acidic cleaners should be avoided.

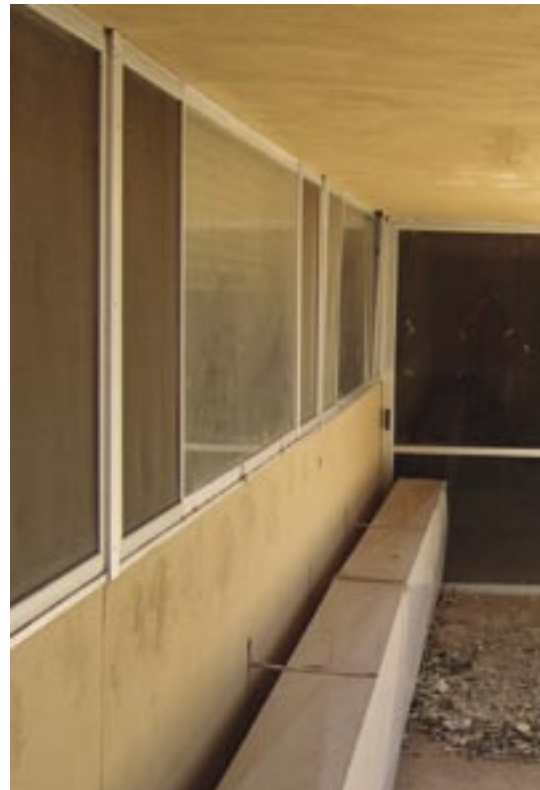
Often it is the case that it isn't the failure of the window itself that is the problem at the PDCCHD, but the failure of the window due to shifting soil conditions. 2004 Photo by author

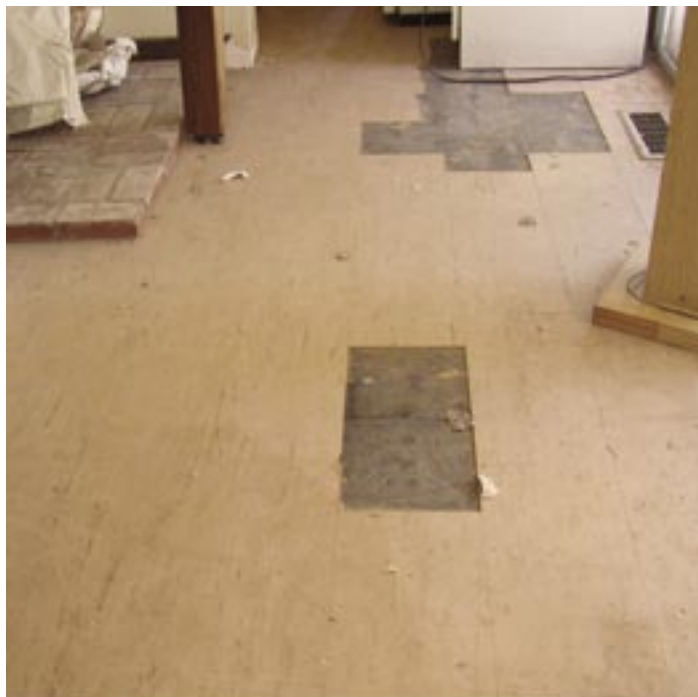
Floor tiles installed prior to 1980 are likely to contain asbestos. Floor tiles are considered non-friable. 2004 Photo by author

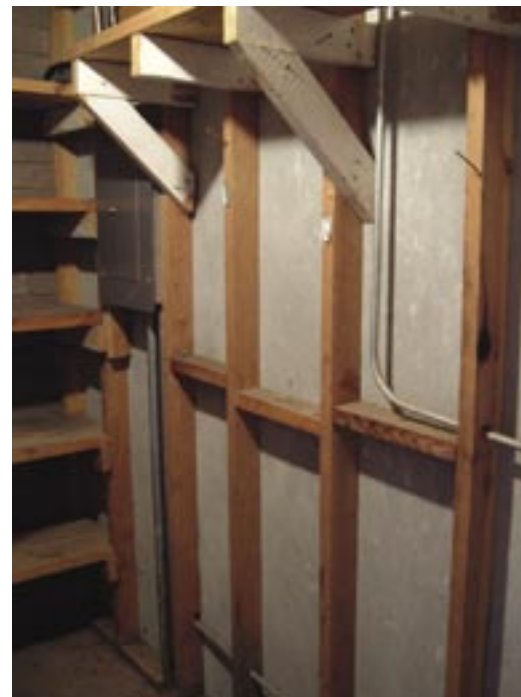
It is likely that wall panels used in the Painted Desert carports and gatehouse contain asbestos. 2004 Photo by author

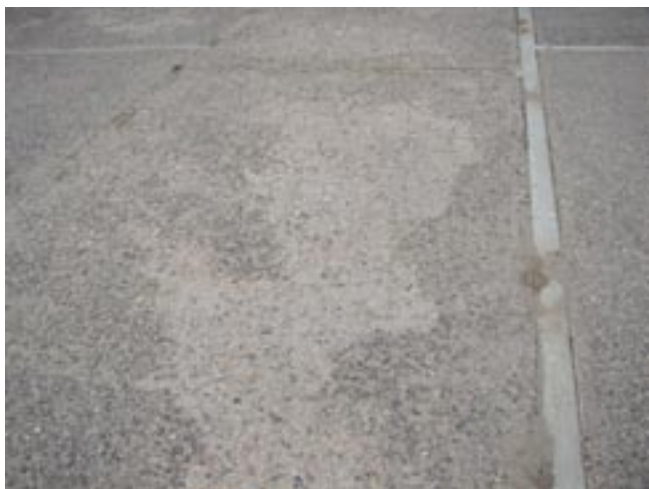
This concrete surface is uneven and the exposed aggregate has been loosened and removed by foot traffic and weathering.

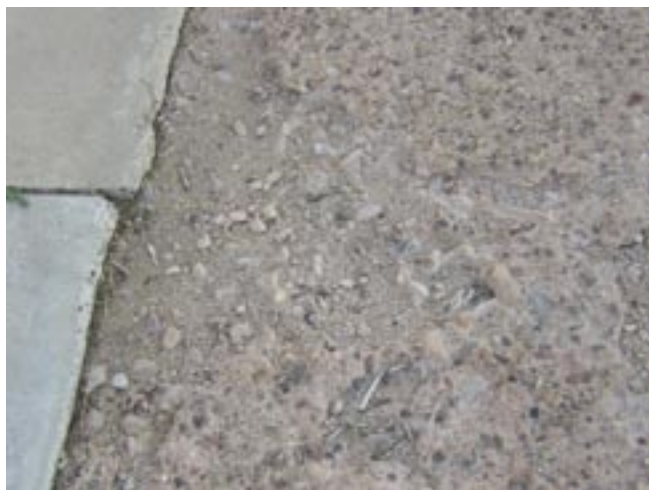
The unevenness of the surfaces in the PD Plaza does not meet accessibility guidelines and is a tripping danger to park visitors.

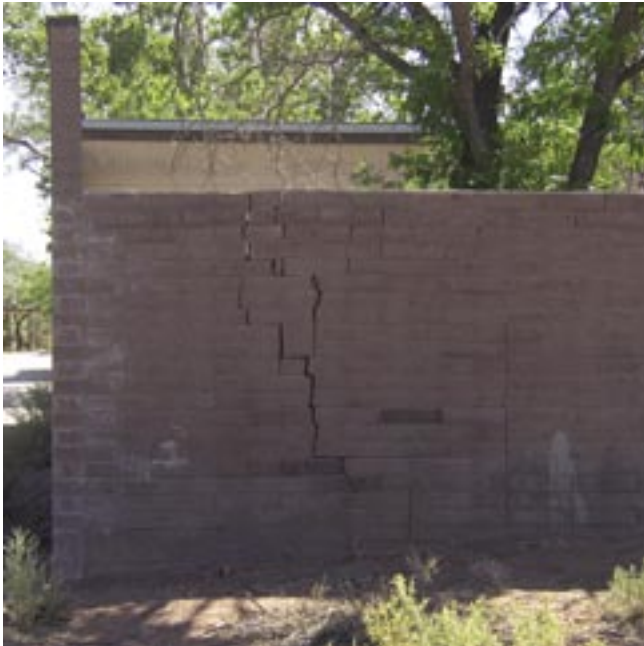
Cracks in this wall are typical of those caused by the significant heaving and settlement of soils throughout the Painted Desert Complex. Damage to this wall is so severe that this wall cannot be repaired in place and should be reconstructed. *Photo by author*

Figure 1: Cracks in this wall are typical of those caused by the significant heaving and settlement of soils throughout the Painted Desert Complex. Damage to this wall is so severe that this wall cannot be repaired in place and should be reconstructed. (photo by author)

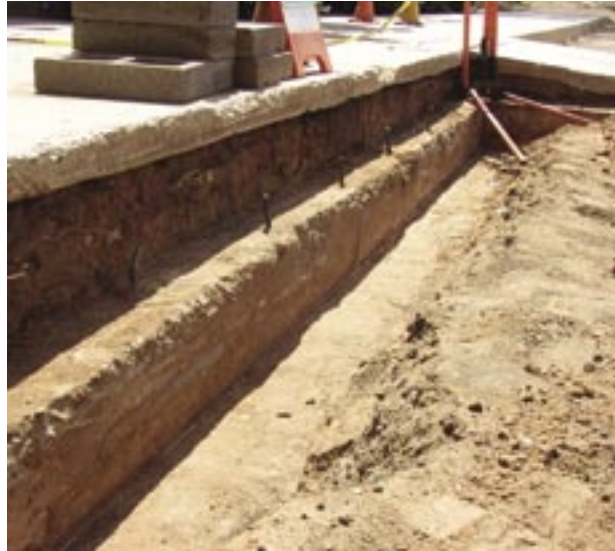
Footing and reinforcing should be adequate to support CMU. Verify footing depth and reinforcing with a structural engineer before starting new walls. *Photo by author*

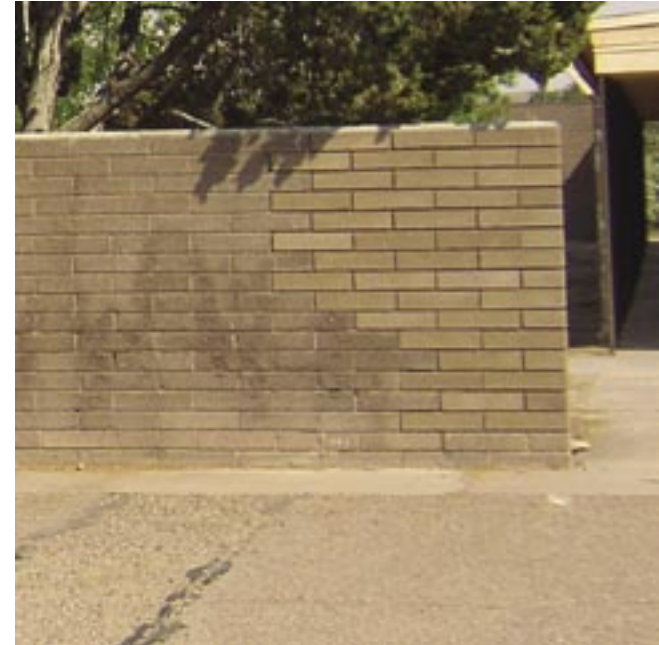
Inappropriate repair. Replacement block is randomly "toothed" into existing wall. Color and texture of the new block is emphasized by random replacement pattern. A more distinct separation, including a control joint, should exist between new block and the historic block.

Figure 4: Inappropriate repair. Replacement block is randomly "toothed" into existing wall. Color and texture of the new block is emphasized by random replacement pattern. A more distinct separation, including a control joint, should exist between new block and the historic block. (photo by author)

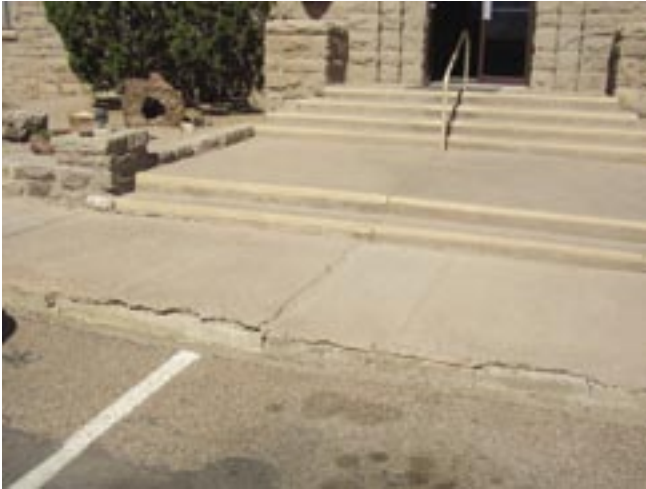
A flush joint should exist between historic sandstone curbs and concrete walks. The concrete should be removed from this curb in front of the Rainbow Forest museum. *Photo by author*

When repairing or replacing walks at Rainbow Forest, it is important to not damage or disturb the historic sandstone curbs. New concrete should be flush with historic curbs and damage to curbs should not be repaired with concrete. If curbs cannot be repaired, they should be replaced with a unit of similar color, texture and dimension.

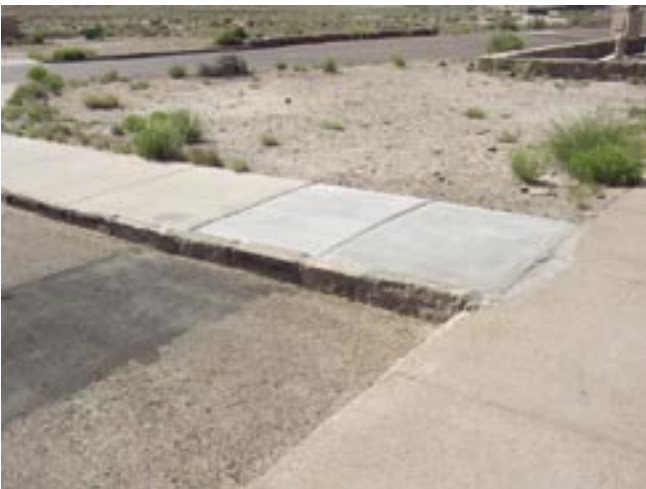
New concrete walks should match the color and texture of existing concrete walks. Here, the color of the new concrete patch has not been closely matched to the existing. *Photo by author*

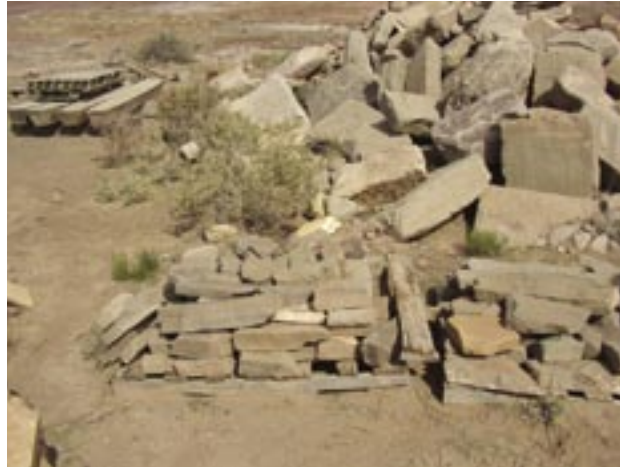
A good source for historic sandstone is the boneyard. It is best to replace historic curbs, in-kind, rather than with a new material that does not match the color or texture of the historic stone. *Photo by author*

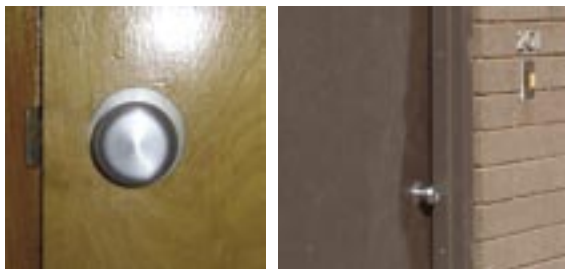
Original door hardware used on natural wood doors or aluminum frame doors has a satin anodized finish. Hardware used on hollow metal doors has a bright chrome finish. 2004 photos by author

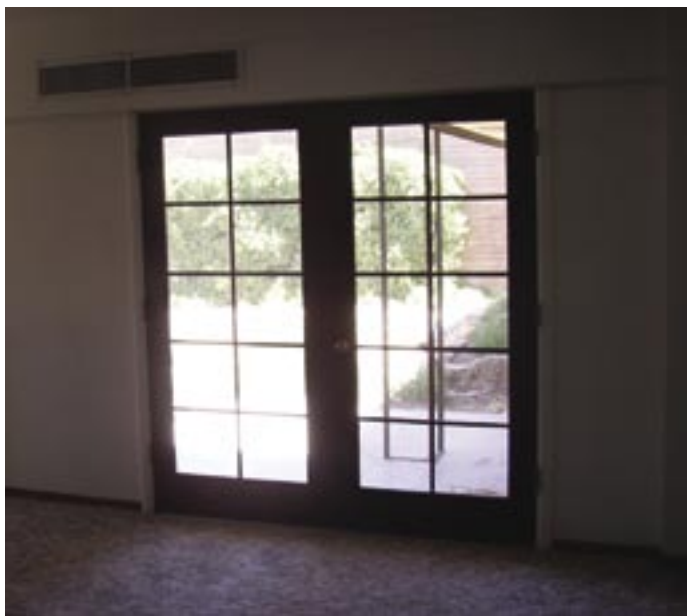
Originally there was a sliding glass wall where this set of doors are. While restoring the glass wall is not currently in the park's agenda, an attempt should be made to adhere as much as possible to the aesthetic of the original design. In this case that means removing the decorative mullions. 2004 photo by author

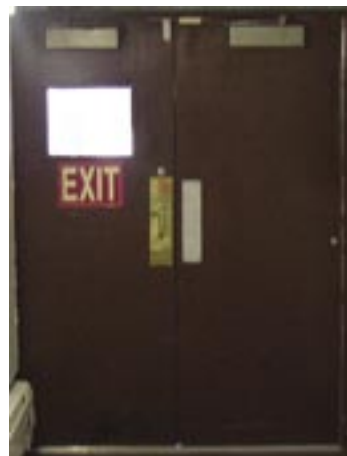
Either of these doors that separate the administration portion of PD 251 from the apartment portion would be appropriate. However, these doors should match. The hardware on the door on the left is inappropriate. There should no metal with a gold/brass finish anywhere in the Painted Desert Community Complex. 2004 photo by author

- Non-historic solid wood doors can be painted to resemble historic metal doors, as long as the two doors are not adjacent. Portions of the door that come in contact with other painted surfaces should not be painted.
- Doors that are inappropriate aesthetically should be replaced by doors that match the original door in design and material as closely as possible.
- All door hardware at Painted Desert should be anodized aluminum.

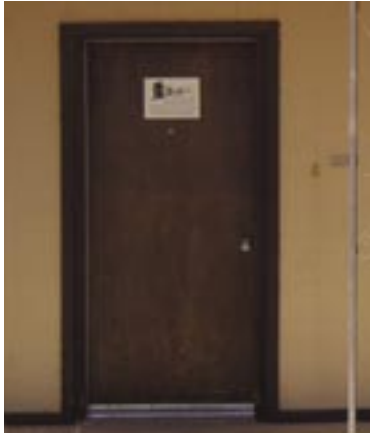
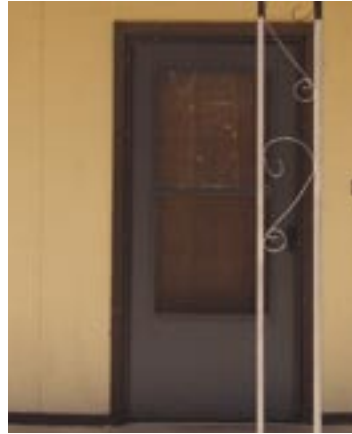
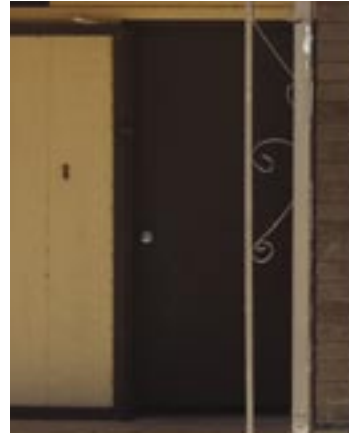
Since a strict restoration is not feasible for most of the Painted Desert residences, it is not necessary that all doors be of the original material. However, a sense of unity is not unachievable and should be strived for. These three doors along the south facade of residential block C vary greatly in materiality and appearance. All doors should be either screened or not screened, preferably using a lower profile screen door. Doors that are made from wood should be painted to match doors made of metal. All hardware should match. 2004 photo by author

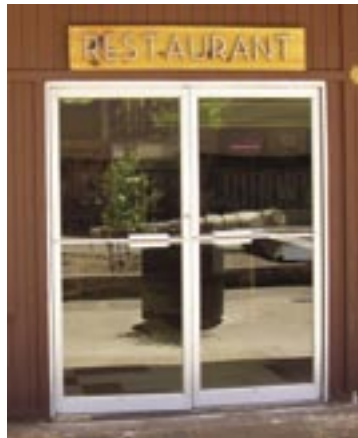
Aluminum Frame-These doors are used in public buildings between interior and exterior spaces. The exception is the sliding walls used in residences, now only extant in PD208. 2004 photo by author

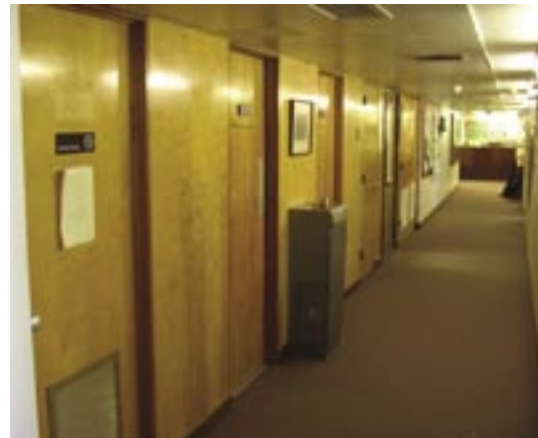
Natural Wood-These doors are used in all buildings between interior spaces. In most cases the door is associated with wood paneling. Careful attention should be paid to preserve these details when natural wood doors must be replaced. 2004 photo by author

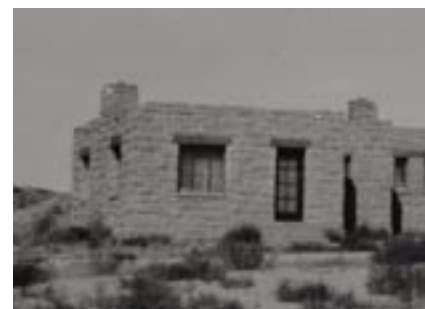
RF Employee Residence #52-A in 1938 showing a 8-lite exterior door. *PEFO Photo Archive #15678*

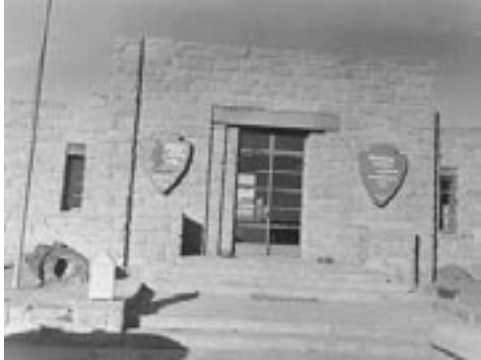
Rainbow Forest Museum original entry doors. PEFO Photo Archive #19097

The doors at the Rainbow Forest Museum are historically important. The main entry doors were originally steel with glass panels and a glass transoms above. The interior doors, many of which are still in place, are multi-panel steel and wood doors.

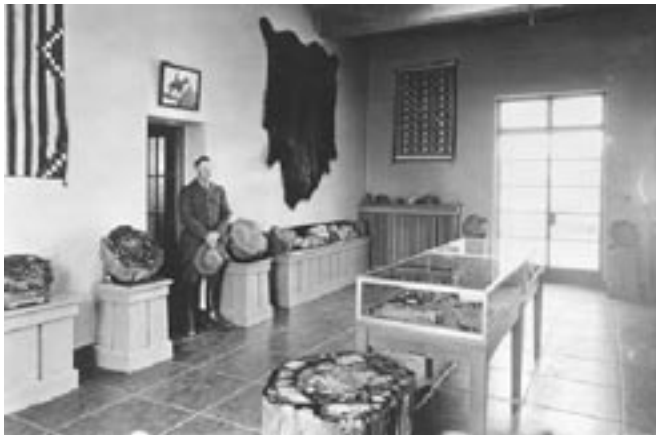
Interior of Rainbow Forest Museum looking towards the original entry doors. PEFO Photo Archive #15765

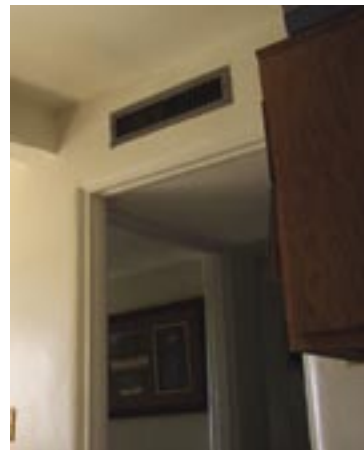
Typical interior door frame at RF residential units. Photo by author

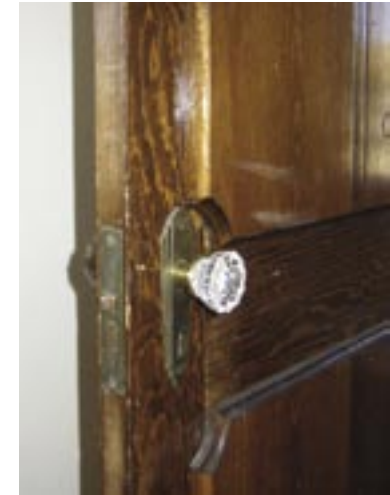
Historic hardware, such as this art deco inspired knob and escutcheon in RF #52-C should be preserved. New hardware should be complimentary in design and finish. Many suppliers manufacture reproductions of historic styles, such as Craftsman and Art

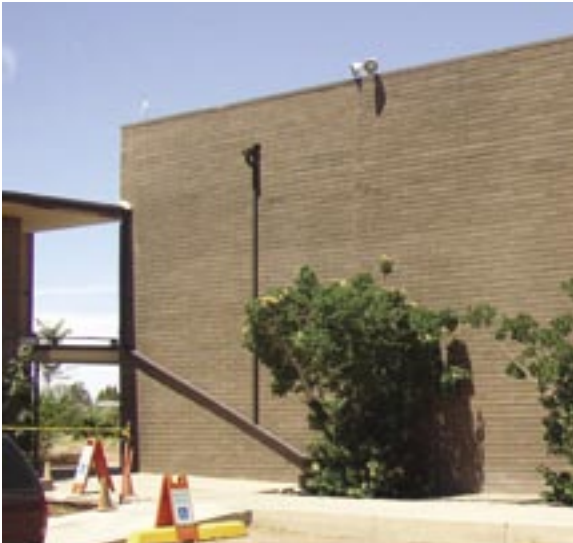
Because the Petrified Forest Community Complex was designed only using right angles, this downspout configuration looks especially out of place. 2004 photo by author

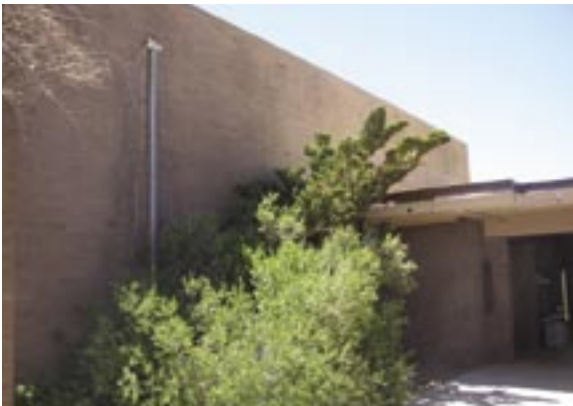
There are two problems with this downspout. One, it should be painted to better blend with the surrounding buildings. Two, there is an broken seal where the downspout leaves the roof that is causing damage to the wall beneath . 2004 photo by author

- If downspout / gutter is removed, repair any holes / damage caused by its removal appropriately.
- Work towards a unified drainage system
- Downspouts should compliment the aesthetics of the buildings attached to.

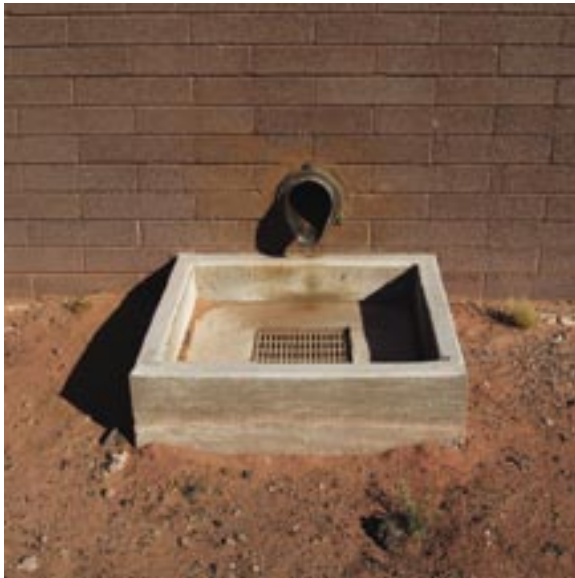
This water removal system, implemented on the Maintenance building, is well designed. Unsightly downspouts have been eliminated, the materials and components are durable and handsome, and the system was carefully inserted into the building. *2004 photo by author*

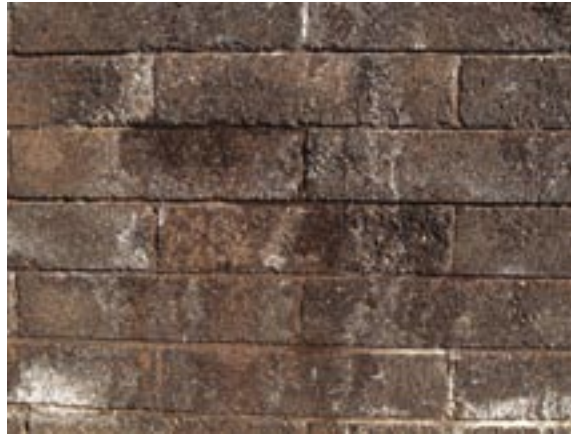
Efflorescence and deterioration caused by a sprinkler. See National Park Service Preservation Brief 1 for efflorescence removal information. *2004 photo by Author*

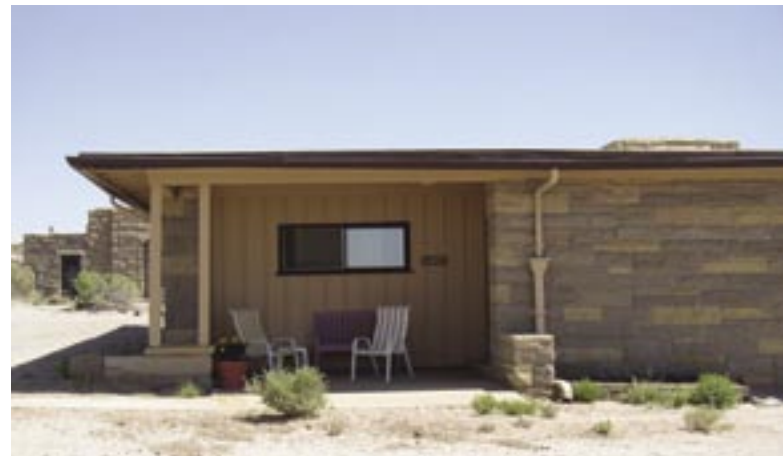
This downspout at Rainbow Forest complements the building it is serving well, but where is the water going? *2004 photo by author*

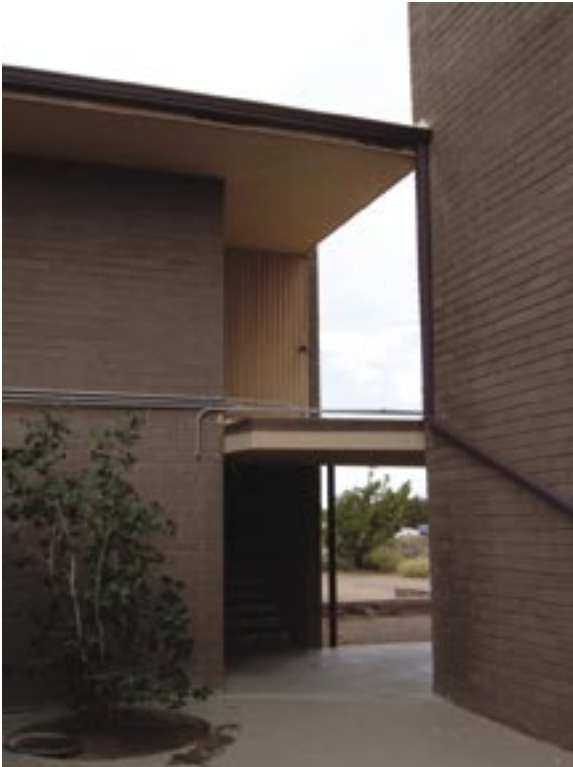
This confluence of conduits mars this architecturally significant building intersection. Horizontal conduit should be enclosed in interior ceiling or floor spaces and only exposed when necessary. *2004 photo by author*

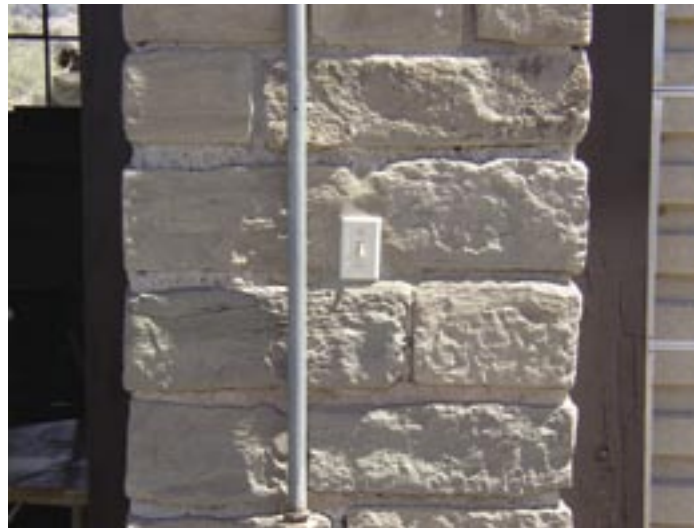
The insertion of this light switch at Rainbow Forest was carefully executed. But could it have been located less conspicuously? Also, the choice of a plastic switch and plate is out of character with the rest of the building. When an alteration to irreparable historic fabric is being considered, the greatest care should be taken to minimize its impact. *2004 photo by author*

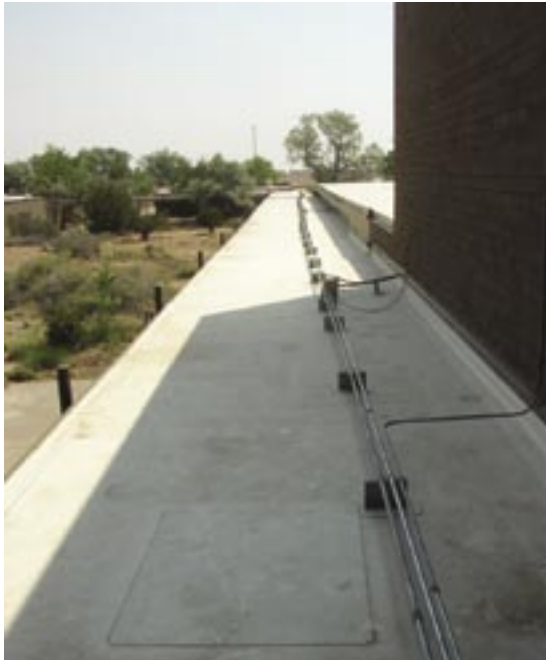
This conduit has been carefully placed along the top of the covered walkway at Painted Desert. Because it is raised off the roof it is protected from water damage, but still remains invisible from the ground. *2004 photo by author*

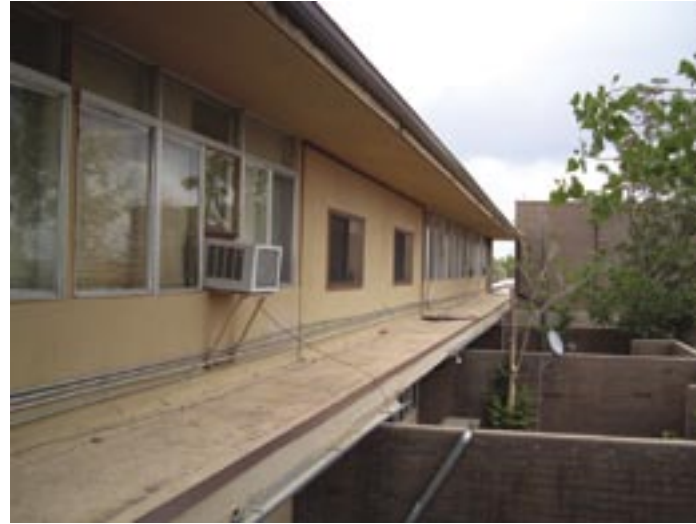
This conduit could have been run long the top of the overhang below, thus hiding it from view from the ground, as in the photograph below. *2004 photo by author*

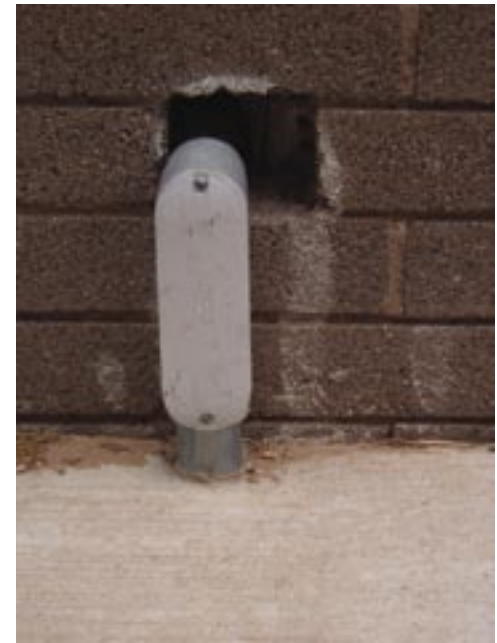
The insertion of this electrical equipment is unobtrusive in that it enters the building relatively low to the ground. However, much more of the masonry was removed than needed, then left exposed. This leaves the inside of the wall exposed to water damage. *2004 photo by author*

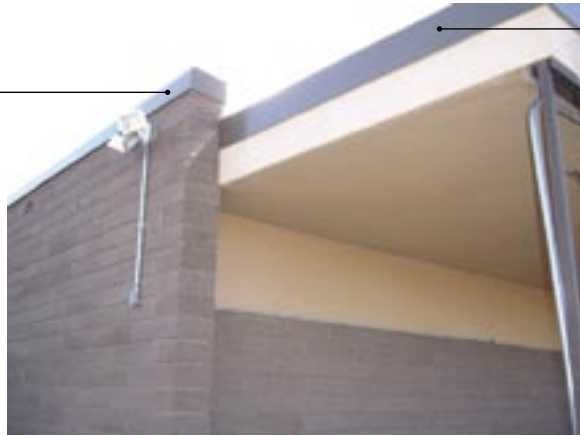
Coping should be 2 1/4"

Flashing should be 3 1/4"

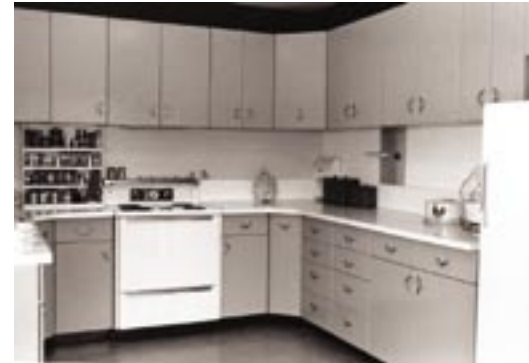
Original Youngstown Cabinets. PEFO Photo Archive photo by Stitt

Every effort should be made to maintain and preserve the original Youngstown™ kitchen cabinets. Not only do they add to the overall historic feeling of the Painted Desert Community Complex, but it is unlikely that any replacements currently within PEFO's budget will hold up as well as the original cabinets have for the last 40 years. If cabinets must be replaced, then a simple cabinet, either white or a solid, light color should be used. Wood cabinets with a light finish, similar to original wood doors used within the residences would also be appropriate. If a solid color cabinet is used, hardware from the original cabinets should be fitted to the new cabinets, as per PD205. Cabinets with a dark wood finish or with panels with decorative relief should be avoided. Counter tops should be of a solid, light color.

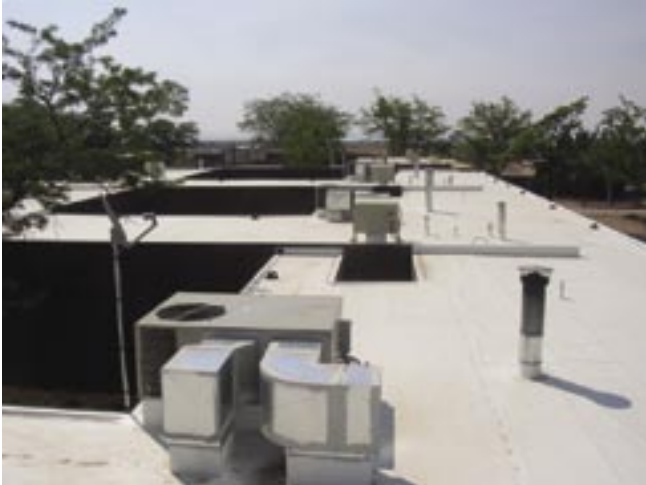
Many of the roofs at the park have lots of equipment and roof penetrations where water can find its way into the building. Flashing and curbs should be inspected to insure they are sealed. Furthermore, joints between membrane should be inspected.

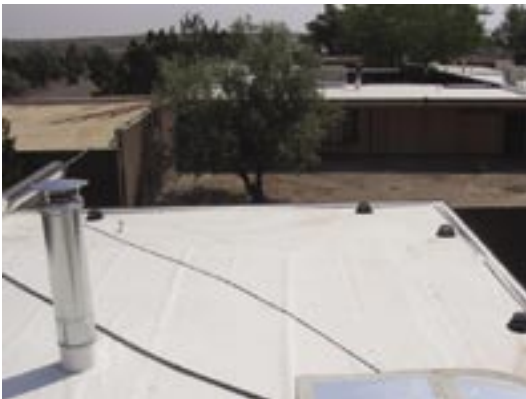
Inspecting roof drains should be completed each year to insure that they are working properly.

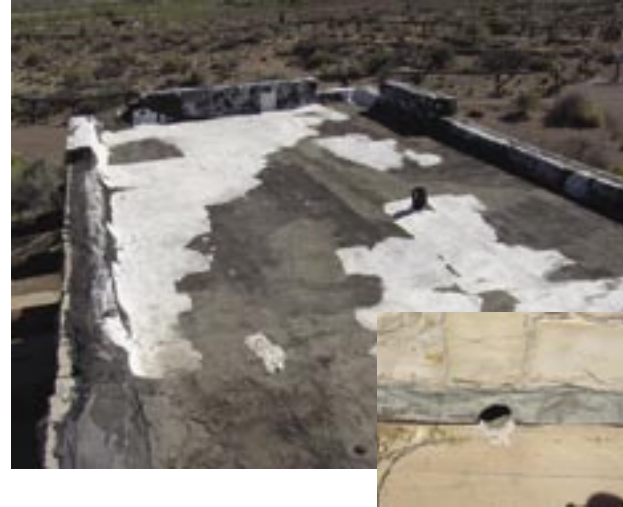
Some of the buildings in Rainbow Forest and along the park road have foam or built up roofs. The condition of roofs should be evaluated periodically. Roofs should be repaired before they reach the state of deterioration seen at Puerco Pueblo. Flashing is another critical component that should be inspected. At the Puerco Pump House, the copper flashing remains in excellent condition and has prevented water from entering this structure.

- Periodically inspect roofs looking for signs of damage, including low spots and ponding, loosened seams and loose and missing flashing.
- If gutters and downspouts are present, are they functioning correctly?

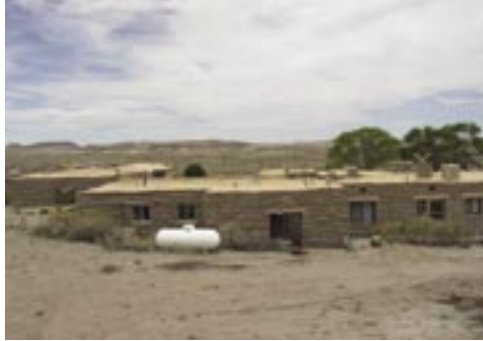
Because of the change in elevation at Rainbow Forest, many roof tops can be seen from public areas. New roofs should blend with the sandstone color of the walls and surrounding landscape, as best as possible. *Photo by author*

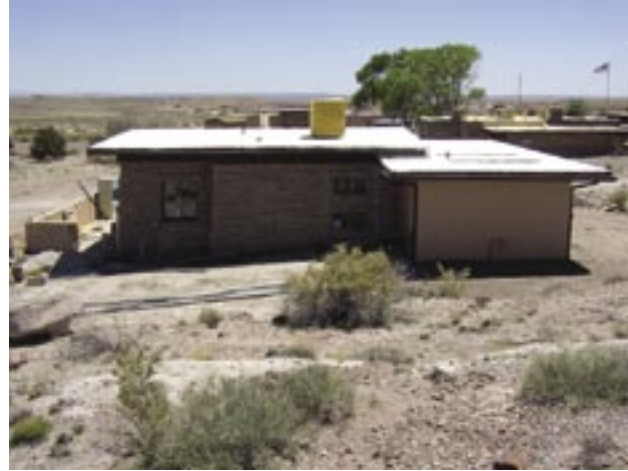
The glaring white color of this roof is inappropriate. A better color choice would be tan or a color that helps to blend the roof with the distant landscape

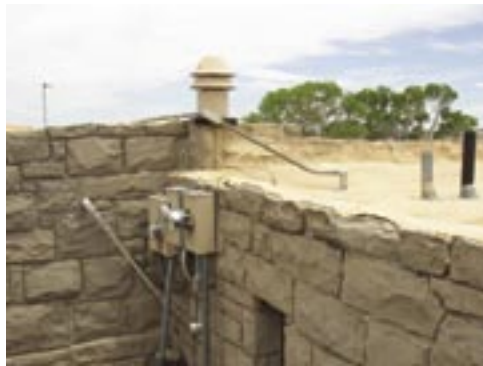
Detail of foam roofing applied to parapet.

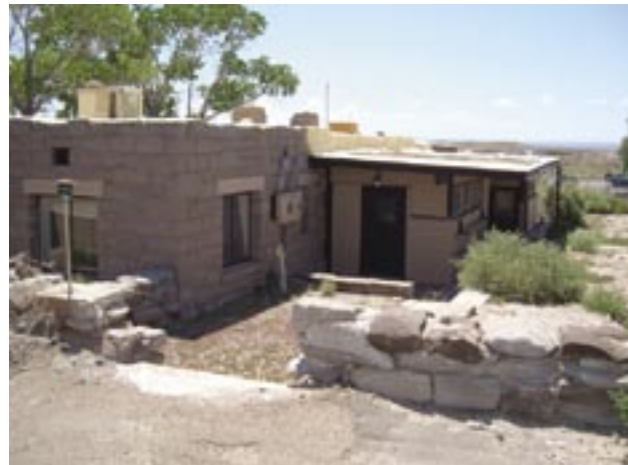
Foam roofing applied to the parapets and walls of buildings at Rainbow Forest should be removed carefully and with the assistance of an experienced professional. See Sandstone Masonry Cut Sheets for more info. *Photo by author*

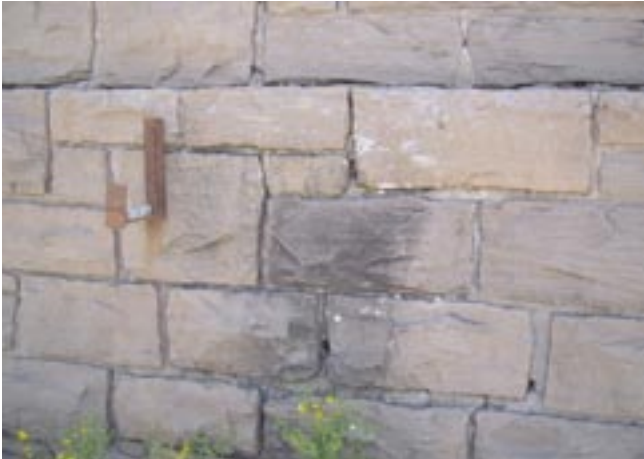
Stained areas of masonry walls should be identified. Taking note of what caused the staining is important to being able to remove the stains properly. *Photo by author*

- Identify areas of staining and deposits and their possible causes.
- Determine if the material to be removed safely without invasive means

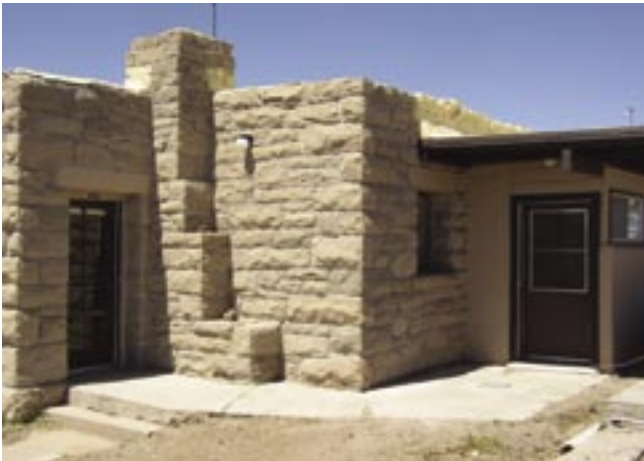
Foam roofing has been applied over sandstone parapets and to vertical sandstone surfaces throughout the park. Care should be taken when removing. *Photo by author*

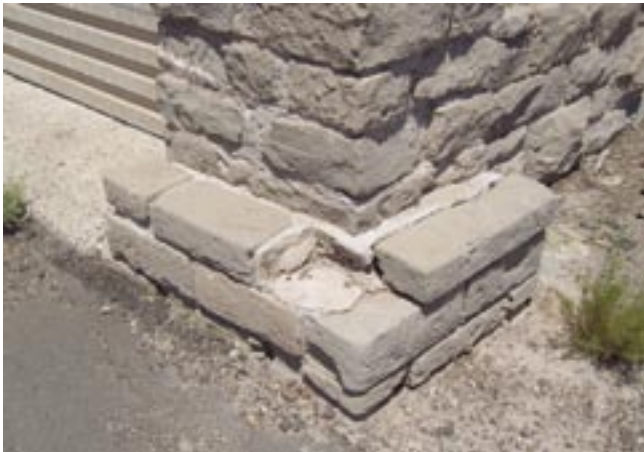
A periodic inspection of sandstone masonry should uncover missing masonry units and areas in need of repointing, such as those with loose and cracked mortar. The missing corner block shown in the above photo is allowing moisture to enter this building's corner.

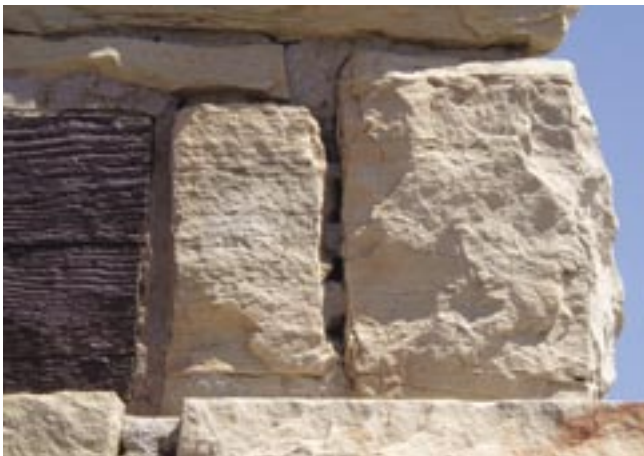
Inspections should identify areas of missing or loose masonry.

- Identify loose or missing masonry.
- Identify areas of missing or disintegrating mortar.
- Identify areas of soft sandstone that are spalled and may need to be redressed.
- Identify root cause of damage, including standing water.

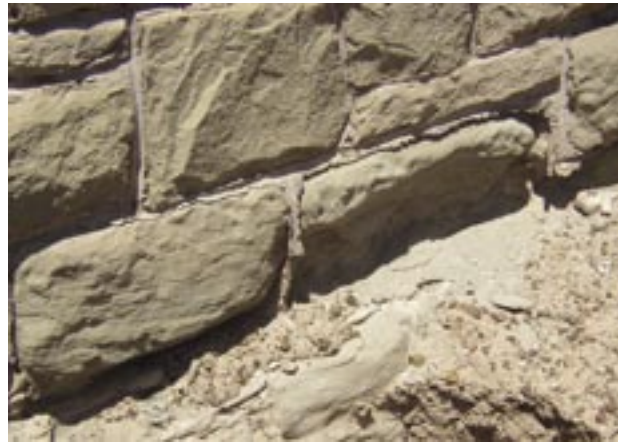
Areas of spalled sandstone caused by water damage should be identified. This sandstone block, on the east side of RF 51-A, will need to be redressed. *Photo by author*

- Determine a mortar mix that is chemically and visually compatible with the building.
- Determine level of treatment necessary to repair severely damaged or spalled sandstone.

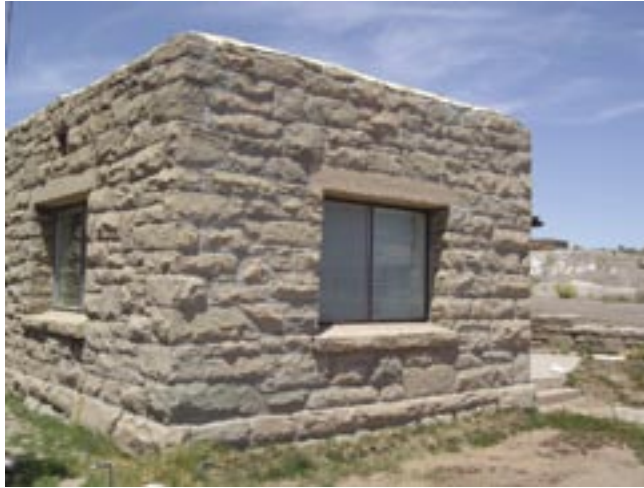
The color of the mortar should match the color of the original mortar. The use of gray mortar, as seen in the repointing of RF unit 52-C should be discontinued. *Photo by author*

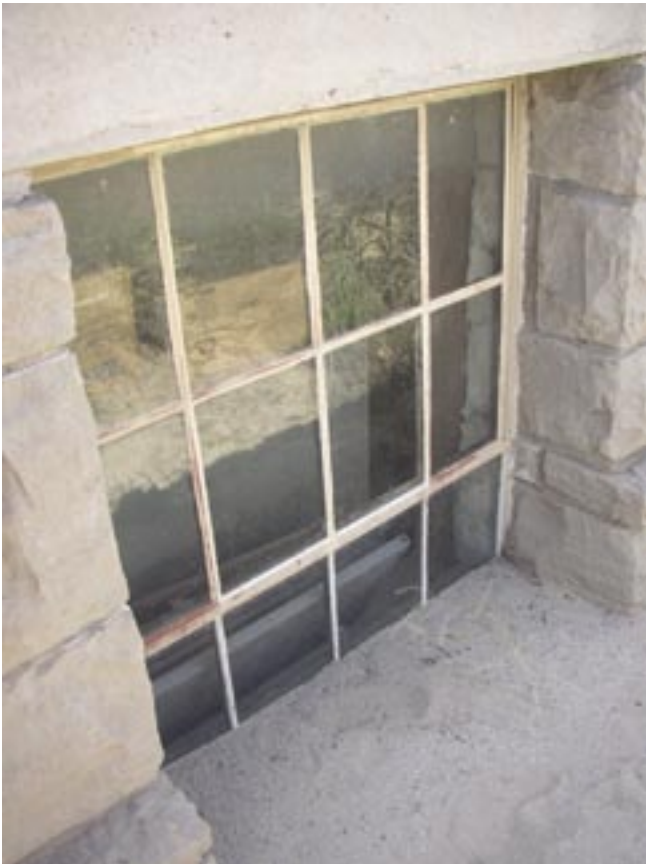
Blown sand should be periodically removed from the exterior of windows in exposed areas of Rainbow Forest, like this one on the north elevation of building 51-E. Sand against the window may also cause water infiltration and rust. Once sand is removed, the steel window can be properly inspected for damage to the frame and sash. *Photo by author*

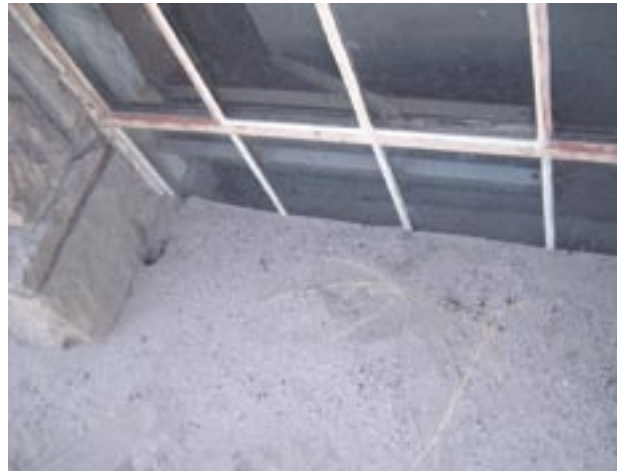
When deterioration is limited to surface rusting and flaking paint, simple techniques can be used to clean and preserve the steel. *Photo by author*

1. Removal of light rust, flaking and excessive paint.
2. Priming of exposed metal with a rust-inhibiting primer.
3. Replacement of cracked or broken glass and glazing compound.
4. Replacement of missing screws or fasteners
5. Clean and lubricate hinges
6. Repaint steel sections with two coats of finish paint compatible with the primer.
7. Caulk masonry surrounds with elastomeric caulk.

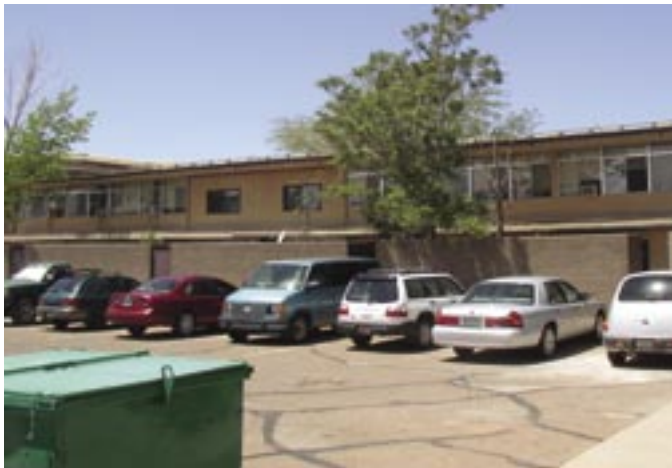
In many cases, in areas where a section of aluminum sash windows have been removed, such as this section of the apartment building, many nearby examples still exist to guide the selection of replacement windows. If no precedents exist to guide window replacement the original architectural drawings and specifications should be consulted when replacing a historic window for finishing details and product information. *Photo by author*

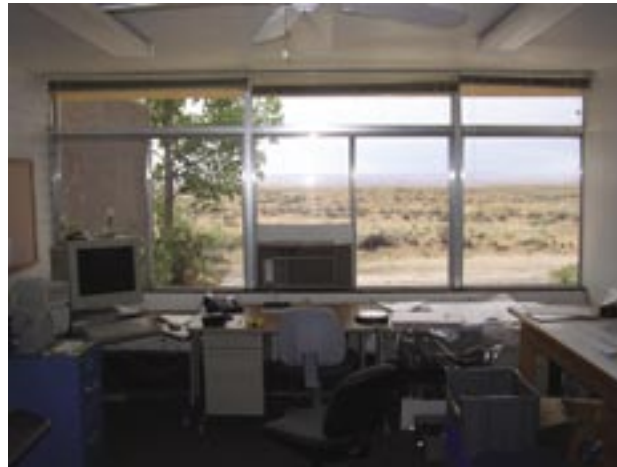
When preparing to replace windows at PDCCHD special care should be given to window size and proportions, frame depth and thickness, finish, and what sections of the window being replaced are operable or non-operable. *Photo by author*

- Replacement window shall be attached to a solid substrate.
- Window shall completely fill existing opening to within 1/2" tolerance
- Provide solid backer rod and caulk around window.

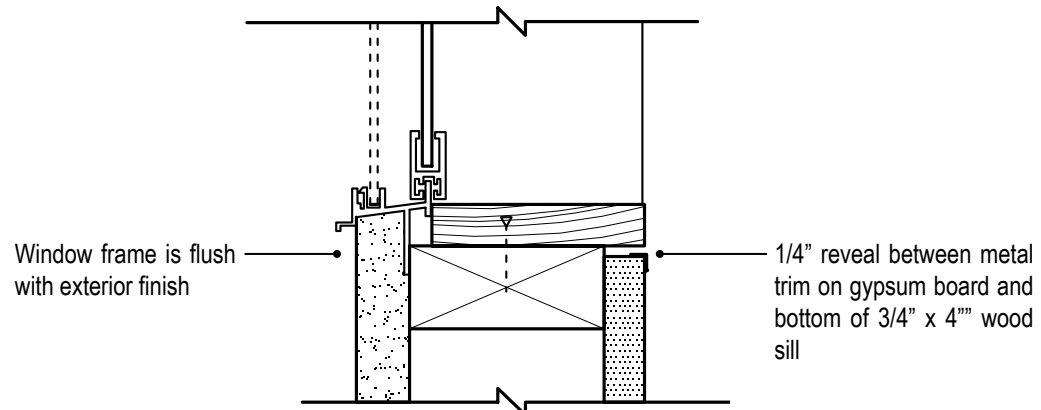
Typical PDCCHD historic aluminum window section. Generated from original window details from bedrooms in residences PD201-218

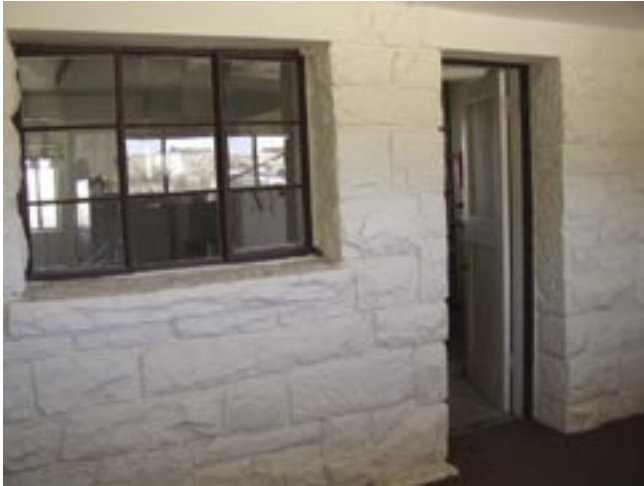
Original 9 pane window at Employee Residence #52-B.
Photo by author
