Maintenance Guides for the Treatment of Historic Properties

Petrified Forest National Park

Andrew Gorski and Michael Lovato

June 2005

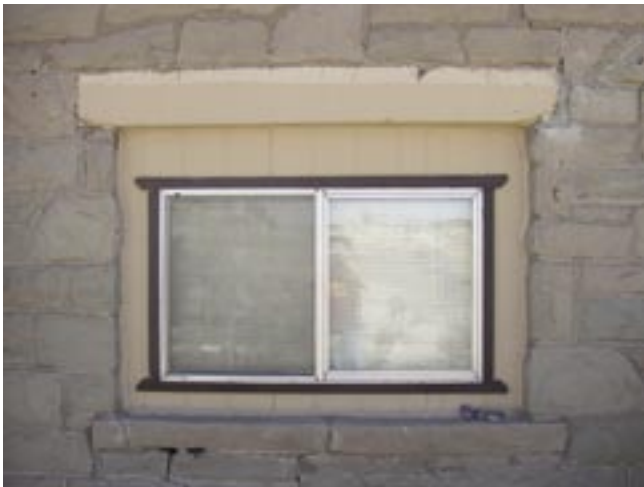
Inappropriate replacement. This aluminum replacement window is too small for the existing masonry opening. Replacement windows shall fill existing masonry openings and infill around windows shall be avoided. *Photo by author*

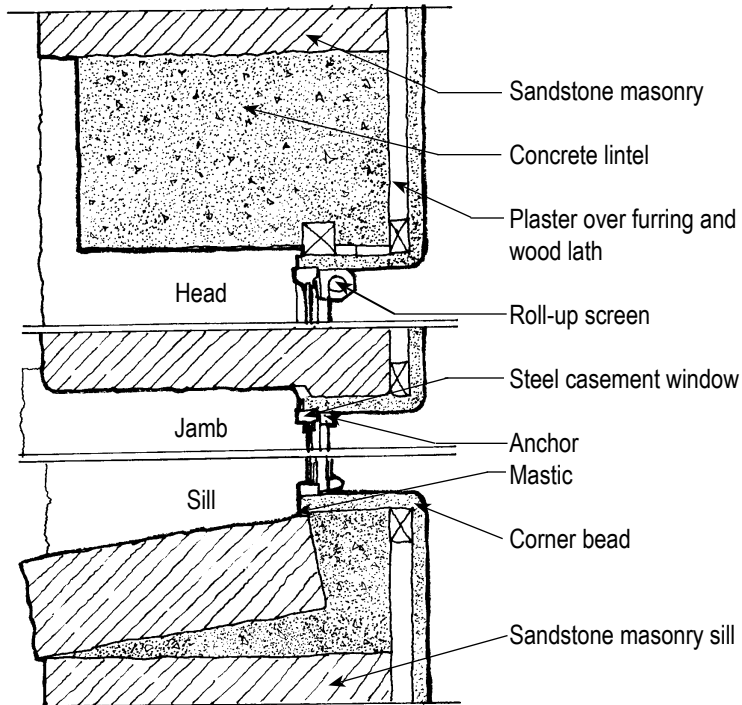
Detail of typical casement window at RF Museum. Note how window is recessed from exterior surface of sandstone masonry. Replacement windows should maintain placement and detailing of historic windows. Redrawn from original construction documents. Not to scale.

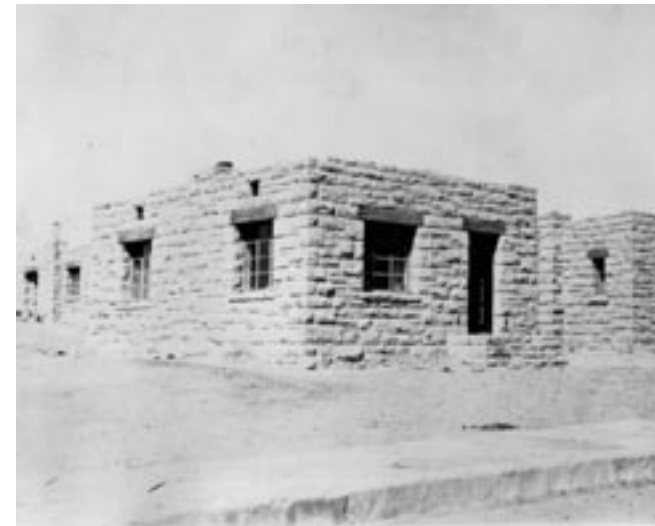
Historic photo of RF52-A showing original 9 lite windows. PEFO Photo Archive #15675

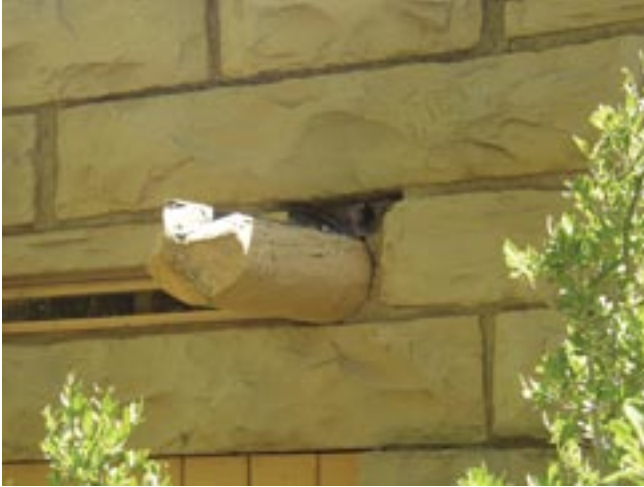
Existing viga end, with integrated canales, at Rio Puerco Comfort Station. *Photo by author*

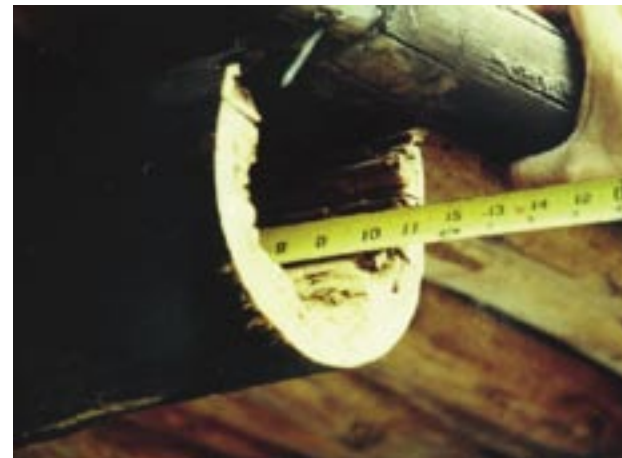
Measuring existing viga for correct diameter and length. *Photo courtesy Jake Barrow, NPS*

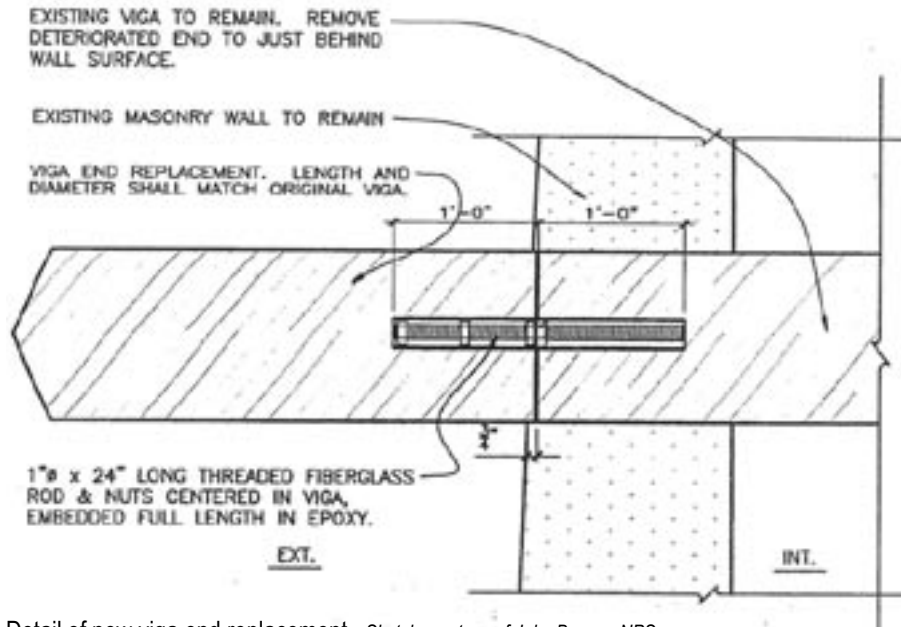
Detail of new viga end replacement. Sketch courtesy of Jake Barrow, NPS

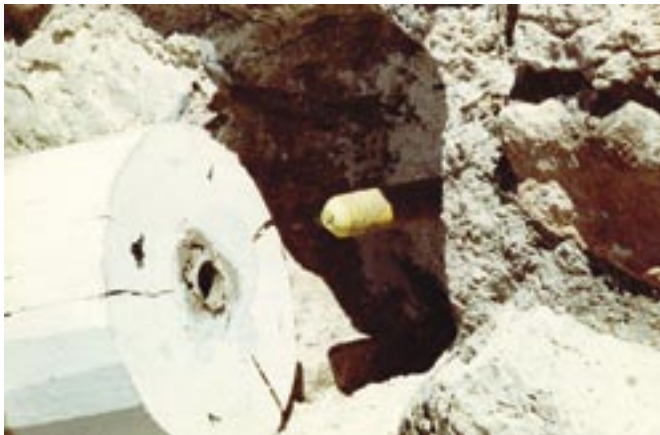
The viga end has been removed and a threaded rod has been set with epoxy into the existing viga. Note how viga end was removed just below the surface of the wall.

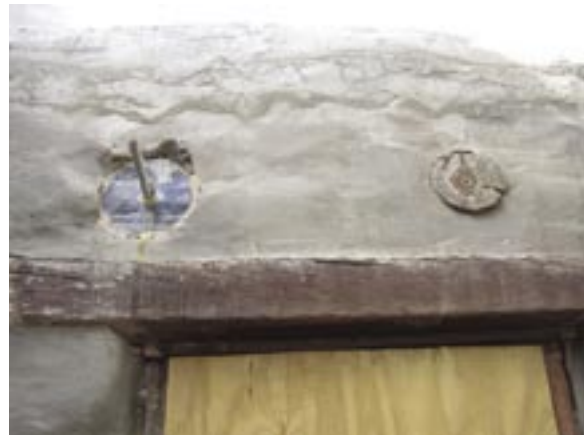
Surface prepared to receive new viga end. Photo by author

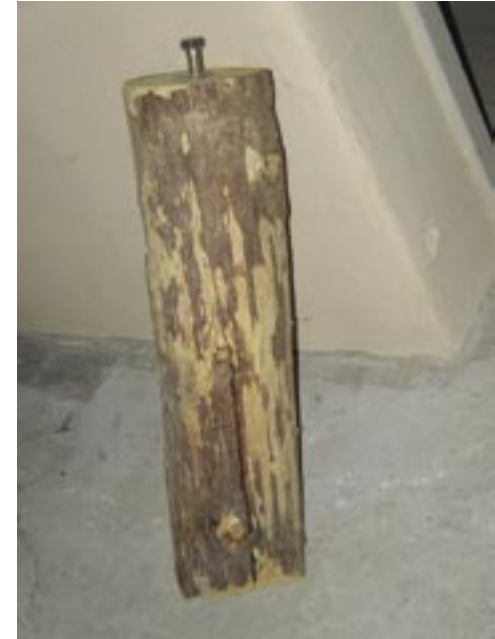
New viga end showing receptacle for receiving threaded rod. In this case, receptacle is being protected from damage with a bolt before installation. Photo by author
