# Honda Inova Fairfax Hospital CIREN Team

# The Role of Vehicle Size in Side Impact Head Injuries

Honda Inova Fairfax Hospital CIREN Center

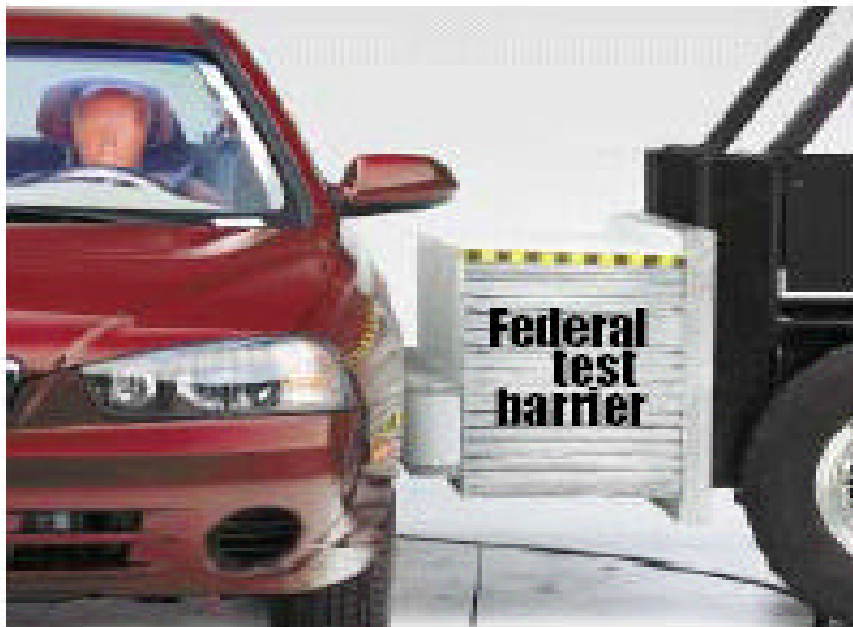
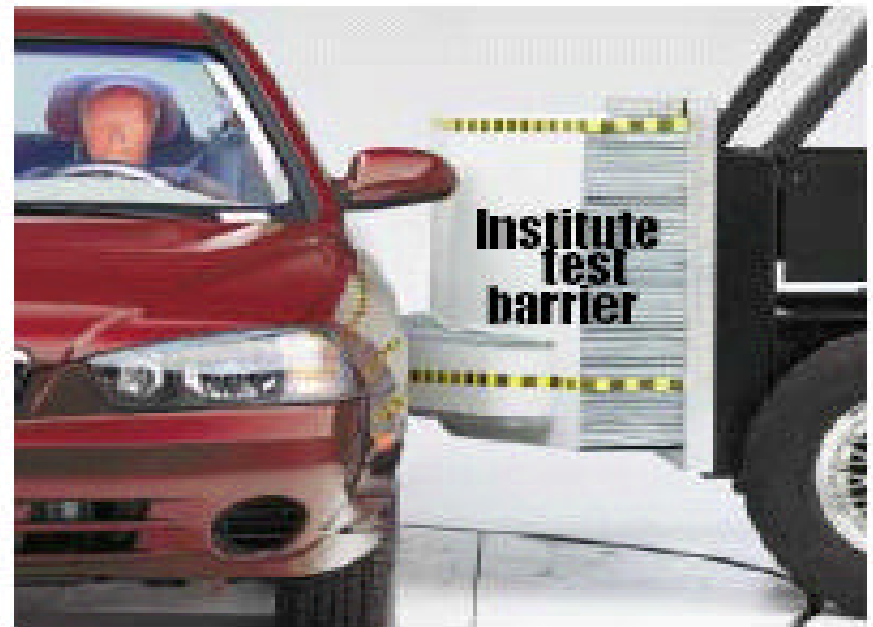
- Insurance Institute for Highway Safety new Side Impact Test Program with Barrier higher and heavier than FMVSS 214 to better represent trucks and SUVs

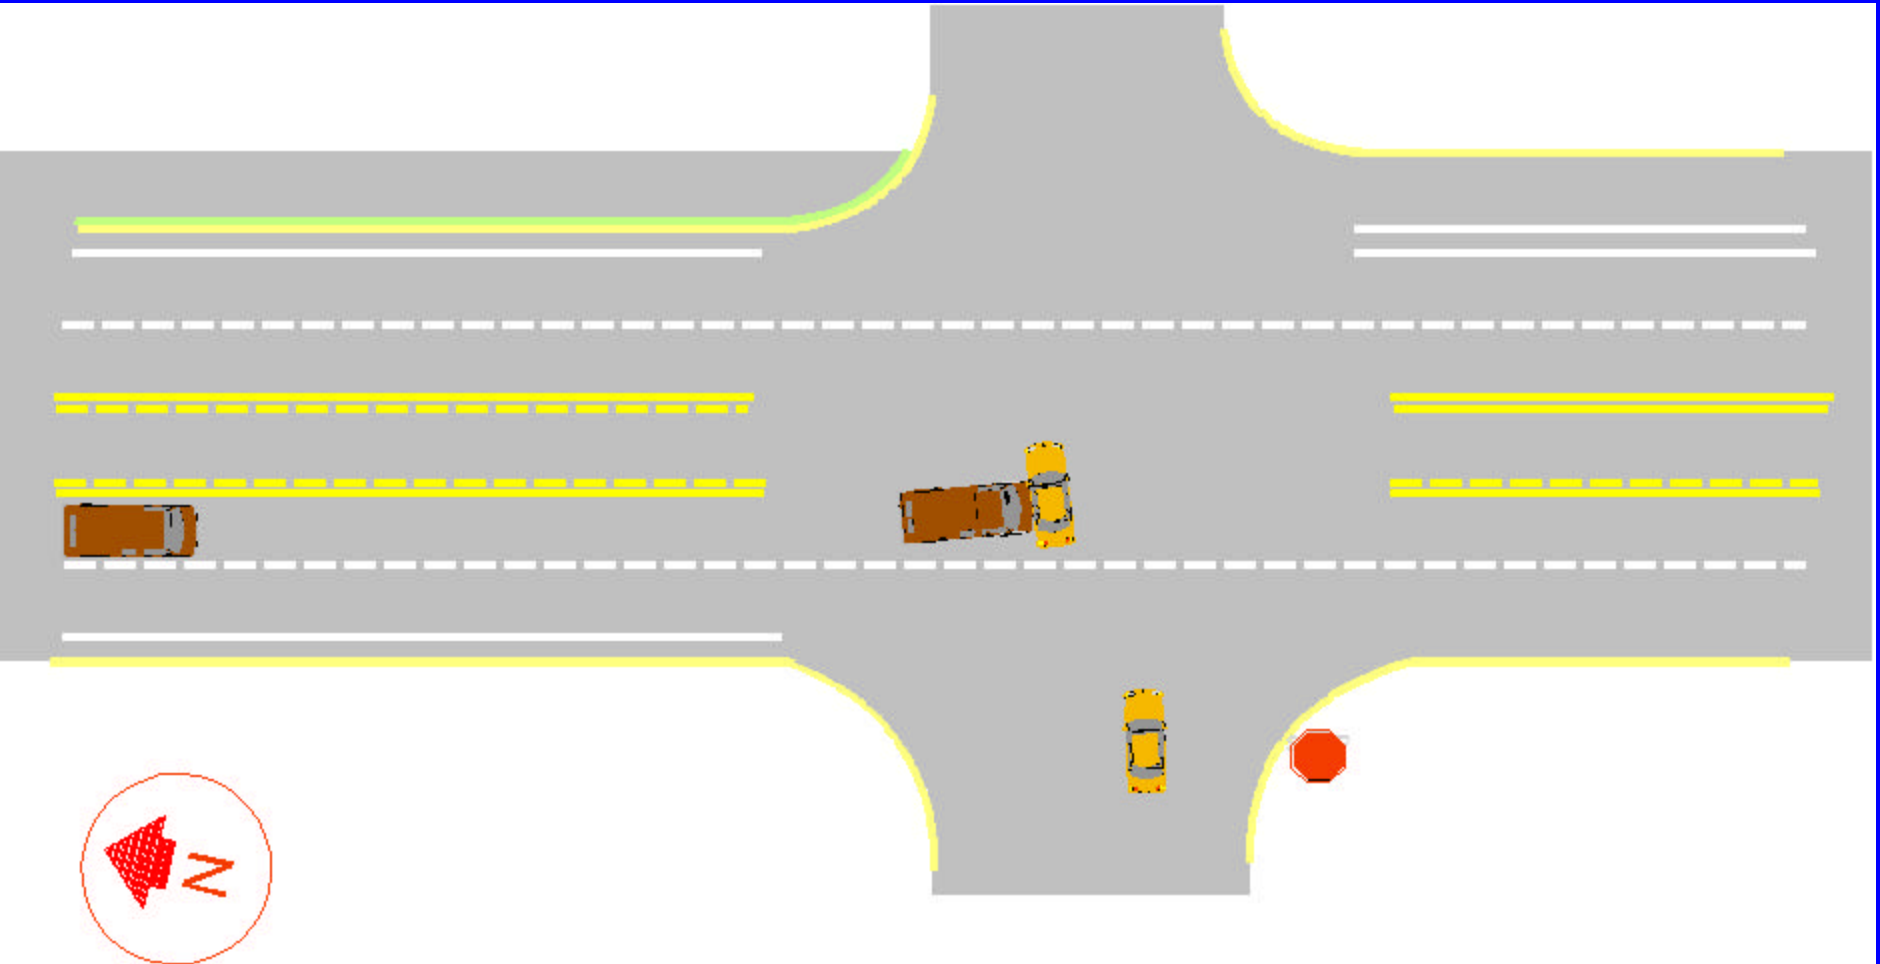
# Scene Impact

Vehicle 1: 1995 Saturn SCI, 2 door

Vehicle 2: 1997 Ford Econoline, E250

Cargo Van, loaded with Electrical  
Equipment

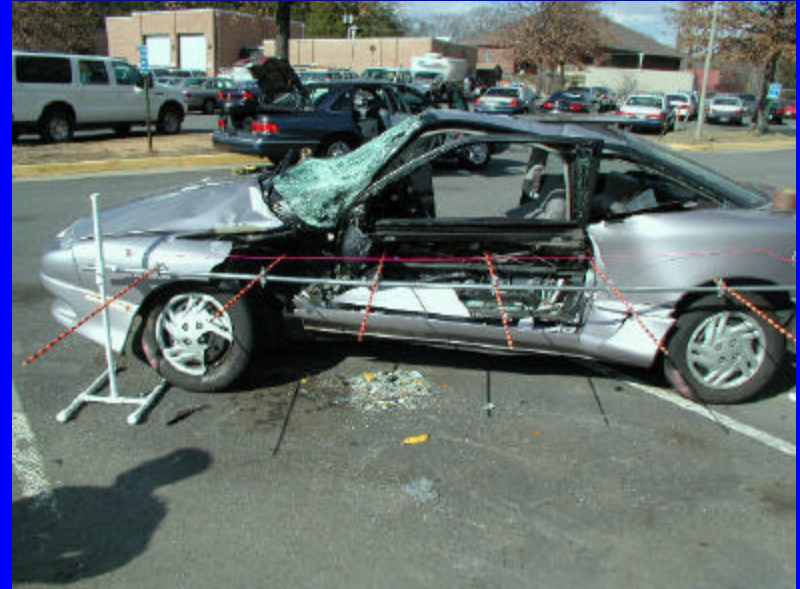
# Crush Analysis

CDC: 09LDYW3

PDOF: 280 degrees

Delta V: Beyond scope of Winsmash

BES: 40 kmp/h/24 mph

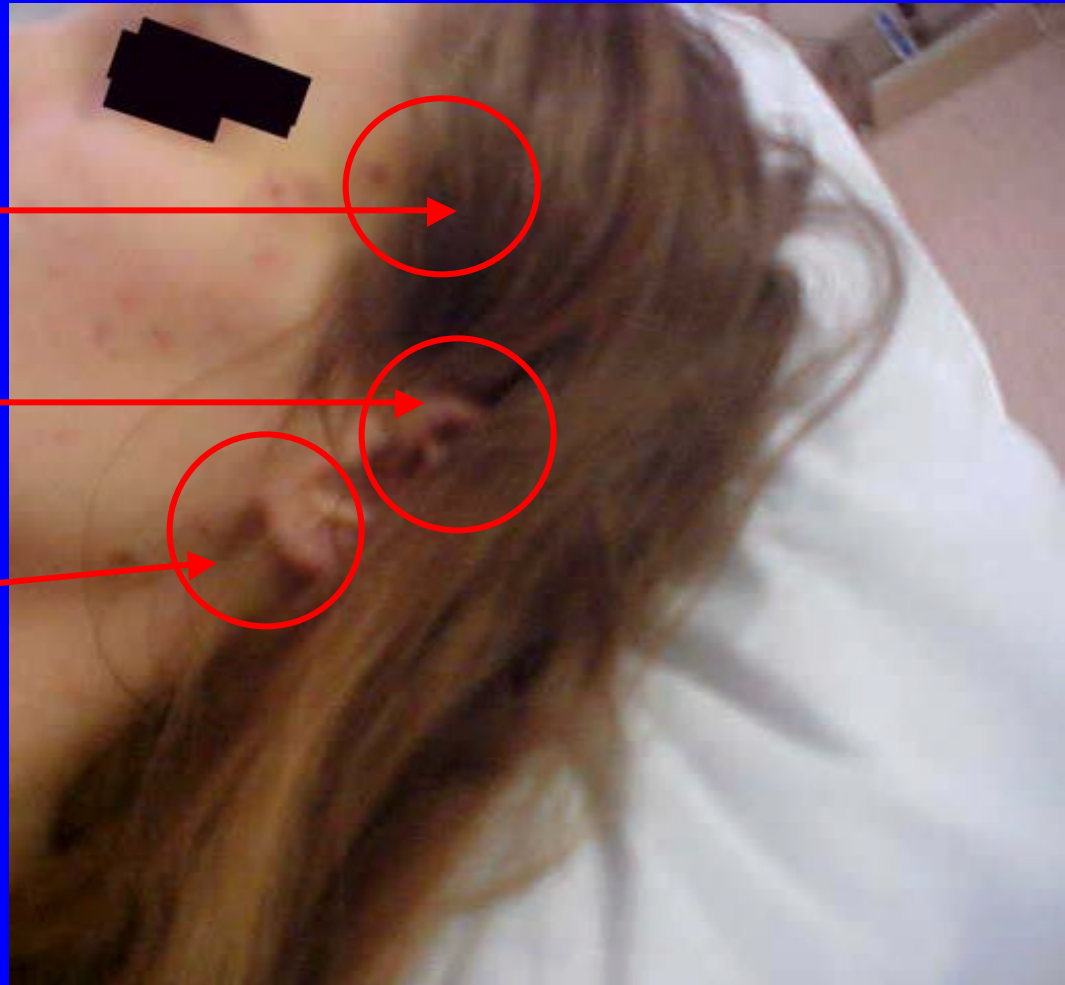
# Injuries

Fading contusion  
at left temple

Ear laceration

Dicing lacerations

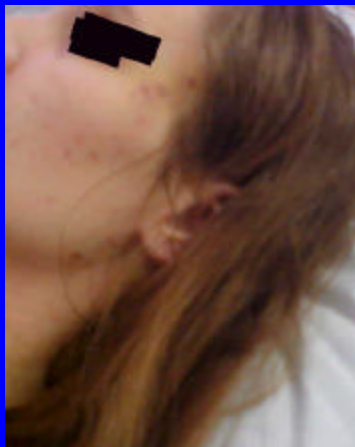
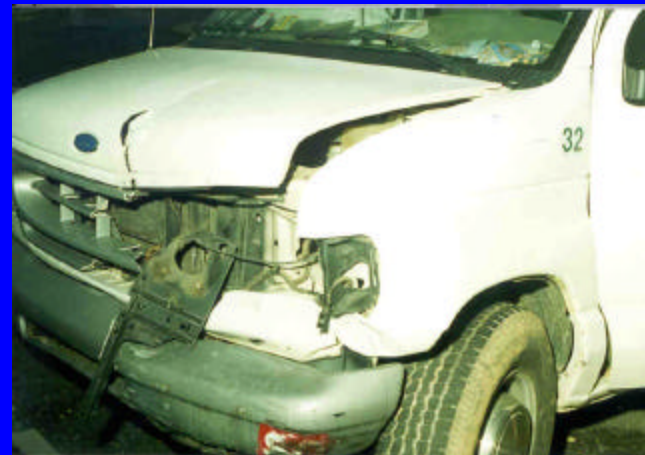
Injuries (ICD)	AIS Severity	Info Source	Aspect (R,L,bilat,etc)	Contact Area (door, seat,etc)
Cerebral concussion (850.1)	161000.2	Clinical	Whole	2 <sup>nd</sup> vehicle
Ear lacerations (872.0)	290602.1	Exam	Left	2 <sup>nd</sup> vehicle
Facial lacerations - dicing 873.41	290602.1	Exam	Left – temple/cheek	Glass
Facial contusions (920)	290402.1	Exam	Left – temple/cheek	Glass

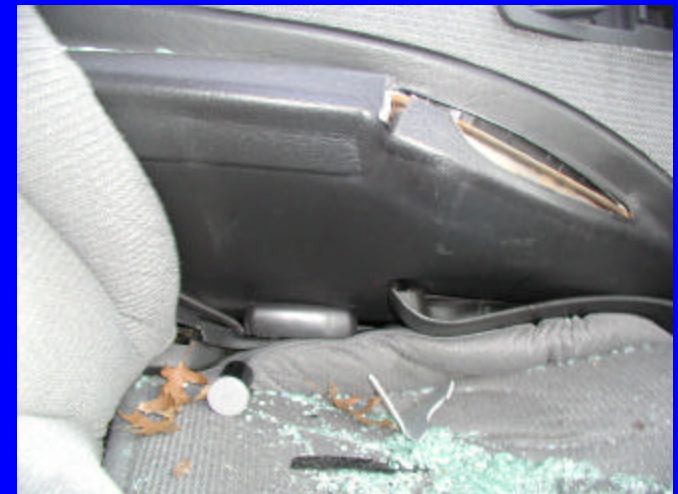
Injuries (ICD)	AIS Severity	Info Source	Aspect (R,L,bilat,etc)	Contact Area (door, seat,etc)
Rib fracture (807.01)	450212.1	CT	Left	Door – Armrest
Splenic laceration – grade III (865.03)	544224.3	CT	Left	Door into rib rib into spleen
Renal laceration – grade III (866.0)	541624.3	CT	Left	Door – Armrest
Abrasion hip (916.0)	890202.1	Exam	Left	Door – Armrest

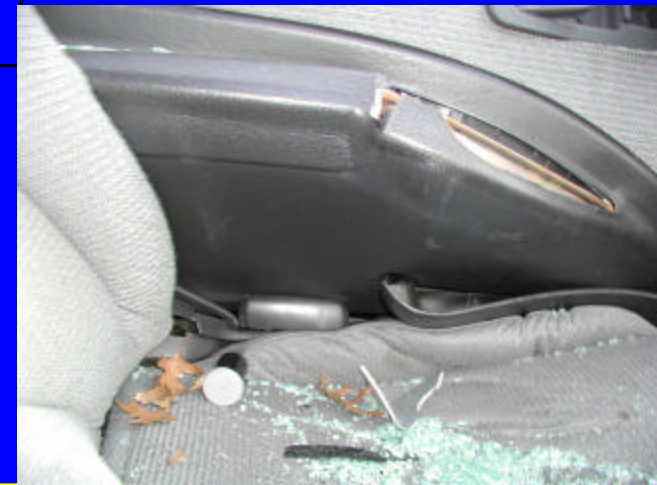
Injuries (ICD)	AIS Severity	Info Source	Aspect (R,L,bilat,etc)	Contact Area (door, seat,etc)
Obturator artery laceration (902.8)	521402.3	Angio	Left pelvis	Door panel
Inferior & Superior pubic rami fractures (808.2)	852602.2	X-ray	Left	Door panel
Pubic symphysis fracture (808.2)	853000.3	X-ray	Right	Door panel
Iliac wing fracture (808.41)	852602.2	X-ray	Left	Door panel
Diastasis - sacroiliac joint (839.42)	852602.2	X-ray	Left	Door panel

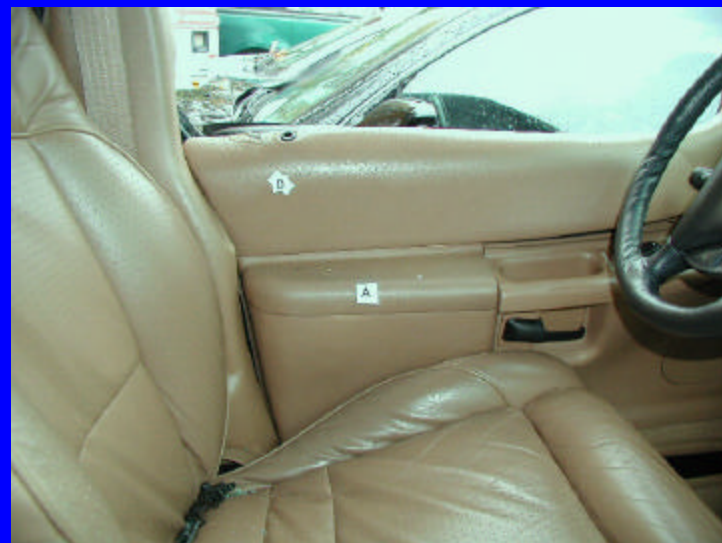
Injuries (ICD)	AIS Severity	Info Source	Aspect (R,L,bilat,etc)	Contact Area (door, seat,etc)
PTX w lung contusion (860.0)	450214.3	CT	Left	Door panel – arm rest
Rib fracture x 1 (807.01)	450214.3	CT	Left – 8 <sup>th</sup> posterior	Door panel – arm rest

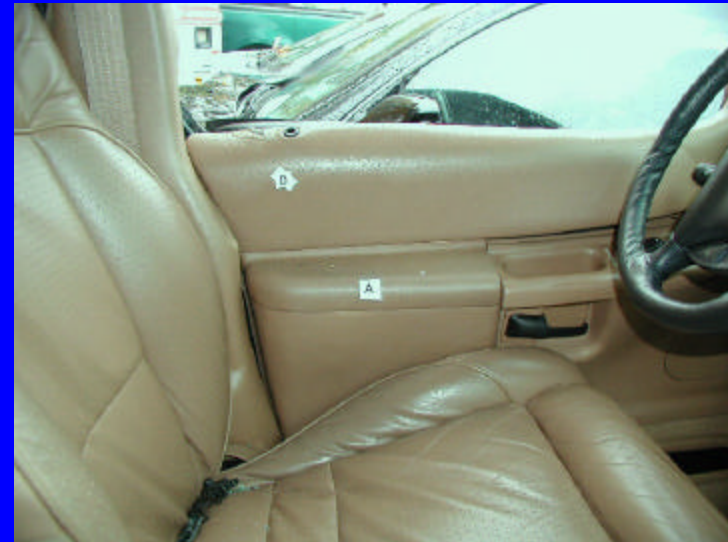
Injuries (ICD)	AIS Severity	Info Source	Aspect (R,L,bilat,etc)	Contact Area (door, seat,etc)
Grade IV spleen laceration (865.04)	544226.4	CT	Left	Door panel – arm rest
