# **Hydrodynamic Characteristics and Salinity Patterns in Estero Bay, Lee County, Florida**

By Michael J. Byrne, and Jessica N. Gabaldon

Prepared in cooperation with the South Florida Water Management District

Scientific Investigations Report 2007–5217

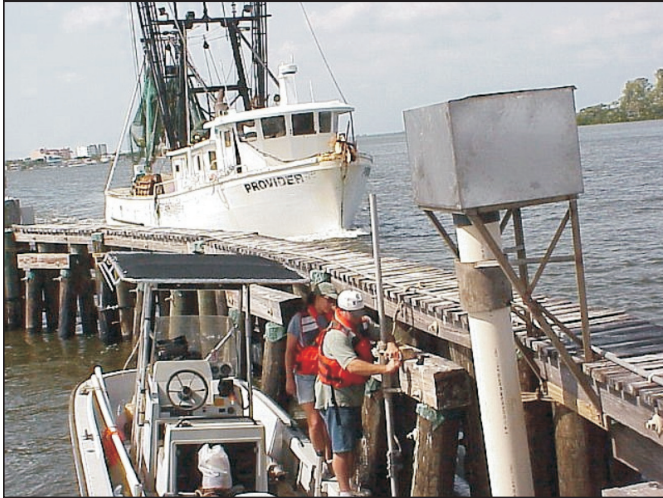
**Figure 3.** Matanzas Pass facing the Gulf of Mexico.

Matanzas Pass, at bridge (fig. 3), is 700 ft wide and 16 ft deep and exchanges water with San Carlos Bay and Hell Peckney Bay. The pass is 4 mi long and highly developed on one bank with a fleet of commercial shrimp boats on the other bank.

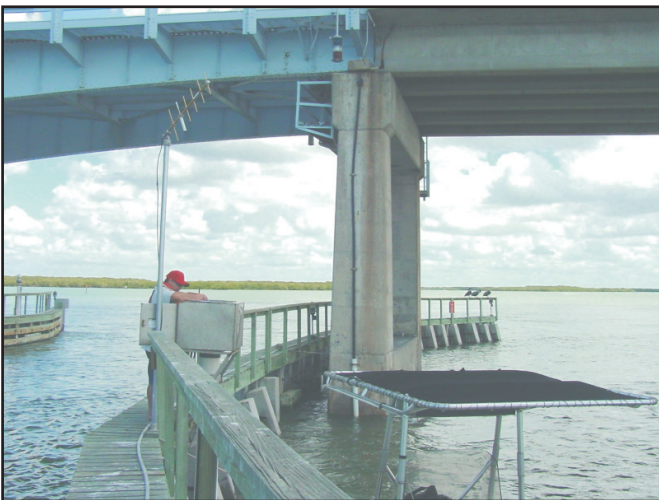
**Figure 4.** Big Carlos Pass facing Estero Bay.

Big Carlos Pass, at bridge (fig. 4), is 1,600 ft wide and 20 ft deep and exchanges water with the Gulf of Mexico and three tributaries: Hendry Creek, Mullock Creek, and Estero River. The pass is less than 1 mi long with development of one bank and Lover's Key State Park on the other bank.

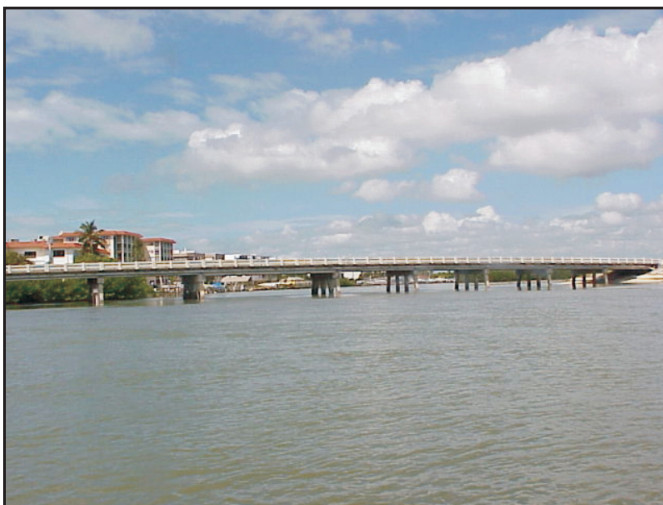
**Figure 5.** Big Hickory Pass facing the Gulf of Mexico.

Big Hickory Pass, at bridge (fig. 5), is 600 ft wide and 8 ft deep and exchanges water with the Gulf of Mexico and Imperial River. The pass is greater than 1 mi long and is between Big Hickory Island and Bonita Beach.

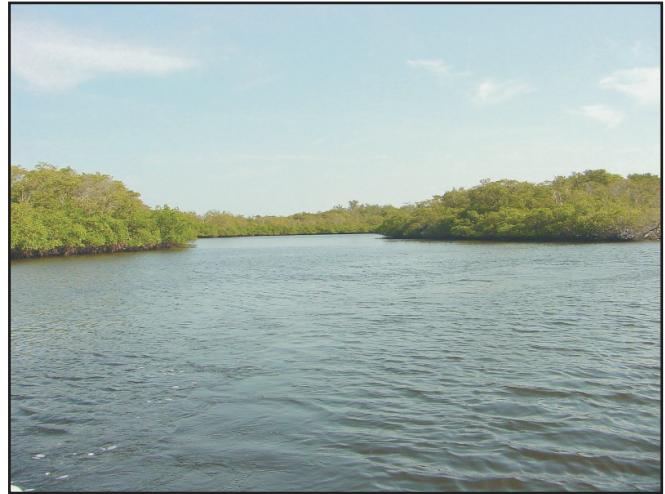
**Figure 6.** Mullock Creek looking upstream.

Mullock Creek, near station, is 160 ft wide and 6 ft deep (fig. 6) and flows into Rocky Bay. Mullock Creek receives discharge from both Ten-Mile Canal and Six-Mile Cypress Slough. Discharge into the creek is controlled at a gated structure located along Ten-Mile Canal (fig. 2). The gated structure is designed to minimize the effects of flooding of nutrient-laden water on surrounding areas. Commercial and residential development is limited to the upper reaches of the creek.

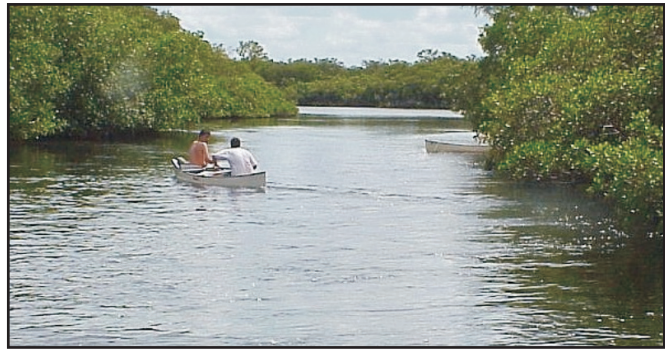
**Figure 7.** Estero River looking downstream.

Estero River, near station, is 120 ft wide and 4 ft deep (fig. 7) and flows into the southern portion of Rocky Bay. Even though the upper reaches of the tributary are developed, discharge is not restricted by weirs. Land areas adjoining the river near its mouth are protected from future development.

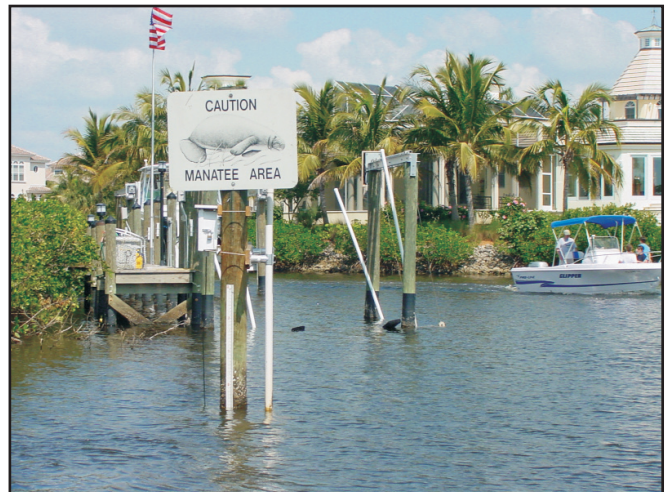
**Figure 8.** Imperial River looking upstream.

Imperial River, near station, is 250 ft wide and 10 ft deep (fig. 8) and a portion of the discharge flows to Big Hickory Pass and some discharge travels south away from Estero Bay. Weirs control freshwater discharge and prevent saltwater encroachment. Development extends from the mouth of the river to the upper reaches.

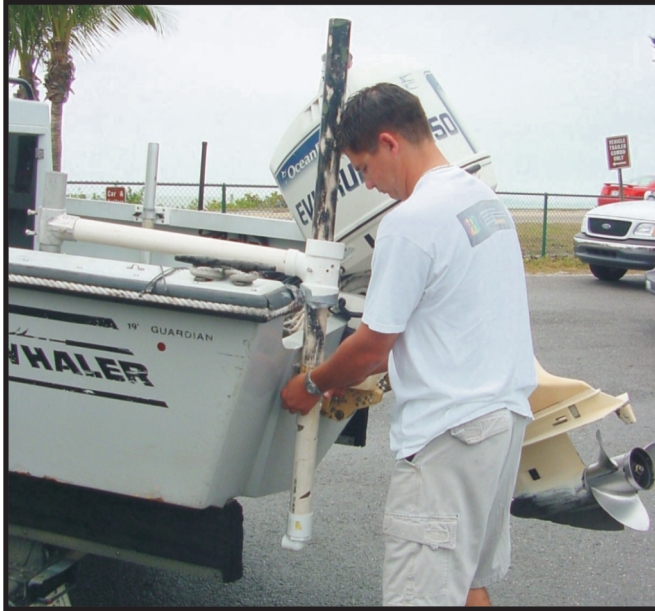
**Figure 9.** Flow-through chamber, for salinity survey, mounted to the transom of the boat.

Surface-water salinity and temperature were measured throughout Estero Bay, its tributaries, San Carlos Bay, and the mouth of the Caloosahatchee River by boat with a water-quality probe mounted in a flow-through chamber 4 in. below the transom (fig. 9). Synoptic surveys were conducted frequently (14 times) and over a range of conditions from July 24, 2002, to January 30, 2004. A data logger was used to record the salinity, water temperature, and GPS location for each of the surveys. Two boats were used to reduce the time (about 5 hours) that was required to collect 5,000 data points for each survey (fig. 10).

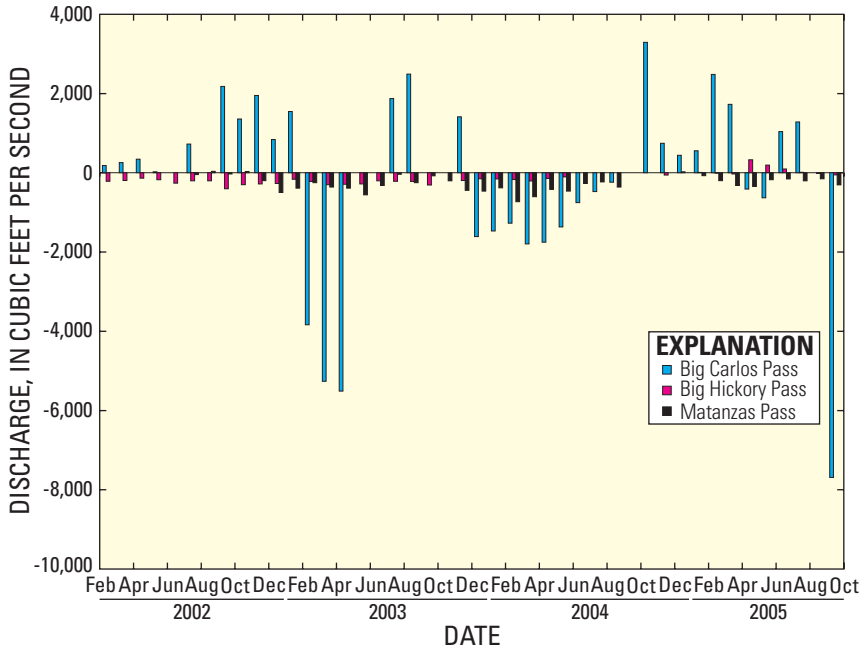
Figure 12. Mean monthly discharge at selected passes during the study period.

Matanzas Pass failed to exhibit a seasonal discharge pattern and mean monthly discharge was consistently negative (fig. 12). Negative discharge suggests that tributary discharge from Cow Creek and No Name Creek is insignificant. The average daily discharge at Matanzas Pass ranged from about 10,800 to -11,200 ft<sup>3</sup>/s (table 5). Generally, the water discharging into Matanzas Pass extends to the Pleistocene ridge at Julie's Island, and to Cow Creek and No Name Creek in Hell Peckney Bay. Discharge at this pass is governed by external forces, mainly the Caloosahatchee River. The impact of the Caloosahatchee River discharge exceeds the impact from Cow Creek and No Name Creek.

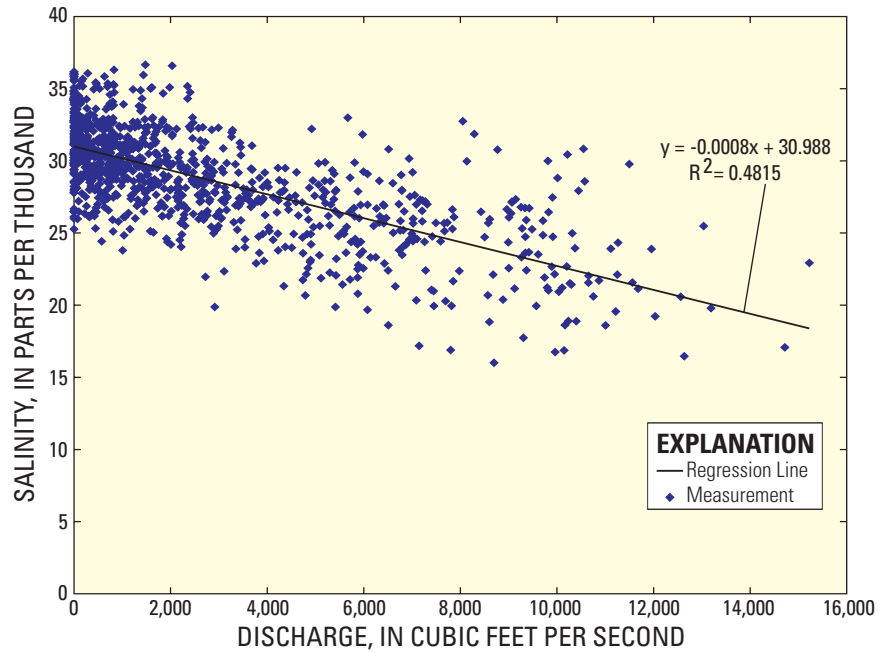
Figure 14. Relation between S-79 discharge and Matanzas Pass salinity.

Reduced salinity at Matanzas Pass was negatively correlated ( $R^2 = 0.48$ ) to freshwater discharge from the Caloosahatchee River at Franklin Locks (S-79). Matanzas Pass is hydrologically linked to Hell Peckney Bay; therefore, water-quality problems associated with the Caloosahatchee River also affect Hell Peckney Bay. Rocky Bay was significantly less saline than Coconut Point and Matanzas Pass was significantly less saline than Ostego Bay, based on data from the salinity surveys. The quality-checked and edited continuous data and the salinity maps have been compiled and are stored on the U.S. Geological Survey South Florida Information Access (SOFIA) website (<http://sofia.usgs.gov>).

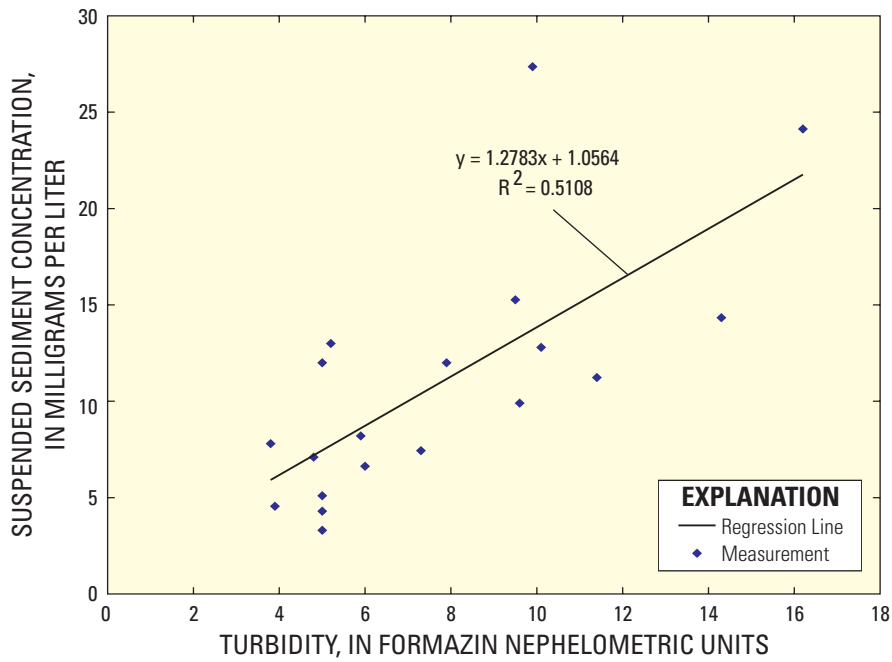
**Figure 17.** Relation between suspended sediment concentration and turbidity at Mullock Creek.

stations were near the lower instrument detection limits. Greater suspended sediment concentration would, therefore, be necessary to establish a strong relation with turbidity in this tidal environment. The adjusted  $R^2$  value of 0.51 for turbidity to suspended sediment concentration at Mullock Creek suggests that turbidity still is a promising surrogate for suspended sediment concentration (fig. 17); however, the correlation is poor due to unexplained variances.
