**Arsenic Removal from Drinking Water by Adsorptive Media  
U.S. EPA Demonstration Project at Oak Manor Municipal Utility  
District at Alvin, TX  
Six-Month Evaluation Report**

**Battelle  
Columbus, OH 43201-2693**

**Contract No. 68-C-00-185  
Task Order No. 0029**

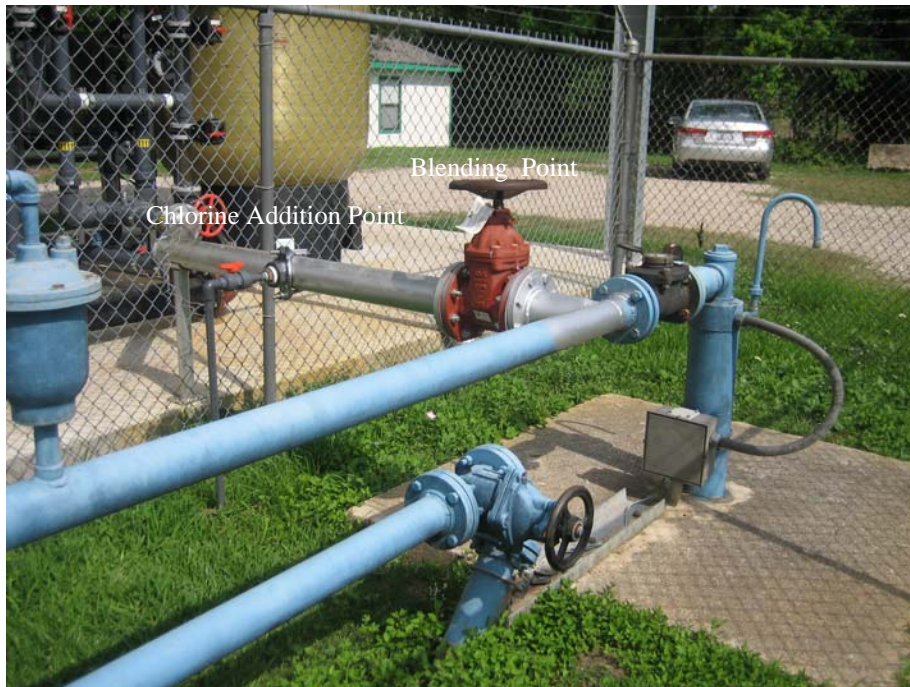
**Figure 4-1. Preexisting Chlorine Addition Point and Wells 1 and 2 Blending Point**

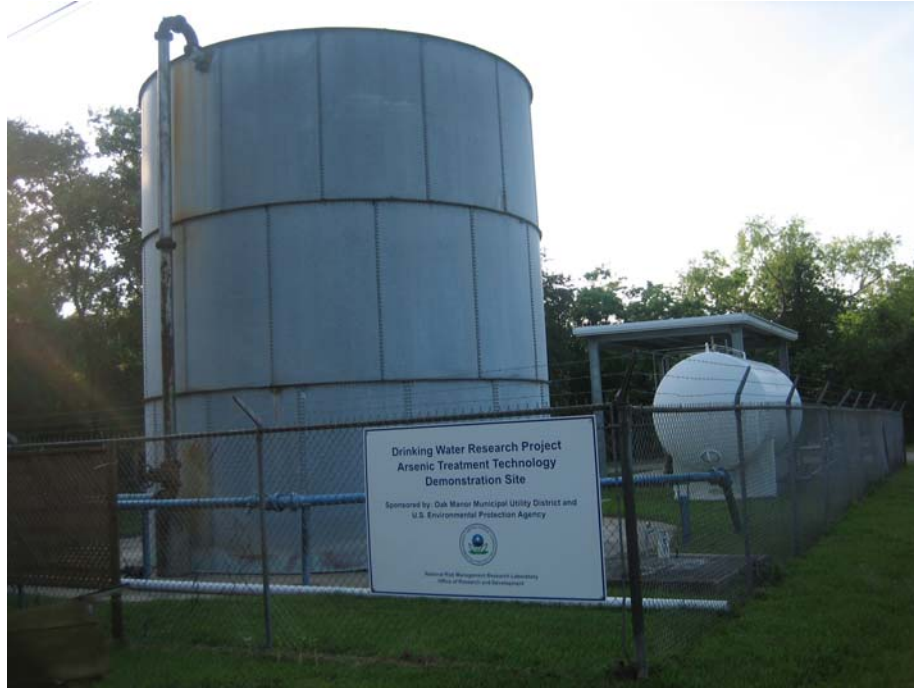
**Figure 4-2. Preexisting Storage Tank (in Foreground) and Hydropneumatic Tank (in Background)**

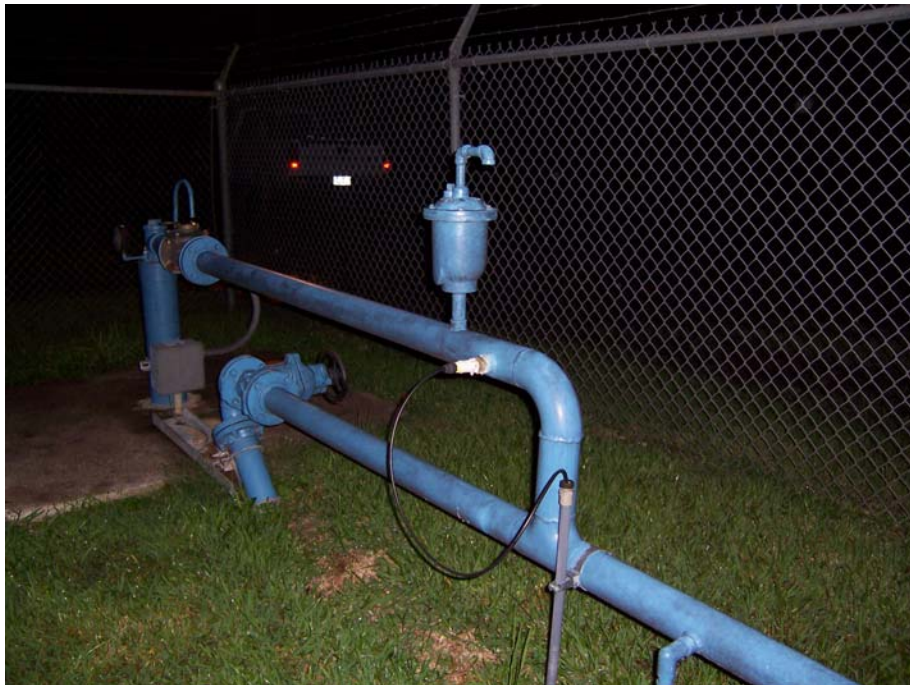
**Figure 4-3. Preexisting Polyphosphate Addition Point**

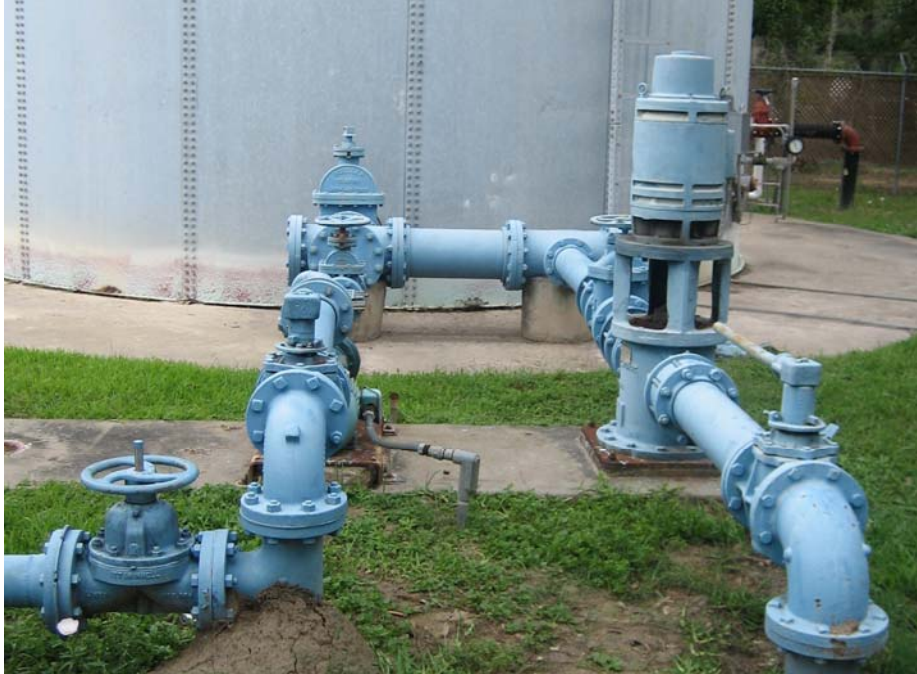
**Figure 4-4. Booster Pumps and Entry Piping to Distribution System**

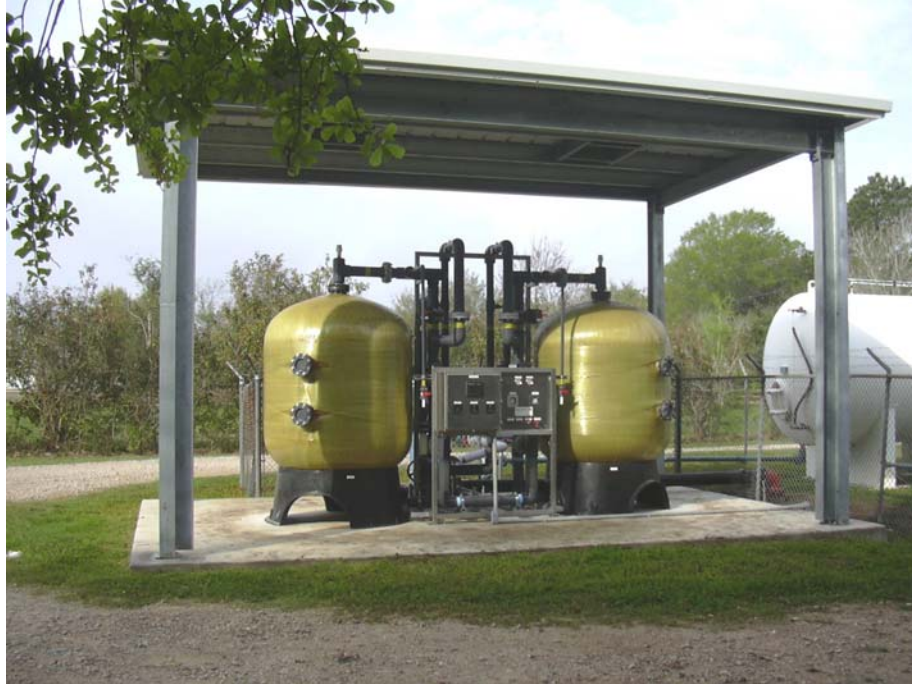
**Figure 4-5. Photograph of APU-30S Arsenic Removal System**

**4.3.2 Building Construction.** A canopy (Figure 4-5) was built to shield the treatment system from direct sunlight exposure. Construction of the concrete pad (Figure 4-11) began on October 6, 2005, and the canopy was completed on November 12, 2005.

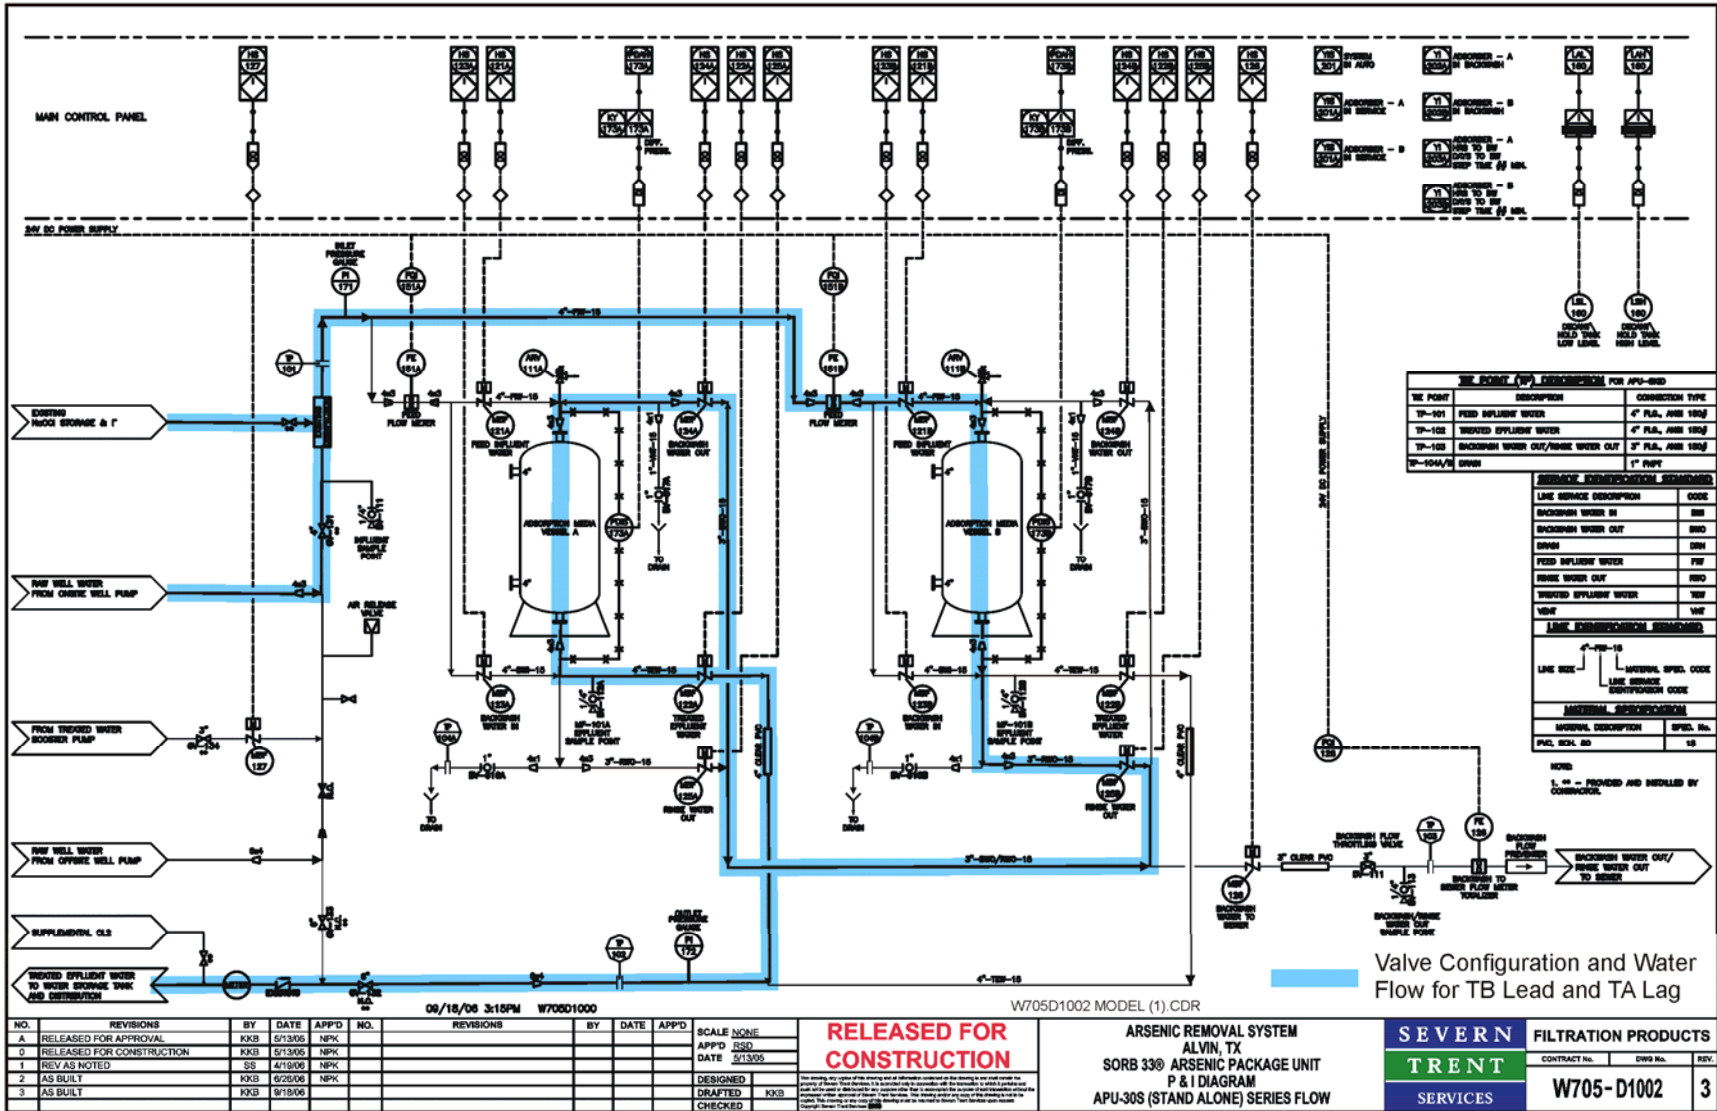
Figure 4-6b. Process Flow Diagram for APU-30S System with Vessel B in Lead Position

The piping and valve configuration of the APU-30S system consists of electrically actuated butterfly valves to divert raw water flow into either Vessels A or B depending on which is operating as the lead vessel. The piping and instrumentation diagrams (P&IDs) presented in Figures 4-6a and 6b use bolded lines to indicate the process flow for series configuration with Vessels A and B, respectively, in the lead position. Table 4-3 presents key system design parameters.

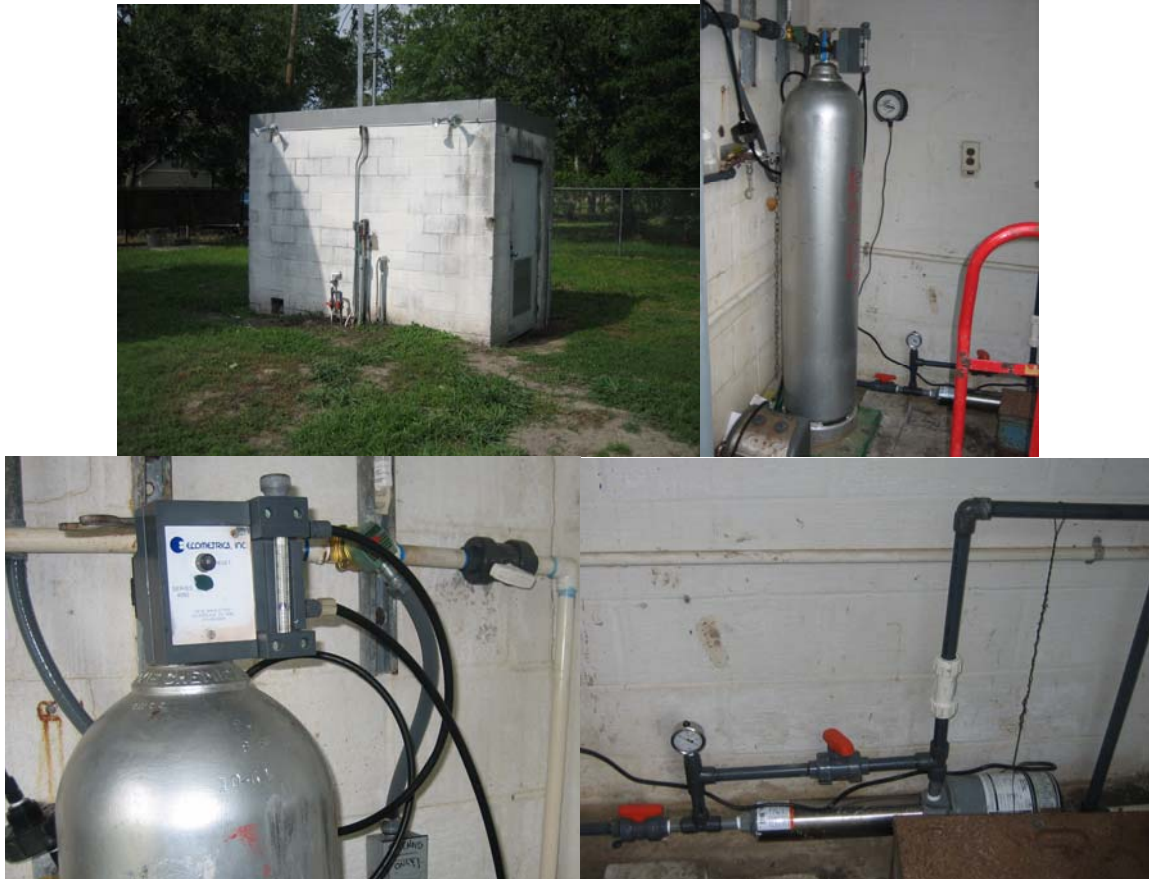
**Figure 4-7. Gas Chlorination System**  
*(Clockwise from the Top: Shed Housing Gas Chlorination System, Gas Cylinder, Chlorine Ejector, and Chlorinator Unit)*

- **Prechlorination/Oxidation.** The existing gas chlorination system manufactured by Ecometrics in Silverdale, PA, was used to oxidize As(III), Fe(II), and Mn(II) prior to the adsorption vessels and provide a target total chlorine residual level from 1.5 to 2.0 mg/L (as Cl<sub>2</sub>) for disinfection purposes. The chemical feed system consisting of one 150-lb cylinder, a chlorinator unit (sitting on top of the chlorine gas cylinder), and an ejector was located in a secured shed in the close proximity of the treatment system in the fenced area. Figure 4-7 presents composite of pictures of the gas chlorination system. Note that the current chlorine injection point (not pictured) was relocated after the Wells 1 and 2 blending point to >10 ft downstream of the raw water sample tap, after system startup on April 25, 2006 (see Table 4-5). Operation of the chlorine feed system was linked to the well pumps so that gas chlorine was injected only when the wells were on. Chlorine consumption was tracked daily by recording the weight of the chlorine gas cylinder.

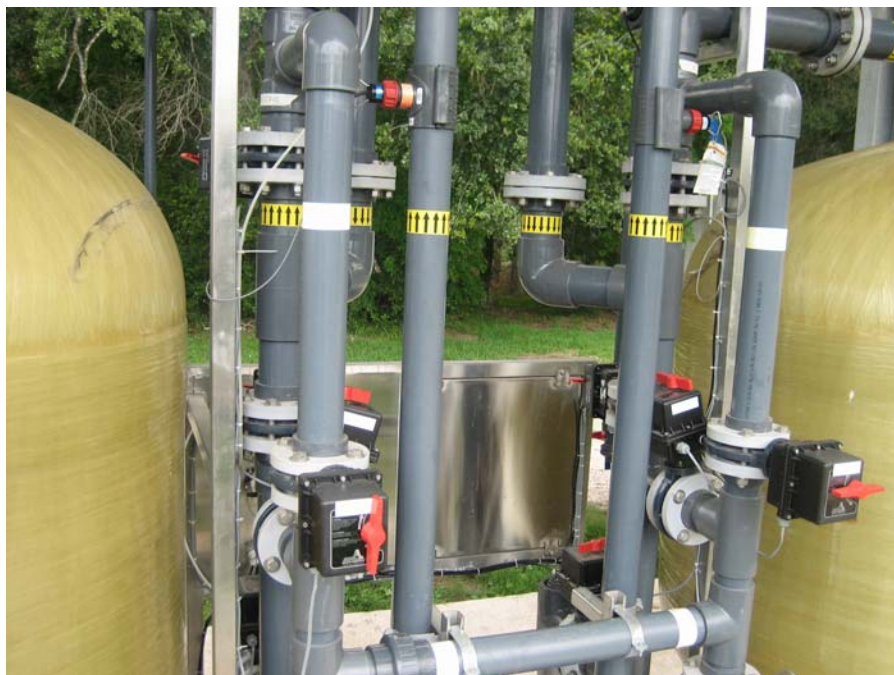
**Figure 4-8. APU-30S System Valve Tree and Piping Configuration**

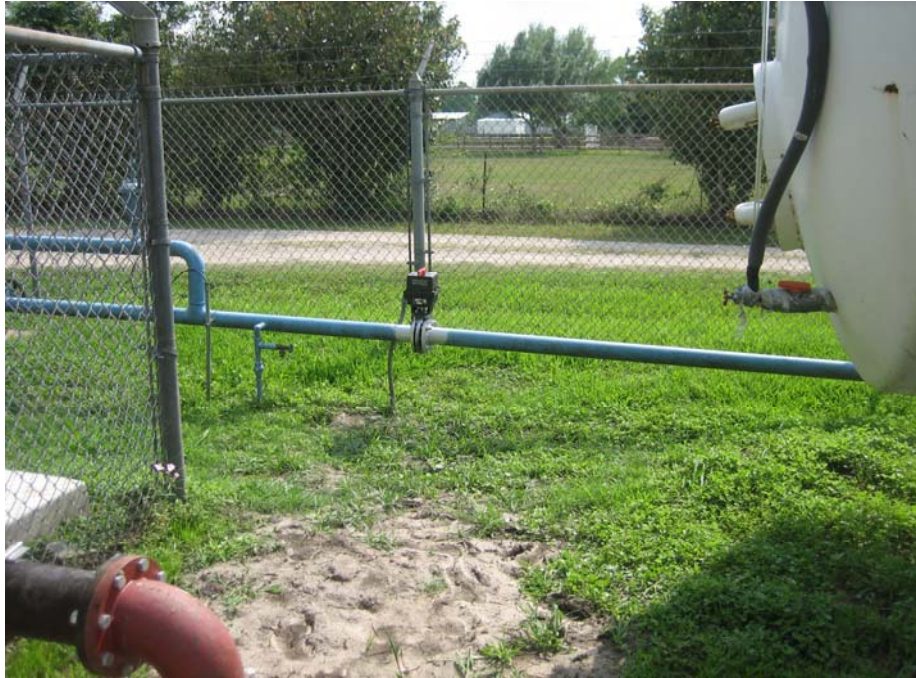
**Figure 4-9. Valve MB-127 to Supply Additional Treated Water from Hydropneumatic Tank During Backwash**

STS recommended a minimum backwash flowrate of 210 gpm (or 9.7 gpm/ft<sup>2</sup>), which exceeded the maximum well capacity of 150 gpm. The remedy was to modify the preexisting plumbing, including the installation of an automatic valve (MB-127), to deliver the treated water from the hydropneumatic tank to supplement the backwash flow. Also, in order to prevent polyphosphate from entering the adsorption vessels to cause adverse effects on arsenic adsorption, the preexisting polyphosphate addition was relocated downstream of the APU-30S system and, later as discussed below, discontinued due to concerns that polyphosphate in treated water might come in contact with the media during backwash.

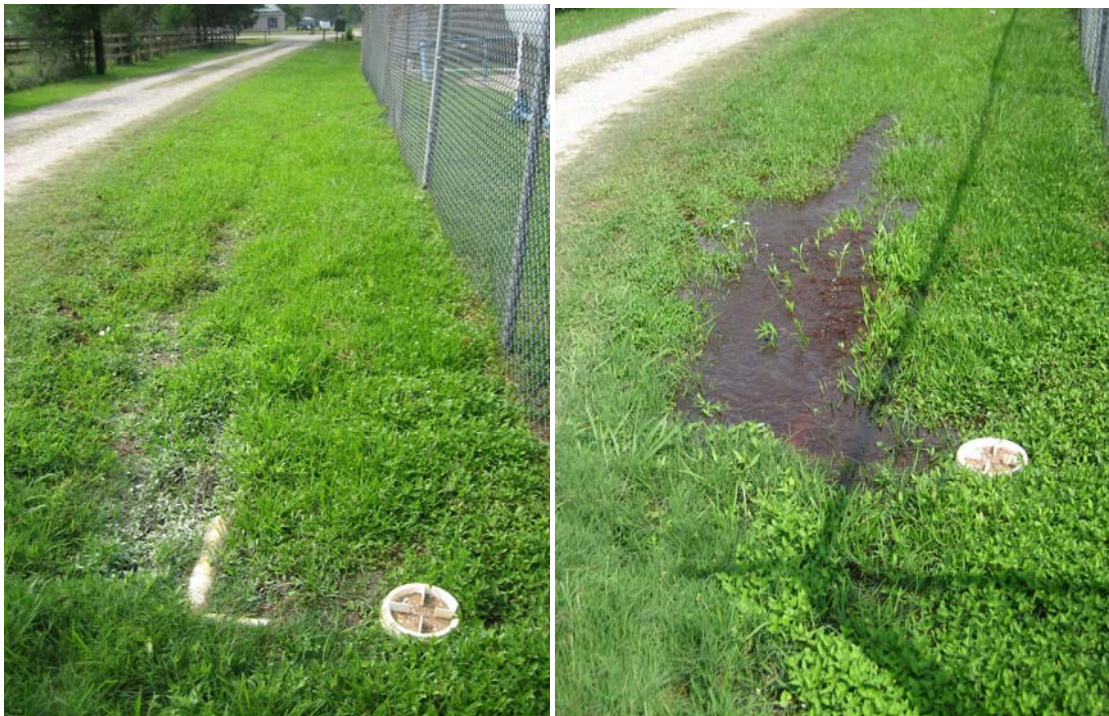
**Figure 4-10. Small Ditch**

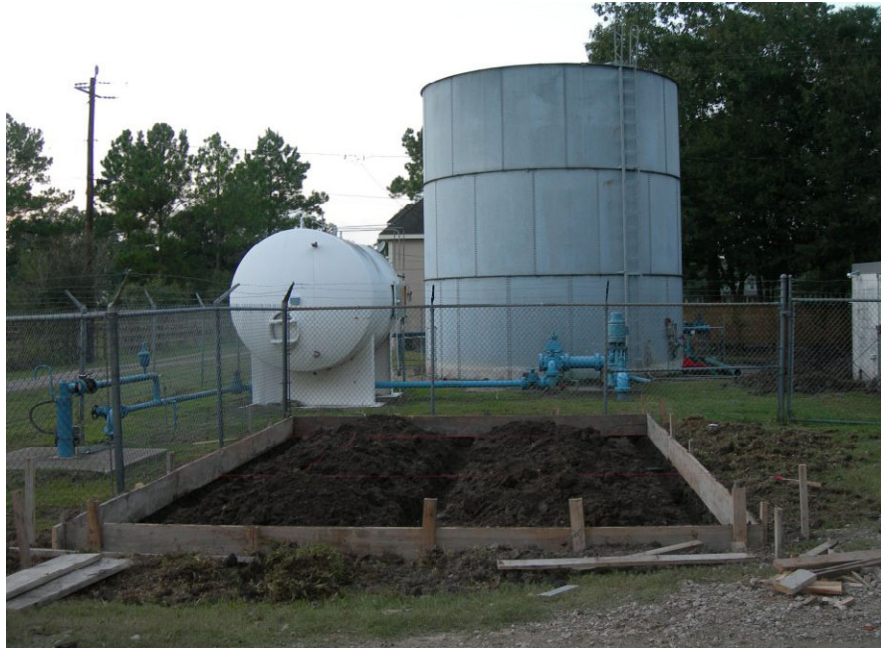
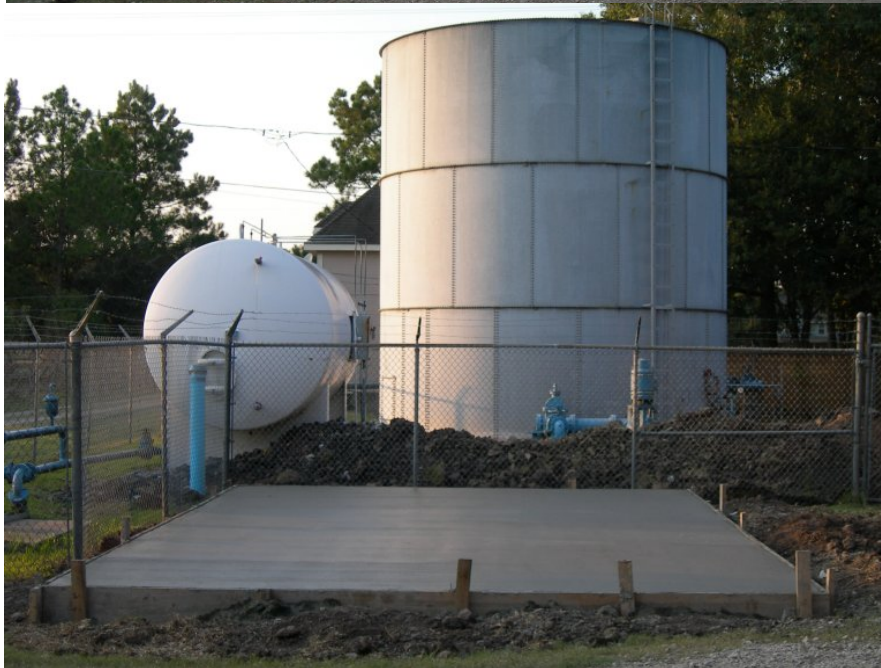
**Figure 4-11. Construction of Concrete Pad with Storage Tank and  
Hydropneumatic Tank (in Background)**

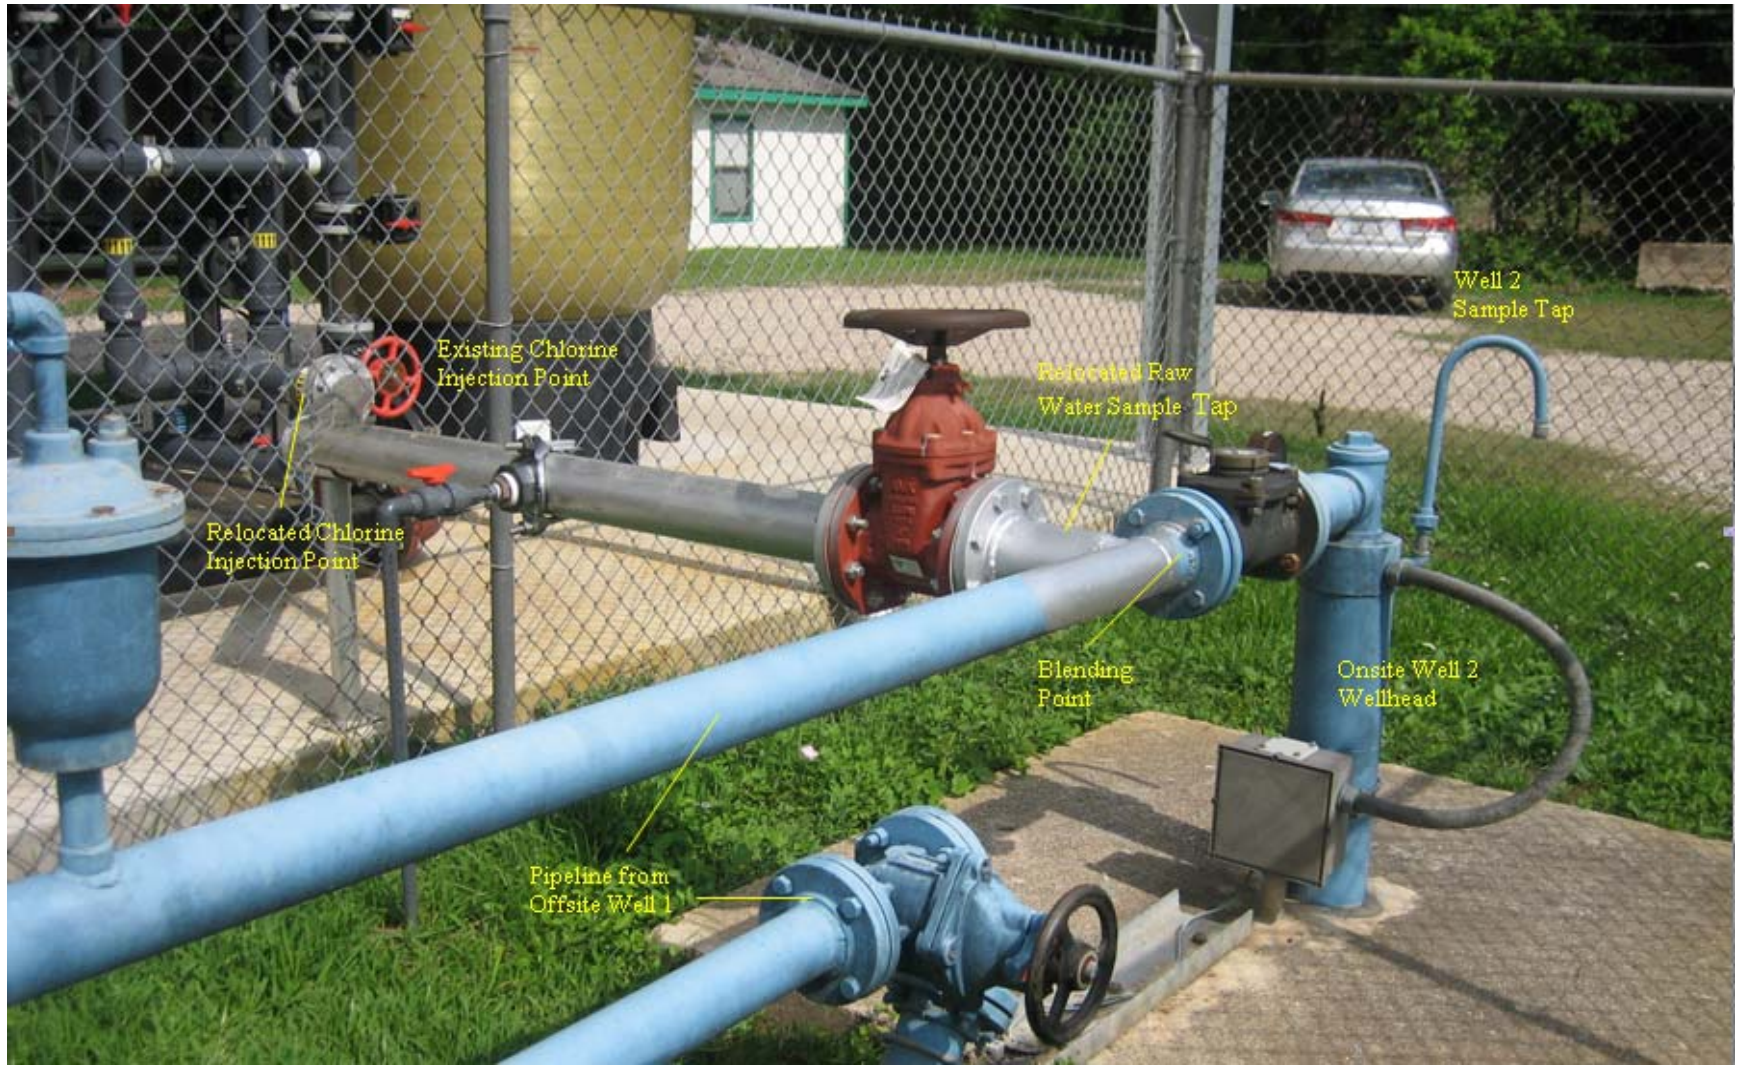
Figure 4-12. Photograph of Piping, Sample Taps, and Chlorine Injection Point Prior to Treatment System

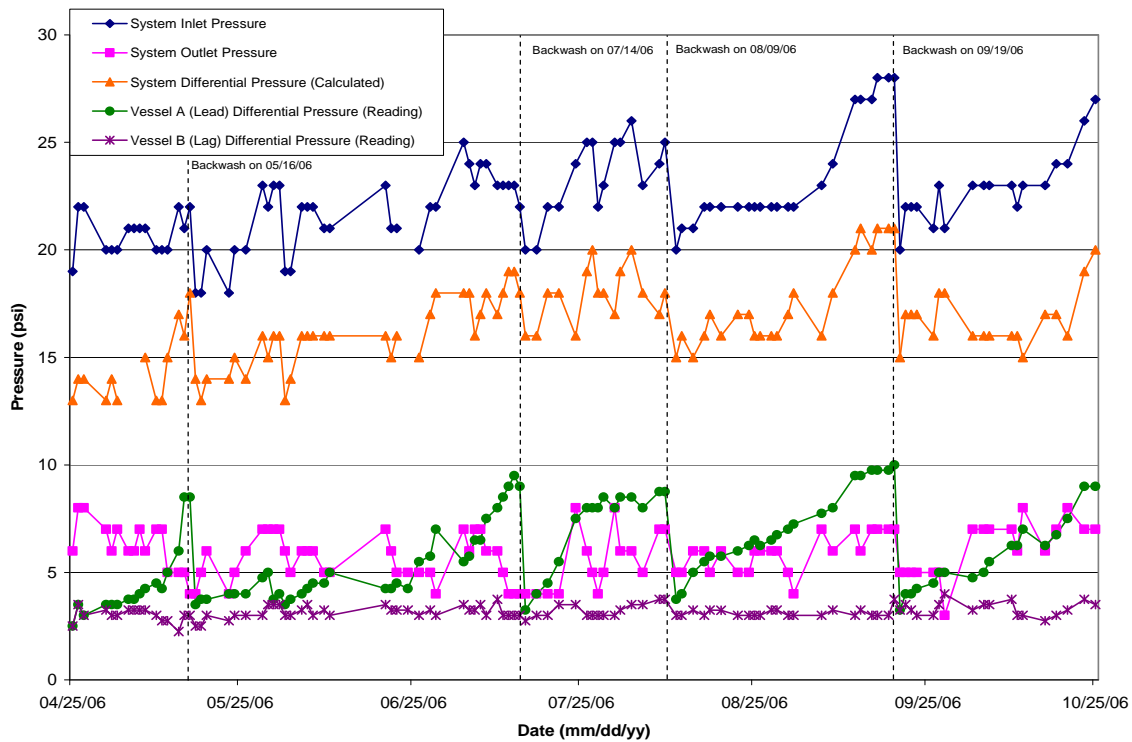
**Figure 4-13. System Pressure Readings**

It is postulated that the  $\Delta p$  rise across Vessel A was caused by the accumulation of precipitated solids in the media bed caused by the addition of chlorine before the adsorption vessels. In addition, based on several trip reports provided by STS, sediments produced from the wells also might have accumulated in Vessel A contributing to the observed  $\Delta p$  rise.

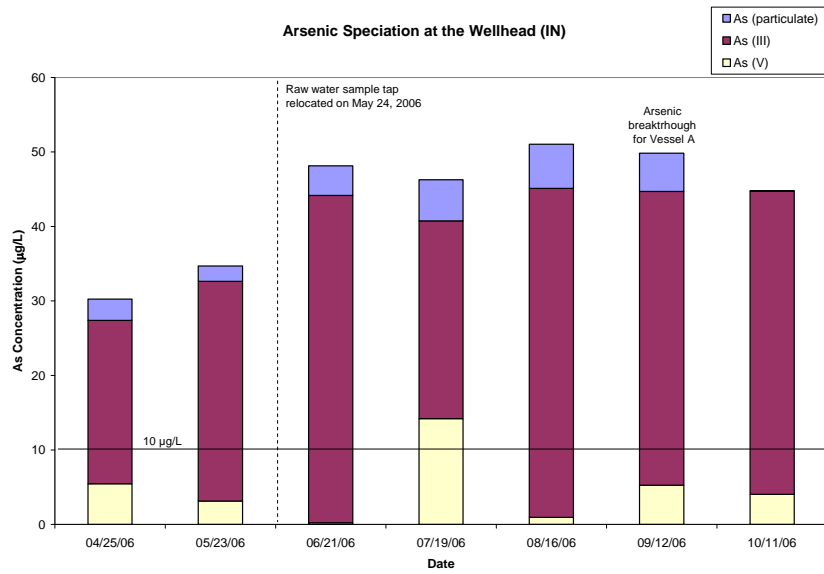
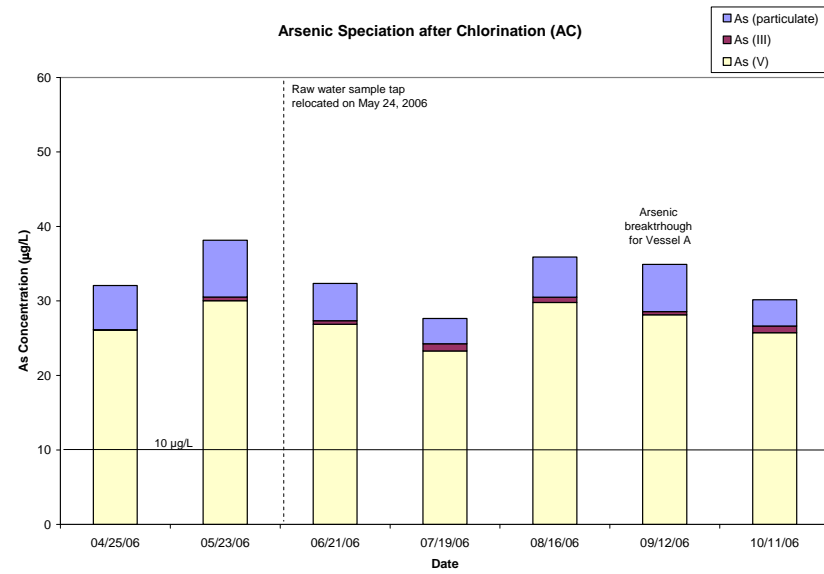
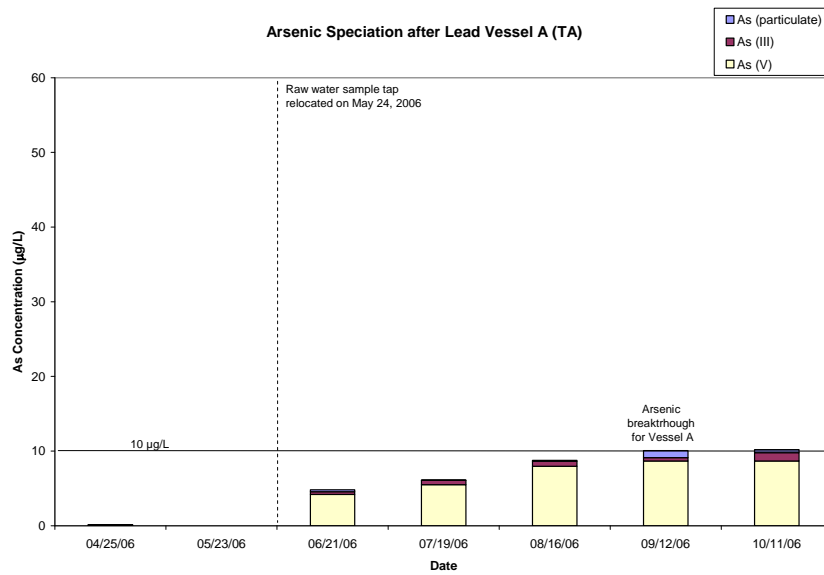
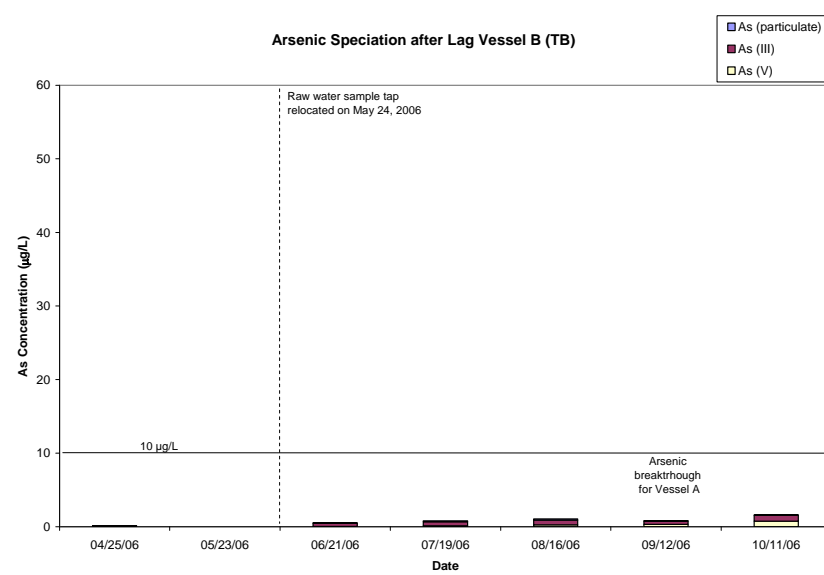
Figure 4-14. Concentrations of Various Arsenic Species at IN, AC, TA, and TB Sampling Locations

After chlorination at AC sampling location, the average As(III) and As(V) concentrations were 0.6 and 27.1 µg/L, respectively, indicating effective oxidation. Free and total chlorine levels at the AC location both averaged 2.1 mg/L (as Cl<sub>2</sub>) (see Table 4-10) and their corresponding ORP readings averaged 602 mV, compared to 344 mV in source water. As expected, the relocation of the raw water sample tap on May 24, 2006, did not affect the water samples taken at the AC location. The average total arsenic levels remained unchanged, i.e., averaging 34.7 µg/L before relocation and 30.7 µg/L after relocation. These concentrations were in the same range of the raw water sample results before the raw water sampling location was relocated.

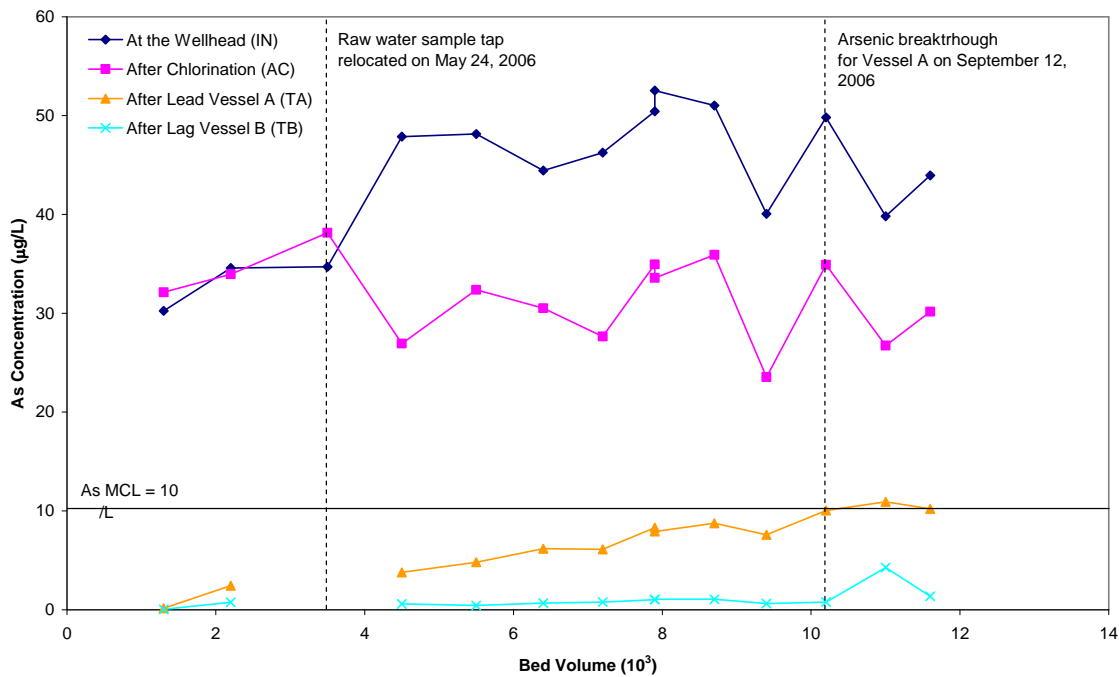
Figure 4-15 presents total arsenic breakthrough curves from the lead and lag vessels, along with total arsenic concentrations in raw water and after chlorine addition. The lead vessel, Vessel A, removed the majority of arsenic, existing predominately as As(V) because of prechlorination. On September 12, 2006, after treating approximately 10,240 BV of water, arsenic was 10.0 µg/L following the lead vessel and 0.8 µg/L following the lag vessel. Through the end of the first six months of system operation, the system treated only 12,170 BV, or 11,241,500 gal, of water.

As shown in Figure 4-15, total arsenic concentrations following the lag vessel remained <1.1 µg/L until September 27, 2006, when a concentration spike up to 4.3 µg/L was observed. Total arsenic concentrations decreased back to 1.4 µg/L during the following sampling event on October 11, 2006. The spike might have been caused by a power outage on September 24, 2006, when the system was reverted back to its default parallel configuration (Section 4.4.3).

**Figure 4-15. Total Arsenic Breakthrough Curves**

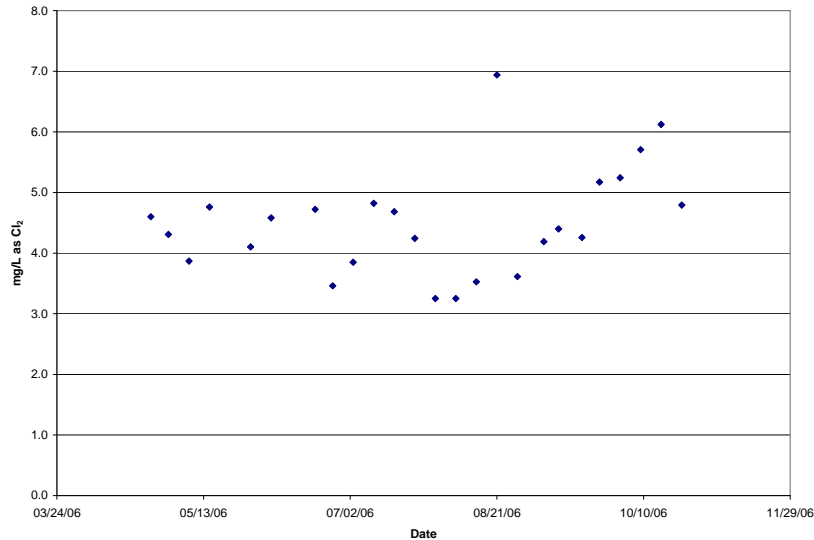
**Figure 4-16. Chlorine Consumption Based on Chlorine Gas Usage**

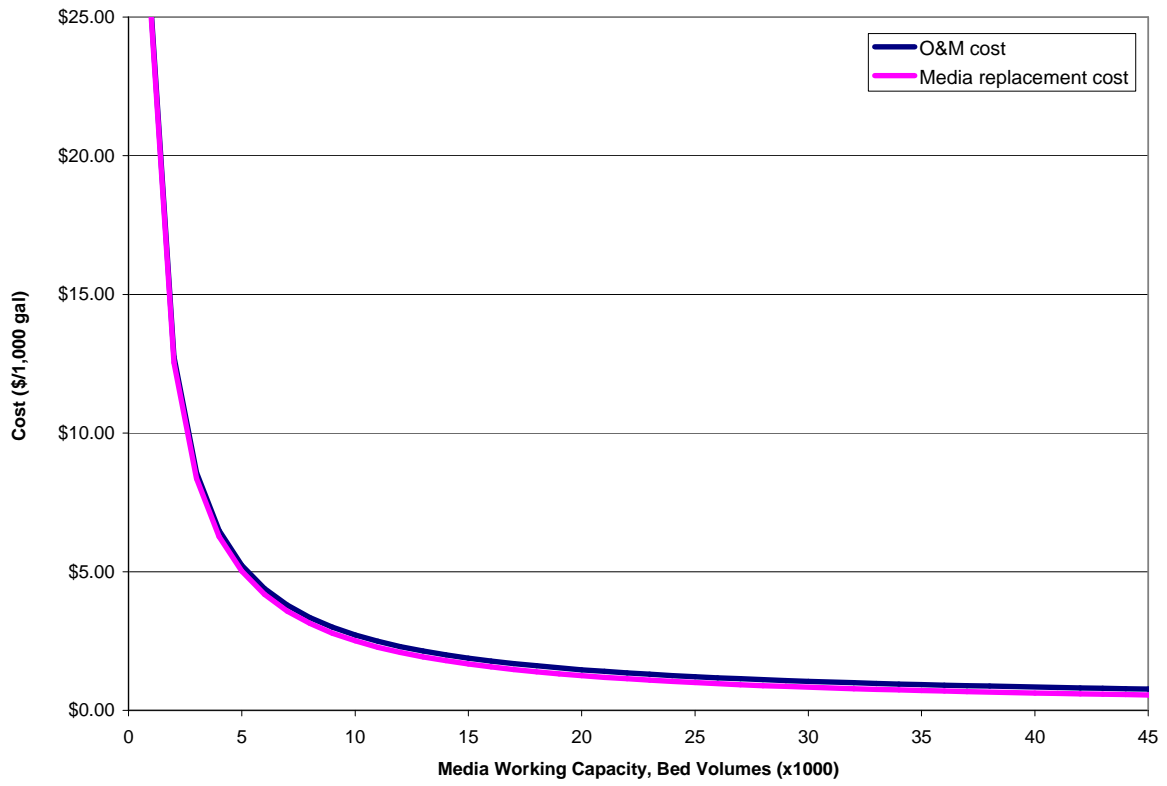
**Figure 4-17. Media Replacement and Operation and Maintenance Cost**

**4.6.2 Operation and Maintenance Cost.** The O&M cost included the cost for such items as media replacement and disposal, electricity, and labor (Table 4-15). Although media replacement did not take place during the first six months of system operation, the media replacement cost would represent the majority of the O&M cost and was estimated to be \$23,568 to change out the lead and lag vessels. This media change-out cost would include the cost for media for two vessels, freight, labor, travel, and media disposal. This cost was used to estimate the media replacement cost per 1,000 gal of water treated as a function of the projected system run length at the 10 µg/L arsenic breakthrough from the lag vessel (Figure 4-17). Because the actual media change-out most likely will take place only for the lead vessel, a revised cost estimate (or actual) for one vessel will be used for the preparation of the Final Performance Evaluation Report.
