*Performance Evaluation of the New Orleans and
Southeast Louisiana
Hurricane Protection System*

*Final Report of the Interagency Performance Evaluation
Task Force*

Volume 1 – Executive Summary and Overview

26 March 2007

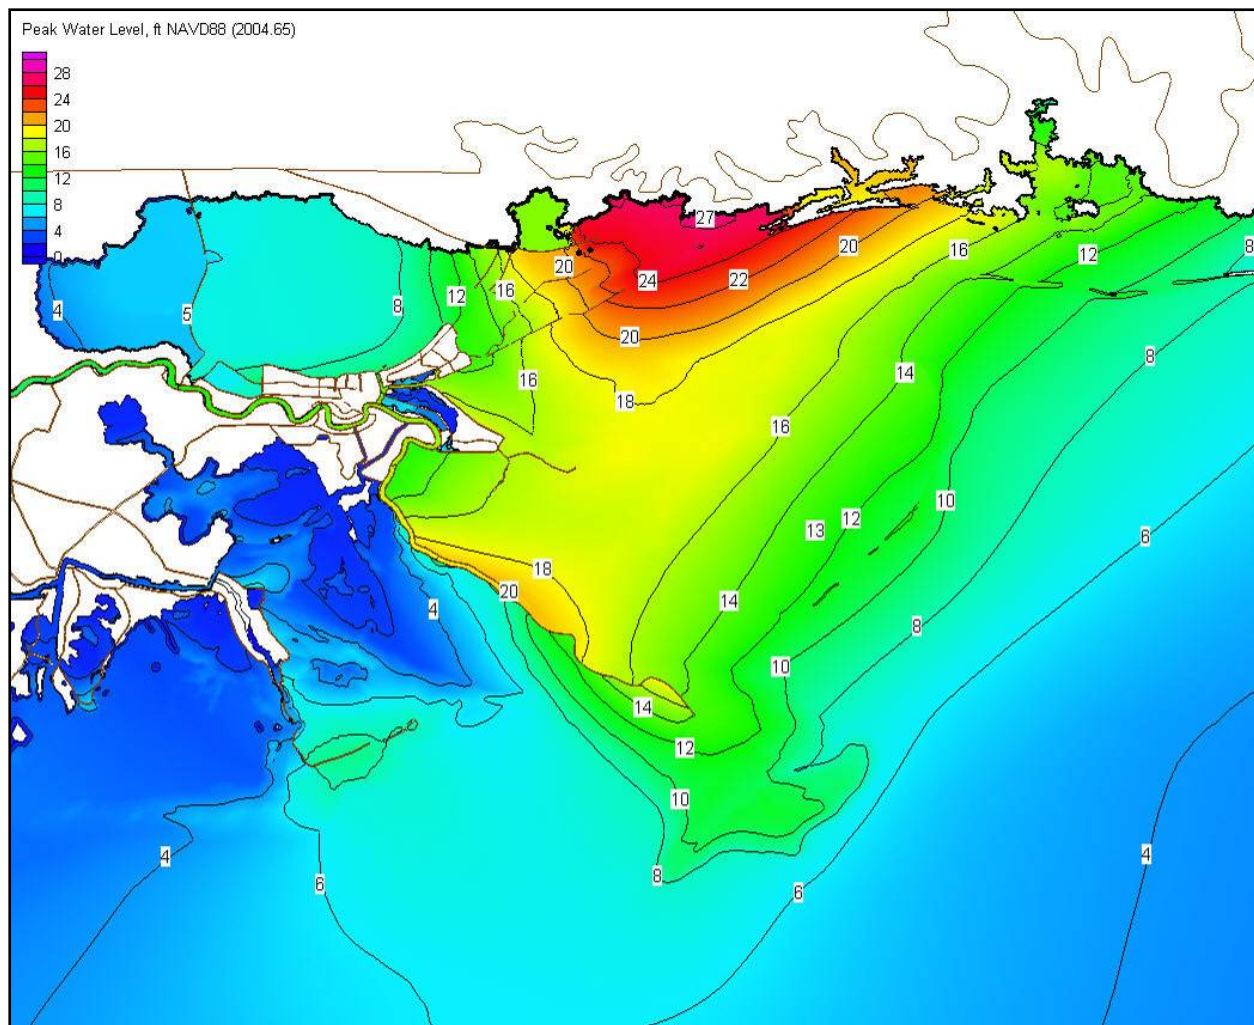
Figure 9. Maximum computed storm surge levels using the ADCIRC model, Mississippi to Louisiana region, water levels in feet NAVD88 (2004.65).

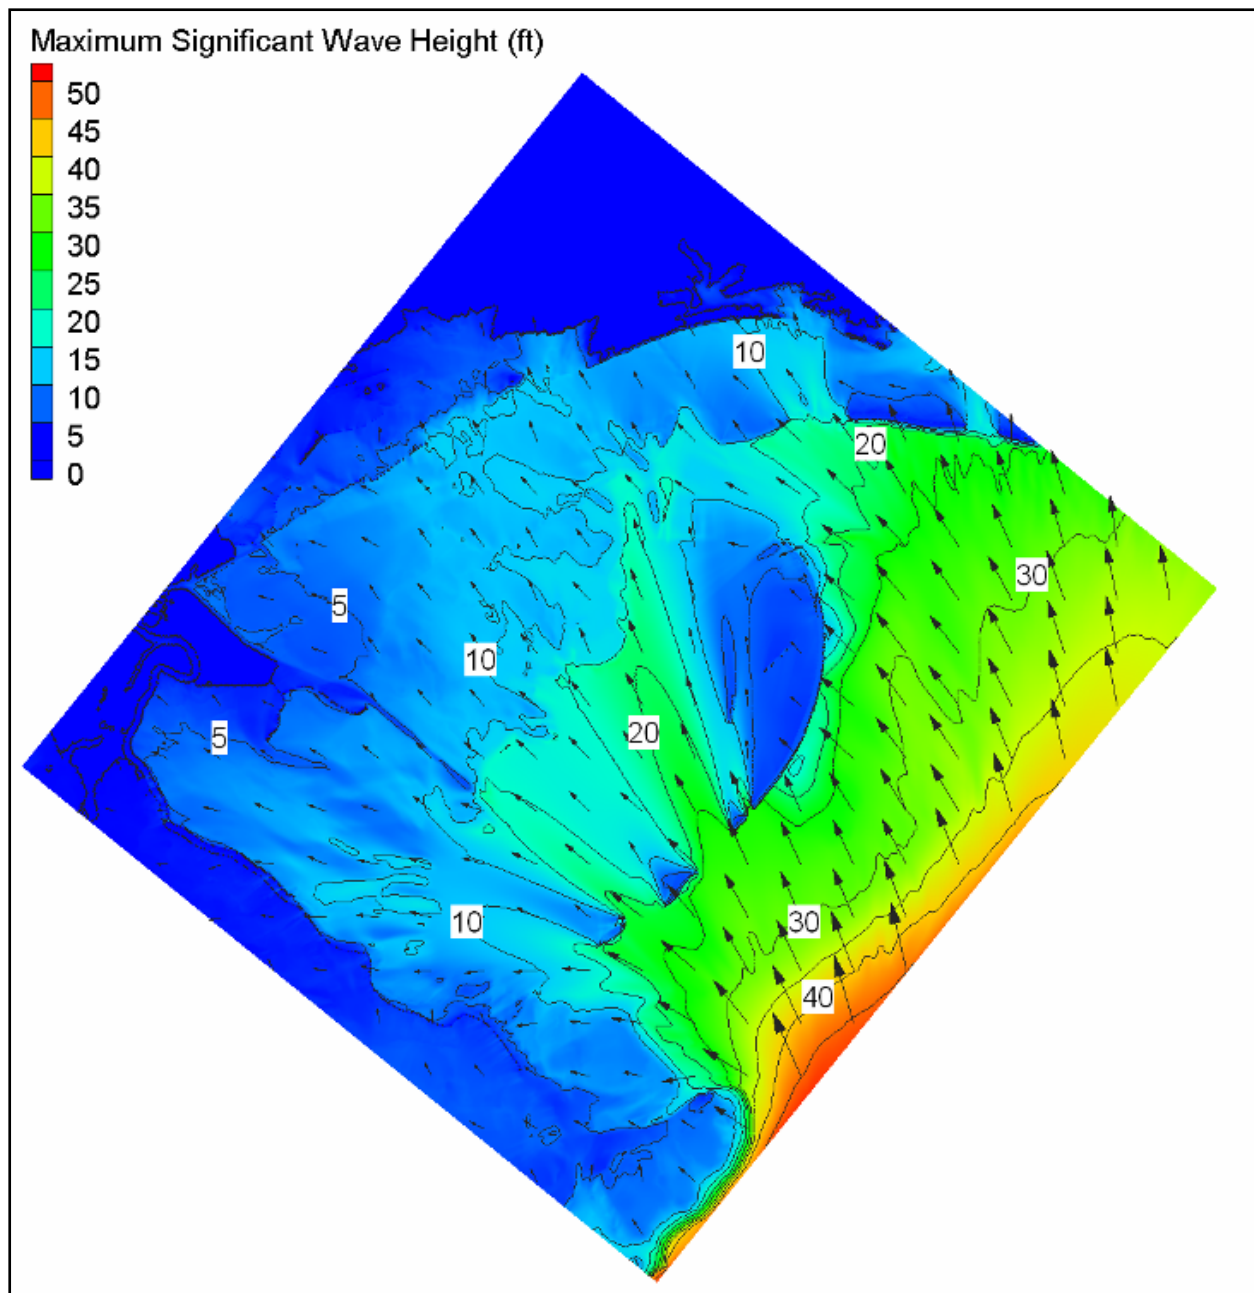
Figure 12. Southeast Louisiana maximum modeled wave height and corresponding mean direction (wave heights in feet).

resulting wave heights and wave periods are shown in Figures 10 to 13. They demonstrate that the Katrina-generated wave environment was severe. The most significant finding was that the waves along the GIWW, St. Bernard, MRGO, and Plaquemines Levees were ocean-generated waves, with wave period in the 15 to 16-second range, much more capable of overtopping structures than the design-assumed wind waves with periods of 5 to 6 seconds.

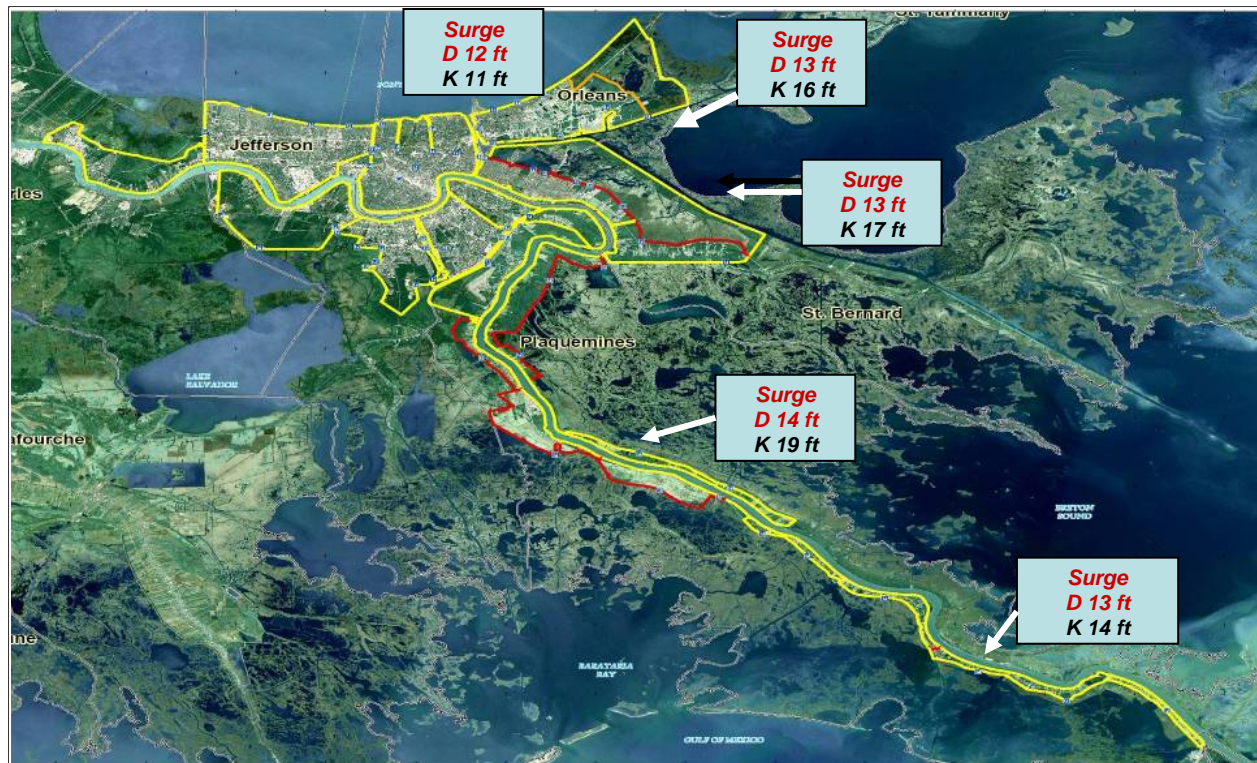
Figure 14. Comparison of general surge levels assumed in the SPH design (D) and estimated from Katrina (K). See Volume IV for more detailed information.

It is instructive to examine the surge and wave environment created by Katrina with respect to that assumed from the SPH from which the existing structures were designed. Figure 14 presents a simple comparison of the surge generated by Katrina with that used for the HPS design. Much more detailed information is available in Volume V of this report. Note that the surge in Lake Pontchartrain was roughly the same as the design levels assumed for the HPS. On the east side of New Orleans, Katrina generated surges were significantly greater than the design criteria, ranging from 17 to 20 ft compared to the 12 to 14 ft assumed in the design.

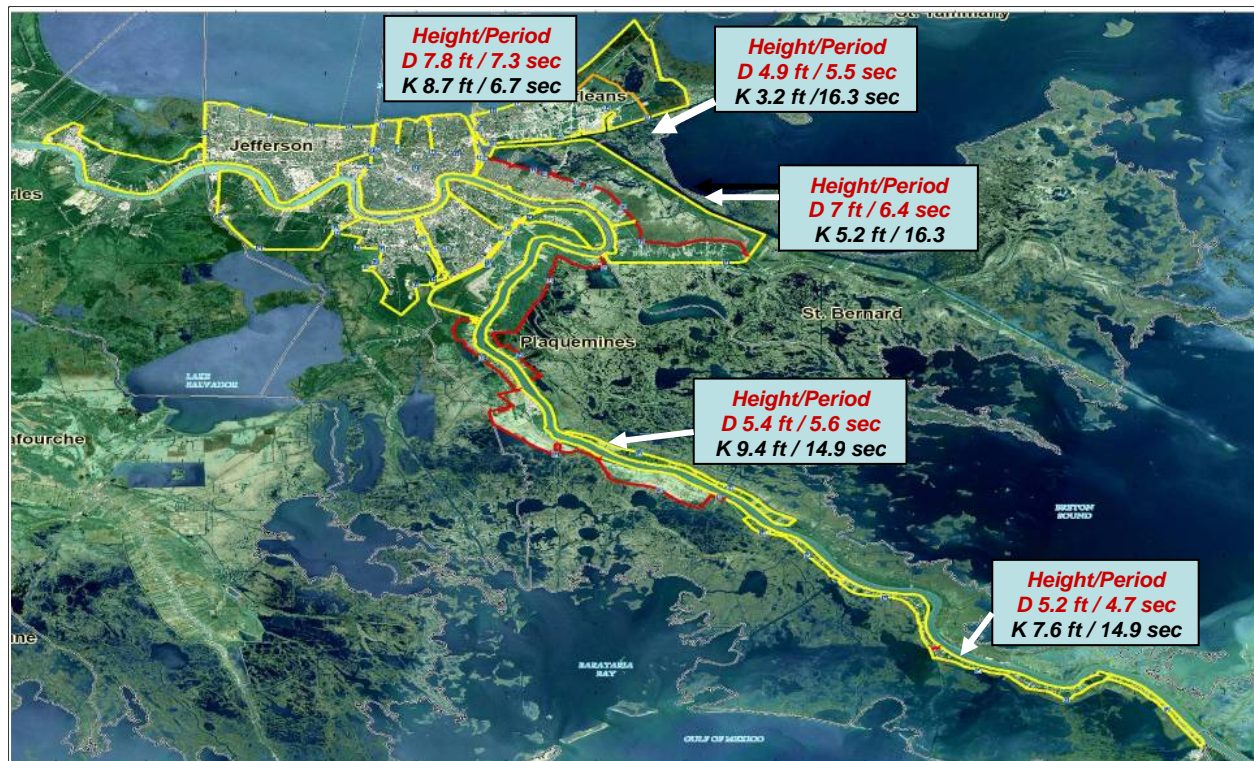
Figure 15. General comparison of wave height and period assumed in HPS design (D) and estimated from Katrina (K). See Volume IV for more detailed information.

Figure 15 compares the wave conditions assumed for the SPH design and those estimated from Katrina. With the exception of Plaquemines Parish, Katrina generated wave heights were not much different from the design assumptions. In Plaquemines Parish, Katrina did generate significantly higher waves. Wave periods were a different story. In Pontchartrain, the period of Katrina-generated waves was similar to the design assumptions, in the 6- to 7-second range. Along the St. Bernard and Plaquemines Levees, however, Katrina generated 14- to 16-second period waves, approximately three times the design wave periods. This is very significant in that the longer period waves were largely generated in the Gulf and propagated in to shore and have much greater potential for runup and overtopping of HPS structures.

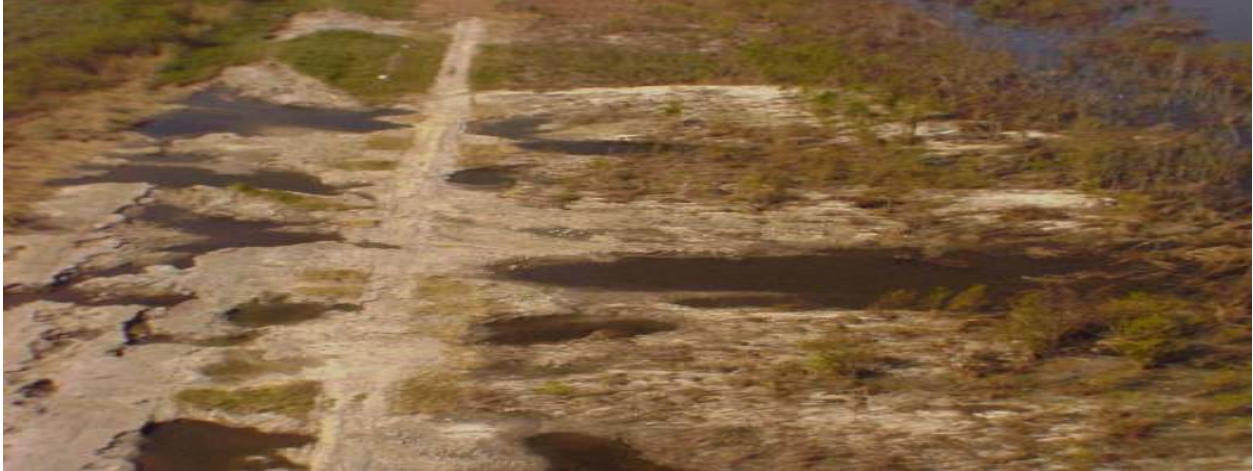
Figure 17. Example of levee along New Orleans East, GIWW, breaching from overtopping and scour of erodible materials.

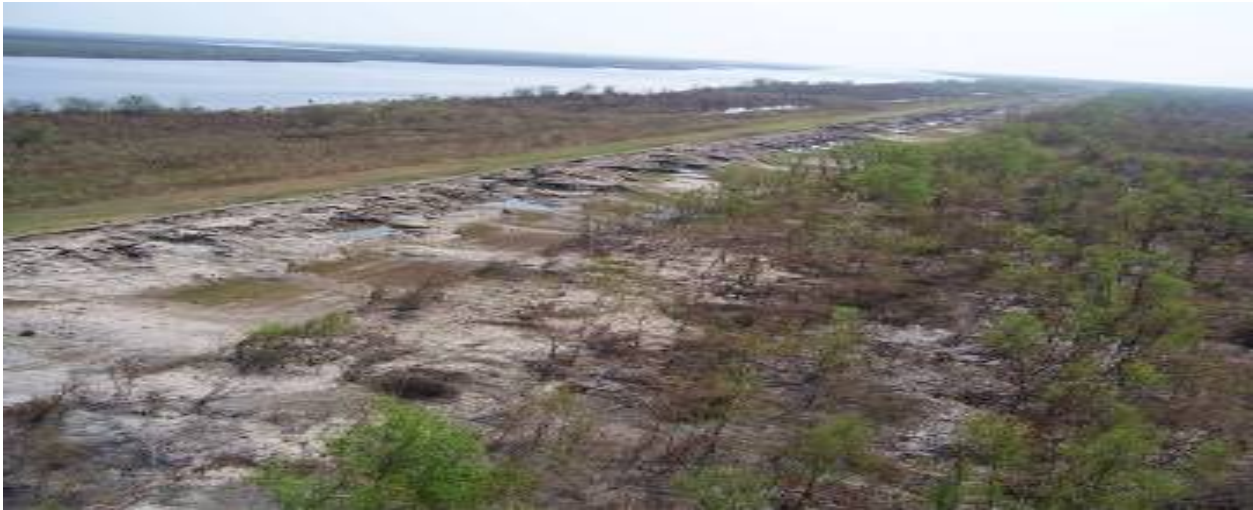
Figure 18. Example of levee breach along MRGO from overtopping and scour of erodible materials.

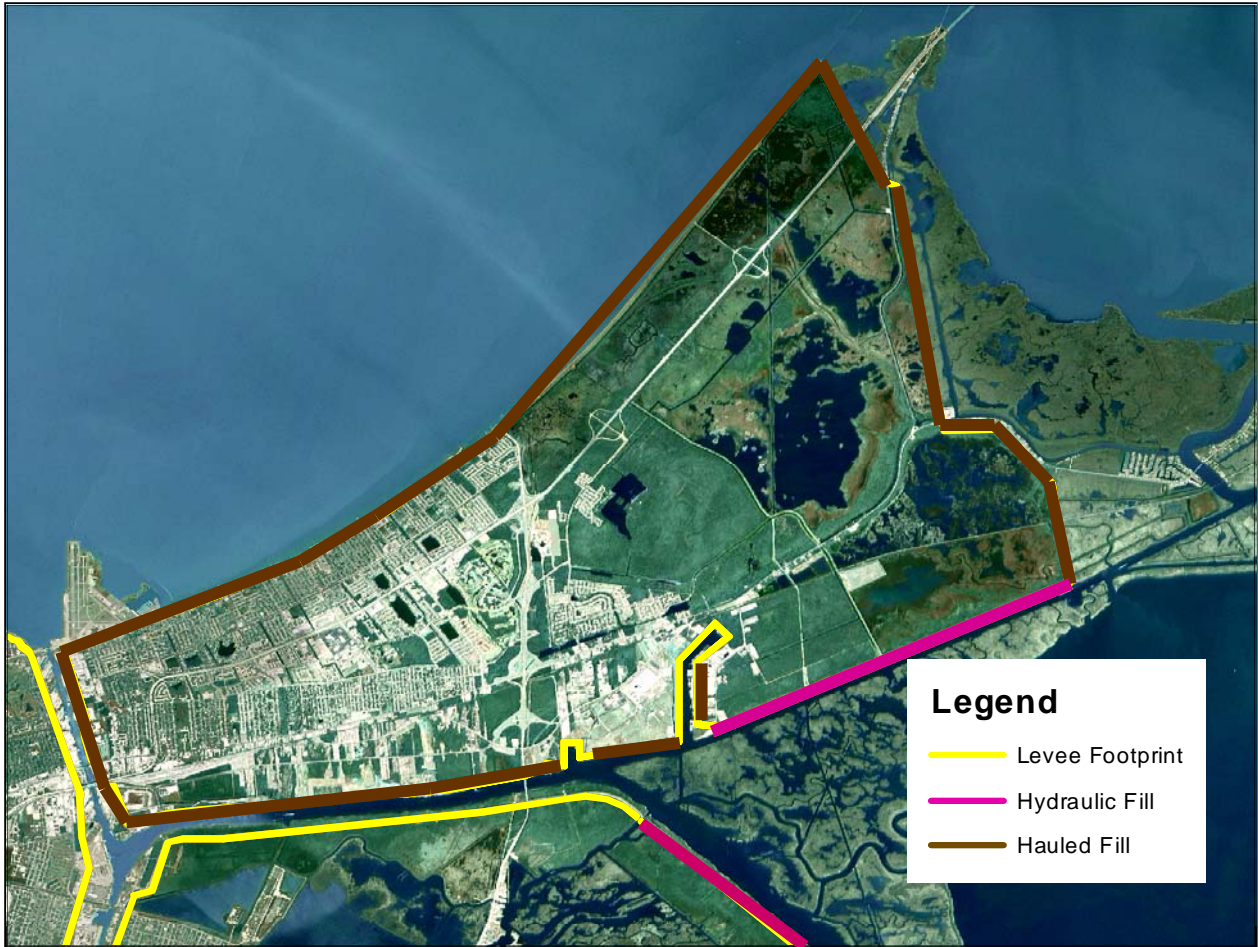
Figure 19a. Character of levee materials, New Orleans East and northern St. Bernard. This slide is incomplete for St. Bernard and shows only the hydraulic fill section along the MRGO.

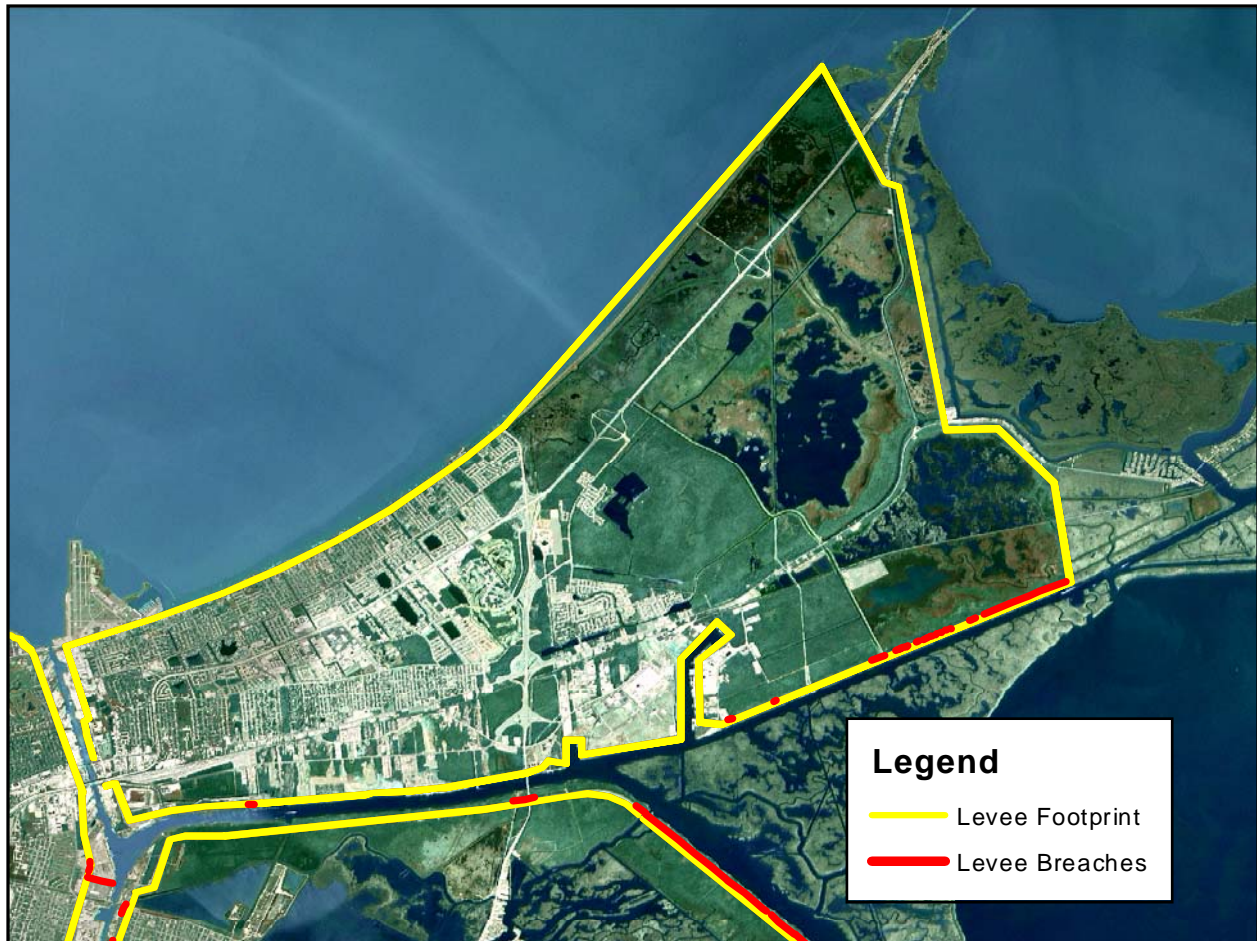
Figure 19b. Distribution of levee breaching, New Orleans East and northern St. Bernard.

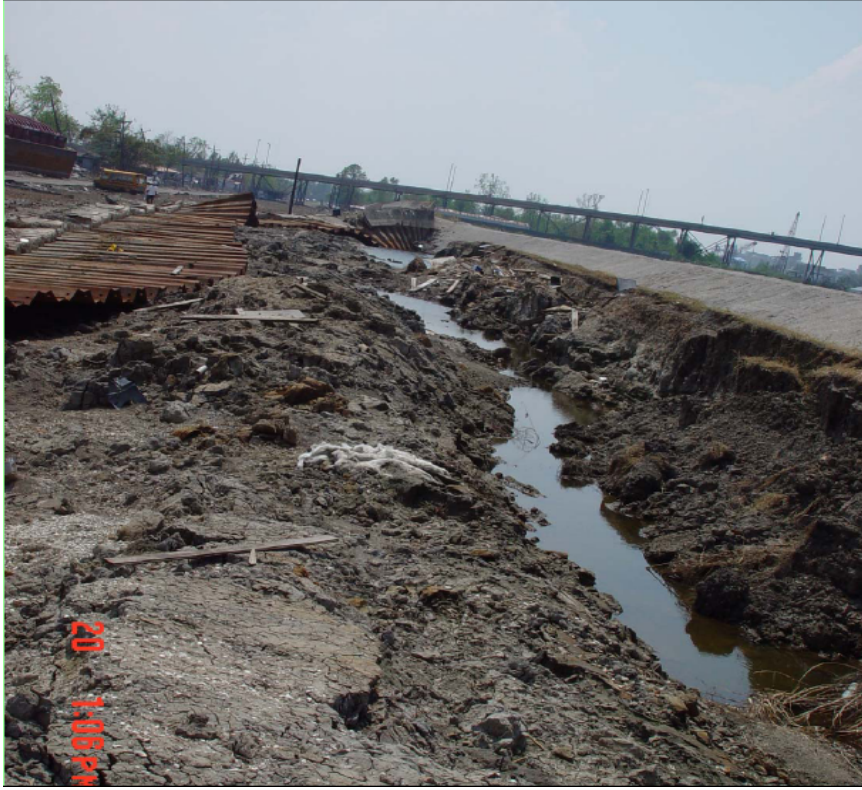
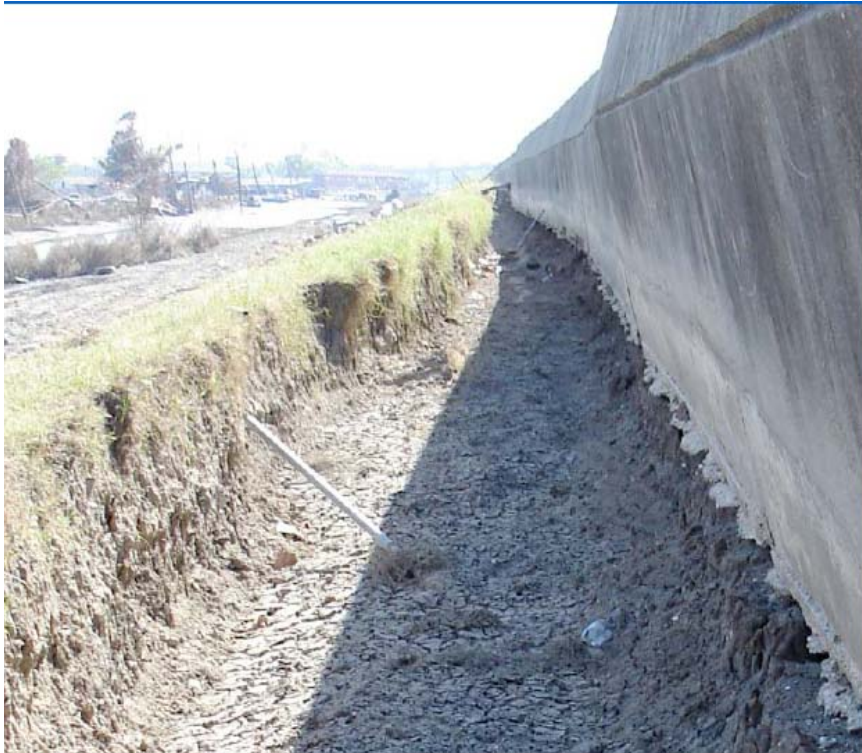
Figure 22. Example of breach along IHNC (east side) from overtopping and scour (top) and scour behind adjacent section that did not fail (bottom).

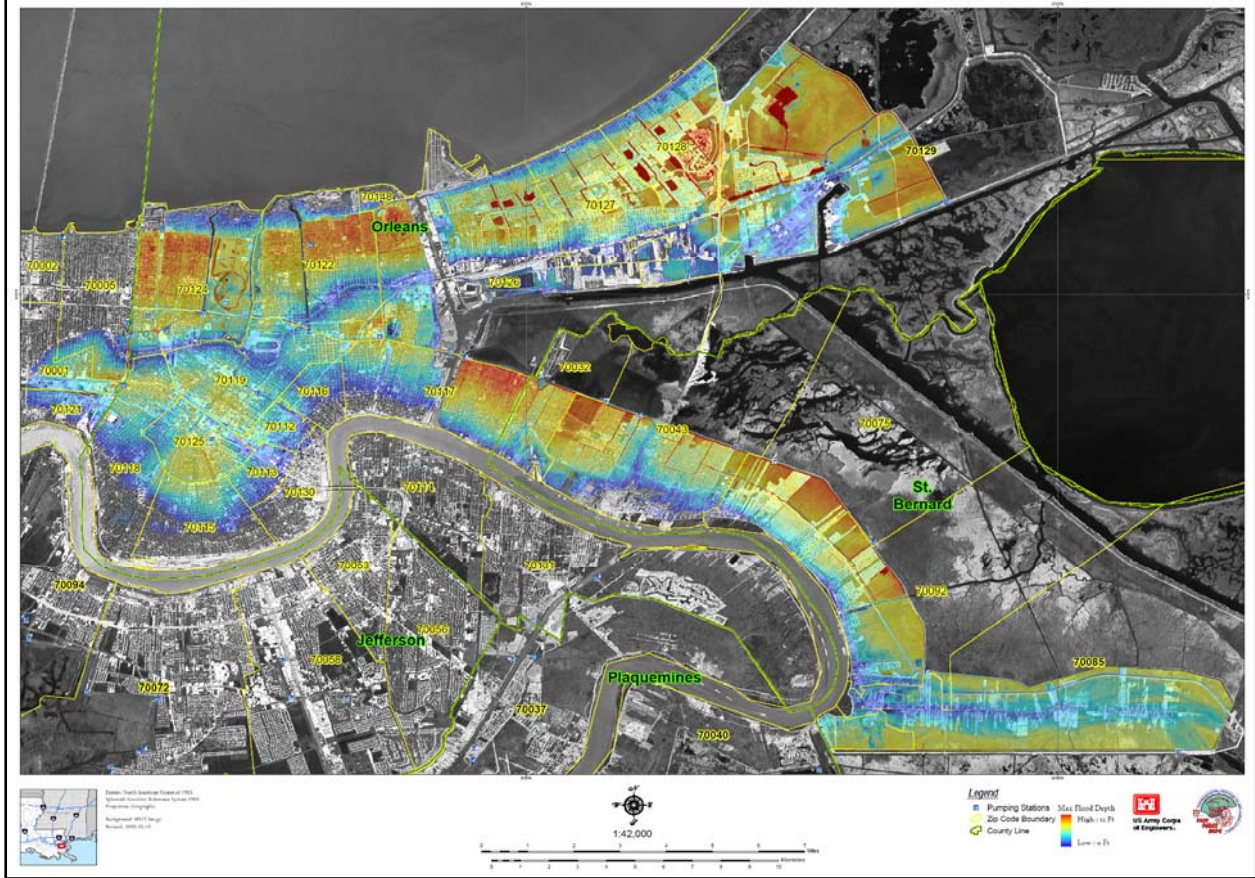
Figure 23. Map of maximum depths of flooding from Katrina. Greatest depths of flooding exceed 15 feet.

The flooding resulting from the overtopping and breaching was catastrophic. Figure 23 shows the extent and depth of flooding for the New Orleans metropolitan area where almost 80 percent was inundated. Pumping stations were for the most part not operating due to prior evacuation of operators, loss of power, or loss of clean cooling water for the pumps. An evaluation of the pumping performance as a percentage of the total capacity is given in Figure 24. The pump stations in New Orleans were simply not designed to operate during major storms. A few stations, notably in Orleans Parish, may have continued to operate if the flooding had not been so extensive. Had the pumps been able to operate, the extent of flooding may not have been impacted greatly, but the duration of flooding could have been significantly reduced. Using temporary pumps and slowly bringing the permanent pumps on line after Katrina required 53 days to unwater the city.

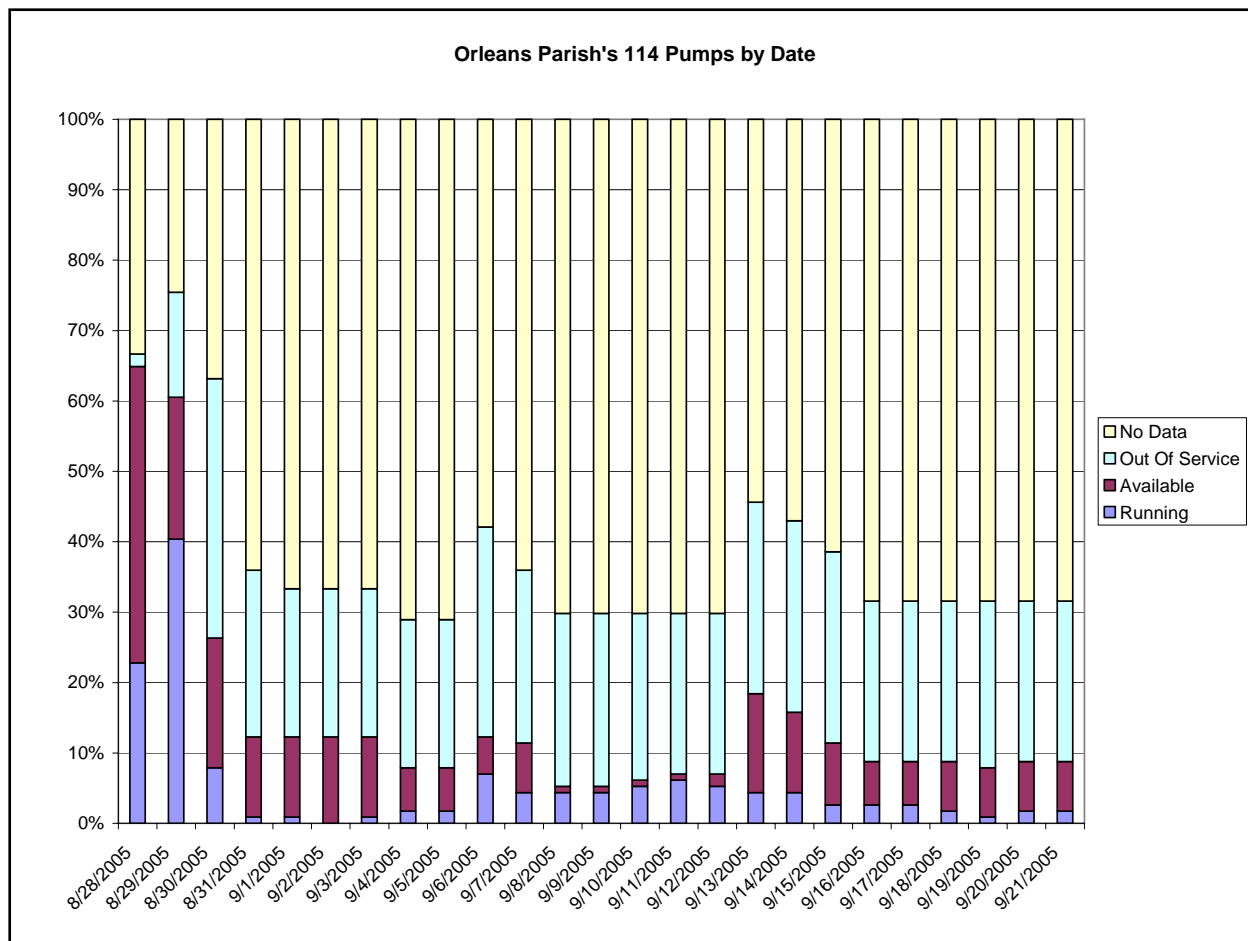
Figure 24. Example of pumping performance during Katrina.

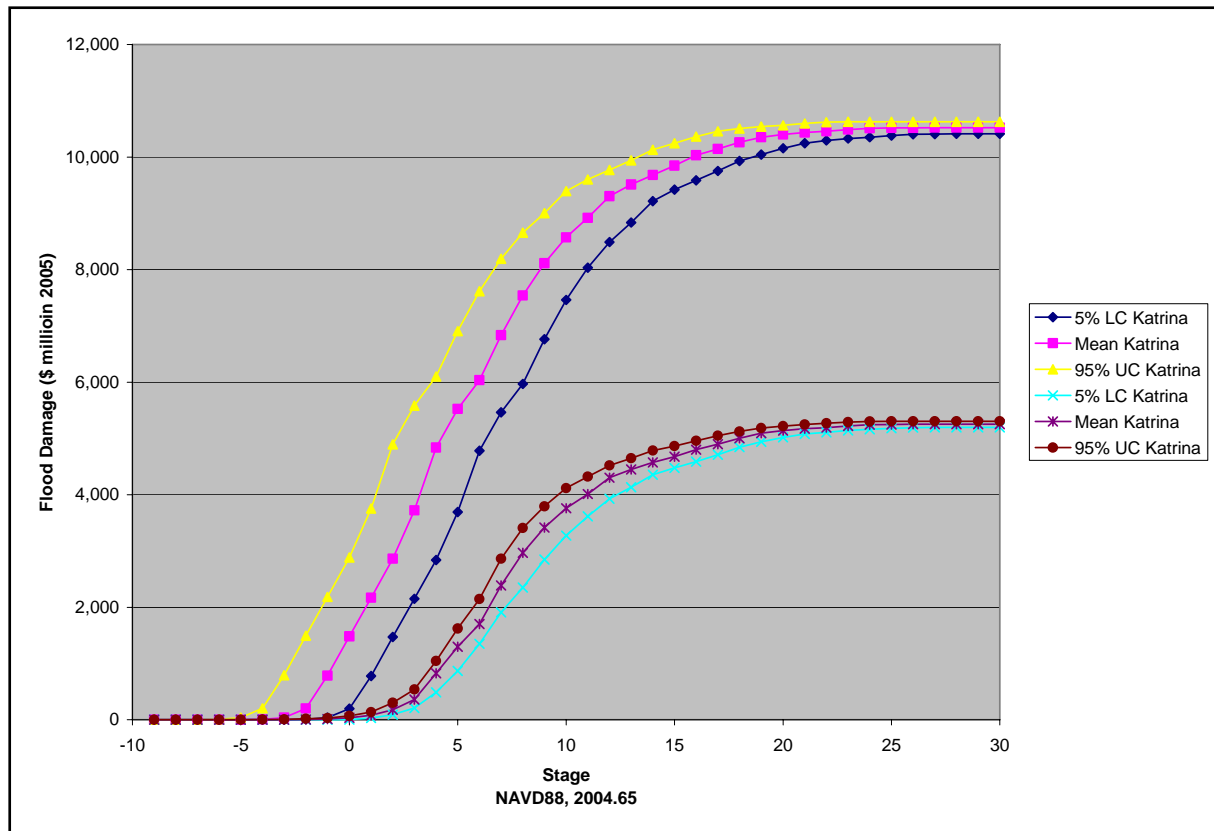
Figure 30. Comparison of flood damage – water level (in feet) relationships for pre- and post-Katrina scenarios for Orleans subbasin 5. LC and UC represent the lower and upper confidence limits of the data.

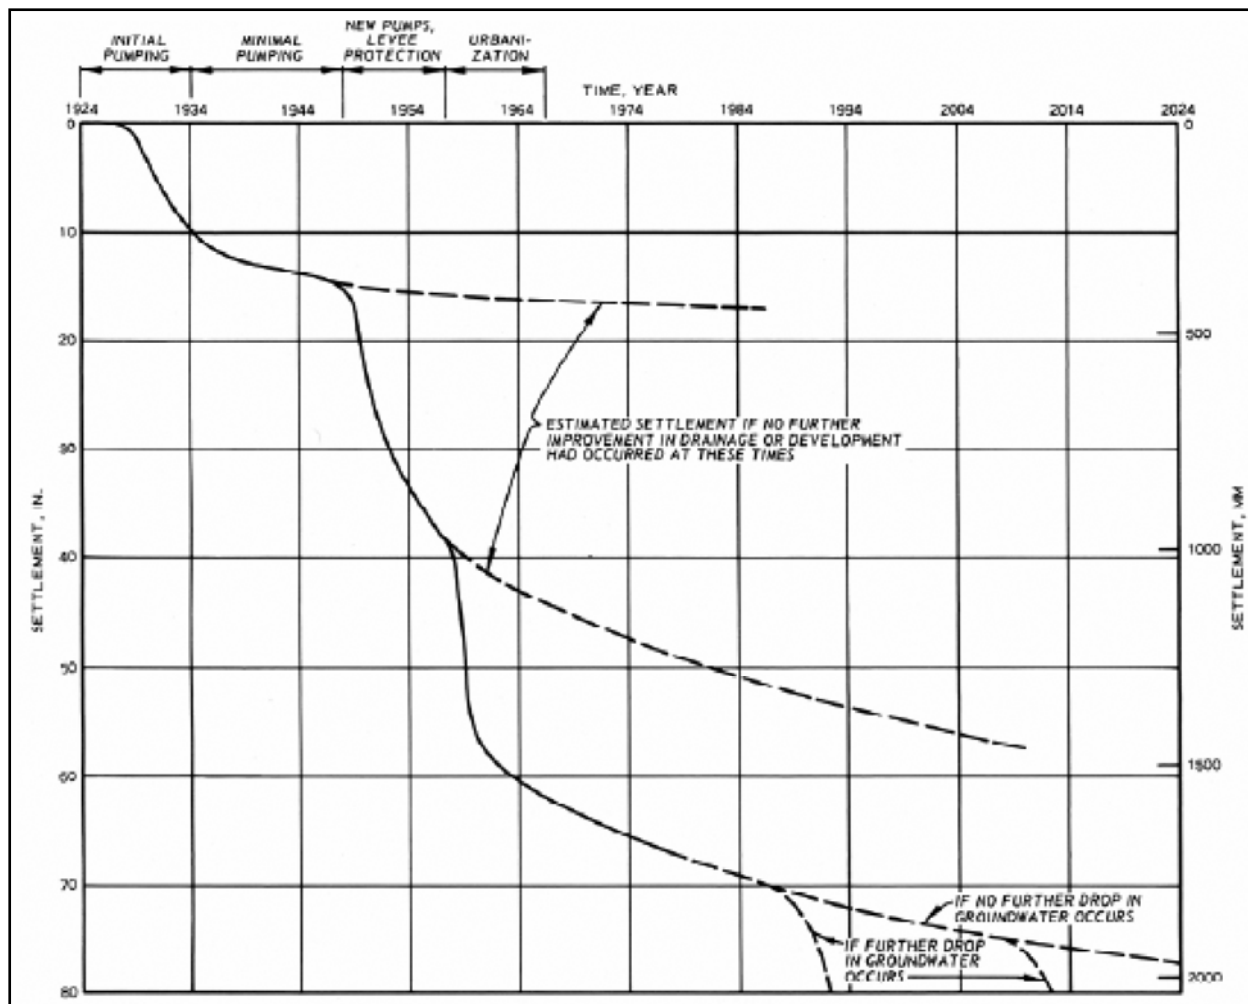
Figure 5-7. Estimated settlement history in the Kenner area due to dewatering of near surface organic sediments by drainage canals and pumping (from Kolb and Saucier (1982) using unpublished data by Traughber and Gore). Dewatering of organic sediments causes volume reduction in these sediments and results in oxidation, which lowers the ground surface.

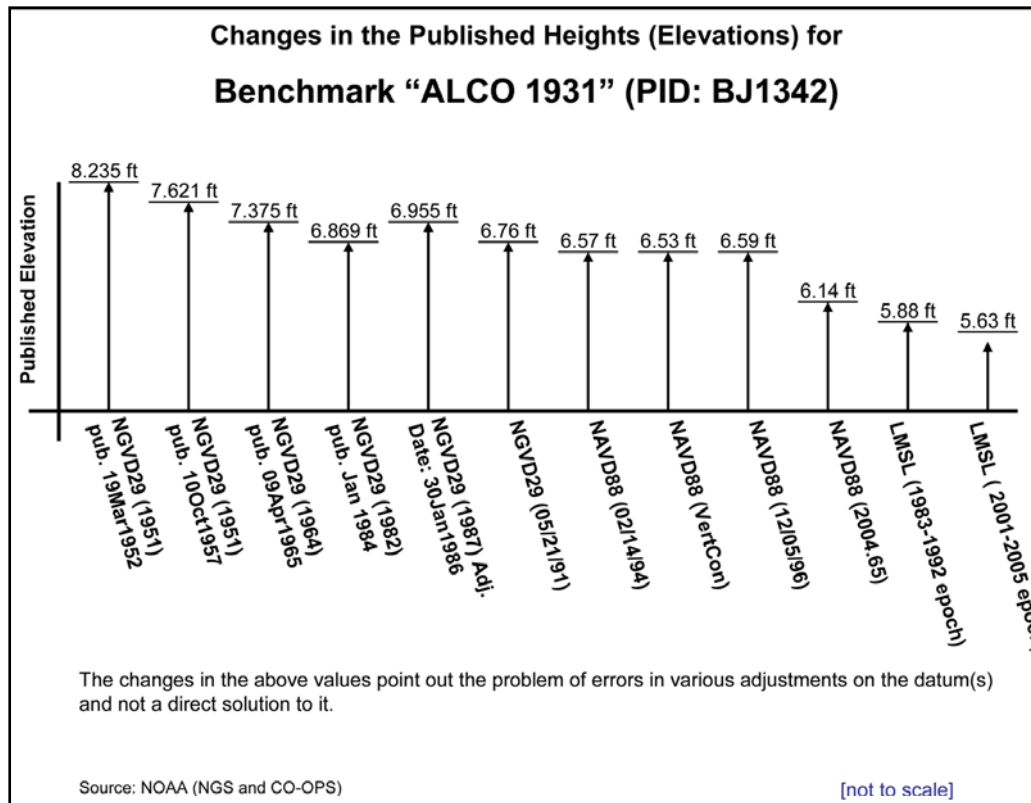
Figure 5-9. Changes in elevation reported for the ALCO benchmark, near the Hammond Highway Bridge at 17th Street Canal (from IPET, Chapter 2, Figures 69 and 33, respectively).

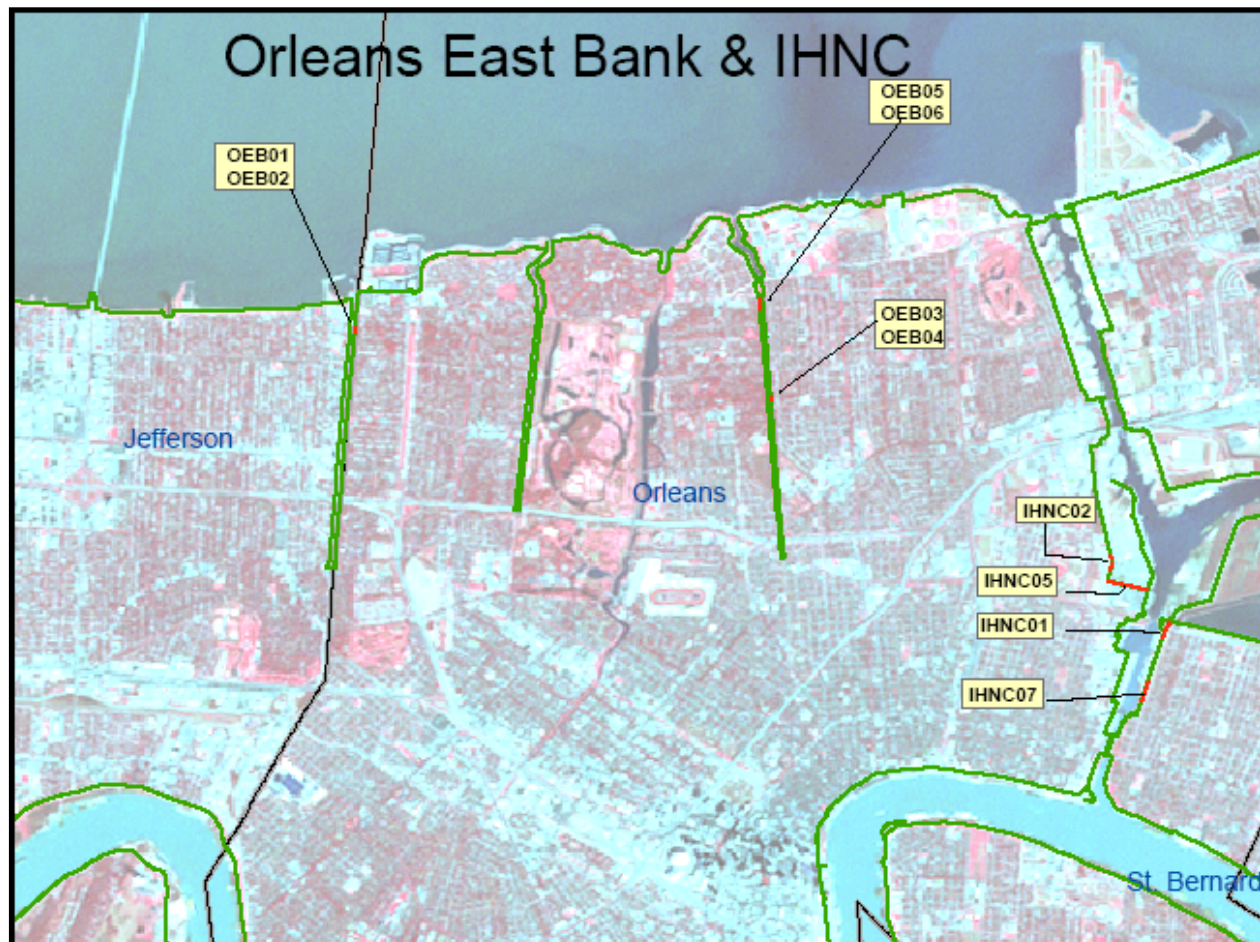
Figure 8-1. Distribution of breaches, Orleans East Bank.

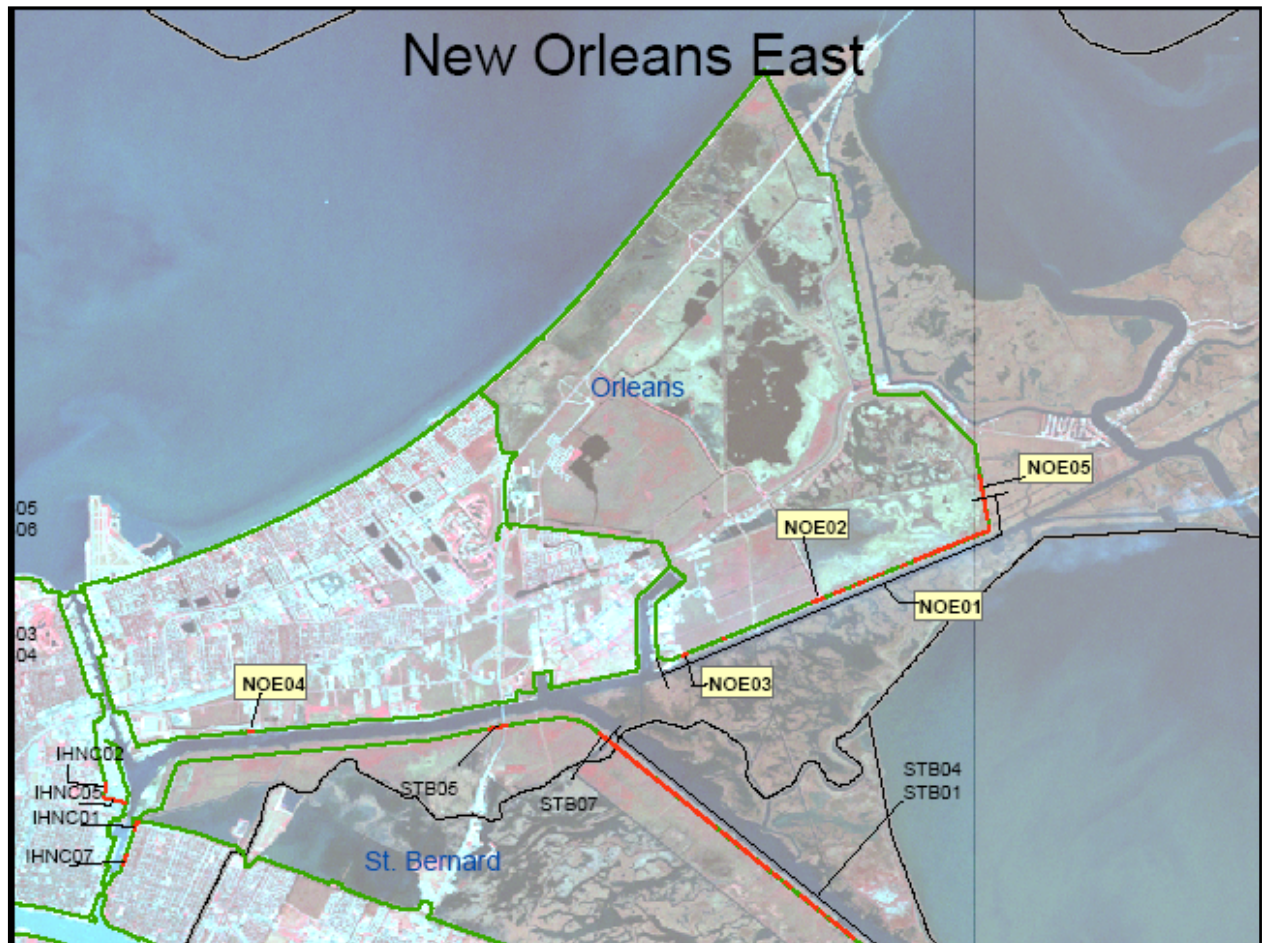
Figure 8-2. Distribution of breaches, New Orleans East.
