Appendix 1

Soil Data Report for 17th Street Canal

This is a data report detailing the data collected by the Interagency Performance Evaluation Task Force (IPET) to support the analysis of the I-wall section that breached at the 17th Street Canal as a result of Hurricane Katrina on August 29, 2005. The location of the 17th Street Canal is shown in Figure 1-1. The site of the breach, located on the east bank near the north end of the canal, is also noted on Figure 1-1.

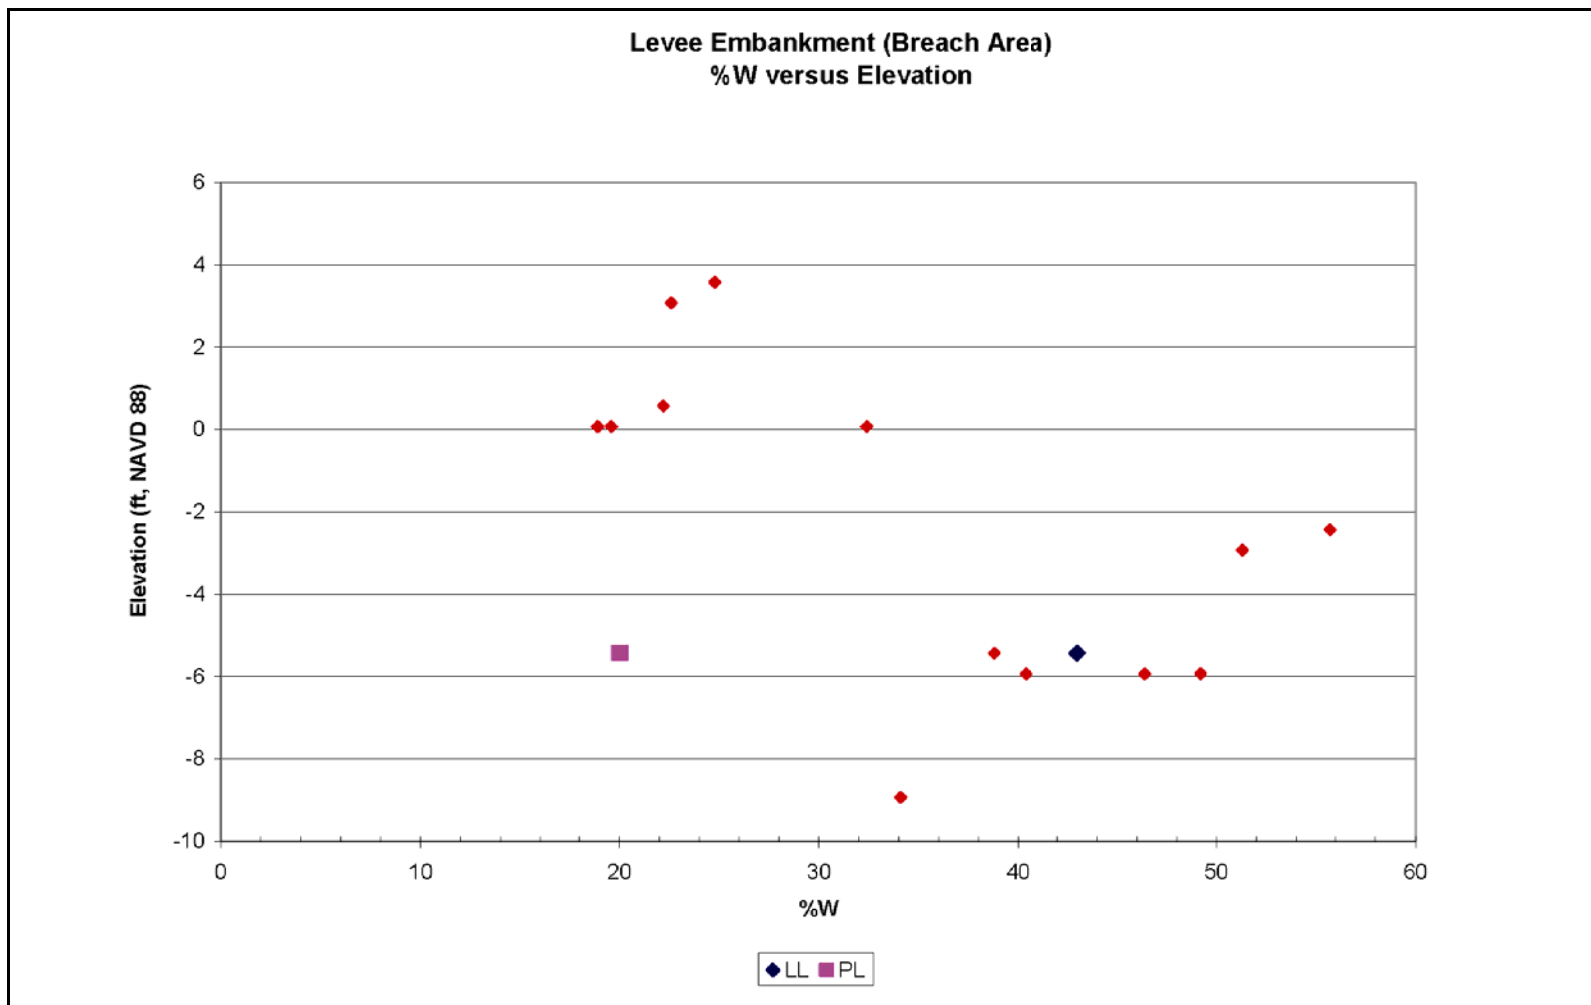
Figure 1-14. Levee Embankment (Breach Area), %w versus Elevation

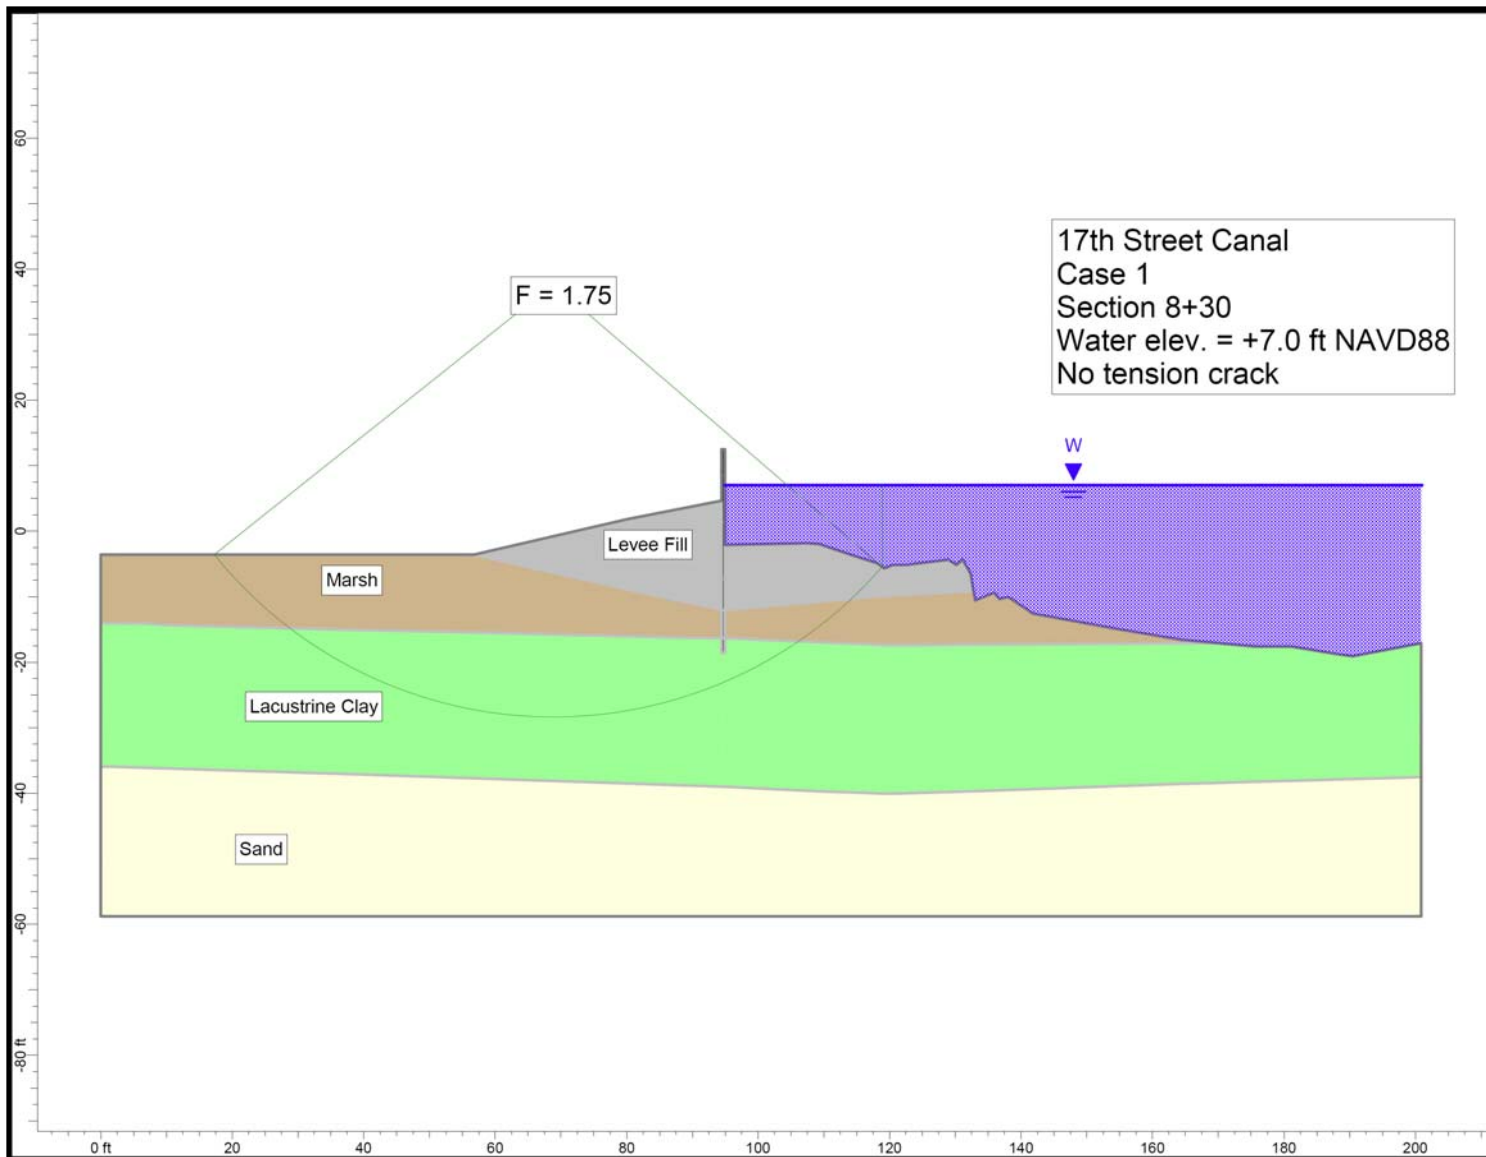
Figure 4-1. Critical Circle for 17th Street Canal Station 8+30 – Water Elevation 7.0 ft, No Tension Crack

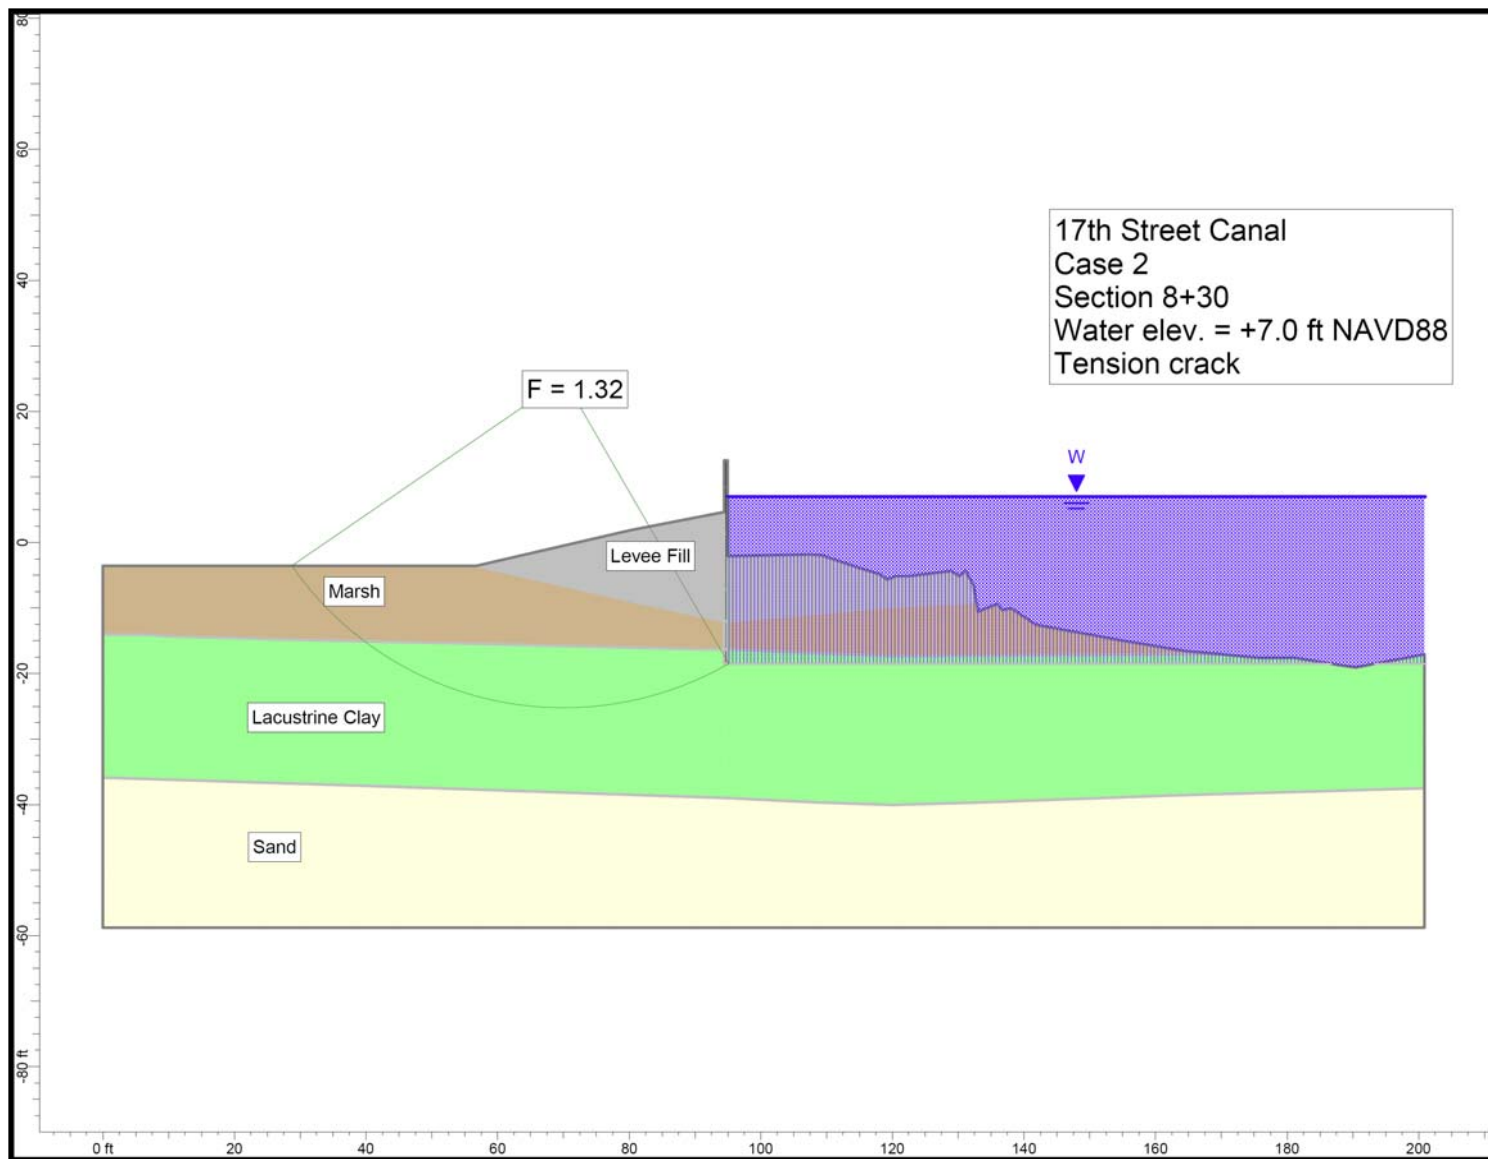
Figure 4-2. Critical Circle for 17th Street Canal Station 8+30 – Water Elevation 7.0 ft, Tension Crack

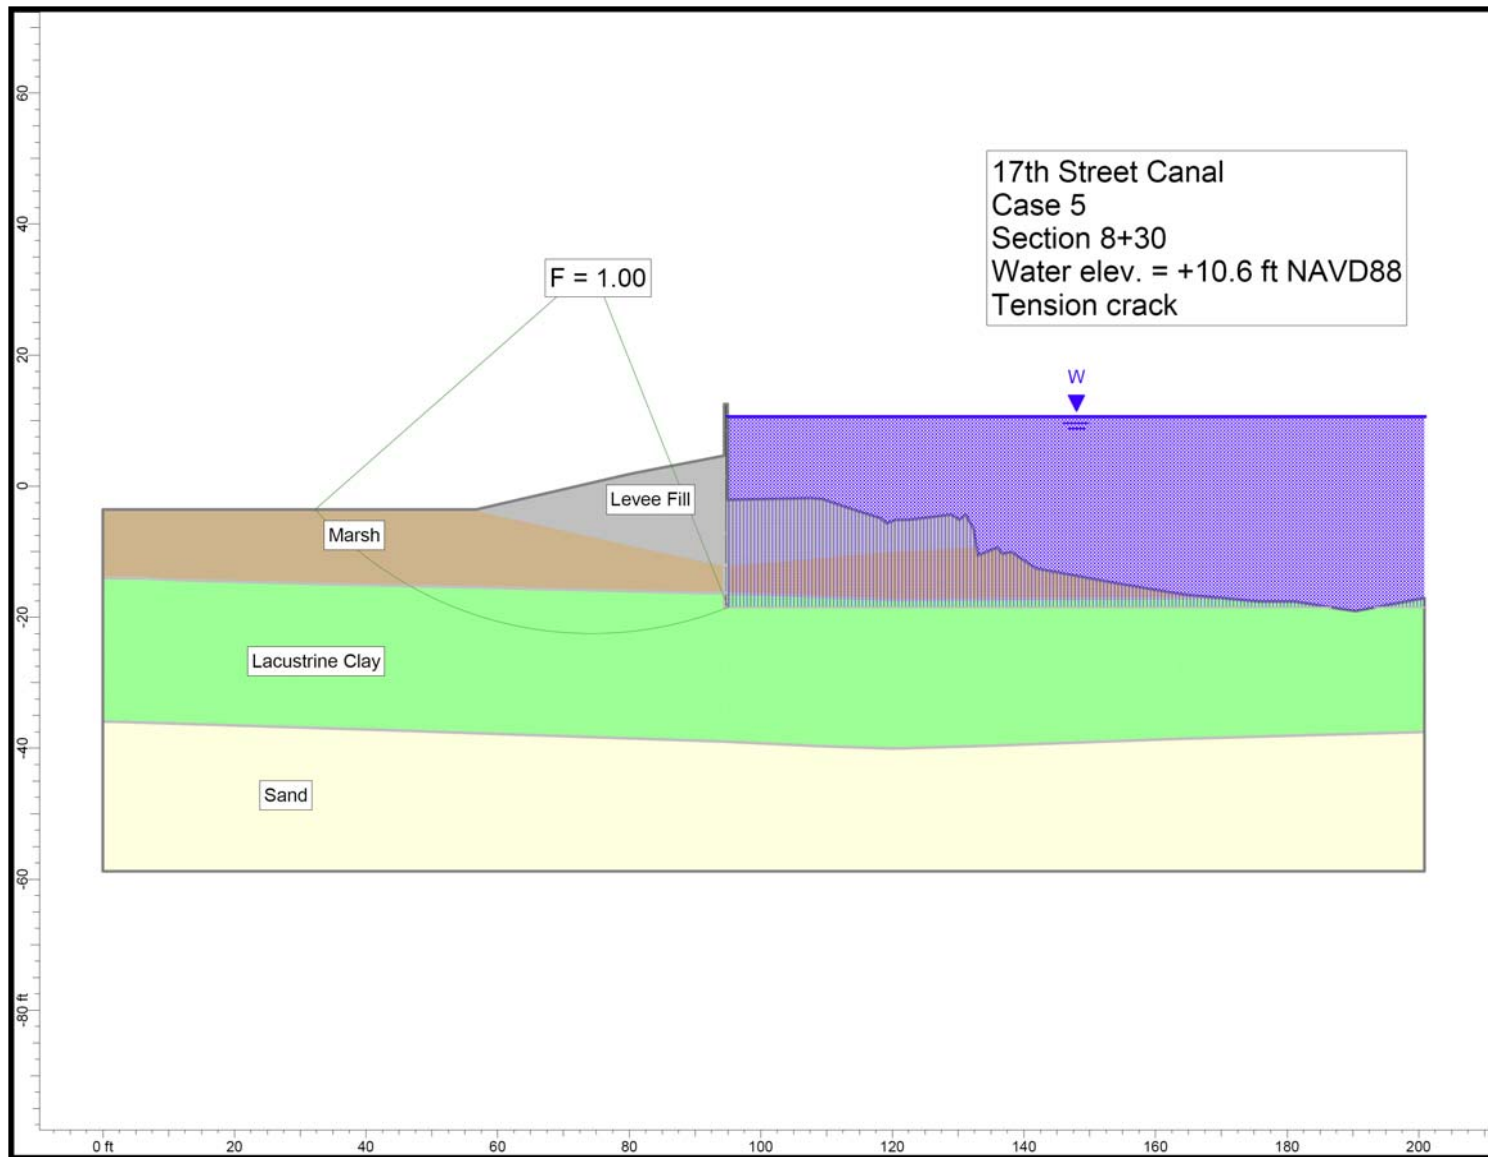
Figure 4-5. Critical Circle for 17th Street Canal Station 8+30 – Water Elevation 10.6 ft, Tension Crack.

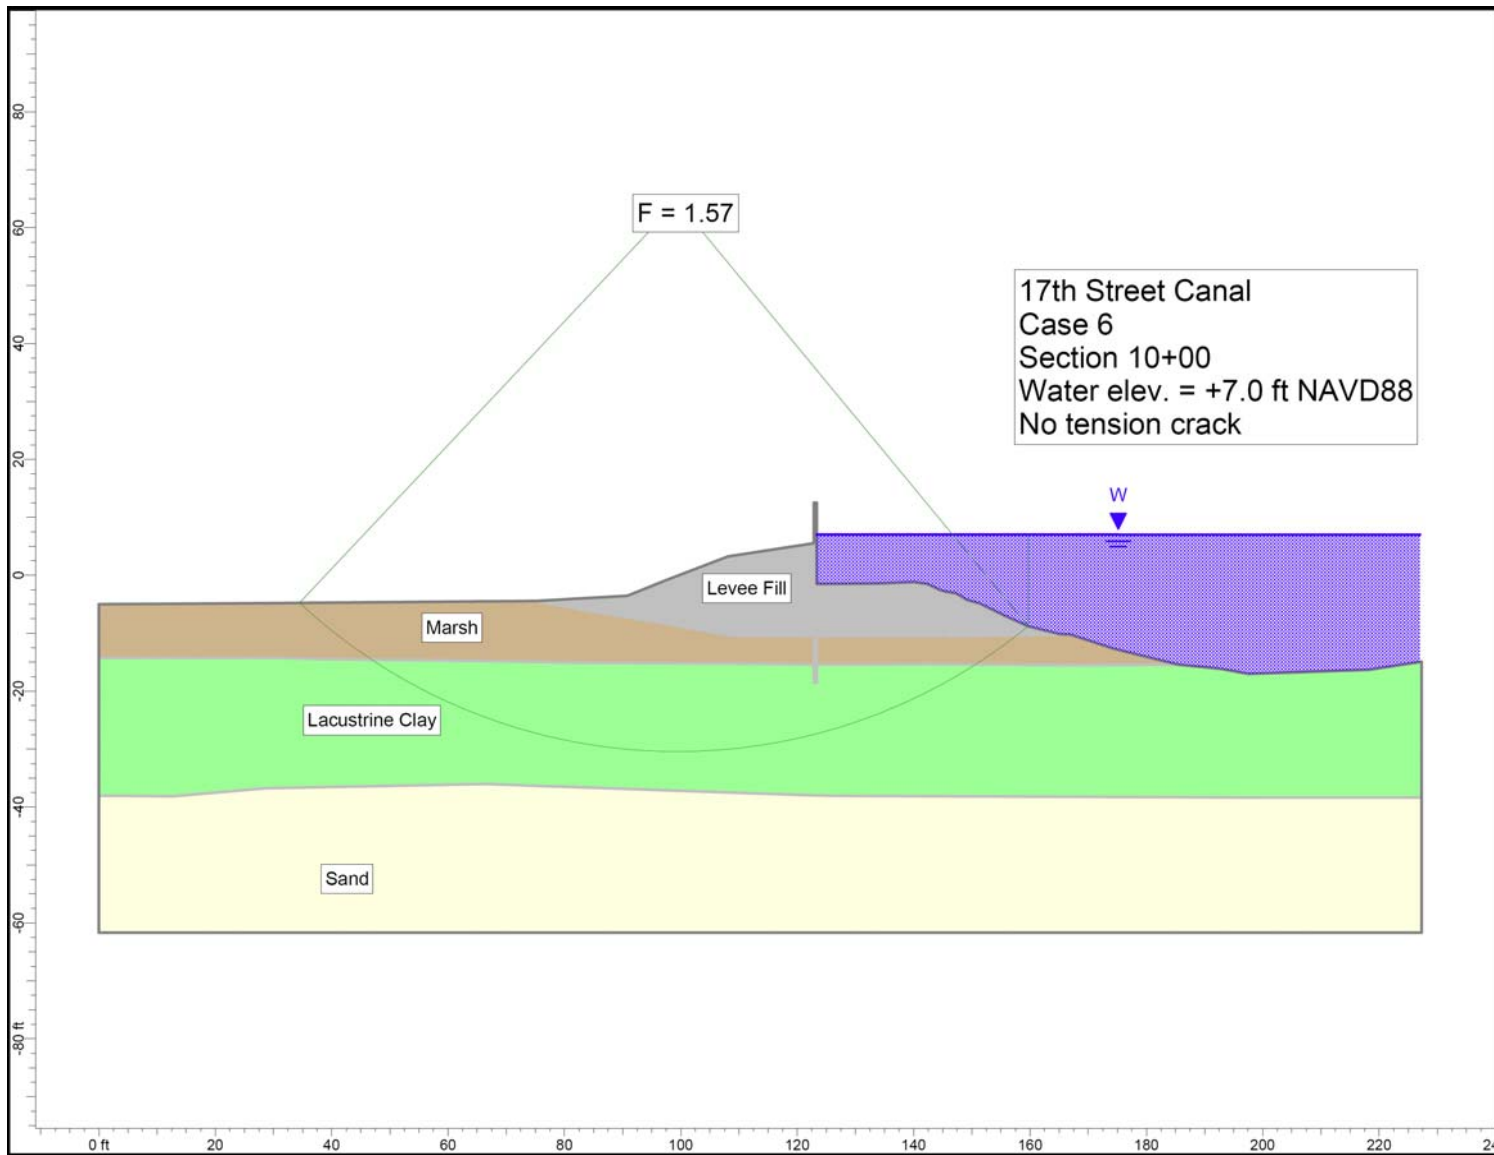
Figure 4-6. Critical Circle for 17th Street Canal Station 10+00 – Water Elevation 7.0 ft, No Tension Crack

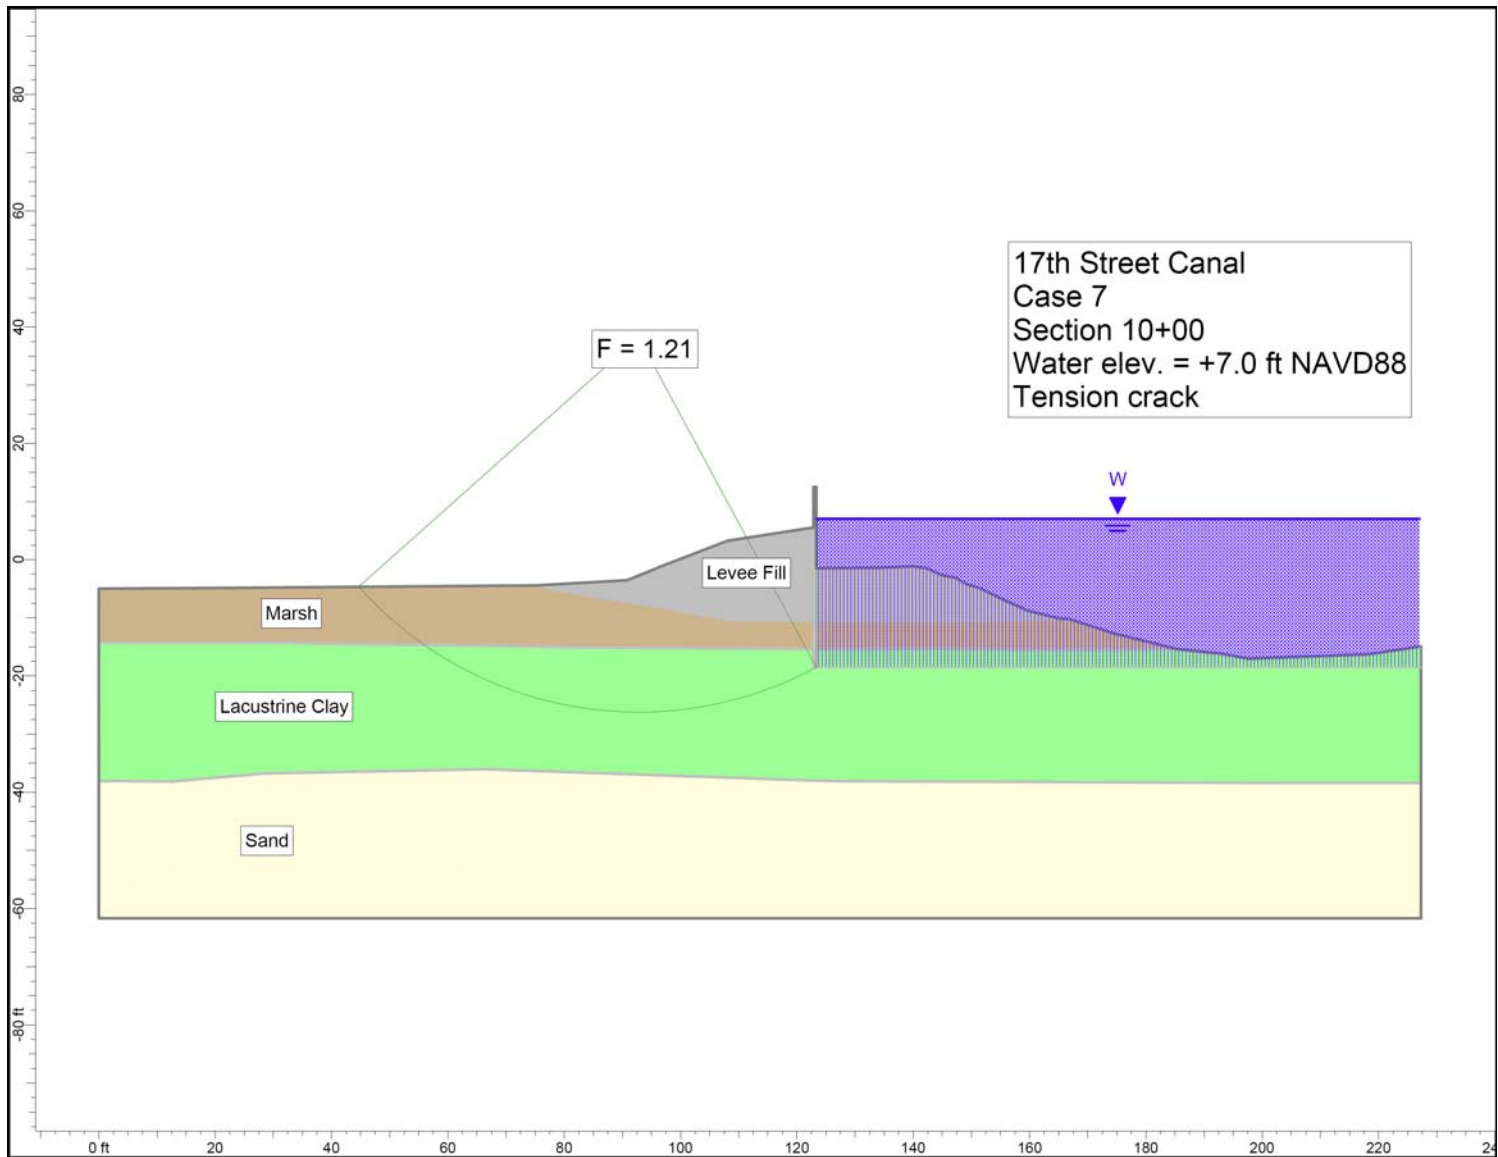
Figure 4-7. Critical Circle for 17th Street Canal Station 10+00 – Water Elevation 7.0 ft, Tension Crack

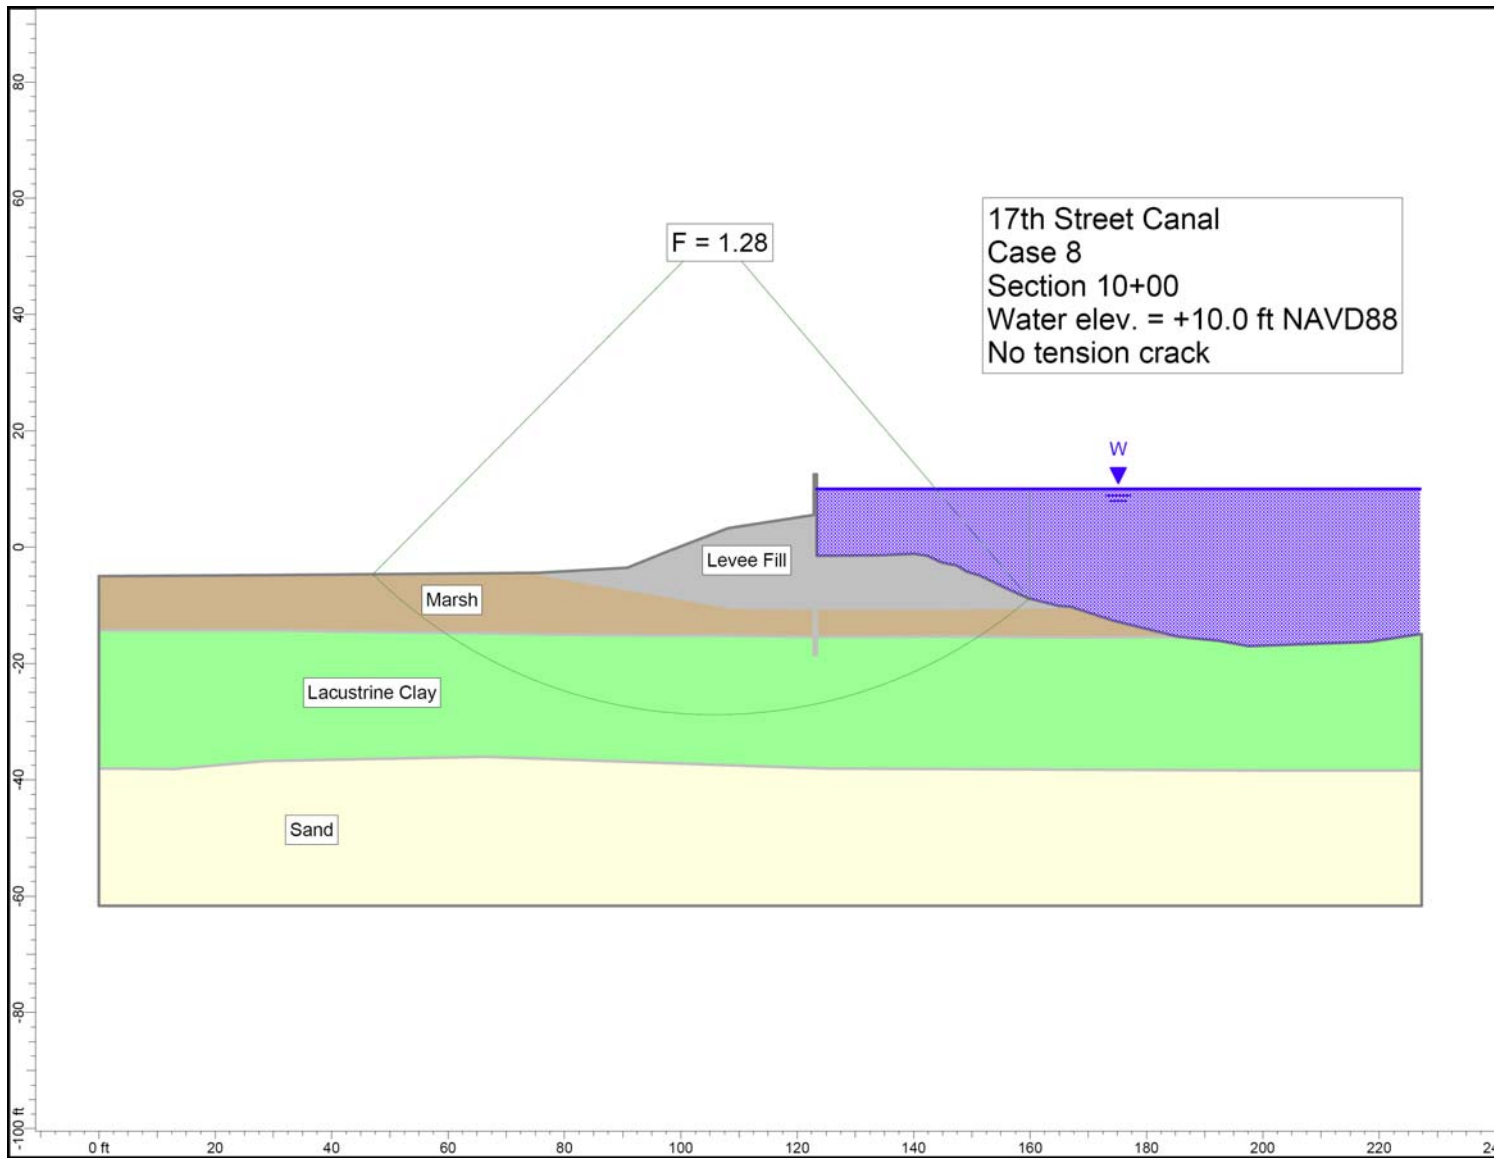
Figure 4-8. Critical Circle for 17th Street Canal Station 10+00 – Water Elevation 10 ft, No Tension Crack

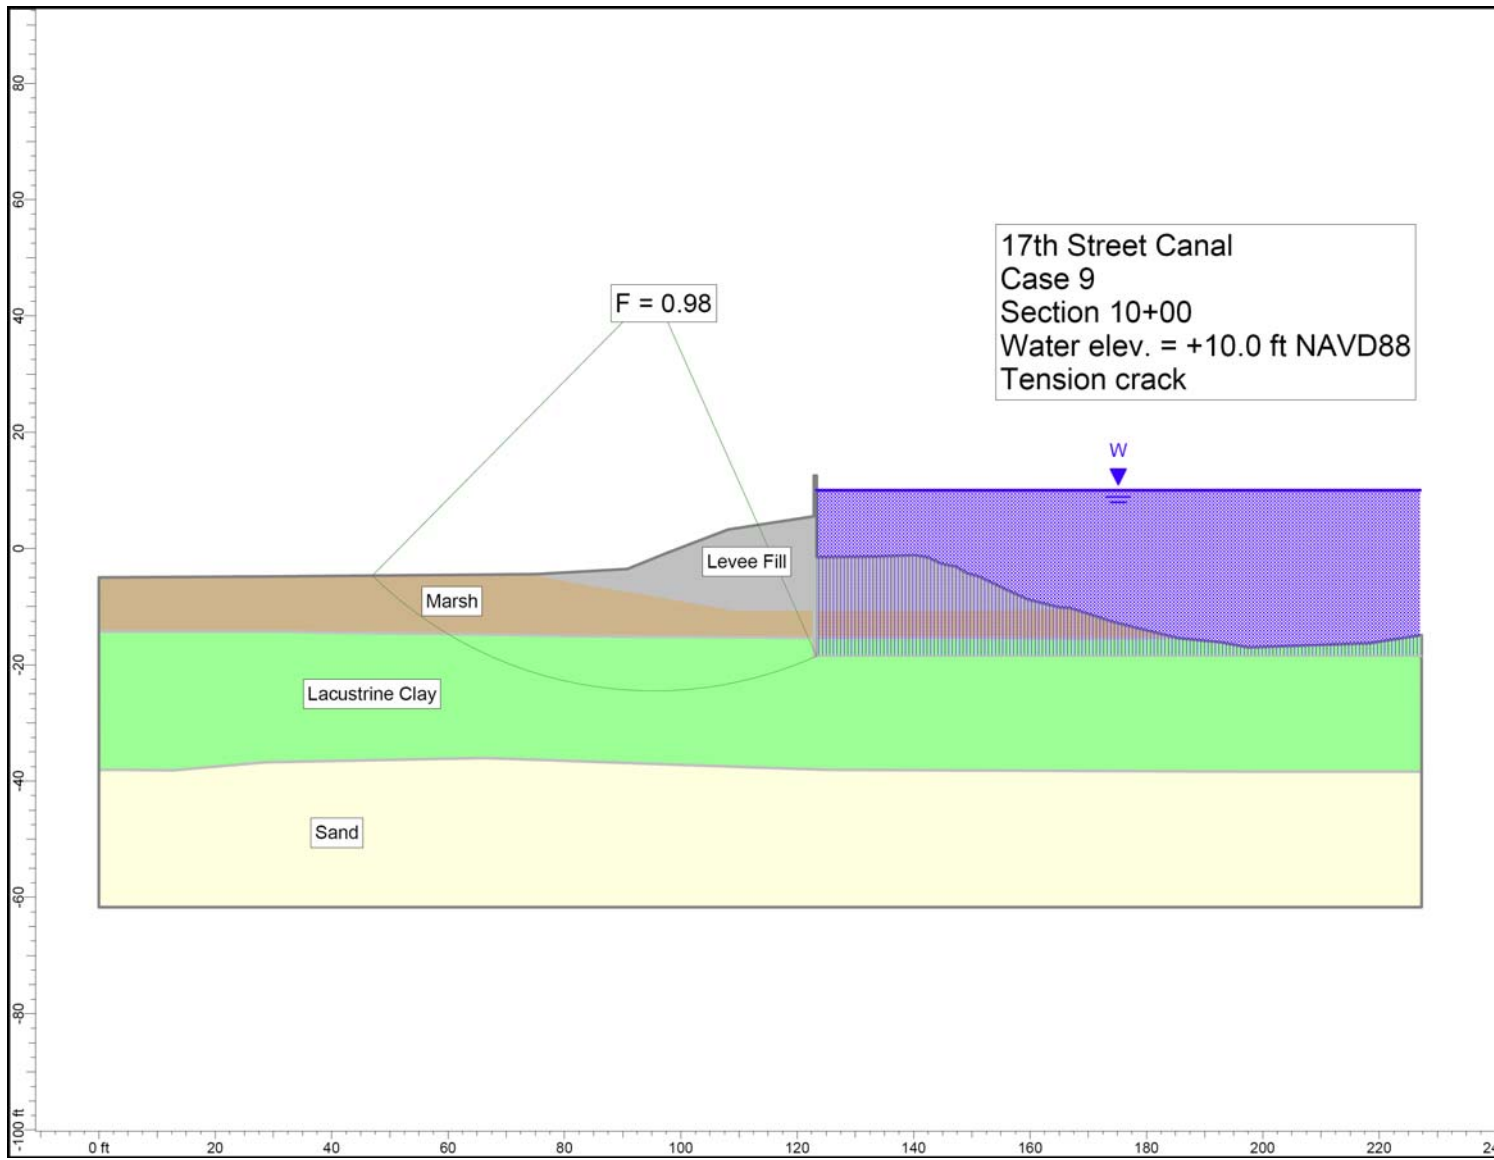
Figure 4-9. Critical Circle for 17th Street Canal Station 10+00 – Water Elevation 10 ft, Tension Crack

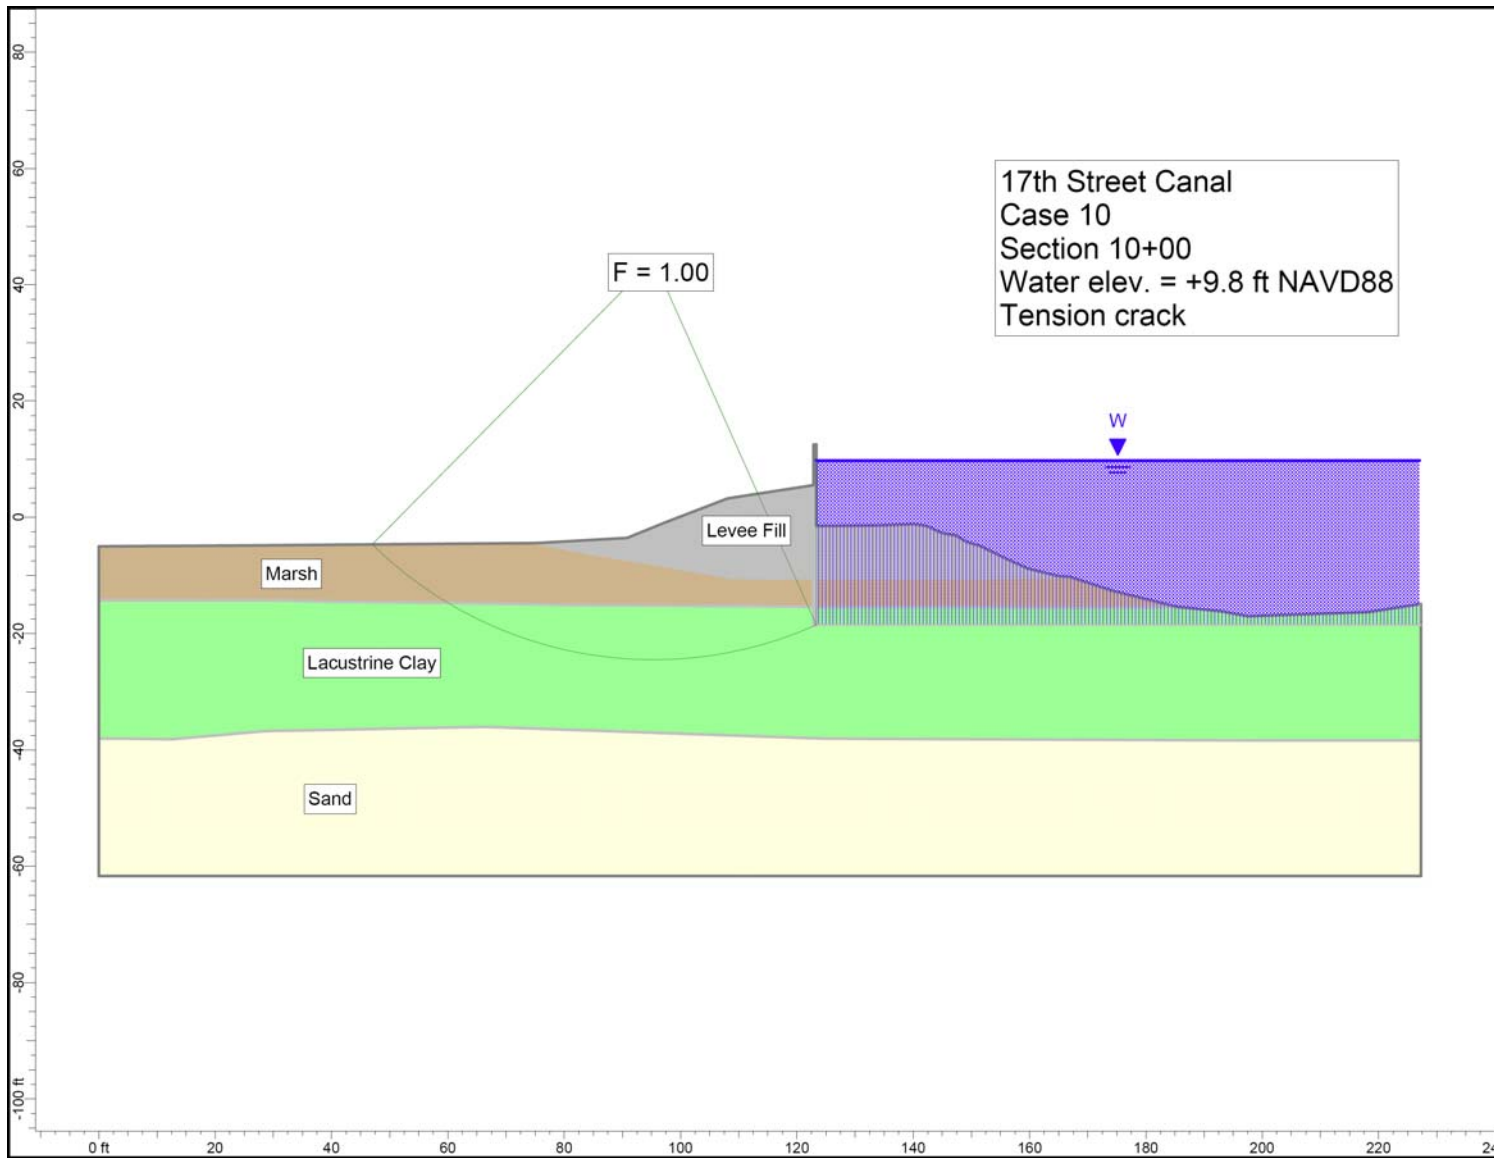
Figure 4-10. Critical Circle for 17th Street Canal Station 10+00 – Water Elevation 9.8 ft, Tension Crack

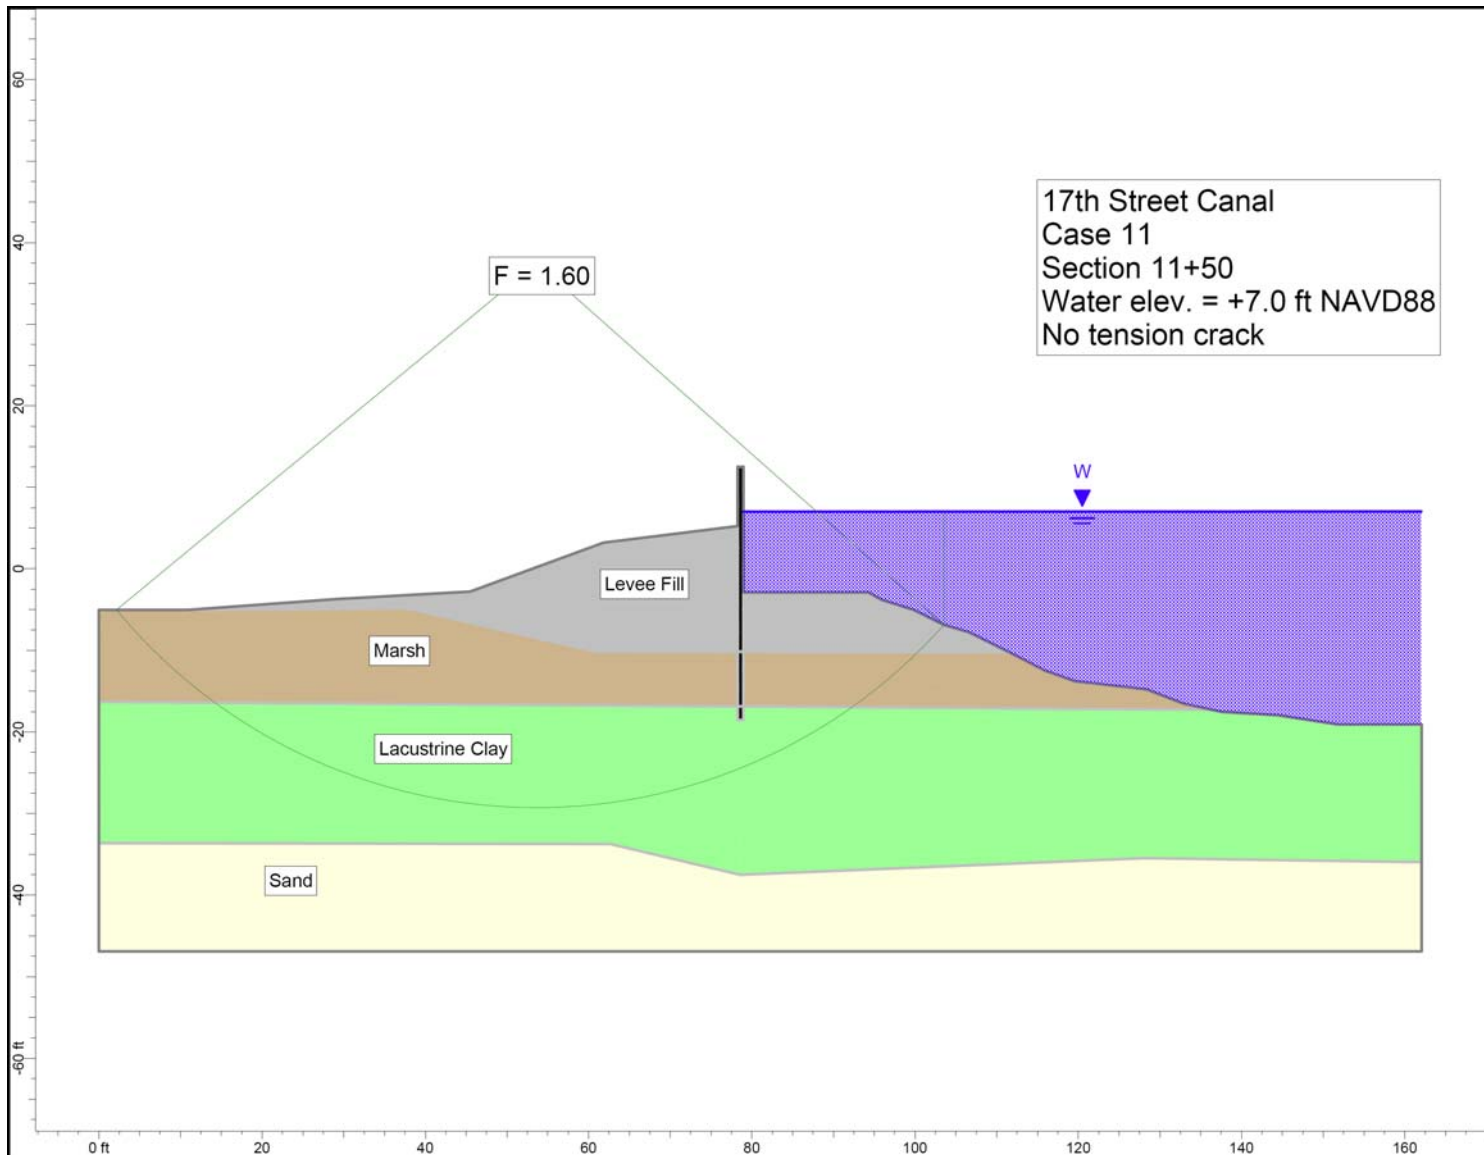
Figure 4-11. Critical Circle for 17th Street Canal Station 11+50 – Water Elevation 7 ft, No Tension Crack

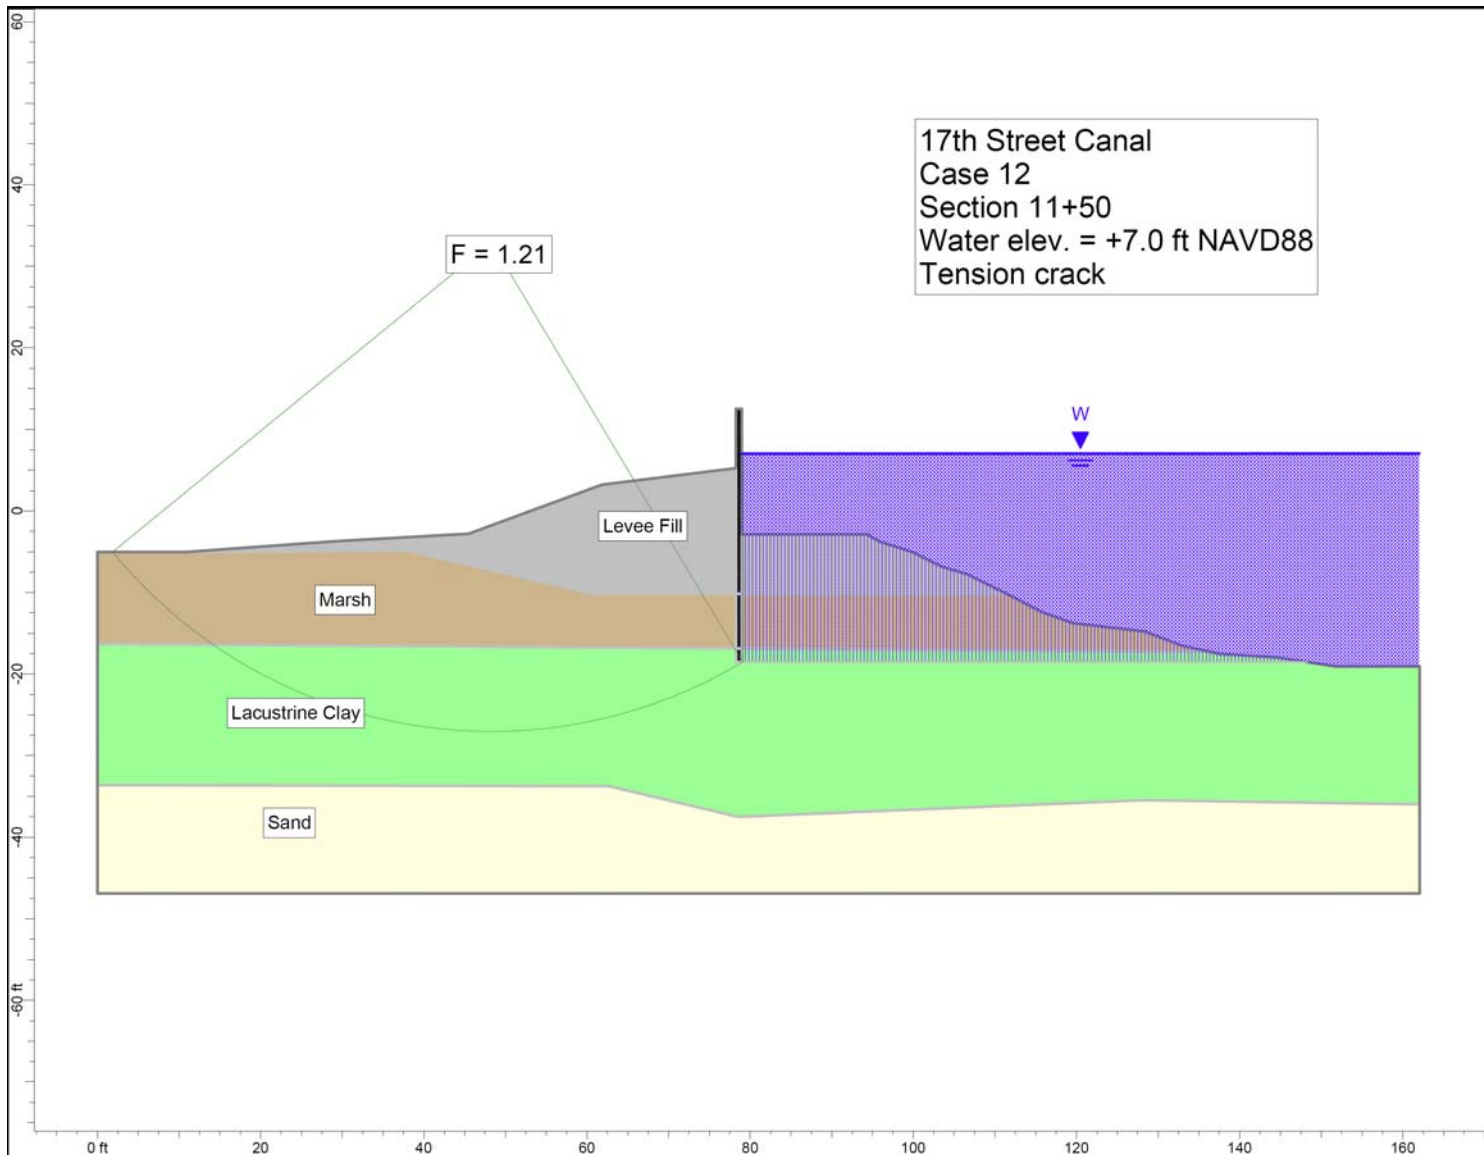
Figure 4-12. Critical Circle for 17th Street Canal Station 11+50 – Water Elevation 7 ft, Tension Crack

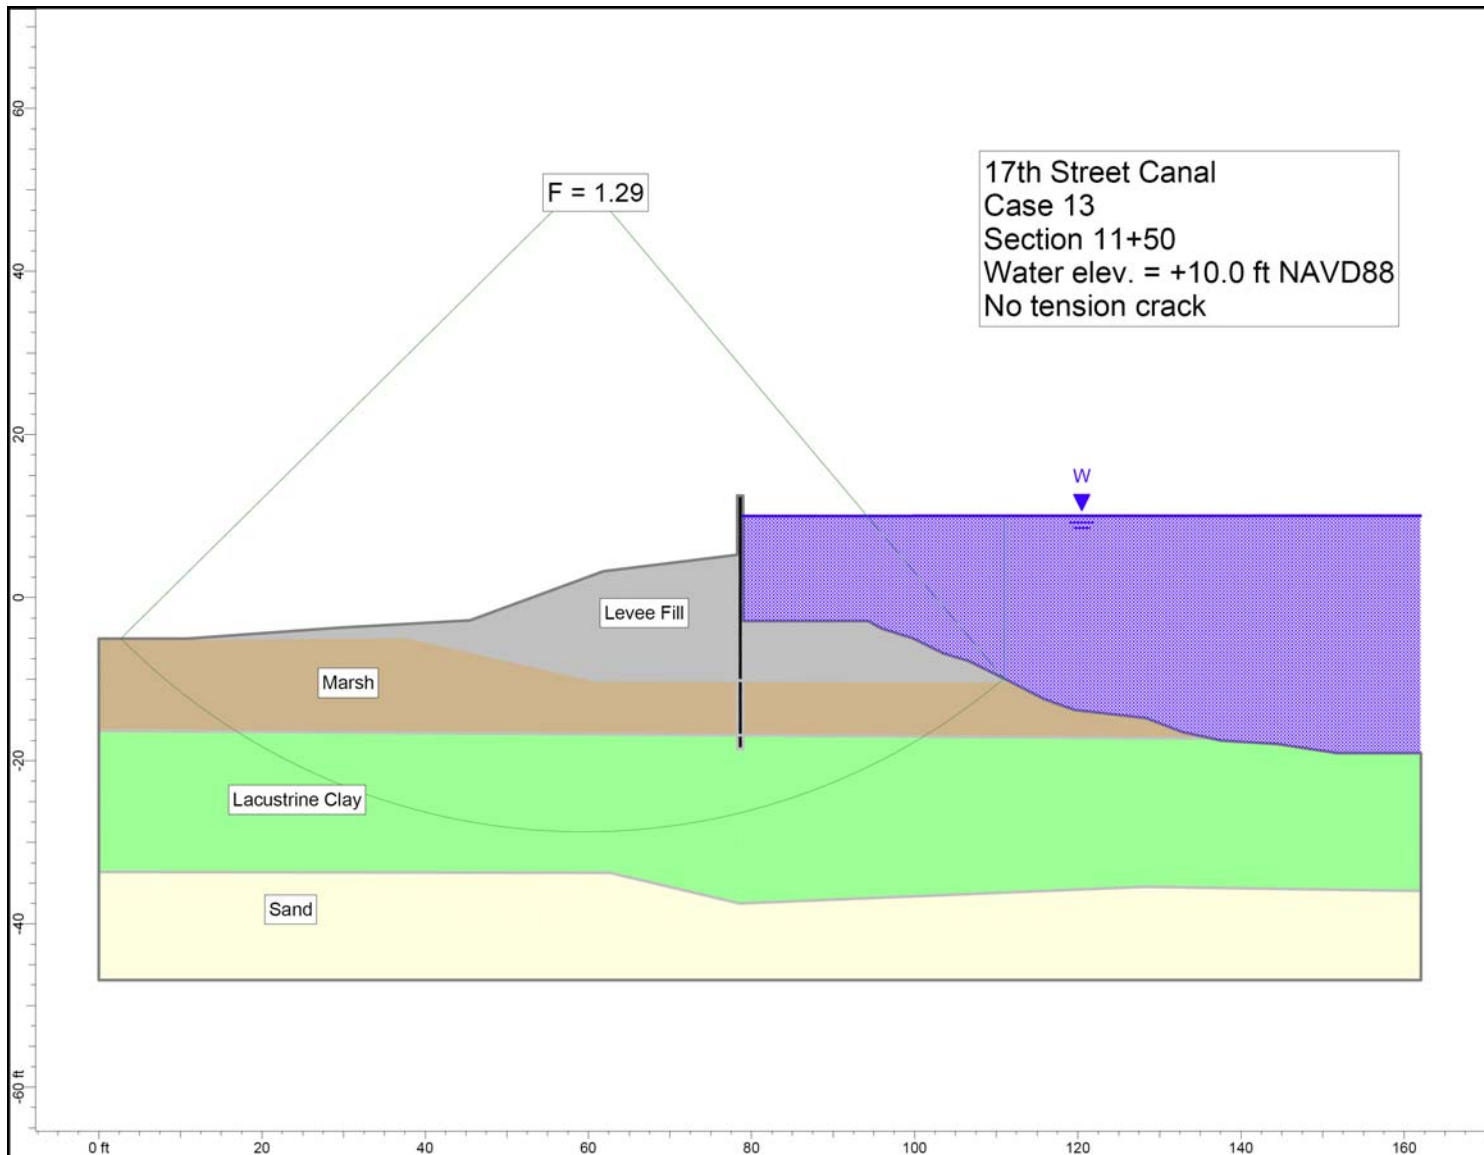
Figure 4-13. Critical Circle for 17th Street Canal Station 11+50 – Water Elevation 10 ft, No Tension Crack

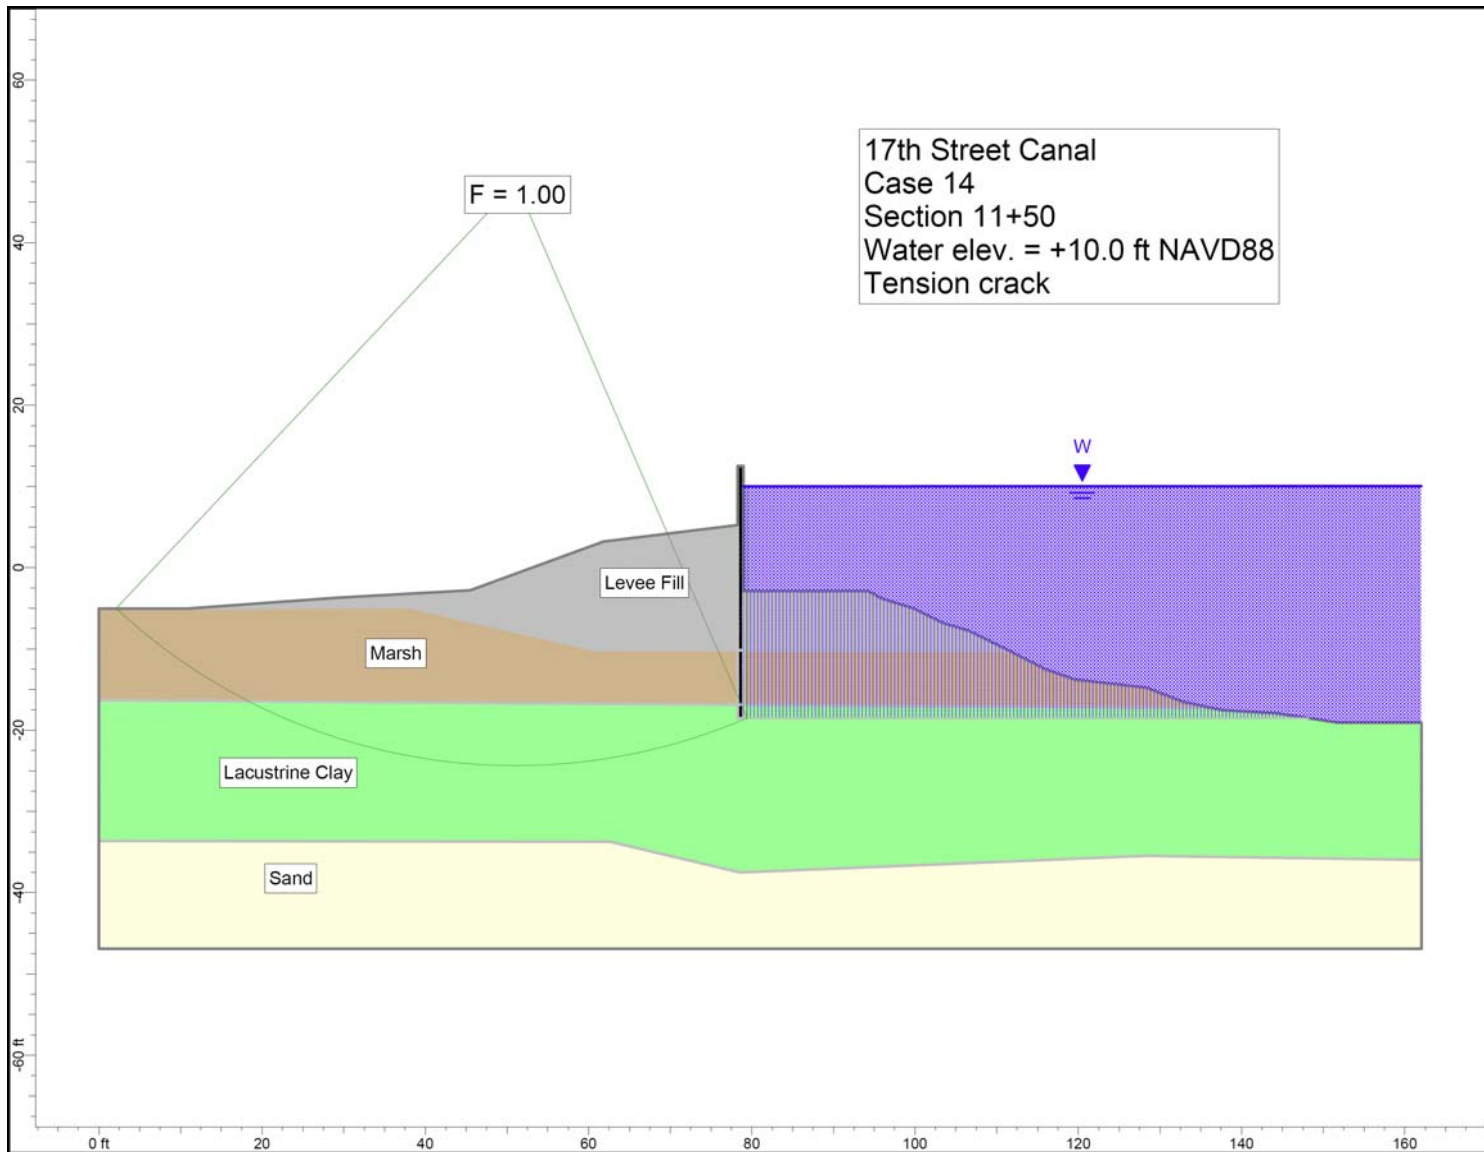
Figure 4-14. Critical Circle for 17th Street Canal Station 11+50 – Water Elevation 10 ft, Tension Crack
