Appendix 1

Soil Data Report for 17th Street Canal

This is a data report detailing the data collected by the Interagency Performance Evaluation Task Force (IPET) to support the analysis of the I-wall section that breached at the 17th Street Canal as a result of Hurricane Katrina on August 29, 2005. The location of the 17th Street Canal is shown in Figure 1-1. The site of the breach, located on the east bank near the north end of the canal, is also noted on Figure 1-1.

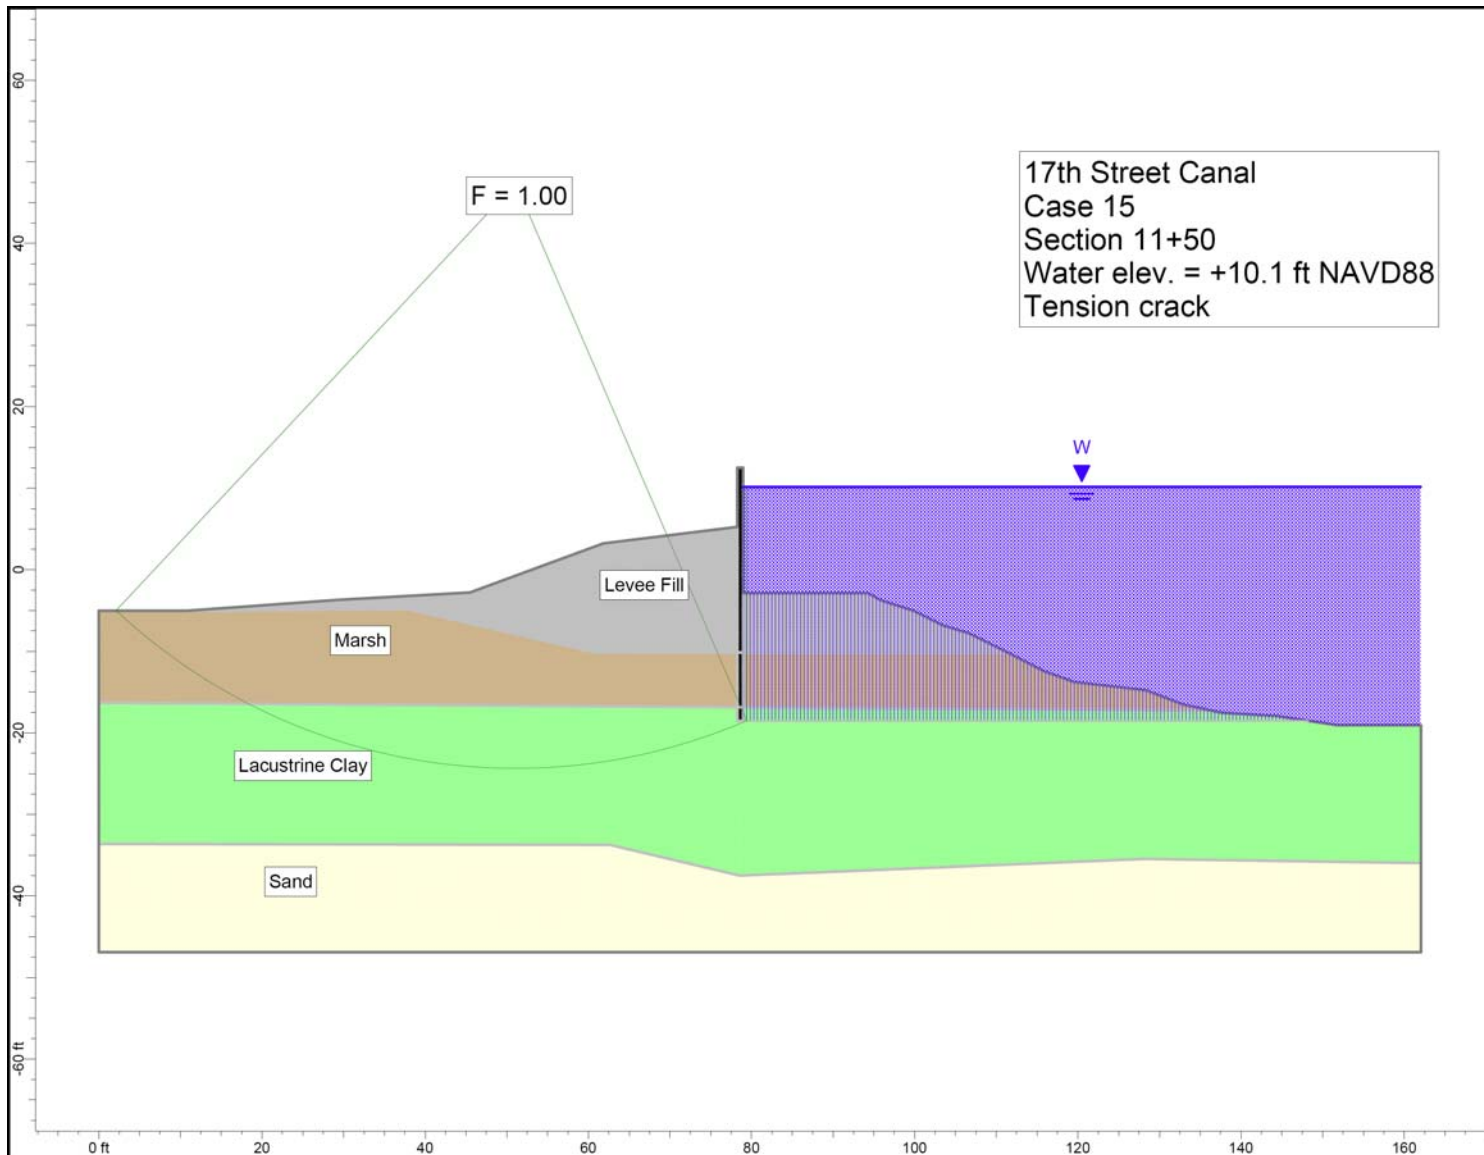
Figure 4-15. Critical Circle for 17th Street Canal Station 11+50 – Water Elevation 10.1 ft, Tension Crack

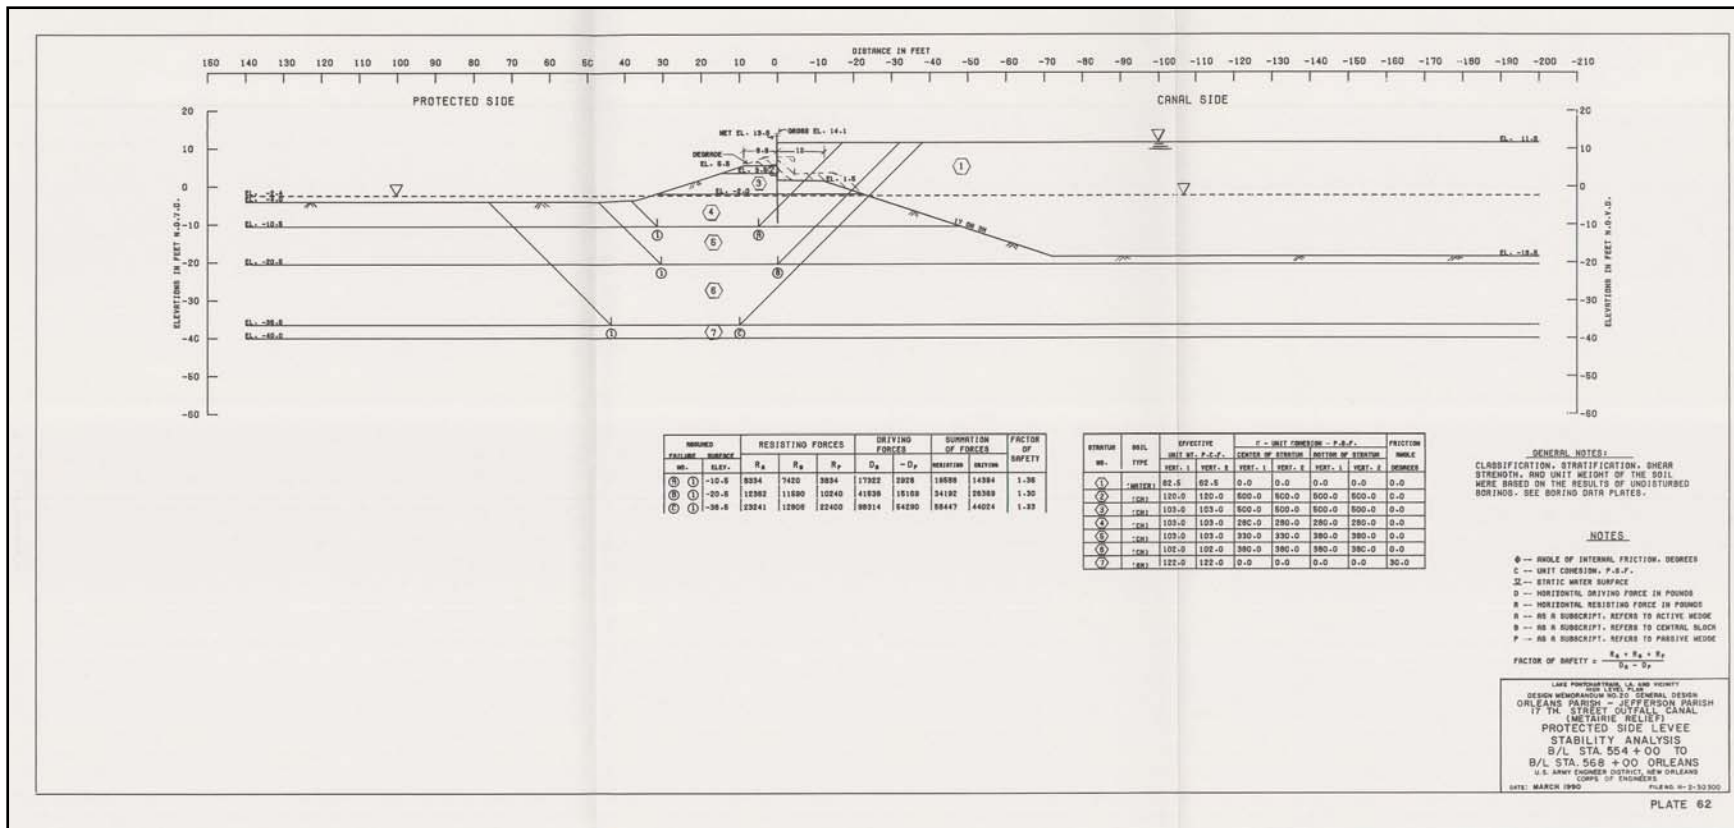
Figure 4-16. Design Cross Section, from GDM 20, Plate 62

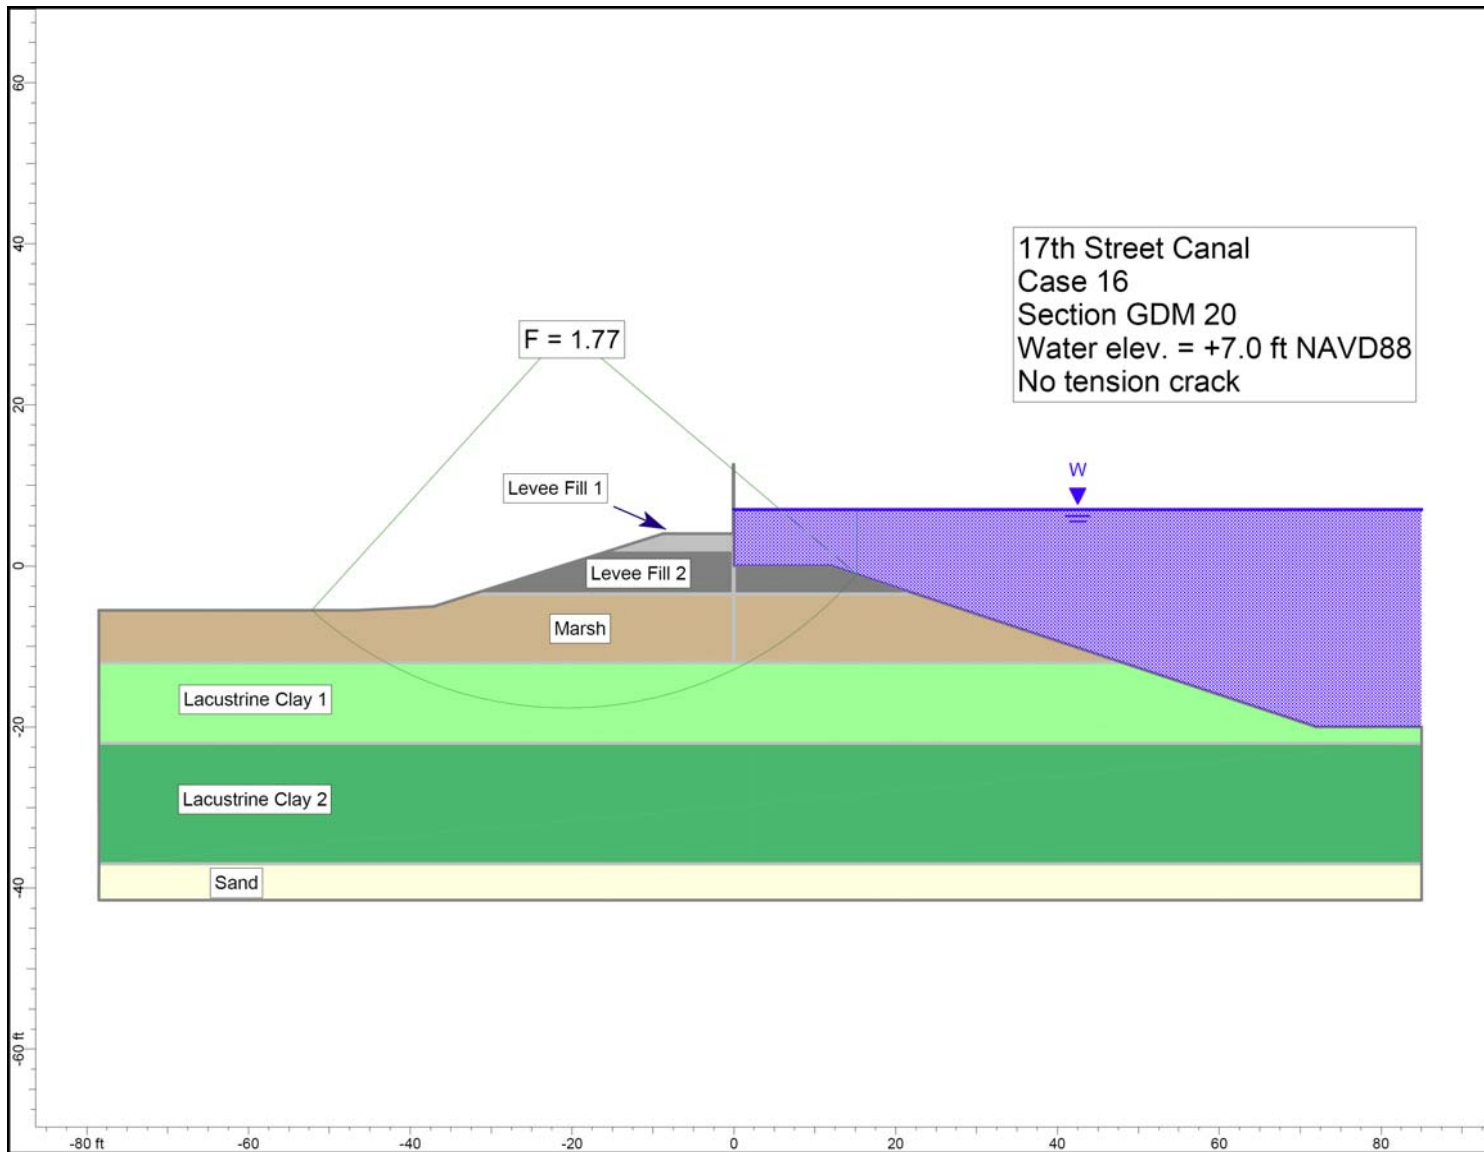
Figure 4-17. Critical Circle for 17th Street Canal Design Cross Section – Water Elevation 7 ft, No Tension Crack

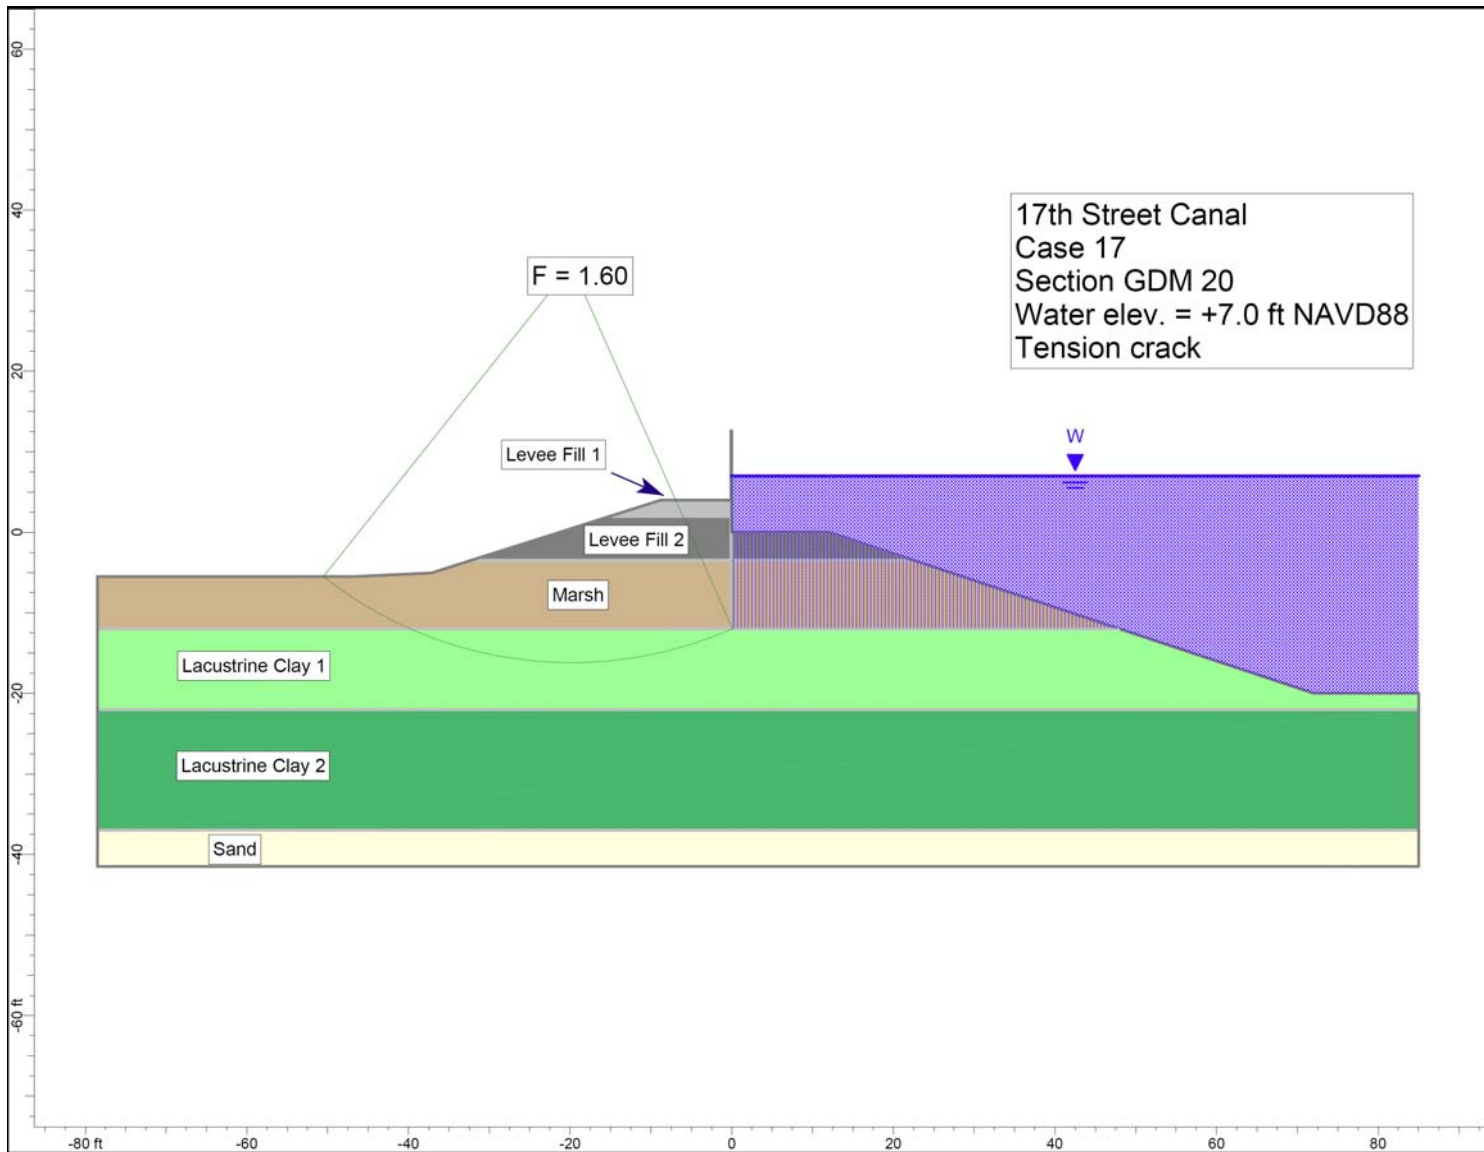
Figure 4-18. Critical Circle for 17th Street Canal Design Cross Section – Water Elevation 7 ft, Tension Crack

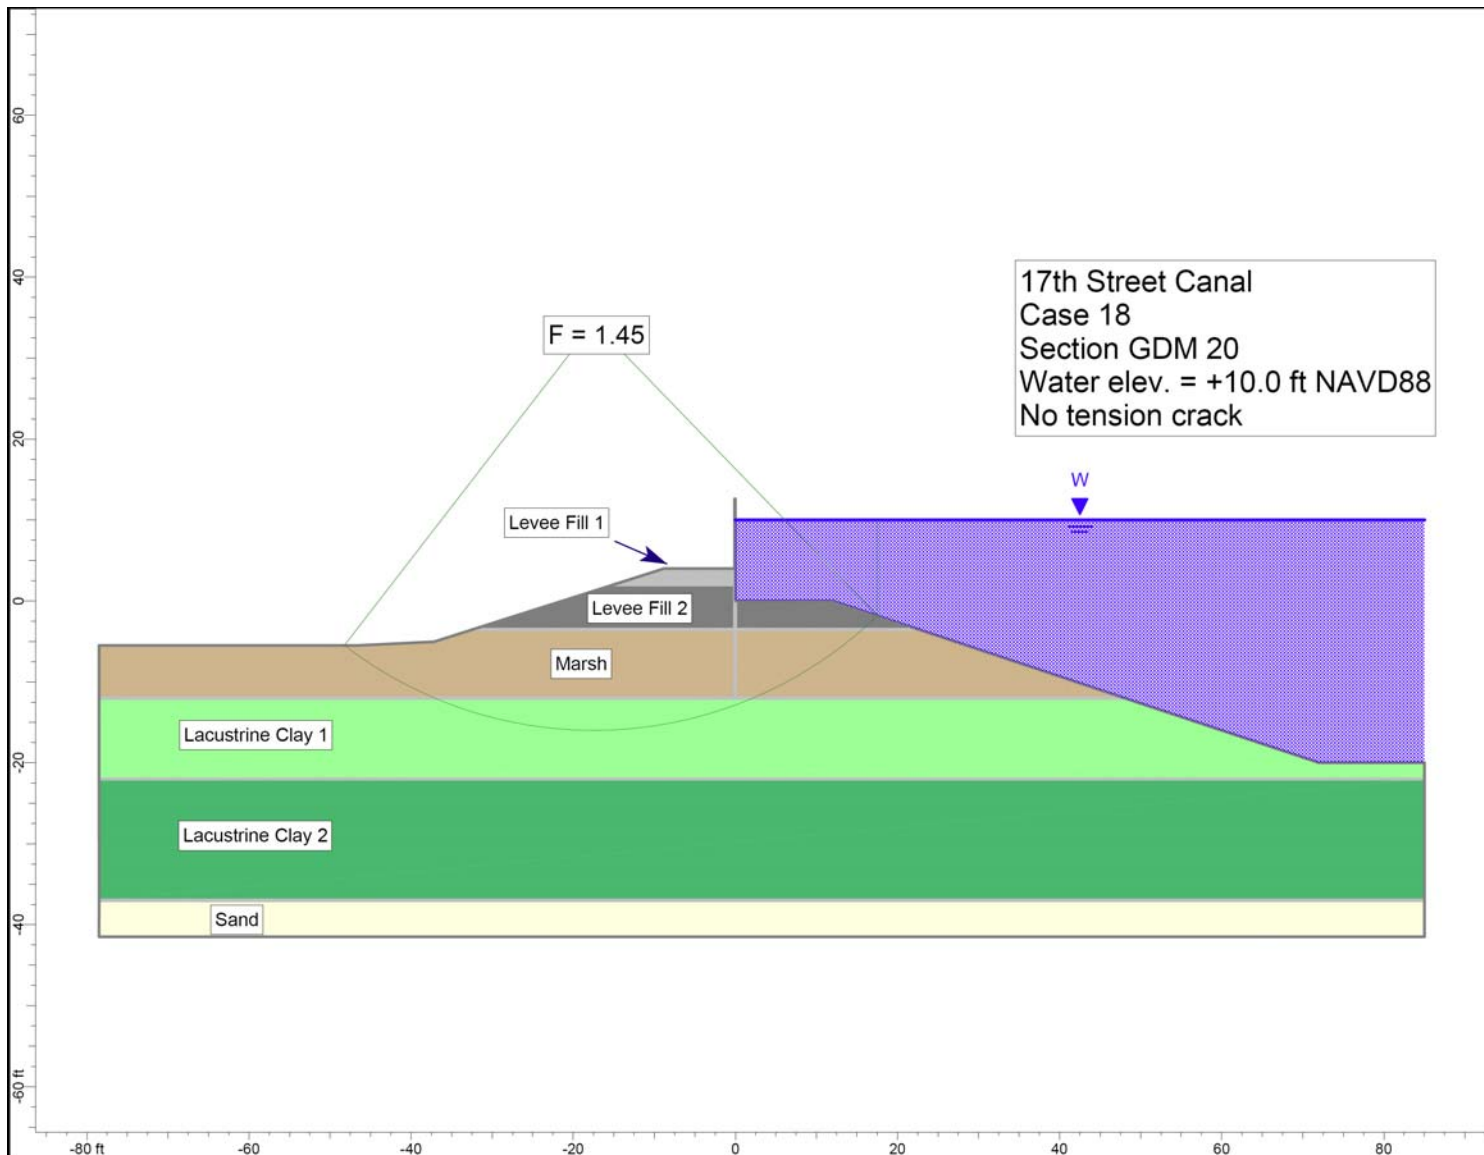
Figure 4-19. Critical Circle for 17th Street Canal Design Cross Section – Water Elevation 10 ft, No Tension Crack

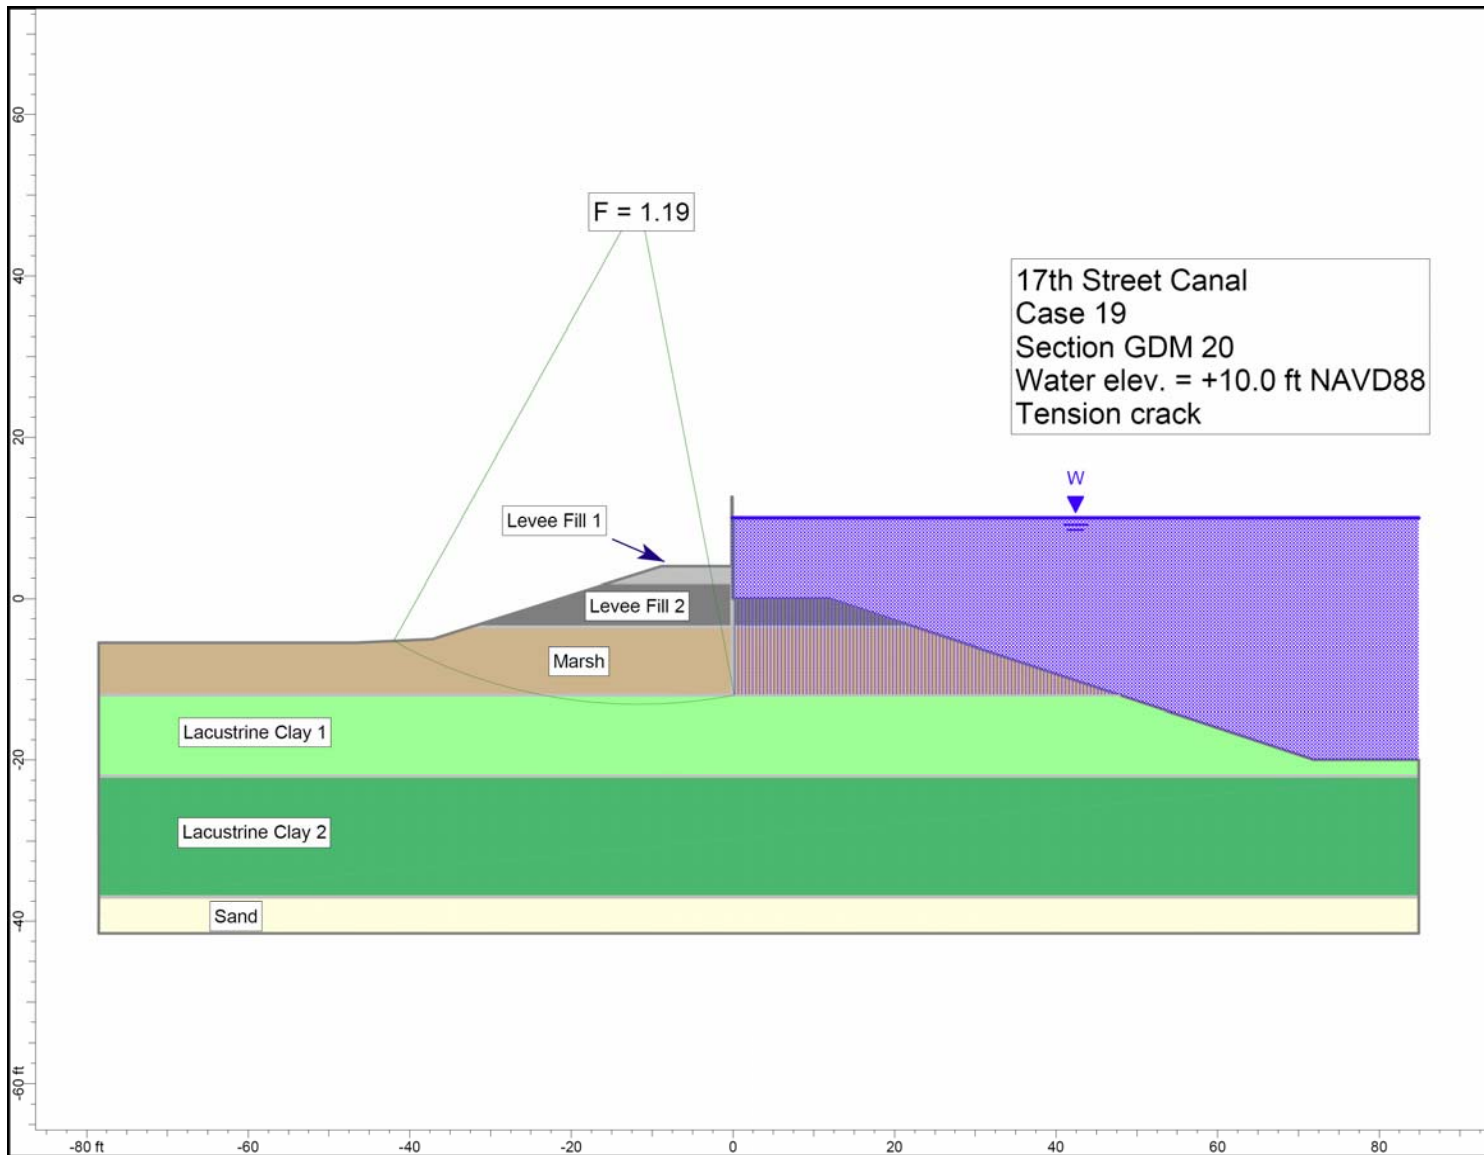
Figure 4-20. Critical Circle for 17th Street Canal Design Cross Section – Water Elevation 10 ft, Tension Crack

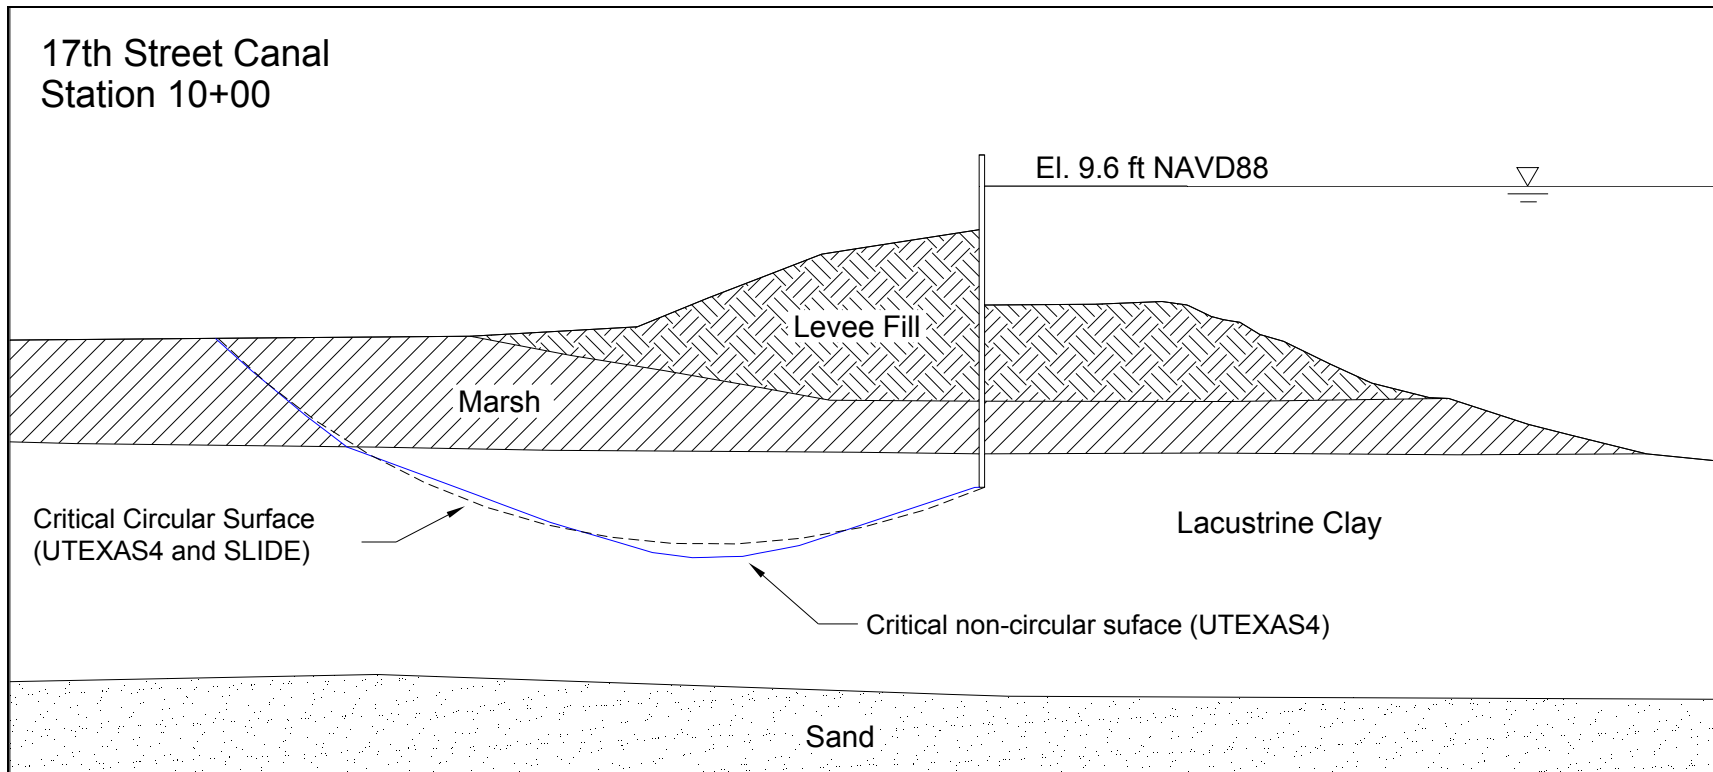
Figure 4-22. Critical Circular and Noncircular Slip Surfaces for 17th Street Canal, Station 10+00, Fully Cracked Condition

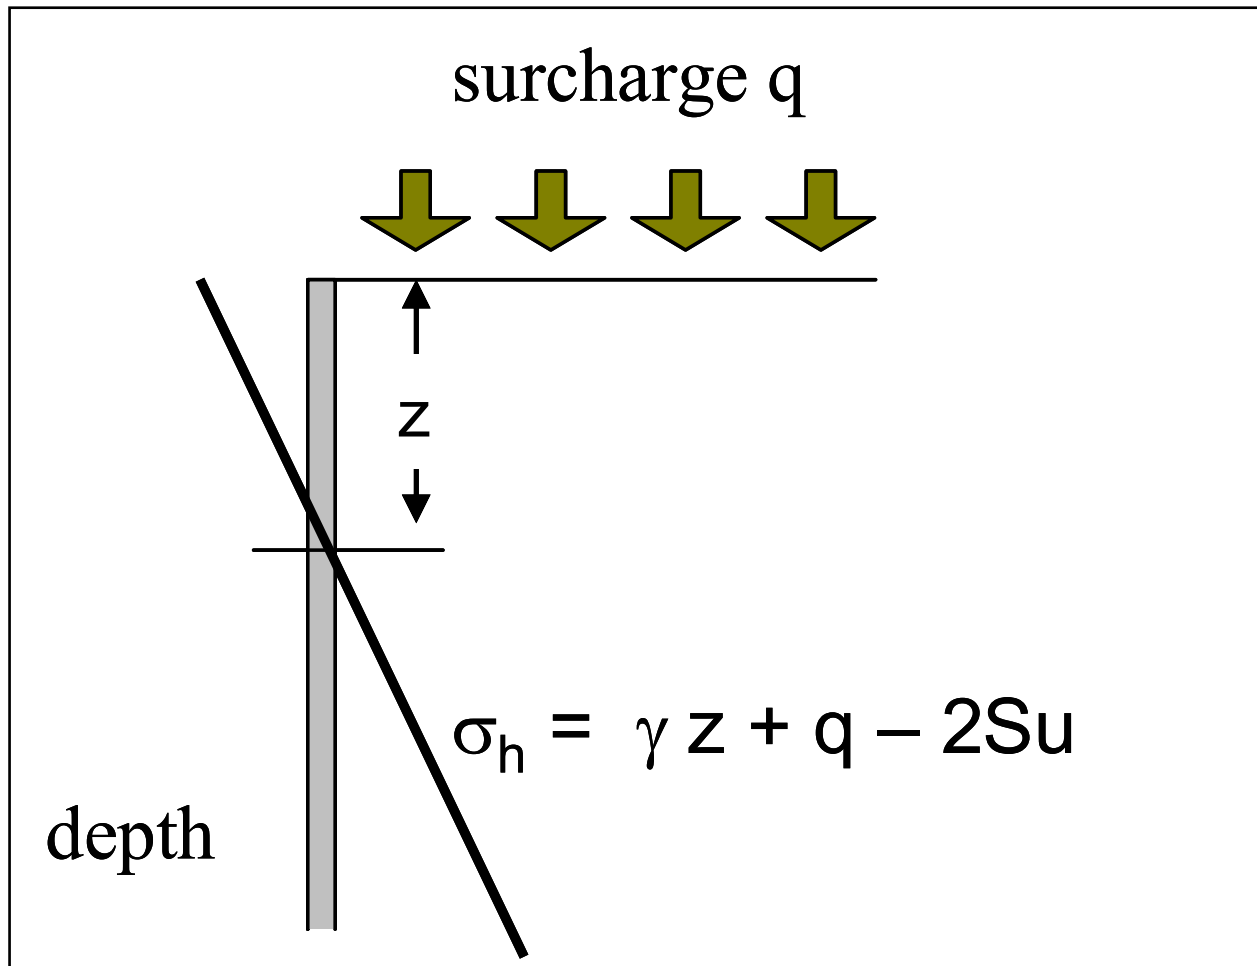
Figure 5.9. Depth z , of a dry crack behind an unpropped smooth retaining wall, limiting active Rankine stress state

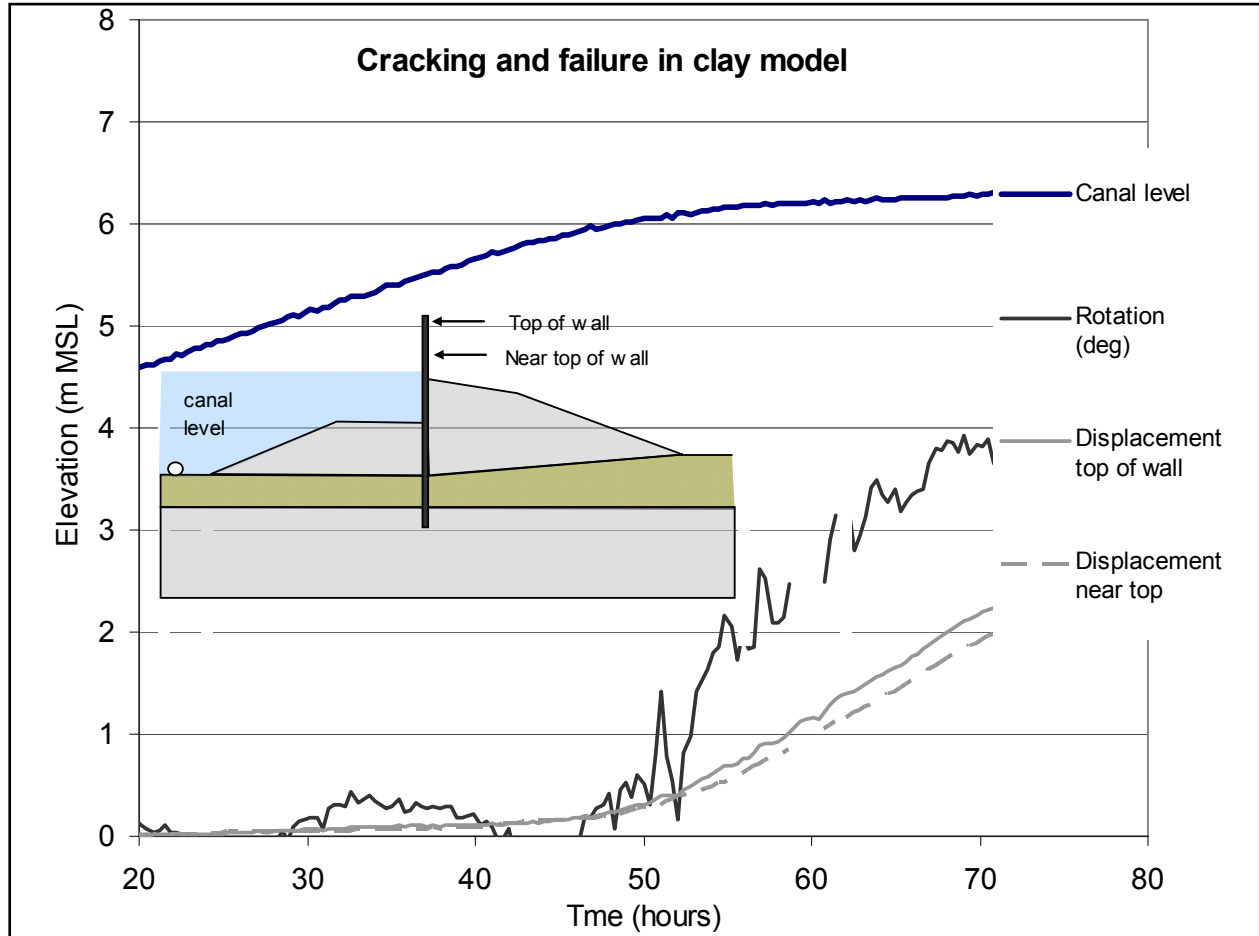
Figure 5.16. Rotation and translation evidence of crack formation prior to failure, 17th Street model

Katrina flood level. At higher flood levels, the rate of landward movement of the wall increases sharply as the crack forms. The formation of the crack increased both the load and the moment on the wall. In this model test the flood wall remained in place and did not show the same unstable response to high flood levels as the levee sections on 17th Street and London Avenue though its performance did appear to be close to failure (discussed below).

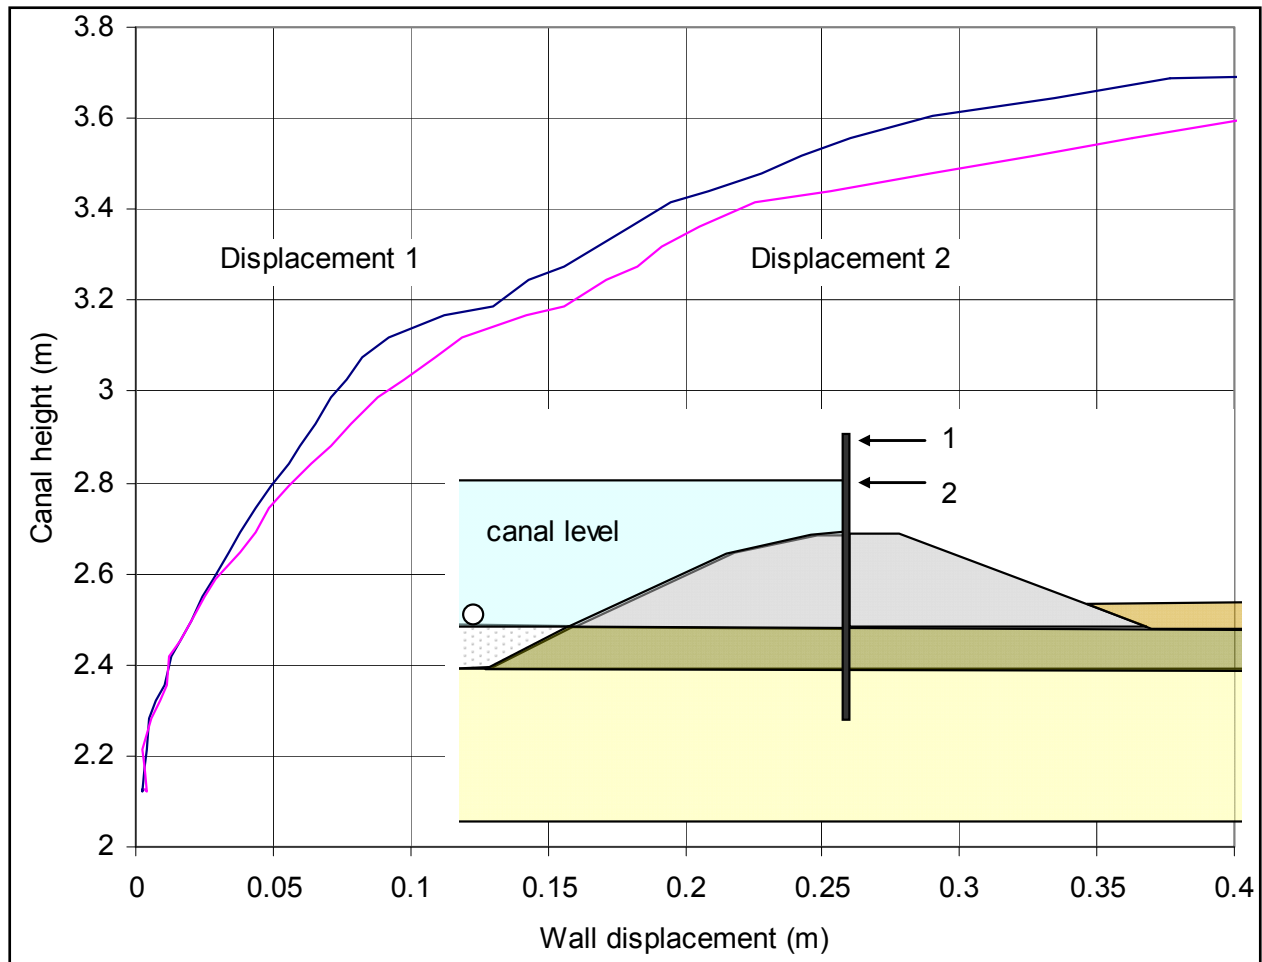
Figure 5.19. Rotation of the wall as canal level increases followed by failure, London South, Model 1

Figure 5.19 shows rotation of the wall in a London South model and Figure 5.20 shows a sequence of video images of the rotational movement in progress. A similar sequence was found for the repeat model of London South, Model 2, Figure 5.21.

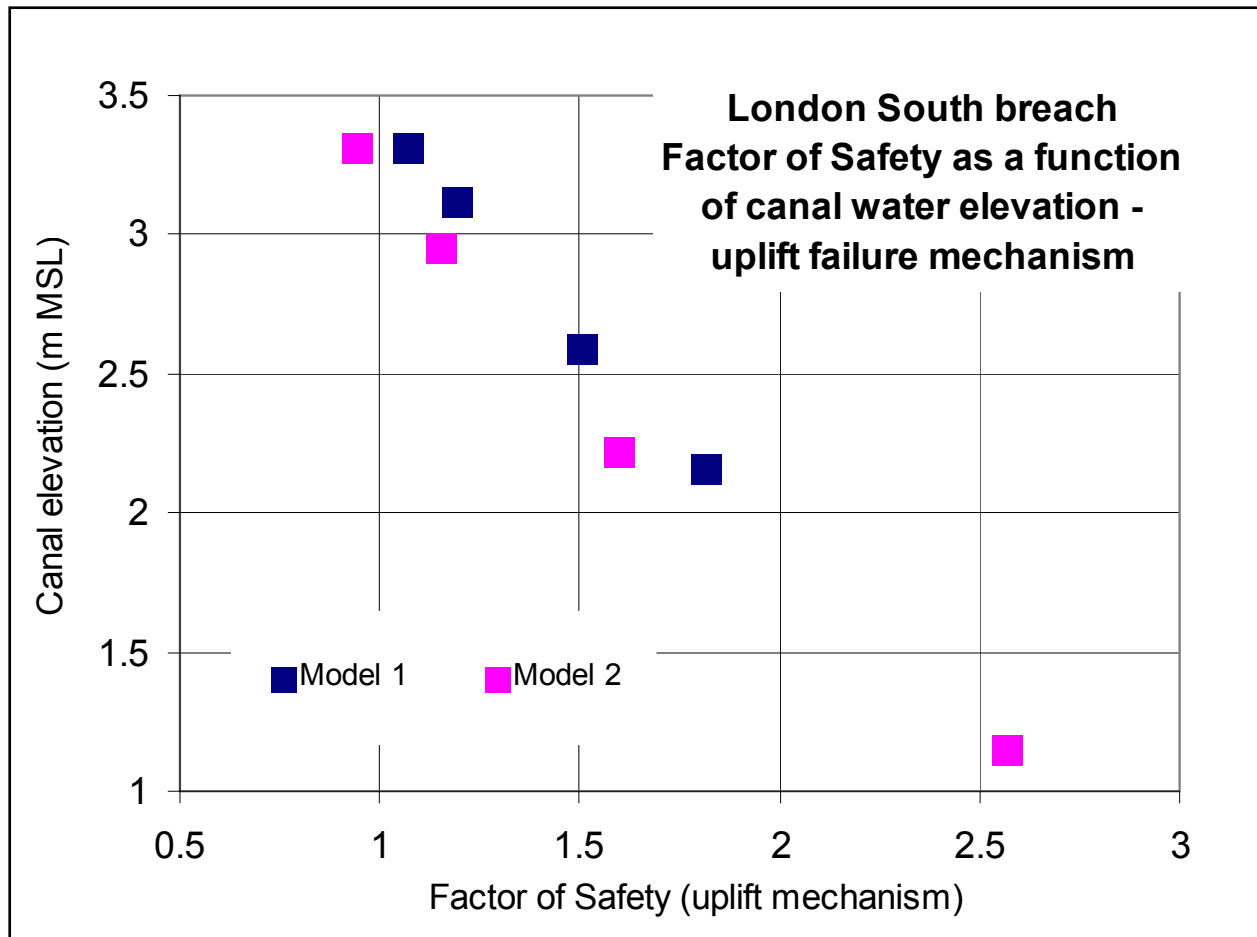
Figure 5.27. Factor of Safety for observed failure mechanism (uplift and rotation) for two London South models carried out at ERDC and RPI

The results of the calculation for two different models were highly consistent, showing that this mechanism of failure was in a limiting condition at the instant of failure, based on the measured data from the model tests. Figure 5.27 shows the Factor of Safety calculated for the two models, at four different stages of normal (typical) canal level, crack opening, crack formed and the onset of wall failure.

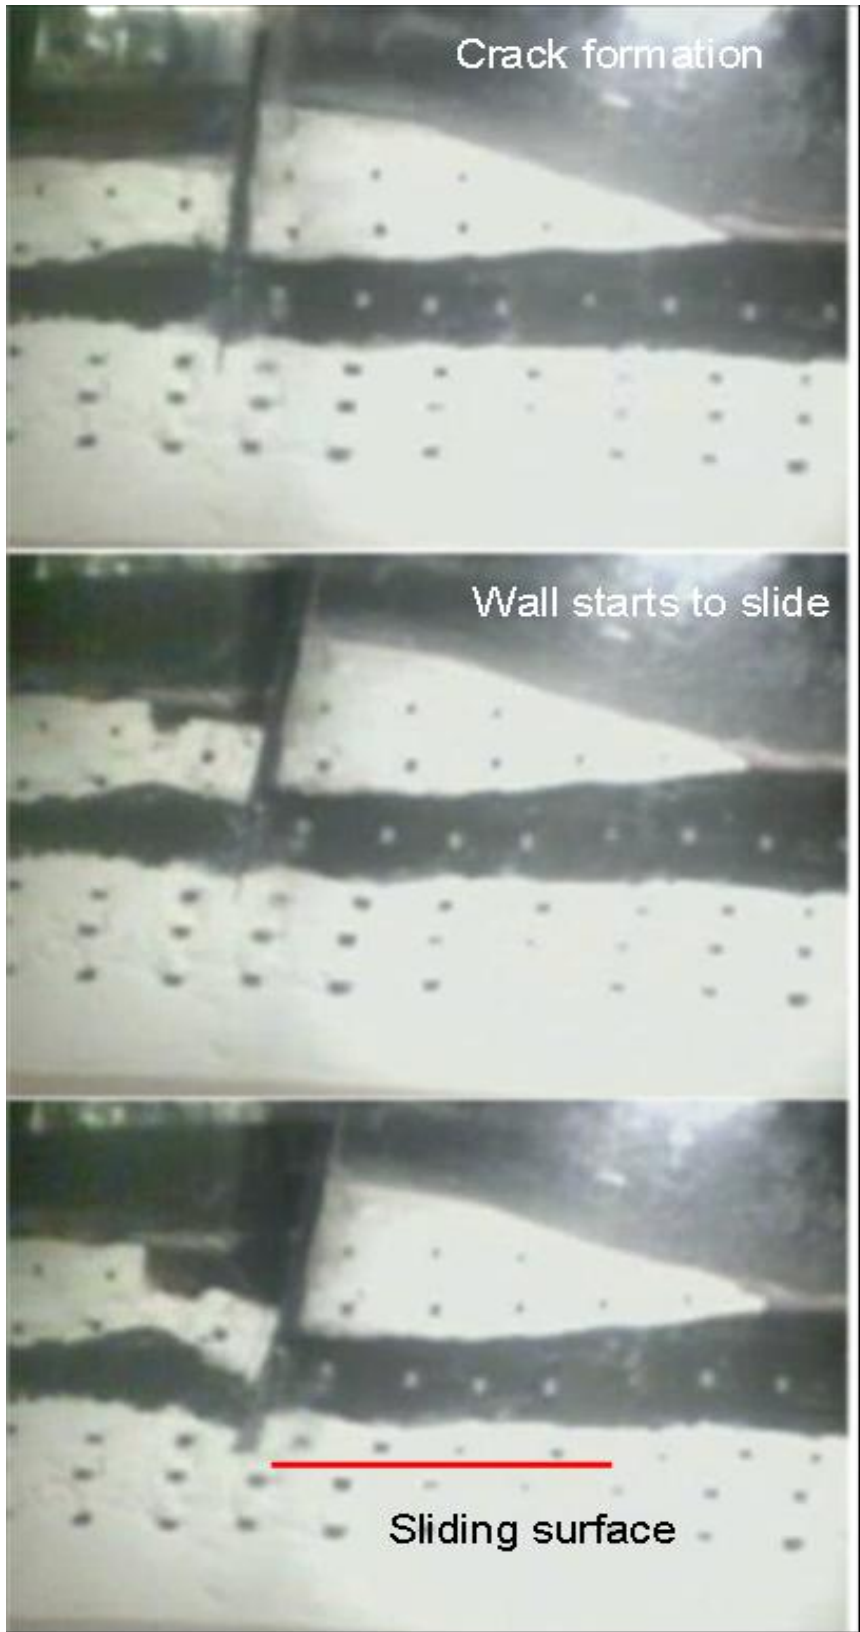
Figure 5.32. Sliding surface forms at top of clay layer in 17th Street Model 1

In one model of the 17th Street levee, the weight of the levee on the landward side was sufficient to provoke bearing failure in the clay foundation, Figure 5.33, with the formation of inclined slip planes, prior to the flood condition. This is a situation analogous in the field to raising the height of the levee too rapidly, without allowing time for the high excess pore pressures in the foundation to dissipate and the strength of the clay to develop. On the surface, the only evidence is increased settlement. At depth, however, local slip surfaces form in the soft clay and swampy marsh

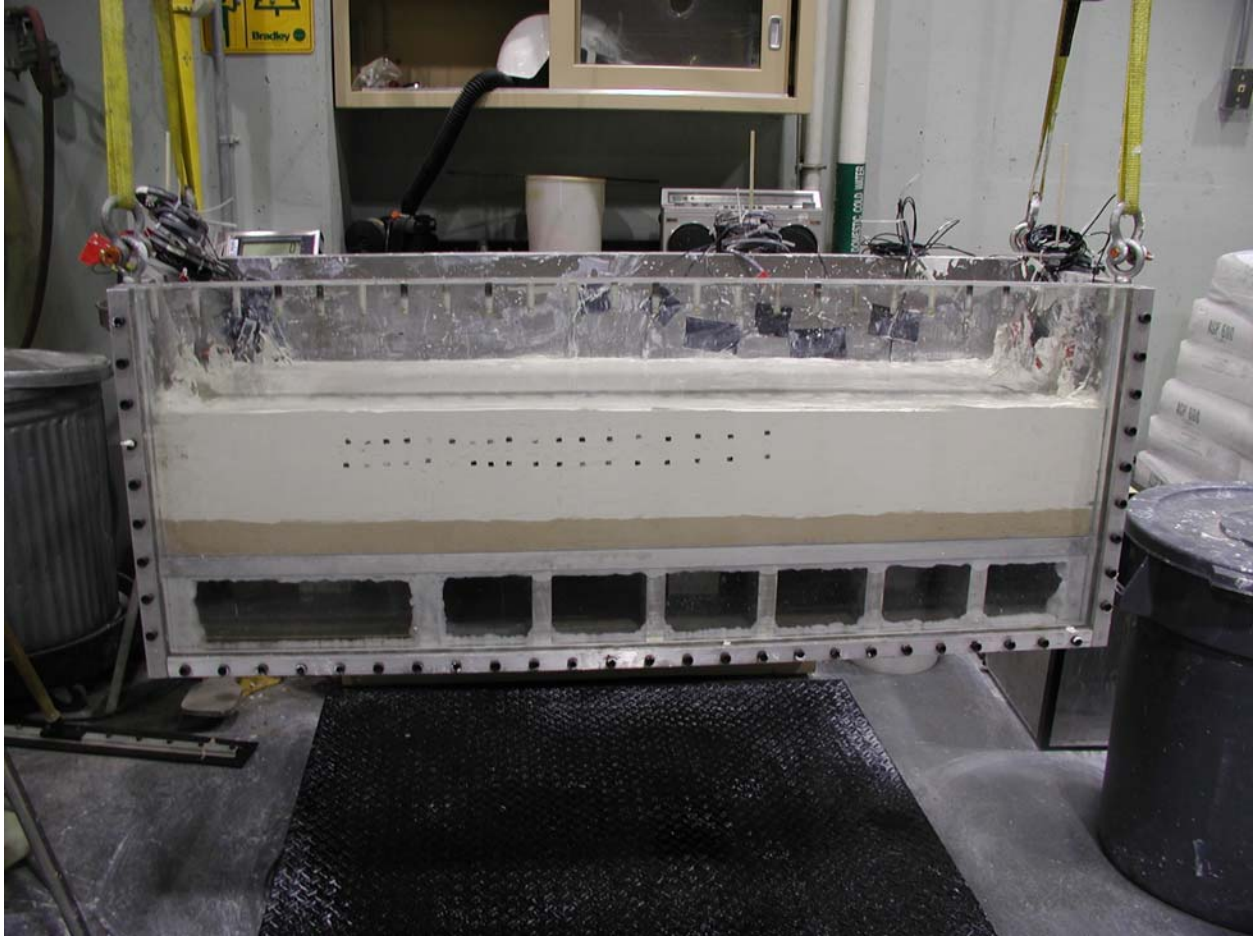
Figure 5.43. View of the completed clay layer for the ERDC 17th Street model

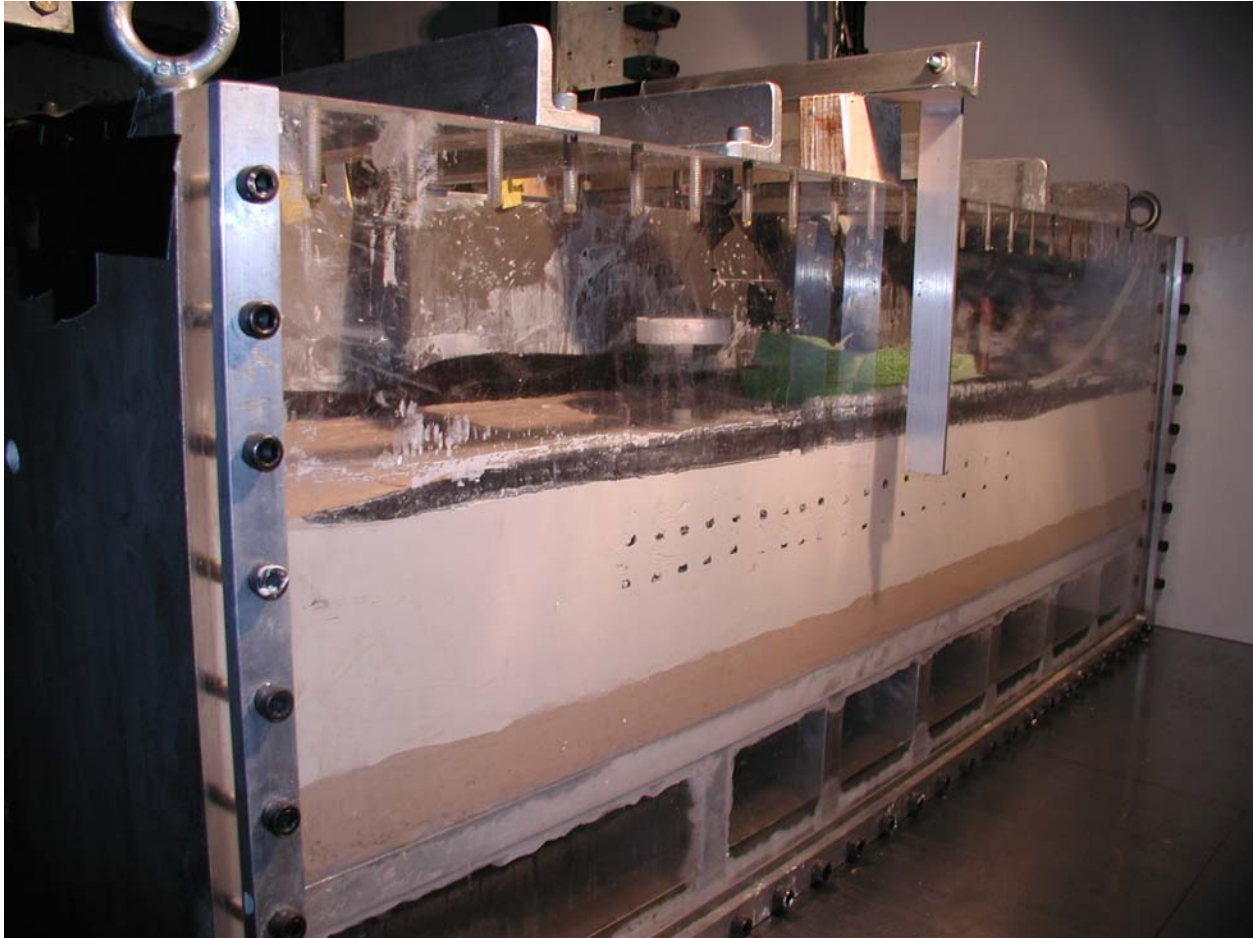
Figure 5.44. View of ERDC 17th Street model with swampy/marsh layer

After completion of the clay layer, the swampy/marsh layer was placed. This was material taken directly from the site collected in 40.5 cm cube undisturbed block samples. The material was stored in a humid room prior to use and sliced into segments of the appropriate thickness for use in the model. A view of the model with swampy/marsh layer in place is shown in Figure 5.44.

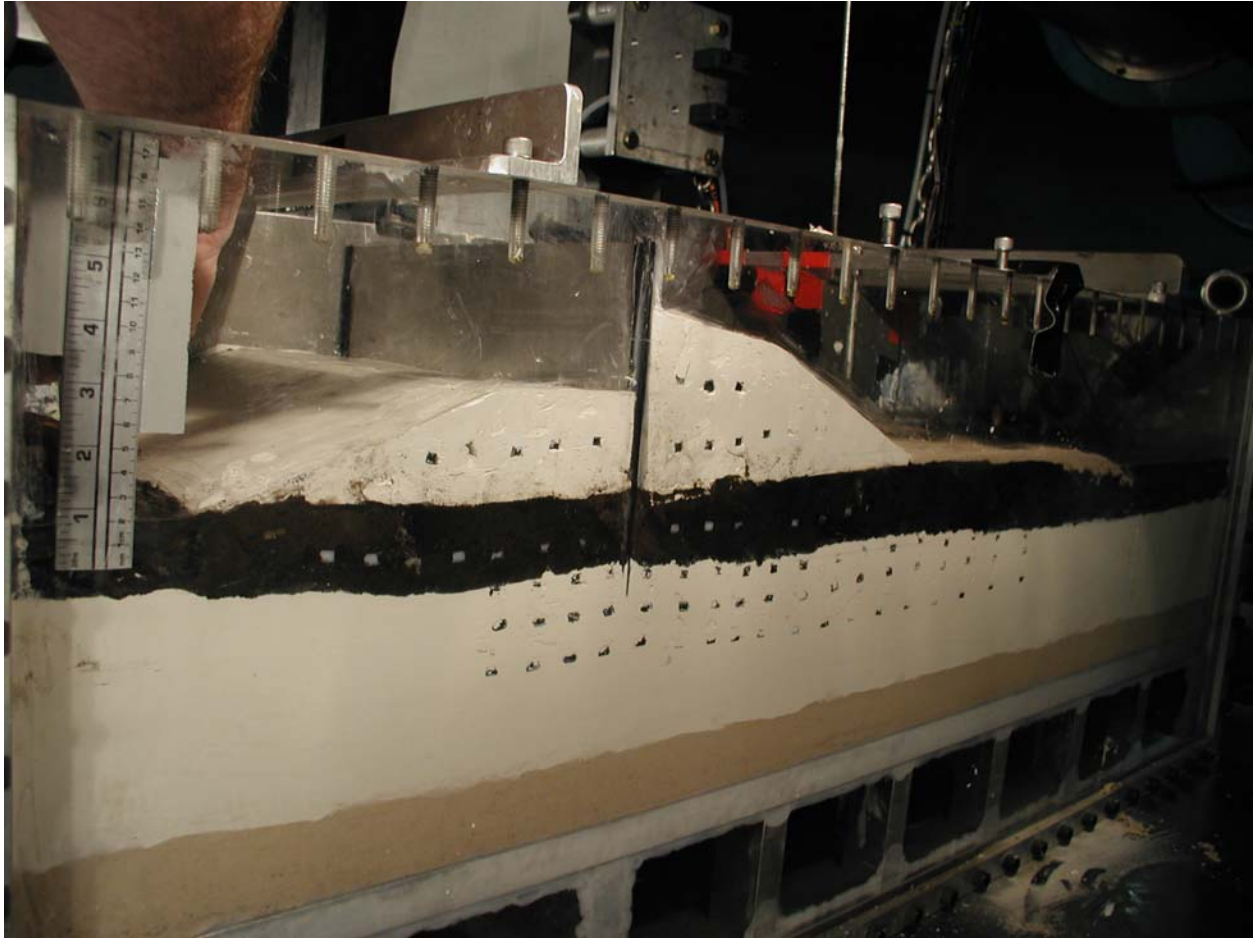
Figure 5.45. Completed ERDC 17th Street model

The clay layer was normally consolidated at 50 g. Additionally, gravel was added of a shape and weight simulating the levee to further consolidate the swampy/marsh layer. This material was removed and the consolidated clay levee added. Vane shear measurements of the clay levee material averaged 325 psf and moisture contents averaged 105%. Lasers to measure displacements were added and the model was placed on the centrifuge for testing at 50 g. The completed model is shown in Figure 5.45. The canal side is on the left of the model in the figure and the protected land side is on the right. The sheet pile wall on the canal side extends 4.6 m above the top of the levee.
