Appendix 1

Soil Data Report for 17th Street Canal

This is a data report detailing the data collected by the Interagency Performance Evaluation Task Force (IPET) to support the analysis of the I-wall section that breached at the 17th Street Canal as a result of Hurricane Katrina on August 29, 2005. The location of the 17th Street Canal is shown in Figure 1-1. The site of the breach, located on the east bank near the north end of the canal, is also noted on Figure 1-1.

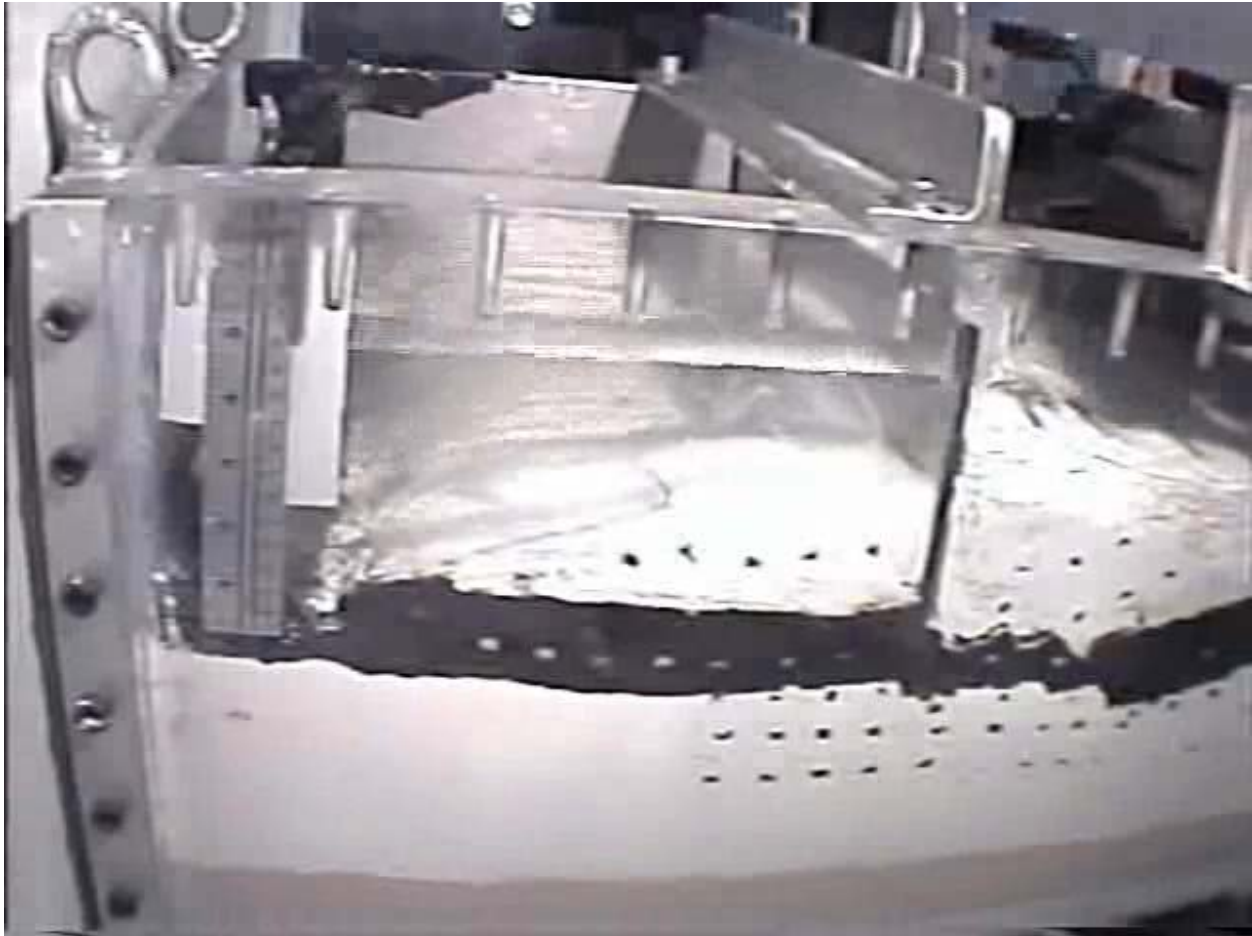
Figure 5.46a. ERDC 17th Street model at flood load just prior to development of crack

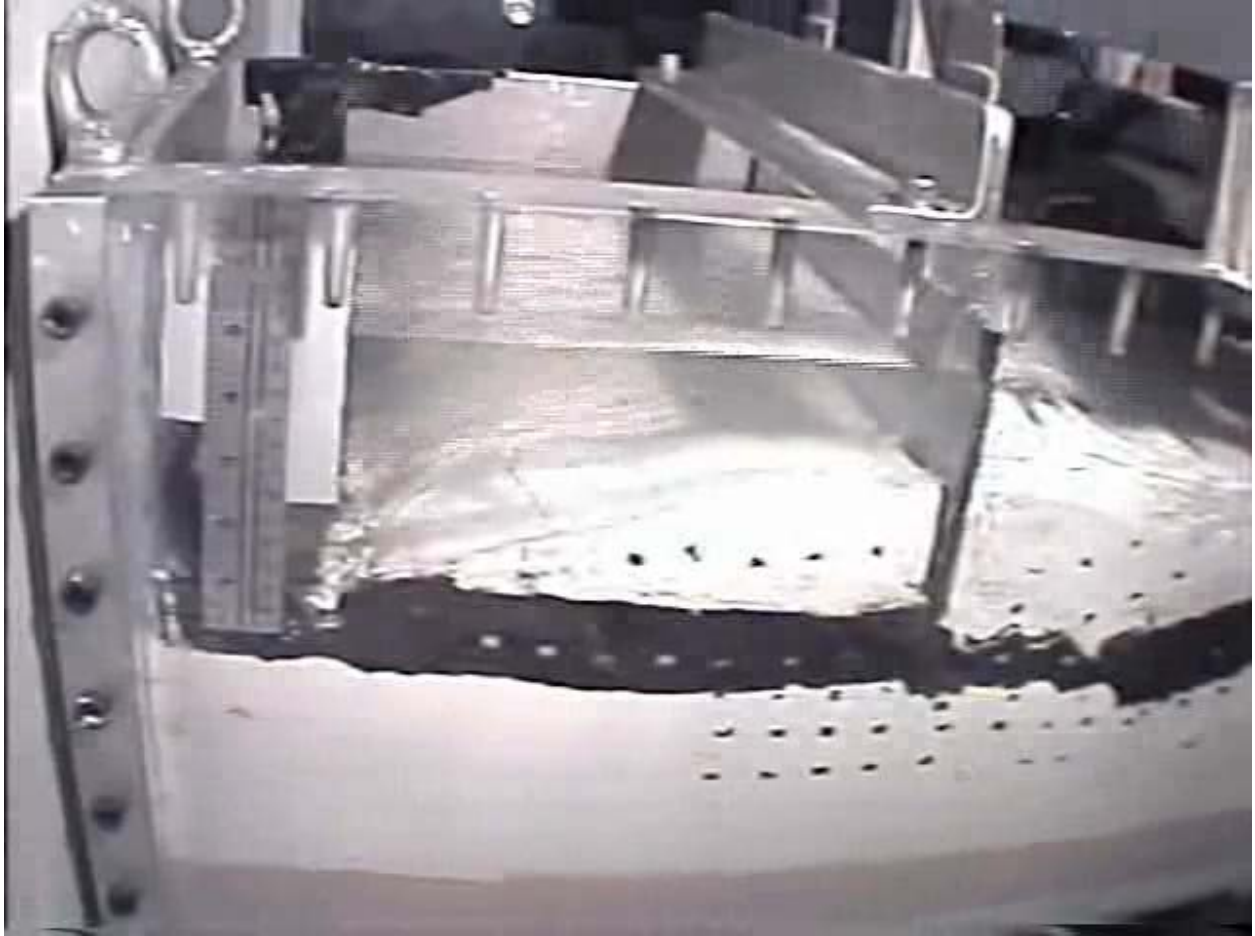
Figure 5.46b. ERDC 17th Street model just after wall movement and crack formation

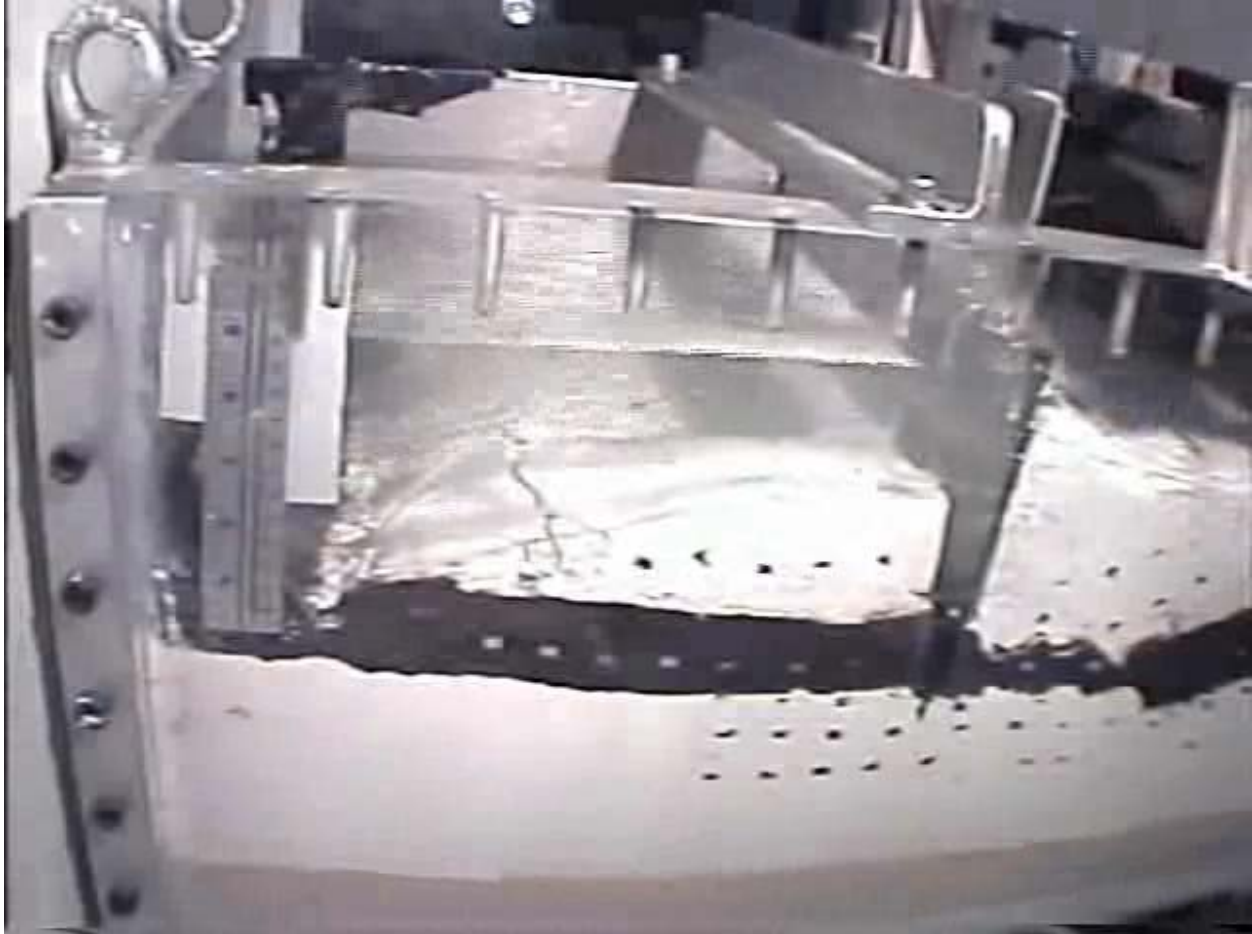
Figure 5.46c. ERDC 17th Street model near end of failure

3. As the crack reaches the bottom of the sheet pile, hydrostatic pressure increases in the foundation soil. The low shear strength in the clay layer just beneath the swampy/marsh is not enough to resist the driving force of the flood load.
4. A near horizontal shear failure surface forms in the clay layer and the entire wall/land side levee begins to translate toward the land side.
5. As the flood load is maintained the translational failure continues.

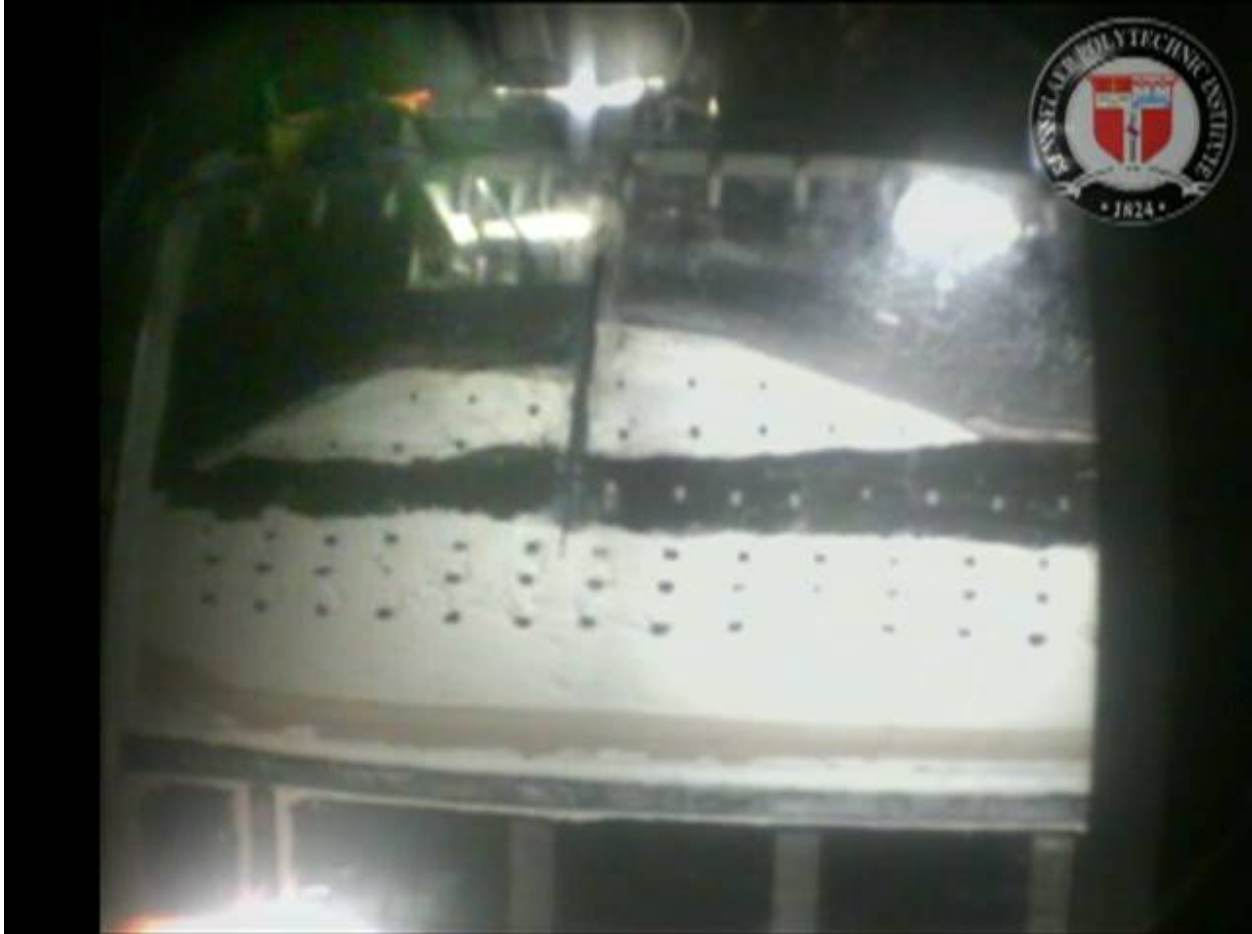
Figure 5.56. RPI 17th Street model during flood load

The following series of pictures are still captures from the video recorded during flood and failure. Figure 5.56 is a shot captured with the water elevation at maximum level just prior to any wall movement. In the figures, the canal side is on the left and the protected side on the right. The sheet pile can be seen in the middle of the figure with the shorter canal levee on the left and the taller land side levee on the right.

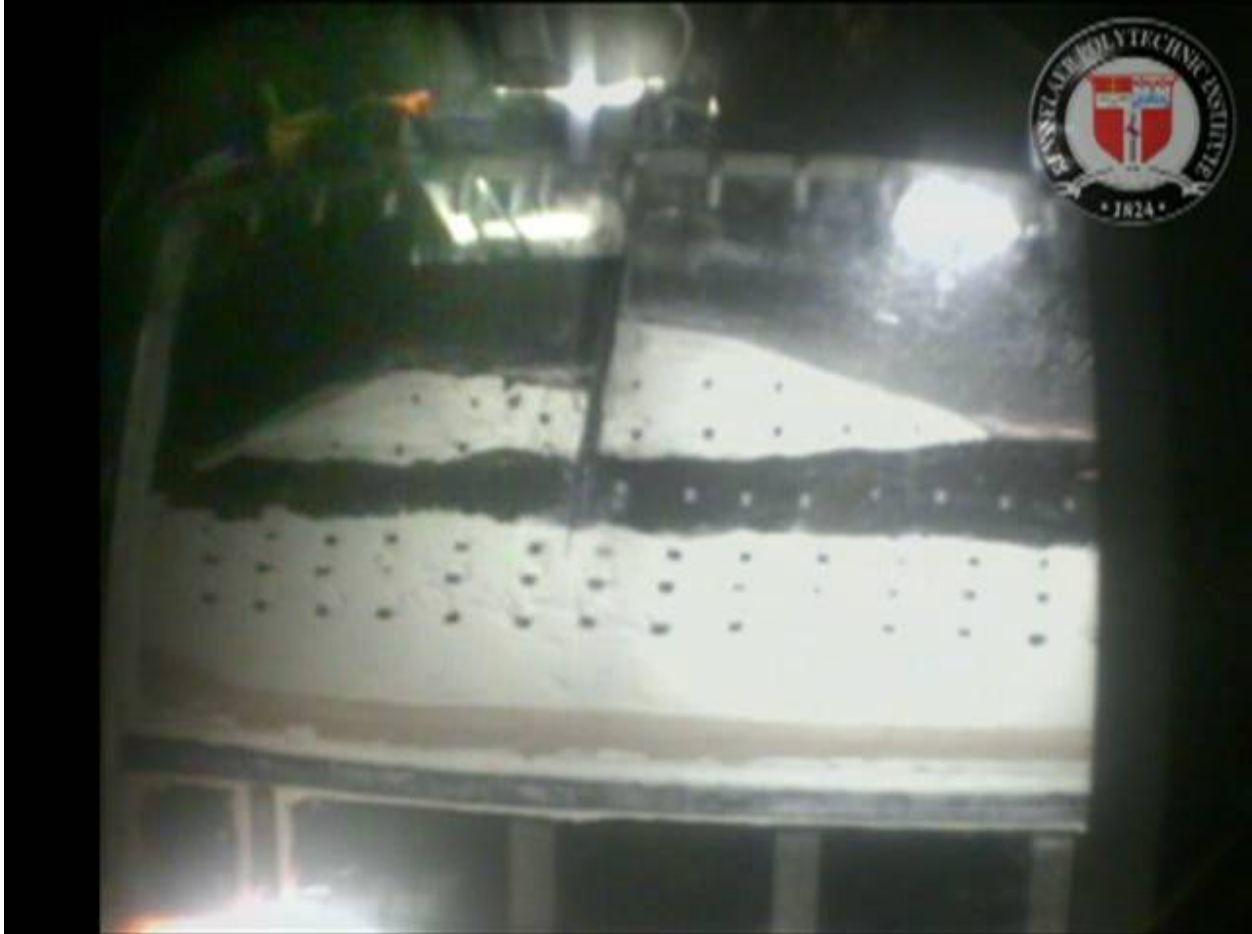
Figure 5.57. RPI 17th Street model just after movement of wall and crack formation

In Figure 5.57, the wall has moved toward the land side, a crack has formed between the sheet pile wall and canal levee. The crack has penetrated through the levee, through the swampy/marsh and into the top surface of the clay layer.

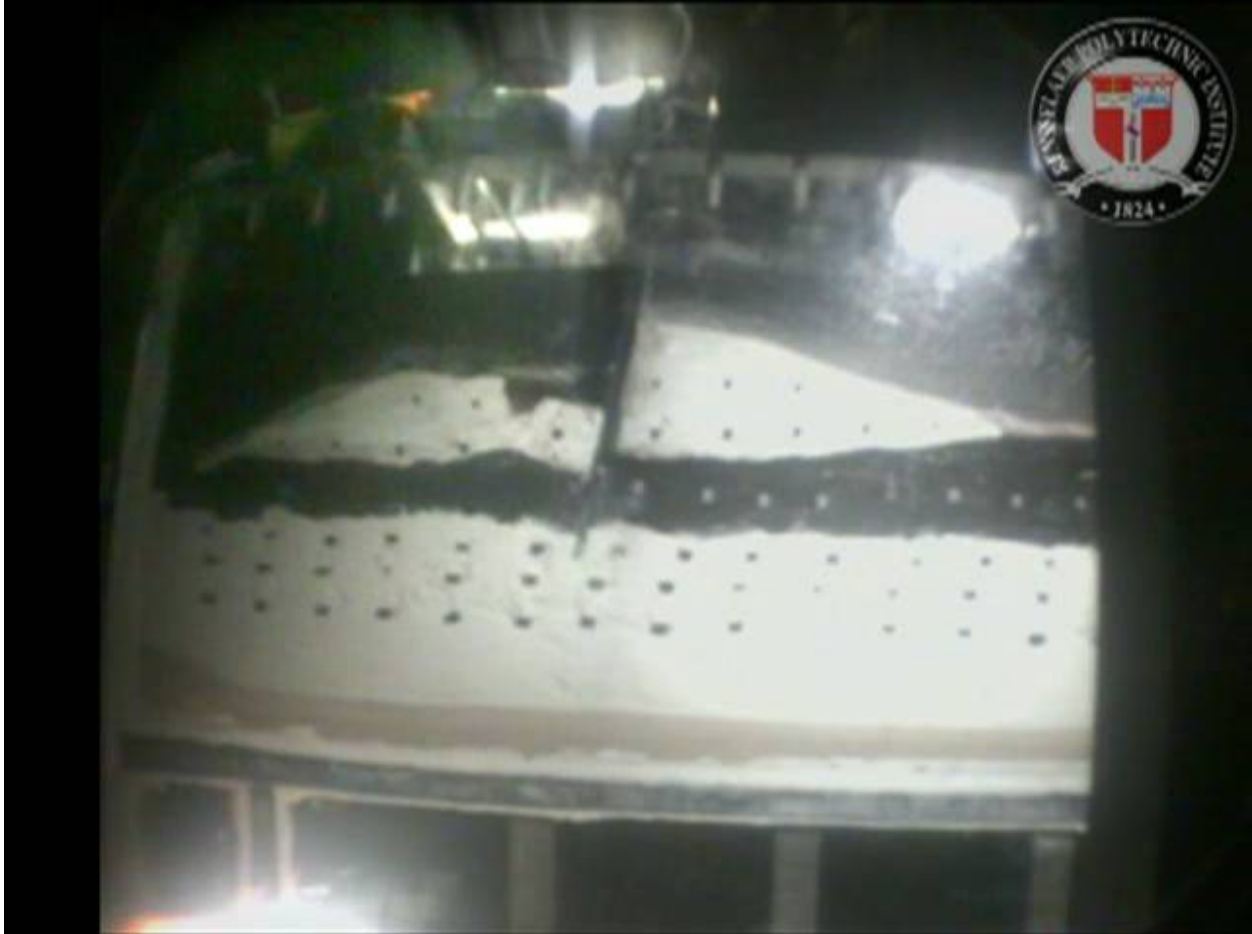
Figure 5.58. RPI 17th Street model in process of translational failure

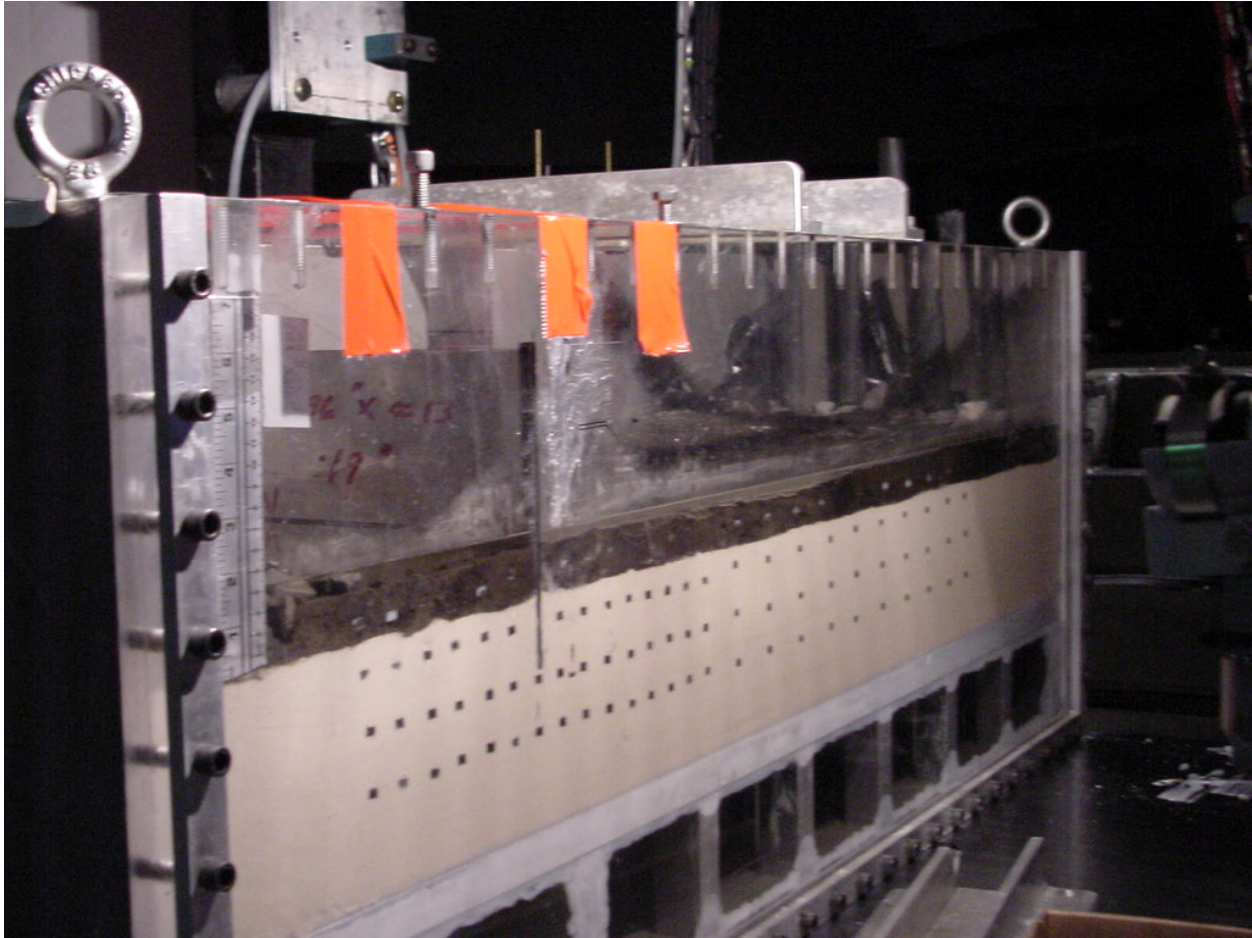
Figure 5.64. View of the ERDC model with sand and swampy/marsh layer

The sequence of model construction and testing were as previously discussed for other models. Prior to placement of the swampy/marsh material both penetrometer and moisture contents were obtained. Average values for the penetration testing were 400 psf and the moisture contents 357%. Penetration measurements of the levee material after consolidation averaged 360 psf and moisture contents averaged 61%. A view of the model with saturated sand layer and swampy/marsh layer in place is shown in Figure 5.64.

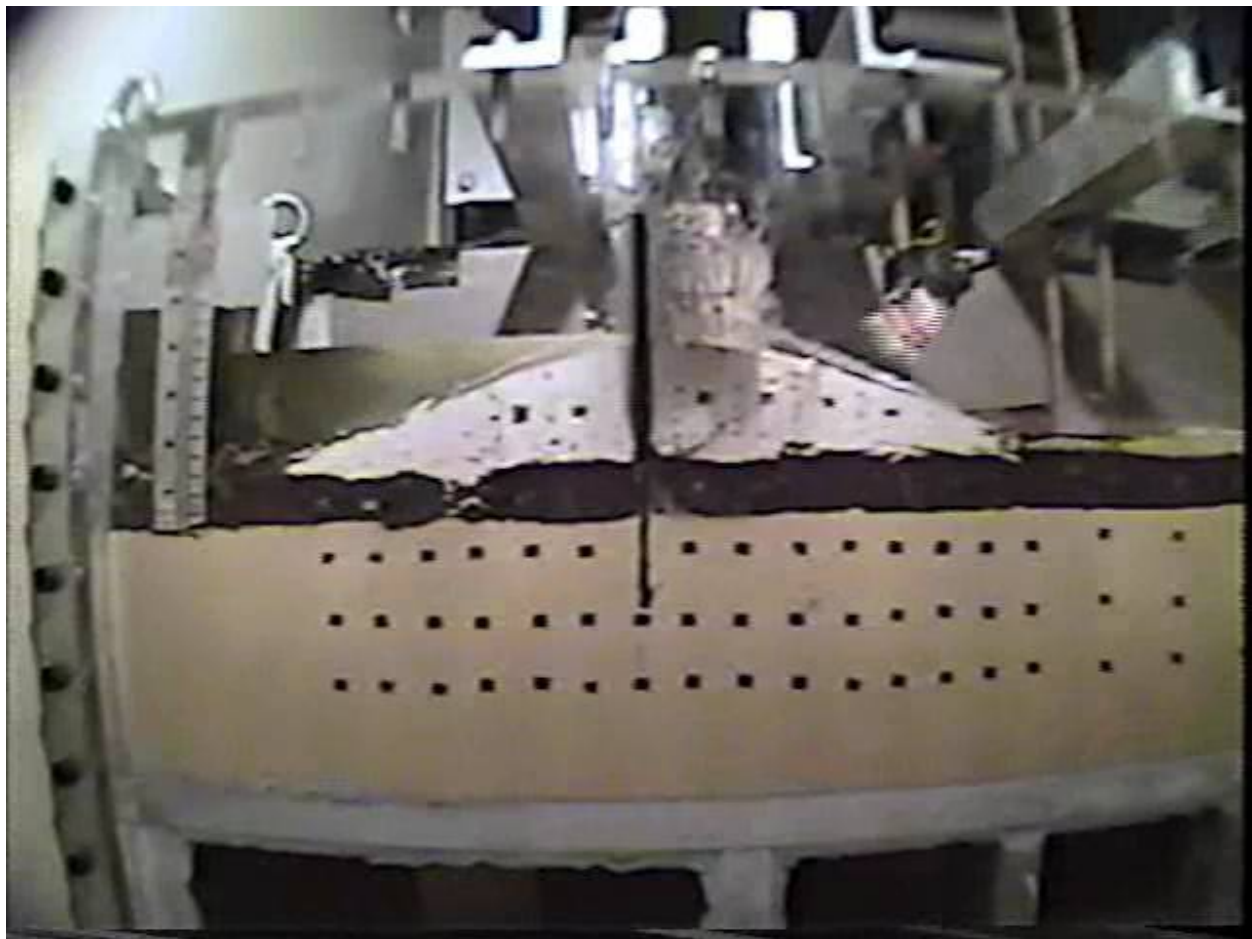
Figure 5.66a. ERDC London Avenue south model at normal canal water level

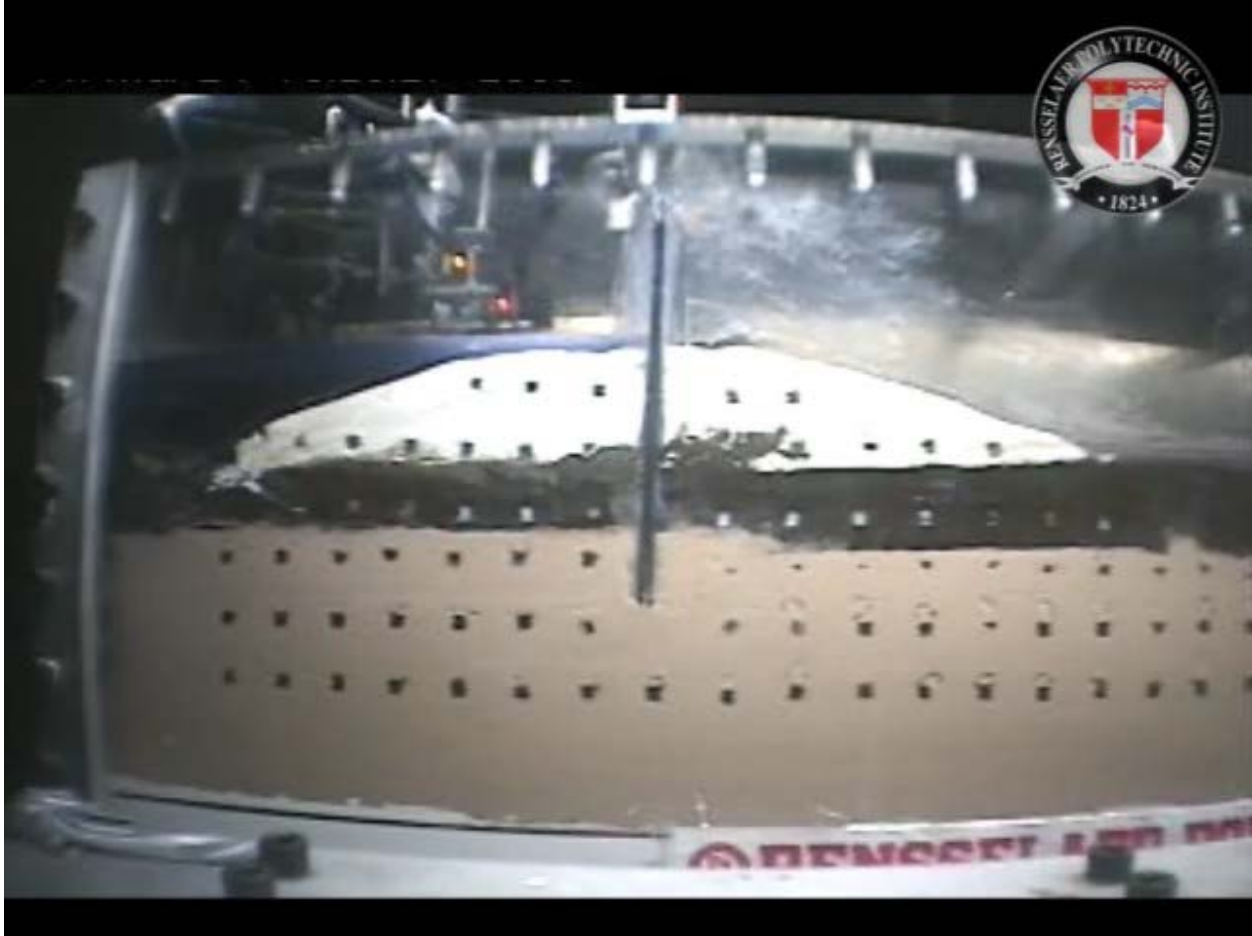
Figure 5.77a. RPI London south model at normal canal water elevation

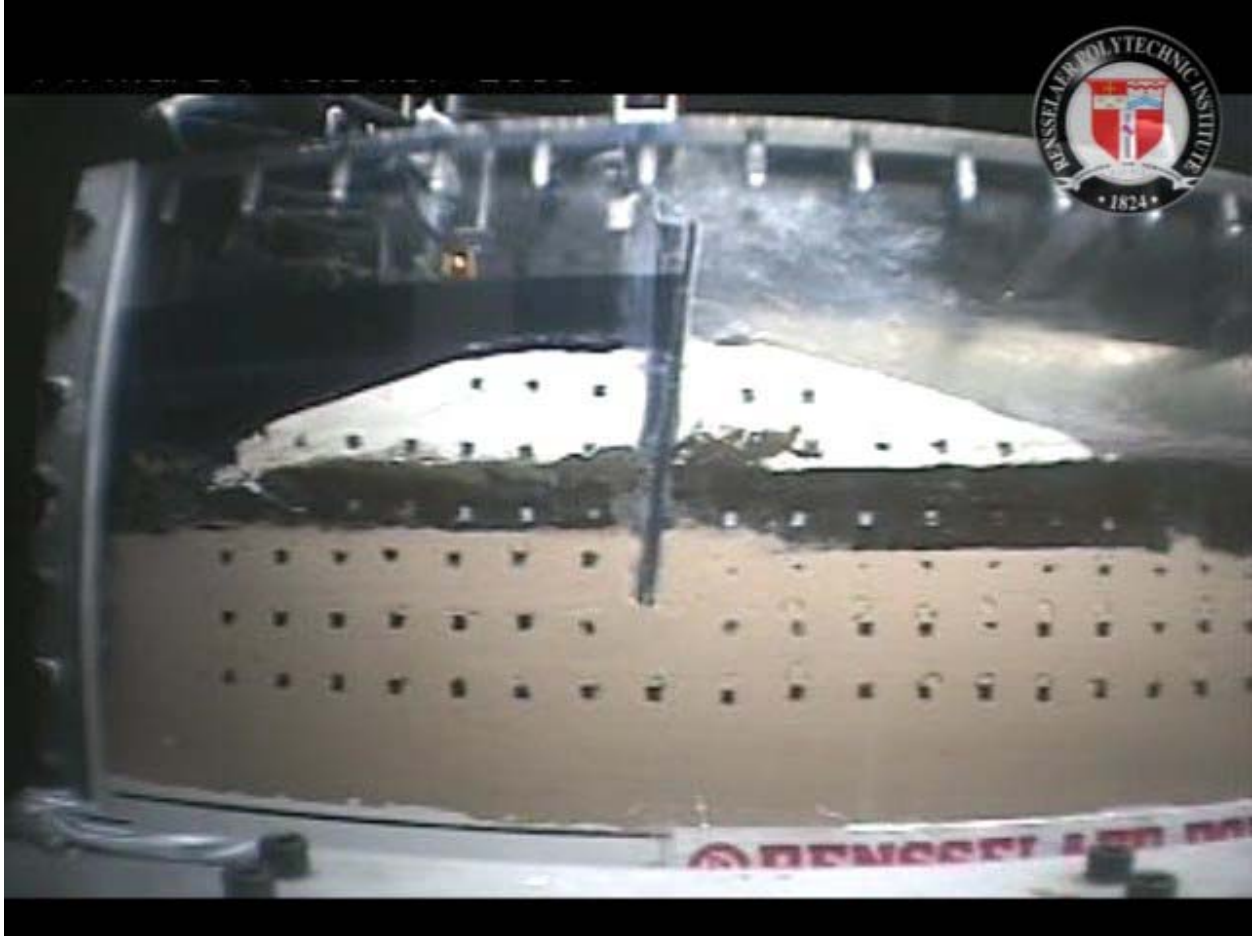
Figure 5.77d. RPI London south model in process of failure

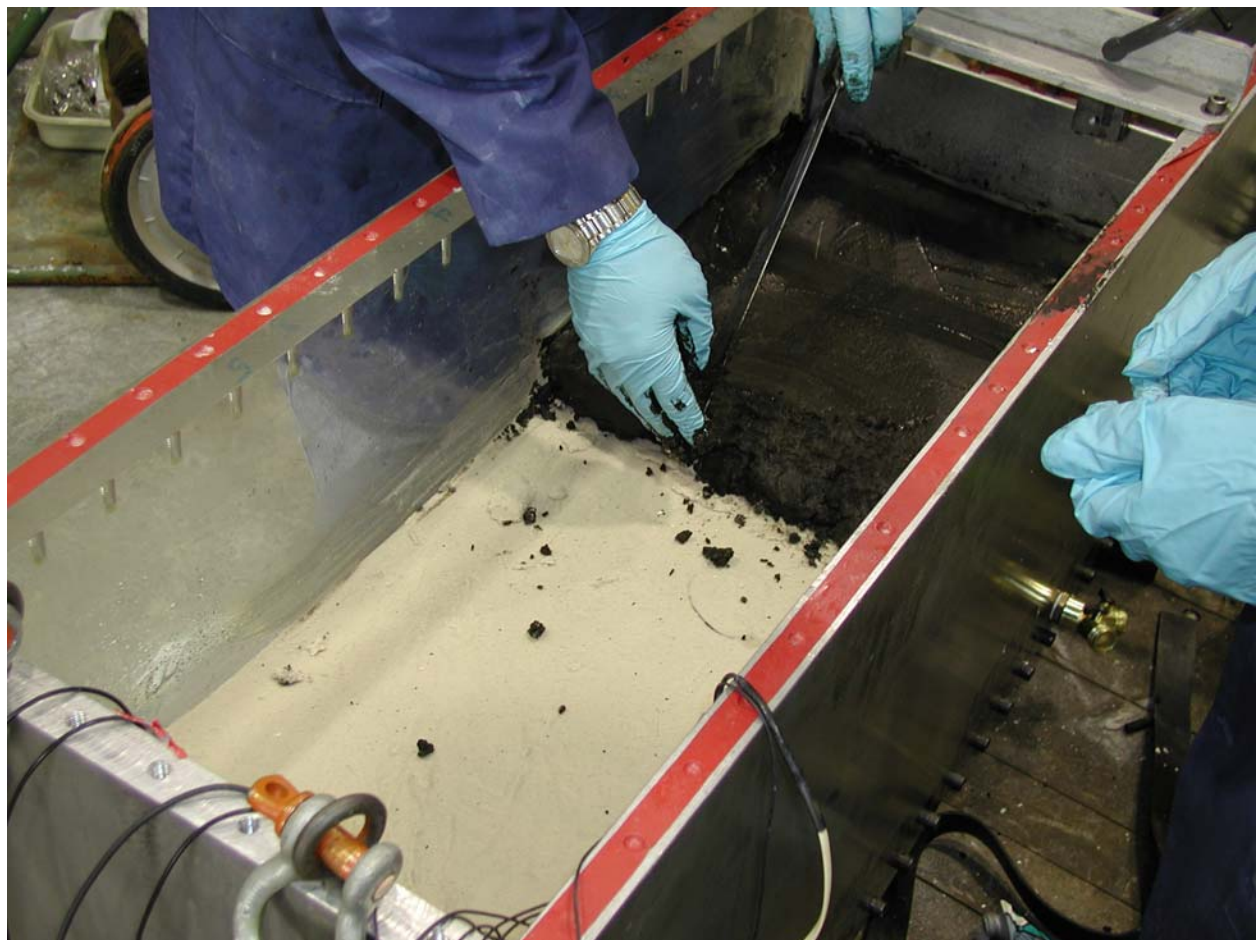
Figure 5.80. View of placement of swampy/marsh layer

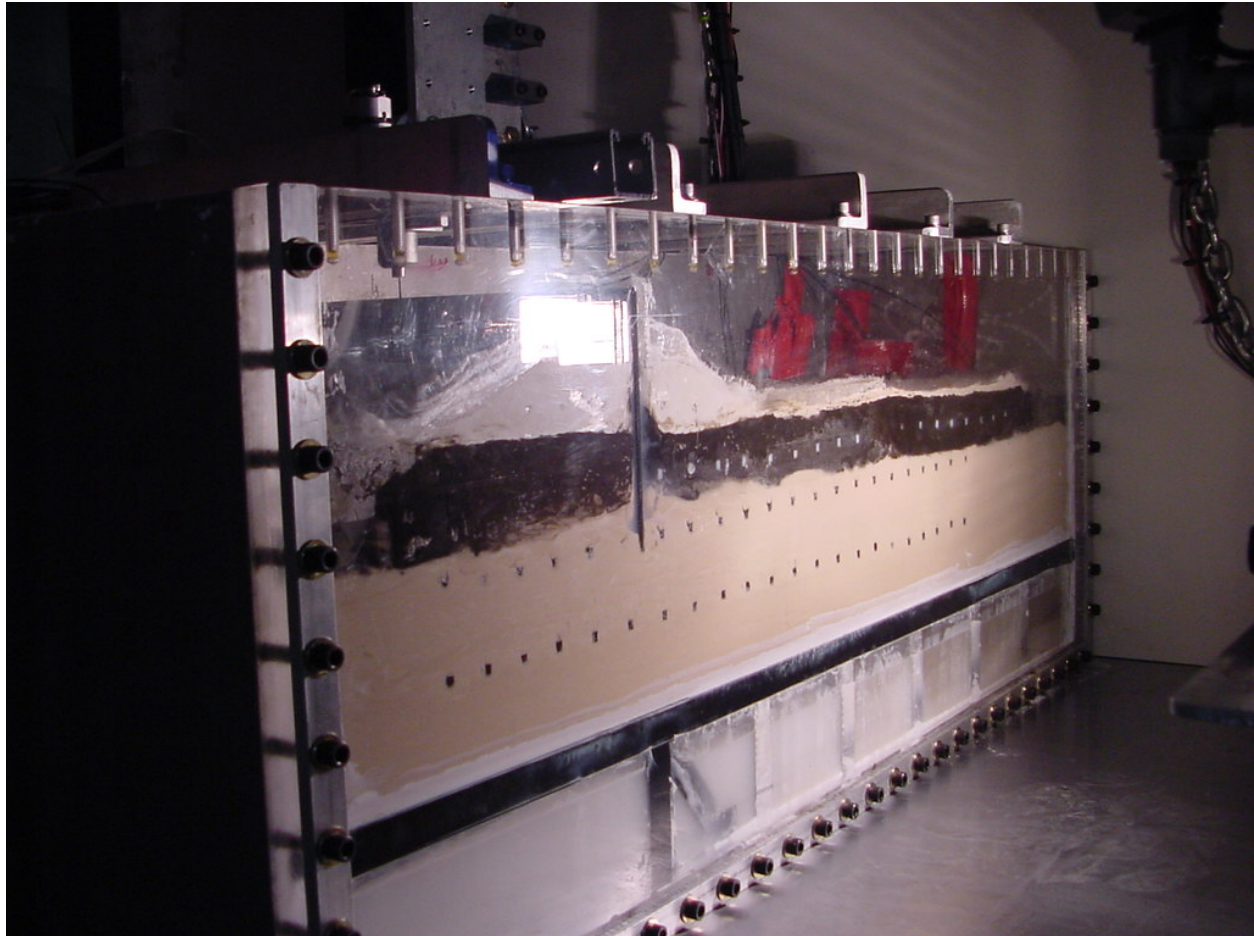
Figure 5.81. View of completed model prior to testing

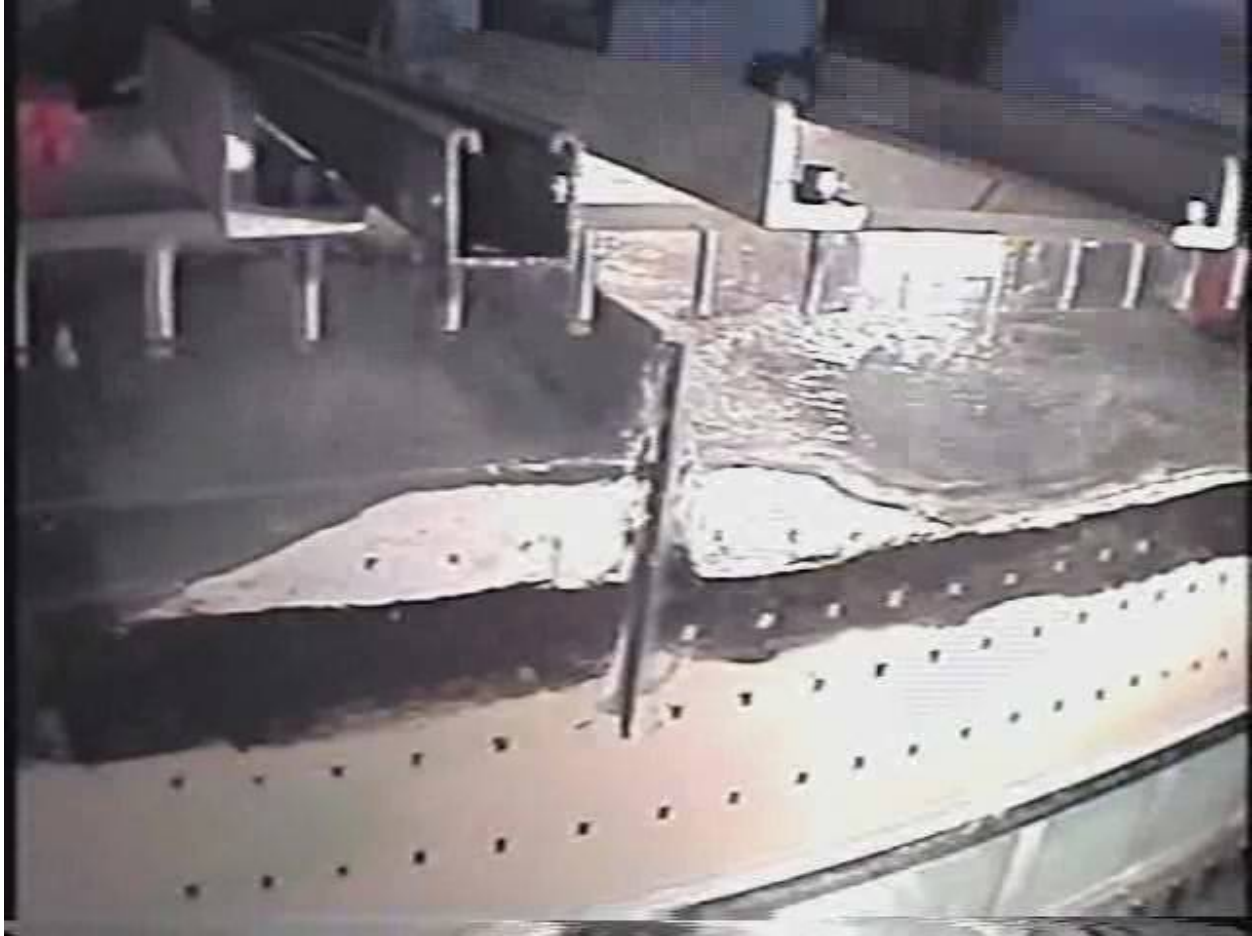
Figure 5.85a. View of ERDC London north model at normal canal water elevation

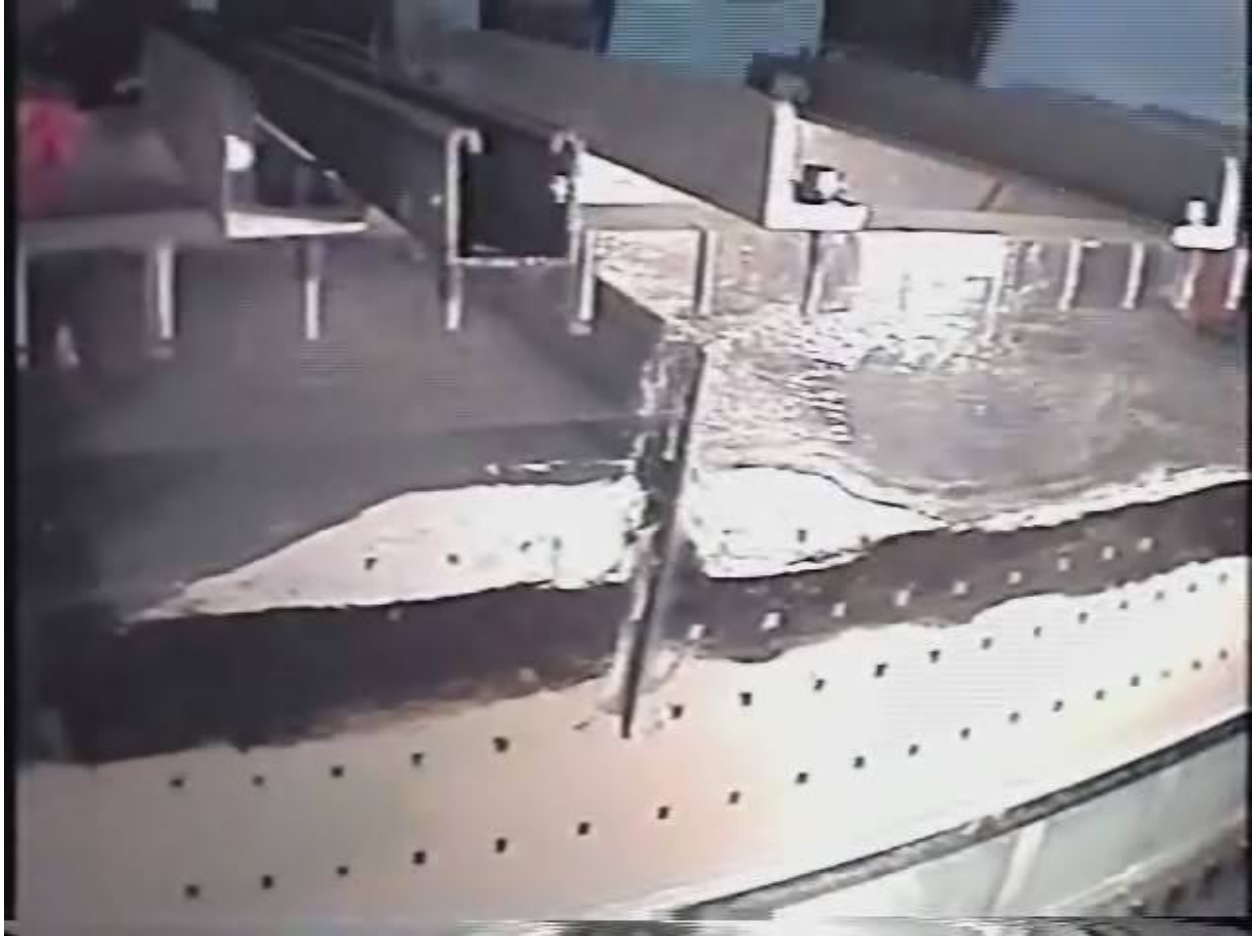
Figure 5.85c. View of ERDC London north model at flood level just after wall movement and opening of crack between wall and canal side levee

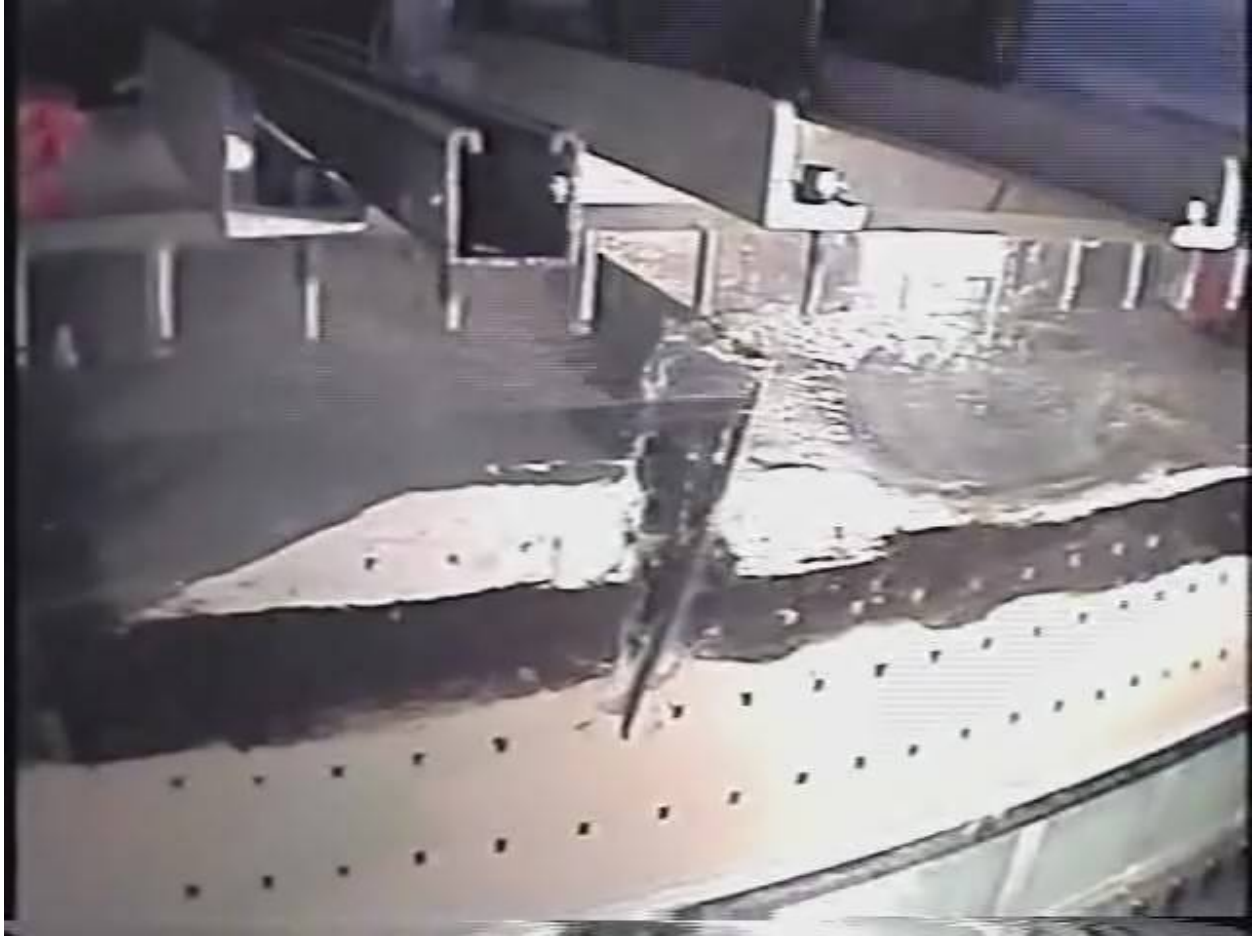
Figure 5.85d. View of ERDC London north model at flood level well into failure

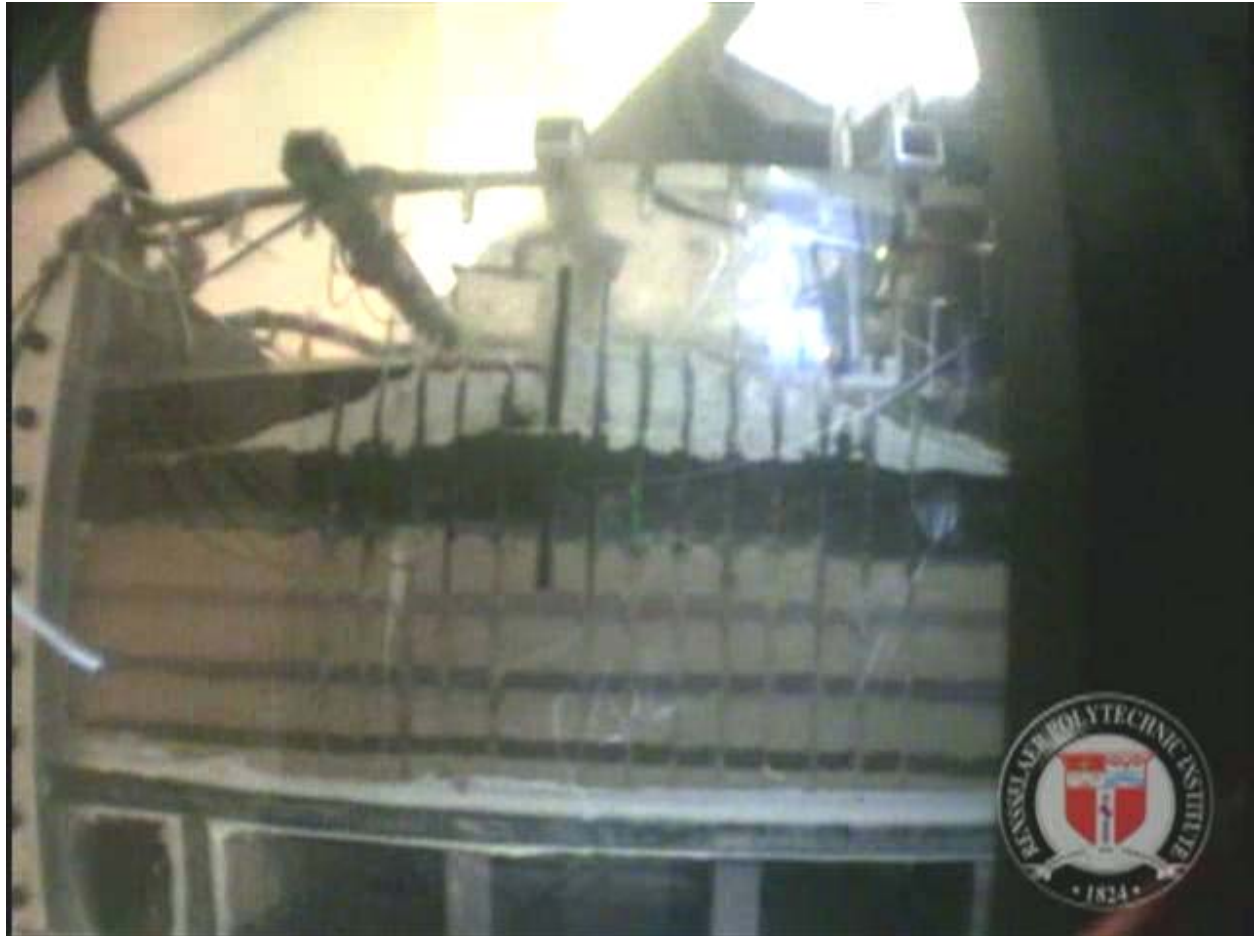
Figure 5.91a. RPI London north model at normal canal water elevation

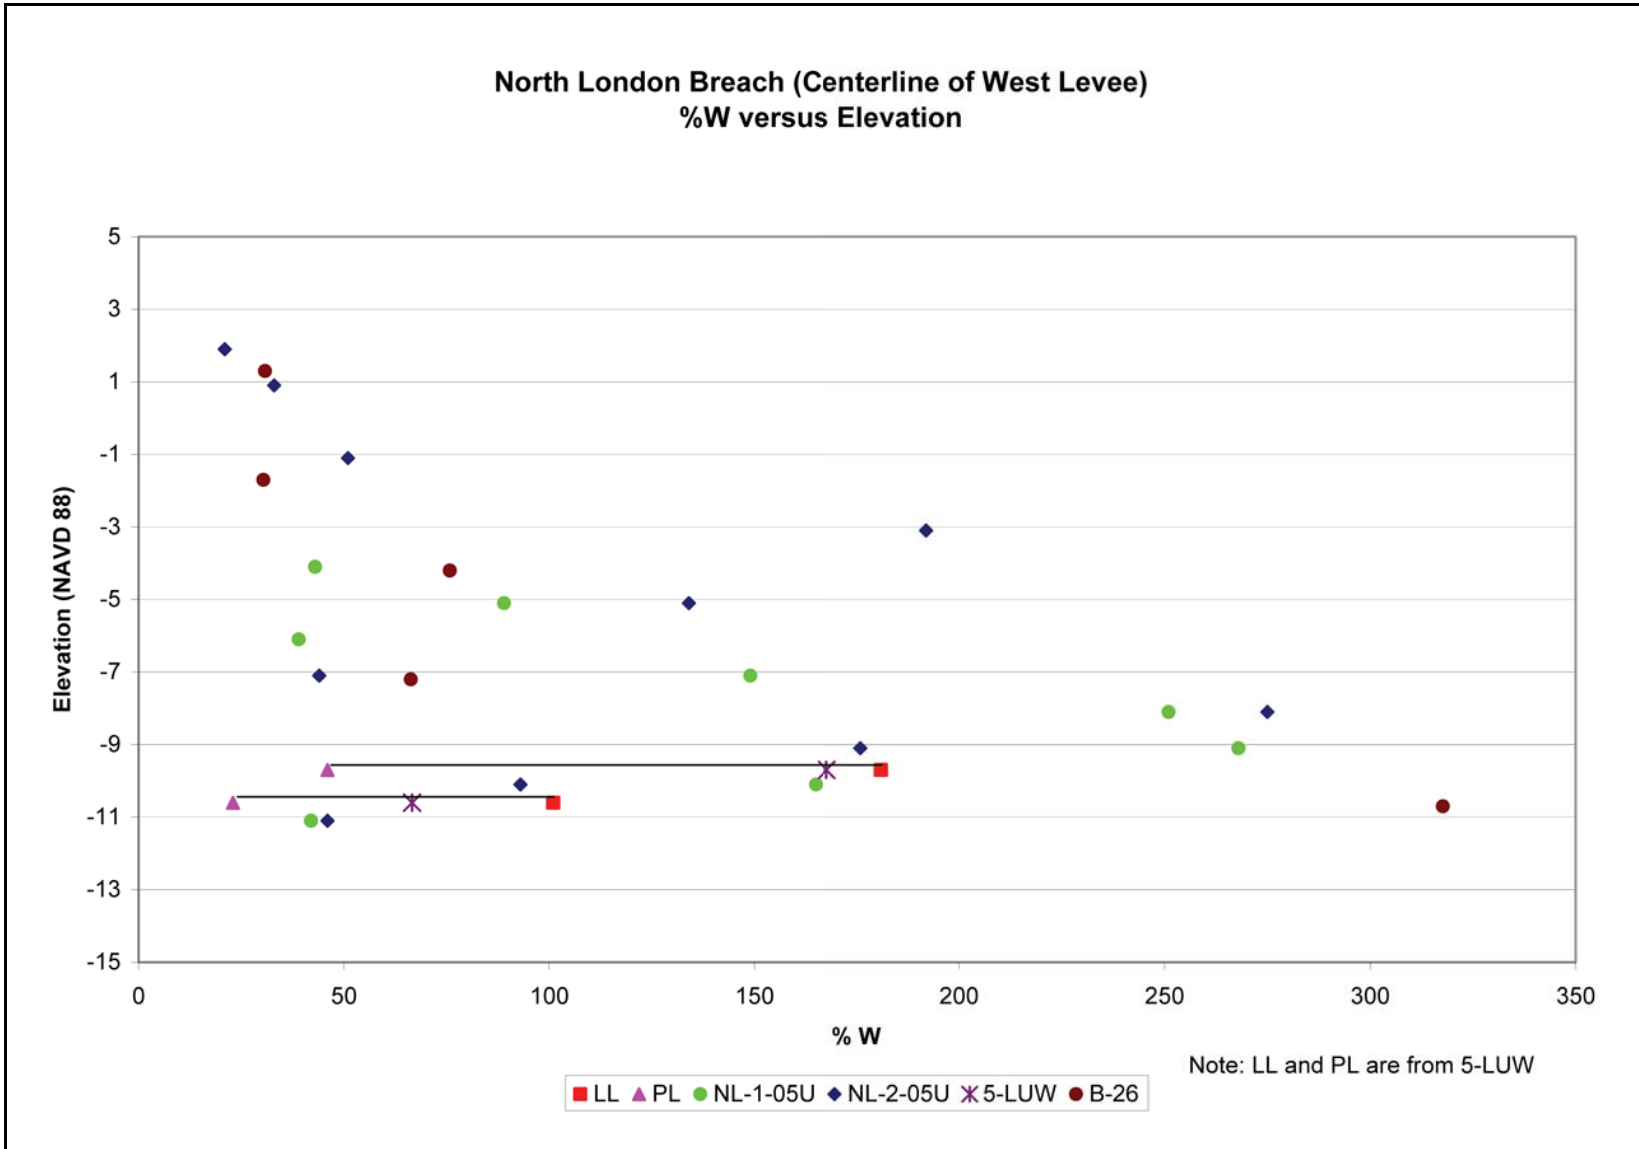
Figure 7-16. North London Breach (Centerline of West Levee), %w versus Elevation

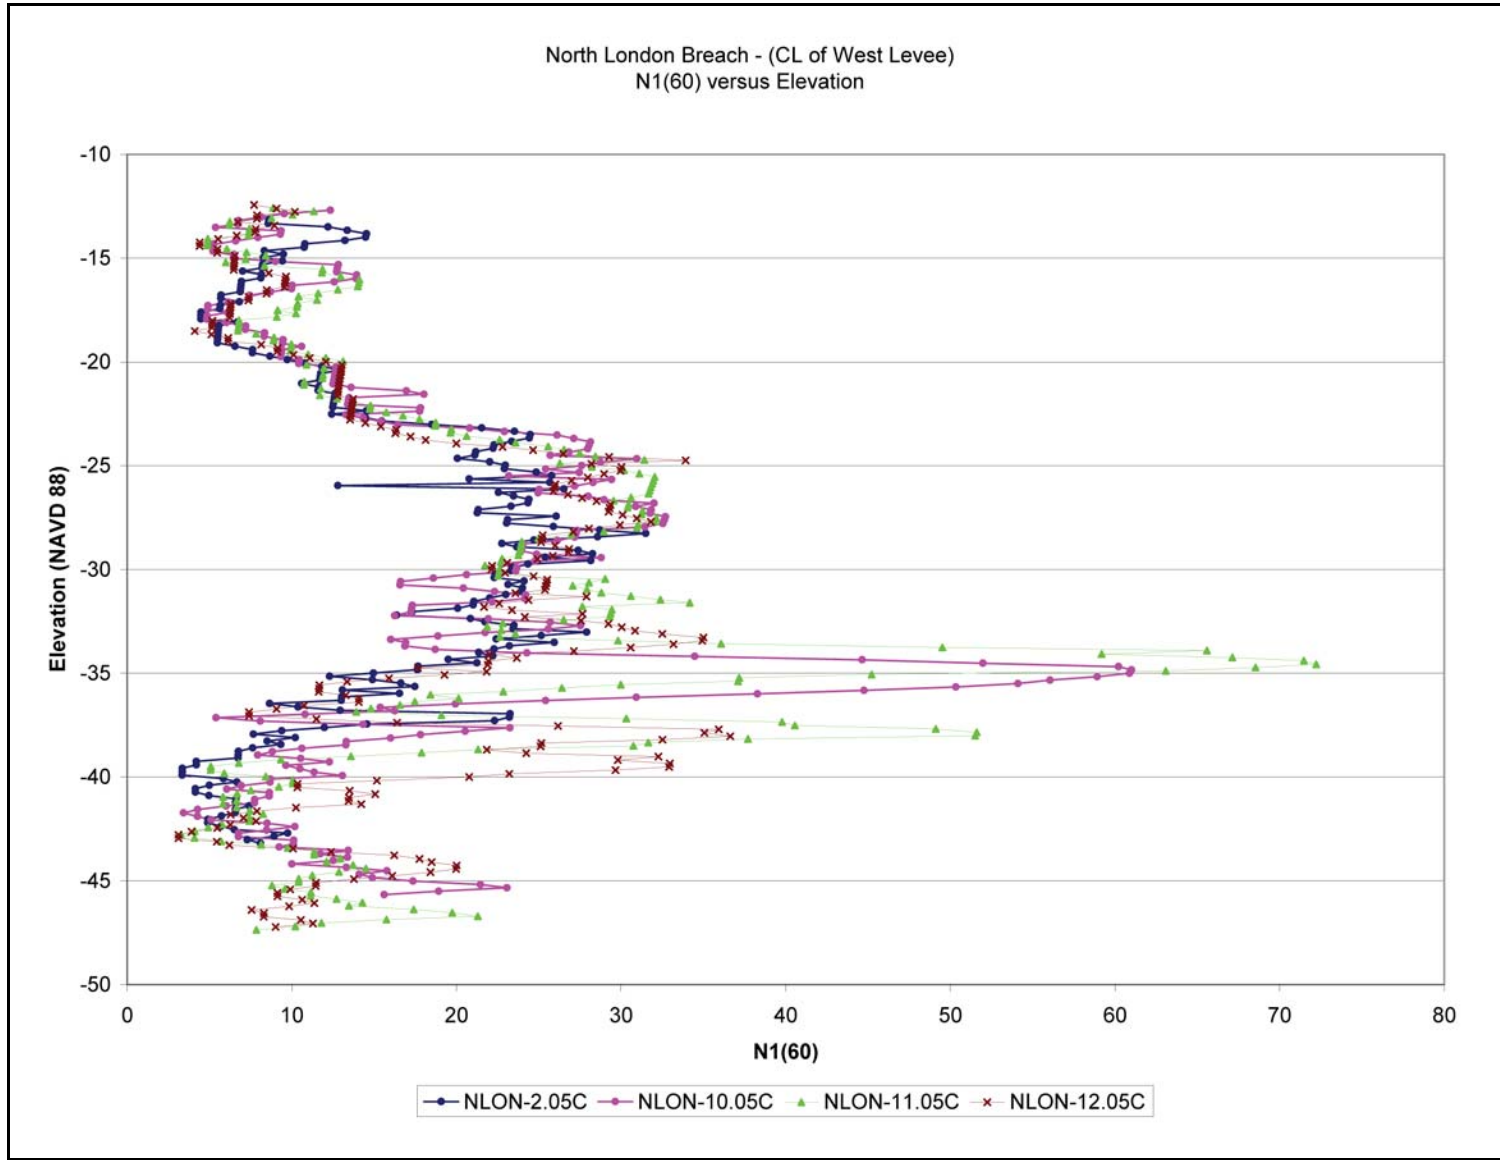
Figure 7-29. North London Breach – Beach Sand Stratum (Centerline of West Levee), N1(60) versus Elevation
