Appendix 1

Soil Data Report for 17th Street Canal

This is a data report detailing the data collected by the Interagency Performance Evaluation Task Force (IPET) to support the analysis of the I-wall section that breached at the 17th Street Canal as a result of Hurricane Katrina on August 29, 2005. The location of the 17th Street Canal is shown in Figure 1-1. The site of the breach, located on the east bank near the north end of the canal, is also noted on Figure 1-1.

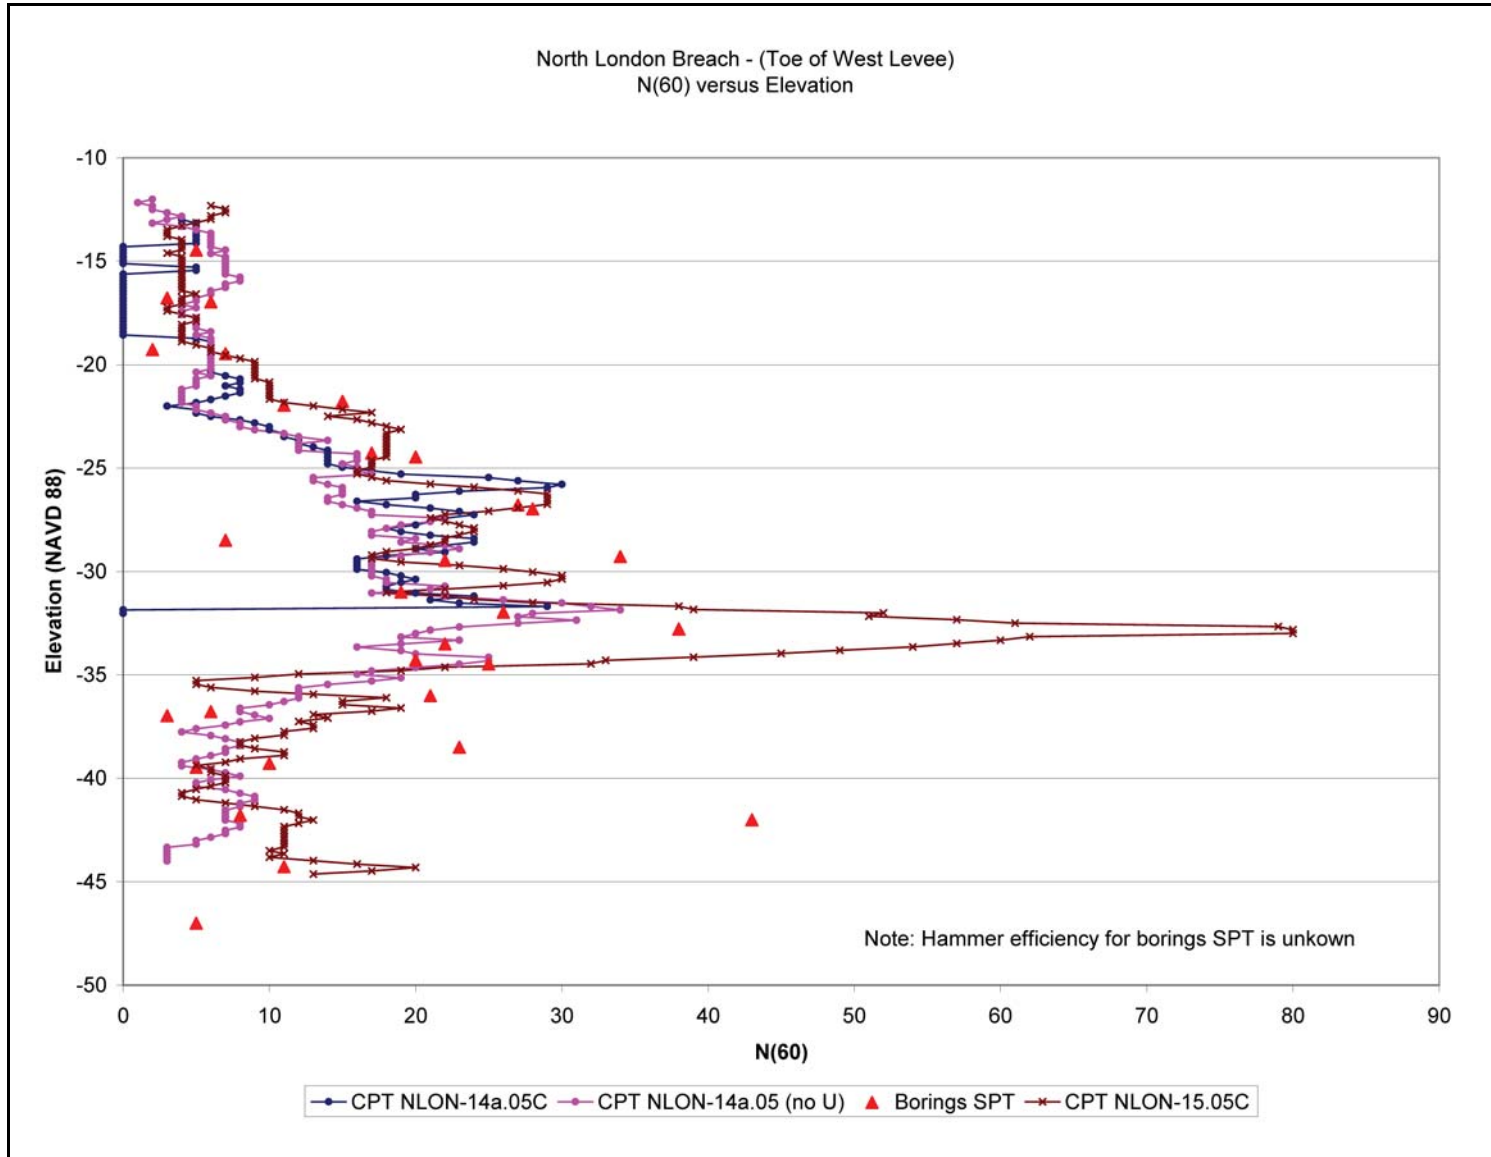
Figure 7-32. North London Breach – Beach Sand Stratum (Toe of West Levee), N(60) versus Elevation

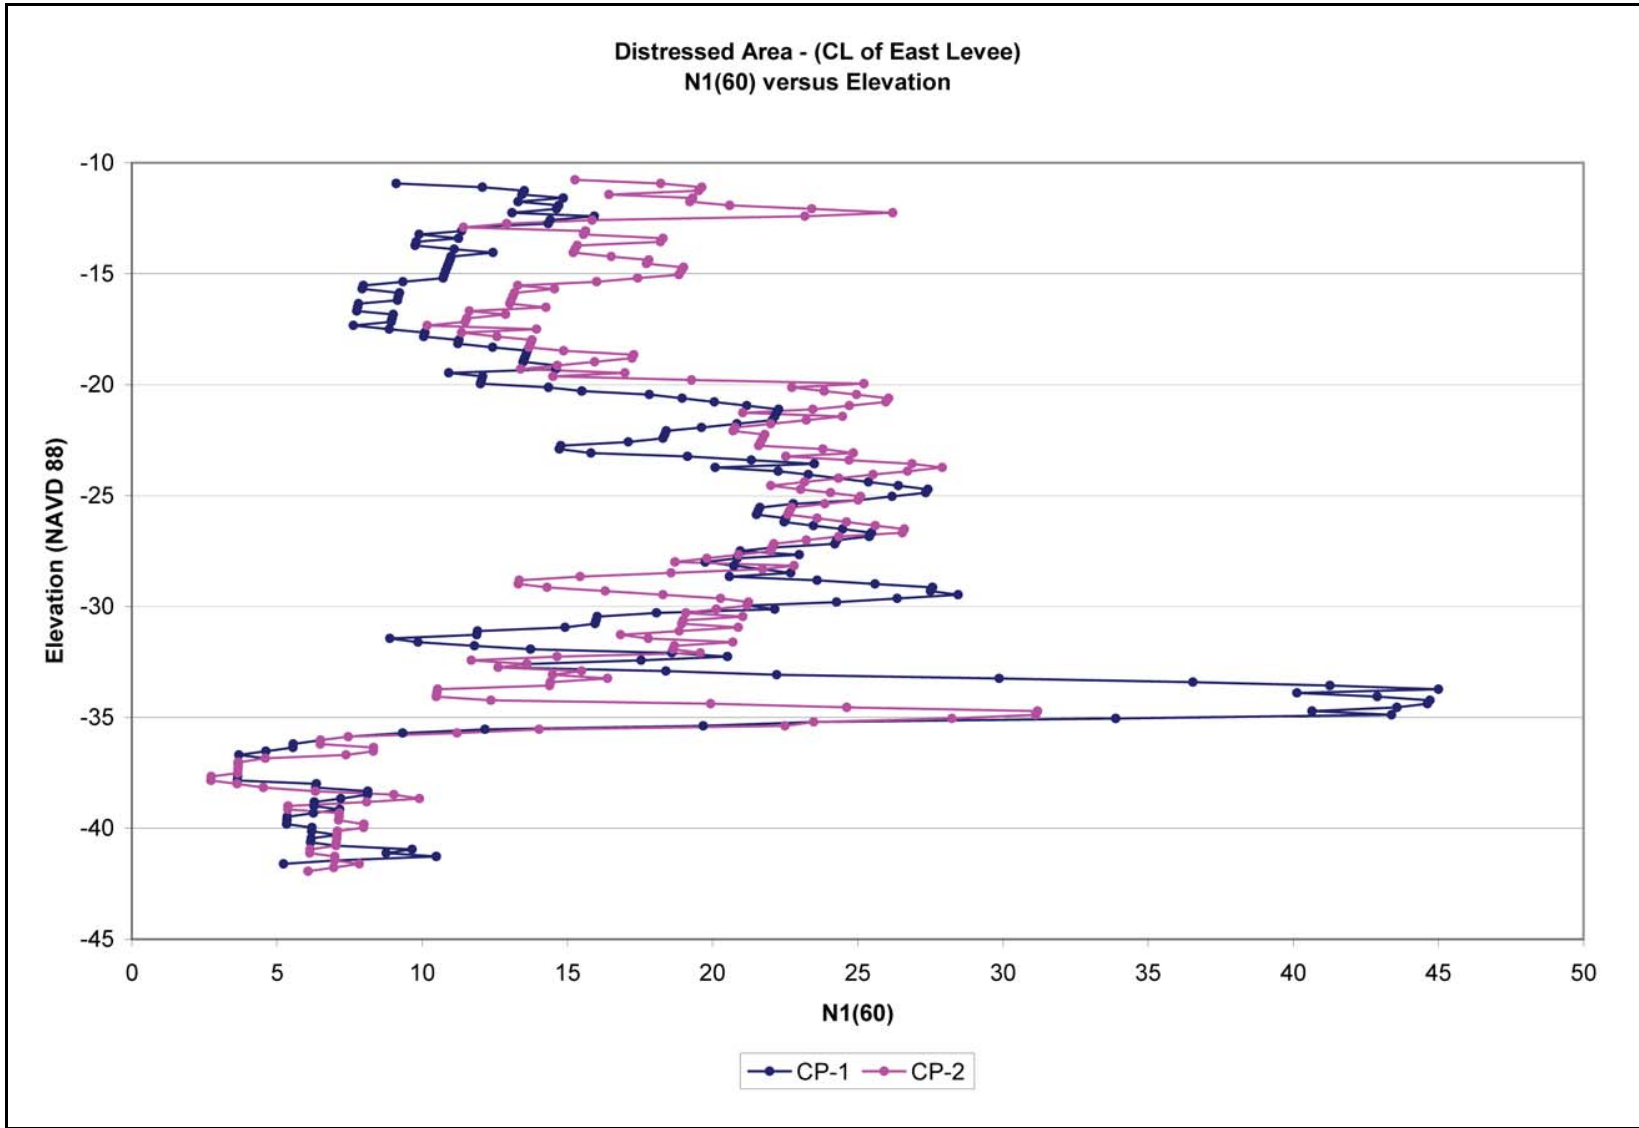
Figure 7-38. Distressed Area – Beach Sand Stratum (Centerline of East Levee), N1(60) versus Elevation for CPTs CP-1 and CP-2

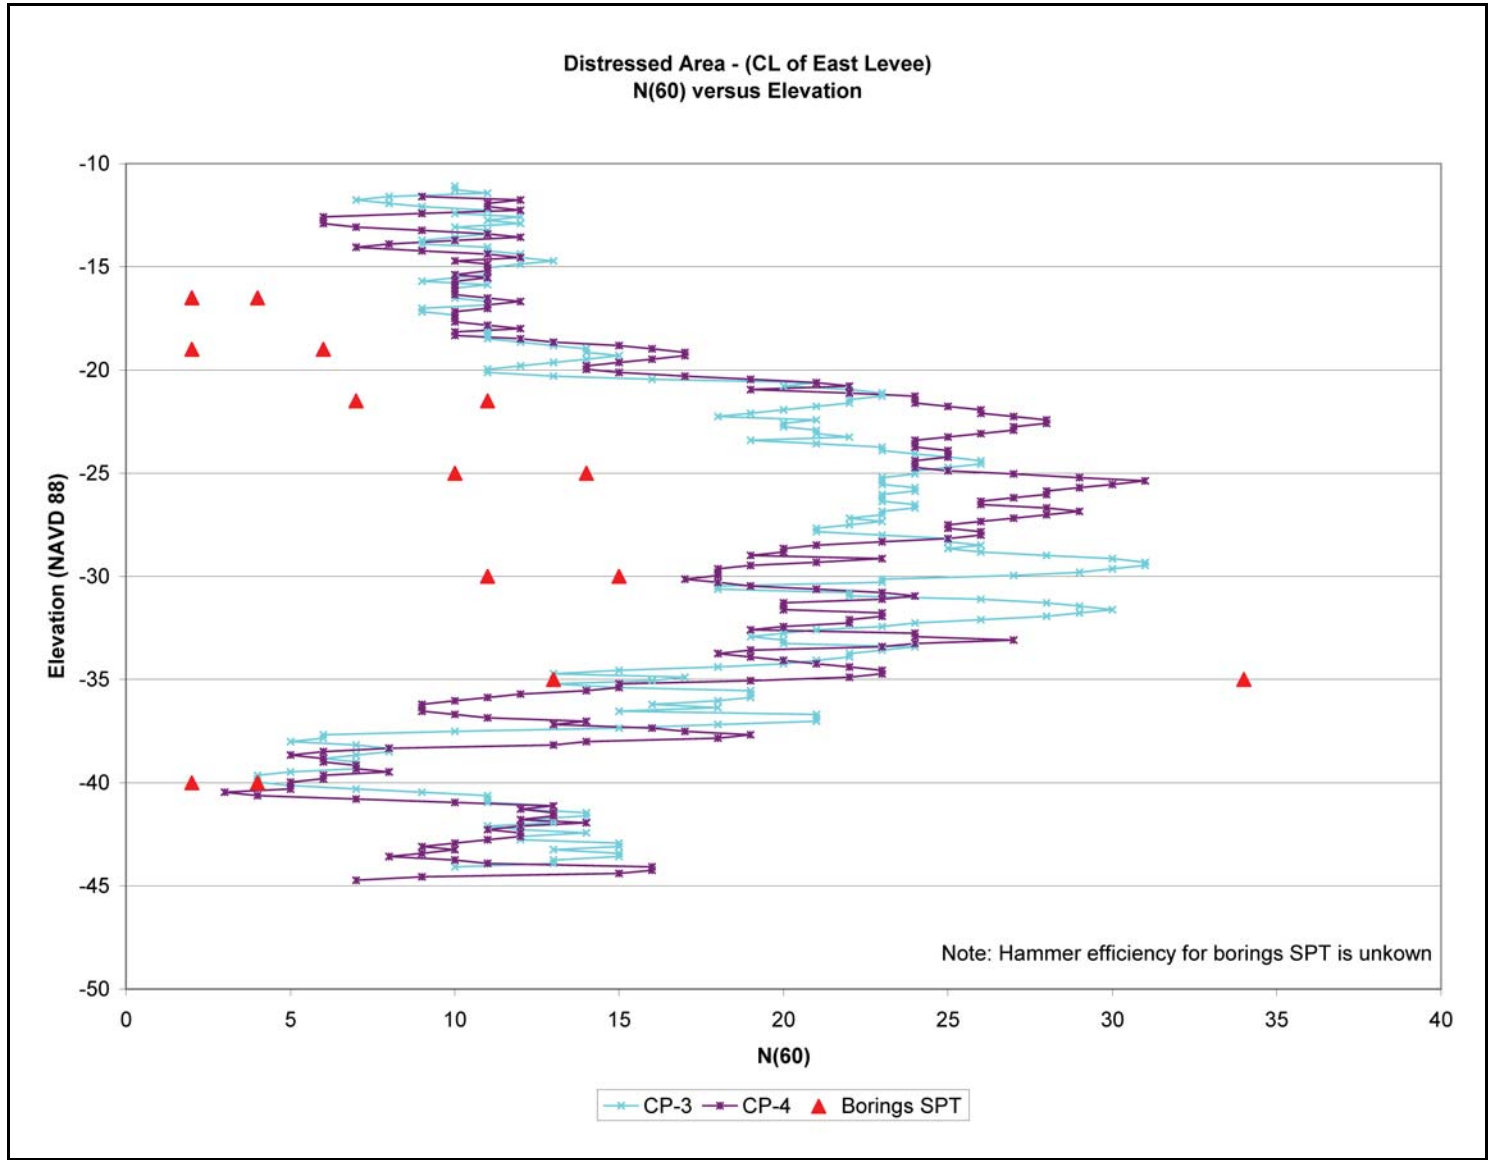
Figure 7-41. Distressed Area – Beach Sand Stratum (Centerline of East Levee), N(60) versus Elevation for CPTs CP-3 and CP-4

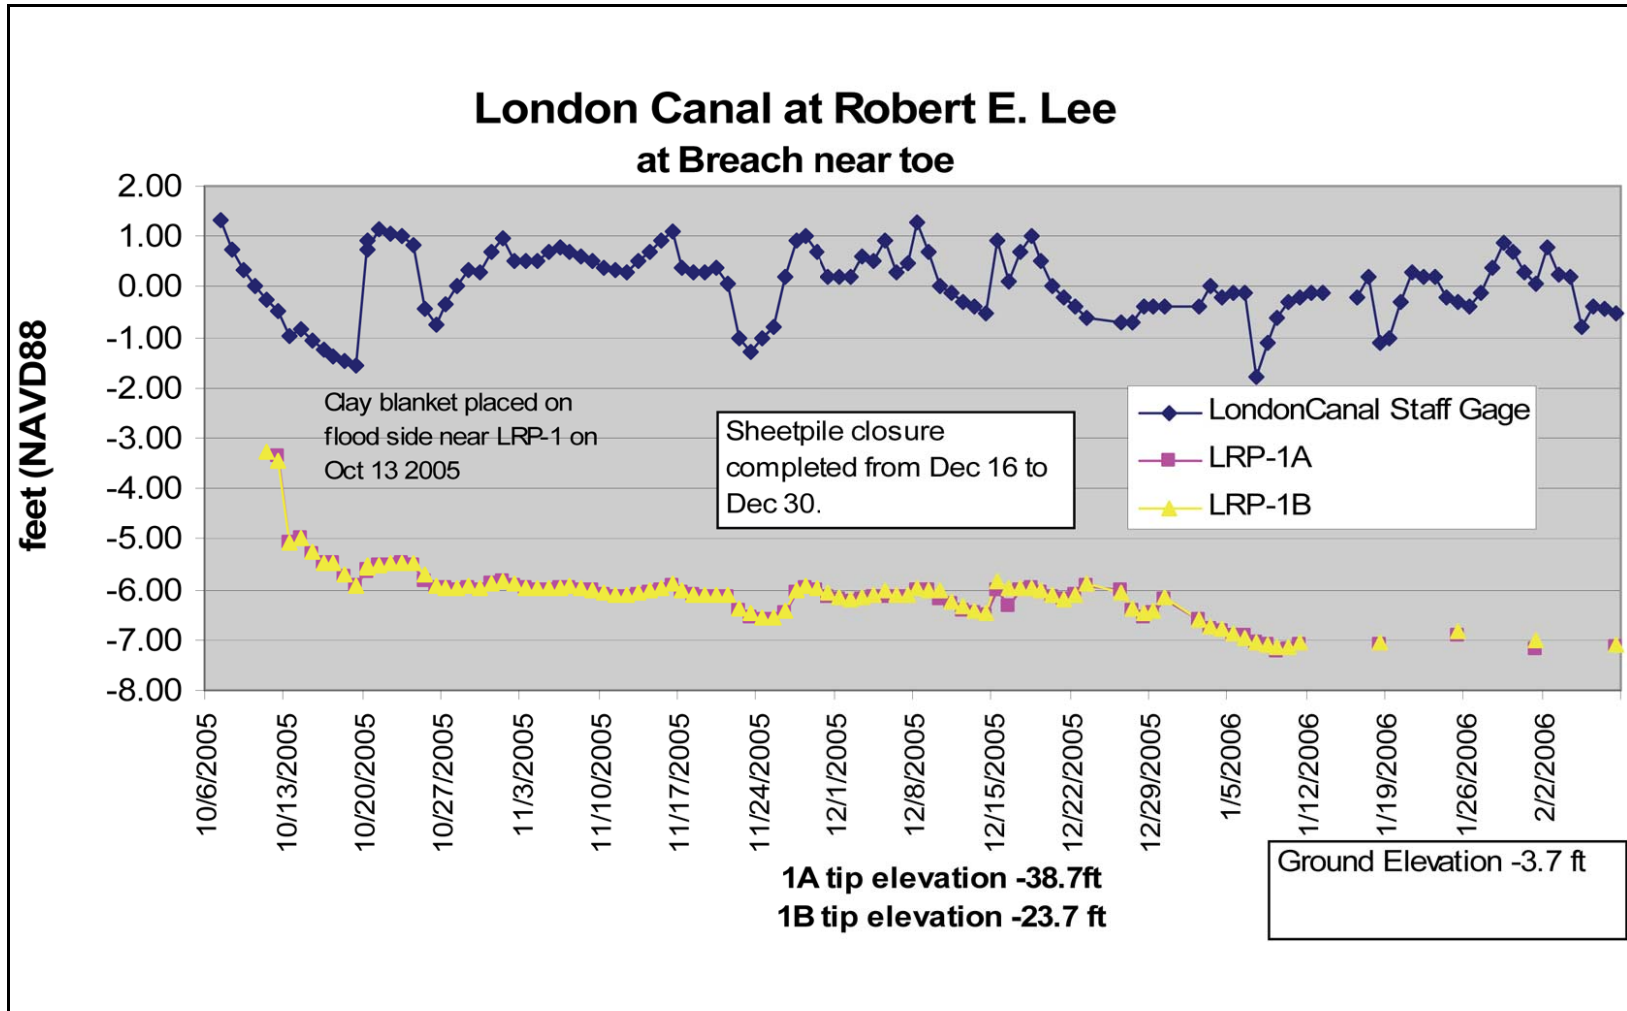
Figure 7-49. Response of Piezometers LRP-1a and LRP-1-B in the Vicinity of the North London Breach Site

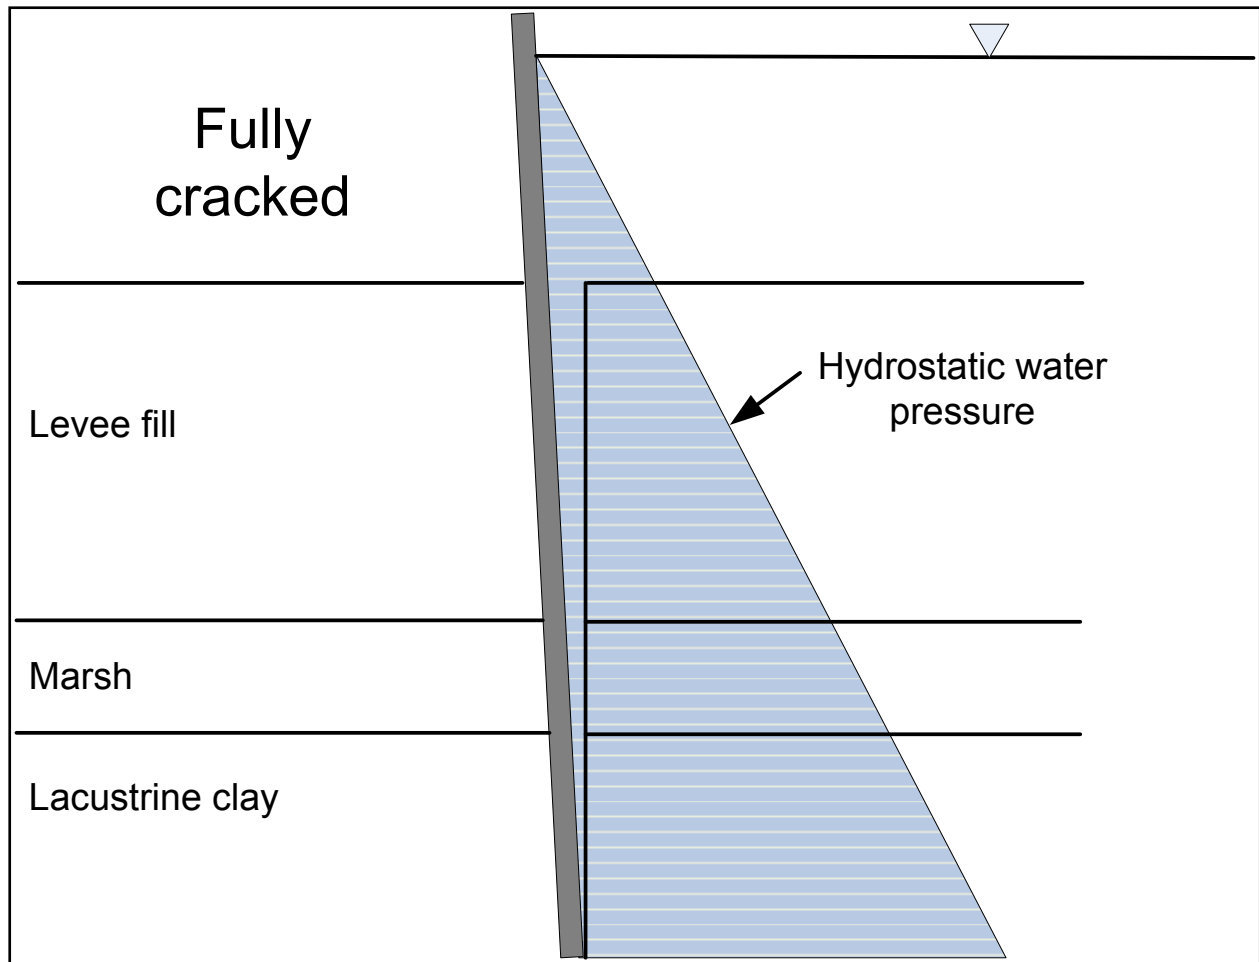
Figure 8-4. Schematic of Gap Used in 17th Street Canal Stability Analyses

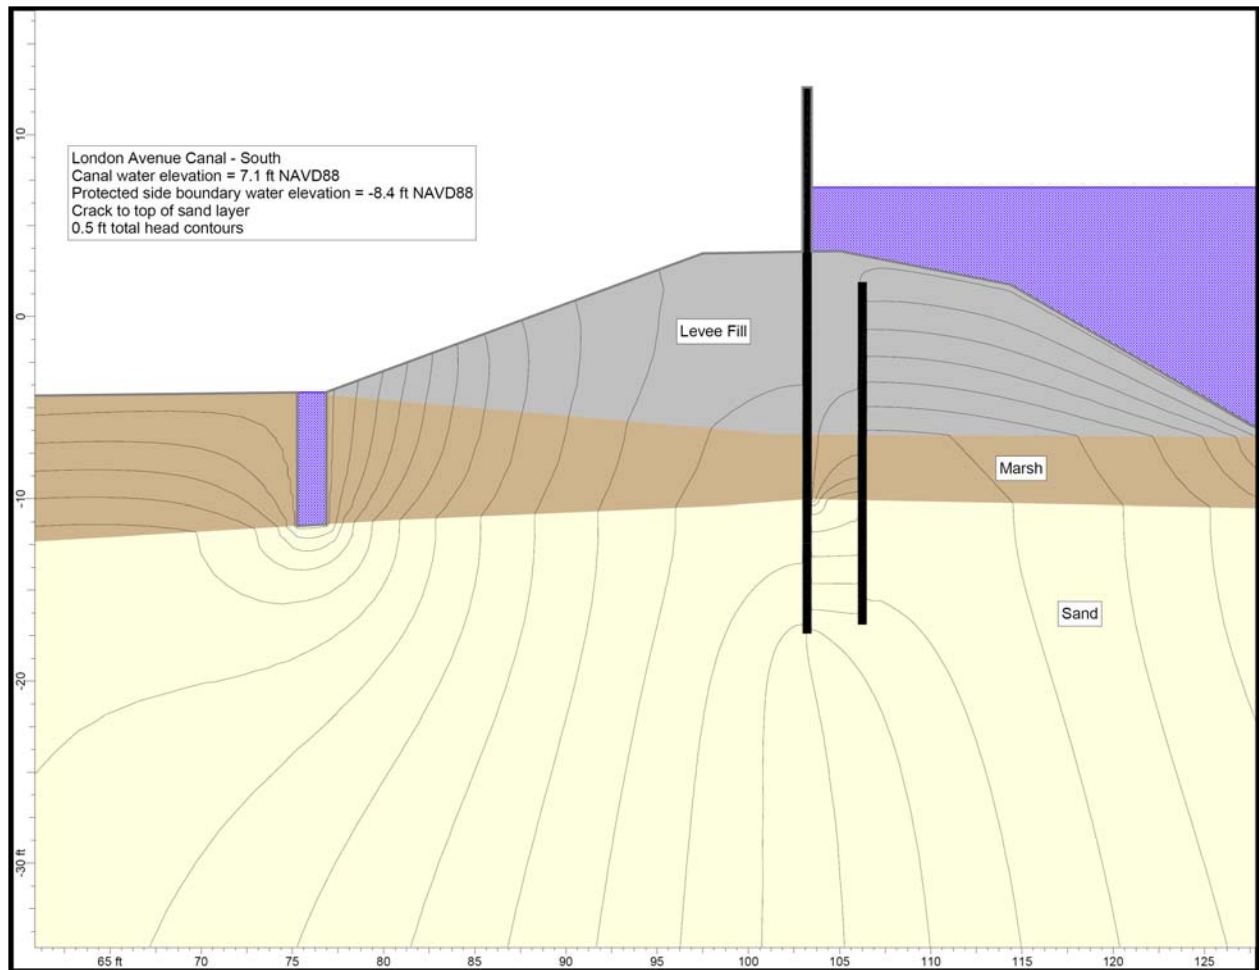
Figure 8-10. Total Head Contours in Vicinity of Rupture for London South Breach

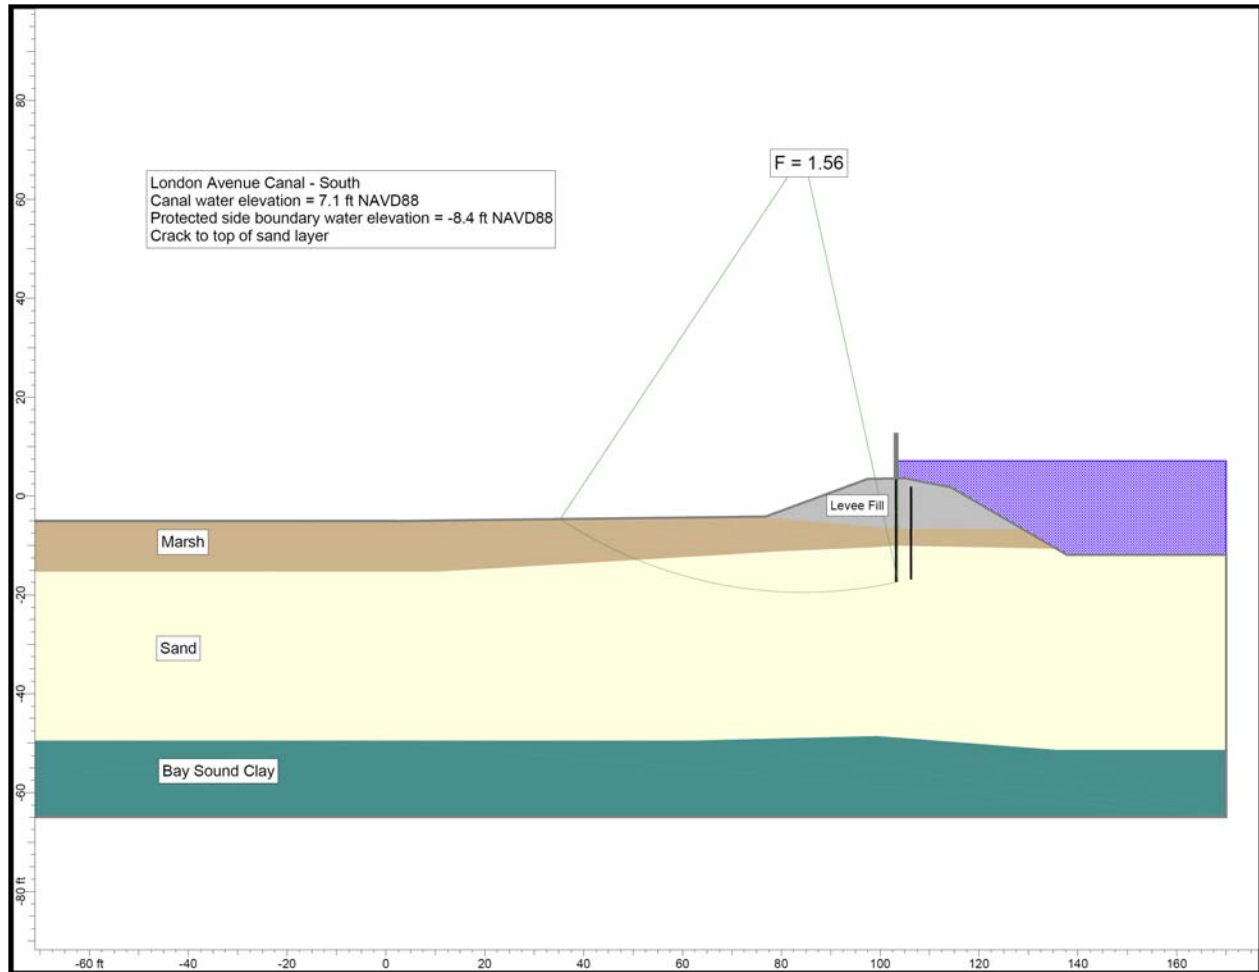
Figure 8-11. London South Breach Case 1 Stability Analysis

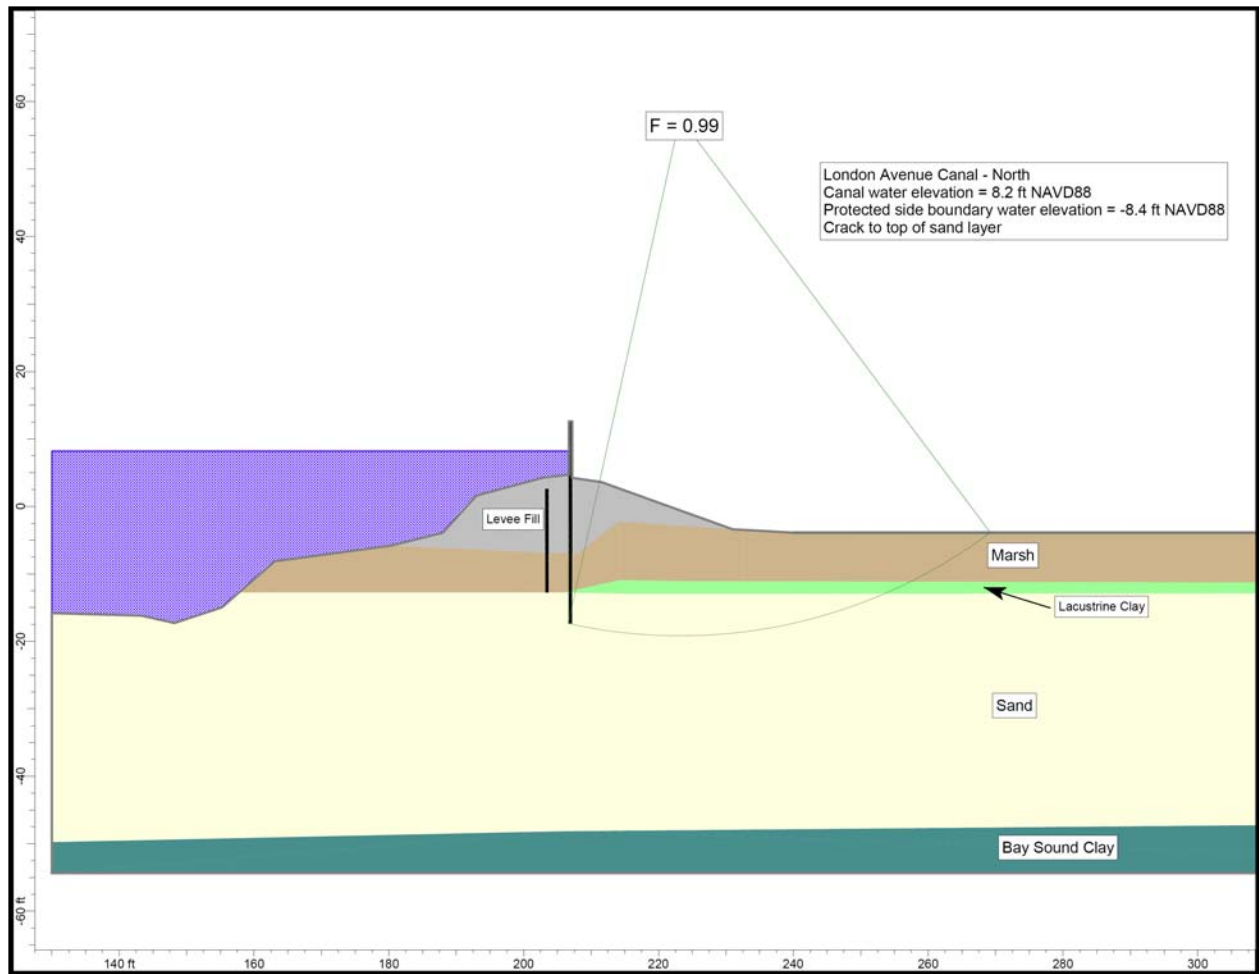
Figure 8-22. London North Breach Case 1 Stability Analysis

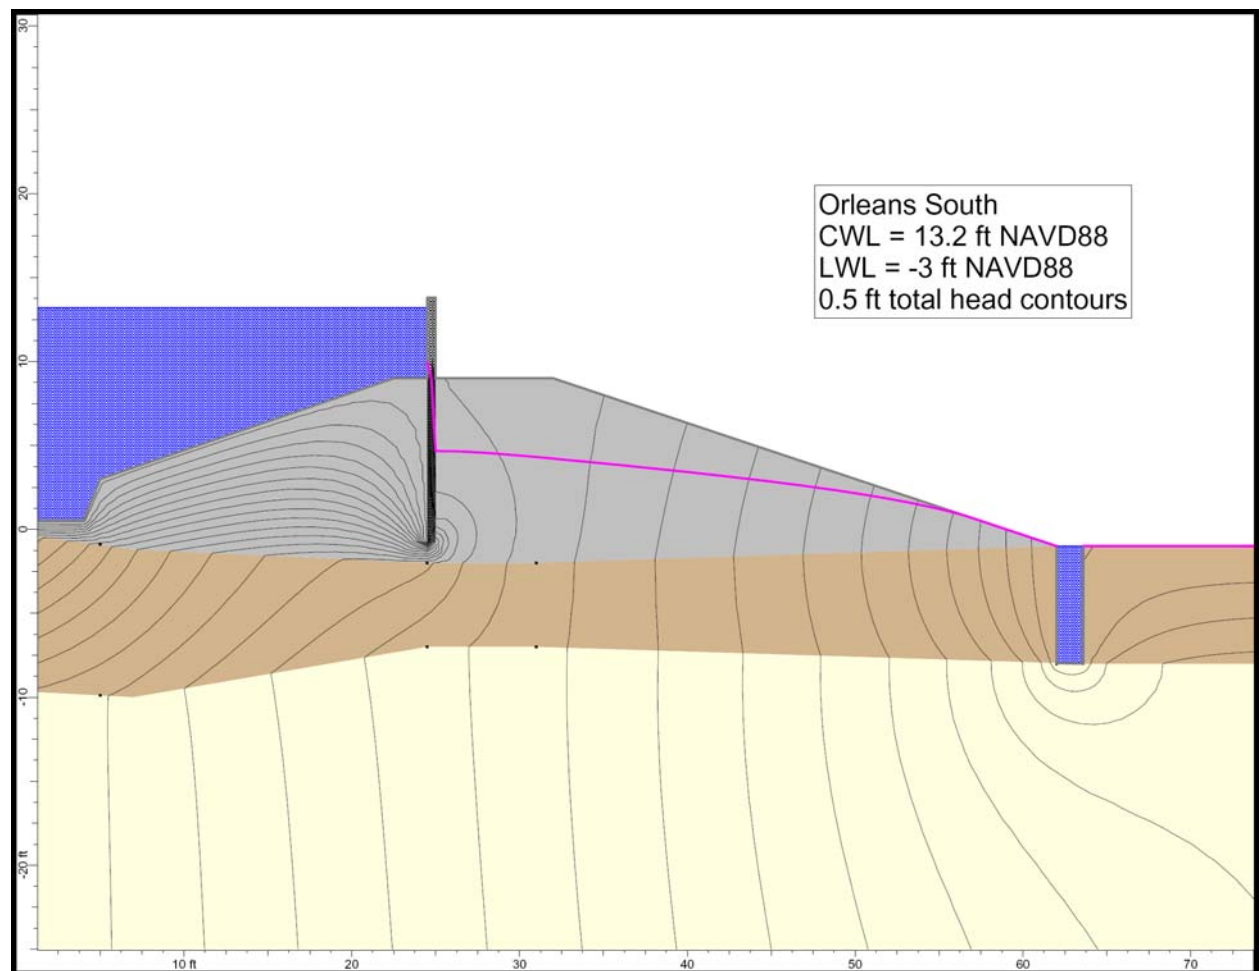
Figure 10-9. Total Head Contours in Vicinity of Rupture for Orleans South (Case 6)
