**Under White Haven:
An Archeological Overview and Assessment of
Ulysses S. Grant National Historic Site, St. Louis, Missouri**

Midwest Archeological Center
Technical Report No. 89

United States Department of the Interior
National Park Service
Midwest Archeological Center
Lincoln, Nebraska

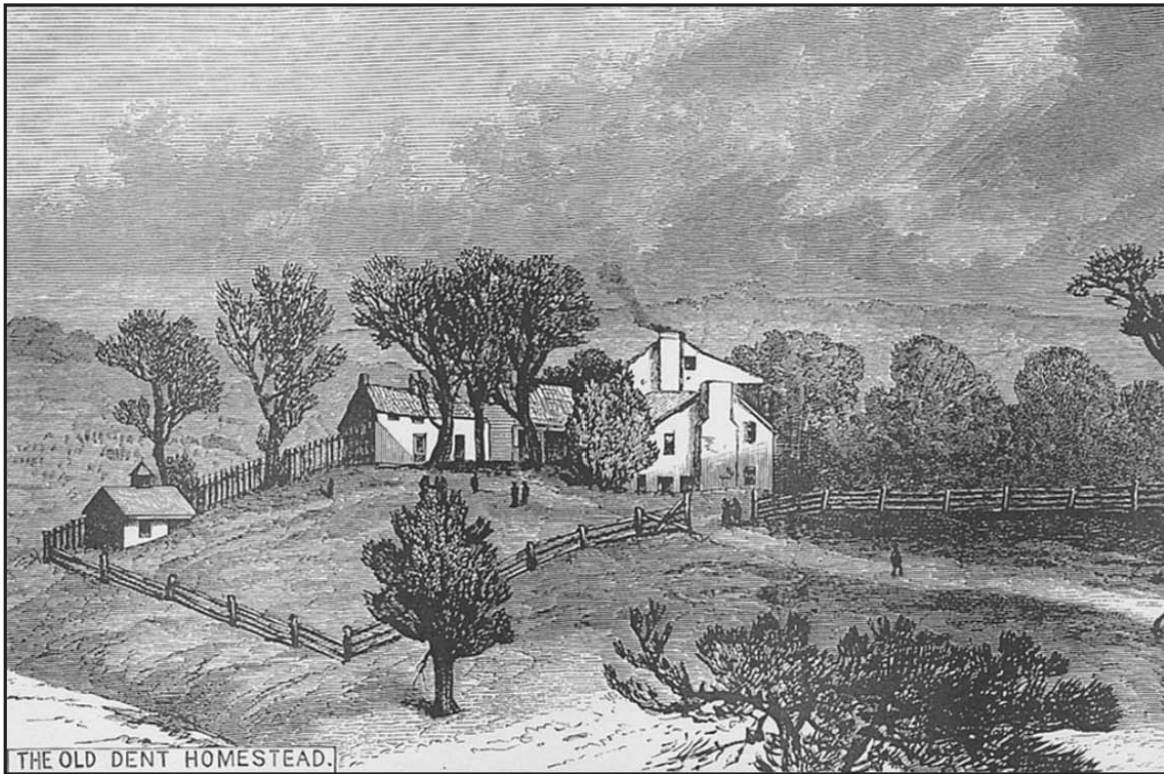
Figure 1. A nineteenth-century illustration of the Dent farmstead showing the Main House, the Summer Kitchen, and the Ice House.

Known by the name White Haven, and more recently as the Dent–Grant home, Ulysses S. Grant National Historic Site (ULSG) was once part of the property of Frederick Dent, father-in-law to Ulysses S. Grant. The Dent farmstead (Figure 1) was a large property encompassing hundreds of acres at its zenith, now about 9.5 ac (3.8 ha). White Haven, which includes the Main House (HS-1) and several associated outbuildings, has undergone a long-term process of architectural documentation and building restoration that has included several archeological investigations.

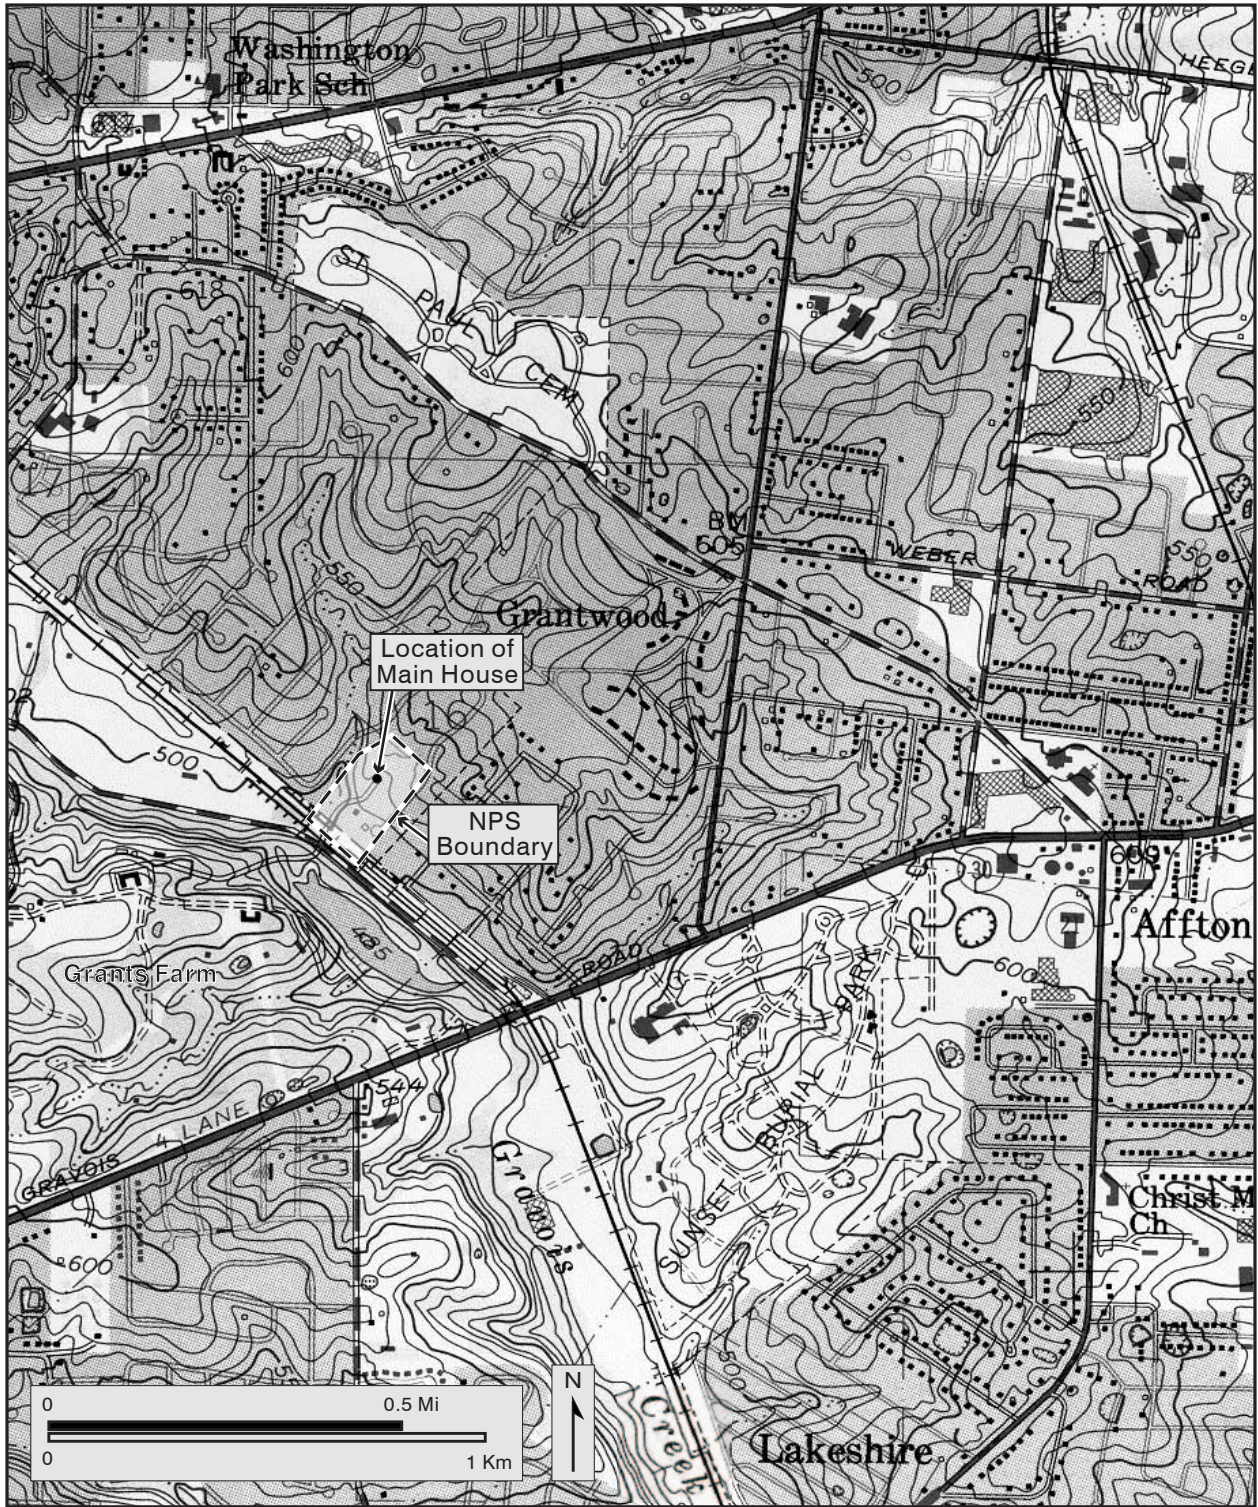
Figure 3. Ulysses S. Grant NHS depicted on the 1979 USGS 7.5-minute Webster Grove quadrangle map.

White Haven is located in St. Louis, Missouri (Figure 2), in part of Section 16, Township 44N, Range 6E, as well as all of Survey 9 (Figure 3). The latter tract is retained from early Spanish claims platted in the area and does not conform to the township and range system established by the Northwest Ordinance of 1796. As depicted on the 1979 USGS 7.5-minute Webster Groves quadrangle map, UTM coordinates for the property are Northing 4270020 to 4270200, Easting 730800 to 730660 (Zone 15). The site covers approximately 9.5 ac (3.8 ha). White Haven is referred to as “Grant’s Home” in the files of the Archaeological Survey of Missouri, which assigned it site number 23SL765. The site was mistakenly assigned a second site number (23SL857) in 1992. The preferred designation is 23SL765/857 to denote the two site number assignments.

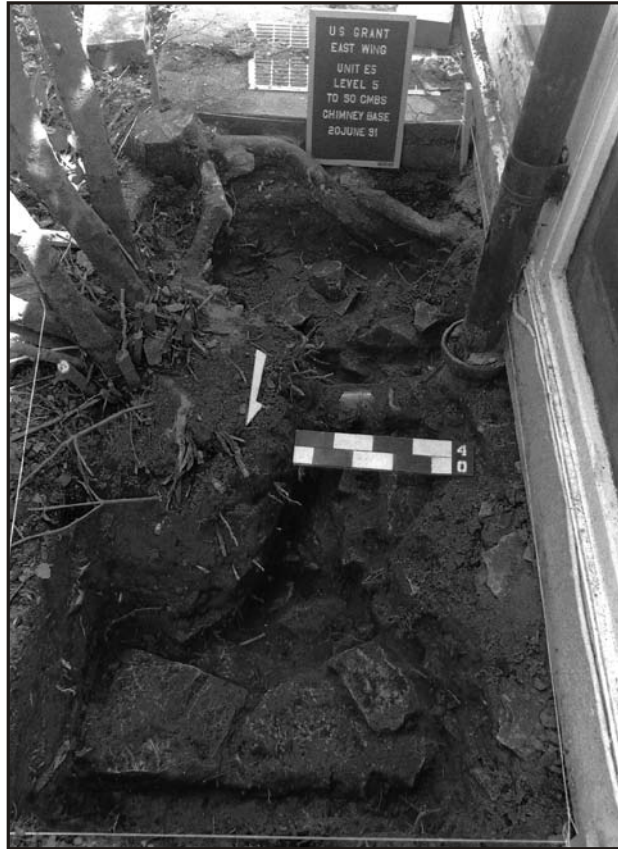
Figure 6. Excavations of the east chimney of the Main House (HS-1) in 1991.

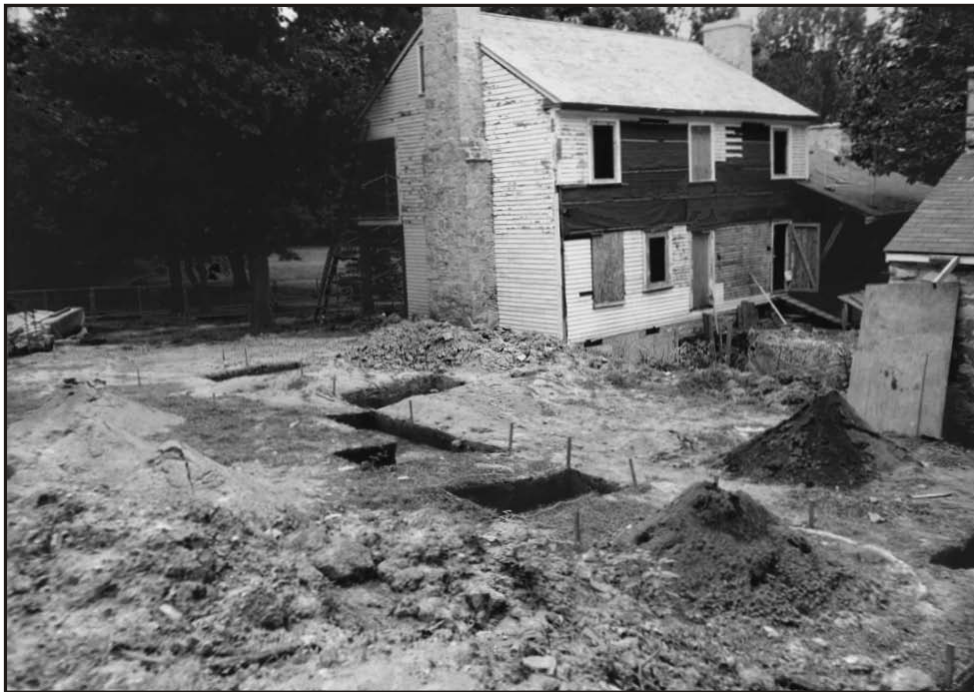
Figure 7. The Hunt Addition was investigated in 1995.

Excavations in the Hunt Addition area between the Summer Kitchen and the north side of the Main House (Figures 5 and 7) revealed the foundation trench and foundation stones of the addition, originally built between 1818 and 1820, and a limestone walkway leading from the Summer Kitchen to the rear of the Main House (Price and Hastings 1998:6). During excavation in this area, it was determined that only a few stones from the bottom of the foundation for the Hunt Addition were still in place and that they had been laid without any mortar. Price hypothesizes that most of the Hunt Addition foundation stones were removed when the structure was razed. A builder's trench with parallel walls approximately 48 cm across was uncovered at the base of the foundation. The limestone walkway, although disturbed, was determined to have originally measured approximately 1 m wide and was constructed of thin slabs. Associated with this walkway was a curbing of limestone slabs set in the original ground surface on their vertical edges and protruding to a height of approximately 10 cm above the top surface of the walkway. Price interprets this arrangement as a small checkdam to retard water flow and erosion between the Hunt Addition and the Summer Kitchen.

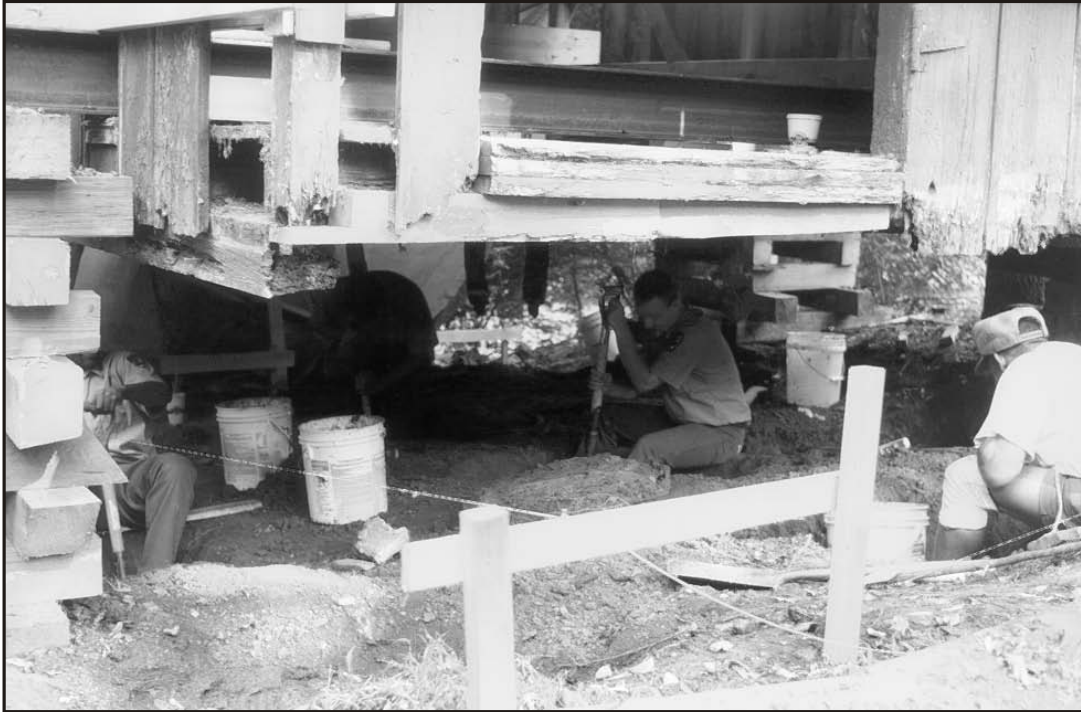
Figure 9. Excavation of the area under the Chicken House (HS-5) took place in 1998.

Most of the Chicken House pier holes yielded no unusual artifacts. Those uncovered were of the same type as those excavated in July 1997 in test units 3 m to the east of the Chicken House. They were primarily small fragments and date to the nineteenth century. Various ceramic sherds were excavated including transfer-printed whiteware, Chinese Export Porcelain, and ironstone. In addition, numerous metal artifacts were uncovered including cut nails, an axe head, and an iron. Flat glass fragments and a variety of bottle glass fragments were found.

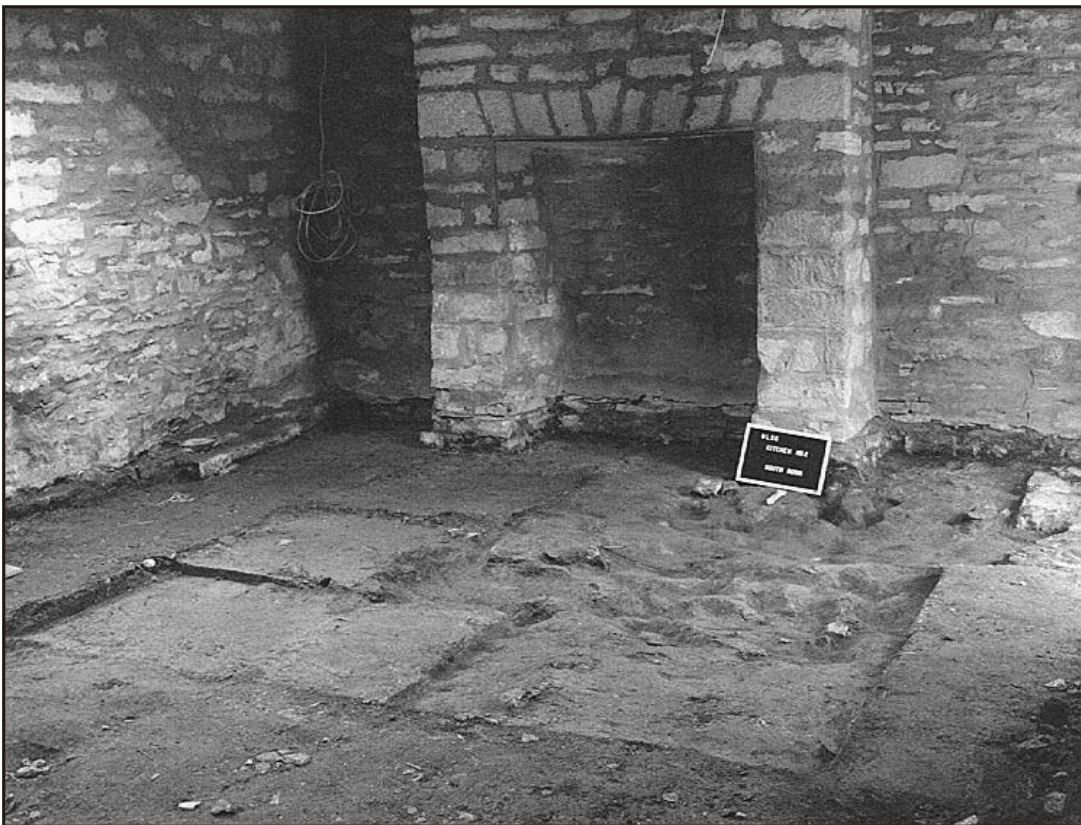
Figure 10. During 1999 the Summer Kitchen (HS-2) was excavated in preparation for its restoration; some of the excavation units and the large fireplace in the kitchen's south room are shown.

The other architectural detail observed was a remnant of building's original west wall foundation. This segment was found at the southwest corner. The remaining stones were dressed and laid. The remaining section is about 24 inches (60 cm) wide. Two other features were noted in the building. One is the remains of a line of glazing compound (Feature 2) that suggests a window fell or was stored in this location at sometime in the past. The other feature is a fire-reddened and baked pit in the floor of the south room (Feature 1). Its age and function could not be determined.

The large number of artifacts found in the Summer Kitchen tended to cluster in the western portion of the building and in the southwestern area in particular. There was less fill over the eastern and northern portion of the floor, and deeper deposits in the south and west areas. The western portion also had extensive evidence of rodent disturbance, which might account for the concentration of artifacts in those areas.

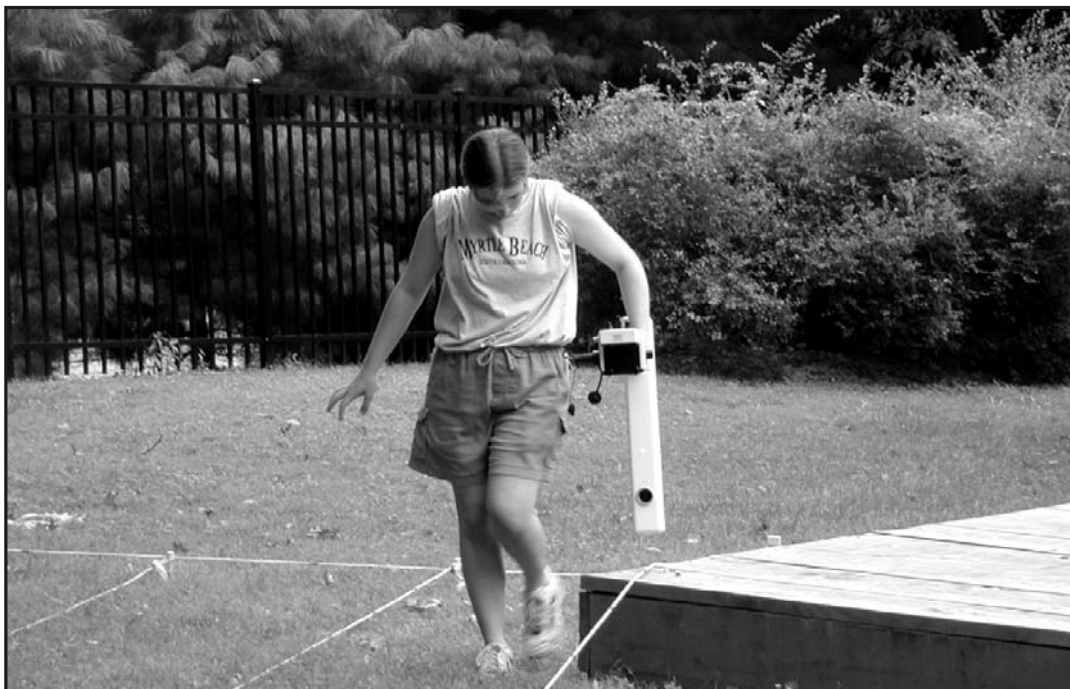
Figure 11. Geophysical remote sensing work with a fluxgate gradiometer was undertaken in 2000 as part of project planning work to relocate the 1868 barn out of the floodplain.

The geophysical and archeological investigation of the proposed Grant Barn relocation area revealed structural foundations probably associated with the ca.-1818 cow barn. Geophysical survey within six grids located several anomalies. These all proved to be of recent origin (water and electric lines), with one possible exception, a linear anomaly in Grids 1, 2, and 5. This linear anomaly could not be located or defined with archeological testing. It might be a runoff area that has a higher magnetic susceptibility than surrounding soils, or it might be a zone of compacted earth outlining an old path or roadway leading to the original Grant Barn site.

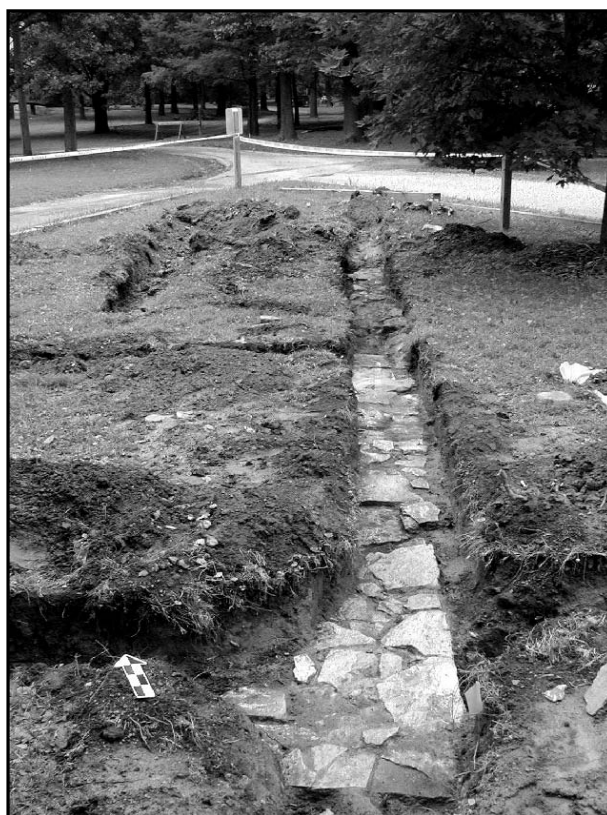
Figure 12. One feature found during the 2000 shovel testing and further extensively tested is a massive stone foundation that is probably associated with an 1818-era barn.

The substantial limestone foundation located in Grid 1 is likely associated with the 1818-era cow barn. The two wall segments are relatively intact and quite substantial, but at least one course of stone is gone from the foundation and its integrity is compromised by the fact the remaining wall segments are not complete in either height or length. Backhoe trenching in the interior area found no intact floors or early-nineteenth-century deposits. The earth in the interior appears to be imported fill used to level the area for construction of the nearby Cottage garage and driveway. Four limestone footings or piers were located south of the foundation and probably represent footings for sills associated with sheds that were once attached to the cow barn. Other than cut nails, no artifacts dating to the early nineteenth century were found in association with the limestone footings or piers.

The cow barn's west wall segment was severely impacted by a pit or trench cut through it during the early twentieth century. Some foundation elements may yet remain intact under the Cottage garage. With the exception of a few cut nails, the majority of artifacts recovered during the shovel testing and backhoe operations were late nineteenth to twentieth century in date. No materials were found dating to the Dent or Grant occupations exclusive of the architectural features themselves.

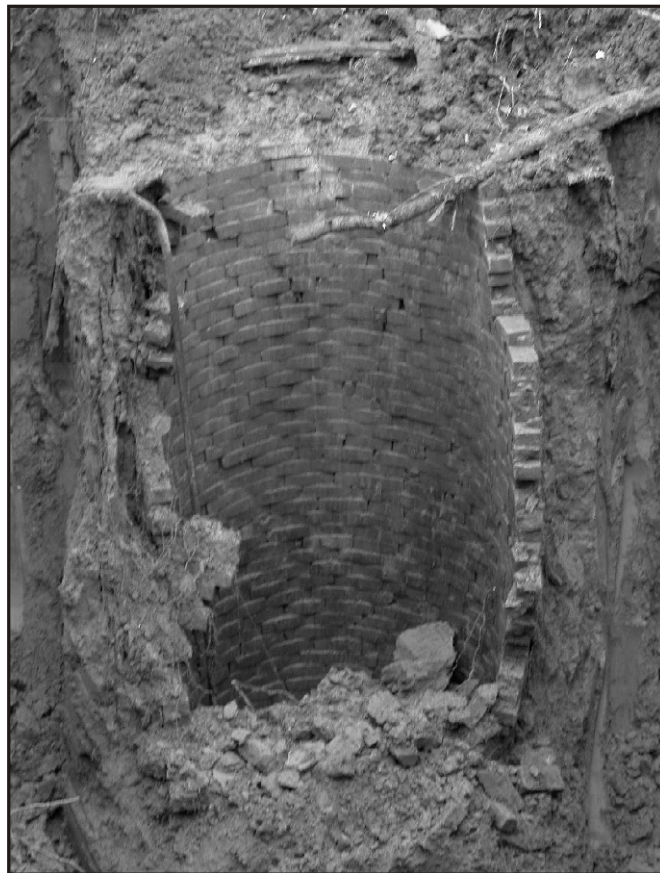
Figure 14. The shaft and the lining of the Barn Well in profile after the collapse of the west wall. Vertical scale is approximately 14 feet from ground surface to the base of the well; view is to the east.

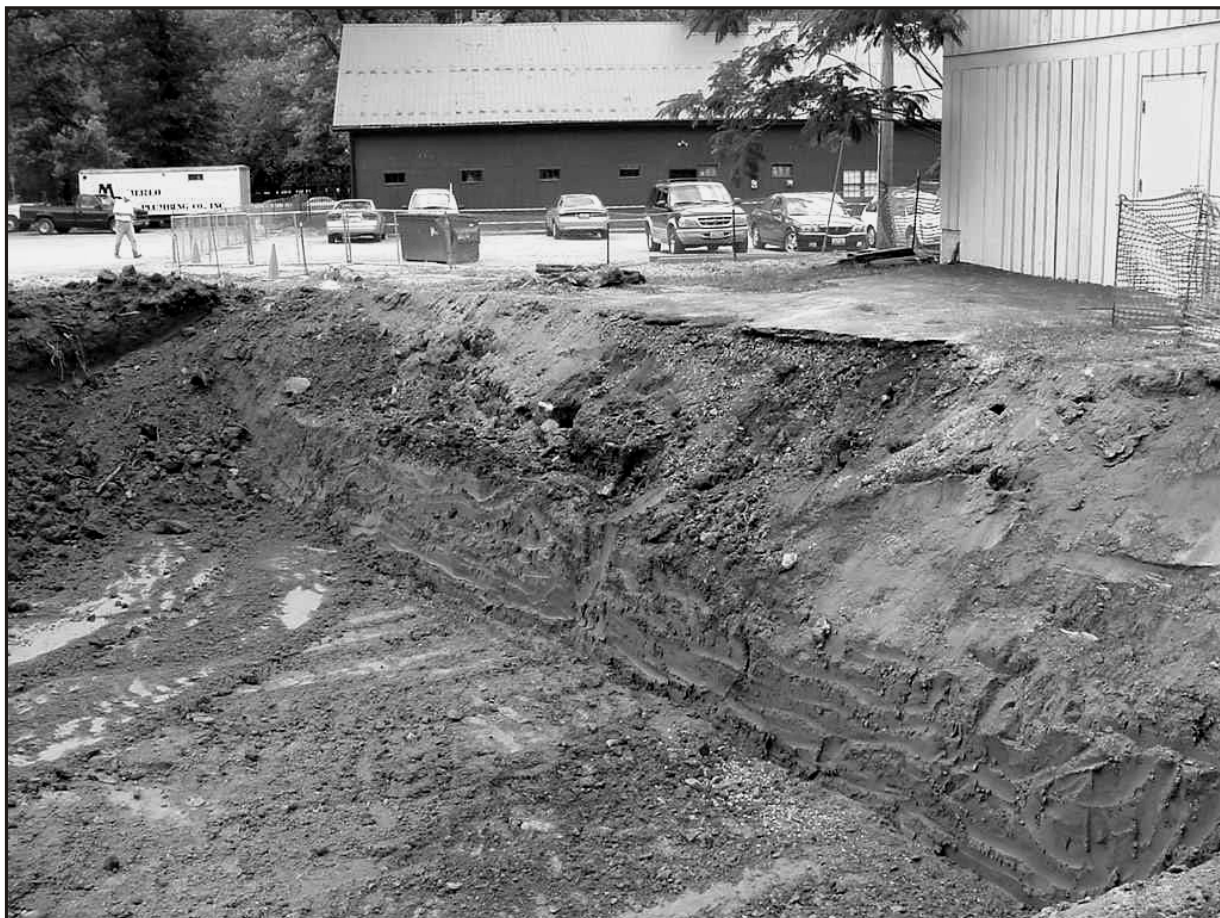
Figure 15. Rectangular mid-twentieth century pit feature located during new visitor center basement excavations grid south of the cottage. The feature destroyed much of the 1818 barn foundation when it was dug to dispose of demolition debris after the fire that destroyed the upper floor of the cottage during World War II.
