Performance Assessment and Validation of Piezoelectric Active-Sensors in Structural Health Monitoring

Gyuhae Park*, Charles R. Farrar*, Francesco Lanza di Scalea**, Stefano Coccia**

ABSTRACT

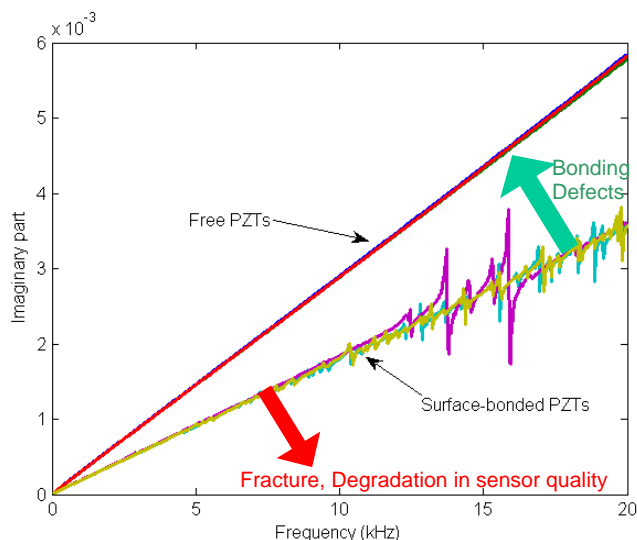
Figure 1 illustrates the measured admittance of free and surface bonded PZT patches. The 5A PZT materials with dimensions of 20 x 20 x 0.25 mm are used. The admittances of three free PZT patches were measured in the frequency range of 40-20,000 Hz using an Agilent 4294A impedance analyzer. These PZT patches were then surface-mounted to a thick aluminum beam and plate using a super-glue

Figure 1: Electrical Admittance Measurement from PZT patches under free and surface-bonded conditions

As can be seen in Figure 1, the downward shifting effect of the bonding layer is remarkable. The slope of the imaginary part, which is the capacitive value of the PZT material, was changed from 29.1 nF to 18 nF, resulting in a 38 % reduction. The slopes of the admittance (capacitances) measured from three bonded PZT patches are about the same, confirming that the bonding conditions of three PZT sensors are approximately identical. In addition, the figure demonstrates that bonding defects would also affect the measured admittance and can be identified by monitoring the slope of the admittance. Contrary to the sensor breakage, bonding defects would cause an upward shift in the slope of the imaginary part of the electrical admittance. Therefore, the sensor functionality including the sensor breakage and the degradation of the bonding condition can be assessed by monitoring the imaginary part of the admittances (capacitance) of the piezoelectric materials. Figure 1 also graphically describes the effects of sensor failures, both the sensor fracture and the bonding defects, on the measured electrical admittance.

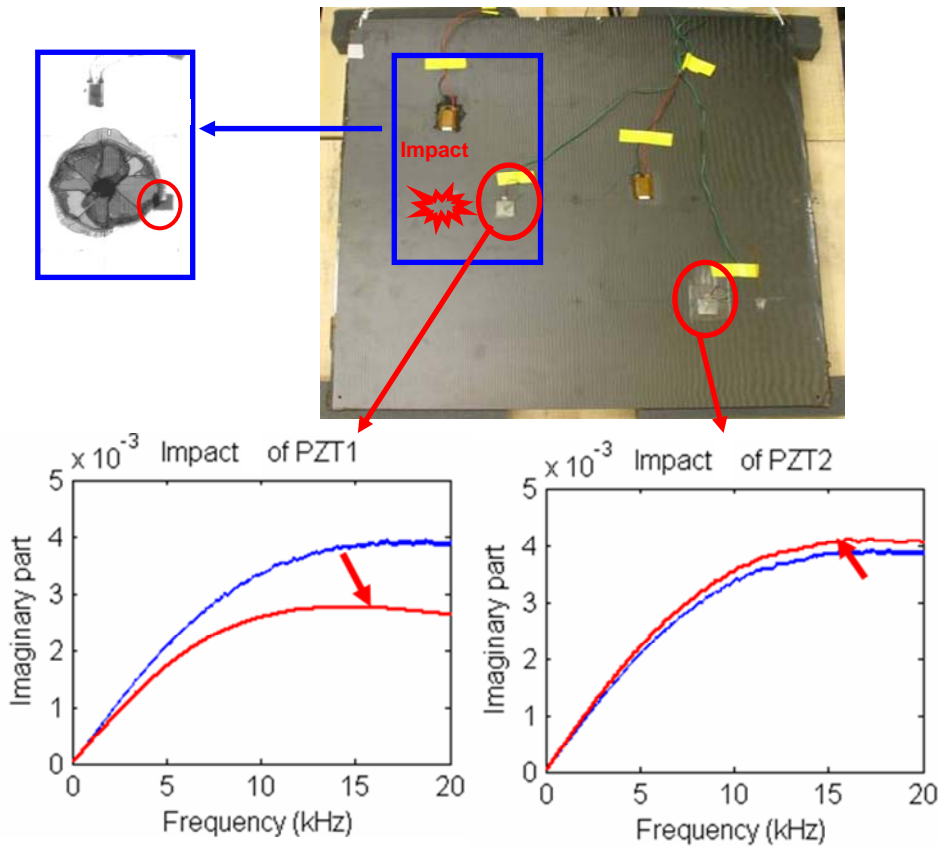
The test structure is shown in Figure 2. The dimension of the quasi-isotropic composite plate is 609 x 609 x 6.35 mm. The lay-up contains 48 plies stacked according to the sequence [6(0/45/-45/90)]_s using 60% Toray T300 graphite fibers in a 934 Epoxy matrix. Two pairs of piezoelectric (5A) and Macro-Fiber Composite (MFC) patches are mounted on one surface of the plate, as shown in Figure 2. The sizes of the PZT and MFC patches are 25.4 x 25.4 x 0.254 mm and 25.4 x 12.7 x 0.254 mm, respectively. The MFC patches are a relatively new type of piezoelectric sensors that are more flexible than the conventional PZT transducer (Wilkie et al 2000). The Young's Modulus of a flexible MFC is 15 GPa, only a fifth of traditional piezoceramic materials (5A, 66 GPa). The MFCs are expected to be less affected by the shear lag loss or bonding defects than traditional PZT transducers because of the lower value in γ_p^E , as described in the previous section.

Figure 2: The composite plate used for the test. The Impact causes the downward shift of PZT 1 and the upward shift of PZT 2 in the imaginary component admittance measurements.

The impact produced considerable changes in response of PZT 1, causing a 20% downward shift in the slope, which indicates an internal fracture occurred within the sensor by the proposed procedure. Using an ultrasonic C-scan method, the structural delamination induced by this impact was identified, as shown in the left side of Figure 2. The increasingly dark region shows delamination between different plies, with the darkest area near the surface of the impact zone. This structural delamination was located partially under the PZT 1 (shown in the circle), and it is believed that this delamination caused a partial sensor breakage. For the PZT 2, the impact caused a slight upward shift of the measured admittance slope and this shift could be considered as an indication of de-bonding. Therefore, with the proposed sensor diagnostic method, it can be concluded that the impact causes the internal fracture of the PZT 1 and de-bonding of the PZT 2.

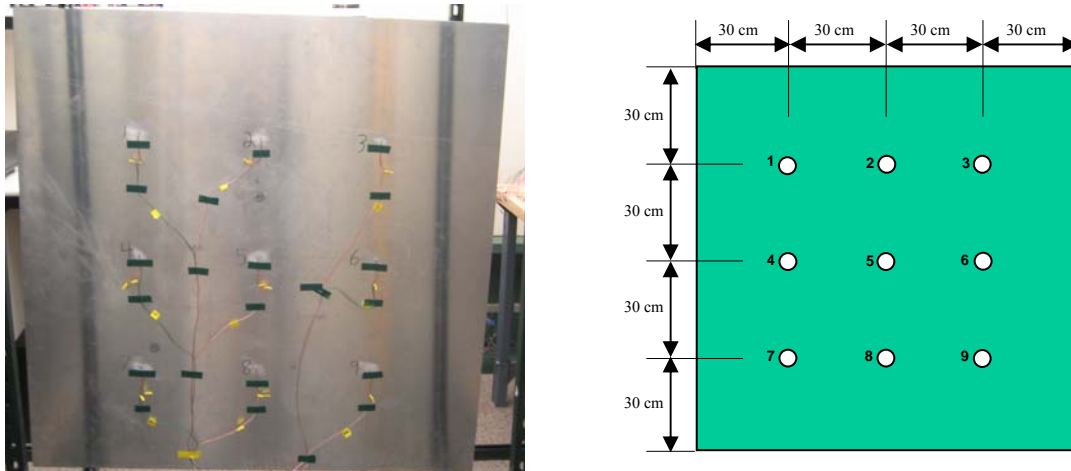
The test structure, shown in Figure 3, is an aluminum plate (1200 x 1200 x 2 mm). Nine circular piezoelectric patches are mounted using super-glue on one surface with a 3 x 3 array of the equal distance. The locations and the numbering schemes of these actuators/sensors are also shown in Figure 3.

Figure 3. An aluminum plate with PZT transducers attached

The size of the circular PZT patch is 5.5 mm diameter with 0.2 mm thickness. Admittance measurements in the frequency range of 1-20 kHz were made to each PZT patch before and after the installation using an Agilent 4294A impedance analyzer.

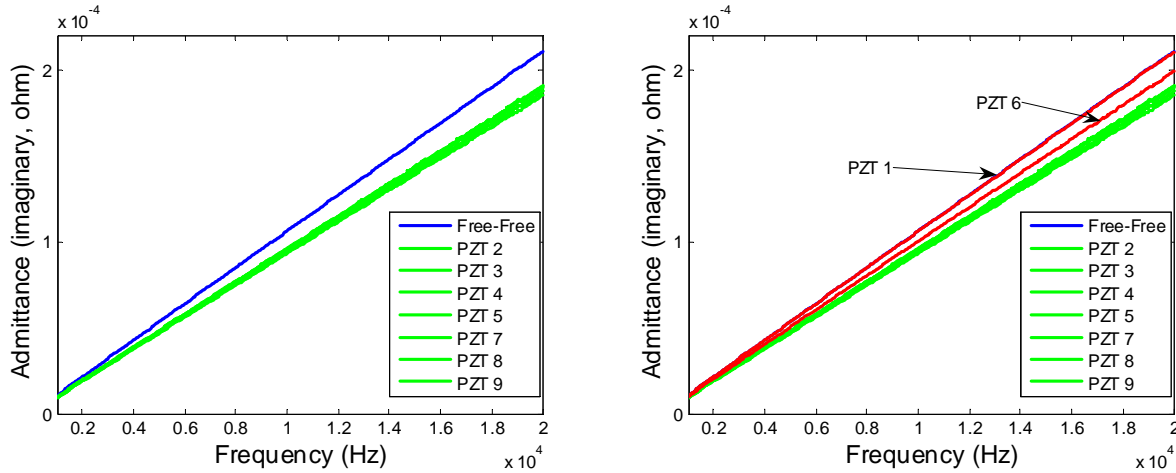
The admittance measurements of PZT transducers before and after the installation are shown in Figure 4 (a). For most PZT patches, the downward shifting effect caused by bonding is clearly observable. The slope of the imaginary part, analogous to the capacitive value of the PZT wafer, results in a 4.5 % reduction. However, for the PZT 1, virtually no change in the slope of the imaginary part of admittance was observed, as shown in the Figure 4 (b). Further, for the PZT 6, only 2% change in the slope was observed. As described earlier, the small or almost no change in the slope could be an indication of the imperfect bonding condition. Therefore, these two sensors are classified as a faulty sensor by the sensor diagnostic method. This poor bonding will be very problematic because it can be easily degraded during the operation.

(a) PZT patches under free-free and healthy conditions (b) PZT patches under healthy and faulty conditions
 Figure 4. Admittance measurements (imaginary part) from PZT transducers

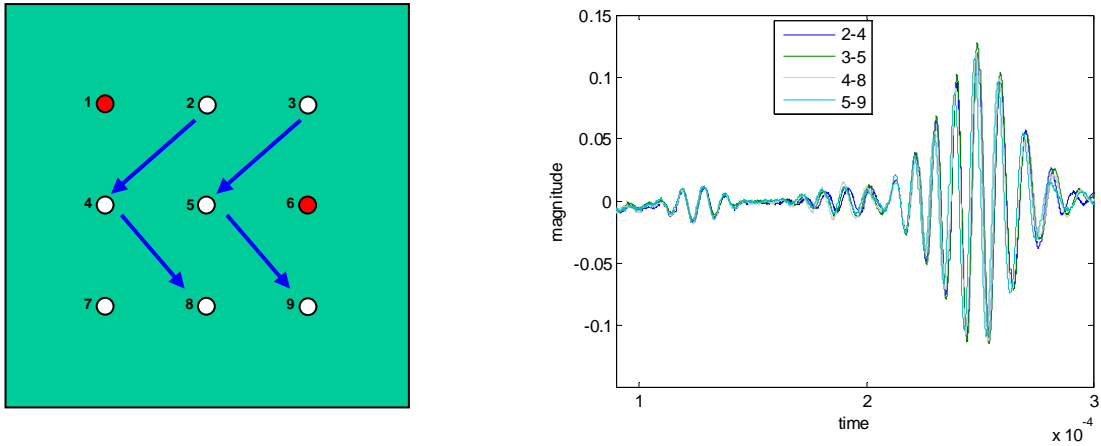
The effect of bonding defects on the Lamb wave propagation was also investigated. First, the wave propagations (at 100 kHz) from the paths consisting of sensors with the good bonding condition were measured (between PZT 2 and 3, PZT 3 and 5, PZT 4 and 8, and PZT 5 and 9), shown in the figure 5. Because the paths are in the equal distance and through the same materials, the propagated waves show the same characteristics. The arrival of the first So and Ao mode is obvious and they also show the approximately same magnitude. Figure 6 shows the overlapping of the wave propagation in the path between PZT 1 and 5 along the measurement with the healthy paths. PZT 1 was identified as a faulty sensor by the sensor diagnostic process. As one can clearly see, there is a remarkable change in the measured response. There is a clear change in the magnitude, and further, the change in the arrival time can also be clearly observed. It is speculated that, with the bonding defects, there might be a delay in PZT excitation, phase distortion, or the PZT transducer may not be able to efficiently excite the input frequency. Currently, we are investigating these issues for better understanding of the bonding defects. It should be noted that the effects of bonding defects are very similar to those caused by structural damage. If signal processing methods based on the wave attenuation or the time-of-flight information are to be used, and the bonding defect occurs during the operation, these changes can be mistakenly considered as structural damage. Another experimental result, providing the effects of faulty sensors in the path

Figure 5. Lamb wave propagations between healthy sensors

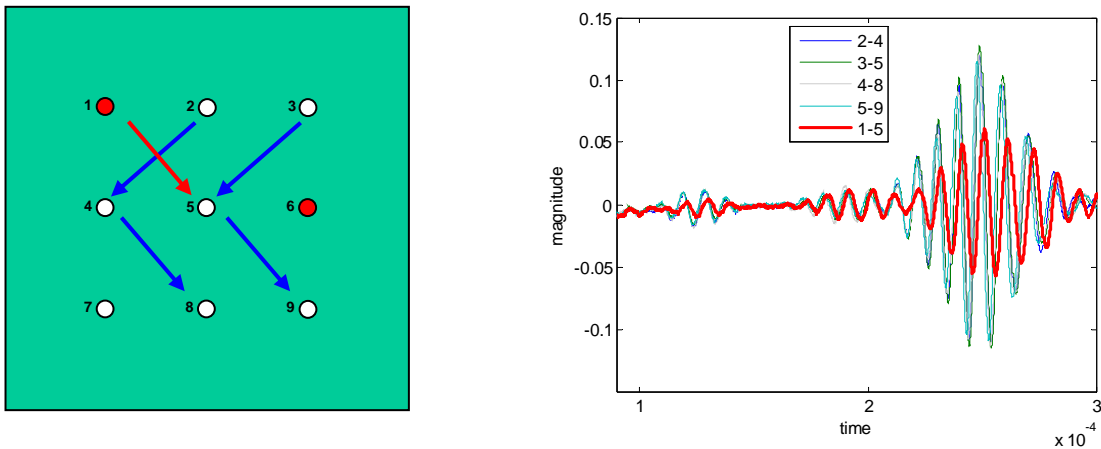
Figure 6. Lamb wave propagations between healthy sensors and faulty sensors

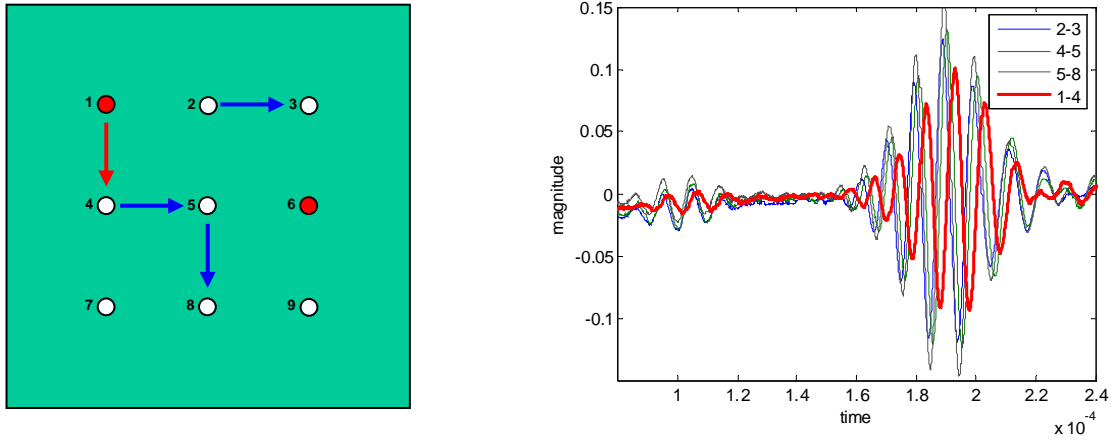
between PZT 1 and 4, are illustrated in Figure 7, along with the Lamb wave propagations of the paths with healthy sensors, including the response between PZT 2 and 3, PZT 4 and 5, and PZT 5 and 8. The same phenomena can be observed and similar conclusions can be drawn from the Figure.

Figure 7. Lamb wave propagations between healthy sensors and faulty sensors

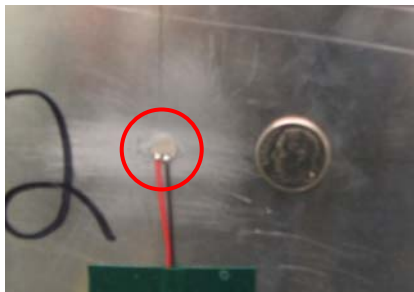
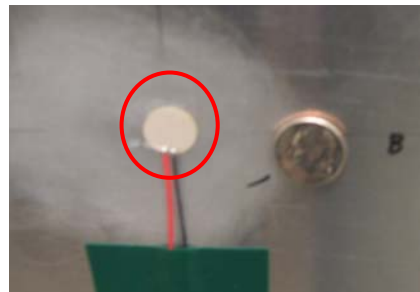
(a) 5.5 mm diameter with 0.2 mm thickness

(b) 11 mm diameter with 0.4 mm thickness

Figure 8. The piezoelectric Sensors used in the testing

Our next experiment includes the use of larger PZT transducers on the same structure. In the new test, the circular PZT patches of 11 mm diameter with 0.4 mm thickness were super-glued on the same aluminum plate with the same orientation. The piezoelectric transducers that were used in the previous and the new test are shown in Figure 8. For the installation status check, admittance measurements in the frequency range of 1-20 kHz were made to each PZT patch before and after the installation using an Agilent 4294A impedance analyzer.

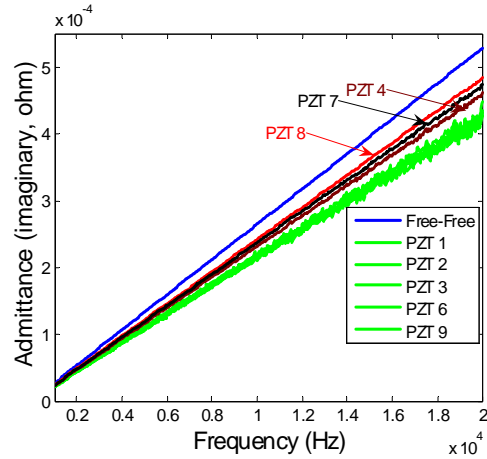
The admittance measurements of the larger PZT transducers are shown in Figure 9. In this experiment, three PZT patches (PZT 4, 7, 8) were classified as faulty sensors because they did not show the expected decrease in the slope compared to other transducers. The well bonded PZT patches showed at least 9%

Figure 9. Admittance measurements (imaginary part) from PZT transducers

decrease in the slope. The effects of bonding defects are expected to be more significant compared to the previous experiment because the influences of the bonding layer become more significant as the size of the sensor increases (Sirohi and Chopra, 2000, Bhalla and Soh 2004).

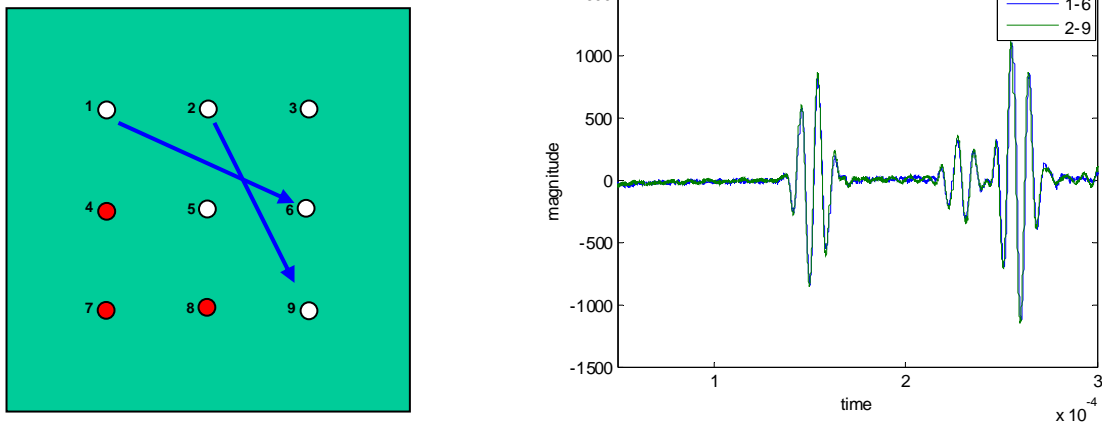
Figure 10. Lamb wave propagations between healthy sensors

The effects of bonding defects on these transducers were also investigated. The wave propagations (at 100 kHz) from the paths with the sensors in the good bonding condition were first measured (between PZT 2 and 9, and PZT 1 and 6), then the measurement of the path with a faulty sensor (between PZT 6 and 7) were compared, as shown in the Figures 10 and 11. As expected, the bonding defects induce much more significant impacts compared to the previous test. As can be seen in the Figures, the bonding defects cause the changes in the shape of the propagated wave, rather than merely causing the decrease in the magnitude. The modification in the arrival time was also clearly observed. One obvious reason would be that the faulty bonding condition would make the excitation of PZT actuators no longer linear; the wave may travel with different magnitude or phase in the different directions. The same would be true for the sensing mechanism. Furthermore, because of the faulty bonding condition, a portion of a PZT transducer might not be directly bonded on the surface of the structure; the results would be the multiple excitations from a single piezoelectric source. The propagated waves from these multiple sources would be overlapped, distorting the shape of the propagated waves. Again, these issues are currently being investigated for better understanding of the effects of a bonding layer on Lamb wave propagations. Another result is shown in the figures 12 and 13. The responses from the paths with good sensors (between PZT 1 and 2, PZT 2 and 3, PZT 3 and 6, and PZT 6 and 9) are compared to that of the path with faulty sensors (between PZT 7 and 8). There is a significant distortion in the measured signals as shown in the figures. It could be concluded that the bonding defects do not merely cause the decrease in magnitude. The effect could be the complete distortion of the measured

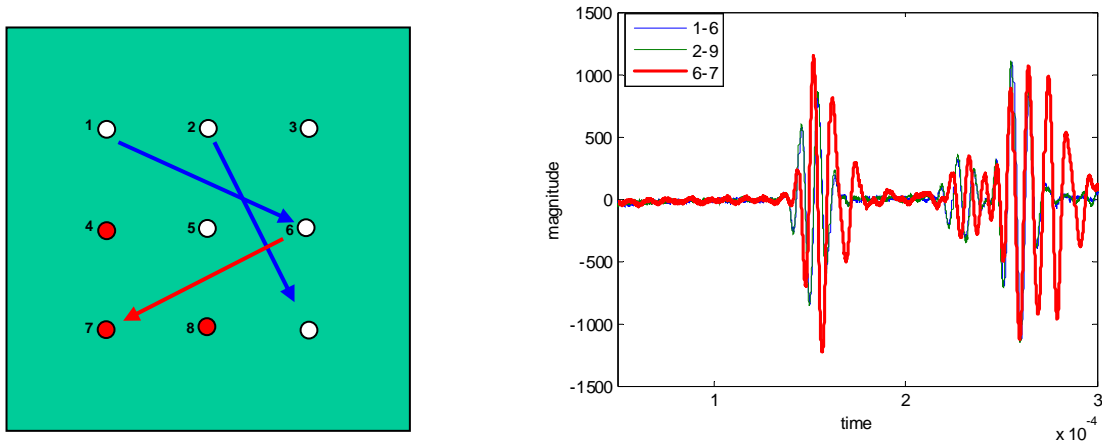
Figure 11. Lamb wave propagations between healthy sensors and faulty sensors

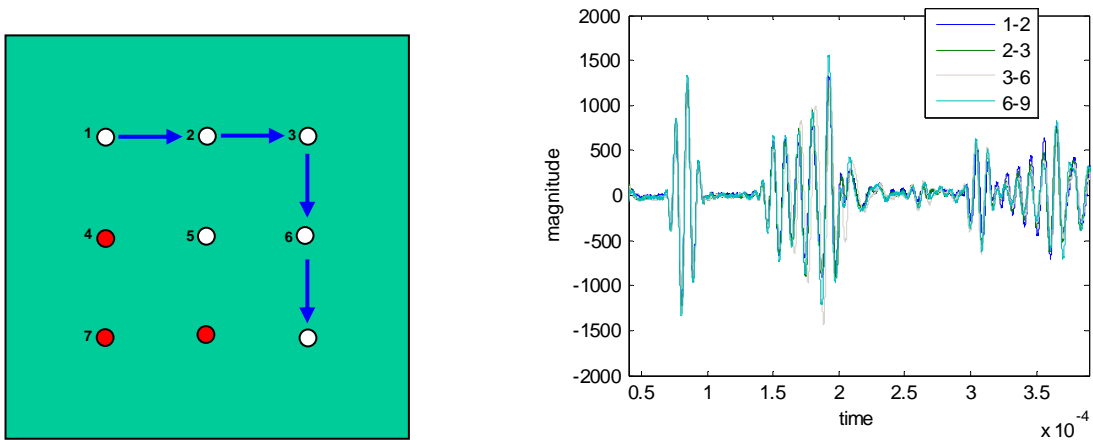
Figure 12. Lamb wave propagations between healthy sensors

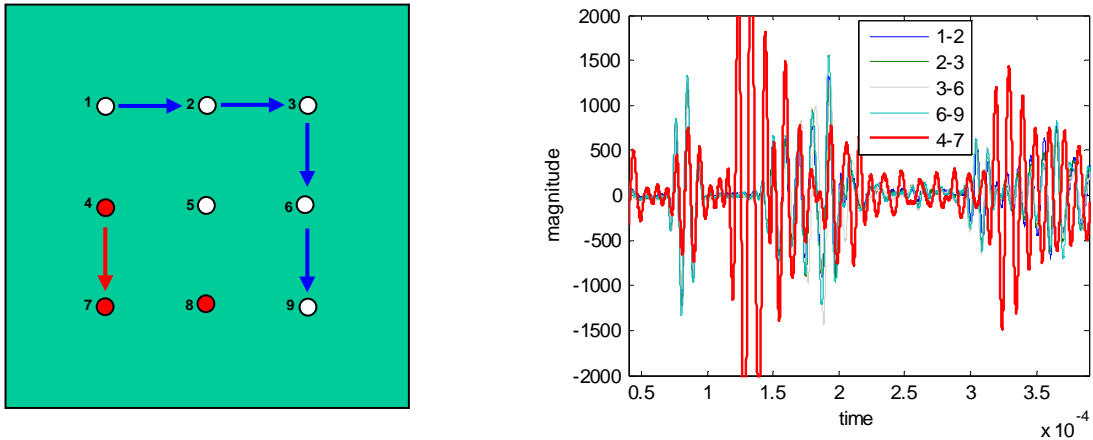
Figure 13. Lamb wave propagations between healthy sensors and faulty sensors

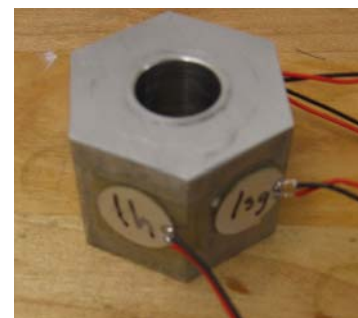
A set of experimental testing was performed with different bonding conditions of the PZT patches. In order to assess the effects of different sensor bonding conditions on measured impedance, an aluminum hexagonal washer (with geometry 25.4 mm high, and 31.75 mm across the flats with a 12.7 mm diameter hole) was instrumented with two circular PZT patches (12.7 mm diameter, 0.2 mm thickness), each on a different face, as shown in figure 14. The patches were attached to the plates using two different bonding techniques to simulate both good and poor bonding conditions. One bonding condition was to use the 3M Thermo Bond film for a temporary (and poor) bonding condition, while the other was to use the superglue for a better bonding condition.

Figure 14. An aluminum washer with two PZT patches installed with different bonding conditions

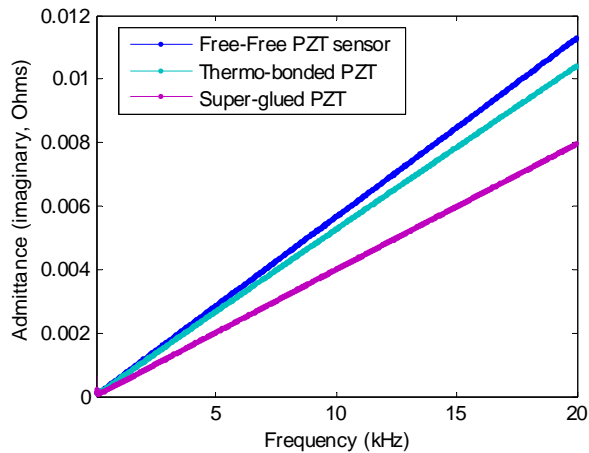
Figure 15 shows the imaginary part of the admittance of each of the sensors bonded to the aluminum hexagonal washer in the frequency range up to 20 kHz. This plot also includes an admittance measurement for an un-bonded 11 mm-diameter PZT patch. The quality of the bond can be determined based on the changes in the slope steepness of the admittance measurement. From Figure 15, one can see that the super-glued sensor demonstrates the lower slope, and therefore can be considered to have a better bonding condition.

Figure 15: Admittance measurements from different bonding conditions from an Aluminum washer.

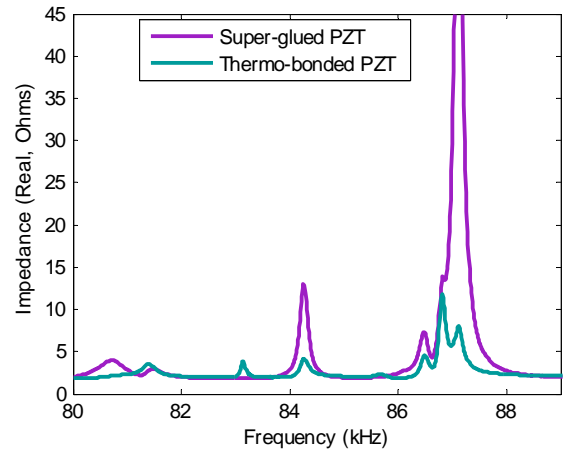
Figure 16: Impedance measurement (real part) under different bonding condition

The impedance measurements (the real part) under the different conditions are shown in the figure 16. It is obvious from the figure that the PZT bonded with the superglue shows the resonances near 84 and 87 kHz much clearer, at least an order of magnitude greater, than the sensor bonded with the thermo film. From the measurements, it once again confirms that the magnitude of the resonance is affected by the bonding conditions. The poor bonding condition may result in erroneous or misleading results as the stress/strain transfer mechanism is modified by the changed electro-mechanical interaction between the structure and PZT patches. Furthermore, near the frequency range at 83 kHz, the PZT active-sensor with the thermo bonded condition exhibits a new resonance of the structure. Therefore, it can be concluded that, as the bonding condition changes, the identified resonances and associated magnitudes are

significantly affected. It is very clear from this figure that the bonding condition significantly influences structural identification and health assessment if not carefully accounted for. Further, it is obvious that, in order to minimize the false indication on the structural condition, the sensor diagnostic process needs to be implemented to discriminate the sensor degradation from structural damage in SHM field applications.
