Mount Everts debris flow and damming of the Gardner River on 21 July 2008  
Yellowstone National Park  
Dianah GrubbWheeler  
Cat Foley

## Mount Everts Debris Flows and Damming of the Gardner River on 21 July 2008

Dianah Grubwheeler and Catherine Foley  
GSA Geocorps Interns  
Geology Program, Yellowstone Center for Resources  
Yellowstone National Park  
September 2008

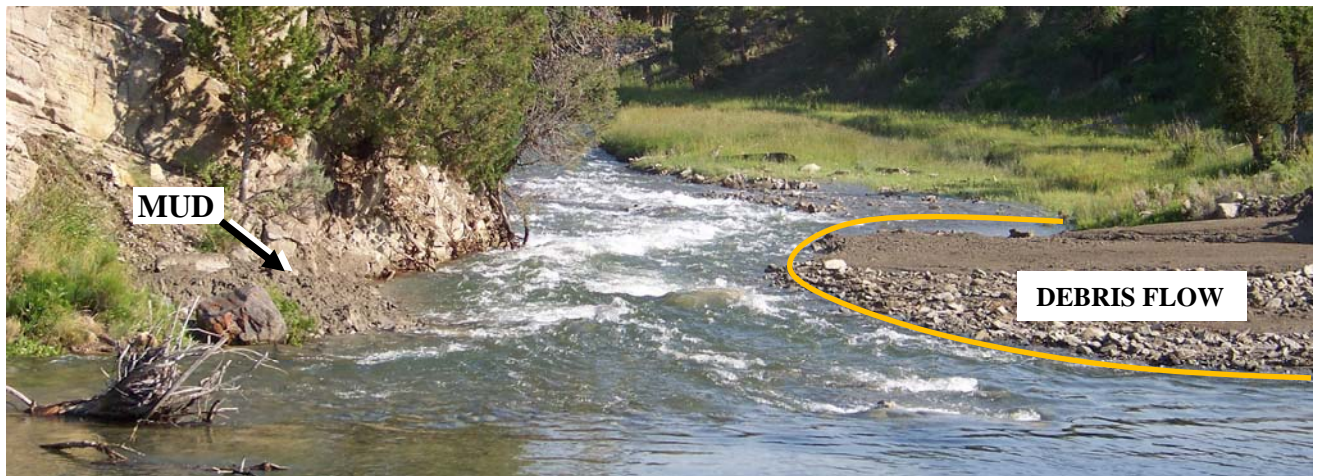
**FIGURE 1:** Photograph of Gardner River flowing through a pinch caused by the 21 July debris flow. This flow was triggered by high precipitation rates in a 15 minute-interval. Notice that the mud reached the opposite bank of the river. This debris flow is suspected to have temporarily dammed the Gardner River. Photograph taken 25 July 2008.

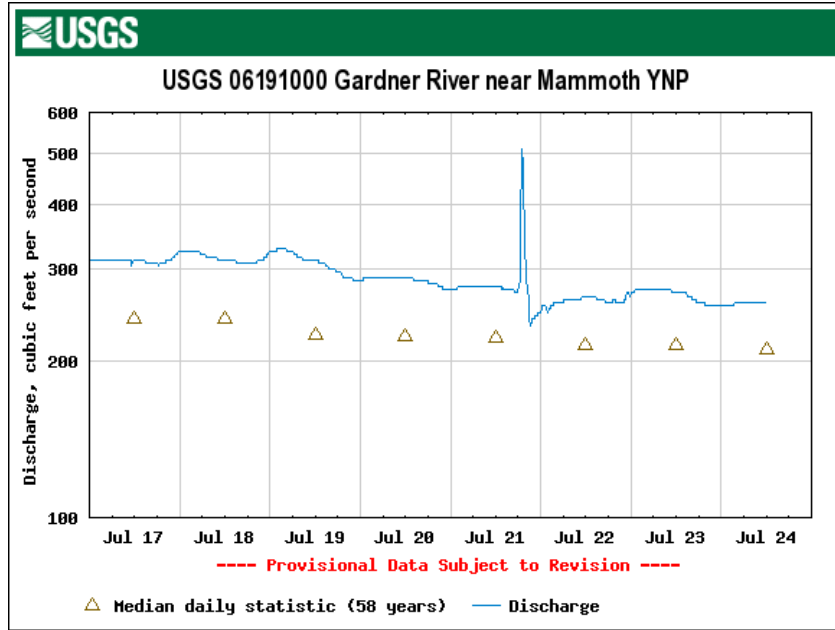
**FIGURE 3:** Graph of discharge data for the Gardner River. Note the rapid rise in discharge associated with the 21 July rain event. After the rapid rise in discharge, there is a decrease in discharge associated with the temporary damming of the Gardner River.

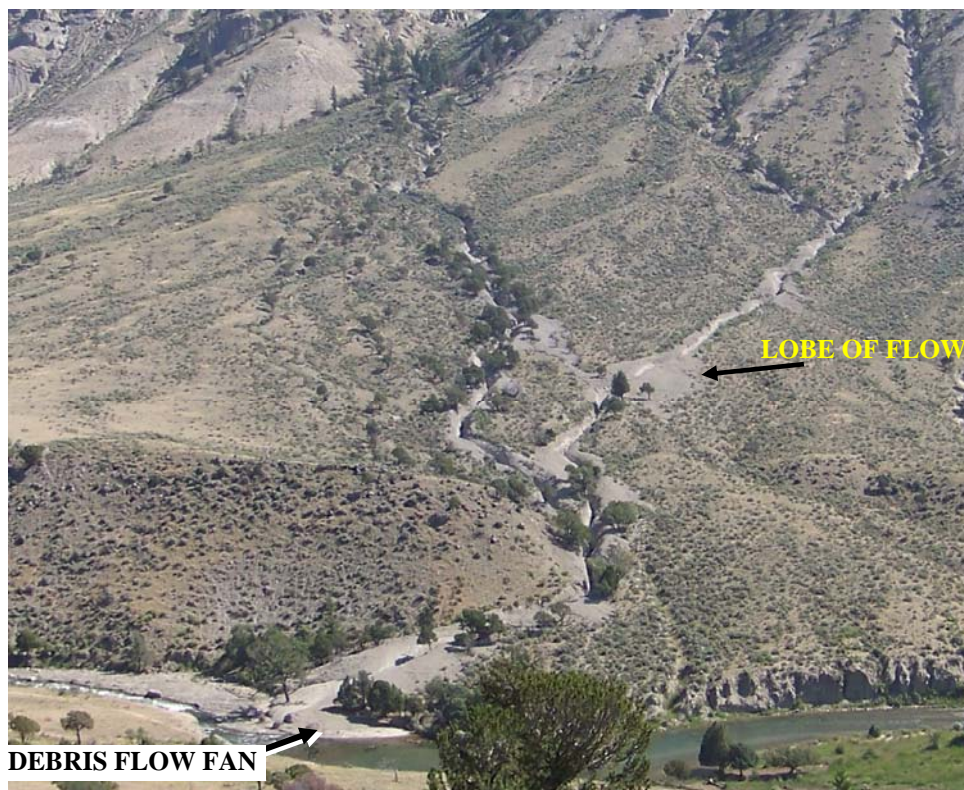
**FIGURE 7:** Photograph of DFA, taken 30 July 2008 facing north. Lighter brown is mud that overtook the levees of the gullies. Larger lobe of mud flowing out over the alluvial fan

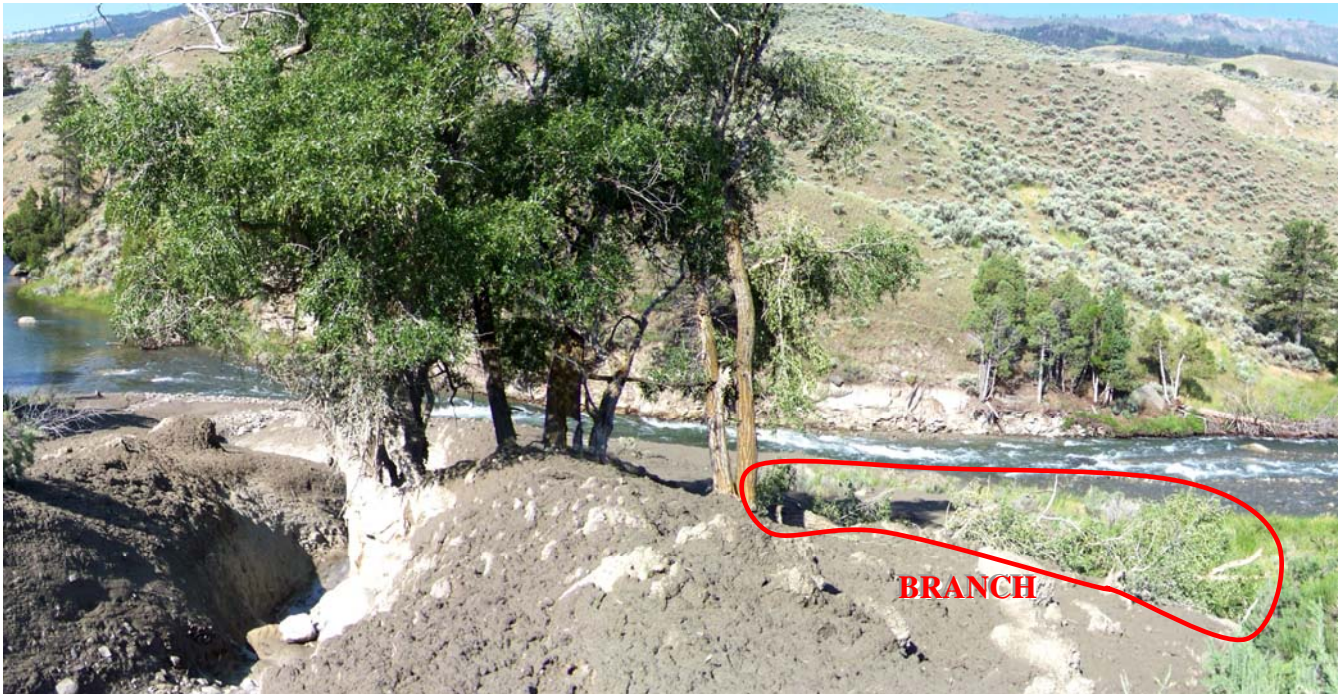
**Figure 8:** Photograph of low hanging branches torn off the trees by 21 July debris flow at DFB. Taken 25 July facing Gardner River, west.

Gullies along Mount Everts transport mud and water triggered by intense precipitation over 1.016cm (0.40in) per 15 minute-interval, these gullies are fed by drainage channels coming from Mount Everts (Figure 14). Figure 15 shows two gullies of DFAs outflow converging into a single gully. Figure 8 shows the same gully further down river just before it empties into the Gardner River. These gullies that transported the debris and mud were extremely variable in depth; however, all the gullies became shallower as they neared the river's edge (Figures 17 and 18). Each of the two debris flows had two contributing gullies which converged about 60m (196.85ft) from the river's edge. In each case the gully further upstream, to the east, was the shallower of the two. DFB had a deep gully of about 7-8m (23-26ft) and a shallow gully of about 0.5-4m (1.64-13ft). The gully that empties into the Gardner River was at its deepest 7-8m (23-26ft) deep. DFA had a 5m (16.4ft) deep gully and a shallower gully of about 2-3m (6.56-9.84ft). The gully that emptied into the Gardner River was at its deepest about 3m (9.84ft). The mud from these gullies flowed across the Gardner River and deposited mud along the river's west bank (Figures 19 and 20). The debris exiting out of this gully (Figure 21) constricted the flow of the Gardner River and caused ponding (Figure 22) of the Gardner River upstream from the Boiling River outflow. DFB also deposited mud on the east bank of the Gardner River and constricted its' flow, momentarily ponding the water (Figure 24). At both locations, the depth of the debris on these banks ranged from approximately 15.24cm to 30.48cm (6-12in).

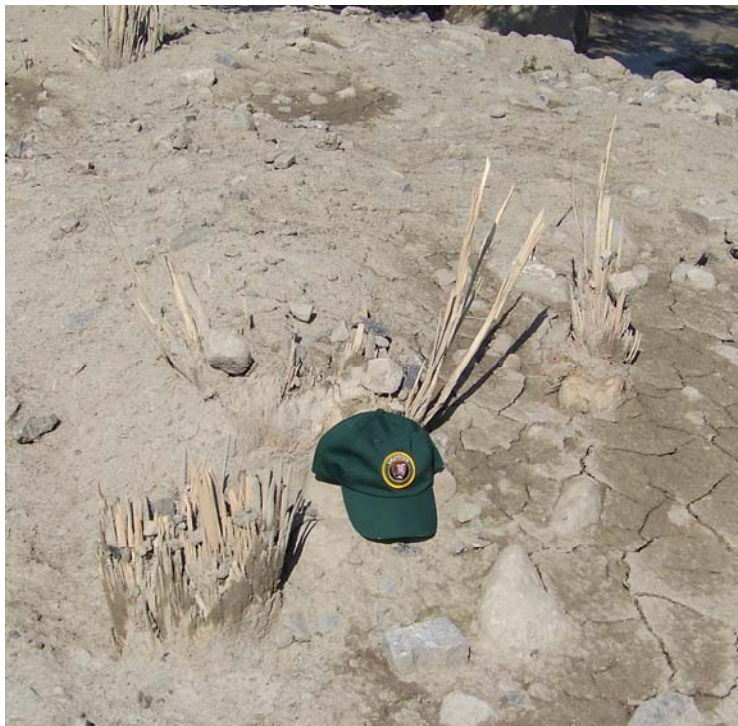
**Figure 9:** Photograph of splintered wood from trees removed by the debris flow at DFA. Taken 25 July facing west, Gardner River in background.

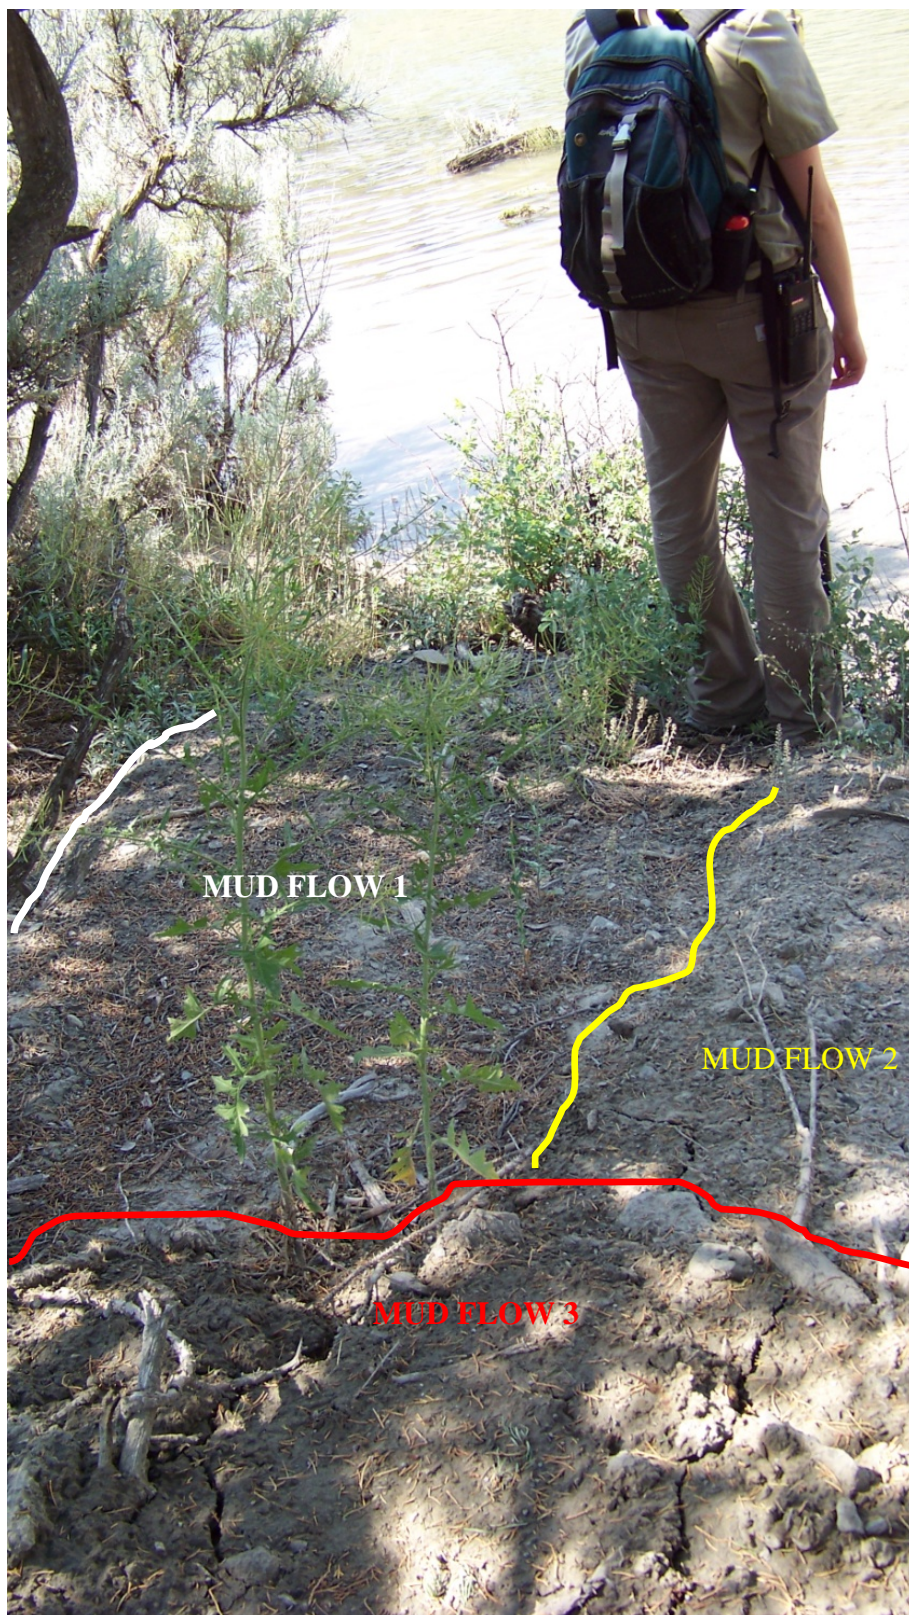
**FIGURE 10:** Photograph at edge of DFA. Note three debris flows, debris flow 3 is the most recent from the 21 July event. This photo shows how the debris flows accumulate overtime. Taken 25 July 2008 facing south west, Gardner River in background.

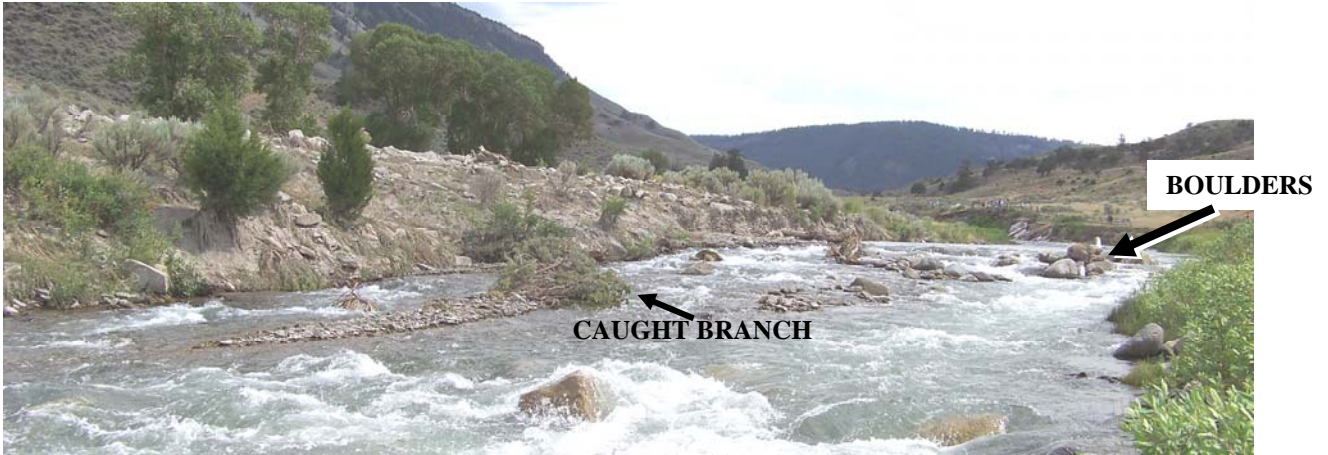
**FIGURE 13:** Photograph of Observed Debris Flow (ODF) downstream from Boiling River swimming area. Note the large boulders in the center of the river and the tree branch caught on the pile of smaller rocks in the river.

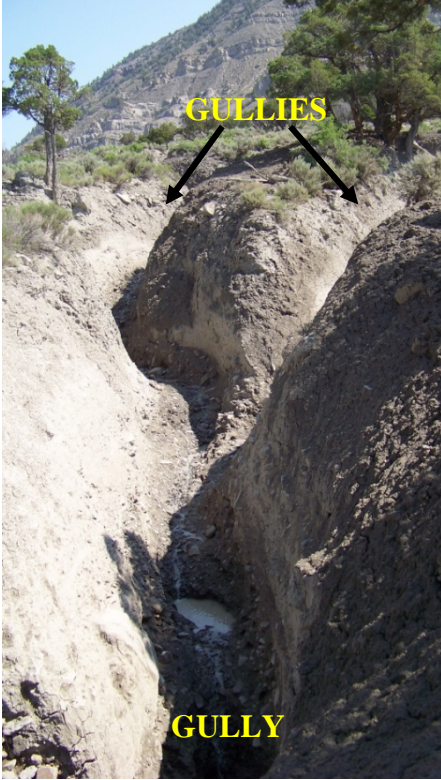
**FIGURE 15:** Photograph of DFA gullies. This is one of the locations where the debris temporarily dammed the Gardner River on 21 July. Photograph taken 25 July 2008 facing north toward Mount Everts.

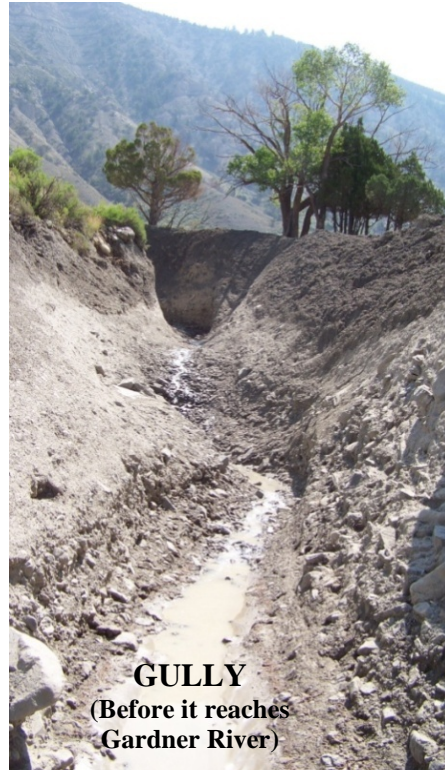
**FIGURE 16:** Photograph of DFA's gully that empties into the Gardner River, nearest Boiling River outflow and the Gardner River, downstream from Figure 7. The 21 July debris flow deposited dark brown mud on both sides of this gully. The dark brown mud is the zone of deposition and the pale brown mud shows the area of erosion. Photograph taken 25 July 2008, facing northeast toward Mount Everts.

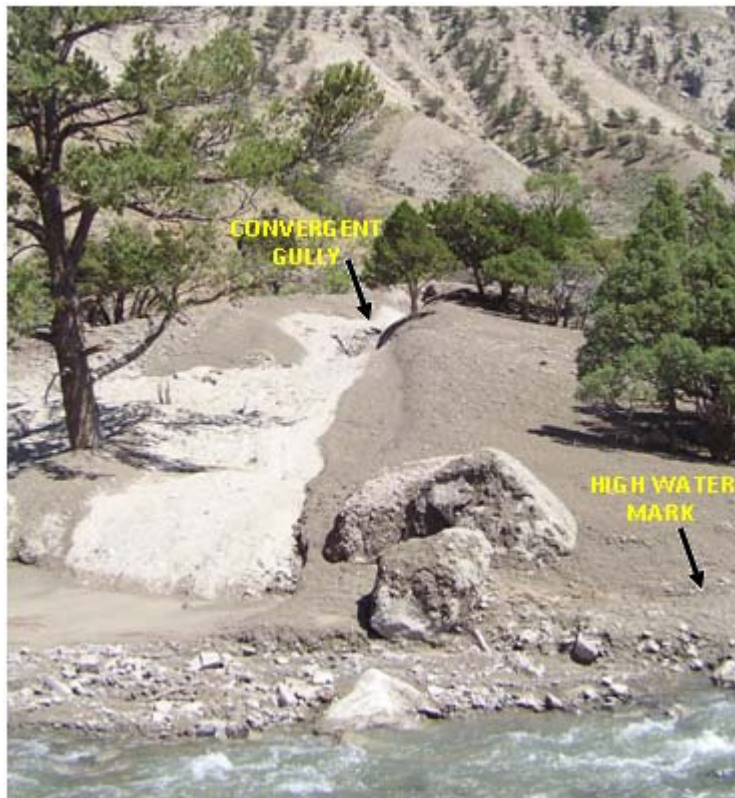
**FIGURE 17:** Photograph of DFA, taken on 23 July showing where 21 July debris flow entered the Gardner River, facing northeast toward Mount Everts.

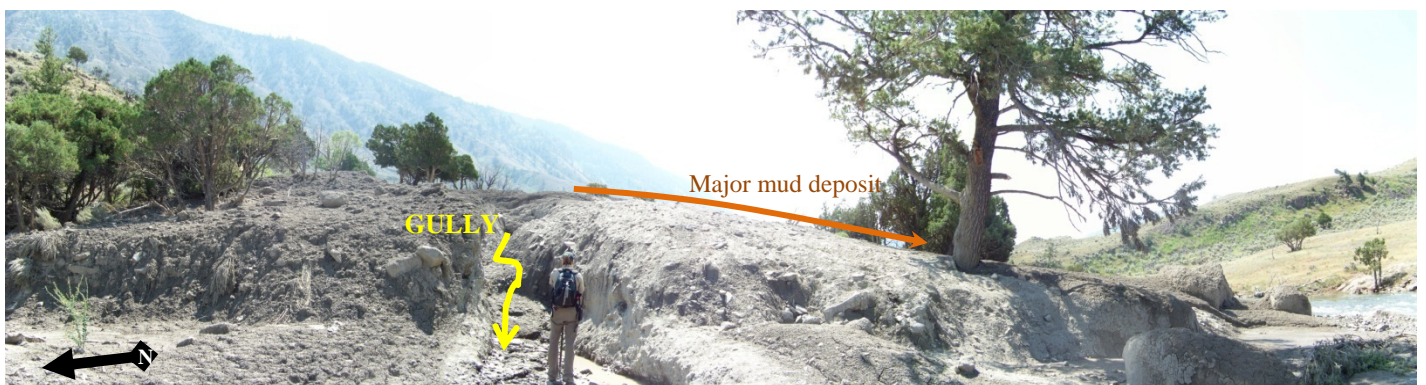
**FIGURE 18:** Photograph of DFAs gully emptying into the Gardner River. Photograph taken on 25 July facing east toward Mount Everts. This is one of the major debris flows that temporarily dammed the Gardner River.

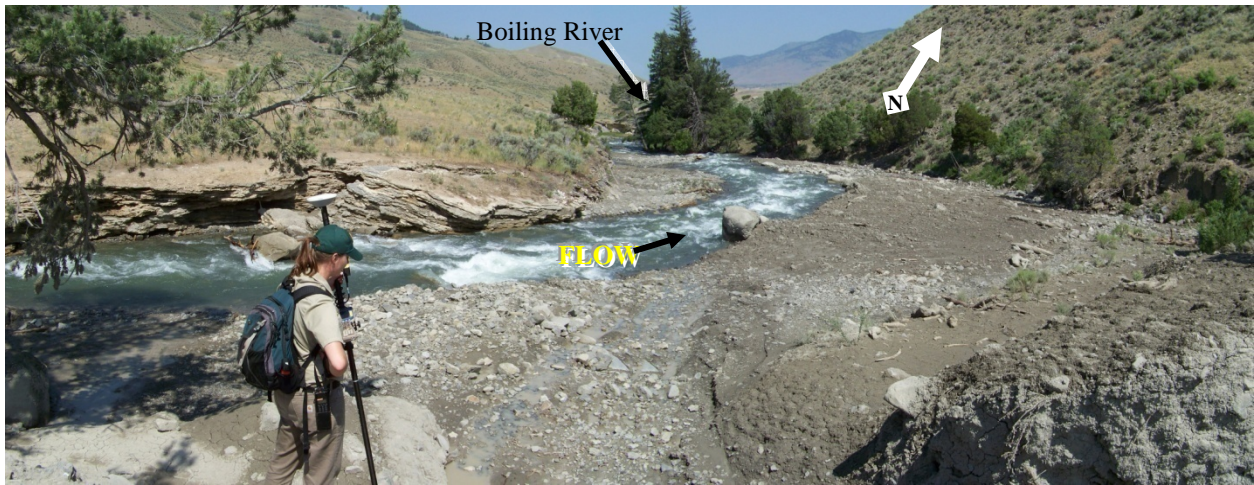
**FIGURE 21:** Photograph of DFA's gully's termination into the Gardner River. Recent debris flows along northeast bank of the Gardner River were deposited during the 21 July rain event. Photograph taken 25 July facing northwest.

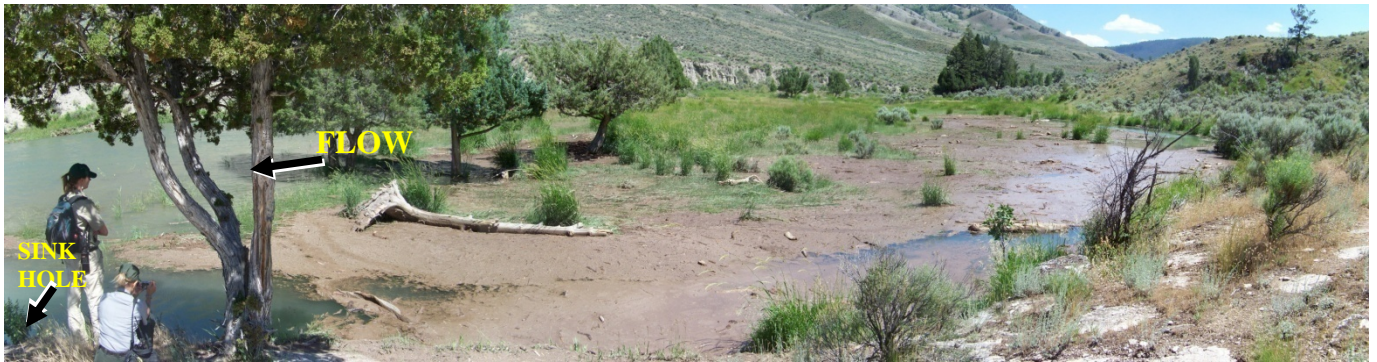
**FIGURE 22:** Photograph of Gardner River upstream from DFA. Note the ponding of the Gardner River caused by the constriction of the river channel. Water level is raised about 1.5ft. Brown area is organic matter floating on water surface. Sink hole cannot be seen from photograph, arrow points to general location, see Map 2 for regional location. Photograph taken 25 July, facing east.

Debris flows off the south flank of Mount Everts were triggered by substantial rain fall on the evening of 21 July 2008. USGS rain gages located at the Gardner and Boiling Rivers recorded the rain event beginning at 18:00 MDT and lasted approximately 1 hour and 15minutes. The intense rains that dropped the 1.016cm (0.040in) and 0.0889cm (0.35in) in two 15 minute-intervals, began at 18:45 MDT. The total precipitation dropped by this one rain event over the hour was about 3.048cm (1.2in) (Figure 4). The mud from the two debris flows that entered the Gardner River, upstream of the Boiling River outflow, extended across the river causing temporary dams to form (Figures 19 & 23). This temporary damming can be seen on the discharge data recorded by the USGS gauging stations at the Gardner Rivers (Figures 3 & 6). Because of the damming water backed up along Gardner River causing ponding. On 23 July the ponding behind DFA was still present (Figure 22).

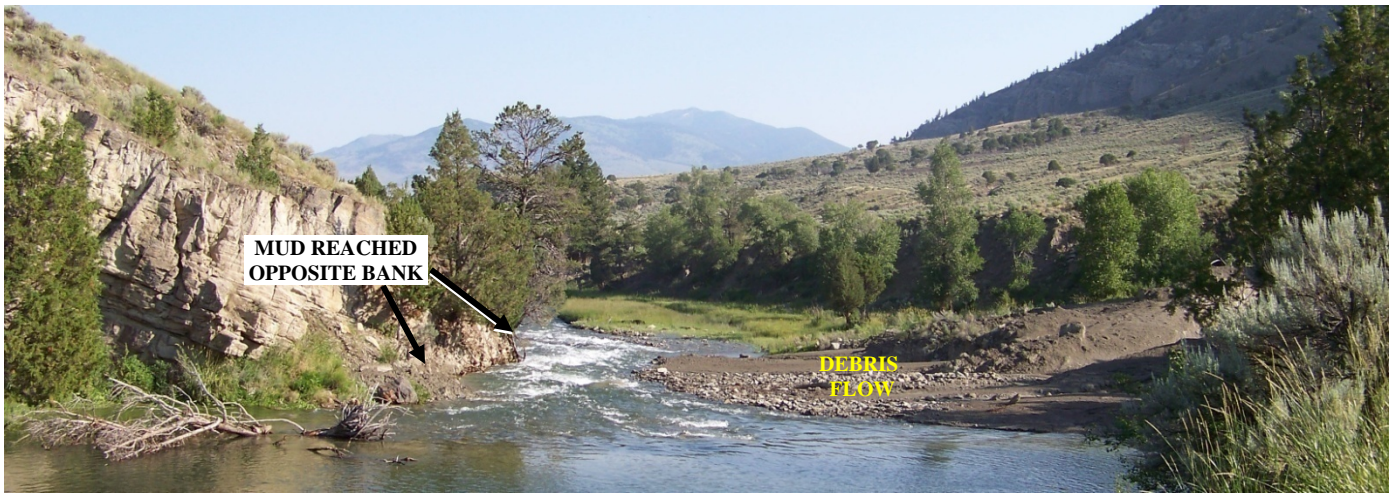
**FIGURE 23:** Photograph of DFB, near Lava Creek Bridge. This is one of the locations where the debris temporarily dammed the Gardner River on 21 July. Notice mud on opposite bank. Photograph taken 25 July 2008, facing north.

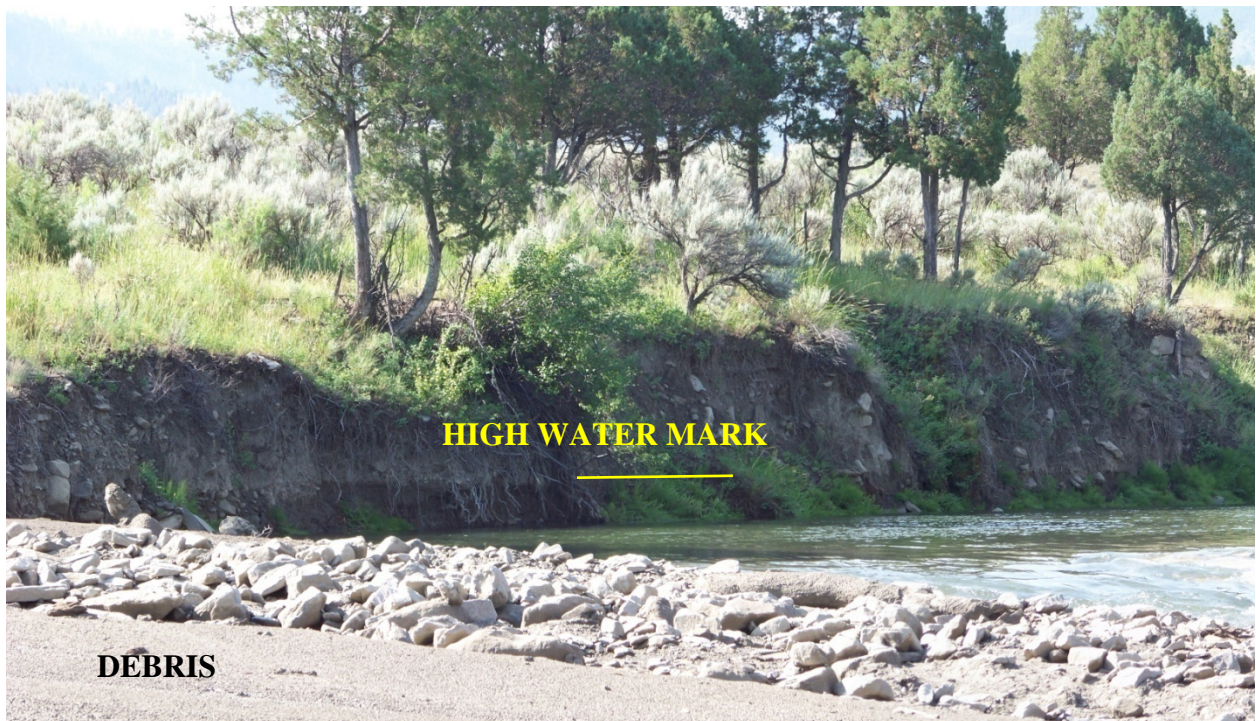
**FIGURE 24:** Photograph of high water mark along east bank of river, height is estimated about 0.46m (1.5ft). Note debris from 21 July debris flow in foreground. Photograph taken 25 July 2008, facing east from the center of the debris fan.
