U.S. Department of Labor
Occupational Safety and Health Administration
Directorate of Science, Technology and Medicine
Office of Science and Technology Assessment

Precast Concrete Panels-Hazardous Storage

Safety and Health Information Bulletin

02-10-2004

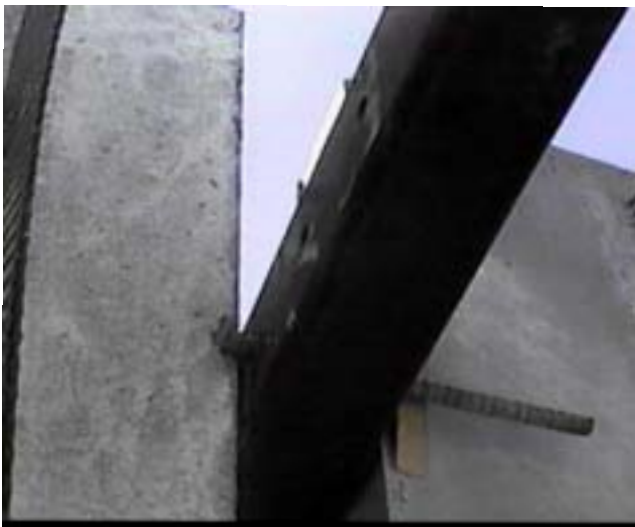
Figure 1. Finger rack with inadequate rebar pin holding panels.
Also the pin is not properly placed

rebar pins that are inserted into the finger rack holes (see figure 1). A single pin can be used on both sides of the finger rack such that the pin is normally positioned to extend out only about 6-7 inches on each side of the square tube. Wooden wedges, of variable widths and thicknesses, are positioned and hammered between the panel and the pins to further secure the panel in an upright position.

The pins used at the site were made of grade 60 billet steel (60-ksi yield strength). Some of the pins used were bent, indicating that they were undersized. The pins did not have any retaining mechanism to prevent the pins from being pushed through the tube holes or for ensuring the pins were inserted the proper distance.

1. Increase the diameter and/or strength of the rebar pins such that they are less subject to permanent bending during use.
2. Place dunnage under each and every panel in at least two locations (each within two feet of each end of the wall panels) to help prevent twisting motions that could cause the panel to tip and/or cause the wedges to come loose.

6. Design the pins so that they are of a consistent size and shape to ensure proper placement during installation (see figure 3), and that they are also restrained from horizontal displacement once installed. One way of restraining movement would be to install a clevis pin.

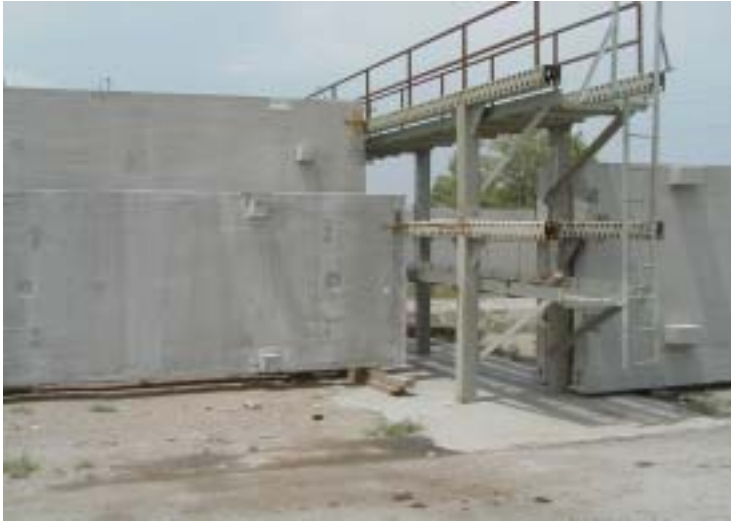
Figure 2. Higher tier finger rack.

4. Secure the wedges to the pin to prevent them from falling out.
5. Include an additional tier rack near the top of the panels to provide additional support (see figure 2).

7. Include additional holes in the rack to minimize the movement of the panels between the pins and minimize the number and sizes of the wedges needed (see figure 2).

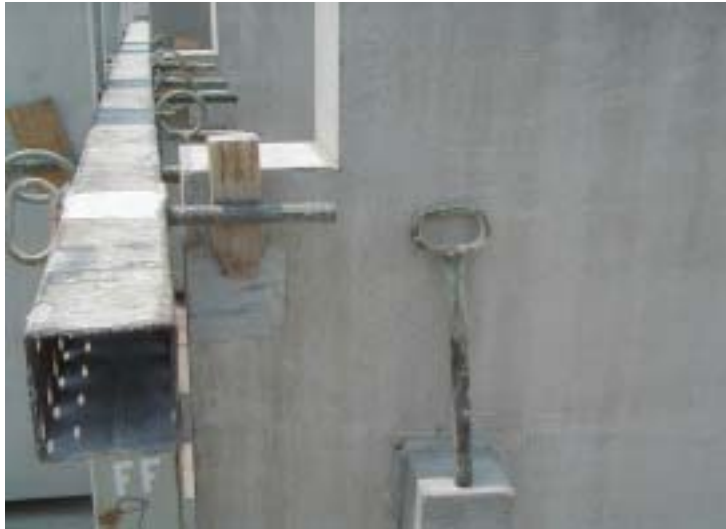
Figure 3. Different types of pins.
