# Creeks and Communities

A Continuing Strategy for  
Accelerating Cooperative  
Riparian Restoration and  
Management

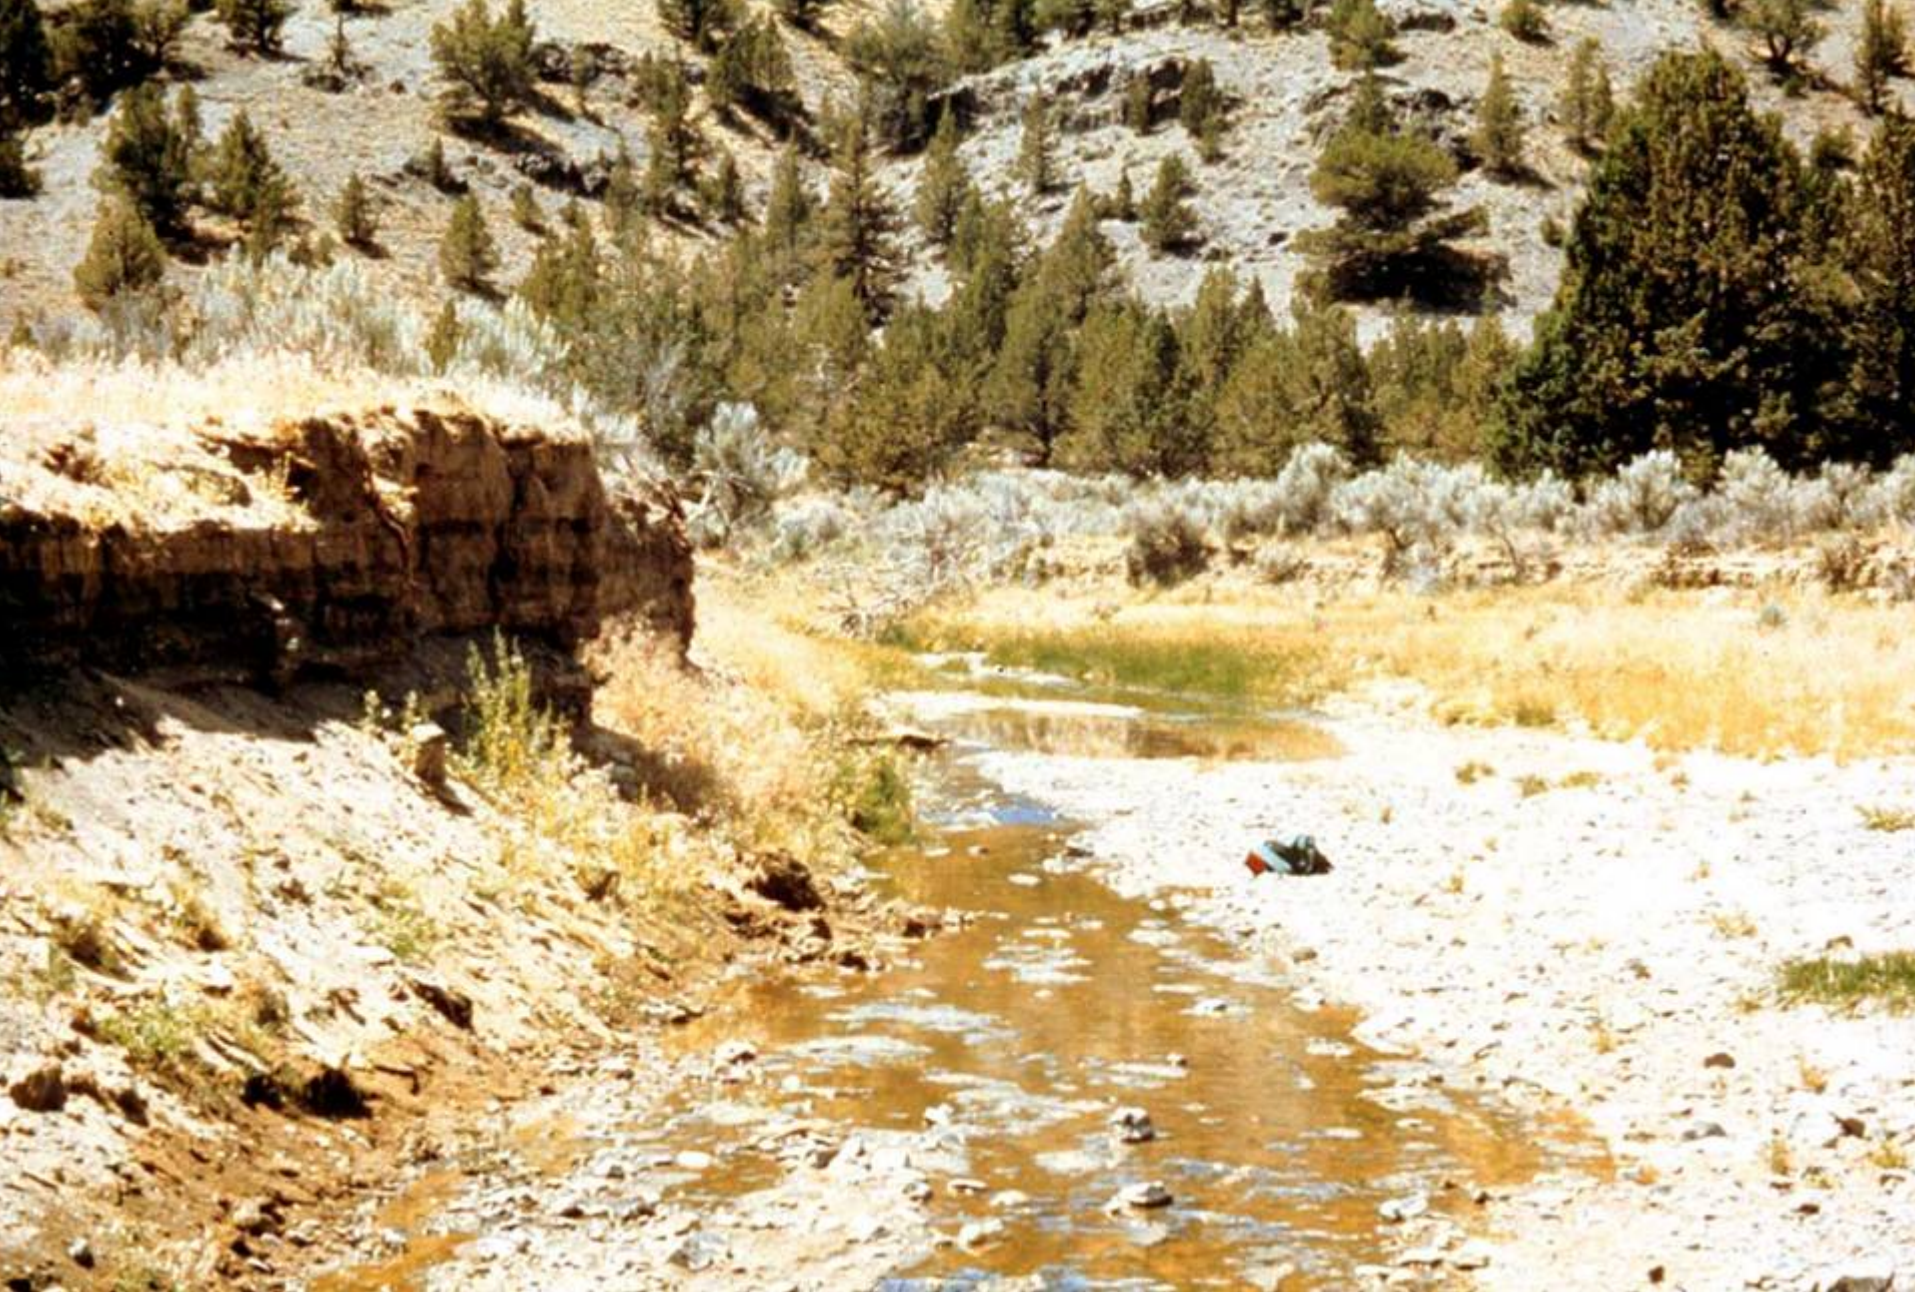
**Bear Creek May 1977**

# Stream Function

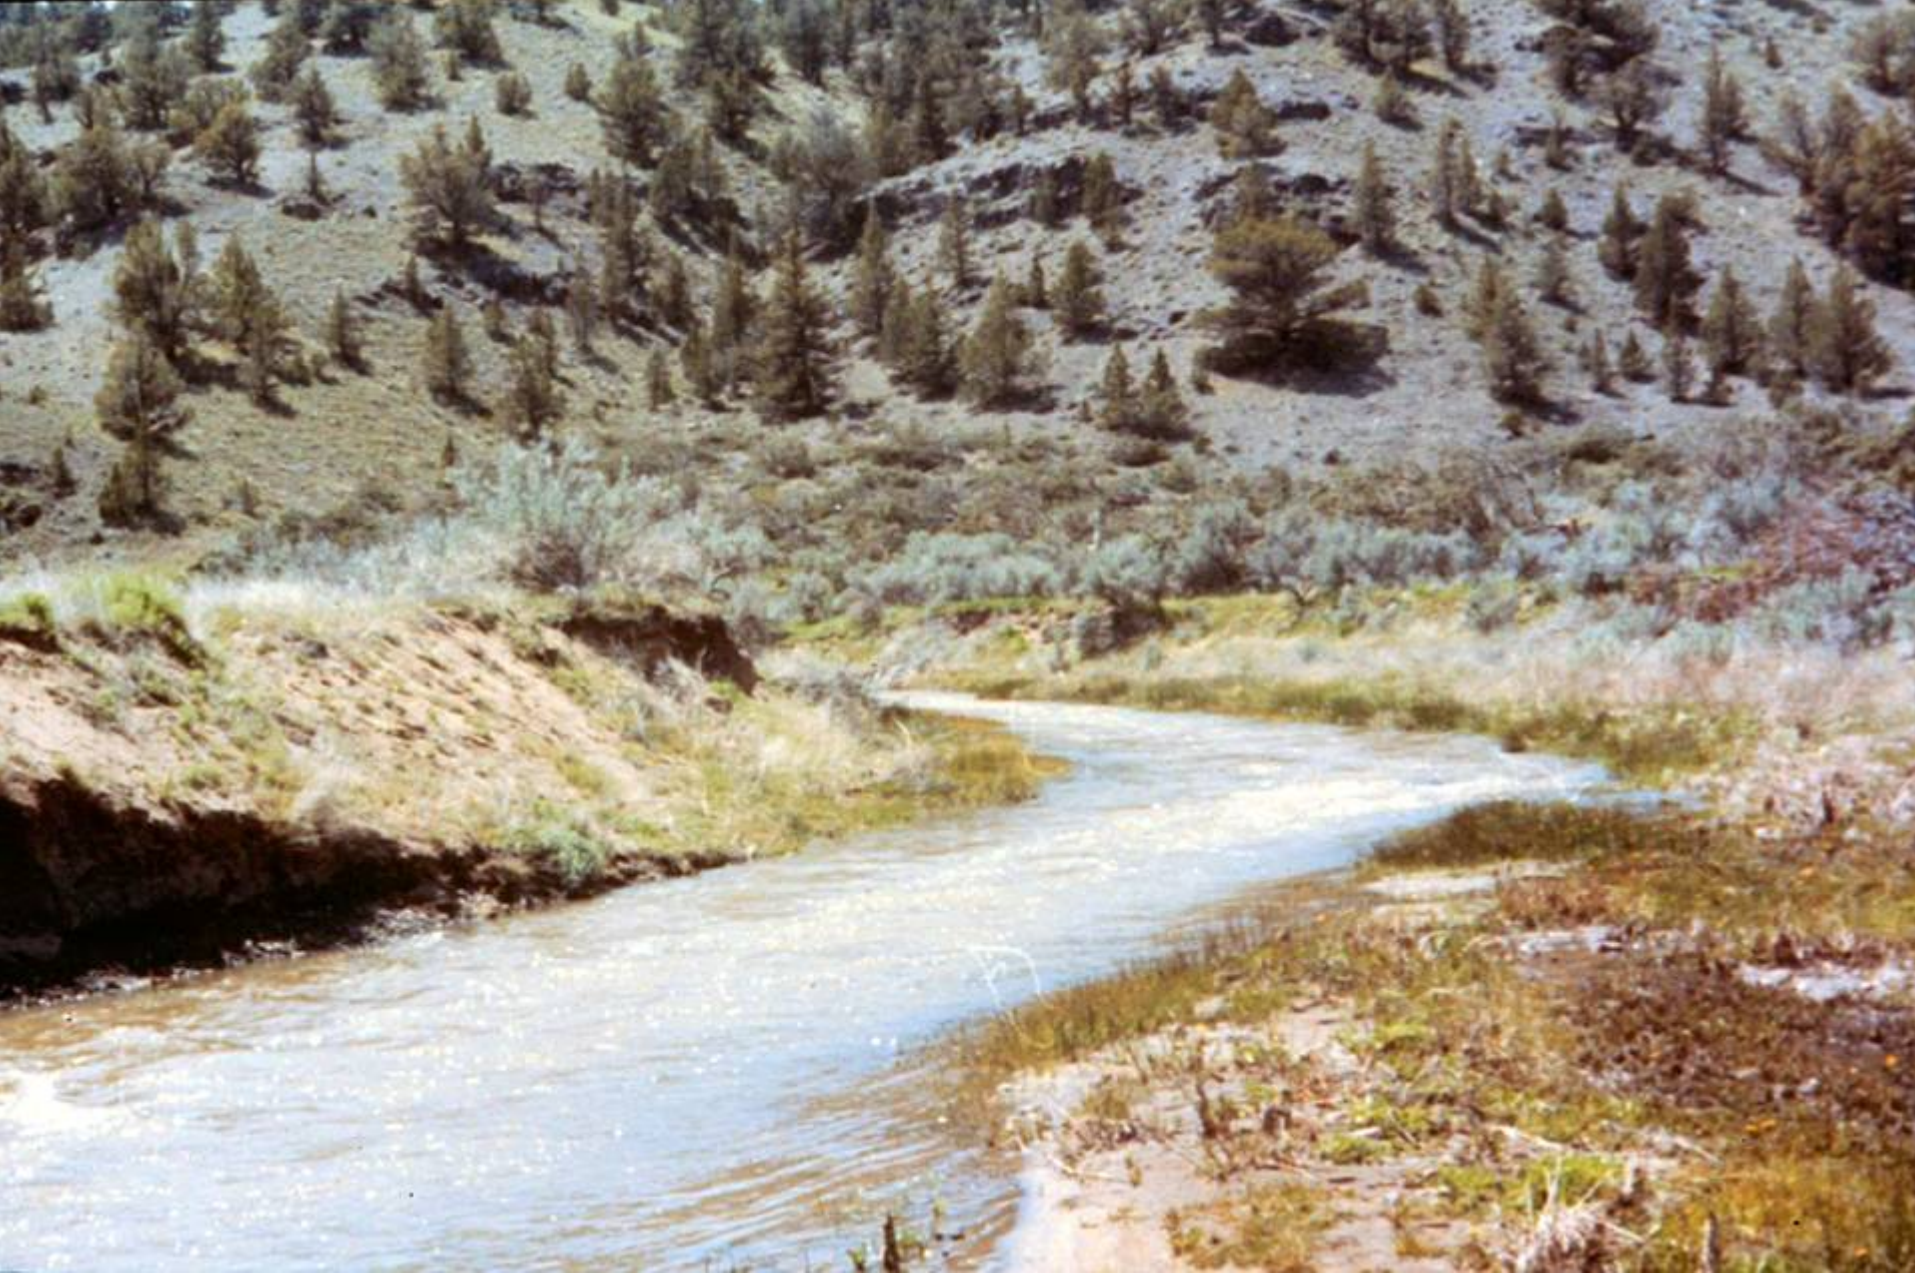
**Bear Creek May 1983**

**6 years**

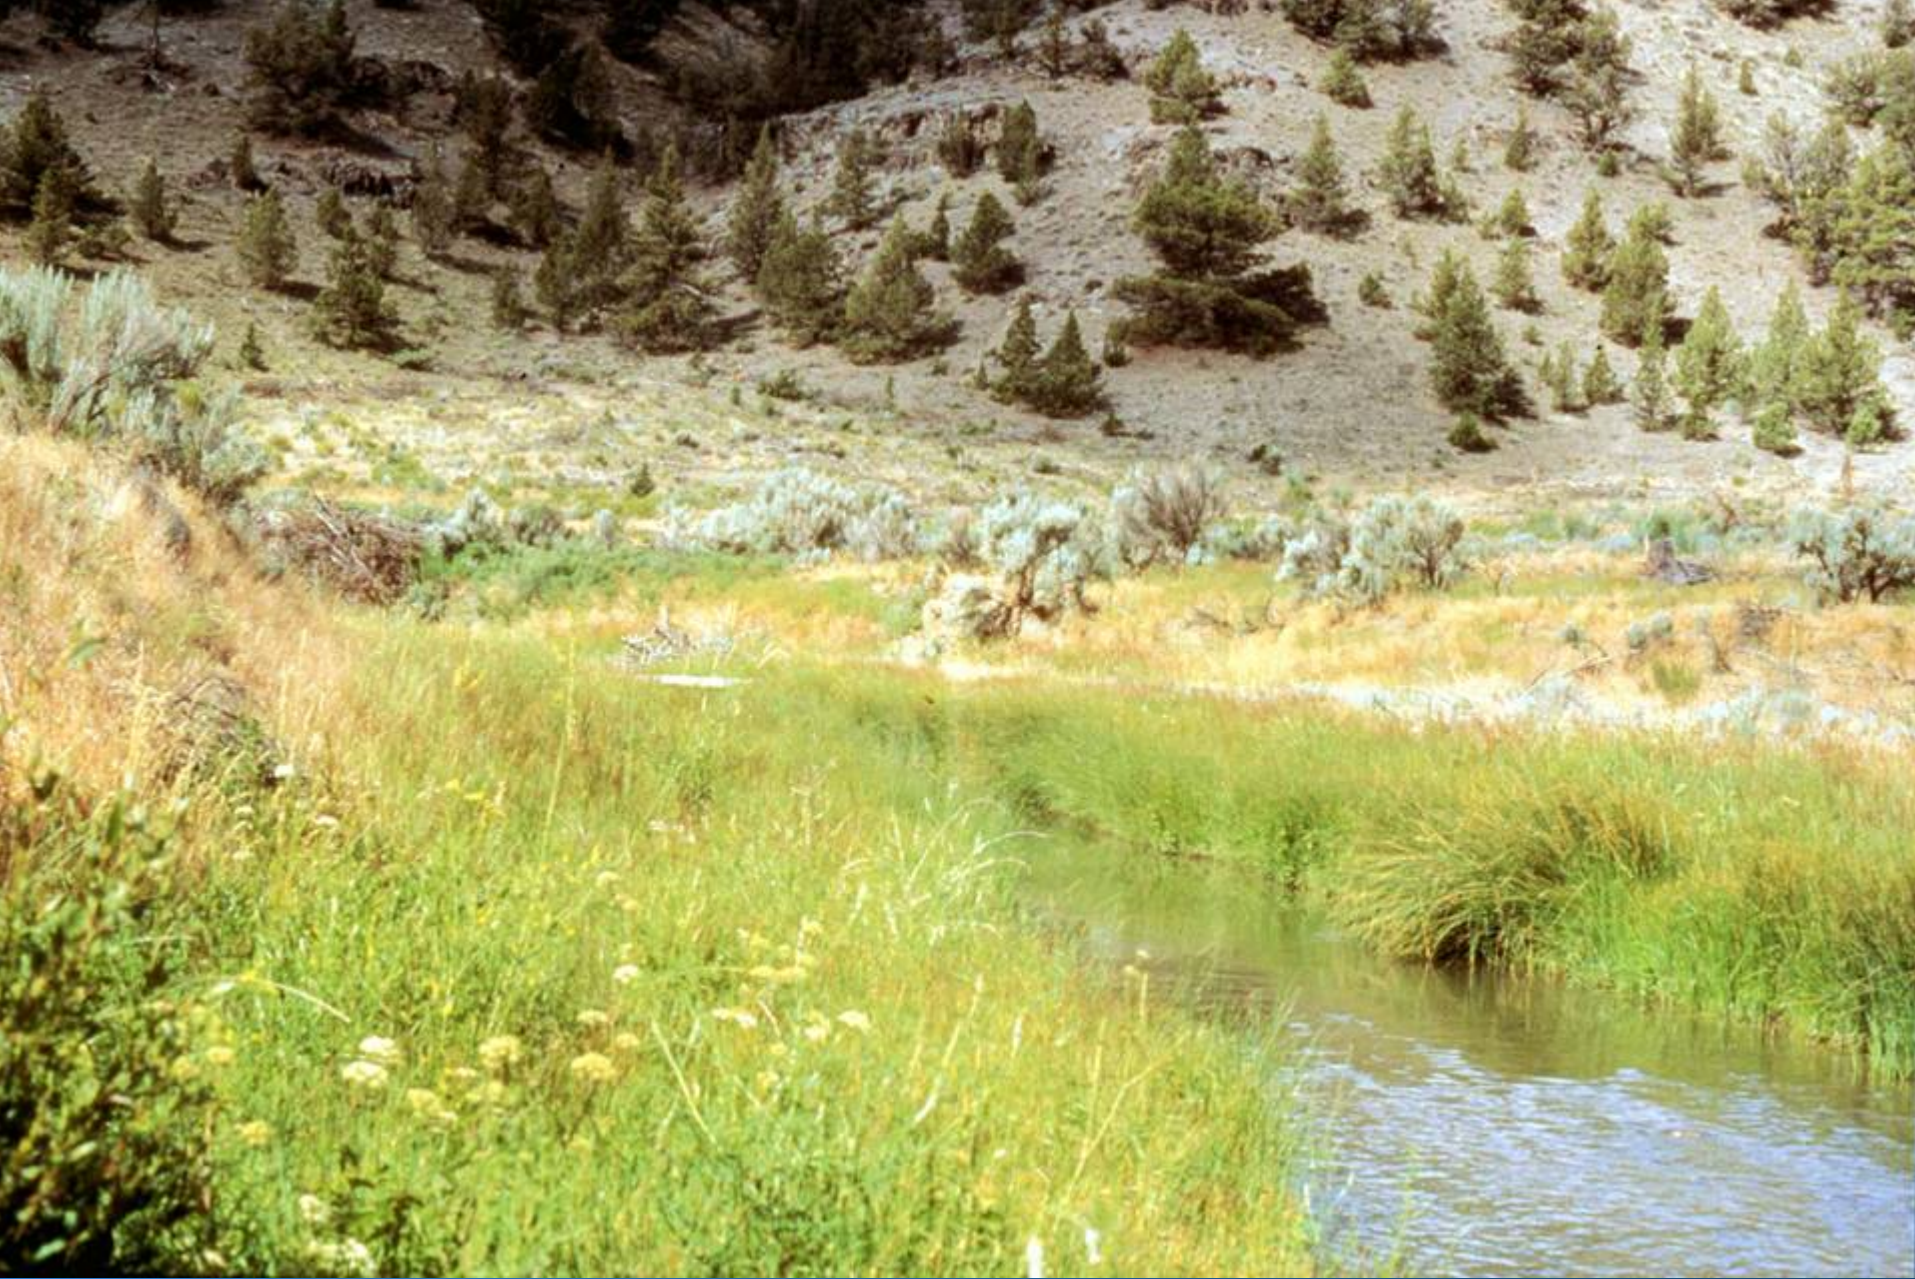
**Bear Creek Aug 1986**

**9 years**

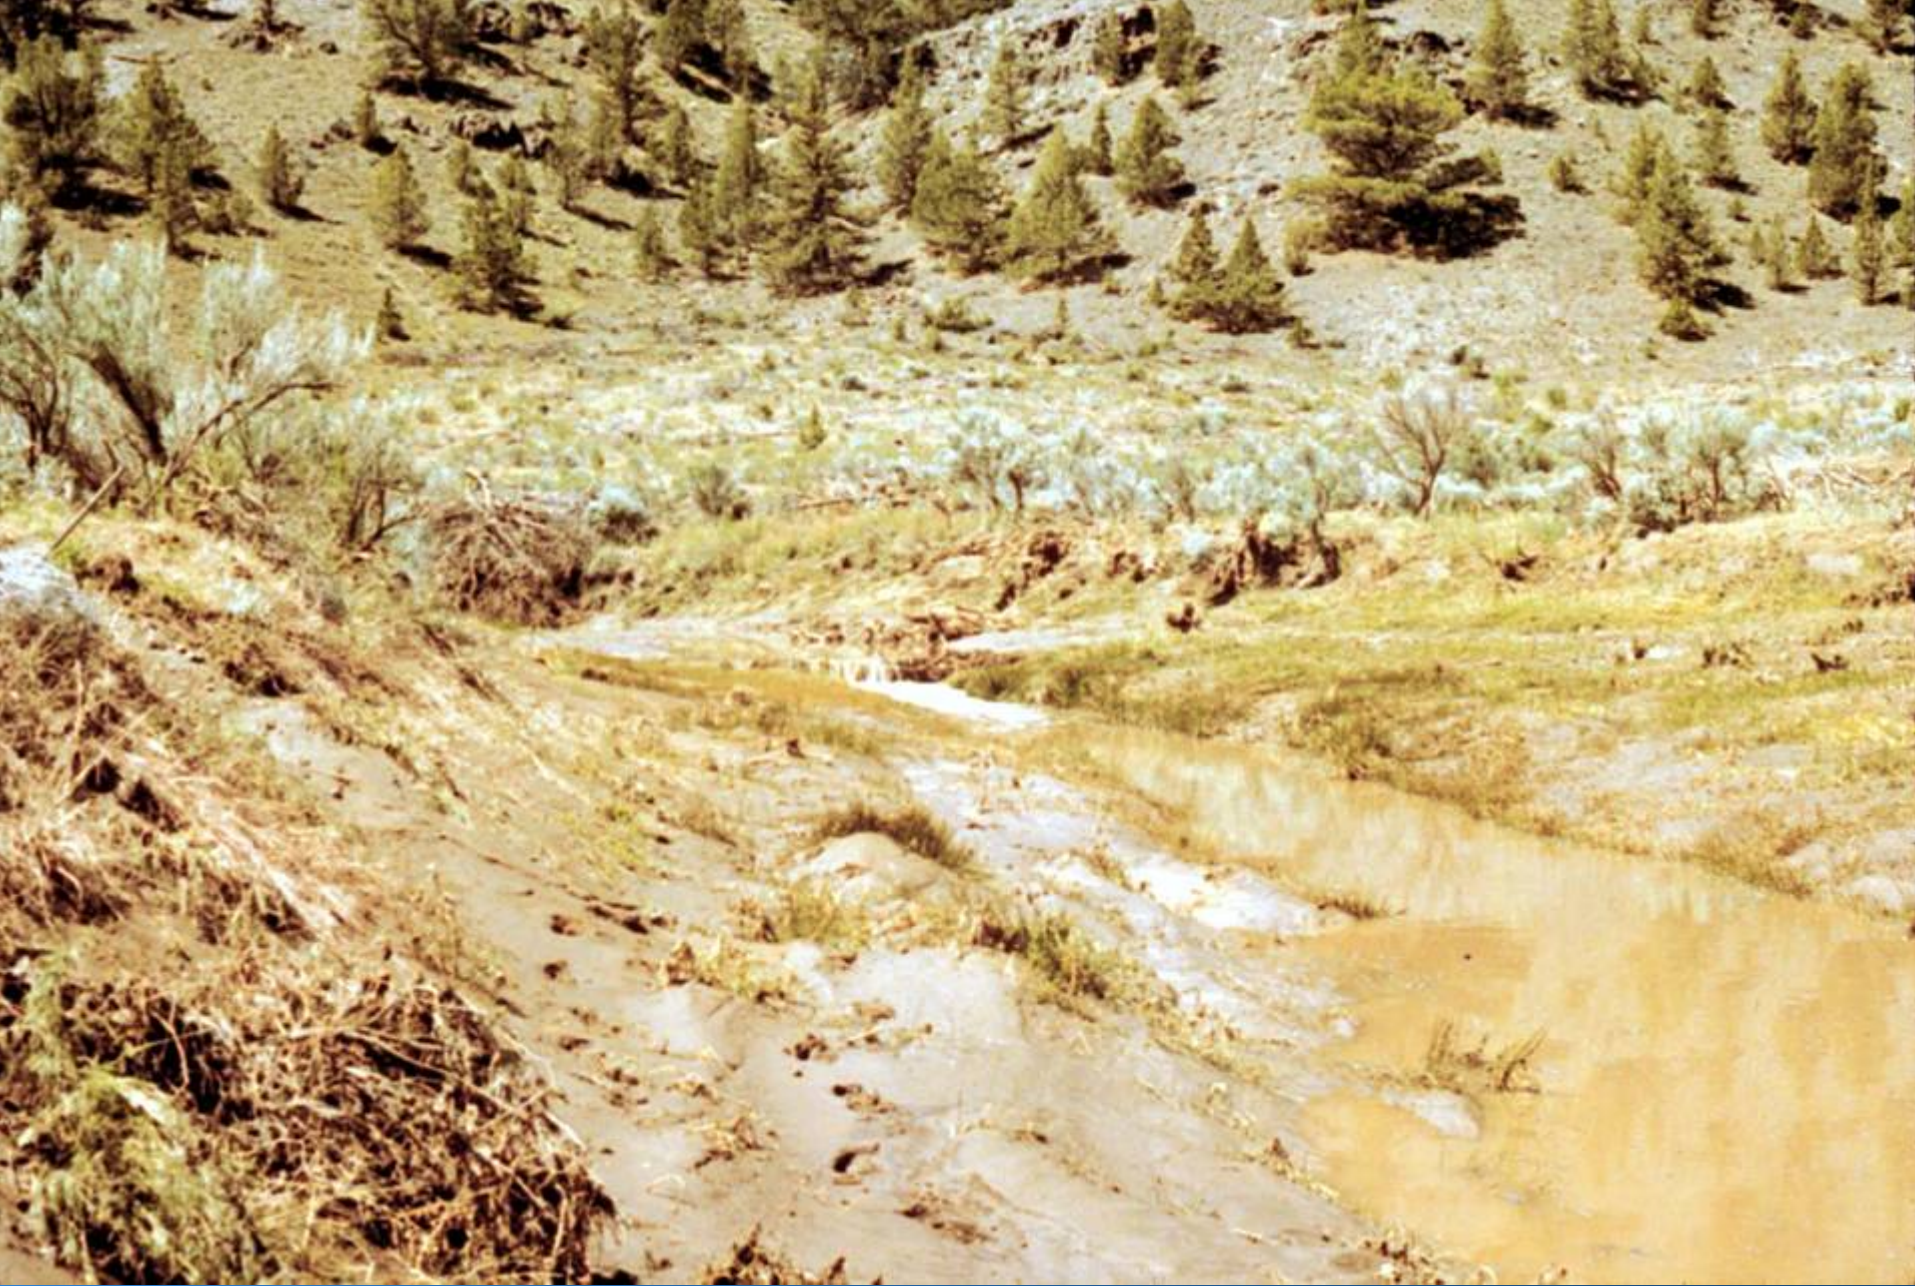
Bear Creek June 1987

9.8 years

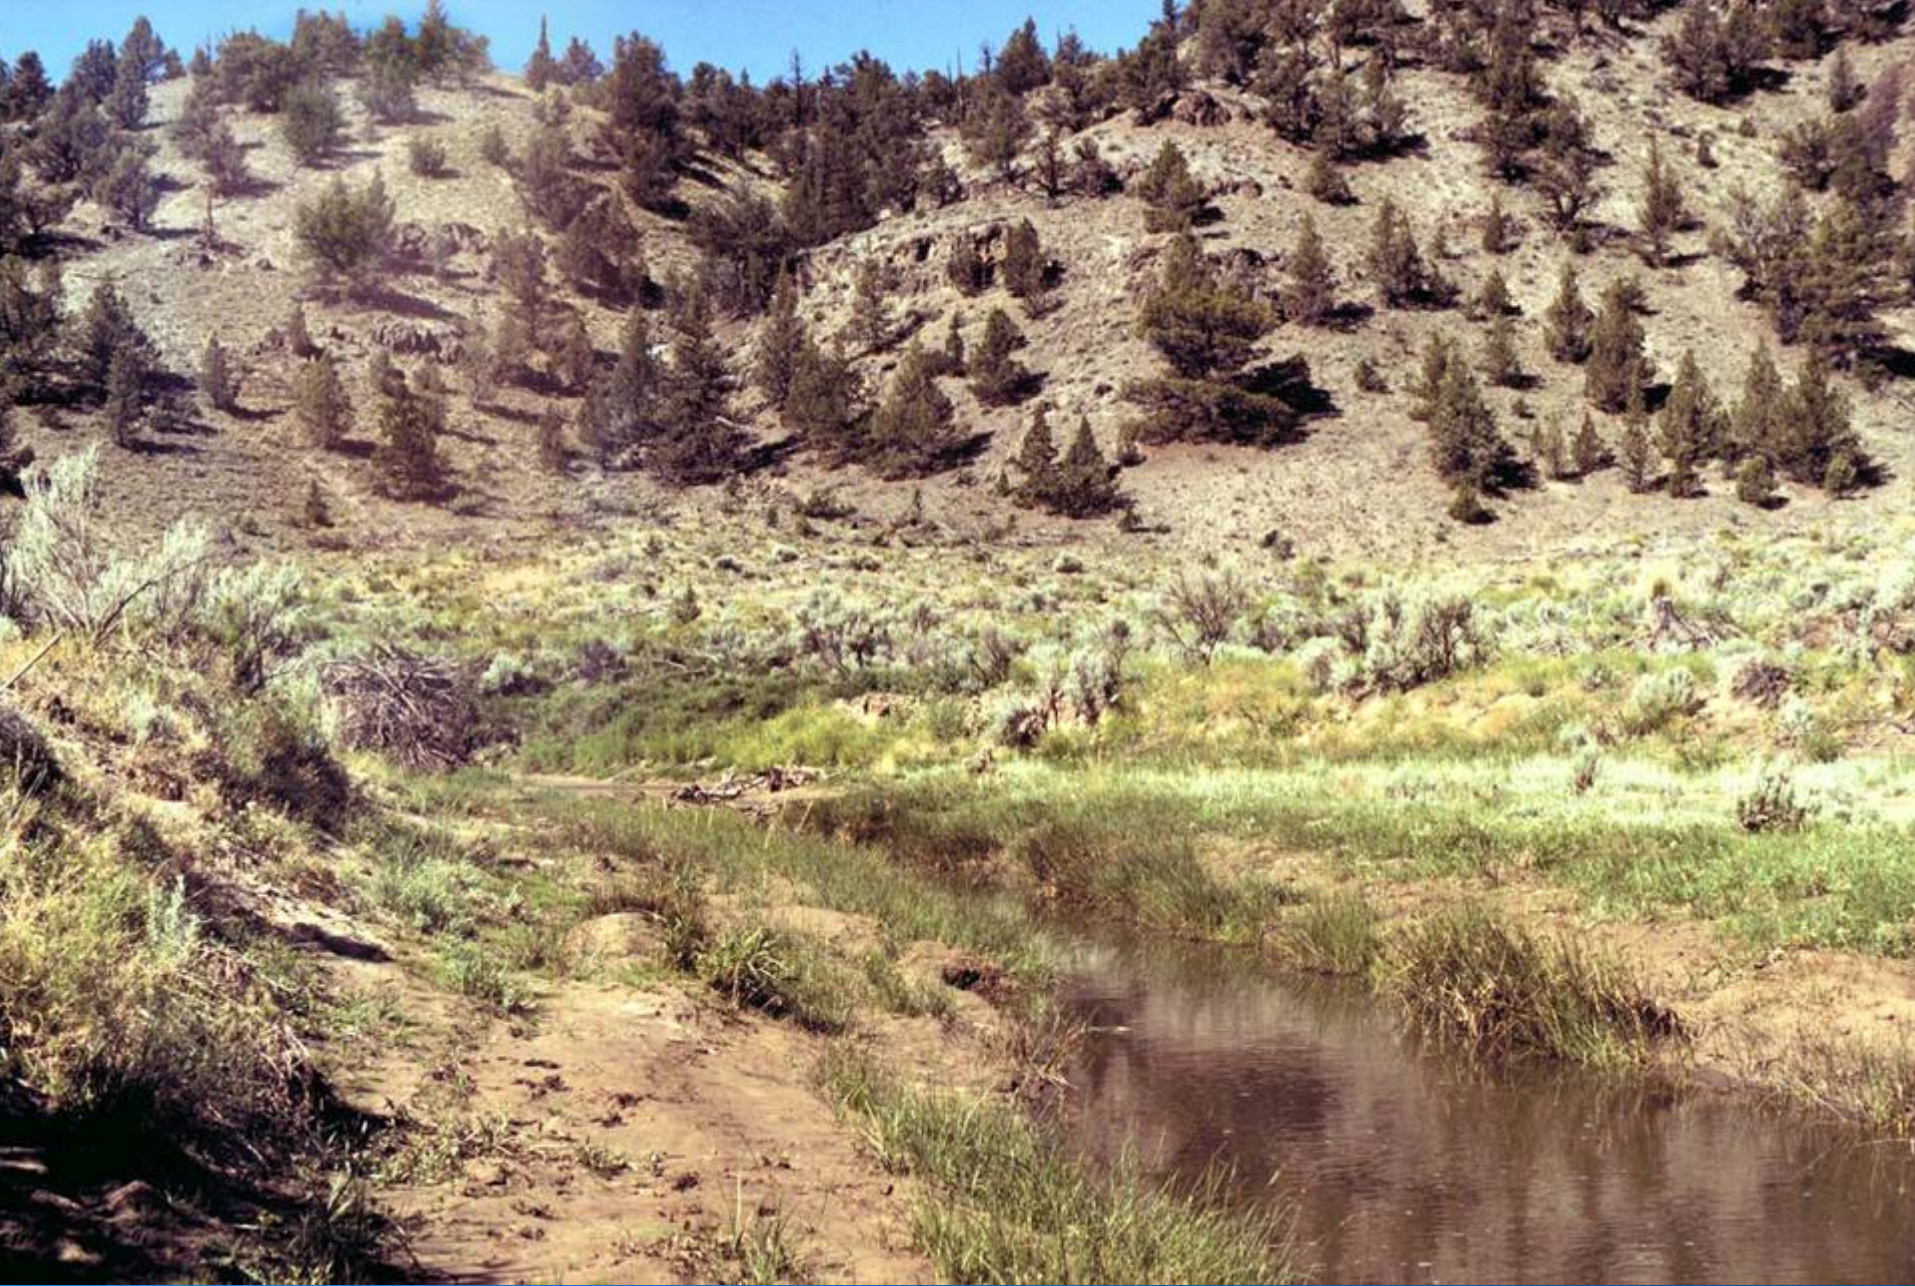
**Bear Creek Aug 1987**

**10 years**

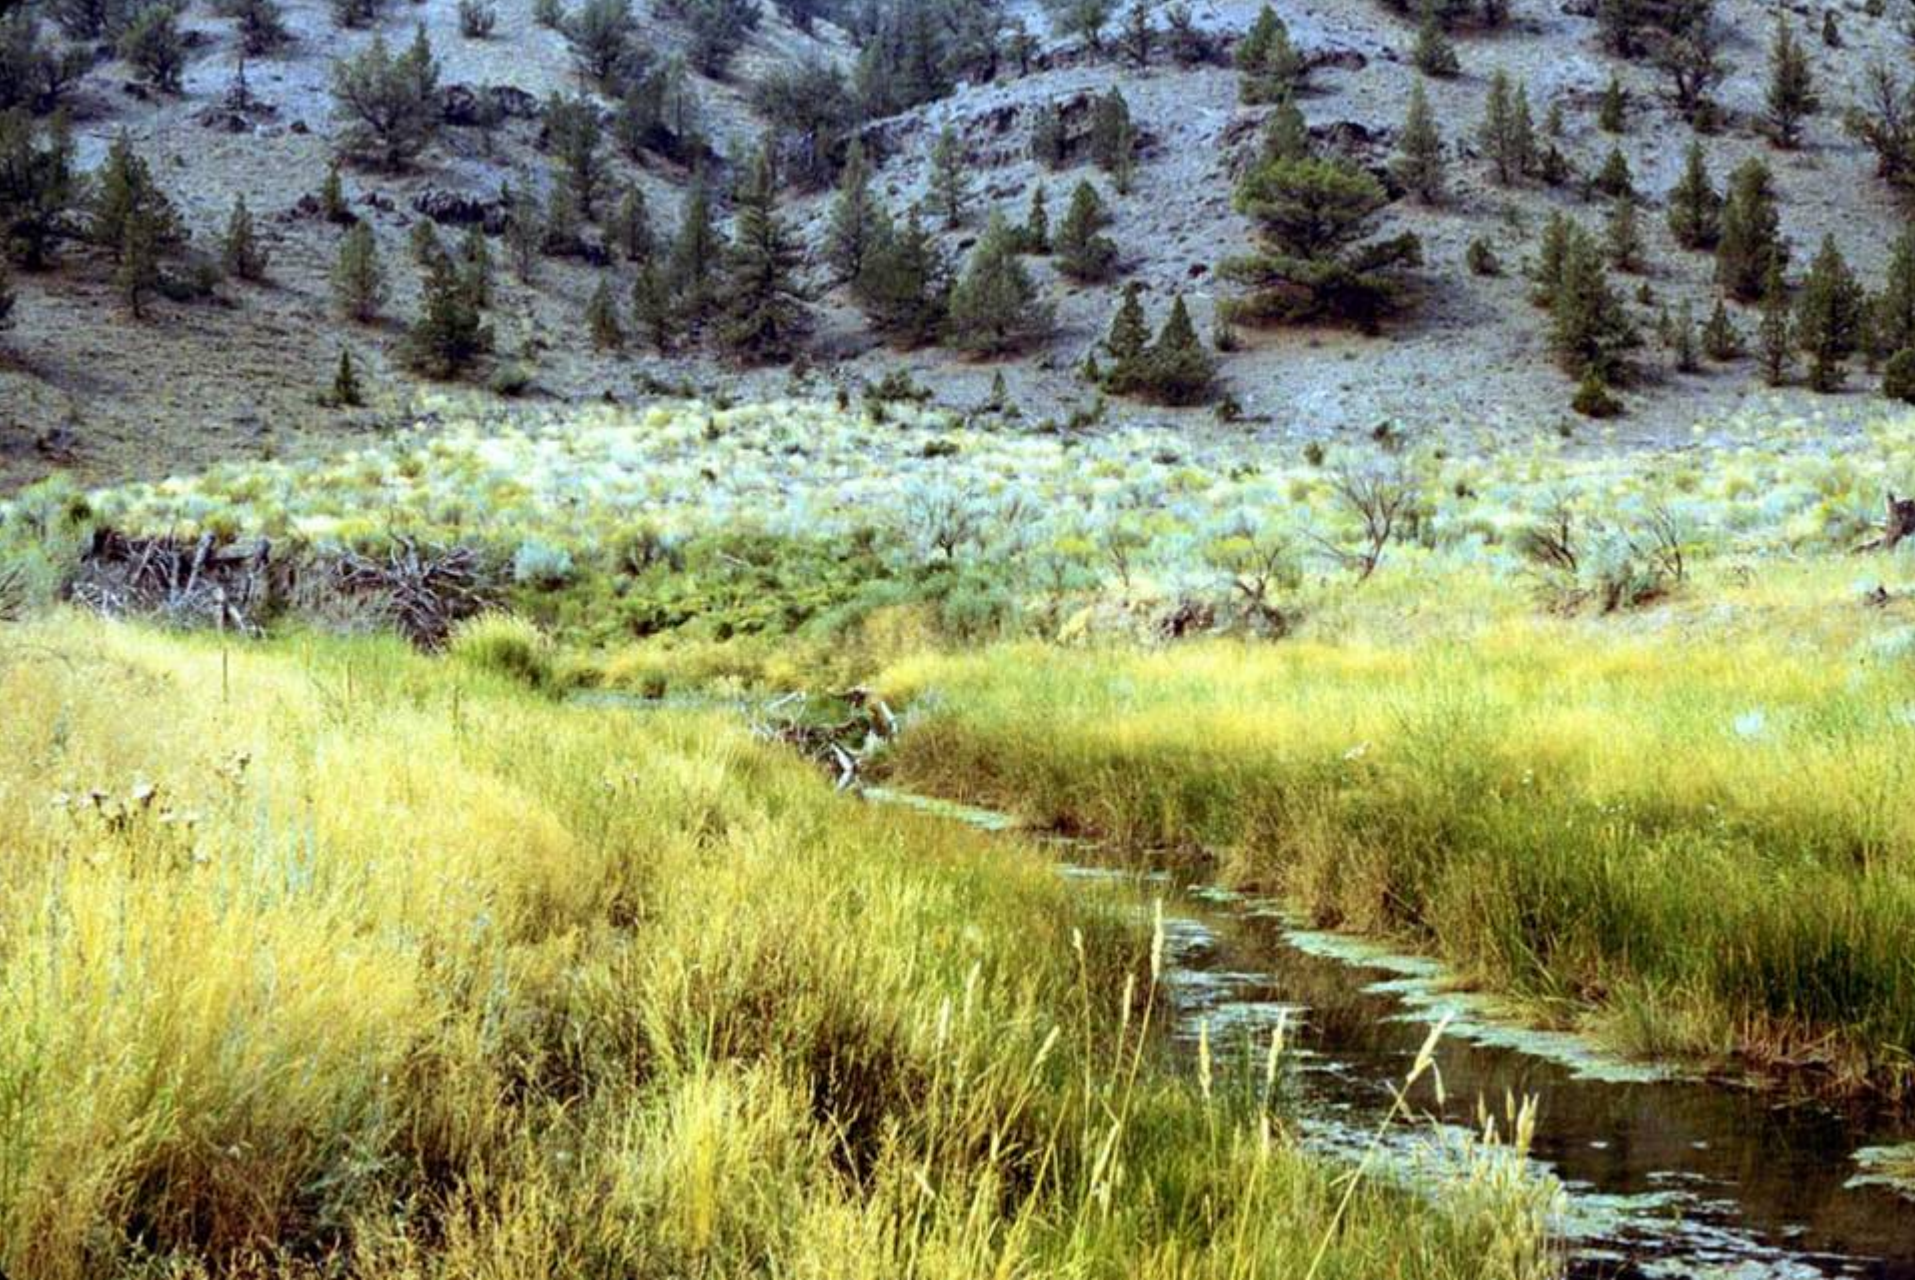
**Bear Creek Oct 1988**

**11 years**

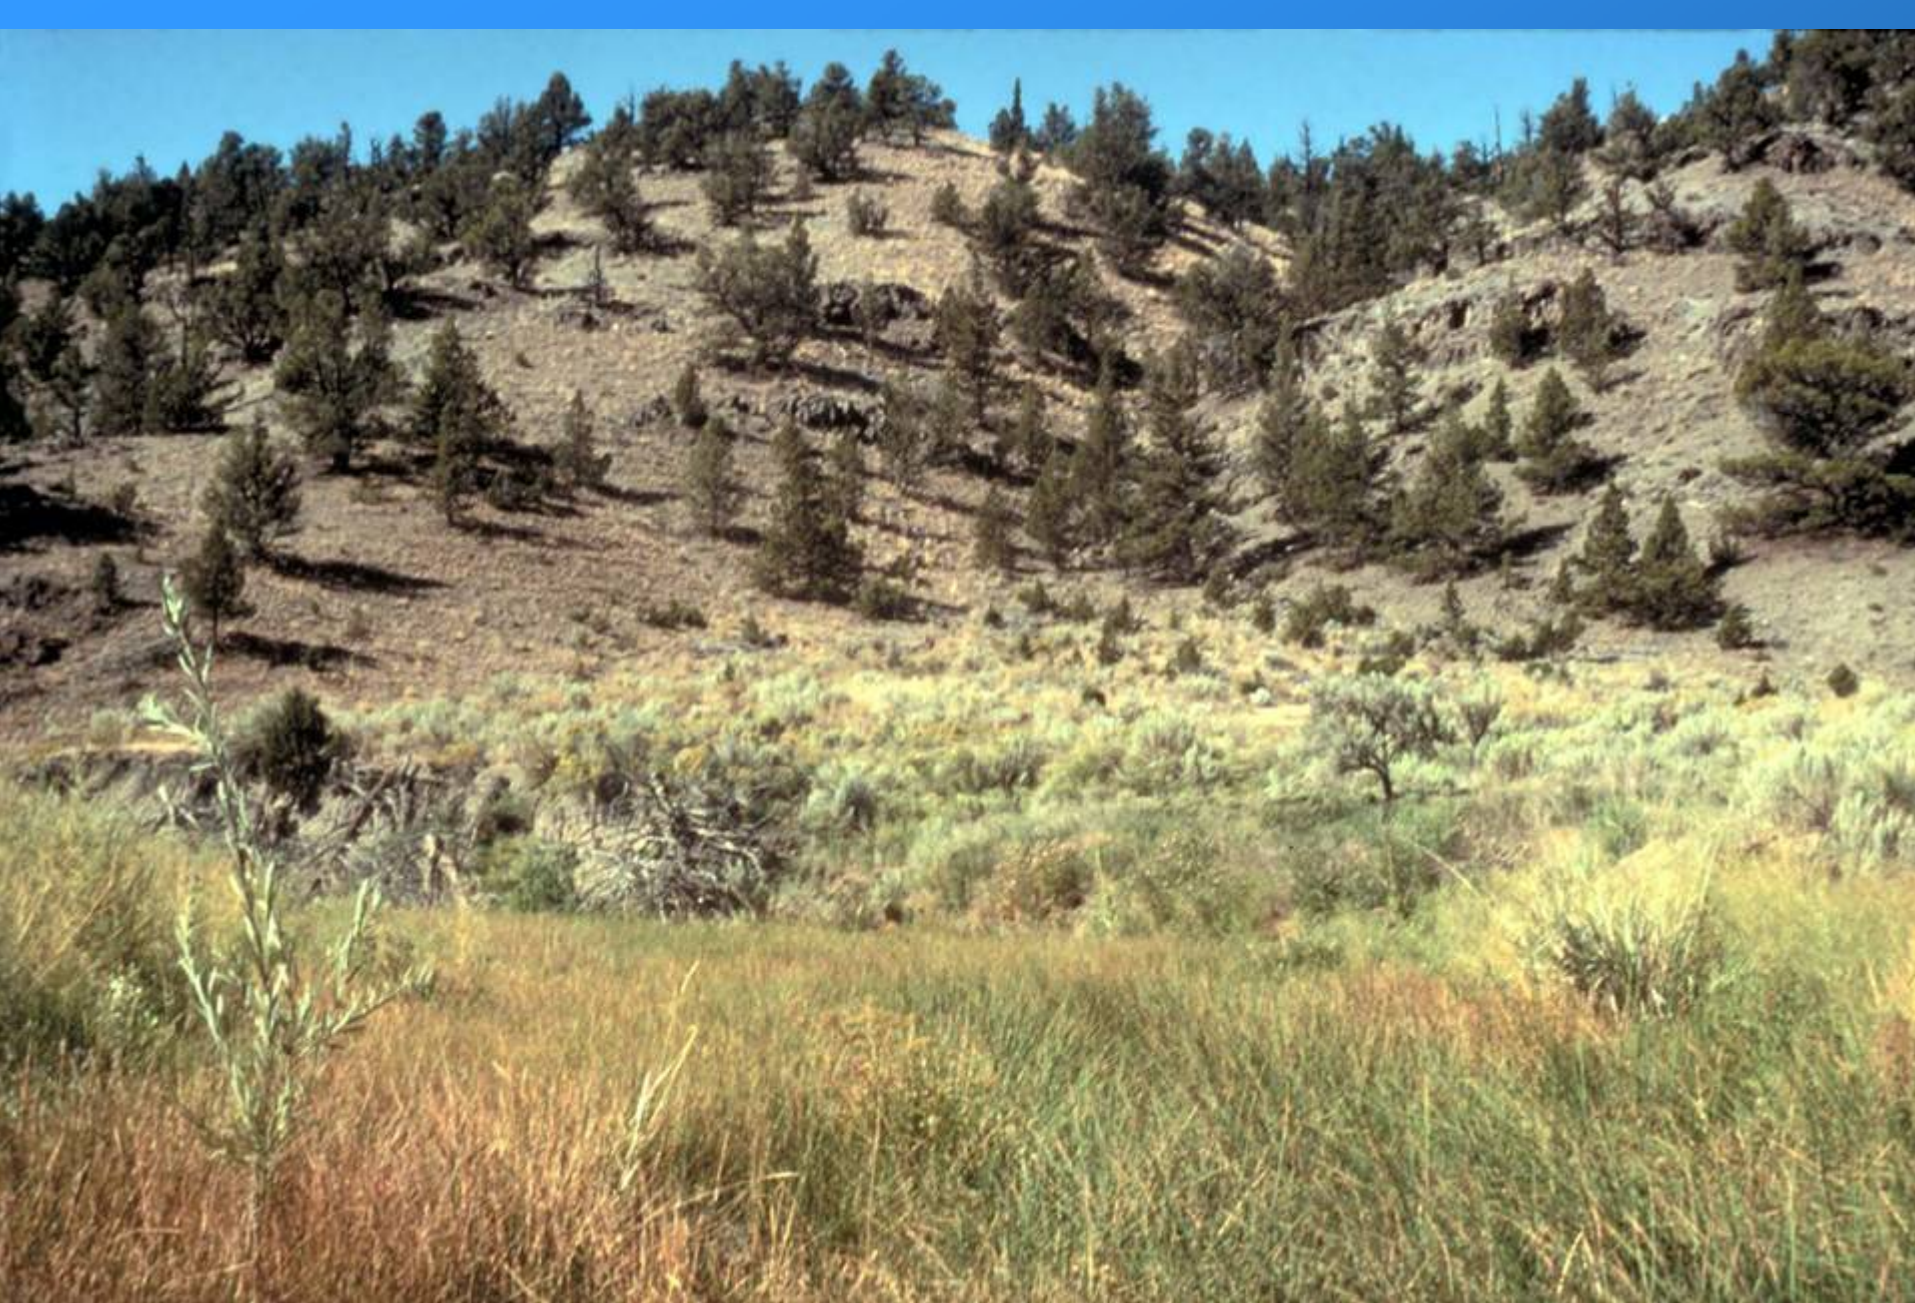
**Bear Creek Aug 1993**

**16 years**

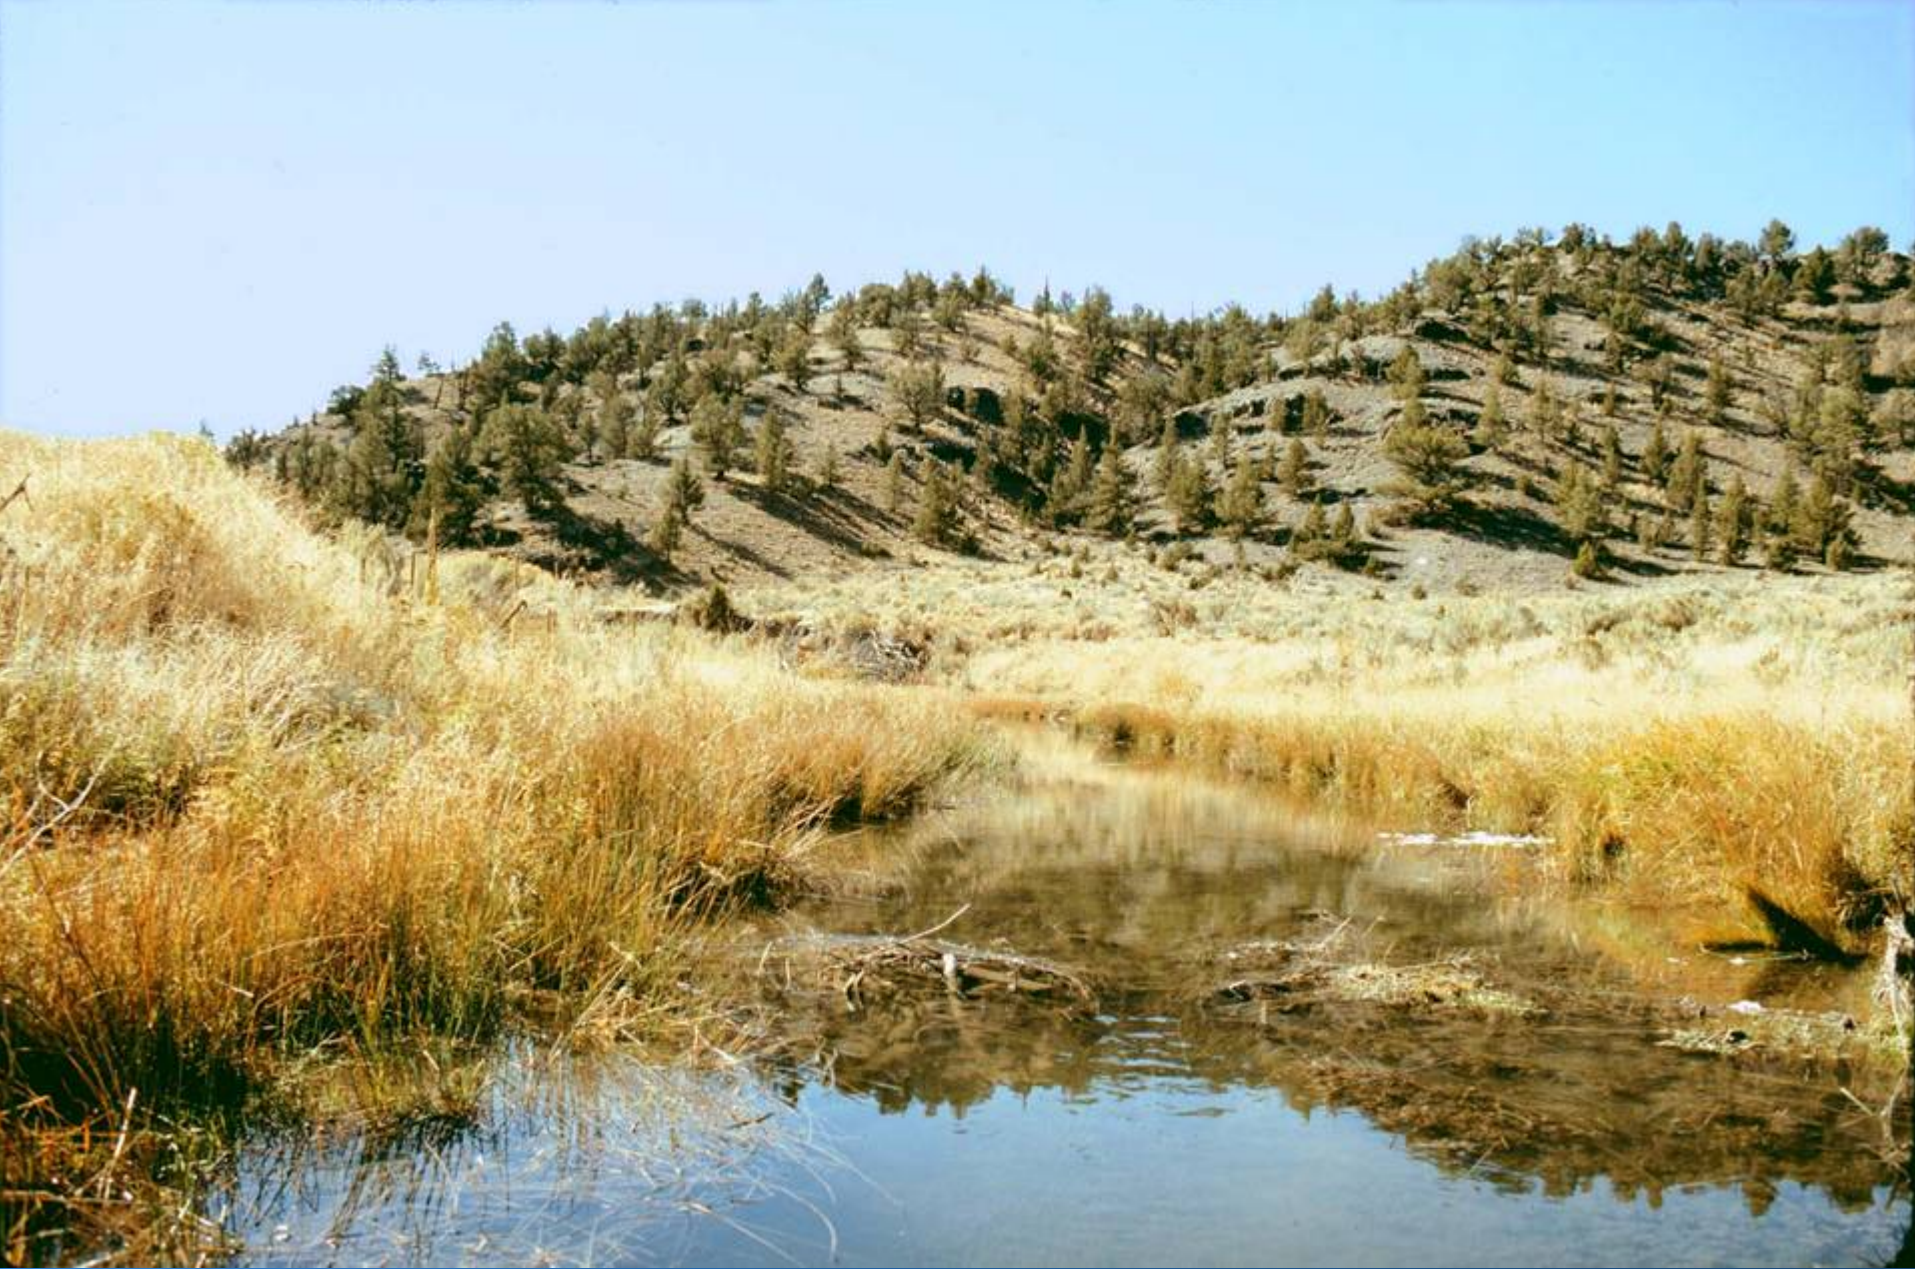
**Bear Creek Nov 1995**

**18 years**

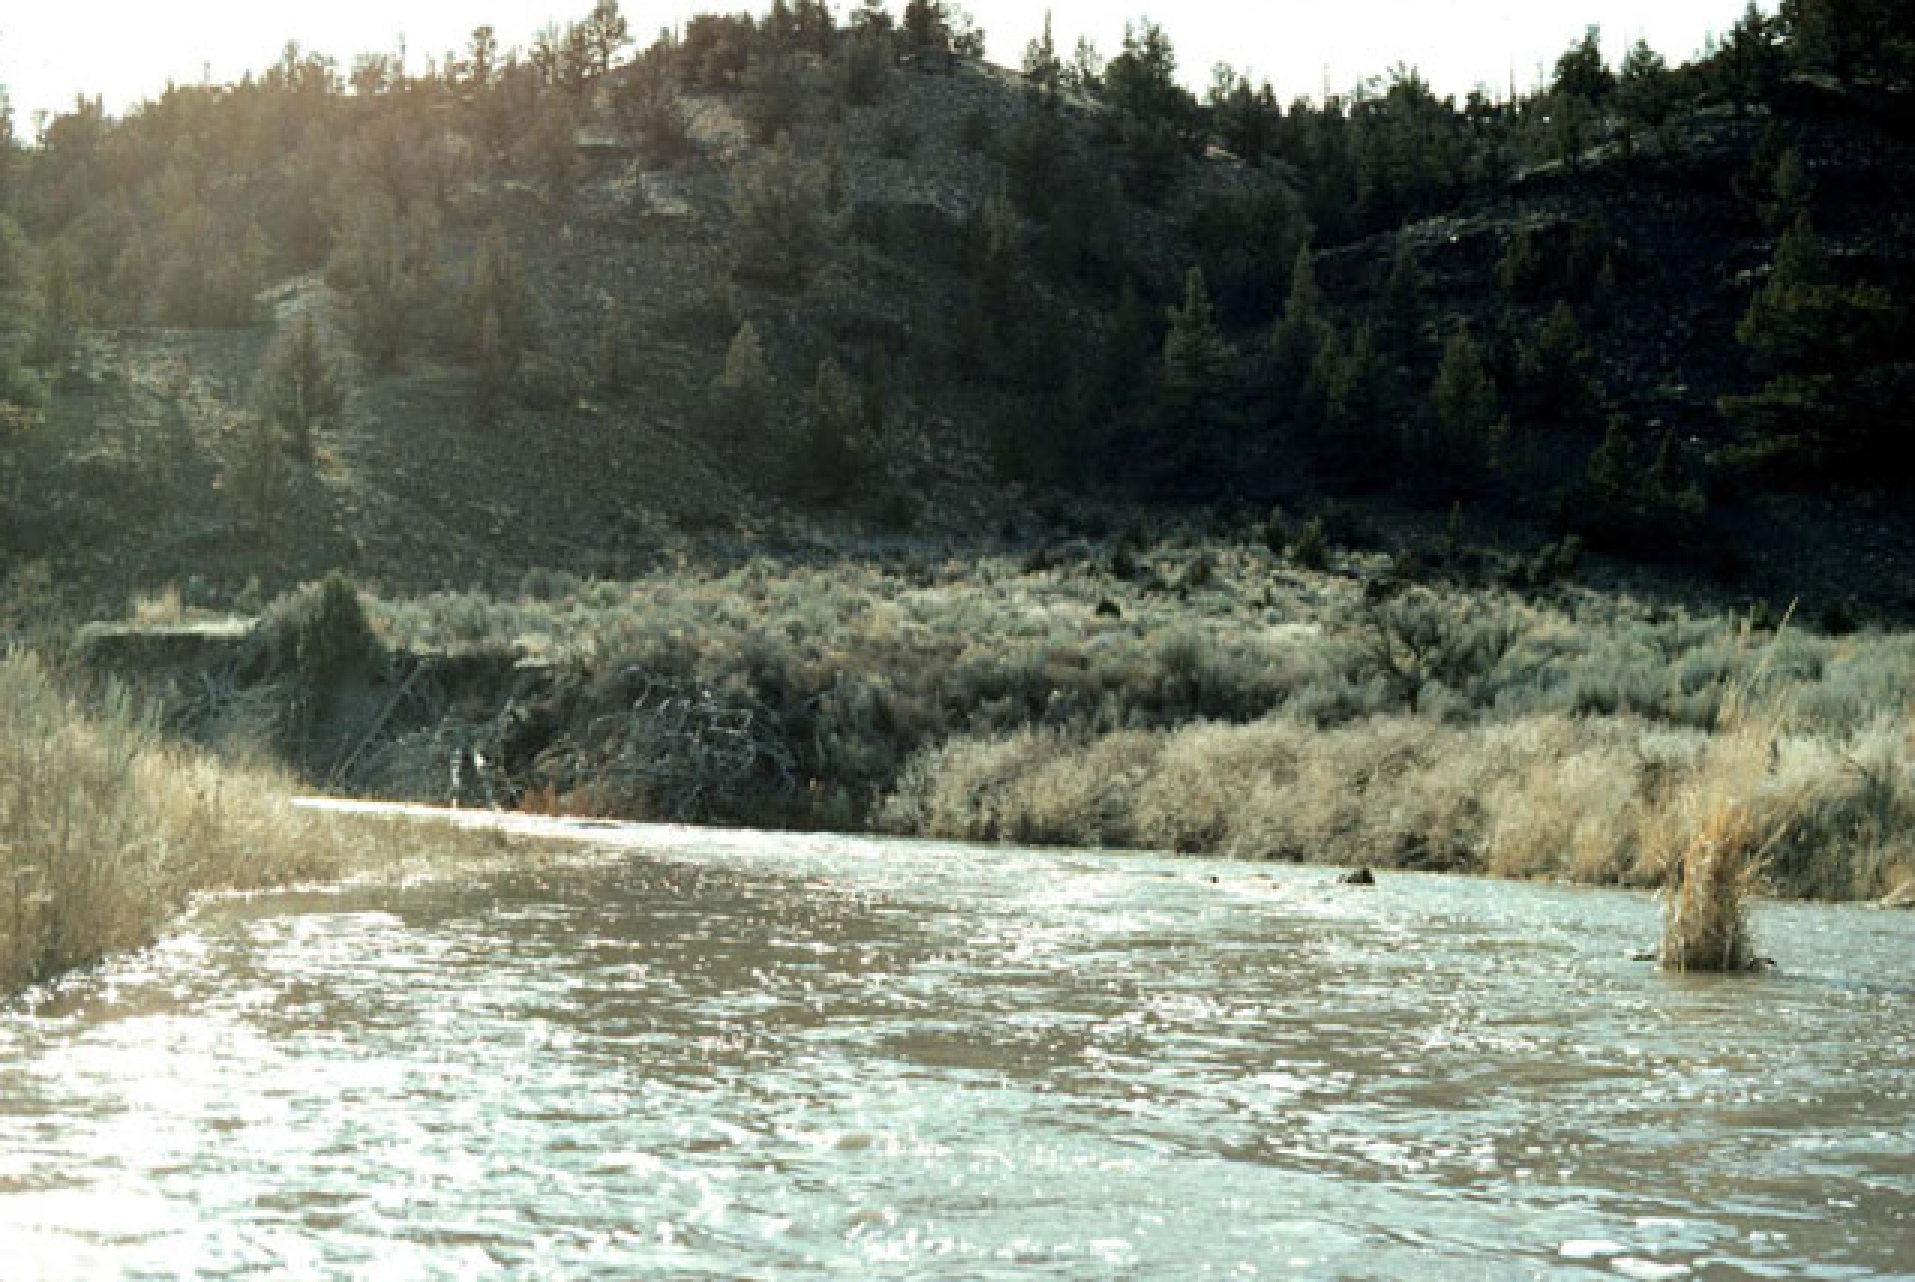
**Bear Creek Feb 1996**

**18.5 years**
