# Creeks and Communities

A Continuing Strategy for  
Accelerating Cooperative  
Riparian Restoration and  
Management

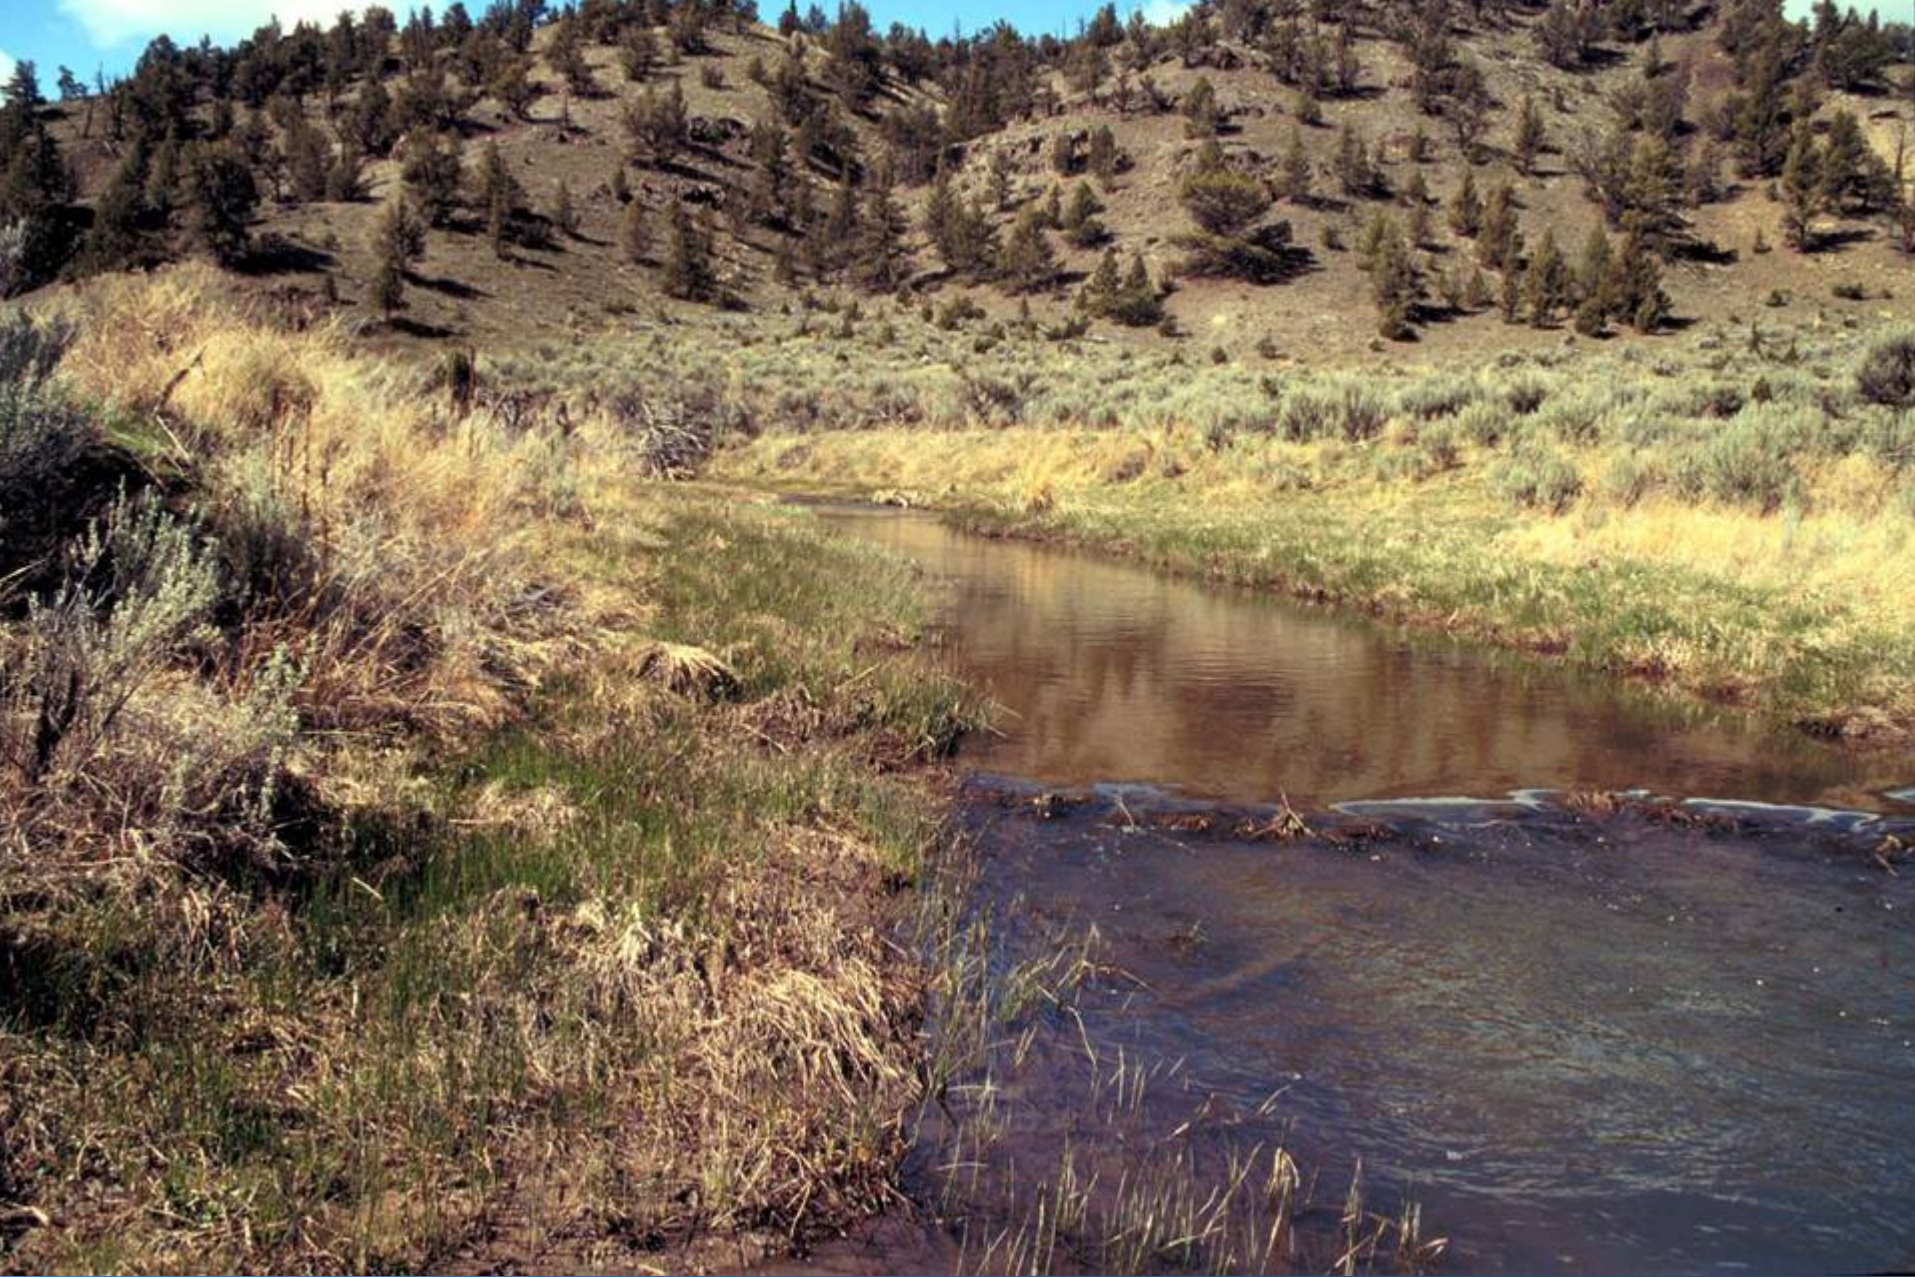
**Bear Creek April 1996**

**18.7 years**

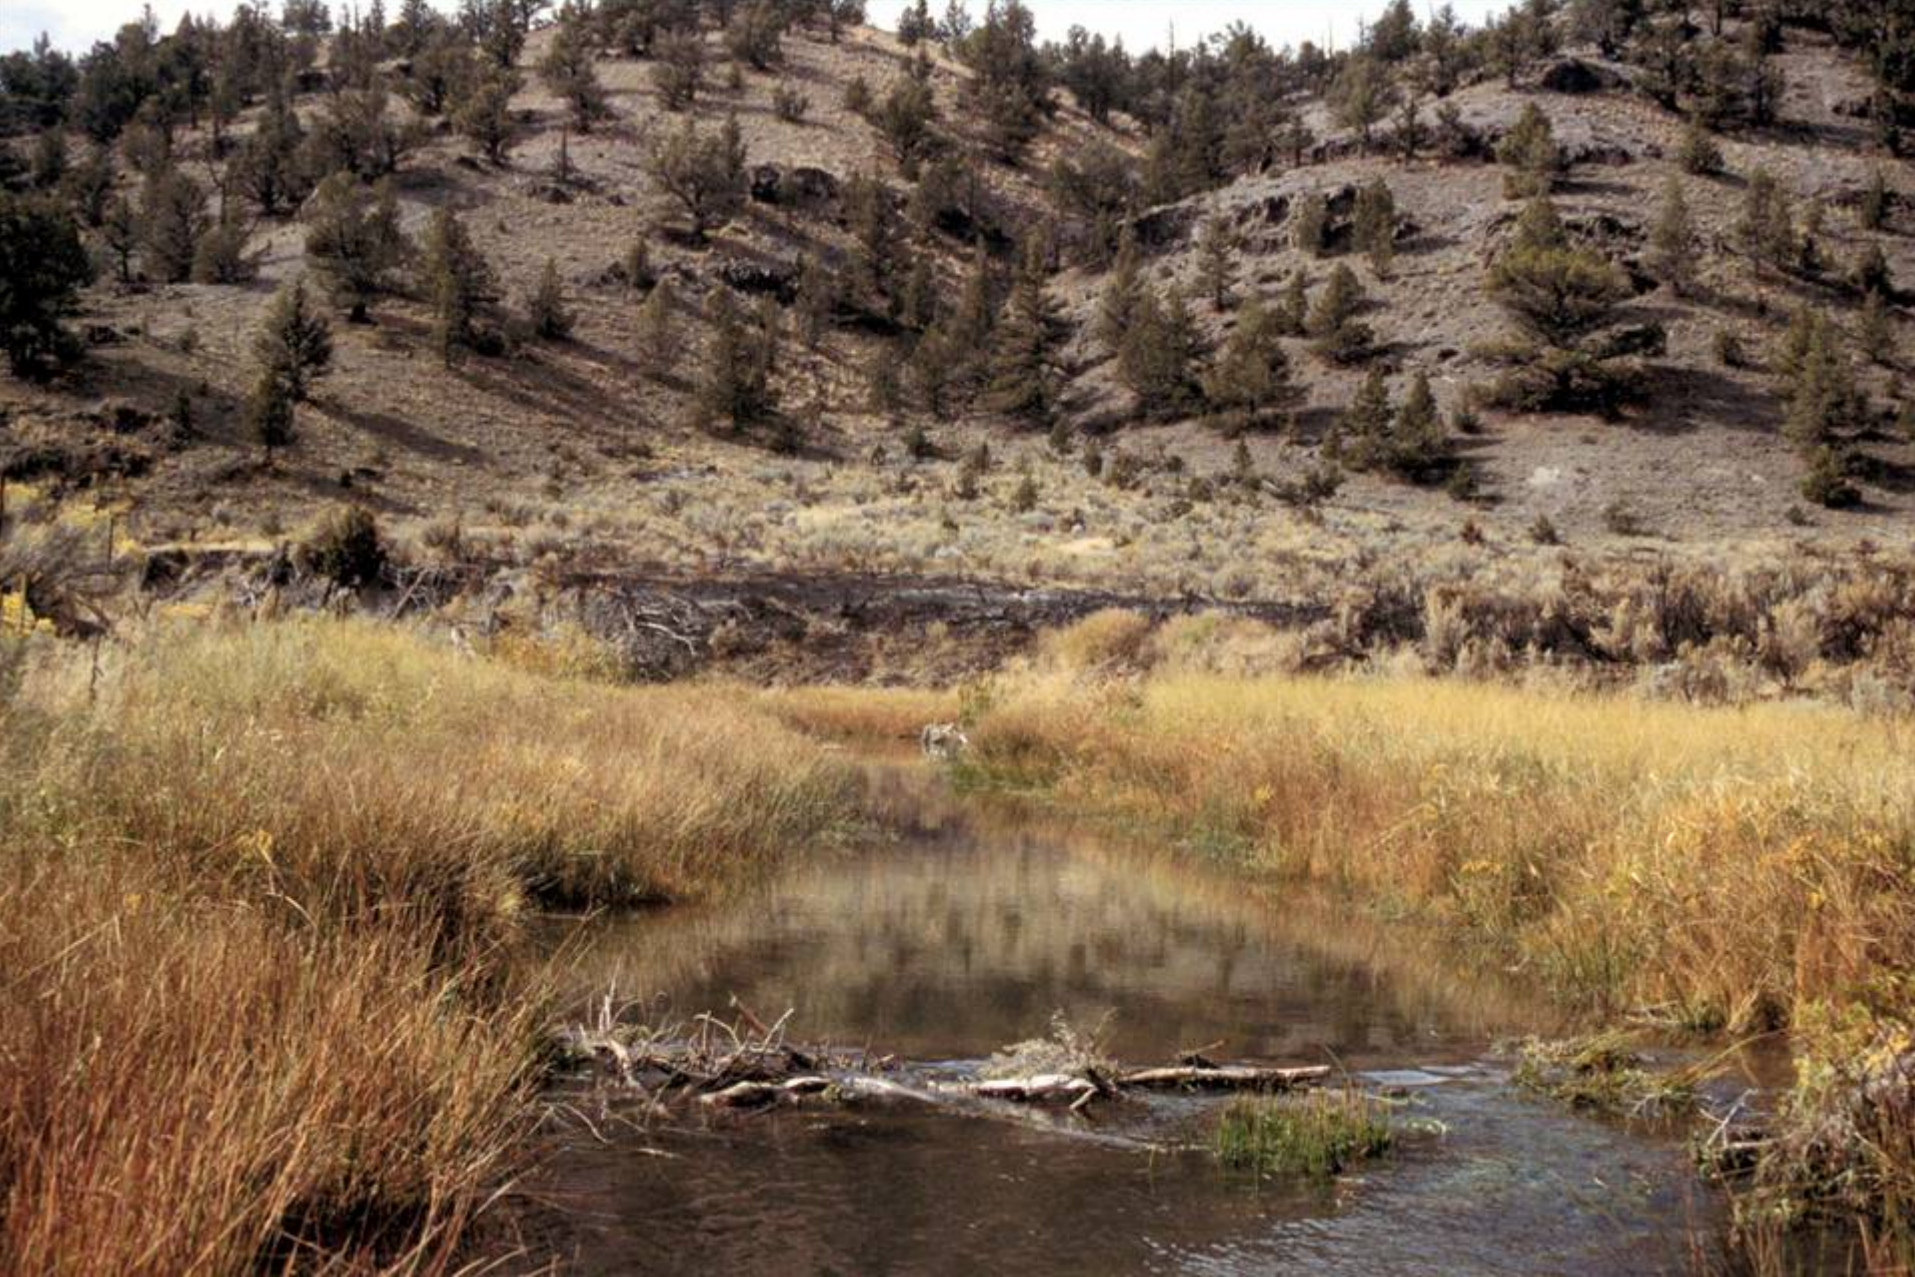
**Bear Creek Oct 1996**

**19 years**

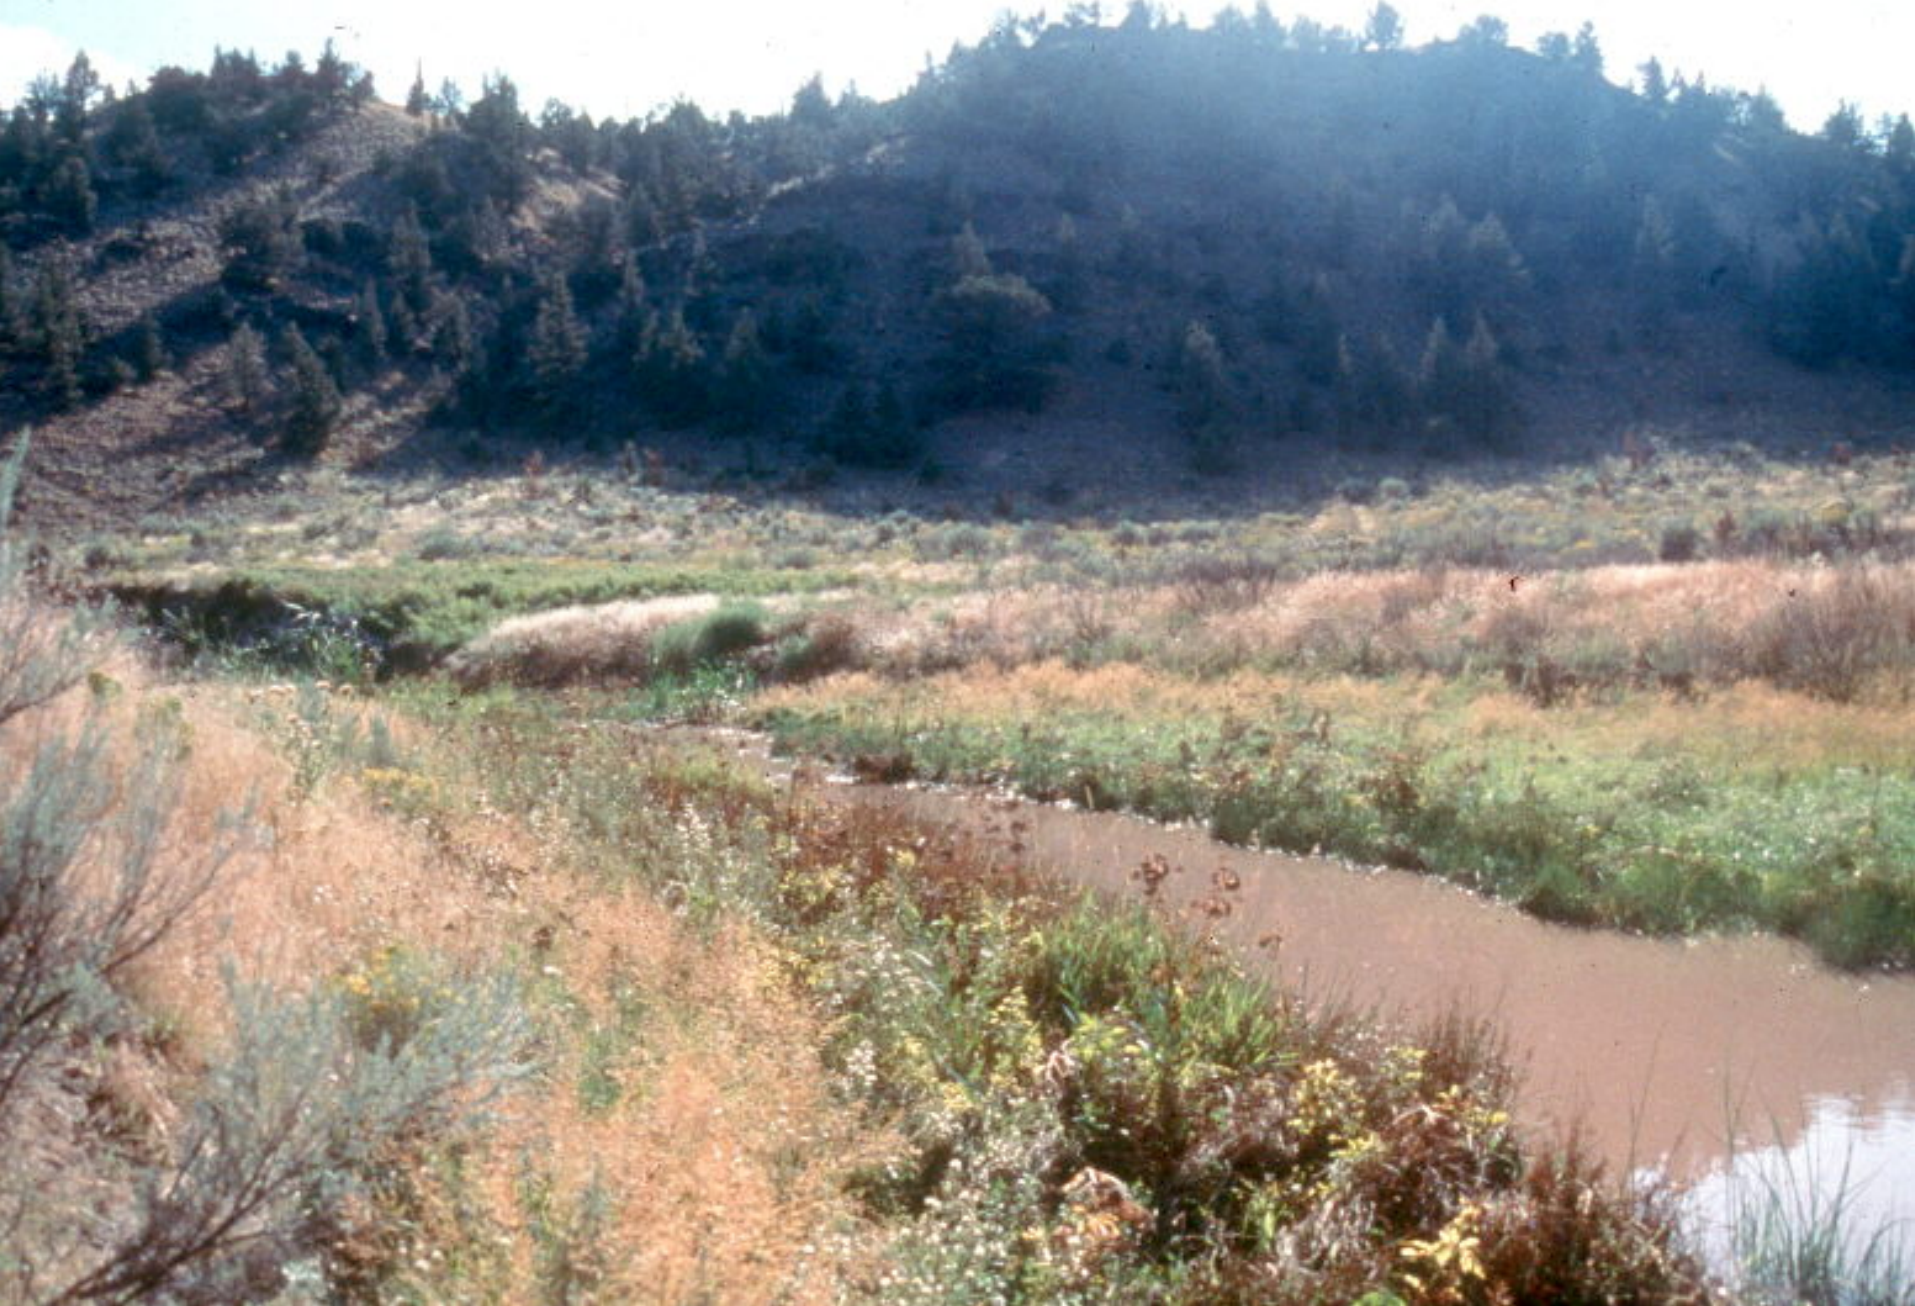
**Bear Creek Sept 1997**

**20 years**

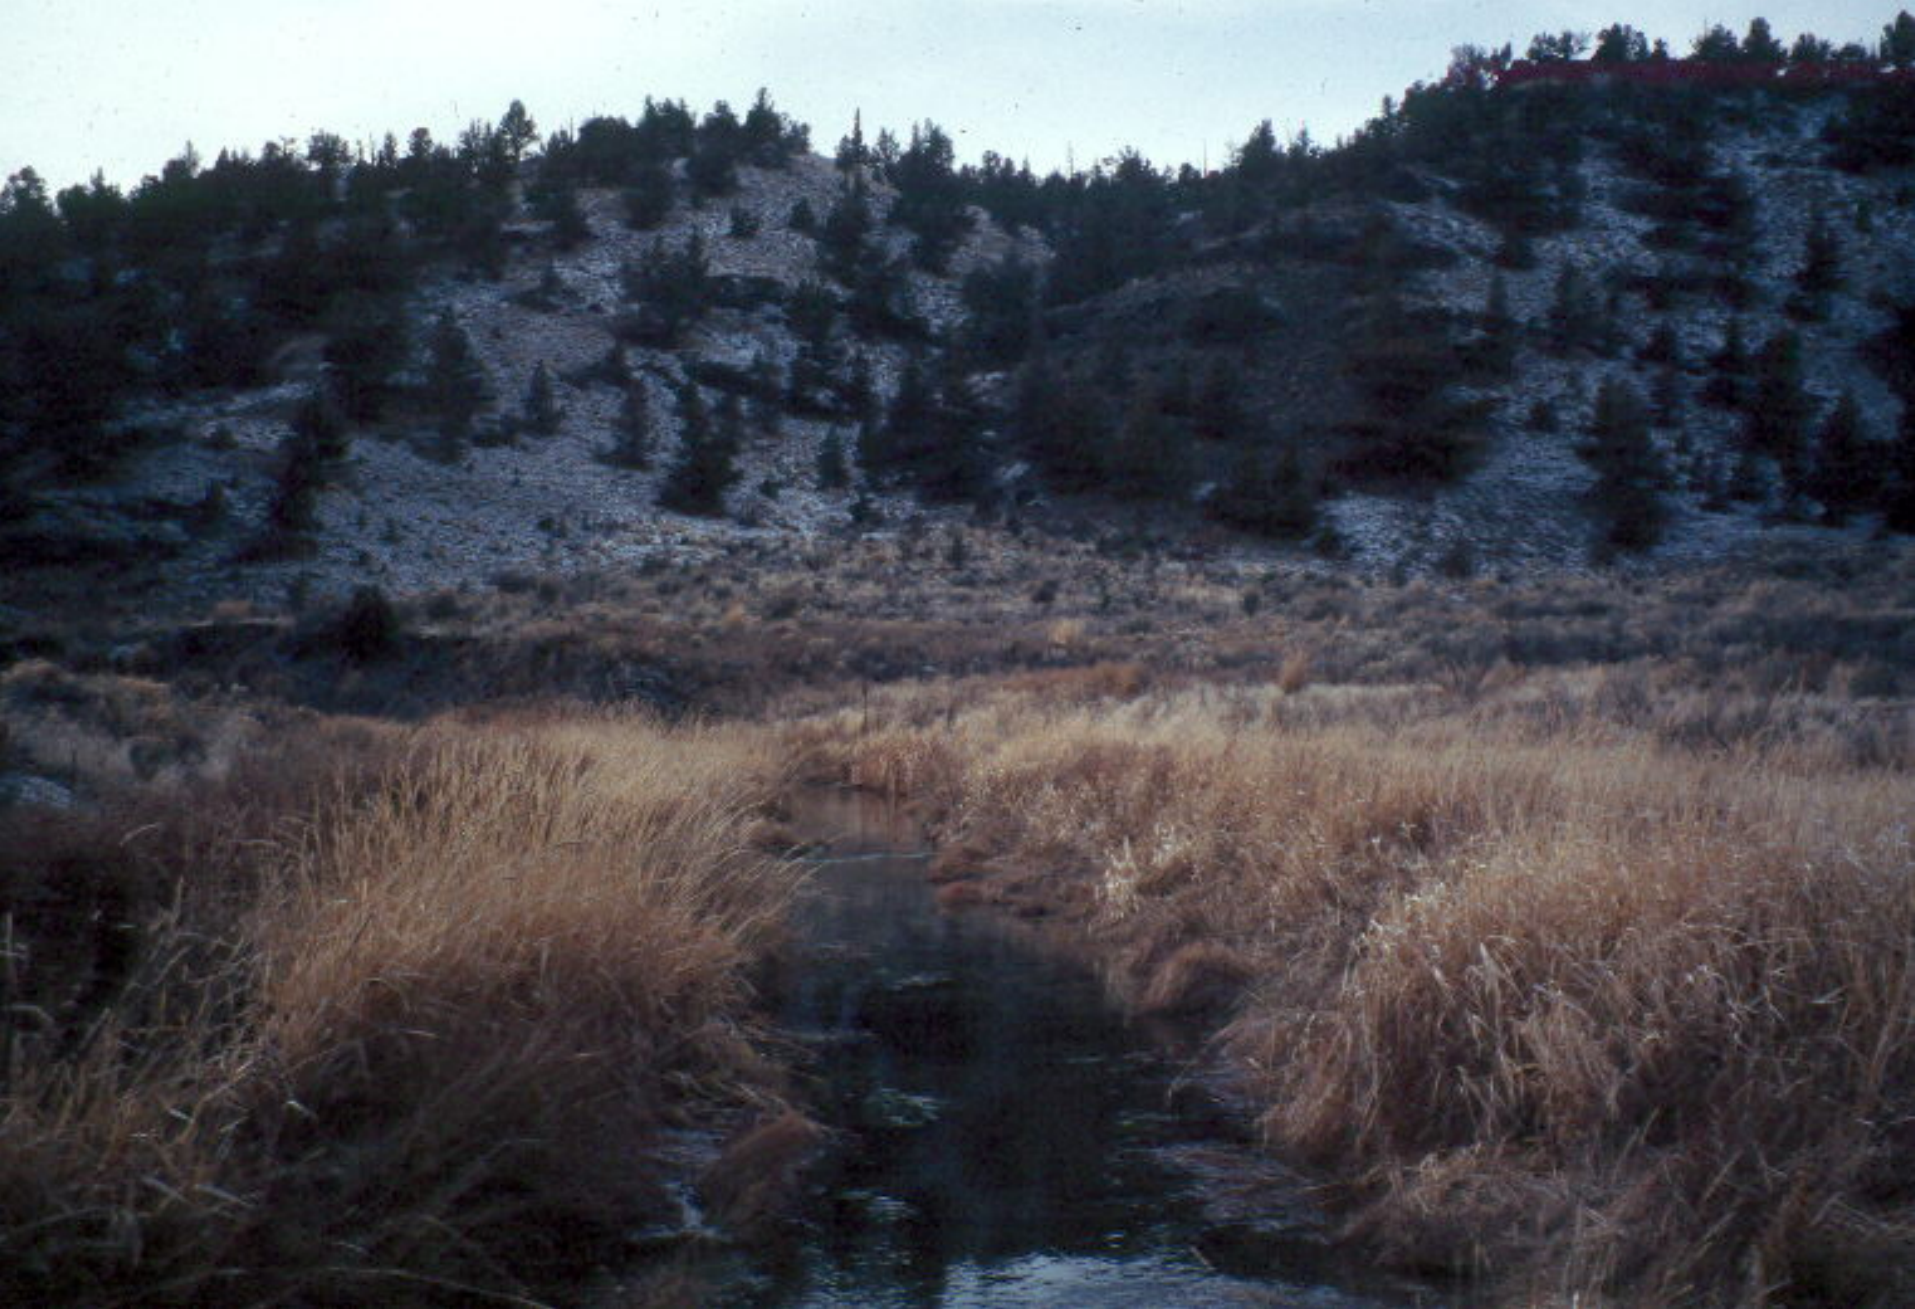
**Bear Creek Dec. 2000**

**22.5 years**

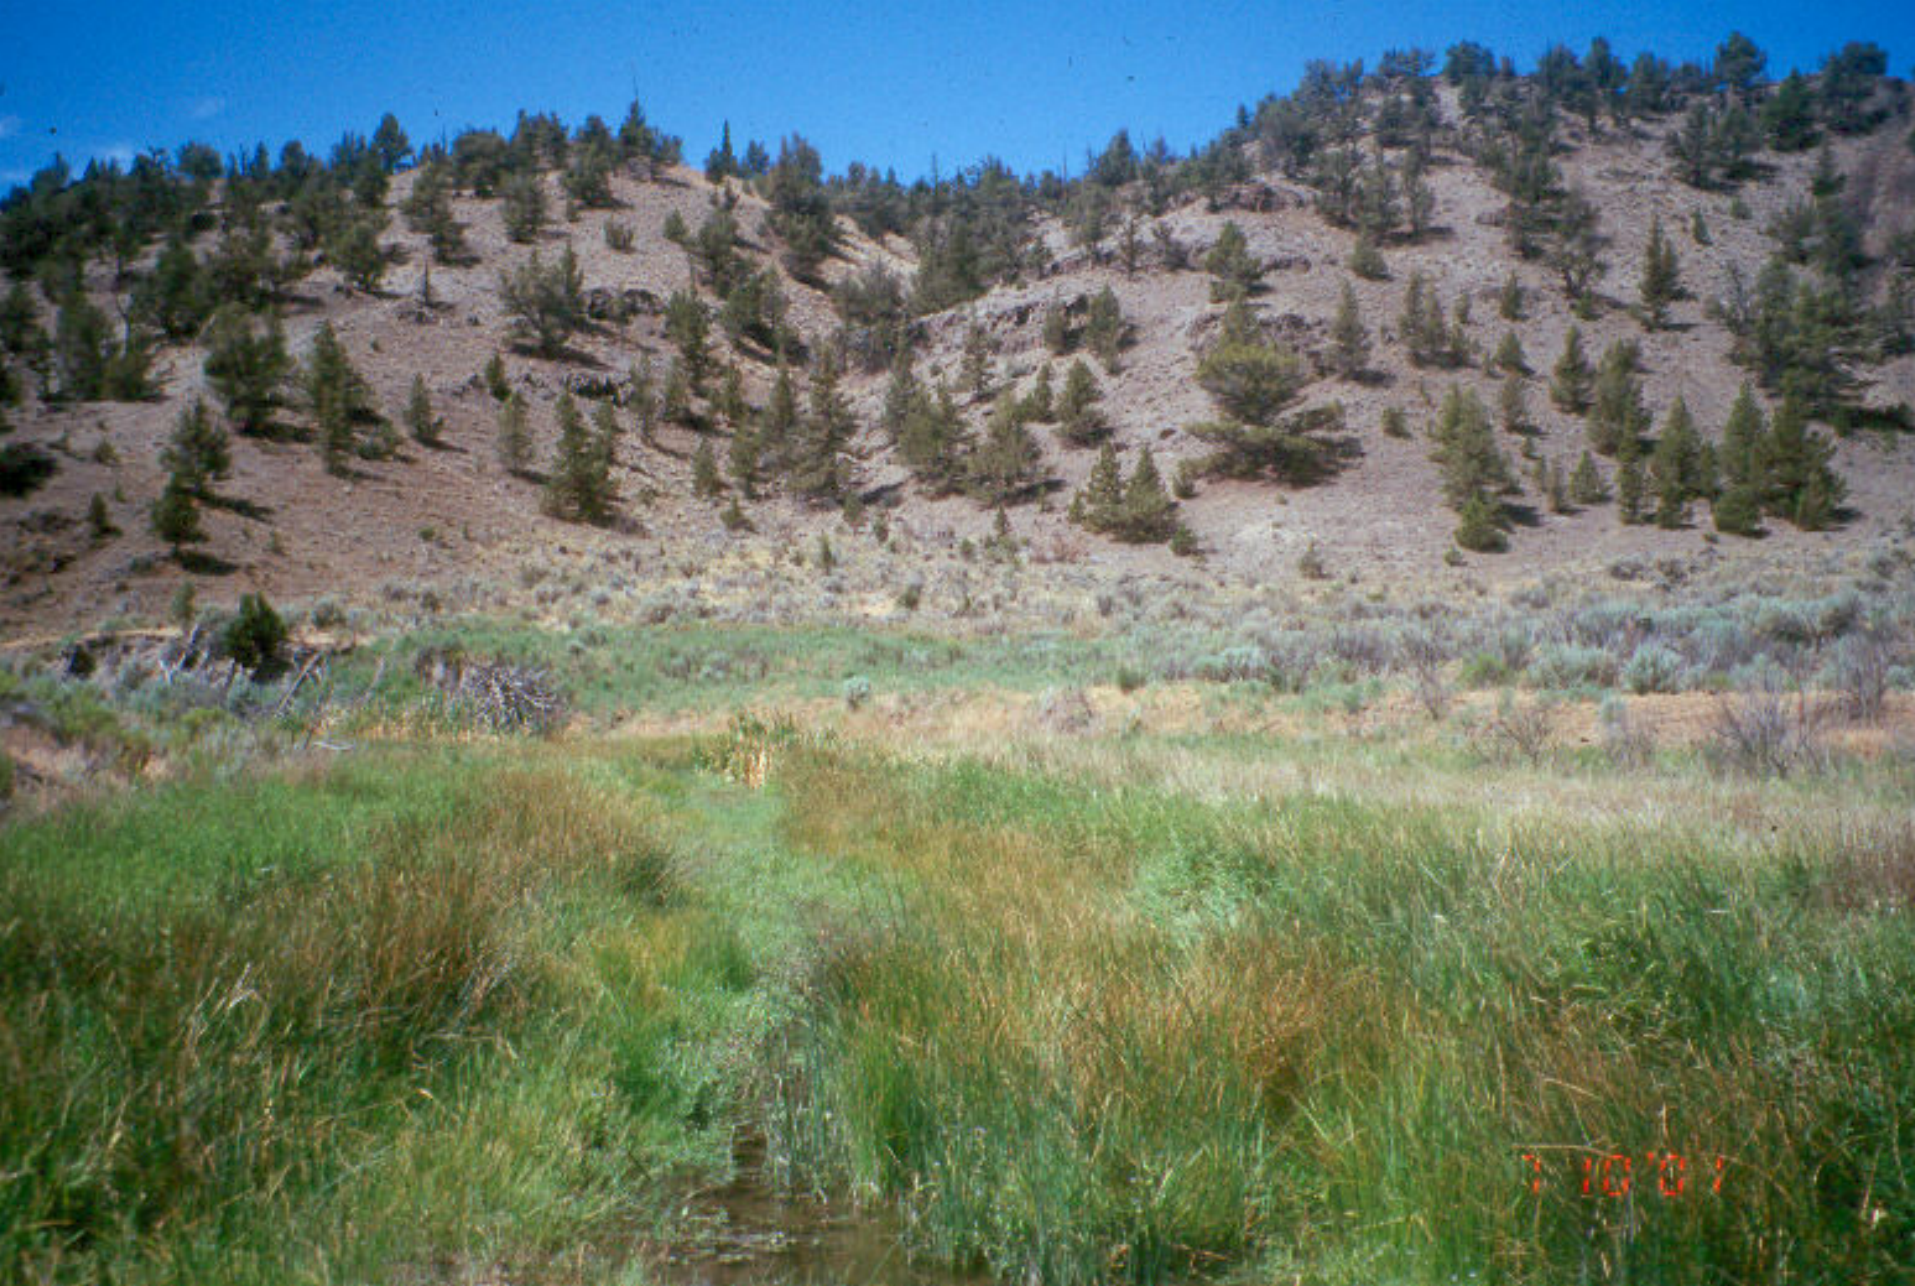
**Bear Creek July 2001**

**24 years**

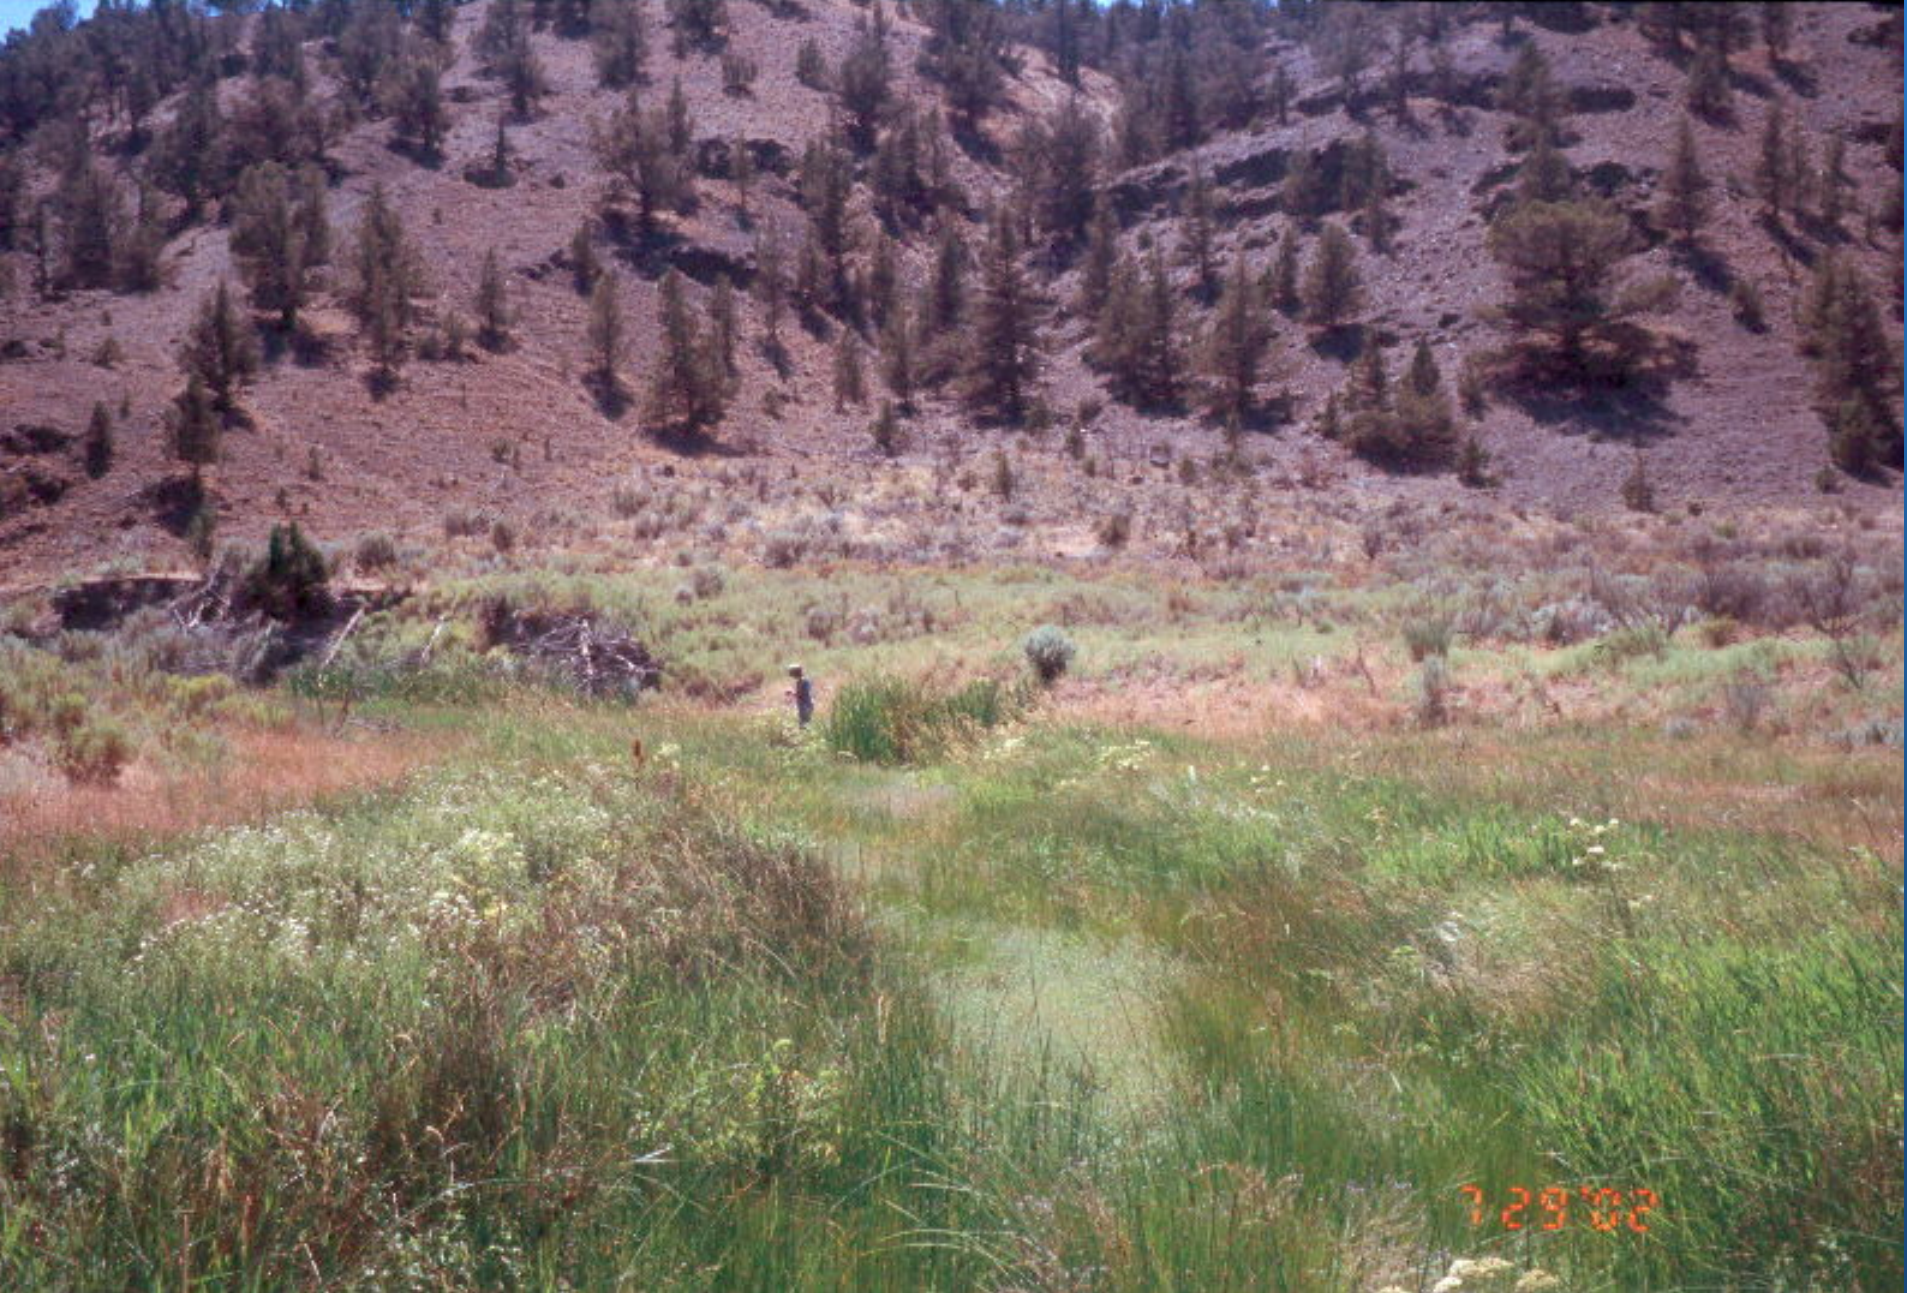
**Bear Creek July 2002**

**25 years**

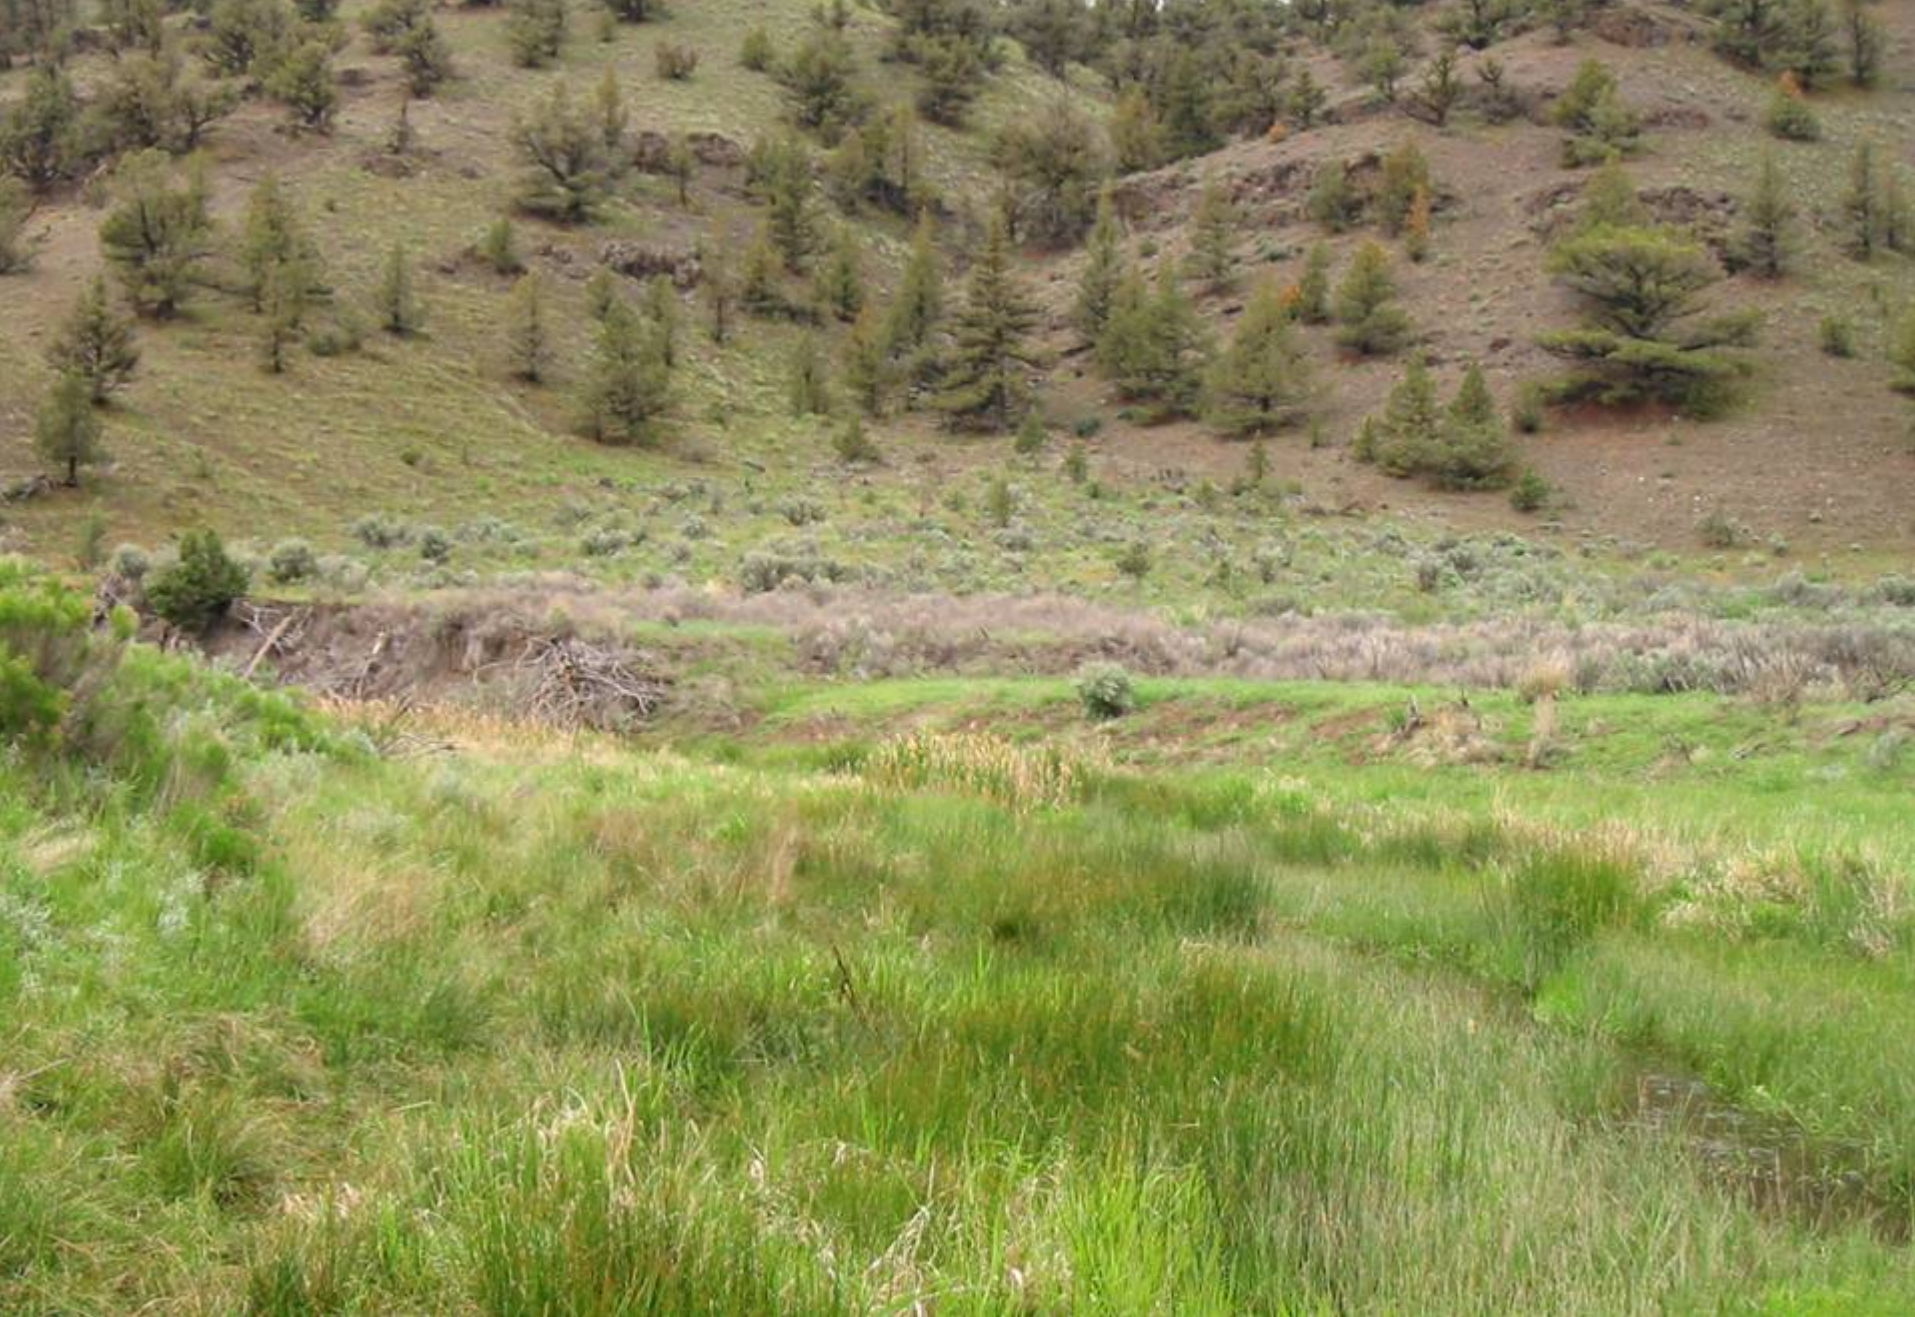
**Bear Creek May 2003**

**26 years**

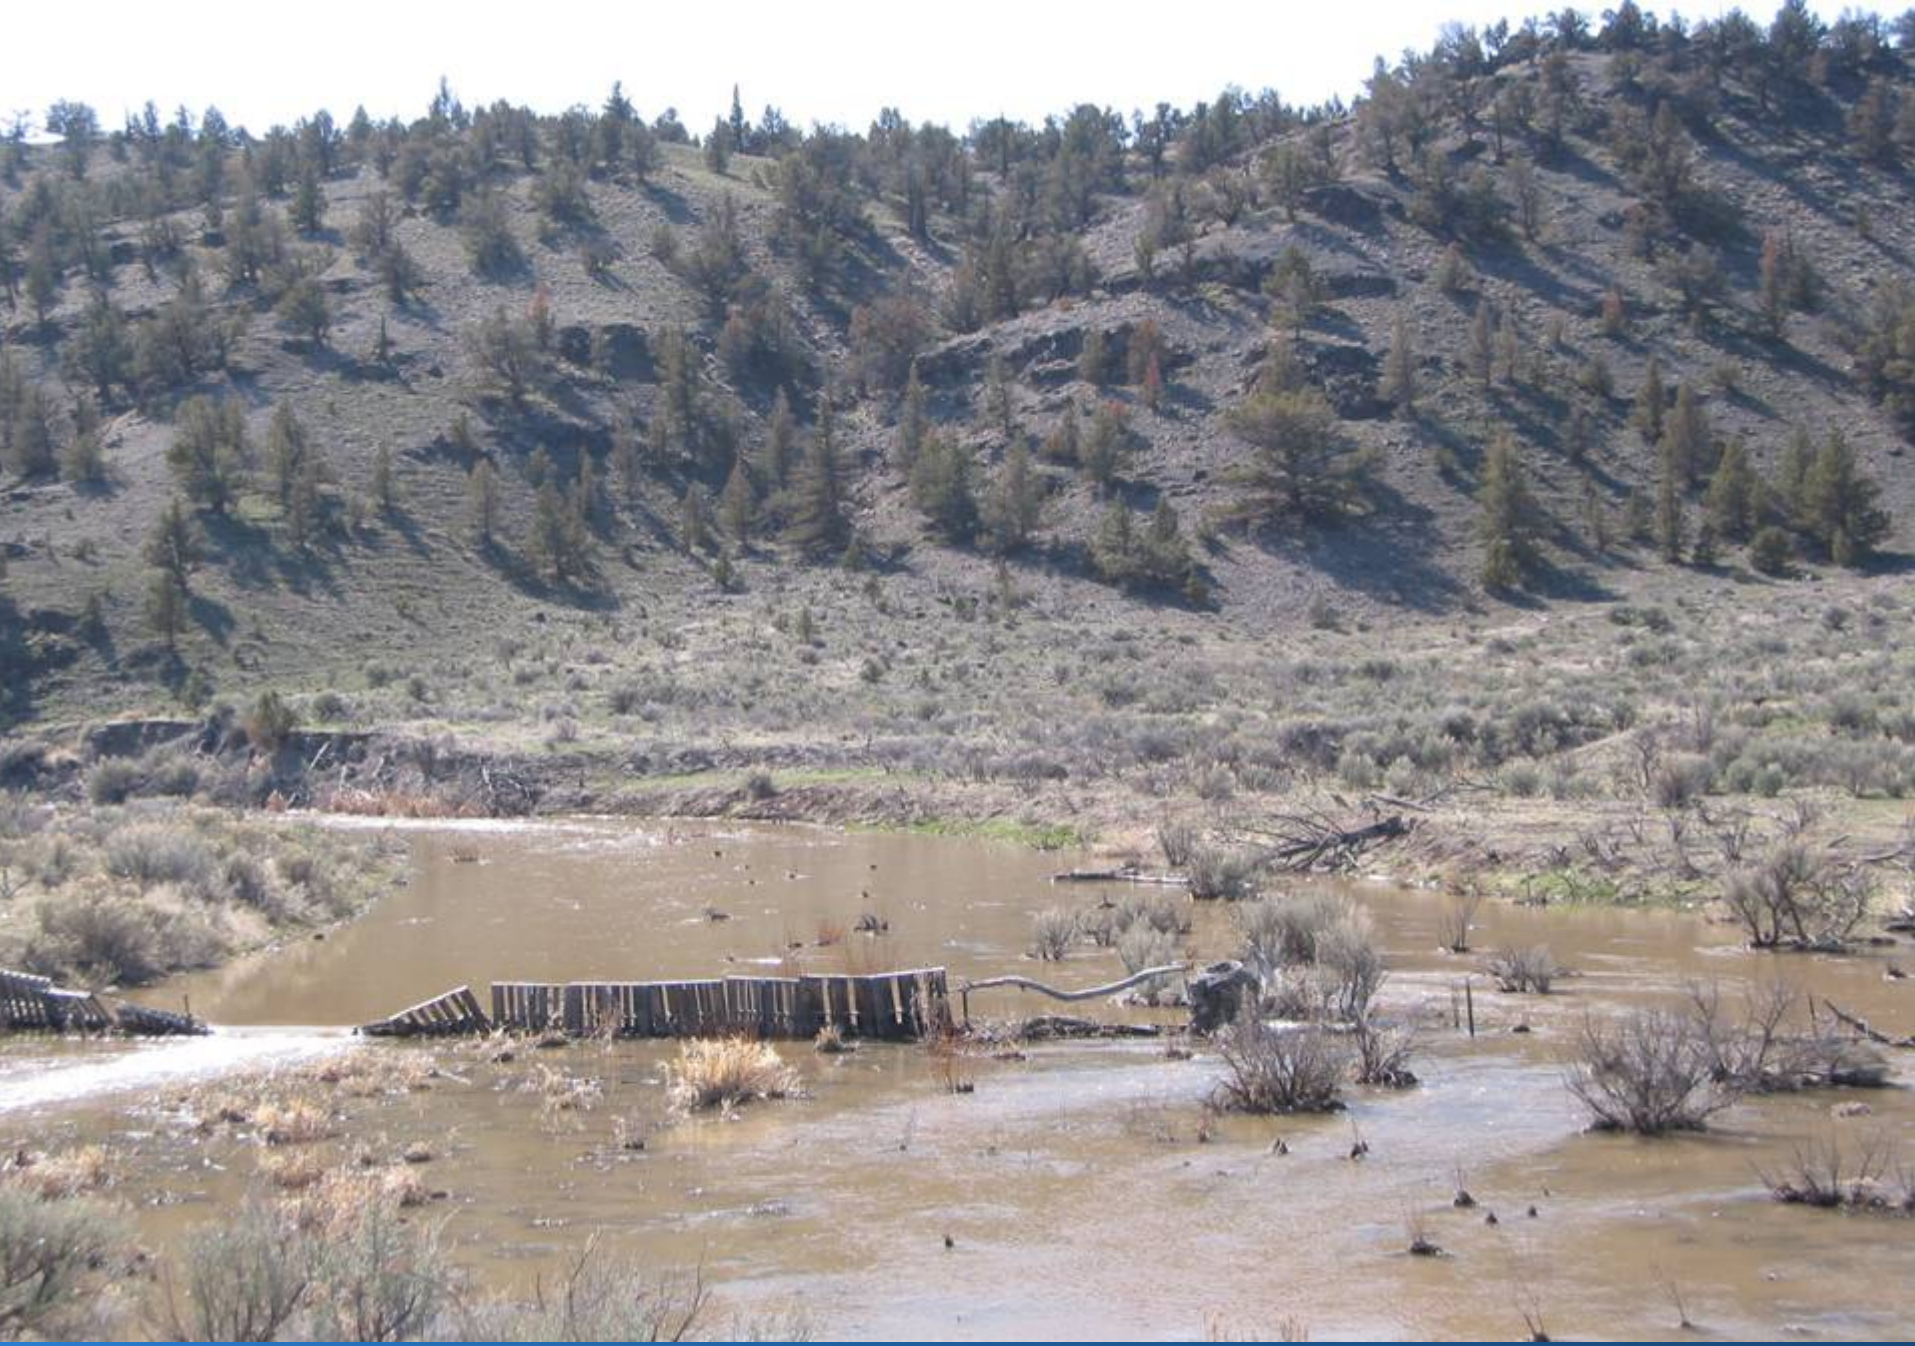
**Bear Creek March 2004**

**27 years**

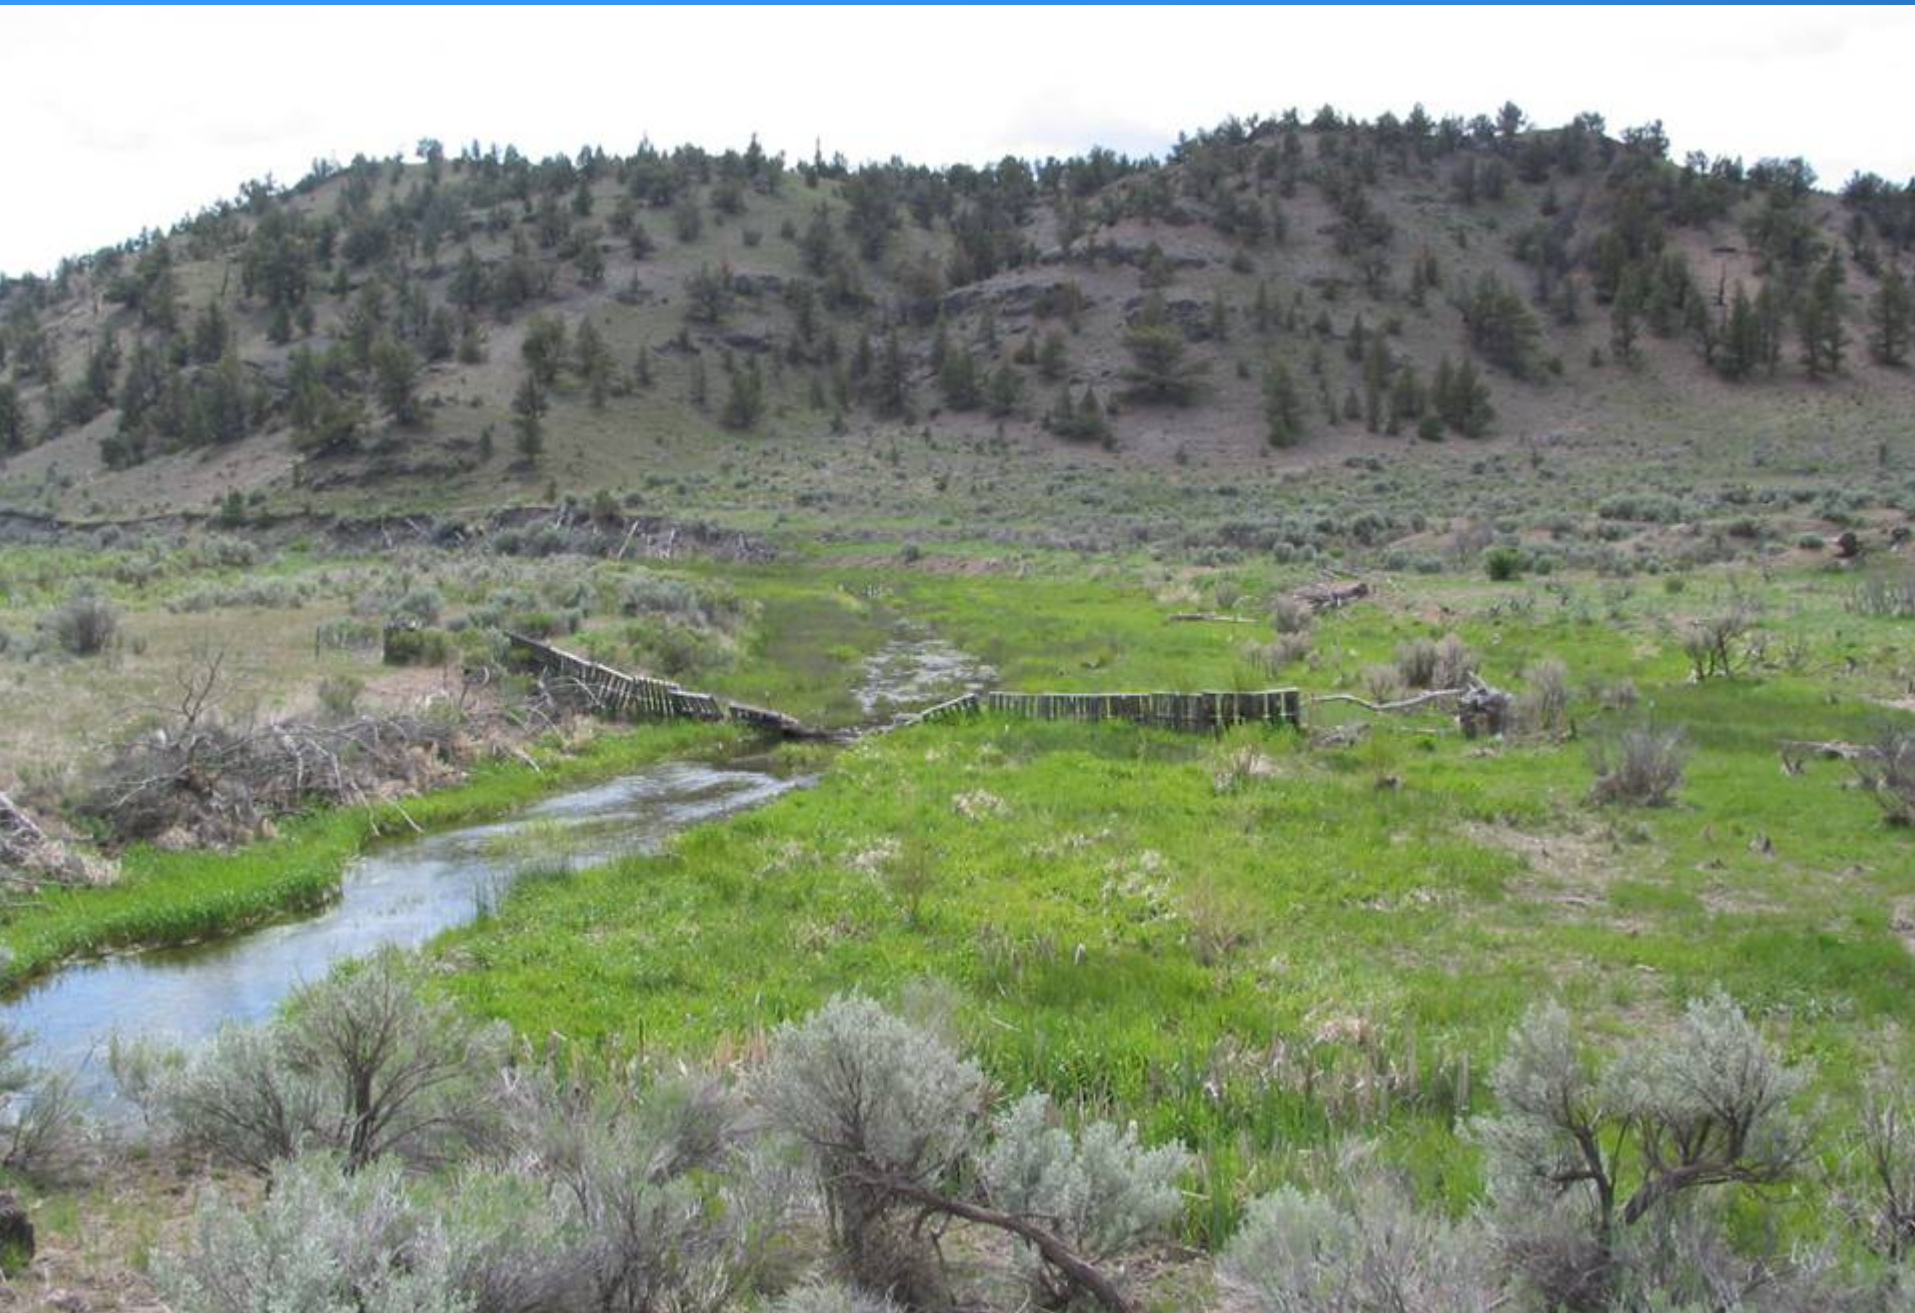
**Bear Creek May 2004**

**27 years**
