# Creeks and Communities

A Continuing Strategy for  
Accelerating Cooperative  
Riparian Restoration and  
Management

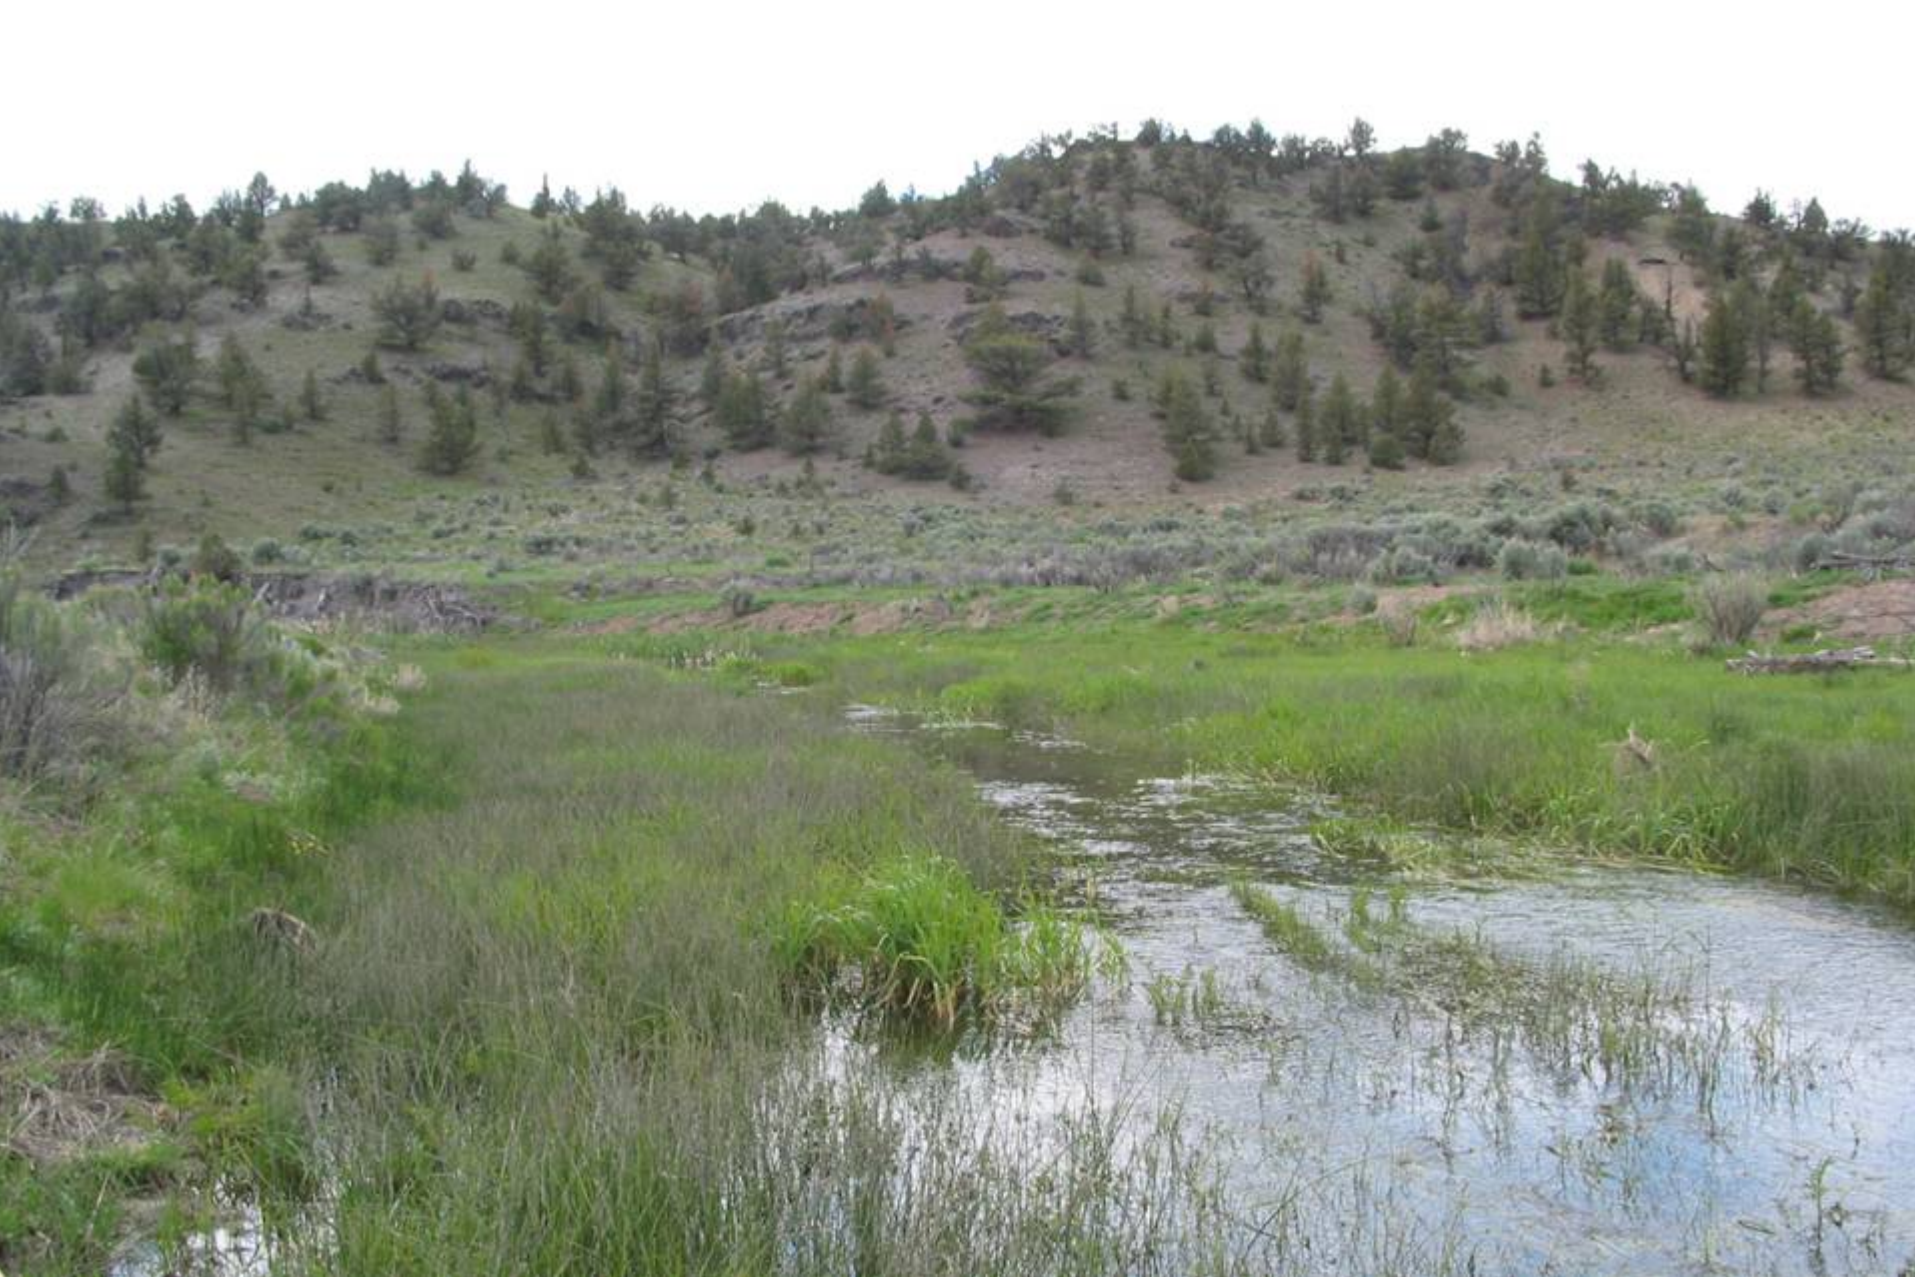
**Bear Creek May 2004**

**27 years**

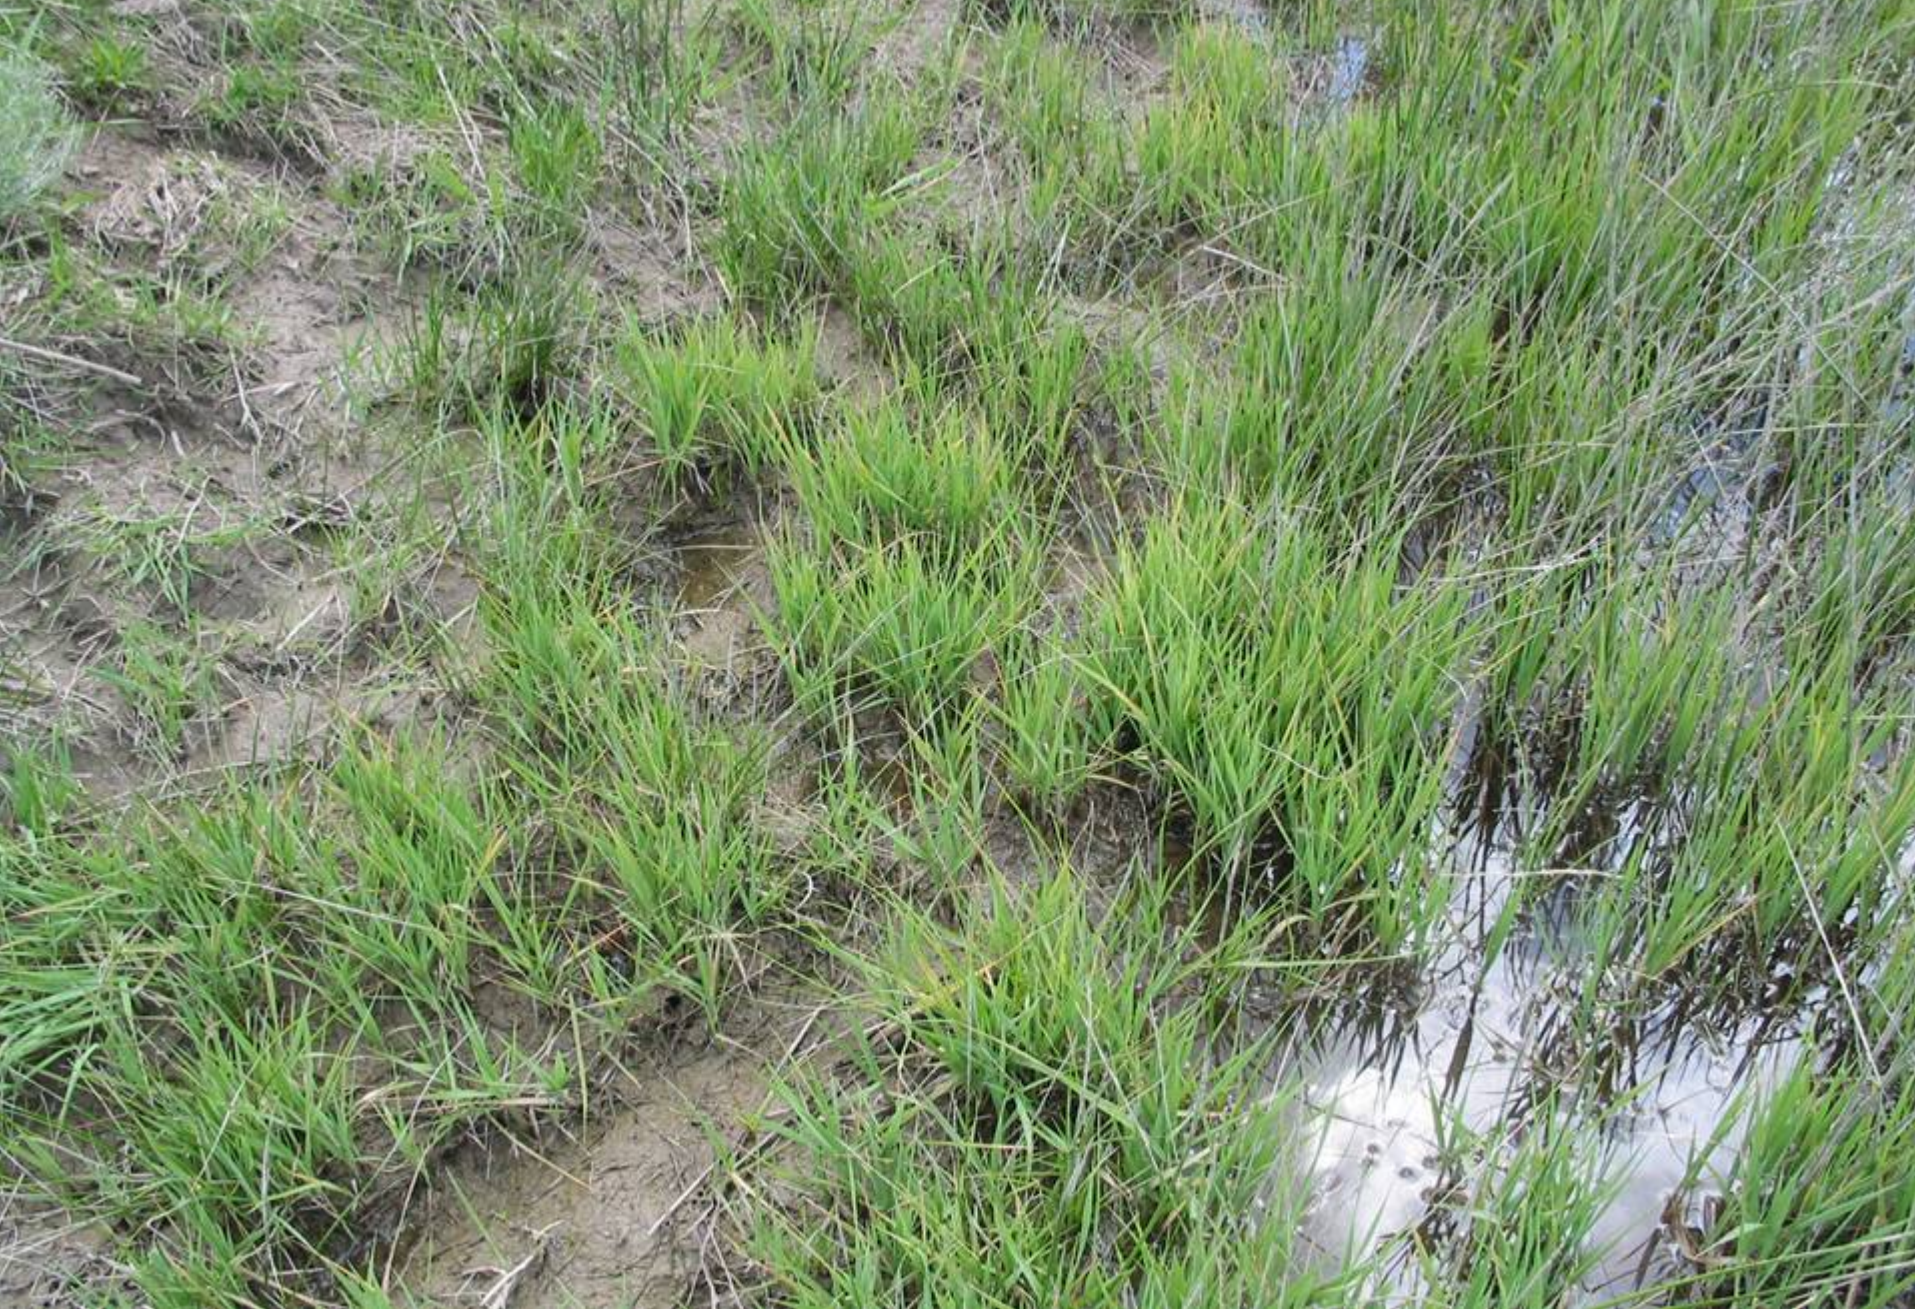
**Bear Creek May 2004**

**27 years**

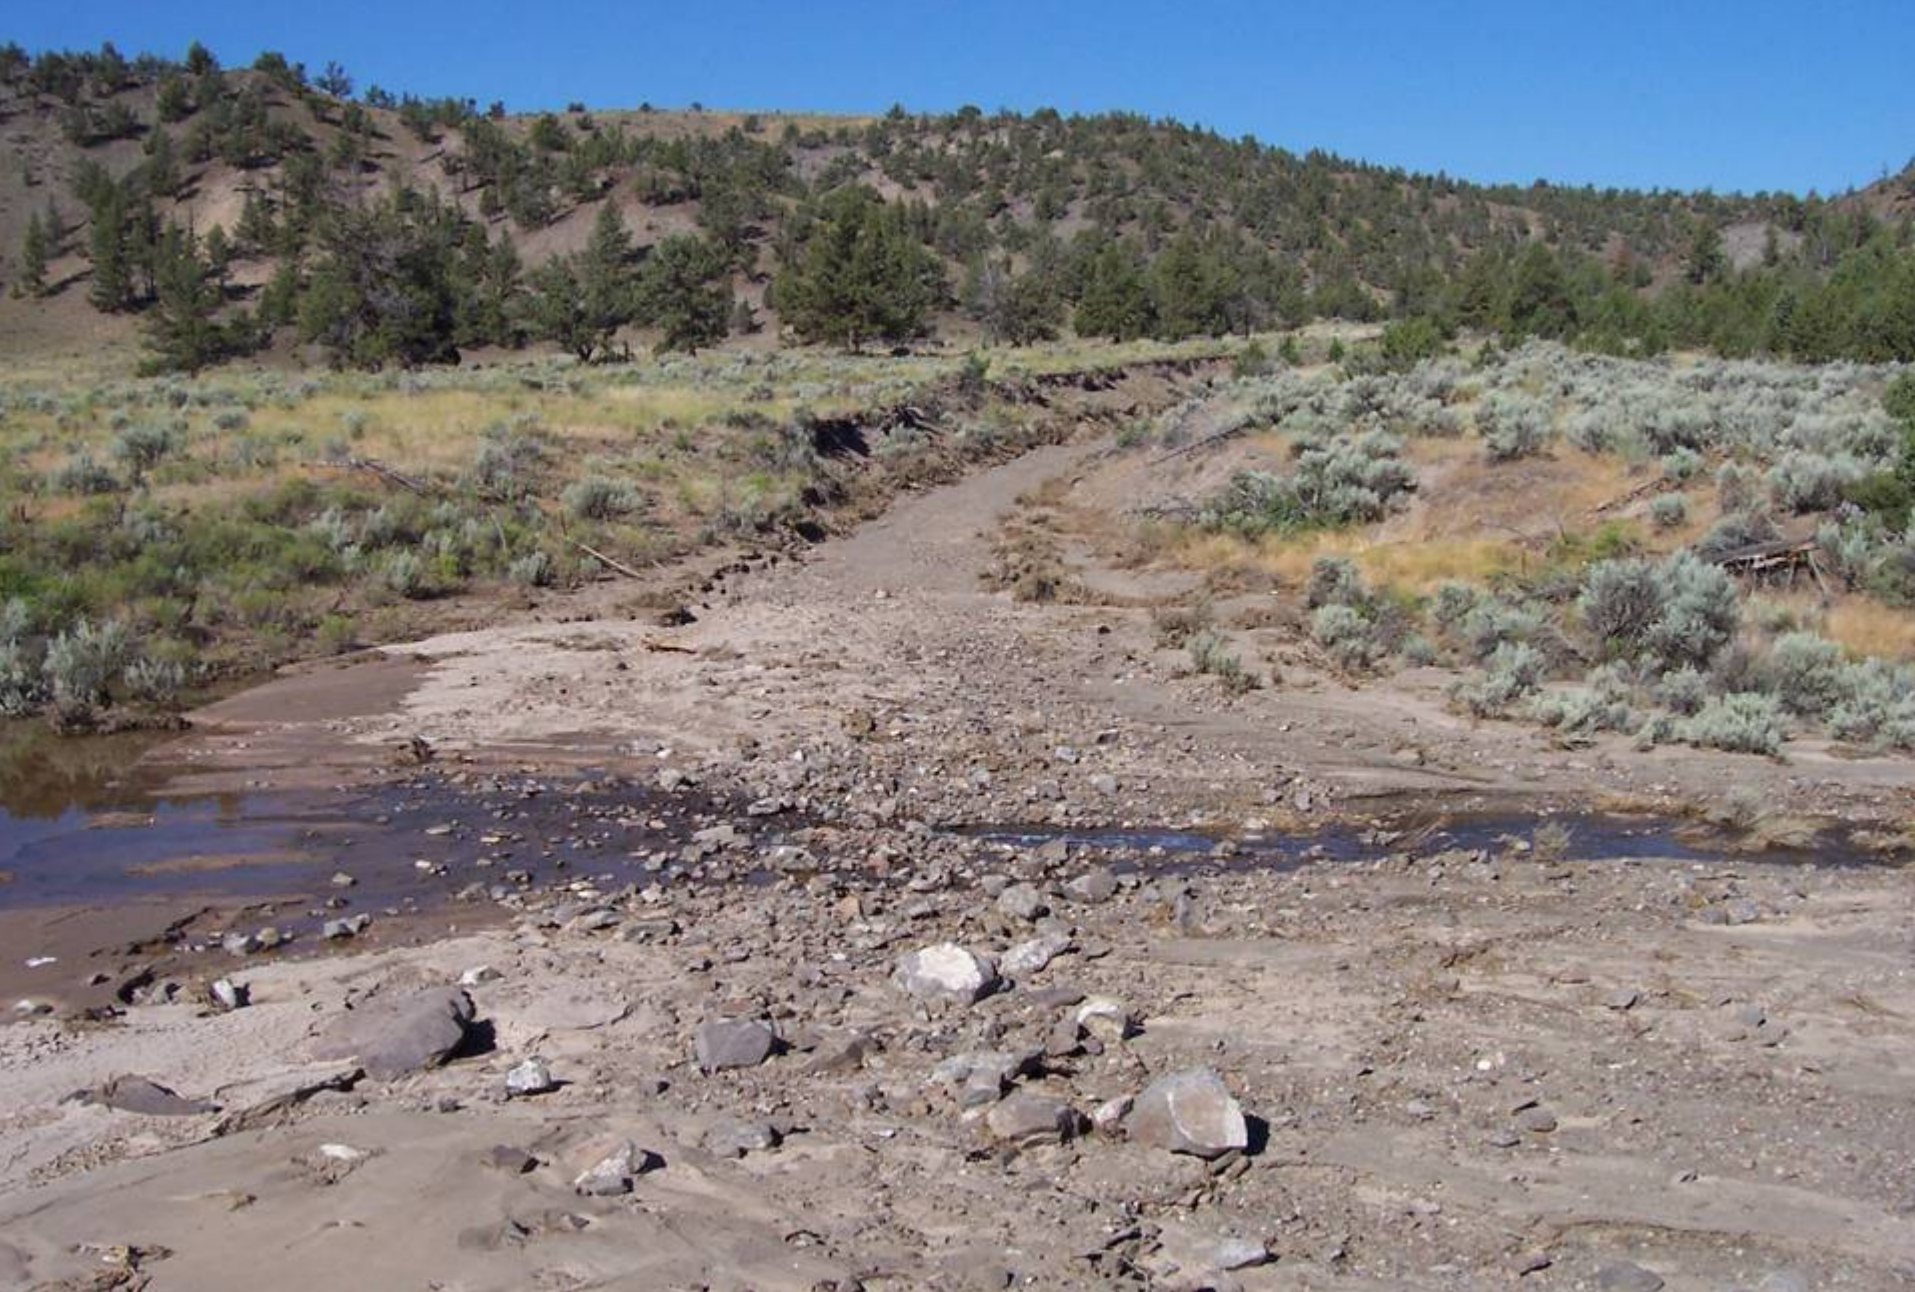
**Bear Creek July 2004**

**27 years**

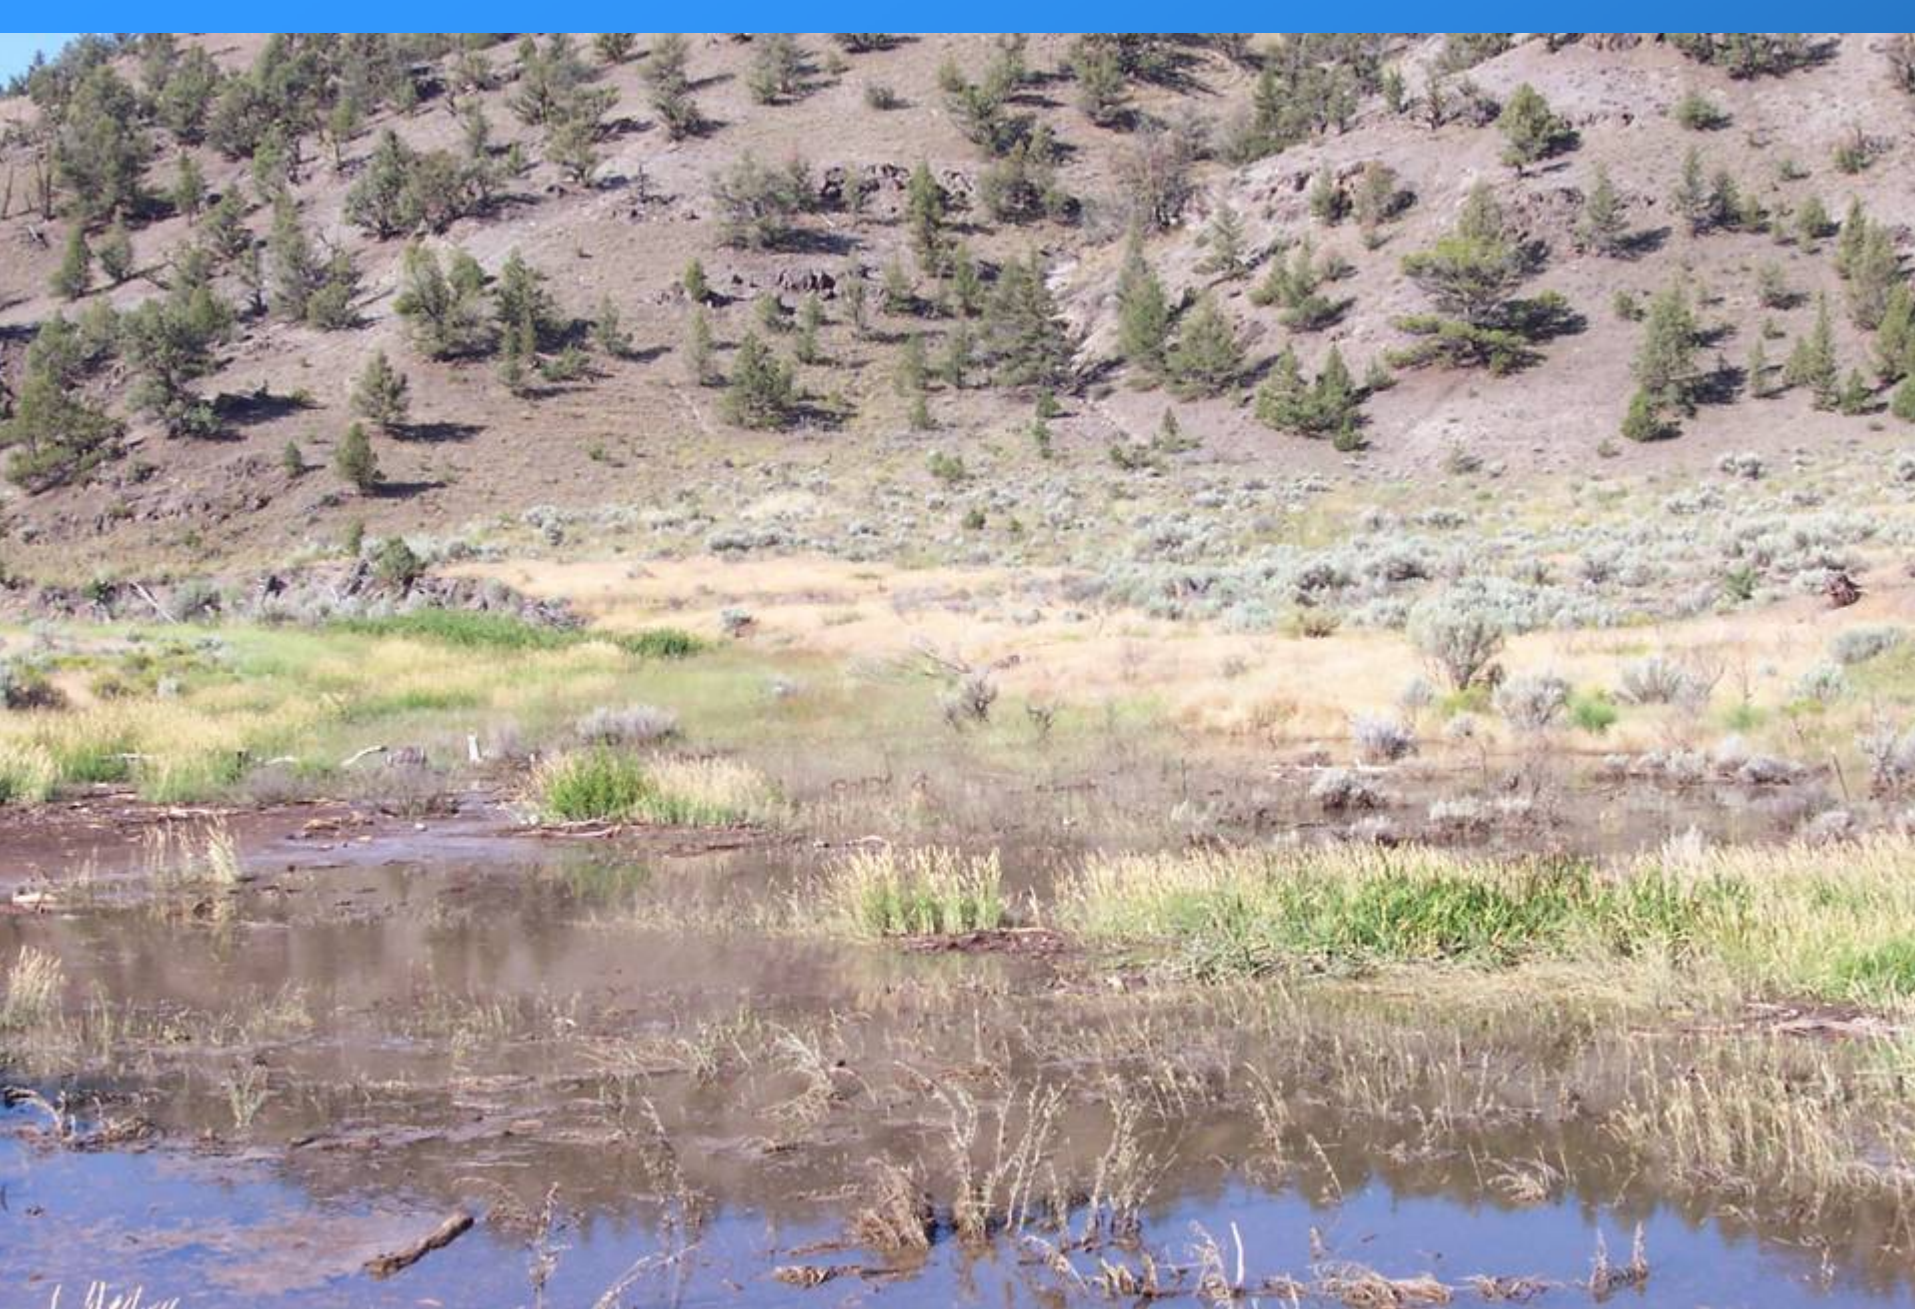
Bear Creek July 2004

27 years

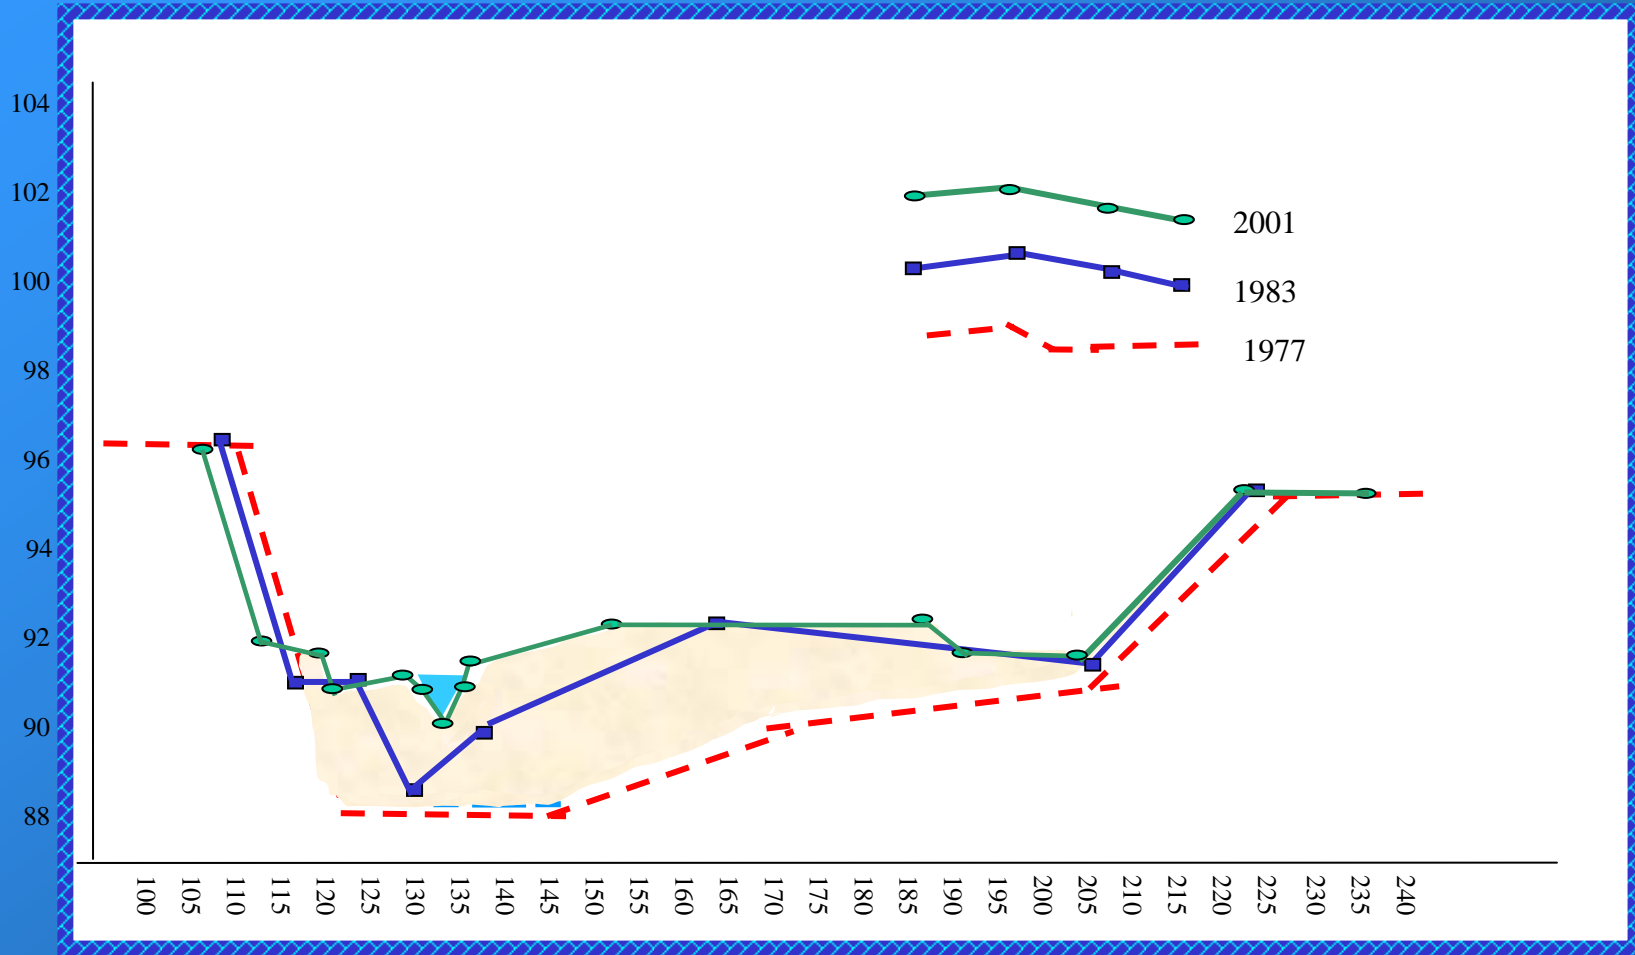
# Bear Creek : Change In Channel Profile (1977 - 2001)

## 2001

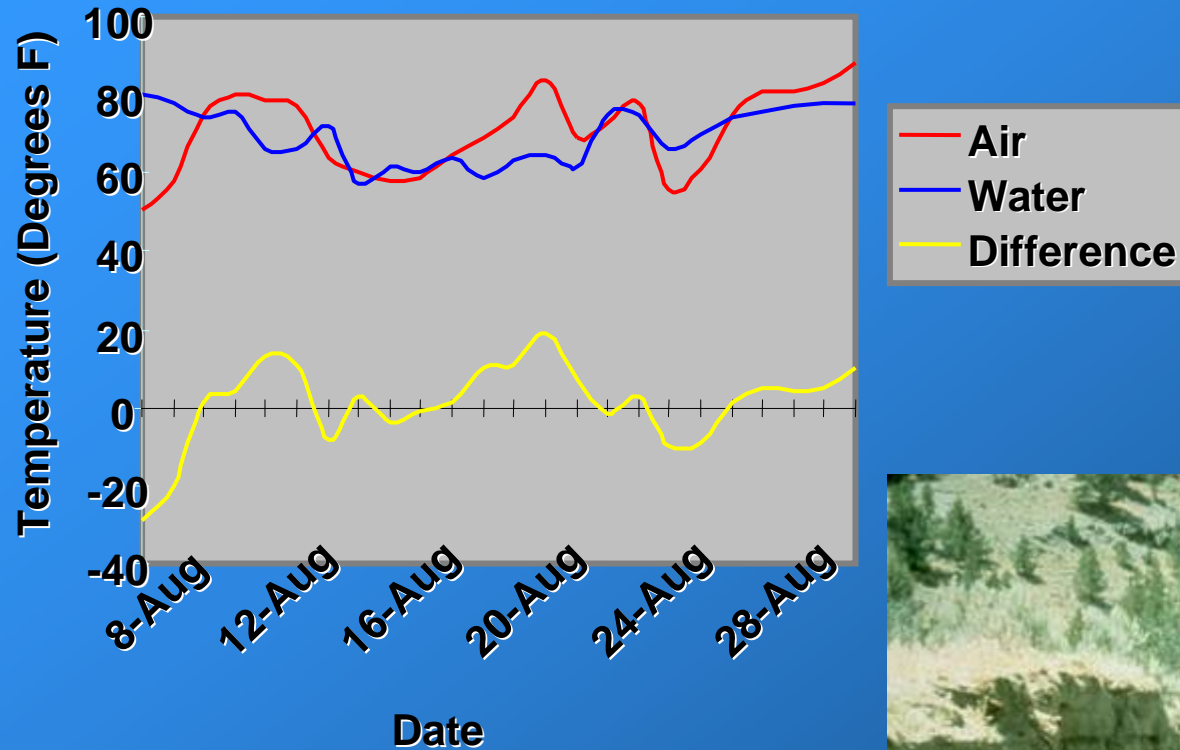
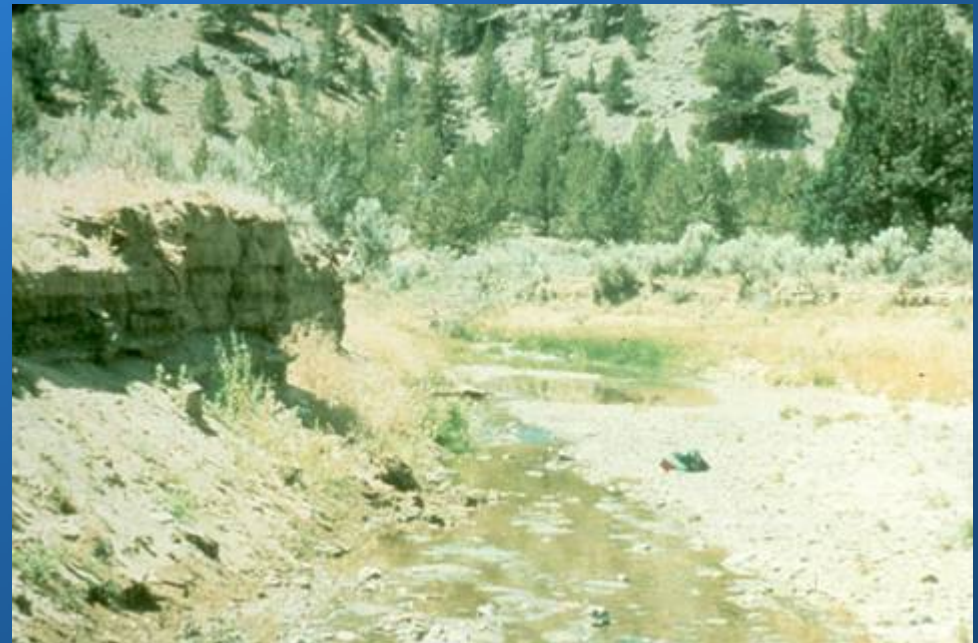
# Difference in Air & Water Temperatures

Bear Creek - Central Oregon  
1976

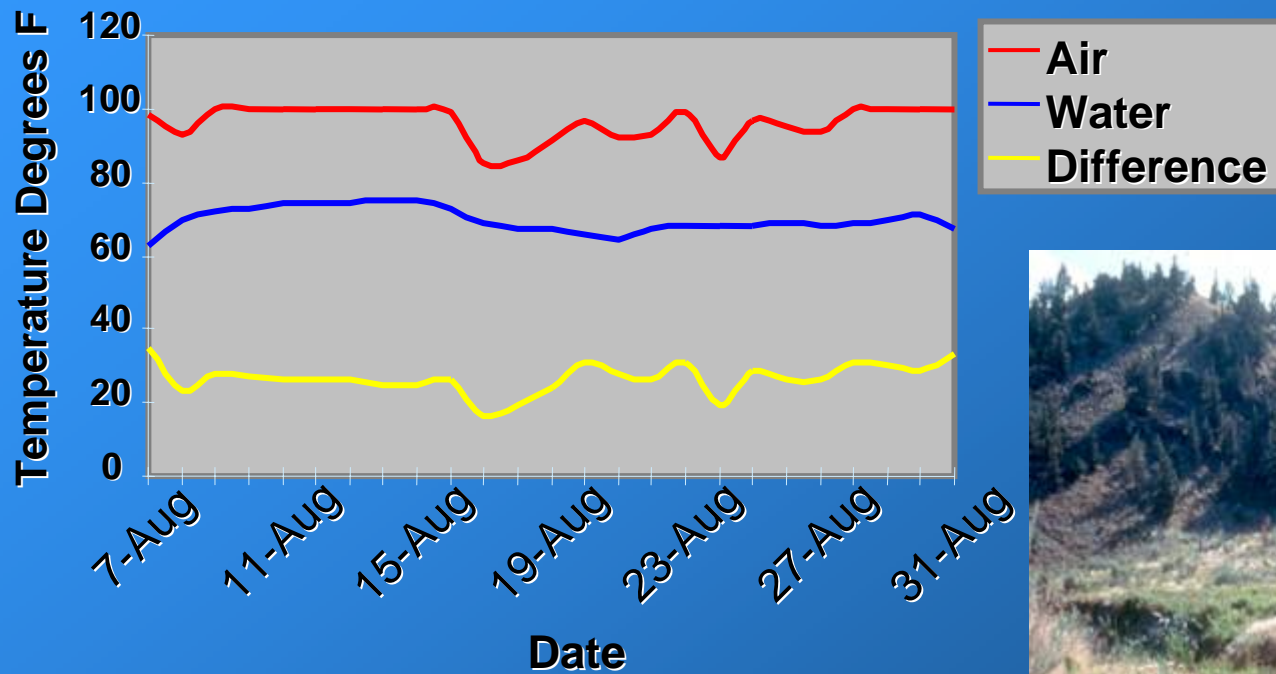
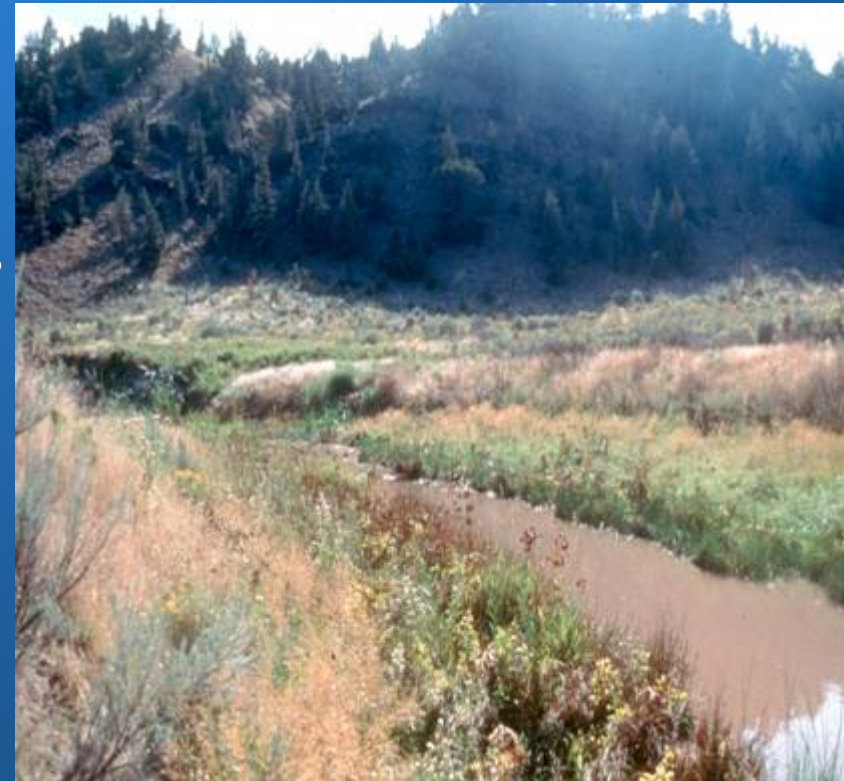
# Difference in Air & Water Temperatures

Bear Creek - Central Oregon  
1998
