Research
Paper
FPL-RP-590

Field Performance of Timber Bridges

19. North Yarmouth Stress- Laminated Truss Bridge

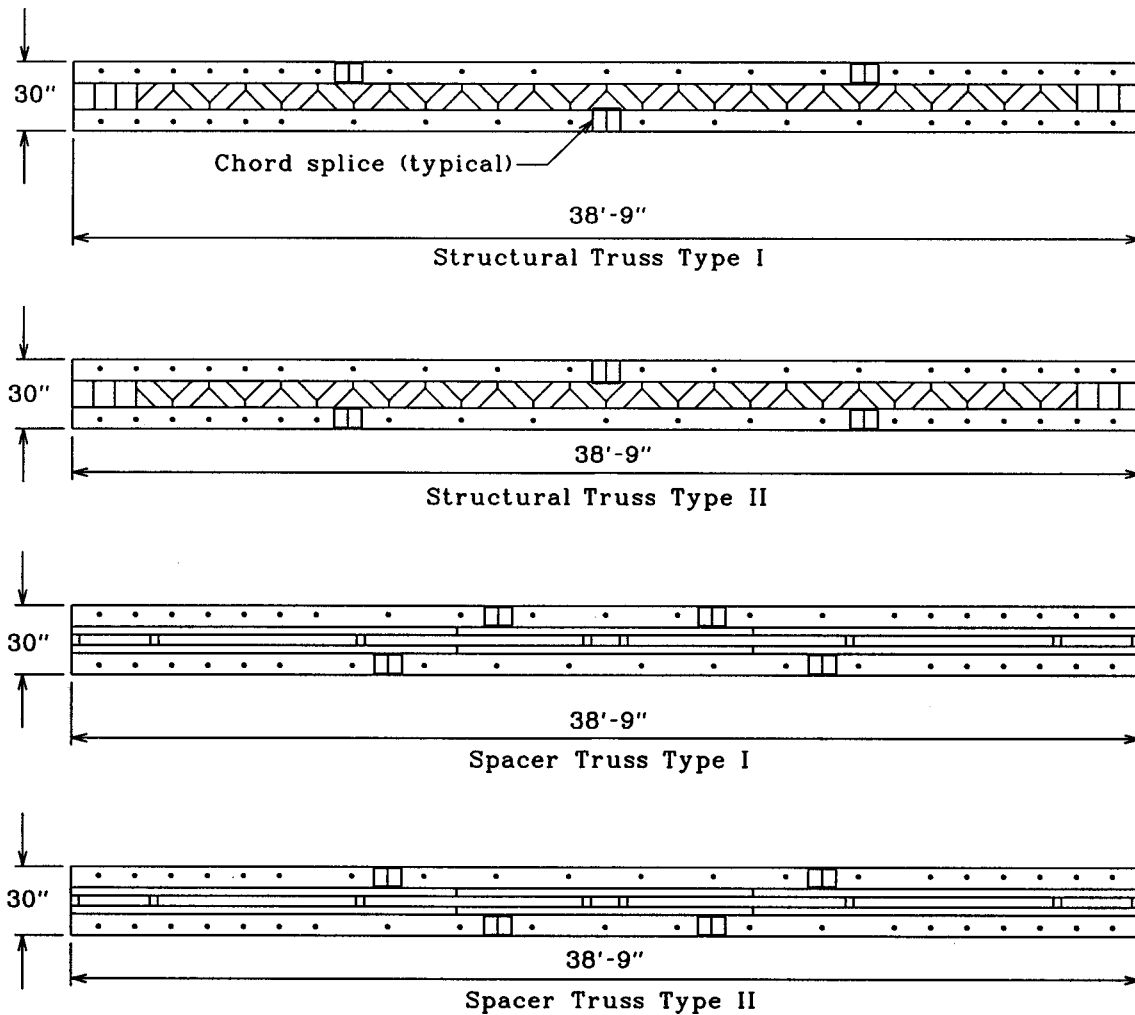
Figure 3—Profile of structural and spacer trusses.

Two truss configurations were used: structural and spacer. Each structural truss had 26 diagonal webs that connected the top and bottom chords. These were placed next to spacer trusses. The spacer trusses have deeper top and bottom chords and were connected with only enough metal plate connector joints and vertical webs to allow the truss to be handled as a single unit. The deeper chords of the spacer trusses covered the metal plate connectors of the structural trusses. This detail prevented the structural trusses metal plate connectors from withdrawing as a result of cyclic loading and moisture and temperature changes.

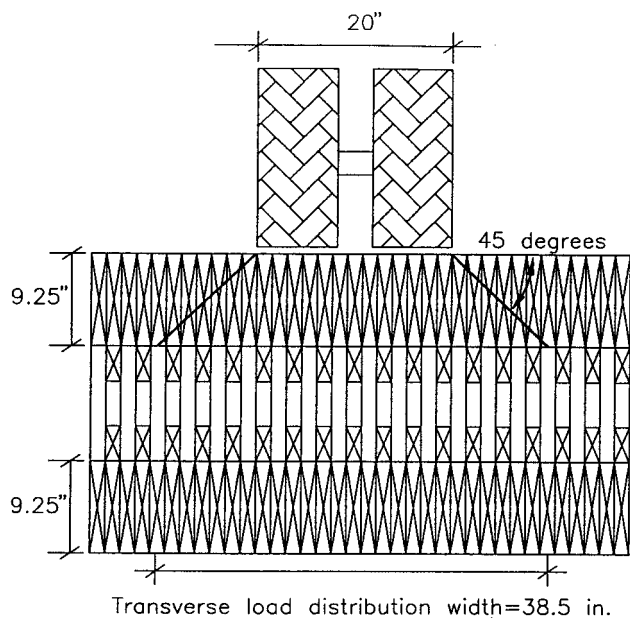
Figure 4—Simplified depiction of load distribution.

The second research program developed and verified a simplified transverse load analysis procedure for stress-laminated truss decks (Altmore 1995). The analysis procedure assumes that the AASHTO design truck wheel load is distributed transversely at a 45° angle through the thickness of the top chord of the bridge (Fig. 4). Therefore, normal to the direction of the span, the wheel load is distributed over the width of the tire plus twice the thickness of the top chord of the deck. For deflection calculations, the distribution width was increased by 15%, paralleling the AASHTO recommendation for solid stress-laminated decks (AASHTO 1991). A two-dimensional model was used to analyze the trusses with top and bottom chords modeled as continuous beam elements and the webs as truss elements.

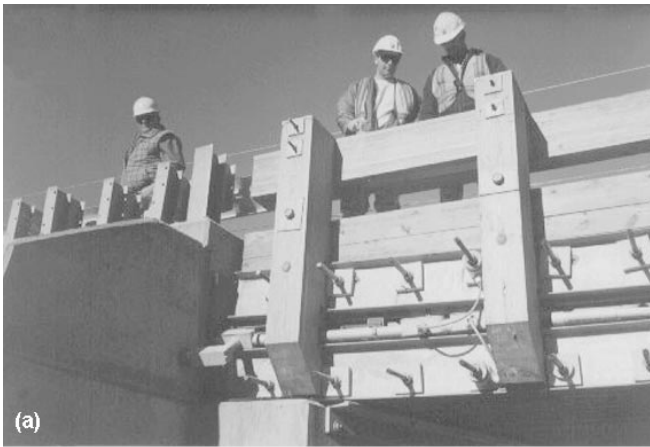
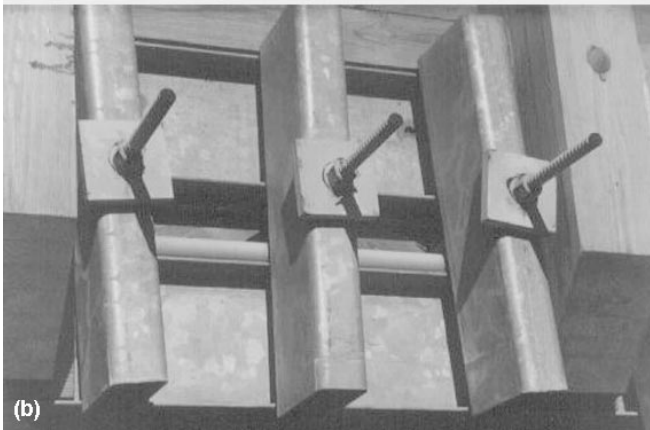
Figure 5—Anchorage system: (a) continuous steel channel and discrete plate bar configuration; (b) continuous steel channel and vertical structural tube bar configuration.

Two types of anchorage systems were used in the North Yarmouth bridge. Because of the 11.5° skew, the bars in the ends of the bridge did not pass completely through the bridge. In this region, the bars passed through holes drilled in the top and bottom chords and used a discrete plate anchorage system. The bar ends bear on continuous C 12 by 30 channels through 6- by 6- by 1.25-in. anchorage plates (Fig. 5a). In the remaining portion of the bridge, the rods passed through the openings in the webs and used a vertical tube anchorage system. The bar ends bear on continuous C 12 by 30 channels through 10- by 4- by 0.50-in. structural tubes and 6- by 6- by 1.25-in. anchorage plates (Fig. 5b). All components of the stressing system were provided with corrosion protection. The stressing bars, nuts, and anchorage plates were epoxy coated. The structural steel tubes and continuous steel channels were specified to be Grade 50, all-weather steel.

The continuous steel channel anchorage system was performing satisfactorily. There were no visible signs of wood crushing beneath the channels. Surface rust was visible on some of the steel components in areas where the epoxy coating had chipped off. It is recommended that these areas be brush coated with an approved epoxy-based paint.

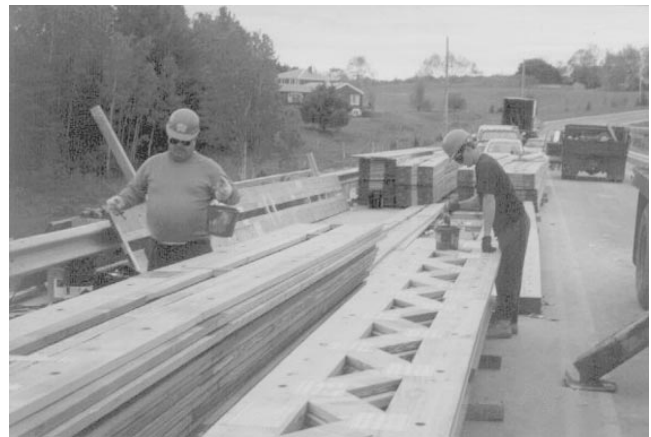
Figure 6—Galvanized metal plate connectors of each truss were brush-painted at the site for additional protection from corrosion.

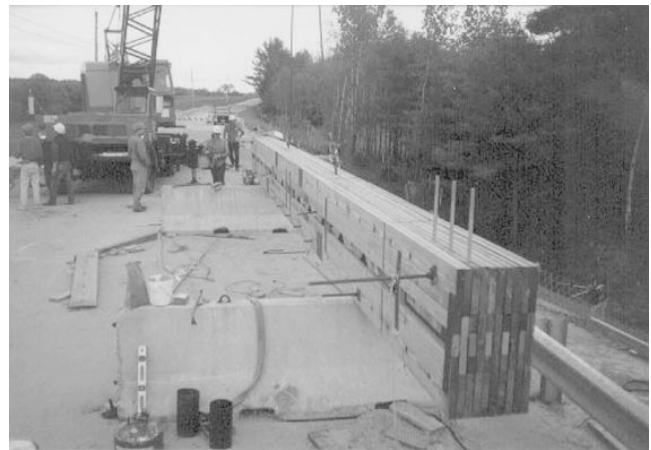
Figure 7—Bridge components were preassembled into mini-modules at construction site.

The CCA-treated trusses were fabricated and transported to the site on a flatbed trailer in bundles banded together with light metal straps. Prior to assembly of the bridge, the galvanized metal plate connectors of each truss were brush painted at the site with an epoxy-based protective paint for additional corrosion protection (Fig. 6). After the paint dried, the trusses were placed by crane onto temporary supports to form mini-modules (Fig. 7).

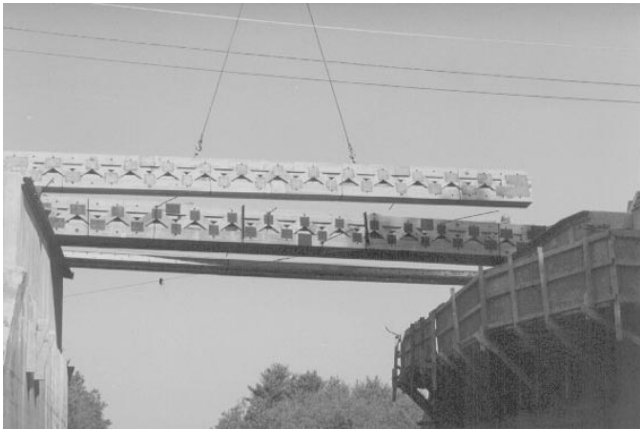
Figure 8—Mini-modules were lifted by crane onto concrete abutments.

The mini-modules consisted of 10 to 12 trusses and were formed by nailing structural trusses to spacer trusses. When the 10 to 12 trusses were nailed together, the mini-modules were again banded together with light metal straps. The mini-modules were lifted by a large overhead crane (Fig. 8) and

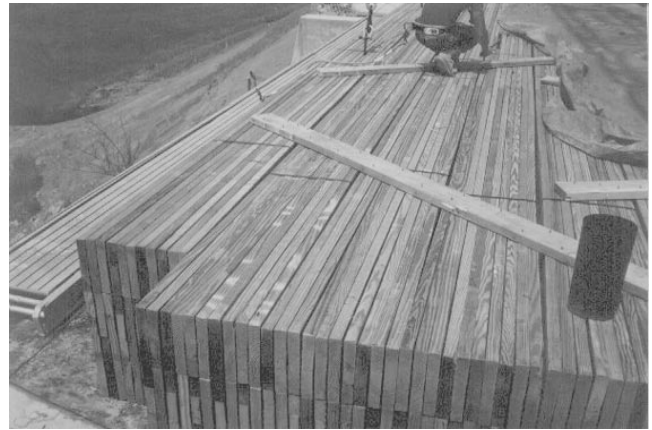
Figure 10—Modules were staggered to accommodate 11.5° skew.

placed side by side to form the width of the bridge (Fig. 9). The mini-modules were positioned to form six rectangular modules to account for the 11.5° skew (Fig. 10). Several steel bars were inserted through holes in the chords as the modules were assembled to hold the trusses in position. After all the modules were assembled, the remaining steel stressing bars were inserted through pre-drilled holes in the truss chords and through some of the web openings. Steel-bearing channels were installed on the edge of the bridge, followed by the structural tubes, anchor plates, and nuts.

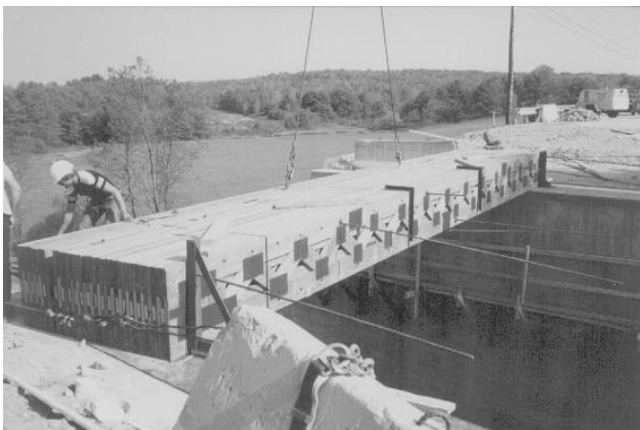
Figure 9—Modules were placed side by side to form bridge width.

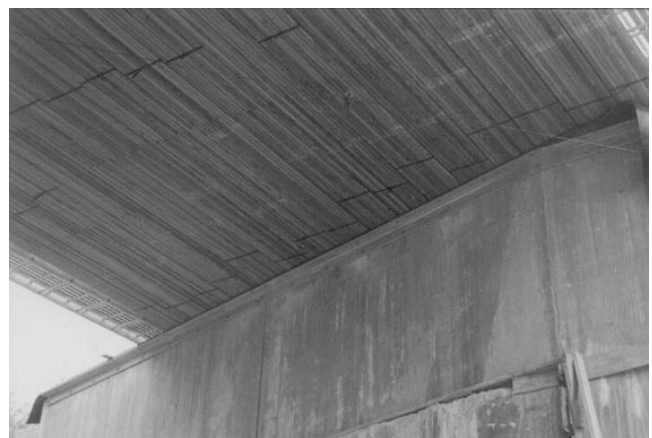
Figure 11—Superstructure was attached by bolting steel angles to sides of abutments, then bolting bridge to steel angles.

in the design. As a result, four additional trusses were added to increase the width of the bridge. The width of a stress-laminated deck is typically increased during fabrication to compensate for the anticipated losses as a result of high compressive stresses during the stress-laminating process. The reduced bridge width was probably due to underestimating the amount of compression caused by gaps created from the metal plate connectors. The superstructure was attached by bolting steel angles to the side of the substructure abutments, then bolting the bridge to the steel angles (Fig. 11).

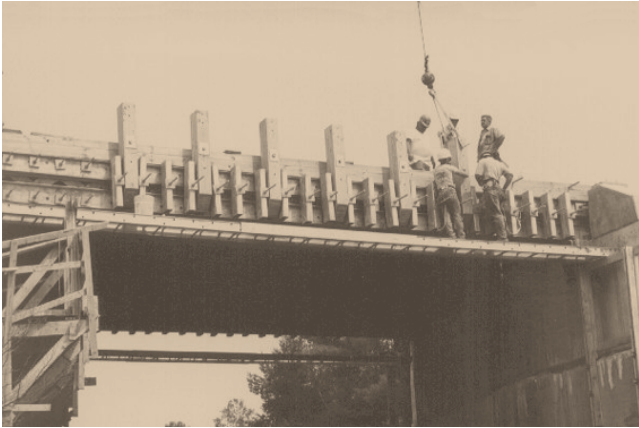
Figure 12—Installation of rail system.

After the superstructure was attached, construction of the concrete backwalls was completed. The glulam posts and rails were installed shortly after the backwalls were poured (Fig. 12). To protect the bridge from moisture, one coat of adhesive primer was painted directly onto the deck, followed by the installation of two layers of self-sealing waterproof membrane (Fig. 13). The waterproofing membrane was wrapped over the backwalls to completely seal the top surface of the structure from moisture. The bridge was paved

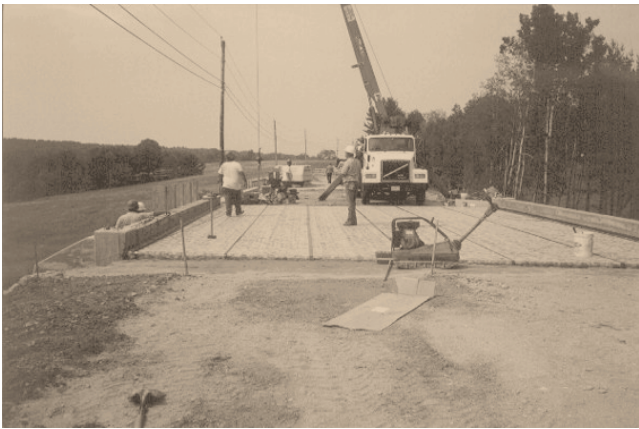
Figure 13—Bridge after installation of waterproof membrane.

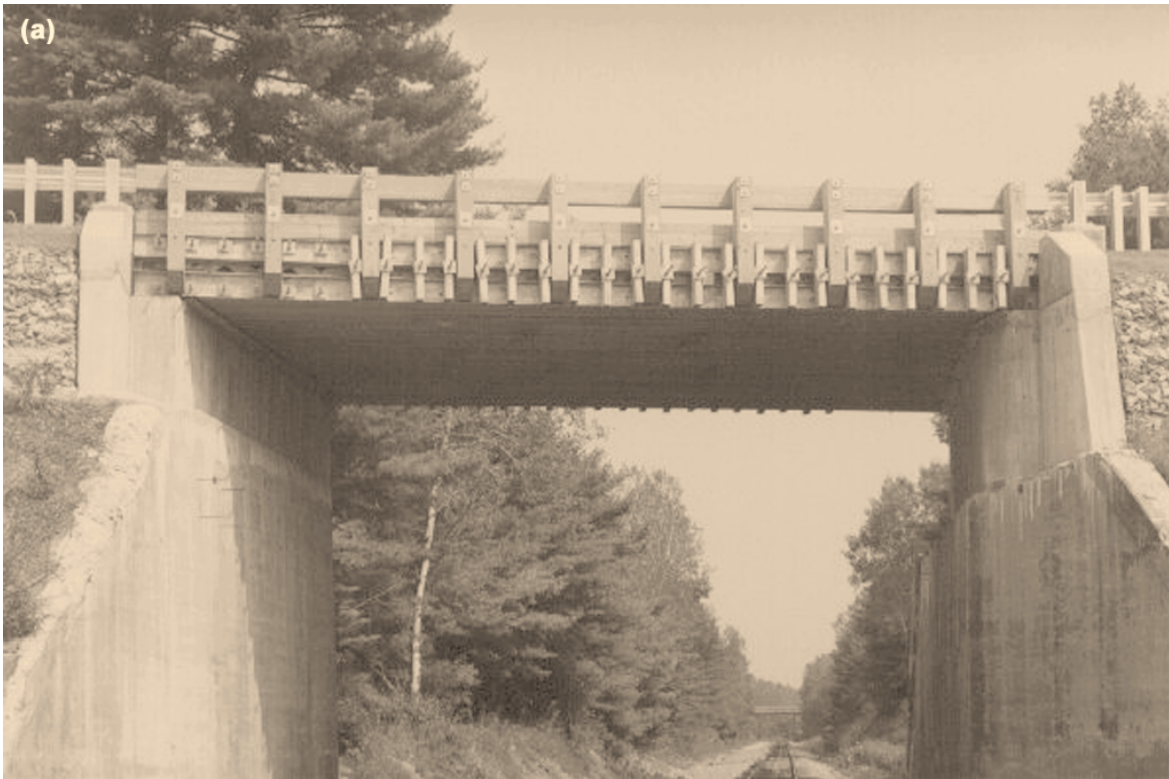
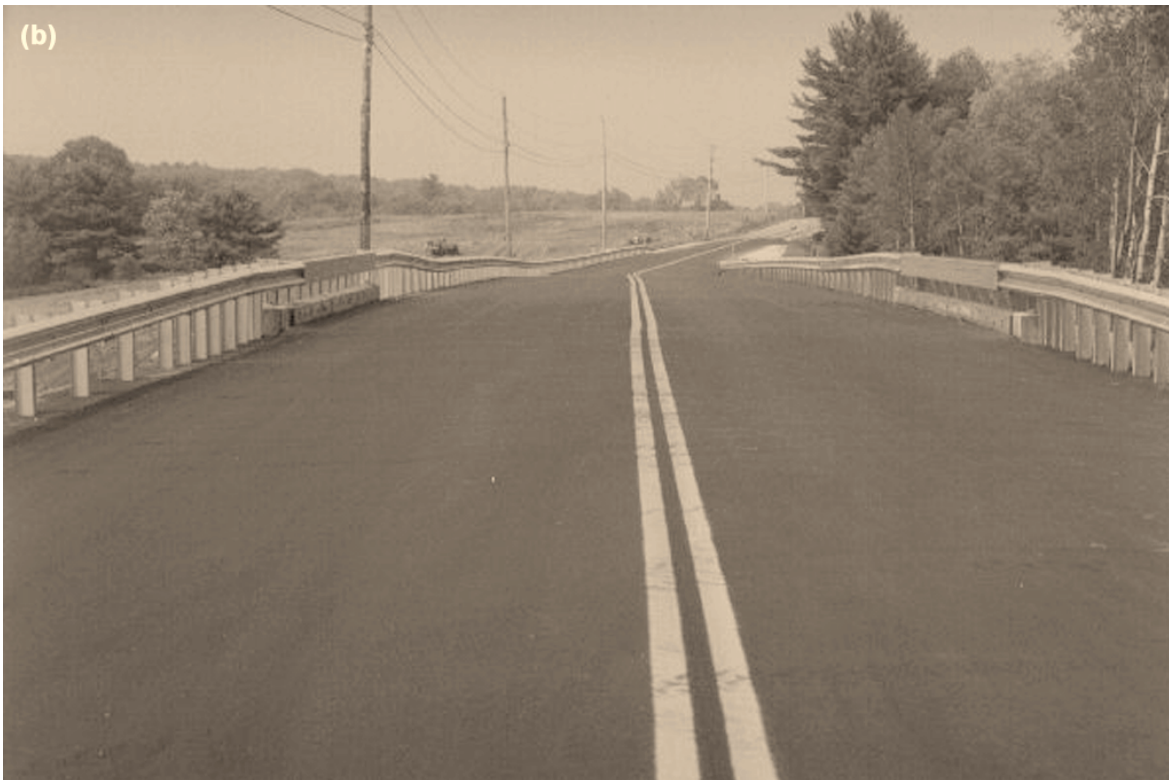
Figure 14—Completed North Yarmouth bridge: (a) profile of completed bridge (looking east); (b) completed bridge just after paving (looking north).

with a 1-in. leveling course and an asphalt wearing surface measuring 3.5 in. at the crown and 1.5 in. at curb. The completed North Yarmouth bridge is shown in Figure 14.

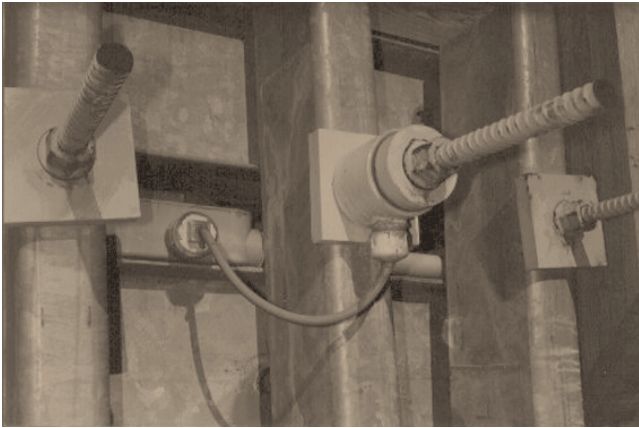
Figure 15—One of six load cells installed on stressing bars to monitor changes in bar tension.

Bar force was measured with calibrated steel load cells developed at the University of Maine (Fig. 15) and with a hydraulic jack during the scheduled retensionings. The load cells were installed on six bars prior to the initial construction stressing. Load cell measurements were obtained using a computer-controlled data acquisition system. Strain measurements were converted to units of bar tensile force by applying a calibration factor to the strain reading. Bar force measurements were also obtained from five bars prior to each retensioning by noting the jack pressure required to move the anchorage nut away from the anchorage plate of each of the five bars. The jack pressure was converted to bar force by applying a laboratory calibration factor to the jack pressure.

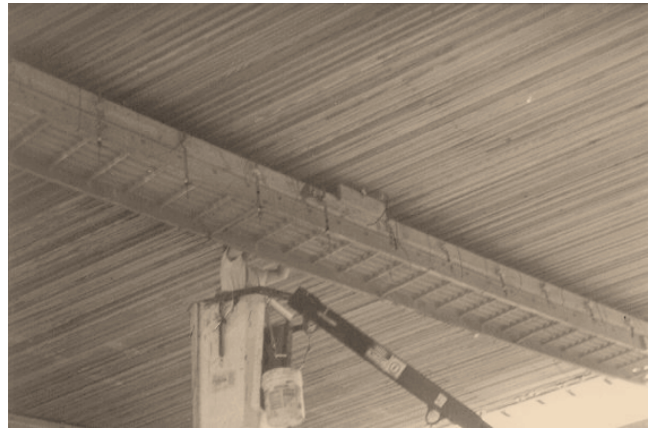
Figure 16—Displacement transducer used to measure bridge deflections in load tests 1 and 2.

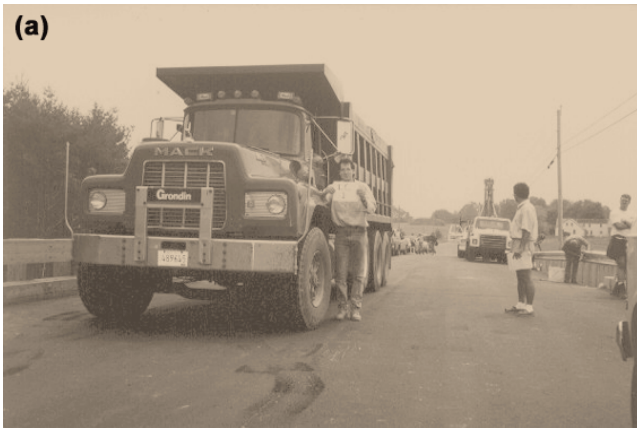
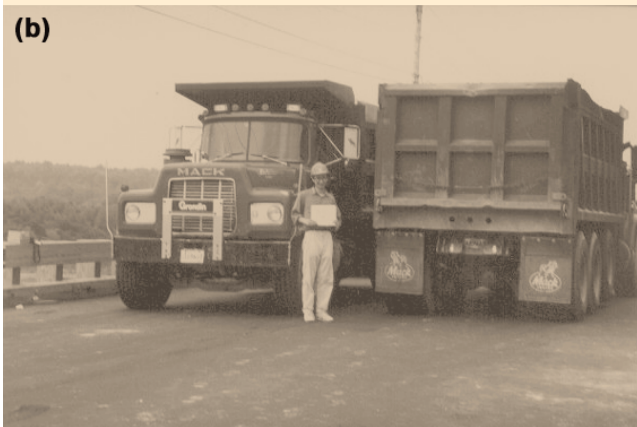
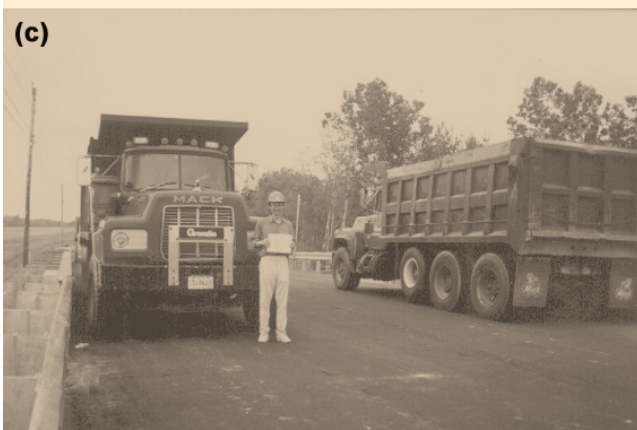
Figure 18—Truck positions for load test 1 for three load cases (looking north): (a) load case 2, (b) load case 3, (c) load case 6.

Load test 1, conducted June 20, 1994, consisted of six load cases and used two fully loaded, three-axle dump trucks: truck A with a gross vehicle weight of 71,000 lb and truck B with a gross vehicle weight of 70,900 lb (Fig. 17). For load cases 1 through 3, the trucks were positioned transversely 2 ft from the bridge centerline. For load cases 4 through 6, the trucks were positioned transversely 6.5 ft from the bridge centerline. For all load cases, the truck center of gravity was positioned at midspan, and deflections were measured to within 0.01 in. Load cases 2, 3, and 6 are shown in Figure 18.

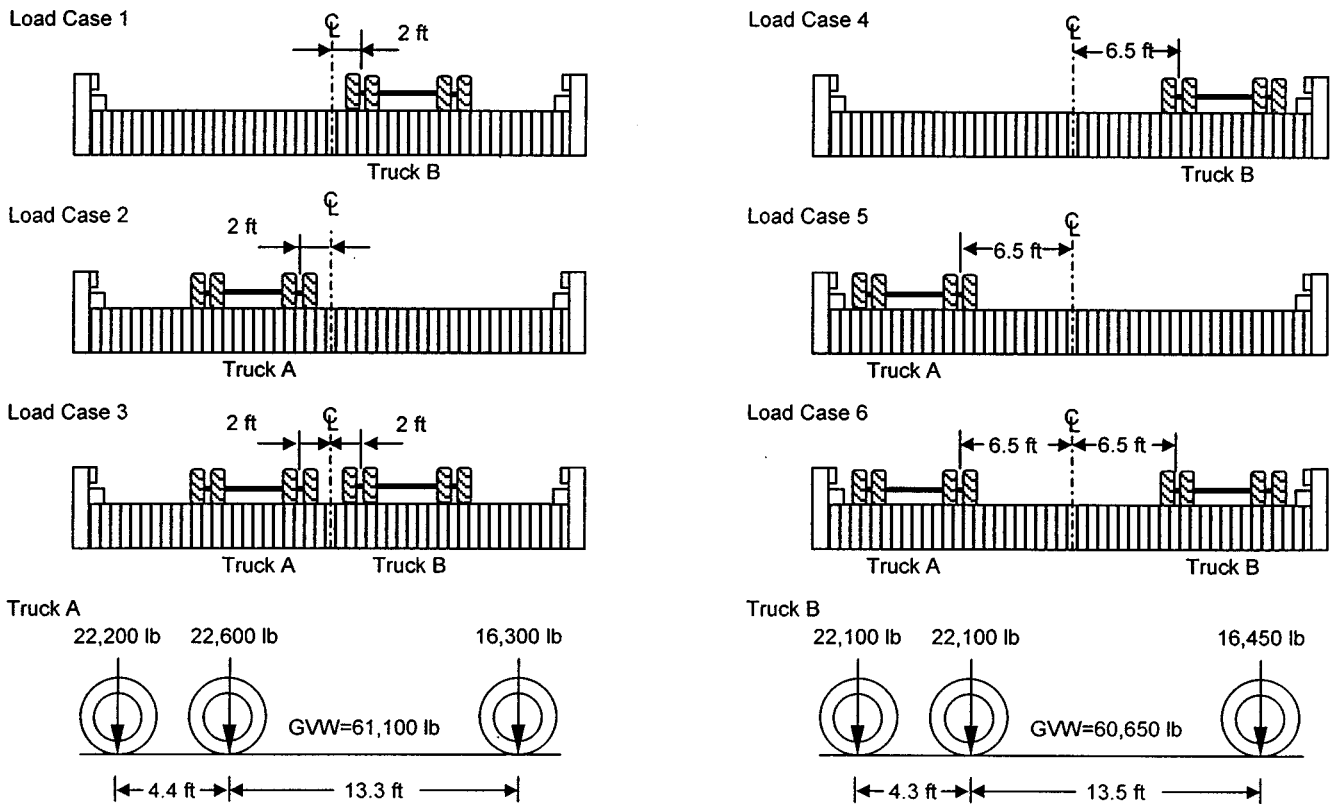
Figure 19—Truck weights, axle spacings, and transverse load test positions for load test 2.

Load test 2, conducted November 7, 1995, also consisted of six load cases and used two fully loaded, three-axle dump trucks: truck A with a gross vehicle weight of 61,100 lb and truck B with a gross vehicle weight of 60,650 lb (Fig. 19). For load cases 1 through 3, the trucks were positioned transversely 2 ft from the bridge centerline. For load cases 4 through 6, the trucks were positioned transversely 6.5 ft

from the bridge centerline. For all load cases, the truck center of gravity was positioned at midspan, and deflections were measured to within 0.01 in.

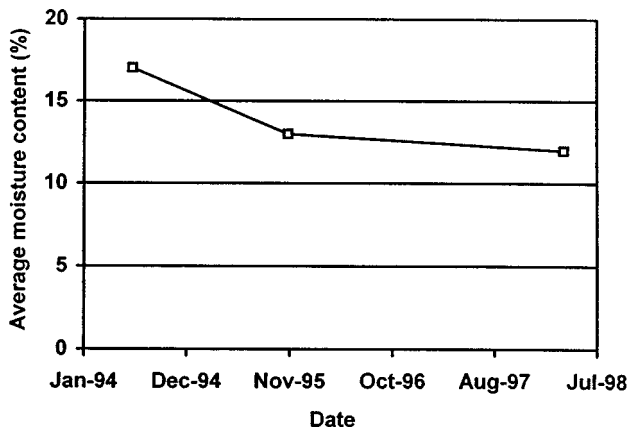
Figure 20—Average trend in moisture content.

The average trend in wood moisture content is presented in Figure 20. At the initiation of the monitoring, the average moisture content was approximately 17%. After 18 months of service, the moisture content decreased to 13%. After 46 months of service, the moisture content of the North Yarmouth bridge seemed to have stabilized at approximately 12%. The stable moisture content of the wood indicates that the waterproof membrane and pavement crown have been effective in protecting the bridge from water.

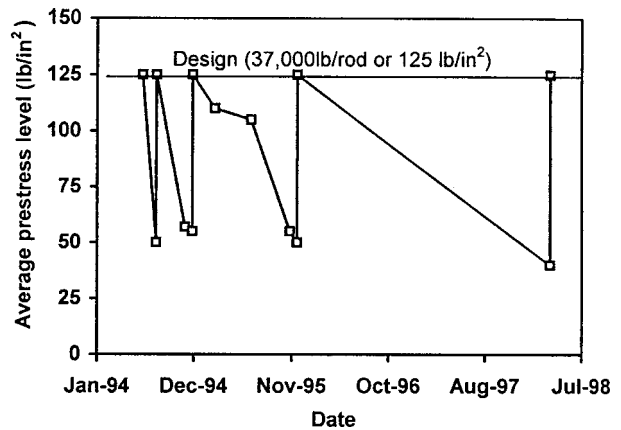
Figure 21—Average trend in prestress level.

The average trend in bar force is shown in Figure 21. For stress-laminated structures to perform efficiently, an adequate bar force must be maintained to prevent interlaminar slip. Bar force was expected to decrease after construction as a result of the combined effect of several factors. Therefore, the bridge was retensioned to the full design value of 37,000 lb or 125 lb/in² interlaminar compression after 6 weeks, 6 months, 18 months, and 46 months of service.

Data collected during the first retensioning indicated that the average bar force had decreased 60% to approximately 15,000 lb or 50 lb/in² interlaminar compression during the 6 weeks. Data collected during the second retensioning indicated that the average bar force had decreased 57% to approximately 16,000 lb or 55 lb/in² interlaminar compression during the 4½ months.

Bar force measurements taken 12 months after the second retensioning indicated that the bar force had again decreased 60% to approximately 15,000 lb or 50 lb/in² interlaminar compression. Subsequently, the bars were retensioned. Measurements taken 28 months after the last retensioning indicated that the bar force had decreased 70% to approximately 12,000 lb or 40 lb/in² interlaminar compression. Therefore, the bars were again tensioned.

Bar force was expected to decrease as a result of the combined effects of a decrease in wood moisture content, stress relaxation, and seating of the metal plate connectors. The 5% decrease in moisture content caused wood shrinkage and was probably most significant during the first half of the monitoring period when the greatest moisture content loss occurred. Stress relaxation in the wood laminations has been observed to cause bar force loss in numerous other stress-laminated bridges. Shrinkage and stress relaxation are primary sources of bar force loss in solid stress-laminated decks. However, additional bar force loss was expected for the North Yarmouth bridge because of seating of the metal plate connectors into the wood of an adjacent truss.

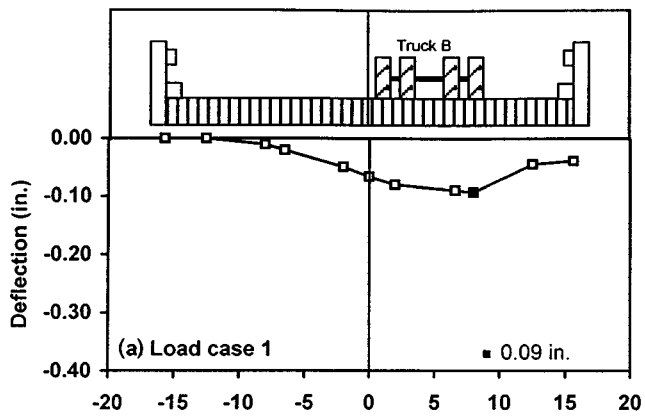
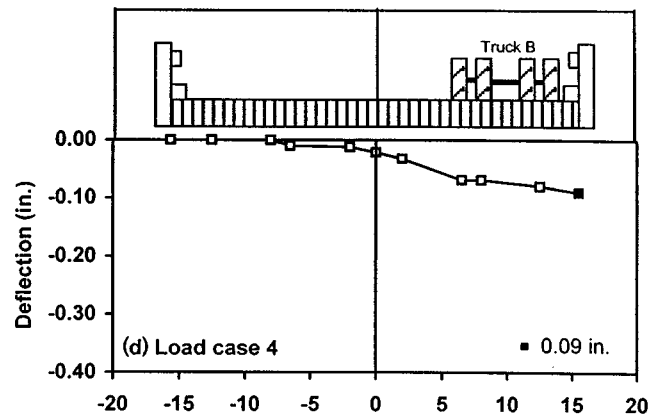
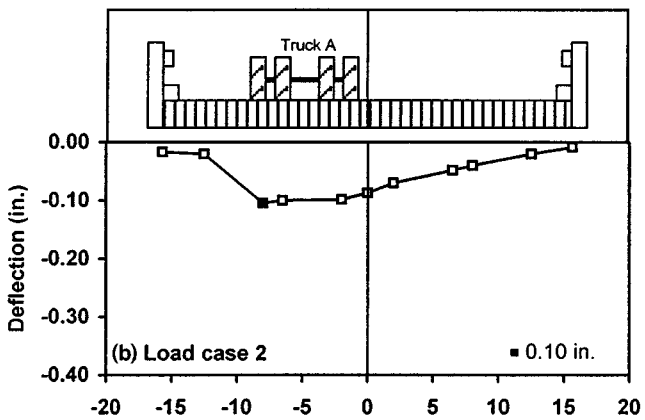
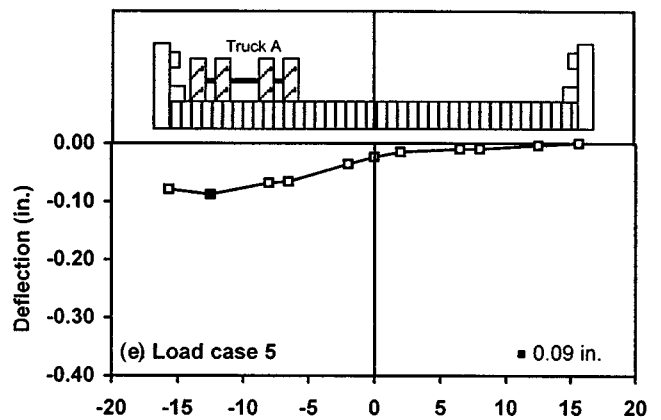
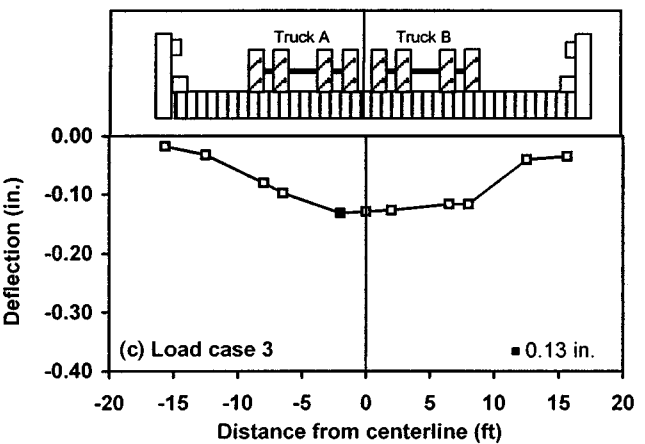
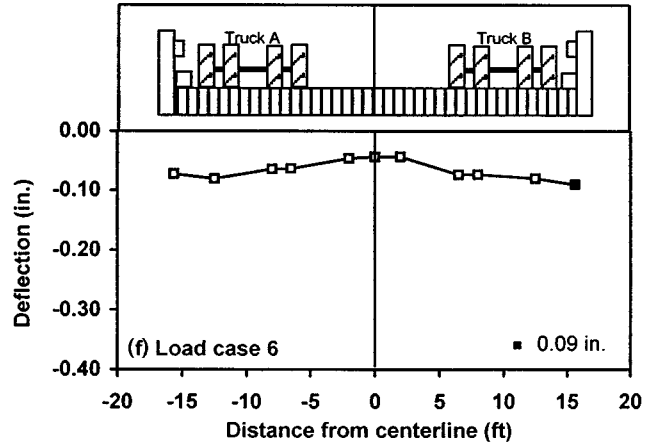
Figure 24—Transverse deflections for load test 2, measured at bridge centerspan (looking north). Bridge cross section and vehicle positions are for the purpose of interpretation only and are not drawn to scale.

Results of static-load testing are shown in Figures 22 to 26. For each load case, transverse deflections are given at the bridge centerspan as viewed from the south end (looking north). No permanent residual deflection was measured between load cases or at the conclusion of the load testing. In addition, no significant movement was detected at the bridge supports during testing. At the time of load tests 1 and 2, the average bridge interlaminar compressive stress was 125 and 55 lb/in², respectively. The allowable deflection for design purposes was L/500 or 0.90 in.

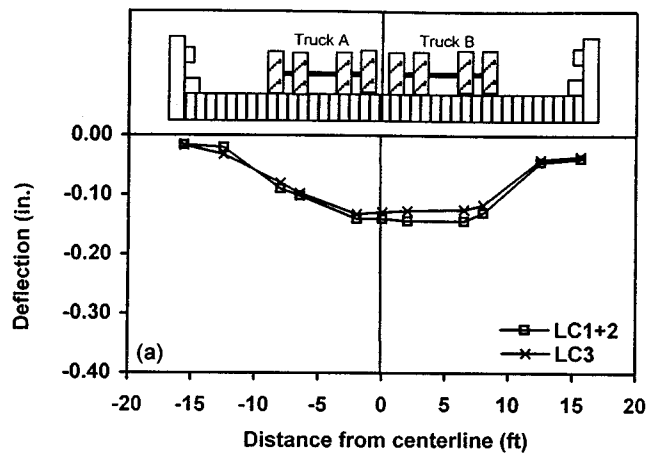
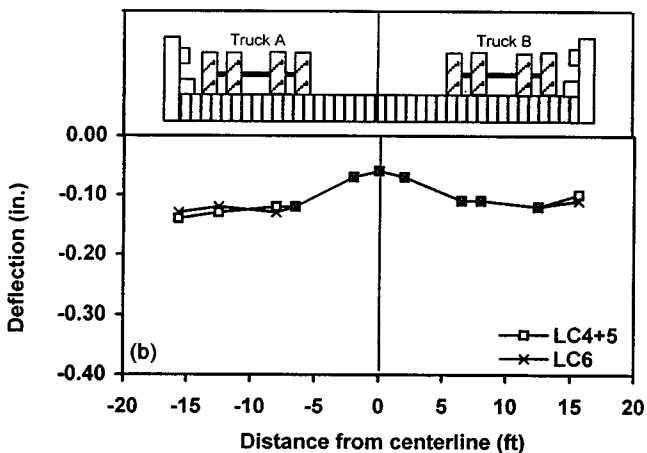
Figure 25—Measured deflections for load test 2: (a) sum of measured deflections for LC1+2 compared with measured deflections for LC3; (b) sum of measured deflections for LC4+5 compared with measured deflections for LC6.

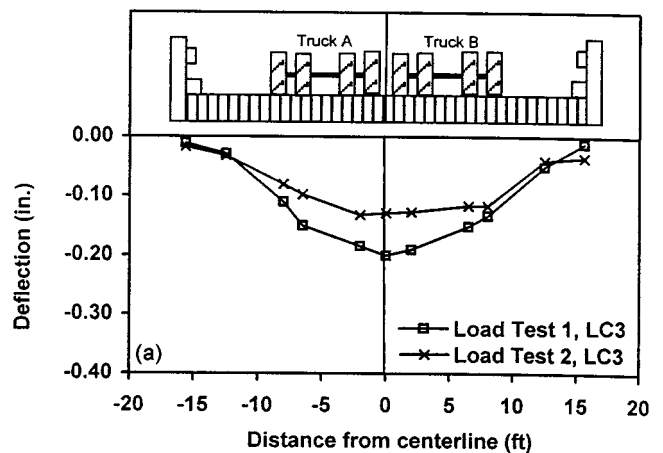
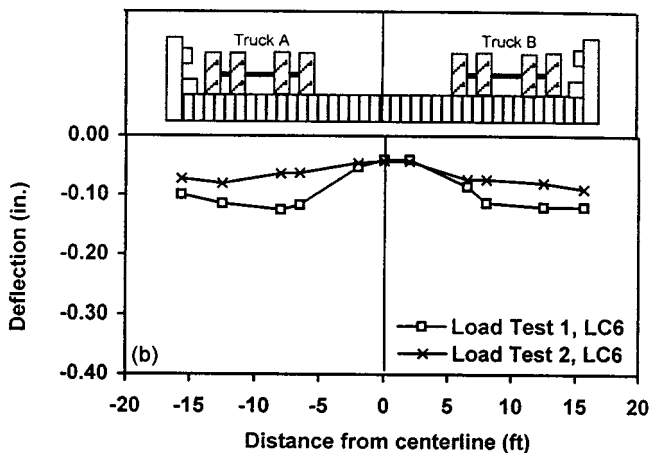
Figure 26—Comparison of load test 1 and 2 deflections.
