# Rehabilitating Historic Timber Transportation Structures At Burnt Cabins Grist Mill, Burnt Cabins, Pennsylvania

**William J. Collins**, Registered Landscape Architect, Principal  
Simone And Jaffe Incorporated, Landscape Architecture,  
Berwyn, Pennsylvania

Burnt Cabins Grist Mill is an operating, water-powered grist mill on Little Aughwick Creek in Fulton County, Pennsylvania. The mill and ten acres of the privately owned site are listed on the National Register of Historic Places. Two heritage timber transportation structures were redesigned to combine traditional timber construction techniques with modern materials, treatment and construction methods, including:

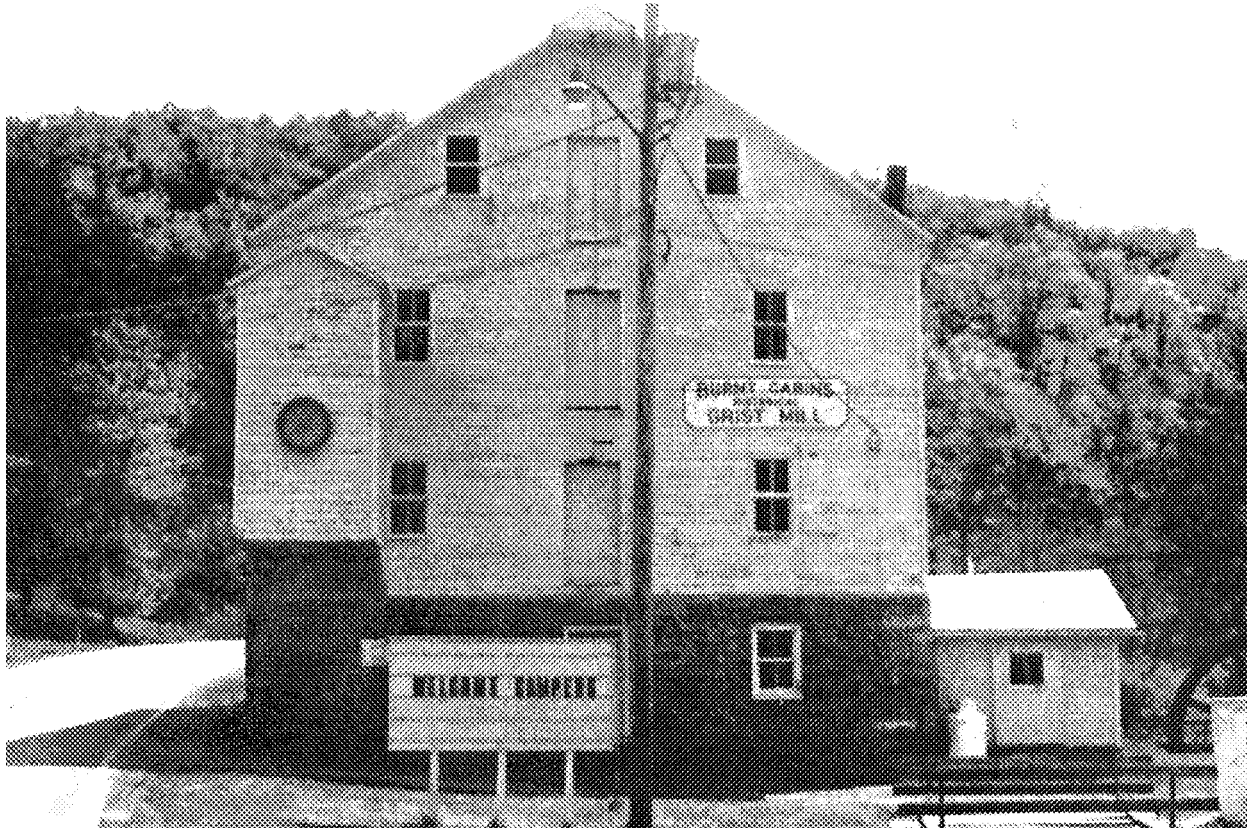
**Figure 2 - Burnt Cabins Grist Mill, West Elevation, 1995 (Note: scale bed at lower left.)**

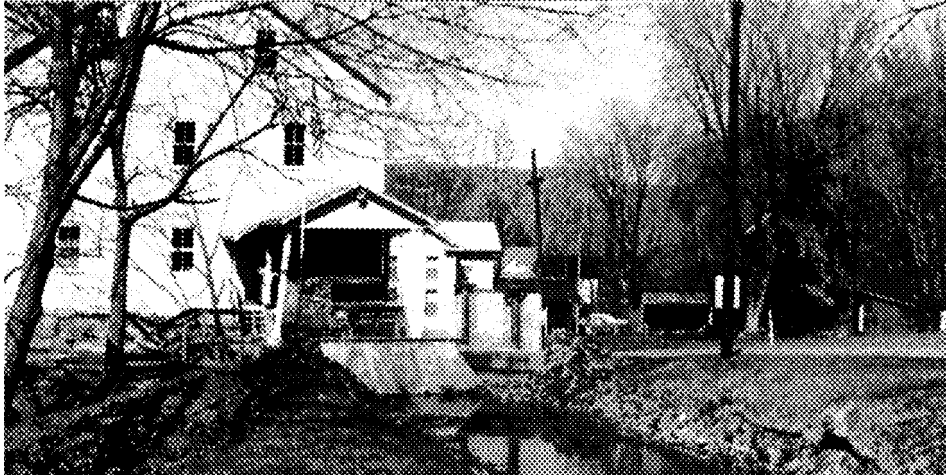
**Figure 3 - Eastern Elevation showing Existing Mill Race, Head Wall and Trash Screen.**

**Concrete Headwall** - The formed concrete headwall includes flared upstream walls and a short section of concrete flume and apron. Most of the existing headwall was in good condition, except for the uphill wingwall which was cracked and heaving.

**Control Gate** - Between the parallel walls of the headwall, a slot was formed to house a wooden control gate which is raised and lowered with vertical screw rod to regulate the amount of water which flows through the flume to the waterwheels.

**Trash Screens** - The Owners have installed two wooden vertical-slatted trash screens within the existing flume and headwall. These devices catch debris before it enters the mill and require periodic raking to keep the flume open.

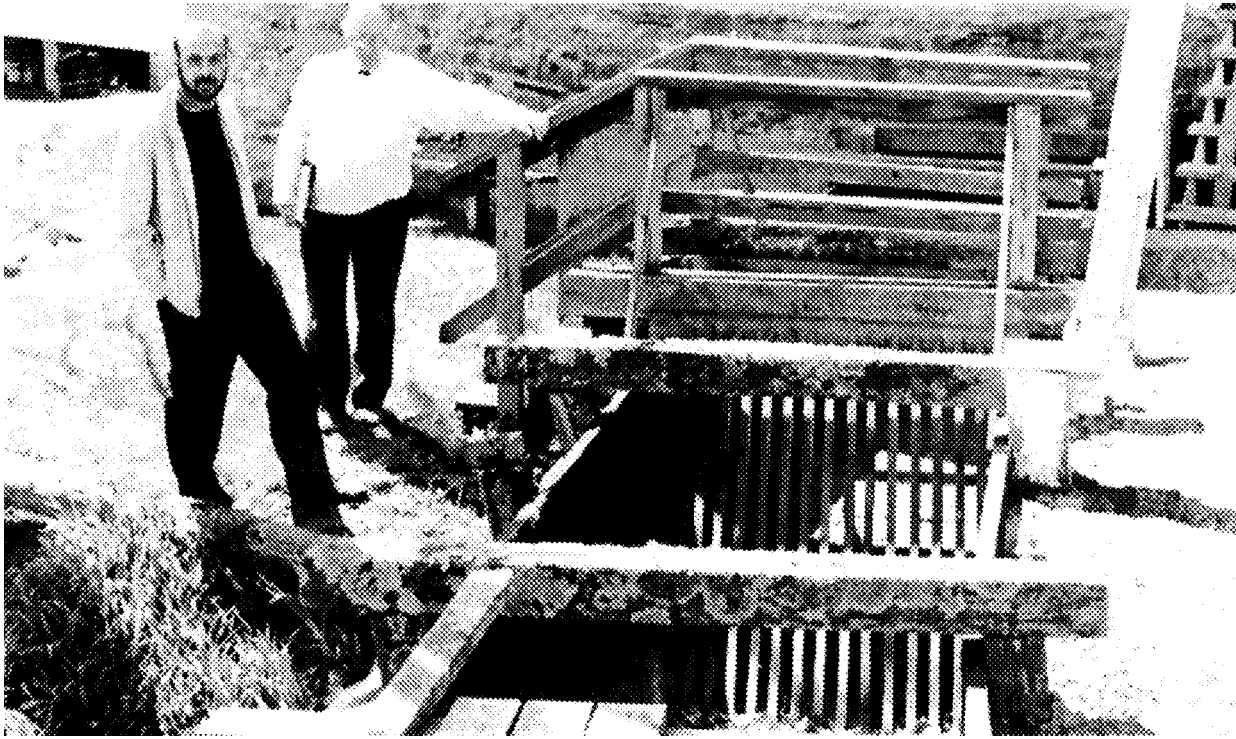
**Figure 4 - Existing Timber Flume, Pedestrian Bridge, and Trash Screen.**

The existing timber mill race flume was approximately 40 feet long by 48 inches deep by 48 inches wide on the inside. The flume was framed by a series of rectangle bents which consisted of a sill, two posts, and a header. The bents were traditionally constructed with mortise and tenon joinery and fastened with tapered wooden pins. By Summer of 1995, about half of the original timber bents had been temporarily repaired with pressure treated Yellow Pine.

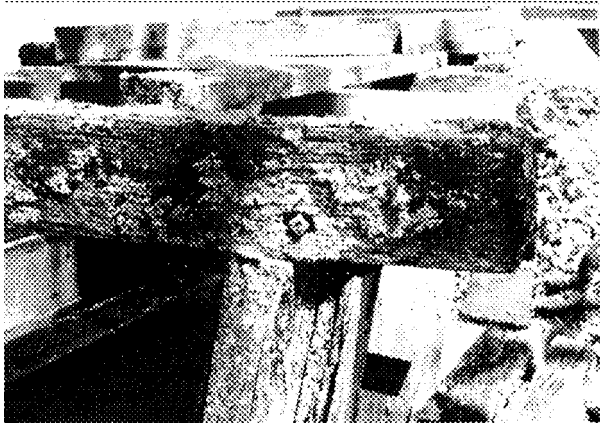
**Figure 5 - Existing Timber Flume Bent Detail.**

**Flume Bents** - The new bents were redesigned to be very similar to the original structure. All joinery was designed to allow drainage. All joinery and pre-drilling was specified to be performed prior to preservative treatment to prevent perforation of the protective treatment shell. Shaved white oak timber pegs were specified as bent fasteners. Tops of the headers were sloped to prevent standing water and discourage their use as “balance beams.”

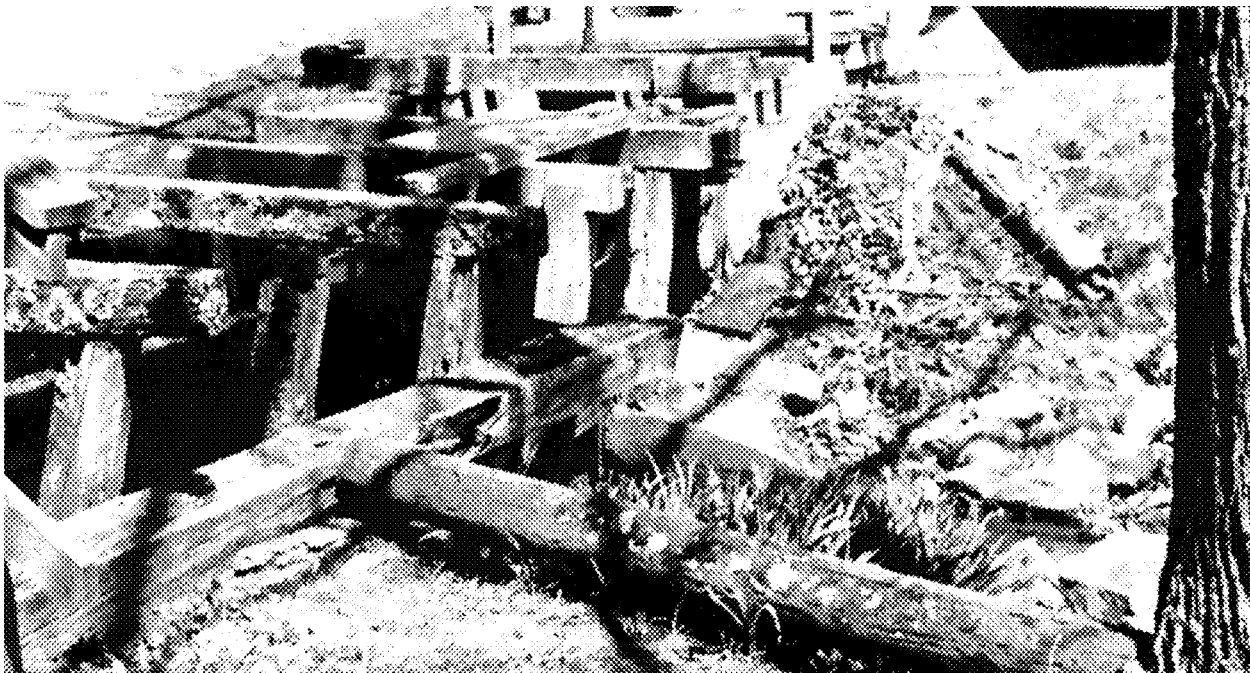
**Figure 6 - Existing Timber Flume, Waste Gate and Stone Spillway.**

**Waste Gate** - The waste gate is constructed in the downhill side of the timber flume with openings in the top and bottom of the wall boards in one bay near the concrete headwall. The top opening is an overflow. The bottom opening is controlled with a simple board on a stick which uses water pressure to hold the board against the opening. The gate can be raised and lowered to adjust the flow of wastewater.

**Required Demolition** - The entire timber flume was found to require demolition and replacement. One wing of the concrete headwall was cracked and shifted, and required removal and replacement. The existing overflow spillway was a series of deteriorated stone wall terraces stepping down to an overflow pond, which drains into the tail race. Demolition and reconstruction of these stone walls was incorporated into this project. Two wooden foot bridges over the flume were specified to be removed and reconstructed.

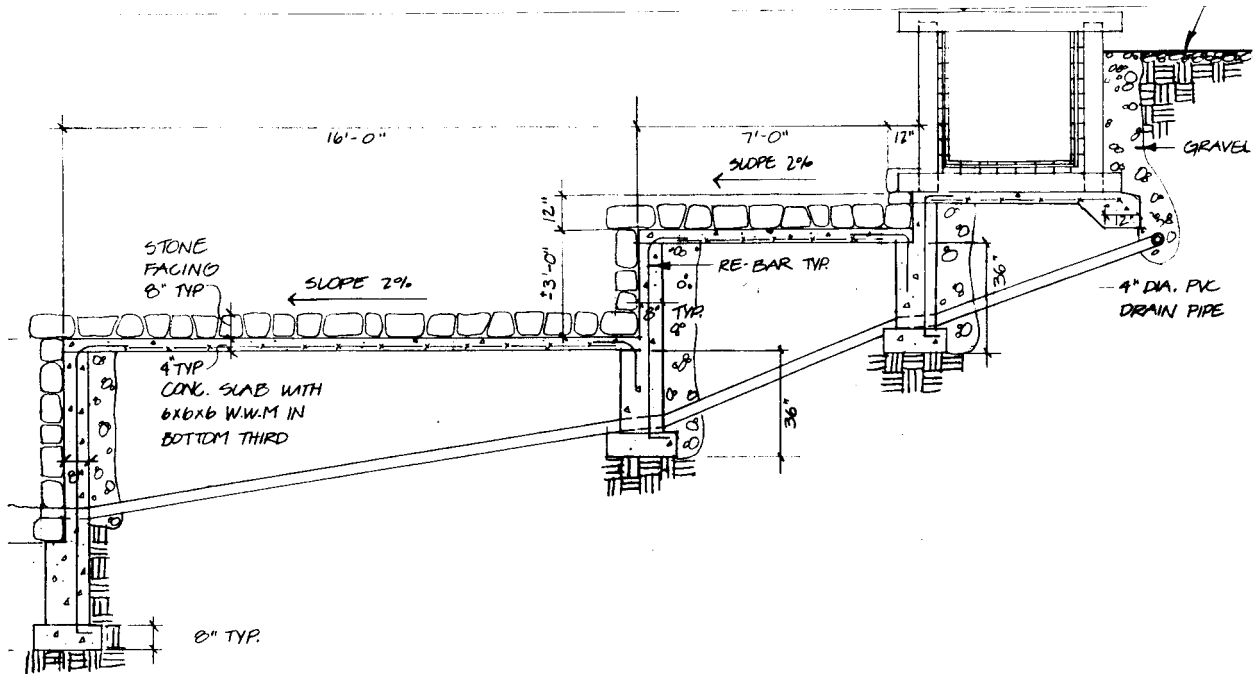
Figure 8 - Section through new Timber Flume and Spillway

**Structural Design Improvements** - A system of structural concrete walls and slabs were designed as the foundation for the new timber flume and spillway. The structure was designed to be hidden below grade and to support an exposed native field stone facade. The design provided for surface and subsurface drainage from the uphill sides of the flume and retaining walls.

New timber bents were designed to sit on a new 4" reinforced concrete slab placed under the flume alignment between the headwall and mill foundation. The bents and structural liner were surrounded by gravel backfill to promote drainage and air movement around the below-grade timbers. A porous geotextile fabric was specified to separate the gravel backfill from the earthen grade.

Two inch thick structural liner boards were designed to be nailed to the insides of the bents in the traditional way, but not to hold water. An impermeable liner was specified to be installed against the inside of the structural flume walls and floor, as one piece, between the mill foundation and the concrete headwall. A "facade" liner was designed as removable sections of longitudinal flooring and siding on sleepers which cover and protect the membrane. The facade wall sections were designed to wedge the floor sections in place without nailing through the membrane below the waterline. In fact, the membrane is employed to prevent leaks, not to protect wooden members. The liner was designed to be sealed to the concrete head wall with battens and to continue inside the mill to line the water distribution box.

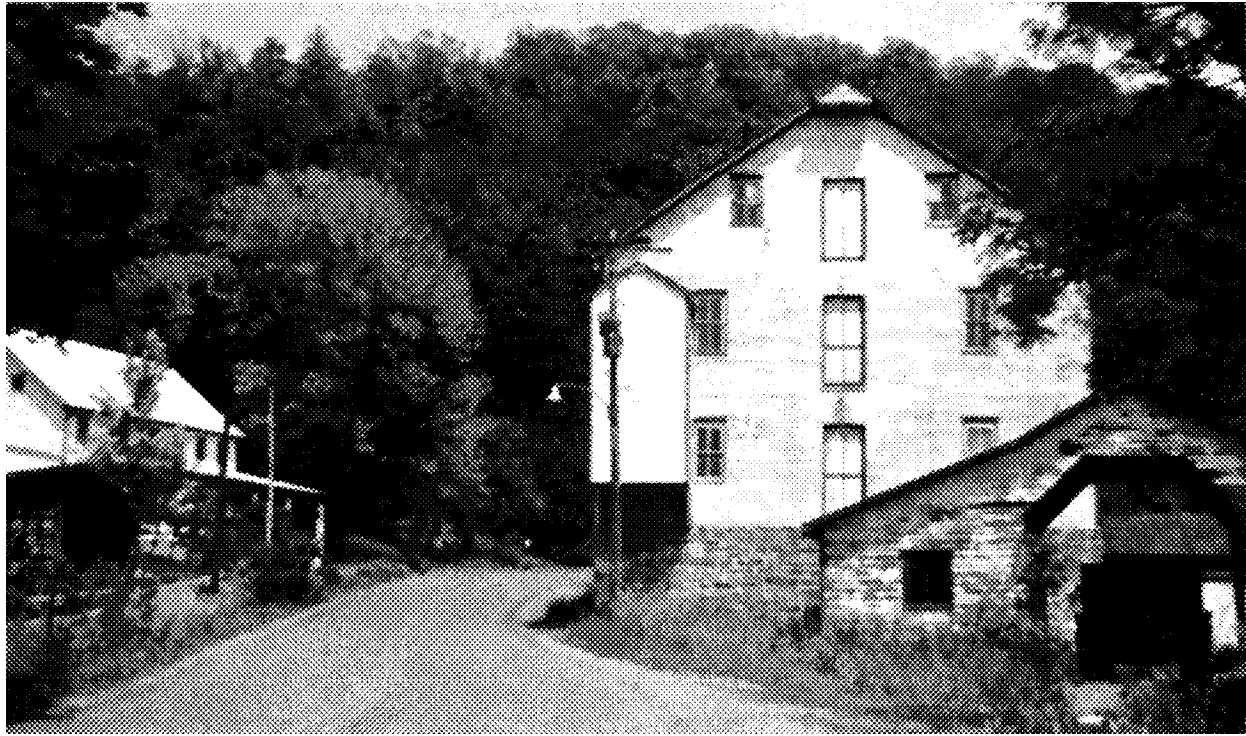
**Figure 9 - Previous Weigh Station Canopy (date unknown.)**

The previous weigh station canopy was a roofed, drive-through structure with portals under both gables. The structure was asymmetrical with an enclosed shed section toward the north.

**Canopy Structure Type** - The original canopy was used to protect grain wagons. The weigh station canopy was probably "stick" framed, however no evidence exists outside of an original photo. The new canopy was designed to invite visitors, and protect them from the elements during orientation to the mill. It could not exactly replicate the original design.

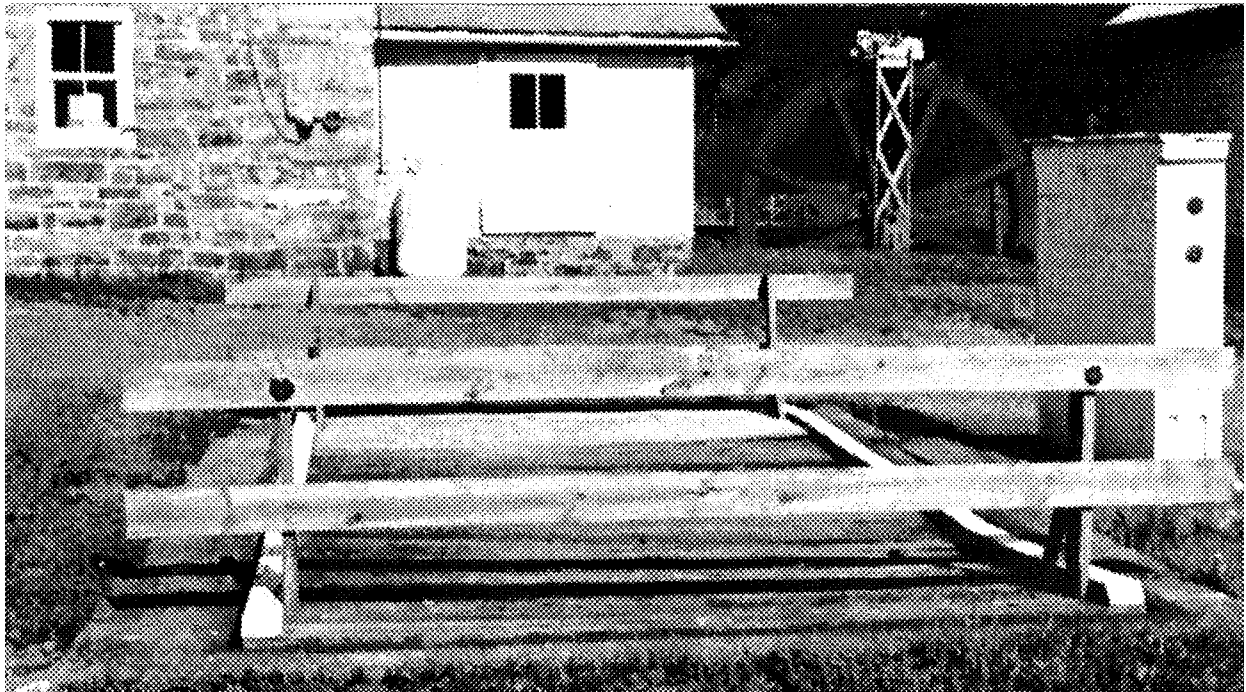
Figure 10 - Existing Scale Bed (view to east.)

**Scale Bed** - The existing timber scale bed was rotten and cordoned off from the public. Before demolition, sizes of existing members were documented. The new scale bed was designed using the original member sizes.

The timber bed structure was designed to bear on the three longitudinal steel I-beams of the existing scale carriage, each measuring 12 1/2” deep x 5” wide. Timber transverse beams measuring 6” deep x 8” wide spanned the three carriage beams at 16” centers. Longitudinal sleepers measuring 2” deep x 5” or 4” wide were used to span the transverse beams as nailers for the decking. Three inch thick transverse decking was used at random widths between 7” to 12”.
