5.1 INTRODUCTION

5.2 SELECTION OF STRUCTURAL MATERIALS AND SYSTEMS

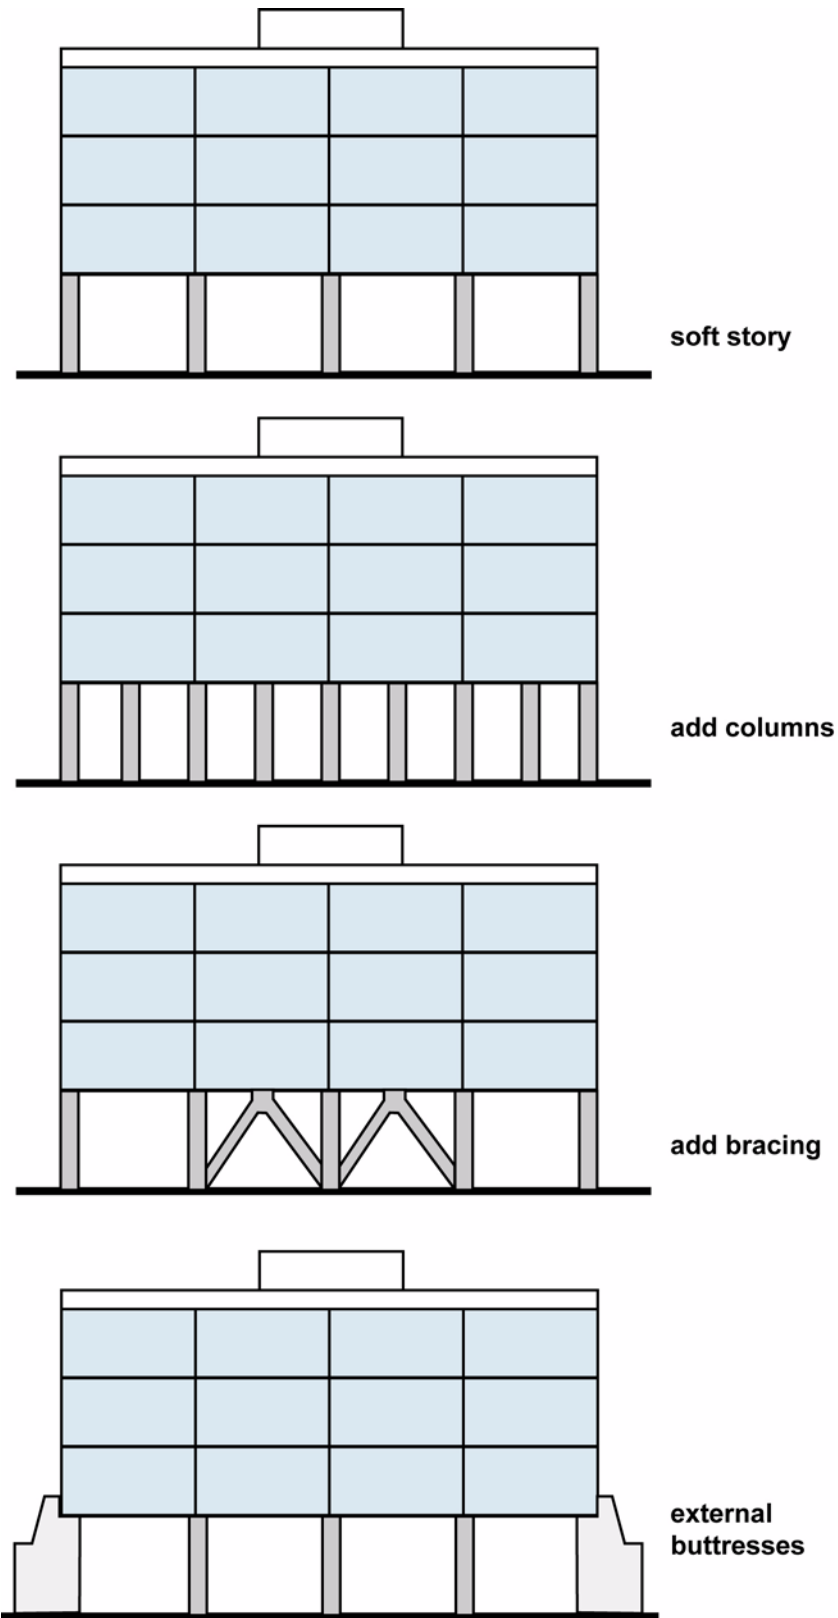
Figure 5-1 Example design solutions for addressing soft story condition.

Design solutions for a soft first story condition that the architect and engineer might explore together include (see Figure 5-1):

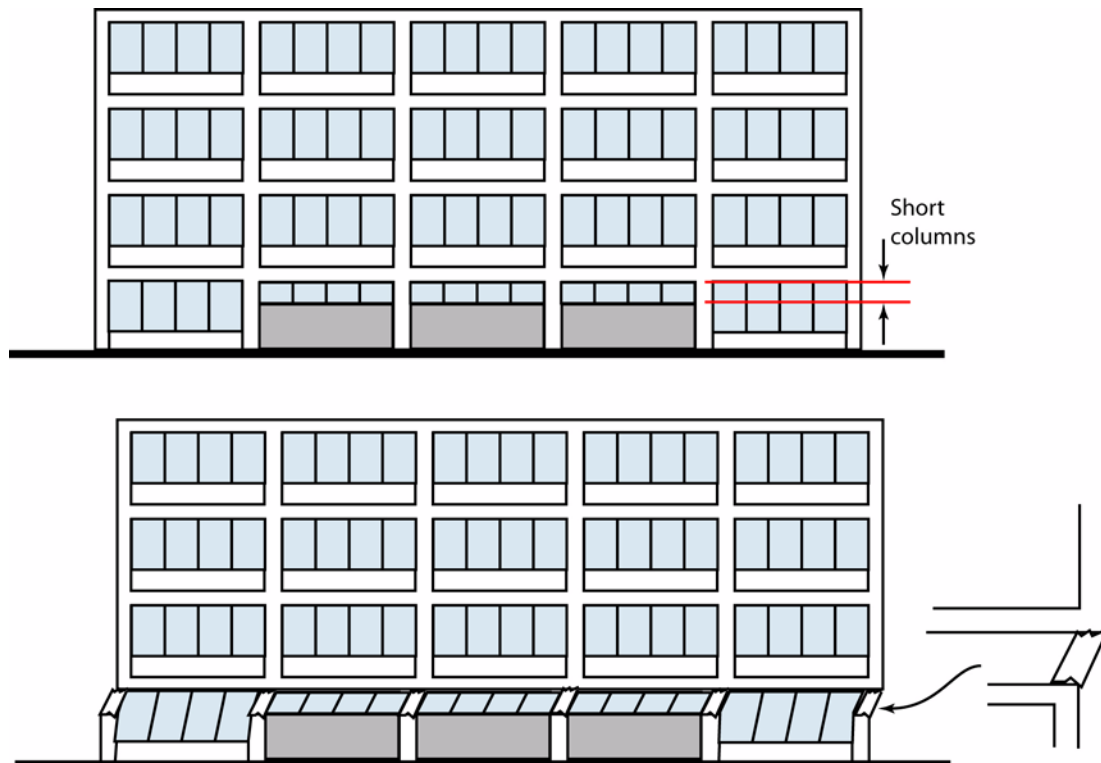
Figure 5-2 Elevation views of building with short columns between first and second floors. Upper sketch show the building in an unshaken state; lower sketch shows damage mechanism under earthquake lateral loading.

- Heavy masonry partitions that are rigidly attached to columns and under floor slabs, can, if asymmetrically located, introduce localized stiffness and create stress concentrations and torsional forces. A particular form of this condition, that has caused significant structural damage, is when short column conditions are created by the insertion of partial masonry walls between columns. The addition of such partial walls after the building completion is often treated as a minor remodel that is not seen to require engineering analysis. The result is that the shortened columns have high relative stiffness, attract a large percentage of the earthquake forces, and fail (Figure 5-2).

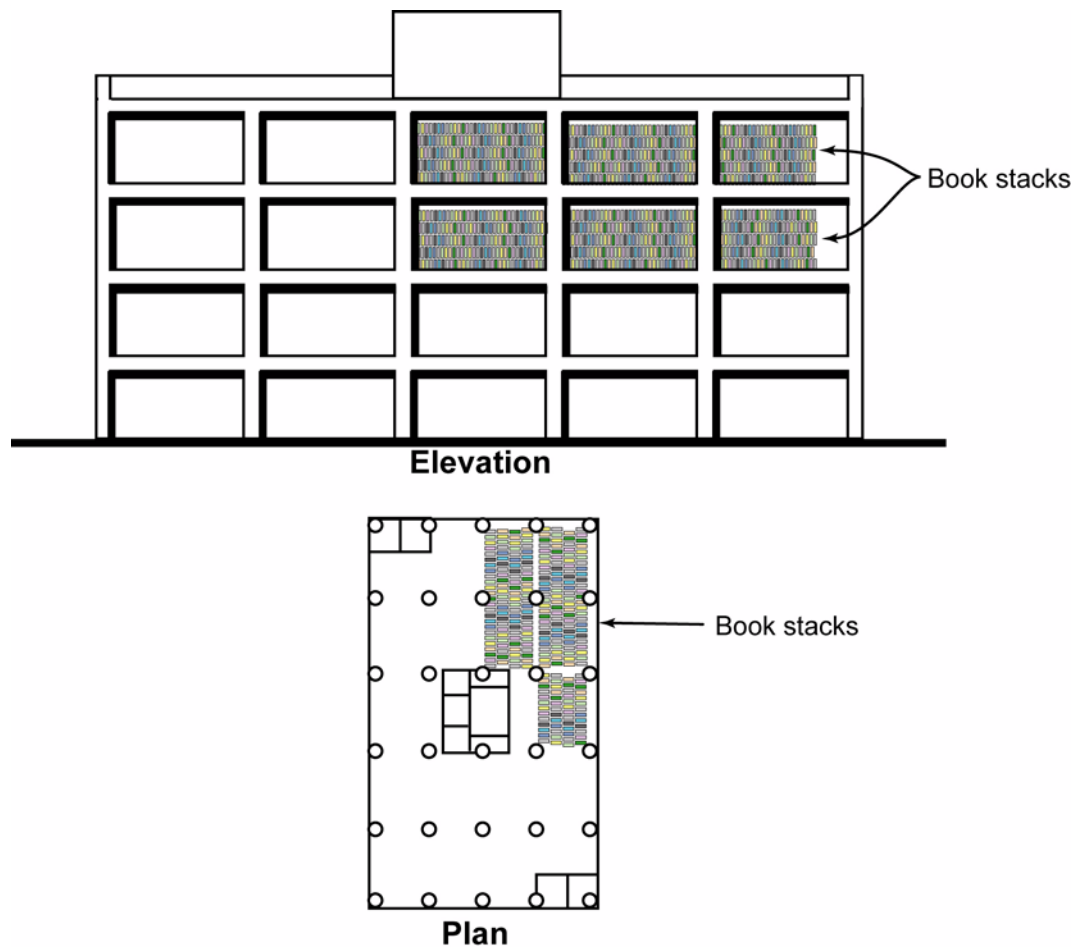
Figure 5-3 Nonsymmetric loading of book stacks in library building. Position and weight of stacks could induce torsional response of building during earthquake shaking.

- In smaller buildings, stairs can act as bracing members between floors, introducing torsion; the solution is to detach the stair from the floor slab at one end to allow free structural movement.
- In storage areas or library stacks, heavy storage items can introduce torsion into a structure. The structure may have been calculated to accommodate the maximum dead load but consideration be lacking for the effect of nonsymmetric loading over time as, for example, when library books are acquired (Figure 5-3).

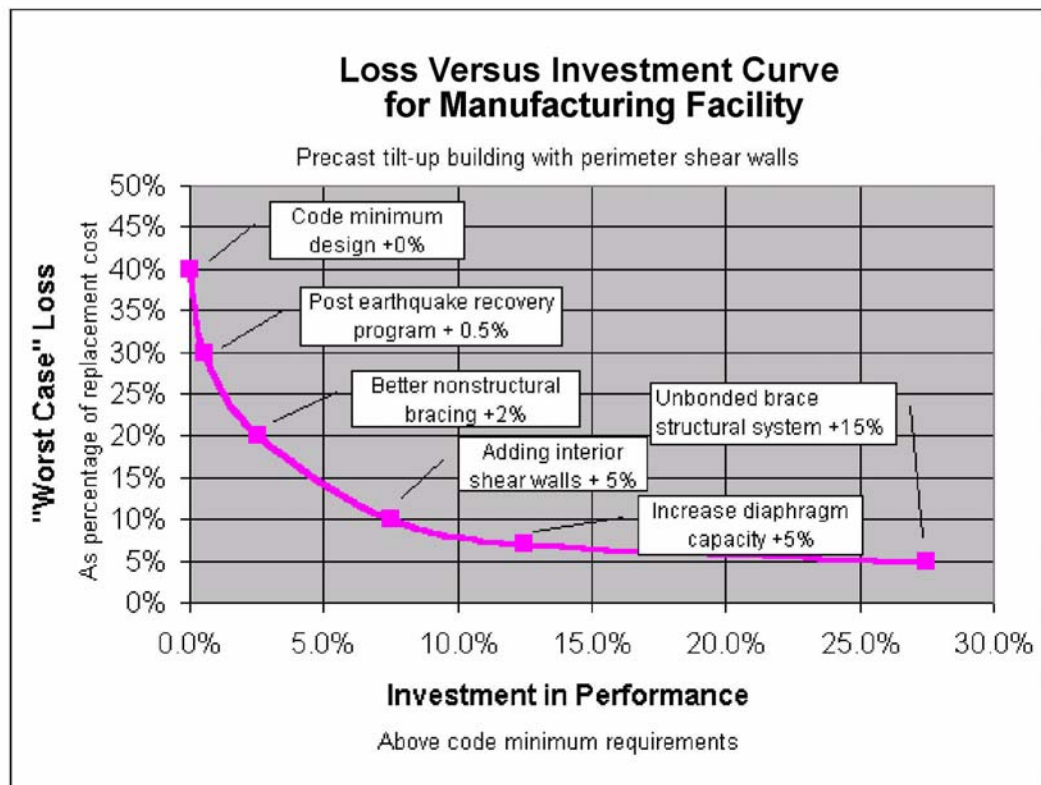
Figure 5-4 Relationship between cost and performance for hypothetical example.

A more refined way of achieving a specified performance in a cost efficient manner is to develop “learning curve” type relationships between the two. Consider the example in Figure 5-4. A hypothetical precast concrete tilt-up manufacturing facility is to be constructed in a moderately high seismic zone. The lowest cost for the building is that which meets the minimum requirements of the building code. At this design level, the building will be expected to suffer some loss in the “worst case” earthquake, however that is defined. Additional investments in

improved performance might be considered by the design team and owner. If the cost for each investment is added cumulatively as each is included in the construction budget then the expected worst case loss should decrease. As this example shows, investments in postearthquake response and nonstructural bracing result in a relatively large benefit in terms of reduced losses. Adding interior shear walls results in a moderate benefit. Increasing diaphragm strength and changing the entire structural system to unbonded braces produce a relatively low benefit.

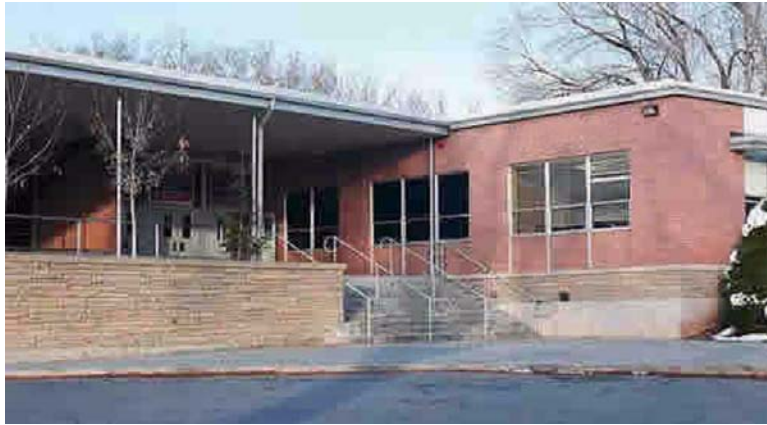
Figure 5-6 Sample existing school building in Salt Lake City K-12 School District.

The Salt Lake City School District consists of 30-40 sites and contains buildings more than 70 years old, as shown in Figure 5-6. The District

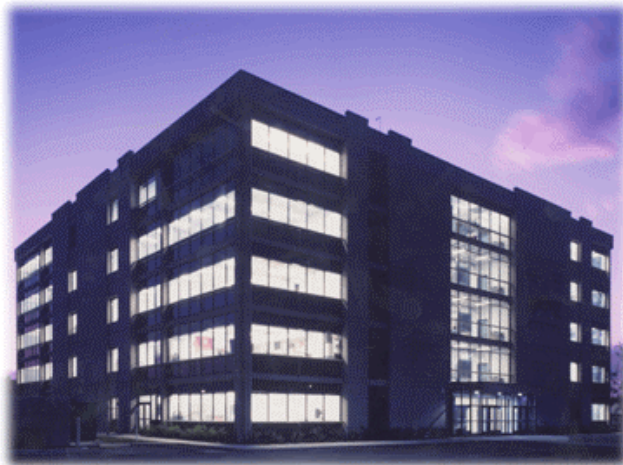
Figure 5-7 Sample new school building design in Salt Lake City K-12 School District.

Its study of the existing school facilities found that when nonstructural rehabilitation costs (e.g., heating, electrical, roofing, and deferred maintenance) were added to the structural costs necessary to achieve the high performance objective, many of the rehabilitations would cost more than the replacement cost of the building. In these cases the decision was made to replace the facilities with new designs such as that shown in Figure 5-7.

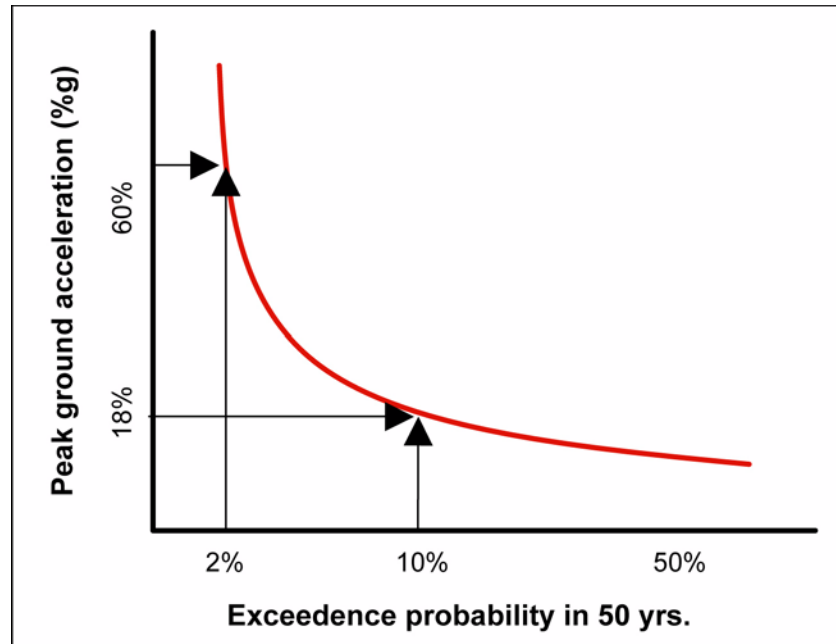
Figure 5-8 Site hazard curve for Salt Lake City K-12 School District seismic risk study.

Recognizing that building codes can change dramatically even over the course of ten to twenty years, the District asked its engineering consultant to evaluate the performance needs with its long lifetime in mind. The engineer crafted simple yet effective graphics similar to the plot shown in Figure 5-8 to help the District determine its risk tolerance. A site hazard curve (see discussion in Section 3.2) was developed (see Figure 5-8) to show the expected ground accelerations plotted against their probability of exceedence in 50 years. Salt Lake City is in *Uniform Building Code* (UBC) Seismic Zone 3, and the vertical line at 10% show the design ground motion specified by the UBC. Over a 70-year period, the probability of exceedence of this level of ground shaking increases from 10% to 14%. Another vertical line is drawn at 2% probability of exceedence in 50 years, representing perhaps the maximum credible event in the area. Over a period of 70 years, the probability of exceedence of this level of ground shaking increases from 2% to approximately 3%. Most notable is the dramatically higher ground motions that would be expected in the 2% probability of exceedence in 50-year event. This analysis showed that designing only for ground motions having a 10% probability of exceedence in 50 years meant there was still a risk of much higher ground motions that could seriously damage the facilities. The District wanted to achieve a higher level of confidence than 14% over the 70-year lifetime that damage would be

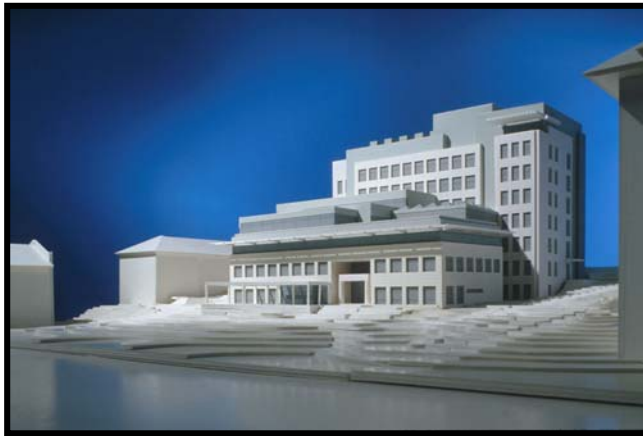
Figure 5-9 New bioengineering laboratory building designed for UC Berkeley campus.

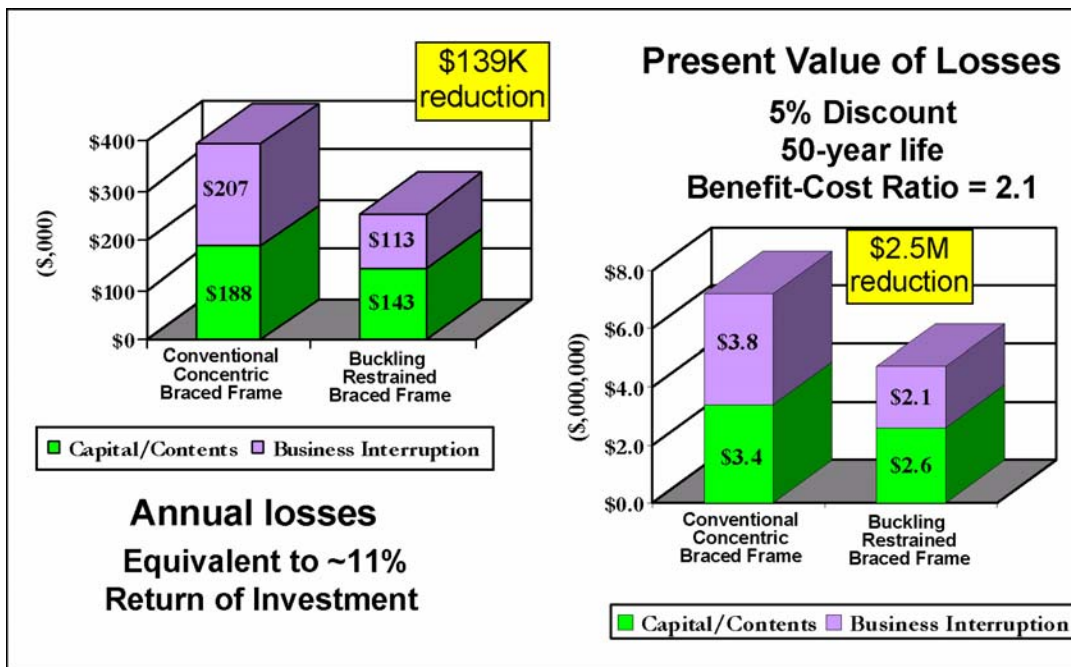
Figure 5-10 Comparison of future losses for two different structural system options for new UC Berkeley laboratory building.

considering reduction of capital, contents and business interruption losses was approximately 11%. Figure 5-10 shows that the reduction in business interruption provided the majority of the projected benefits. Using a 5% discount rate as a benchmark, the benefit-cost ratio (BCR) for the enhancements was over 2 considering a fifty year life. At that discount rate, the BCR reached one at a building life of about 15 years as shown in Figure 5-11.

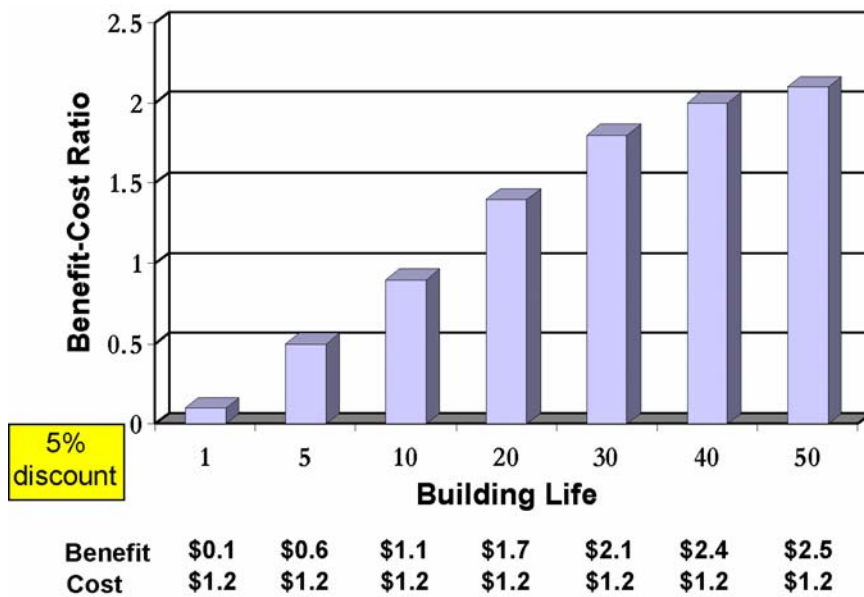
Figure 5-11 Comparison of benefit to cost of using a buckling restrained braced frame, instead of a conventional concentric braced frame, for new UC Berkeley laboratory building. Cost equals cost differential.
