## **2.1 INTRODUCTION**

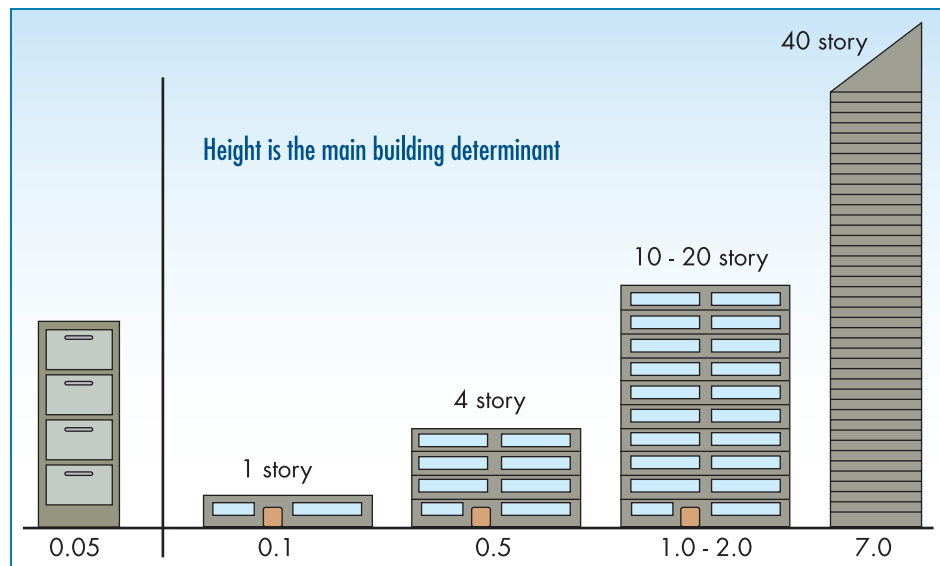
Figure 2-6:  
Period (in seconds)  
and building height

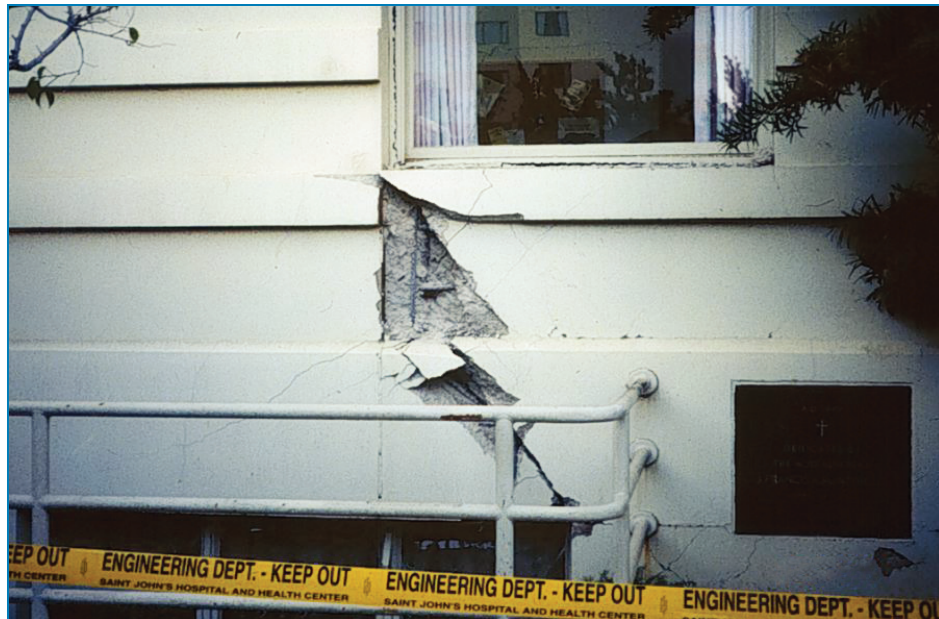
**Figure 2-19:**  
Damage to an exterior concrete wall. This hospital building was evacuated.

When the ground shakes in an earthquake, the shaking is transferred to the building, potentially causing structural damage. The damage can consist of cracks in structural walls, bent or broken braces, or damage to columns and beams. Damage can range from minor (a few cracks), to major (parts of the structure rendered ineffective and potentially unsafe), to complete collapse. See Figures 2-16, 2-17, 2-18, and 2-19 for examples of structural damage.

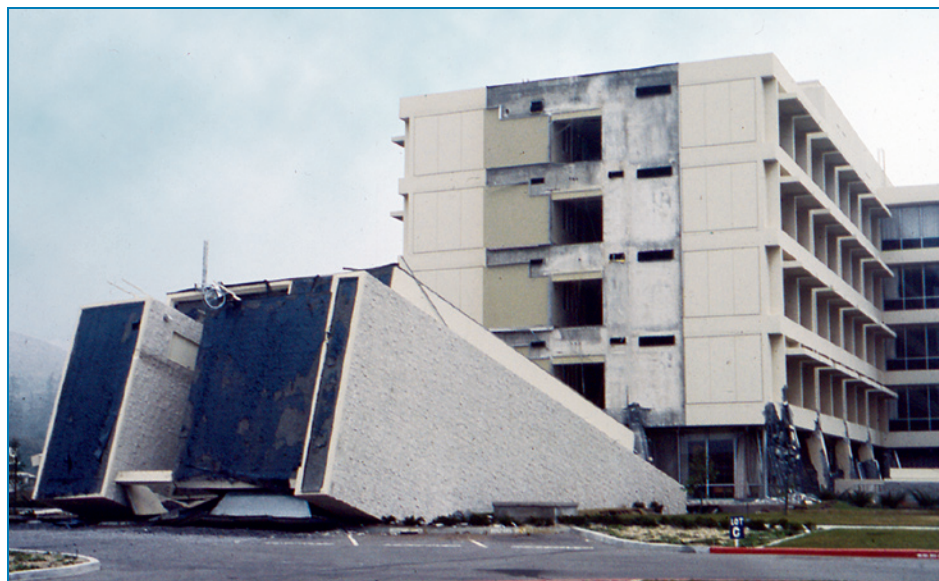
**Figure 2-21:**  
Collapsed stair tower  
in main building of  
Olive View Hospital

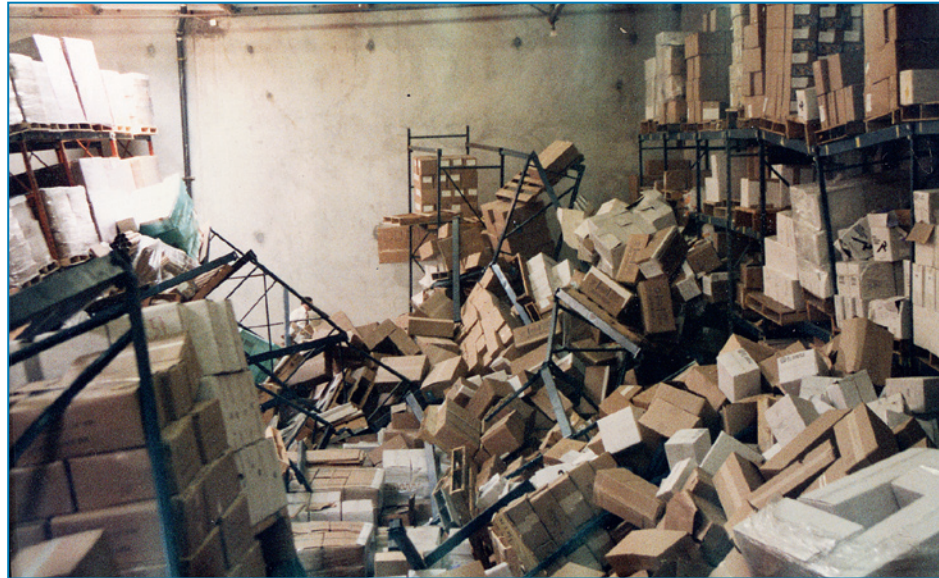
**Figure 2-28:**  
Chaos in a storage area similar to central storage or medical records

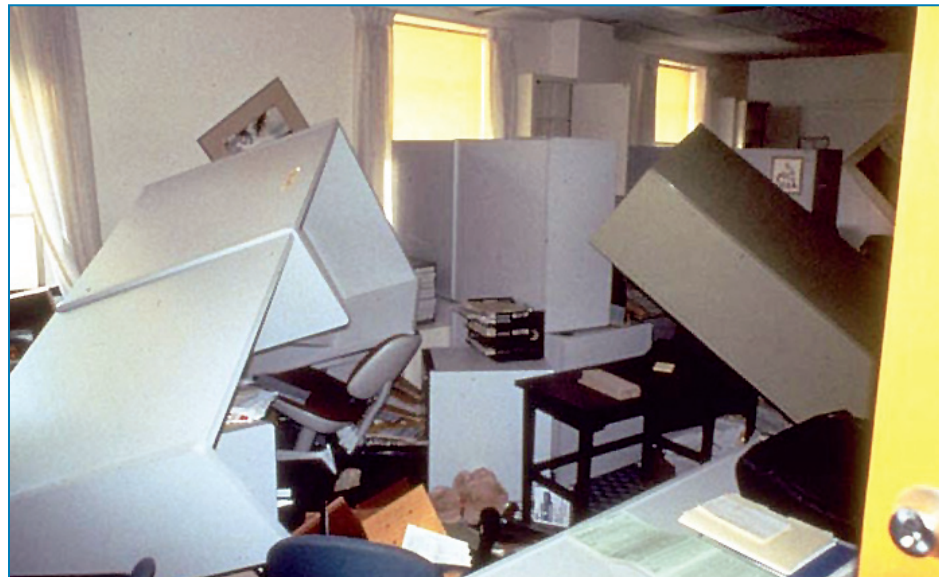
**Figure 2-29:**  
Jumbled contents of a typical office

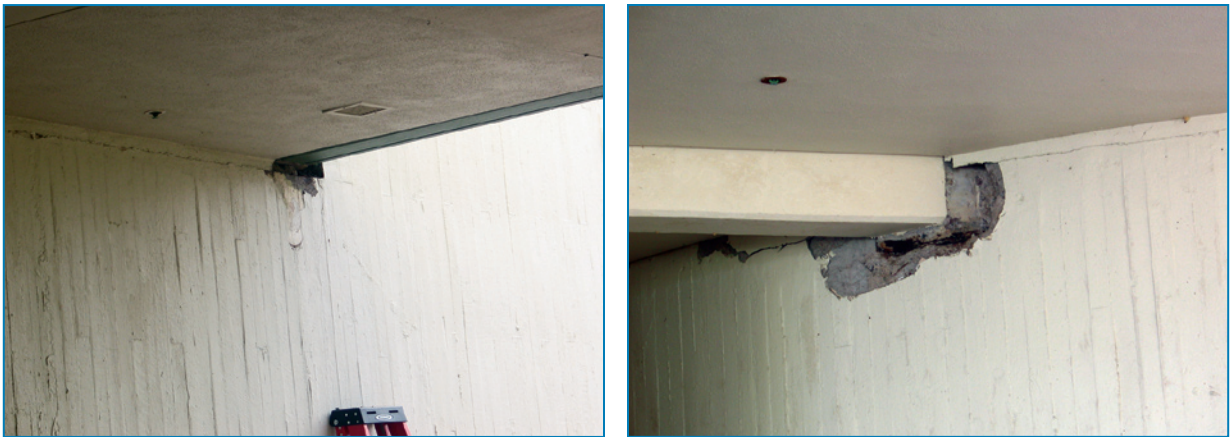
Figure 2-40: Spalling at beam connections

The potential torsional response of the building addition, identified in the 1993 evaluation, proved prophetic, as the column-supported west end attempted to rotate around the stiffly supported east end. As shown in Figure 2-40, the two beam connections tending to restrain the motion spalled. Similarly, in the partially enclosed penthouse, the embedded connection of a steel beam spanning between two exterior concrete walls pulled out due to a stiffness incompatibility. This damage was not considered serious enough for the structure and did not affect the occupancy status.
