Title **Progress Report on Los Alamos National Laboratory
Cerro Grande Fire Rehabilitation Activities
Status of Burned Area Rehabilitation Two Years Postfire**

Prepared by **Kevin J. Buckley and Jeffrey C. Walterscheid,
Water Quality and Hydrology Group
Samuel R. Loftin, Ecology Group
Gregory A. Kuyumjian, USDA Forest Service**

**Progress Report on Los Alamos National Laboratory
Cerro Grande Fire Rehabilitation Activities
Status of Burned Area Rehabilitation Two Years Postfire**

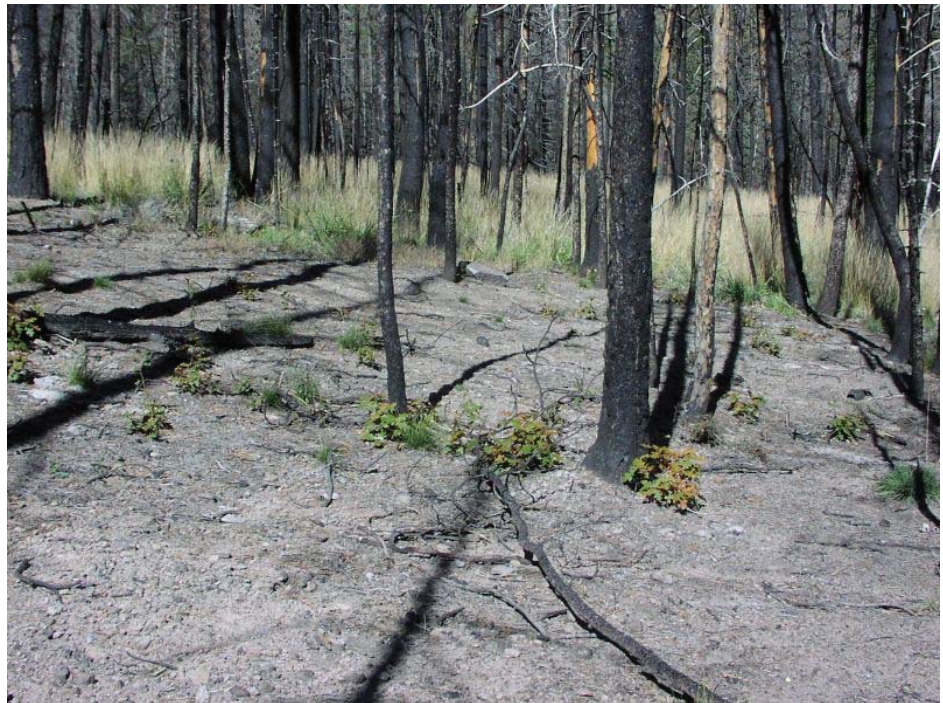
Cover photo: October 2002, watershed divide between Pueblo and Quemazon Canyons three growing seasons after the Cerro Grande Fire. Area in foreground was treated by aerial seeding only while the background received aerial seeding and a straw mulch application.

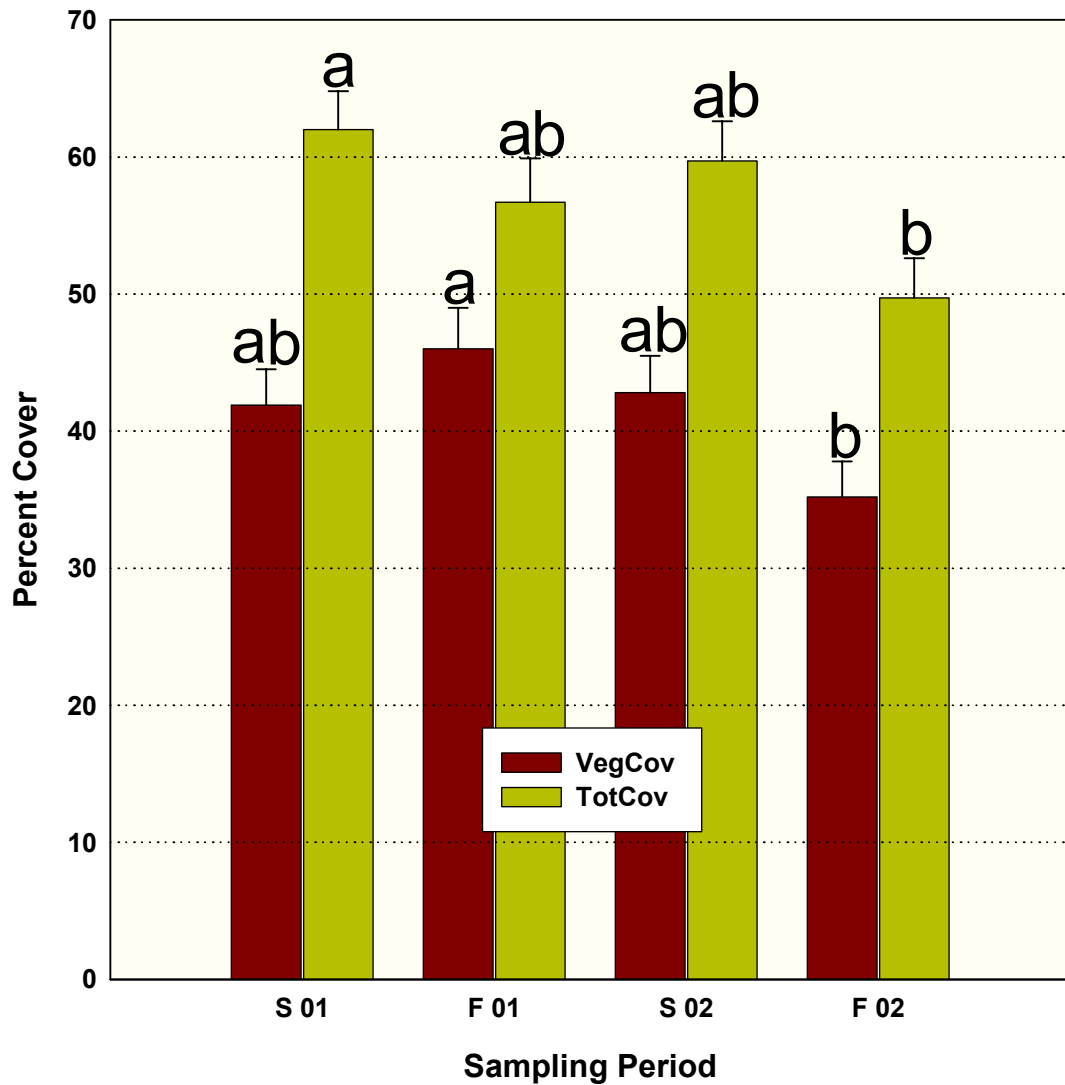
Figure 2. Changes in total and vegetation cover (%) on LANL rehabilitation units. Columns topped with the same letter (within a cover type) are not significantly different ($p \leq 0.05$). According to the ANOVA test, the only significant difference between samples was summer 2001 (S 01) and fall 2002 (F 02) for total cover and fall 2001 (F 01) and fall 2002 (F 02) for vegetative cover. Sampling periods are summer 2001 (S 01), fall 2001 (F 01), summer 2002 (S 02), and fall 2002 (F 02).

Previous BART survey results show that there were no significant changes in percent total ground cover and percent vegetative cover on the rehabilitation units between summer 2001 and fall 2001 (Buckley et al. 2002). Between fall 2001 and summer 2002 percent total cover increased while percent vegetation cover decreased (Fig. 2). Neither change was significant. This trend might be expected as green vegetation dies over the winter and contributes to the litter cover. However, both ground cover and vegetation cover decreased between summer 2002 and fall 2002. Again, neither change was statistically significant, but this reduction was unexpected. There are two likely explanations for this observed response. One, the summer/fall of 2002 was very dry and little precipitation was recorded before October, leaving little time for herbaceous vegetation response. Obviously, the lack of rain should have less effect on total cover than vegetation cover. Secondly, there have been extensive thinning activities on some of the rehabilitation units. Thinning has occurred on 125 ha (310 acres) of the 242 ha (599 acres), or 51%, of the total area that received rehabilitation treatments. In most cases trees were cut on the site and chipped or skidded off site. In some cases all of the ground cover, including the rehabilitation treatments, was removed from the site. Figure 3 shows significant differences in total and vegetation cover between thinned and unthinned rehabilitation units. Total cover was approximately 25% less and vegetation cover was approximately 15% less on thinned sites. Much of these differences may be due to the timing of the thinning activities and the rehabilitation surveys. Surveys may have been conducted before the thinning crews had a chance to implement secondary rehabilitation treatments. At this time, the CGRP plans to complete all thinning and rehabilitation activities by September 30, 2003. Monitoring and maintenance will continue as a component of long-term management of these sites.
