# OLD MINES

# UNDERMINE

# HIGHWALL STABILITY

AT SURFACE MINES

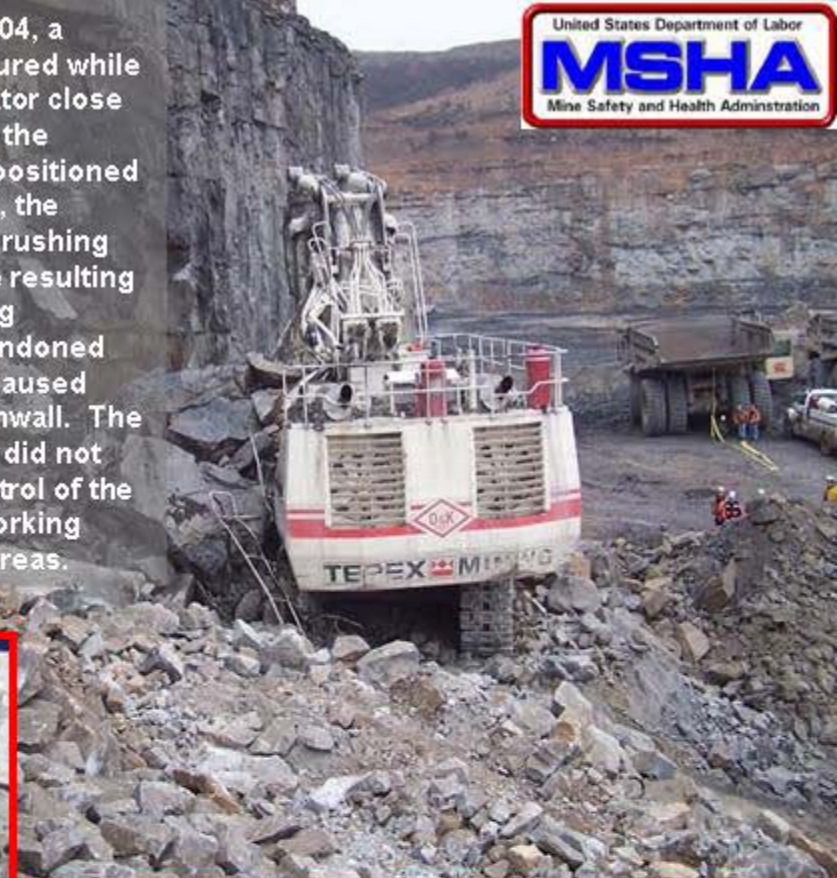
On November 20, 2004, a miner was fatally injured while operating an excavator close to a highwall. While the operator's cab was positioned on the highwall side, the highwall collapsed crushing the cab. Subsidence resulting from the pillar mining performed in an abandoned underground mine caused instability in the highwall. The ground control plan did not provide for safe control of the highwall and safe working conditions in such areas.

- Establish ground control plans that require the angle, height, benches, etc. of highwalls to be designed to provide stability when adverse conditions are encountered.
- Perform complete and thorough examinations of highwalls at a frequency consistent with the conditions.
- Be aware of changing highwall conditions.
- Train examiners to recognize adverse conditions and environmental factors that can decrease stability.

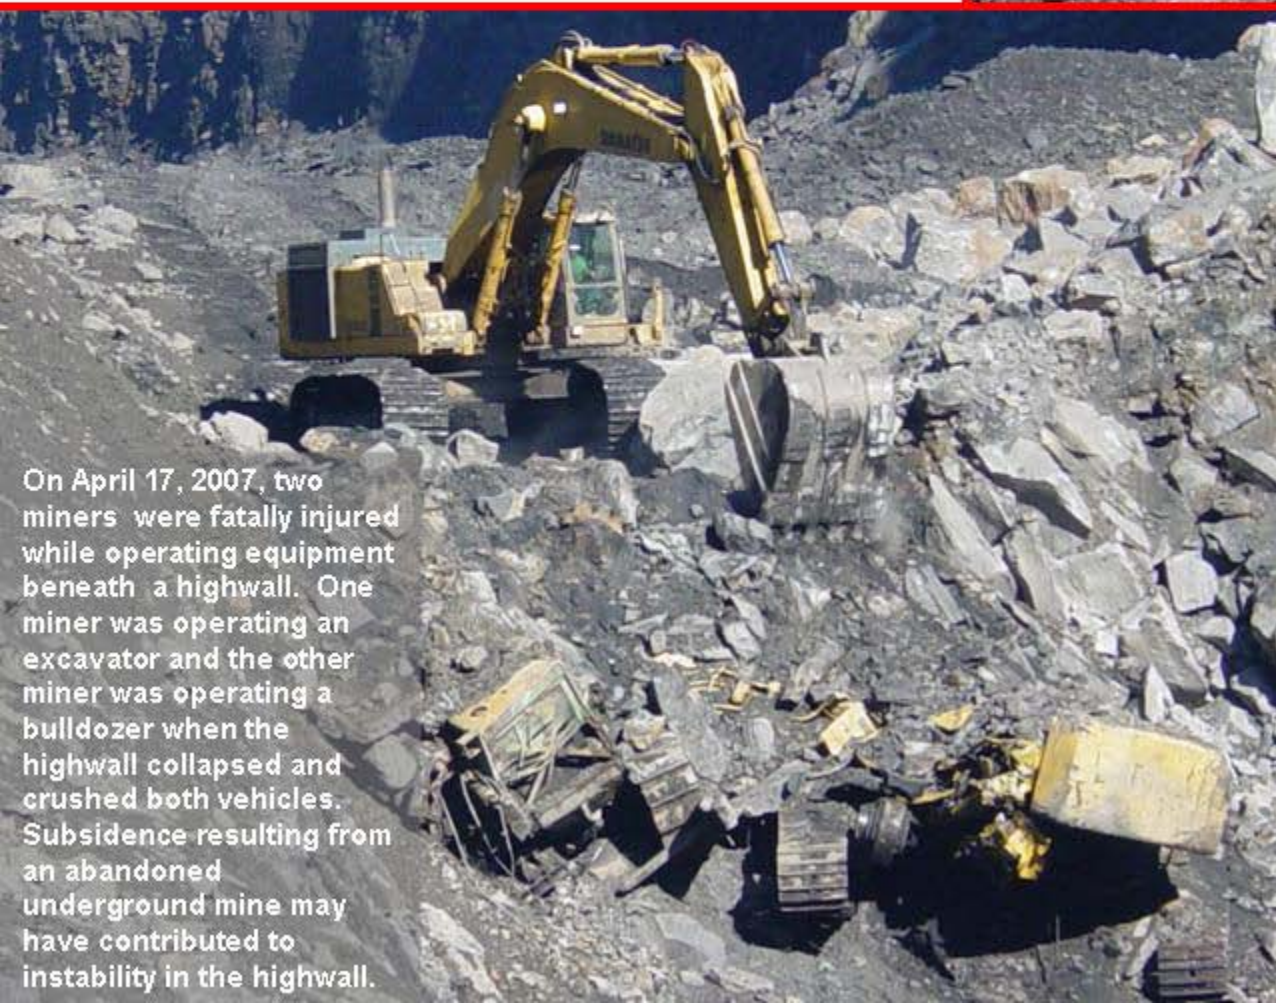
On April 17, 2007, two miners were fatally injured while operating equipment beneath a highwall. One miner was operating an excavator and the other miner was operating a bulldozer when the highwall collapsed and crushed both vehicles. Subsidence resulting from an abandoned underground mine may have contributed to instability in the highwall.
