Appendix H-3
Sago Mine, MSHA ID 46-08791
Wolf Run Mining Company

Appendix J - Bottom Mining Supplements to the Ventilation Plan

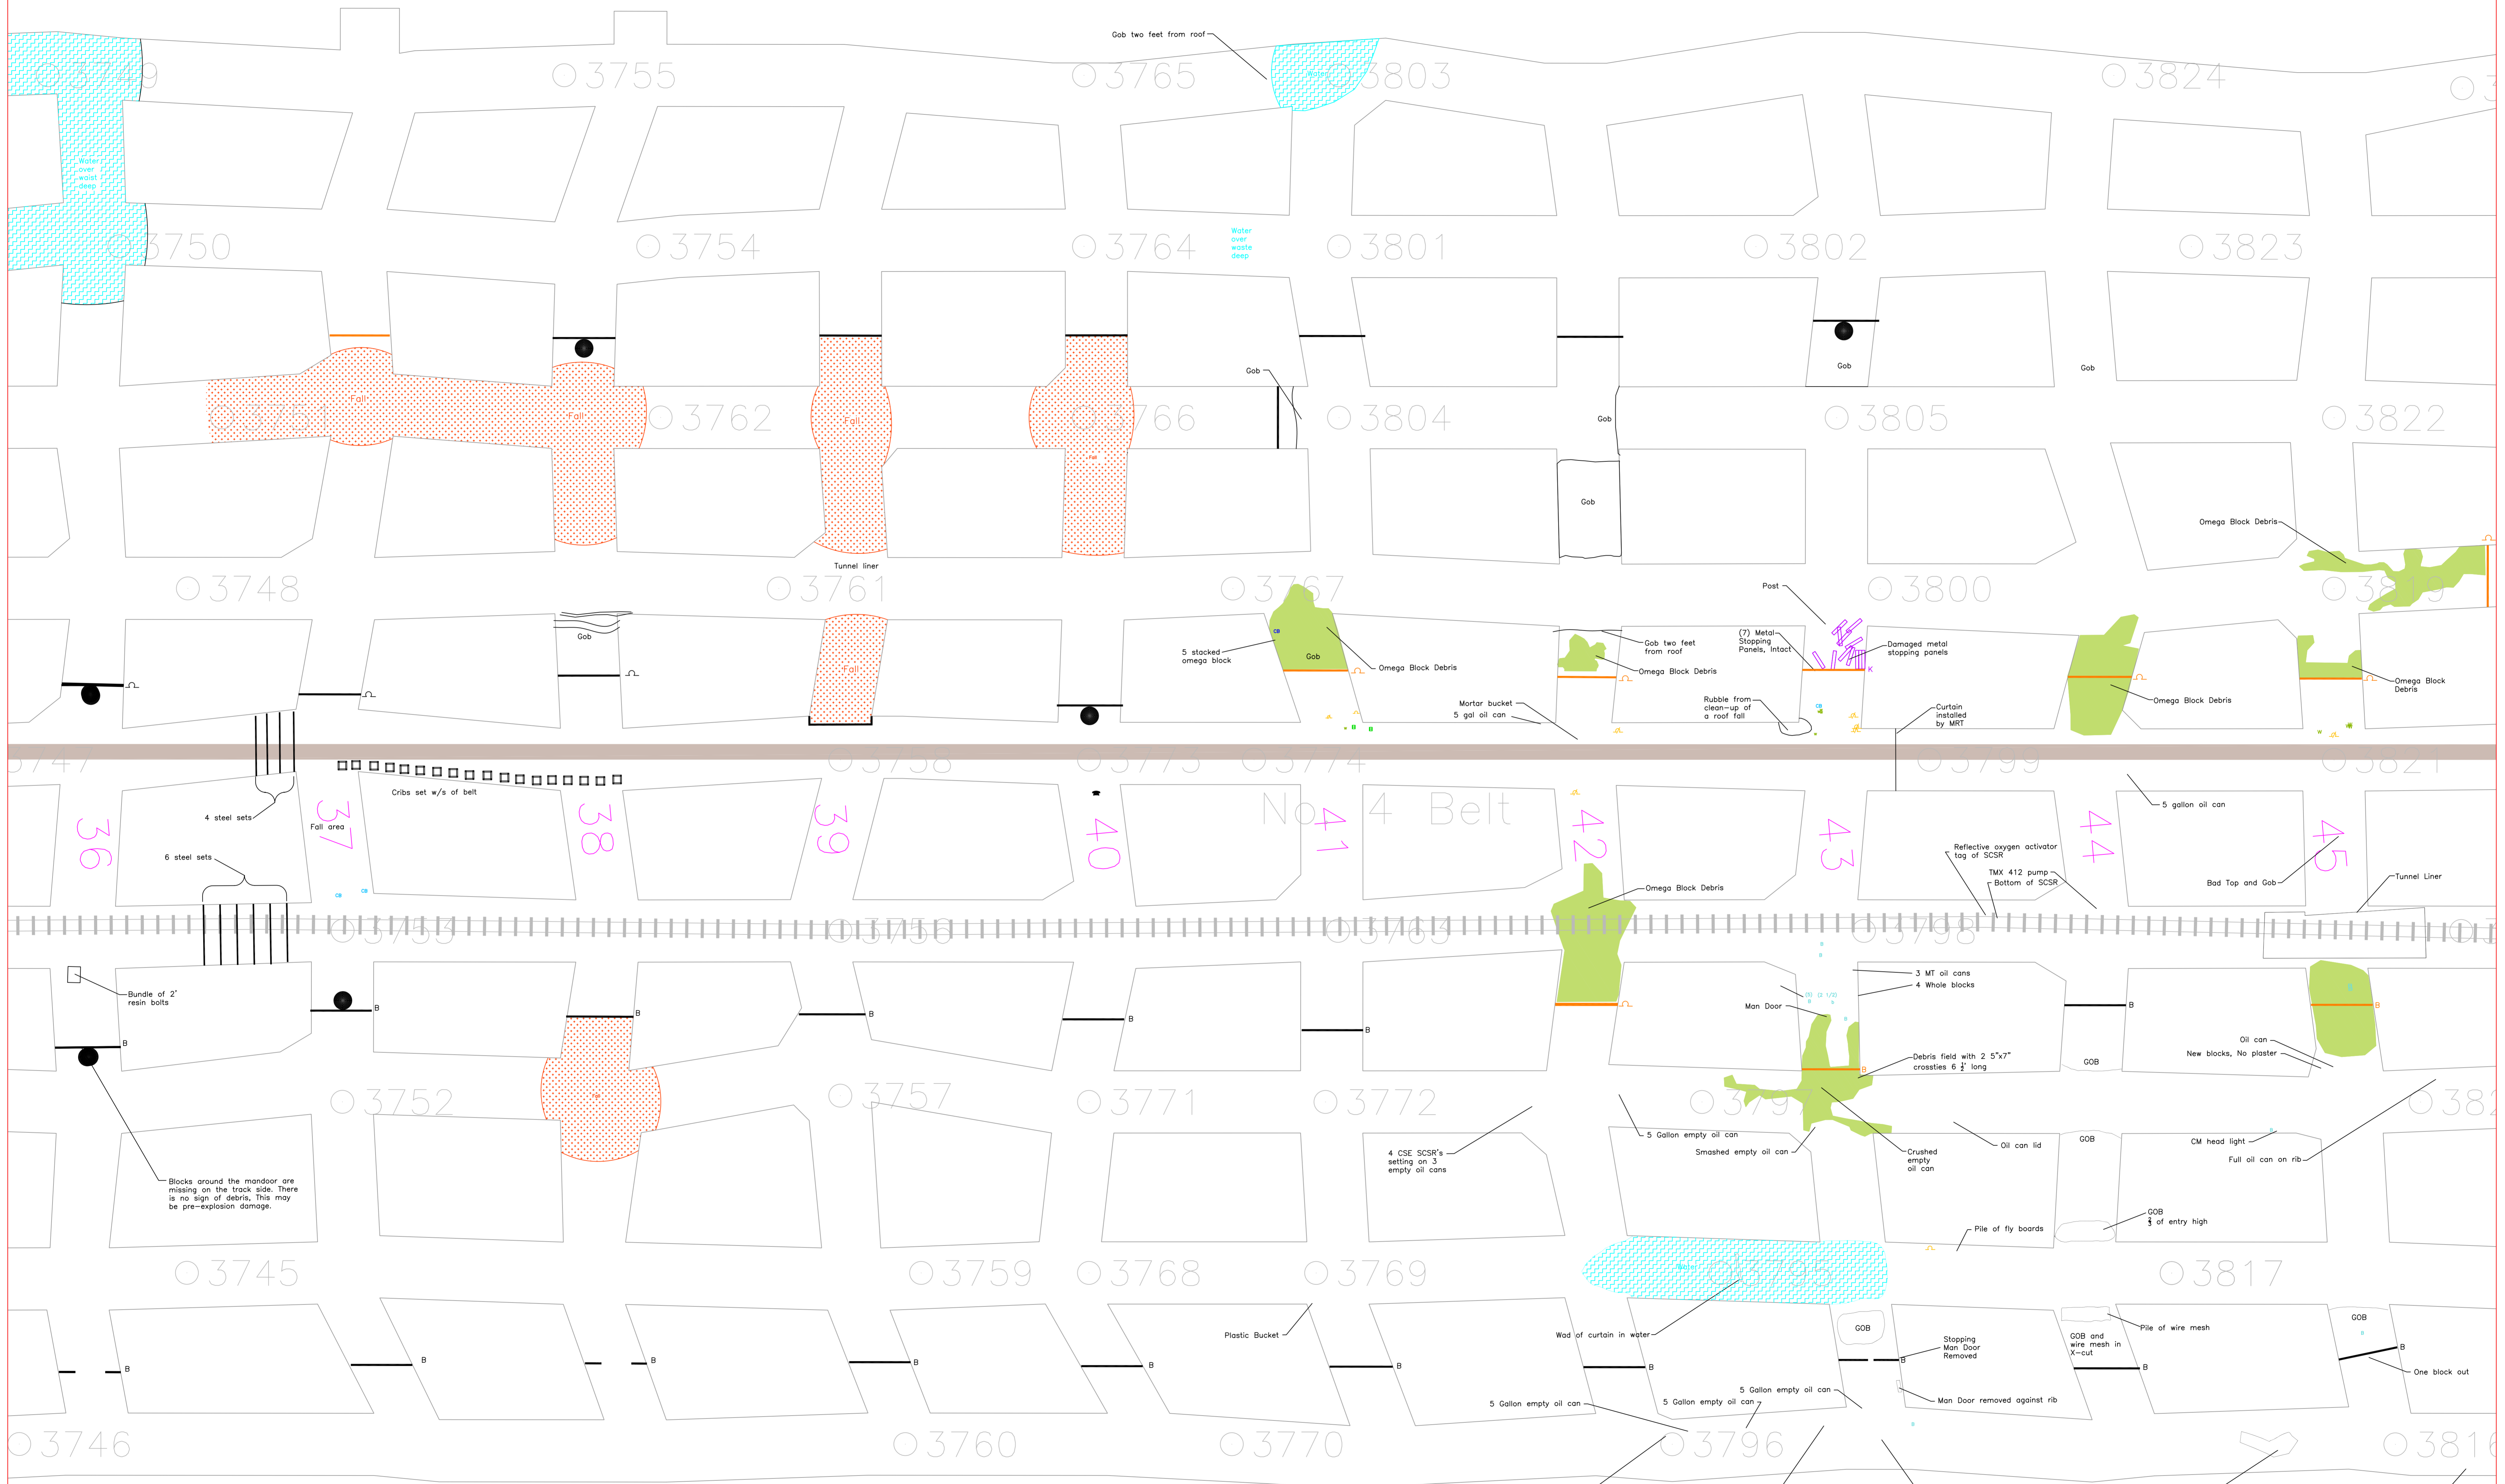
(Inby direction) Few damaged pie pans bent inby between xcuts in #8 entry
 Roof fall
 Outby fall shown on map, roof fall visible location inby xcut appears dark dust covered outby end of fall just inby bottom cut
 Approx. inby end of bottom cut

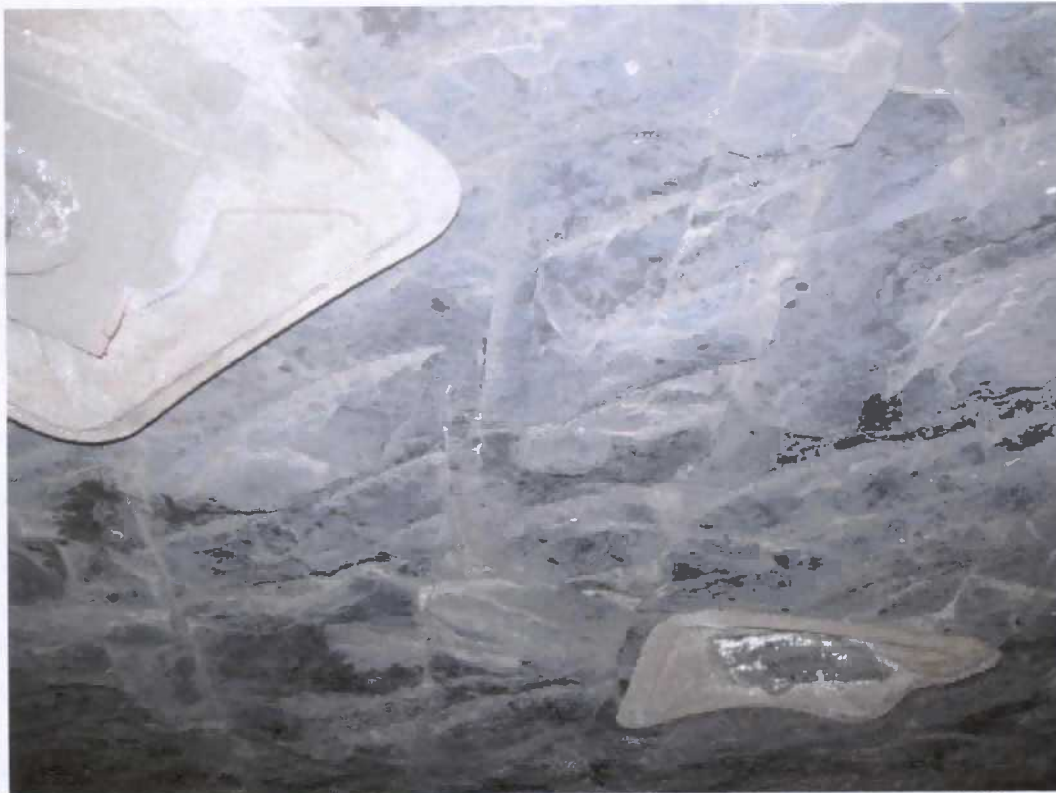
Figure 1. Very well developed joint set, characterized by N 85°E-striking joints spaced 12-20 inches apart. Photo taken in the crosscut between spads 4010 and 4011.

The observation area is characterized by a variety of abundant structural geologic features and stress-related features. Abundant, very well developed joints were observed in the roof (Figure 1). The dominant joint set is oriented with a strike of N 85°E, and is characterized by nearly vertical joints that are spaced approximately 12-20 inches apart. Joints of this set were present across the entire observation area, from the spad 4010 intersection to the spad 4063 intersection, a distance of two crosscuts. Two minor, irregularly spaced sets of joints, oriented respectively at N 57°W and N 30°E, are aligned parallel to the trend of slickenside planes. A prominent slickenside plane that controlled a zone of buckled roof strata was oriented N 30°E, with a dip of 35° toward the southeast, and is located in the southeast corner of the spad 4047 intersection. A pair of slickenside planes, oriented N 67°W and dipping 50° NE, formed a linear, coffin-shaped roof cavity that trended through the spad 4045 intersection, crosscutting a wide, deep horizontal stress pot-out.

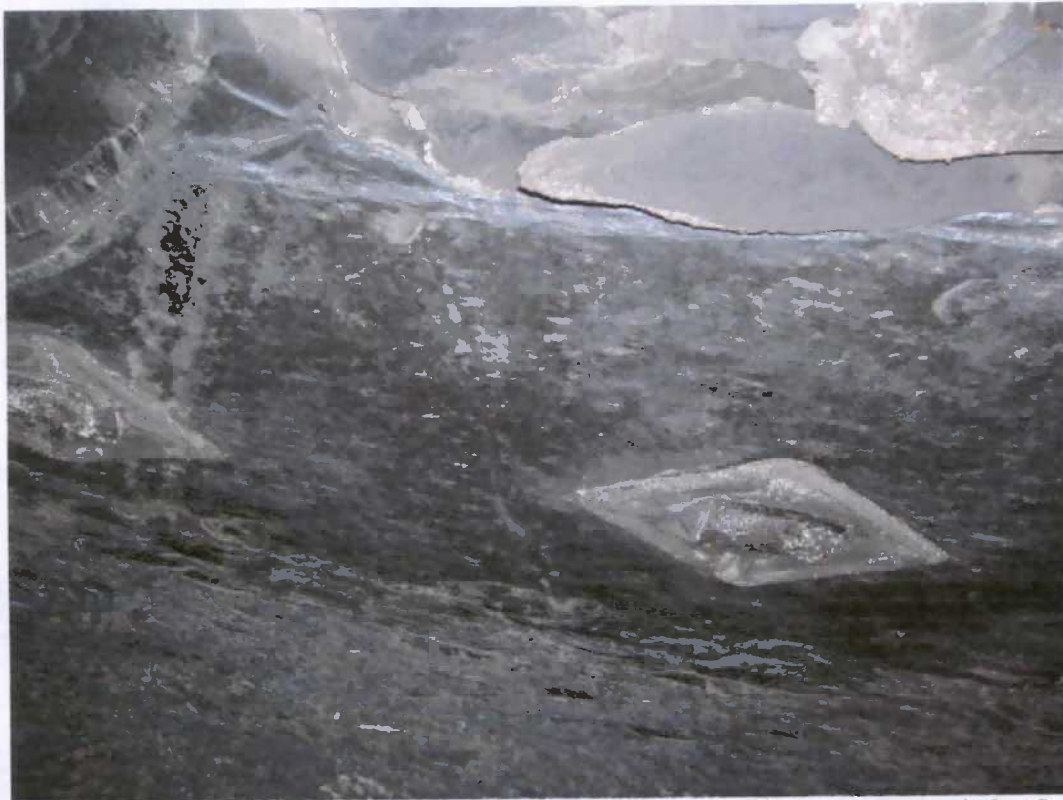
Figure 4. Two pairs of linear, parallel ridges exposed on the bottom surface of the gray shale. Center feature lies along a trend of N 70°E, forming an acute angle with the feature at left, which is oriented along a trend of N 43°E. There is no indication of the linear features extending above the thinly laminated immediate layer of the roof, as exposed in the thin brow formed by the stress pot-out.

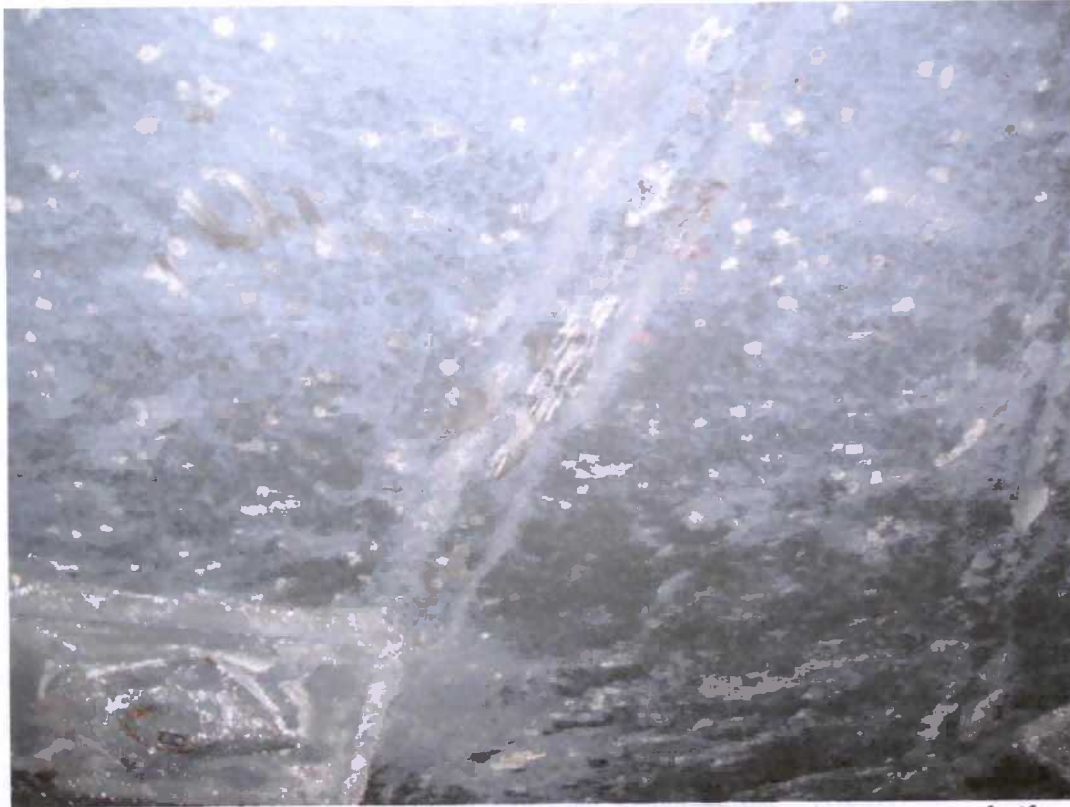
Figure 5. Light brown linear streaks along the trend of the parallel linear ridges represent knife scratch marks from an attempt to collect fossil material. Location is the vicinity just inby the spad 4010 intersection. Twin parallel ridges pass beneath the embossed, square skin control plate.

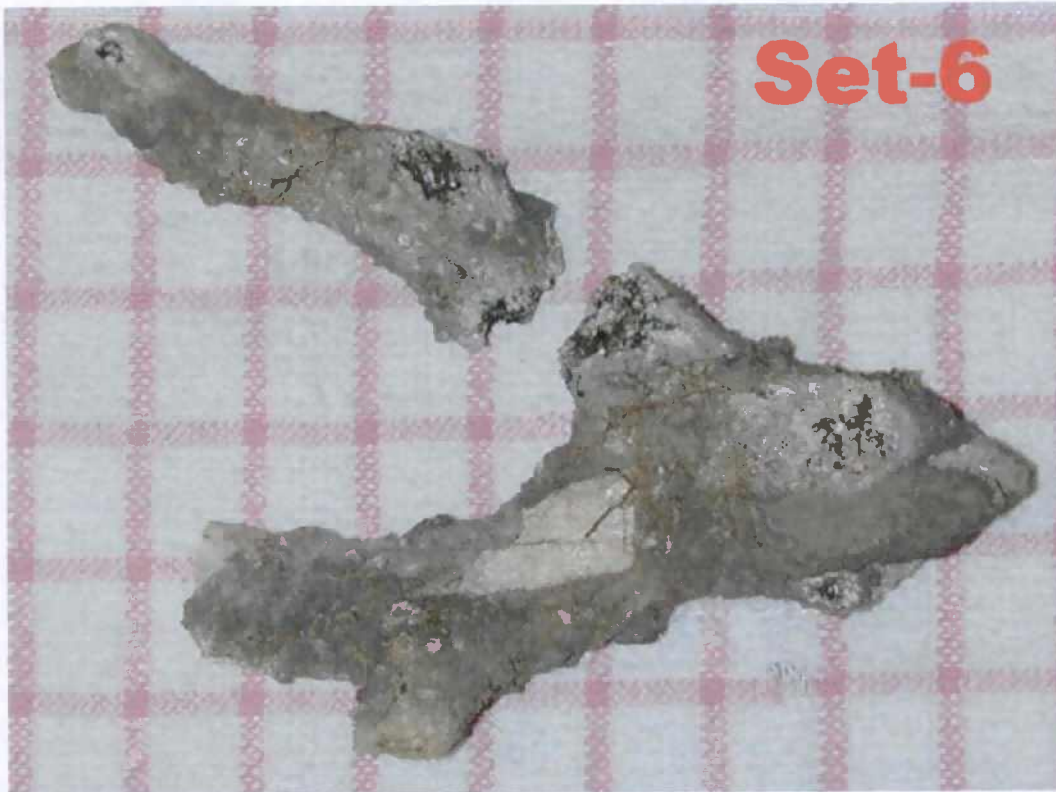
Figure 3. Sample of fulgurite for sale on internet website, showing branching texture of bubbled silica glass.

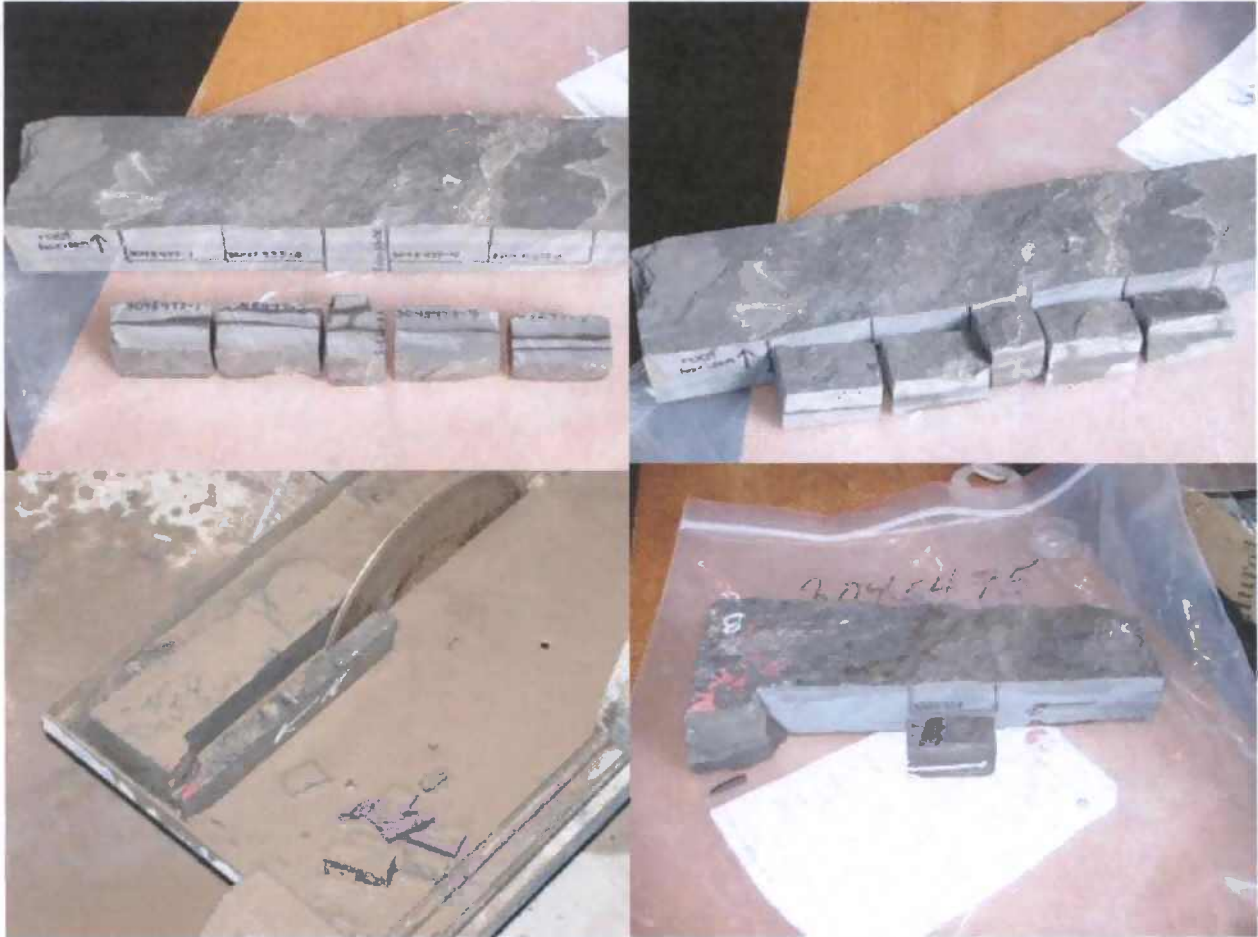
Figure 6. Cross section slice from Sample 3045477 (top pair) and Sample 3045475 (bottom pair) further separated into individual chips ready to be made into thin sections for detailed study. The work shown was performed at the Approval and Certification Center.

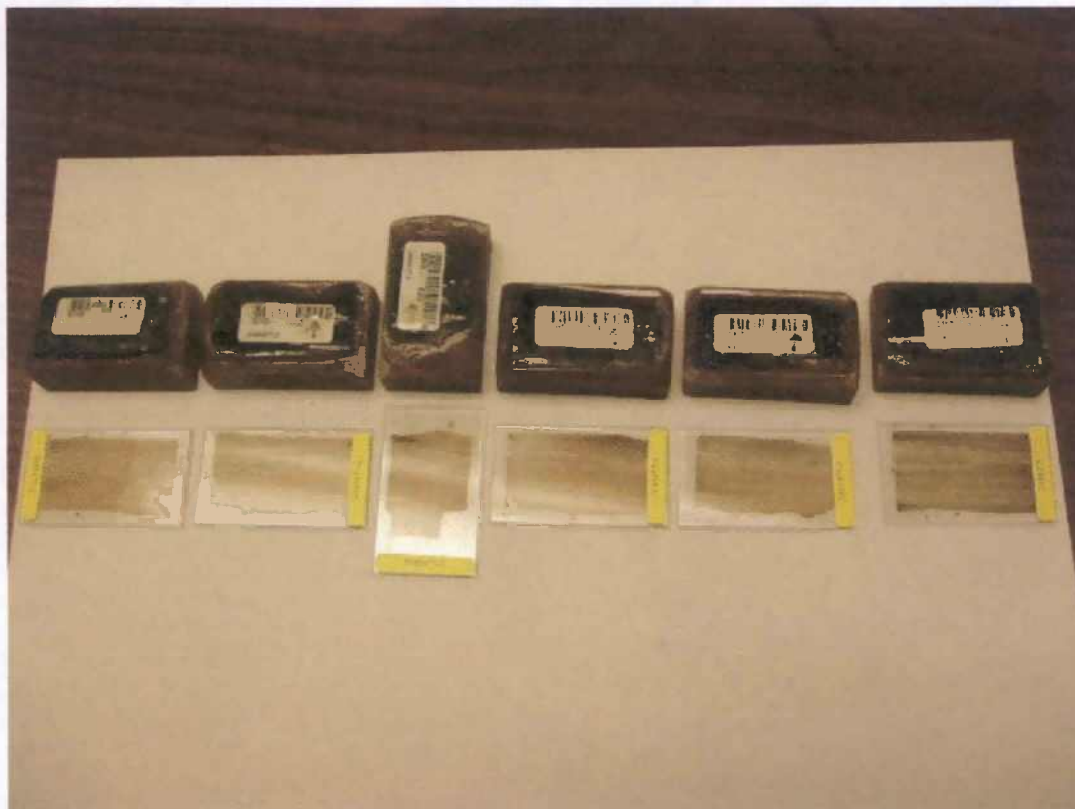
Figure 7. Completed thin sections (glass microscope slides) and original sample chips prepared at A&CC returned by Spectrum Petrographics laboratory on April 7, 2006.

Splits of the three samples obtained by R. J. Lee were passed to MSHA on March 13, 2006, and obtained by the author on March 16, 2006. Two of the samples were cut with a water-cooled, diamond blade rock saw at the Approval and Certification Center (A&CC) to obtain a cross section through the area where the linear feature appears (Figure 4). The cross section slice was annotated with five rectangular blocks to be prepared for thin sections. Locations of the rectangular blocks were marked on the mating surface of the original sample split (Figure 5). Each outlined block was then sawed from the cross section slice to define an individual sample (Figure 6). The chips were then sent via FedEx to Spectrum Petrographics in Vancouver, Washington, to prepare thin sections of the samples. Thin sections are slices of the rock that are ground so thin that light can pass through the sample, while glued to a microscope slide so that microscopic textures and details can be documented. The completed thin sections were received on April 7, 2006 (Figure 7).

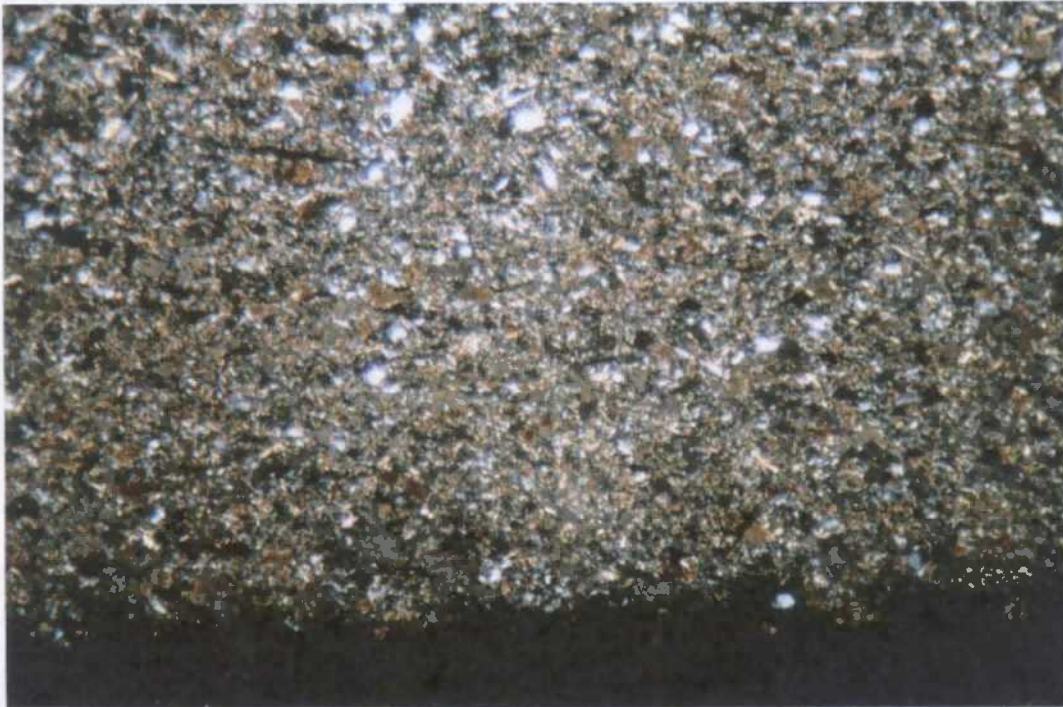
Figure 9. Lowest layer of shale immediate roof exposed at mine roof horizon, showing angular quartz grains (bright white) scattered in a matrix of very fine-grained lathes of muscovite (rectangular, brightly colored yellow/pink/blue). Brown represents patchy iron staining. Field of view 2.4 mm at 40X, taken under crossed polars.

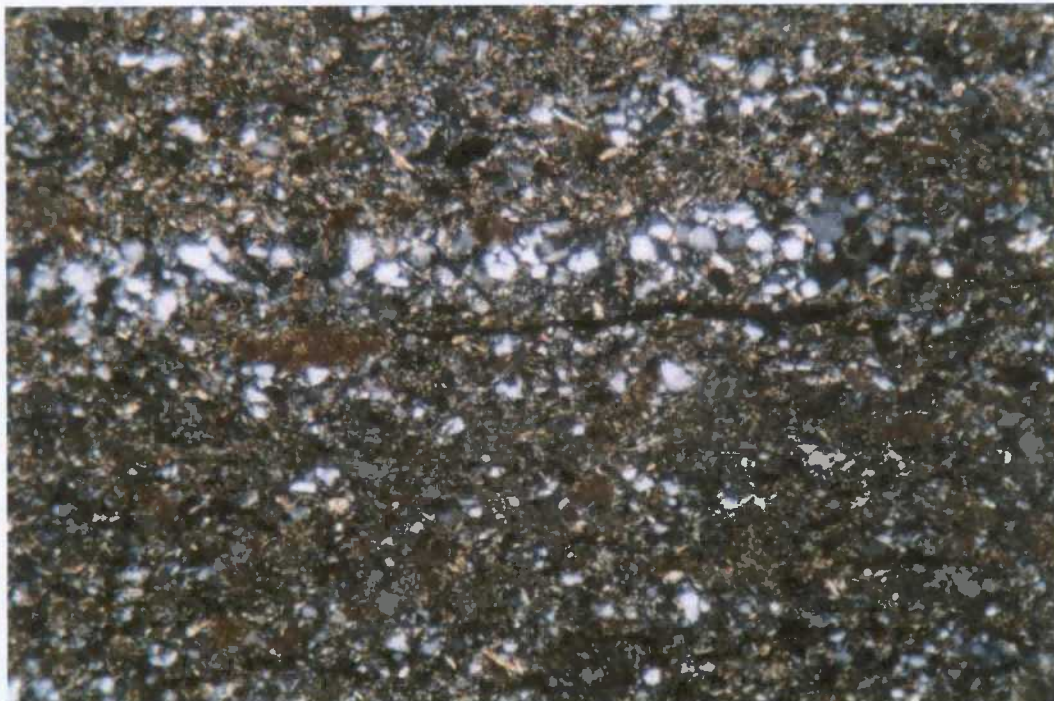
Figure 10. Lamination of angular quartz grains of "very fine sand" size. Angular grains touch along tangential contacts. Long axes of quartz grains and rectangular muscovite lathes are not strongly oriented parallel to bedding, indicating that burial compaction was not intense enough to force grain rotation. Field of view 2.4 mm at 40X, taken under crossed polars.

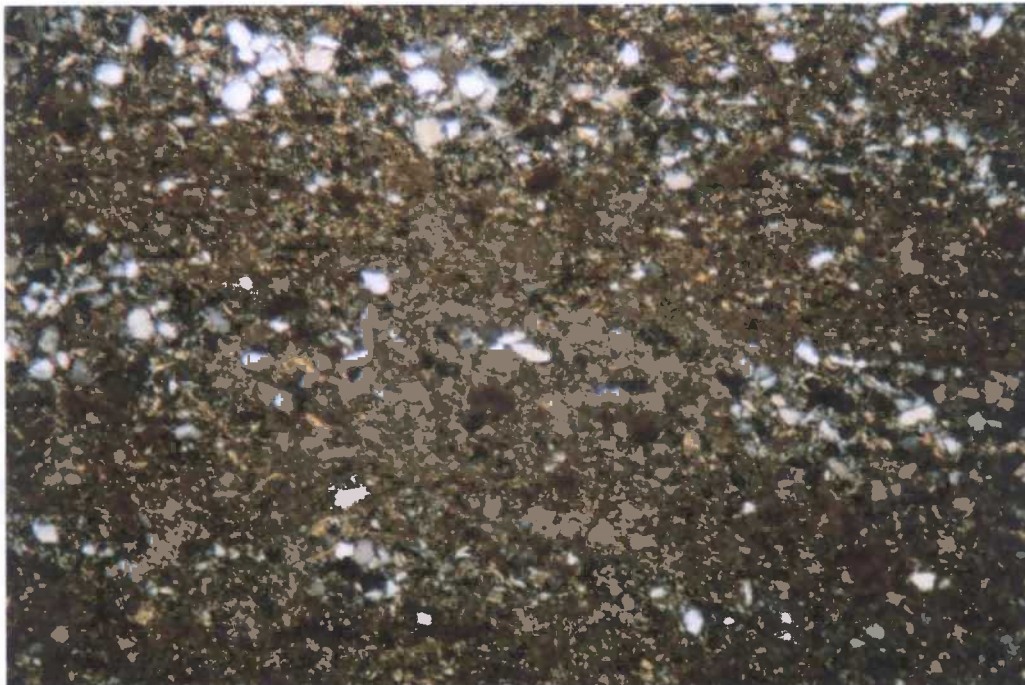
Figure 16. Field of view approximately 5 mm above the area in Figure 15, showing interbeds of quartz that gently rise from right to left above the compaction zone. Although locally a compaction zone, the long axes of quartz grains and muscovite lathes are not strongly oriented parallel to bedding, indicating that burial compaction was not sufficient to force grain rotation. Field of view 2.4 mm at 40X, taken under crossed polars.

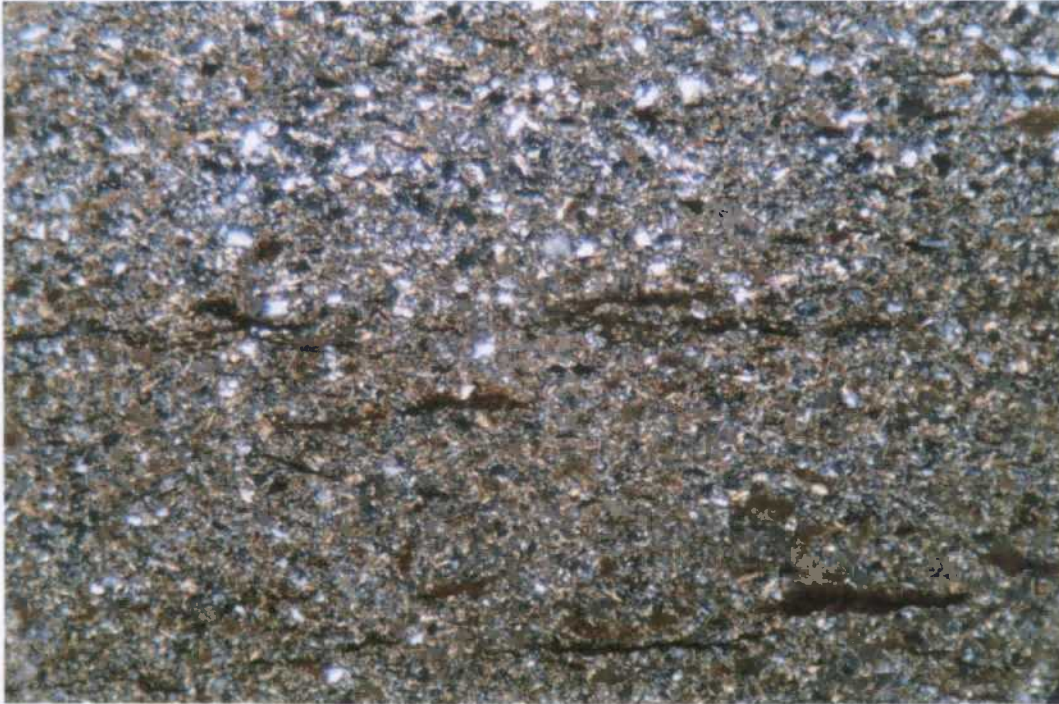
Figure 18. Very regular, continuous bedding contact between lower, fine-grained lamination characterized by scattered, angular quartz grains (bright white) in a very fine-grained matrix of muscovite (speckled yellow/pink), grading upward into lamination with abundant, angular quartz grains. Some quartz grains touch along tangential contacts, while most are isolated by surrounding muscovite. Discontinuous stringers of iron hydroxide (black to very dark brown), which may represent diagenetic alteration of original biotite flakes, are aligned parallel to define bedding. Field of view 2.4 mm at 40X, taken under crossed polars.

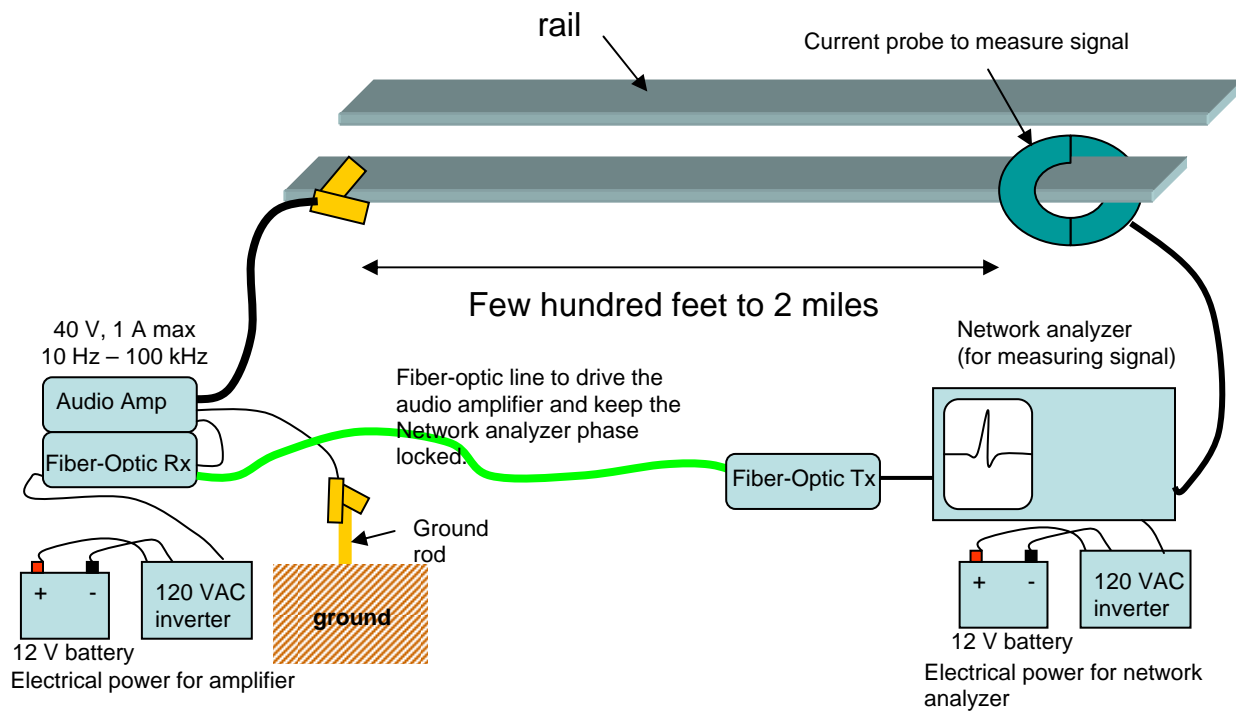
Figure 3-1 Direct Drive Conceptual Drawing.

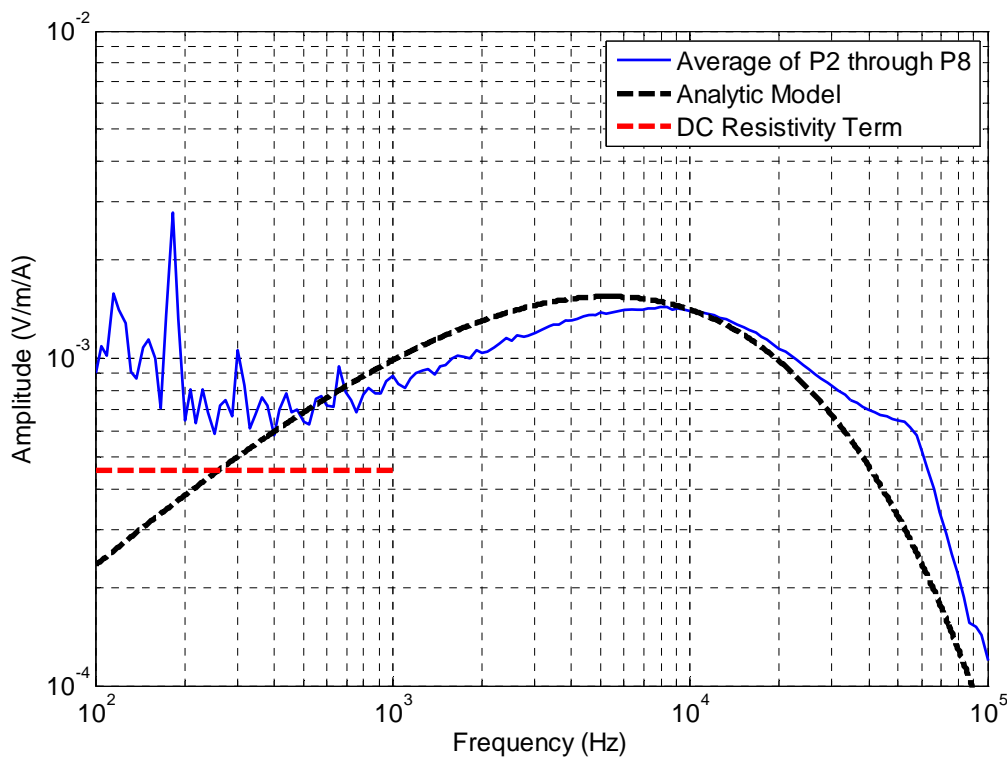
Figure 3-16 Average of P-directed fields from P2 to P8 compared with diffusion model.

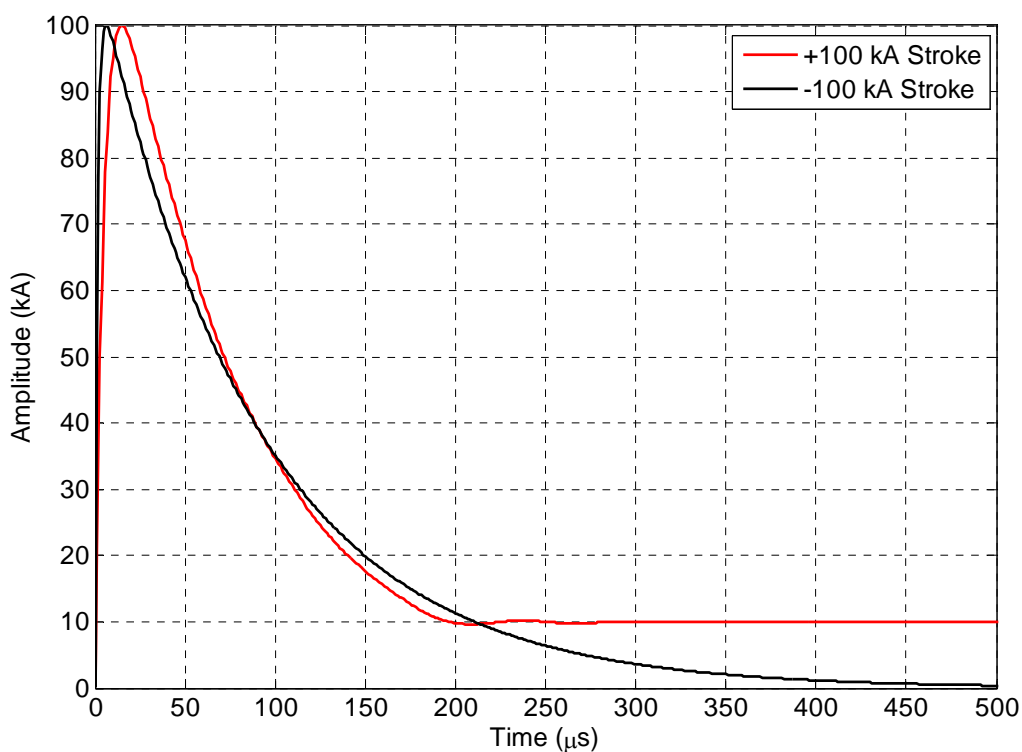
Figure 4-1 Basic positive and negative lightning waveforms used as inputs for analysis.

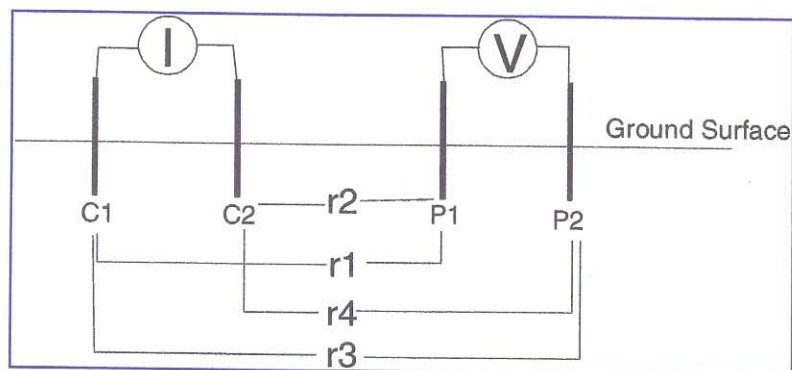
Figure A.1 Dipole-dipole array configuration.

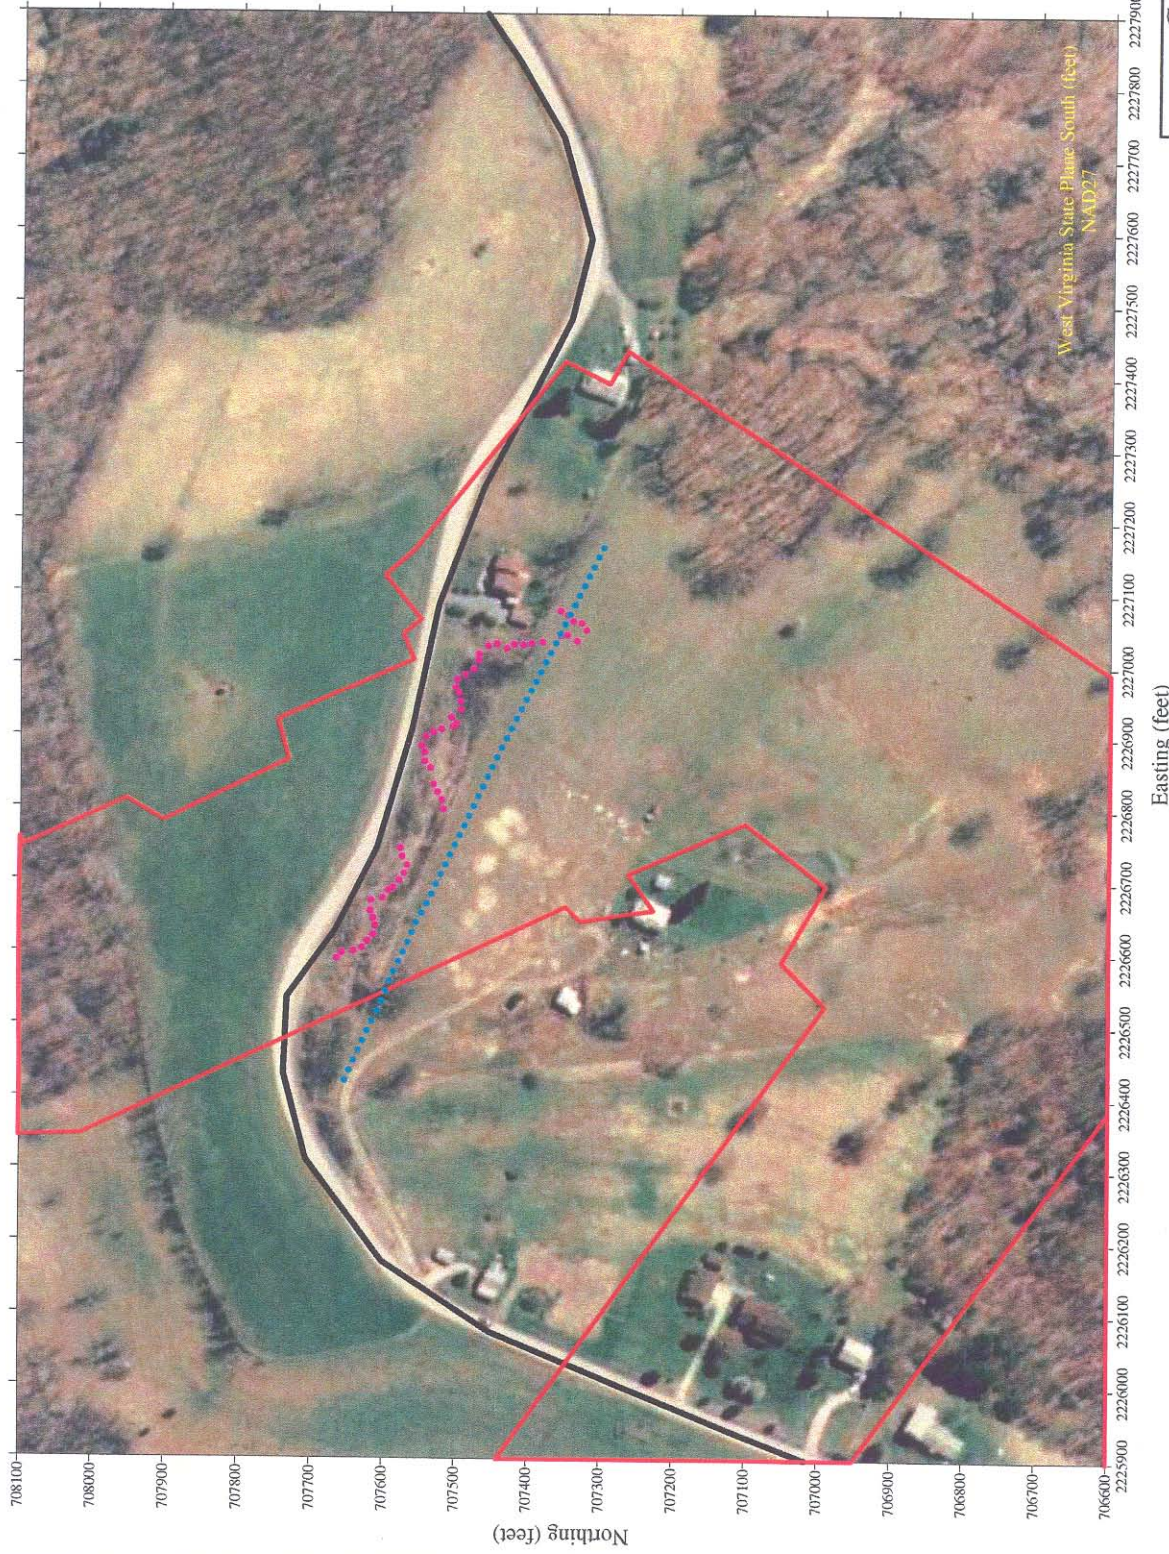
High Resolution Resistivity Line Location

- Sago Mine Boundary
- Surface Electrode Location
- Roof Bolt Location

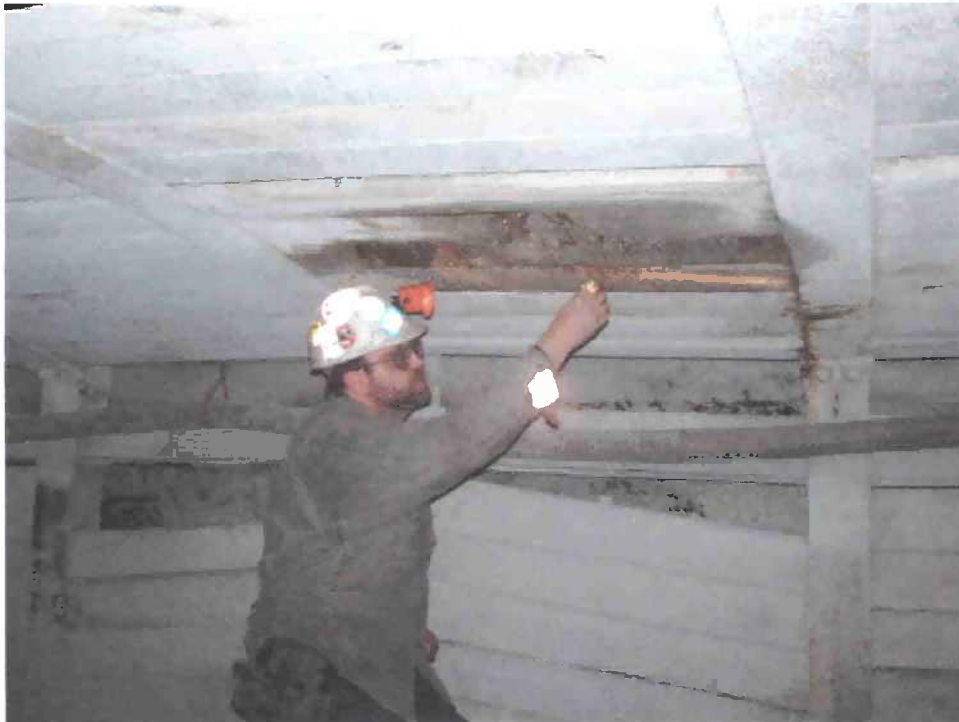
Figure 1. Collection of dripping water in the track entry of the Main, between Crosscuts 32-33.

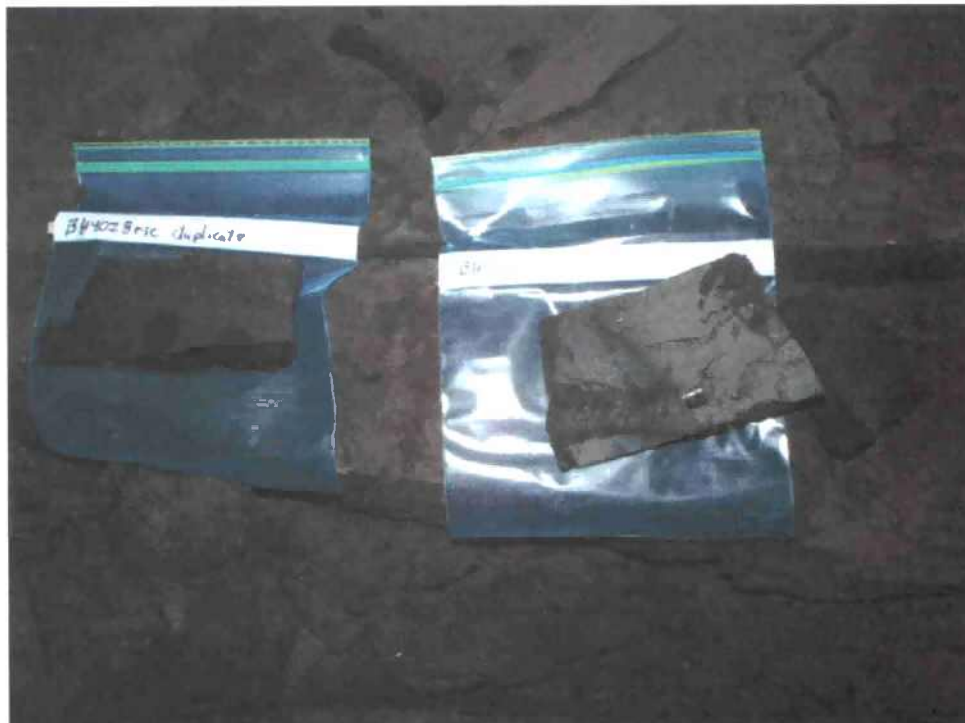
Figure 5. Samples collected from the right inby crosscut in the spad 4028 intersection. Half of the sample was retained by MSHA in a bag labeled "BH4028ric" and the other half was retained by mine personnel in a bag labeled "BH4028ric duplicate."

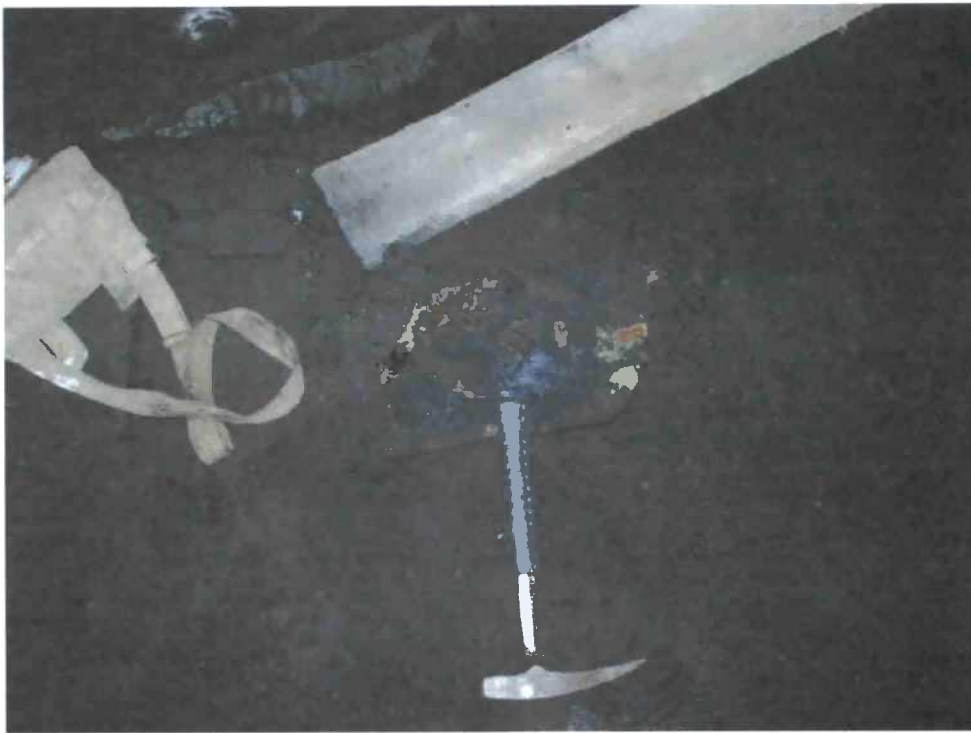
Figure 6. Slab of “blue haze” coated rock retrieved from the right rib approximately 55 feet inby spad 4010. This slab was subsequently split in half, with each half retained by mine and MSHA personnel present.

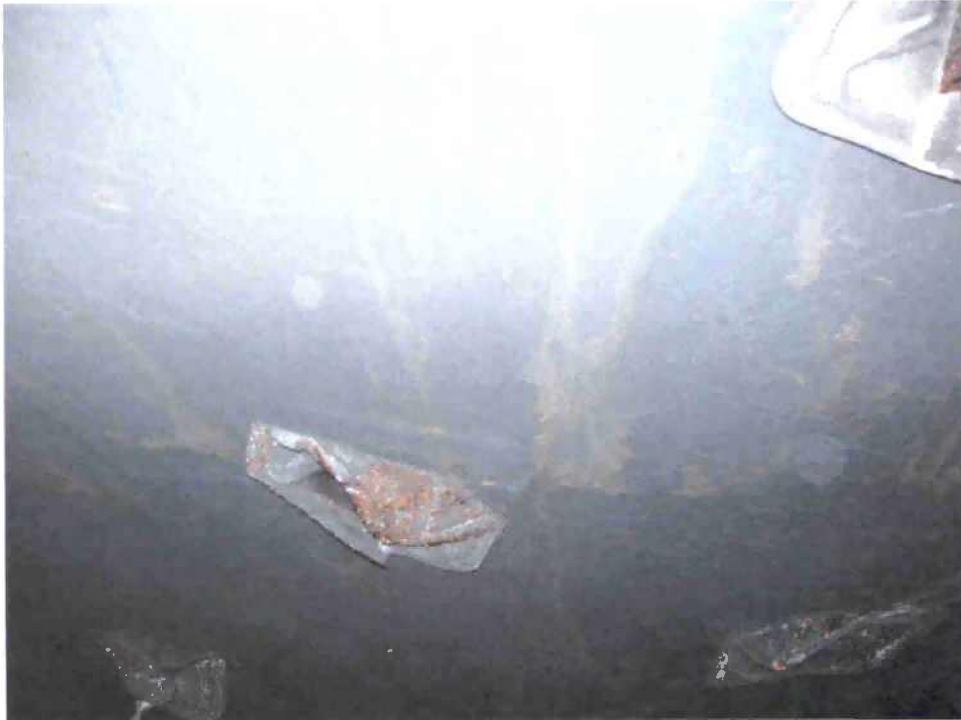
The intersection is characterized by a series of wavy brown streaks, which extend into the adjacent #8 Entry and crosscut. Each wavy brown streak has a linear, although undulatory trend that was measured with a Brunton compass. The streaks in the outby side of the #8 Entry exhibit a trend of approximately N 13-15°E, such that they project into the right inby corner of the intersection (Figure 8 and 9). Traversing from the #8 Entry inby to the left-hand crosscut, the brown wavy streaks change their orientation, and continue to trend toward the right inby corner of the intersection. Thus, the brown wavy streaks define a radiating pattern with a center point about the right inby corner of the intersection. These long, roughly linear, but wavy brown streaks are developed in flat, planar portions of the exposed roof. Several brown wavy streaks were observed that are approximately perpendicular to those developed on the planar roof horizon. These perpendicular streaks were developed along protrusions or small brows from the roof, and represented the exposed ridges of bedding asperities, and are generally less than 4 feet long. Comparatively, the longer linear, but wavy streaks are generally 7-12 feet long. The brown wavy streaks do not represent surficial dust, and instead represent actual linear exposures of rock. The brown shale is masked by a very thin bedding parting of black, carboniferous shale, except where it has been removed to expose the brown wavy streaks. The removal mechanism gave the appearance of sand blasting or scouring, rather than gouging. There were no depressions associated with the streaks that would suggest a geologic origin such as scour marks or trace fossil imprints. Despite the straight rib profiles observed even in the benched portions of this

Figure 8. Photo of linear, wavy brown streaks in the terminated #8 Entry, viewed looking inby along #8 Entry. Streaks are actually the exposed based of the brown shale that overlies the thin black carbonaceous shale bedding parting.
