Bayou Bonfouca Superfund Site Slidell, Louisiana

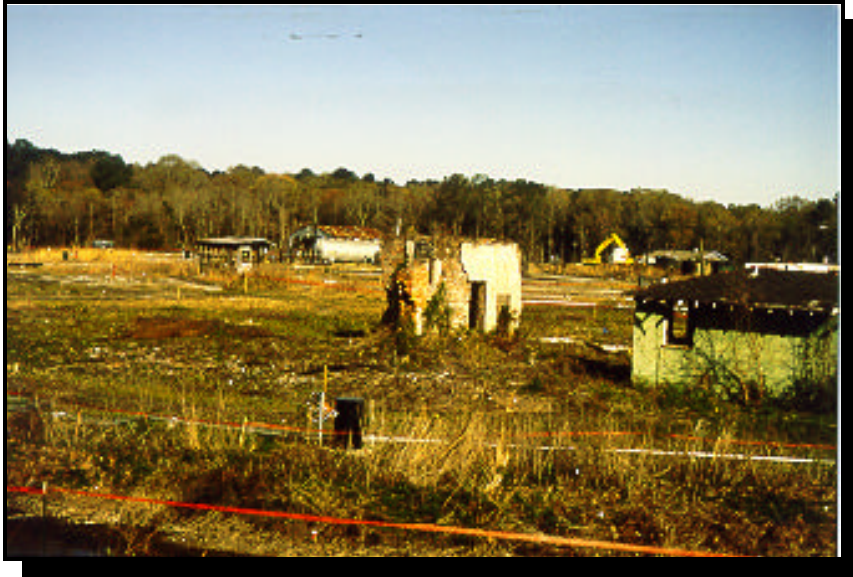
PHOTO #1 - The abandoned American Creosote plant in 1987. Creosote contamination was present in surface soils with heavy contamination in bayou sediments. The creosote plant's safe, made of 4-foot thick brick walls, is in the center of the picture.

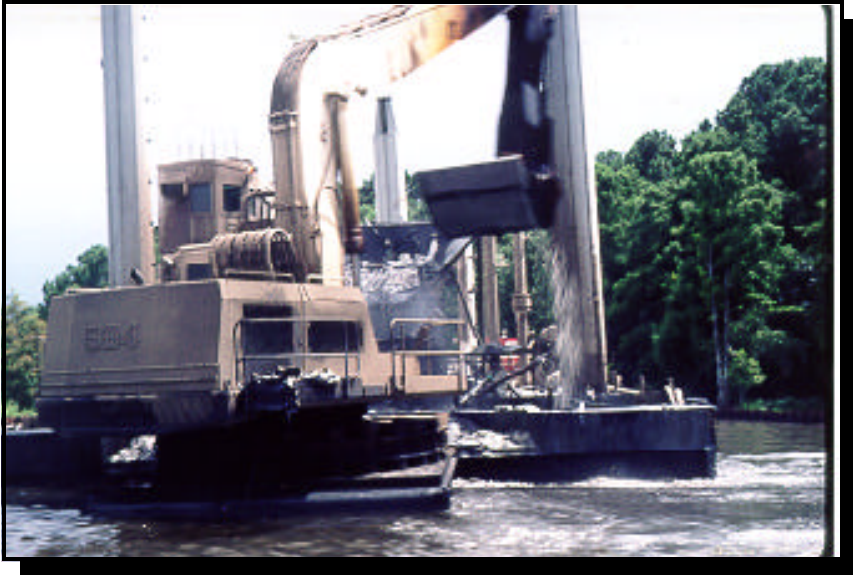
PHOTO #2 - Computer controlled dredging of bayou sediments. Debris (tires, logs, rocks, cars, etc.) was removed from the sediments at the dredge. Sediments were conveyed via floating pipeline (24 inch diameter) to a holding pond where water was removed. The sediments were then transferred to a filter press and blended for homogeneity.

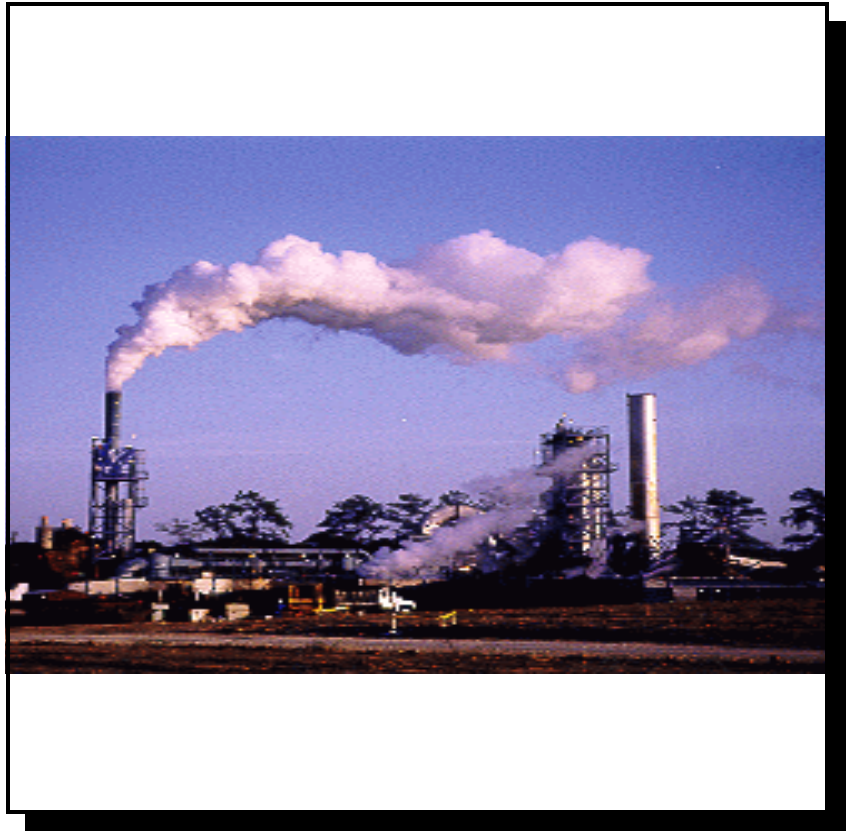
PHOTO #3 - Incineration operations at the Bayou Bonfouca site on a cold morning in December 1995. The incinerator and associated equipment were dismantled and removed in late 1996 following destruction of wastes from the nearby Southern Shipbuilding Corporation Superfund site.

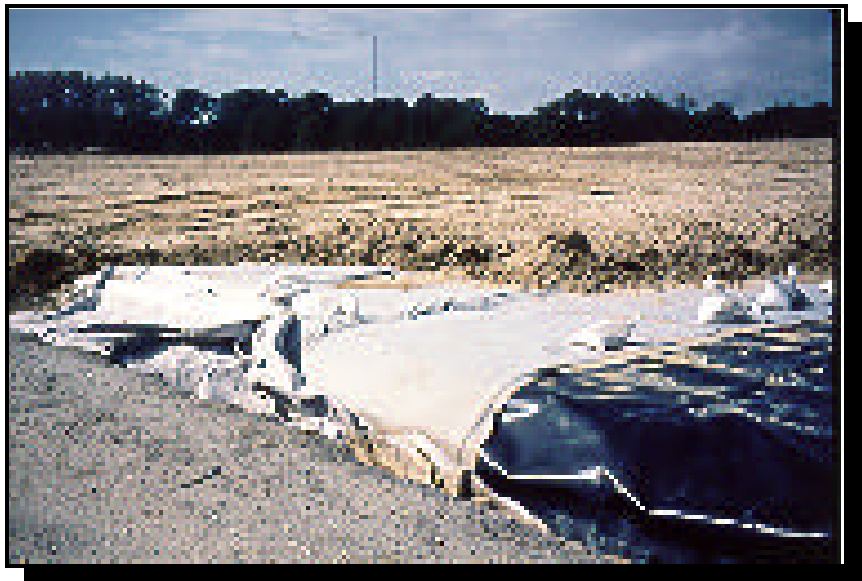
PHOTO #4 - Following thermal treatment the incinerator ash was placed in an onsite landfill, along with marginally contaminated soil and debris. An engineered cap was then constructed of high density polyethylene (HDPE), a geotextile material (Claymax) and native clay soil.

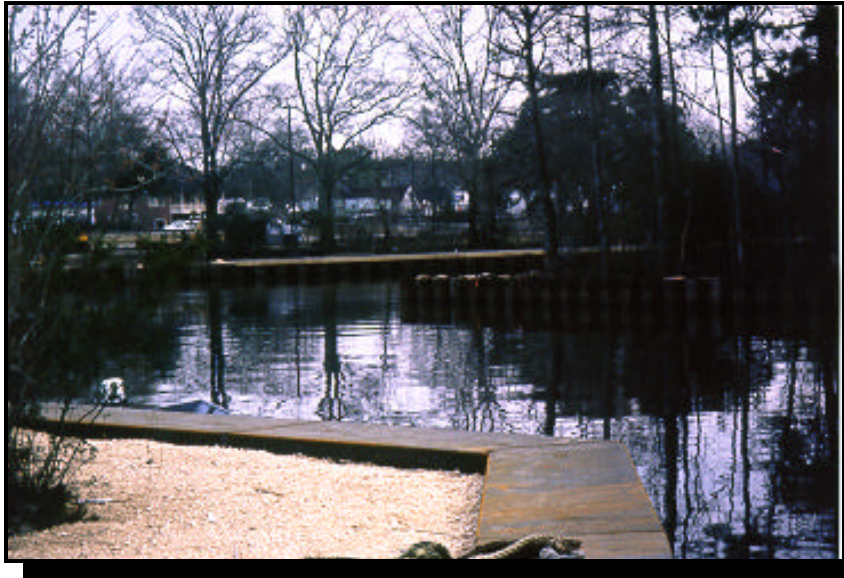
PHOTO #5 - Bayou Bonfouca following remedial action (December 1995). A public boat launch facility, built by the City of Slidell, has increased recreational use of the area. Aquatic organisms and water birds have returned to the area.

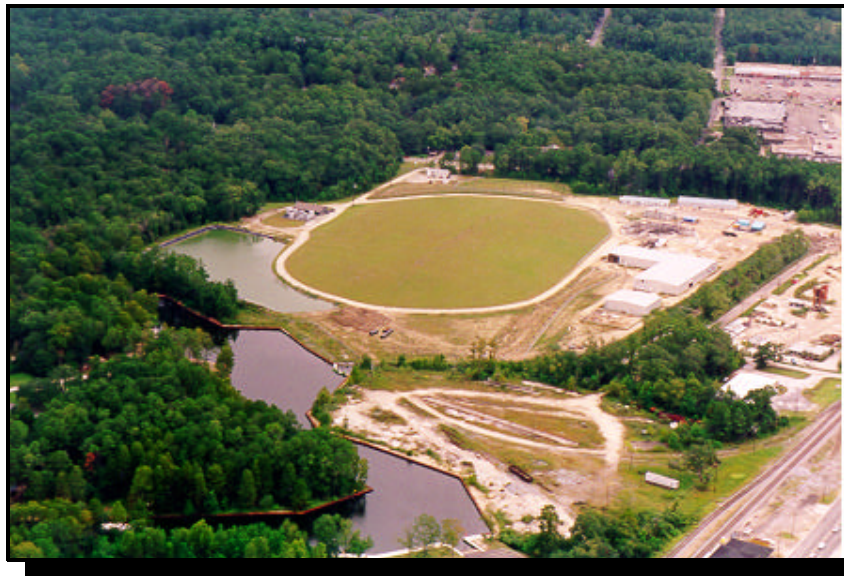
PHOTO #6 - Aerial view of the Bayou Bonfouca site in January 1997. The grassy area in the center of the picture is the treated material (ash) disposal area. Bayou Bonfouca is on the bottom left side of the photo. Construction of a new City of Slidell sewage treatment facility is beginning in the center right side of the photo.
