Preliminary assessment of landslide-induced wave hazards:

Tidal Inlet, Glacier Bay National Park, Alaska

U. S. Geological Survey Open-File Report 03-100

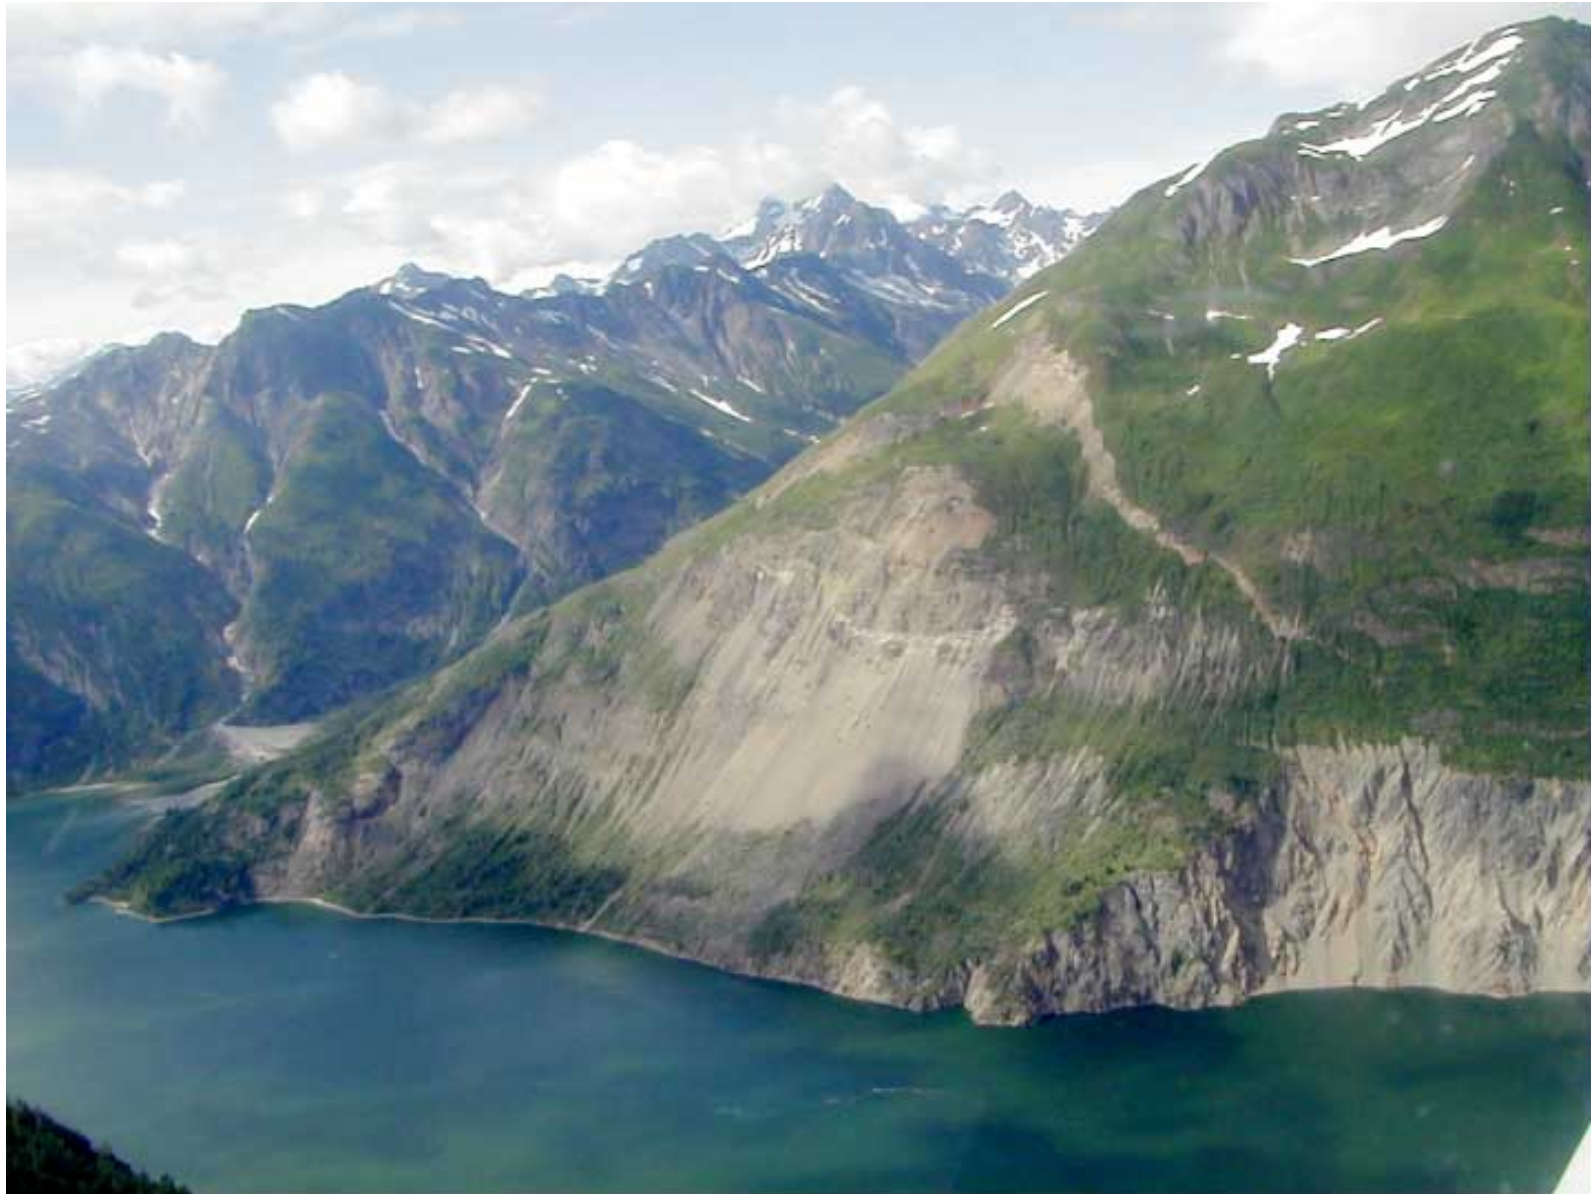
Figure 1.-- Detached landslide mass perched above the northern shore of Tidal Inlet, Glacier Bay National Park, Alaska. Peak at top right edge of photo is about 1130 m high. In the lower left, the distance across Tidal Inlet is about 800 m. Photograph taken on July 12, 2002.

A large detached mass of rock and debris ([fig. 1](#)) above the northern shore of Tidal Inlet, Glacier Bay National Park in southeastern Alaska ([fig. 2](#)) was recognized in 1964 by geologist David Brew (pers. commun., 2002). Brew et al. (1995) suggested that this perched mass of rock posed a threat similar to what occurred in Lituya Bay, Alaska ([fig. 2](#)). On July 9, 1958, a magnitude M 7.9 earthquake on the Fairweather Fault triggered a rock avalanche at the head of Lituya Bay. The landslide generated a wave that ran up 524 m on the opposite shore and sent a 30-m high wave through Lituya Bay sinking two of three fishing boats and killing two persons (Miller, 1960). In 1995, after Matthias Jakob recognized the unstable mass of rock above Tidal Inlet, he submitted a proposal (EBA Engineering, 1997) to the National Park Service (NPS) to assess the potential risks that this landslide posed to visitors and ships. Between May and September cruise ships carry several thousand passengers daily past Tidal Inlet. In 2002 the NPS supported this investigative field research team to assess the potential hazards and risks in Tidal Inlet. This preliminary report focuses on the hazards posed by the Tidal Inlet landslide; a later report will include a detailed wave model analysis and risk assessment.

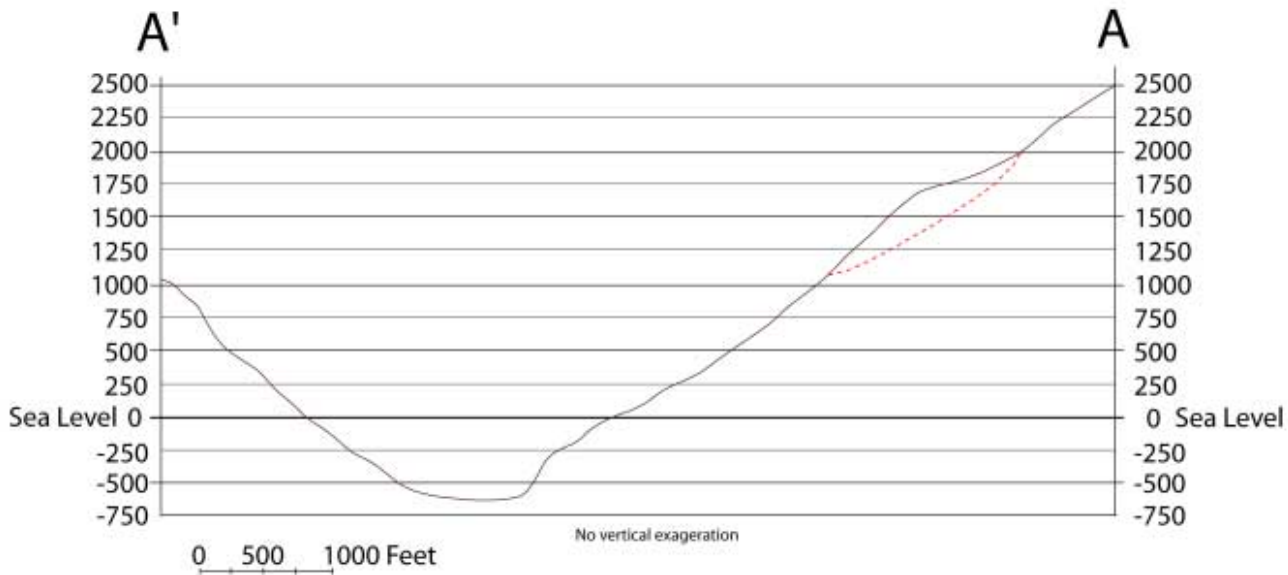
Figure 3B)-- Profile A-A' across Tidal Inlet. Approximate location of cross section of recent Tidal Inlet landslide shown as dashed red line.

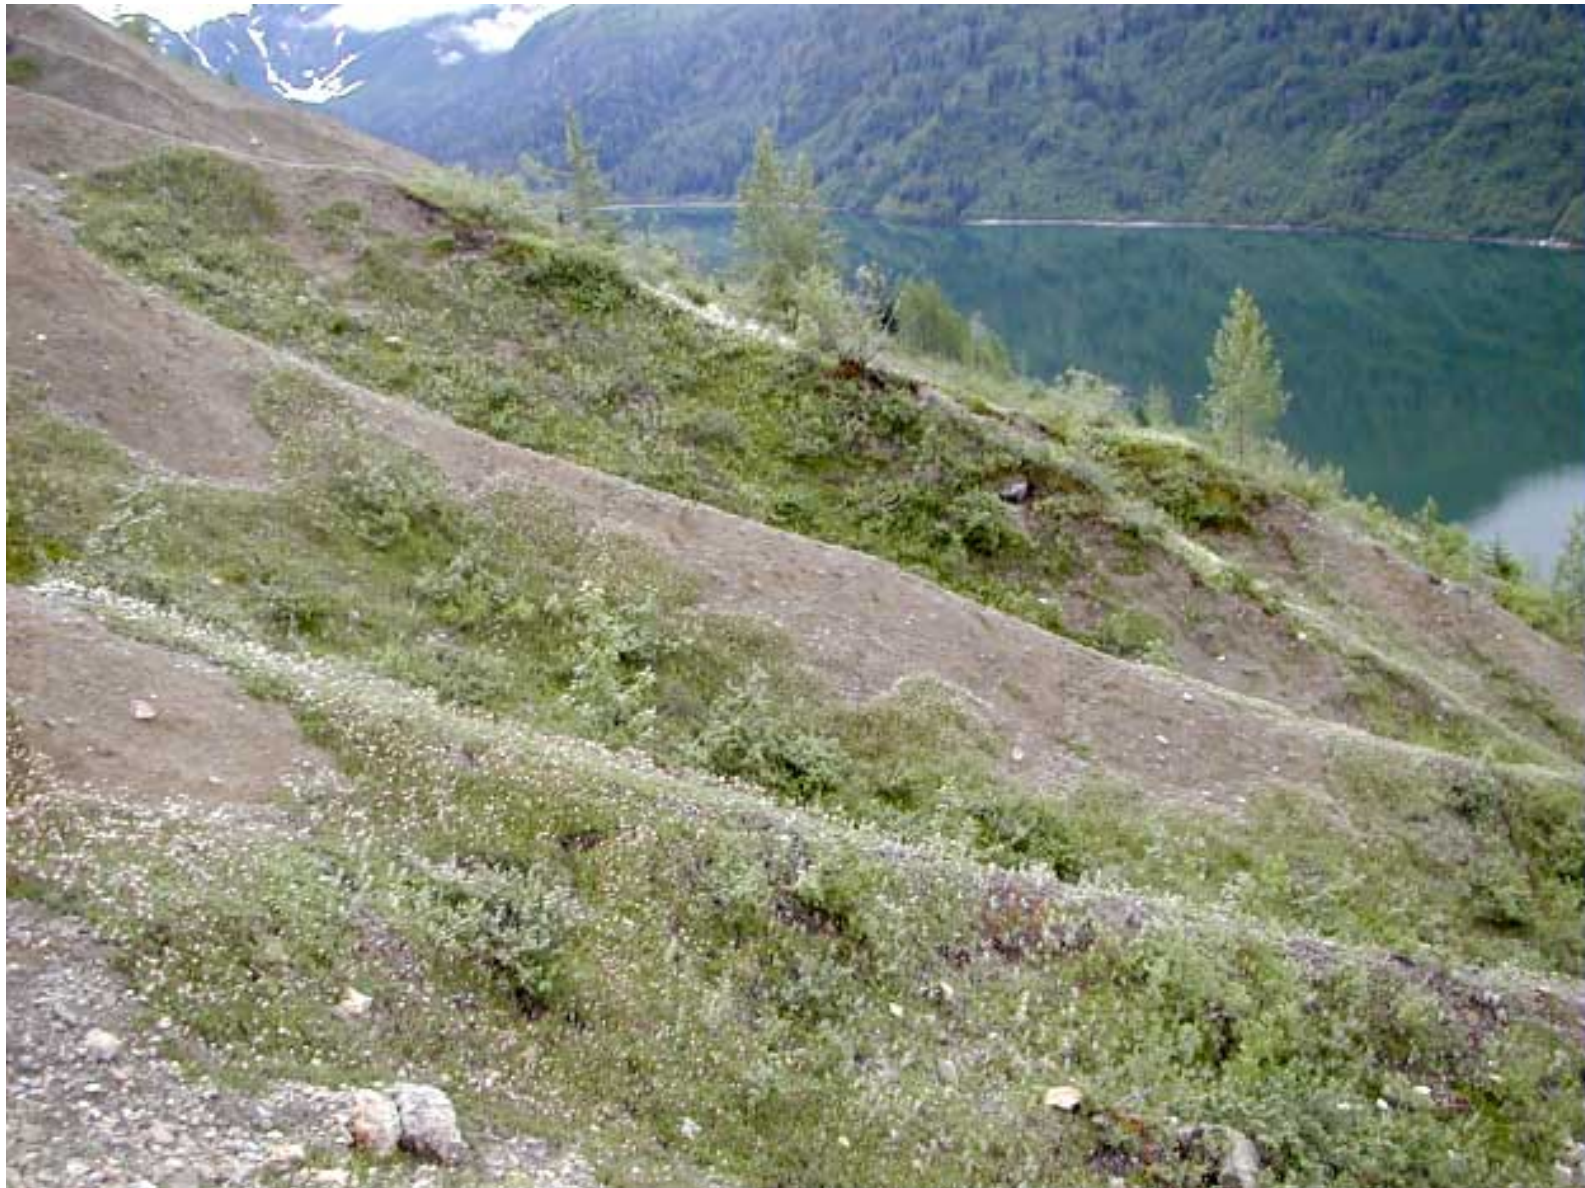
Figure 5.-- Deeply eroded LIA glacial till below the left (east) flank and toe of the recent Tidal Inlet landslide. Distance between small ridge tops is about 15 m. View southeast towards Tidal Inlet.

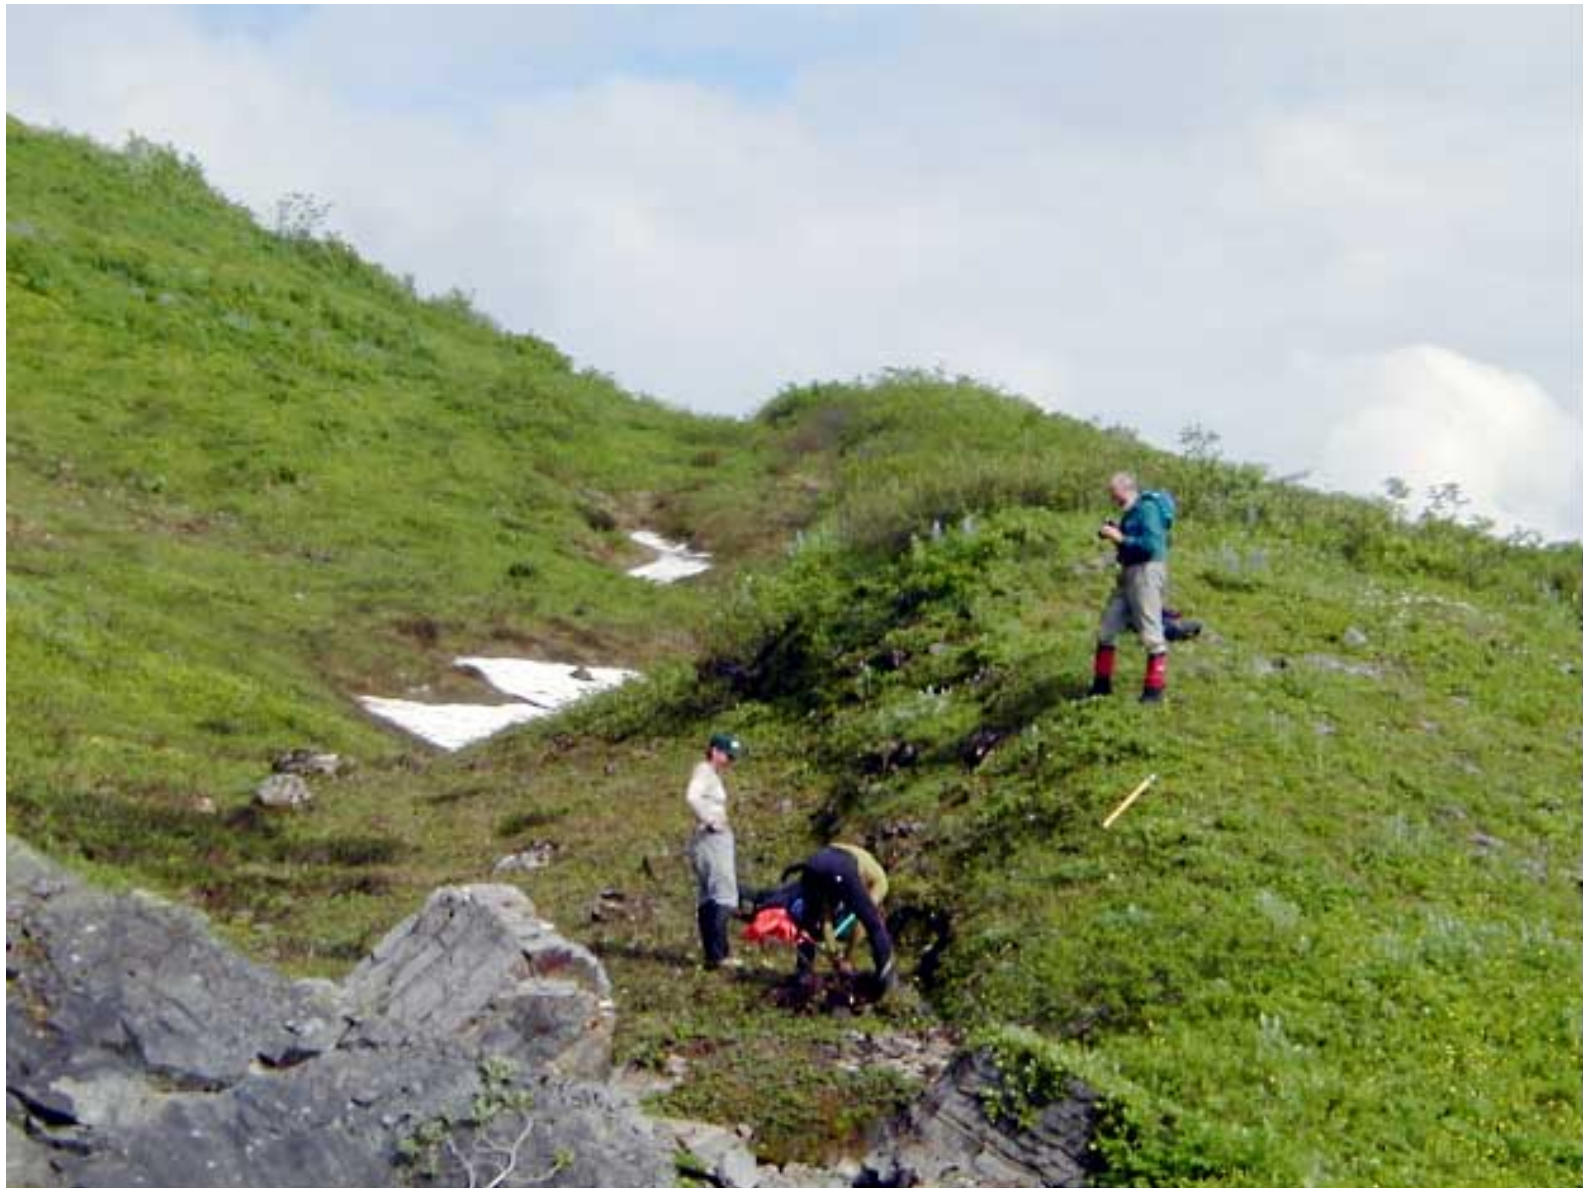
Figure 7.-- View looking east along lineament L1 with its steep, backfacing escarpment. The general downslope profile can be seen from left to right along the horizon.

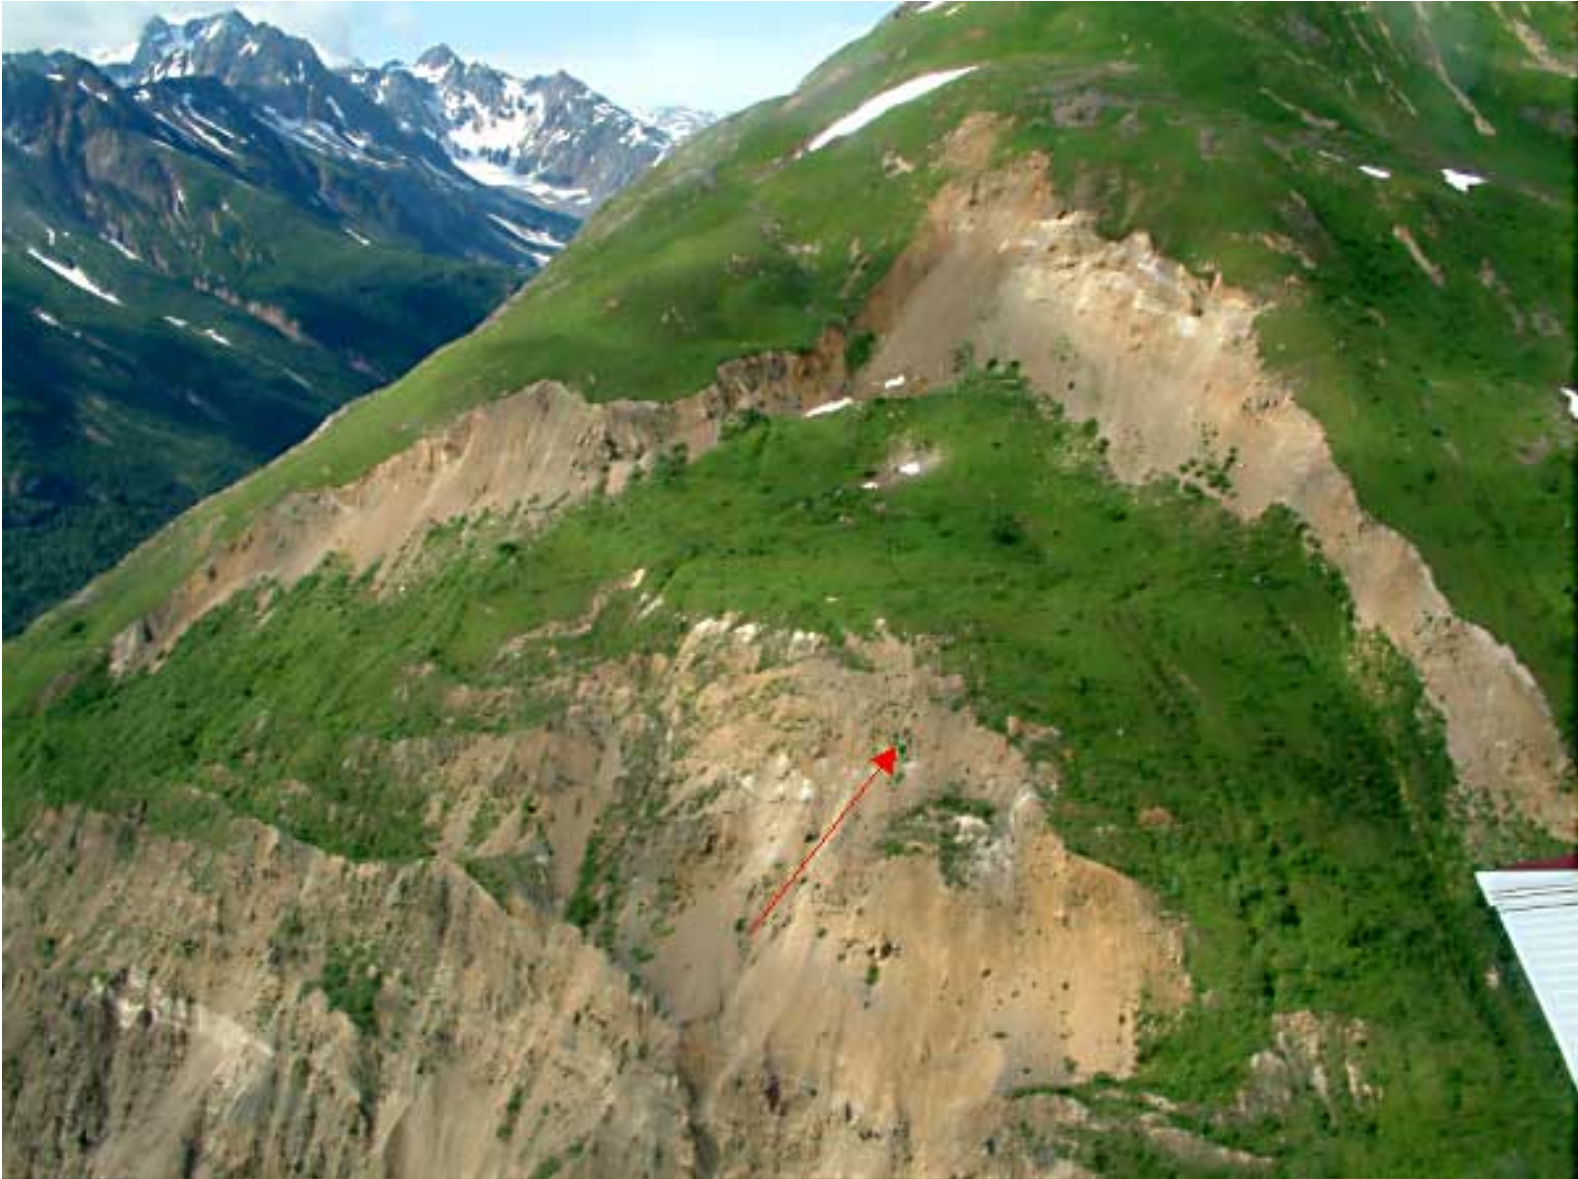
Figure 9.-- Main (upper) and minor (lower) scarps of recent Tidal Inlet landslide. Evidence of the secondary landslide movement is the lighter bare slope in center of the photograph (arrow). Photograph taken July 12, 2002.

In the center of the main body of the landslide there is evidence of a secondary landslide movement that has removed surficial material from some of the rotational blocks on the lower section of the landslide ([fig. 9](#)). The depth of this secondary landslide movement appears to be relatively shallow, and principally involves glacial till. The secondary movement appears on the 1919 Mertie photography, so the timing of the secondary movement in relation to the initial movement of the main body of the landslide is unknown. Cracks and fissures coincident with this secondary movement, with a maximum lateral displacement on the order of one meter, extend up through portions of the rotational blocks within the main body of the landslide.

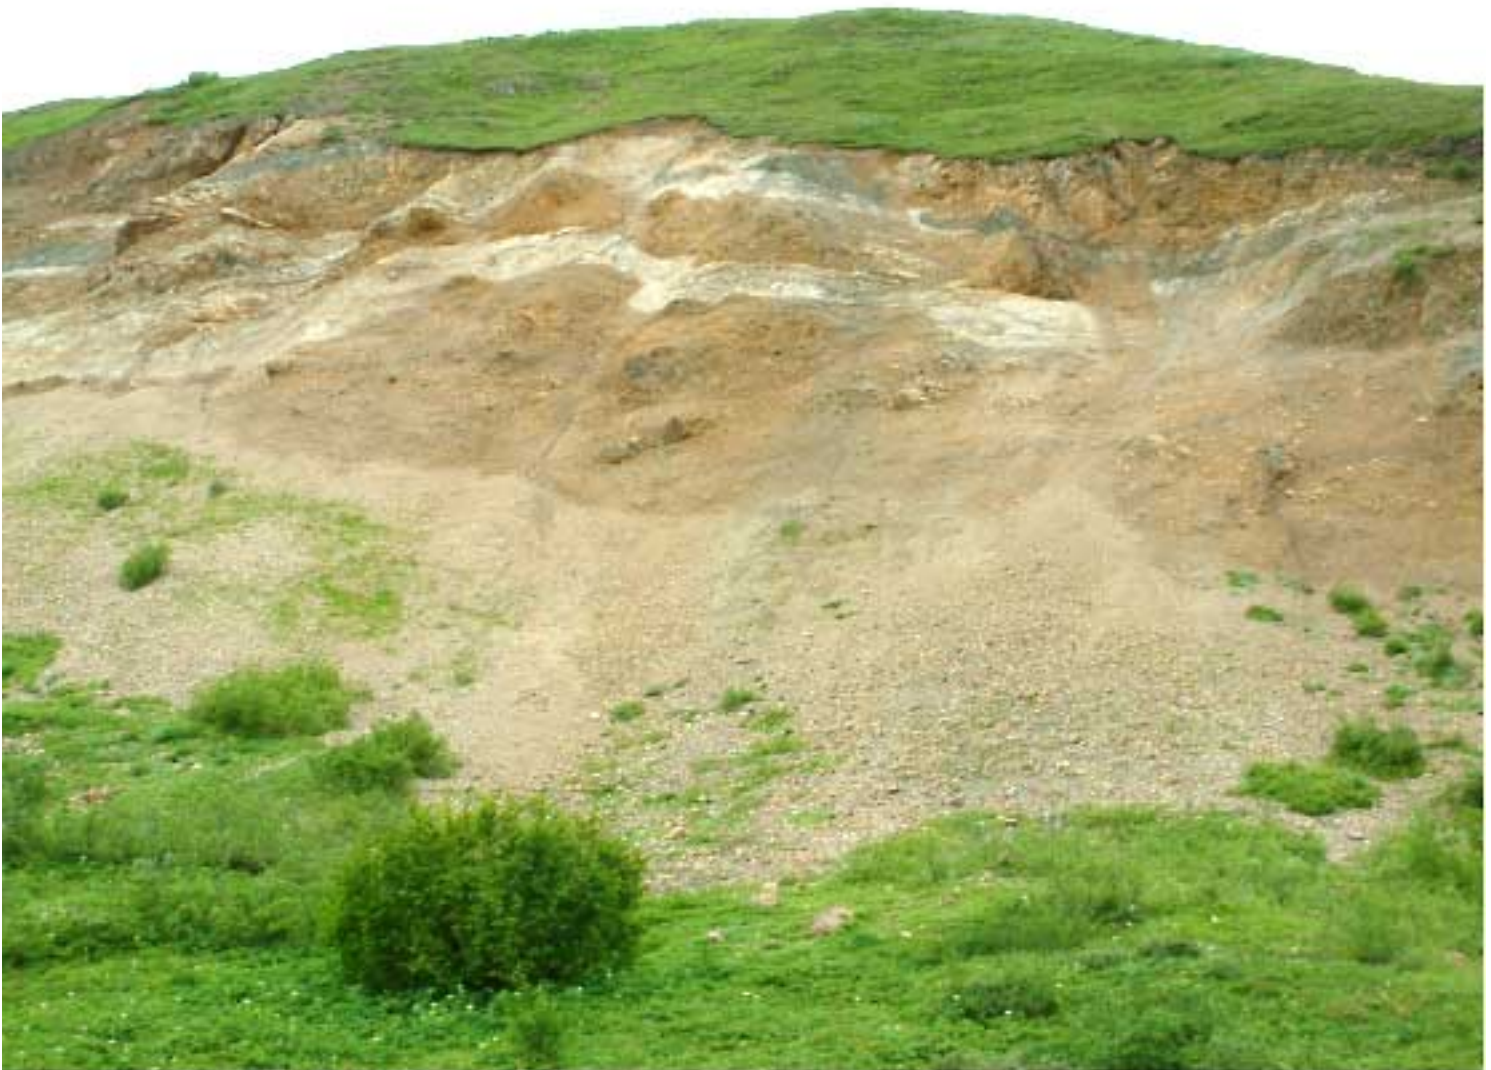
Figure 10.-- Eastern section of the main scarp. Note the subsequent accumulation of rockfall talus below the main scarp. Photograph taken July 15, 2002.

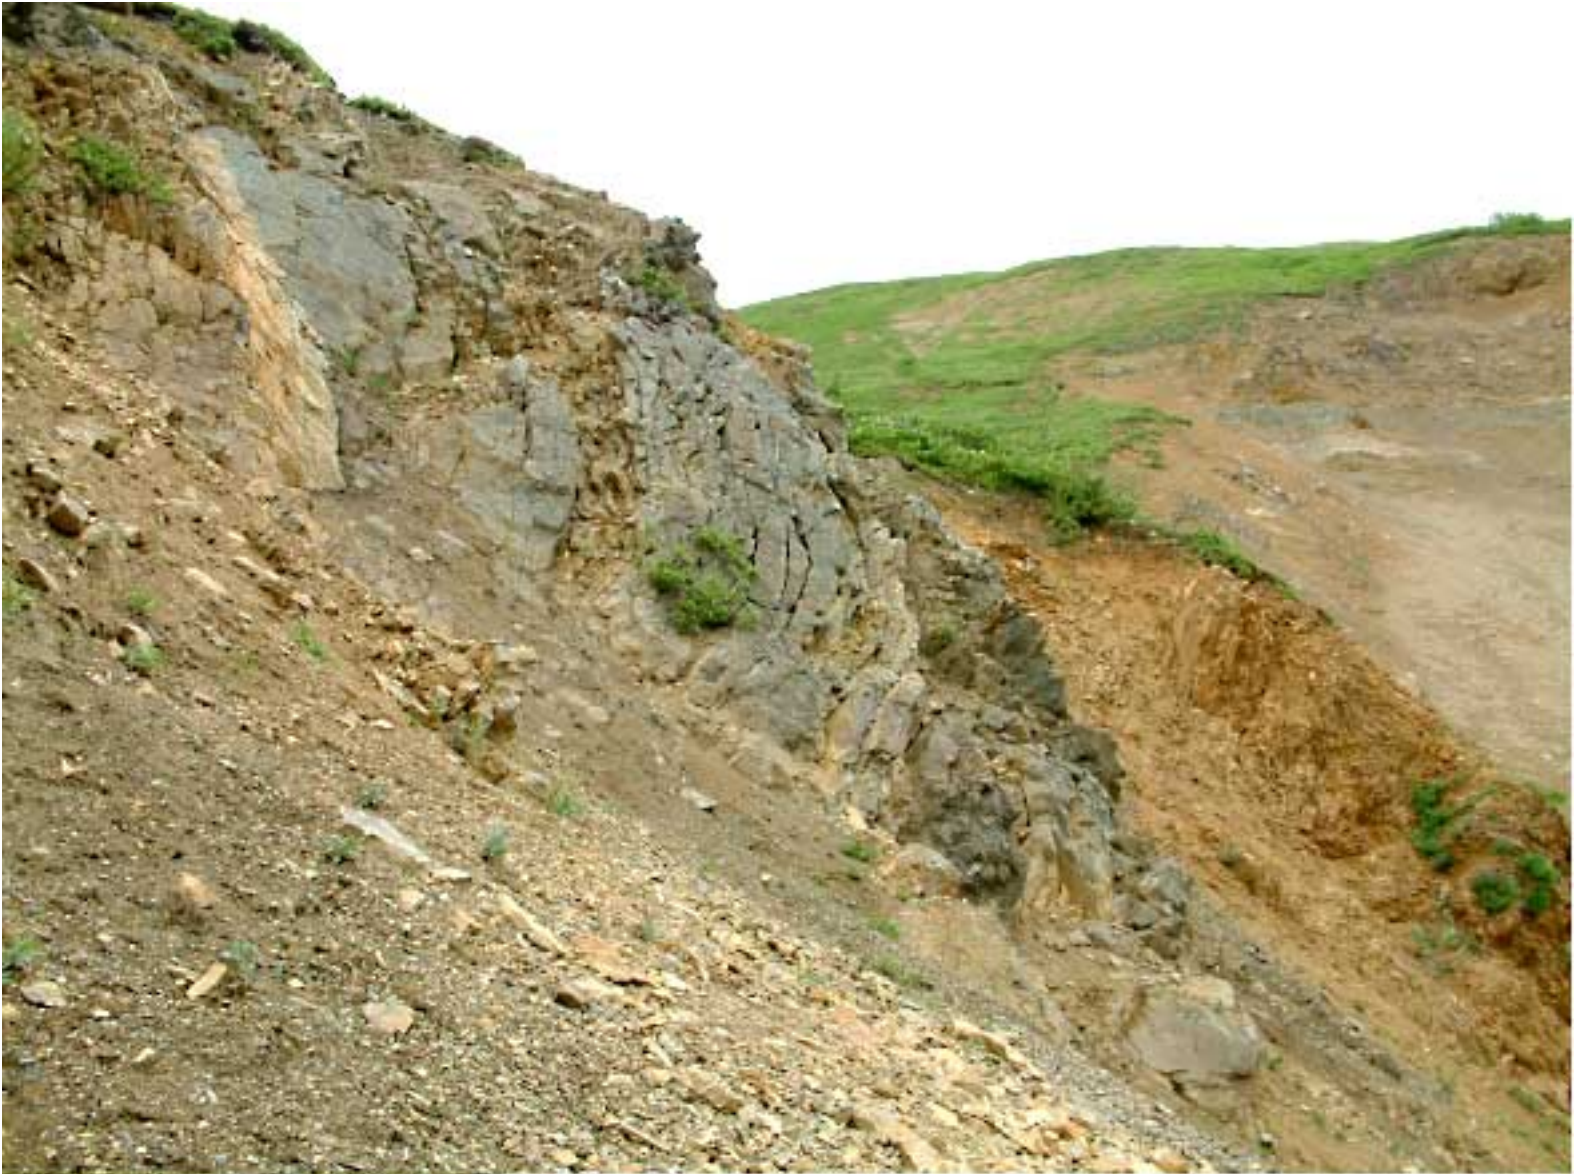
Figure 11.-- Western portion of the main scarp in thinly layered, slightly folded and fractured bedrock, turbidite of Tidal Formation. Note the small revegetation (bushes) in the center of the escarpment. Photograph taken July 15, 2002.

[Figure 11.](#) Western portion of the main scarp in thinly layered, slightly folded and fractured bedrock, turbidite of Tidal Formation. Note the small revegetation (bushes) in the center of the escarpment. Photograph taken July 15, 2002.

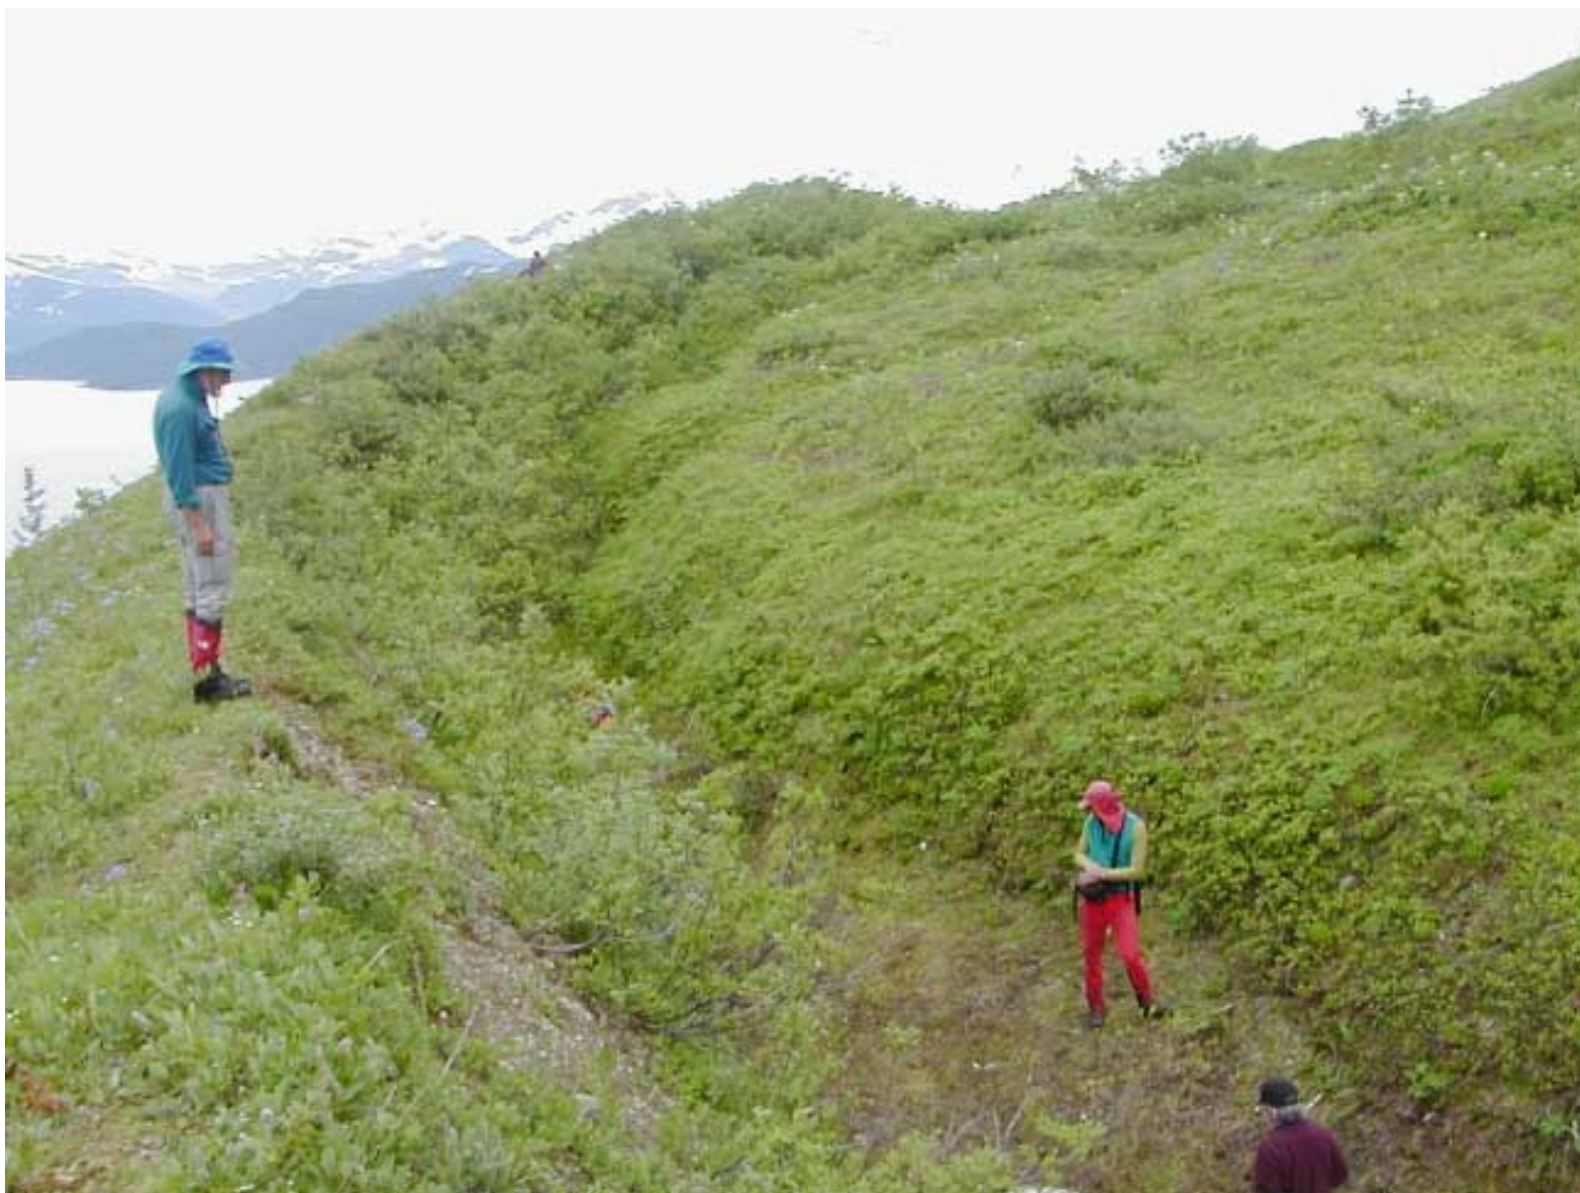
Figure 12.-- Back-facing rotational escarpments and resulting trough, roughly perpendicular to the downslope direction within the main body of the Tidal Inlet landslide. Direction of landslide movement is to the left, the same as the predominant downslope direction.

Within the main body of the landslide the surface topography is severely disrupted by many (13?) rotational blocks with prominent back-facing scarps ([figs. 6, 12](#)). In the upper portion of the main body the exposed portions of these blocks are within glacial till, but further downslope bedrock can be seen within the blocks. The back-rotated faces of these blocks are quite steep, ranging several meters in height with slope angles of 35 to 50 degrees. These north-facing backscarps are thinly vegetated in places suggesting relatively recent movement. The troughs formed by these blocks tend to collect snow and because of lack of downslope stream runoff, result in increased infiltration of water into the main body of the landslide. Several drainage channels through glacial till were found to be truncated at the crest of the rotational blocks, with the previous originally continuing channels displaced further downslope. Such disrupted drainage features indicate sudden rather than slow rotation, which would of course have allowed incision through the erodible till cover. Fluvial erosion could not keep pace with the upthrusting of the blocks, which now is leading to water accumulation in the ditches parallel to the elevation contours. Consequently, the degree of saturation and ground-water level(s) within the landslide mass remains higher than on adjacent slopes, which reduces the relative stability of the landslide mass. Below the escarpment at the toe of the landslide ([fig. 3](#)-Pt. 5), two springs were observed (07/16/02) flowing from the base of the landslide talus with an estimated rate of about 0.01 m³/s each. These springs had built up calcareous deposits on talus debris indicating that some groundwater flow was probably issuing from the limestone of the Pyramid Peak Formation above the main scarp of the landslide, although limestone is also present in the Tidal Formation.
