# PERFORMANCE OF HIGHWAY BRIDGE ABUTMENTS ON SPREAD FOOTINGS

Report No.  
FHWA/RD-81/184

Final Report  
October 1982

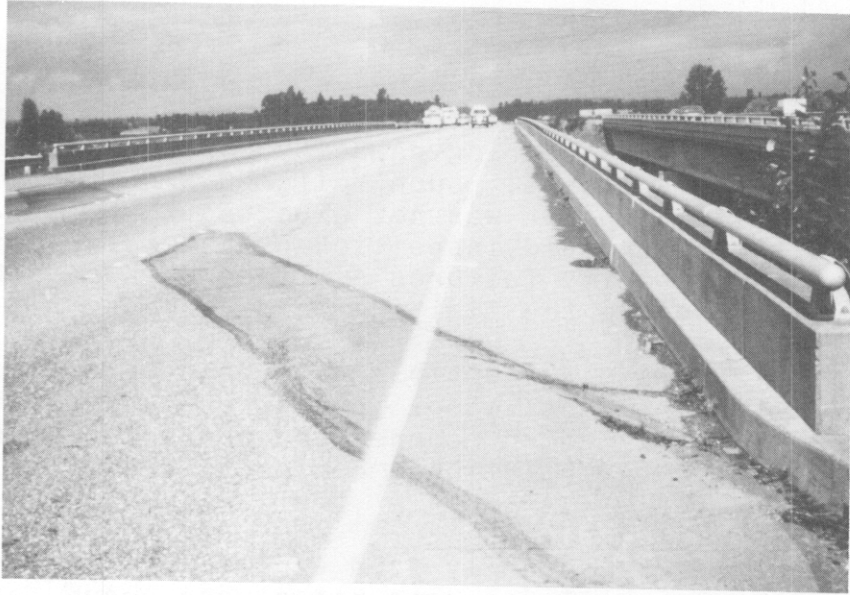
Figure 8. Pavement Patch at Bridge End

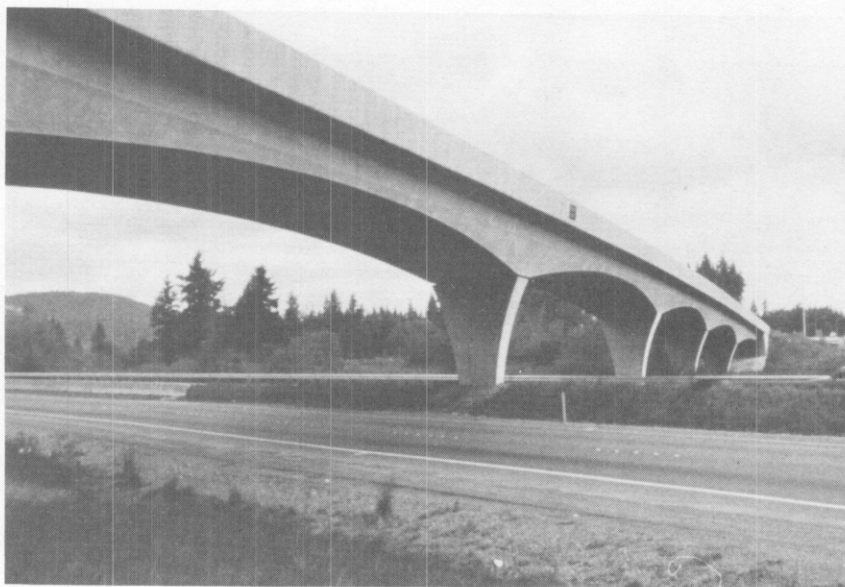
The abutment on fill has settled almost 2 inches (50 mm) differentially from the adjacent pier on piles. There are no signs of distress anywhere. The structure is in excellent condition.

Figure 13. Evergreen Parkway Under-crossing

Figure 14. Evergreen Parkway Pier #2 and Underside of Box Girder

Figure 15. Abutment No. 1 of Evergreen Parkway Structure

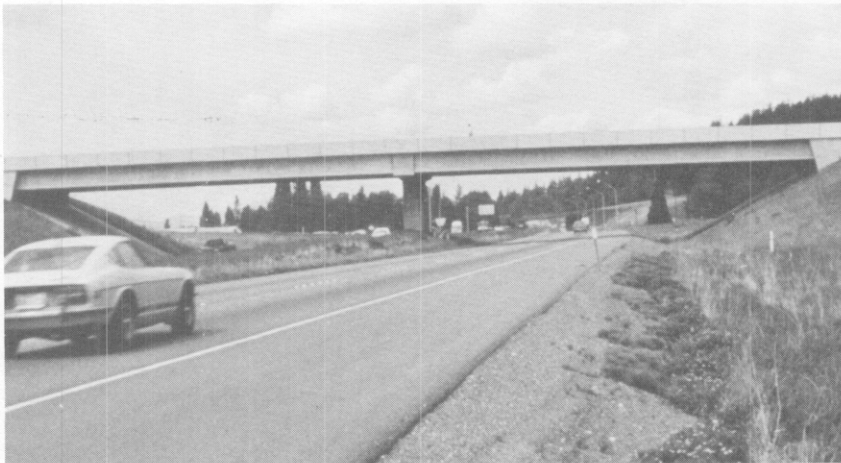
This bridge is in very good condition. There were no bumps at the bridge ends; but there were 15-20 foot (4.6-6.1 m) pavement patches at both ends. The bridge deck, curbing and barrier walls had minor cracks; however, the reason for the cracks was unknown.

Figure 16. Anderson Road over Interstate 5

Figure 17. Pier No. 2 and Concrete Girders of Anderson Road Overpass

Figure 18. Closeup View of Pier No. 2 of Anderson Road Overpass

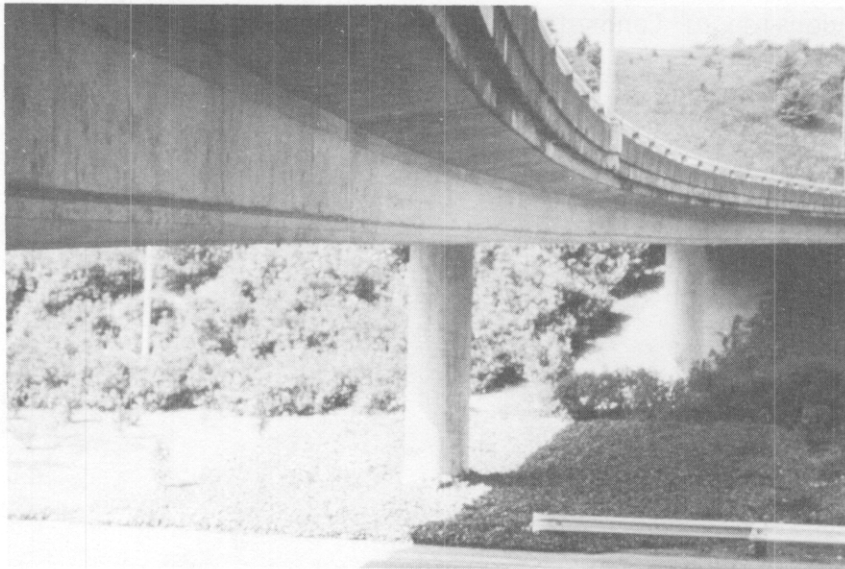
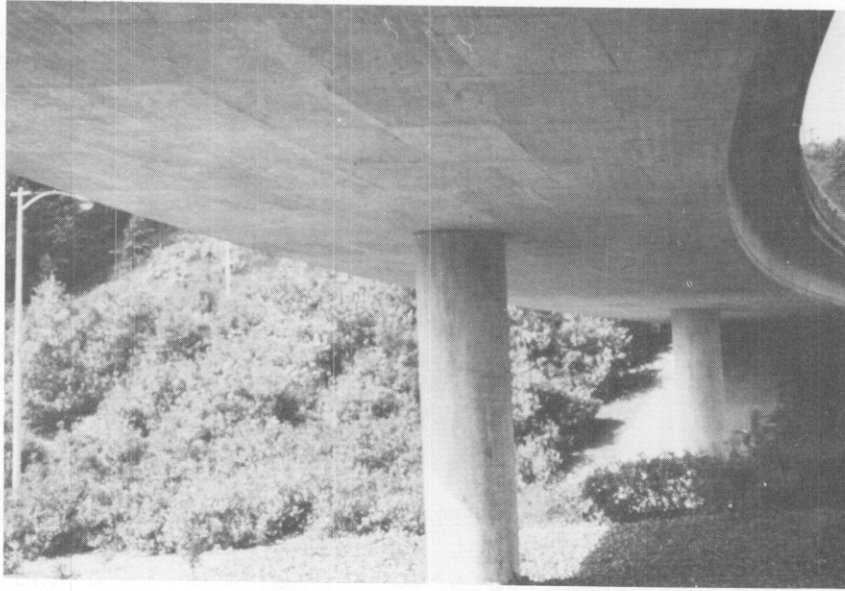
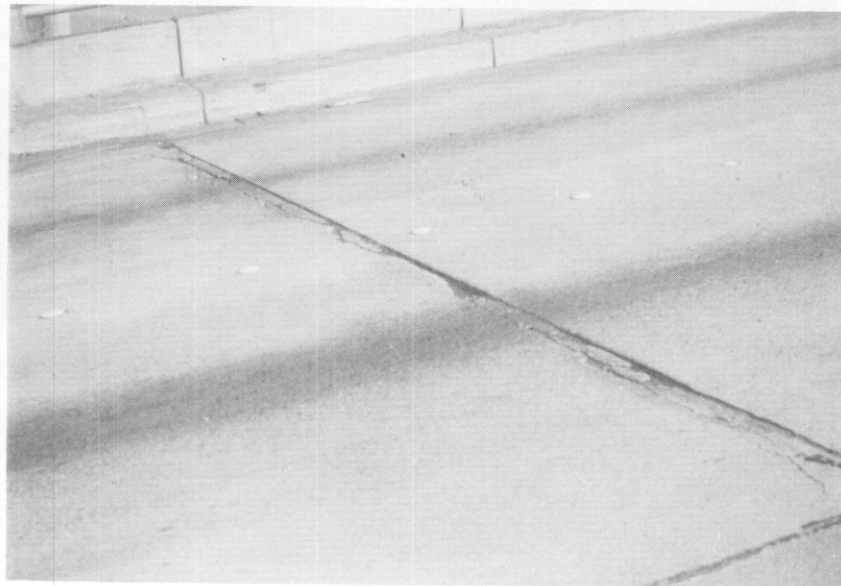
This bridge is also in good condition. There is a slight bump at pier 5 (abutment on fill), but no patching has yet been done. Minor spalling and cracking has occurred in the deck and in some girders, and there is a 1 inch (25 mm) displacement between the bridge deck and fill curbs near pier 5.

Figure 19. AR 19 Ramp in Pacific Avenue Interchange

Figure 20. Underside of Concrete Box Girder Bridge (AR 19 Ramp)

Figure 21. Bridge Approach Pavement for AR 19 Ramp

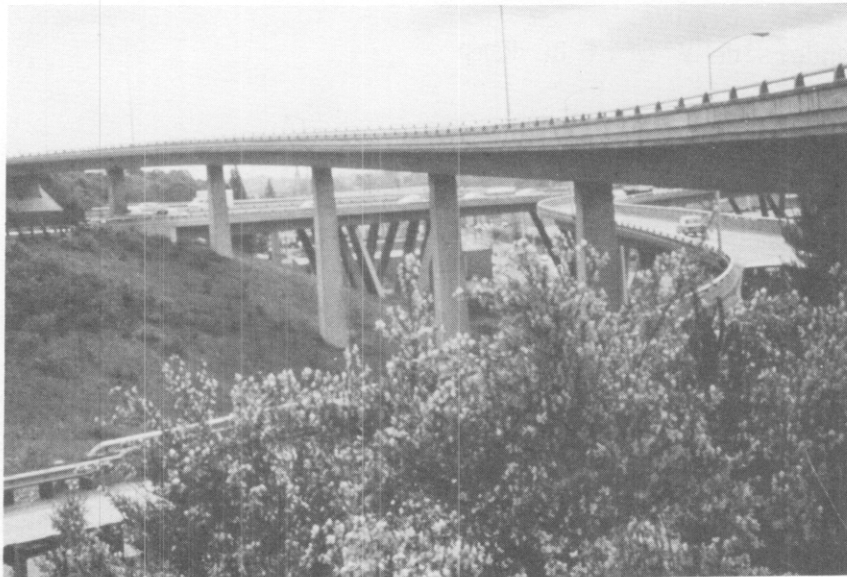
The bridge is in good condition. There are neither bumps, patches, nor signs of distress. There is some deck cracking, but it does not seem to come from differential settlement.

Figure 22. BL Ramp in Nalley Valley Interchange

Figure 23. Underside View of BL Ramp

Figure 24. Abutment of BL Ramp

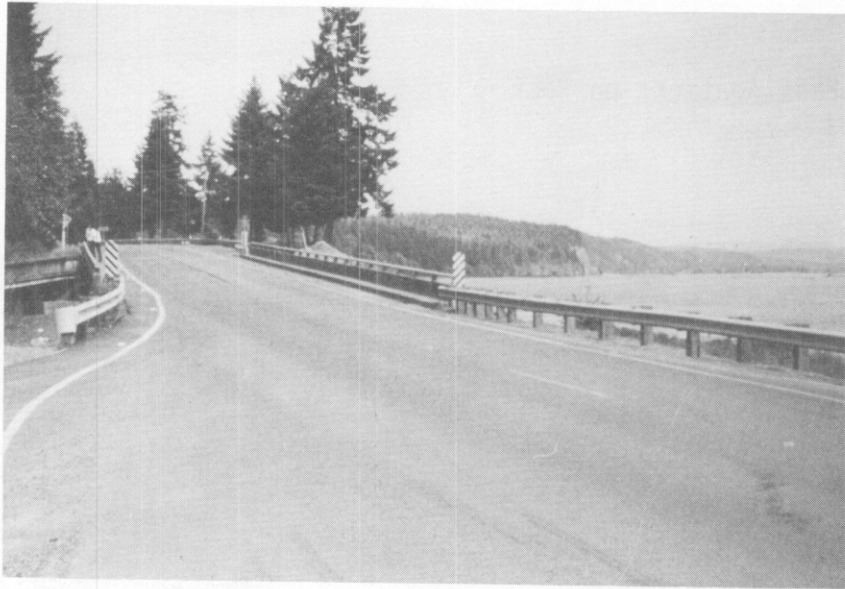
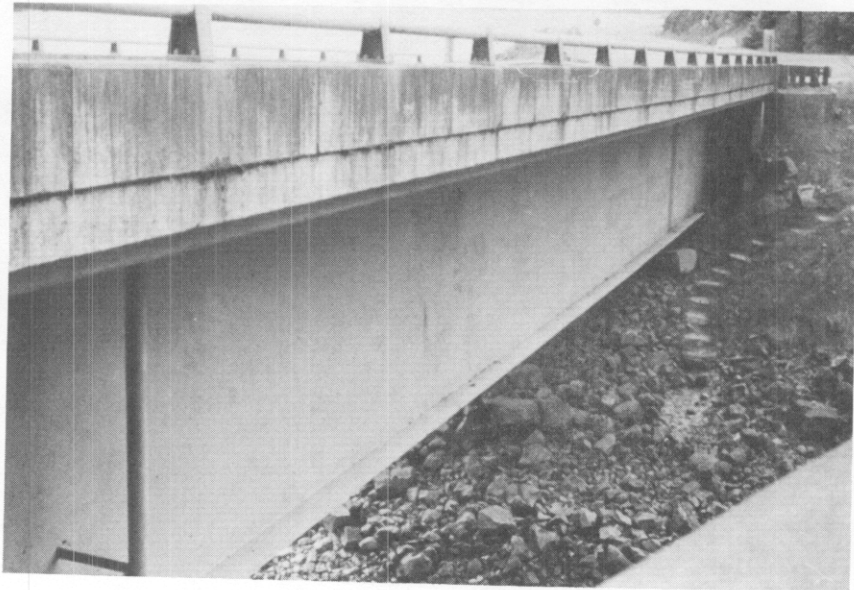
The abutment on fill continued to settle after construction and has settled 15 inches (0.4 m); but the bridge is in very good condition. There are no bumps at either end, and deck cracking is minimal. Each corner of the bridge has very slight vertical and lateral displacements. The most significant sign of distress is that bearing rockers at the fill abutment are tipped slightly inward.

Figure 25. Mill Creek Bridge on SR 4

Figure 26. East Abutment on Rock

Figure 27. West Abutment on Fill

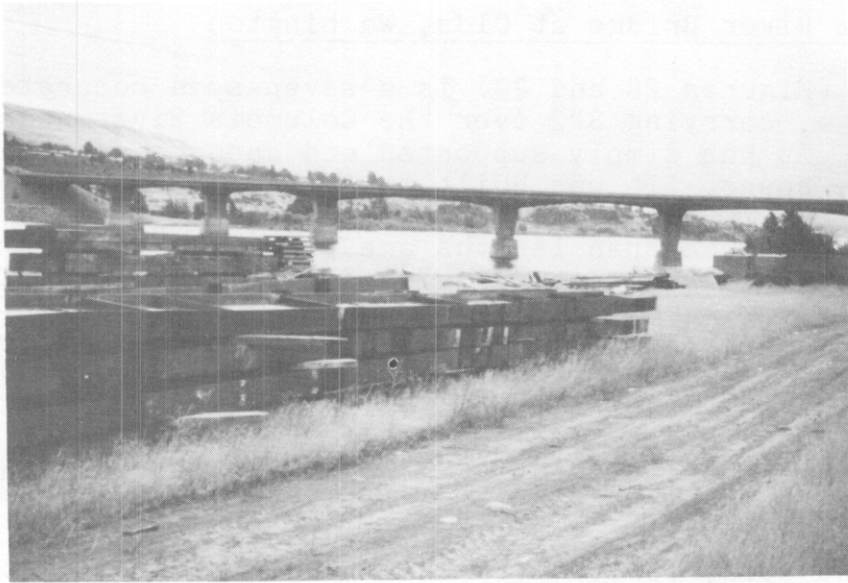
The bridge is in very good condition. There are neither bumps, patches, nor signs of serious distress. The inspection report shows only one hairline crack in the bottom flange of one girder.

Figure 28. Columbia River Bridge at Olds, Washington

Figure 29. Underside of Concrete Box Girder and Piers of Columbia River Bridge

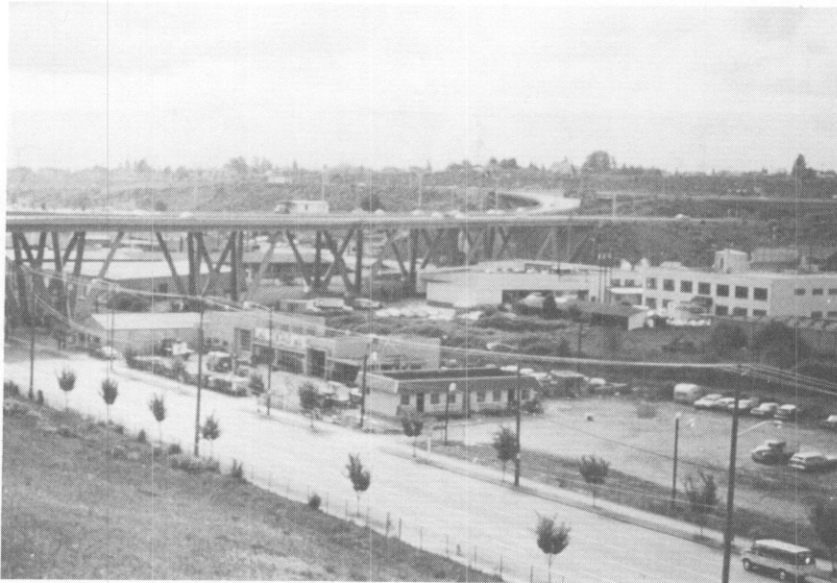
Figure 30. Nalley Valley Viaduct

This bridge is a continuous concrete T-beam structure with one 70 foot (21.3 m) span and 6 spans at 92 feet (28 m). One abutment is on a 25 foot (7.6 m) approach fill and the other abutment is on natural ground.

The foundation soils consist generally of compact to very compact silty sand and gravel overlain by variable depths of loose to medium compact silt, sand and gravel. In general the loose zones are due to site regrading and in several instances the loose fill becomes rather extensive. An allowable bearing pressure of 3 tons per square foot (.287 MPa) was used to design the spread footings.

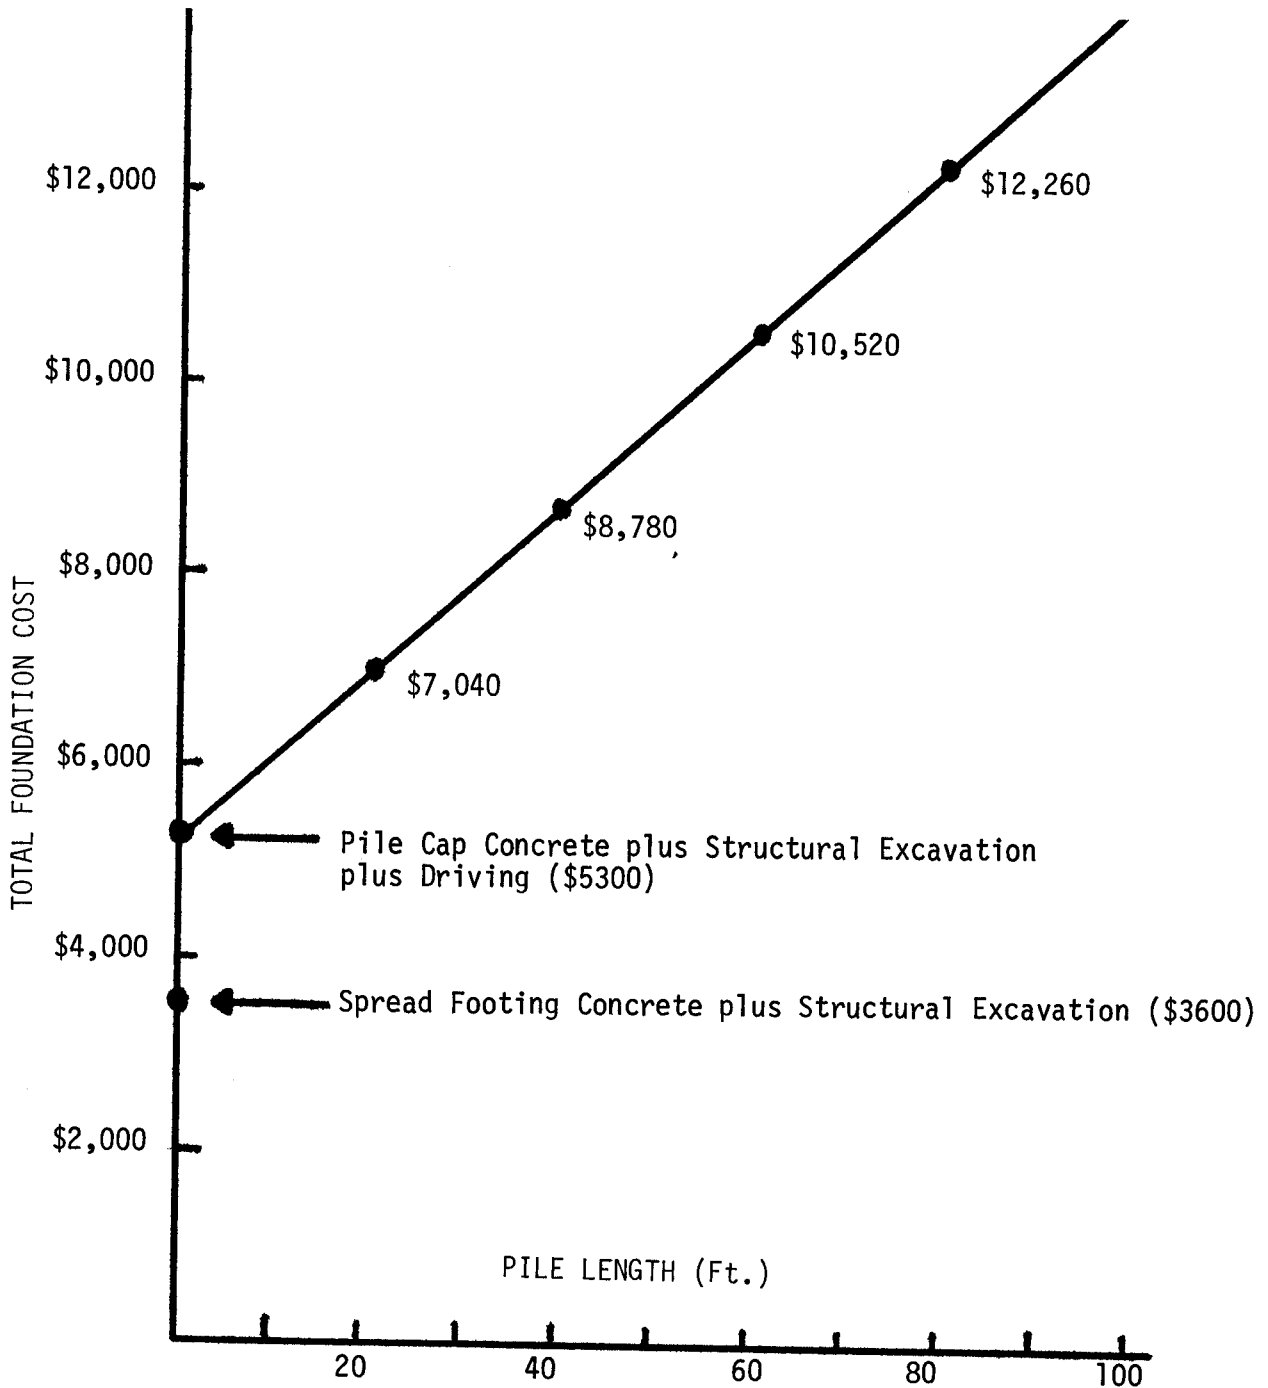
The actual savings will vary with the length of piles furnished. The size of the spread footing and pile cap, and the number of piles will remain unchanged for this project, but the pile lengths will vary with driving resistance. Figure 34 shows the effect that pile lengths have on the cost comparison of spread footings and piles.

Figure 34. Pile Lengths versus Total Foundation Cost for one abutment

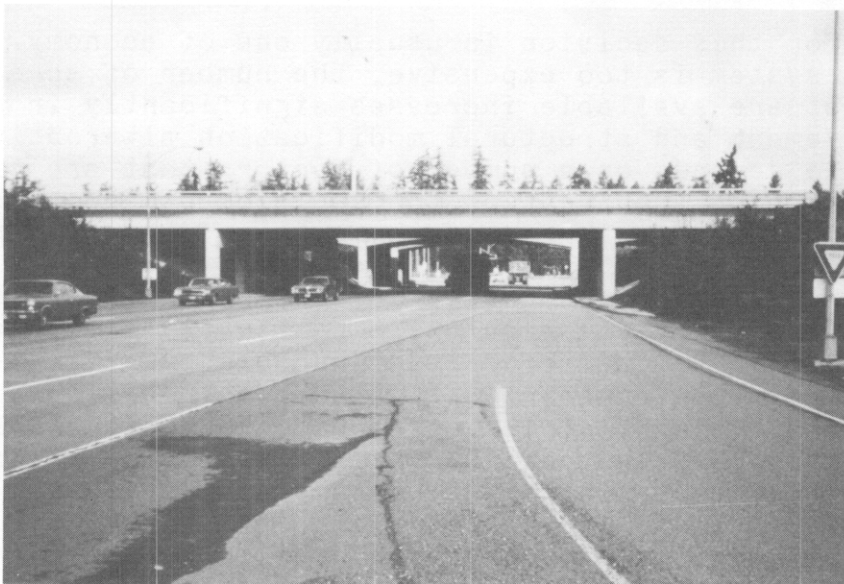
Figure 36. North Fort Lewis Interchange Structure

This comparison concerns two parallel structures in the same interchange; Interstate 5 was being widened in 1969 to four lanes divided, with new ramp facilities. The main structure would carry the northbound lanes of I-5, and the other structure would be the northbound collector-distributor ramp (Figure 36). The southbound lanes would run on the existing bridge, west of the new structures. The mainline structure is a continuous, prestressed concrete girder bridge with 45-foot (13.7m) end spans and an 86-foot (26.2m) center span.

Abutment #1 was built on 12 steel "H" piles (21BP53) at an average pile length of 25 feet (7.6m). The contract price for furnishing them was \$5.88 per foot, and the cost of driving each pile was \$71. The savings in pile costs for the opposite abutment of the mainline bridge amounted to \$2,616 (12 x 25 x \$5.88 + 12 x \$71).

The abutments for the ramp structure were to be supported by eight piles which amounted to a savings of \$3,488 (16 x 25 x \$5.88 + 16 x \$71). The total savings came to \$6,104 in 1969. That figure would be at least three times greater in 1981 dollars. The savings from using spread footings to support the intermediate piers was not estimated; but they would also be substantial. In terms of percentages, the spread footing for abutment #2 cost 35 percent of the cost of piles to support abutment #1.

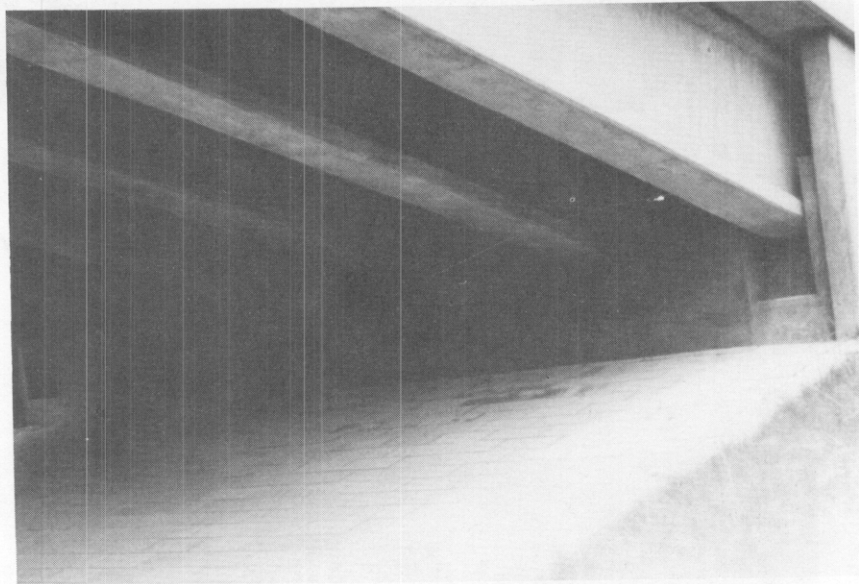
Figures 37, 38 and 39 illustrate three types of jackable abutments. Figure 37 shows a small concrete pad built on the abutment wall under each girder to support the jacks. Figure 38 shows a jacking shelf and Figure 39 shows a series of jacking nooks.

Figure 39. Jacking Nooks for Jackable Abutment on Anderson Road Bridge

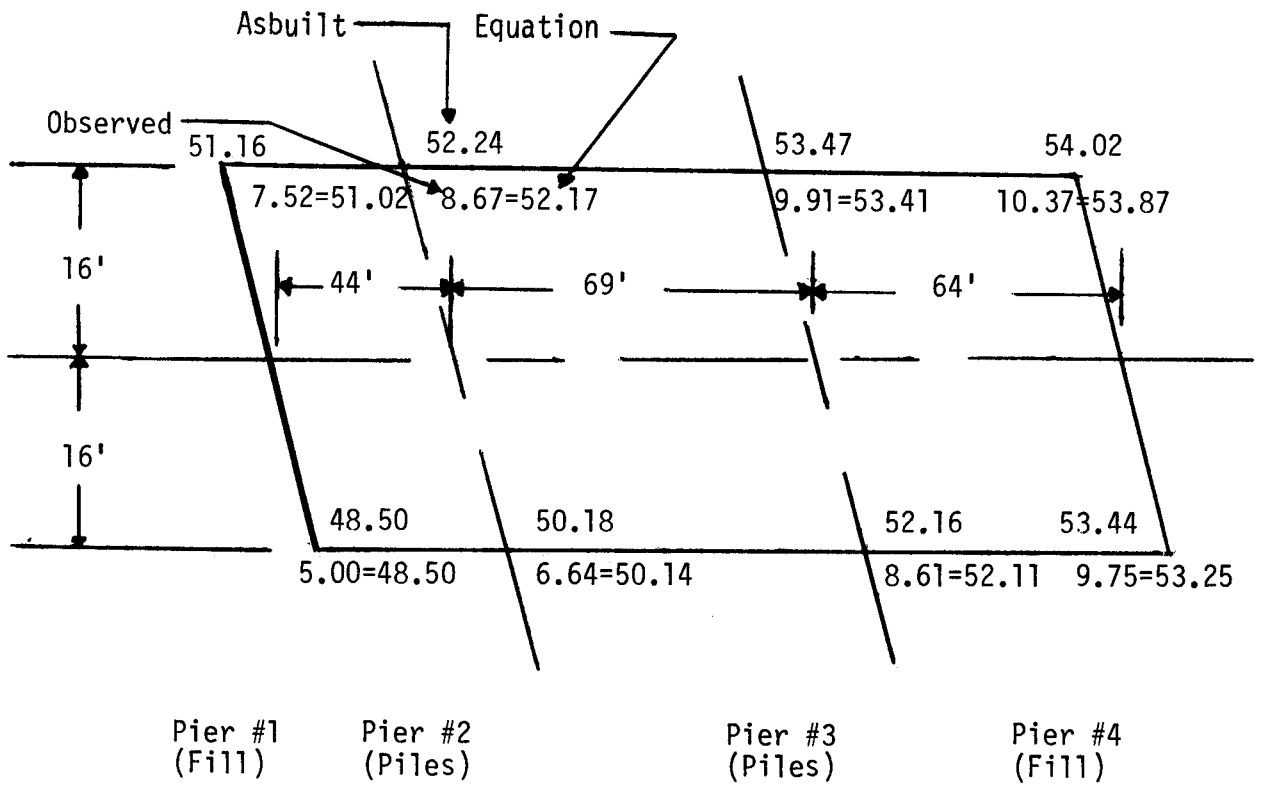
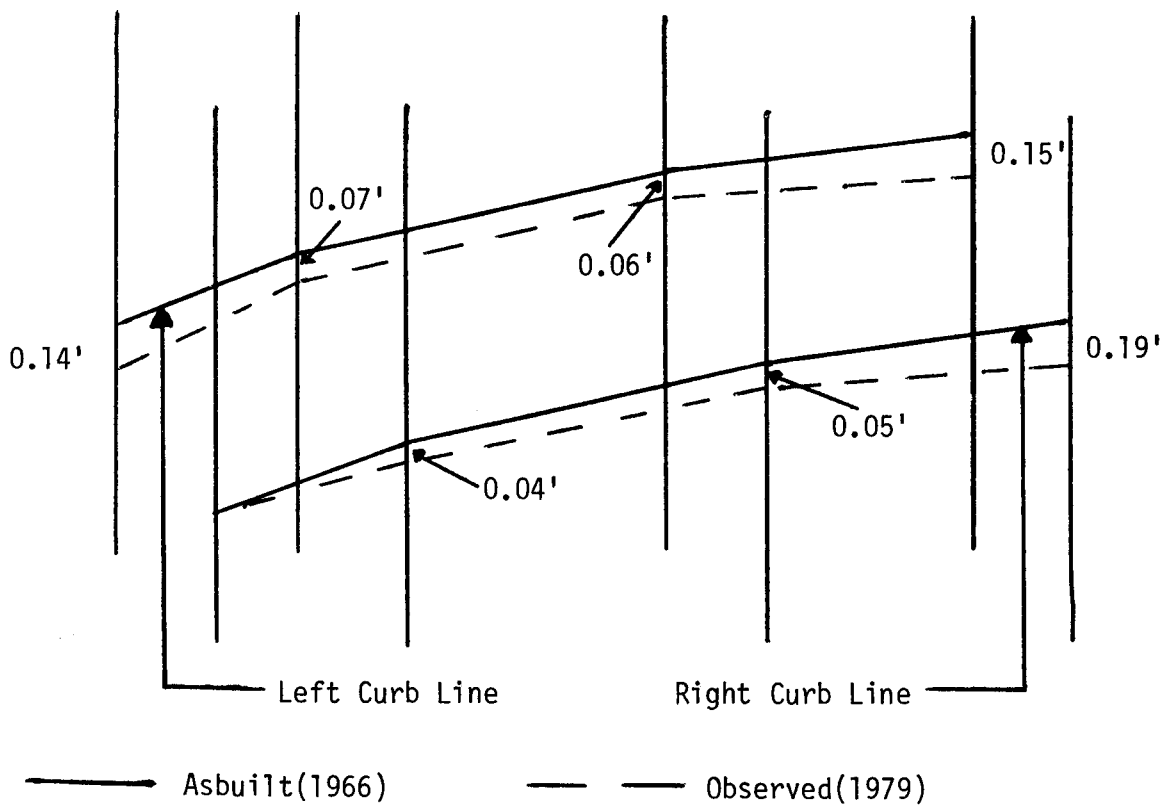
Figure 40 illustrates this procedure. The survey crew assumed a base elevation of 5.00 feet at Pier 1's south end. They set that figure equal to the as-built elevation of 48.50 feet. Then they subtracted these values to get the adjustment factor of 43.50 that was needed to determine the differential settlement at the other points. The crew added the adjustment factor, 43.50, to the observed elevations to get an adjusted elevation. The differential settlement at the south end of Pier 2 is calculated by subtracting the adjusted elevation, 50.14 feet, from the as-built elevation, 50.18 feet. The difference, 0.04 feet, is the differential settlement between the south end of Pier 1 and the south end of Pier 2.

Figure 40. Profile of Differential Settlement for Tukwila Interchange Ramp E Bridge
