Remediation of the Black Lagoon Trenton, Michigan

Great Lakes Legacy Program

March 2009

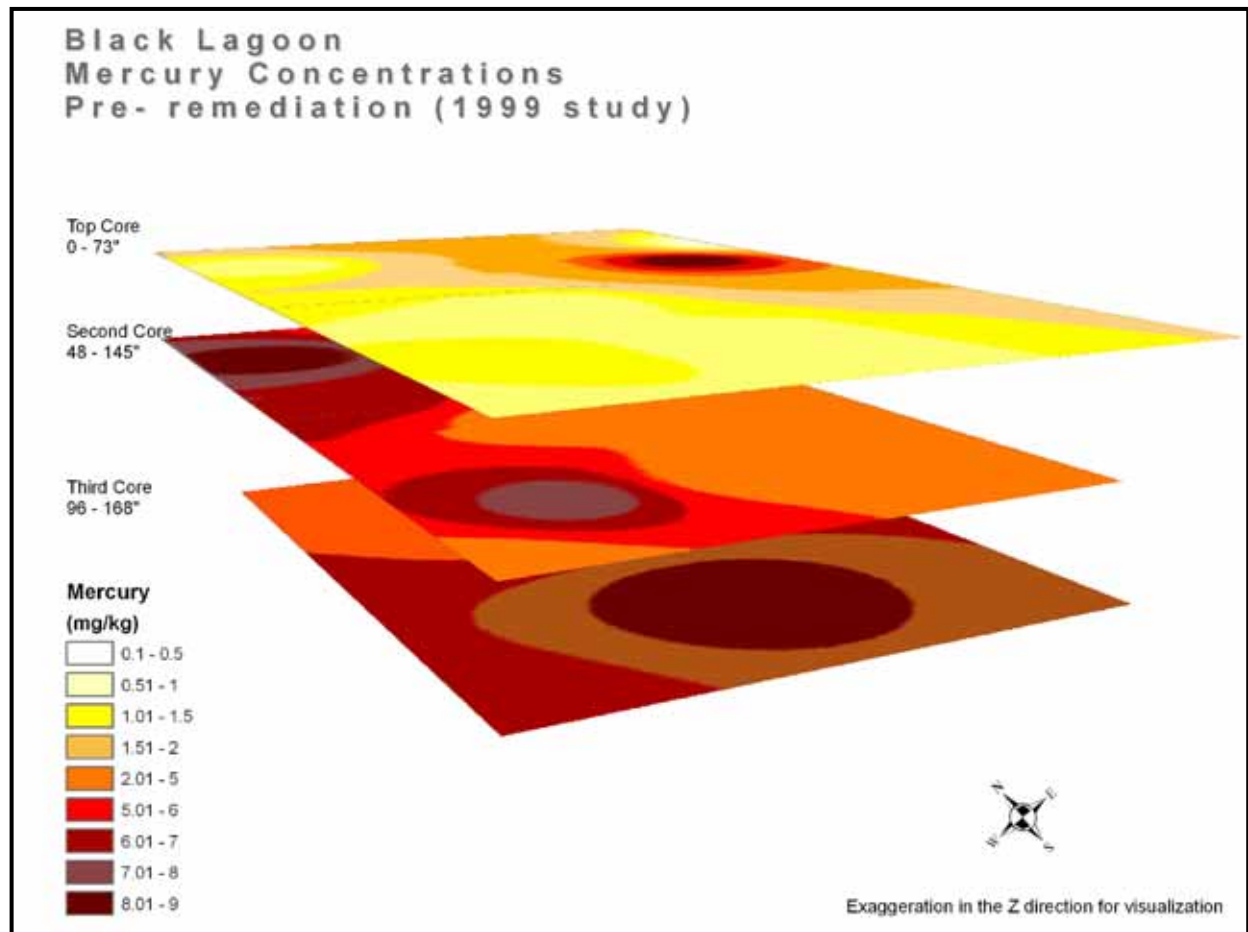
Figure 1-2 Pre-remediation Sediment Mercury Concentrations at Depth in Black Lagoon

Contamination of the sediments was observed at depths of 0.5 to 12 feet below the surface of the sediment. Mercury concentrations were found to increase with depth in some locations within the lagoon (Figure 1-2).

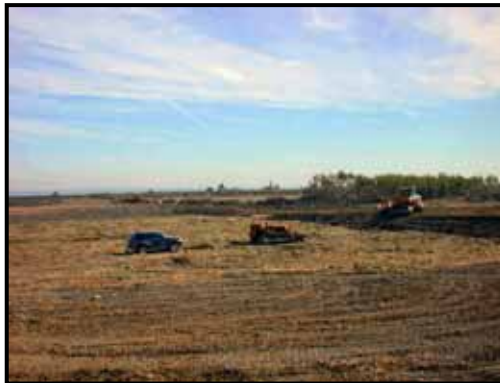
Cross Dike Construction. A new interior cross dike was installed along the southern end of the sub-cell between the existing perimeter dikes. The interior dike segregated and confined the dredge materials from existing and future materials in Cell 5. The dike was constructed in accordance with USACE drawings and specifications.

Dike construction material was originally to be obtained from within Cell 5, in the borrow area shown on the USACE drawings. This material was inappropriate, due to its water content and composition, therefore, material was conveyed from the offloading area to the cross dike location via 35-ton off-road articulated dump trucks.

Placed borrow materials were shaped, graded, and compacted using a D6 LPG dozer. Soil material was placed in layers not more than 12 inches in loose thickness. Each layer was compacted by a minimum of 3 passes of the D6 LPG. Dike construction tolerances adhered to the required engineering specification of plus 0 and minus 6 inches.

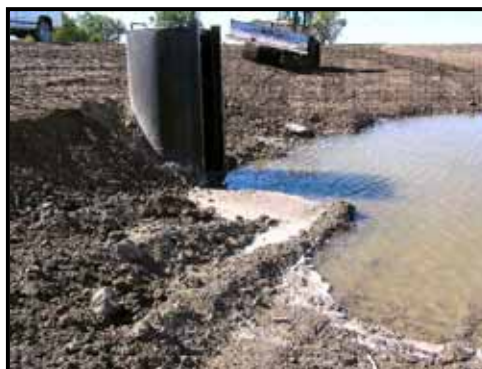
Existing Dike Liner. A 2-foot soil layer was placed over the interior of the existing dike to cover the riprap and to prepare the surface for placement of the synthetic liner. The soil materials were obtained from areas directly adjacent to the interior of the existing dike (i.e., the soil/dredge spoil material that is in the floor of Cell 5).

The soil was placed in layers not more than 12 inches in loose thickness, and each layer was compacted by a minimum of 3 passes of the D6 LPG dozer. Woven fabric liner of polyethylene geotextile was installed along the interior slope of the existing perimeter dike to confine the solidified dredged material and to prevent any seepage through the dike wall into Lake Erie or the Pointe Mouillee Wildlife Refuge. Inspections were made

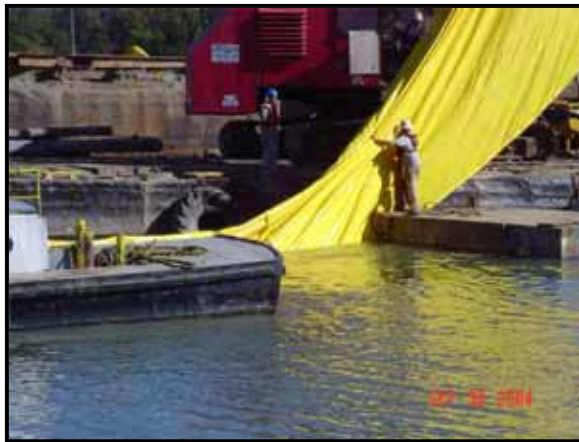
The original work plan called for anchoring the turbidity curtain every 50 feet to a pipe piling at the water surface and to the river bottom using H-beams attached to the ballast chain. Due to strong and erratic currents, the initial placement failed. The project team explored several options with USACE and decided to decrease the spacing between anchor pilings to 10 feet.

This method proved to be successful for a short period of time (approximately 60 days). However, sporadic tears in the fabric eventually appeared. The tears were addressed by adding additional layers of turbidity curtain at the tear locations. This method eventually failed when the river current scoured a hole under the turbidity curtain. Ultimately, an inner curtain made from a permeable material was deployed along the entire length of the project. This curtain performed very well and proved successful for the remainder of the project (Figure 3-1).

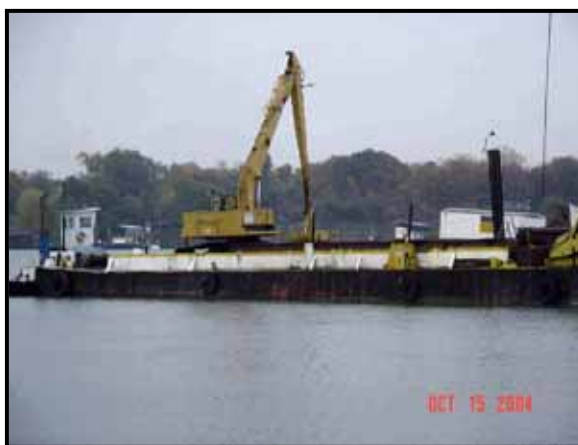
Phase I dredging was accomplished by mechanical means with a 320L long-reach excavator and a CAT 235DL excavator equipped with an environmental clamshell. The excavators were mounted on two deck barges, 28'x111' (#744) and 33'x138' (#102), equipped with spuds. Dredged material was placed into a steel hopper located on the back of each dredge

barge (dredge plant). The hoppers contained weep holes, which allowed necessary bulk dewatering of the sediment. Absorbent pads or sausage boom were placed on and around the hoppers to contain any oil. A silt fence and filter fabric panels were attached on the inside of the hoppers in front of the weep holes. This allowed the material to shed water, yet prevented as much re-suspension of the sediments as possible.

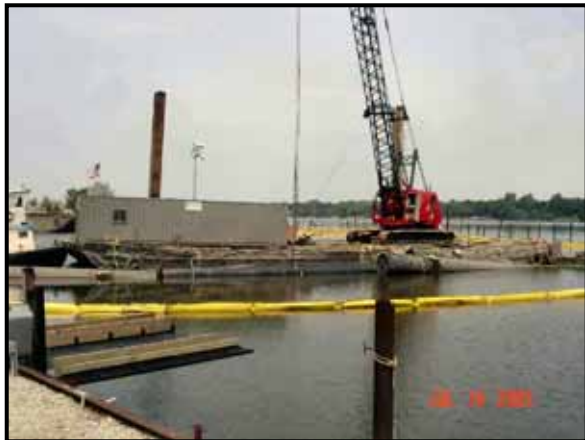
Dredging Equipment. One mechanical dredge plant equipped with an 8-ton crane and a 4-cubic yard environmental clamshell replaced the two dredge plants equipped with hydraulic excavators. This dredge plant was also outfitted with real-time positioning software, which monitored the horizontal position of the dredge plant as well as the horizontal and vertical position of the clamshell. The dredge plant offloaded directly into the hopper barges, which were shuttled to the solidification and offloading area on the northern shore of the lagoon, using the 35-ft harbor tug. There were no changes in solidification or transportation procedures other than the amount of solidification agent used. A 15% increase was required because bulk shedding of water was eliminated from the operation.

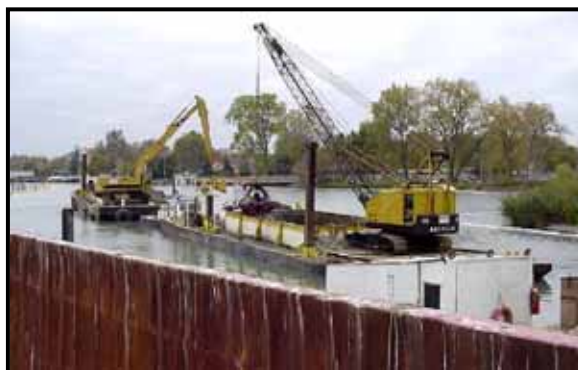
Four isolation curtains were installed, creating five cells. All isolation curtains were attached to a new inner perimeter curtain before any dredging began, but isolation curtains were not positioned or pulled into place until a cell had been dredged. Dredging along the northern edge of each cell extended approximately 25 feet beyond the limits of the cell, up to the

barrier pipe, and then the isolation curtain was pulled into place. Survey data for the entire lagoon were updated and recorded throughout the dredging process by the onboard equipment and software prior to designating an area as completed and before placing the isolation curtain. After the isolation curtain for an individual cell was placed, the barrier pipe was pumped out, floated into its next position, flooded again, weighted, and sunk into place. This allowed the operator to overlap dredging areas to ensure that the best possible coverage was achieved. In conjunction with the above procedures, careful operation of the clamshell was crucial to the overall success of the project. For this reason, Hypack's Dredgepack[®] system was employed and individual training conducted on-site, prior to, and during, dredging activities. Training was provided directly by Hypack. In addition to technology and training, clamshell descent and ascent through the water column was restricted to a maximum of 1 foot per second, minimizing resuspension in the water column.

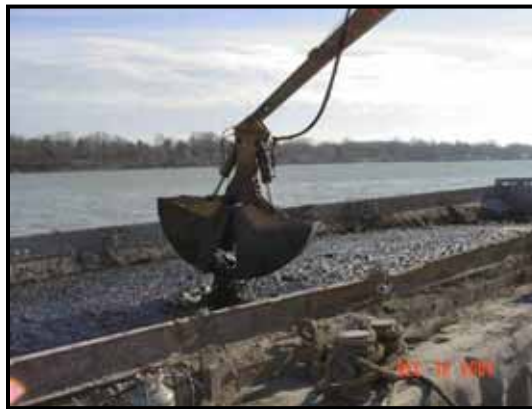
Transport barges were loaded outside of the silt curtain. This was accomplished by locating the transport barges immediately adjacent to the outside perimeter of the curtain, and then loading them by extending the excavator boom over the curtain from the dredge plant and dumping the material into the transport barges. Various engineering

controls and careful operator practices were used to prevent removed sediment from being released into the river channel. The primary control was a “spill prevention plate,” which consisted of a steel plate that overlapped the transport barge and the silt curtain and lead back to the dredge plant. This plate was welded to 6 of the steel pipe pilings that

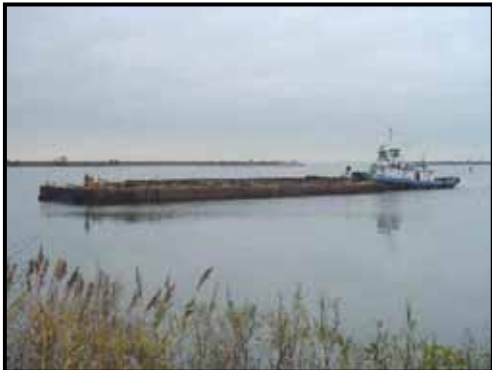
Three transport barges were used to convey the dredged materials to the government-provided CDF on Pointe Mouillee. The barges were moved using the *Robin Lynn*, a 90-foot, 1,800-horsepower tugboat, up the Trenton Channel to the north, under the Grosse Ile toll bridge, and into the Detroit River Channel.

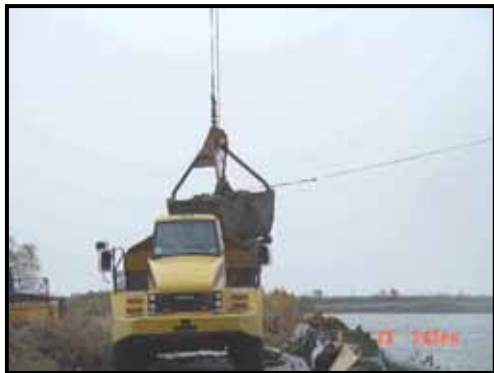
Dredged sediment from the Black Lagoon was received at the transfer/offloading area of the CDF. The tug and barges entered the CDF through the Southeast Interior Channel, where a smaller harbor tugboat (e.g., 35-foot, 300-horsepower) was used to maneuver the barges and place them at the transfer site. The barges

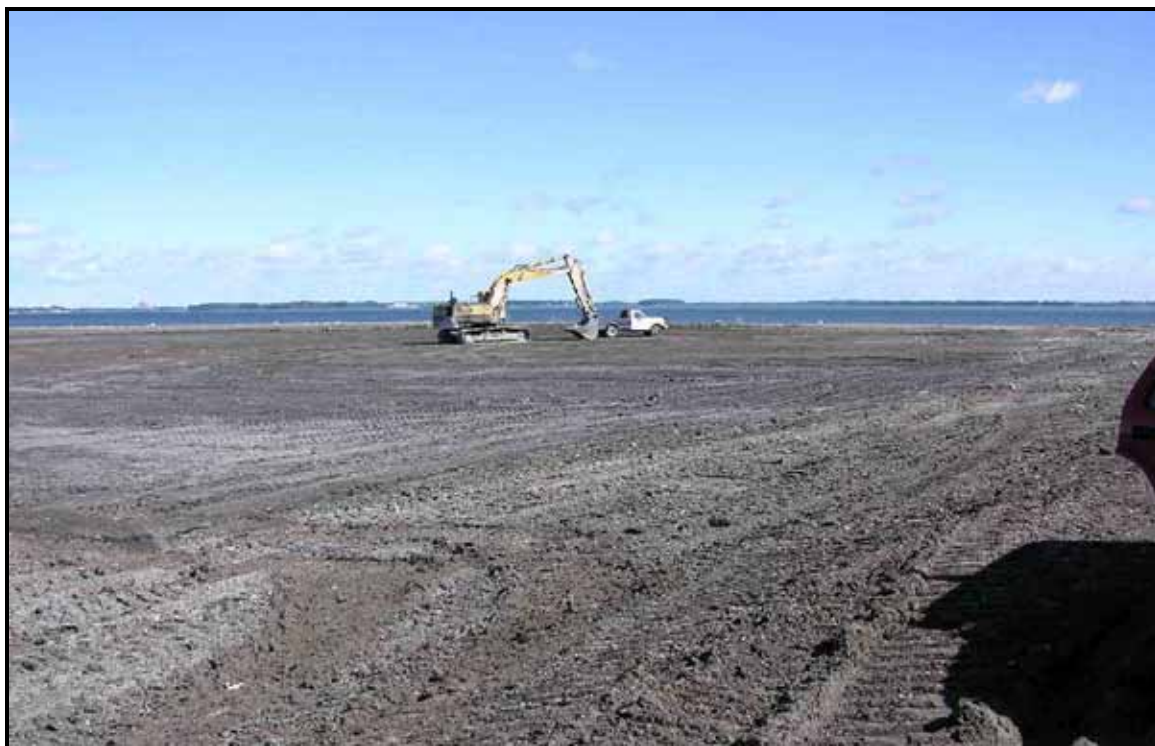
A minimum of a 2-foot cap was placed on top of the dredged materials. Cap material was obtained from areas adjacent to the offloading site within Cell 5. The material was excavated with a CAT 330 excavator and spread in 1-foot lifts, then compacted with a D6 LGP dozer. At least 3 passes were made with the D6 LGP dozer over all placed cap material. The top of the cap did not exceed an elevation of 581.0 feet.

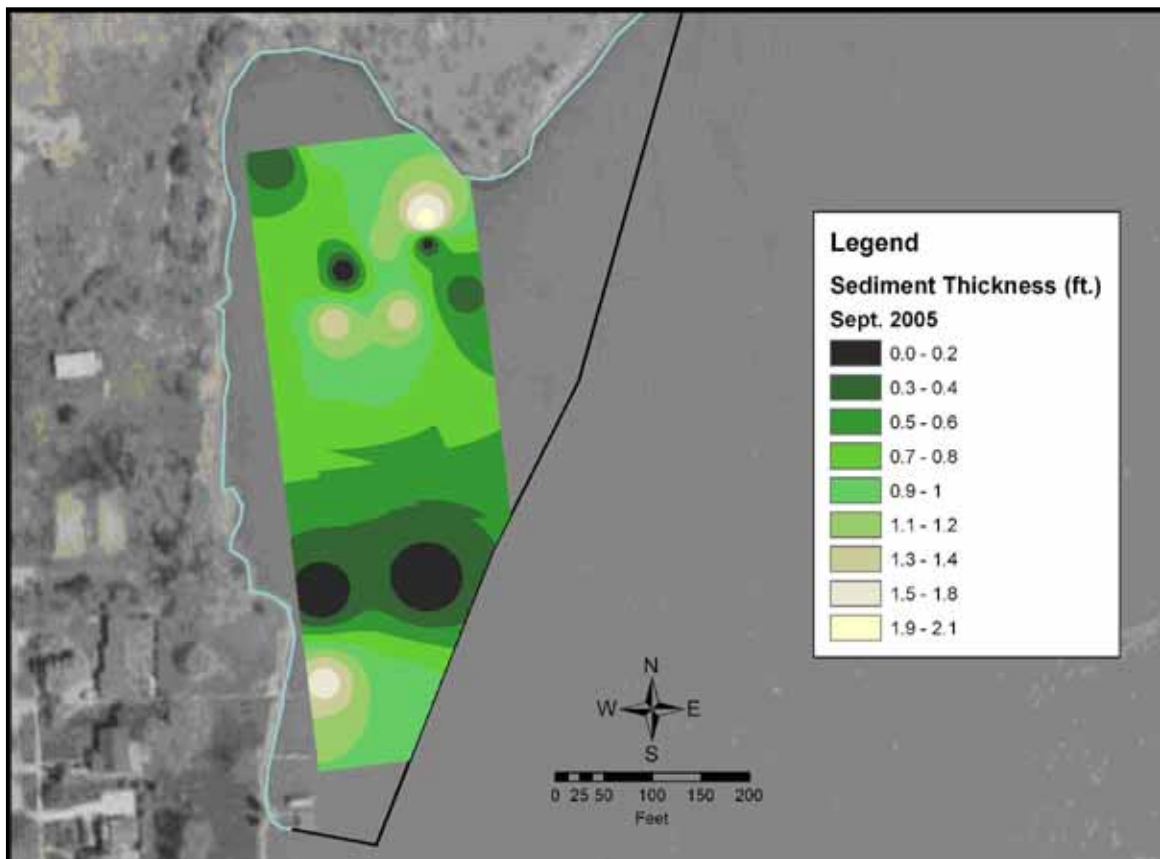
Figure 6-2 Black Lagoon Sediment Thickness After Completion of Phase II Dredging (based on data collected in August and September 2005)

A new map of the sediment thickness after the second phase of dredging is presented in Figure 6-2.

Results suggest that, although the Phase II dredging activities did not completely reduce contaminant concentrations to the levels targeted, the second round of dredging was successful in reducing both the overall concentration and the distribution of those contaminants. Figures 6-3 and 6-4 illustrate this by showing the estimated concentration and distribution of oil and grease before and after contaminated sediments were removed in Phase II. Figures 6-5 and 6-6 present similar information for total PCB distributions. A similar pair of figures could not be presented for mercury due to the lack of confirmation samples in the southern half of the lagoon because of the decision to halt the sample analysis when results reported for oil and grease showed all samples exceeded the target levels (see Table 6-1). As can be seen from these figures, dredging efforts in the Black Lagoon dramatically reduced the levels of contamination across the site. See Section 6.3 for final sediment confirmation results after placement of the residual cover.

The accuracy of the revised calculations was substantiated by the estimates obtained from the kriging maps presented in Figures 6-1 and 6-2. A three-dimensional view of both surfaces is provided in Figure 6-8 to show the difference in the estimated sediment thickness before and after Phase II dredging activities.

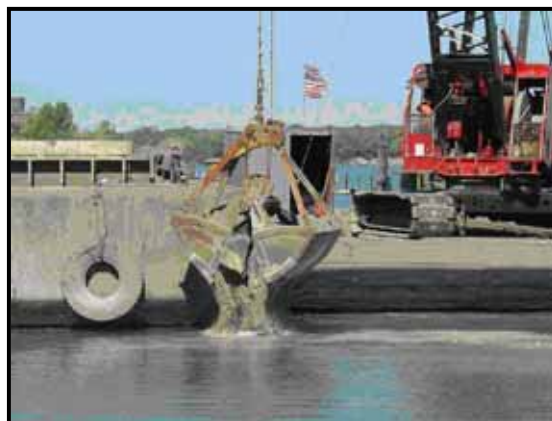
surface of the water to achieve a greater rate of dispersion and to reduce mounding. The cover materials were shuttled from the north end of the lagoon by hopper barge and tugboat, and the progression of cover material was from south to north.
