Historic Building Assessment

for the Department of Energy Conveyance and Transfer Project

Historic Building Survey Report No. 178

Los Alamos National Laboratory

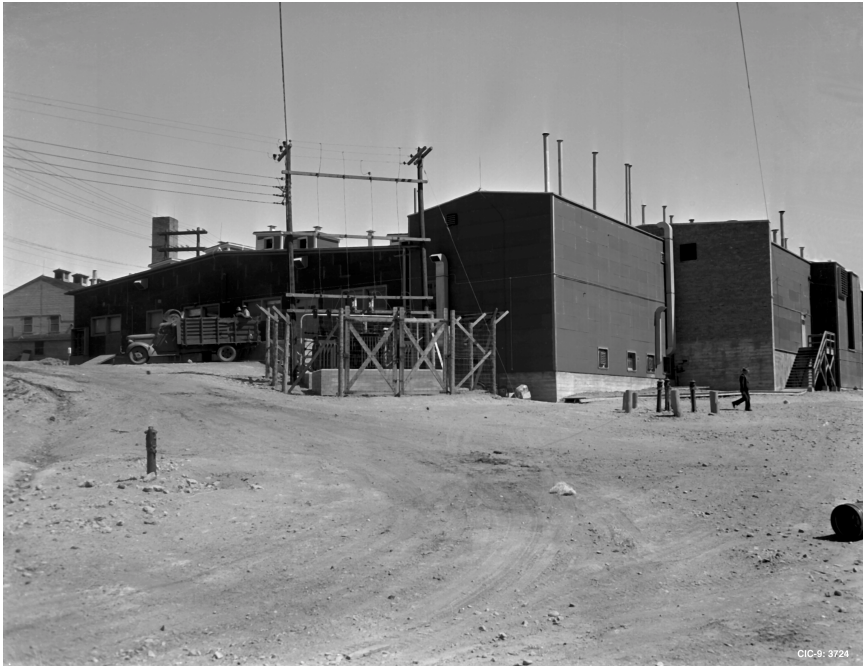
Figure 9. D Building at TA-1, circa 1943 (under construction).

Los Alamos scientists conducted the first experiments on methods of plutonium purification using other elements as stand-ins (LANL 1993a). This work was conducted in D Building, a wooden laboratory building located south of Ashley Pond in the main TA, TA-1 (Figures 7–10). Initial plutonium research, metallurgy, and World War II plutonium core production were carried out in this facility. The world’s first significant piece of plutonium metal was produced in the centrifuge at D Building in the spring of 1944.

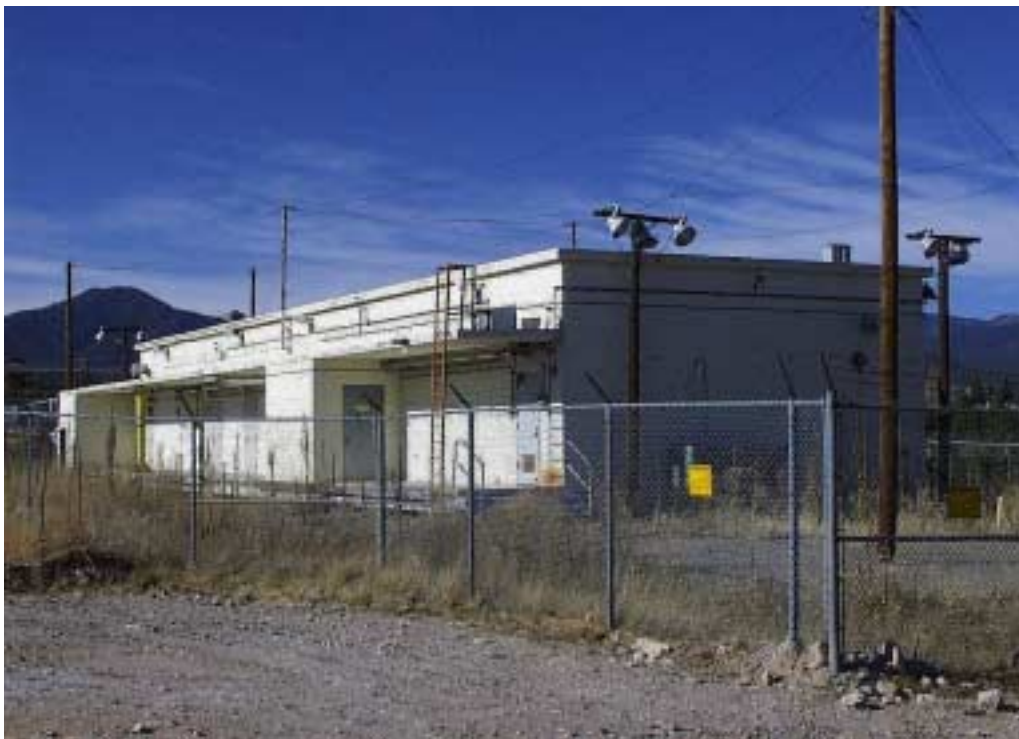
Figure 26. Building TA-21-21.

The very early years at DP Site—just at the end of World War II and before the AEC’s involvement with the Laboratory in 1947—were extremely important to the nation’s earliest stockpile of critical atomic weapons components. Plutonium pit manufacture and storage activities, although later shifted to other AEC facilities, were centered in the plutonium operations area at DP Site. Uranium and plutonium metal resulting from the operations at DP West were secured and stored in TA-21-21, the vault building (LANL 1991) (Figure 26).

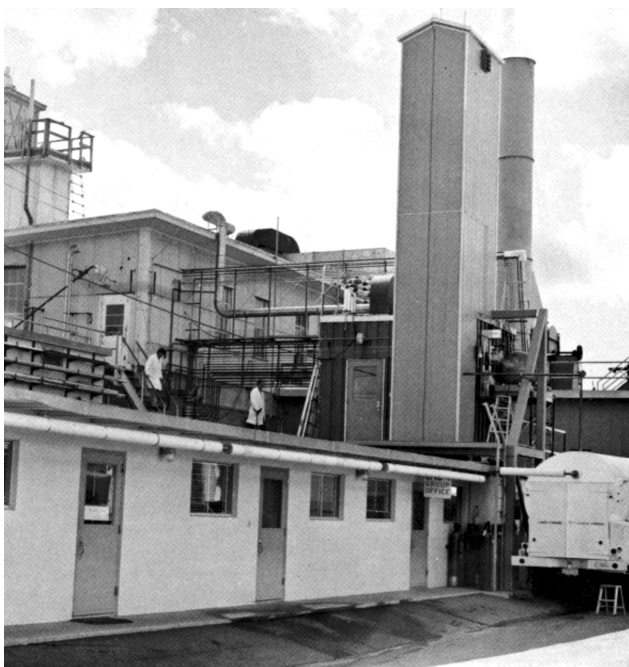
Figure 27. Tower structure, at right, used to house ICONS distillation columns, Building TA-21-3 North.

CNC-4's Isotopes Separation section separated isotopes of carbon, oxygen, nitrogen, and sulfur (ICONS) at Building TA-21-3 North for use in basic chemistry, biology, medicine, agriculture, and environmental improvement. Clinical and environmental research and development programs use these isotopes to trace material containing carbon, oxygen, nitrogen, or sulfur. Facilities at DP Site included long distillation columns that passed from a tower structure down into 100-ft deep subfloor holes (LASL 1971) (Figure 27).

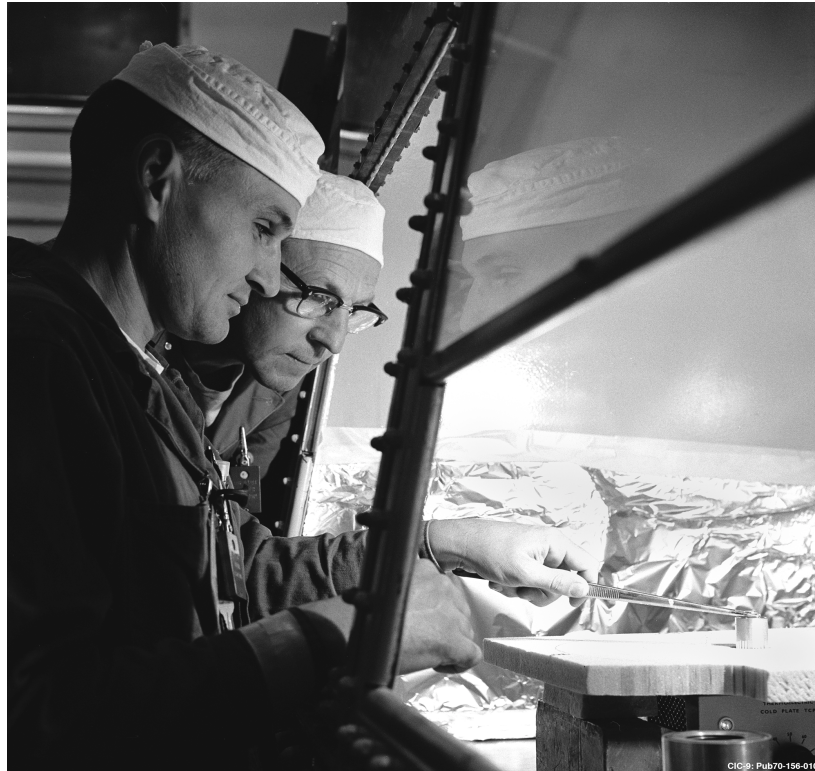
Figure 29. Workers remove a plutonium-238 heat source from a “target.”

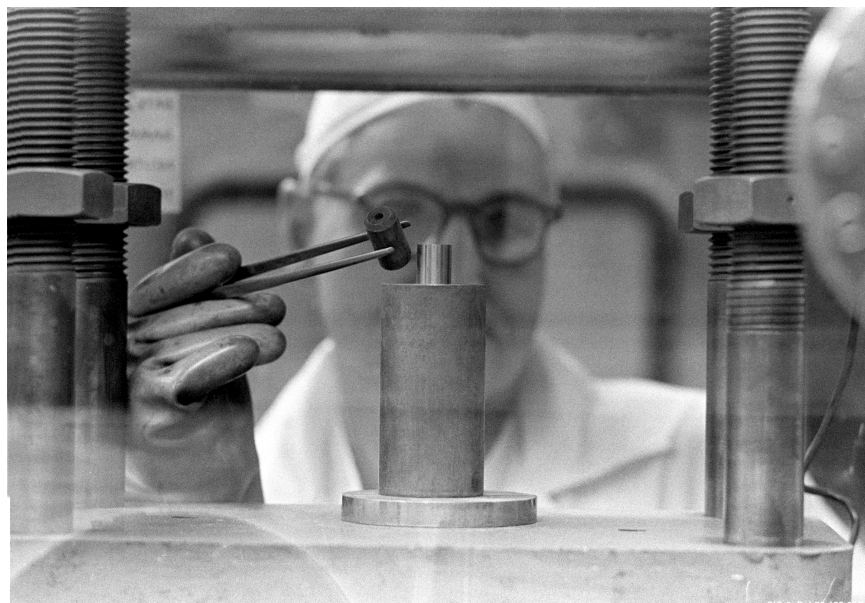
Figure 30. A heat source (a mix of plutonium dioxide fuel and a binder) is removed from a press.

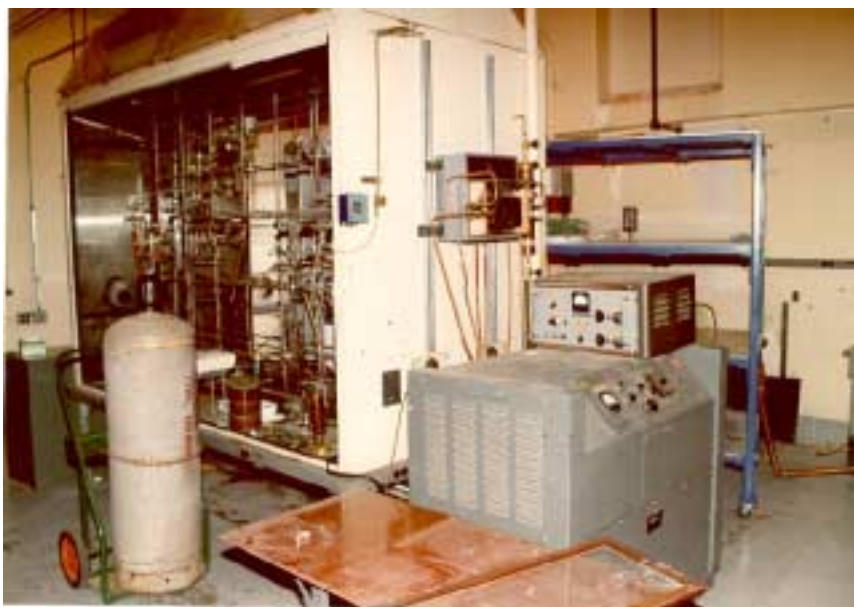
Figure 33. TA-21-152, Bay 5208 – “California Hood.”

Over the years, operations at DP East have supported high temperature research including carbide coatings associated with Project Rover and superconductivity research. These investigations involved the use of welding machines, radio frequency furnaces, DC arc melters, bead blasters, and mass spectroscopy (LANL 1995c). Some of the work was carried out in Building TA-21-152 (Figures 33–38).

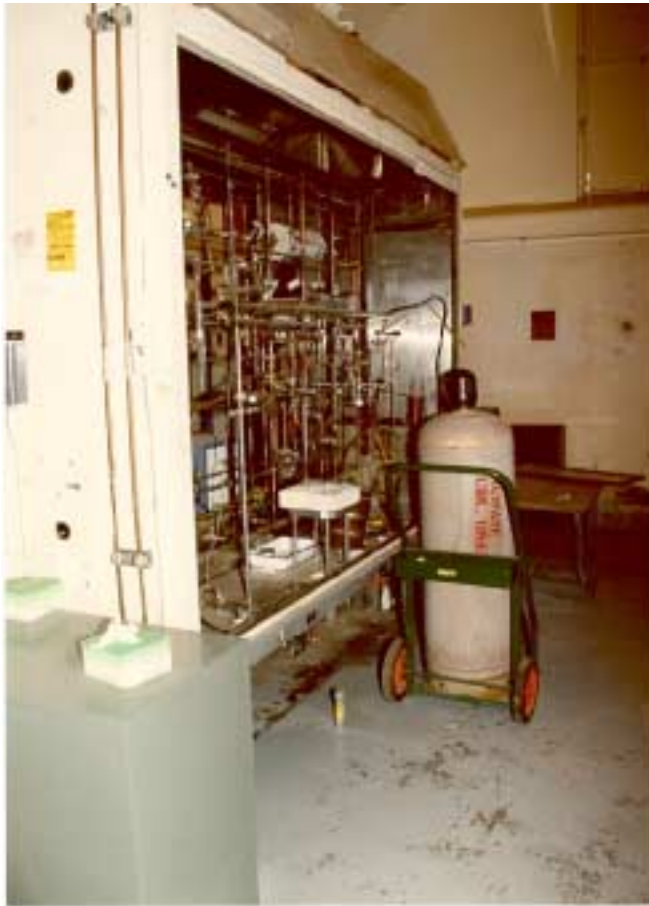
**Figure 34. TA-21-152, Bay 5208 –
“California Hood.”**

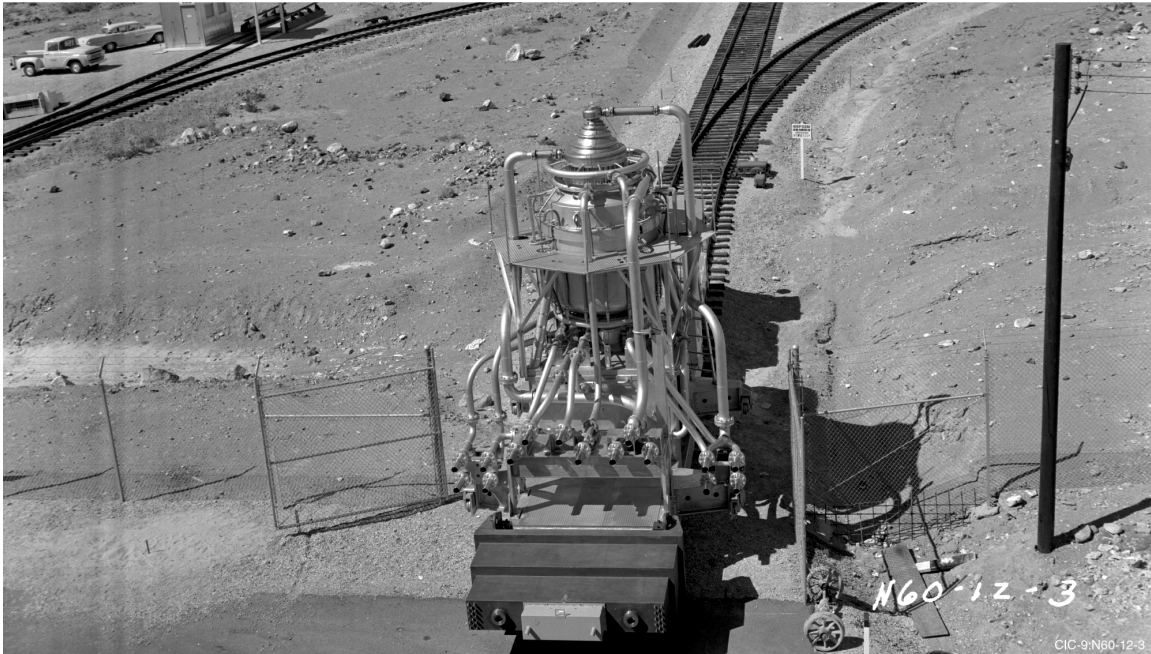
Figure 39. A Los Alamos Kiwi reactor at the Nuclear Rocket Development Station in Nevada.

Project Rover had two phases of reactor development and testing—Kiwi (1959 to 1964) and Phoebus (1965 to 1972) (LANL 1997) (Figures 39–42). The first reactor, Kiwi A, was tested in 1959. “Kiwi” reactors were named after the New Zealand flightless bird since these reactors were never meant to fly (LASL 1967a). The Kiwi A uranium-graphite reactors were of a 100-MW design. Later Kiwi B reactors were of a 1000-MW design and were the first Project Rover reactors to be run with liquid hydrogen. The “Phoebus” reactor was named after Phoebus Apollo, the Greek god of light. Although actual operating times were short, the Phoebus reactors developed very large power levels, comparable to the power generated by Hoover Dam (LASL 1967a).

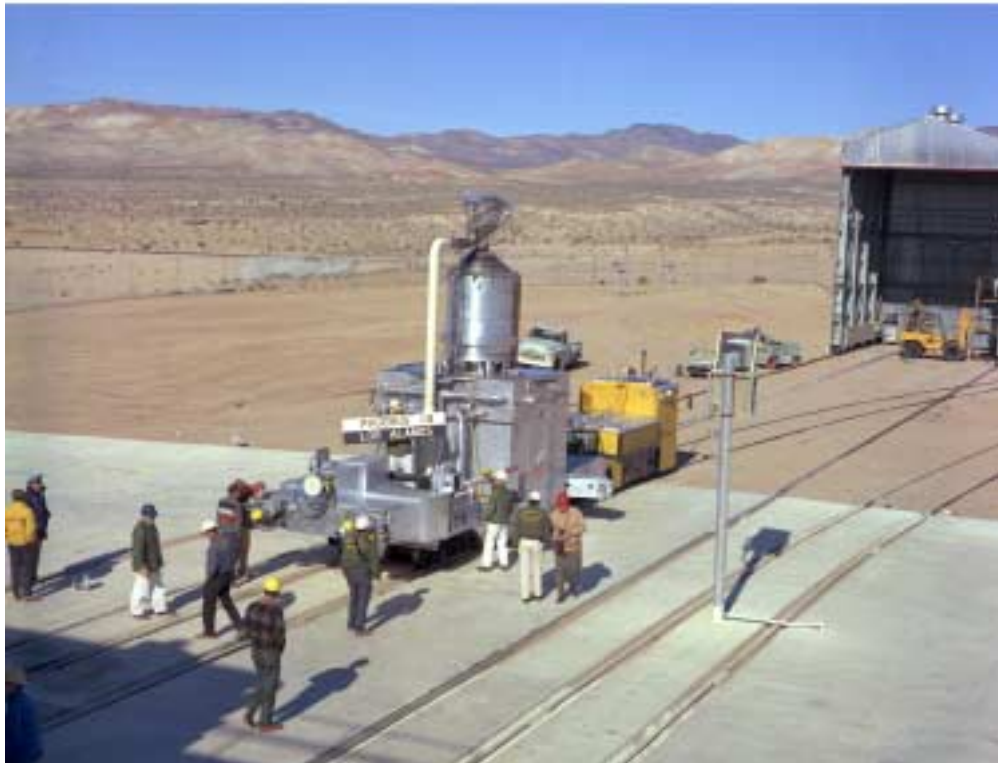
Figure 40. The Phoebus-1B reactor in Nevada before a 1967 full power run.

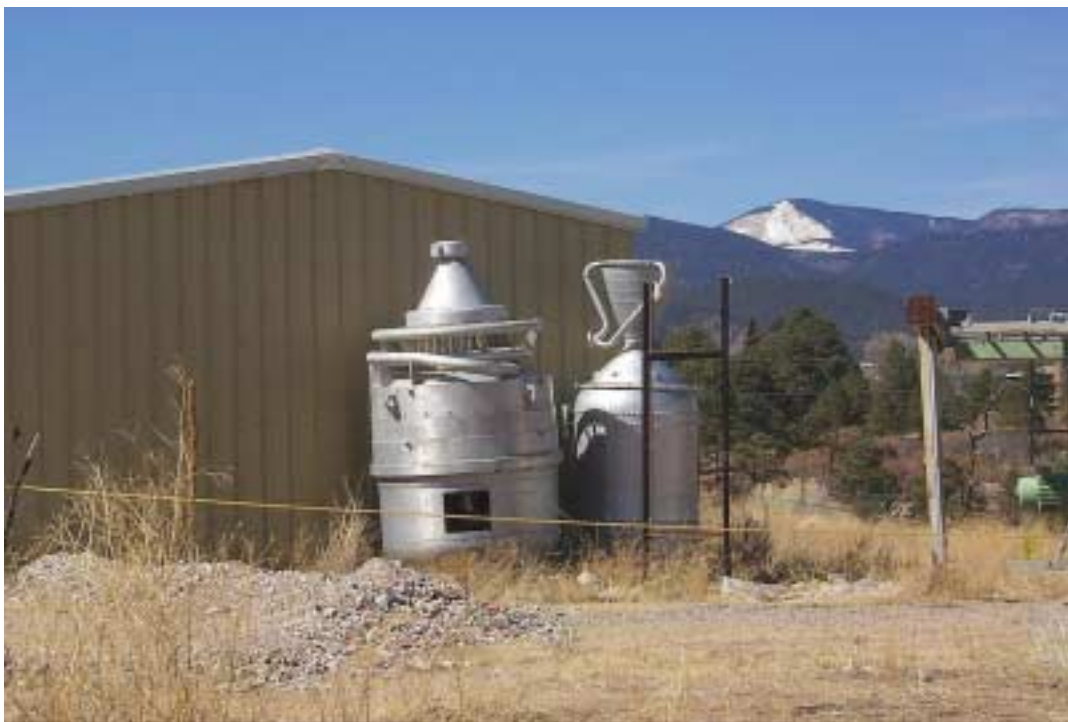
Figure 42. Kiwi A, left, and Kiwi B, right, reactor vessels at TA-21, LANL.

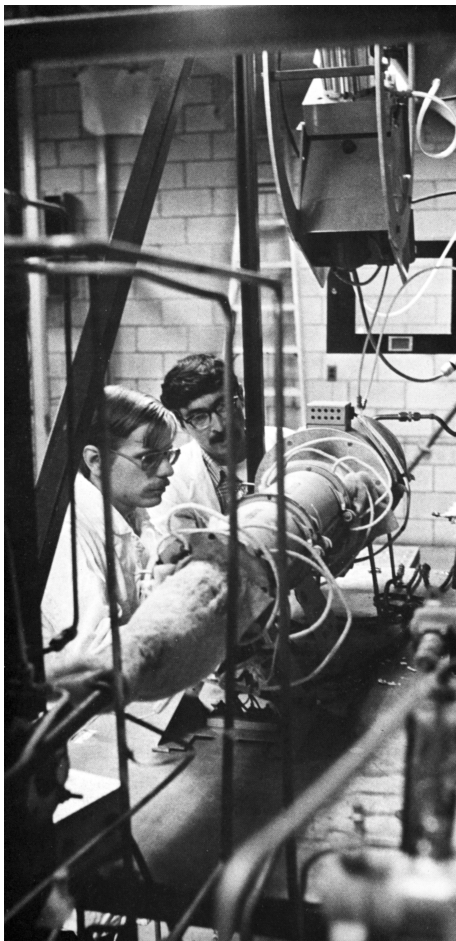
LANL photo from September/October 1974 Atom article, Vol. 11, #5

Figure 43. Workers at DP East operate the vapor deposition device constructed, in part, with components from the defunct Project Rover.

Using surplus Project Rover equipment, chemists from CMB-3 conducted vapor deposition experiments at DP East related to superconducting transmission research (Figure 43). The work at DP Site drew on advances in coating methods developed during Project Rover. Vapor deposition techniques were originally developed to protect reactor components from corrosion. Chemical vapor deposition causes gaseous materials to react and form a solid compound on a surface. The vapor deposition method used in the superconducting experiments allowed the buildup of a niobium and germanium compound in 50-micron-thick films that carried very large currents with no resistive losses at high temperatures. These films began superconducting at temperatures produced by using hydrogen slush as a coolant. This was an important development since hydrogen slush is inexpensive and readily available (LASL 1974).

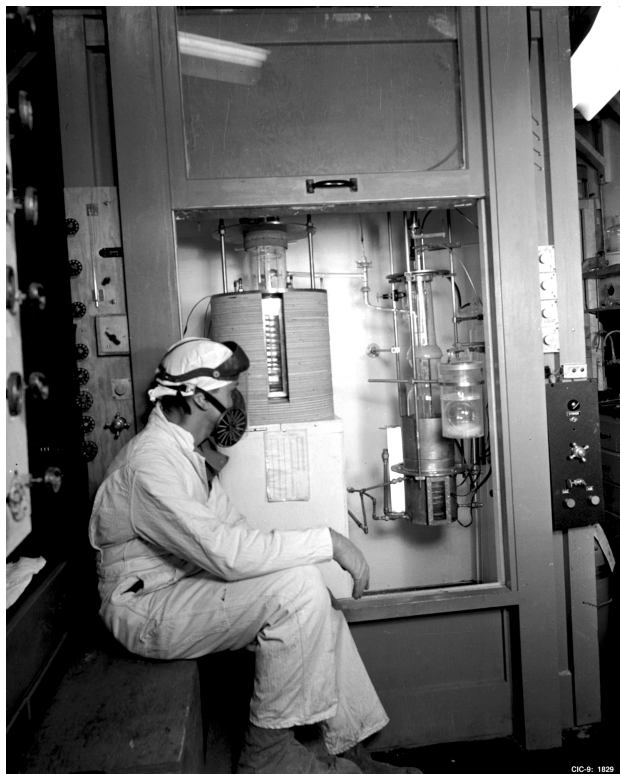
LANL # CIC-9: 1829, photo from April 1973 [Atom](#) article, Vol. 10, #3

Figure 44. An early plutonium worker performs a purification operation in an open chemical hood.

Early nuclear chemistry operations were crude in comparison to today's operations (LASL 1973). Workers typically used open hoods, hood-type cabinets with sliding doors, and even unventilated gloveboxes (Maraman *et al.* 1975, LANL 1995b) (Figure 44). The prototype gloveboxes, called "dry boxes," were made of plywood and constituted a fire hazard (LANL 1983).

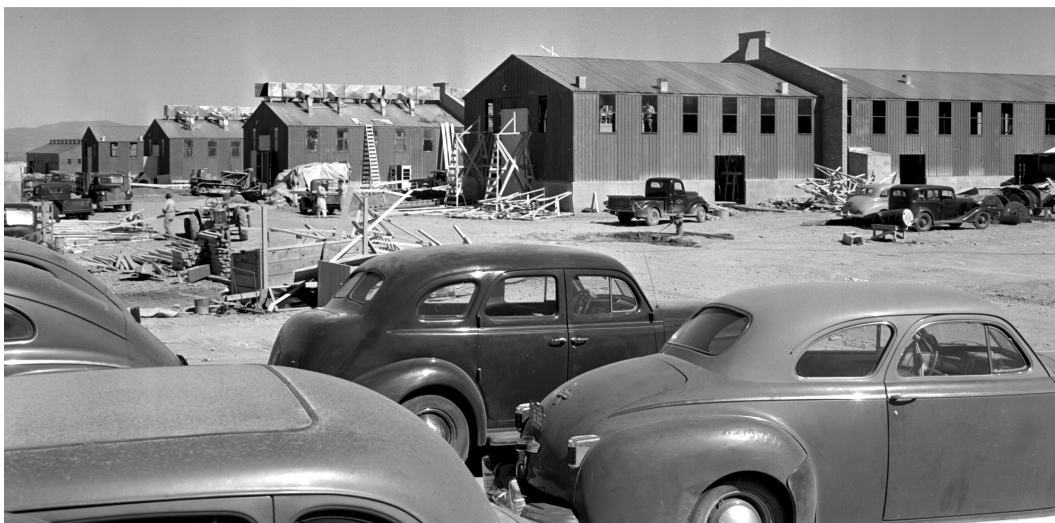
Figure 45. DP West under construction, 1945.

The inadequacies of D Building were apparent by 1944. A larger and safer facility was needed, one where greater amounts of radioactive material could be handled in an environment designed to protect workers from the health hazards of plutonium and polonium. The wooden D Building was a fire risk and the new facilities at DP Site (Figure 45) were planned to be entirely noncombustible—operations areas had nonflammable steel walls and roofs. In a vast improvement over the facilities at D Building, the rooms were designed to be easily decontaminated. State-of-the-art features at DP Site included elaborate ventilation-filtration

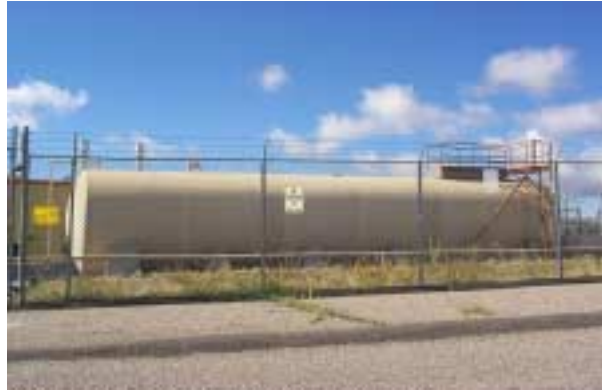
TA-21-57 is a 6,000-gallon oil fuel tank built in 1945. The tank is constructed of light gauge steel plate and rests on concrete saddles.

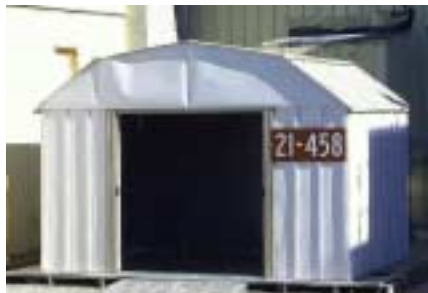
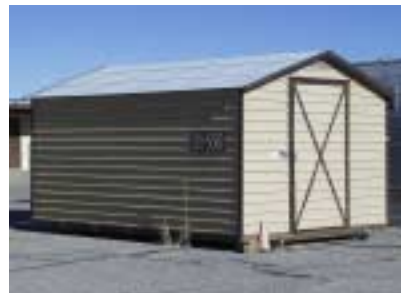
TA-21-387, -458, and -550 are prefabricated metal storage sheds. They are situated on concrete slabs or on wood pallets or sleepers on asphalt pads. Sheds TA-21-387 and TA-21-550 are Morgan™ type sheds. TA-21-387 has a gambrel roof and TA-21-550 has a pitched roof.

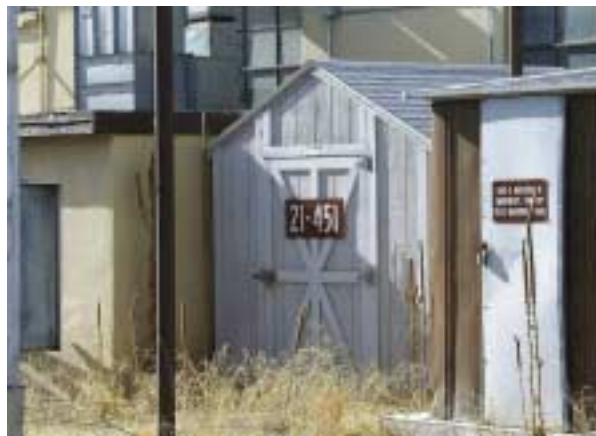
TA-21-451 is a pre-engineered wooden storage shed. It is situated on a concrete slab.

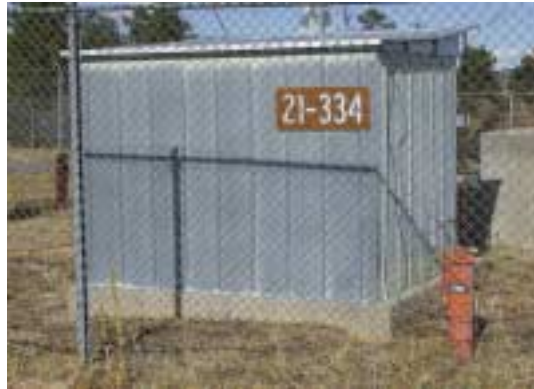
TA-21-334 is a small (4 ft by 6 ft 8 in. by 8 ft) corrugated light gauge steel utility shed set on a concrete slab.

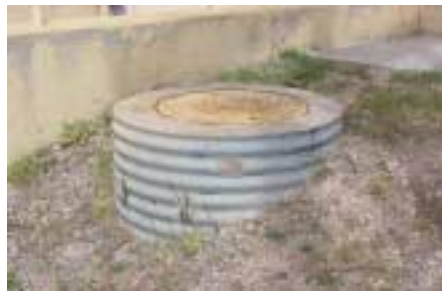
Manholes, whether they are for water, steam, sewer, acid waste, power, or phone vary in size from approximately 3 ft 6 in. by 4 ft by 5 ft deep to approximately a 5-ft 6-in. diameter by 10-ft deep holes. They are constructed with brick or concrete walls, sometimes lined with plastic liners and have steel or wood covers.

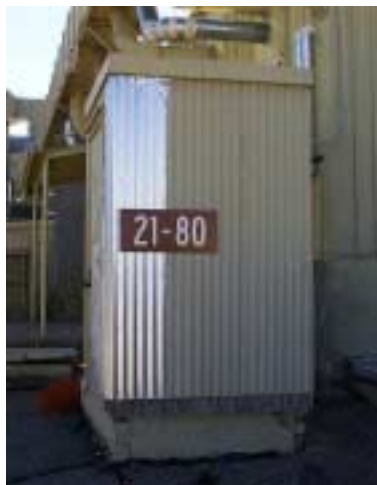
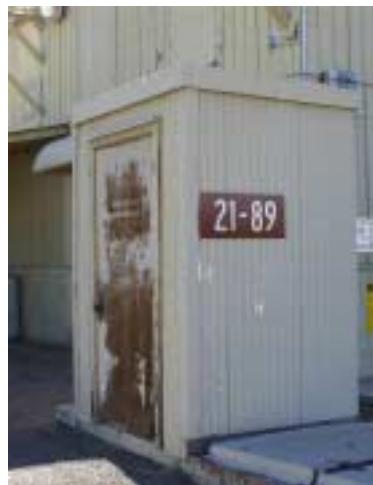
Buildings TA-21-80 and -89 are examples of the small metal utility shelters/structures that can house mechanical equipment such as back flow prevention equipment or pressure relief valve pits. These structures are approximately 7 ft by 5 ft by 7 ft tall.

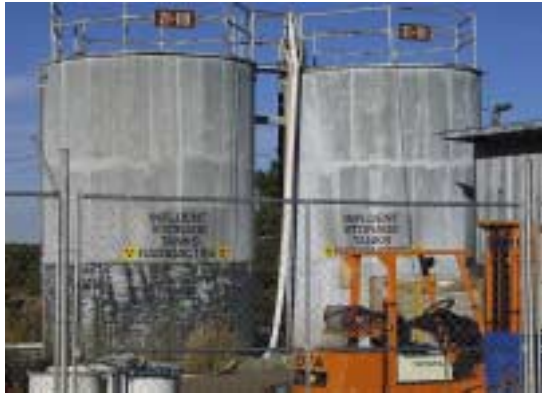
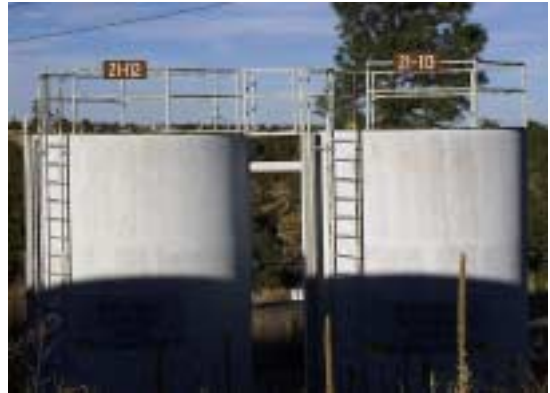
Acid holding tanks are steel plate tanks located on reinforced concrete pads with pipe railing along the top of the tank. These tanks contain low-level radioactive material from operations at DP Site. The tanks are labeled “Influent Storage Tanks Radioactive.”

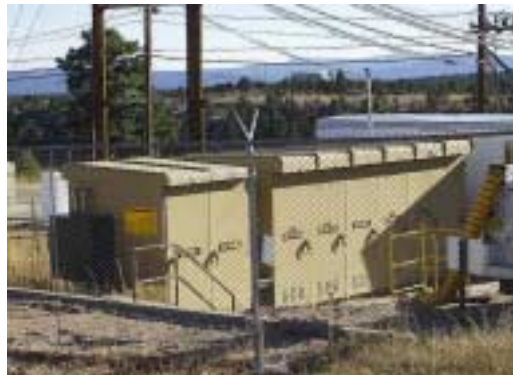
TA-21-148

Electrical substations are mounted on reinforced concrete pads. There are several located around DP Site that service different buildings. They range from a 2,500-KVA three-phase 13,200-2,400 volt to 300-KVA three-phase 13,200-480Y/277 volt, and to a switch substation that provides stand-by services and is only used in an emergency. There are also transformers associated with these substations.

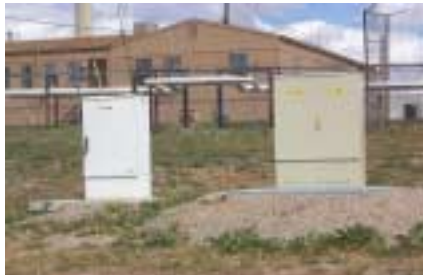
Telephone Pedestals/Cabinets

Telephone cabinets are steel cabinets mounted on reinforced concrete pads that can be as large as 5 ft by 5 ft by 9 ft.

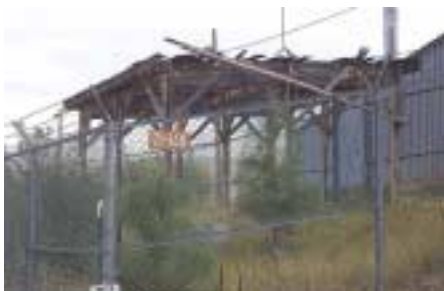
TA-21-160

These are canopy-type open-sided structures utilized for covered outside storage of gas tanks and equipment.

TA-21-160, built in 1945, is wood framed with concrete footings and no formal foundation or floor. There are concrete cradles still present that were used to hold gas tanks.

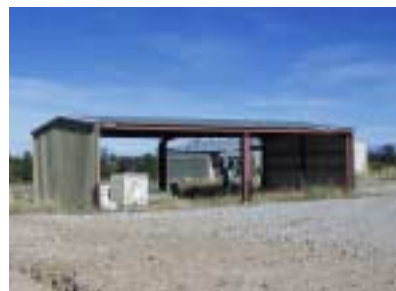
TA-21-402 is a pre-engineered metal structure with two bays. The end walls are of rolled steel panels attached to the steel frame. This structure has concrete footings, stem walls, and spot footings but no formal floor, only dirt and gravel.

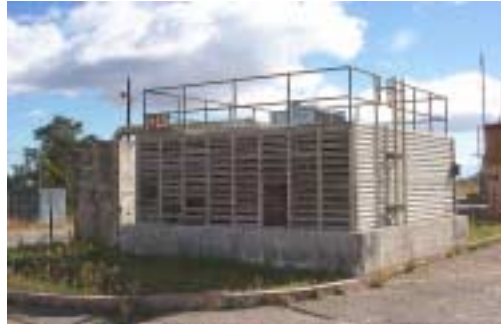
TA-21-220

Cooling tower TA-21-220, constructed in 1964-1965, is not in use and is abandoned. It originally serviced the air cooling system in Building TA-21-155.

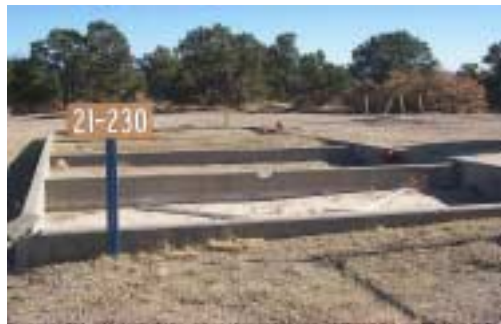
TA-21-230 is the sludge drying beds for the sewage treatment plants TA-21-227 and TA-21-229. These beds were put in place at the same time as the sewage treatment plant was constructed in 1965-1966. The beds are concrete framed with a layer of drain tiles, roofing paper, compacted earth, then crushed rock, pea gravel, followed by sand. A main sanitary sewer manhole is connected to the sludge beds.

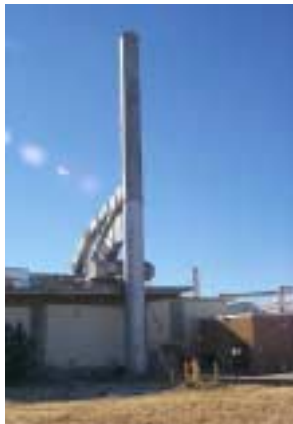
TA-21-466

These exhaust stacks are constructed of steel and range from 36 in. to 54 in. in diameter and stand 50 ft tall. They are mounted on reinforced concrete pads and are connected to particular buildings by ductwork. The stacks release treated filtered air from the laboratory buildings back into the environment.

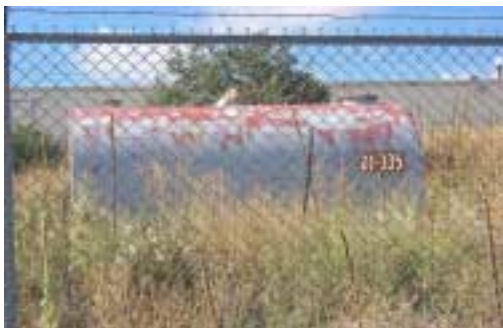
TA-21-335 is a 6,000-gallon containment vessel designed to receive any liquids discharged from the vault building, TA-21-21, in the event of an emergency release. It is constructed of light gauge steel and is approximately 9 ft diameter by 16 ft long and is mounted on a steel cradle that holds the tank above a concrete pad.

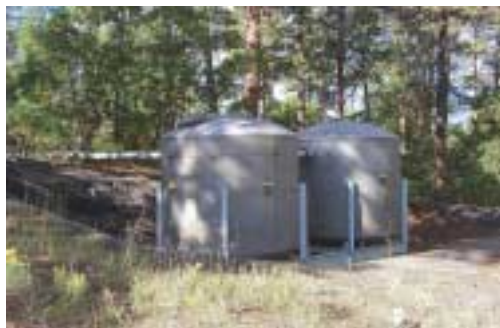
TA-21-346 is a set of two 3,000-gallon stainless steel acid pumping station tanks connected to acid sump TA-21-223. Each tank is approximately 9 ft in diameter and 9 ft high. Both are mounted on steel legs above the surface of an asphalt-lined berm in which they are situated. The tanks were sited at their current location in 1979.

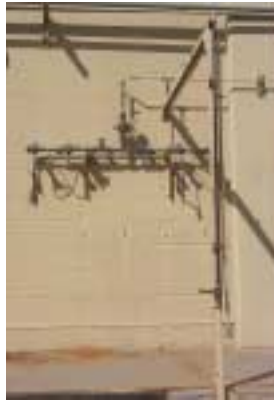
Example of small gas manifold

A gas manifold is a compressed gas distribution system. It is a centralized location where there are compressed gases (gas cylinders) connected to pipes and valves that distribute the gas to various locations.

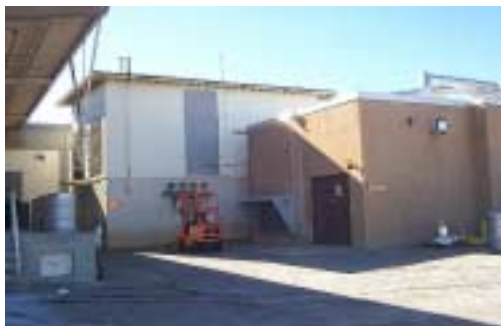
TA-21-370 is a new mechanical equipment building for a laboratory building, TA-21-152. It was constructed in 1985 of stuccoed concrete masonry units. New air handling equipment is housed in the building that includes a filter plenum, a heat exchanger, a process water evaporative cooler, and a louver.

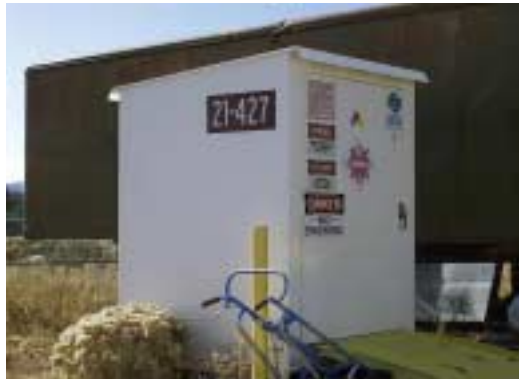
TA-21-427 is a small portable steel shed utilized for chemical storage.

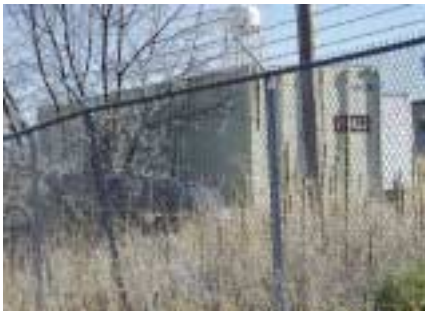
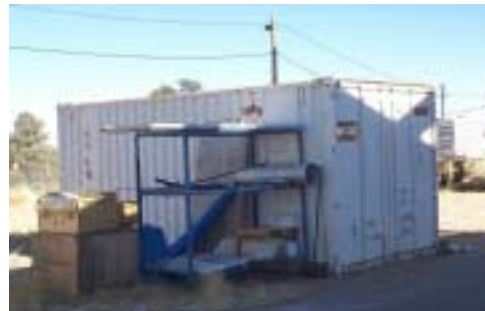
Transportainers are factory-built, heavy-duty steel containers of the type typically used for truck or ship transport. TA-21-462 measures 8 ft by 40 ft and is situated on wood beam sleepers, whereas TA-21-470 measures 8 ft by 20 ft and is situated directly on the ground surface.

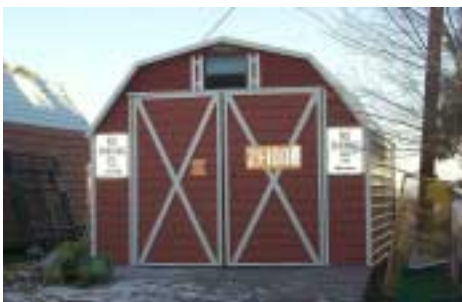
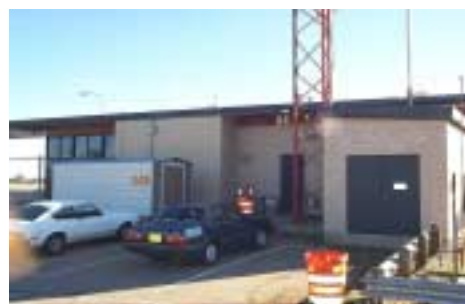
Morgan™ sheds are a type of prefabricated, or factory built, wood-framed storage shed with metal siding. The sheds, present in the land tracts proposed for conveyance and transfer, range in size from 8 ft by 16 ft to 12 ft by 18 ft and they either have a gambrel roof or a pitched roof line.

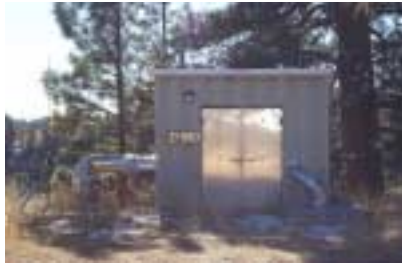
TA-21-1003

Building TA-21-1003, built in 1967, is a small concrete utility building/shelter housing back flow prevention equipment and a water meter. This building is approximately 9 ft by 12 ft by 9 ft.

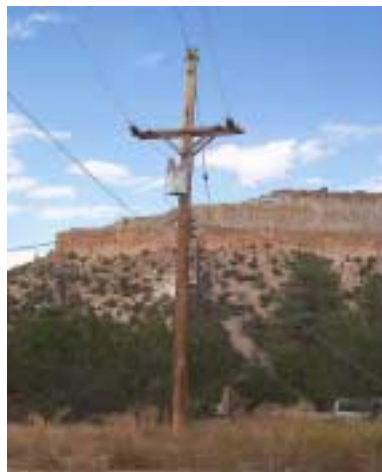
TA-74-1

The style of transformers present are small cylindrical pole-mounted transformers. They are “used to transfer energy, usually that of an alternating current, from one circuit to another, . . . that affect such a transfer with a change in voltage, current, phase, or other electric characteristic” (American Heritage Dictionary 1985:1287).

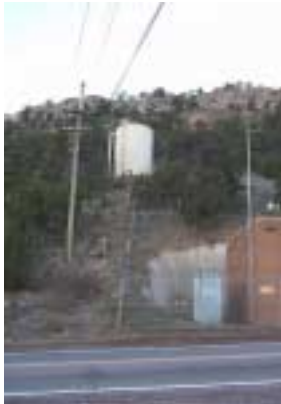
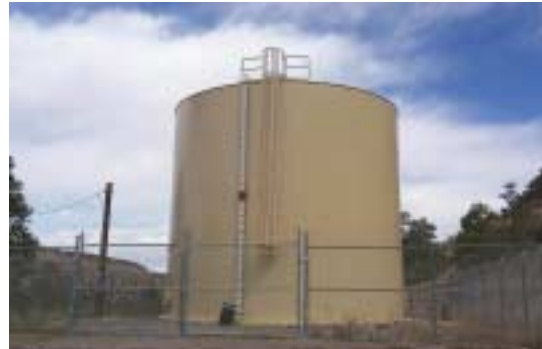
TA-72-2 and TA-72-57 are two surface-mounted water storage reservoirs. TA-72-2 is an approximately 75,000- to 100,000-gallon tank. TA-72-57 is a 200,000-gallon tank (Otowi Well #1 tank) and was built in 1995 to 1996.

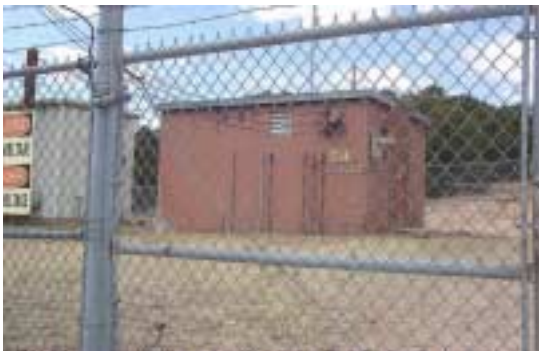
TA-72-4 is a small building constructed of concrete masonry units that have been painted rust in color. It is mounted on a reinforced concrete slab foundation and is approximately 13 ft 4 in. by 18 ft by 9 ft 4 in.

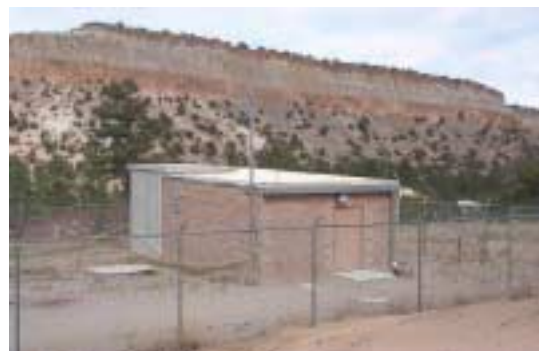
TA-74-3 is a small building also constructed of a type of concrete masonry unit and is mounted on a reinforced concrete slab foundation.

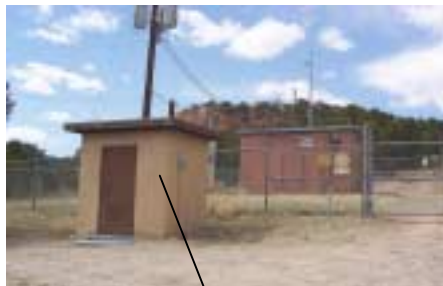
TA-72-53

TA-72-53, built in 1958, is a small building constructed of concrete masonry units that have been painted tan in color. This building is also part of the water well system and is associated with Pajarito Well #1. It contains fluoride treatment equipment for the water well system of Los Alamos County and the Laboratory.

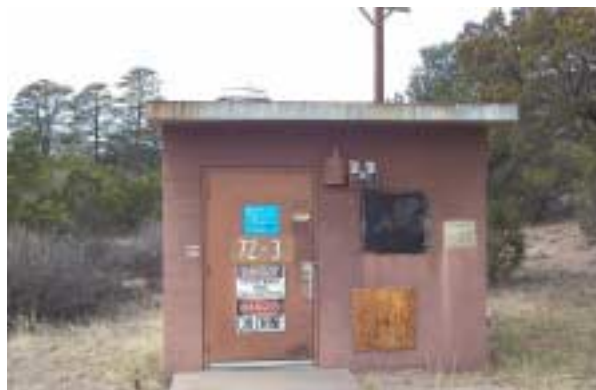
TA-72-3

TA-72-3, built in 1968, is a small building constructed of concrete masonry units that have been painted rust in color. This building is also part of the water well system and is associated with Pajarito Well #1. It contains chlorinator equipment for the water well system of Los Alamos County and the Laboratory.

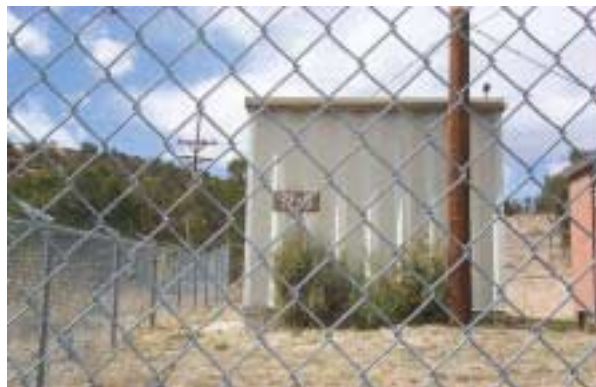
TA-72-5

TA-72-5, built in 1970, is a small (9 ft by 12 ft by 10 ft) ribbed steel-framed building. This building is also part of the water well system and is associated with Pajarito Well #1. It contains sand filter equipment also known as a building sand trap for the water well system of Los Alamos County and the Laboratory.

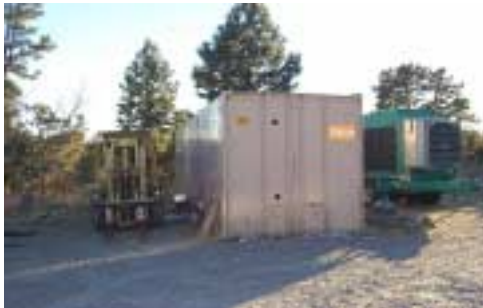
Transportainers are factory-built, heavy-duty steel containers of the type typically used for truck or ship transport. They have steel walls and steel roofs. TA-21-1010 measures 8 ft by 20 ft and is situated directly on the ground surface. There are three other transportainers that do not have building designation numbers. Santa Fe County and Los Alamos County own these. One is located in the TA-74 Tract. It is at least as large if not larger than transportainer TA-21-1010 and is situated on wood “sleepers” and has a poured concrete step leading up to the doors. The other two are located in the Rendija Canyon Tract and are smaller than the above mentioned transportainers and are situated directly on the ground.

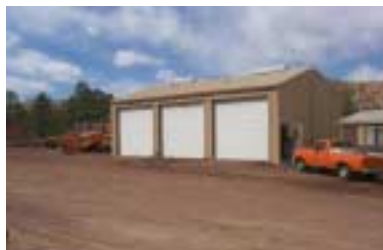
Highway Department Vehicle/Equipment Garage

There is no building designation number on this building. Santa Fe County owns it. This is a pre-engineered metal building, built on a metal frame with metal siding. It has three large garage type roll-up vehicle/equipment doors and is located in the TA-74 Tract at the Santa Fe County Highway Department road maintenance yard.

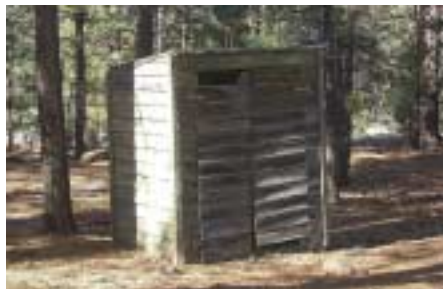
Shed - Located at TA-43

This small shed is constructed on a wood frame with wood-plank siding and has a slightly sloping roof. There are two hinged doors on the front (east elevation) of the building. At one time the wood siding was painted green. The wood-plank roof originally was covered with rolled asphalt roofing material. From its appearance this shed appears to have possibly been utilized as a storage shed for lawn maintenance equipment. This building is located in the DOE LAAO Site tract.

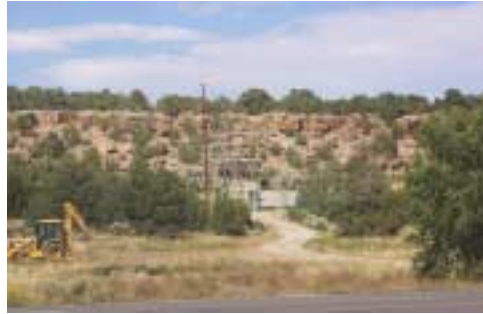
White Rock Substation

Electrical substations are mounted on reinforced concrete pads. There is no information regarding the specifics of this substation that is located in the White Rock Site tract.

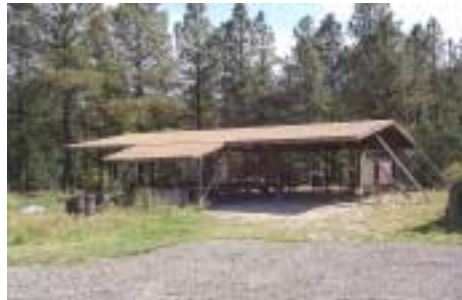
Open Shelter at Los Alamos County Sportsmen's Club

This is a canopy-type open-sided structure used as a covered shelter for picnic tables and an outdoor grill at the Los Alamos County Sportsmen's Club. It is wood framed with concrete footings but no formal floor, only dirt and gravel. It is located in the Rendija Canyon Site tract.

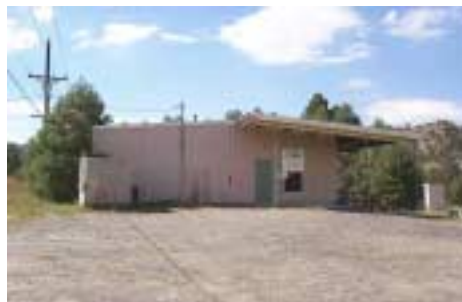
Los Alamos County Sportsmen's Club Clubhouse

The Los Alamos County Sportsmen's Club clubhouse is a pre-engineered ribbed metal building with a slight pitched roof and a canopy over most of the entrance side (east elevation) of the building. It is located in the Rendija Canyon Site tract.

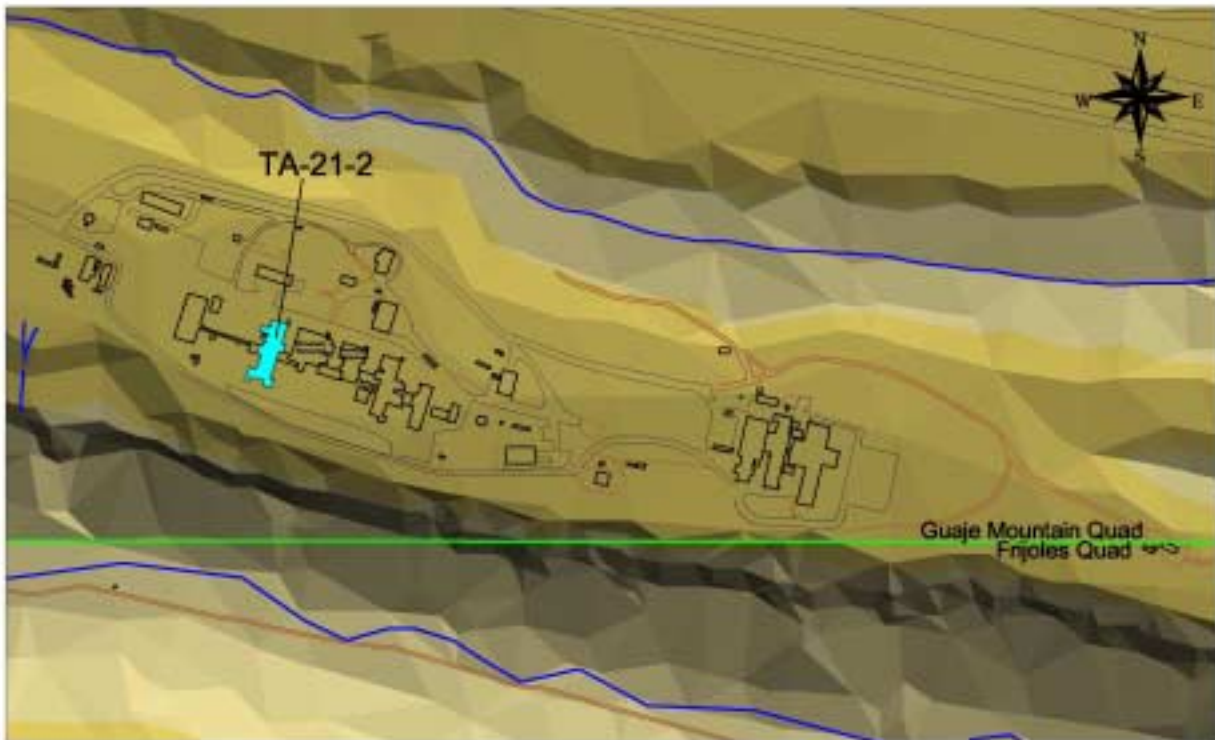
TA-21-2 North and West Elevations

Eligibility: Eligible under Criterion A. The interior of this building has been extensively modified as a result of decontamination activities. The building has little or no interior integrity. However, the exterior of the property still retains its historic feeling and character and would be recognizable to a contemporary.

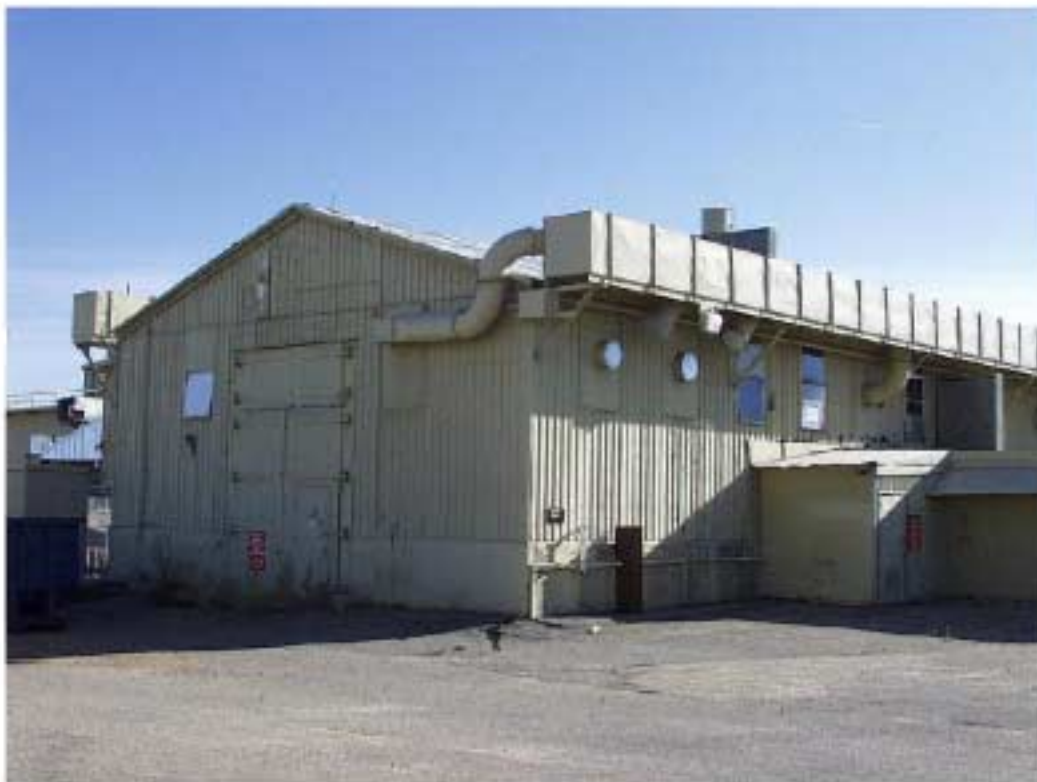
TA-21-2

Condition at Time of Survey: Deteriorating

Architectural features - The building is a composite of various elevations and roof slopes with a high bay in the center of the building. Exterior elevations are of metal siding with a metal roof. Multi-ply composite roofing material is used in other sections of the building. The building elevations are void of any predominant window penetrations other than those at various exterior personnel doors. There is a large double door opening at the center high bay on the north side of the building, presumably for equipment access. Heating, ventilation, and air conditioning ducting runs along the top of the outside walls with penetrating ducts from the building interior to the outside. There is an access stair on the outside of the southeast wall of the building with access to the high bay. This building houses rooms that were the site of the 1958 Cecil Kelley criticality accident.

Eligibility: Eligible under Criterion A. The interior of this building has been extensively modified as a result of decontamination activities. The building has little or no interior integrity. However, the exterior of the property still retains its historic feeling and character and would be recognizable to a contemporary.

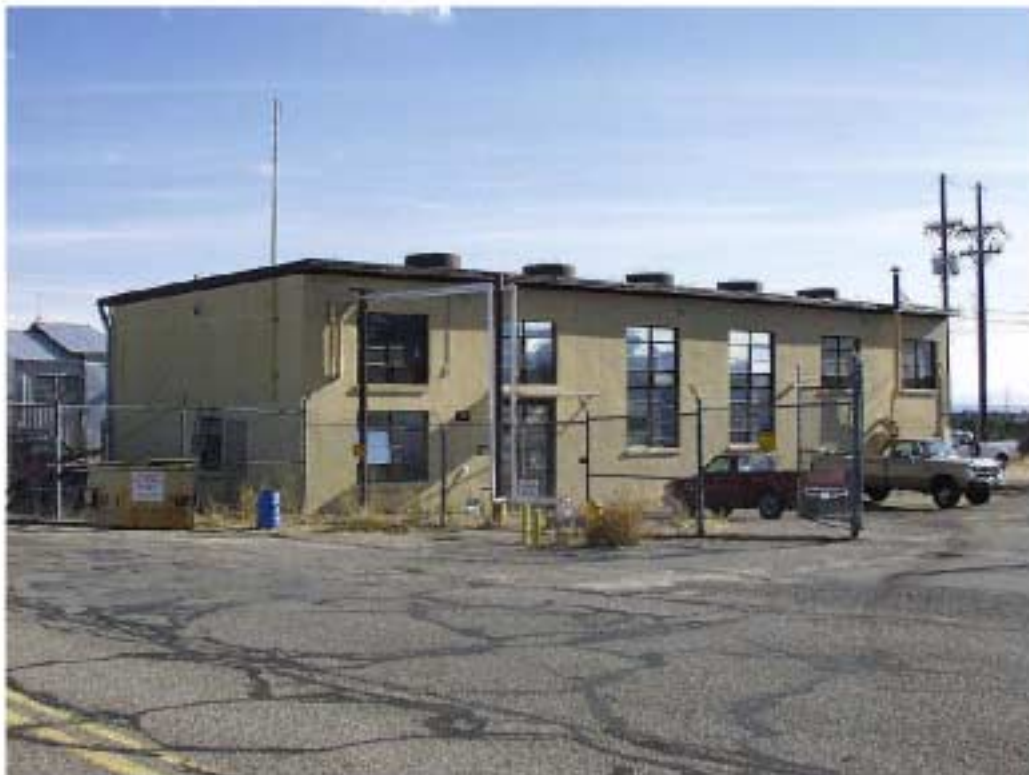
TA-21-14 North and West Elevations

Condition at Time of Survey: Good

The north side of the building currently has one window with two individual panes of glass and, where the third, center pane of glass should be, is a room air conditioner. Also can be seen is the location where the door that shows in the 1985 plans was walled up.

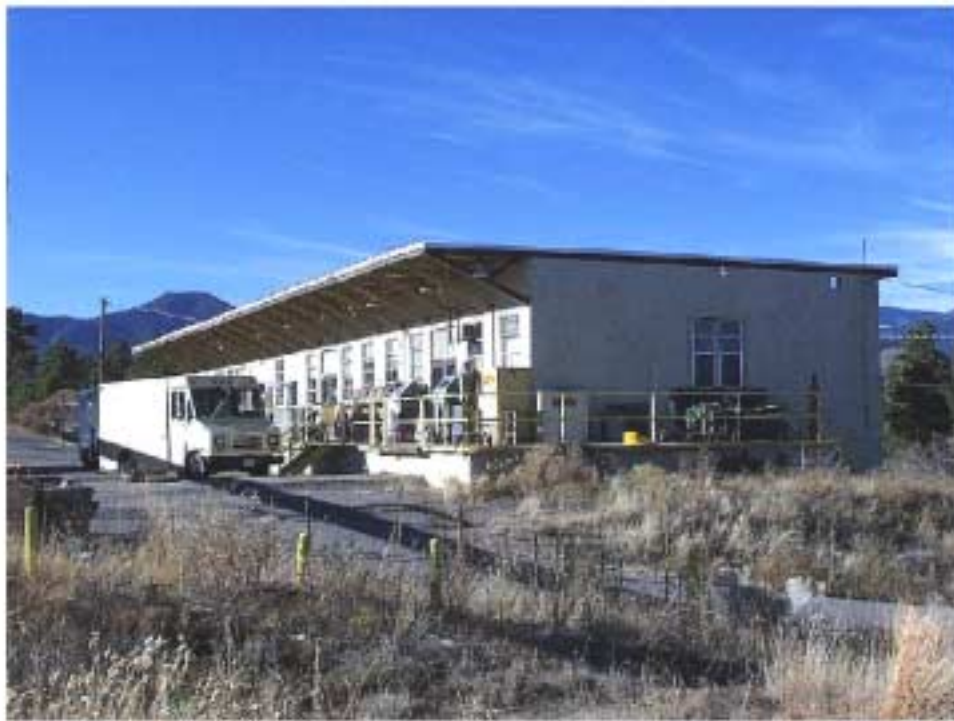
TA-21-31 South and East Elevations

Condition at Time of Survey: Good

Remodeling History: The roof trusses were repaired in 1950.
