Historic Building Assessment

for the Department of Energy Conveyance and Transfer Project

Historic Building Survey Report No. 178

Los Alamos National Laboratory

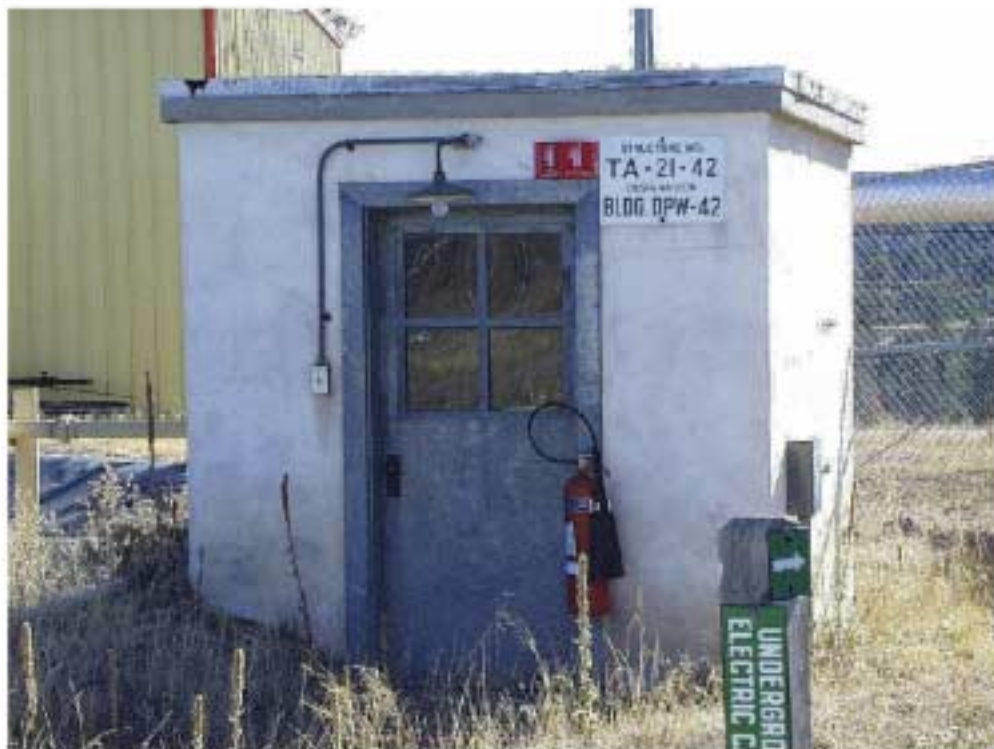
TA-21-42 North and West Elevations

Condition at Time of Survey: Good

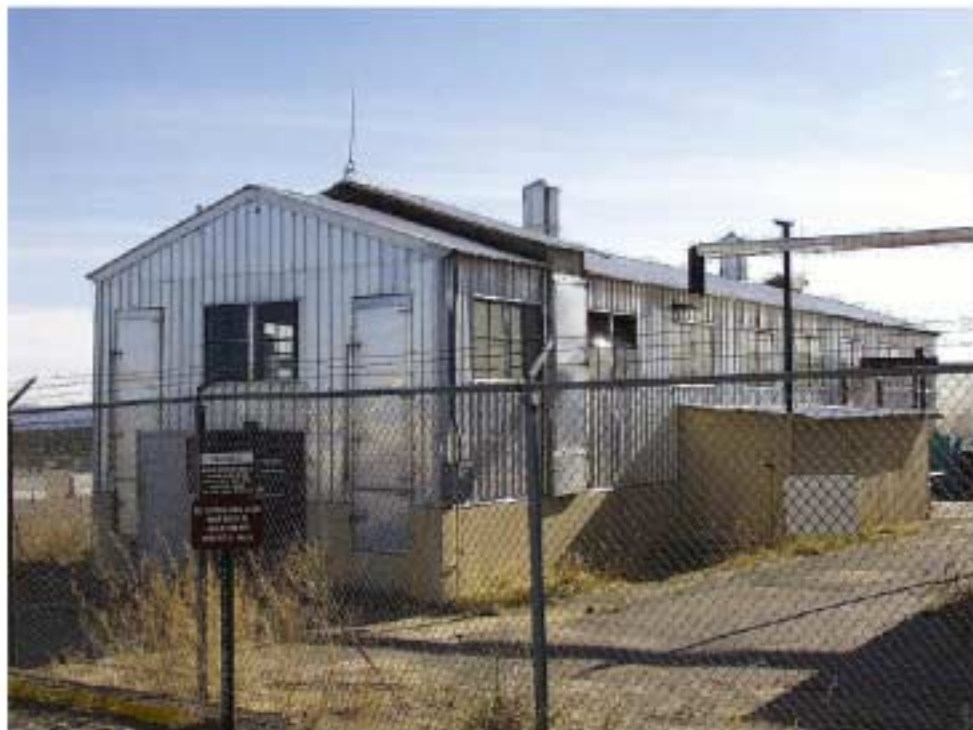
TA-21-46 North and West Elevations

Condition at Time of Survey: Fair

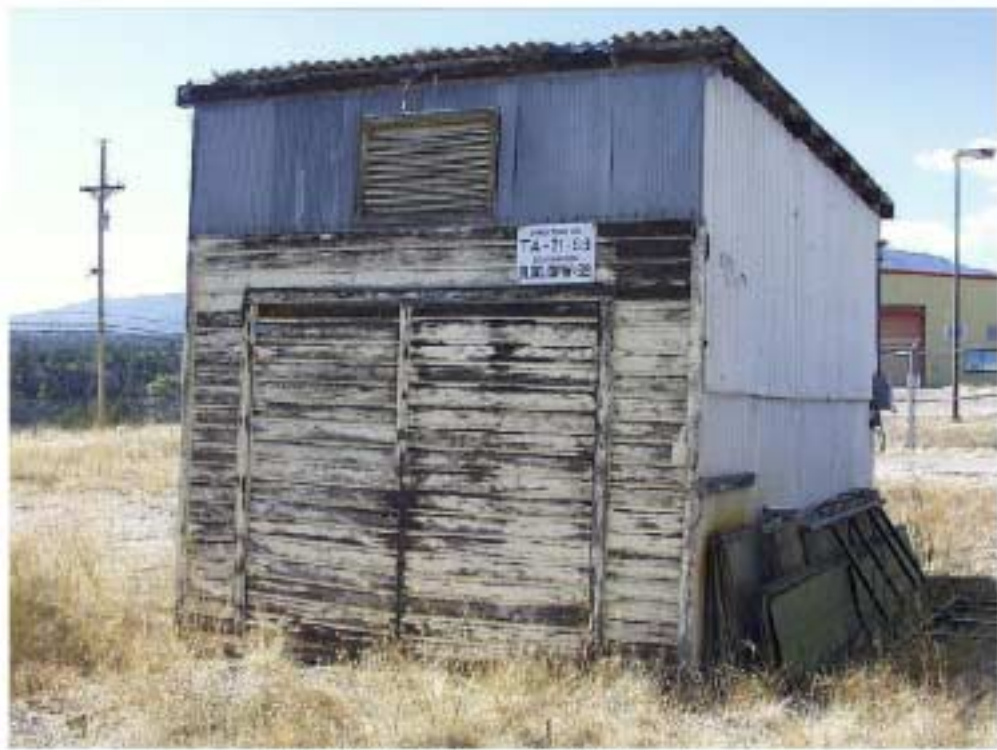
TA-21-59 East and North Elevations

Condition at Time of Survey: Fair

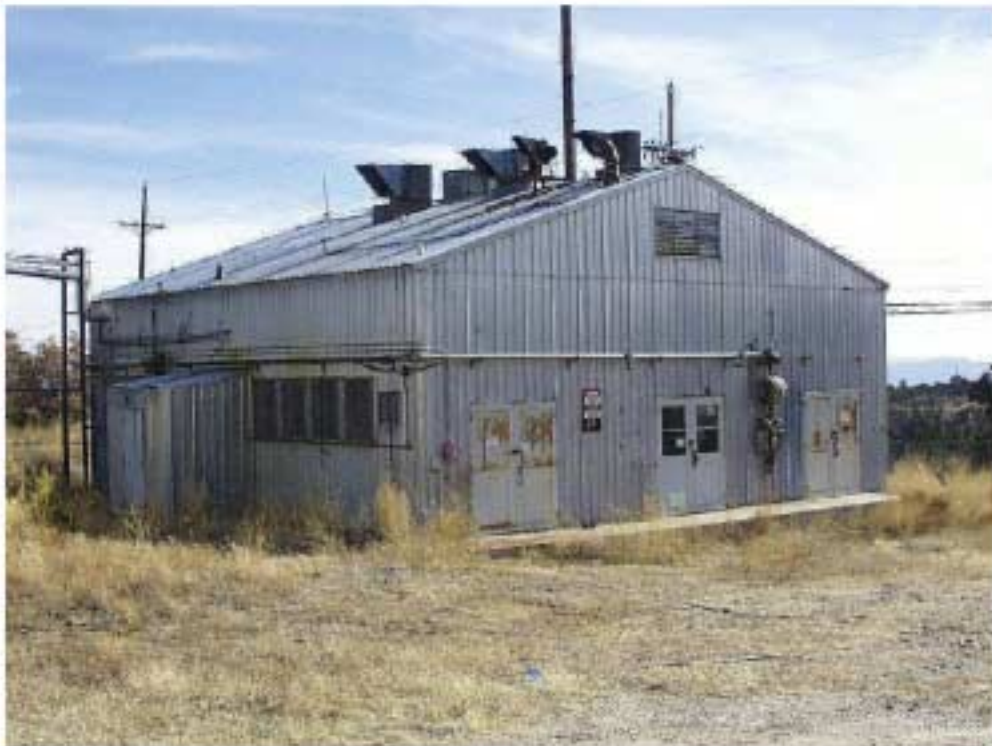
TA-21-61 North and West Elevations

Condition at Time of Survey: Fair

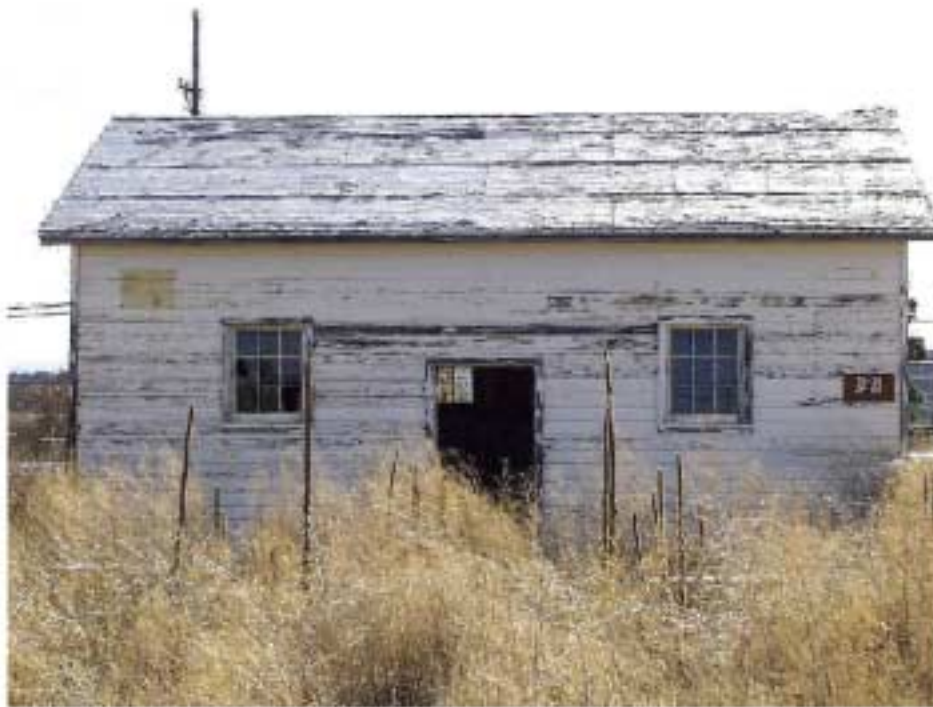
TA-21-65 North Elevation

Condition at Time of Survey: Poor

Architectural features - TA-21-65 is a small approximately 360-sq-ft wood building with tongue-and-groove siding. The original exterior paint on the siding is deteriorating. The pitched roof is composed of rolled asphalt-roofing material. The interior of the building is not finished; the wood frame work and roof trusses are exposed. Light fixtures were suspended from the roof.

On the west elevation there is a set of wooden double doors that at one time would have had glass windows. At the top of the pediment there is a metal-framed louver that replaced the original wood louver.

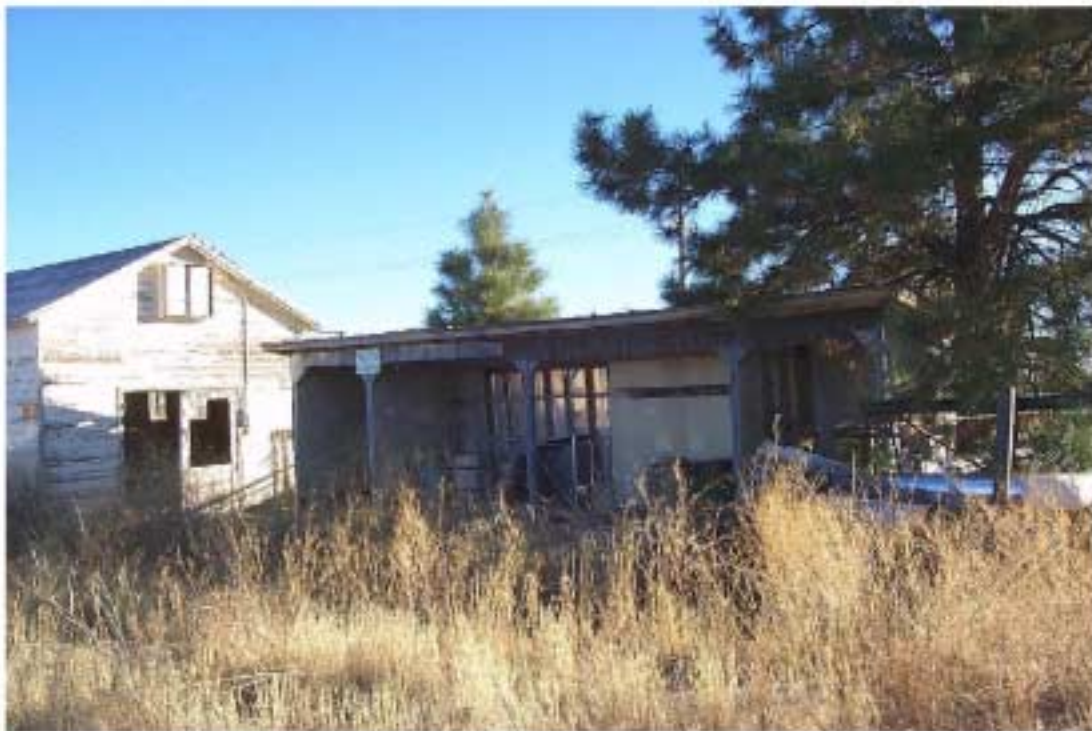
TA-21-66 North and West Elevations

Condition at Time of Survey: Deteriorating but fair

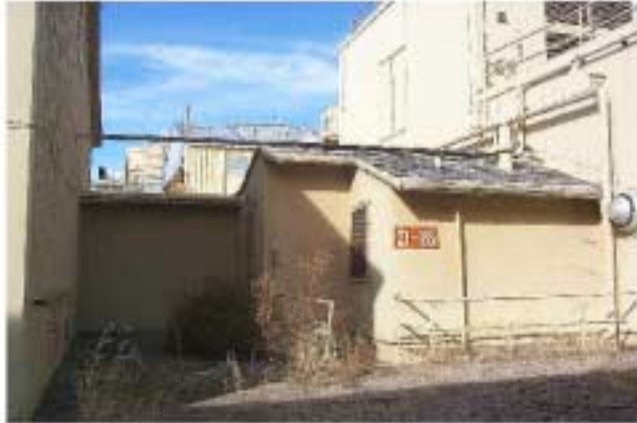
TA-21-116 South and East Elevations of 1950 Portion

Condition at Time of Survey: The 1950 portion of the building is deteriorating and showing signs of age. The 1957/1958 portion is in fair to good condition.

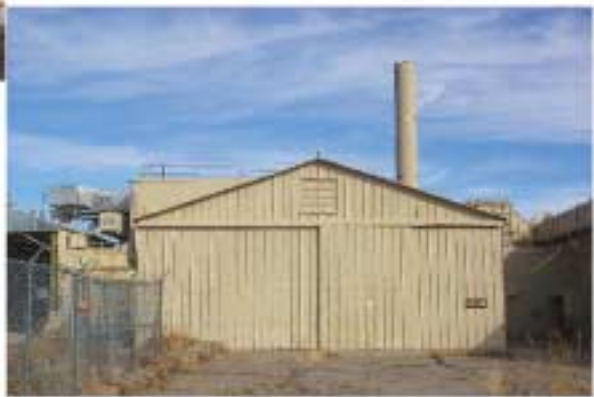
TA-21-116 South Elevation of 1957/1958 Portion

On the south side of the building there are four sliding doors. Three of the four doors have been fixed leaving only one in operable condition. There is also a louver in the pediment on this side of the building.

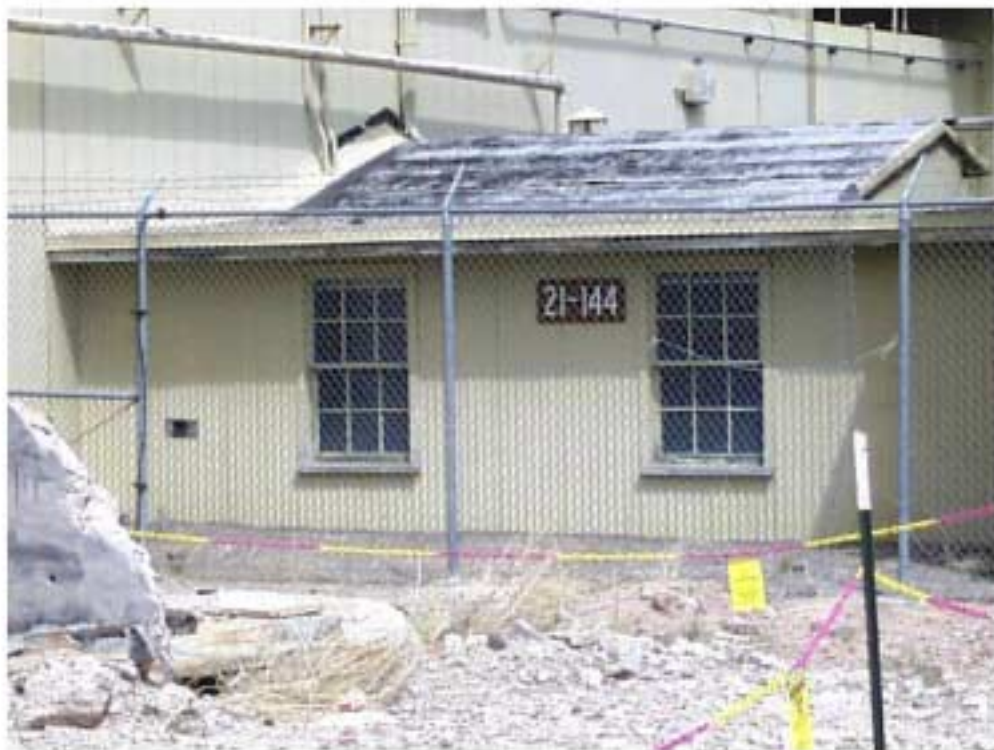
TA-21-144 West Elevation

Condition at Time of Survey: Fair

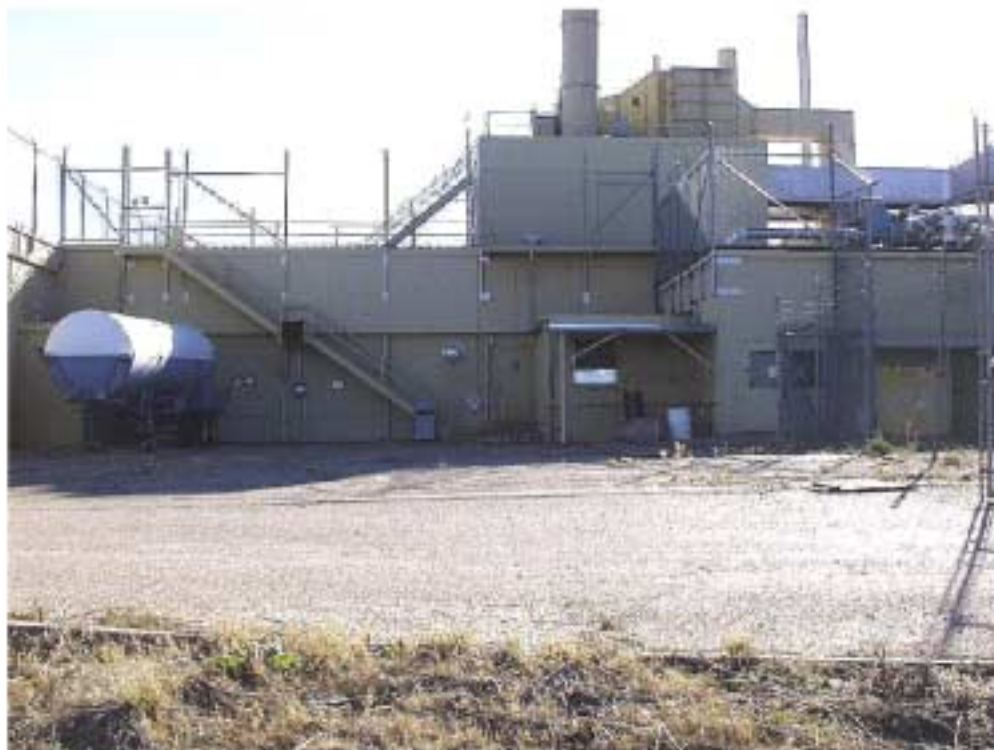
TA-21-149 North Elevation

Condition at Time of Survey: Good

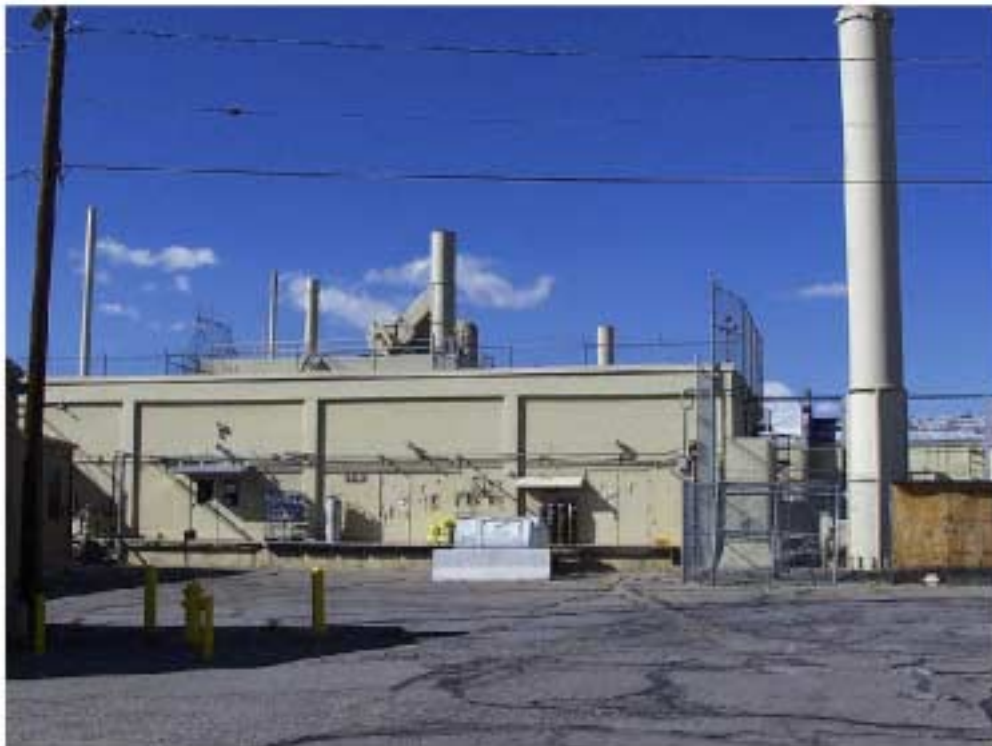
TA-21-150 East Elevation of North Wing

Condition at Time of Survey: Fair to good

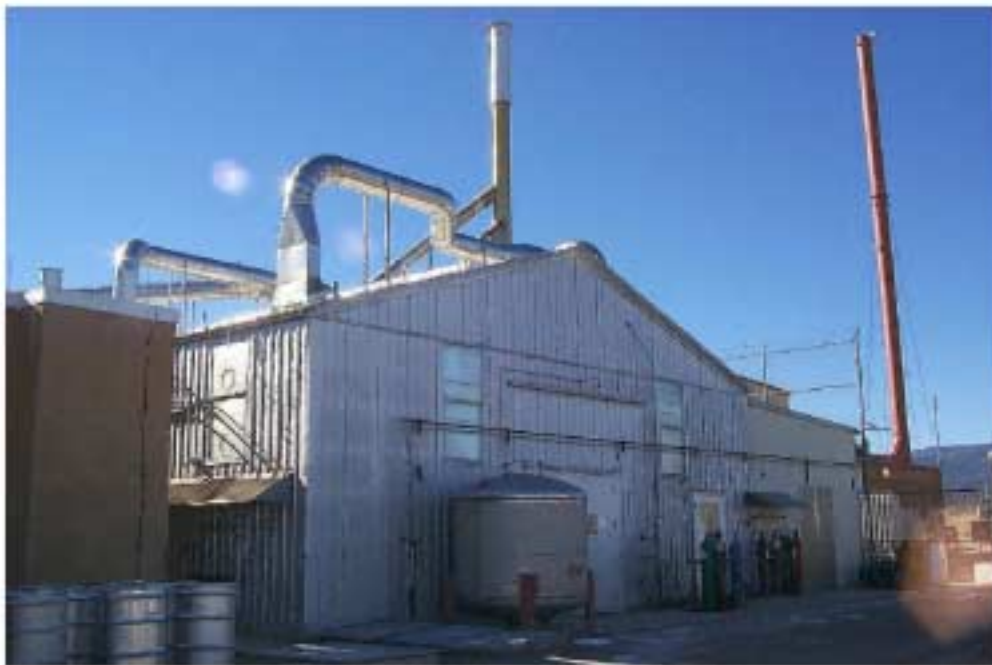
TA-21-152 East and North Elevations

Condition at Time of Survey: Fair - Good

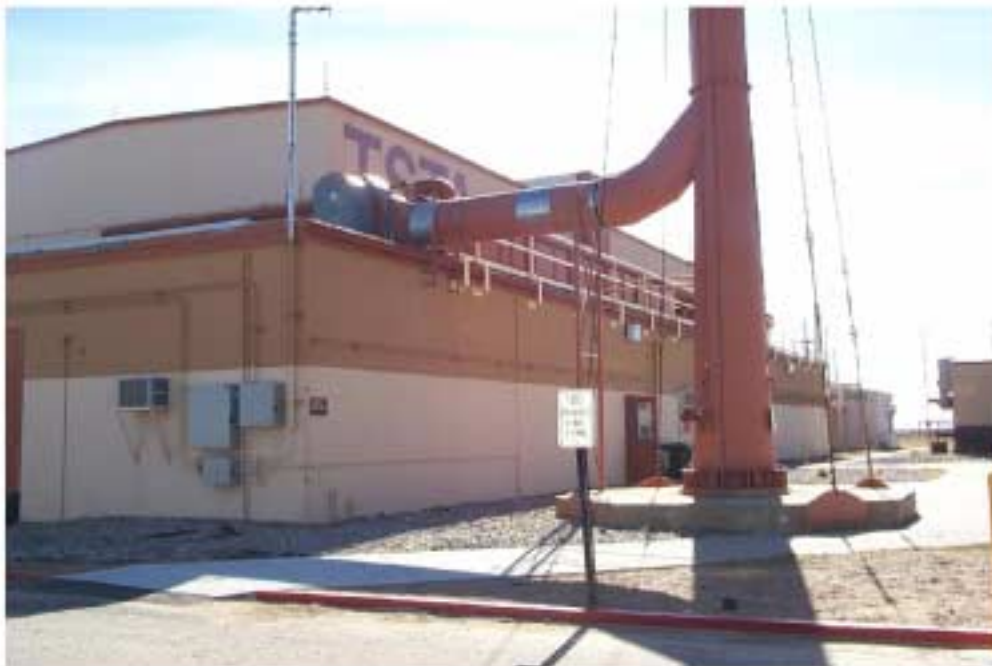
TA-21-155 North and West Elevations

Condition at Time of Survey: Good

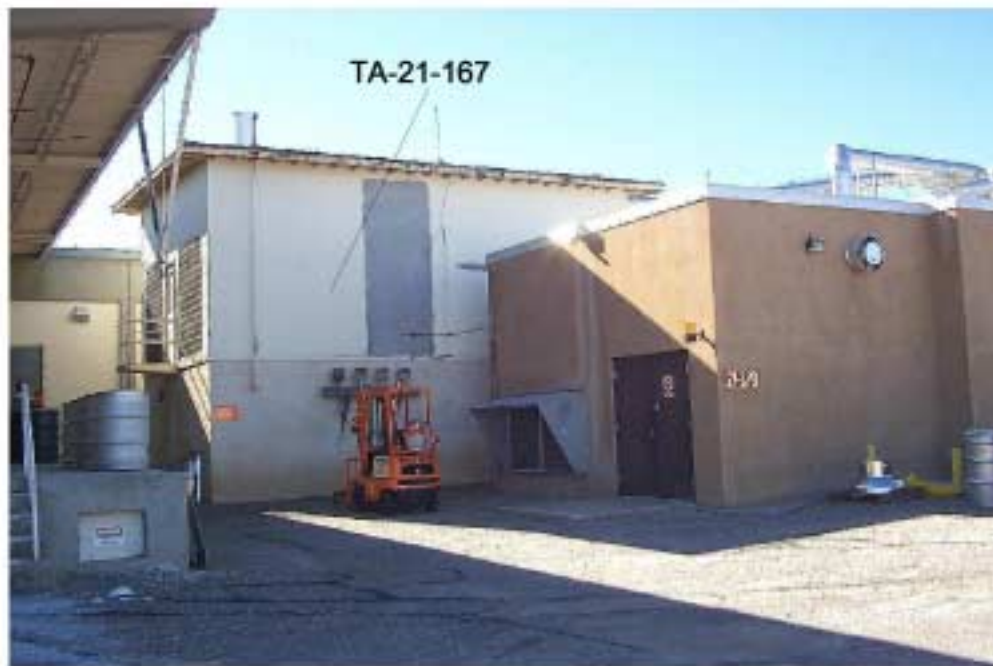
TA-21-167 East and North Elevations

Condition at Time of Survey: Fair to good

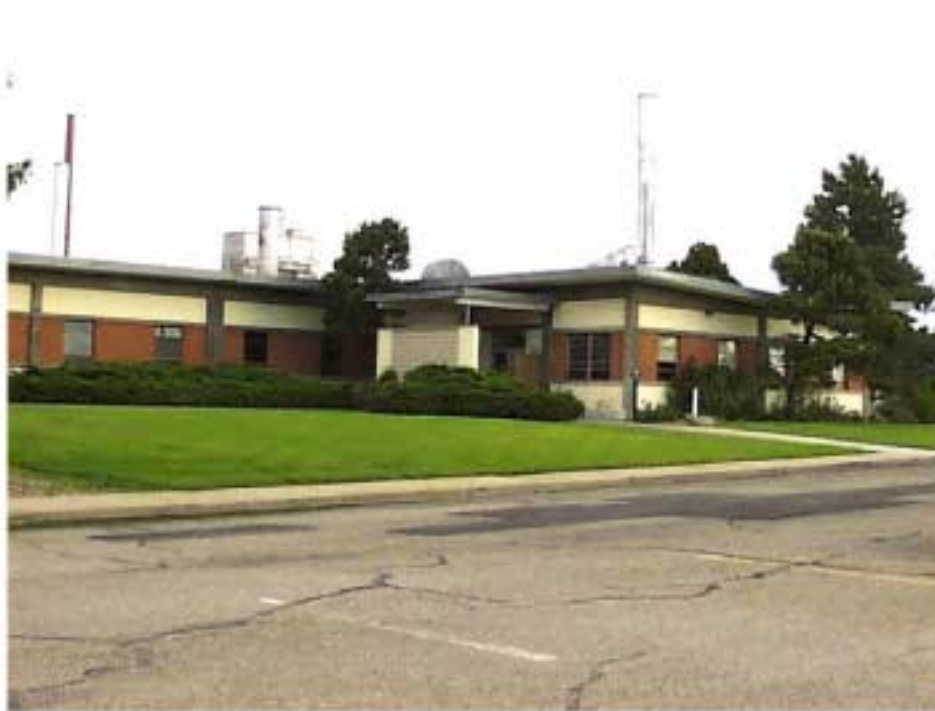
TA-21-209 East Elevation

Condition at Time of Survey: Good

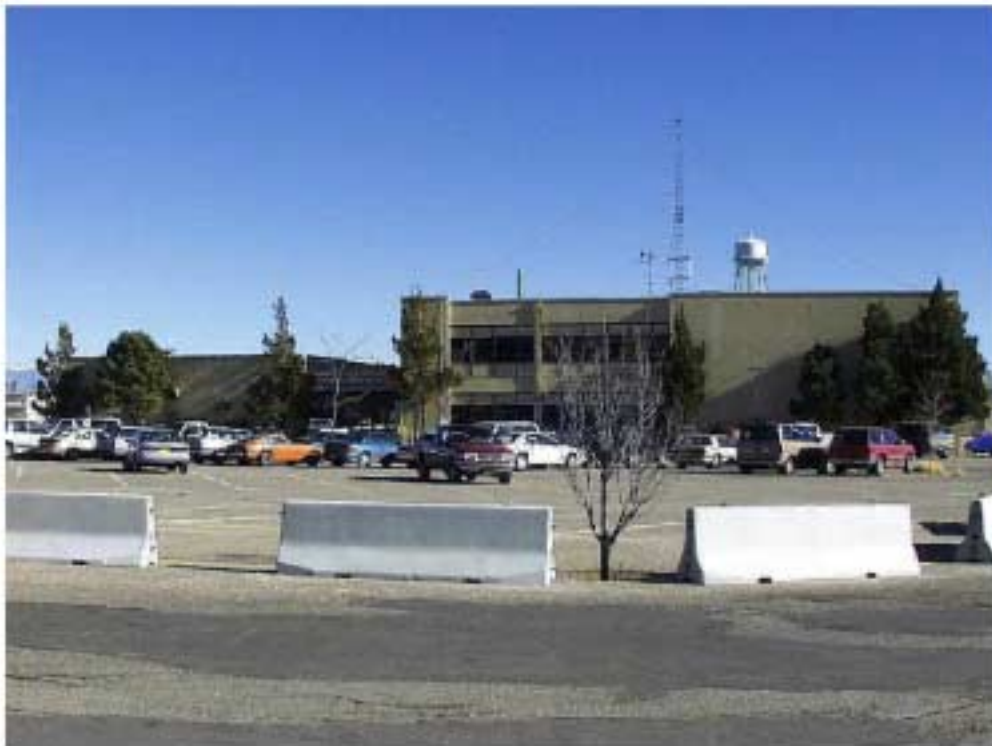
TA-21-210 West Elevation

Condition at Time of Survey: Good

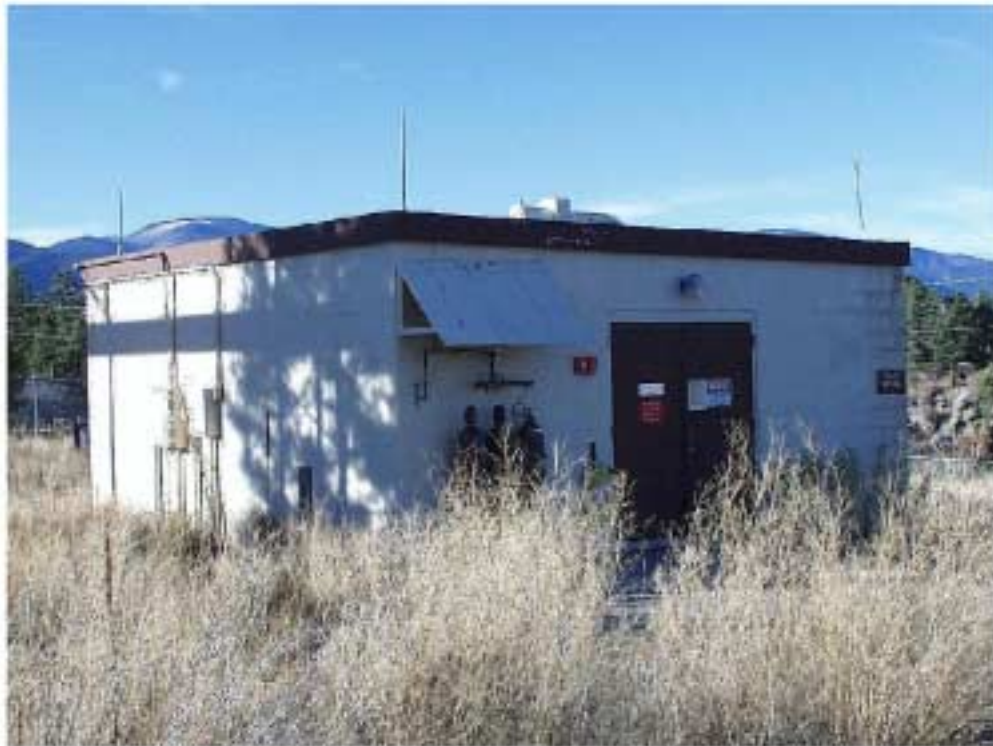
TA-21-212 South and East Elevations

Condition at Time of Survey: Fair to Good

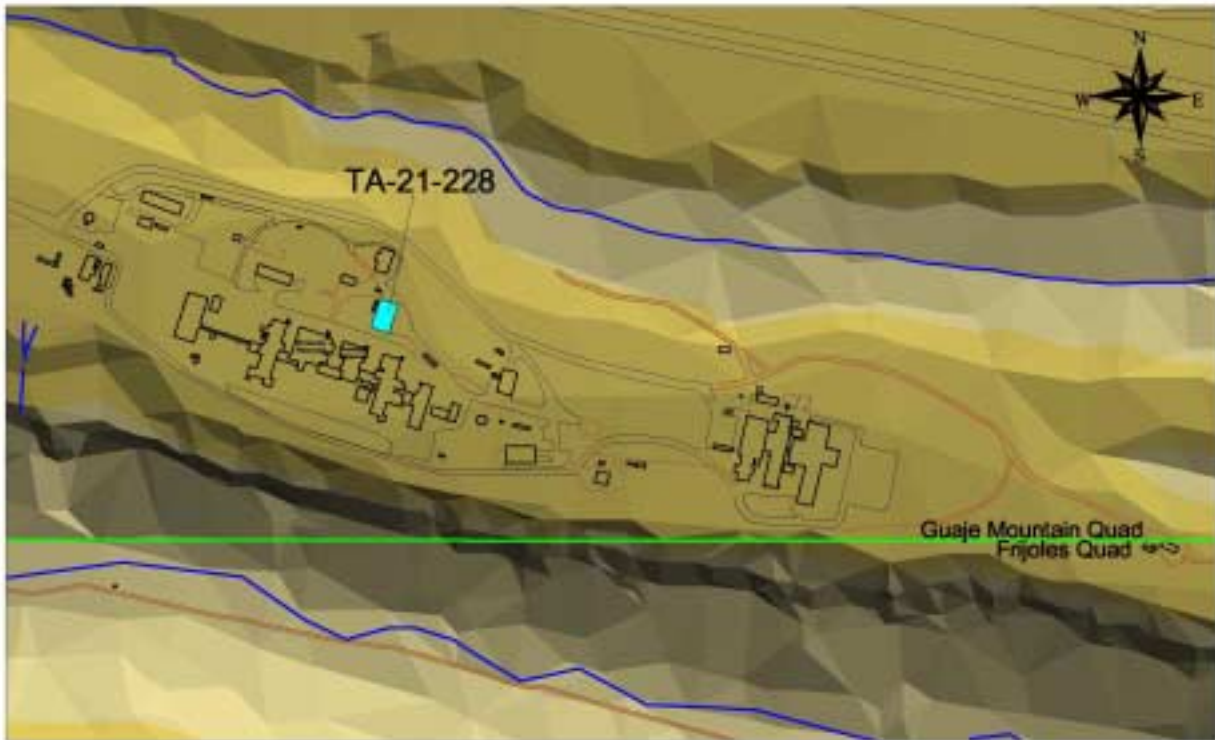
TA-21-228 East Elevation

Special Note: There is an error in the north orientation on both the July 1966 and the June 1984 floor plans. The north arrows are off 90° to the west (the north arrow points to west, not to north).

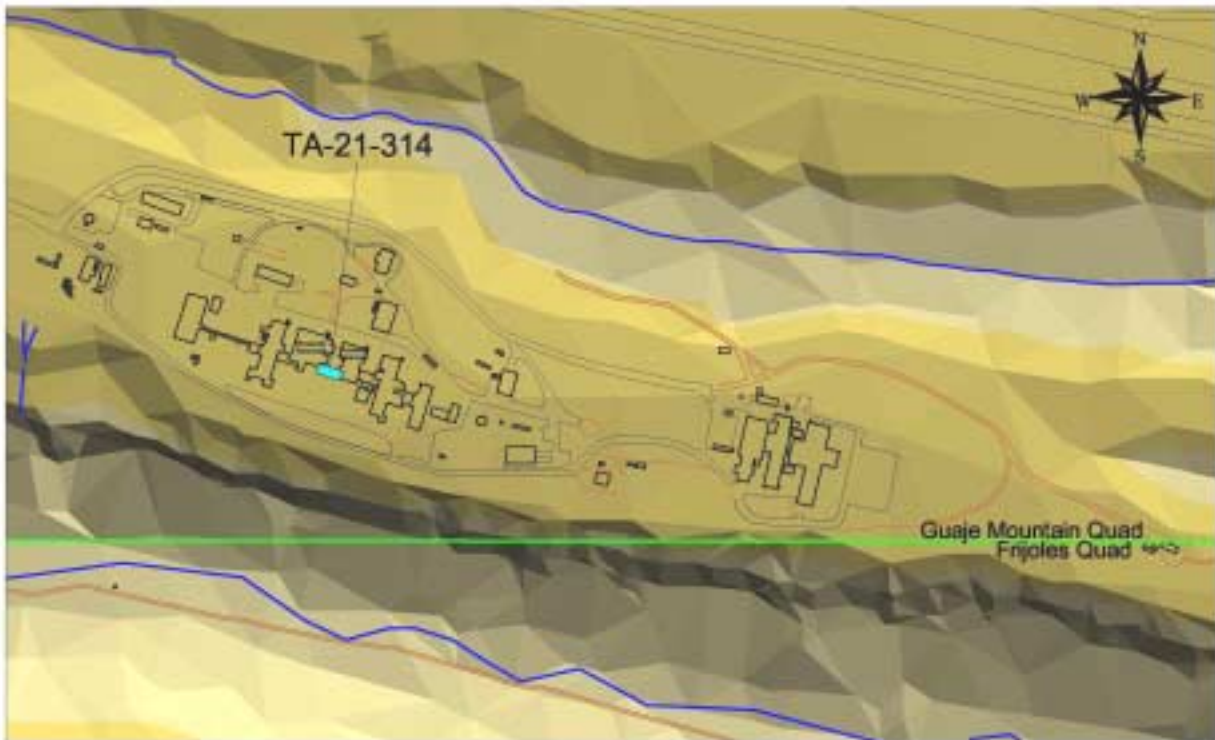
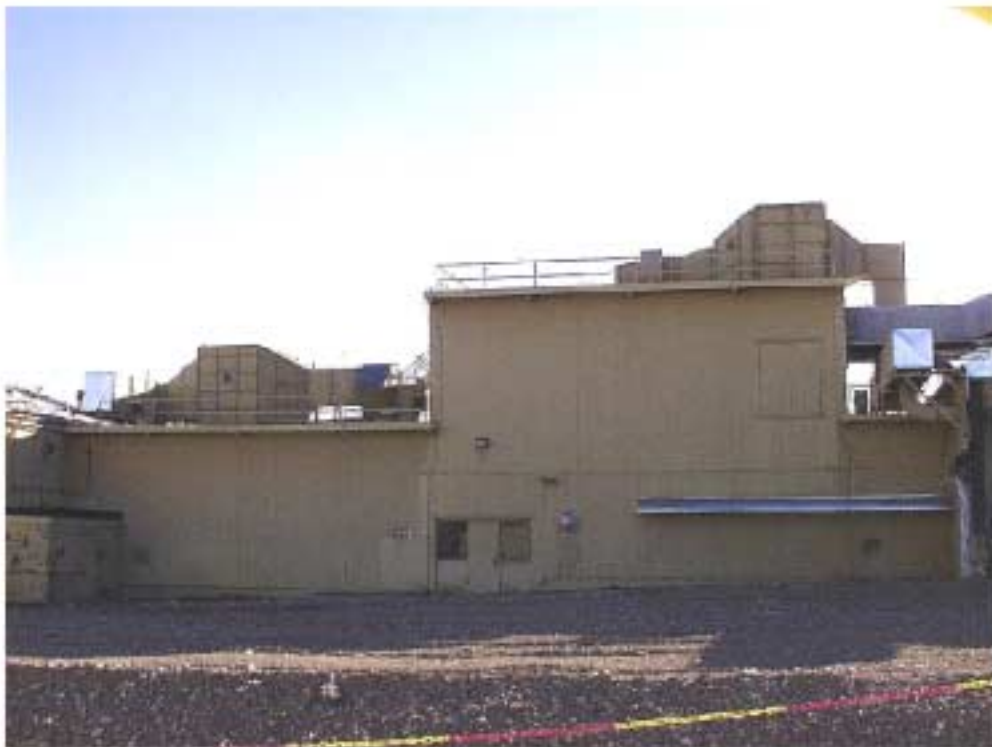
TA-21-314 North Elevation

Condition at Time of Survey: Fair to Good

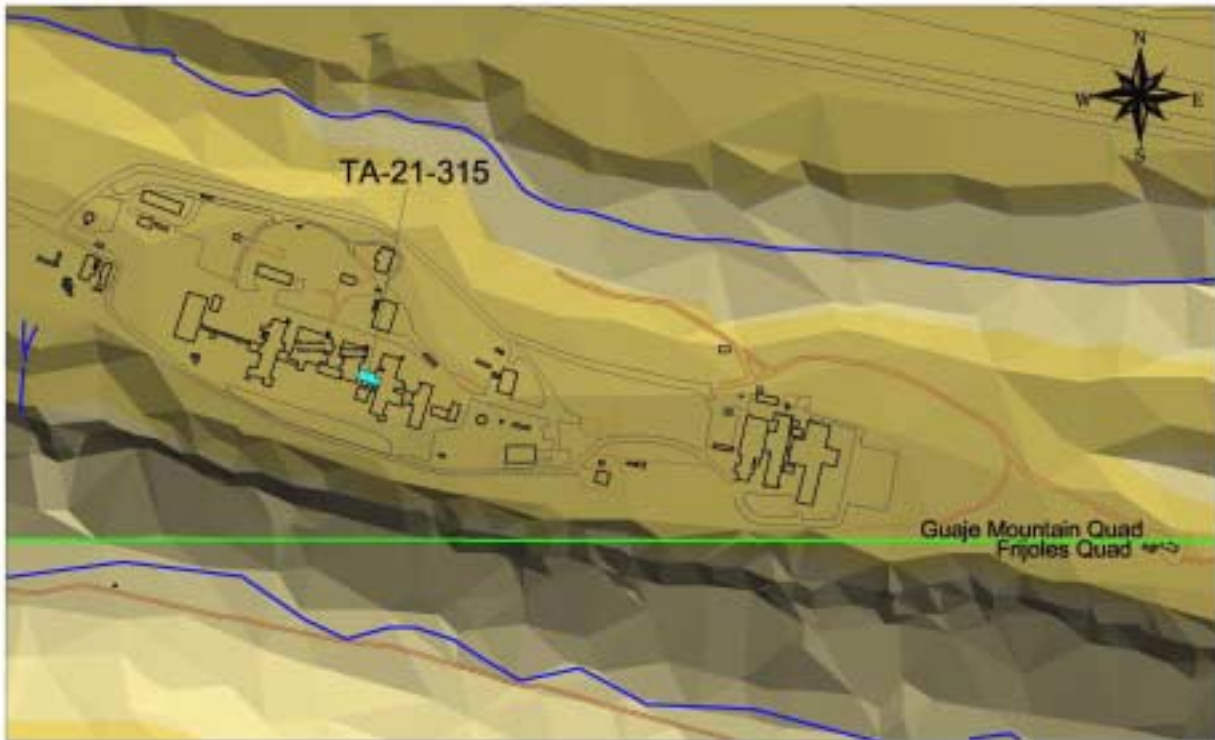
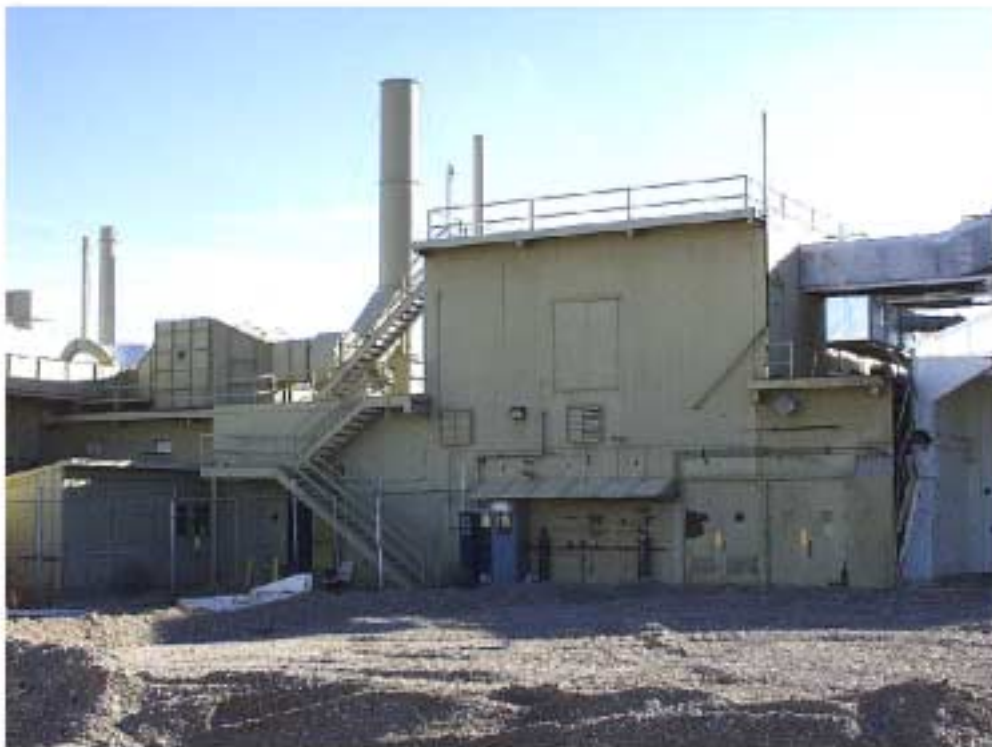
TA-21-315 North Elevation

Condition at Time of Survey: Fair to Good

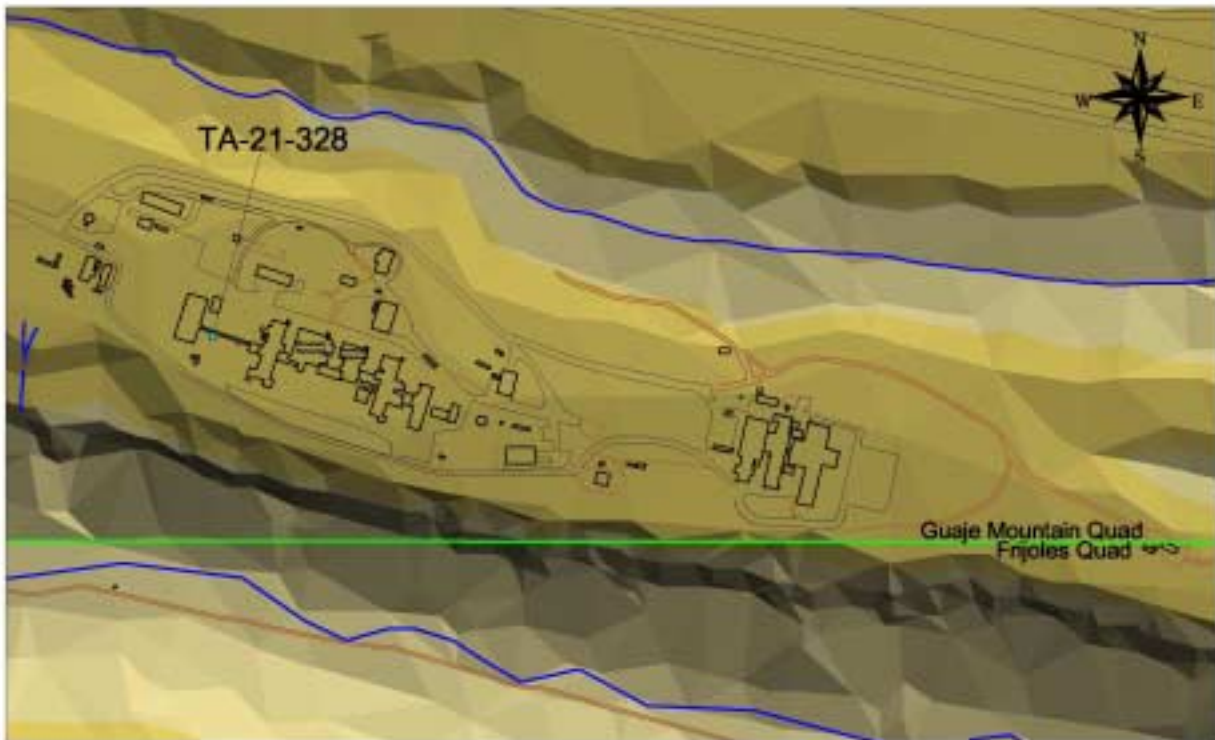
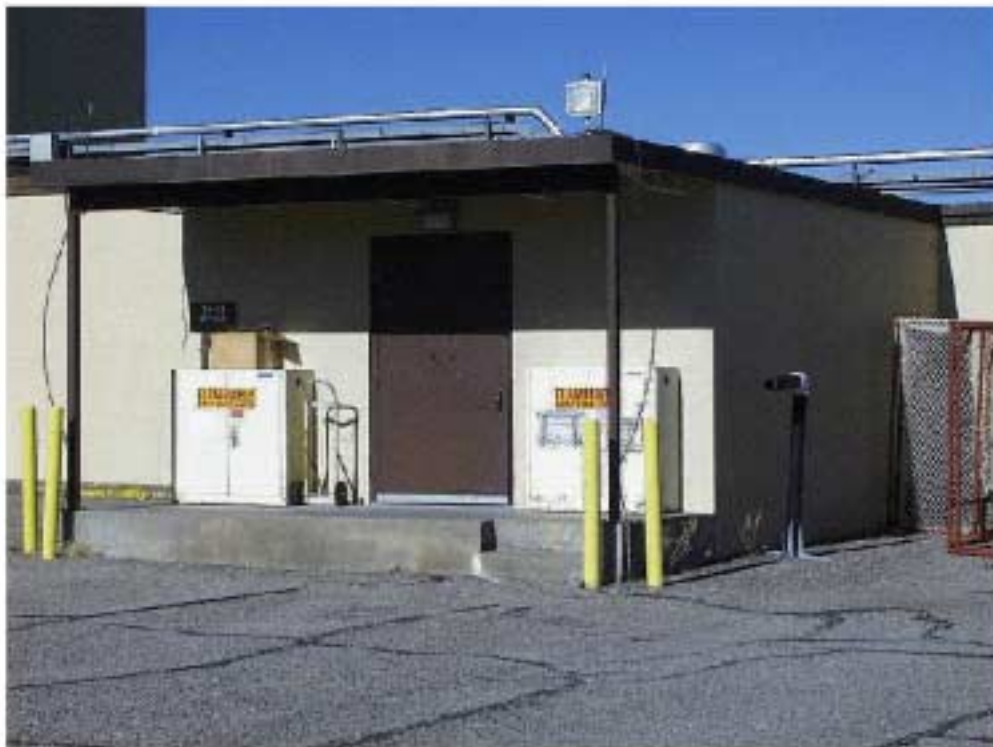
TA-21-328 South and East Elevations

Condition at Time of Survey: Good condition.

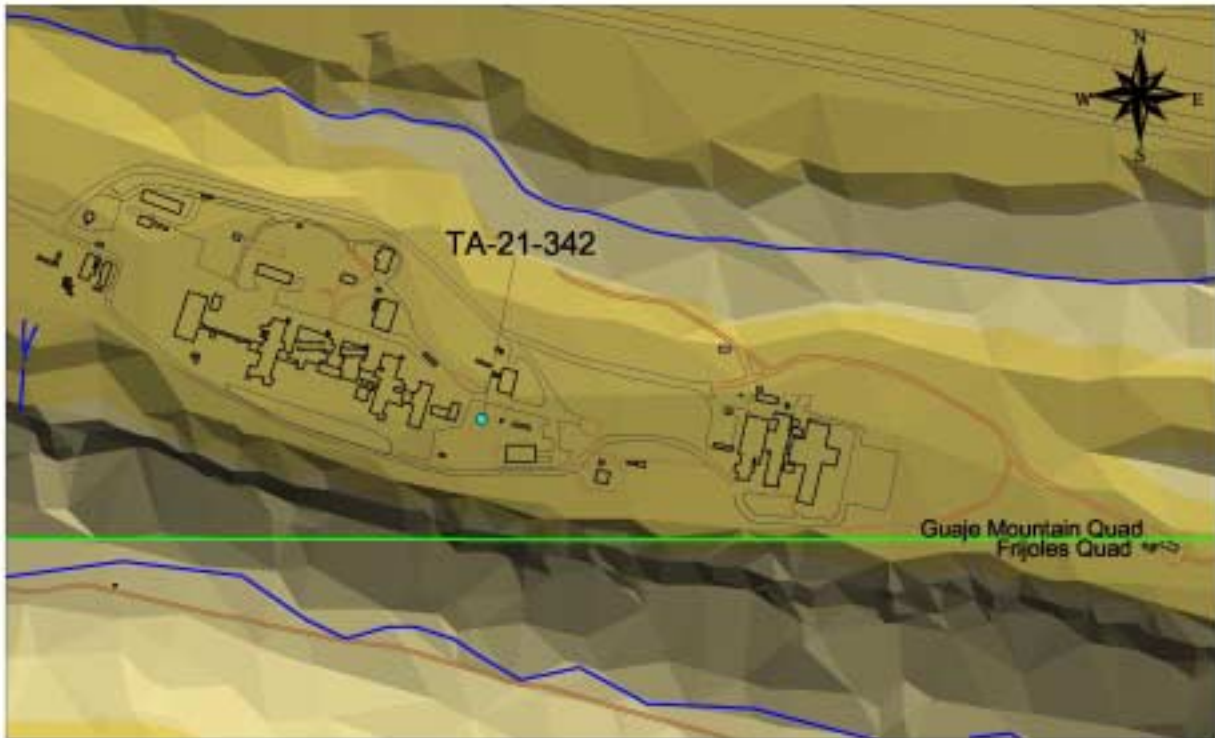
TA-21-342 South and West Elevations

Condition at Time of Survey: Fair to good condition.

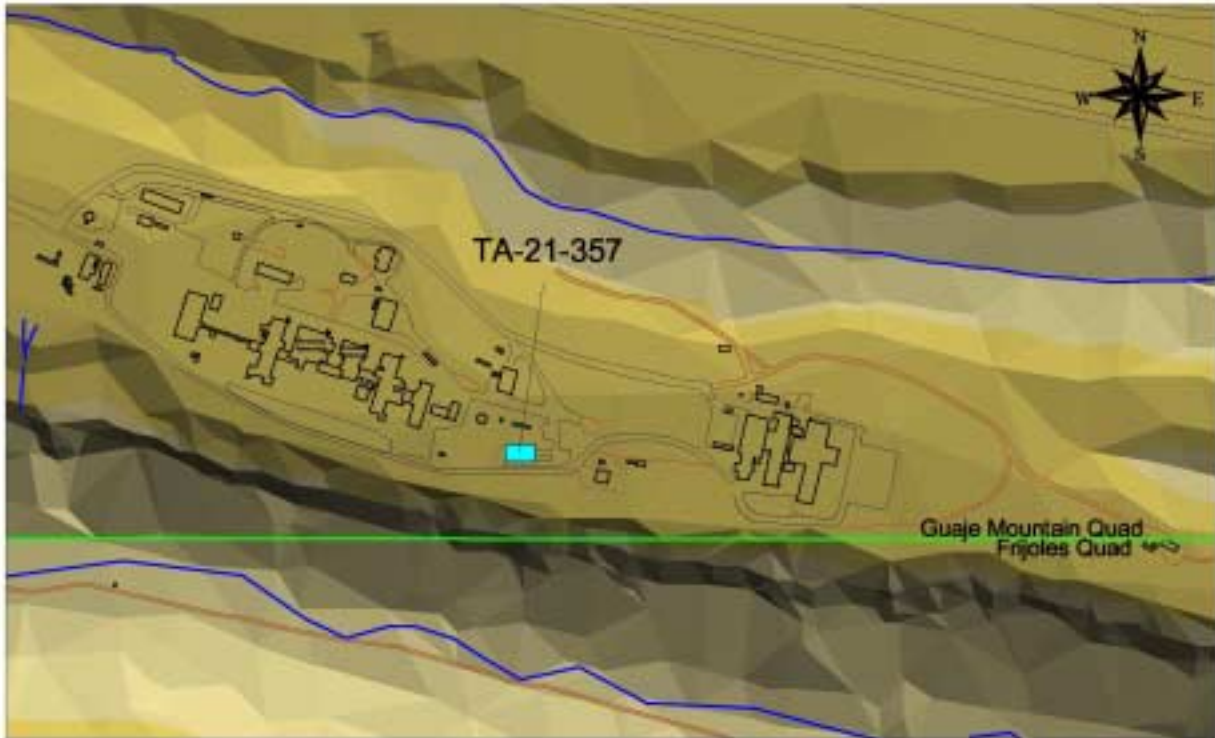
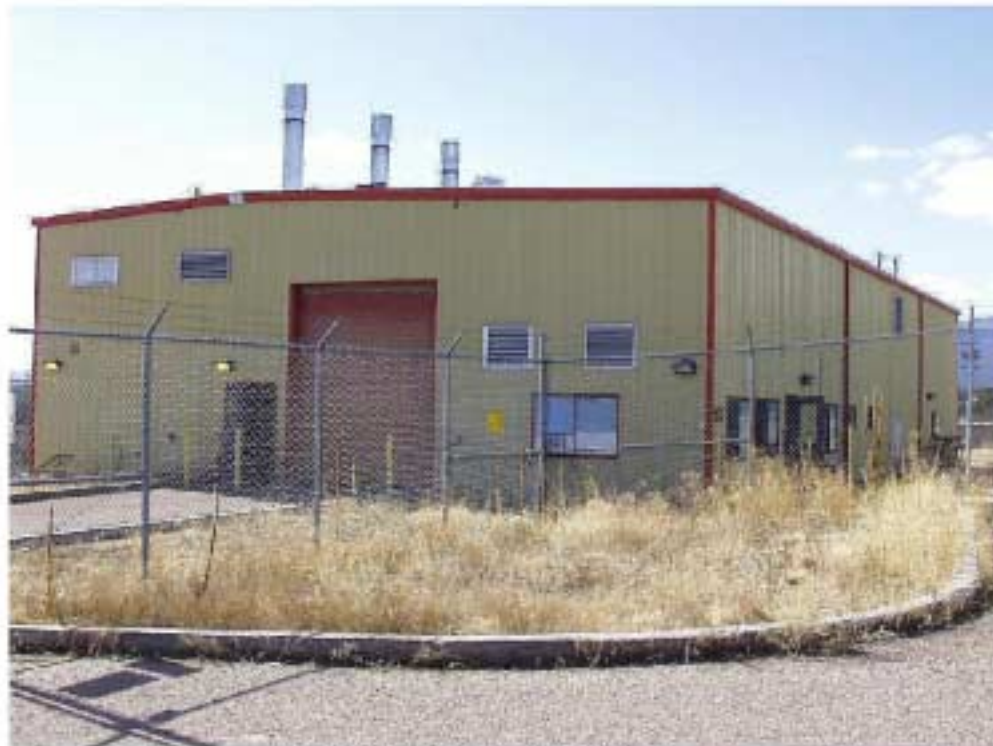
TA-21-357 East and North Elevations

Condition at Time of Survey: Excellent

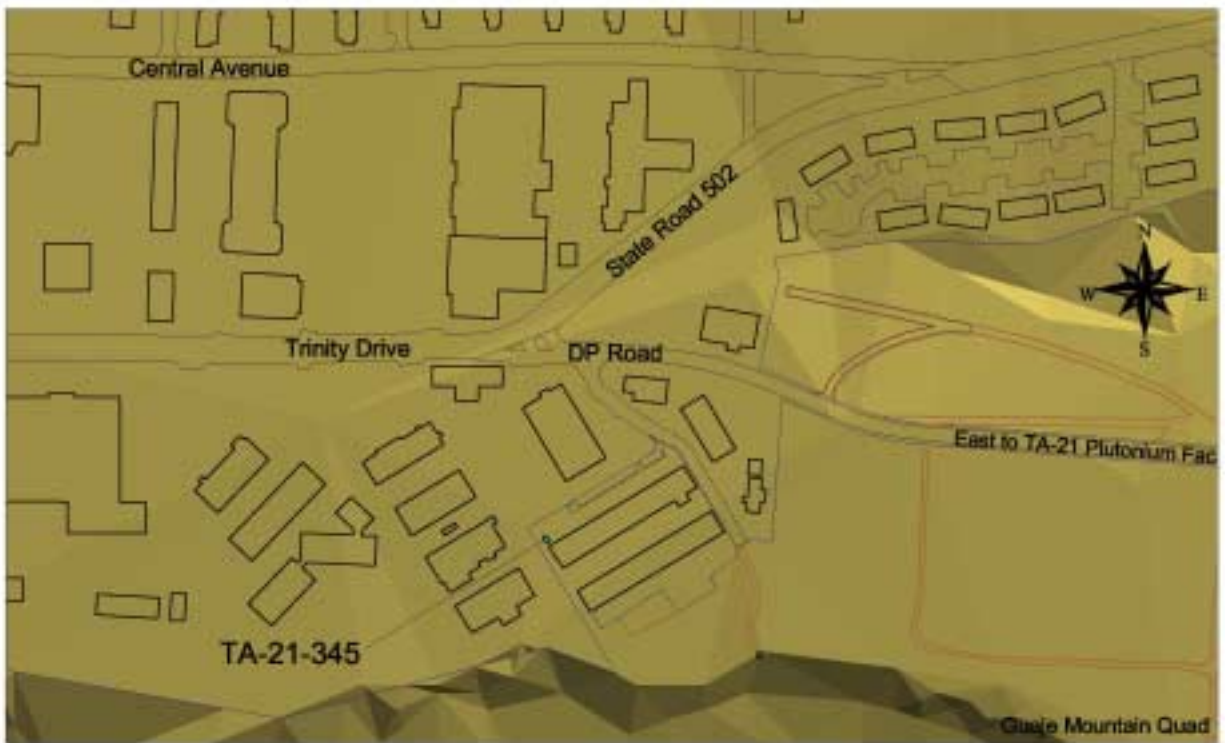
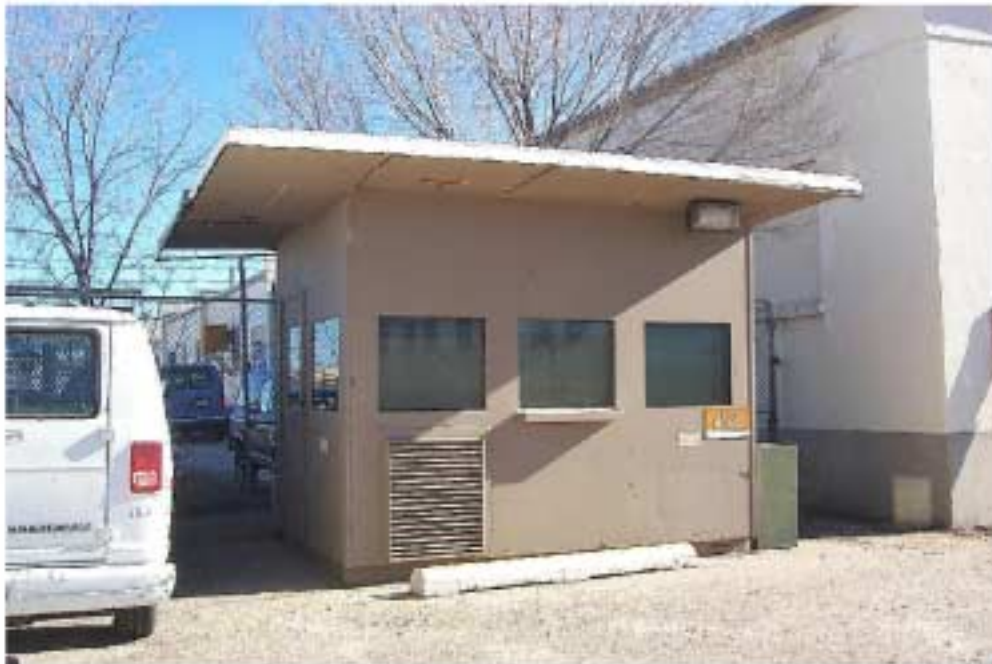
TA-21-345 North and West Elevations

Condition at Time of Survey: Fair to Good

The east and west elevations are virtually identical. They both have three fixed, single-paned windows. The east elevation has a small air conditioner unit or compressor attached to the building along the northern portion of the wall.

The west elevation has a metal louver on the northern portion of the wall, across from the air conditioner/compressor. Under the center window on the west elevation there is a small ledge the width of the window. Probably at one time this window was operable and was used as a pass window.

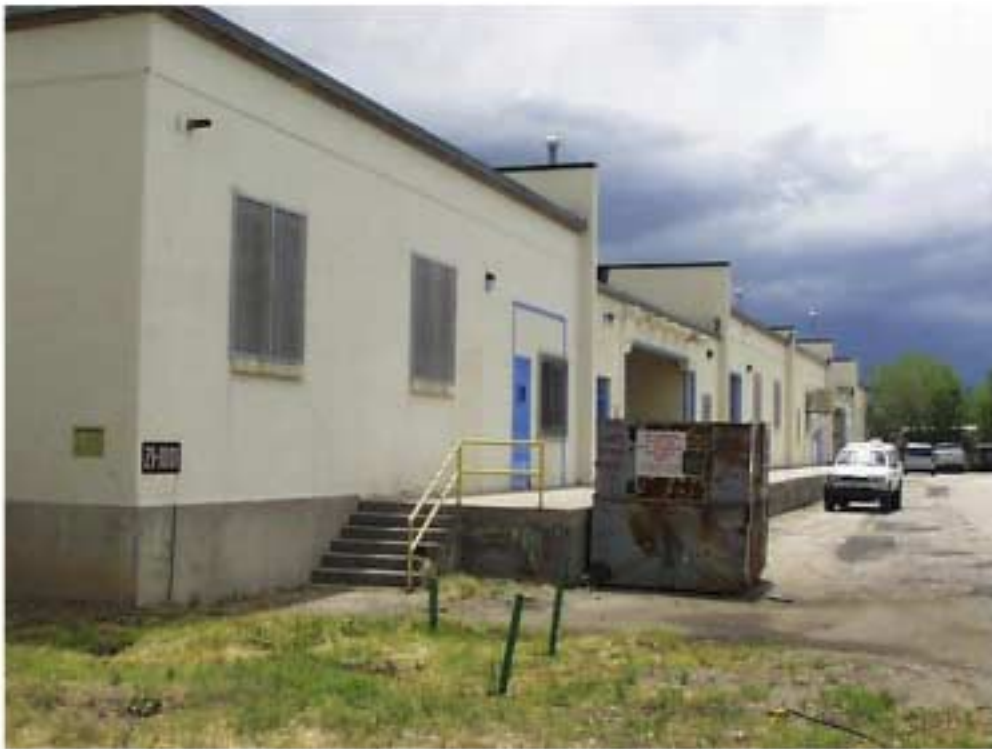
TA-21-1001 North Elevation

Condition at Time of Survey: Good
