Historic Building Assessment

for the Department of Energy Conveyance and Transfer Project

Historic Building Survey Report No. 178

Los Alamos National Laboratory

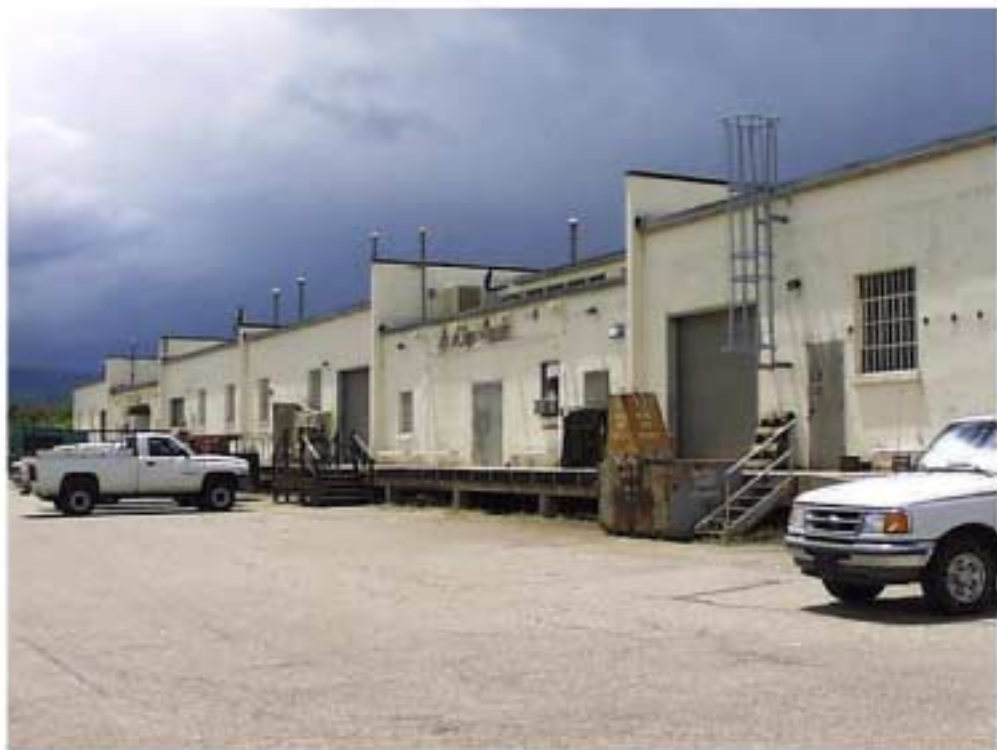
TA-21-1002 South Elevation

Condition at Time of Survey: Good

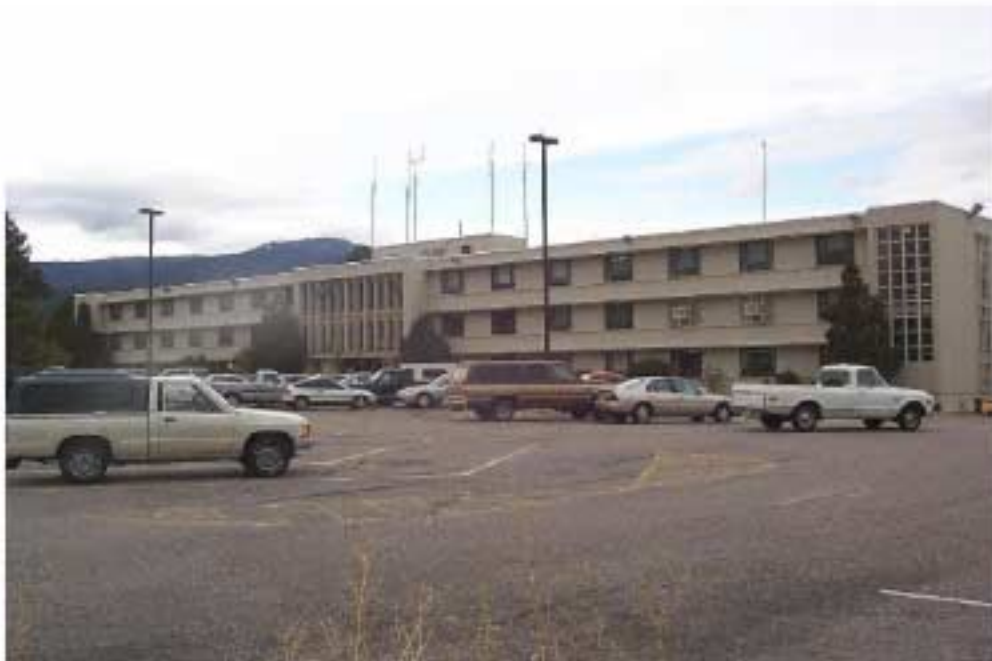
TA-43-39 South and East Elevations

Condition at Time of Survey: Good

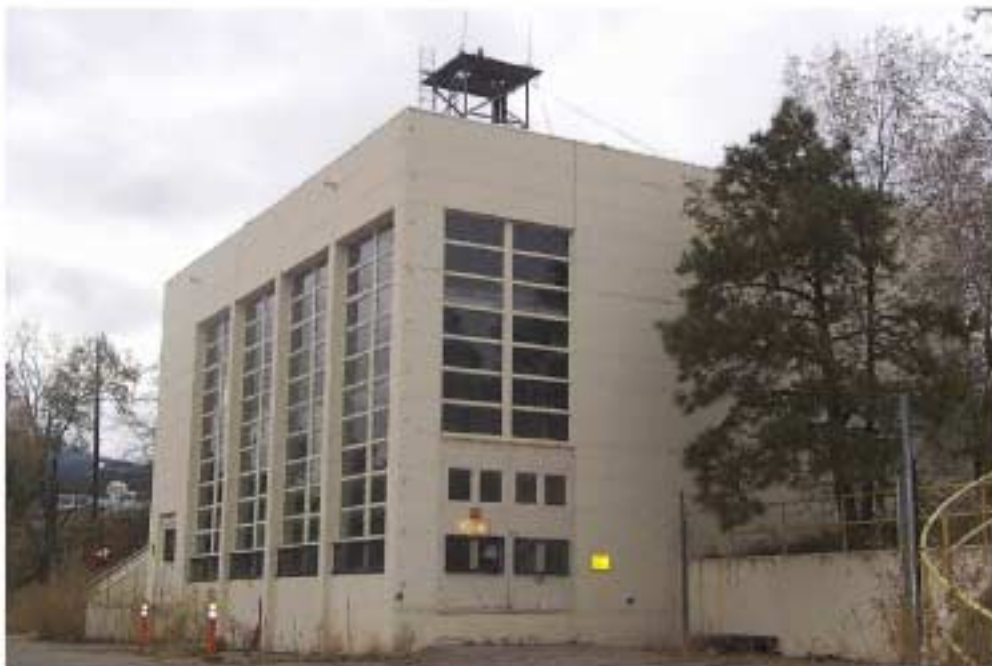
TA-43-41 South and East Elevations

Condition at Time of Survey: Fair to good

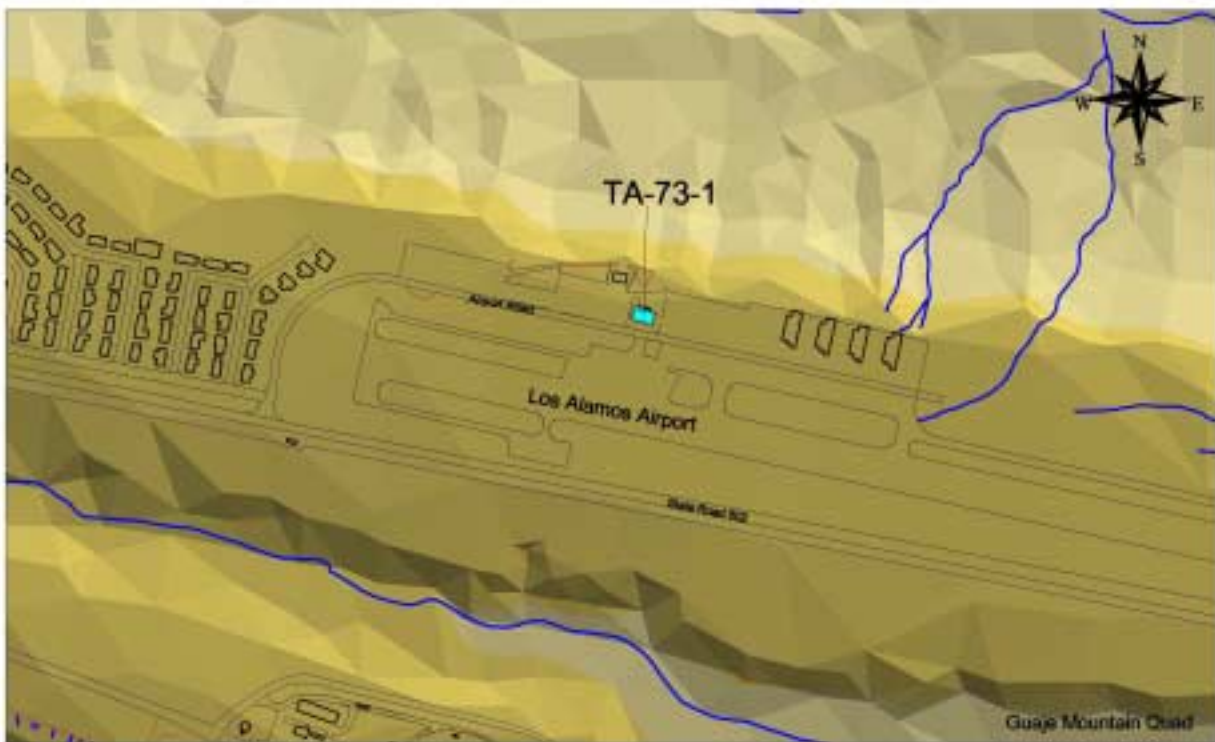
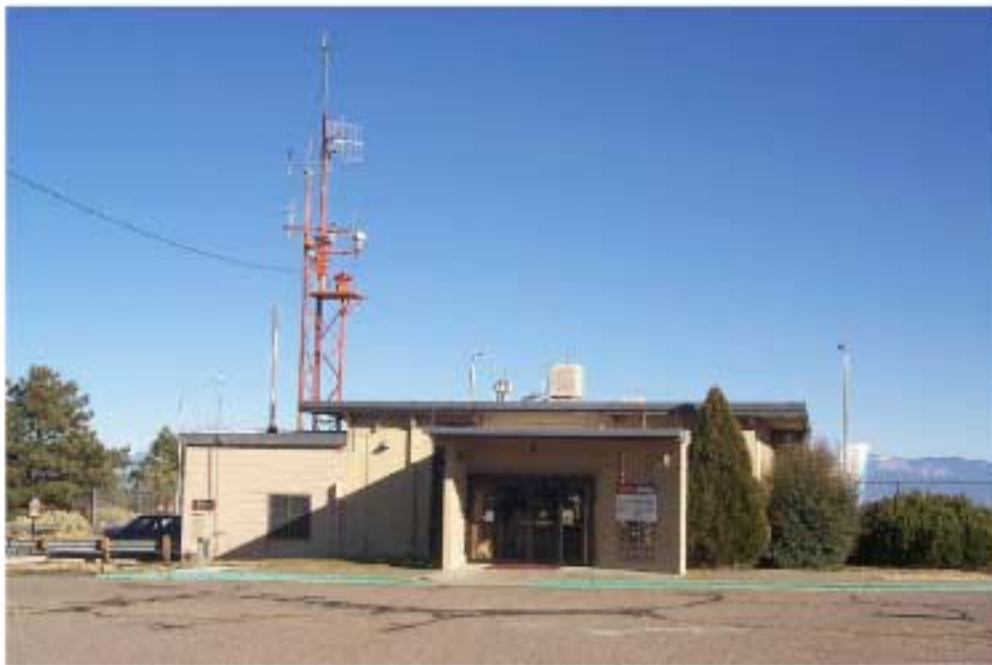
TA-73-1 West Elevation

Condition at Time of Survey: Good

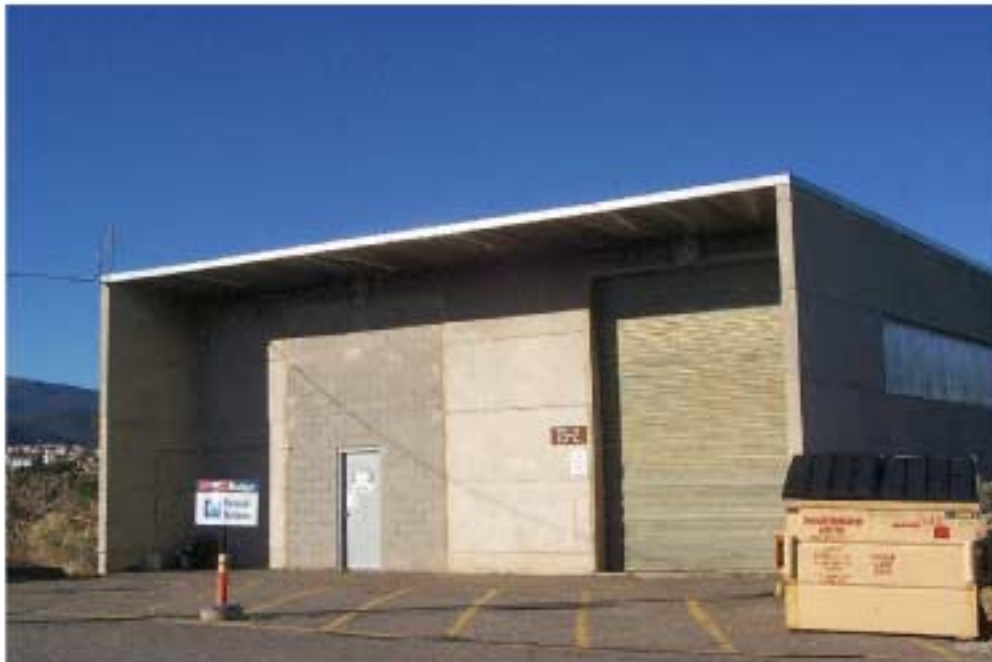
TA-73-2 South and East Elevations

Condition at Time of Survey: Fair to good

These two openings may have been from where the exhaust stack was connected to the building. The foundation to the exhaust stack for the incinerator is located to the north of the building. The stack was removed sometime after 1965.

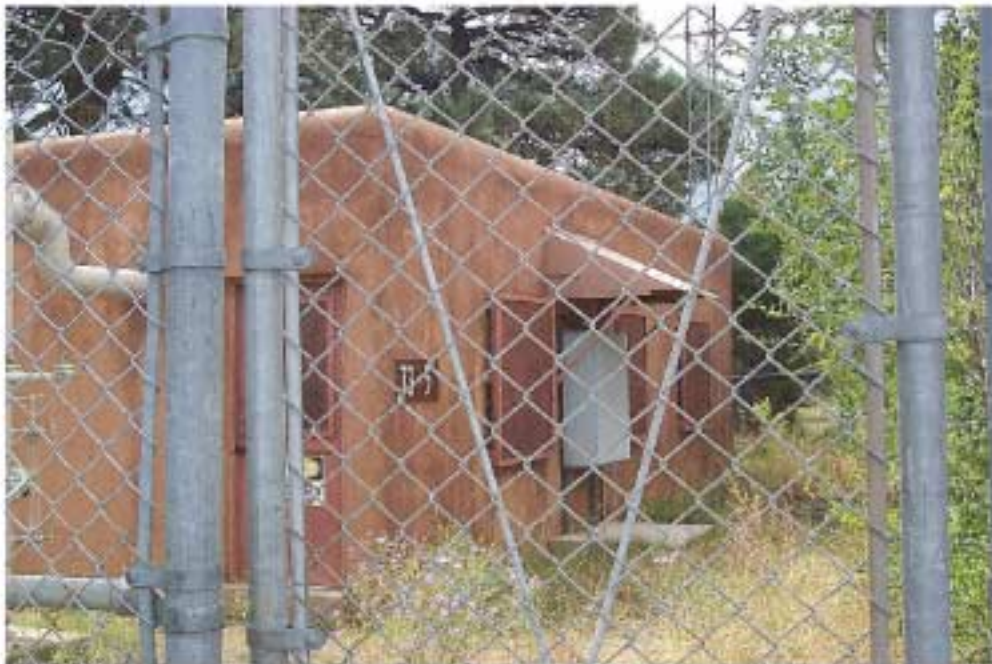
TA-73-5 East and North Elevations

Condition at Time of Survey: Good

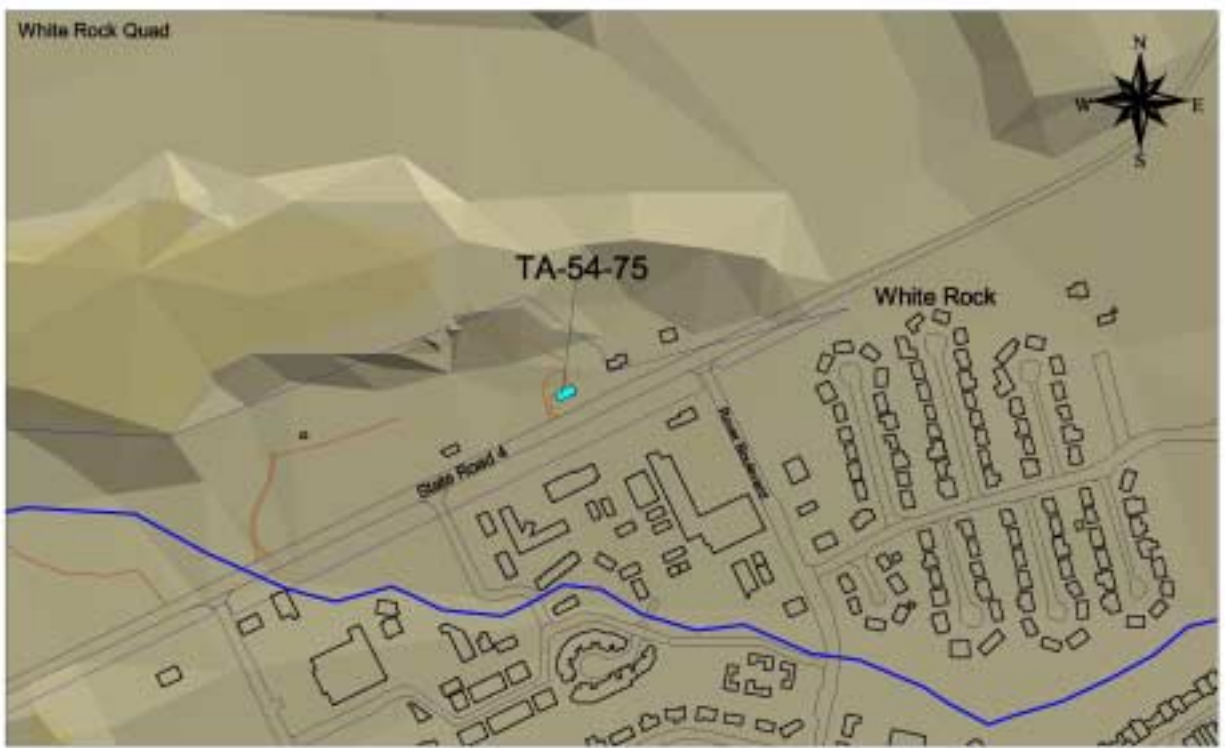
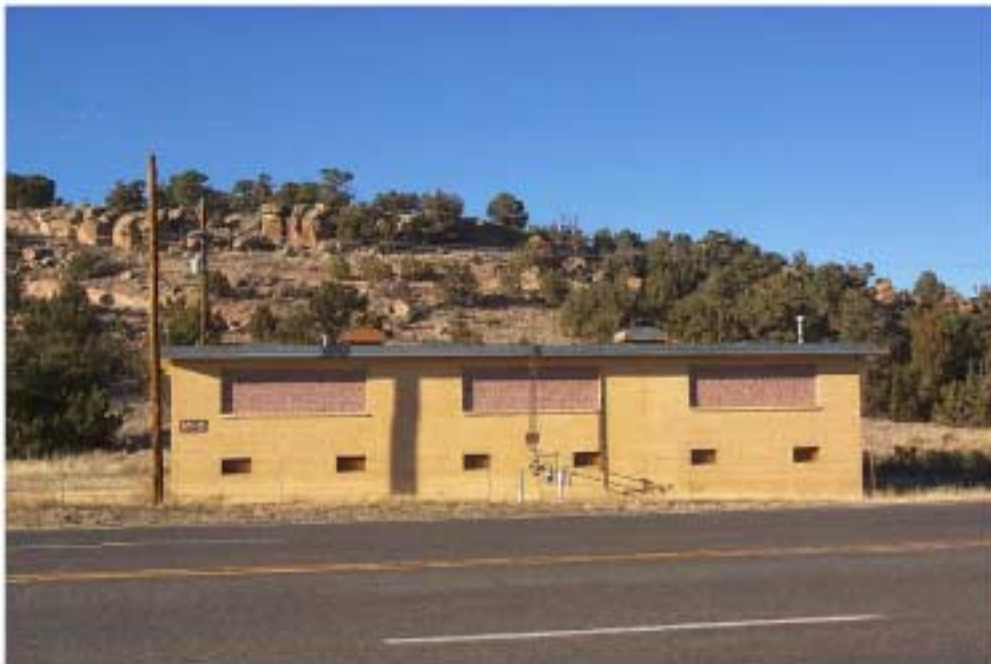
TA-54-75 South Elevation

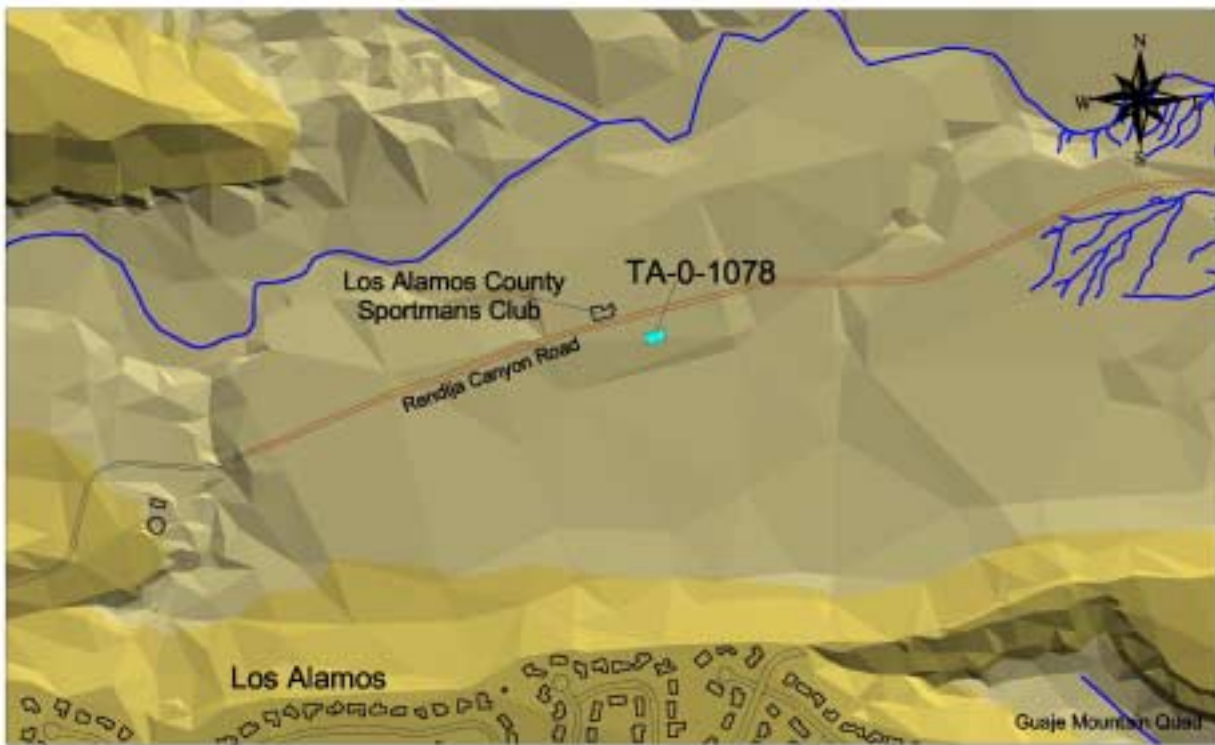
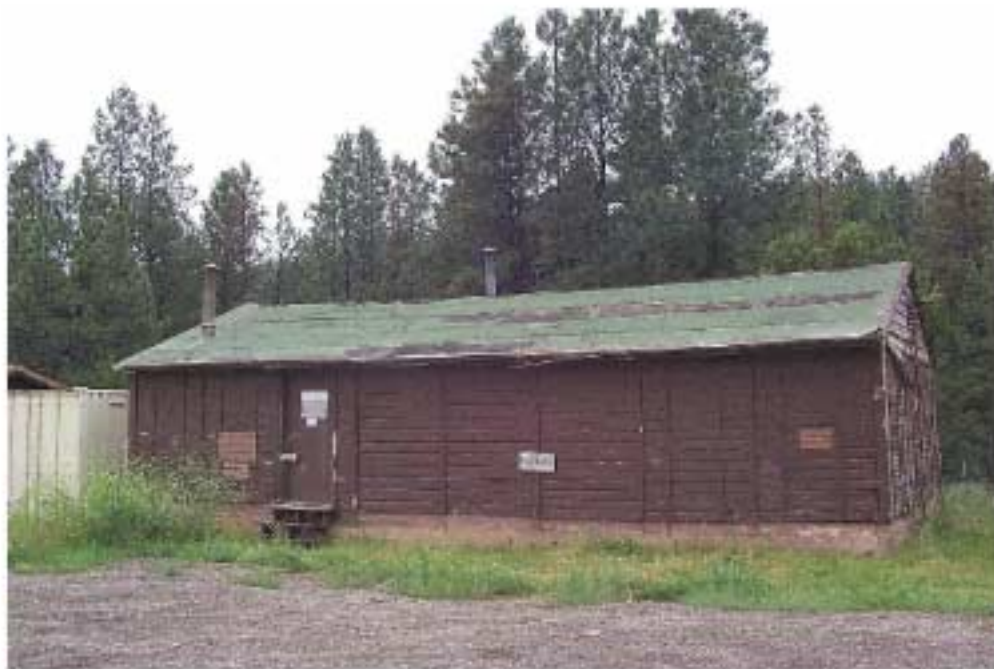
TA-0-1078 North Elevation

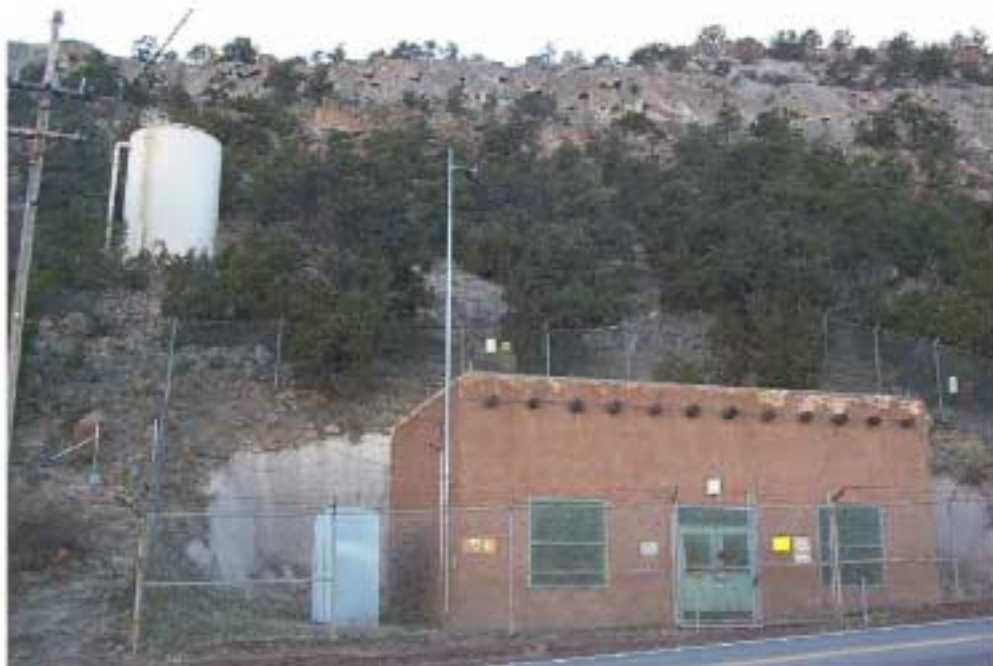
TA-72-1 North Elevation
