*History and Geophysical Description of
Hazardous Waste Disposal Area A
Technical Area 21*

Michael Gerety

John Nyhan

Ronald Oliver

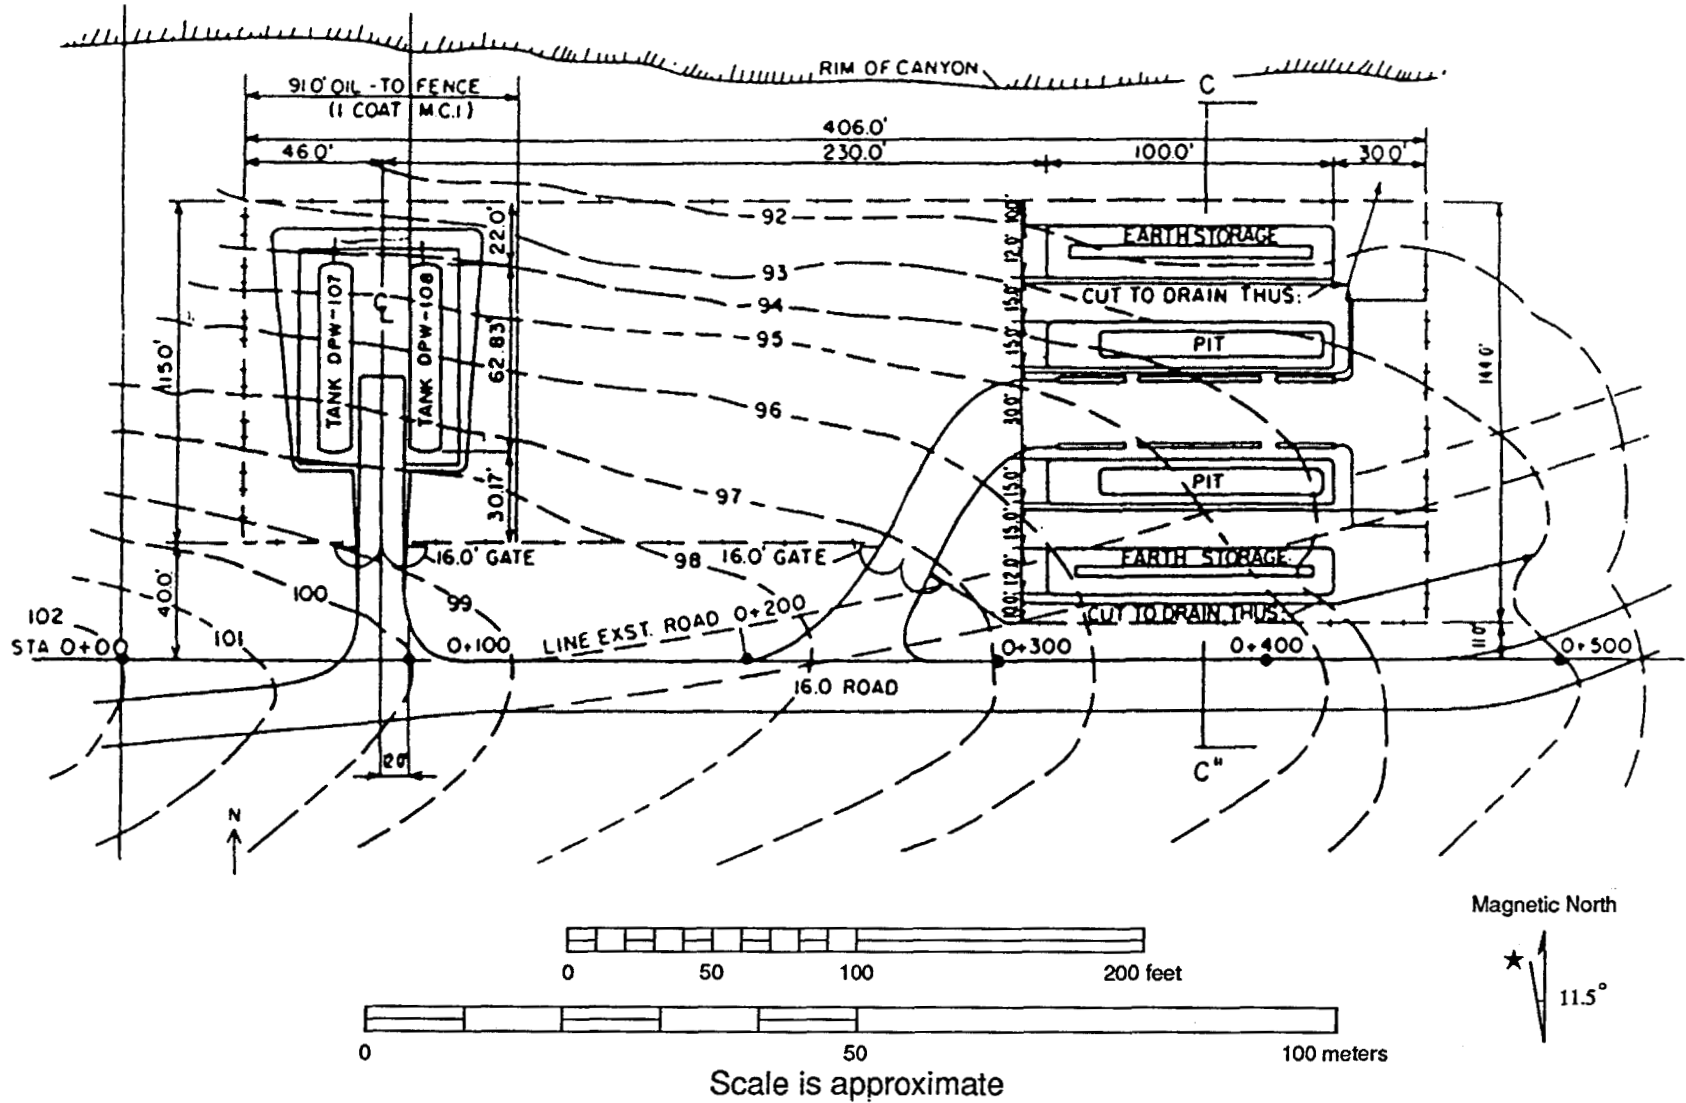
Fig. 2. Construction plan for Area A, January 24, 1945 (Rogers 1977).

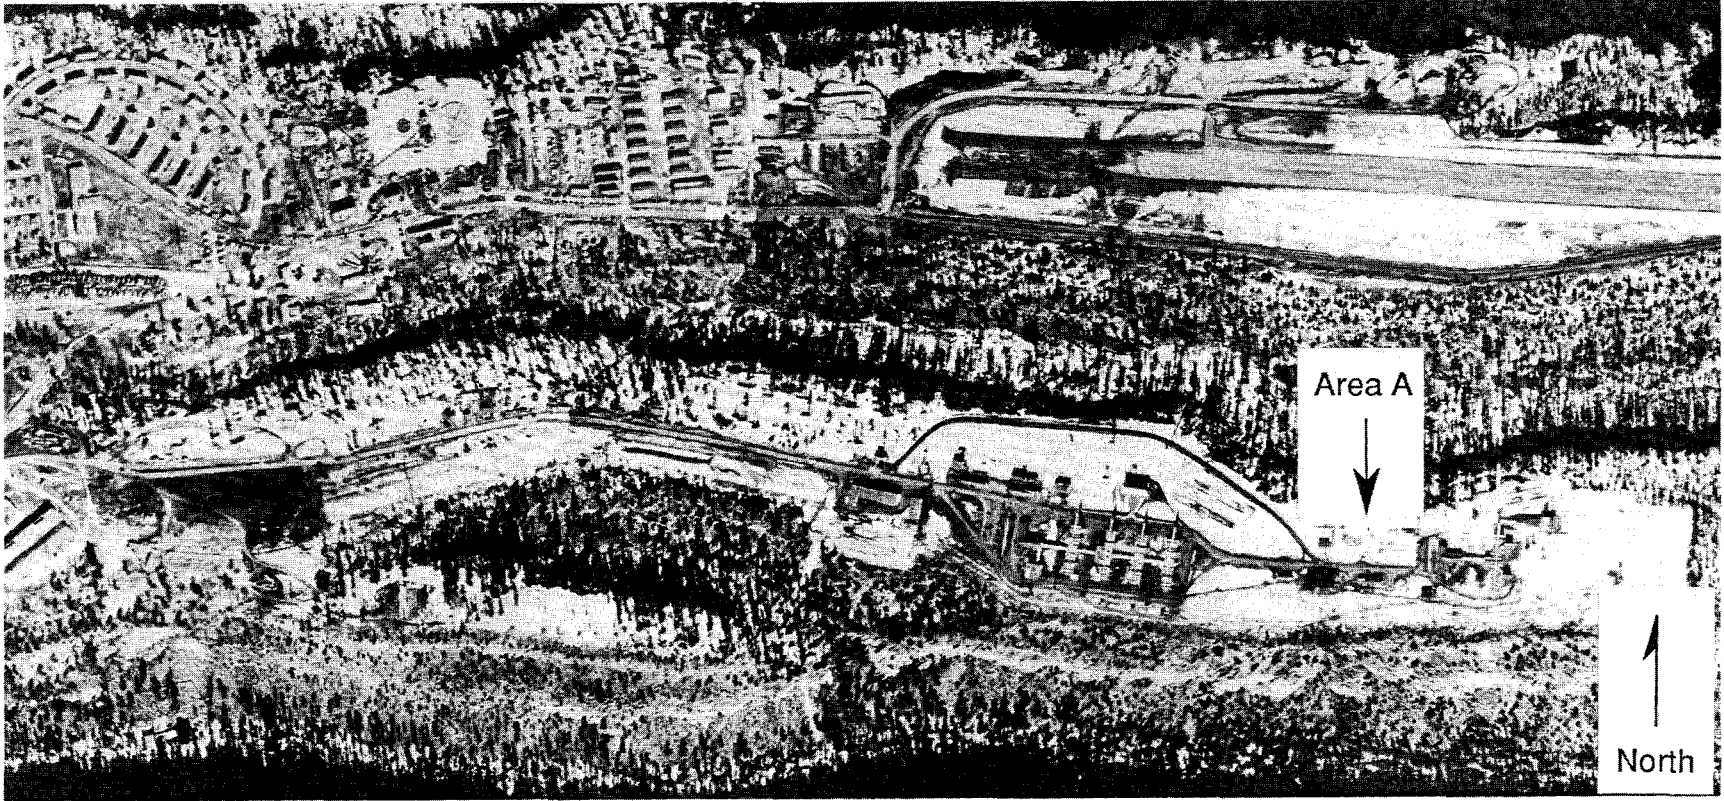
Fig. 3. Aerial photograph of TA-21 and Area A showing two trenches on the eastern side (1947).

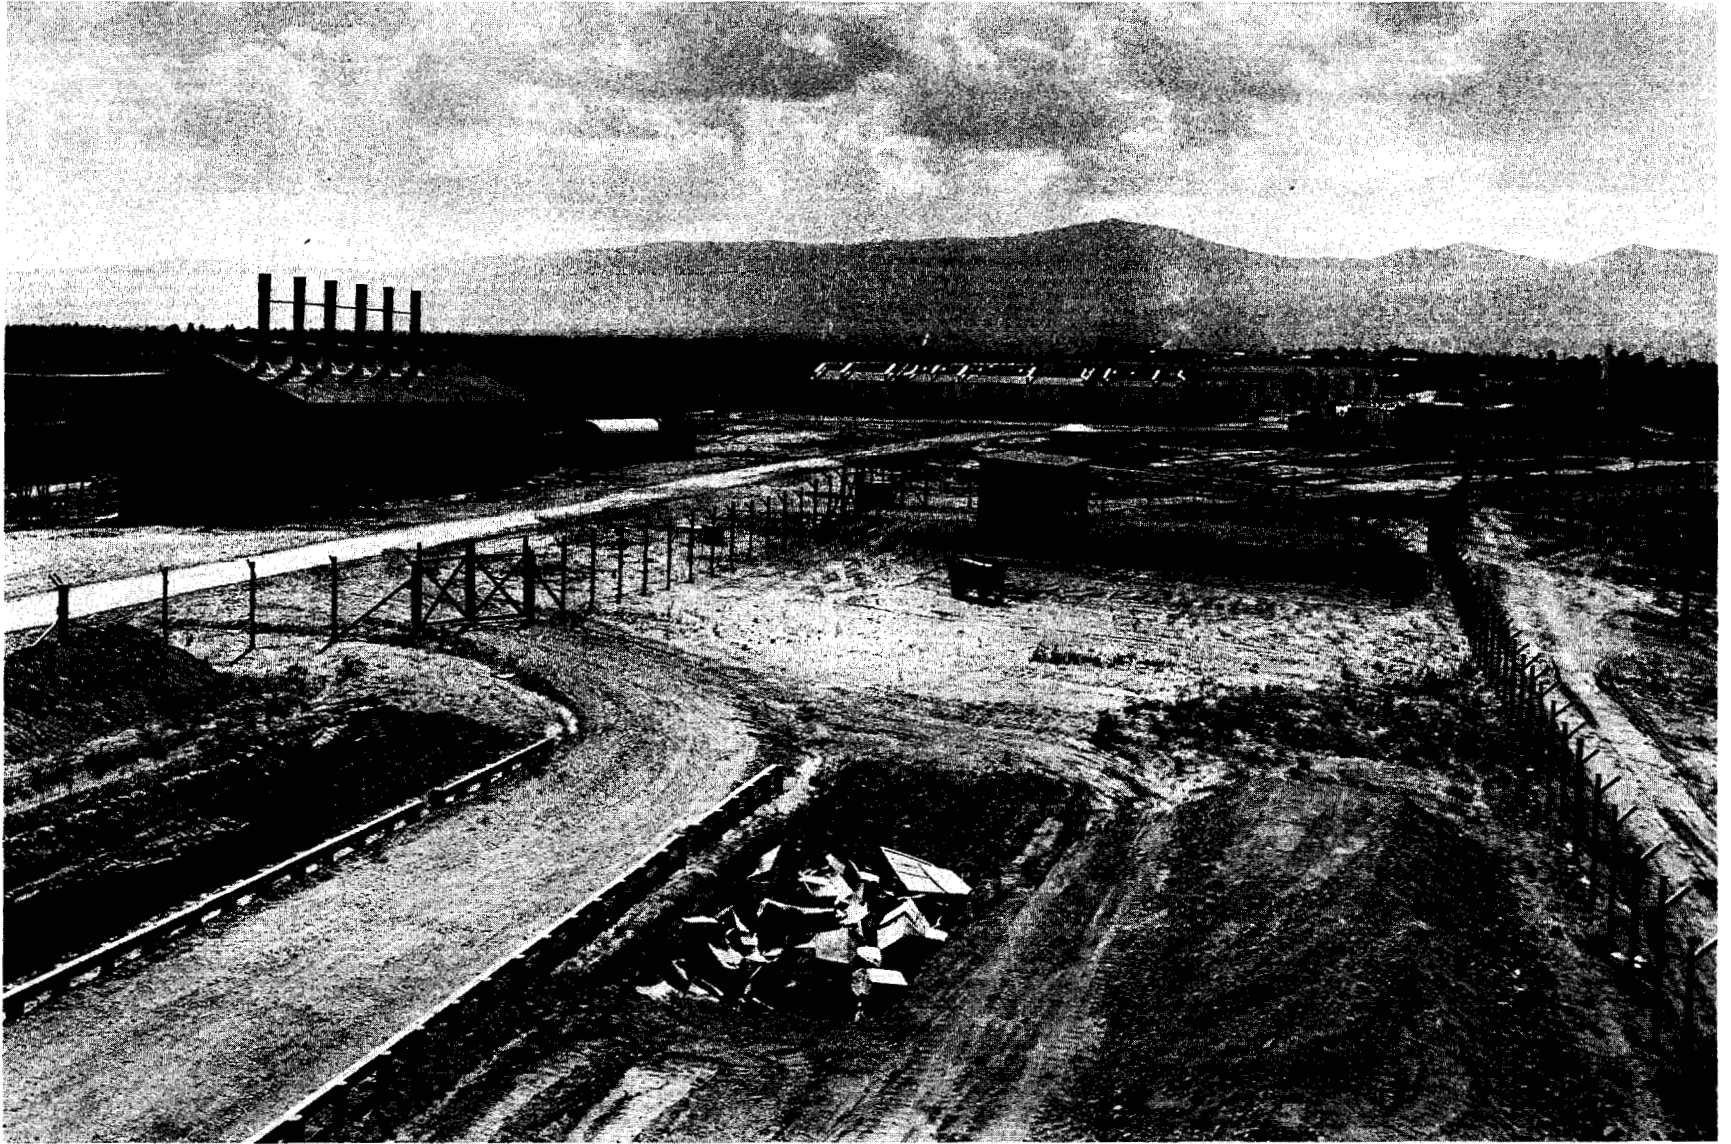
Fig. 4. Photograph taken in 1948 showing waste in the two east side trenches. The small building and raised ground (background) are located above the General's Tanks.

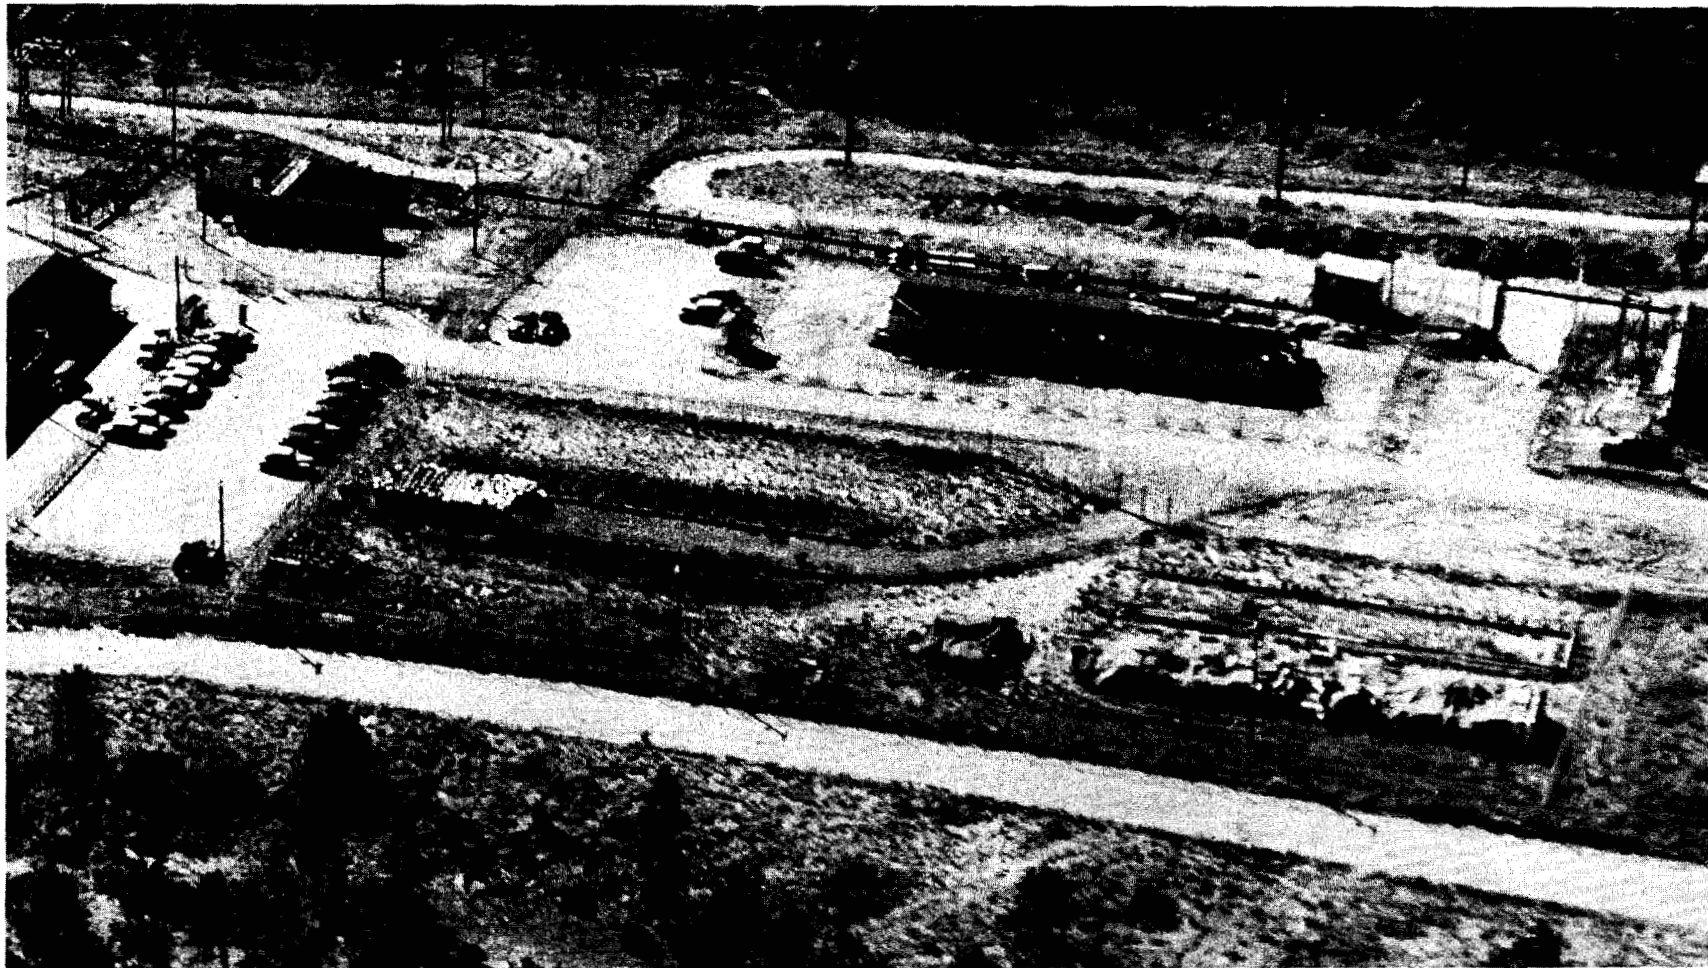
Fig. 6. Aerial photograph (January 1949) showing stored drums on the eastern third of the site (left side, next to parked automobiles).

During the 1950s, the surface of Area A was used to store hundreds of drums of wastes containing radioactive iodide (Figs. 6-8). Many of the 55-gal. mild steel drums, stored on the eastern end of Area A, corroded before they were removed to TA-21-35 and TA-45 in 1960.

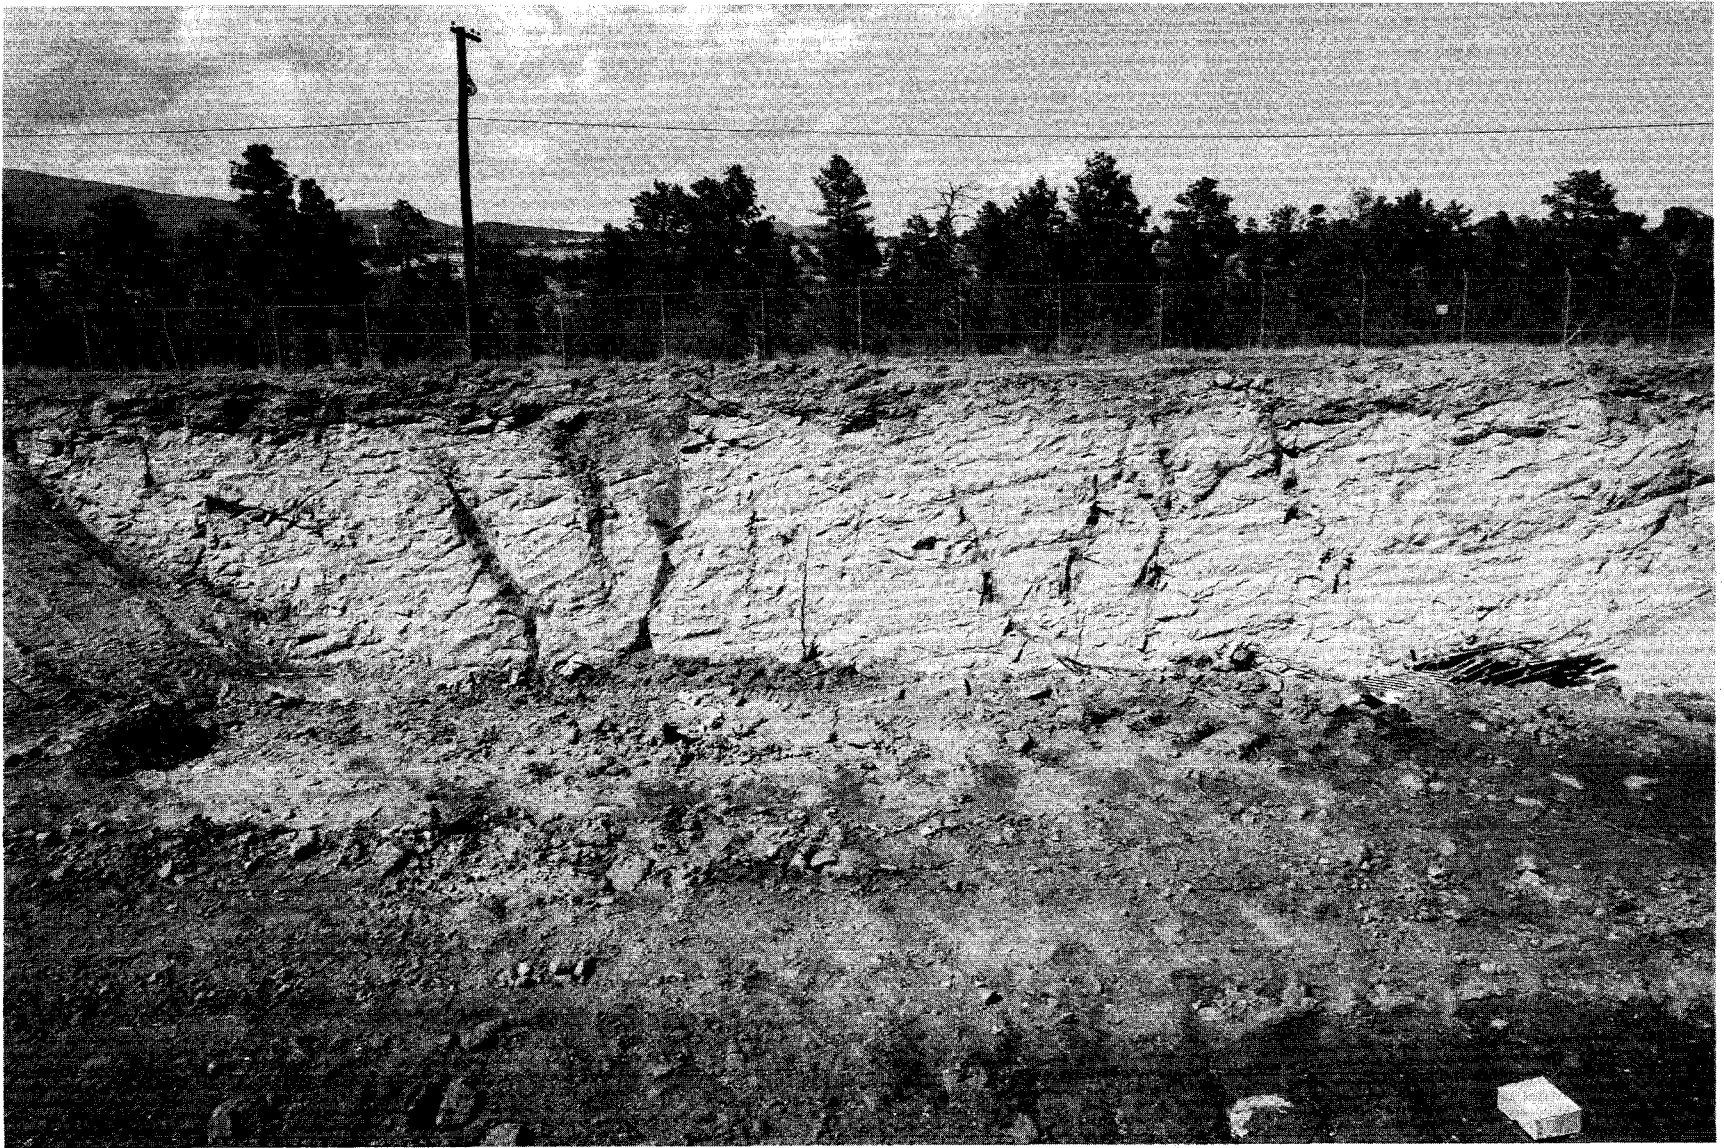
Fig. 9. Photograph (1969) of the northern wall of the central disposal pit.

The central pit is displaced about 5 m to the east of the location shown in Fig. 1. The pit boundaries were not detected directly by any technique. The east/west boundaries in Fig. 25 were placed by superposing Fig. 2 and all the geophysical data to find the best fit. The north/south boundaries were located from photographs (Figs. 9 and 12). The pit geometry is best delineated with a combination of EMI and resistivity data.

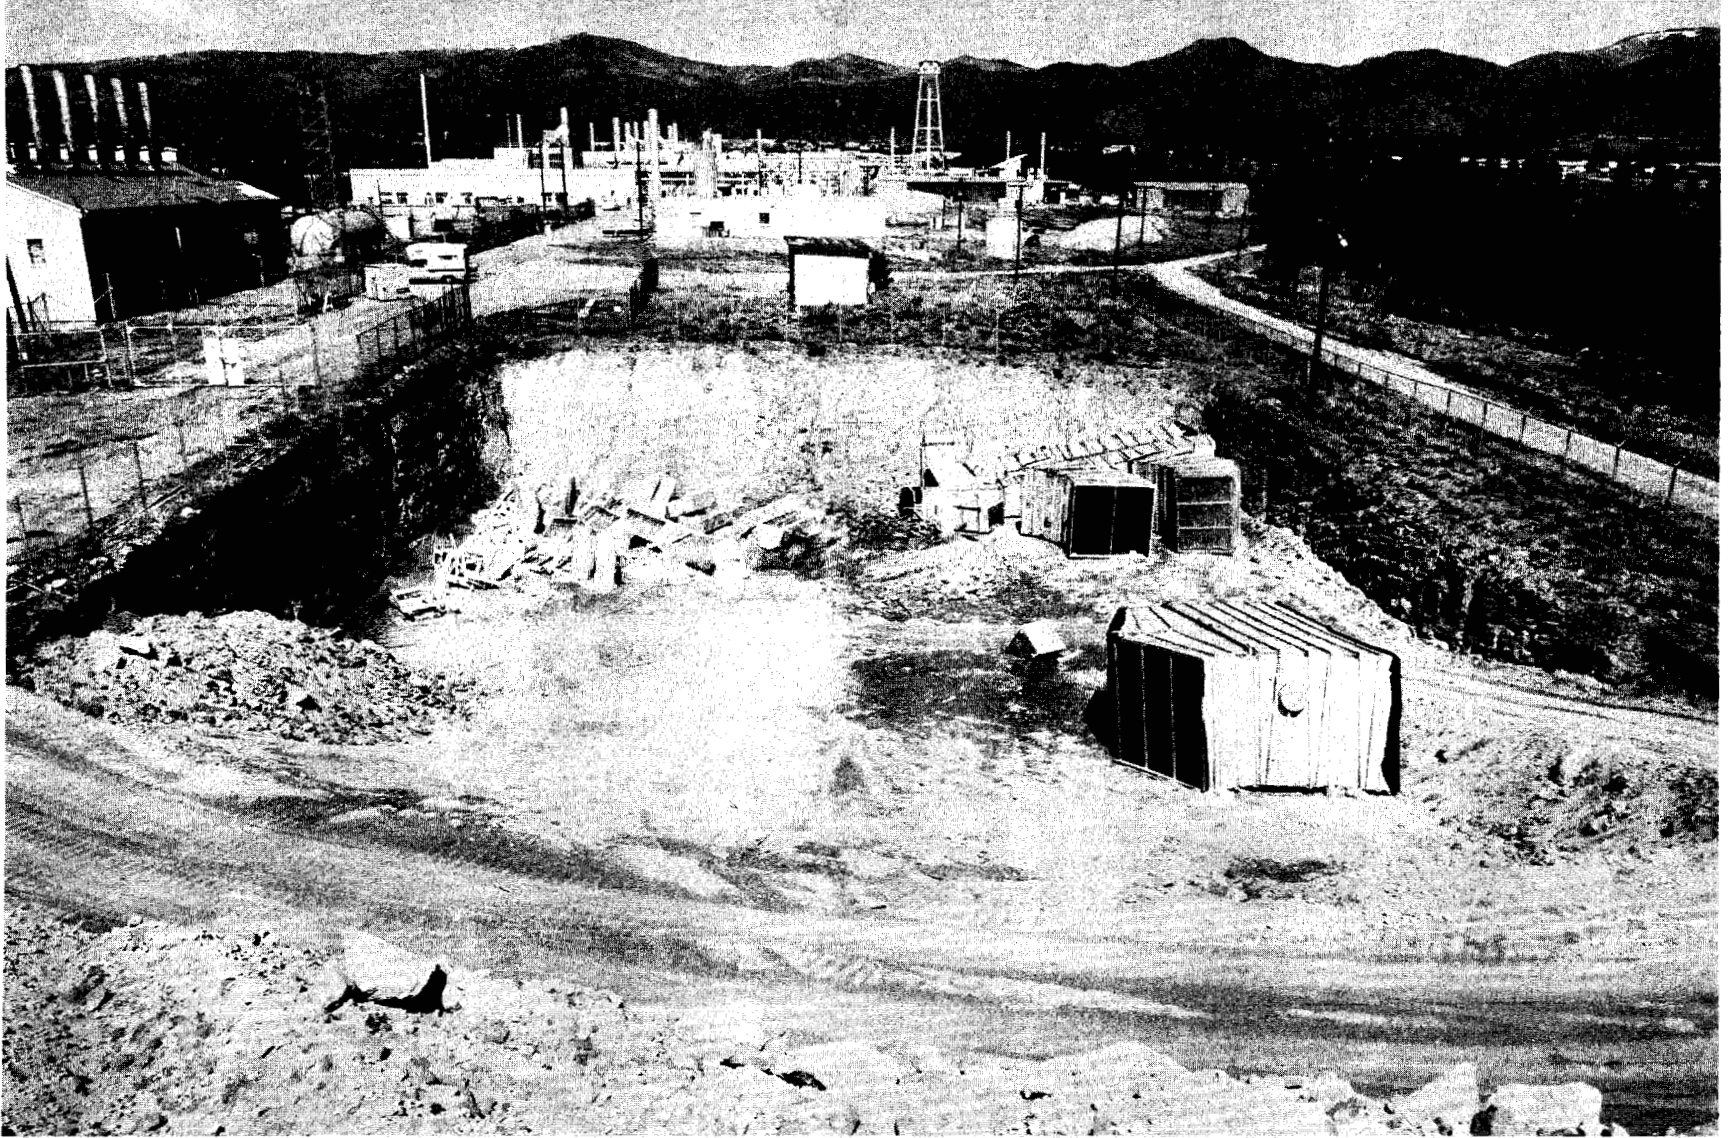
Fig. 12. Photograph (1973) showing burial of building demolition materials in the disposal pit.

In 1972, the pit was enlarged (52.4 x 40.8 x 6.7 m or 172 x 134 x 22 ft). Between February and July 1973 it received plutonium contaminated building debris (Figs. 12-15) from the demolition of building TA-21-12 (Christensen et al. 1975). Figures 16 and 17 show backfill being stockpiled in Area A. The pit continued to receive waste from TA-21 through September 1977 (Fig. 18) and was finally backfilled with crushed tuff in May 1978, thus retiring Area A as an active materials disposal area (Figs. 19-22). The total buried waste volume is about 14 159 m³ (500 000 ft³).

The apparent conductivity of the pit region is about 22 mS/m (45 ohm-m) as compared with 15 mS/m (67 ohm-m) outside the pit area. Anomaly C1 corresponds to the large ductwork illustrated in the background of Figs. 12-15. Anomaly C2 corresponds nicely to the material dumped over the edge of the pit (Fig. 15). Anomaly C3 is located in the vicinity of the ductwork shown in the foreground of Figs. 12, 14, and 15; however, it does not have an associated in-phase anomaly. C3 probably does not result from the ductwork pictured in these figures.

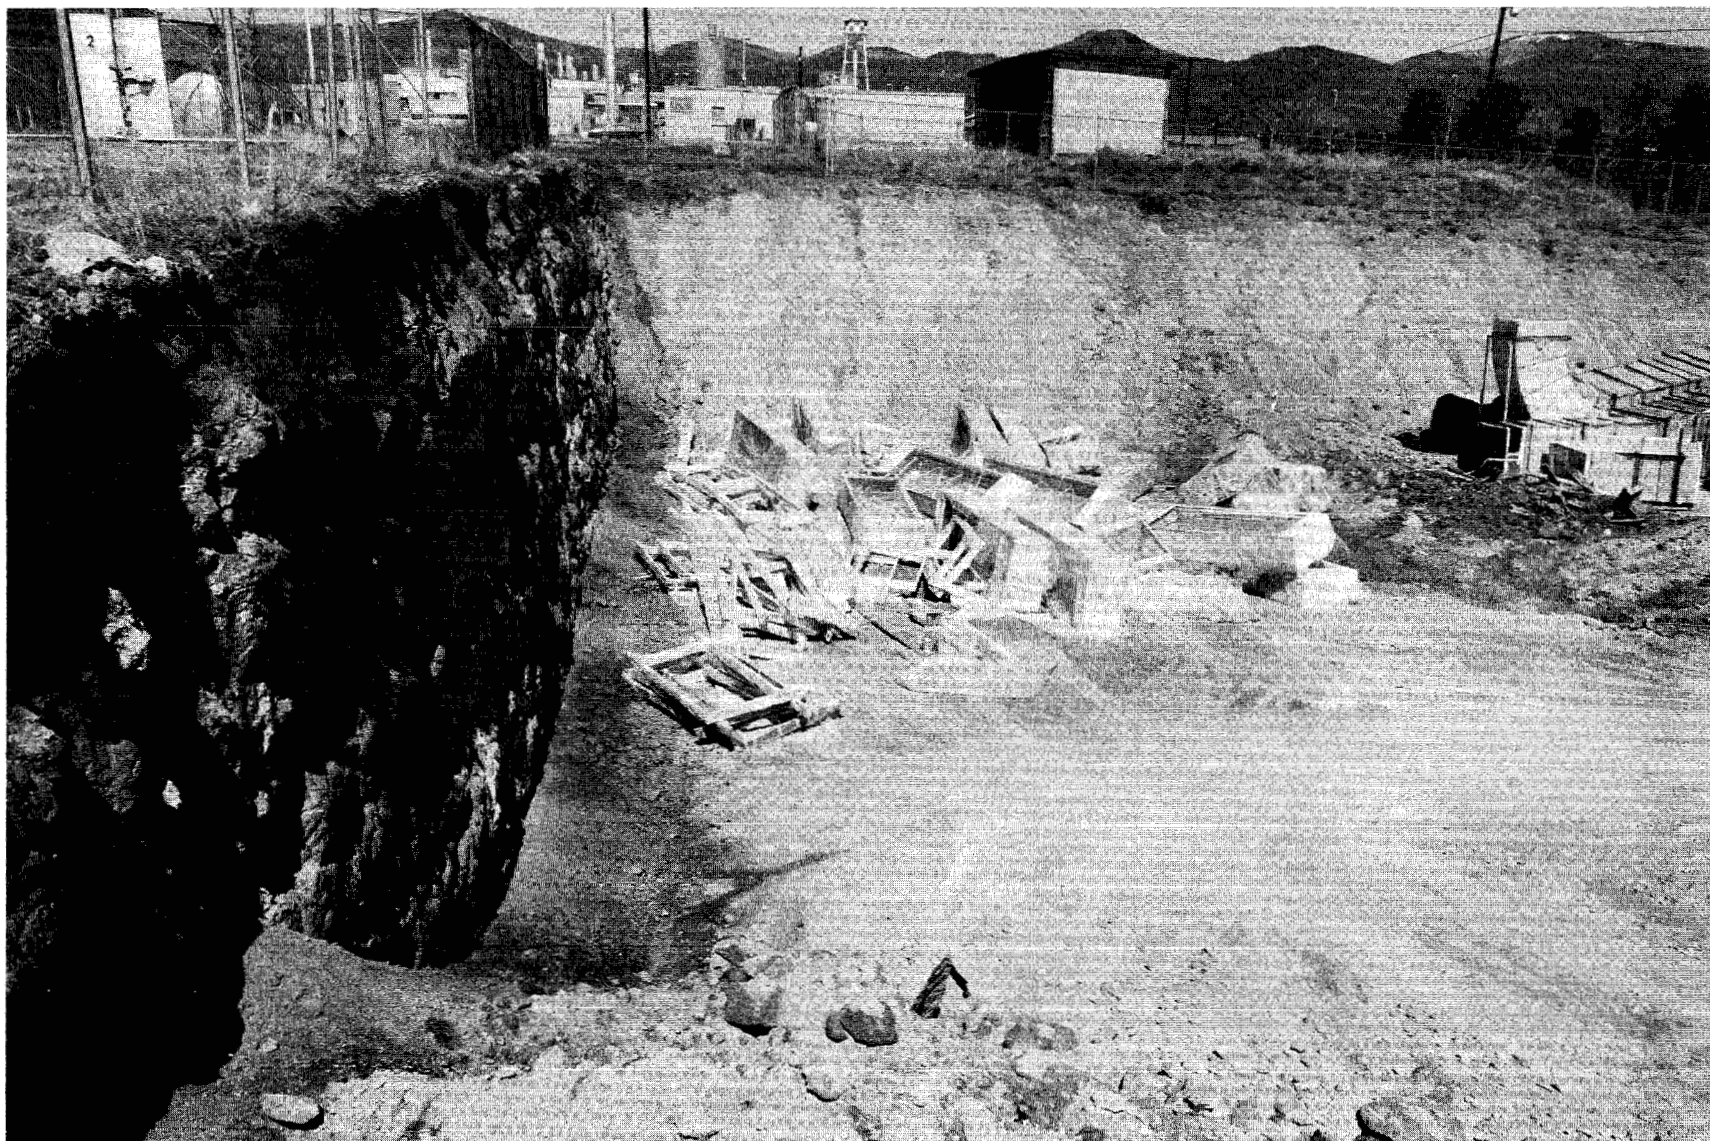
Fig. 13. Photograph (1973) of the southeast corner of the pit showing hoods and other laboratory equipment being buried.

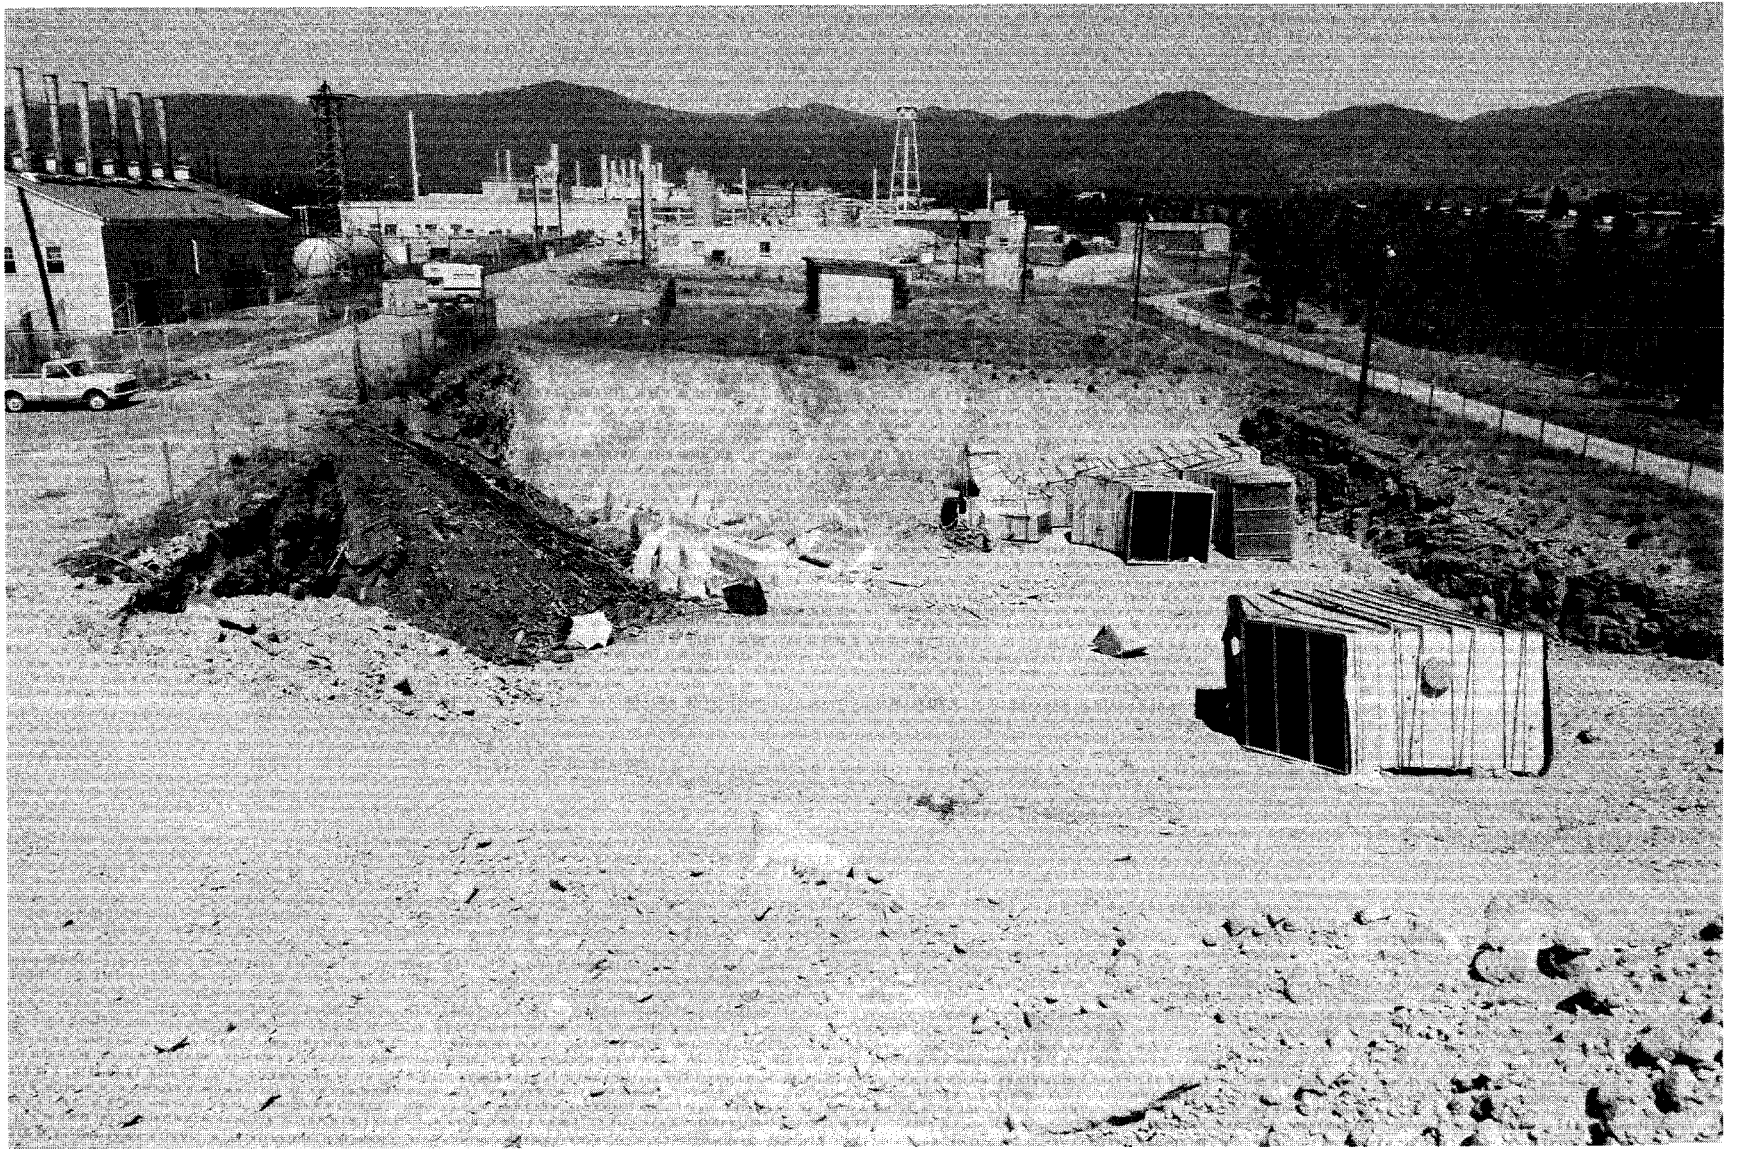
Fig. 15. Photograph (1973) showing material being pushed into the pit (left side).

probably a nonmagnetic metal. C2 corresponds to the material that was dumped into the pit from the south rim as pictured in Fig. 15.

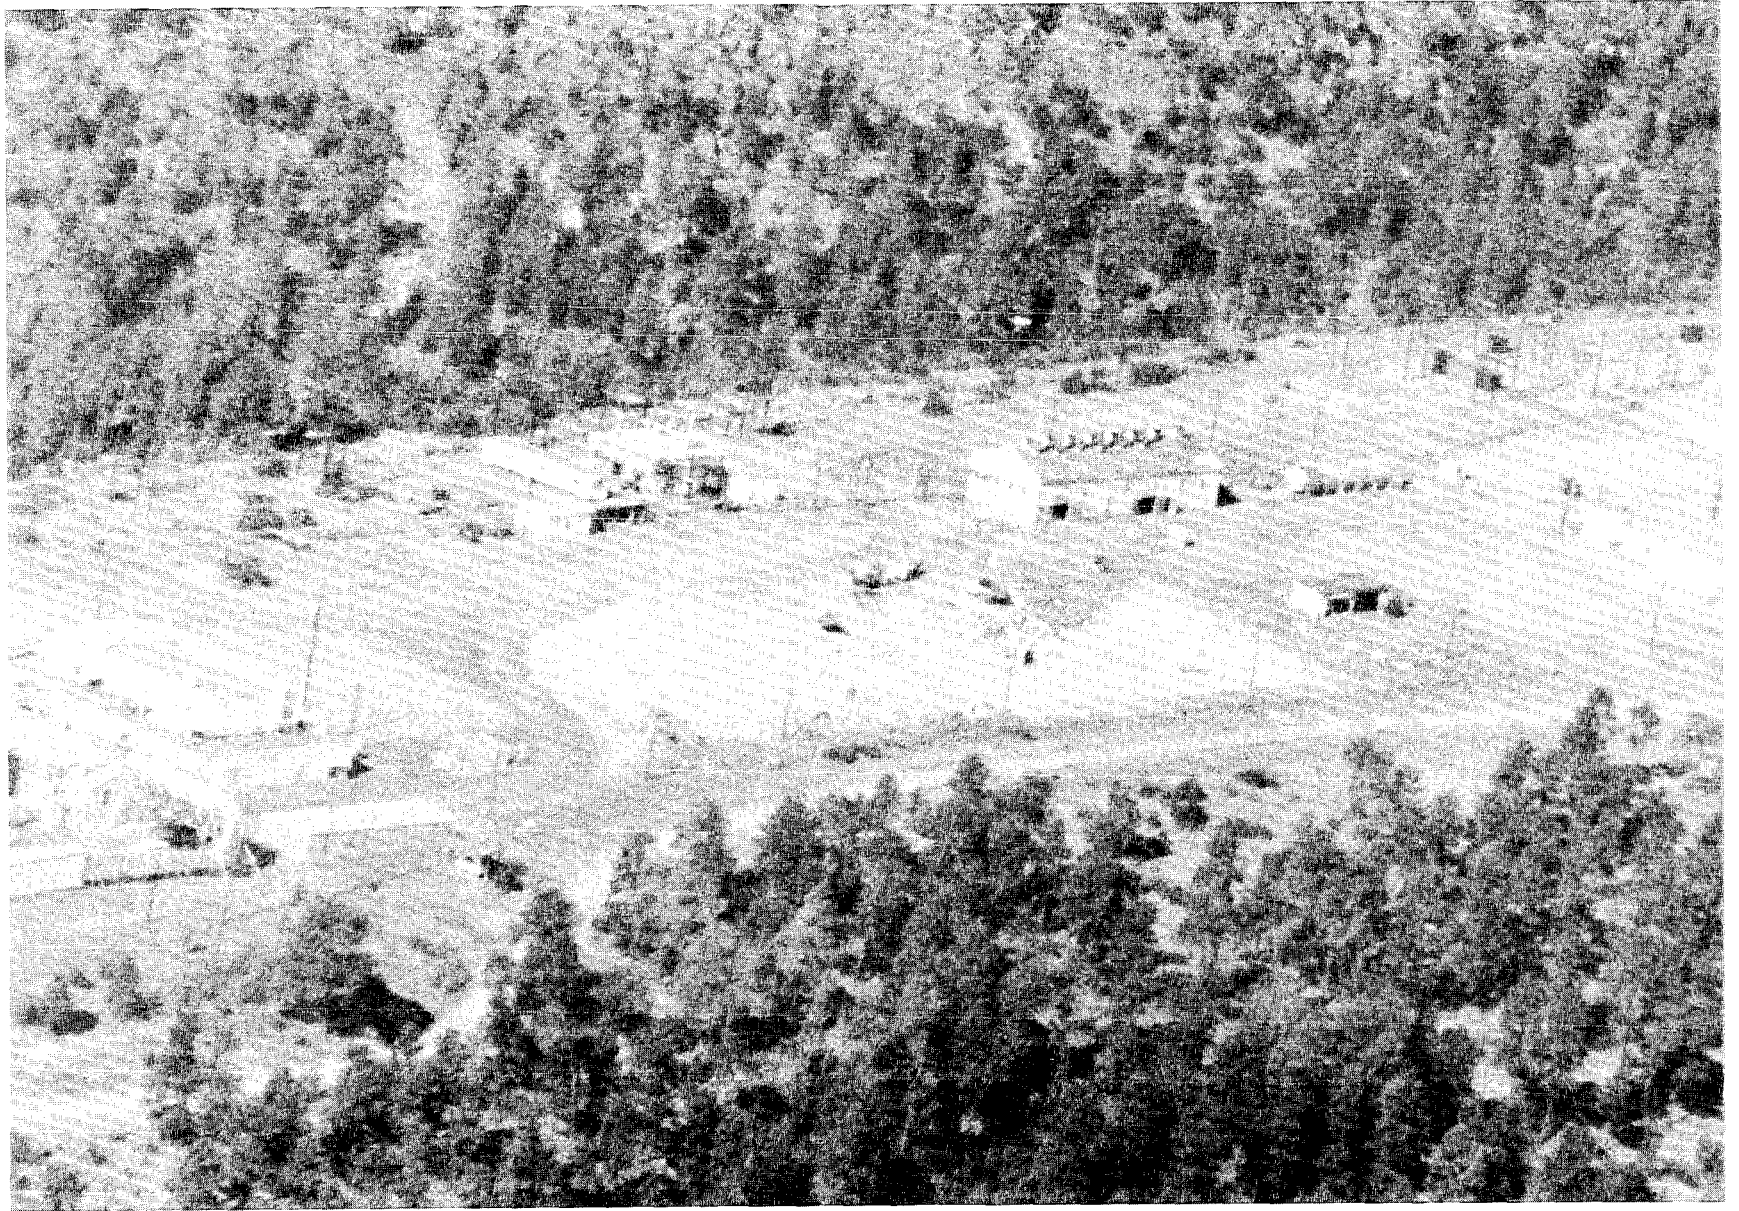
Fig. 17. Aerial photograph (1974) showing stockpiled backfill.

Figure 17 shows the location of the western boundary of the central pit relative to the positions of the telephone poles. The position of the poles relative to the fence line and the relative distance between the poles themselves indicate that the poles in Fig. 17 are the same poles that exist today (Fig. 58). By this line of reasoning, the western edge of the pit is about 16 m west of the pole closest to C1, which is the location derived from the geophysical data. Figure 17 was not available until well after the geophysical interpretation had been made.

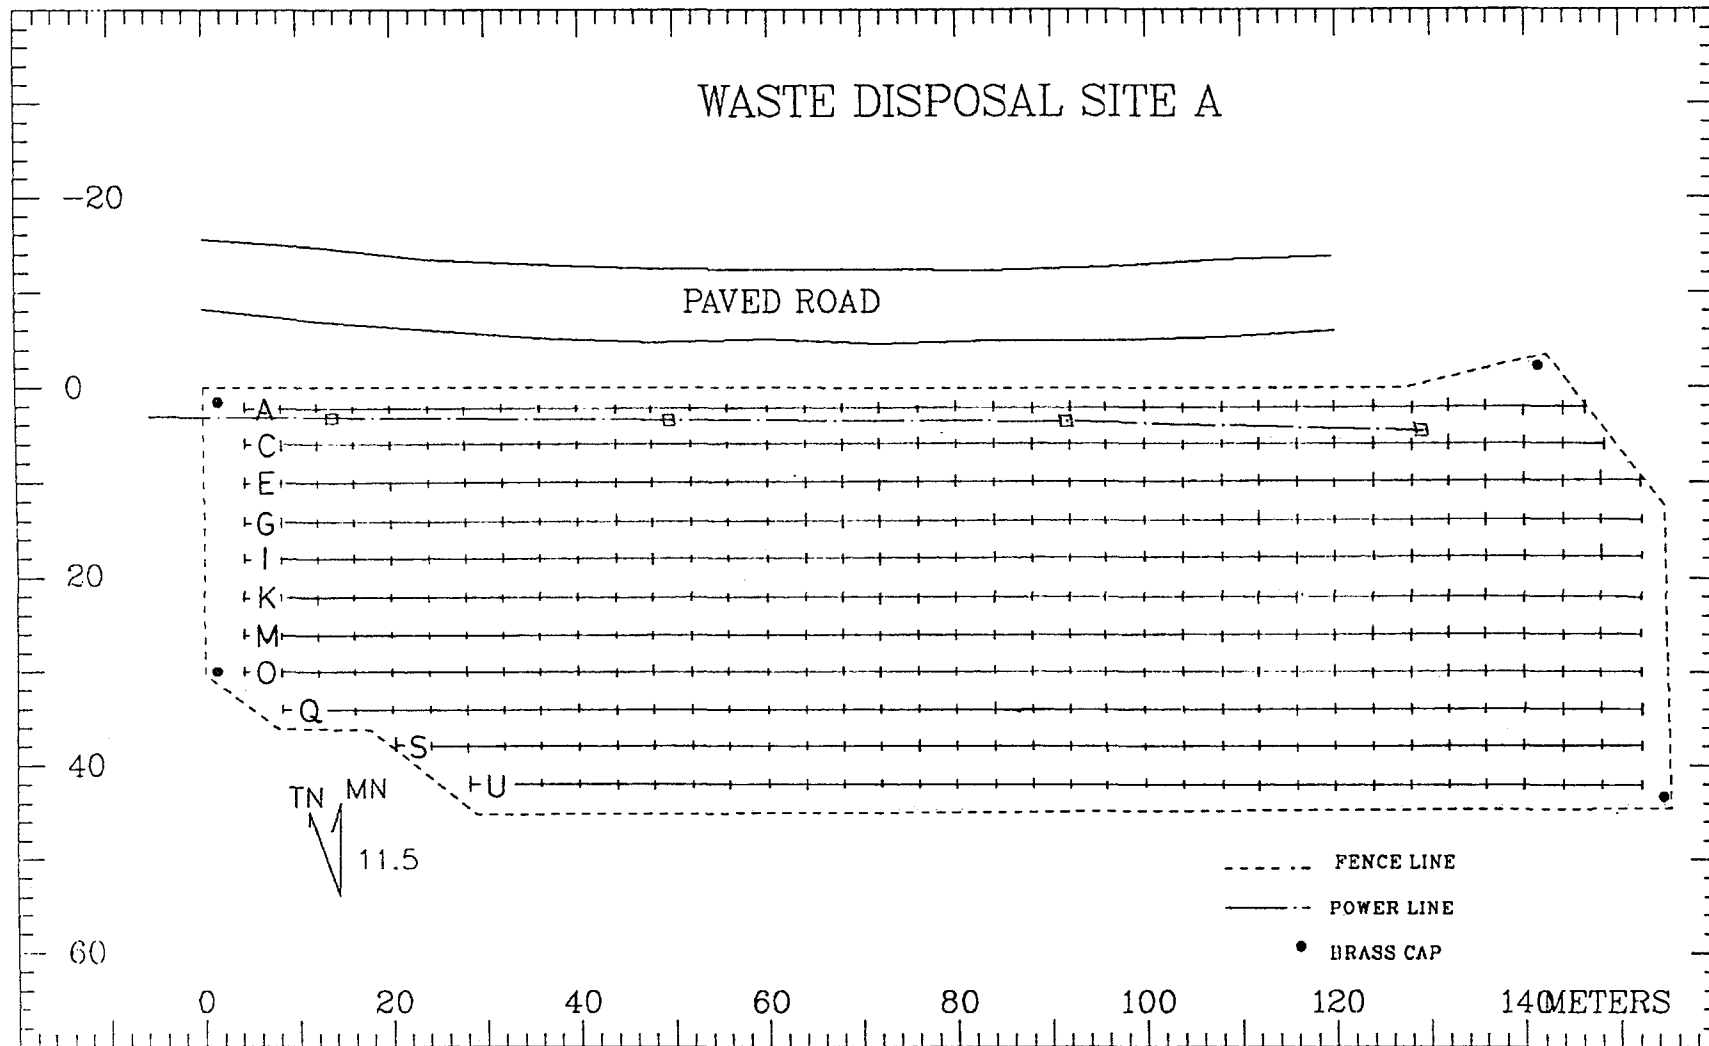
Fig. 23. The geophysical grid system with the road, fence, and telephone lines superposed as they exist now. Every second data line and every second data point are indicated.

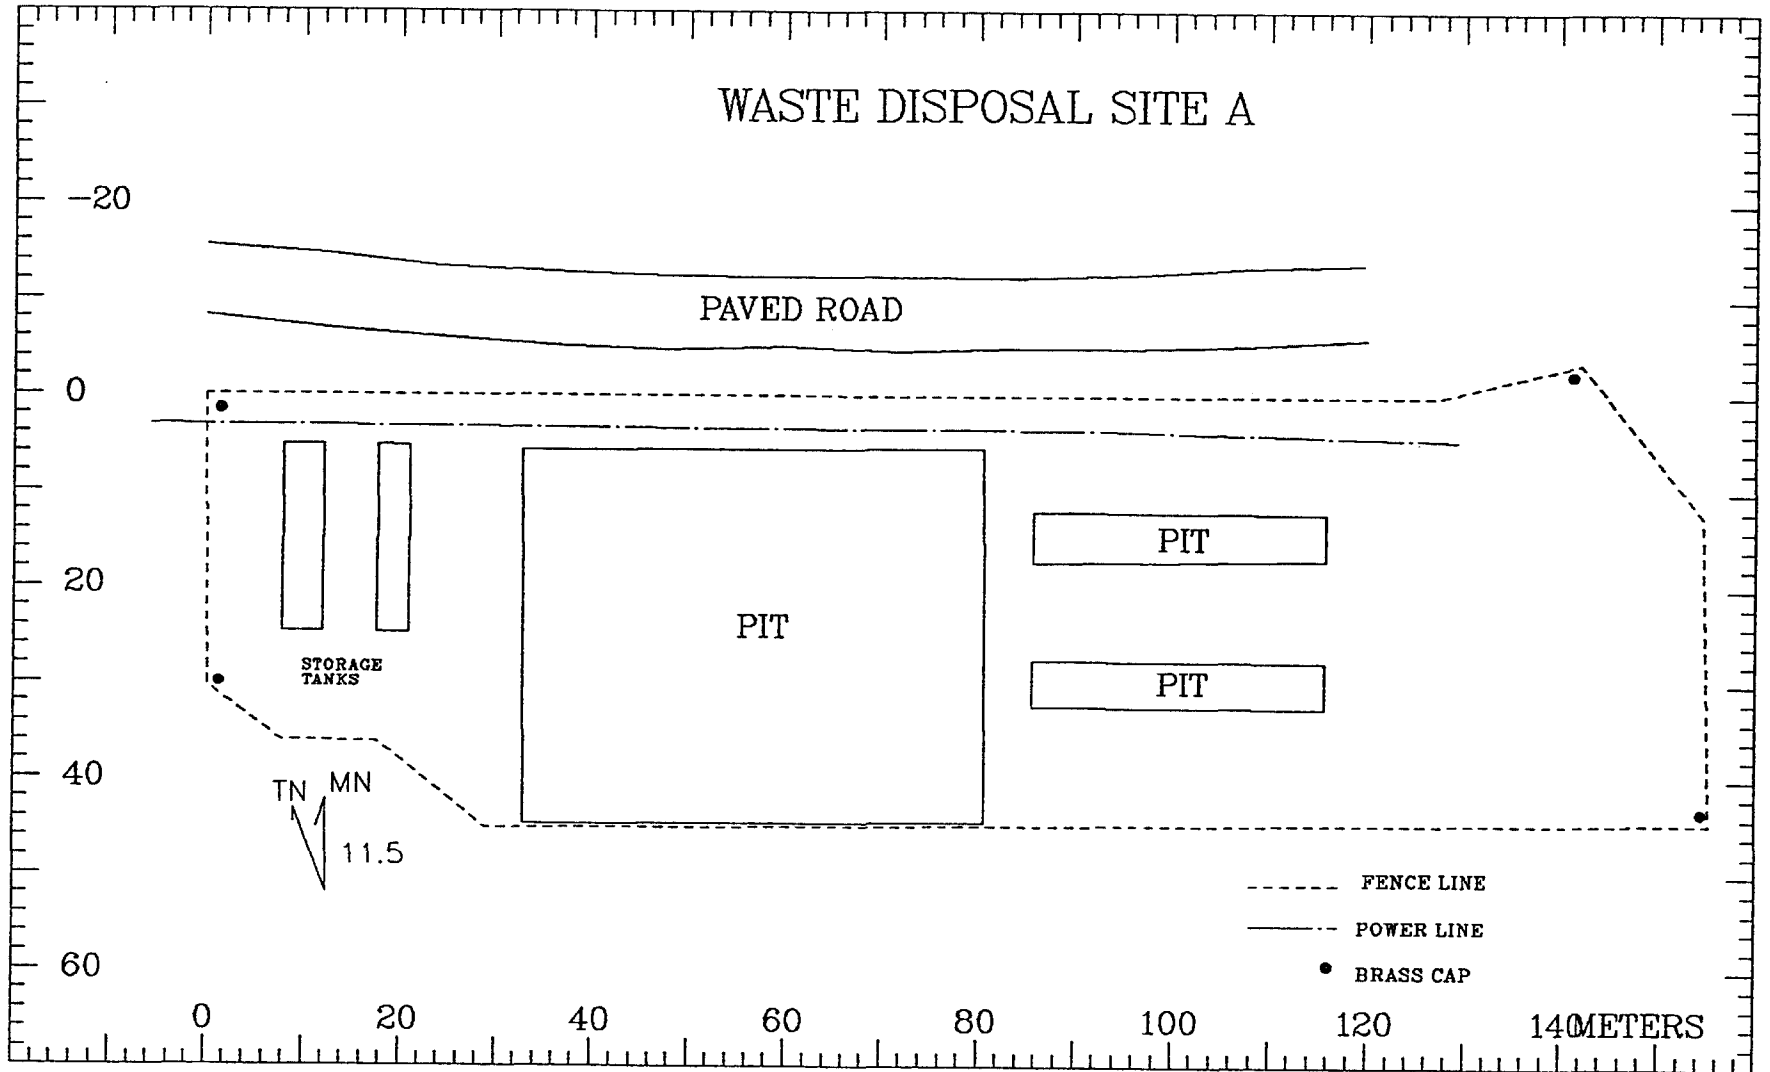
Fig. 24. The geophysical grid system with the storage tanks, pit, and trenches superposed. Locations are from Figs. 1 and 2.
