*History and Geophysical Description of
Hazardous Waste Disposal Area A
Technical Area 21*

Michael Gerety

John Nyhan

Ronald Oliver

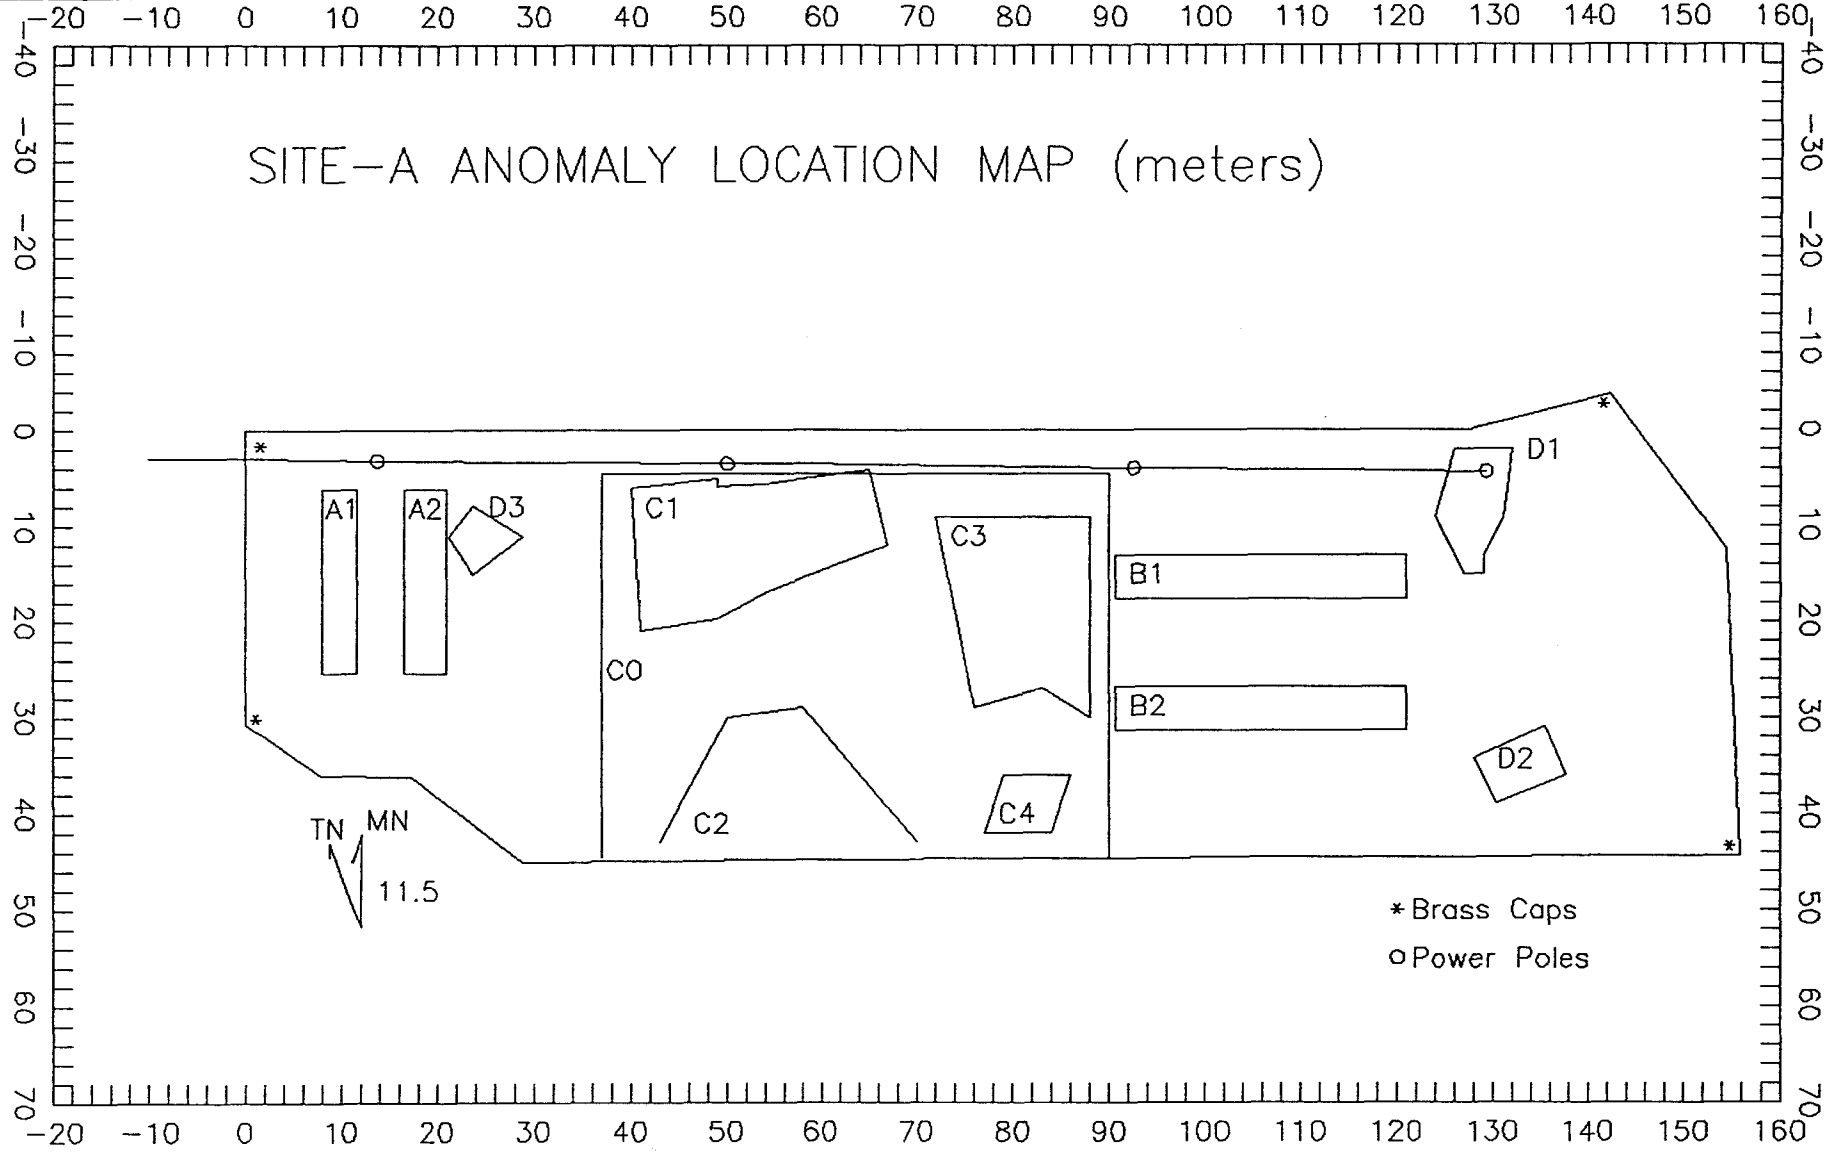
Fig. 25. The geophysical grid system with the storage tanks, pit, trenches and other targets superposed. Locations are based on geophysical data.

The Area A interpretation map, Fig. 25, is presented here as a convenience. Each of the following sections makes reference to this map. The map was compiled using data gathered from all the individual techniques, then determining the combination of regions that yielded the simplest, physically plausible interpretation. This map is a two-dimensional "image" of identifiable objects within Area A. The placement of the General's Tanks, pit, and trenches is based on an integrated interpretation of all the geophysical data. A complete list of the coordinates of these objects is found in Sec. 7.

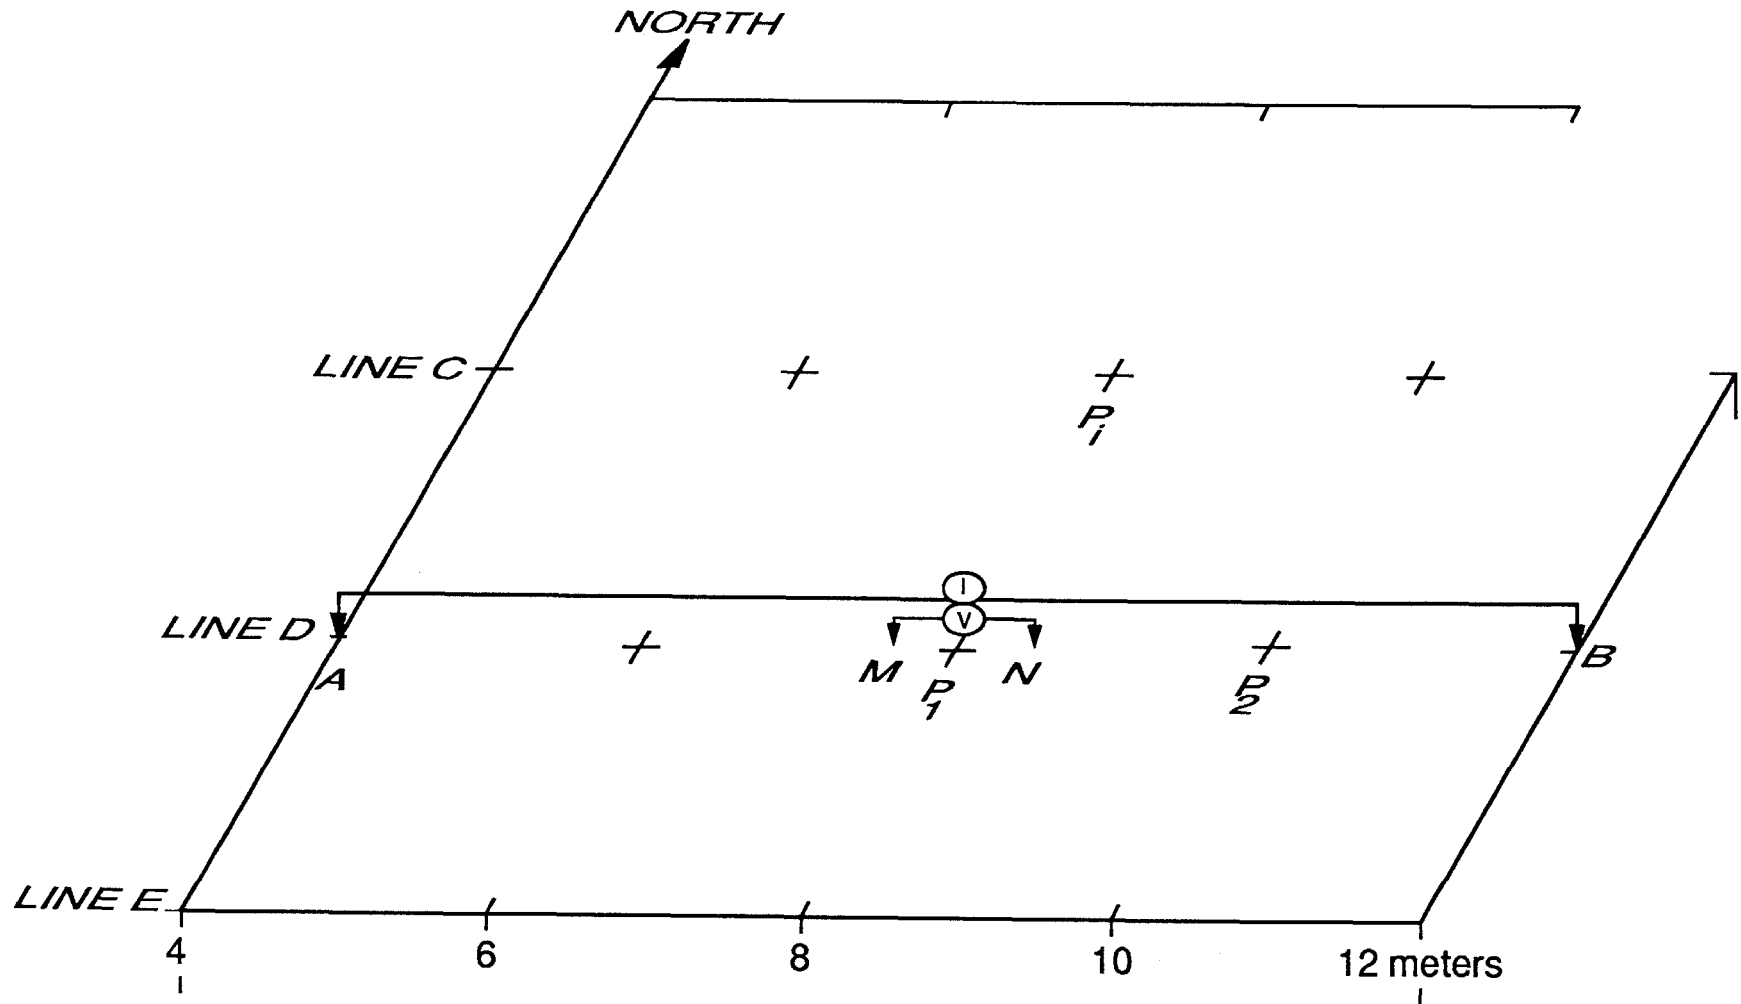
Fig. 26. Schematic representation of the Schlumberger array geometry. Measurements were made in this manner over the entire grid.

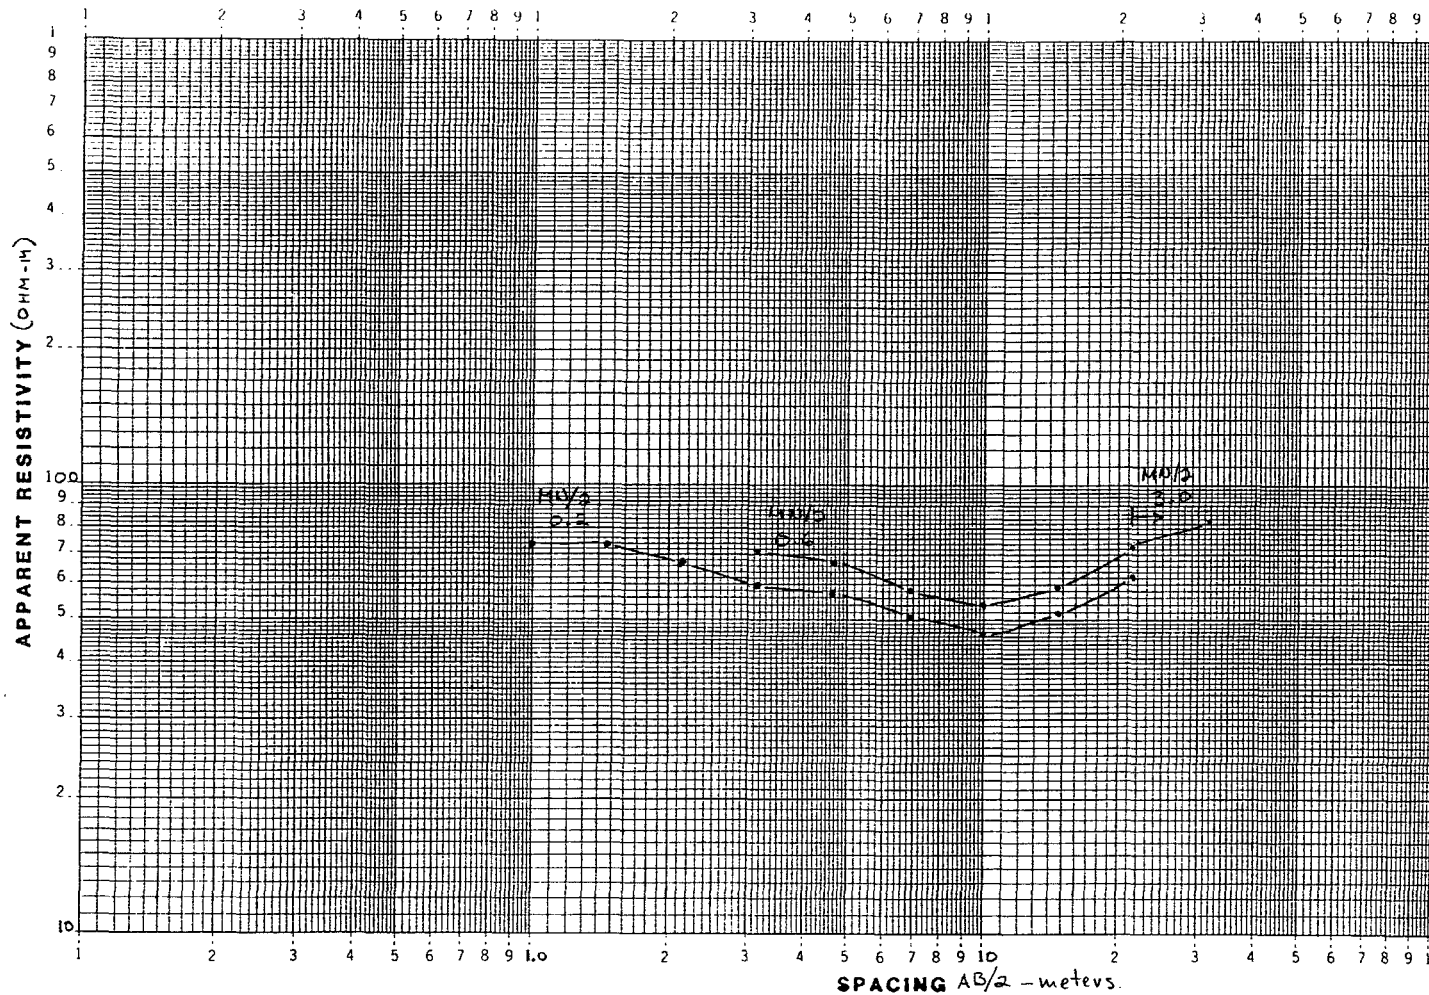
DATE July 15, 1987 OPERATOR Gerety, Cash
 JOB TA-21 Site-A TRAVERSE Sounding M64
 LOCATION/DESCRIPTION Expanded (grid) E/W
 FIELD NOTES quad E is 11.5° south of true E-W

Fig. 27. Schlumberger sounding curve for station M64 (26S,64E) taken on July 15, 1987.
The line is oriented east/west.

1987. The July data show approximately 75 ohm-m material for $AB/2 < 3.1$ m, whereas the August data indicate approximately 60 ohm-m. The differences in apparent resistivity could be caused by changes in moisture from rain or differences in the field procedure used to obtain the data.

Soil cap. The only data collected that relate directly to the properties of the soil cap are the two Schlumberger soundings performed at 26S,64E (Figs. 27 and 28). These soundings show the cap to be 60-70 ohm-m and overlying more conductive material. The soundings are located directly over the central pit (C0) and are affected by the large amount of metal in the pit as well as the fill material and moisture content.

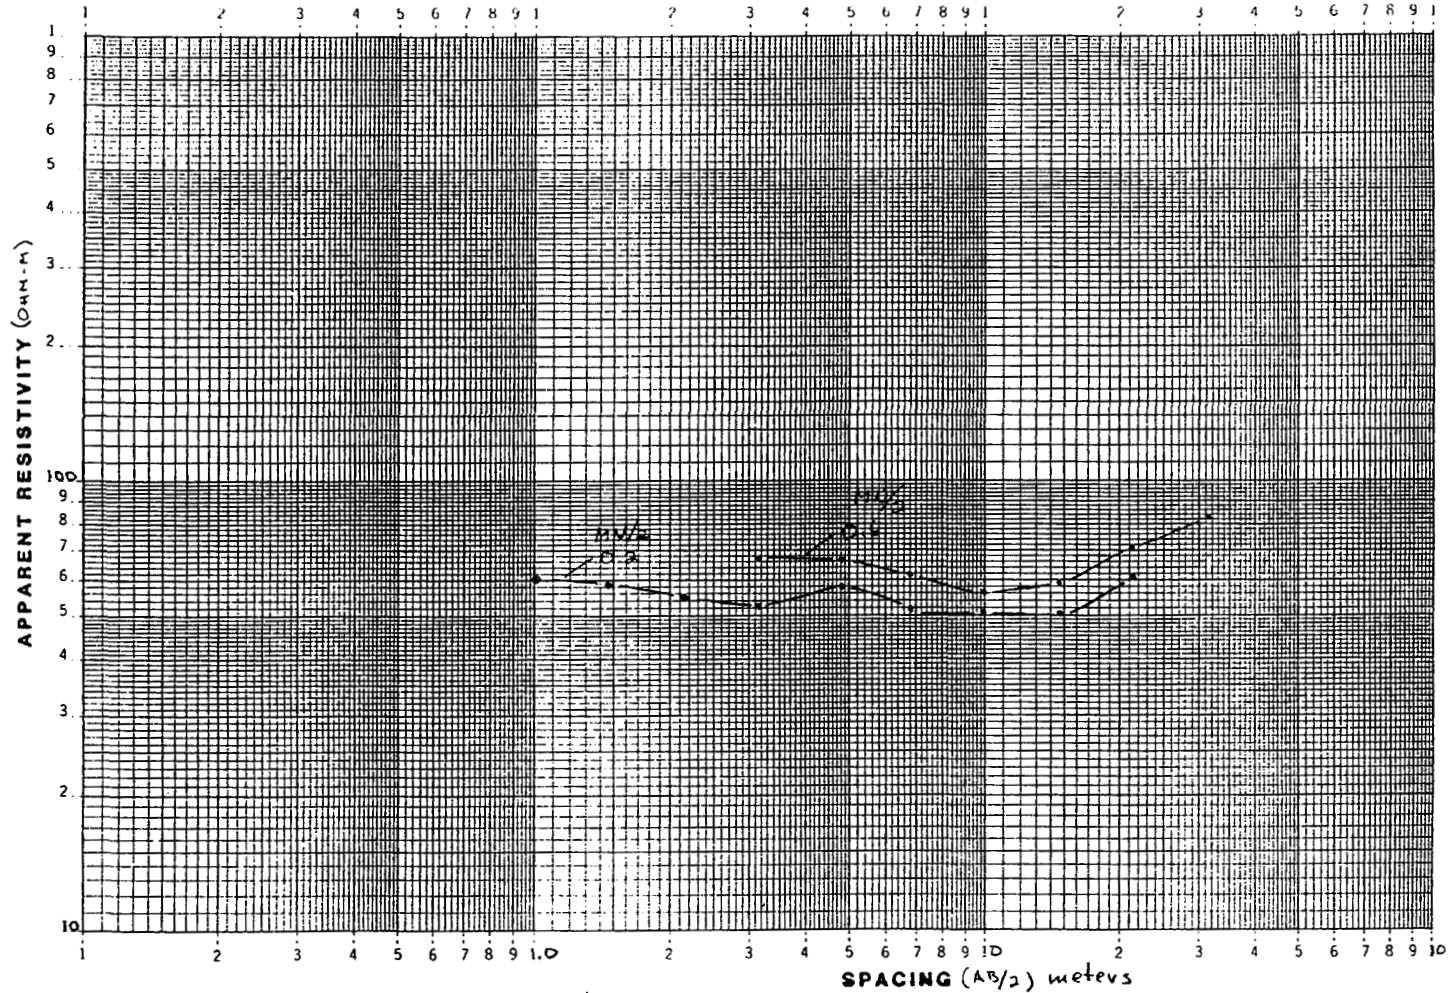
DATE Aug 6, 1987 OPERATOR Cash, Montoya, Long
 JOB TA 21 Site-A TRAVERSE Sounding M-64
 LOCATION/DESCRIPTION Expanded in the E-W direction
 FIELD NOTES Grid E is 11.5° south of true east

Fig. 28. Schlumberger sounding curve for station M64 (26S,64E) taken on August 6, 1987. The line is oriented east/west.

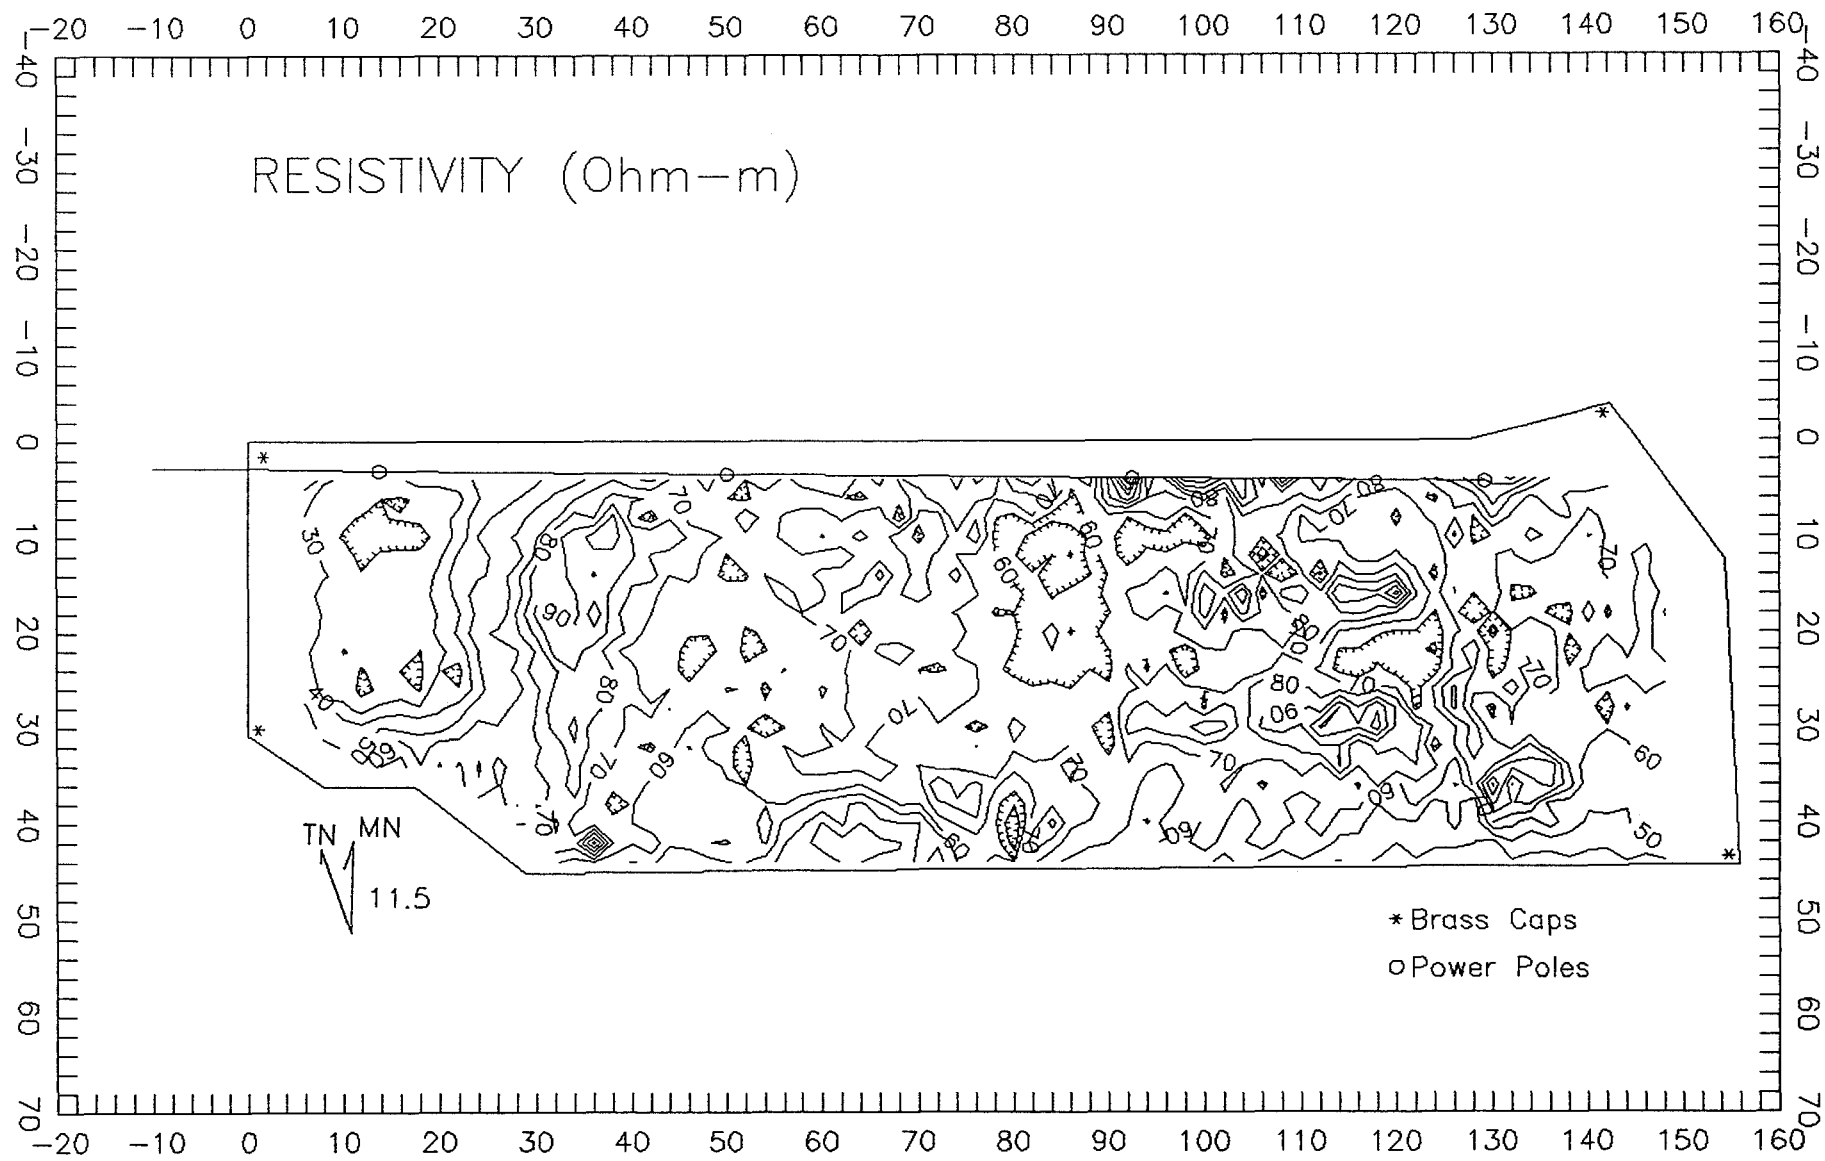
Fig. 29. Apparent resistivity contour map. The contour interval is 10 ohm-m.

Figure 29 presents unfiltered apparent resistivity data contoured at 10-ohm-m intervals. Figure 30 presents the same data filtered to remove some of the "jitter" observed in the raw data. The contour interval of Fig. 30 is 4-ohm-m. The filter used to smooth the data is a five-point mask that averages a data point with its closest four neighbors. The central value is weighted twice the surrounding values. All the features observed in the filtered data can be observed in the unfiltered data as well, but they are more clearly presented.

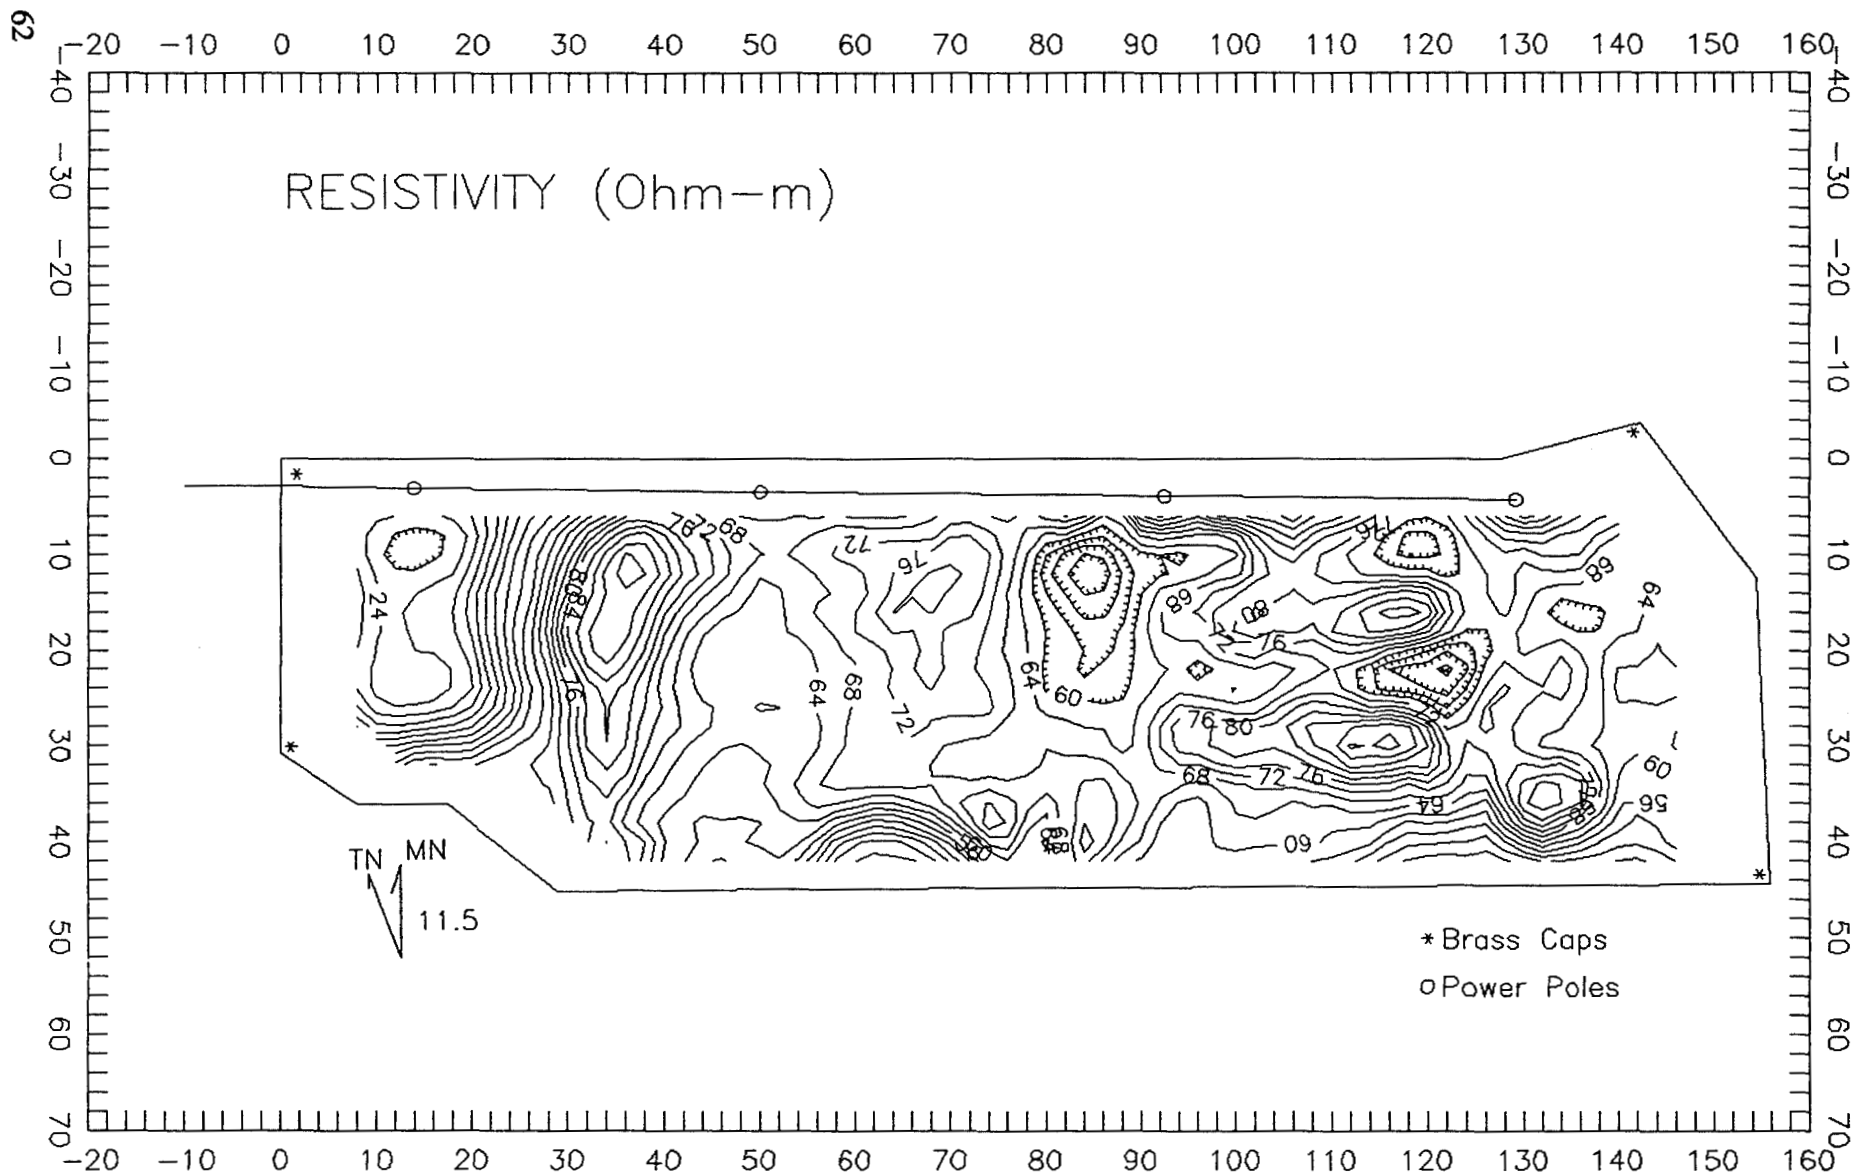
Fig. 30. Filtered apparent resistivity contour map. The contour interval is 4 ohm-m.

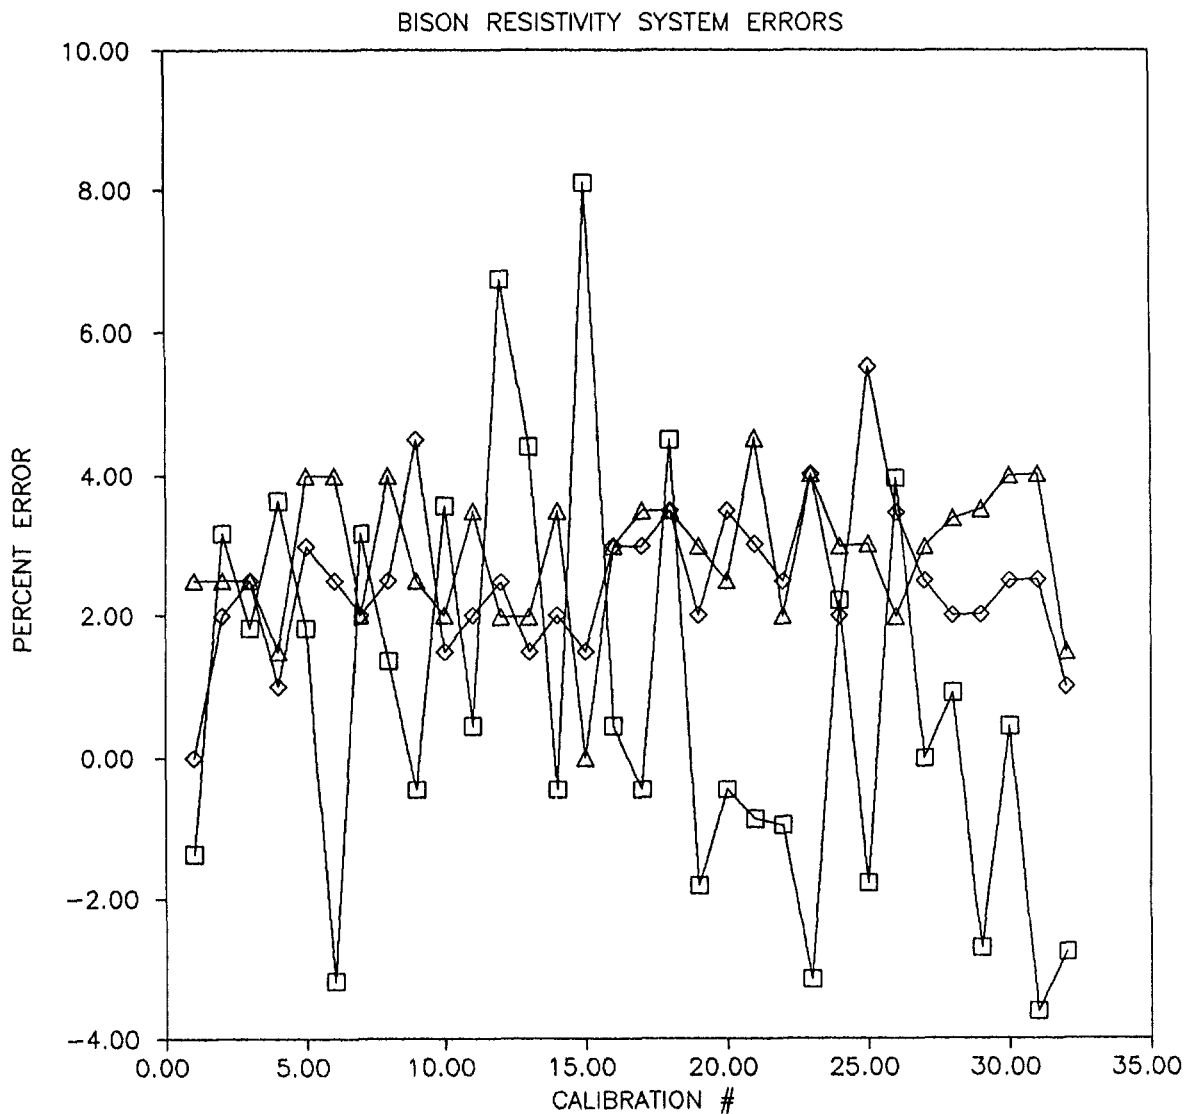
Fig. 31. Bison resistivity system errors measured during daily calibration. Squares, triangles, and diamonds indicate measurements through 0.11-ohm, 1.0-ohm, and 10.0-ohm resistors, respectively.

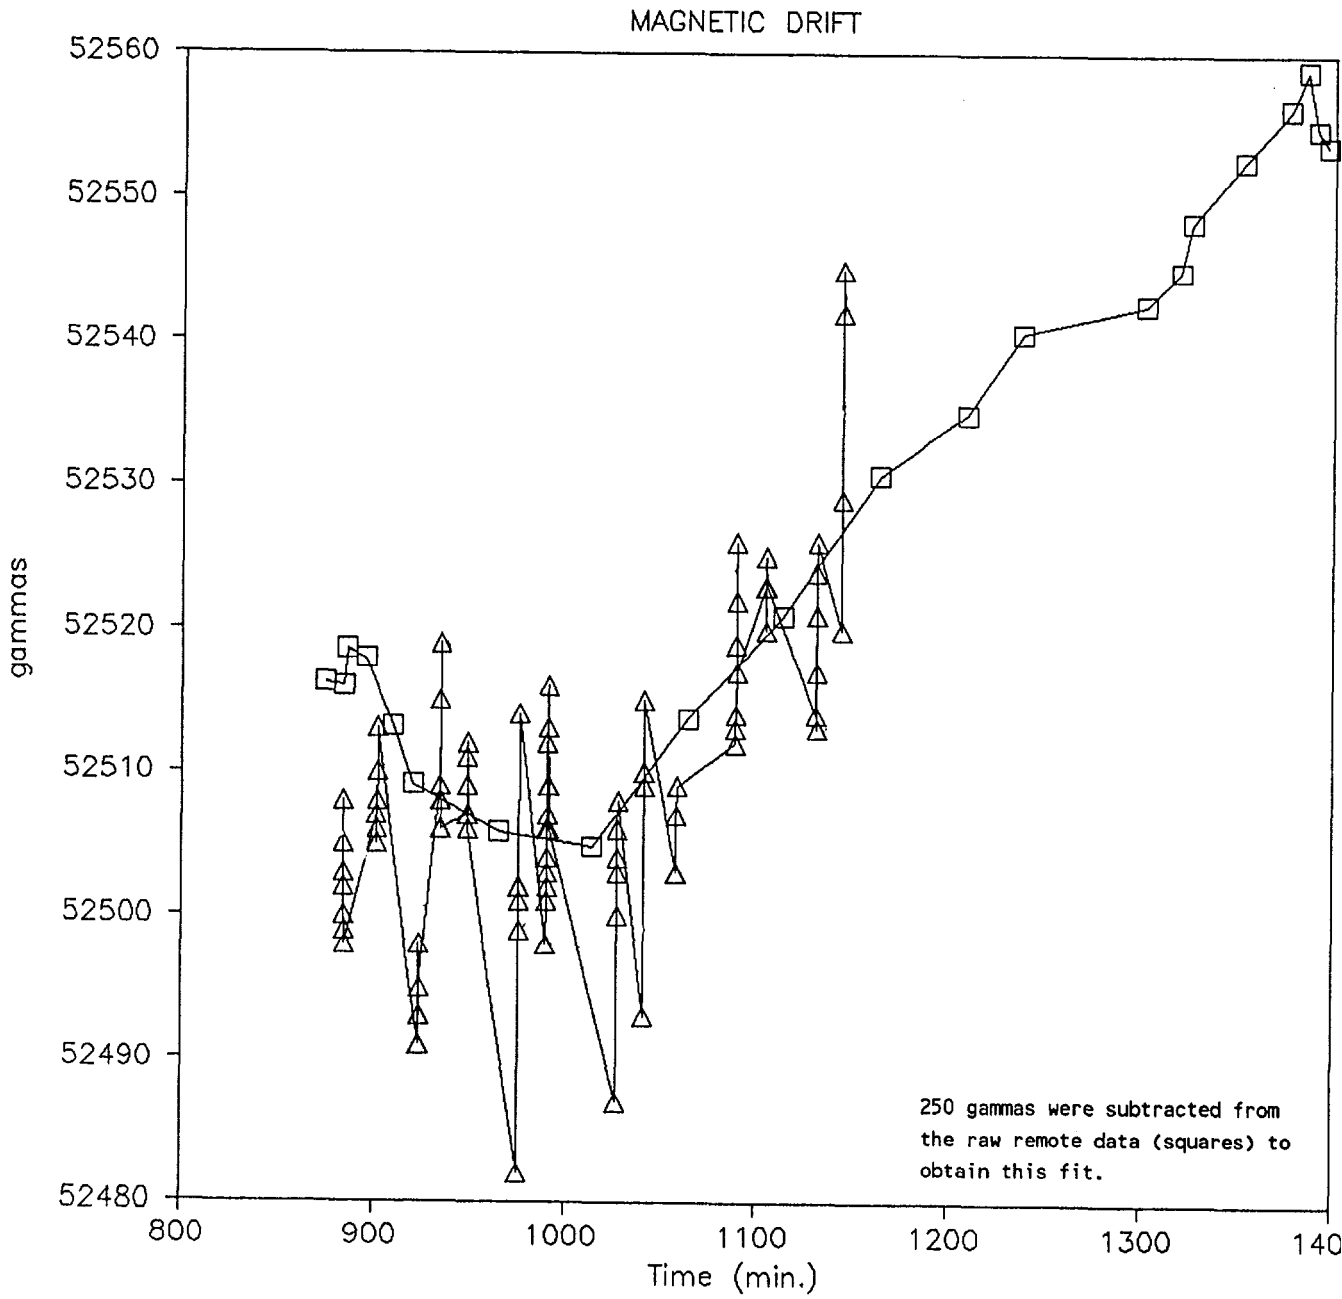
Fig. 34. Magnetic field diurnal drift measurements from station 20S,40E (squares) and diurnal drift measurements recorded during the reoccupations of station 26S,40E (triangles).

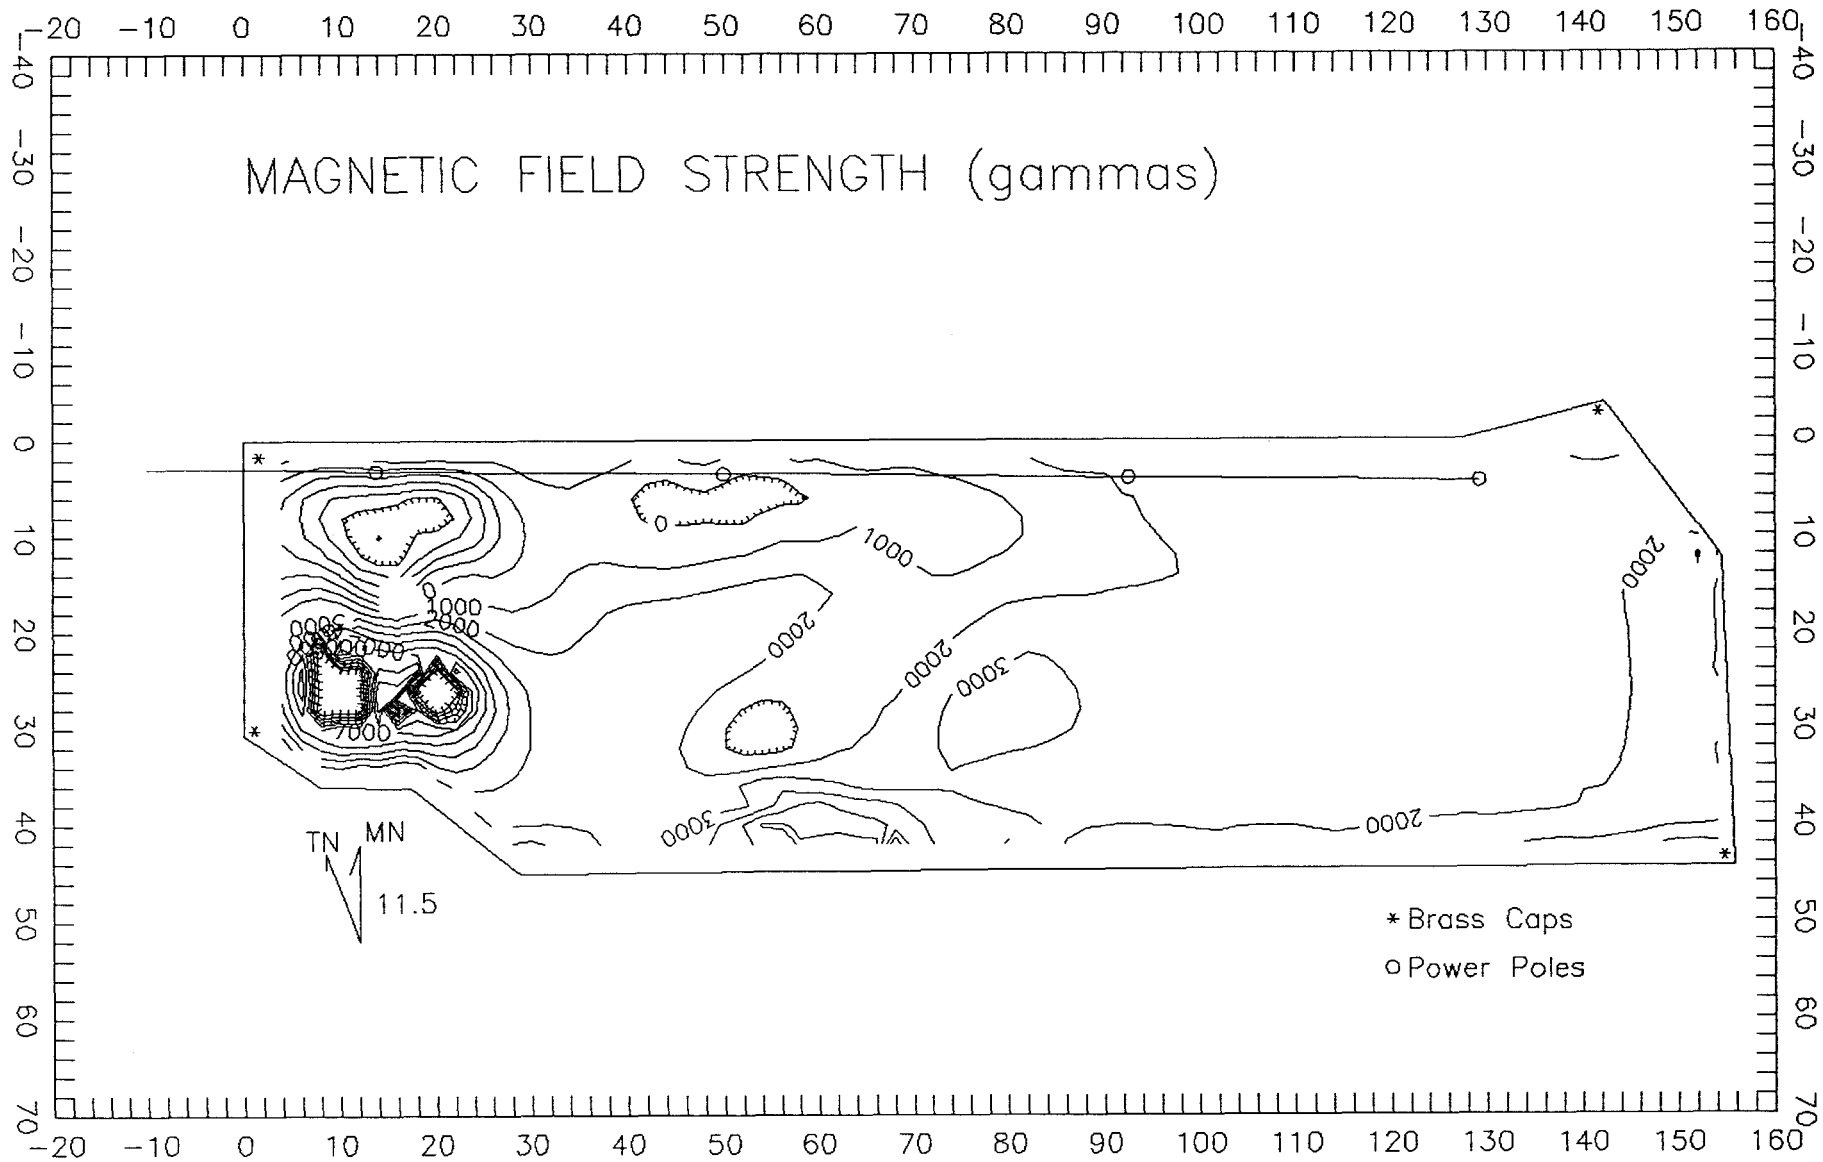
Fig. 35. Magnetic field strength (minus 50 000 gammas) contour map. The contour interval is 1000 gammas.

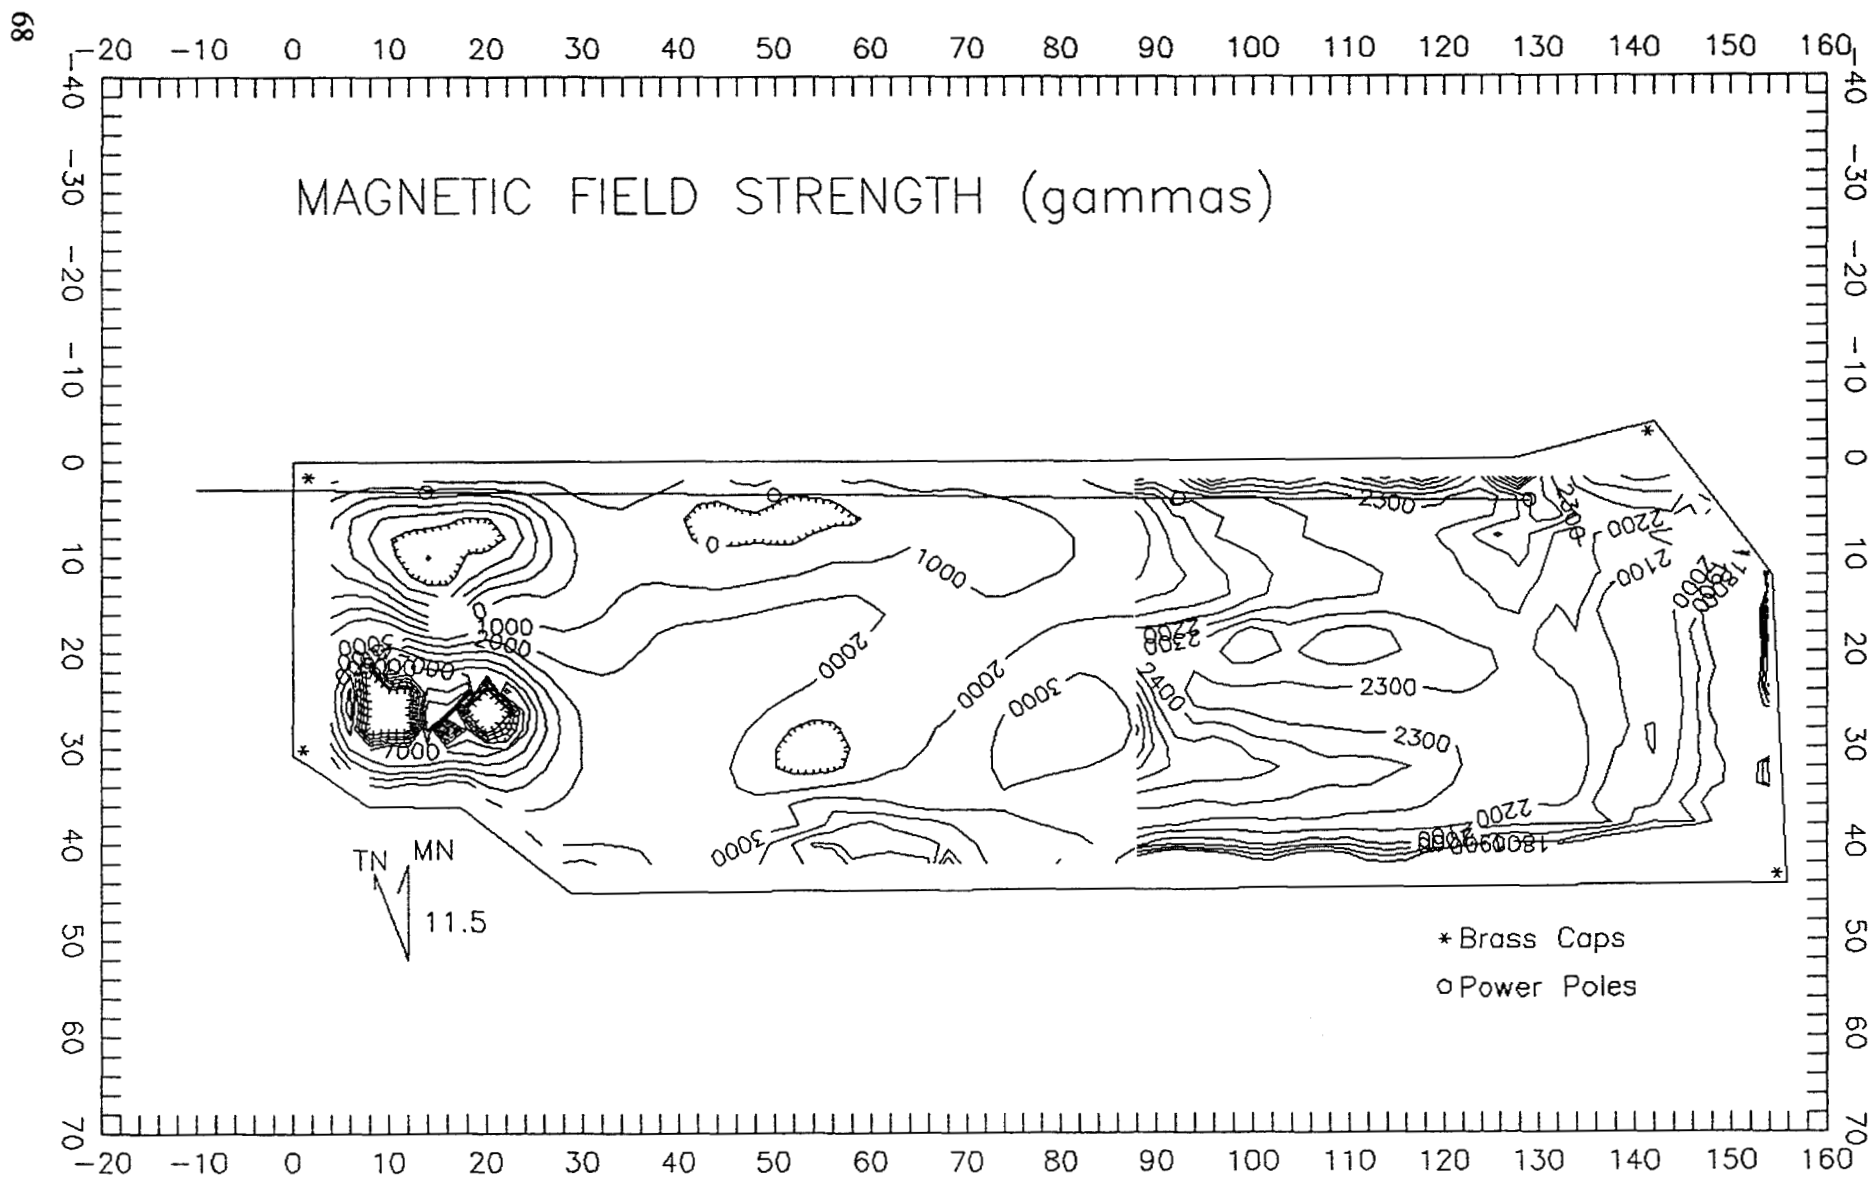
Fig. 36. Magnetic field strength (minus 50 000 gammas) contour map with two contour intervals (1000 and 100 gammas).

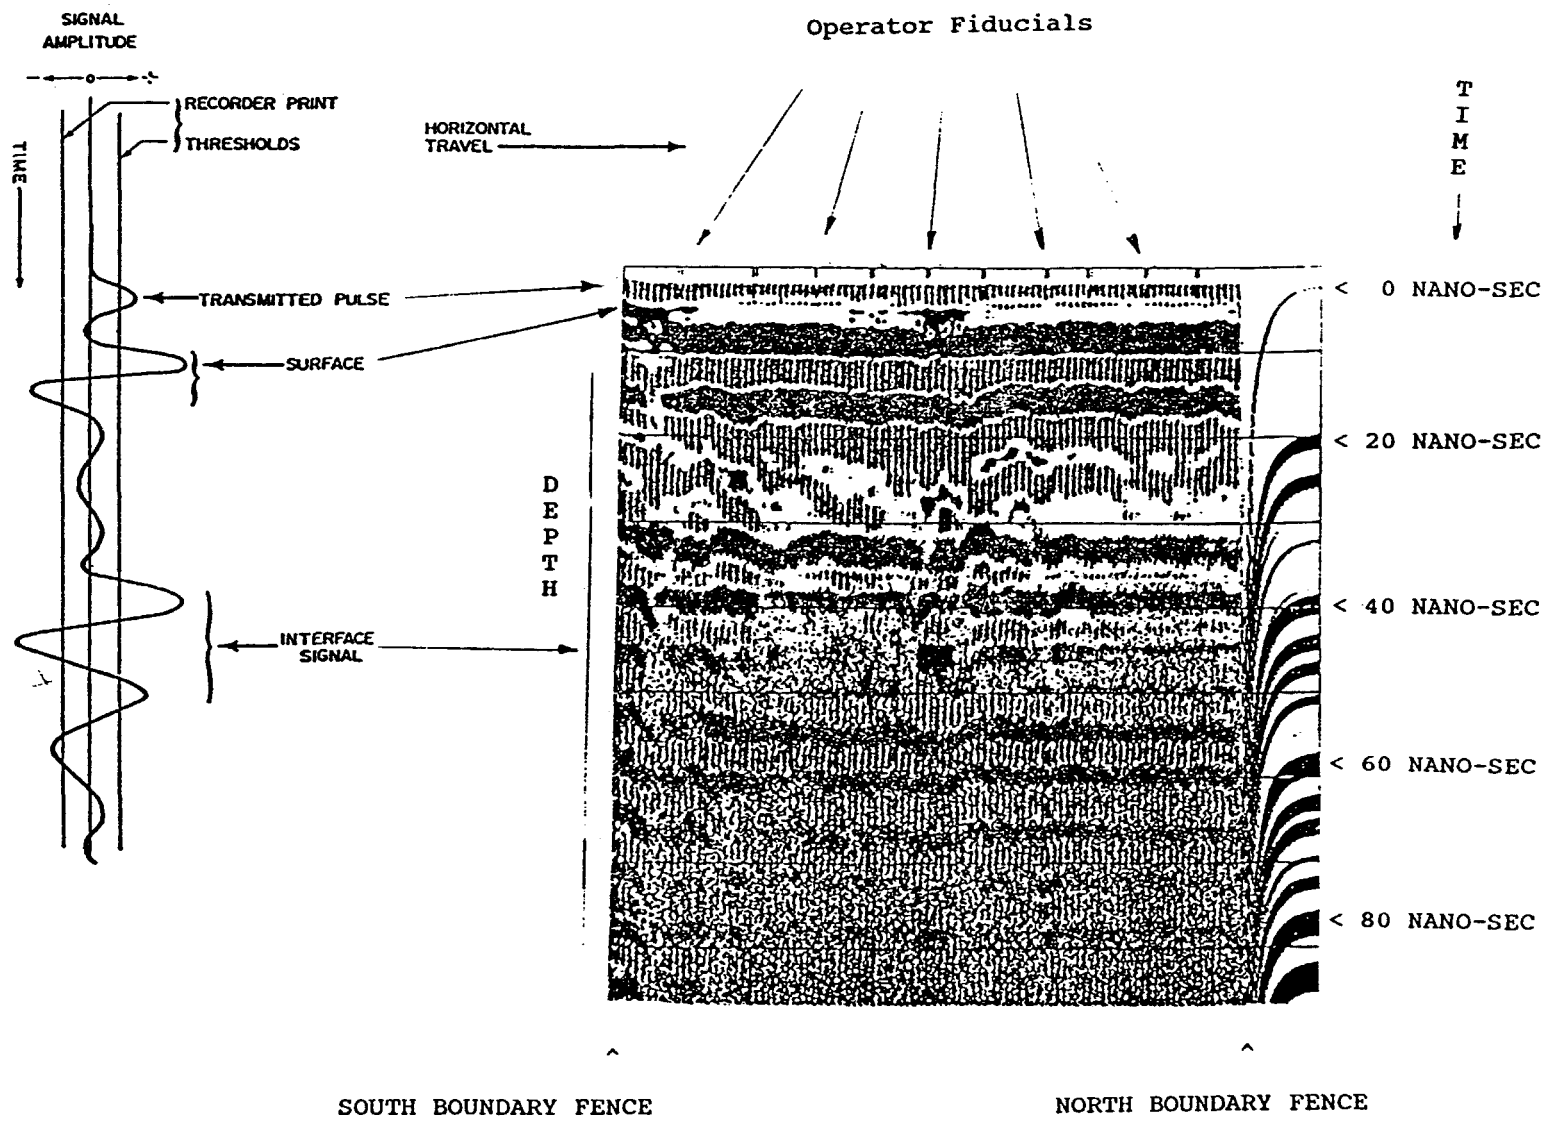
Fig. 37. Example of radar profile information as displayed by the radar system.

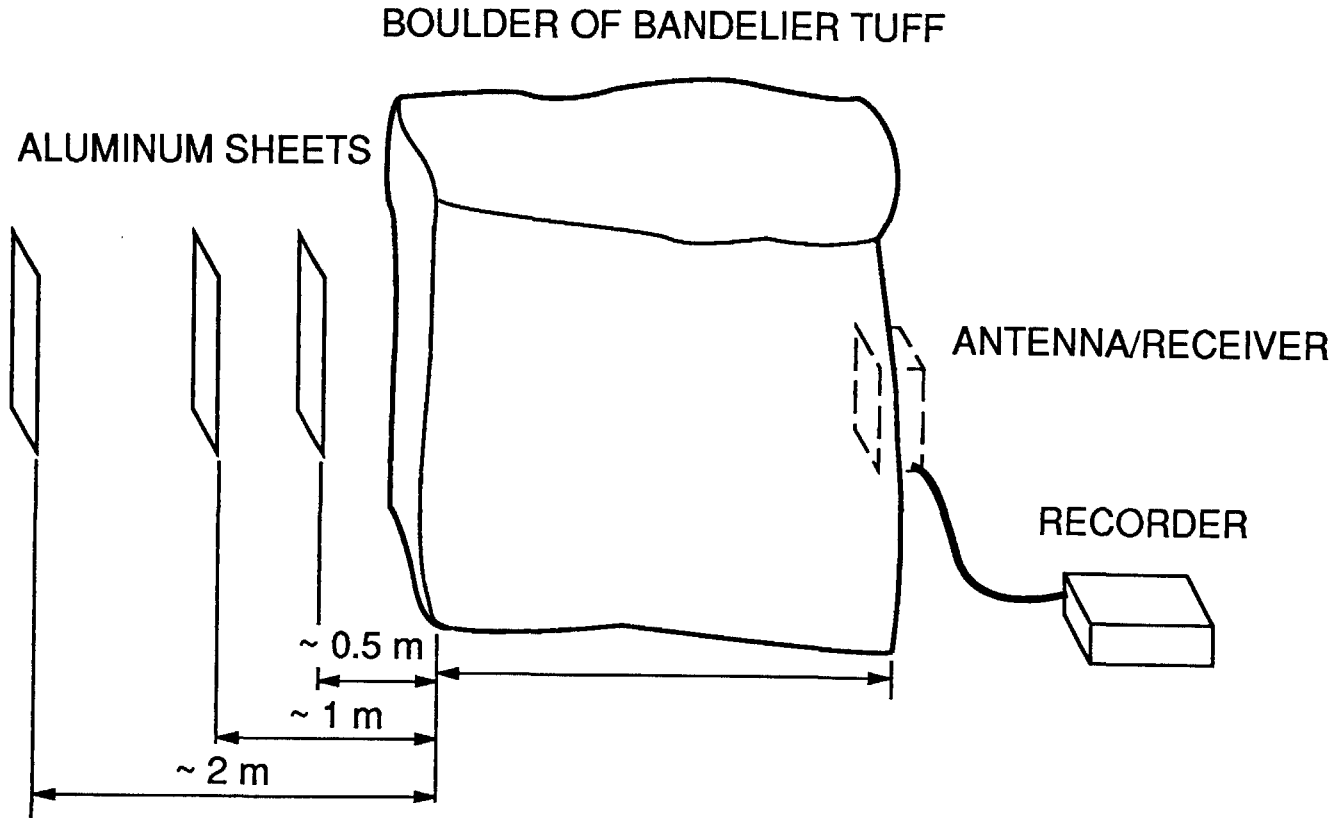
Fig. 38. Illustration of the geometry used to calibrate the radar unit.
