*History and Geophysical Description of
Hazardous Waste Disposal Area A
Technical Area 21*

Michael Gerety

John Nyhan

Ronald Oliver

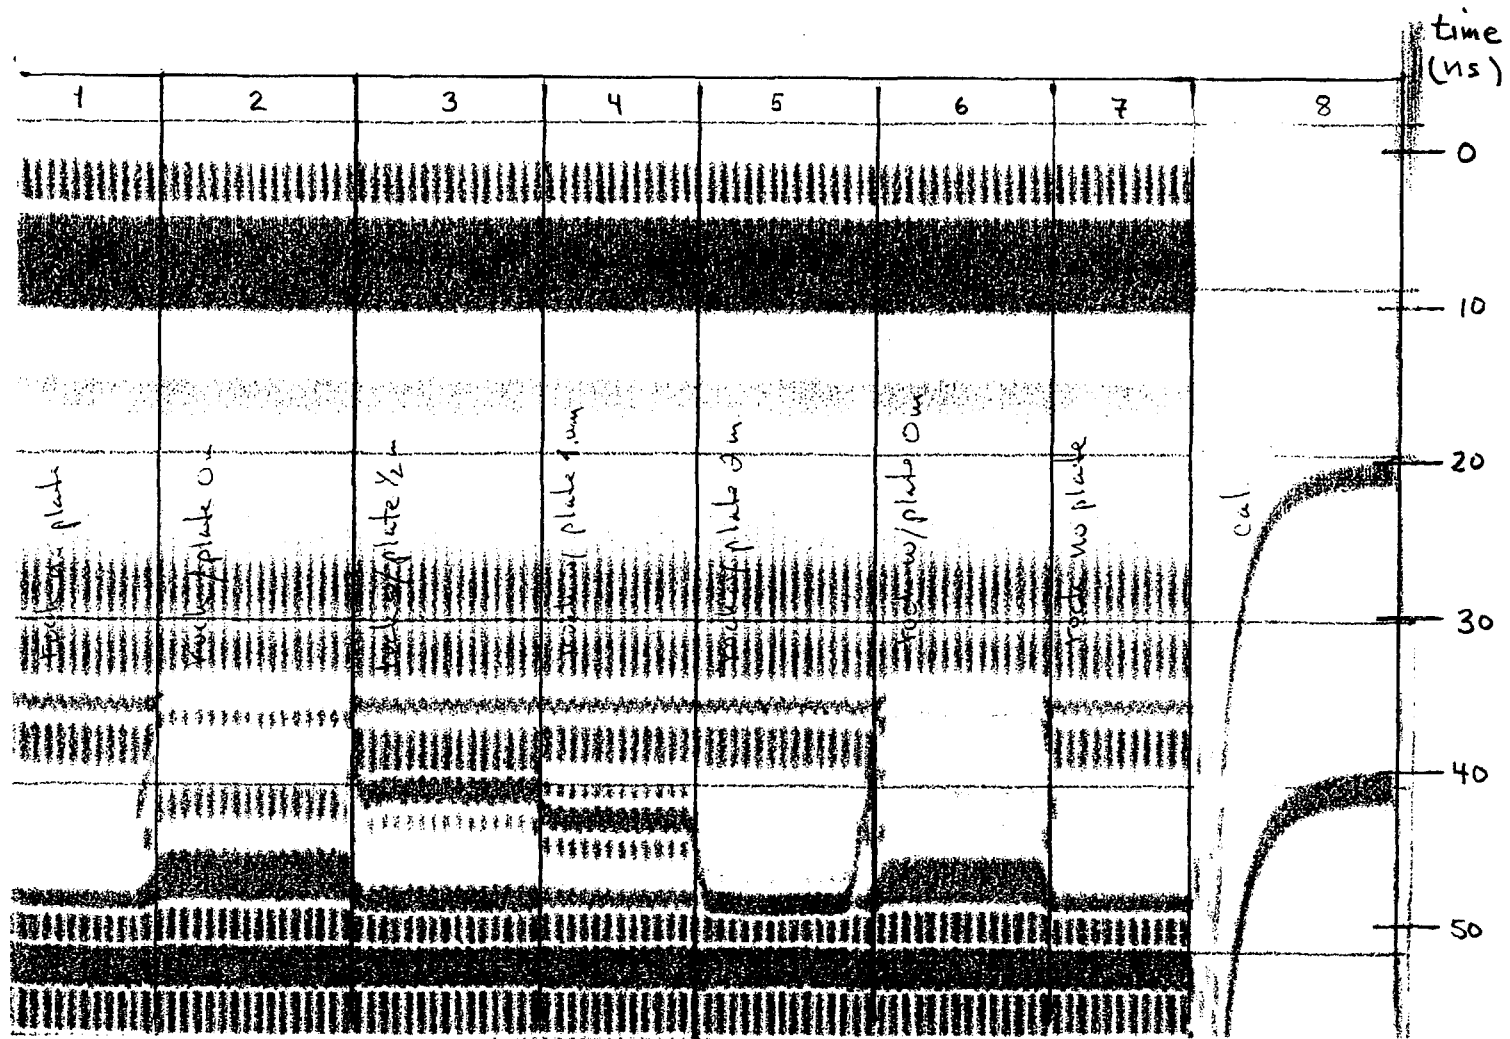
Fig. 40. Radar calibration data resulting from the geometry of Fig. 38. The gains and filter settings are different than used in Fig. 39.

From Figs. 39 and 40 one can see that the radar unit is very sensitive to the filter and gain settings, which must be set qualitatively by the operator in the field. At Area A we observed the reflection trace on an oscilloscope while passing over some of the easiest targets on site. We profiled directly over the large storage tanks and also the two trenches. There was nothing apparent either on the recorded traces or on the oscilloscope that would have helped us adjust the filter and gain settings for the overall site. Therefore, the settings used were our best guess, based on the oscilloscope information.

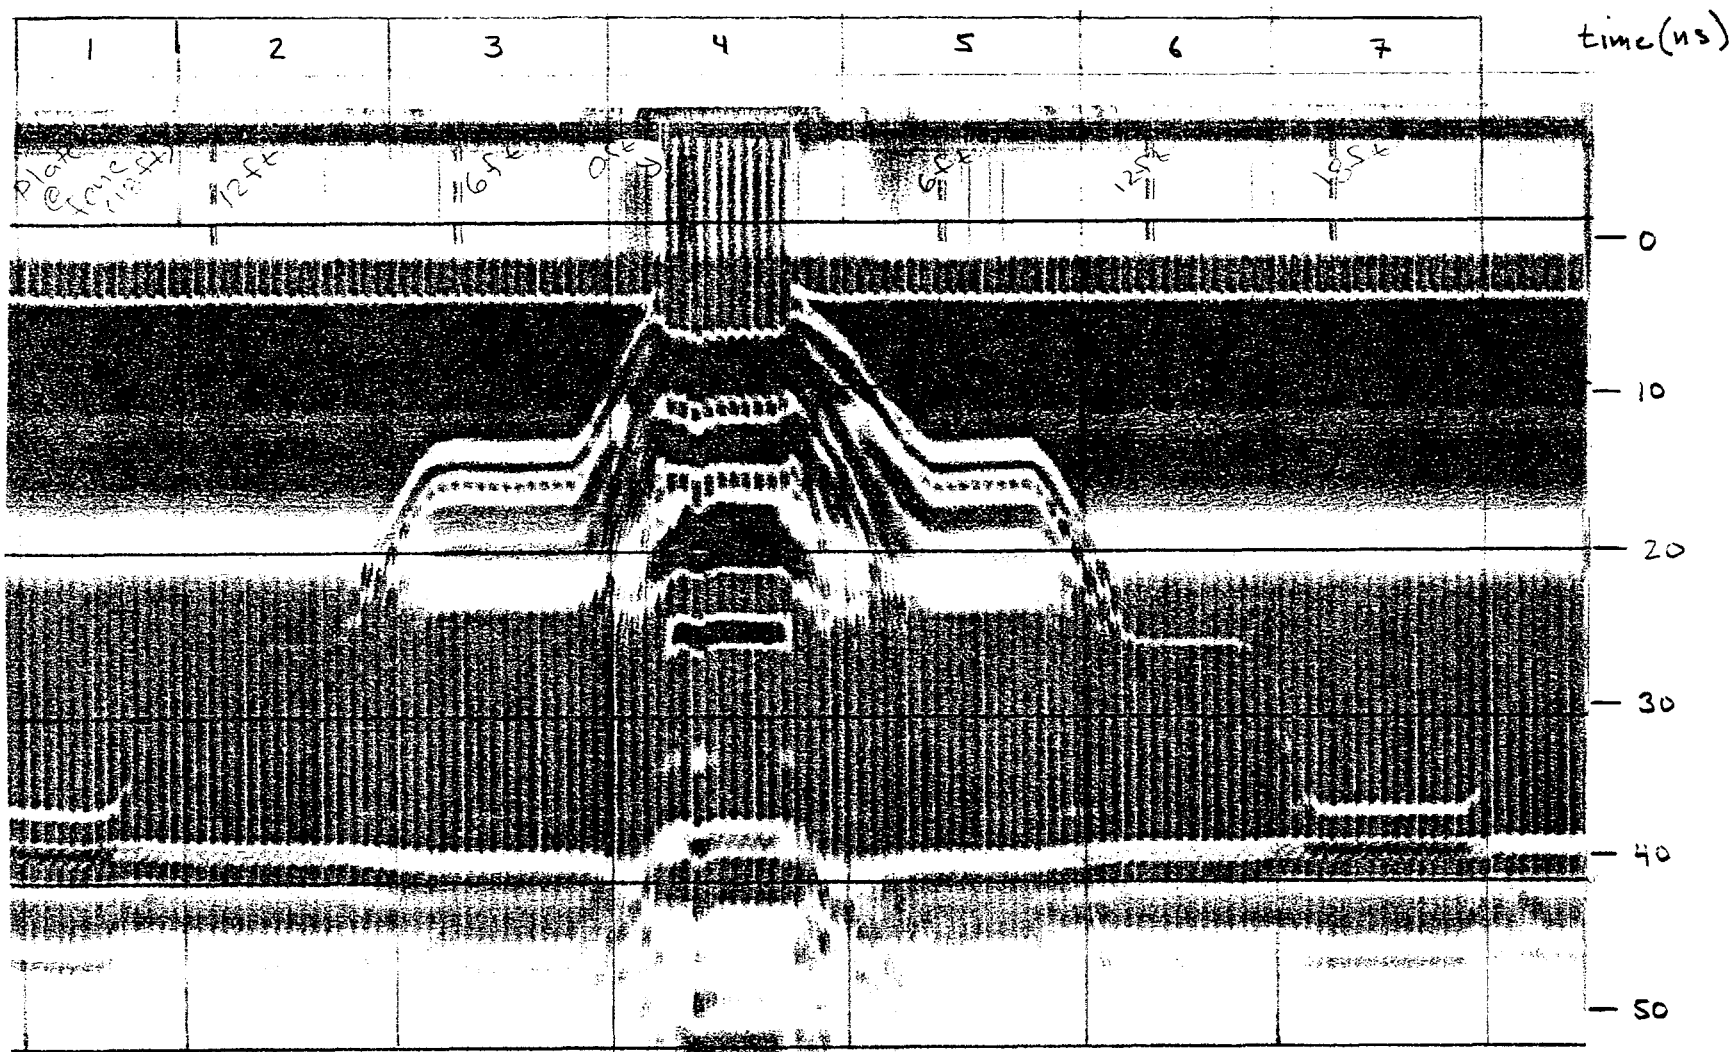
Fig. 41. Radar profiles of the data taken to calibrate the radar system on the fence surrounding Area A.

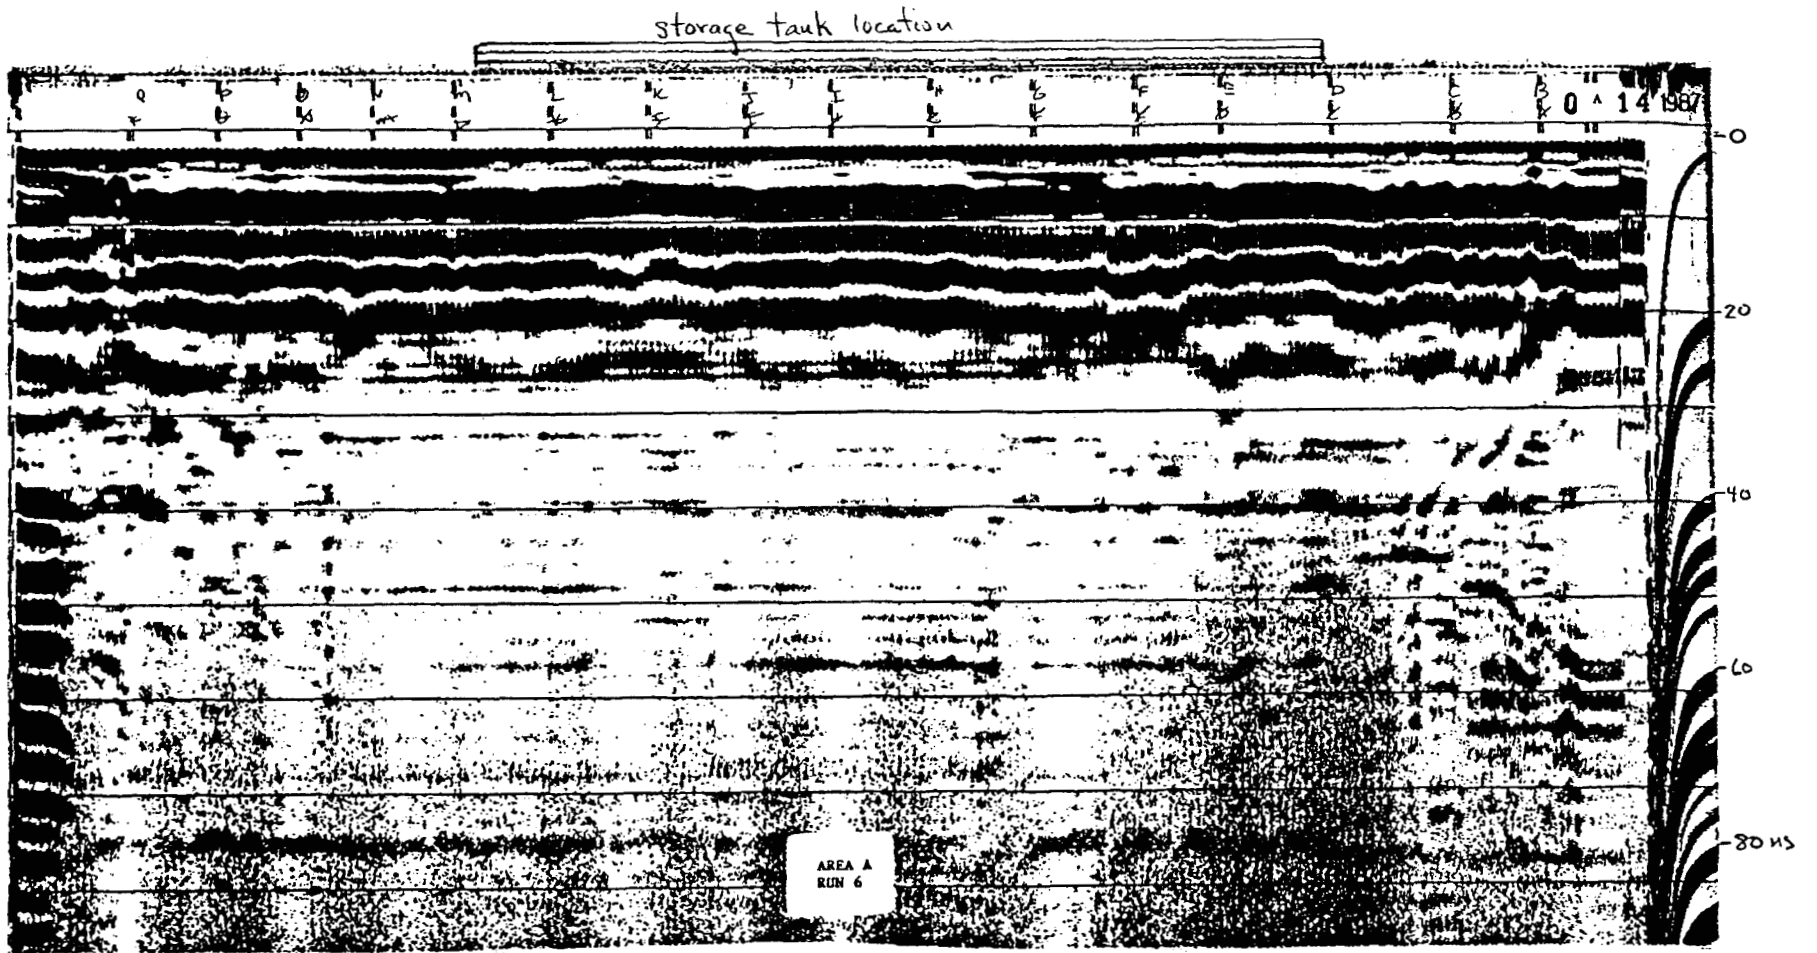
Fig. 42. Radar profile along line 12E over General's storage tank A1.

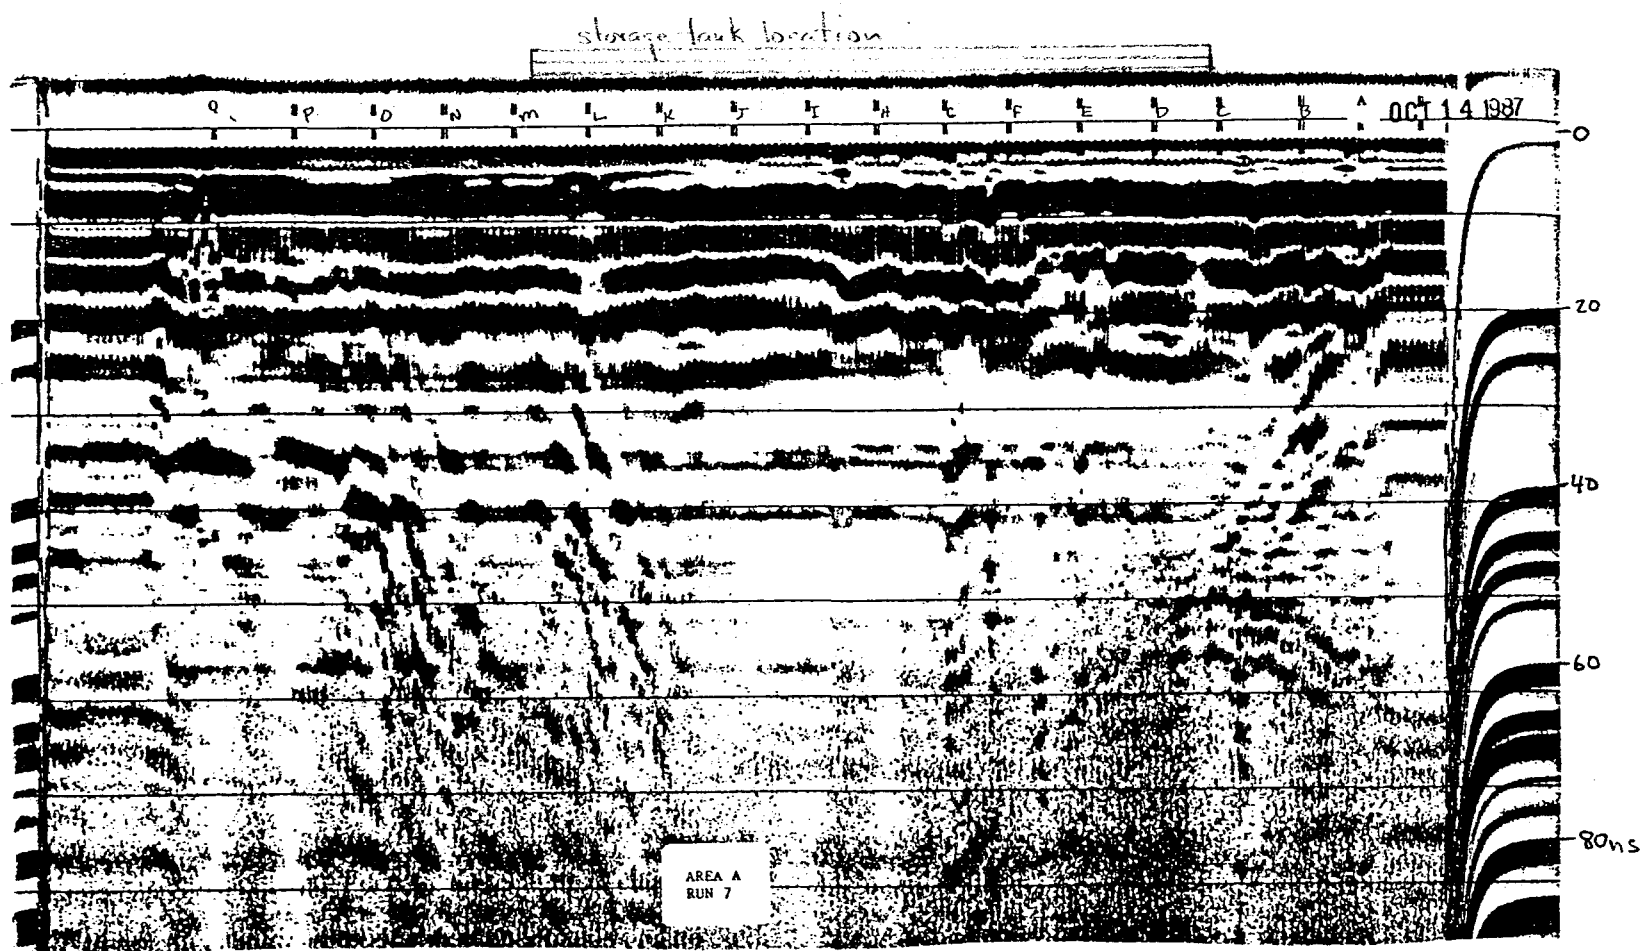
Fig. 43. Radar profile along line 16E over General's storage tank A2.

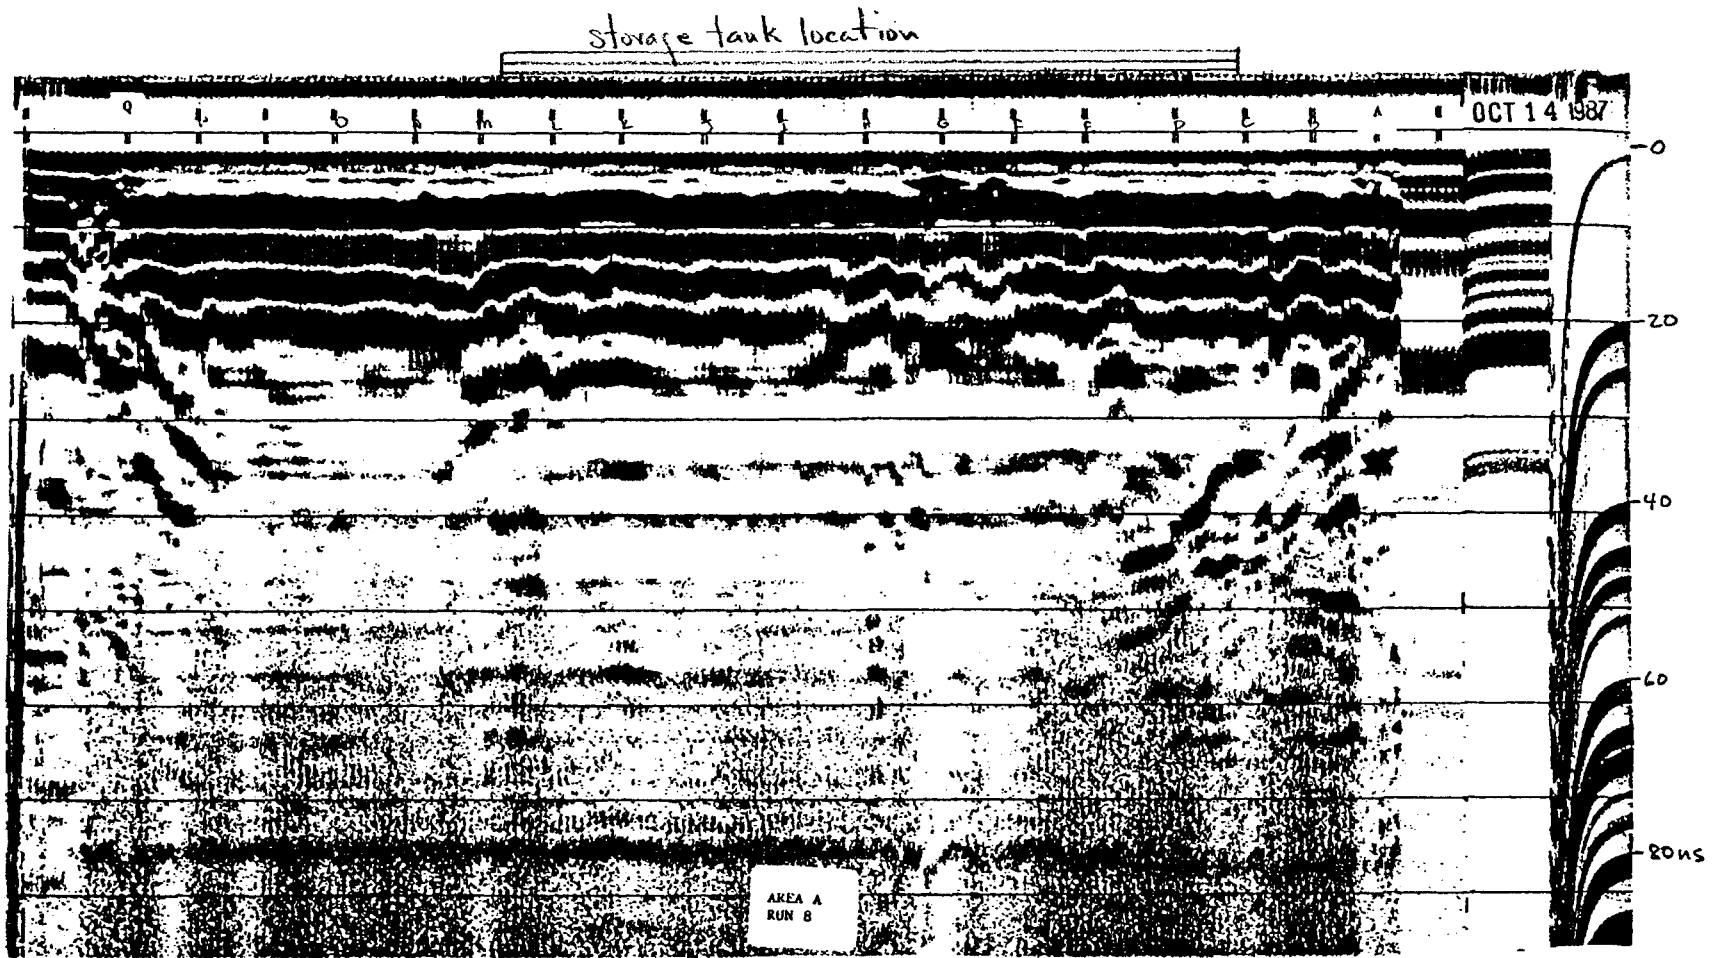
Fig. 44. Radar profile along line 20E over General's storage tank A2.

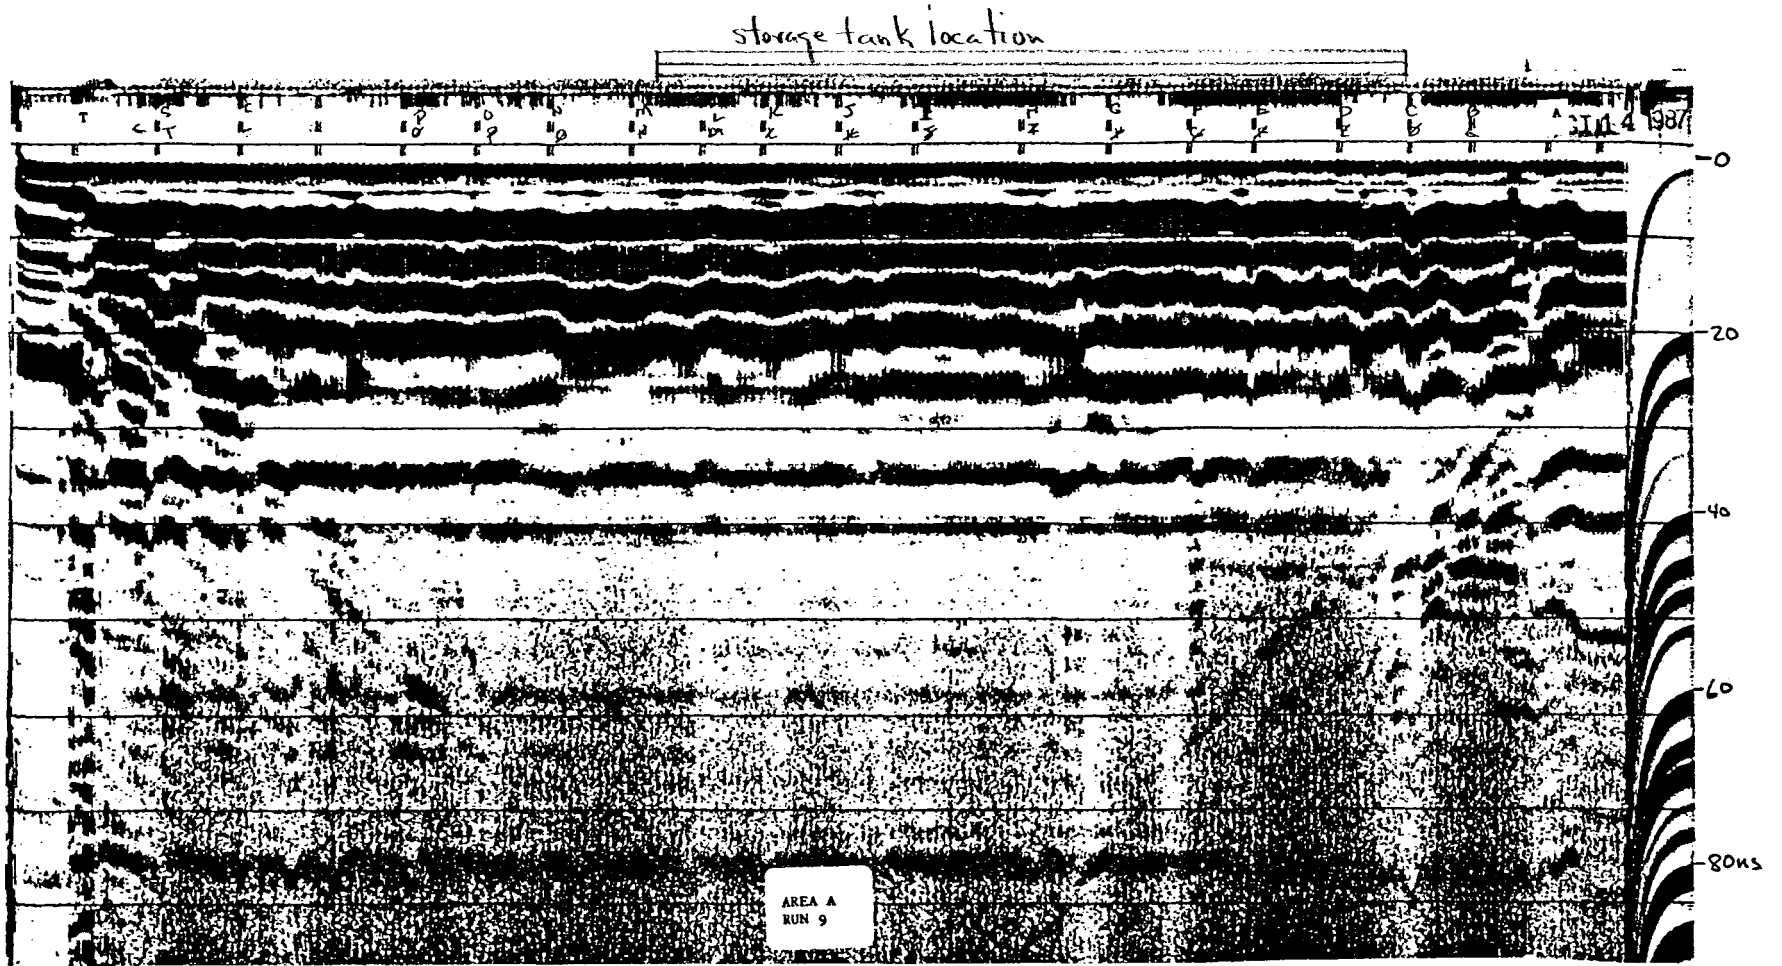
Fig. 45. Radar profile along line 24E over General's storage tank A2.

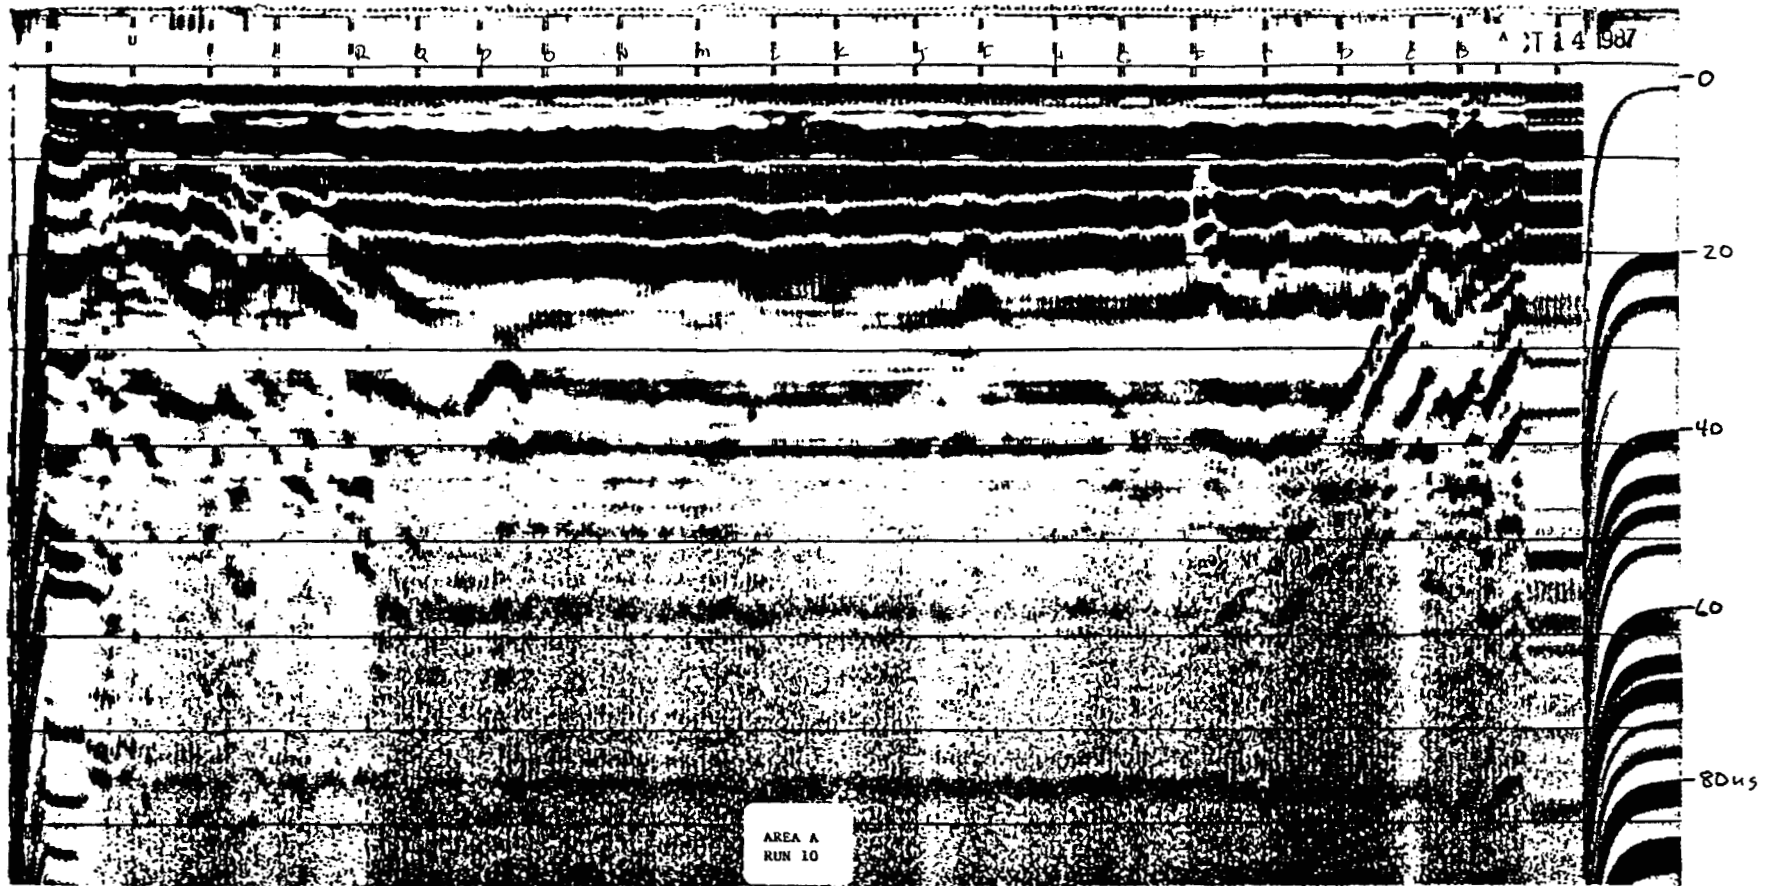
Fig. 46. Radar profile along line 28E. This profile does not pass over any known object, pit or trench.

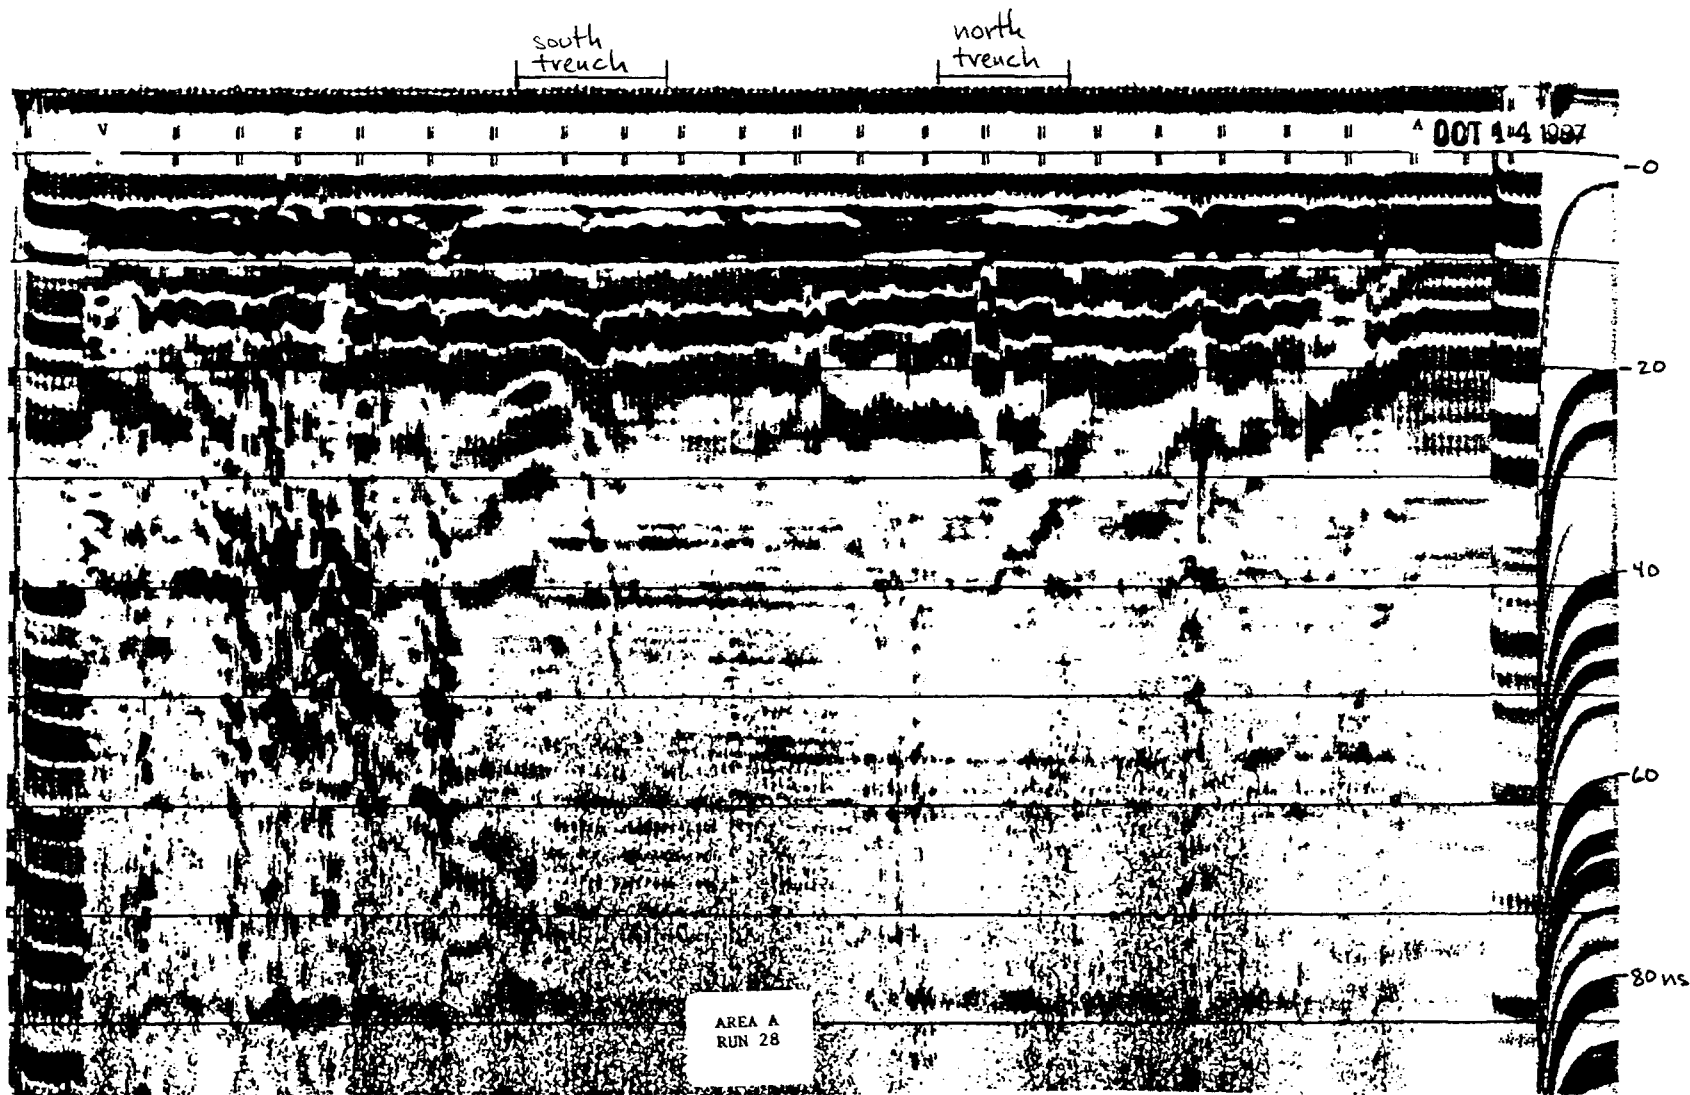
Fig. 47. Radar profile along line 100E over trenches B1 and B2.

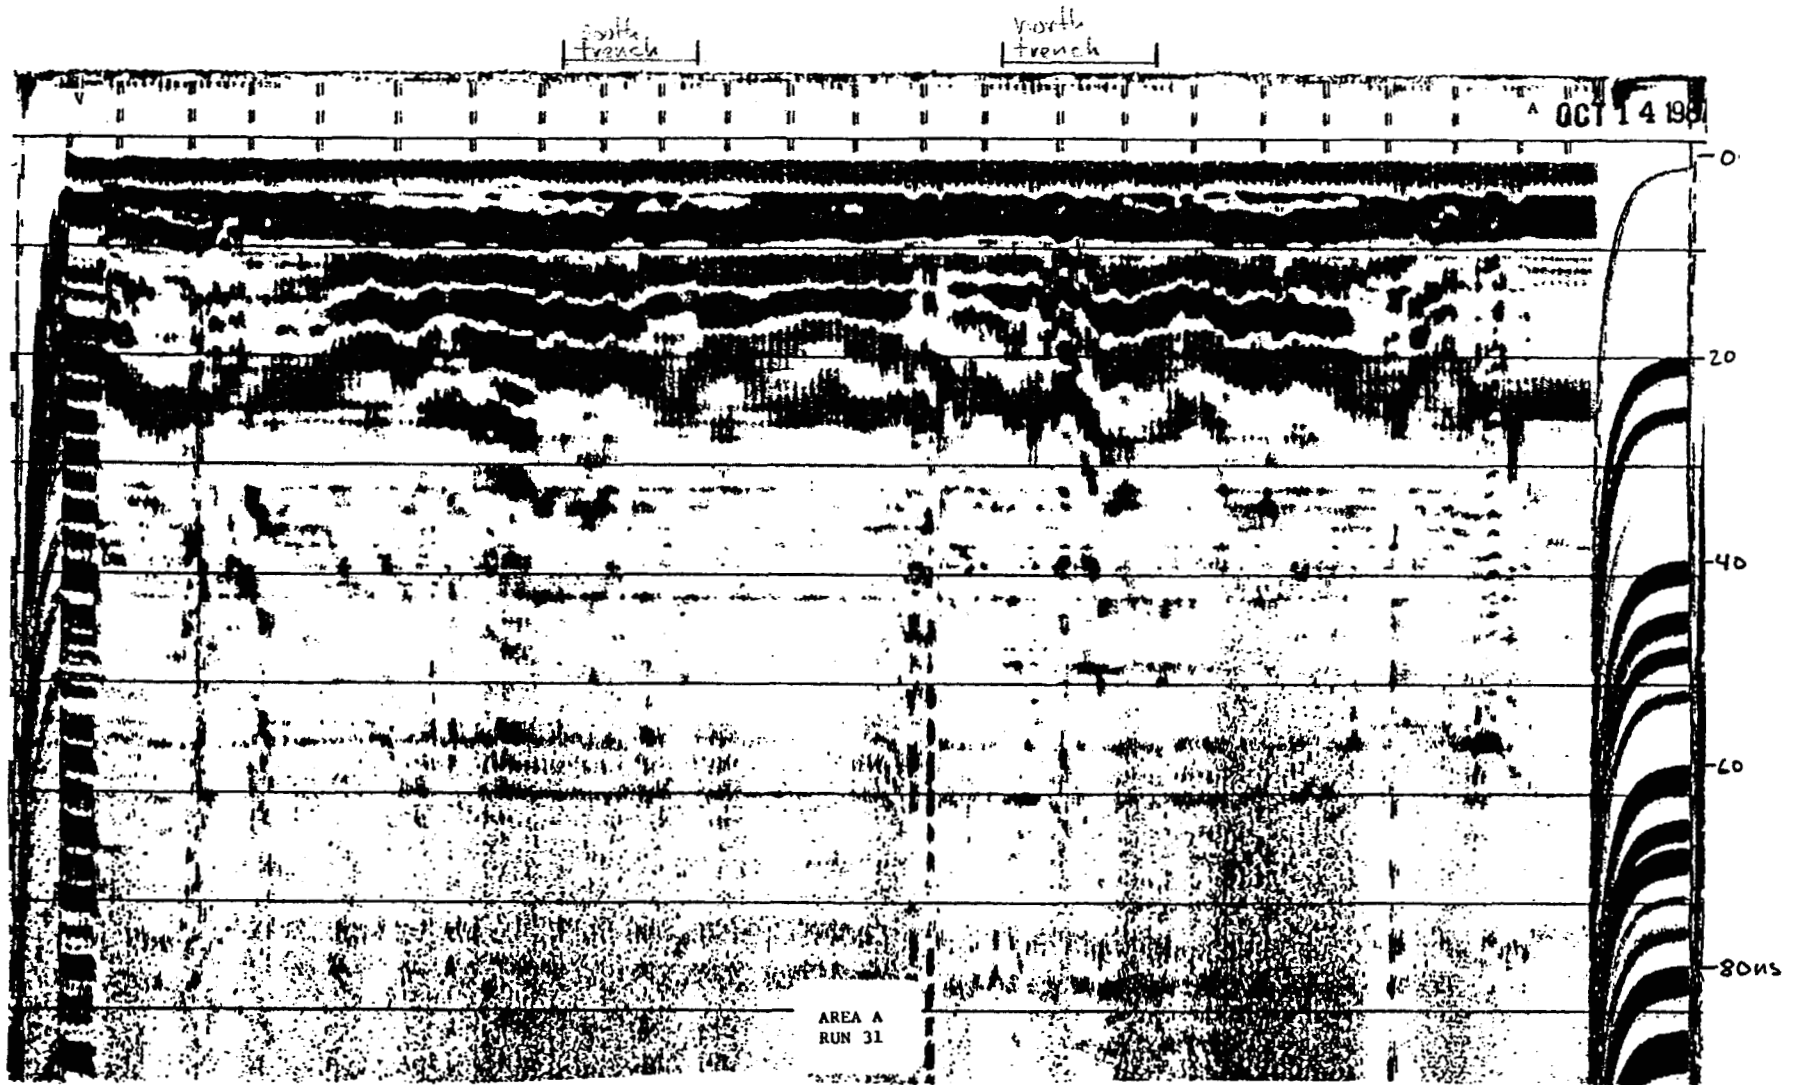
Fig. 48. Radar profile along line 112E over trenches B1 and B2.

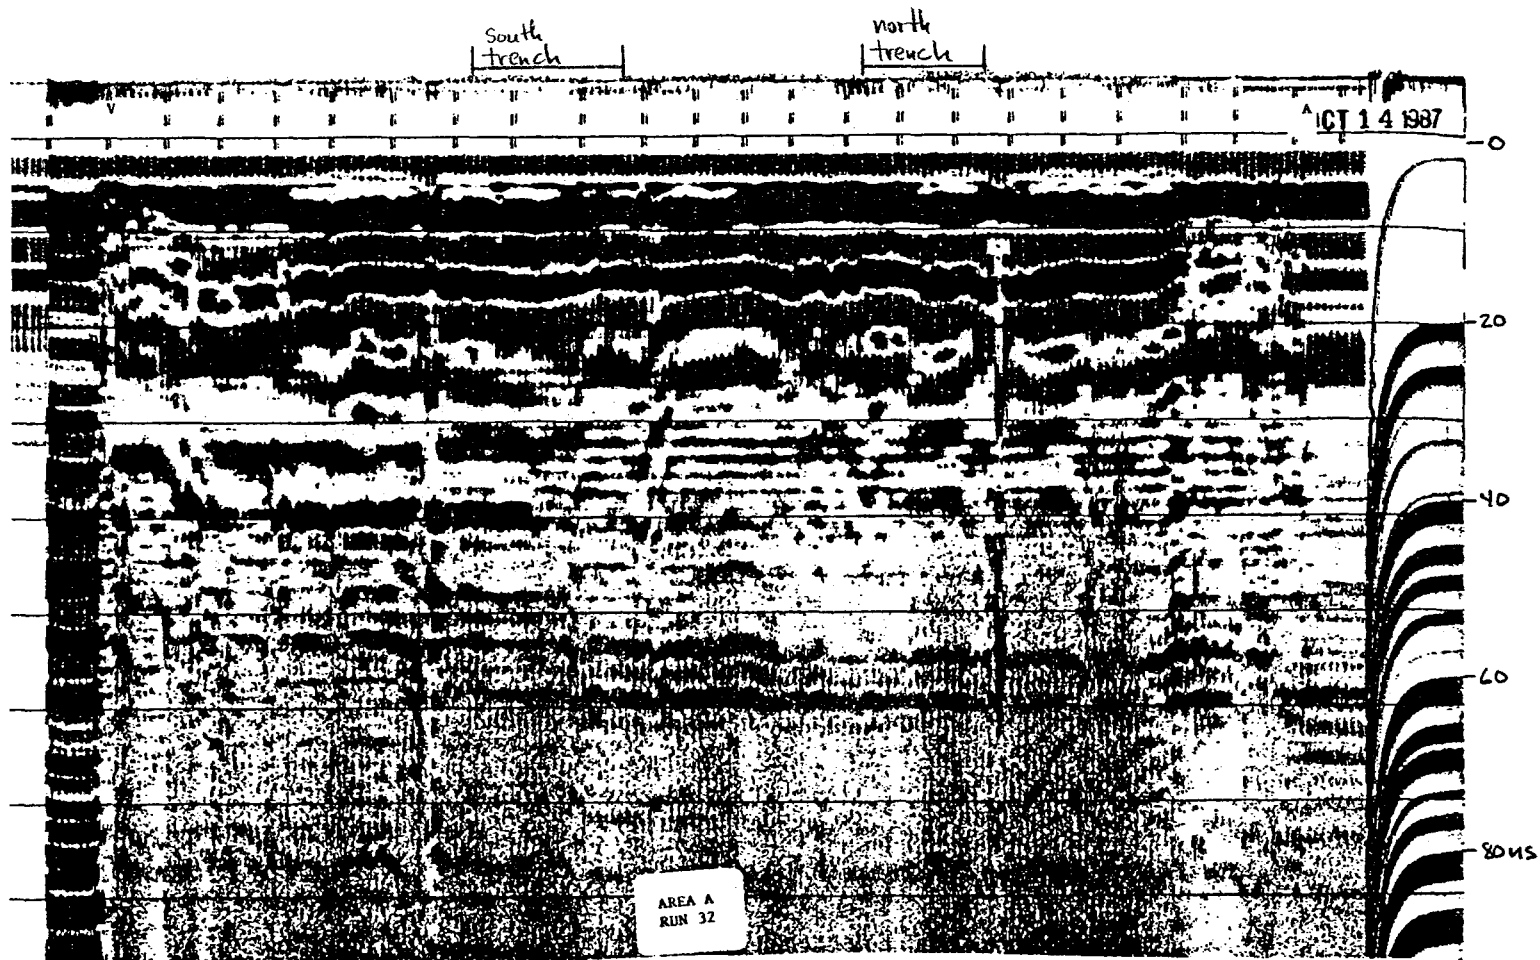
Fig. 49. Radar profile along line 116E over trenches B1 and B2.

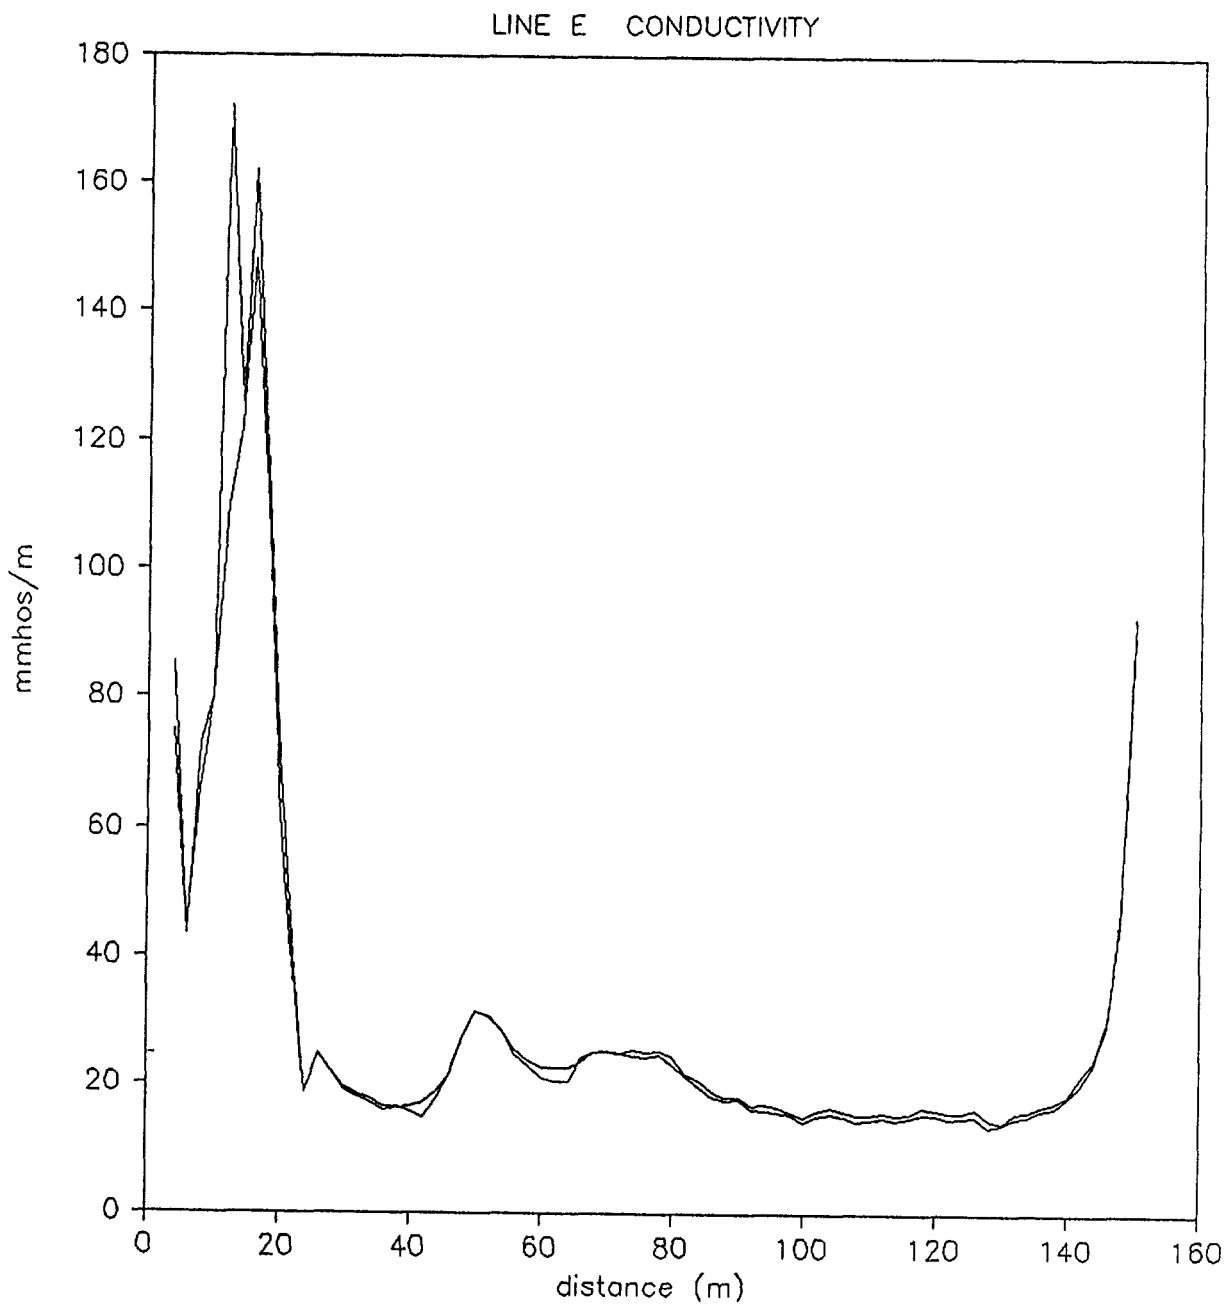
Fig. 50. EMI quadrature component profile line E (10S). Data were measured on two separate days to demonstrate repeatability.

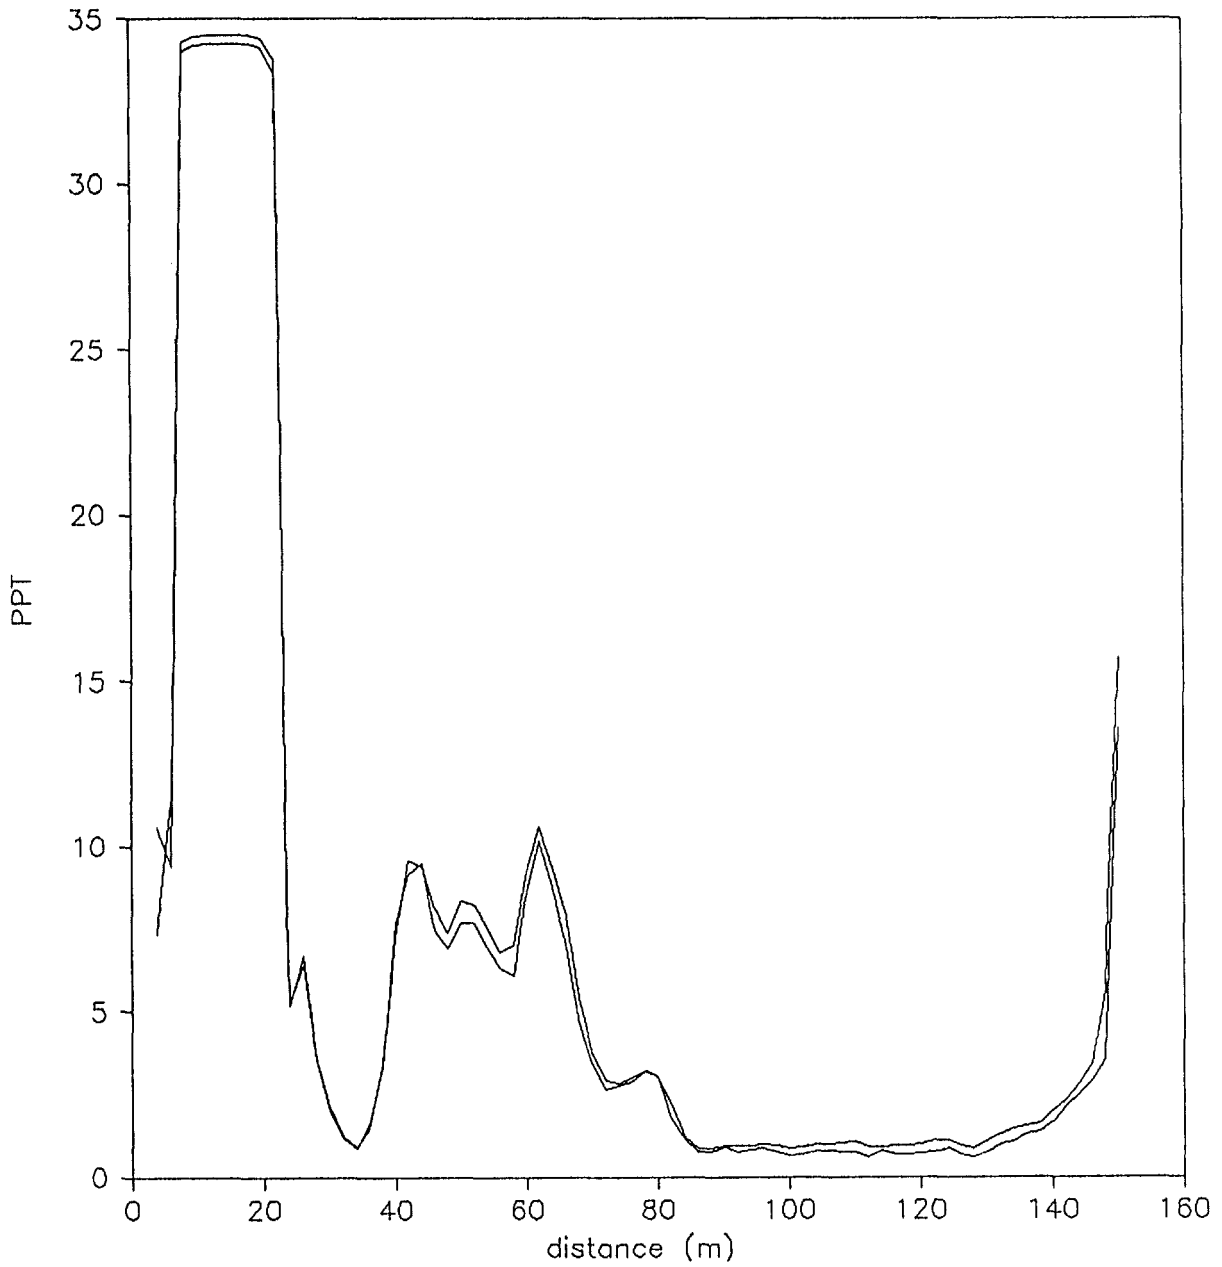
LINE E IN-PHASE

Fig. 51. EMI in-phase component profile line E (10S). Data were measured on two separate days to demonstrate repeatability.

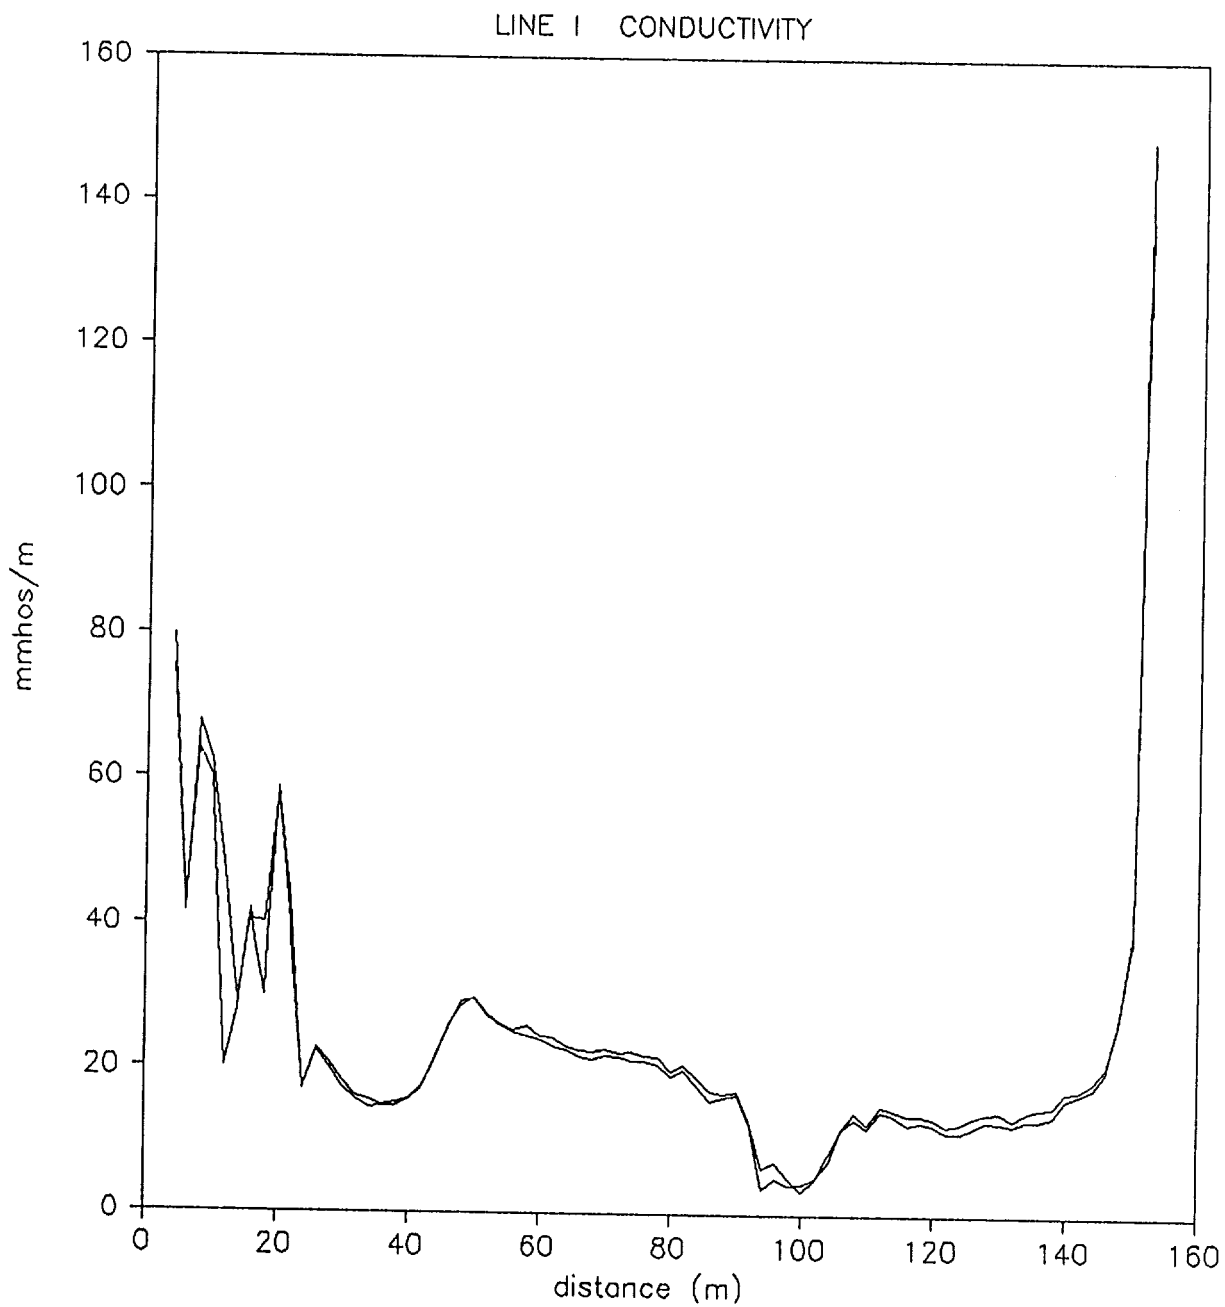
Fig. 52. EMI quadrature component profile line I (18S). Data were measured on two separate days to demonstrate repeatability.
