*History and Geophysical Description of
Hazardous Waste Disposal Area A
Technical Area 21*

Michael Gerety

John Nyhan

Ronald Oliver

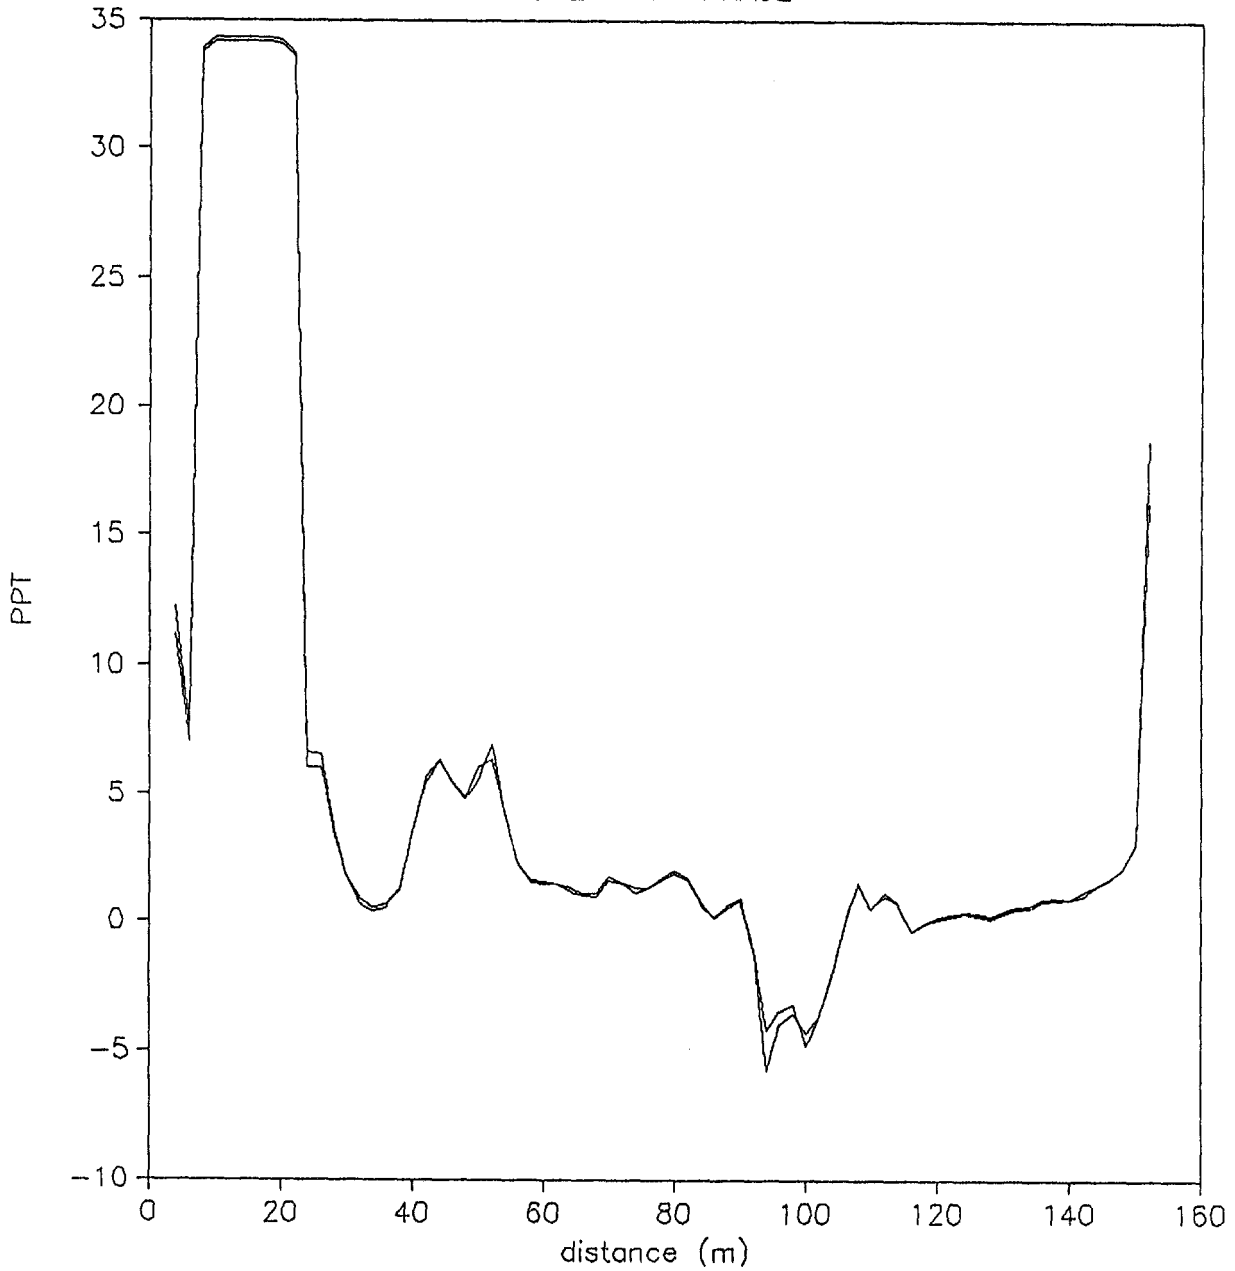
LINE I IN-PHASE

Fig. 53. EMI in-phase component profile line I (18S). Data were measured on two separate days to demonstrate repeatability.
