LA-UR-03-8046
October 2003
ER2003-0643

Material Disposal Area P Site Closure Certification Report

This closure certification report summarizes the activities performed to demonstrate clean closure for two hazardous waste management units: Material Disposal Area (MDA) P and the TA-16-387 Flash Pad (Flash Pad 387). Both units are located at the Technical Area (TA) 16 Burning Ground within the high explosives (HE) exclusion area at Los Alamos National Laboratory (the Laboratory) (Figure 1.0-1). MDA P is also identified as Solid Waste Management Unit (SWMU) 16-018 and Flash Pad 387 as SWMU 16-010(b). Voluntary corrective action (VCA) activities for a consolidated group of SWMUs, designated SWMU 16-016(c)-99, which is contiguous with MDA P and Flash Pad 387, were conducted simultaneously with the MDA P and Flash Pad 387 closure activities. SWMU 16-016(c)-99 includes the TA-16-386 Flash Pad (Flash Pad 386), a former barium nitrate pile, and a septic system [SWMU 16-010(a), SWMU 16-016(c), and SWMU 16-006(e), respectively]; these are sometimes referred to as the "Burning Ground North." The two hazardous waste management units and SWMU 16-016(c)-99 were combined for cleanup purposes and

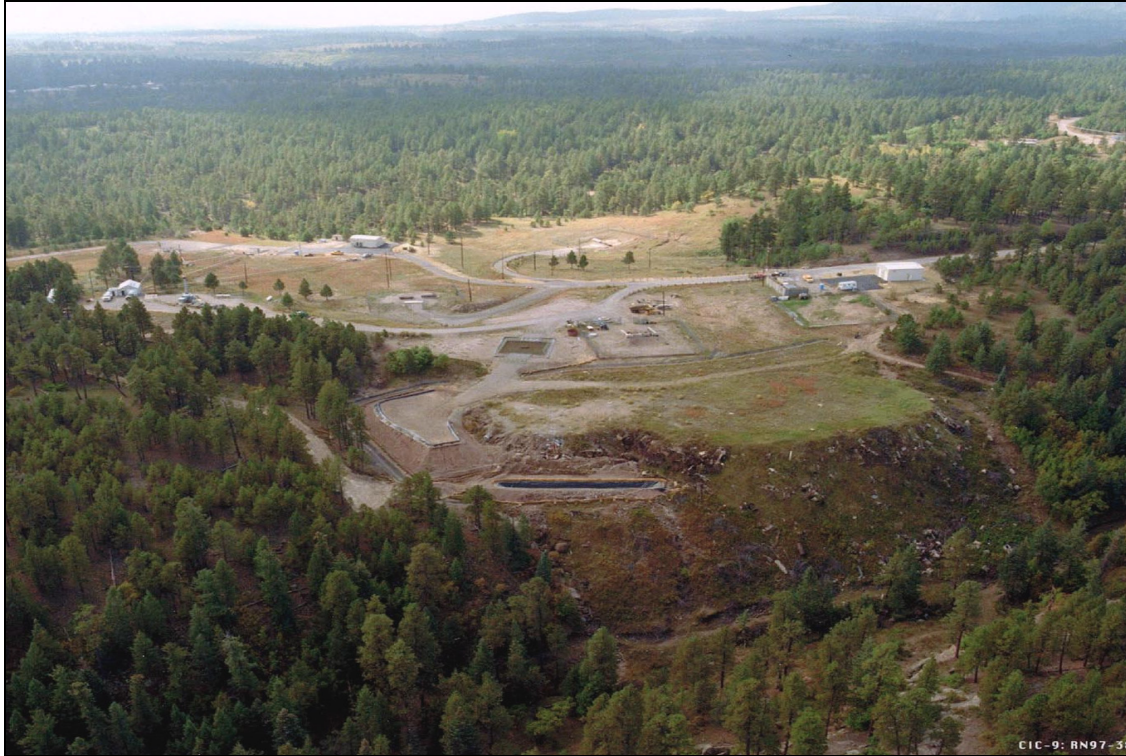
Photograph 1.4-1. Aerial view of the MDA P Site prior to excavation, 1997

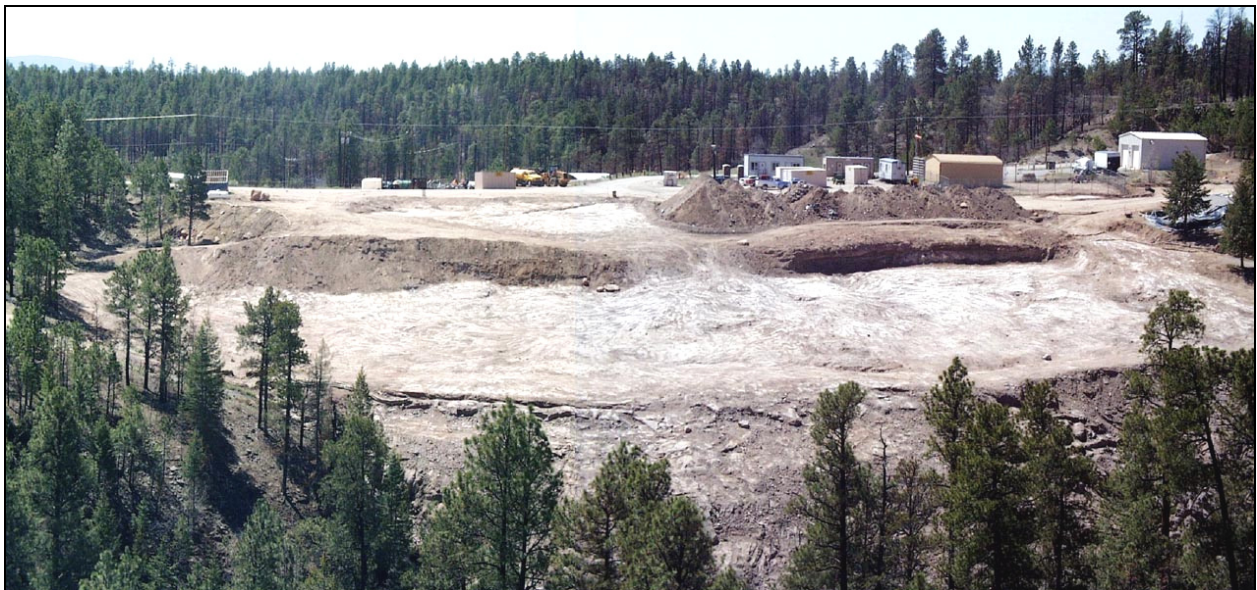
Photograph 1.4-2. Post-excitation condition of the MDA P Site

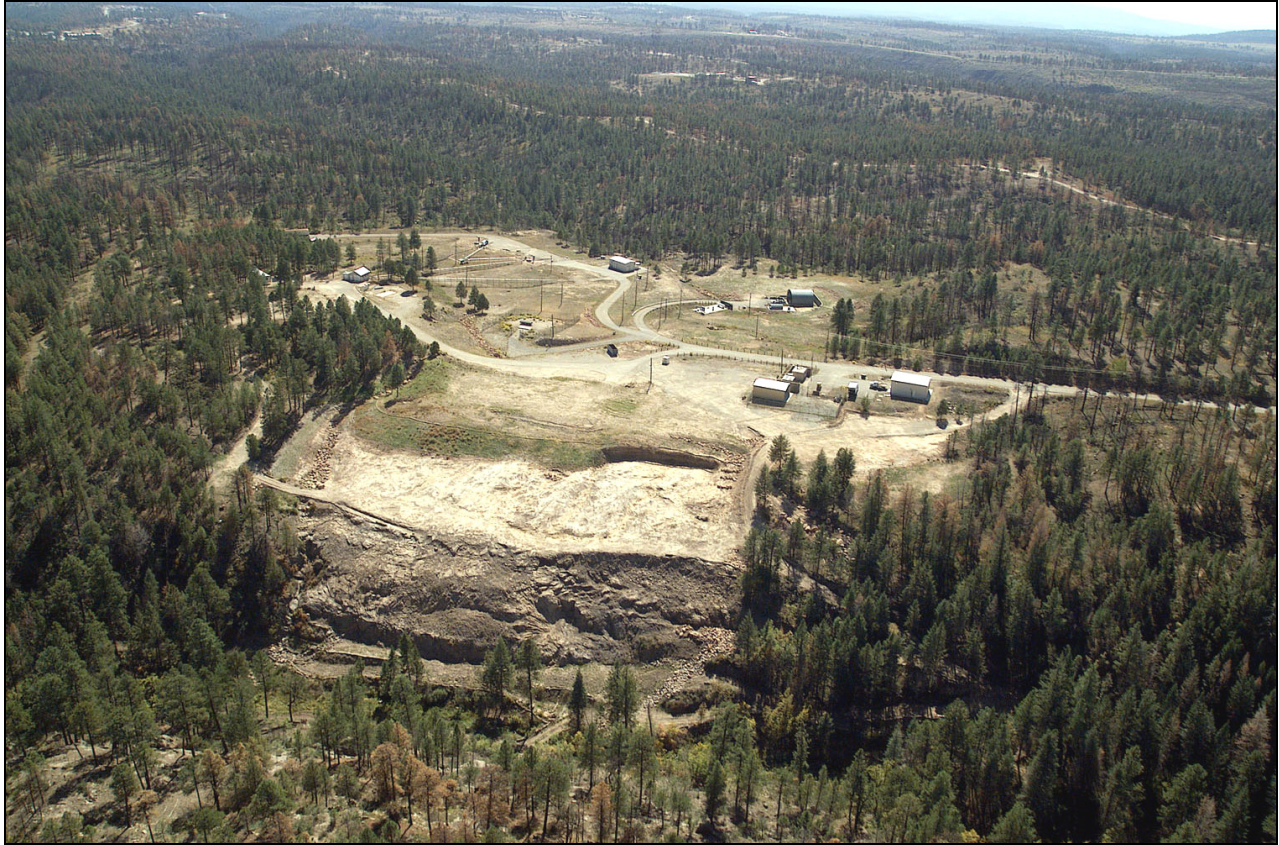
Photograph 1.4-3. MDA P Site, October 2002

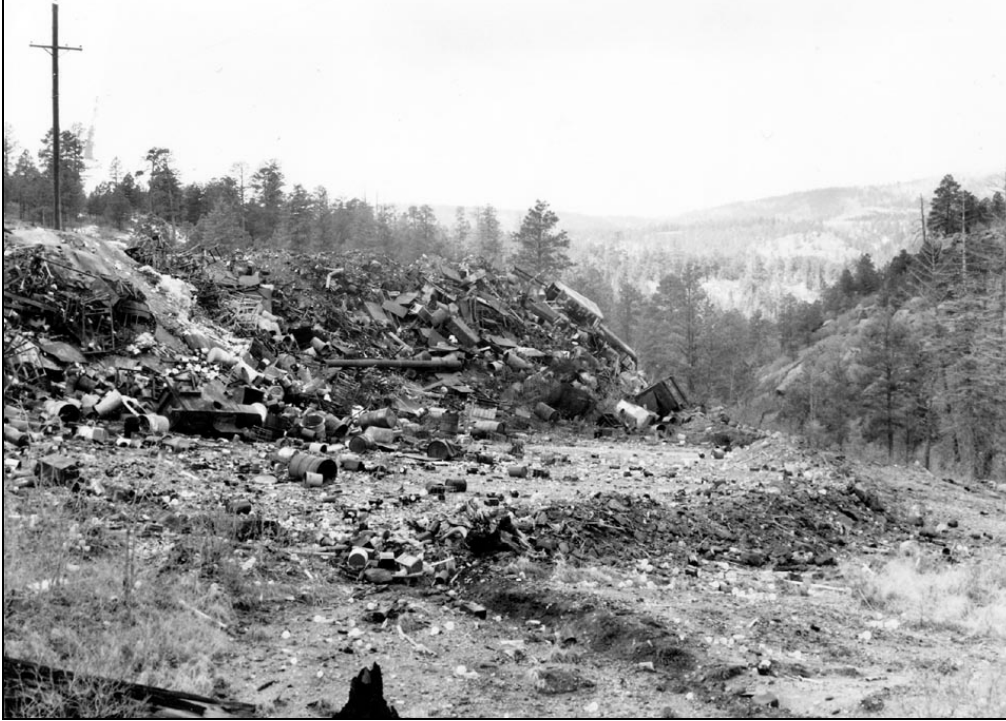
Throughout its history, the east lobe of MDA P was the most active portion of the disposal area. Material from the burning ground was disposed of over the leading edge of the east lobe and occasionally covered with soil. Photographs indicate that the lobe grew slowly but continuously. The leading edge of the east lobe aggraded approximately 60 ft over the entire period of use. Disposed materials excavated at the east lobe included ashes and burned residues of HE compounds, HE-contaminated equipment and materials, barium nitrate compounds, miscellaneous containers from Flash Pad 387, including sands and soils from the sand filters and the base of Flash Pad 387 (Photograph 1.4-4). Although depleted uranium (DU) was detected in trace amounts in some of the soils and debris at MDA P, materials with potential DU contamination were typically not disposed of at MDA P.

Photograph 1.4-4. East lobe of MDA P (waste and debris from adjacent flash pad operations), 1965

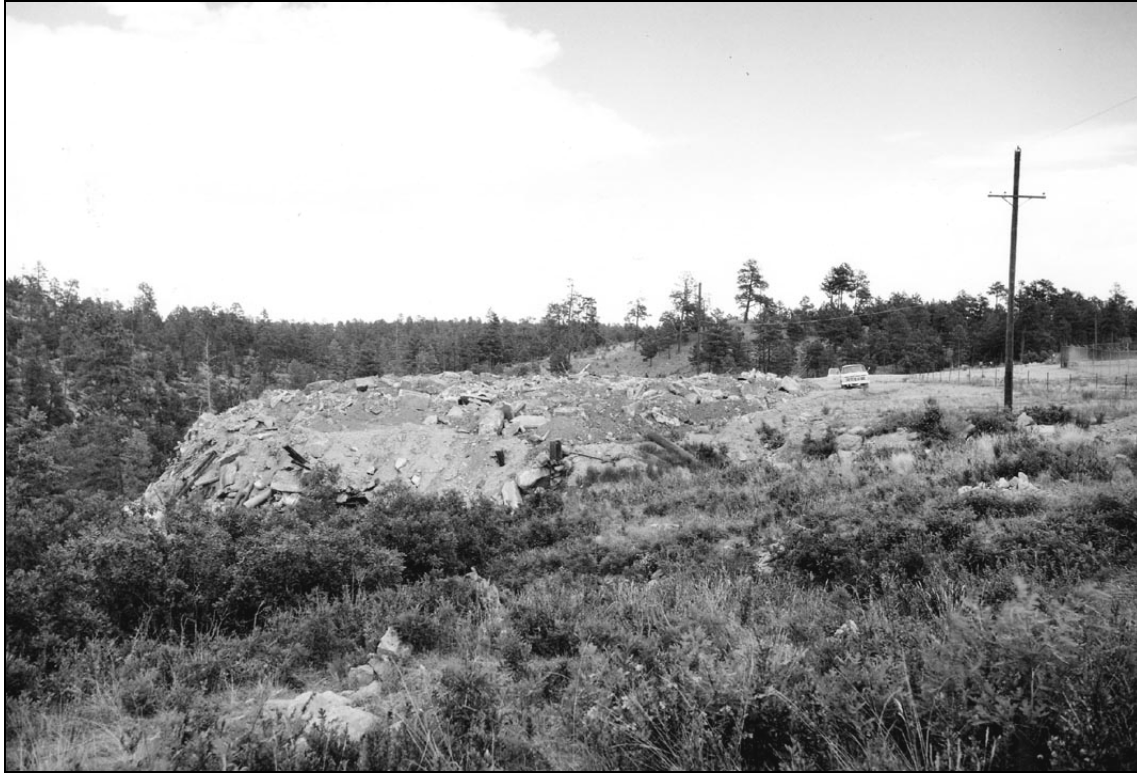
Episodic disposal occurred in the west lobe, which filled a small channel eroded into the southern canyon wall, and which was used primarily for the disposal of HE-contaminated construction debris. In the 1960s, several World War II-era wooden frame structures that housed the original facilities for HE research, development, and production at TA-16 were razed. The west lobe received all noncombustible materials with residual HE from these deconstruction/demolition activities—as many as 1325 dump truck loads (Photograph 1.4-5). Materials and debris included piping (water, sewer, steam, and process piping), electrical conduit, concrete (sidewalks, foundations, and sumps), asbestos tile, and miscellaneous soil and trash. Larger items that had been treated at Flash Pad 387 were also disposed of at the west lobe, including at least ten vehicles in the 1950s and 1960s that had been flashed for the removal of HE residues and pushed over the lobe's edge. In the early 1970s, the rear apron of Building 260 was renovated and concrete from the demolition of sidewalks and sumps was added to the west lobe. With the exception of the periods noted between 1965 and 1975, the annual volume of waste disposed of at the west lobe appears constant.

Photograph 1.4-5. West lobe of MDA P (debris from 1960s burning as well as concrete from 1970s deconstruction of Building 260), 1973

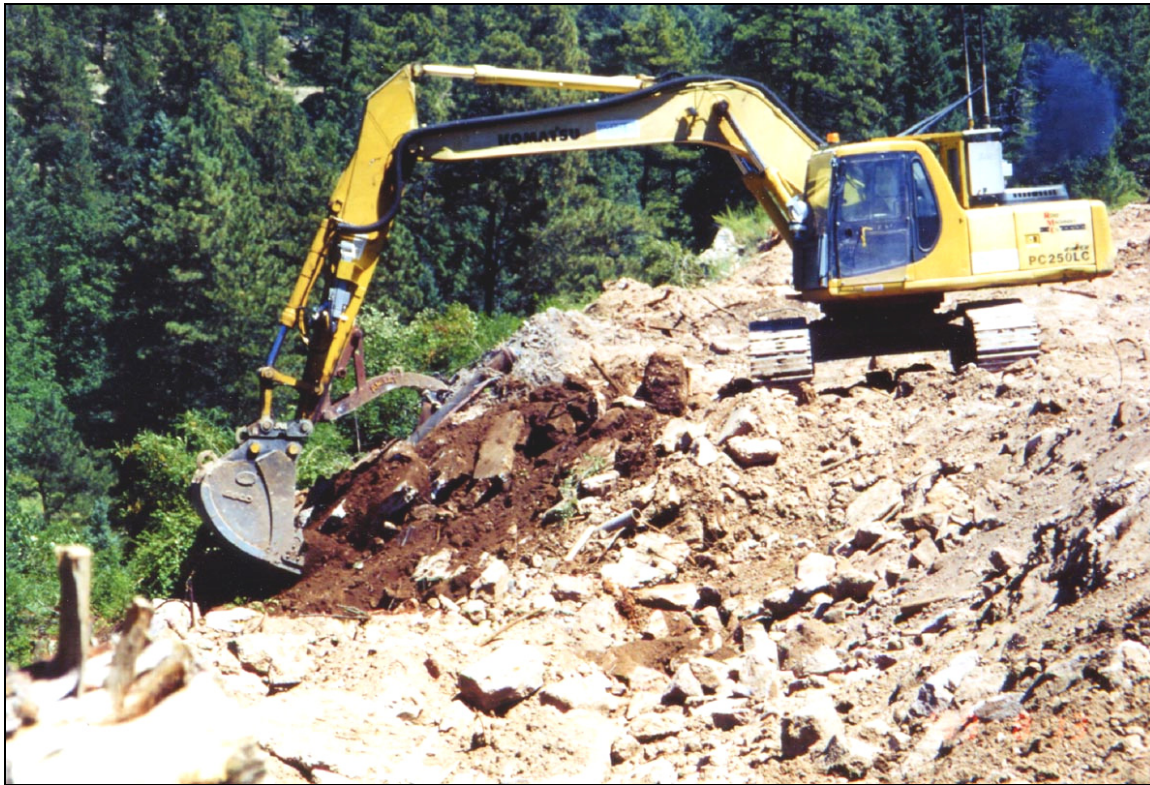
Excavation of MDA P began on February 2, 1999, on the upper portion of the west lobe, followed by excavation of the east lobe. Excavation operations were monitored by an explosives specialist designated by the on-site contractor accompanying the robotics operator and observing operations on a video monitor in the control trailer. Photograph 2.2-1 shows the remote excavation in progress. Benches were excavated across the lobes, providing working surfaces for access down the slopes. Some debris materials were removed from the streambed, but no excavation was performed in the stream. The excavation of the east lobe began in August 2000 and was relatively uneventful. The lobe was entirely underlain by bedrock and the debris of the east lobe did not extend down the lower slopes, as had been the case with the west lobe. No robotics excavation was necessary at the lower east lobe because detonable explosives debris was not identified (or encountered) in this area of the MDA P. The excavation extended southward until no additional debris was encountered.

Photograph 2.2-1. Remote excavation of MDA P contents, 1999 (view to east)

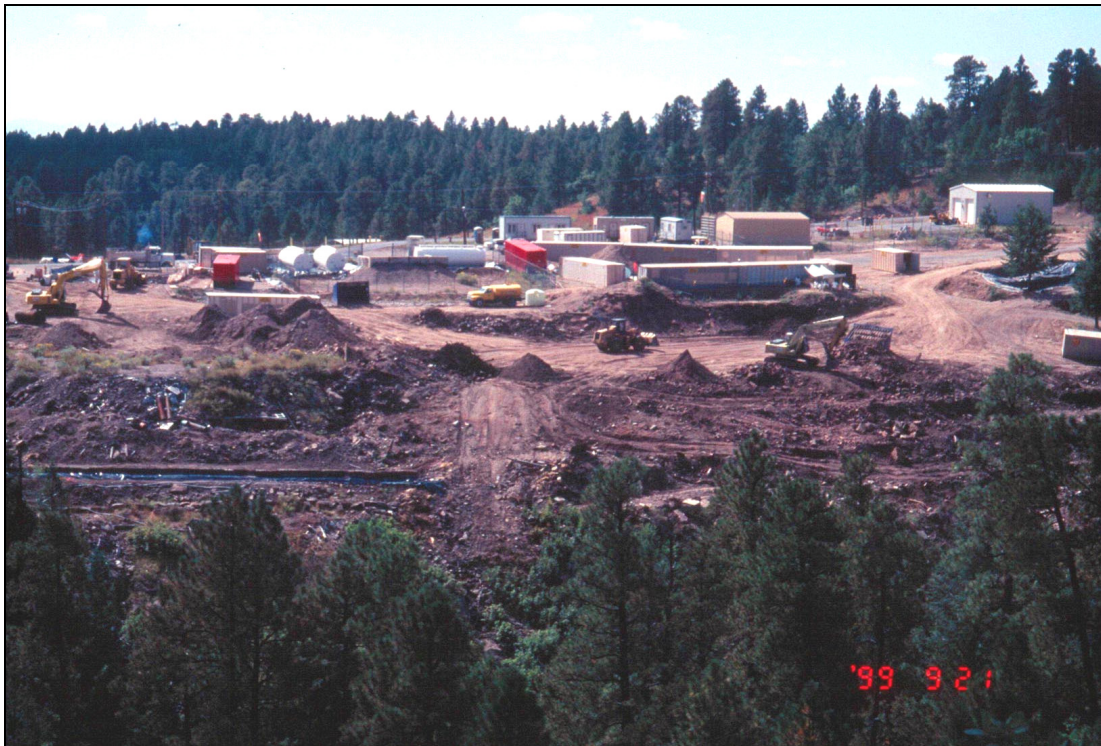
Photograph 2.2-2. Excavation activities in the west lob of MDA P, 1999 (view to south)

Excavation occurred in approximately 100 to 200 yd³ increments. Excavated materials were placed in a pile adjacent to the excavation. Excavation was suspended every 20 to 30 yd³ to allow personnel to inspect the materials to ensure that hazardous explosives materials were not overlooked by the robotics operator. Excavation operations were also suspended to allow additional inspections whenever the robotics operator or the explosives specialist observed suspicious items. After determining there was little danger of a detonation from a large or suspicious object, the excavated materials were handled with conventional heavy equipment equipped with Lexan blast shields. Excavation events typically occurred once a week to allow for inspection and waste segregation of the excavated materials within the limited space for staging materials. Photographs 2.2-2 and 2.2-3 show the west and east lobes of MDA P with excavation in progress. Additional details on excavation of debris at MDA P are presented in the Phase I report (LANL 2003, 76054).

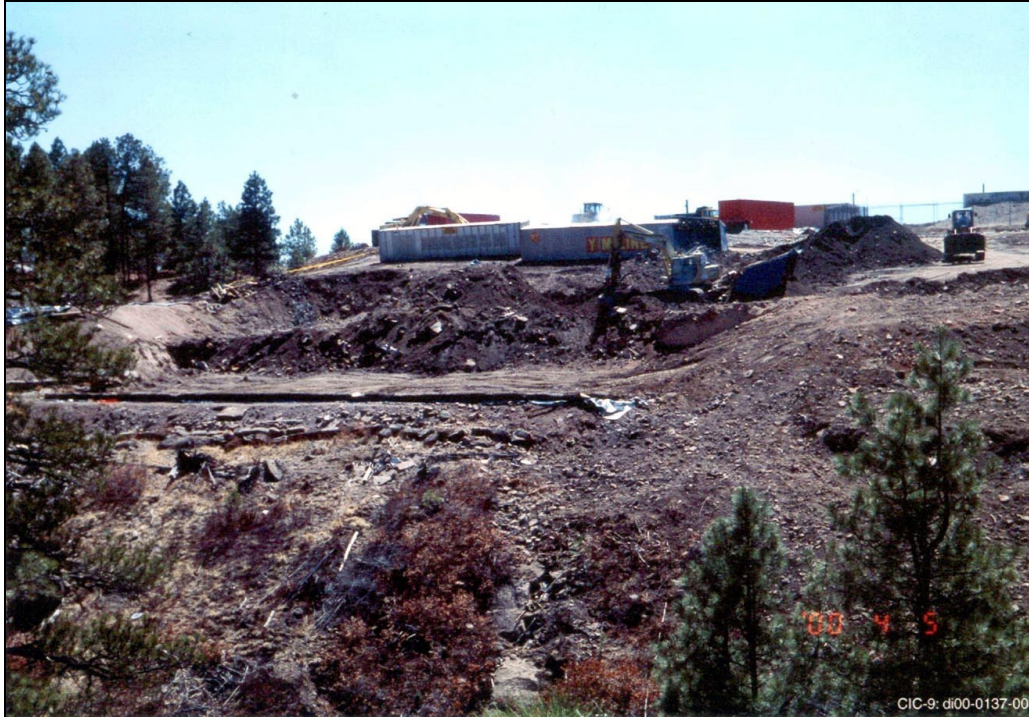
Photograph 2.2-3. Excavation activities in the east lobe of MDA P, 2000 (view to south)

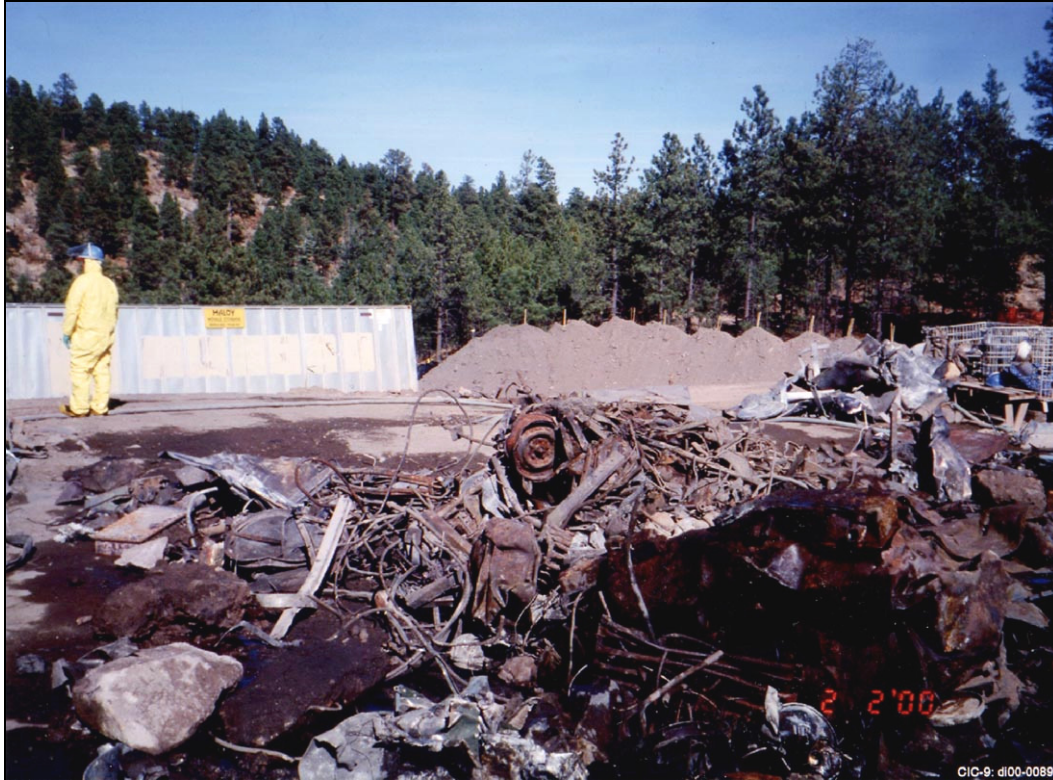
Photograph 2.2-4 shows debris excavated in 2000 from MDA P. After the debris excavation and prior to the start of the excavation of contaminated soils, an interim barium surface survey was conducted across the excavated portions of MDA P and Flash Pad 387 in order to identify areas requiring additional excavation to achieve the operational barium PRG of 2000 mg/kg. Residual barium concentrations were measured using a field XRF instrument collected at the grid centers. Measurement activities designed to test for residual DU were performed using a beta-gamma radiation counter, providing the basis for the removal of RCA restrictions of large areas; no grids had activity measured above instrument background after excavating. Grid cells with barium concentrations greater than the operational PRG of 2000 mg/kg underwent additional excavation. HE concentrations in individual grid cells were not measured in this interim survey. Grid cells that met the barium operational PRG underwent a “final release survey” to determine whether additional excavation was necessary (see section 2.2.5).

Photograph 2.2-4. Example of excavated materials, shown during segregation process, 2000 (view to northeast)

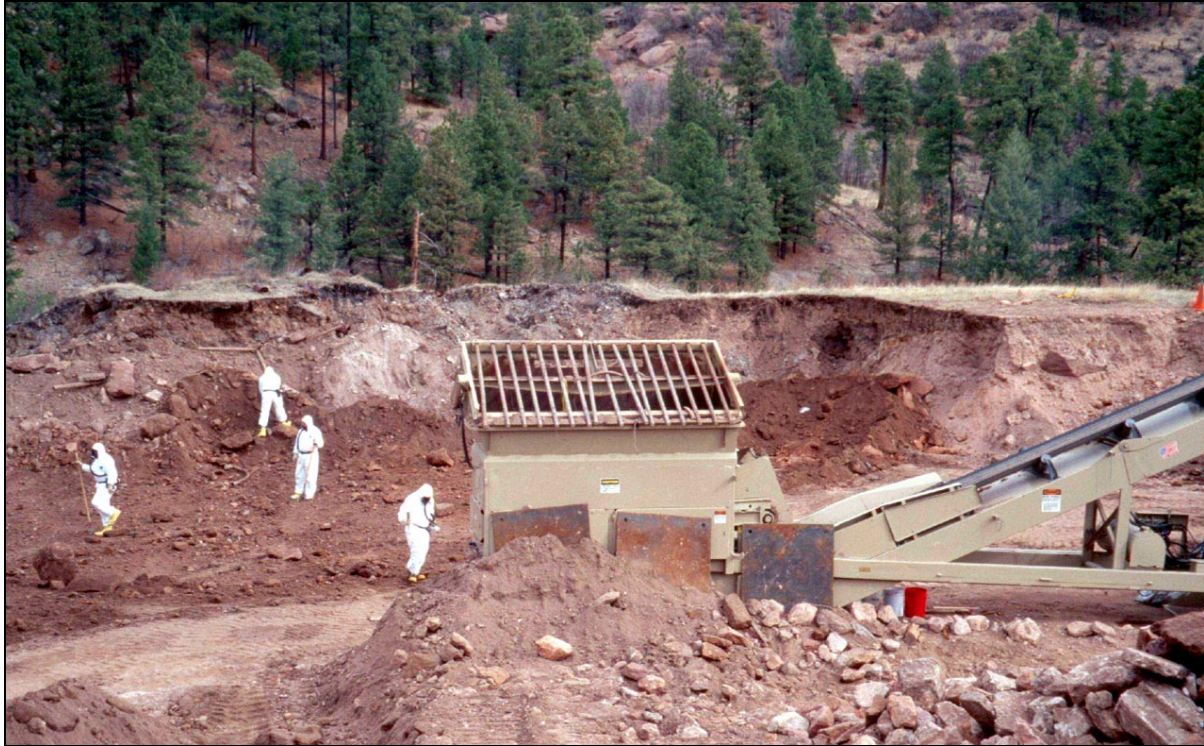
At the completion of the removal of the MDA P contents via remote operations, excavation continued for the removal of contaminated soils (i.e., over-excavation as shown in Photograph 2.2-5) via conventional methods; this began August 13, 2000. Approximately 21,000 yd³ of contaminated soil and rock were excavated from MDA P. Soils were excavated in each grid cell in approximately 6-in. lifts, followed by an XRF survey. XRF measurements of barium concentrations were taken at five locations within a grid cell and then averaged. Material removal continued until the average value met the barium operational PRG of 2000 mg/kg. Once the barium operational PRG was met, a grab sample was collected near the grid center for HE field analysis. As with the barium screen, material removal continued until the operational PRG for RDX (16 mg/kg) was also met, at which time the excavation was deemed complete. The entire former MDA P footprint and the operational support areas were subjected to the field-screening process for barium and RDX to ensure that the extent of contamination had been defined and remediated to the operational PRGs.

Photograph 2.2-5. Soil excavation (over-excavation)

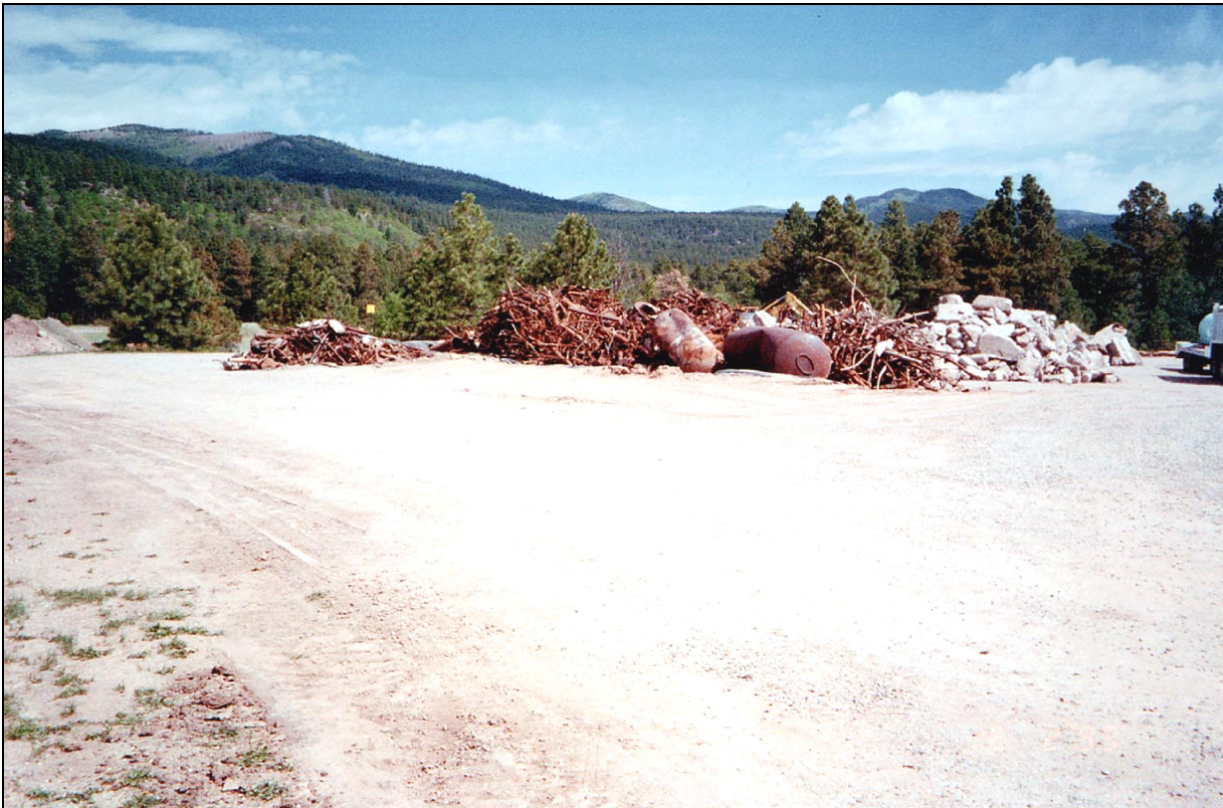
Waste segregation was performed for waste minimization, to facilitate proper waste characterization, and to meet the RCRA treatment, storage, and disposal (TSD) facility's waste acceptance criteria (WAC). Segregation operations included removing pieces of HE, barium nitrate, asbestos, metal and concrete debris, containers of unknown content, and a small amount of DU from soil. The entire contents of MDA P were subjected to this segregation process, although no segregation was performed on soil excavated during the manual over-excavation portion. Soils excavated to achieve the operational PRGs did not contain debris and did not undergo the segregation process because these soils were assumed to be contaminated with barium and HE. Photograph 2.2-6 shows examples of post-segregation debris.

Photograph 2.2-6. Example of metal and concrete debris, post-segregation, 1999

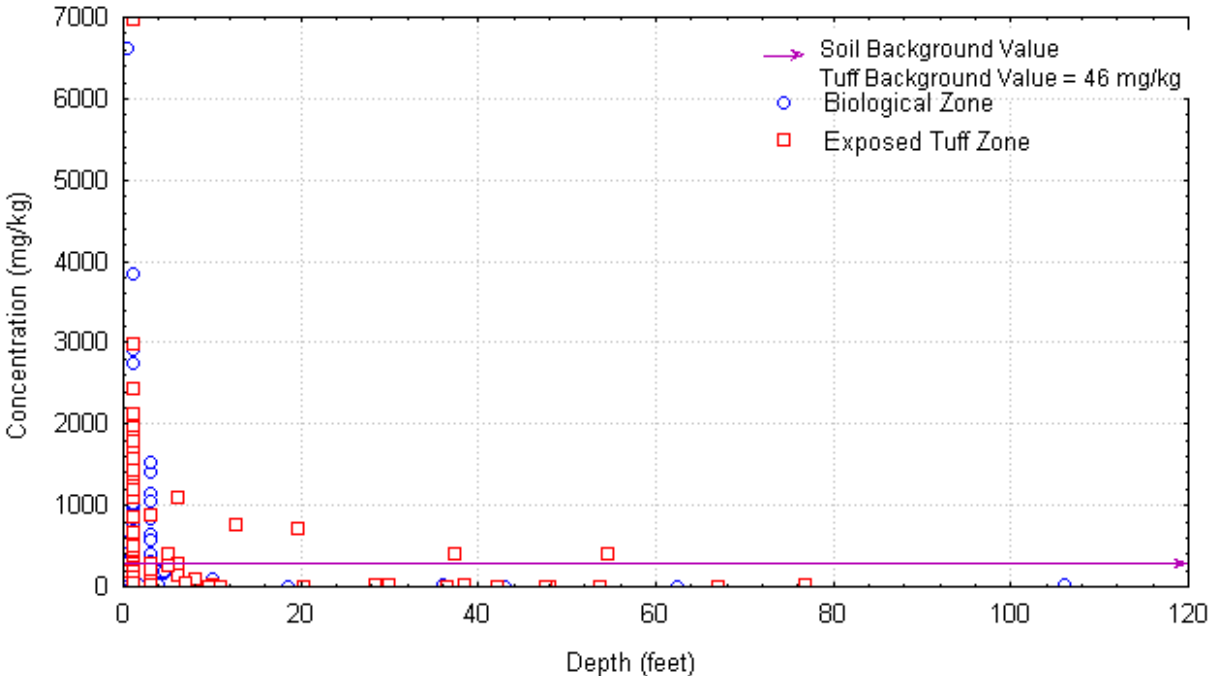
Figure 2.3-2. Barium concentrations with depth, as measured in the MDA P Site confirmation samples

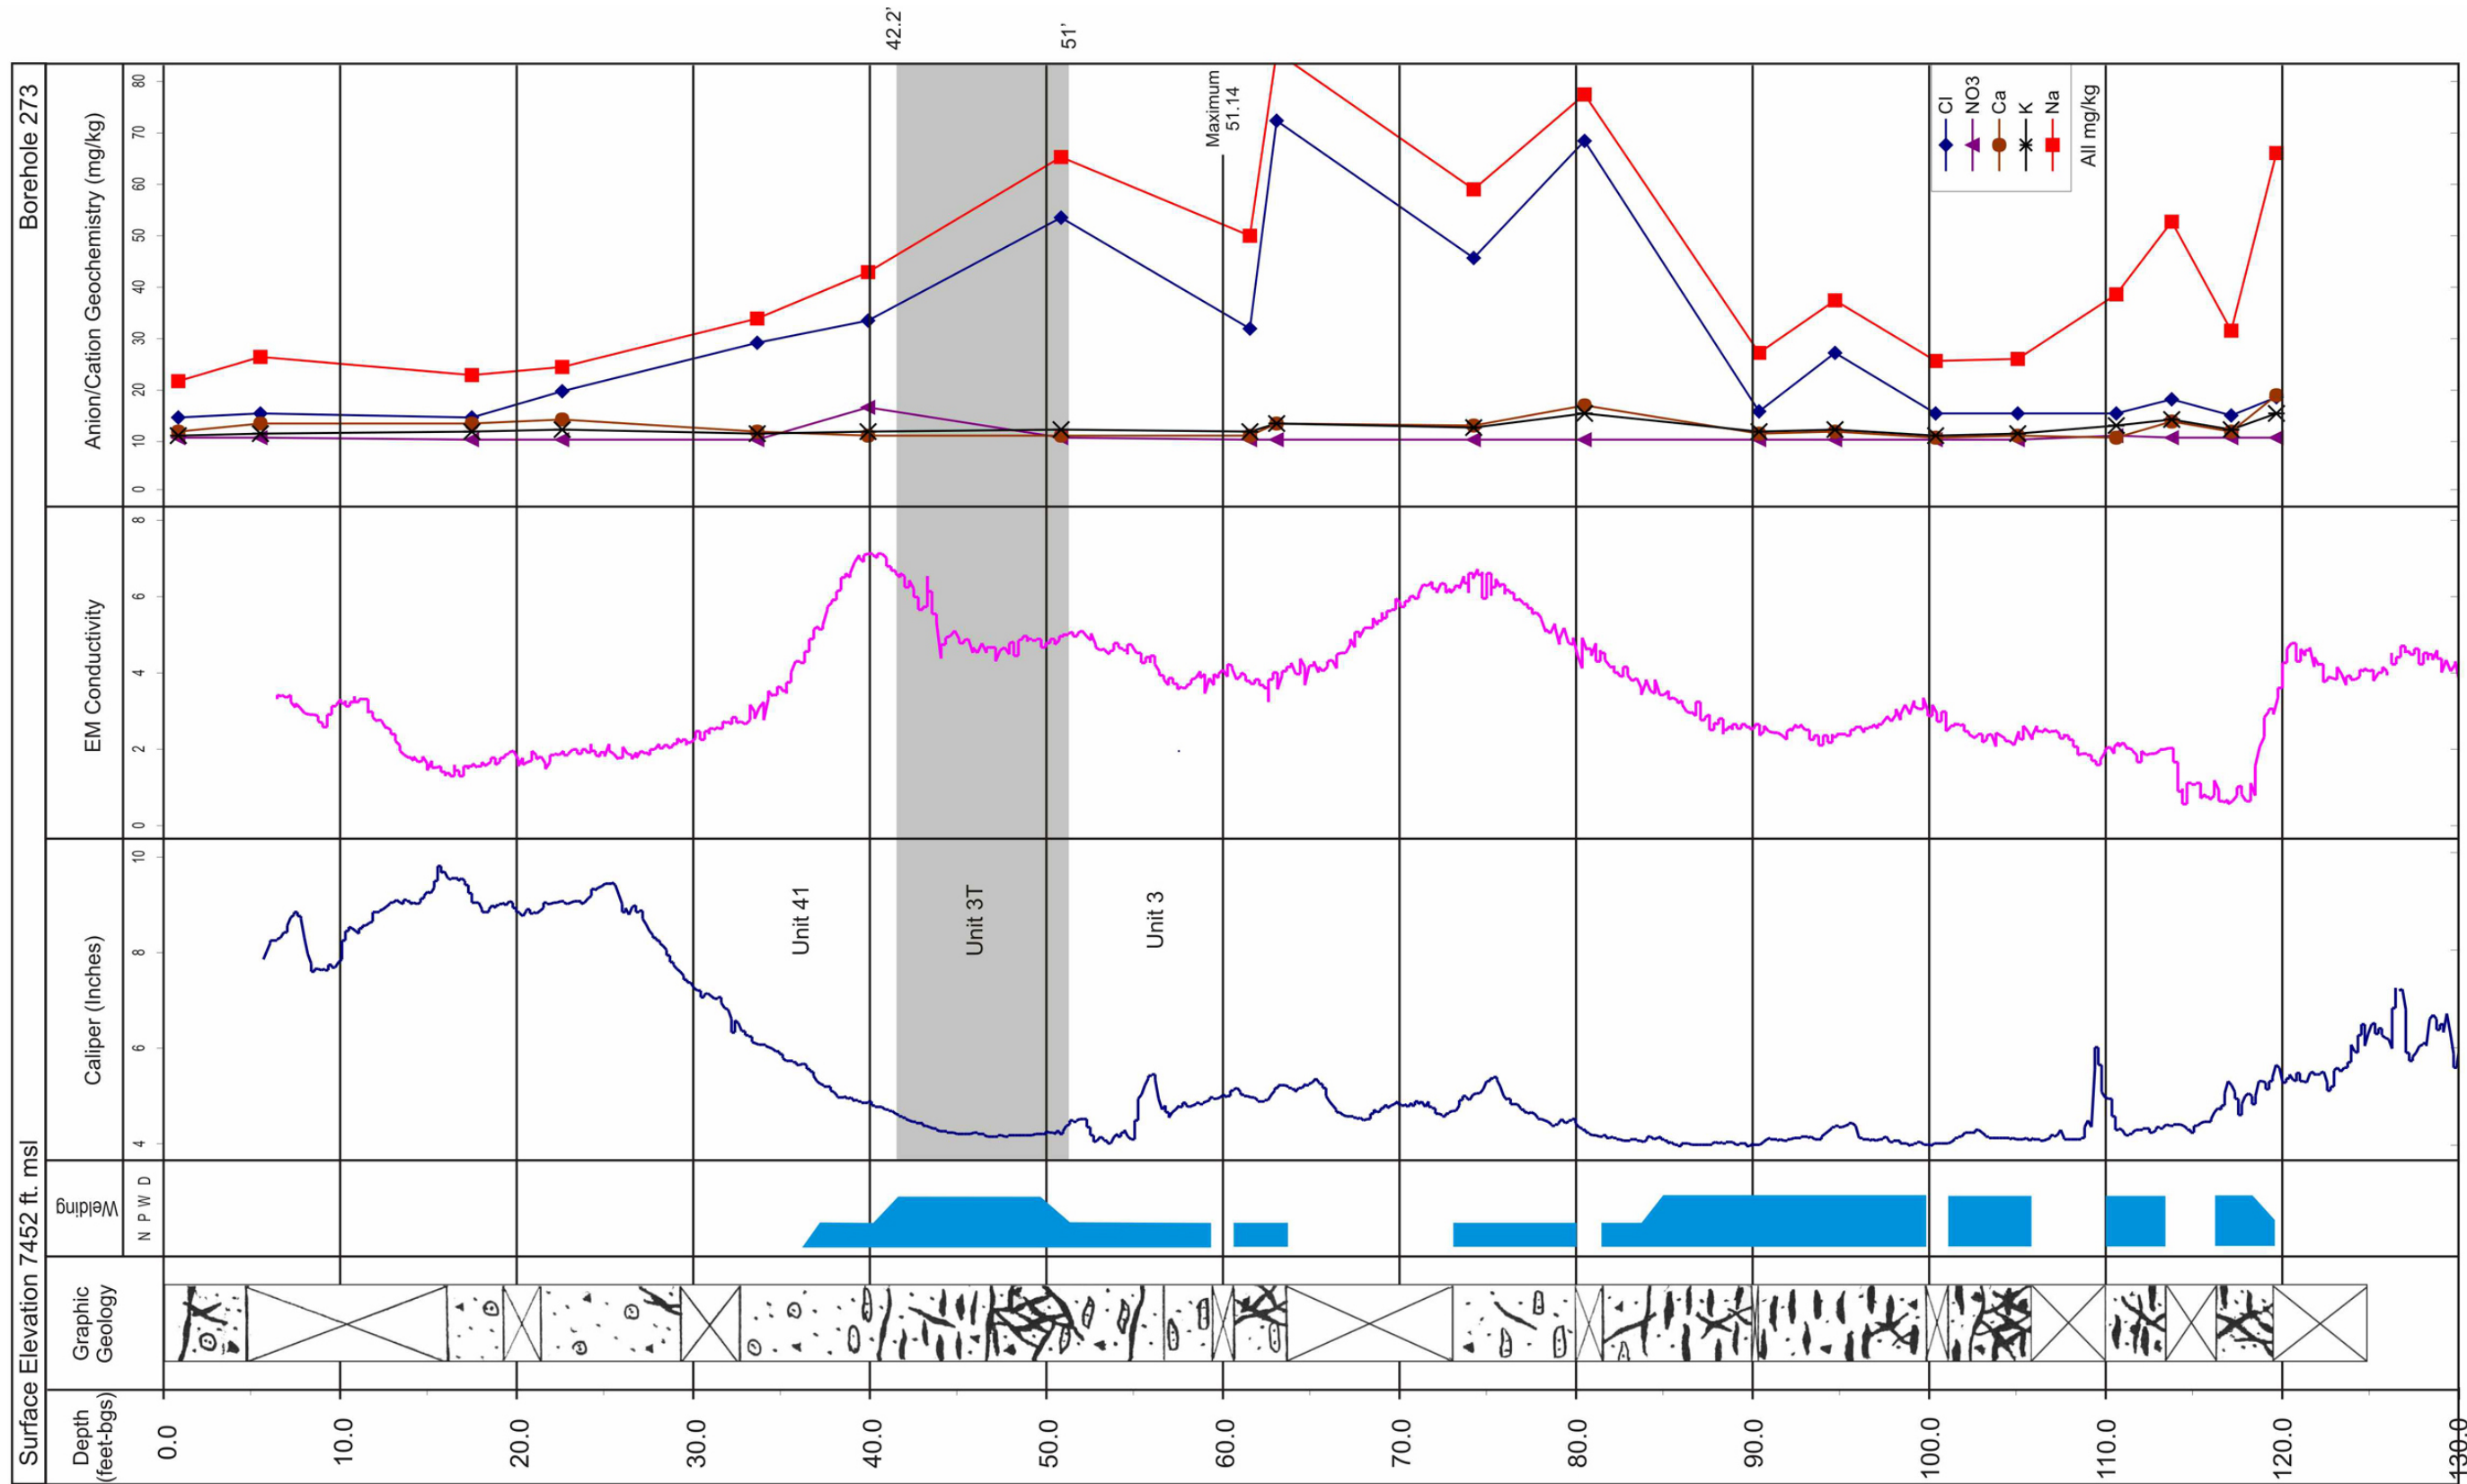
Borehole 273 represents the characteristics of the fracture regime beneath the Flash Pad 387 at the watershed divide. Figure 2.3-5 shows the combined geophysical and geochemical results for Borehole 273. Borehole 273 was drilled to 145.8 ft below surface (approximately 80 ft below the level of the Cañon de Valle stream elevation) from a beginning elevation of 7453 ft above msl. The borehole was dry during and after drilling. The stratigraphic data indicate that the underlying bedrock consists of 42 ft of nonwelded Unit 4I, approximately 9 ft of the densely welded Unit 3T, approximately 34 ft of poorly welded Unit 3, and approximately 35 ft of welded Unit 3 that grades to nonwelded Unit 3 with depth. Flow-meter measurements were not collected because of the influence of high flow rates at 125 ft below surface that exceeded the instrument capabilities. High EM conductivity was measured in two zones: 35 to 45 ft below surface and 65 to 90 ft below surface. In contrast to Boreholes 526 and 554, high zones of EM conductivity did not appear to correlate with caliper logs in the shallow zone, but did correlate with the deeper area of high EM conductivity at 55 to 85 ft below surface. The shallower zone of high EM conductivity in Borehole 273 was located across the welded contact of Units 4I and 3T, which was both overlain and underlain by fracture zones. The deeper zone of high EM conductivity, at depths of 62 and 80 ft bgs, occurred in the partially welded Unit 3, and correlated with the peak concentrations of sodium and chloride.

Borehole 273 data indicated that a broad zone of soluble salt accumulation was present from approximately 35 to 90 ft below surface within the partially welded Unit 3. The upper portion of the zone had a small increase in nitrate concentrations, but much of the zone exhibited high chloride and sodium concentrations. Local low values of chloride and sodium at 61 and 74 ft below surface were correlated with either a fracture zone or lost core, respectively, similar to results in Boreholes 526 and 554 at 45 ft below surface. As found with the other boreholes, the bottom of the accumulation zone was marked by the presence of welded tuff that indicated that the partially welded tuff matrix was acting as an absorbent medium. As with the other boreholes in the MDA P Site, the subsurface conditions beneath Flash Pad 387 contained historic signatures of drying conditions, not of significant subsurface water flow. Hence, the influence of the interconnection of fractures with the walls of Cañon de Valle appeared to extend to the watershed divide.

Figure 2.3-5. Empirical correlation diagram for Borehole 273, Flash Pad 387, at the watershed divide

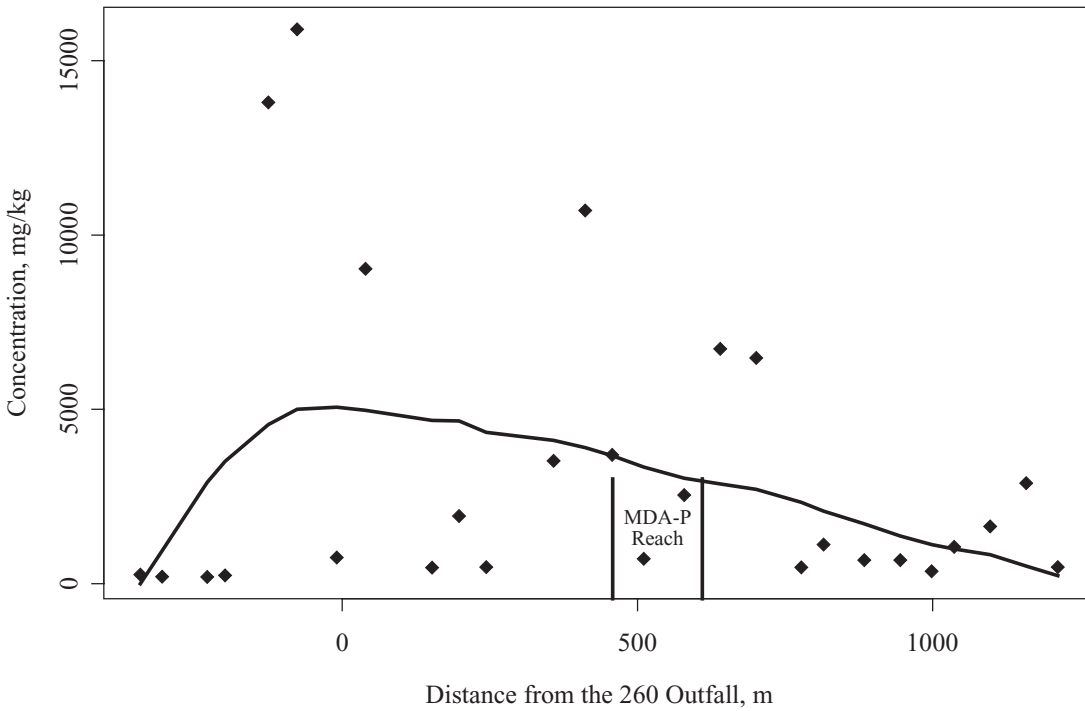
Figure 2.5-4. Down-canyon profile of barium concentrations for the active channel sediments

The COPC concentration patterns, as represented by the barium plots, indicate that ecological investigations for adverse effects in Cañon de Valle that include the reach below the MDA P Site are also useful for evaluating historic effects from the MDA P Site.

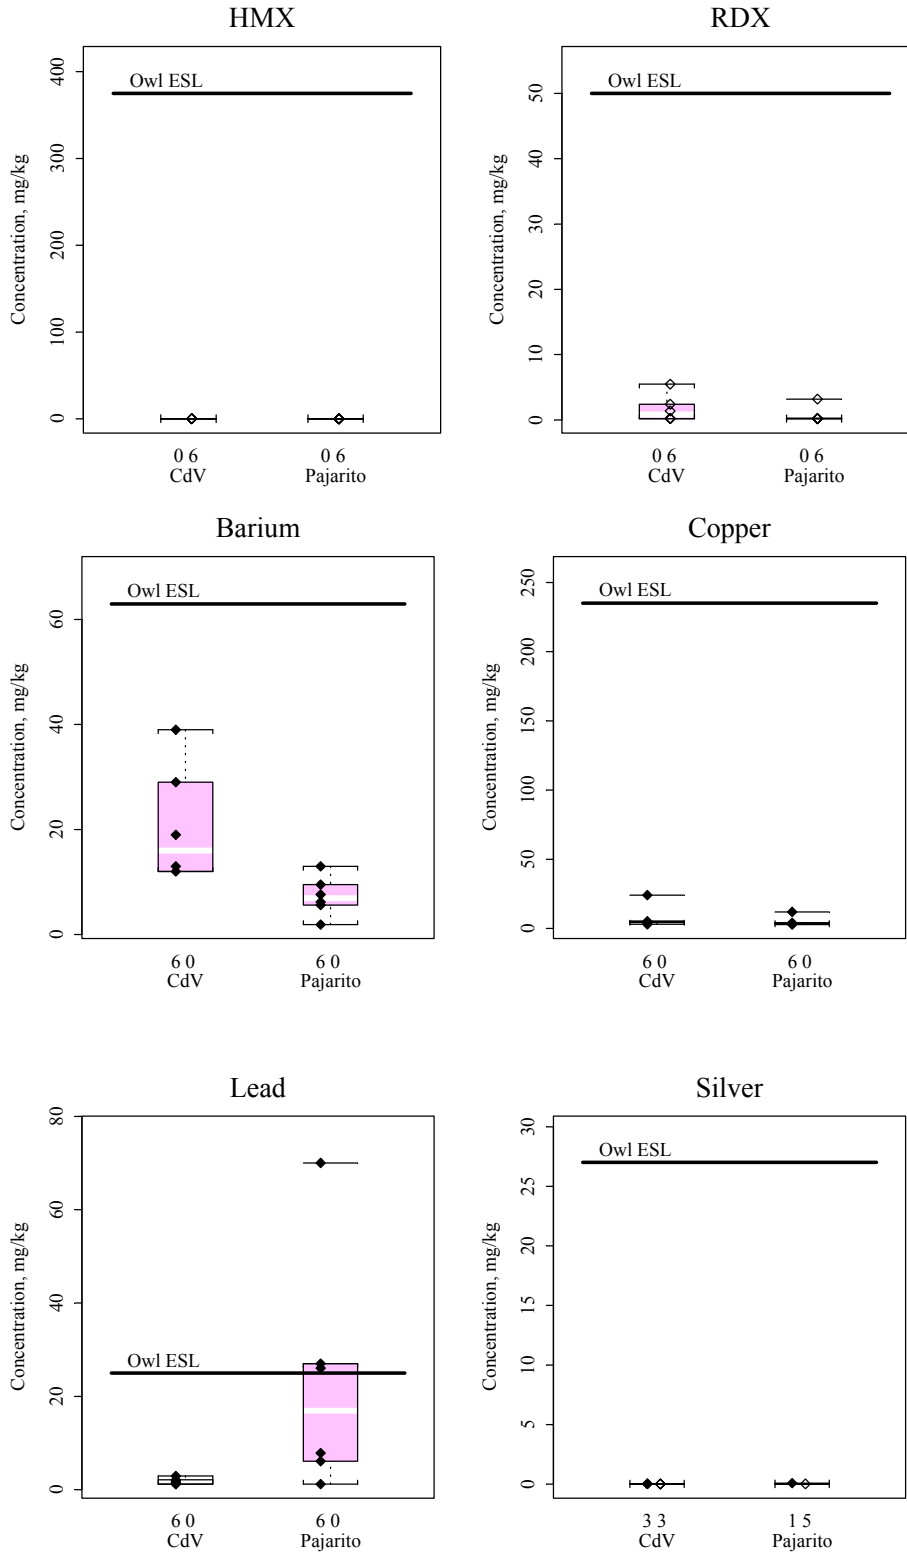
Numbers above data groups are detects (solid symbol) and nondetects (open symbol)

Figure 2.5-5. Deer mouse contaminant body burdens

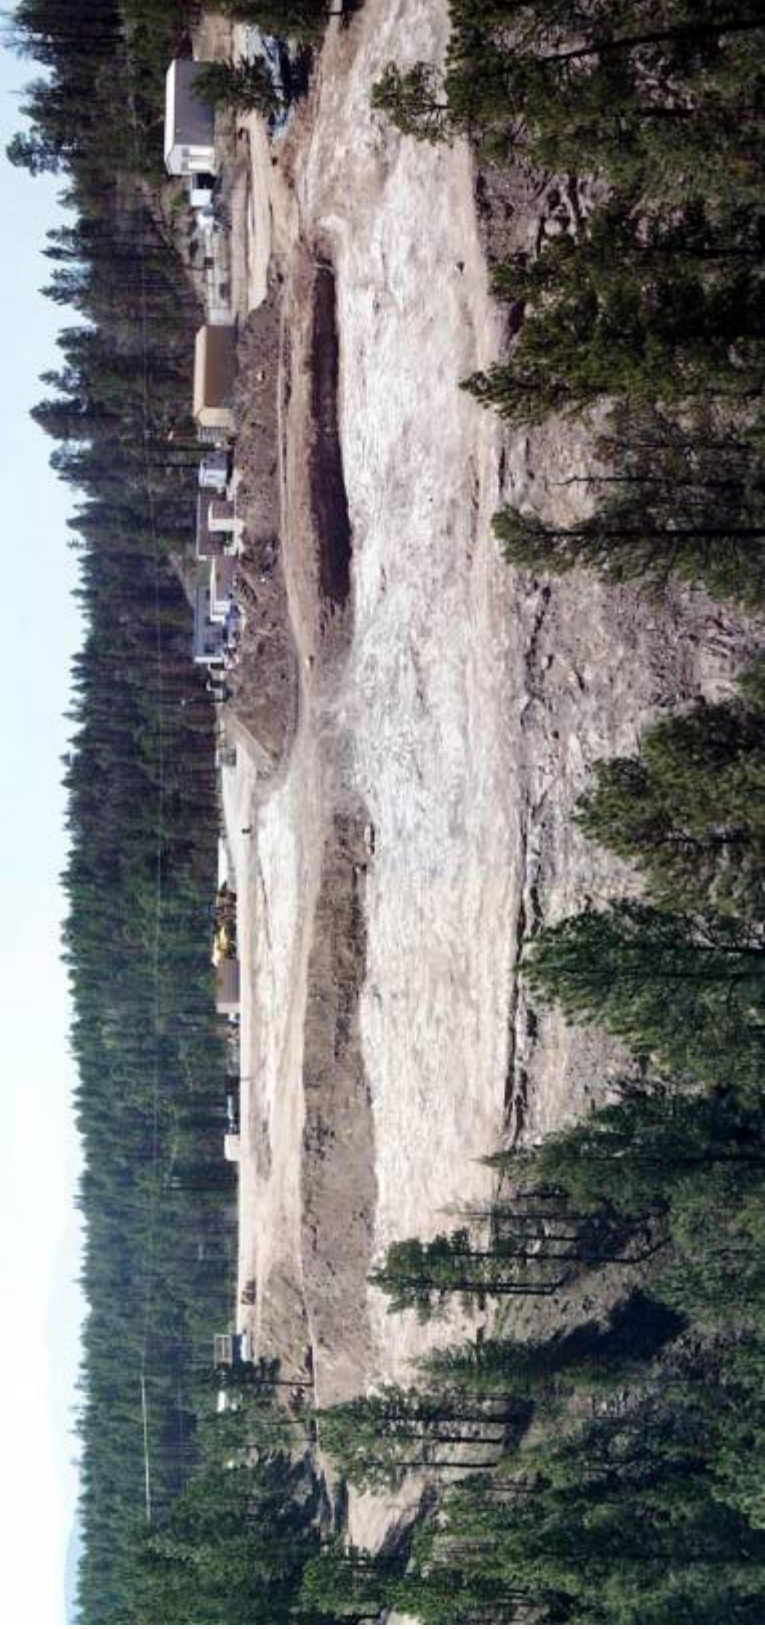
Photograph 2.7-1. Post-excavation condition of MDA P Site, before stabilization and reseeded, 2001

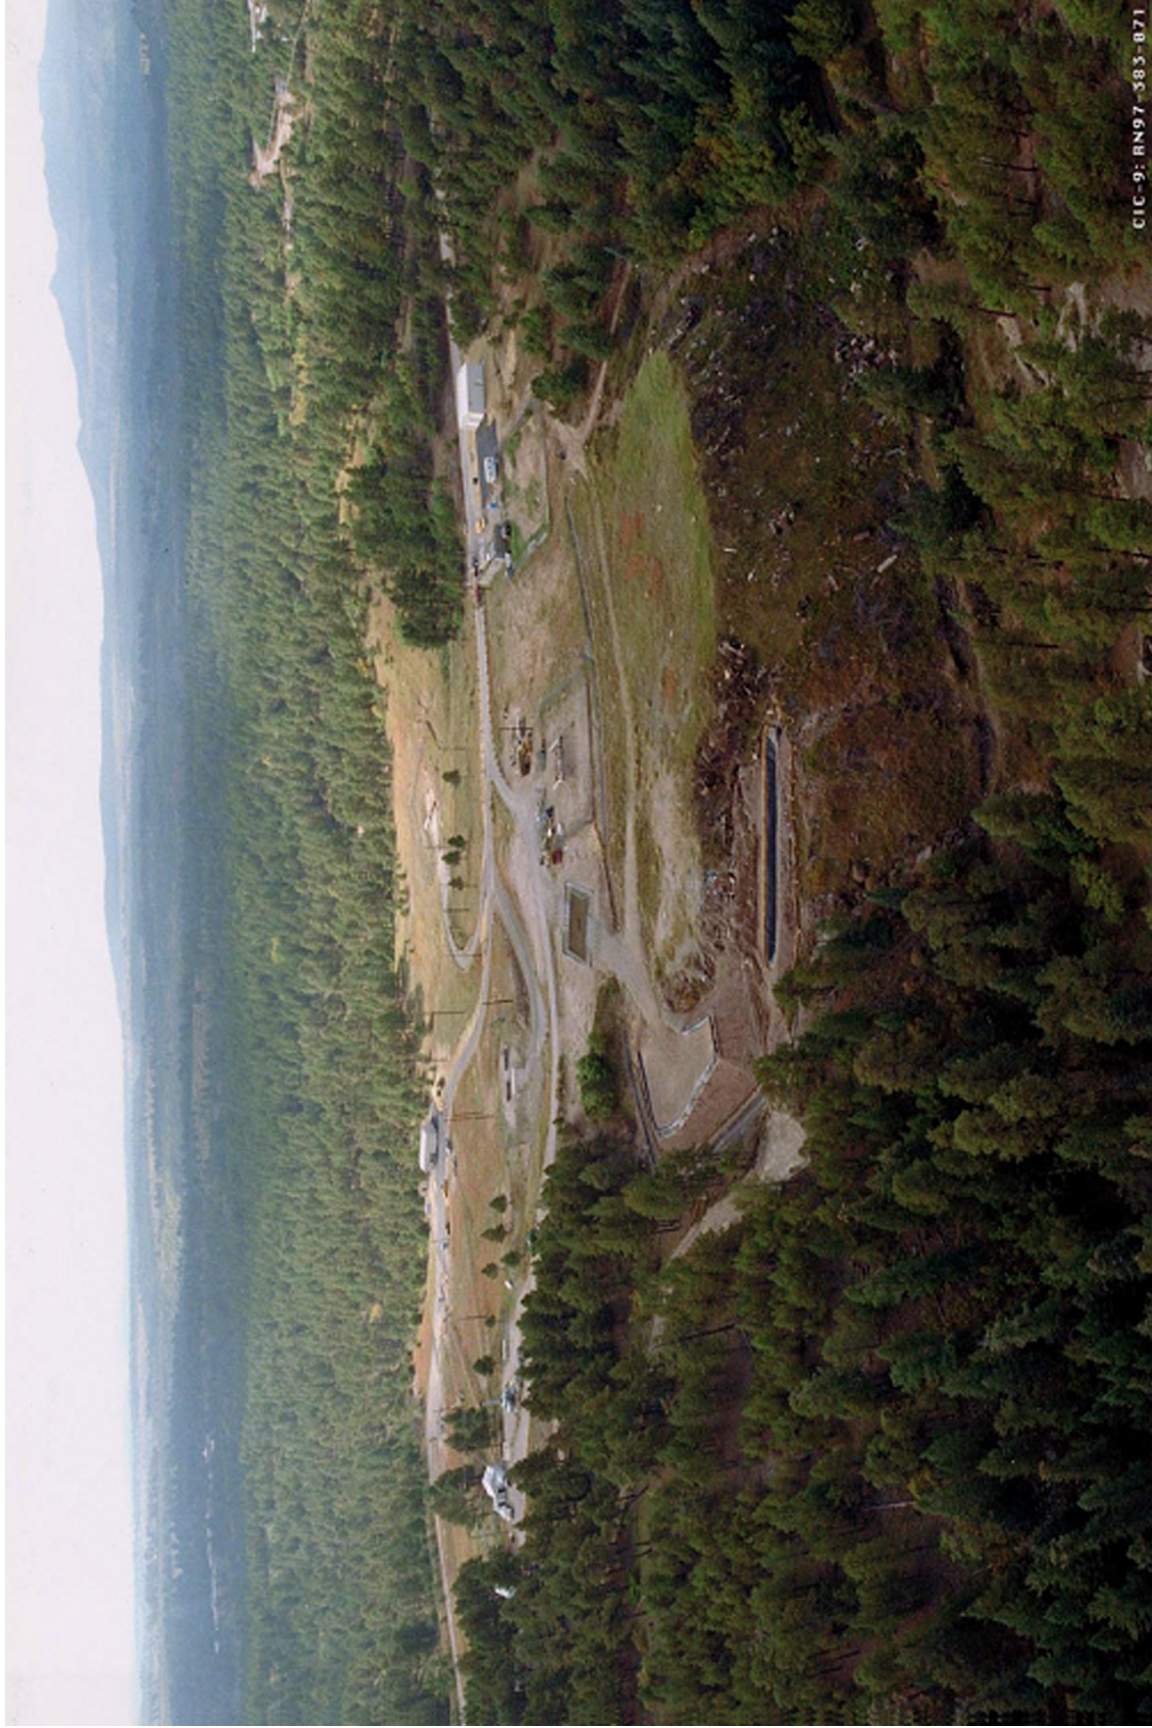
Photograph 2.7-2. Condition of the MDA P Site, October 2002
