Post Cerro Grande Fire Stream Channel Morphology  
In Lower Pueblo Canyon, Reach P-4 East

Los Alamos County, New Mexico

Ralph Ford-Schmid and Dave Englert

January 2004

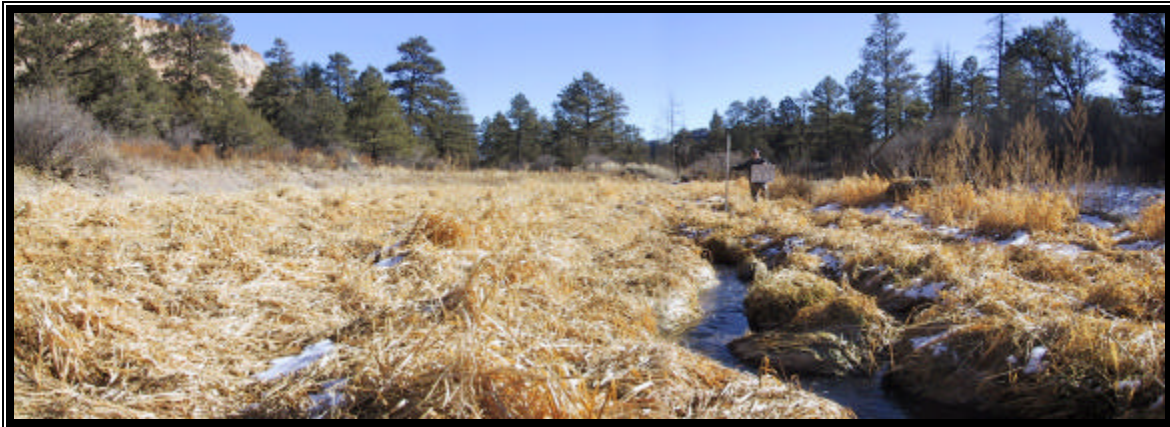
Figure 3 is a downstream view of reach P-4 East (A) channel at cross section ER-1. The photo is oriented so that cross section starts at A, left or north in this photo, and continues south to A'.

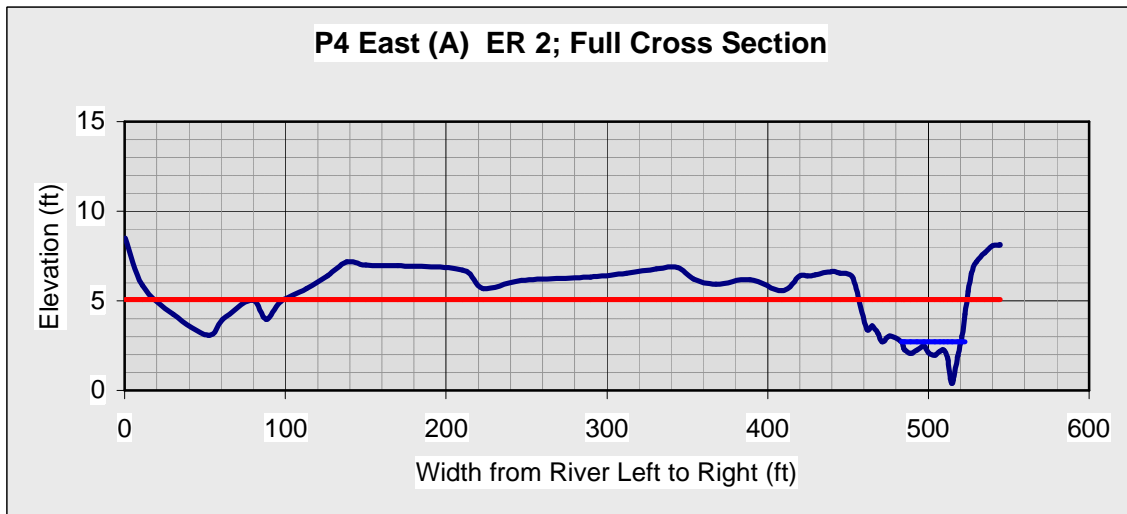
Figure 5 demonstrates the dimensions and characteristics at this location, measured along the entire extent of the NMED cross section. The area under the horizontal blue line represents the cross section area at bankfull stage and the red line depicts the flood prone area height. The water flow is confined within a single channel. The flood prone area is confined within the terrace banks due to vertical incision of the channel.

**Figure 5. Full extent of P4 East (A) ER-2 cross section. The area under the horizontal blue line represents the cross section area at bankfull stage and the red line depicts the flood prone area height.**

Quaternary colluvium is found from 0 to 40 feet at this cross section. Old and recent flood plain deposits extend from 40 to 370 feet. The bank forming c3 abandoned channel-deposits are found on both sides of the active channel at 370 to 460 feet, and 520 feet to the end of the cross section. Evidence of sandbar deposits from a 1991 flood, abandoned channel deposits, as well as recent flood debris exists in the channel from 460 to 485 feet. The thalweg is at 518 feet.

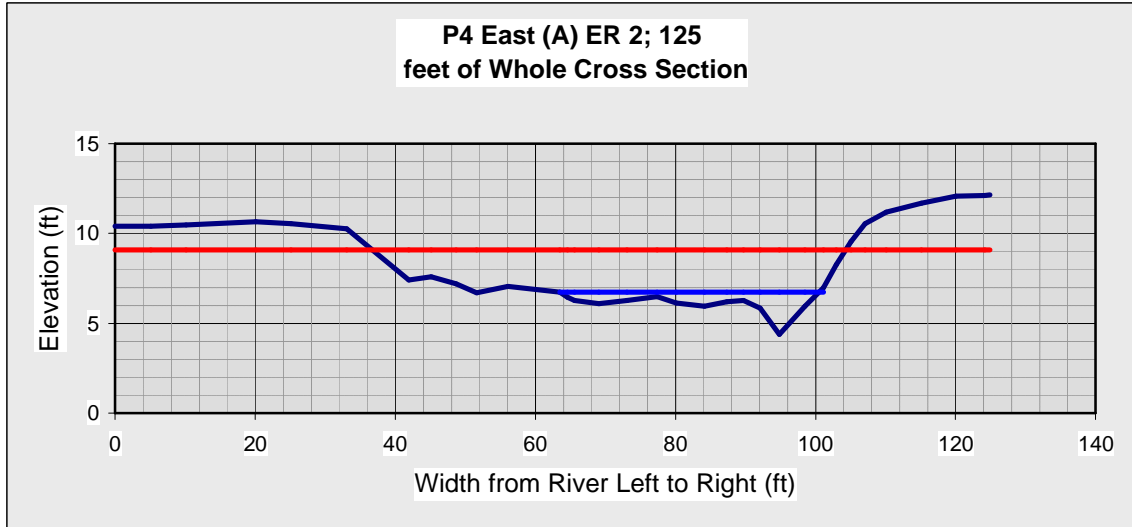
Figure 6 displays 125 feet of the cross section that correlates with an earlier cross section measured by the LANL Environmental Restoration Project.

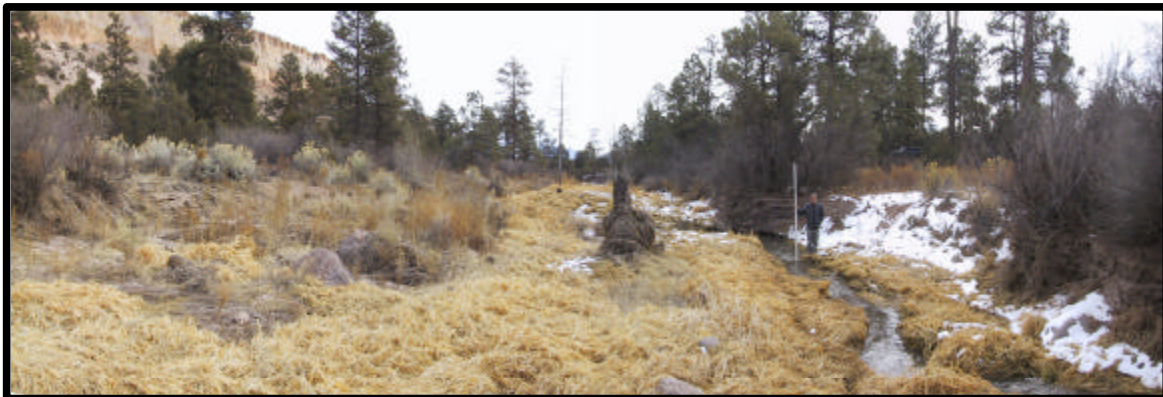
Figure 7 is a downstream view of the P-4 East (A) reach at Cross section ER-2. The photo is oriented so that cross section starts at B, left or north in this photo, and continues south to B'.

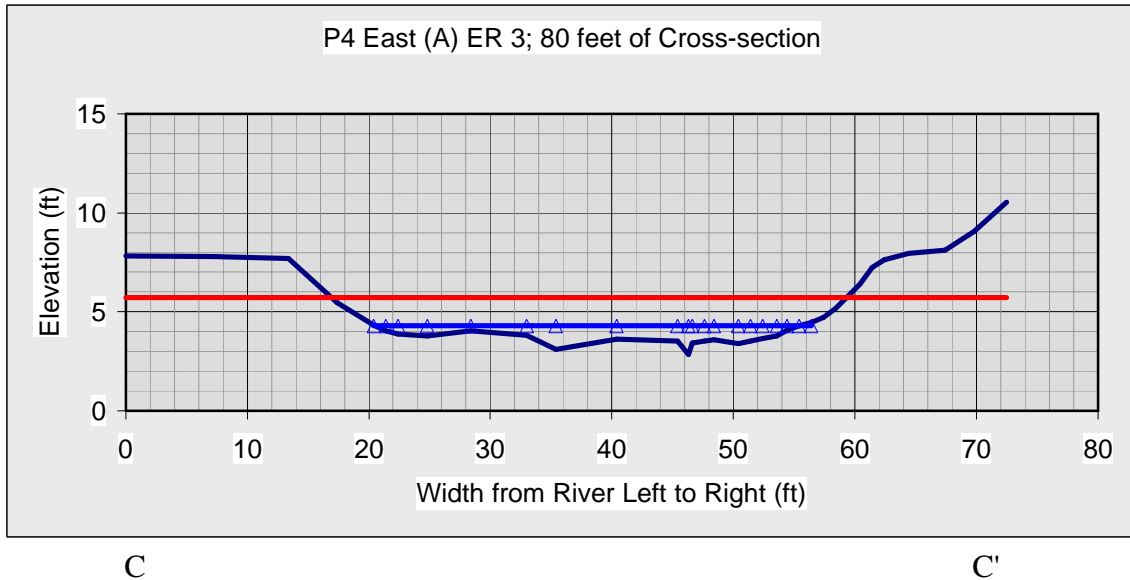
Figure 10 displays 80 feet of the entire cross section that correlates with an earlier cross section measured by the LANL ER Project.

**Figure 10. Portion of P-4 East (A) ER-3 cross section corresponding with previous LANL ER cross section. The area under the horizontal blue line represents the cross section area at bankfull stage and the red line depicts the flood prone area height.**

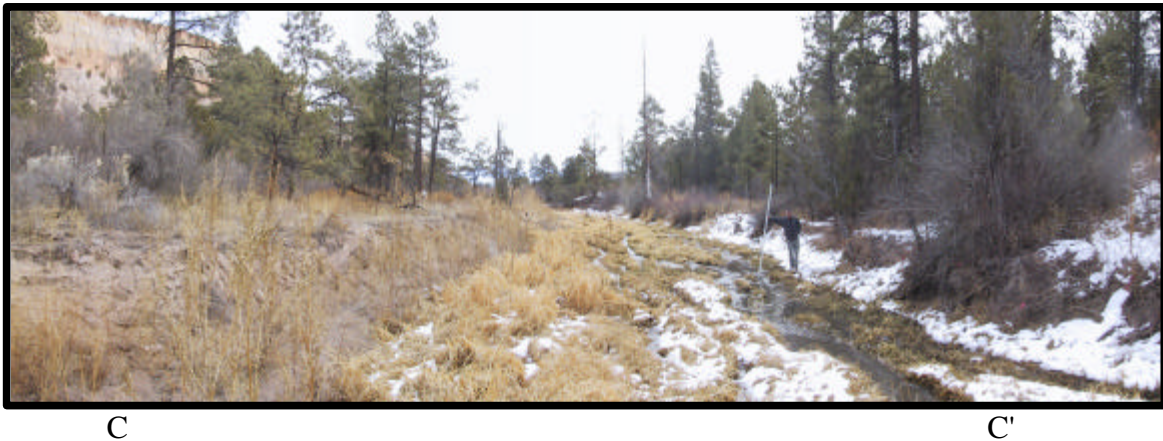
Figure 11 is a downstream view of the P-4 East (A) channel at cross section ER-3. The photo is oriented so that cross section starts at C, left or north in this photo, and continues to C'.

**Figure 11. View of P-4 East (A) ER-3 cross section looking (downstream)**

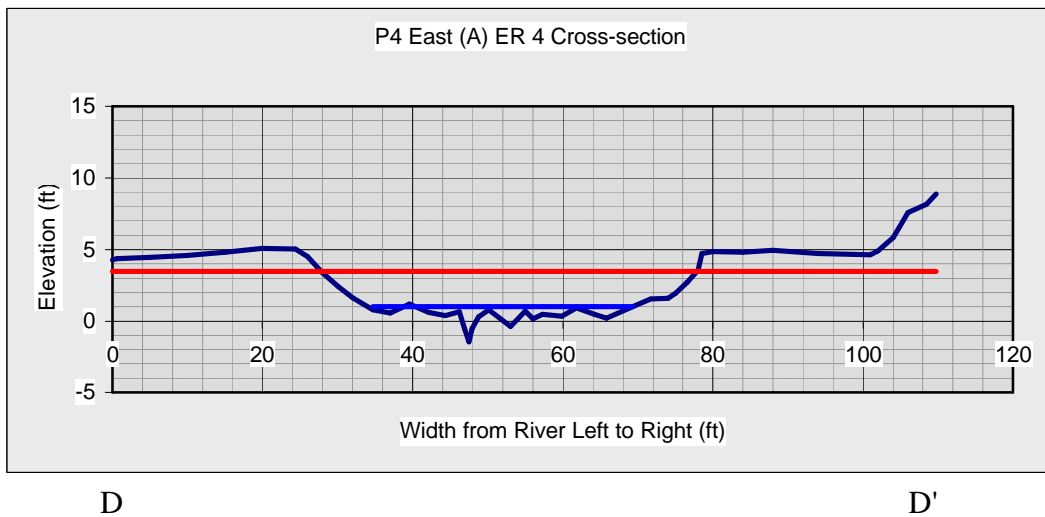
In Figure 13, the area under the horizontal blue line represents the cross section area at bankfull stage. The red line depicts the flood prone area confined within the channel banks.

**Figure 13. P-4 East (A) ER-4 cross section. The area under the horizontal blue line represents the cross section area at bankfull stage and the red line depicts the flood prone area height.**

The dimensions measured at this location and characteristics along the P-4 East (A) ER-4 cross section are illustrated in Figure 13. The c3 bank-forming abandoned channel deposits extend from 0 to 27 feet. The 1991 c1b sandbar, from 27 to 33 feet, is eroded away or buried by the adjacent bank. The active channel is found between 33 and 70 feet, and the thalweg at 48 feet. The south bank, at 78 feet, is formed from the c3 unit (78 to 101 feet). The steep slope at 101 feet to the end of the cross section is Quaternary colluvium. Cross section ER-4 correlates with an earlier cross section measured by the LANL ER Project.

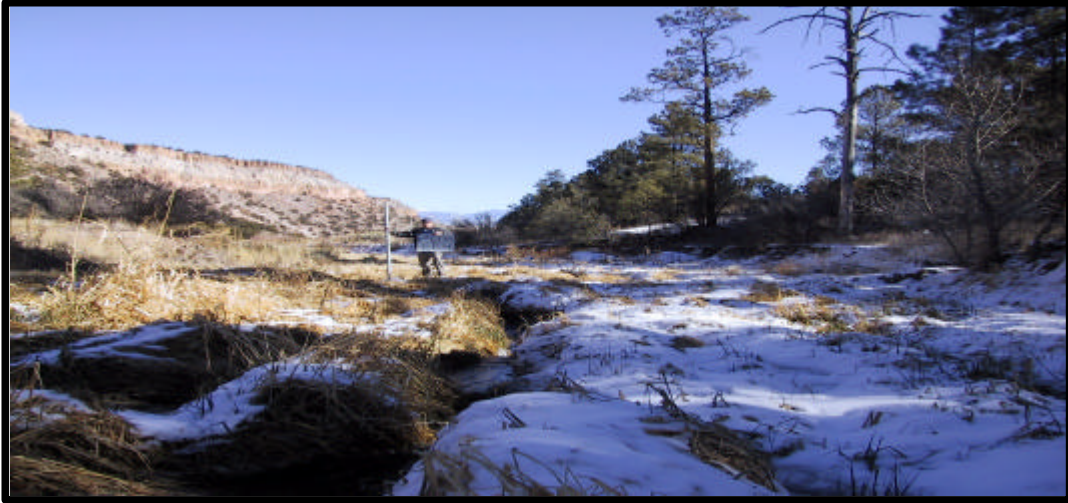
Figure 14 is a downstream view of the P 4 East (A) channel at Cross section ER-4. The photo is oriented so that cross section starts at D, left or north in this photo, and continues to D'.

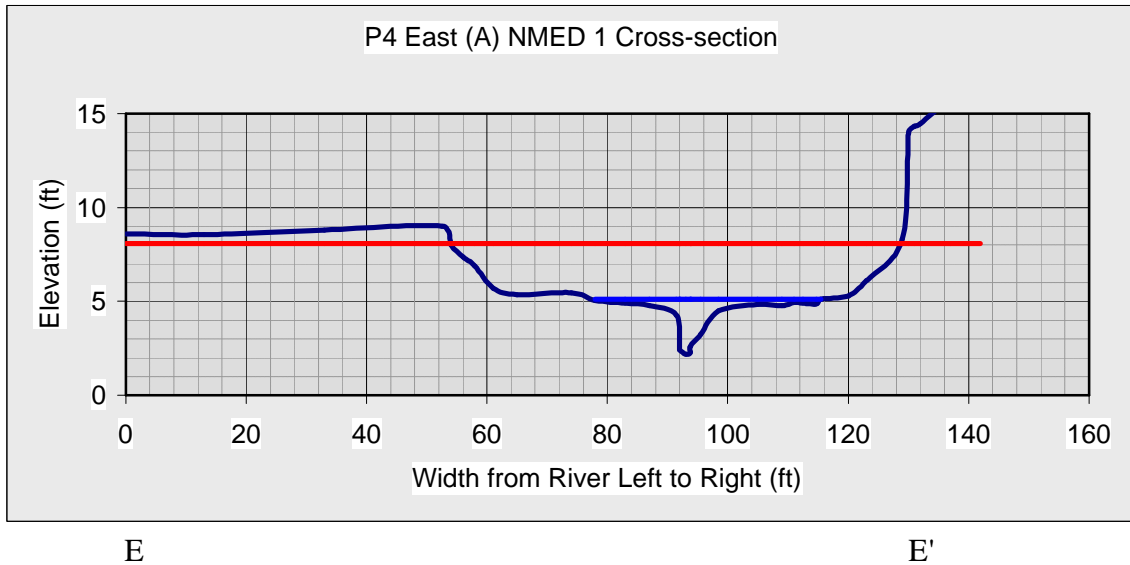
The area under the blue line in Figure 16 represents the cross section area at bankfull stage and the red line marks the flood-prone area.

**Figure 16. P-4 East (A) NMED-1 cross section. The area under the horizontal blue line represents the cross section area at bankfull stage and the red line depicts the flood prone area height.**

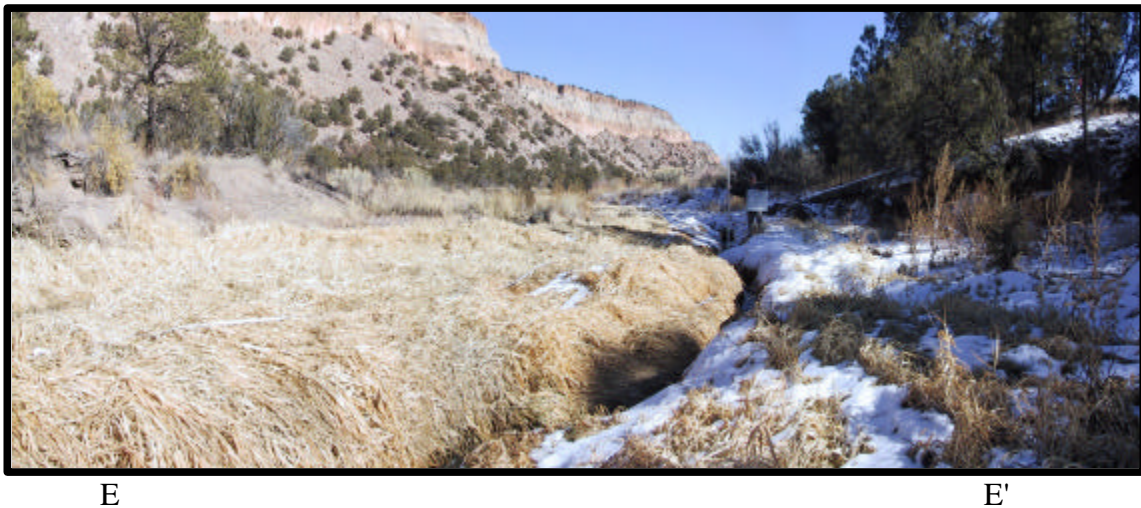
Figure 17 is a downstream view of the P-4 East (A) channel at cross section NMED-1. The photo is oriented so that cross section starts at E, left or north in this photo, and continues to E'.

**Figure 17. View of P-4 East (A) NMED-1 cross section looking downstream**

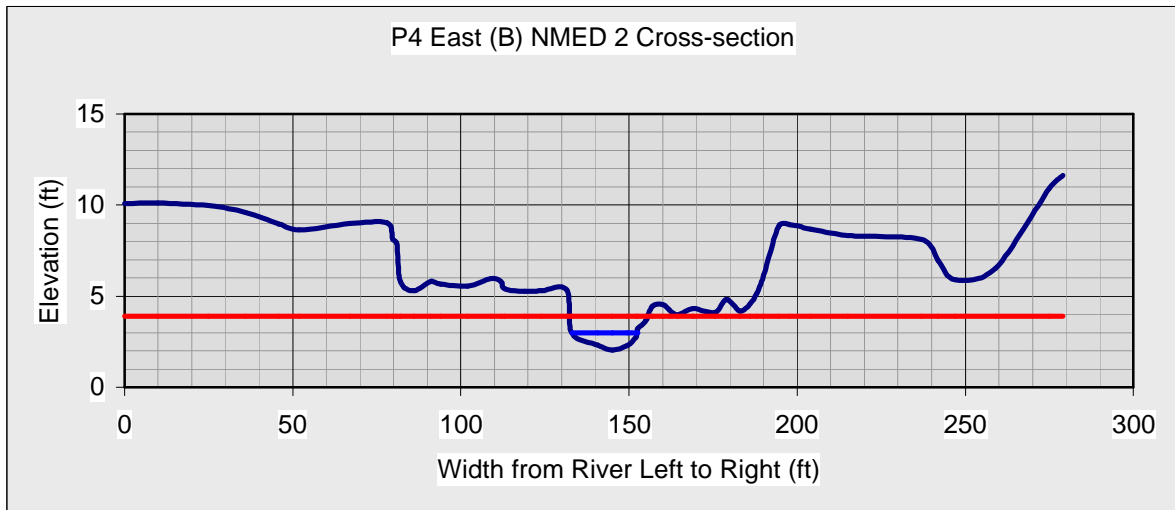
Figure 19 demonstrates the dimensions at this location measured along the entire 279-foot extent of the NMED cross section. Cross section NMED-2, along with the following cross sections (NMED 3-9), does not correlate with a previously measured LANL ER Project cross section. Flood deposits (f1 units) are found from the beginning of the cross section to 80 feet, with abandoned c3 lobes present within that section. Terrace banks are marked at 80 and 195 feet, confining the (c1a) active channel and adjacent (c1b) 1991 sandbar deposits. The widening thalweg is at 145 feet. At this location, the thalweg has migrated north of its original, now abandoned course. The original thalweg channel is not evident in the cross section, but channel-plugging materials could be found at 175 feet. More f1 flood plain units are found between 195 and 240 feet, and abandoned channel deposits (c2a) are found between 240 and 260 feet. Fill material used for the base of State Road 4 exist from 262 feet to the end of the cross section.

**Figure 19. P-4 East (B) NMED-2 cross section. The area under the horizontal blue line represents the cross section area at bankfull stage and the red line depicts the flood prone area height.**

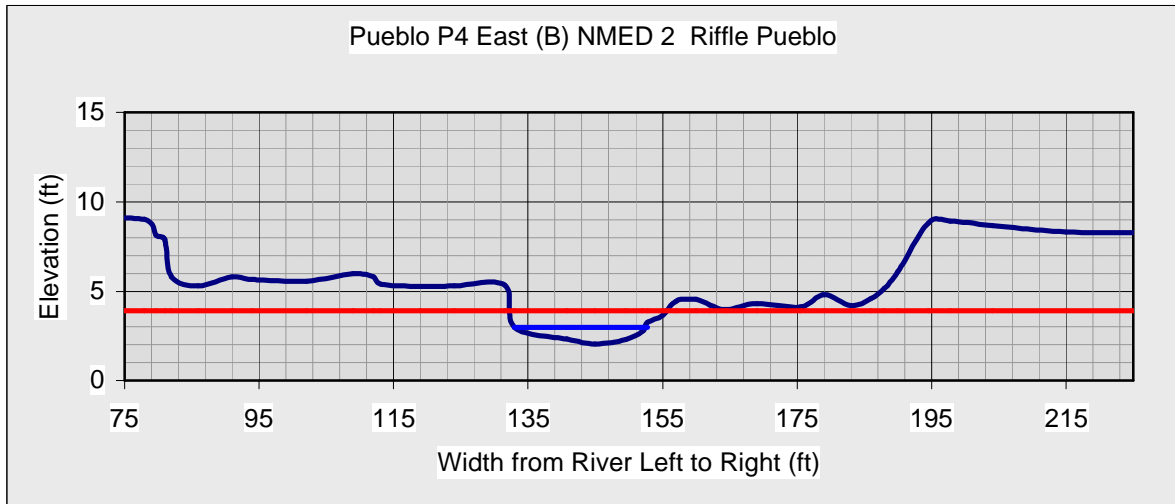
Figure 20 displays 150 feet of the cross section. This figure more plainly shows the c1b sandbar unit at 80 to 130 feet. The area below the horizontal blue line represents the cross section area at bankfull stage and the red line depicts the height of the flood prone area.

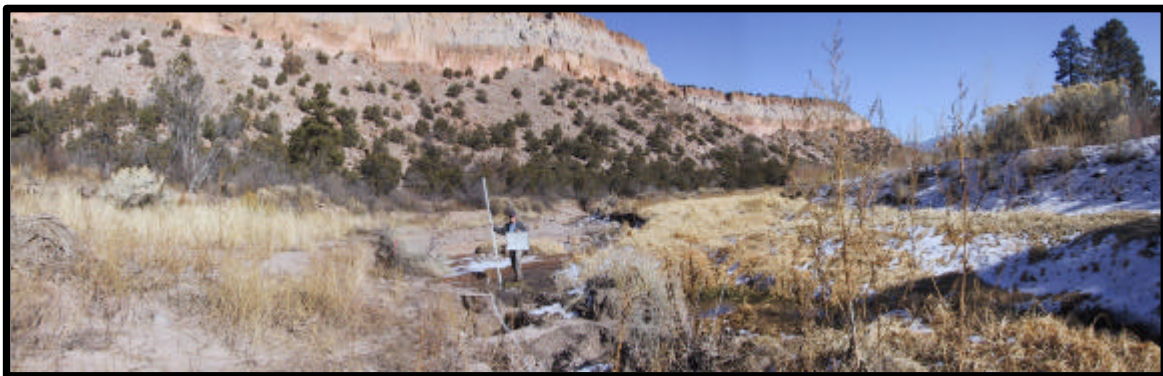
Figure 21 is a downstream view of the channel at P-4 East (B) NMED-2 in Pueblo Canyon, reach P-4 East (B). The photo is oriented so that cross section starts at F, left or north in this photo, and continues south to F'.

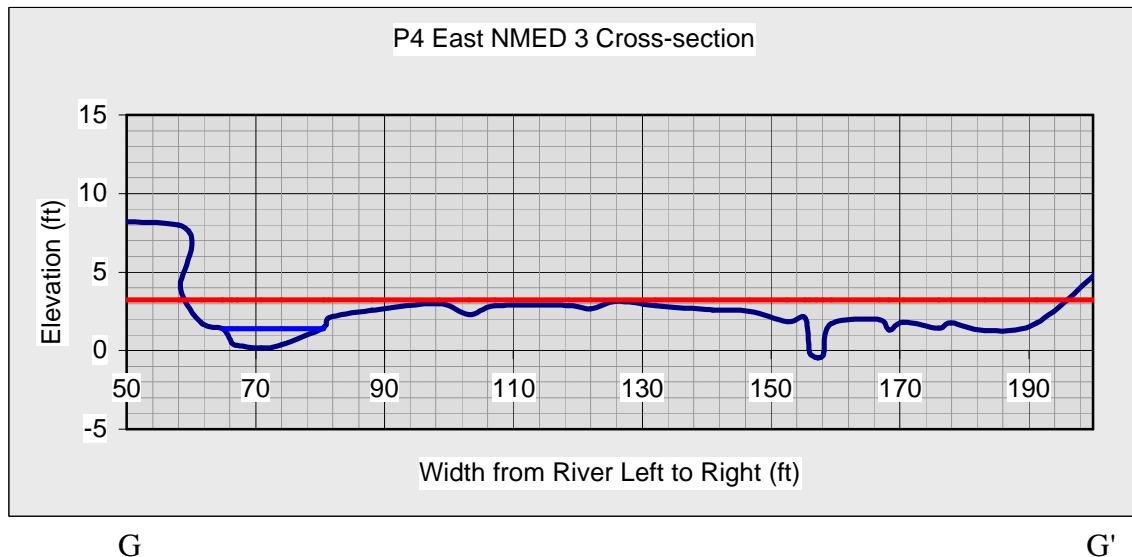
In figure 23, the area under the horizontal blue line represents the cross section area at bankfull stage and the red line depicts the flood prone area height.

**Figure 23. P-4 East (B) NMED-3 cross section. The area under the horizontal blue line represents the cross section area at bankfull stage and the red line depicts the flood prone area height.**

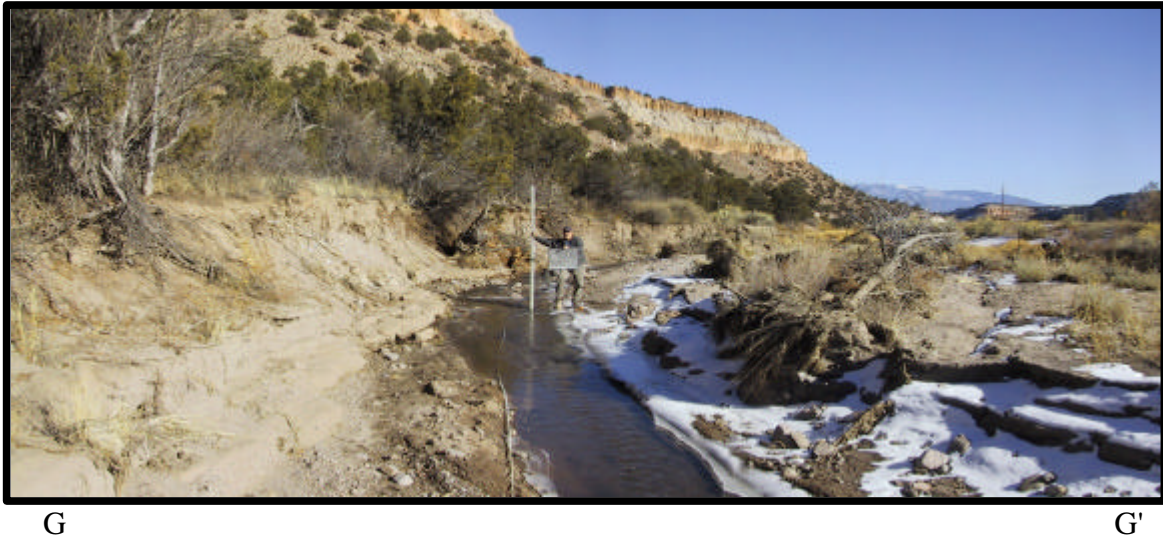
Figure 24 is a downstream view of the channel at Cross section NMED-3 in Pueblo Canyon, reach P-4 East (B). The photo is oriented so that cross section starts at G, left or north in this photo, and continues south to G'.

**Figure 24. View of P-4 East (B) NMED-3 cross section looking downstream.**

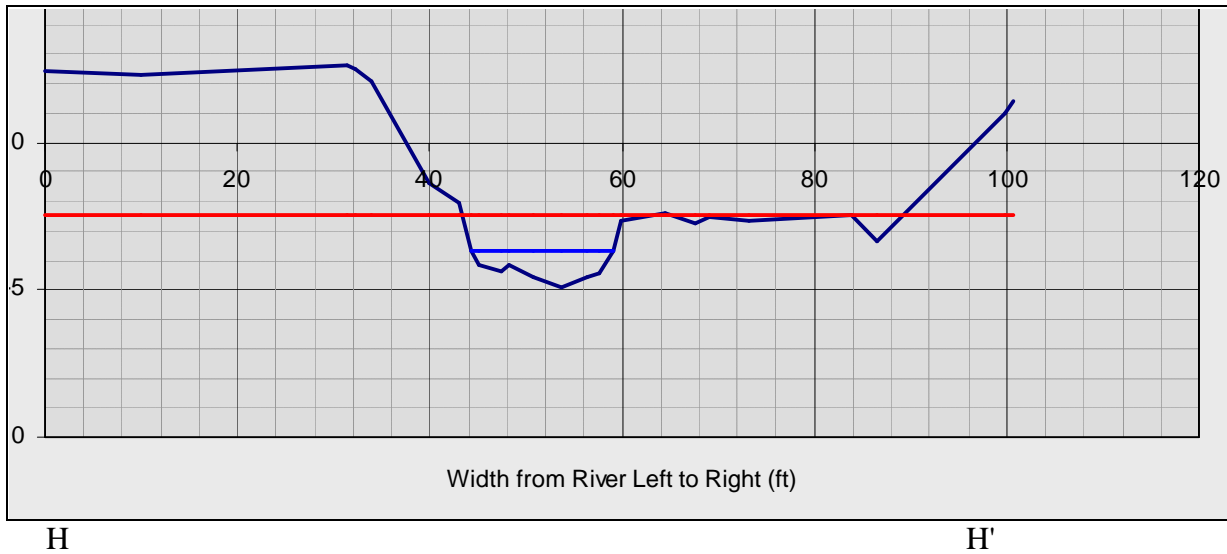
**Figure 26. P-4 East (B) NMED-4 cross section**

Figure 26 demonstrates the dimensions measured at this location and characteristics along the entire 101-foot extent of the NMED cross section. The area under the horizontal blue line represents the cross section area at bankfull stage and the widening of the thalweg. The red line depicts the height flood prone area confined within the terrace banks and SR 4 highway embankment.

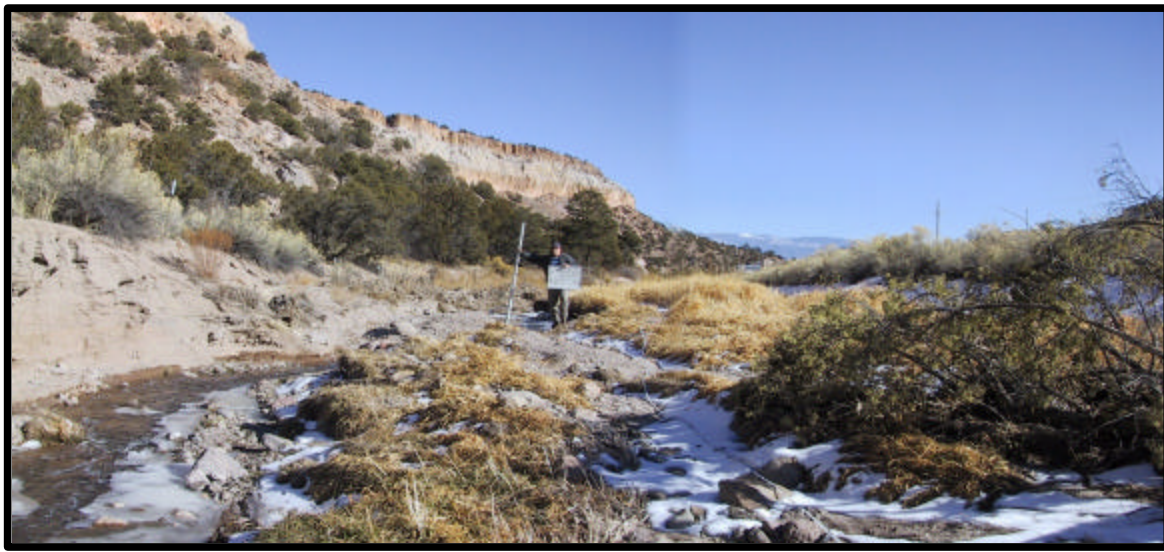
**Figure 27. View of NMED-4 cross section looking downstream**

Figure 27 is a downstream view of the channel at cross section NMED-4 in Pueblo Canyon, reach P-4 East (B). The photo is oriented so that cross section starts at H, left or north in this photo, and continues south to H'. The white steel fence-post (near H) marks a New Mexico Highway Department benchmark (included in cross section).

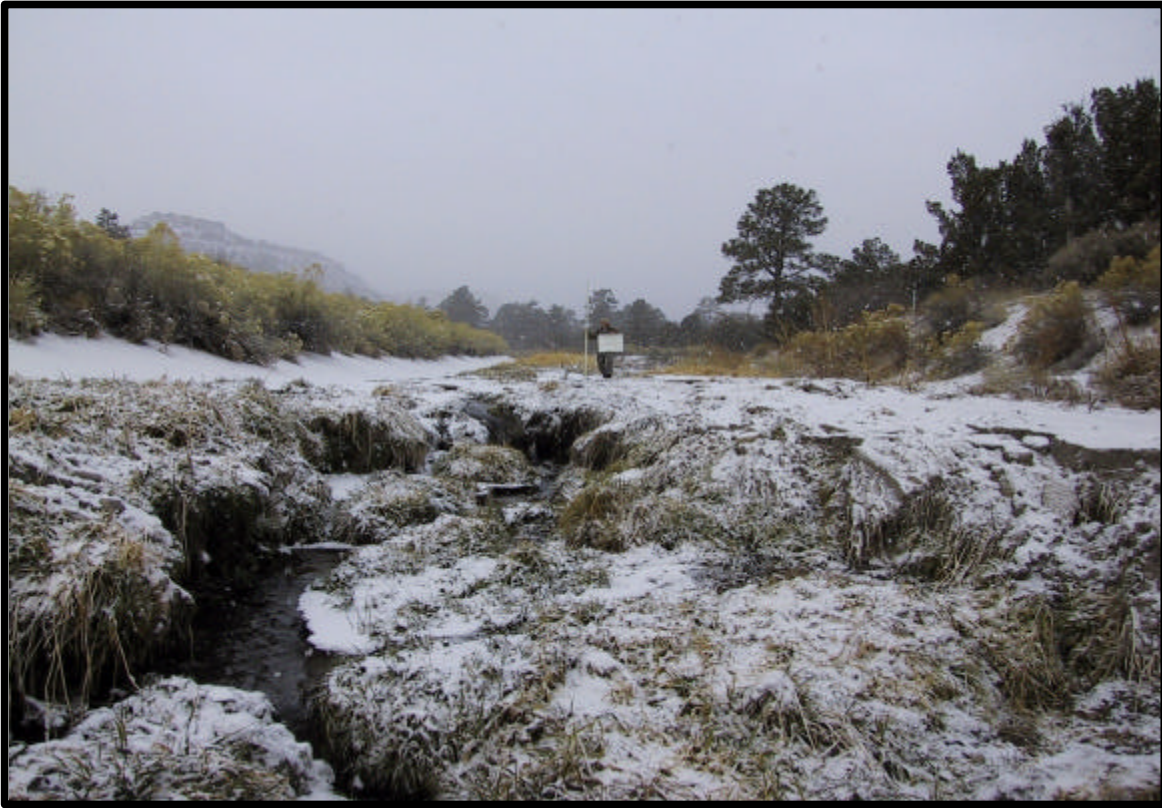
**Figure 30. View of P-4 East (B) NMED-5 cross section looking upstream**

Figure 30 is an upstream view of the channel at P-4 East (B) NMED-5 cross section. The photo is oriented so that cross section starts at I, right or north in this photo, and continues south to I'. This view is different than all preceding photos in that it is an upstream view rather than downstream. It is presented to show the erosion that has produced the head-cut that is forming downstream from NMED-5.

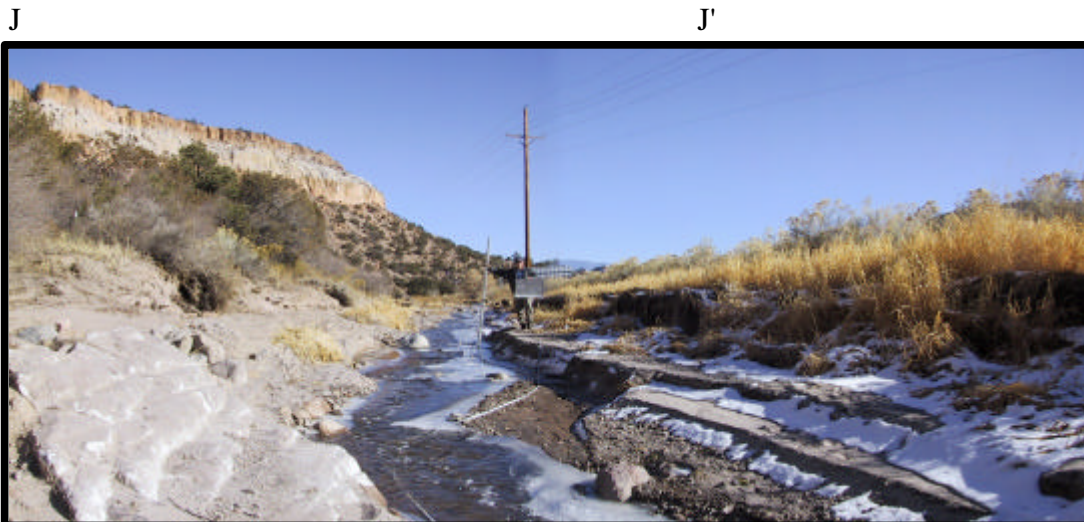
**Figure 33. View of P-4 East (B) NMED-6 looking downstream**

Figure 33 is a downstream view of the channel at cross section NMED-6 in Pueblo Canyon, reach P-4 East (B). The photo is oriented so that cross section starts at J, left or north in this photo, and continues south to J'.

Bedrock is exposed in the left foreground of this photo as well as fresh sand and cobble material in the right foreground. The vertical channel incision has abandoned the previous active channel area demonstrated by the grass-covered banks in the right half of this photo.

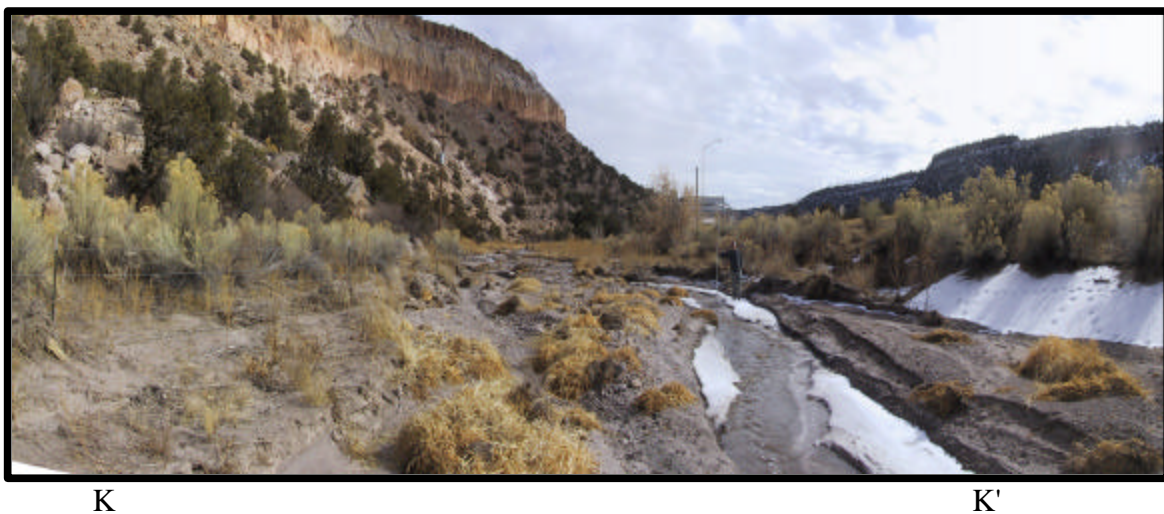
**Figure 36. View of P-4 East (B) NMED-7 cross section looking downstream**

Figure 36 is a downstream view of the channel at P-4 East (B) NMED-7 cross section. The photo is oriented so that cross section starts at K, left or north in this photo, and continues south to K'.

Our researcher is standing on the cross section with a stadia rod in the thalweg. The c1b sandbar unit is located under the chamisa-covered area (yellow bushes in the left portion of this photo). The steep colluvium-covered slope is left and behind the c1b unit. The channel in the foreground demonstrates the alternate alluvial fill and down cutting.

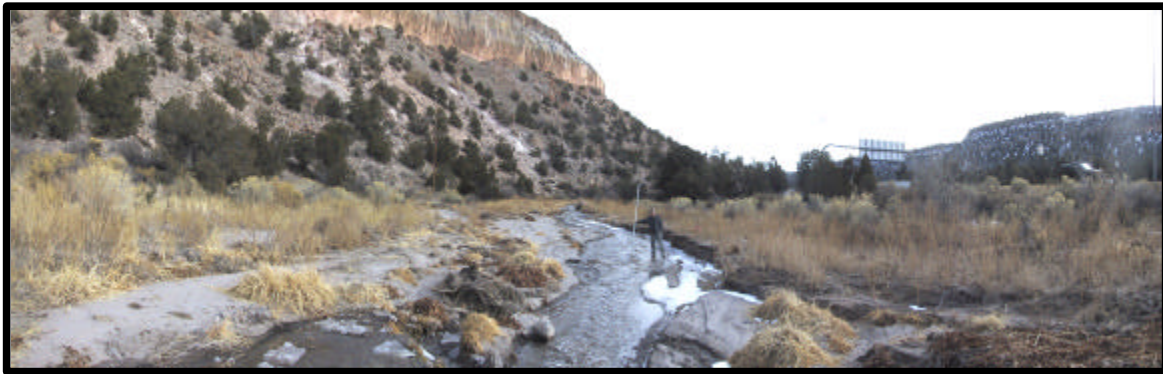
Our researcher is standing on the cross section with a stadia rod in the thalweg. The c1b sandbar unit is located under the grass-covered areas in the left and right portions of this photo. The steep colluvium-covered slope is at the far left, and background. The channel in the fore ground demonstrates the alternate aggradations and degradation.

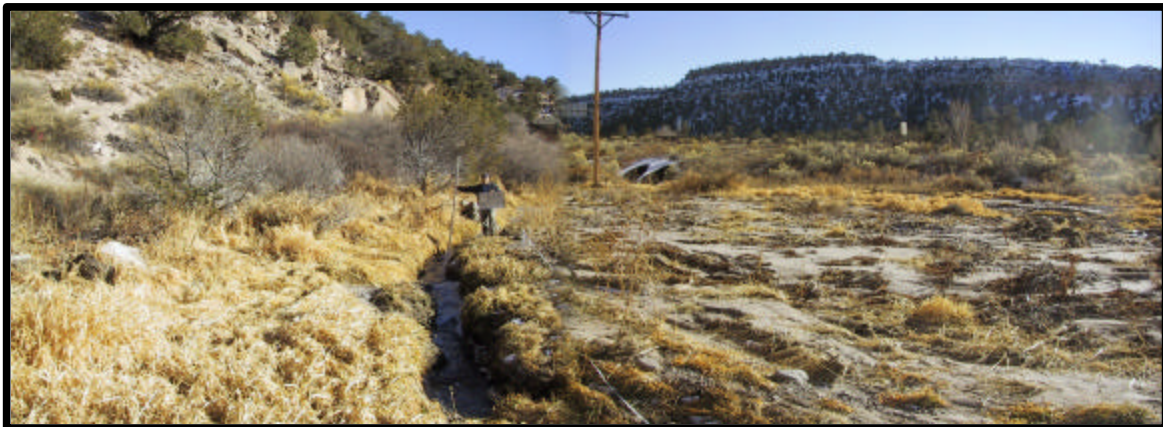
**Figure 43. View of P-4 East (B) NMED-9 cross section looking downstream**

Figure 43 is a downstream view of the channel at P-4 East (B) NMED-9 cross section. The photo is oriented so that cross section starts at M, left or north in this photo, and continues south to M'
