# ENVIRONMENTAL SITE CHARACTERIZATION UTILIZING AERIAL PHOTOGRAPHS AND SATELLITE IMAGERY: THREE SITES AT LOS ALAMOS NATIONAL LABORATORY, NEW MEXICO

*Paul Pope, Naomi Becker, Ed Van Eeckhout and Cheryl Rofer*

*Los Alamos National Laboratory, Los Alamos NM 87545*

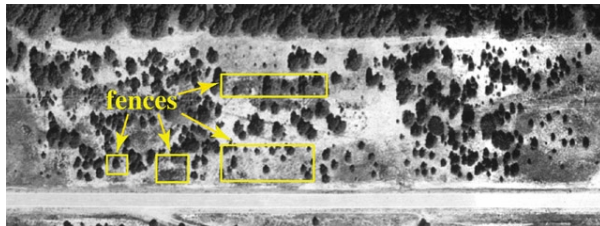
Fig. 3(a). 1991 orthophoto of MDA-F.

Figure 3(a) shows a 1991 orthophoto of the MDA-F area, with the boundaries of suspected trenches overlaid on the photo. Based on these boundaries, a magnetic gradient survey area was defined as shown on Fig. 3(b), and overlaid on a 1958 photograph. Note that the pits and trenches appear to extend beyond the fence lines shown in Fig. 3(a). Because it seemed that the pits and trenches did extend farther than originally thought, a study to evaluate historical photographs of the area was initiated.

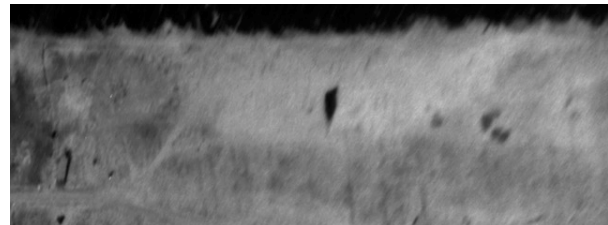
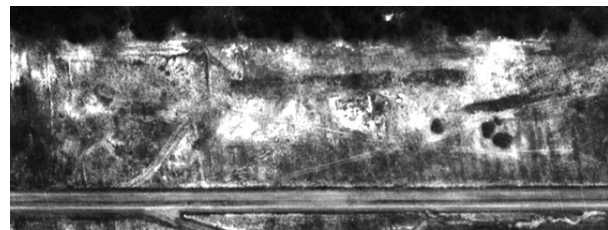
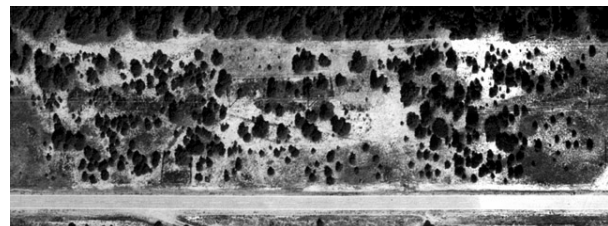
Fig. 4(a). 1935 image of MDA-F area.

Fig. 4(b). 1946 image of MDA-F area.

Fig. 4(c). 1949 image of MDA-F area.

Fig. 4(d). 1958 image of MDA-F area.

Fig. 4(e). 1972 image of MDA-F area.

Fig. 4(f). 1991 master image of MDA-F area.

allowed disparate views of the site to be transformed so that they matched in scale, orientation, and extent. This was especially useful for oblique photographs of the site. The coregistered images were studied individually and collectively to identify features which were indicative of human activity at the site and to provide a physical history of natural and human induced changes. The images used are shown in Fig. 4(a)-(f). Note the clump of scrub oaks that are common to all images.

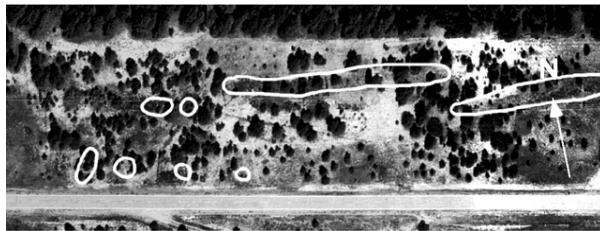
Fig. 5. Suspected trenches and pits within the area of interest. Note the two large trenches. The one on the right wasn't suspected until the historical photography was inspected.

The coregistered images were then imported to a GIS and geographically coded to a common coordinate system. The GIS was used to extract the boundaries of features such as suspected trenches and disturbed soil. The boundaries of disturbed ground, access routes, the main disposal trench, and three other suspected trenches were vectorized from the imagery by on-screen digitizing. These boundaries were overlaid on the most recent image of the site to display the historical characterization features within the context of how the site appears now. This preliminary analysis formed a basis for planning and comparing the results from other surveys of the site. The major trenches found are shown on Fig. 5. Further details of this analysis can be found in Pope and others, 1996.

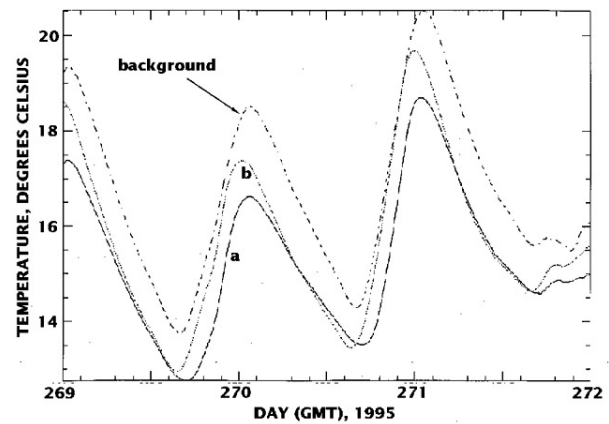
Fig. 8. Comparison of transect a and b temperatures with the background.

shown in Fig. 7. Both moisture and temperature measurements across these transects indicated differences from the surrounding area. In general, soil moisture content in the trenches was twice as wet as the background and soil temperatures were lower. Figure 8 shows the lowering of temperatures at a 6 inch depth of burial in the middle of each trench compared to background.

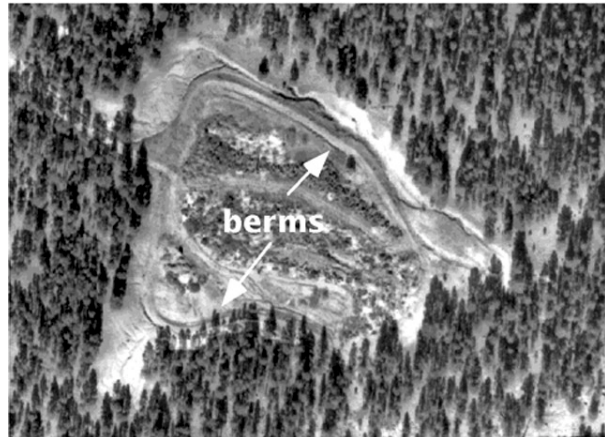
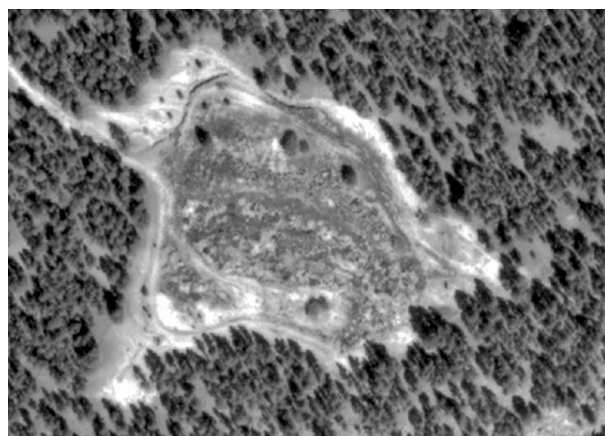
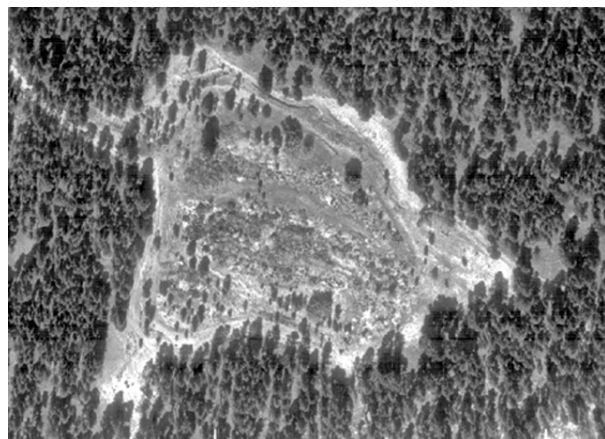
Fig. 9(a). 1935 image of MDA-M area.

Fig. 9(d). 1958 image of MDA-M area.

Fig. 9(b). 1947 image of MDA-M area.

Fig. 9(e). 1974 image of MDA-M area.

Fig. 9(c). 1951 image of MDA-M area.

Fig. 9(f). 1991 master image of MDA-M area.

The 1935 image indicates that this area was an open space even before LANL was established (Fig. 9(a)). This open space most likely provided an easy opportunity for establishing a surface disposal site since no trees had to be removed. Many access trails created by homesteaders were evident. However, no major route to the site was detected in this image.

Surface disposal at the site is indicated by three distinct, east-west oriented mounds, which appear as darker, elongated features on all of the images after 1948 (Figs. 9(c)-(f)). These features have a mottled appearance and contain small, bright pieces of material. These areas change only slightly between 1951 and 1954, with evidence of debris deposition appearing on the western end of the northern and central mounds. Stereoscopic viewing of stereo pairs from 1951 and 1958 revealed significant movement of soil and material in several places. A much brighter material is deposited on the northwestern portion of the first mound between 1951 and 1954. Of special note is the fact that these mounds do not change significantly between 1954 and 1991, which suggests that the majority of the surface disposal was performed between 1948 and 1954. Neither pits nor trenches were detected at this site.

Changes in the drainage patterns across the site are also informative. Major changes in erosional patterns are apparent after the creation of a berm around the site. This berm was created between 1951 and 1958. The berm has restricted runoff from the northwestern portion of the site to travel close to the berm in a west to east fashion, where it eventually spills into the southern tributary of Pajarito Canyon. Some of the deep erosional patterns apparent on the 1947 image (Fig. 9(b)) reappear within the eastern portion of the central debris mound. However, the berm appears to have contained the majority of runoff within the site. The berm does not appear to have eroded significantly since 1958 and is readily apparent from 1958 till 1991 (Figs. 9(d)-(f)).

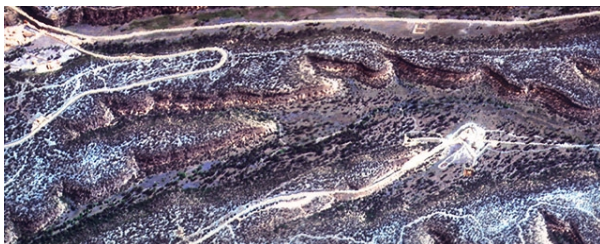
Fig. 10. Daedalus natural color composite image.

A series of multispectral composites of the region around the one firing site, Lower Slobovia, illustrate the contribution from different spectral regions. The natural color image (red, green, blue composite), Fig 10, provides a good overview of the area. Roads and trails stand out as bright linear features. The green vegetation is distinguishable from the stressed (brown) vegetation or bare soils.

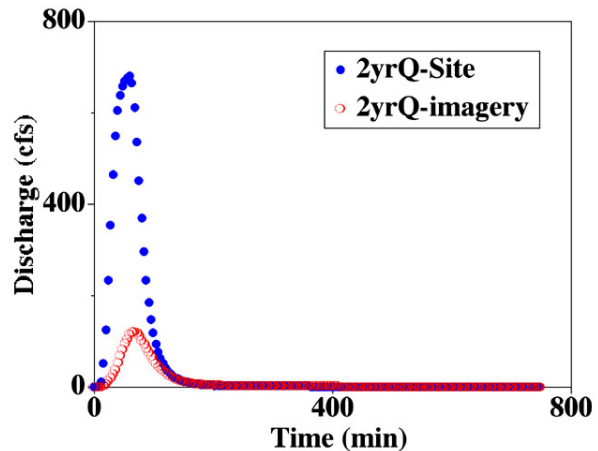
Fig 14. Comparison of ground-based vs. imagery-based hydrographs for the 2-yr recurrence interval.

Assuming that the ground-truth data is calibrated to approximate measured flows, the imagery data alone will under-estimate flow discharge. This is clearly demonstrated in the Two-Year storm case, Fig 14.
