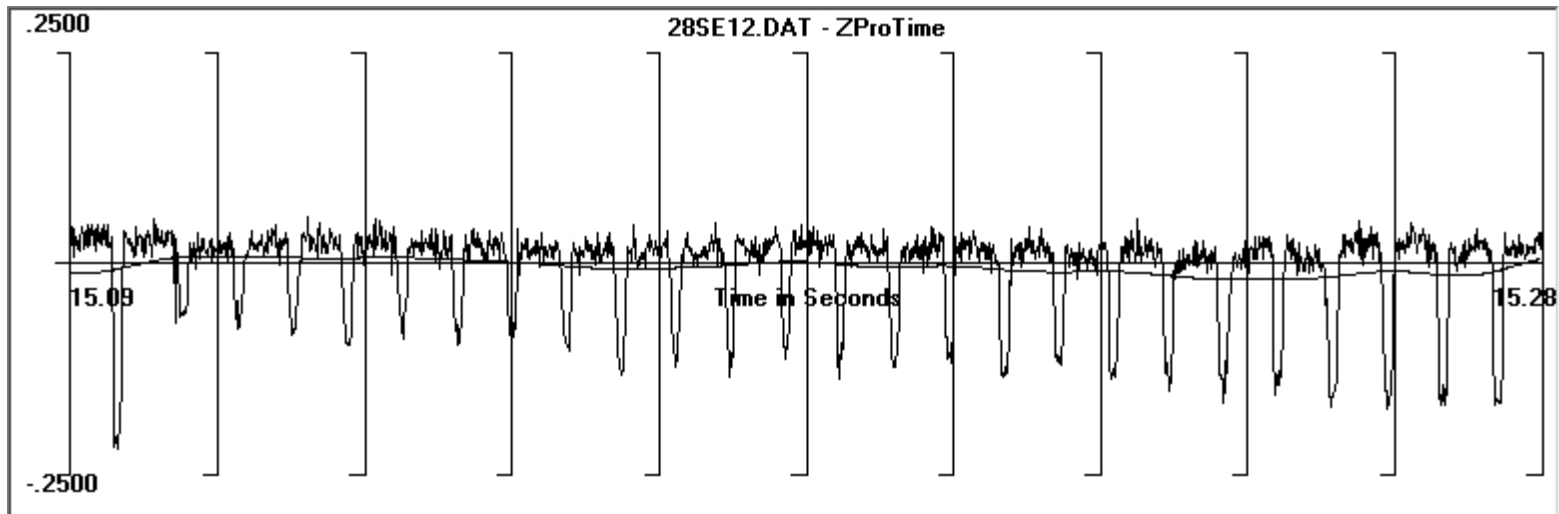
The figure is a close order (0.20 seconds) laser profile of a grooved pavement surface. The figure shows a groove head with 25 blades. Note the slope along the bottom of the grooves. Grooves vary in depth across the head. To minimize bias, the specification calls for the measurements to include at least two blades near the center of the head.

In this instance, measurements would not meet tolerance.

This will not be included in the specification. It provides the reasoning for taking measurements about the middle of each cutting head.
