**Sausalito – Marin City Sanitary District (NPDES No. CA 0038067)
Wastewater Treatment Plant Inspection
US EPA and San Francisco Regional Water Quality Control Board
Date of Inspection: Wednesday, March 21, 2007**

Report prepared by: JoAnn Cola Date prepared: 5/31/07

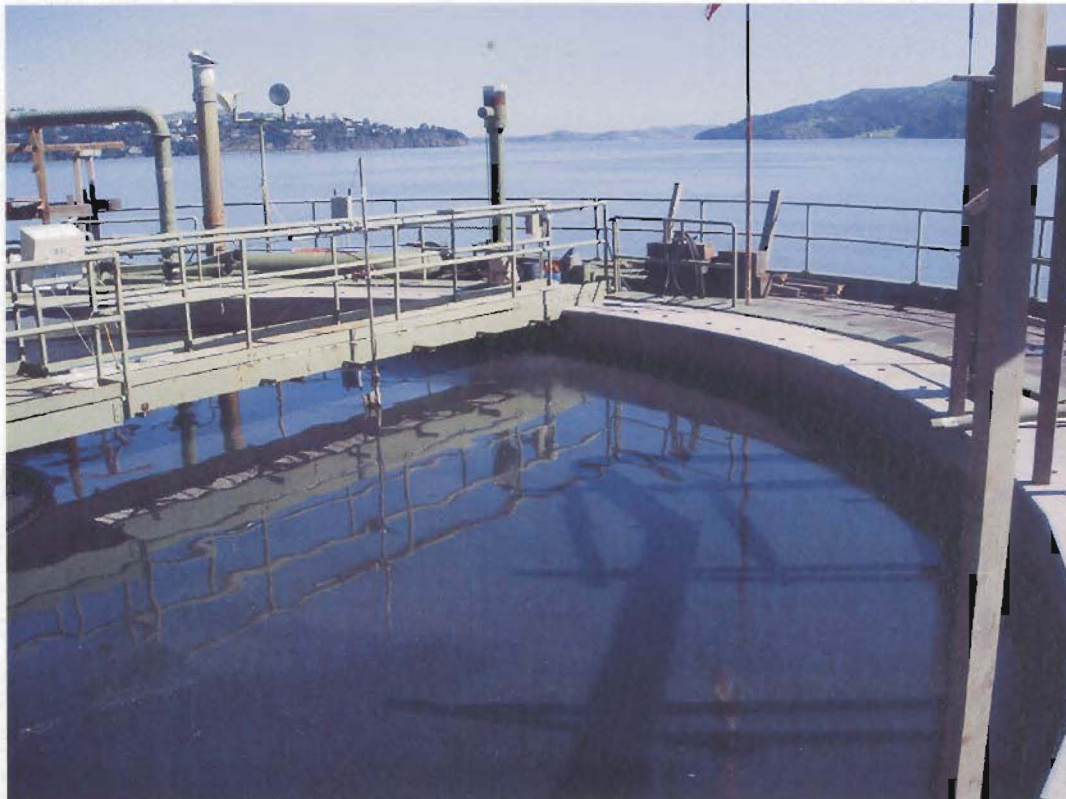
Flow from the energy dissipation box enters the primary clarifier (Fig. 3), along with plant return flows. The primary clarifier weir is covered and the covers must be removed prior to cleaning or maintenance of the weirs, which seems to significantly add to the complexity of routine maintenance. Without preliminary screening, the need for cleaning

and routine maintenance would seem to be increased. Mr. Simmons did not recall how frequently the clarifier was maintained. Because there is only one primary clarifier, it must be taken off-line to perform certain routine maintenance procedures. During such procedures, primary clarification is bypassed, routing the flow to one of the secondary clarifiers, which serves temporarily as primary clarification. When this occurs, capacity of secondary clarification is reduced, which could adversely affect removal of BOD and TSS.

Figure 3: Primary clarifier. Note covered weir.

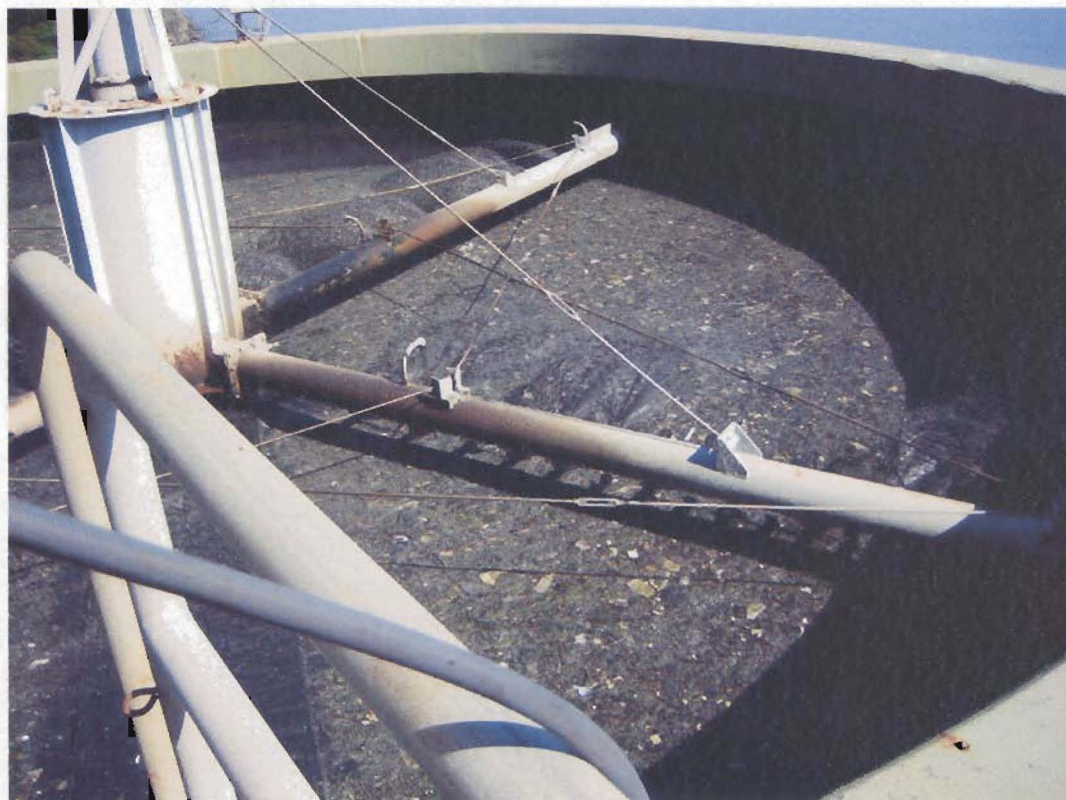
Primary clarifier effluent is normally passed through a grit screen, but capacity is limited and the screen is bypassed at higher flows. Primary clarifier effluent not passing through the grit screen would enter the FFRs containing an excess amount of debris, potentially clogging the FFRs. Primary clarifier effluent enters one of two fixed film reactors (FFRs), which operate in parallel and can handle a total of up to 6 MGD. When 6 MGD capacity of the FFRs is exceeded, the excess flow bypasses the FFRs. According to Bob Simmons, this occurs approximately 7 times per year. FFRs operate in counter-current mode. Distributors spray primary clarifier effluent in at the top of the reactor, while air is blown upward from the bottom. The FFRs are not covered. Mr. Simmons said it was suggested to the District by CH2M Hill that co-current operation with both water and air entering from the top of the unit may result in improved odor control. Inspectors noted significant debris on the screen at the top of each fixed film reactor, which was likely due to the absence of a headworks to provide preliminary screening. Such a layer of debris could cause poor performance of the reactor.

Figure 4: FFR #2. Note extensive debris on screen and debris-clogged nozzles.

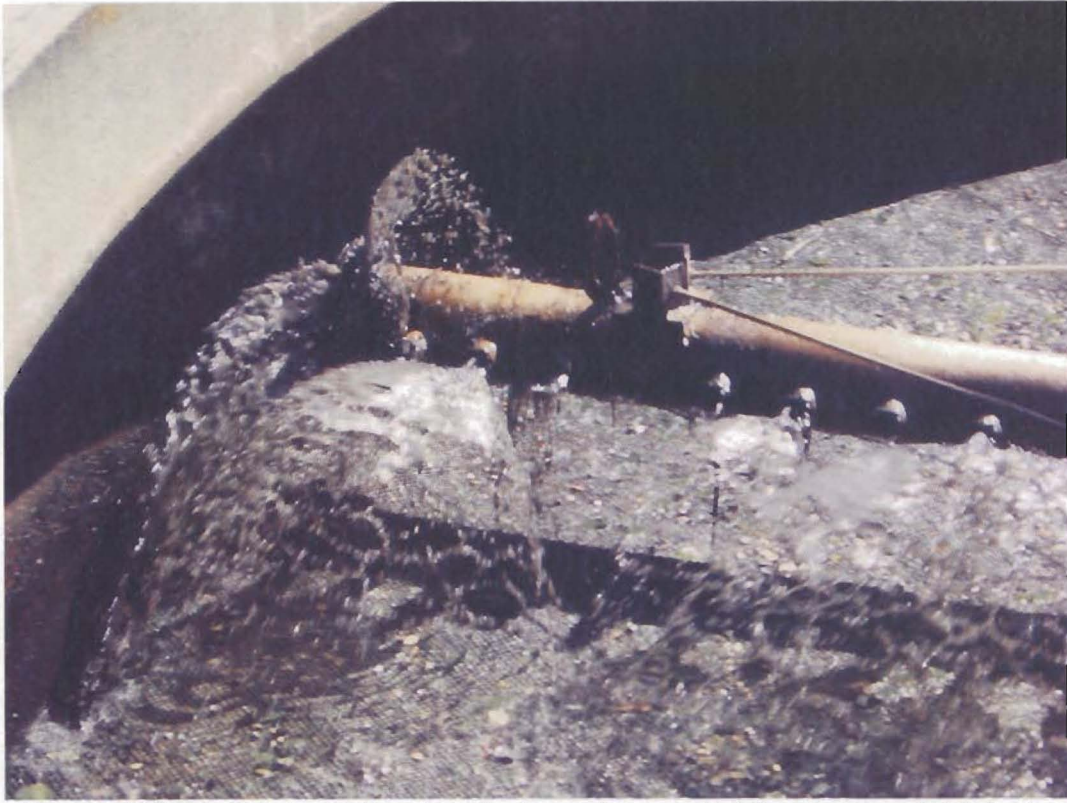
Debris clogged a number of distributor nozzles, and the end cap on a distributor arm of FFR #1 appeared to be broken (Fig. 5). The distributor arm on FFR #1 appeared to rotate slower than the distributor on FFR #2. FFR #2 appeared to have more evenly distributed flow. Uneven distribution of flow across the FFRs would likely cause a number of operational problems, including "short-circuiting" of flow through the reactors, uneven flushing of the biomass, and reduced secondary treatment efficiency. According to the CH2M Hill report, distributor arm speed is controlled only by flow to the arm – the more flow, the faster the distributor arm is propelled.

Figure 5: FFR #1. Note heavy flow from broken end cap on distributor arm and debris-clogged nozzles.

The hydraulic rotary distributors on the fixed film reactors are now 20 years old. According to Mr. Simmons, they presently rotate at 8 revolutions per minute. CH2M Hill recommends slowing to one revolution per 8 minutes to increase flushing of the biomass, as continual shearing of the biomass should improve the settling. A variable speed motorized distributor has been purchased.

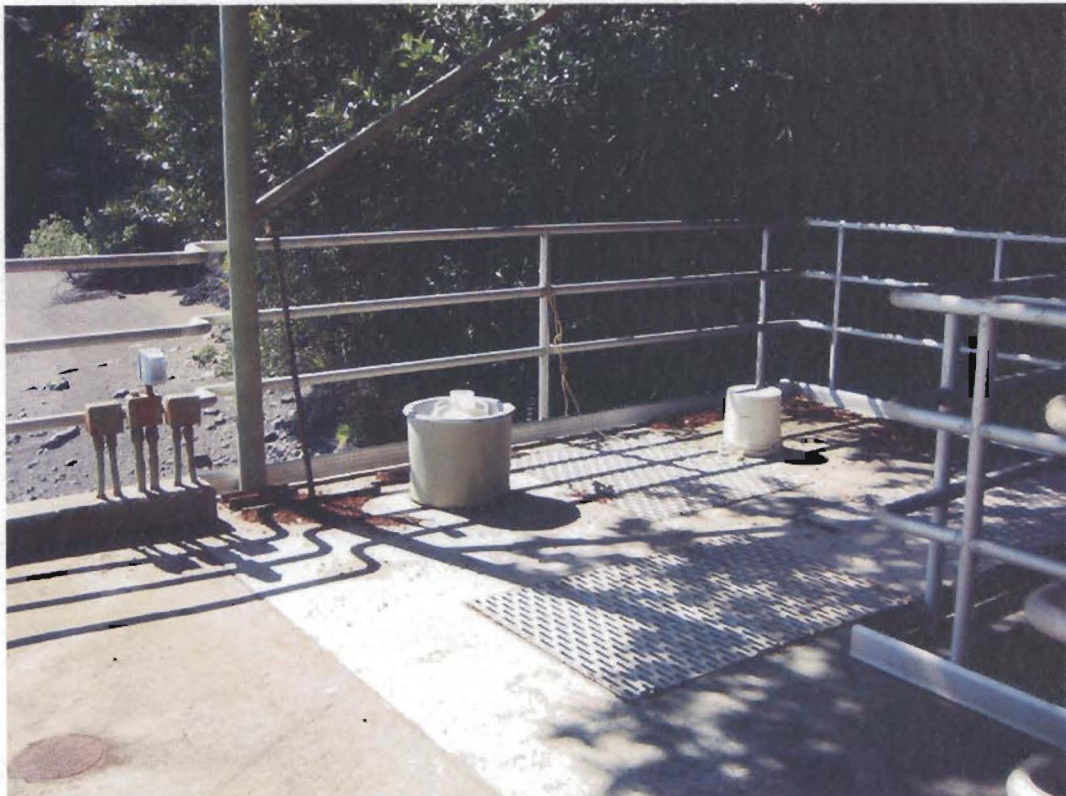
Figure 8: "Water Champ" chlorination point.

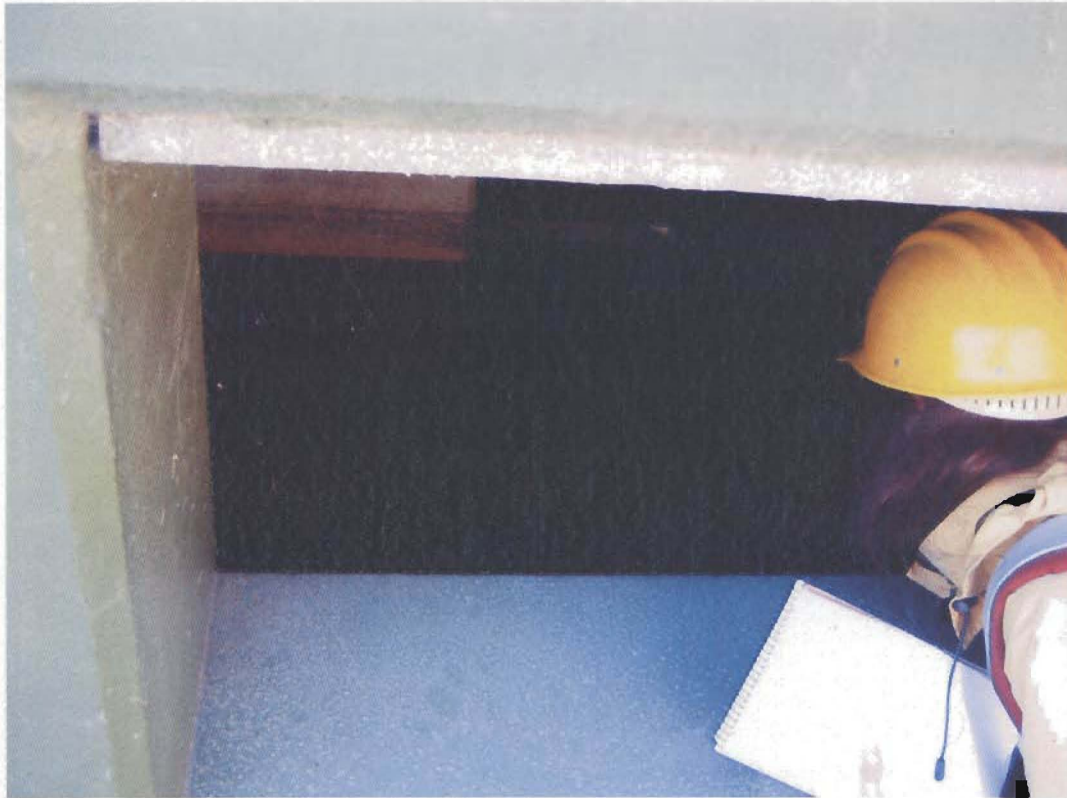
The effluent from the sand filters passes through a rotating screen (Fig. 7) and from there to the chlorine contact chamber which is also located underneath the FFRs (Fig. 9).

Figure 9: Chlorination chamber beneath FFRs.

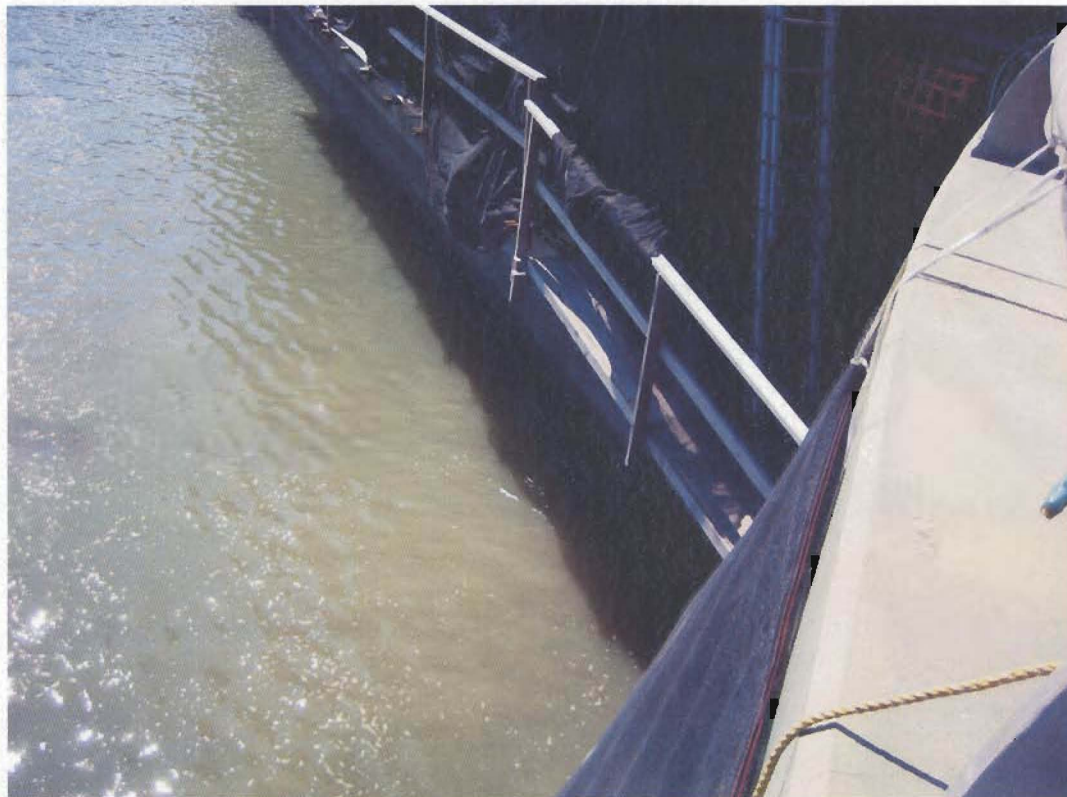
The outfall is located beneath the FFRs (Fig. 10), and is not visible unless tide is low. Discharge occurs 300 feet from the facility into San Francisco Bay.

Figure 10: Location of outfall pipe. Note patches of small bubbles floating at bay surface next to plant, which were visible along the shore adjacent to the plant. Cause of bubbles is unknown.

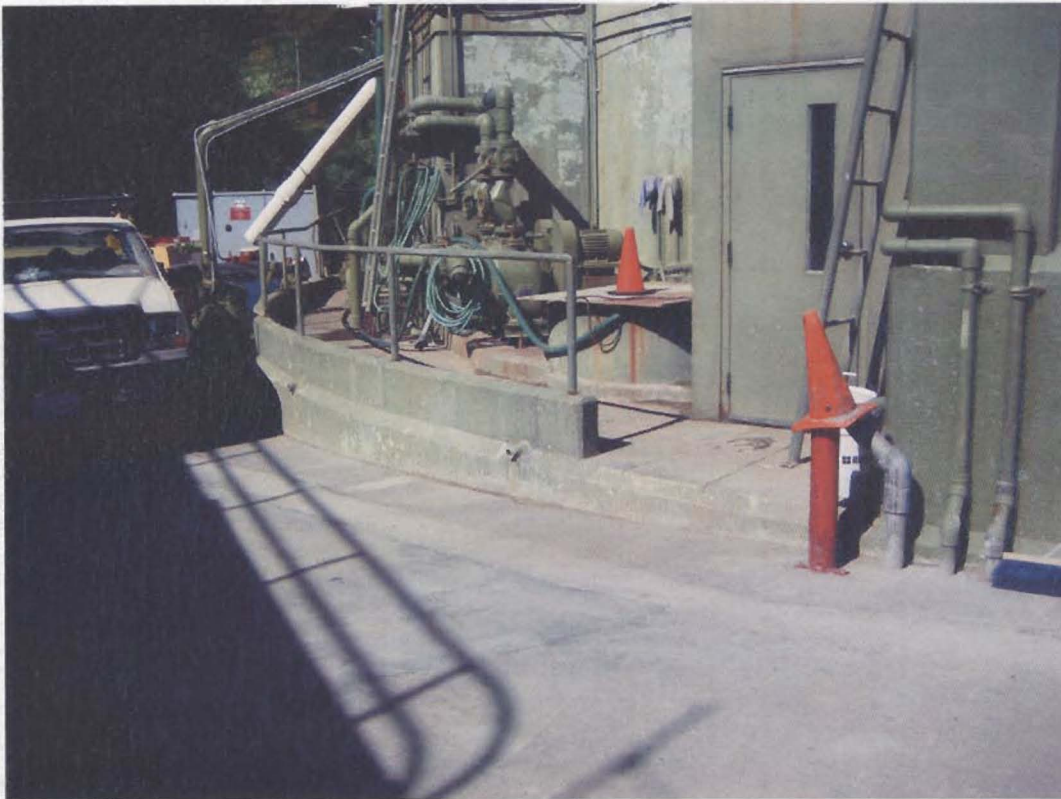
Solids removed from the primary clarifier are screened for grit (Fig. 11) prior to entering the sludge thickening tank (Fig. 12). The thickened sludge enters the digester, located under the primary clarifier (Fig. 13). The digester is 14 feet deep, with most of it below the level of the Bay. Supernatant from the digester is returned to the primary clarifier. Dewatered biosolids are sent to the Redwood Landfill.

Figure 13: Digester located beneath primary clarifier.
