Exhibit 1
Docket No. CWA-309(a)-09-002

U.S. ENVIRONMENTAL PROTECTION AGENCY - REGION IX
WATER MANAGEMENT DIVISION
MSGP STORMWATER COMPLIANCE INSPECTION REPORT

Facility: U.S. Navy
Naval Base Guam

U.S. ENVIRONMENTAL PROTECTION AGENCY - REGION IX
WATER MANAGEMENT DIVISION
CGP STORMWATER COMPLIANCE INSPECTION REPORT

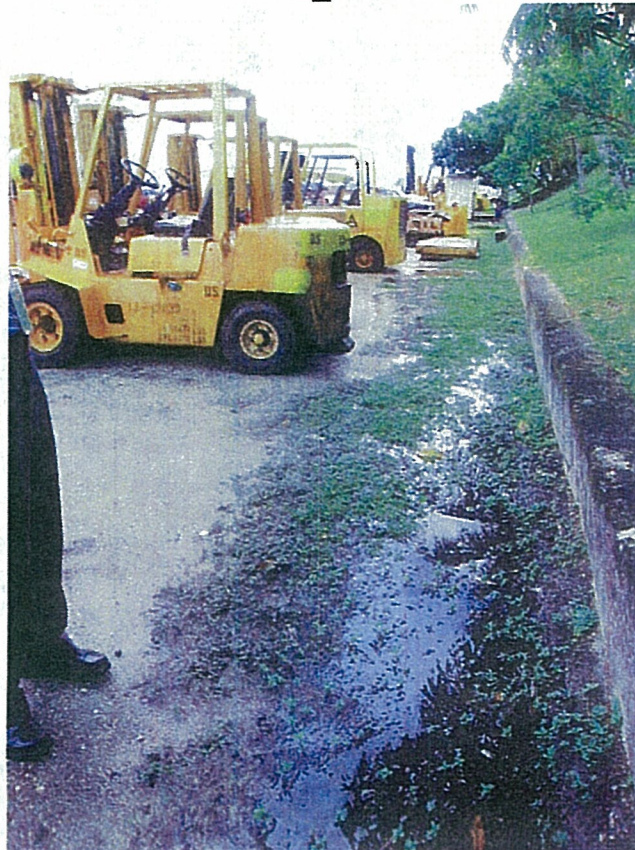
6. However, also at the Transportation Maintenance Shop, several vehicles and pieces of equipment were parked over oil stains, some apparently fresh. As there had been a recent rain shower, there was also a noticeable sheen in the area, but there was no evidence of drip pans in use anywhere at this shop. This issue was also noted in the Aug. 2007 ASCE report for this shop, thus it appears to be a chronic issue. (Photos IMG_0008, IMG_0009, IMG_0010).

- IMG_0006 Crew cleaning up fresh paint that had washed off of roof in a rain event.
- IMG_0008 The water in this photo had a visible sheen on it, also asphalt by the fork lifts showed staining from past or current drips and leaks. There were no

drip pans or other BMPs in evidence.

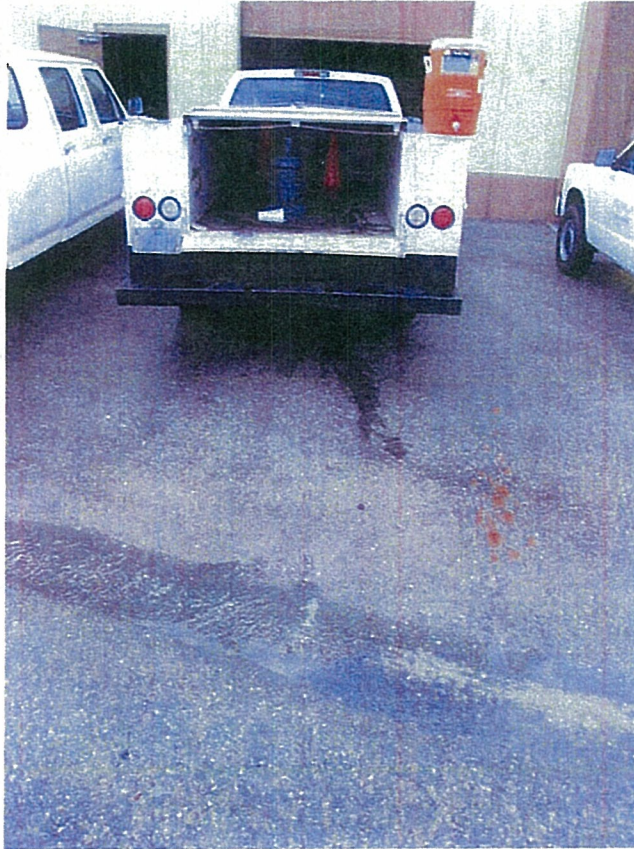
USN Naval Base Guam, MSGP Inspection of Main Base Area, 7/16/08
IMG_0009

IMG_0009 Staining of asphalt, evidence of a drip or leak, under this parked truck, with no drip pan or other BMPs in evidence.

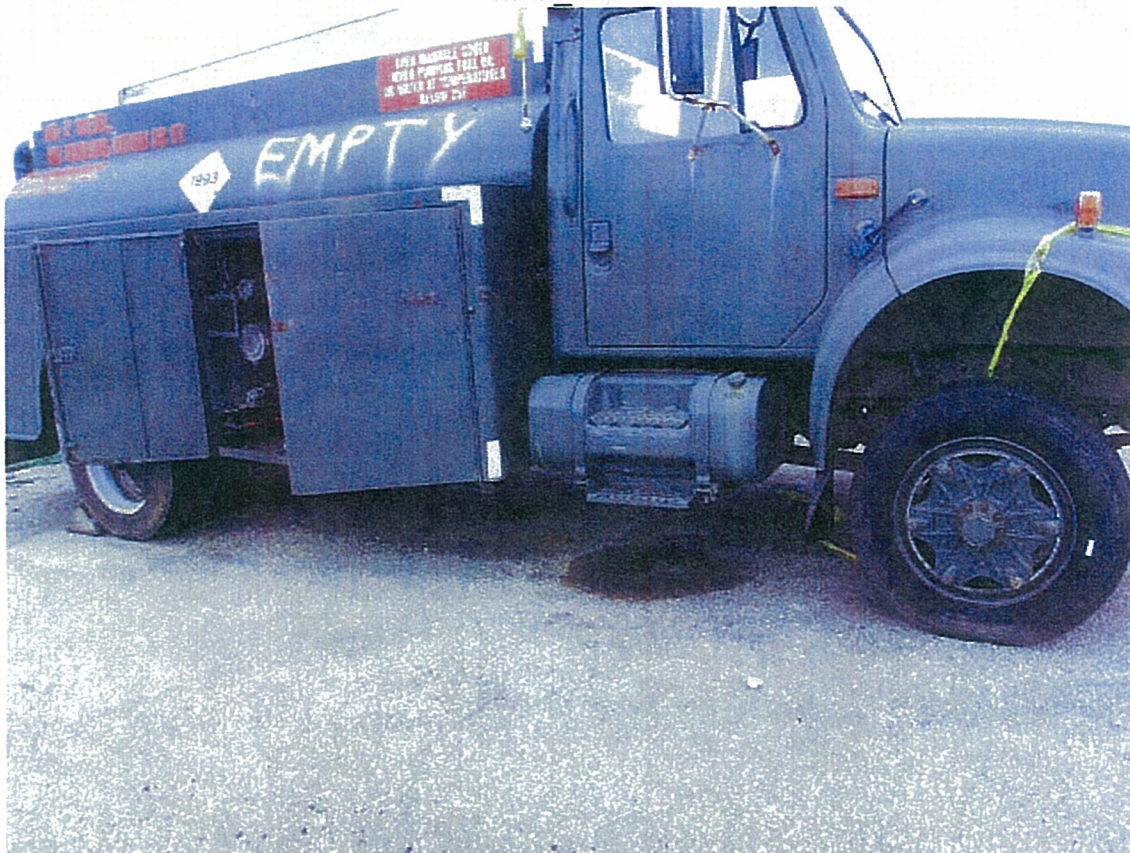
IMG 0010

IMG_0010 Drip stain under another parked truck, with no drip pan or other BMPs in evidence.

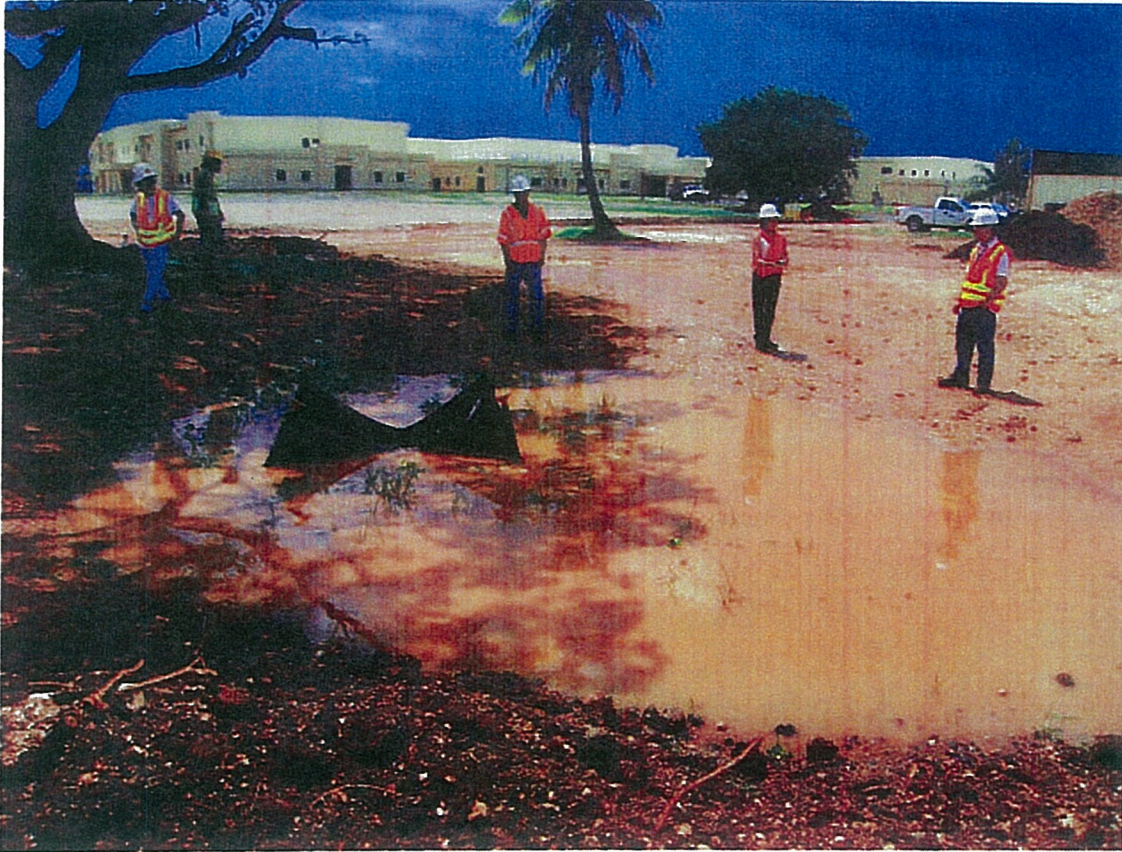
USN Naval Base Guam, CGP Inspection of McCool School Project, 7/16/08
IMG_0014

10. The area near to the contractor's trailer office was still being worked, had unstabilized soils and inadequately maintained drain inlet protection BMPs showing evidence of off-site sediment discharges (Photos IMG_0014, IMG_0016, IMG_0017, IMG_0020).

- IMG_0014 Ponding basin on east side of school near subcontractors' offices. Note turbidity in standing water and failed silt fence used as inlet protection.
- IMG_0016 Failed silt fence used as drain inlet protection, project's southwest perimeter.
- IMG_0017 Unstabilized soils and silt fence used as inlet protection.

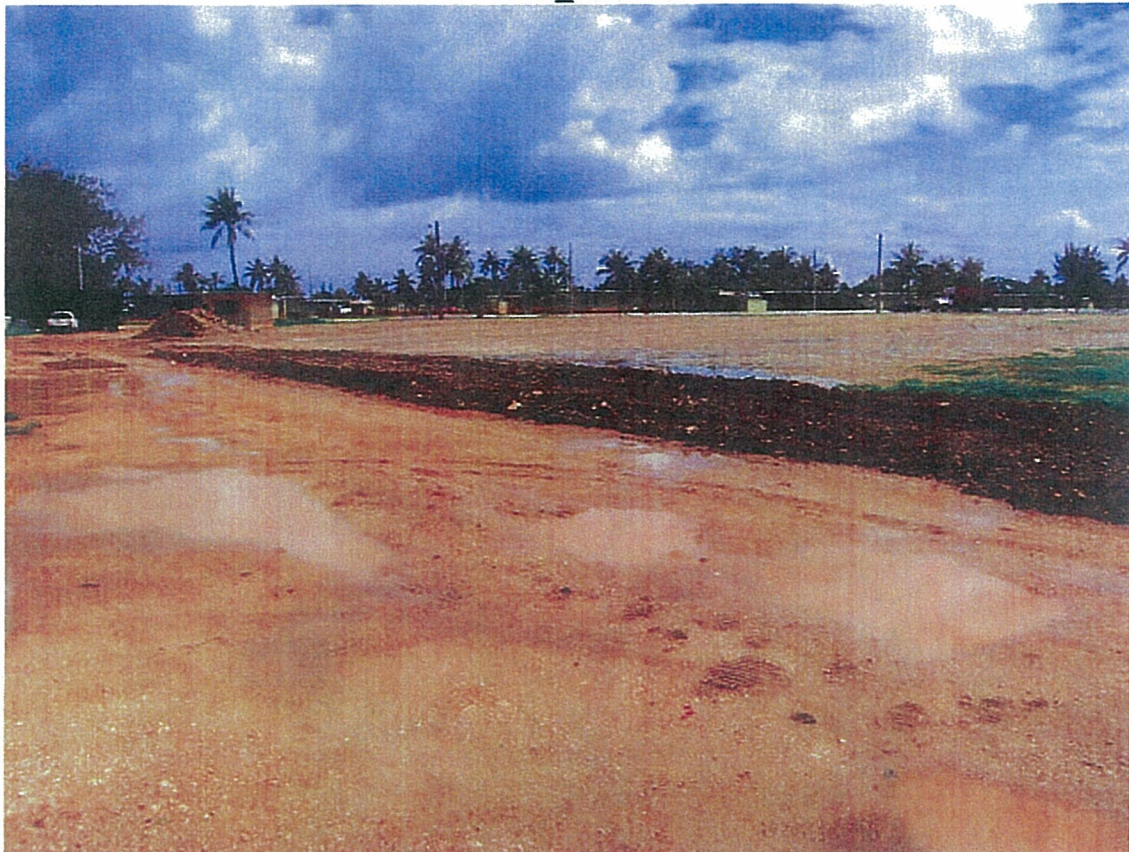
IMG_0020 Unstabilized soils upgradient of the drain inlet shown in IMG_0014.

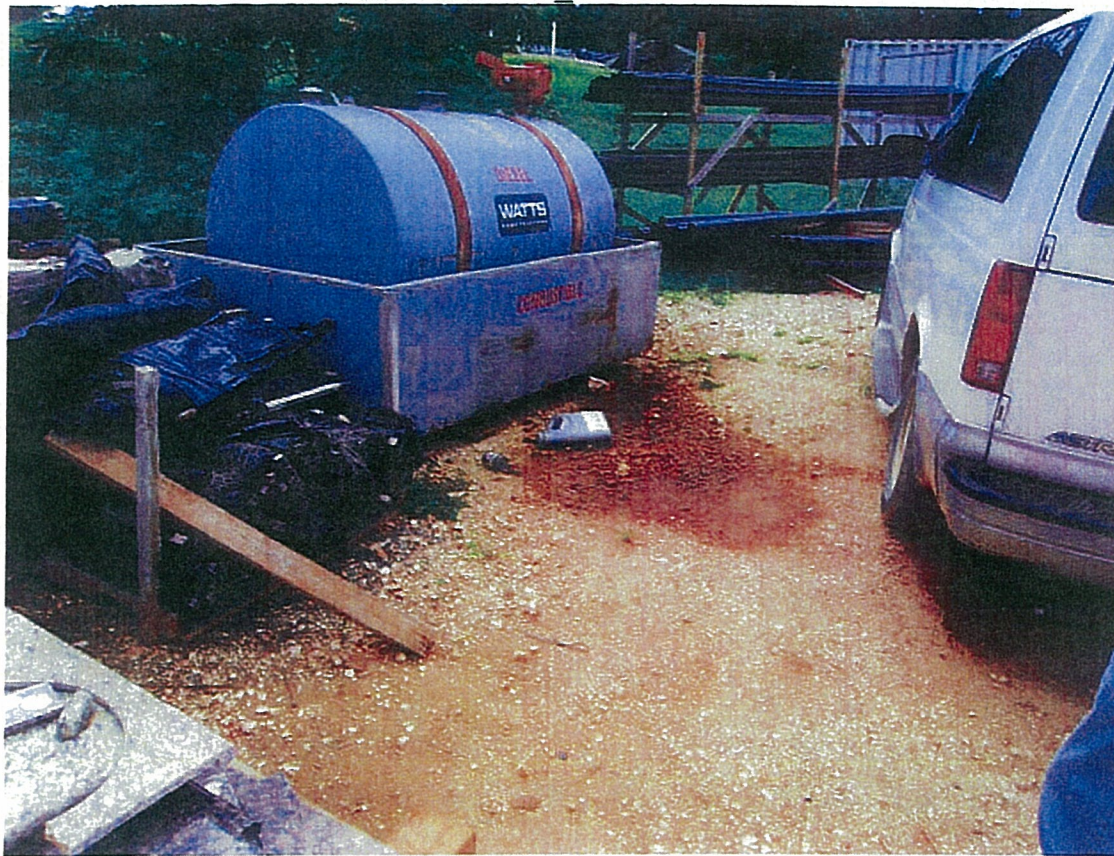
IMG_0022 Stained soil and empty bottle next to a diesel tank

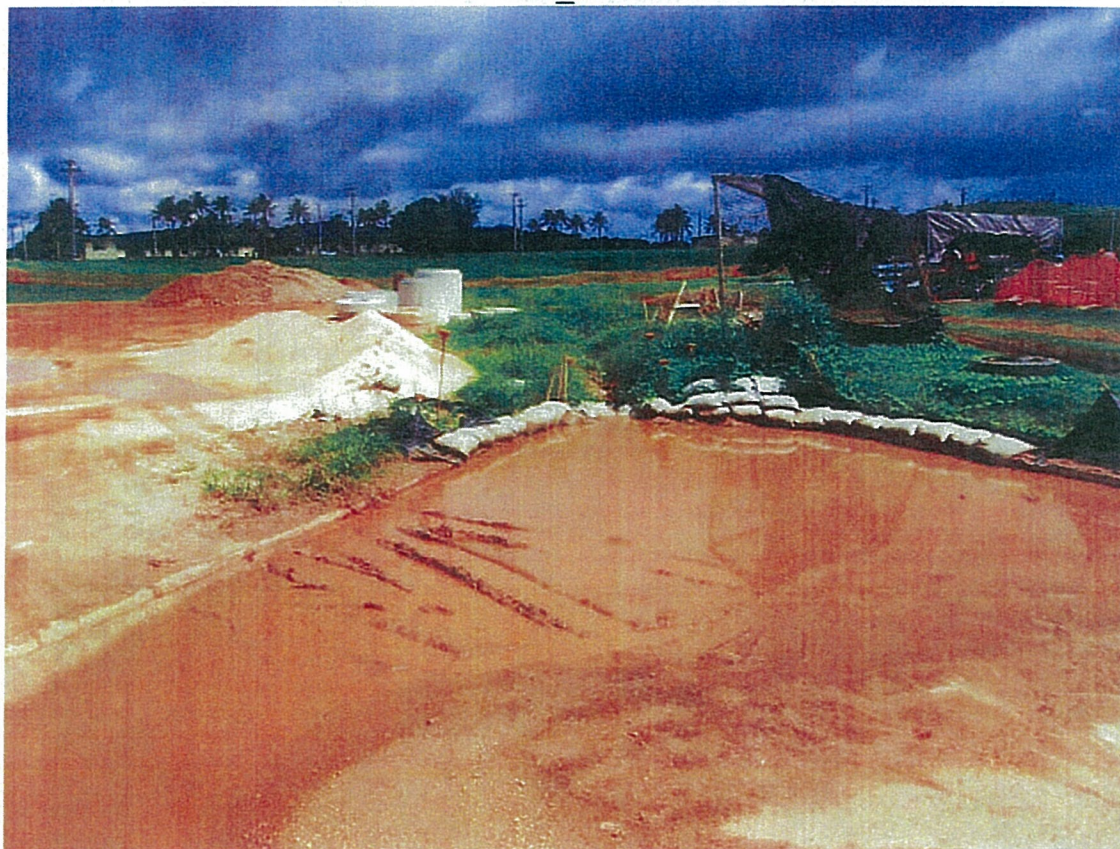
USN Naval Base Guam, CGP Inspection of North Tupalao Housing Project, 7/16/08
IMG_0026

13. The NOI that was submitted on 17 July 2008 indicated Agat Bay as the nearest named receiving water, and also indicated that a SWPPP for the project had been prepared prior to filing. However, no SWPPP was available on-site at the time of the inspection.
14. At the contractor's yard, there was evidence of fluid spillage and staining of the ground, with no clean-up having yet been performed. (Photos IMG_0022, IMG_0023)
15. There were few or no soil stabilization BMPs employed within the project, resulting in sediment transport onto roadways and into drainage systems. (Photo IMG_0034)
16. Drain inlets (DIs) and perimeter sediment controls were inadequately implemented and maintained. (Photos IMG_0026, IMG_0035, IMG_0036)

IMG_0026 Ponded water where runoff leaves the project area at bottom of road by athletic fields. Note gap in gravel bag berm, turbid water, lack of BMPs by stockpiles to left.

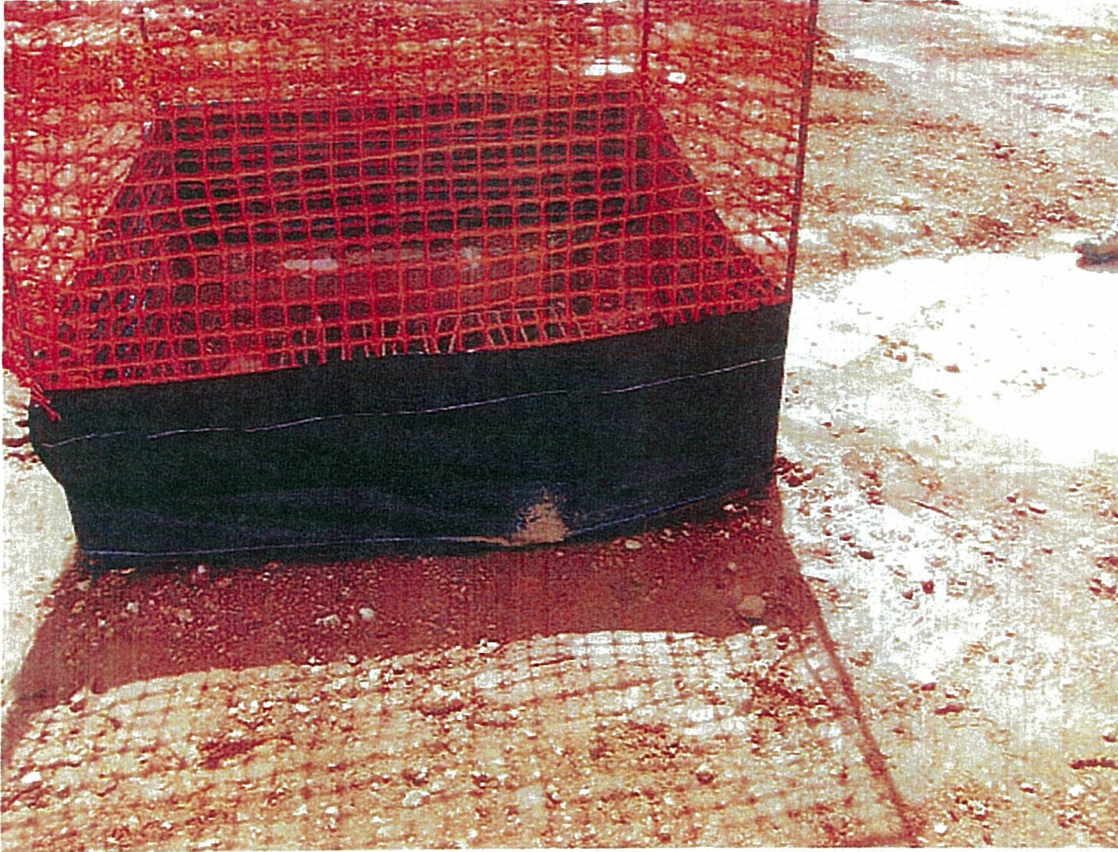
IMG_0035 Silt fence used as drain inlet protection. Note gap beneath, unstabilized soils upgradient, and sediment accumulations in roadway.

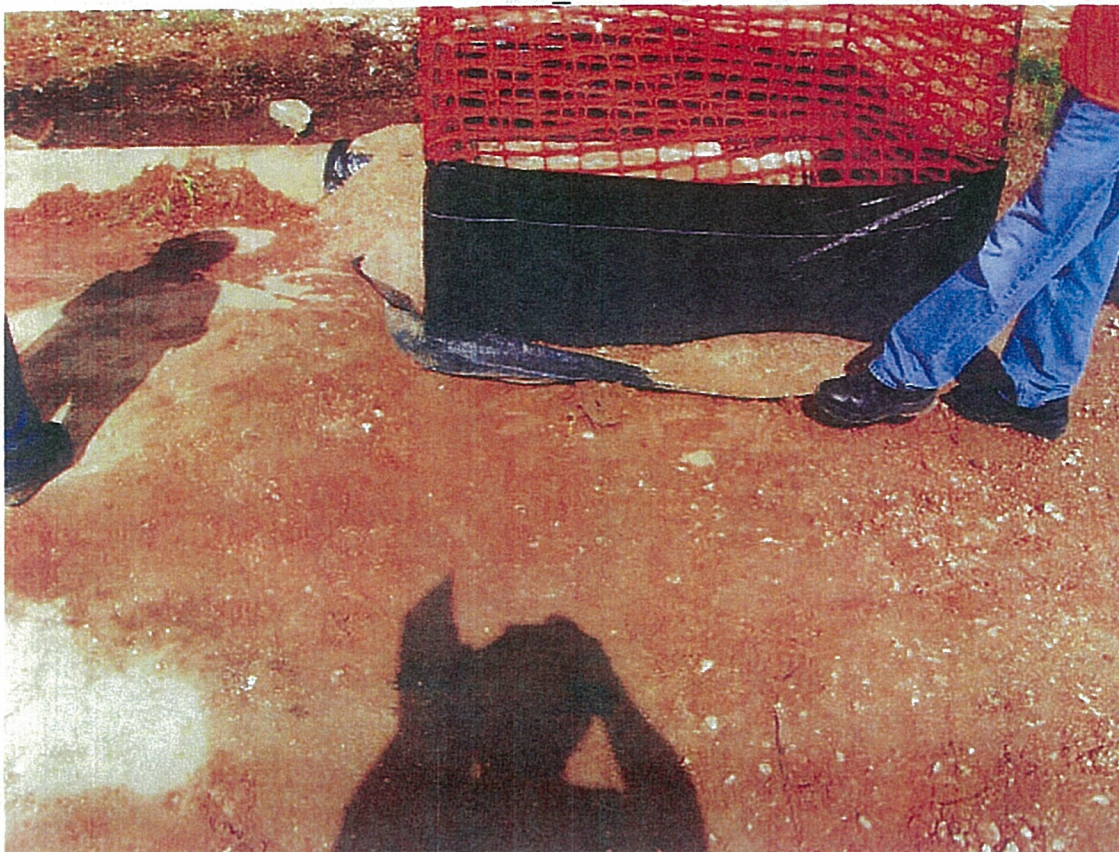
IMG_0036 Silt fence used as drain inlet protection. Note gap beneath and sediment accumulations in roadway.

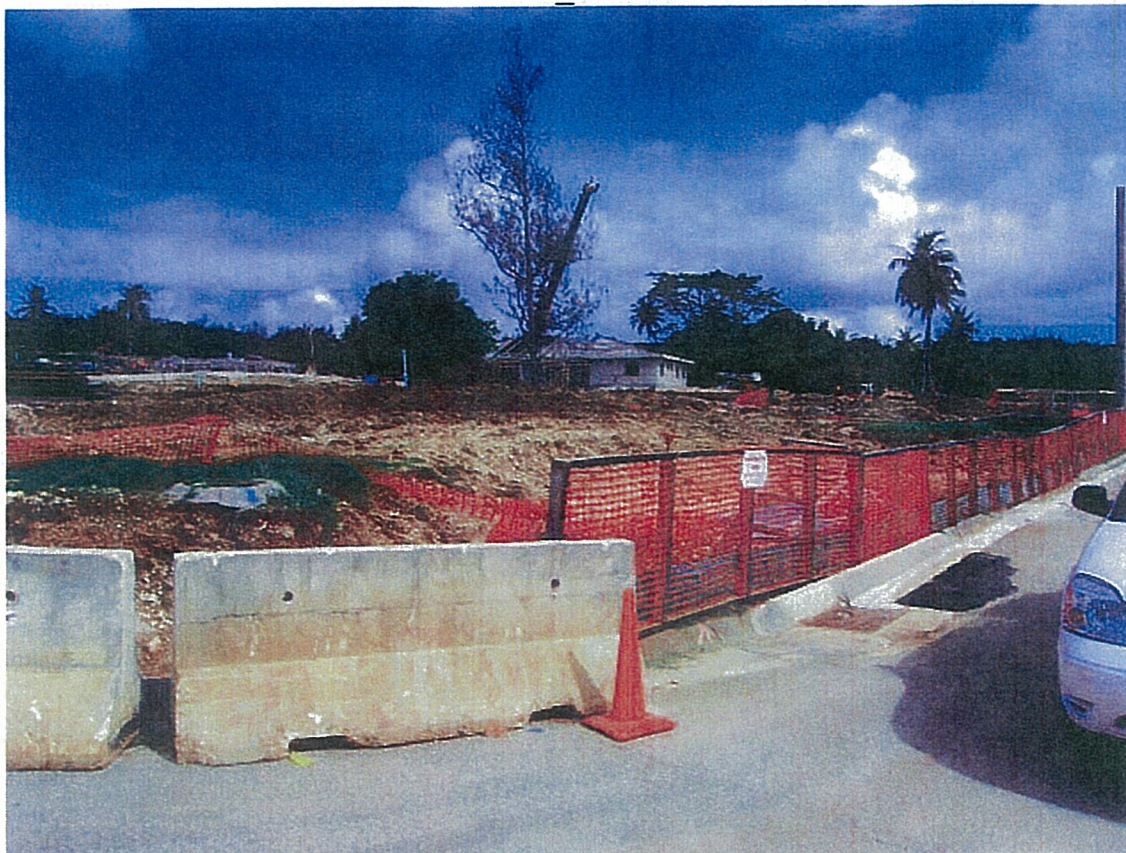
17. This project to revitalize a typhoon-damaged housing complex was viewed only from the public street at the lower end of the project perimeter.
18. The project's general contractor, Black Construction, submitted an NOI seeking coverage under the CGP on 18 October 2007. EPA assigned tracking No. GUR10A090 to the project and granted permit coverage effective 25 October 2007. The NOI indicated a DSA of 62 acres and the Aplacho River was listed as the nearest named receiving water.
19. Viewed from the bottom of the project area, no internal controls were in evidence and installed sediment controls were inadequate in that sediment accumulations were observed immediately adjacent to a DI. There was also evidence of an apparent concrete slurry discharge off site and to this same DI. (Photos IMG_0022, IMG_0023)

IMG_0023 Another view of the drain inlet depicted immediately above, note lack of soil stabilization BMPs.
