Report as of FY2007 for 2006VT25B: "Evaluating Quantitative Models of Riverbank Stability "

Progress Report: Evaluating Quantitative Models of Riverbank Stability

PIs: Mandar Dewoolkar and Paul Bierman

March 1, 2006 – February 29, 2008

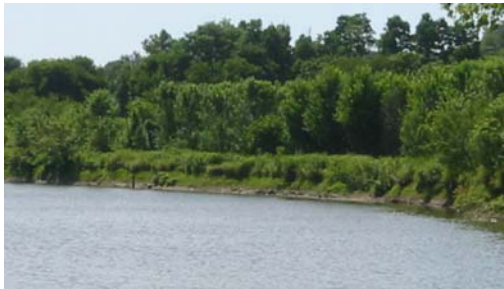
(a) Bank of Winooski River

(b) Site locations

Figure 1 Selected site locations along Winooski River and analysis of aerial photos

for analysis, before investing resources and efforts in instrumenting all sites at once. We chose a stretch of Winooski River (Figure 1) near Ethan Allen Homestead because of its vicinity to UVM. Here, the Winooski River is considered large low-gradient alluvial river. Eight sampling locations along the banks of the river were chosen (Figure 1b – larger blue circle indicates the instrumented site and purple circles indicate other seven sites). All locations were chosen along the outer bank of a meander bend in the river because this is where we expect bank failure is most likely to occur. Of these eight locations, four appeared to be unstable and four appeared to be marginally stable. Figure 1b shows how the banks of the river have changed between 1962 and 2004 from aerial photographs.

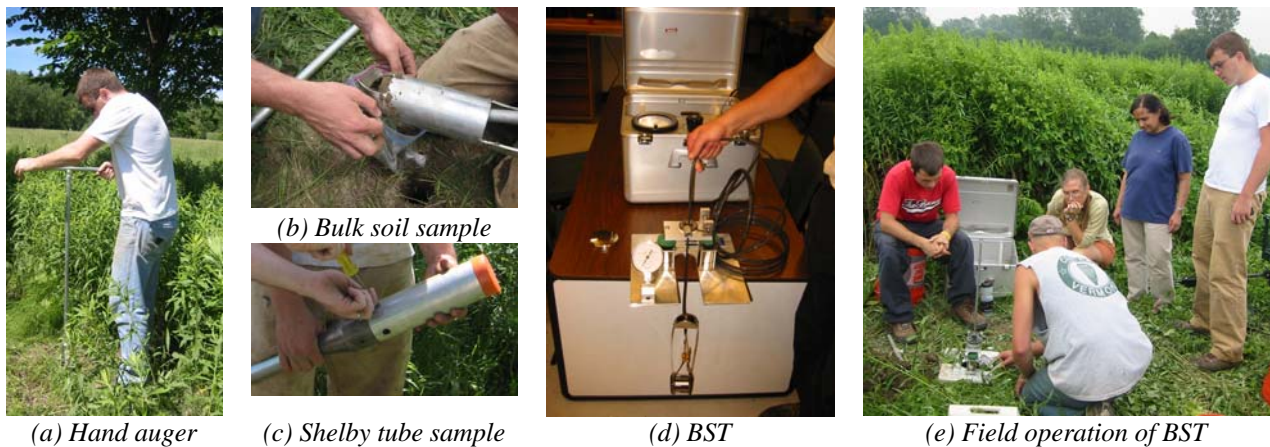
Figure 2: Subsurface investigations and in situ testing

At each of the selected locations, 3-inch diameter boreholes were advanced using a hand-operated auger (Figure 2a). Because of accessibility and safety issues, it was not possible to use a drill rig. We were able to auger to a depth of up to 16 feet using a hand operated auger above groundwater table. At each of the eight sites, multiple boreholes were augured and bulk soil samples were obtained in each soil layer (Figure 2b). In several locations, 10-inch long Shelby tubes (Figure 2c) were used to retrieve “undisturbed” soil samples. These “undisturbed” soil samples were needed for conducting the direct shear and triaxial tests in the laboratory for verifying in-situ shear strength parameters obtained using borehole

shear tests (BST). The BST device (Figure 2d) was acquired for this project. Once the sample was removed from the hole, a BST was conducted to measure the shear strength of the same soil in-situ (Figure 2e).

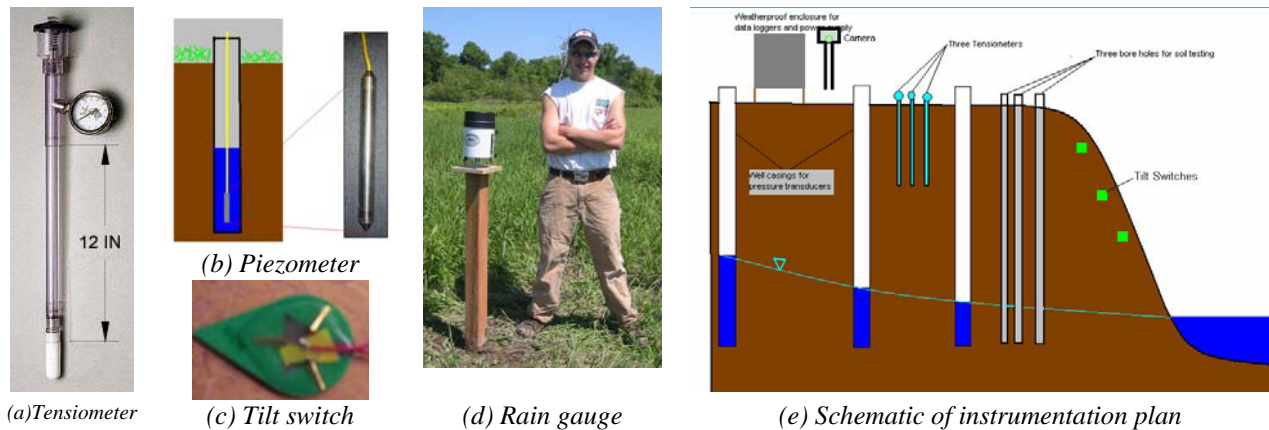
Figure 4: Various Sensors installed at the instrumented site

At the locations of BST measurements, we attempted to obtain soil suction measurements using tensiometers (Figure 4a). Of the six tensiometers installed, three were installed with dial gages and three were installed with pressure transducers attached to a datalogger. These tensiometers worked quite well when tested dry to moist soils in our laboratory. However, they did not record suction in the field. We believe the reason for this is that the soil moisture content in the field was consistently high all summer long. This conclusion was also supported by measuring moisture content, which was generally high indicating that the soils were near full saturation. Continuous measurements of in-situ pore pressures are needed for analysis. This required installing electronic pore pressure transducers in groundwater wells. All summer near bank water table was too high to install wells by hand far enough below seasonal mean elevations. The monitoring wells and pore pressure transducers (Figure 4b) were therefore installed at the instrumented cross-section in September 2006, when the groundwater table was lower. There were also twelve tilt switches (Figure 4c) installed along this section of failing bank. A data logging rain gauge was also installed (Figure 4d) in the beginning of Summer 2006. General instrumentation plan at the site is depicted in Figure 4e.

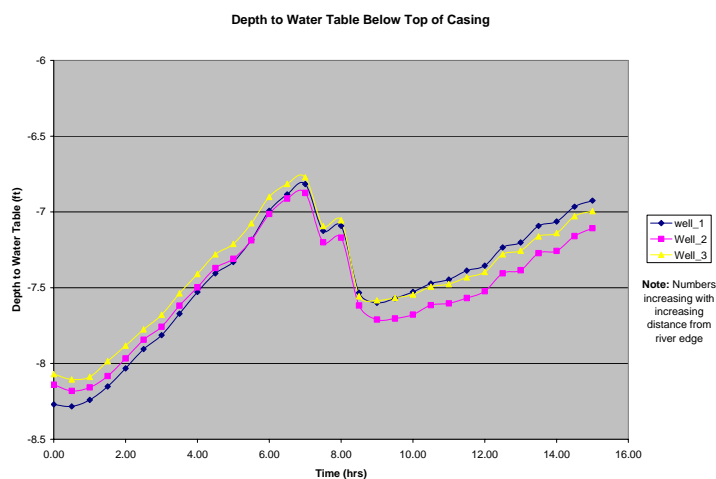
Figure 5: Example of groundwater table measurements

A snapshot of data from water pressure transducers for the on instrumented site is shown in Figure 5, which displays the ground water table during 16 hrs of a storm event.

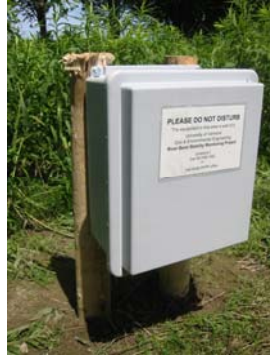
(a) Weatherproof box

Figure 6: Weatherproof box with data loggers and surveying

Signals from the tilt switches are being recorded by an onsite data logger in a weatherproof box (Figure 6a), which is wirelessly connected to a computer in the Winooski Valley Park District Office, which is about 200 meters from the instrumented site. The initial plan was to embed accelerometers in the bank and

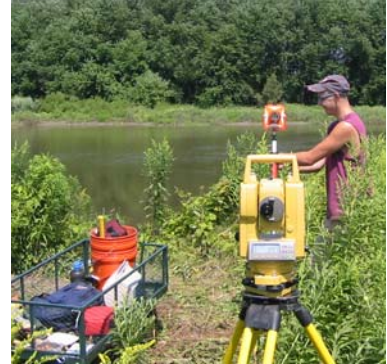
(b) Survey

At each testing site, GPS coordinates were taken as well as several photographs. We also developed procedures for obtaining detailed surveys of bank cross-sections (Figure 6b), which will be required as input geometry for seepage and slope stability analyses.
