# **Integrated Chemical Effects Test Project: Test #5 Data Report**

**Los Alamos National Laboratory**

**U.S. Nuclear Regulatory Commission  
Office of Nuclear Regulatory Research  
Washington, DC 20555-0001**

# INTEGRATED CHEMICAL EFFECTS TEST PROJECT: TEST #5 DATA REPORT

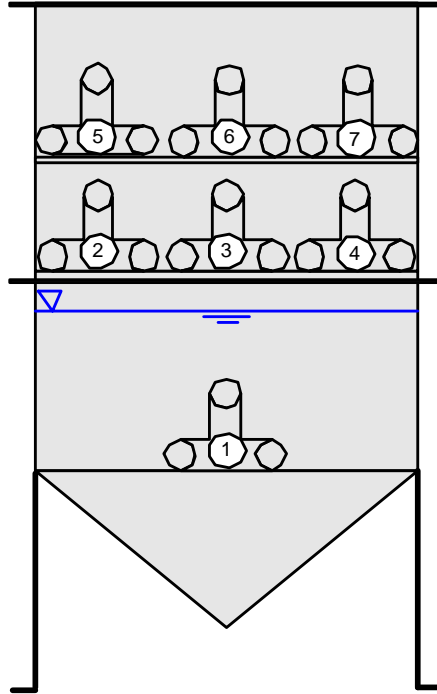
**Figure 2-2. Coupon rack configuration in the ICET tank. The blue line represents the surface of the test solution.**

The arrangement of the coupon racks in the test tank is schematically illustrated in Figure 2-2. The figure shows a side view of the ICET tank, with the ends of the seven chlorinated polyvinyl chloride (CPVC) racks illustrated. The normal water level is indicated by the blue line in the figure. Rack #1 is the only submerged rack, and it sits on angle iron. It is centered in the tank so that flow from the two headers reaches it equally. Racks #2-#4 are positioned above the water line, supported by angle iron in the tank. Racks #5-#7 are positioned at a higher level, also supported by angle iron. Racks #2-#7 are exposed to spray. In the figure, north is to the right, and south is to the left. Directions are used only to identify such things as rack locations and sediment locations.

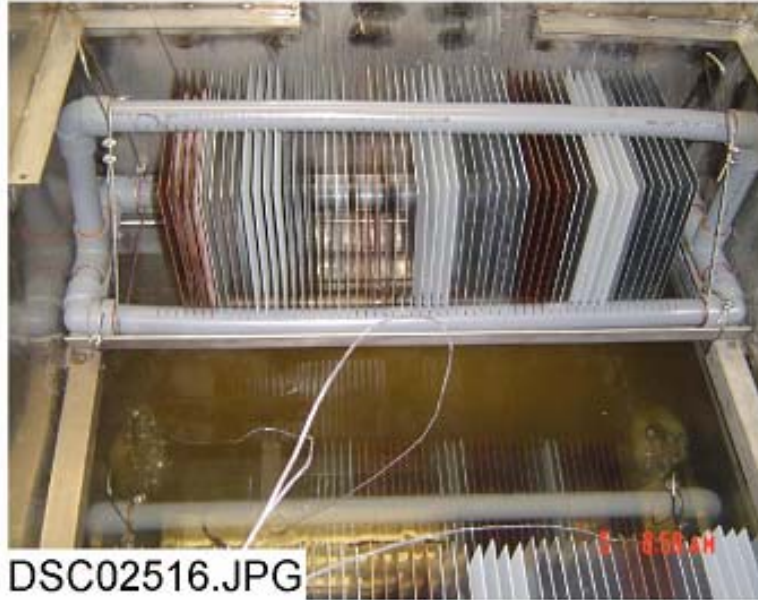
**Figure 2-3. A typical loaded coupon rack in the ICET tank.**

Figure 2-3 shows the configuration of a typical unsubmerged coupon rack loaded with metal coupons in the ICET tank. The loading pattern of the racks was nearly identical, varying by only one or two coupons. Shown in the figure from left to right, the coupons are arranged as follows: 4 Cu, 4 Al, 4 IOZ, 7 GS, 4 Cu, 3 Al, 4 IOZ, 7 GS, 4 Cu, 3 Al, 4 IOZ, and 7 GS.

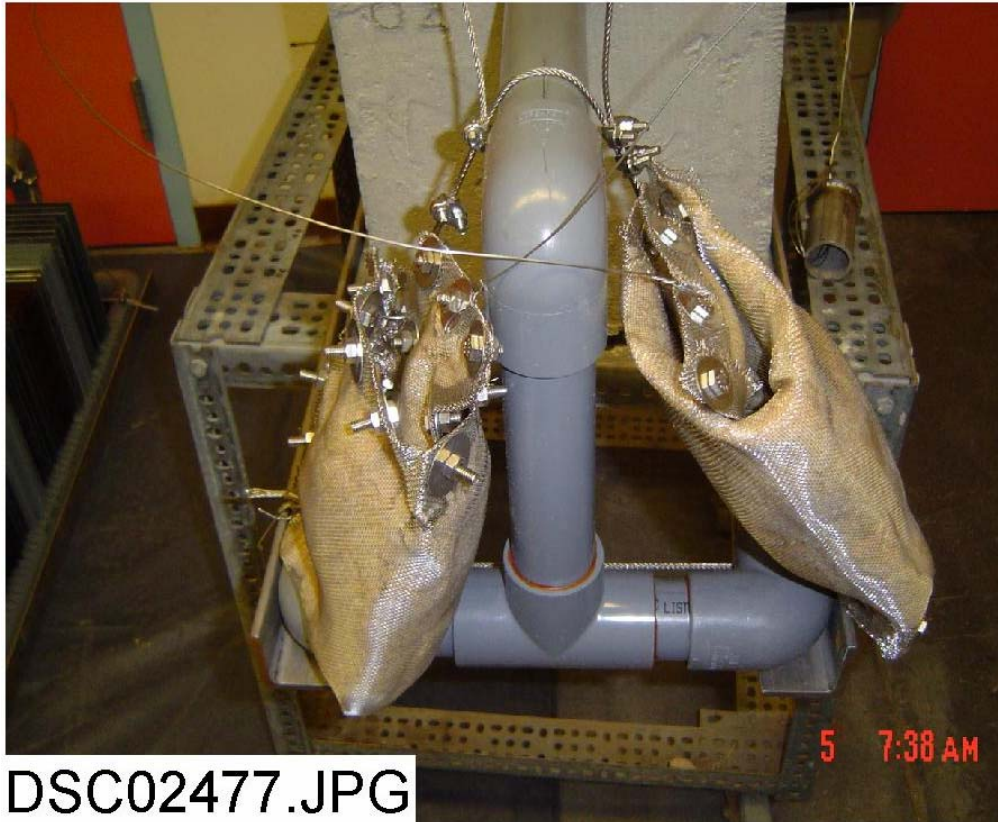
Figure 2-4. Fiberglass samples attached to a coupon rack.

Several fiberglass samples were placed in the ICET tank. Samples were either submerged or held above the water level. The unsubmerged fiberglass samples were positioned so they would be exposed to sprays. The fiberglass samples were contained in SS wire mesh that allowed water flow while confining the fiberglass material. Both loosely packed and more tightly packed samples were used. In addition, some submerged fiberglass samples were located where they would be exposed to relatively high-flow conditions, and others were located in quiescent regions of the tank. Figure 2-4 shows the so-called “sacrificial” fiberglass samples in wire mesh pouches attached to the submerged coupon rack (Rack 1 in Figure 2-2). Each pouch contains approximately 5 g of fiberglass. Those samples were attached with SS wire; removed from the tank on Days 4, 15, and 30; and examined. As shown in the figure, bigger insulation bags were wrapped around the sacrificial specimens during the test. In addition, small, sacrificial samples called fiber pucks were added to the solution. The fiber pucks are described in Ref. 4. Subsection 2.4.1.1 contains descriptions of other fiberglass samples.

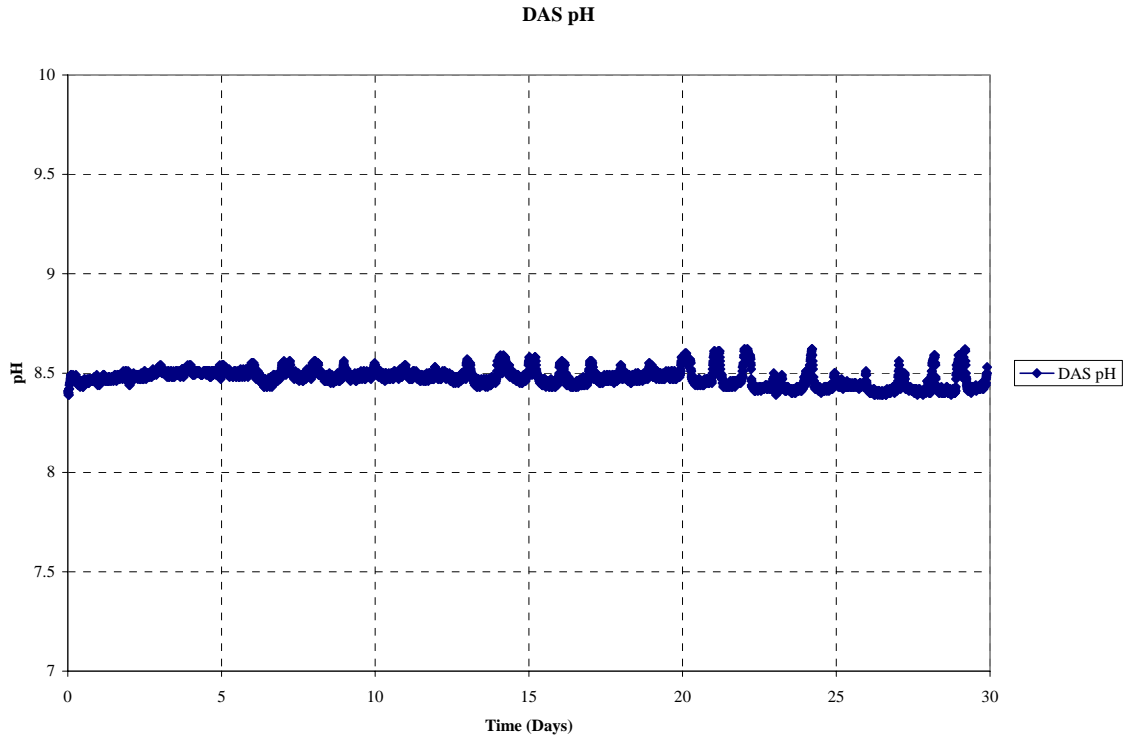
**Figure 3-1. In-line pH measurements.**

**pH:** Before time zero, 6.48 kg of boric acid, 10.0 kg of borax, and 0.284 g of lithium hydroxide were dissolved into the ICET tank. The in-line pH probe, which produced the data in Figure 3-1, provides only an estimated pH measurement. The measured bench-top probe pH was 8.4 at 60°C. During the addition of the HCl, the pH of the system dropped slightly to a value of 8.3. The pH remained in the range of 8.2–8.4 for the duration of the test. This can be seen in Figure 3-2.

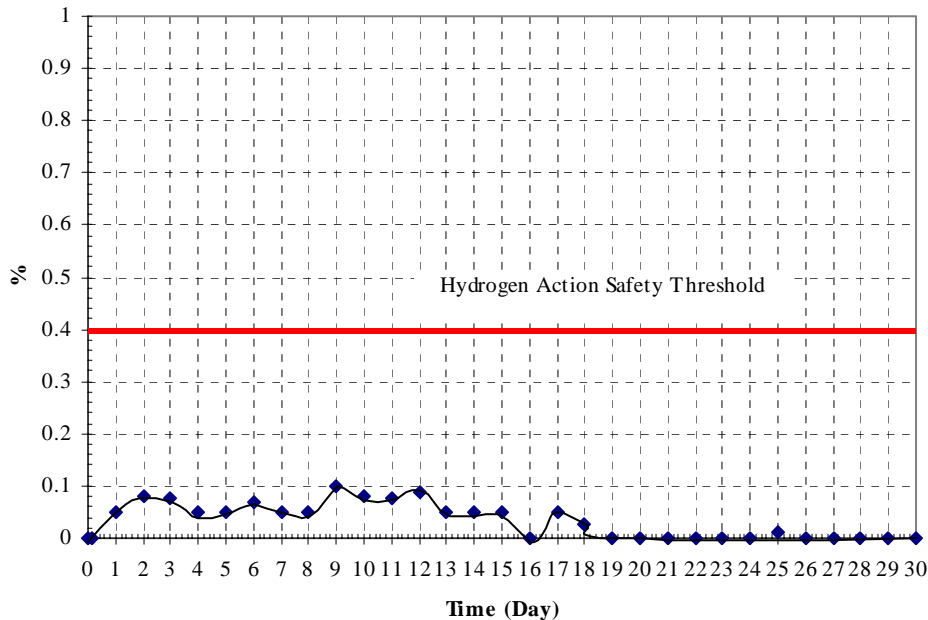
Figure 3-3. Hydrogen generation.

Hydrogen remained at or below 0.15% of the daily samples' air volume (from the tank atmosphere) for the duration of the test as shown in Figure 3-3. All of the measured values were well below the hydrogen safety action threshold of 0.4%.

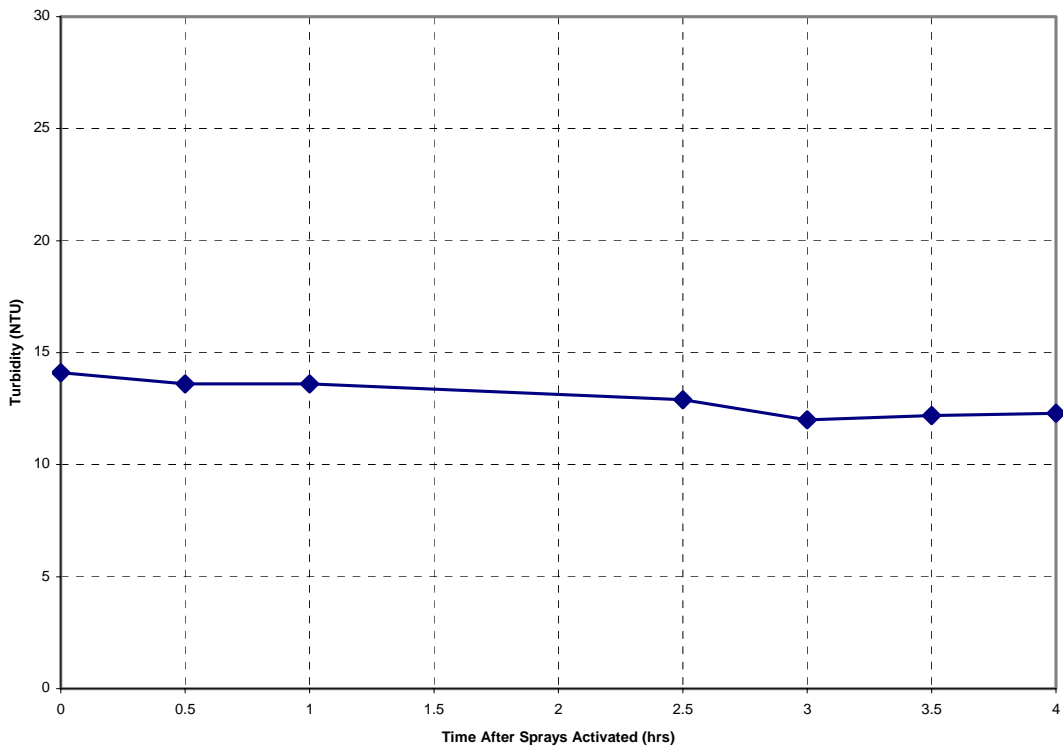
**Figure 3-4. Turbidity results during spray phase.**

Due to the cloudy nature of the water in the tank after the recirculation pump was turned on, turbidity values were measured at 60°C over the initial 4-hour spray phase, in addition to regular daily monitoring. Figure 3-4 shows the turbidity during this time period. The x-axis on the graph represents the time in hours after the spray nozzles were turned on. As can be seen, a slight decrease in turbidity occurred from the time zero value to 12.4 NTU at 4 hours.

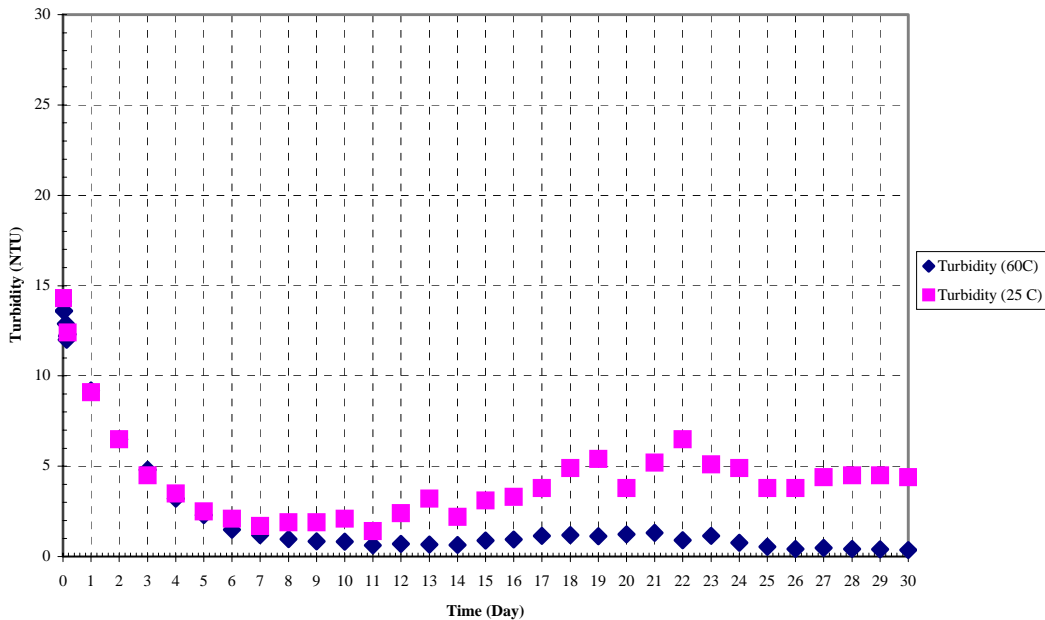
**Figure 3-5. Daily turbidity results.**

Figure 3-5 shows the daily turbidity values at 23°C and 60°C throughout the test. The 60°C curve exhibited a steady decline over that time period. The 23°C turbidity curve exhibited a similar trend through the first seven days of the test. However, beginning on Day 8, the 23°C turbidity values began to deviate slightly, rising higher than the 60°C readings. From Day 8 through Day 30, the 23°C values were, on average, 2.95 NTU greater than the 60°C values. From Day 21 to Day 30, the mean turbidity measurements for the 60°C and 23°C samples were 0.7 NTU and 4.7 NTU, respectively.

**Turbidity:** The baseline turbidity values, which were taken before the latent debris and concrete dust were added, for the 23°C and 60°C water samples were 0.81 NTU and 0.77 NTU. After the addition of latent debris and concrete dust, the tank solution turbidity was 14.1 NTU. The daily turbidity values are shown in Figure 3-5.

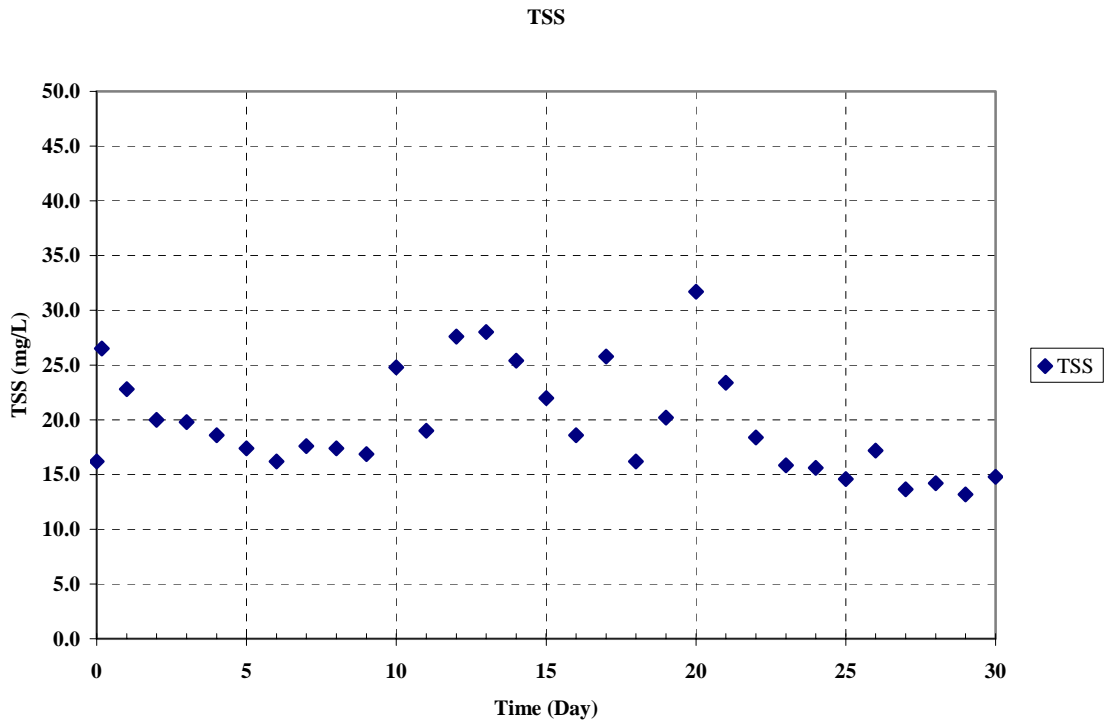
**Figure 3-6. Test #5 TSS results.**

**Total Suspended Solids:** Total suspended solids (TSS) are measured by running a volume of approximately 500 mL through an in-line filter directly at the sample tap and measuring the dried mass added to the filter. The selected equipment assures that TSS measurements are not affected by temperature-dependent or time-dependent precipitation reactions that may occur once the process solution is removed from the tank. Figure 3-6 presents Test #5 TSS data as the experiment progressed. The baseline TSS measurement, taken before time zero, was 16.2 mg/L. At the end of the four-hour spray phase, the TSS value rose to 26.5 mg/L. Following the spray cycle and beginning at 24 hours, the TSS measurements were performed daily. TSS measurements gradually declined over the first seven days, with a Day 7 value of 17.6 mg/L, which is close to the baseline measurement. The TSS measurement remained constant through Days 7 through 9 but began increasing on Day 10 and continued increasing to Day 13. The measurements after Day 13 were somewhat erratic. This unexplained behavior in TSS occurred through Day 21. From Day 22 through the end of the test, the TSS measurements remained similar to the baseline measurement taken at time zero.

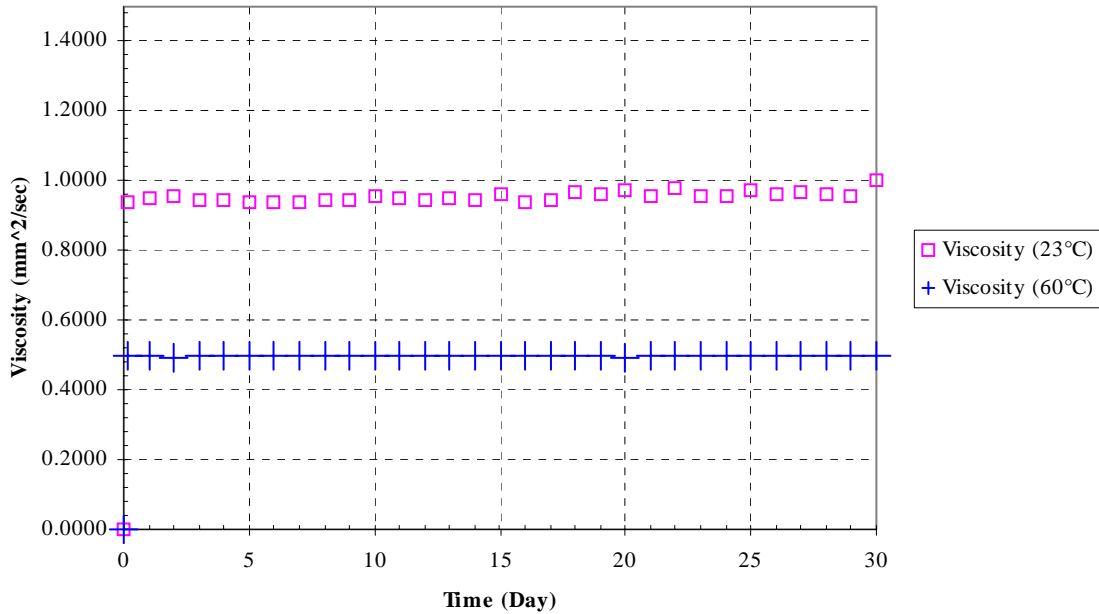
Figure 3-7. Viscosity at 60°C and 23°C.

**Kinematic Viscosity:** Kinematic viscosity was measured with a Cannon-Fenske capillary viscometer. Viscosity was measured on unfiltered samples, each at a temperature of 60°C ( $\pm 1.0^\circ\text{C}$ ) [140°F ( $\pm 1.8^\circ\text{F}$ )] and 23°C ( $\pm 2.0^\circ\text{C}$ ) [73.4°F ( $\pm 3.6^\circ\text{F}$ )]. Water’s viscosity is highly sensitive to temperature, and the allowed temperature range results in a variation of viscosity of 2.9% between 59°C (138.2°F) and 61°C (141.8°F), and a 9.3% variation between 21°C (69.8°F) and 25°C (77.0°F). For this reason, temperature was measured to 0.1°C accuracy with a National Institute of Standards and Technology (NIST)-traceable thermometer for all viscosity measurements, and the measured viscosity values were corrected to a common temperature to facilitate comparisons. The corrected temperatures were 60.0°C (140°F) and 23.0°C (73.4°F). Throughout Test #5, the viscosity measurements remained relatively constant. The average viscosity for the 23°C measurement was 0.96 mm<sup>2</sup>/s, and for the 60°C measurement, it was 0.50 mm<sup>2</sup>/s. The viscosity values are shown in Figure 3-7.
