# **Integrated Chemical Effects Test Project: Test #2 Data Report**

**U.S. Nuclear Regulatory Commission  
Office of Nuclear Regulatory Research  
Washington, DC 20555-0001**

Manuscript Completed: August 2006  
Date Published: December 2006

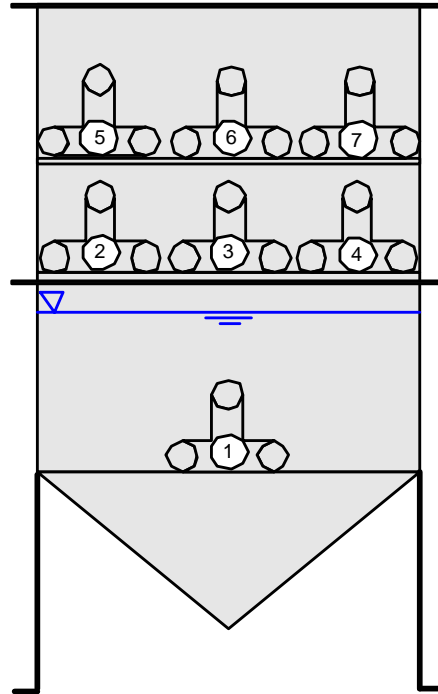
**Figure 3-2. Coupon rack configuration in the ICET tank.**

exposed to spray. In the figure, north is to the right, and south is to the left. Directions are used only to identify such things as rack locations and sediment locations.

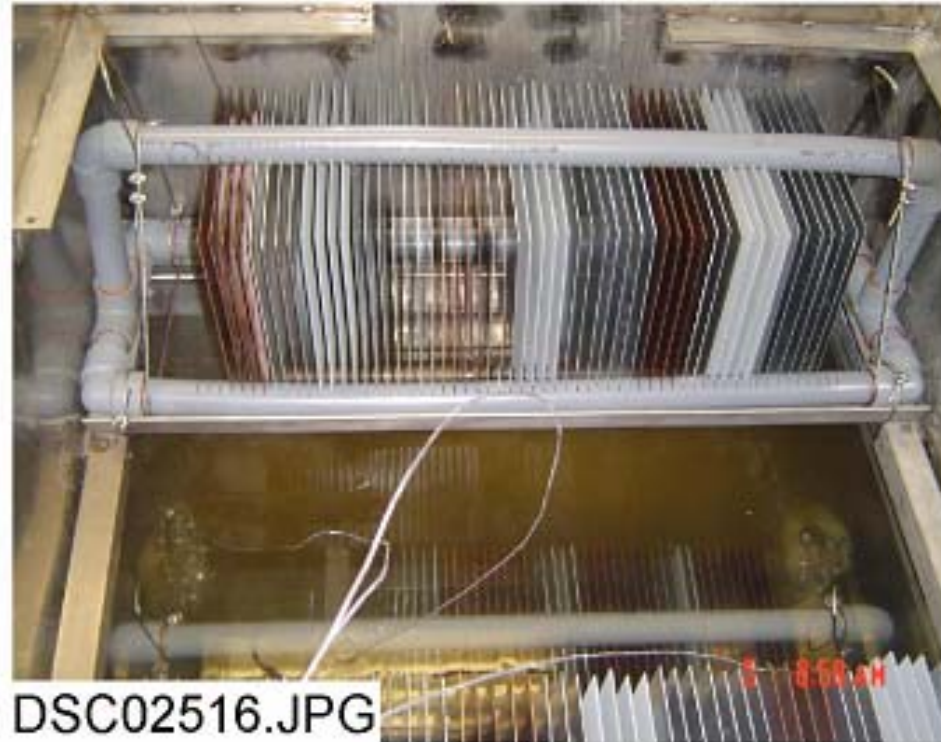
**Figure 3-3. Loaded coupon rack in the ICET tank.**

The configuration of an unsubmerged coupon rack loaded with metal coupons in the ICET tank is illustrated in Figure 3-3. The loading pattern of the racks was nearly identical, varying by only one or two coupons. Shown in the figure from left to right, the coupons are arranged as follows: 4 Cu, 4 Al, 4 IOZ, 7 GS, 4 Cu, 3 Al, 4 IOZ, 7 GS, 4 Cu, 3 Al, 4 IOZ, 7 GS.

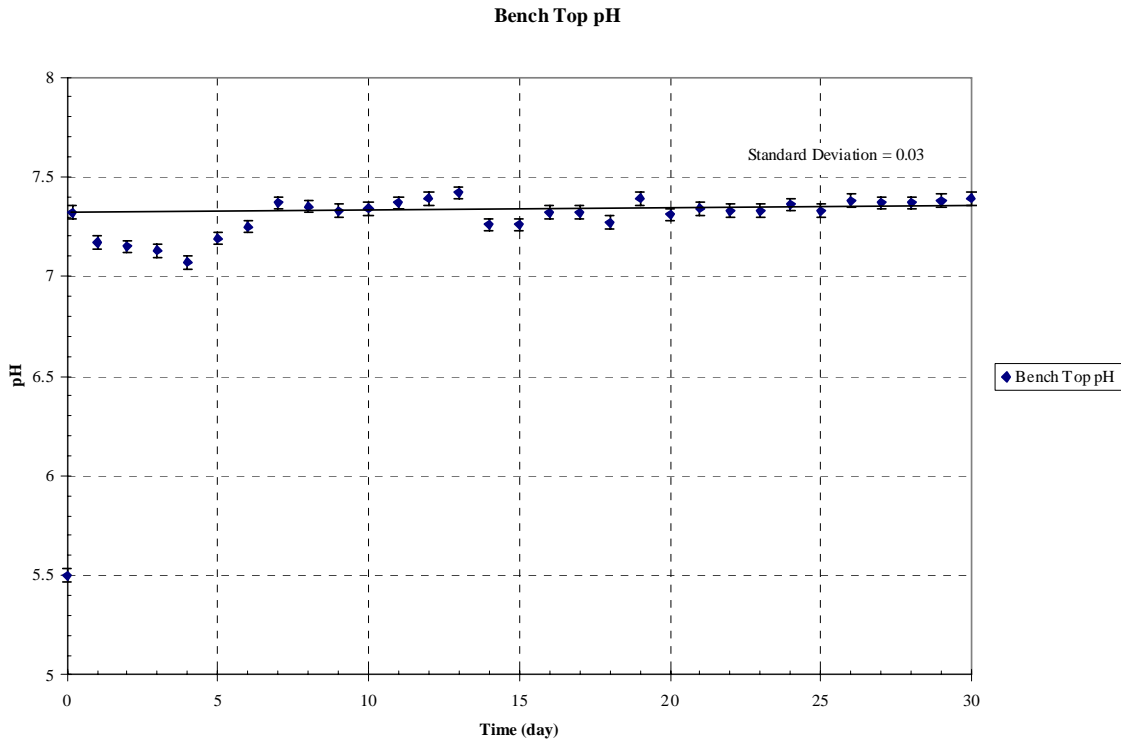
Figure 4-1. Bench-top pH meter results.

Over the first week of Test # 2, the average pH, after the first 4 hours of the test, was 7.2, with a minimum value of pH 7.07 and a maximum value of pH 7.32. During the second week, the average pH rose to 7.3, with a minimum pH of 7.37 and a maximum value of pH 7.42. The average pH remained constant at 7.3 throughout the final 2 weeks of testing. Figure 4-1 shows the pH, as measured by the bench-top pH meter.

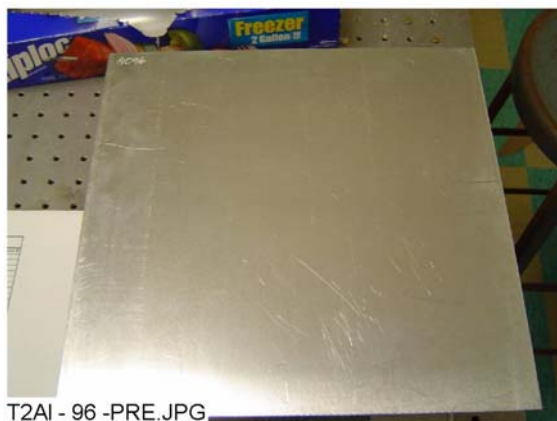
**Figure 4-2. Al-96 submerged, pre-test.**

According to SEM/EDS results, the dominant corrosion products on the submerged aluminum coupons are likely aluminum hydroxide with other substances containing silicon, calcium, sodium, magnesium, phosphorus, carbon, and oxygen. In addition, evidence was found that some copper deposited on the submerged aluminum coupon surfaces. Comparing the redox potential ( $E^0$ ) of  $\text{Al}^{3+}$  and  $\text{Cu}^{2+}$ , which is  $-1.662$  and  $0.3419$  V (Ref. 6), respectively,  $\text{Cu}^{2+}$  in the solution may oxidize aluminum metal. As a result, aluminum metal may be oxidized into  $\text{Al}^{3+}$  and released to the solution. Correspondingly  $\text{Cu}^{2+}$  is reduced into metallic copper and subsequently deposits at the aluminum coupon surface.

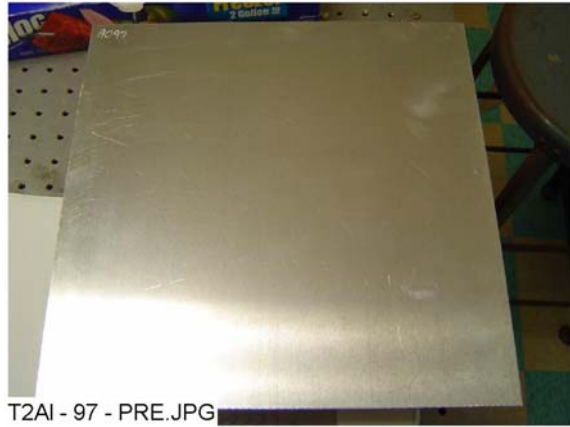
**Figure 4-4. A1-97 submerged, pre-test.**

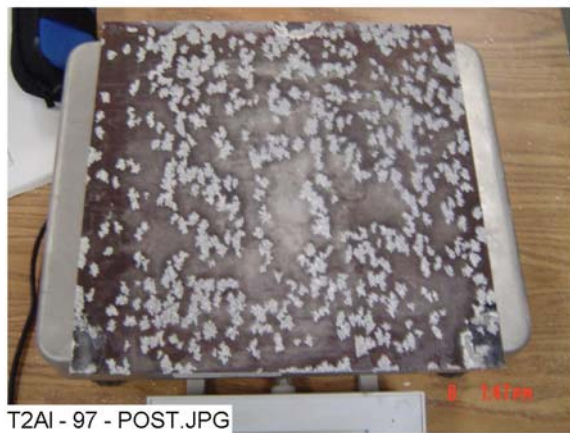
**Figure 4-5. A1-97 submerged, post-test.**

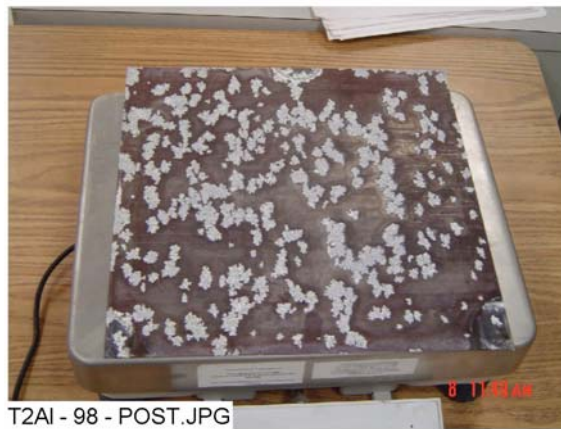
**Figure 4-7. Al-98 submerged, post-test.**

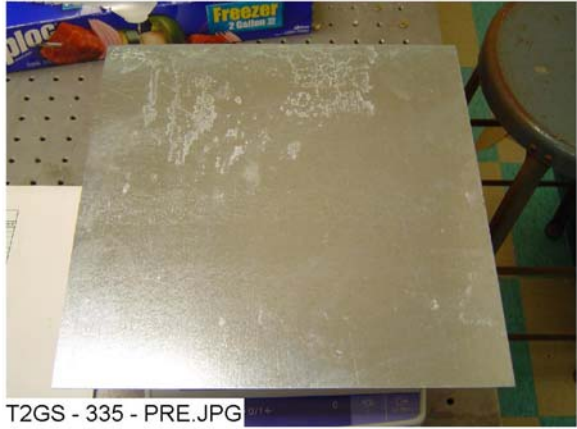
**Figure 4-8. GS-335 submerged, pre-test.**

Figure 4-8 through Figure 4-13 present the pre-test and post-test pictures of three submerged GS coupons. Each post-test GS coupon exhibits nearly identical patterns of dense gray particle deposits. The relative spatial location of these coupons, given in order from the west side of the tank to the east side of the tank, is as follows: GS-337, GS-338, and GS-335. There is no discernable relationship between the spatial location of the coupons and particle deposition patterns or density. For the submerged GS coupons, the possible corrosion products are phosphoric and carbonate compounds of zinc and calcium.

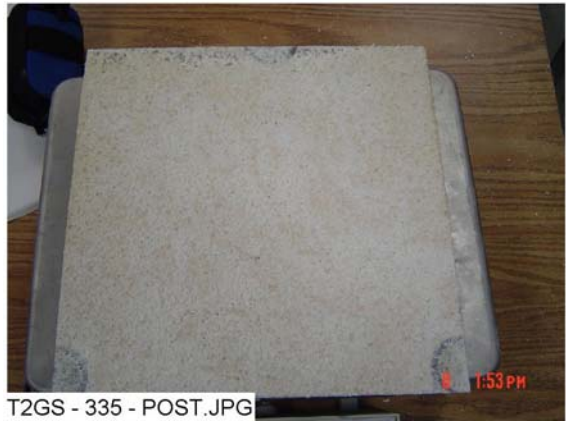
**Figure 4-9. GS-335 submerged, post-test.**

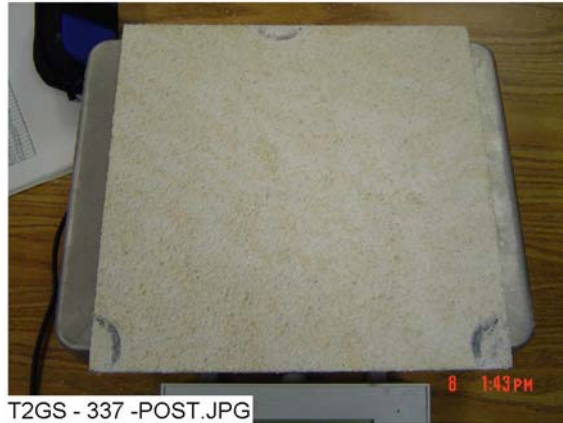
**Figure 4-11. GS-337 submerged, post-test.**

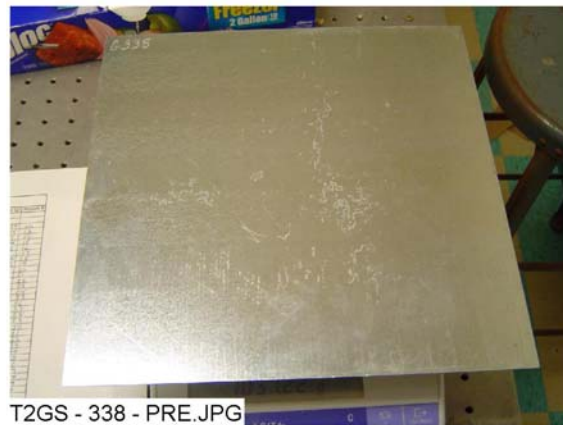
**Figure 4-12. GS-338 submerged, pre-test.**

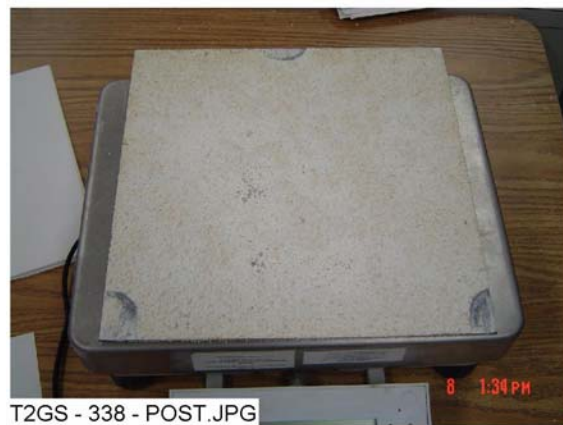
**Figure 4-13. GS-338 submerged, post-test.**

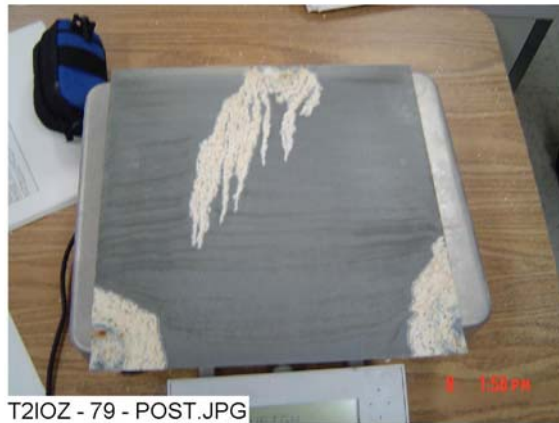
**Figure 4-15. IOZ-79 submerged, post-test.**

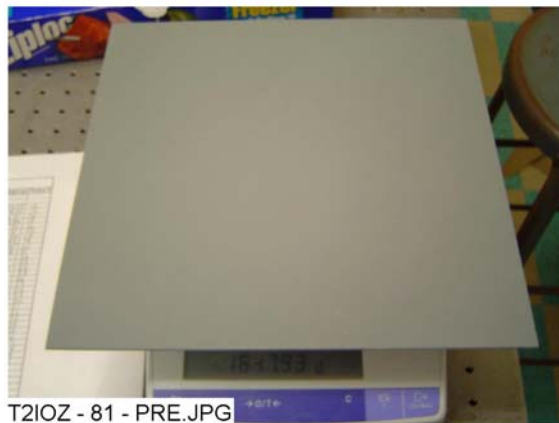
**Figure 4-16. IOZ-81 submerged, pre-test.**

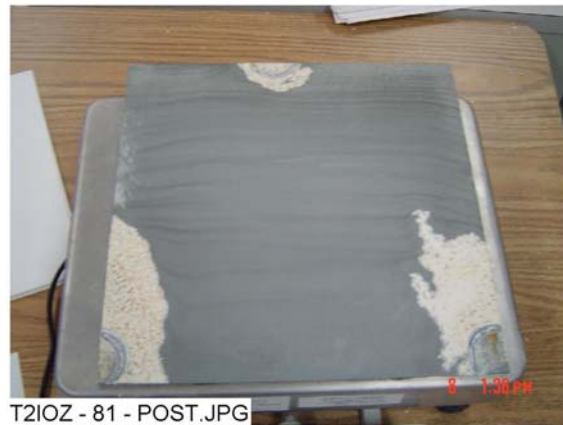
**Figure 4-17. IOZ-81 submerged, post-test.**

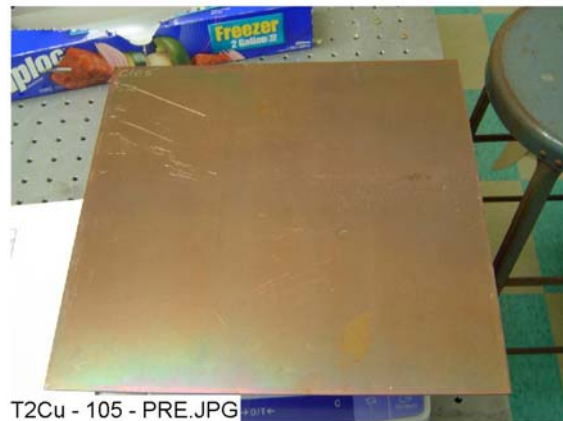
**Figure 4-18. Cu-105 submerged, pre-test.**

Figure 4-18 through Figure 4-21 present the pre-test and post-test pictures of two submerged copper coupons. Each post-test copper coupon exhibits similar patterns of white, streak-like deposits. The deposition streaks are almost perfectly horizontal and are more highly concentrated for coupon Cu-123. Different corrosion effects are visible at the contact points. The Cu-123 coupon is located on the west side of the tank in relation to the Cu-105 coupon. The Cu-105 coupon appears to have a greater distribution of these white, streak deposits. For submerged copper coupons, the possible corrosion products include  $\text{CuO}$ ,  $\text{Cu}_2(\text{CO}_3)(\text{OH})_2$ ,  $\text{Mg}_3(\text{PO}_4)_2$ , and substances containing magnesium, copper, sodium, aluminum, calcium, carbon, and oxygen.

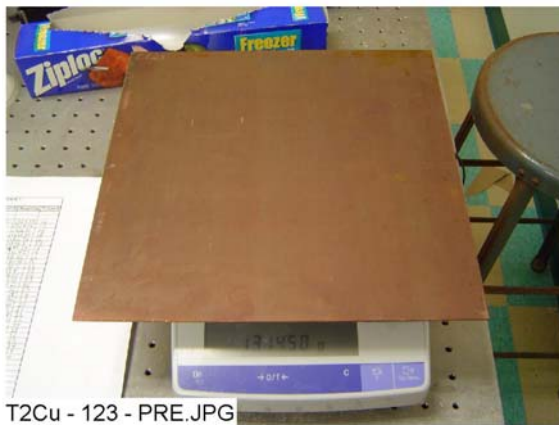
**Figure 4-20. Cu-123 submerged, pre-test.**

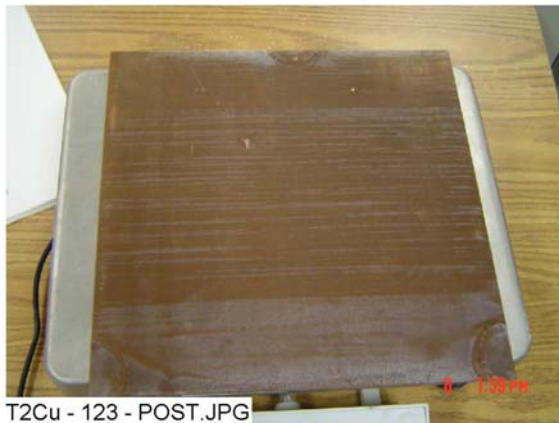
**Figure 4-21. Cu-123 submerged, post-test.**

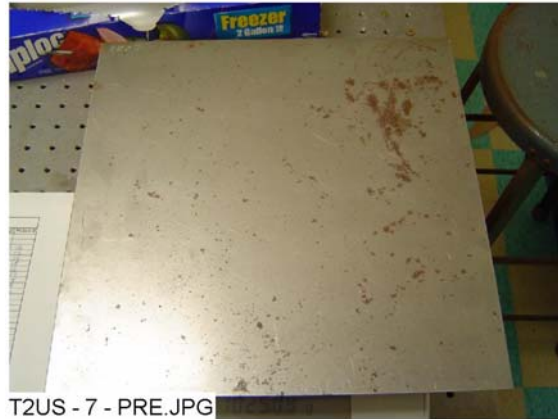
**Figure 4-22. US-7 submerged, pre-test.**

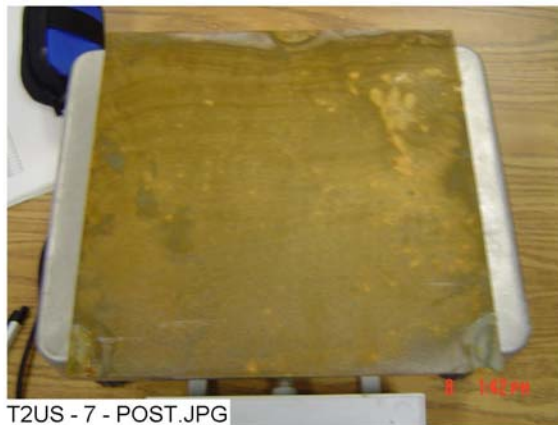
**Figure 4-23. US-7 submerged, post-test.**

and significant corrosion around the edges. Different corrosion effects are visible at the contact points. This carbon steel coupon was adjacent to a copper coupon. For the submerged steel coupon, the possible corrosion products include phosphoric and carbonate compounds of iron and calcium and compounds composed by iron, aluminum, silicon, sodium, calcium, magnesium, phosphorus, and oxygen.

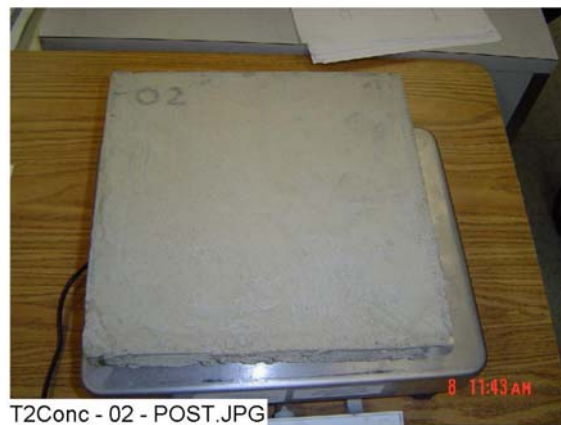
**Figure 4-25. Conc-02 submerged, post-test.**

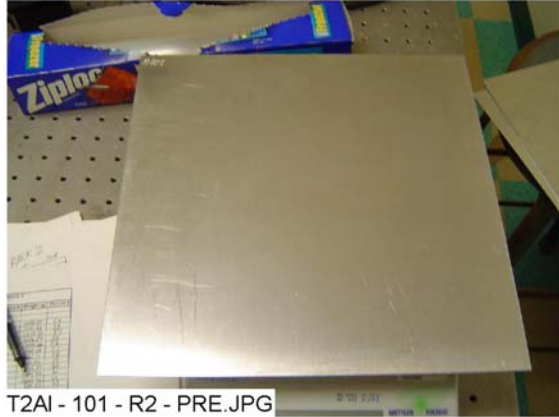
T2AI - 101 - R2 - PRE.JPG

**Figure 4-26. AI-101 unsubmerged, pre-test.**

The physical and chemical changes that the unsubmerged coupons experienced during Test #2 are less significant than the submerged coupons. Figure 4-26 through Figure 4-29 demonstrate the pre-test and post-test pictures of two unsubmerged aluminum coupons. Each post-test aluminum coupon exhibits similar deposits. Also, the texture of each coupon is coarser and the surface is less lustrous than its pre-test appearance. The reddish-brown color that was observed on the submerged coupons is absent on the unsubmerged coupons. The Al-101 coupon was loaded into Rack 2, which was located in the southern position on the tank's middle tier (see Figure 3-2). The Al-132 coupon was loaded into Rack 5, which was located in the southern position of the tank's top tier. The Al-101 specimen exhibits a greater concentration of these deposits.

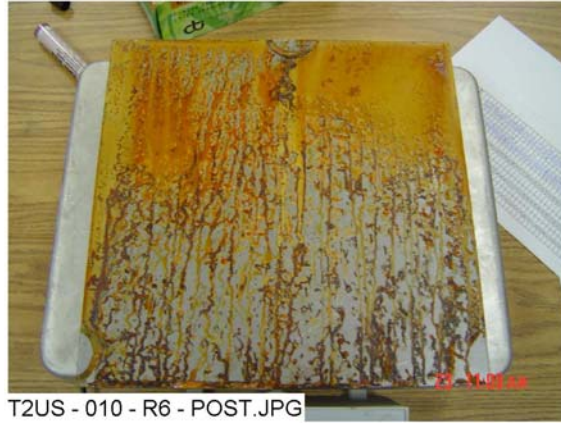
**Figure 4-43. US-10 unsubmerged, post-test.**

Figure 4-42 and Figure 4-43 present the pre-test and post-test pictures of one unsubmerged carbon steel coupon. The post-test carbon steel coupon exhibits a reddish-brown color and significant corrosion around the edges. The color is similar to that of the submerged carbon steel coupon, although the corrosion does not appear to be as severe as on the submerged coupon. The US-10 coupon was loaded in Rack 6, which was in the center position of the tank's top tier.

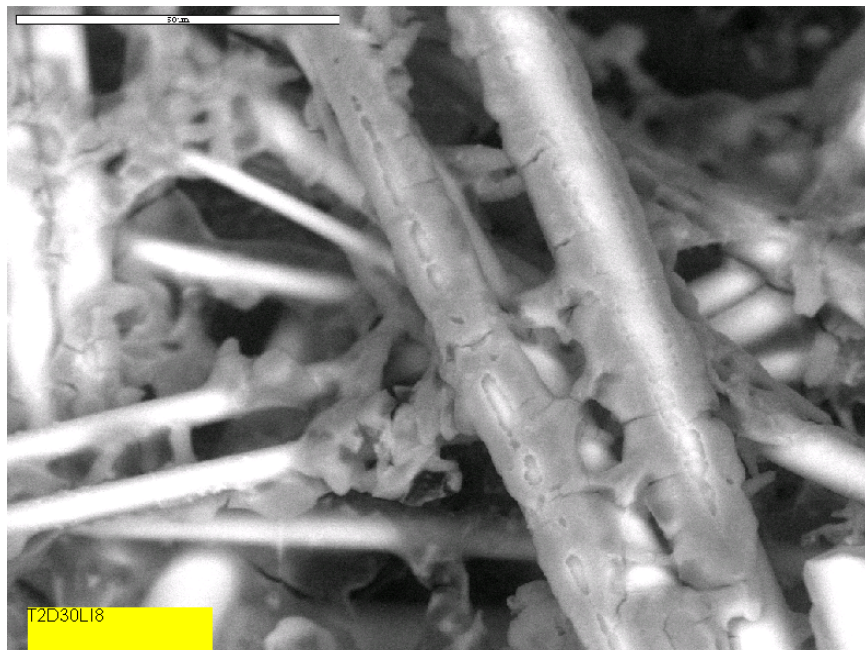
Figure 4-52. Higher-magnification ESEM image of a Test #2, Day-30 low-flow interior fiberglass sample.

Comparing the two samples revealed slightly more deposits on the Day-30 interior low-flow fiberglass sample than on the Day-16 sample. Comparing the exterior and the interior of Day-30 low-flow fiberglass samples revealed more particulate deposits on the exterior sample.

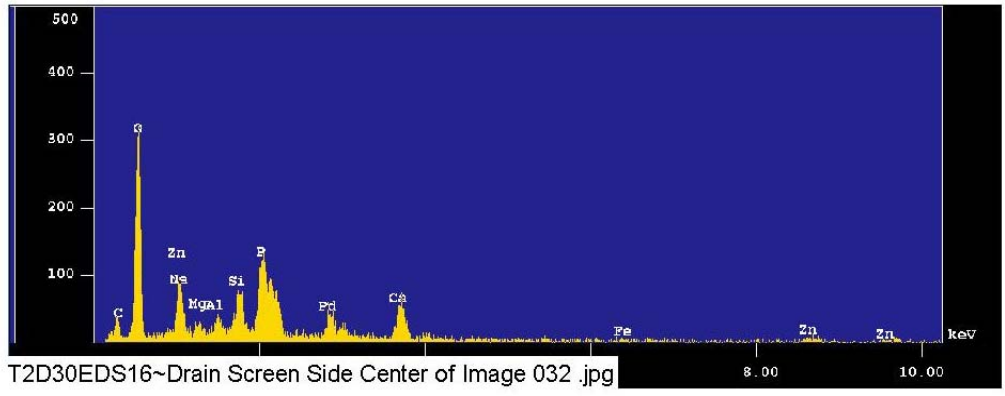
Figure 4-67. EDS counting spectrum for the center of the image shown in Figure 4-66. The deposits are composed of carbon, oxygen, sodium, magnesium, aluminum, silicon, phosphorus, and calcium.

More particulate deposits were observed on the exterior of the Day-30 drain collar fiberglass sample than on the interior. The amount of the deposits on the sample farthest from the drain screen was greater than the amount on the sample next to the drain screen, which was greater than the amount in the drain collar interior. Consistent with the birdcage fiberglass samples, the flocculent deposits were dominant in the interior drain collar samples. EDS results show that the particulate deposits on the drain collar exterior were composed of carbon, oxygen, sodium, magnesium, aluminum, silicon, phosphorus, and calcium. Figures 4-63 through 4-69 illustrate these findings.

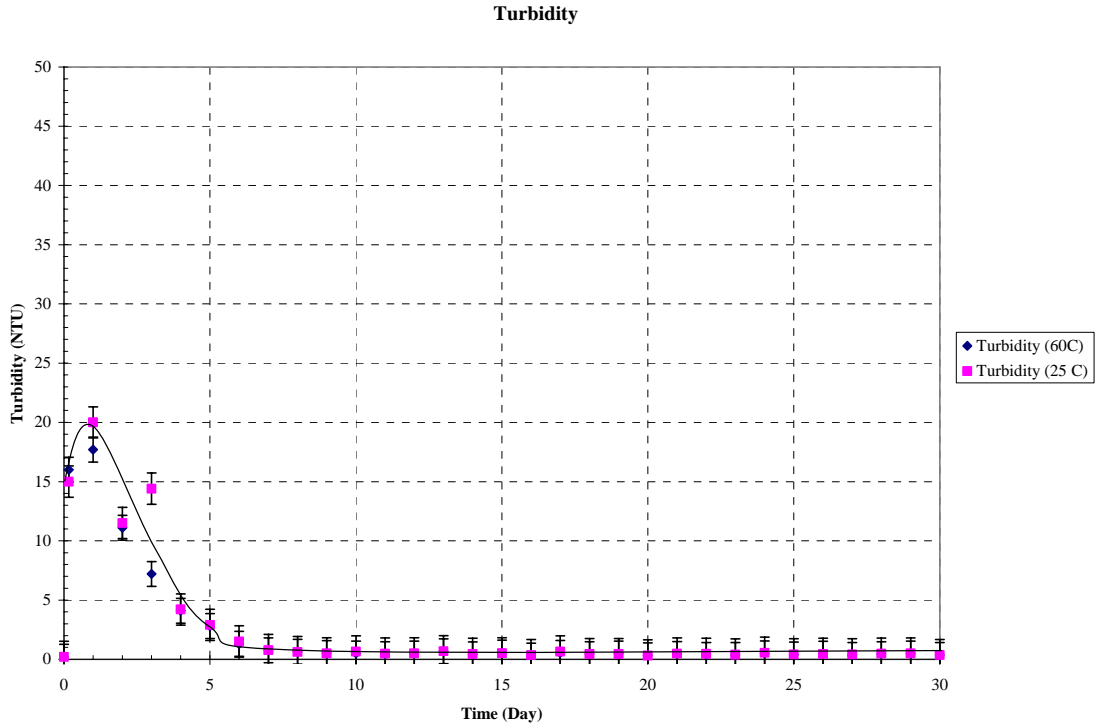
Figure 4-70. Turbidity results.

Thereafter, the turbidity values at both temperatures gradually declined to the baseline measurements. The lone exception to this overall trend occurred on the Day-3 23°C turbidity measurement. On that day, a local turbidity maximum of 14.4 NTU was measured. This was attributable to the fact that the 23°C turbidity sample on that day was immersed in the cold-water bath for a longer time than normal. Steps were taken to rigorously track the immersion time of all subsequent turbidity samples.

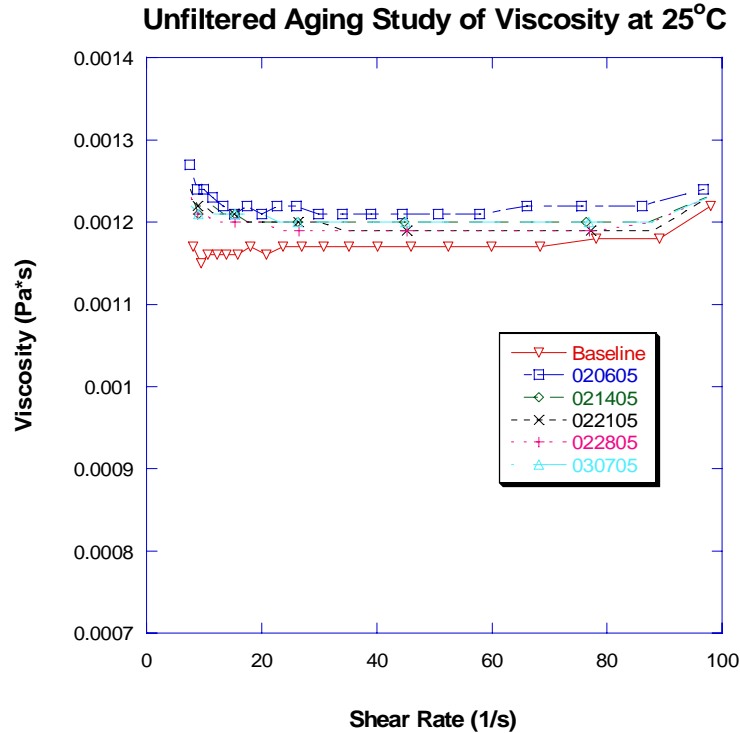
Figure 4-73. Aging study of viscosity at 25°C.

**Strain-Rate Viscosity:** At Day 1 and weekly thereafter, samples were taken off site for strain-rate viscosity measurements. All of the strain-rate viscosity measurements were performed on water samples at 60°C and 25°C. Figure 4-73 shows the results from each sample at 25°C. The legend shows the dates of the samples. For example, “020605” refers to the sample from February 6, 2005. The horizontal lines of each sample indicate that the solution remained Newtonian with no significant changes throughout the 30-day test.

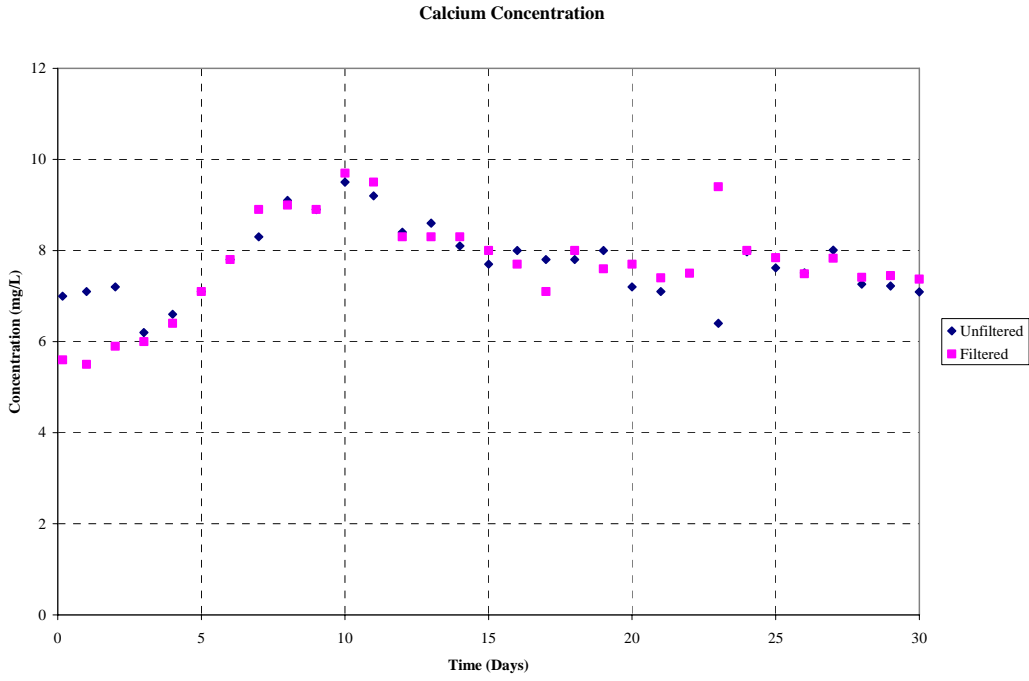
**Figure 4-74. Test #2 calcium concentration.**

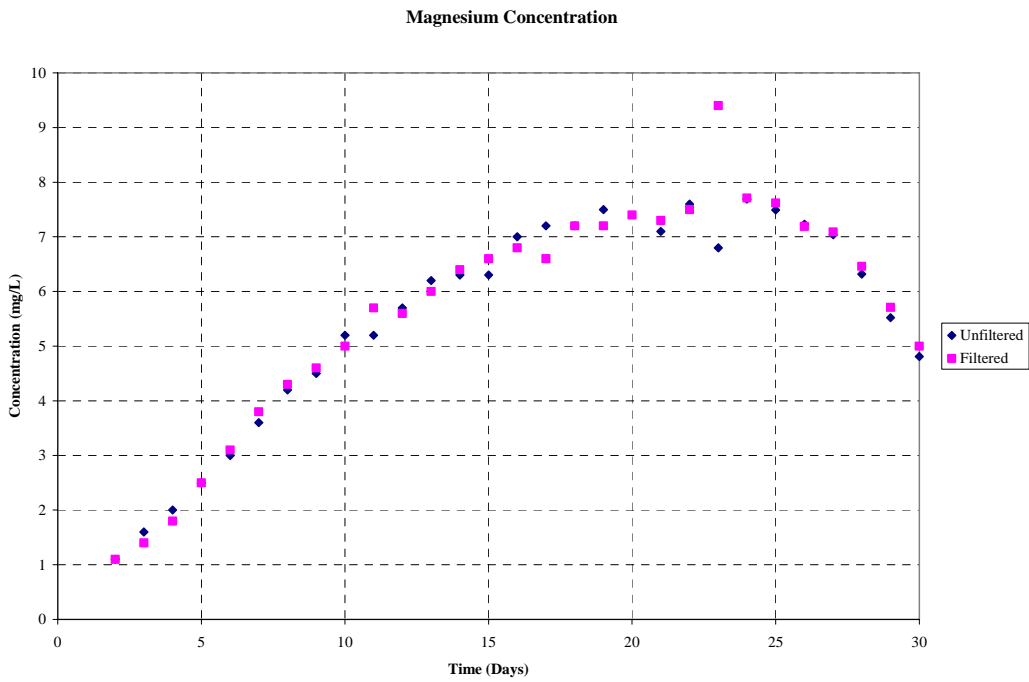
**Figure 4-75. Test #2 magnesium concentration.**

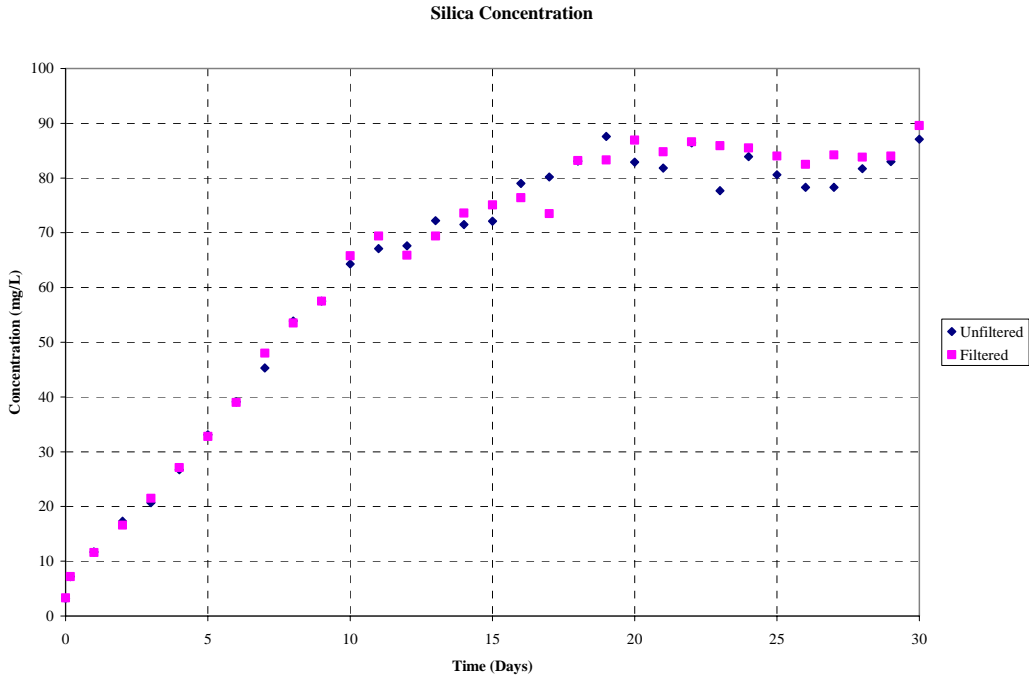
**Figure 4-76. Test #2 silica concentration.**

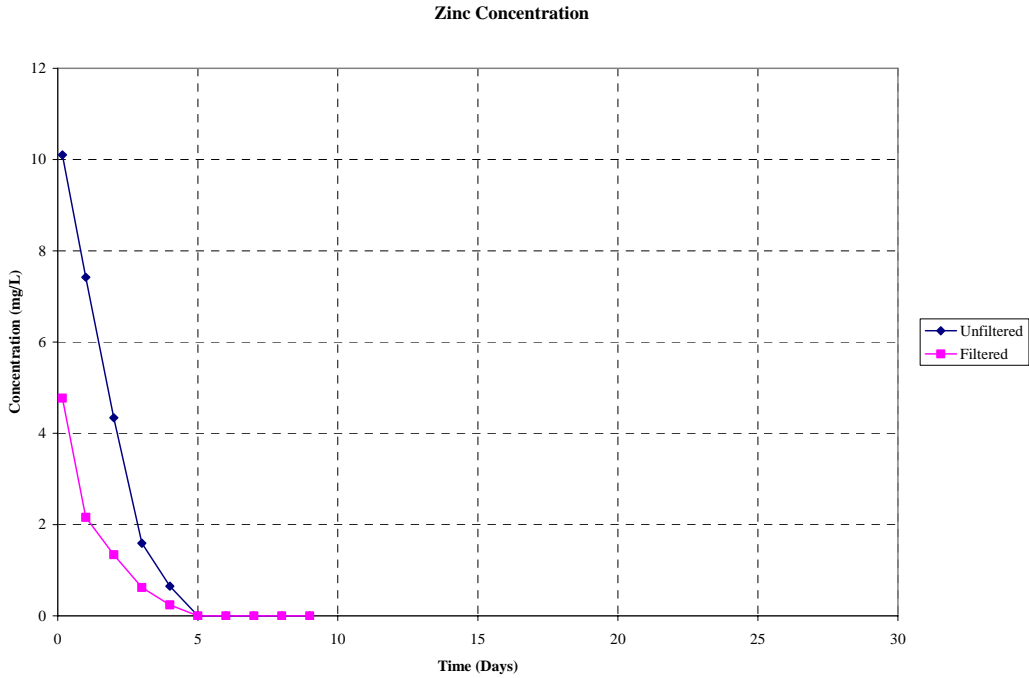
**Figure 4-77. Test #2 zinc concentration.**

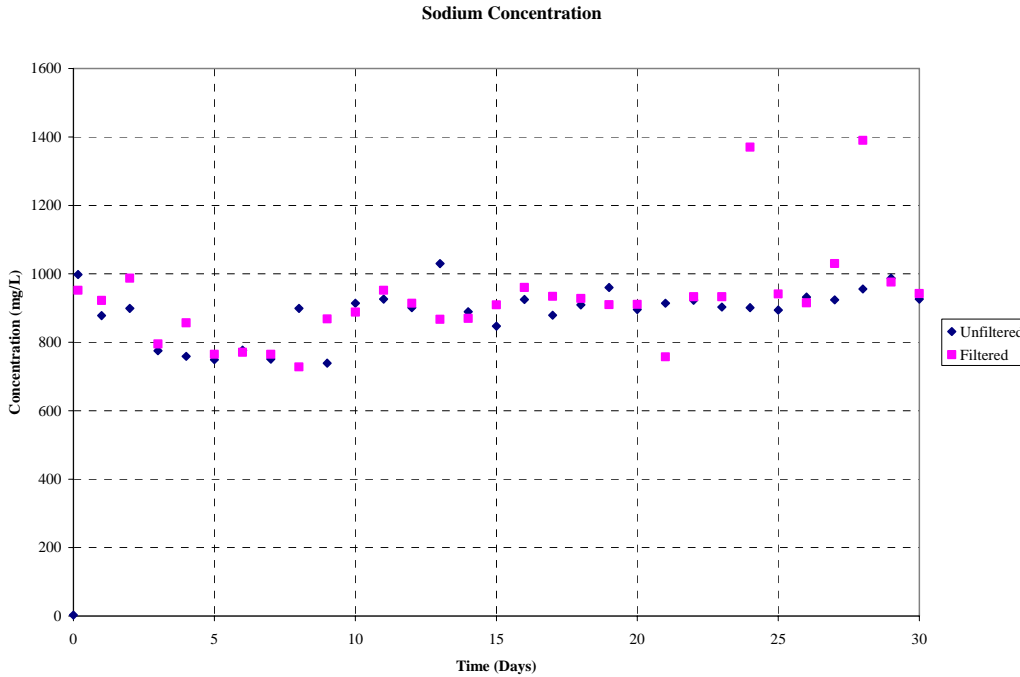
**Figure 4-78. Test #2 sodium concentration.**

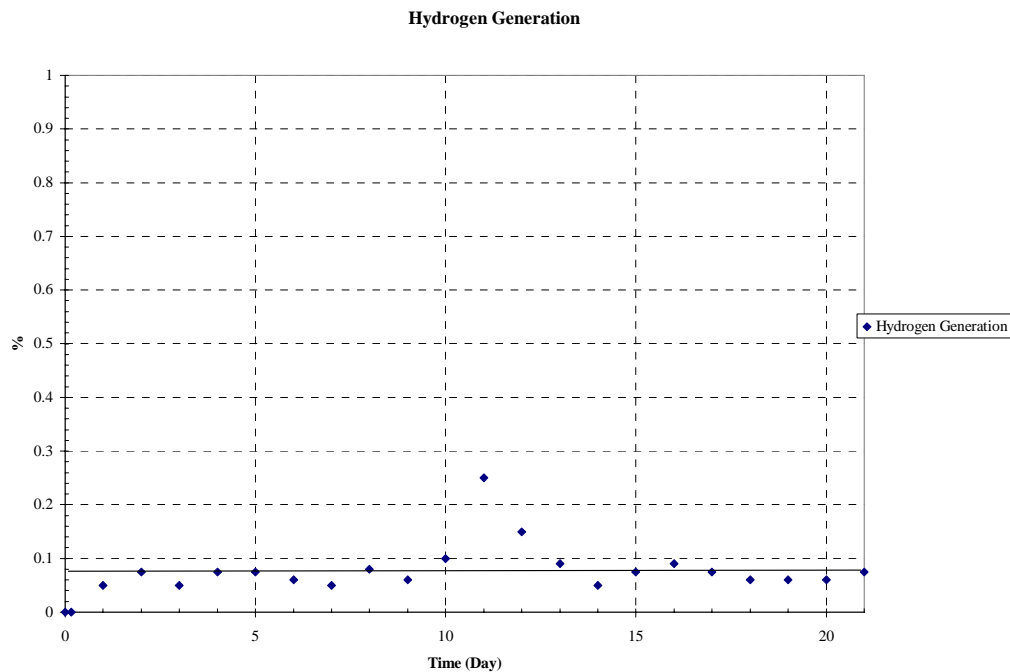
Figure 4-79. Test #2 hydrogen concentration.

During the third week of testing, the operational procedure for hydrogen venting returned to normal test operations and remained unchanged. After return to the normal operational procedure, the hydrogen generation remained constant.

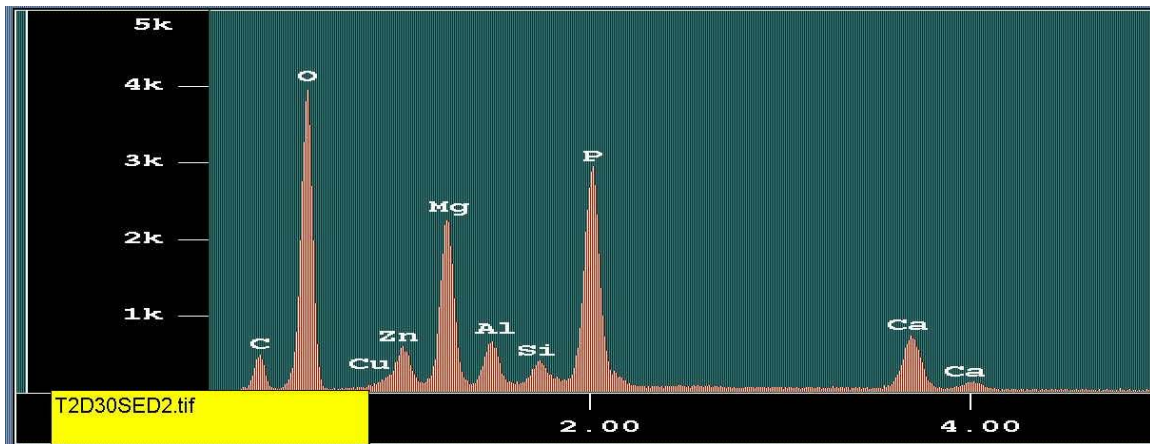
Figure 4-83. EDS counting spectrum for the porously structured material shown in Figure 4-82.
