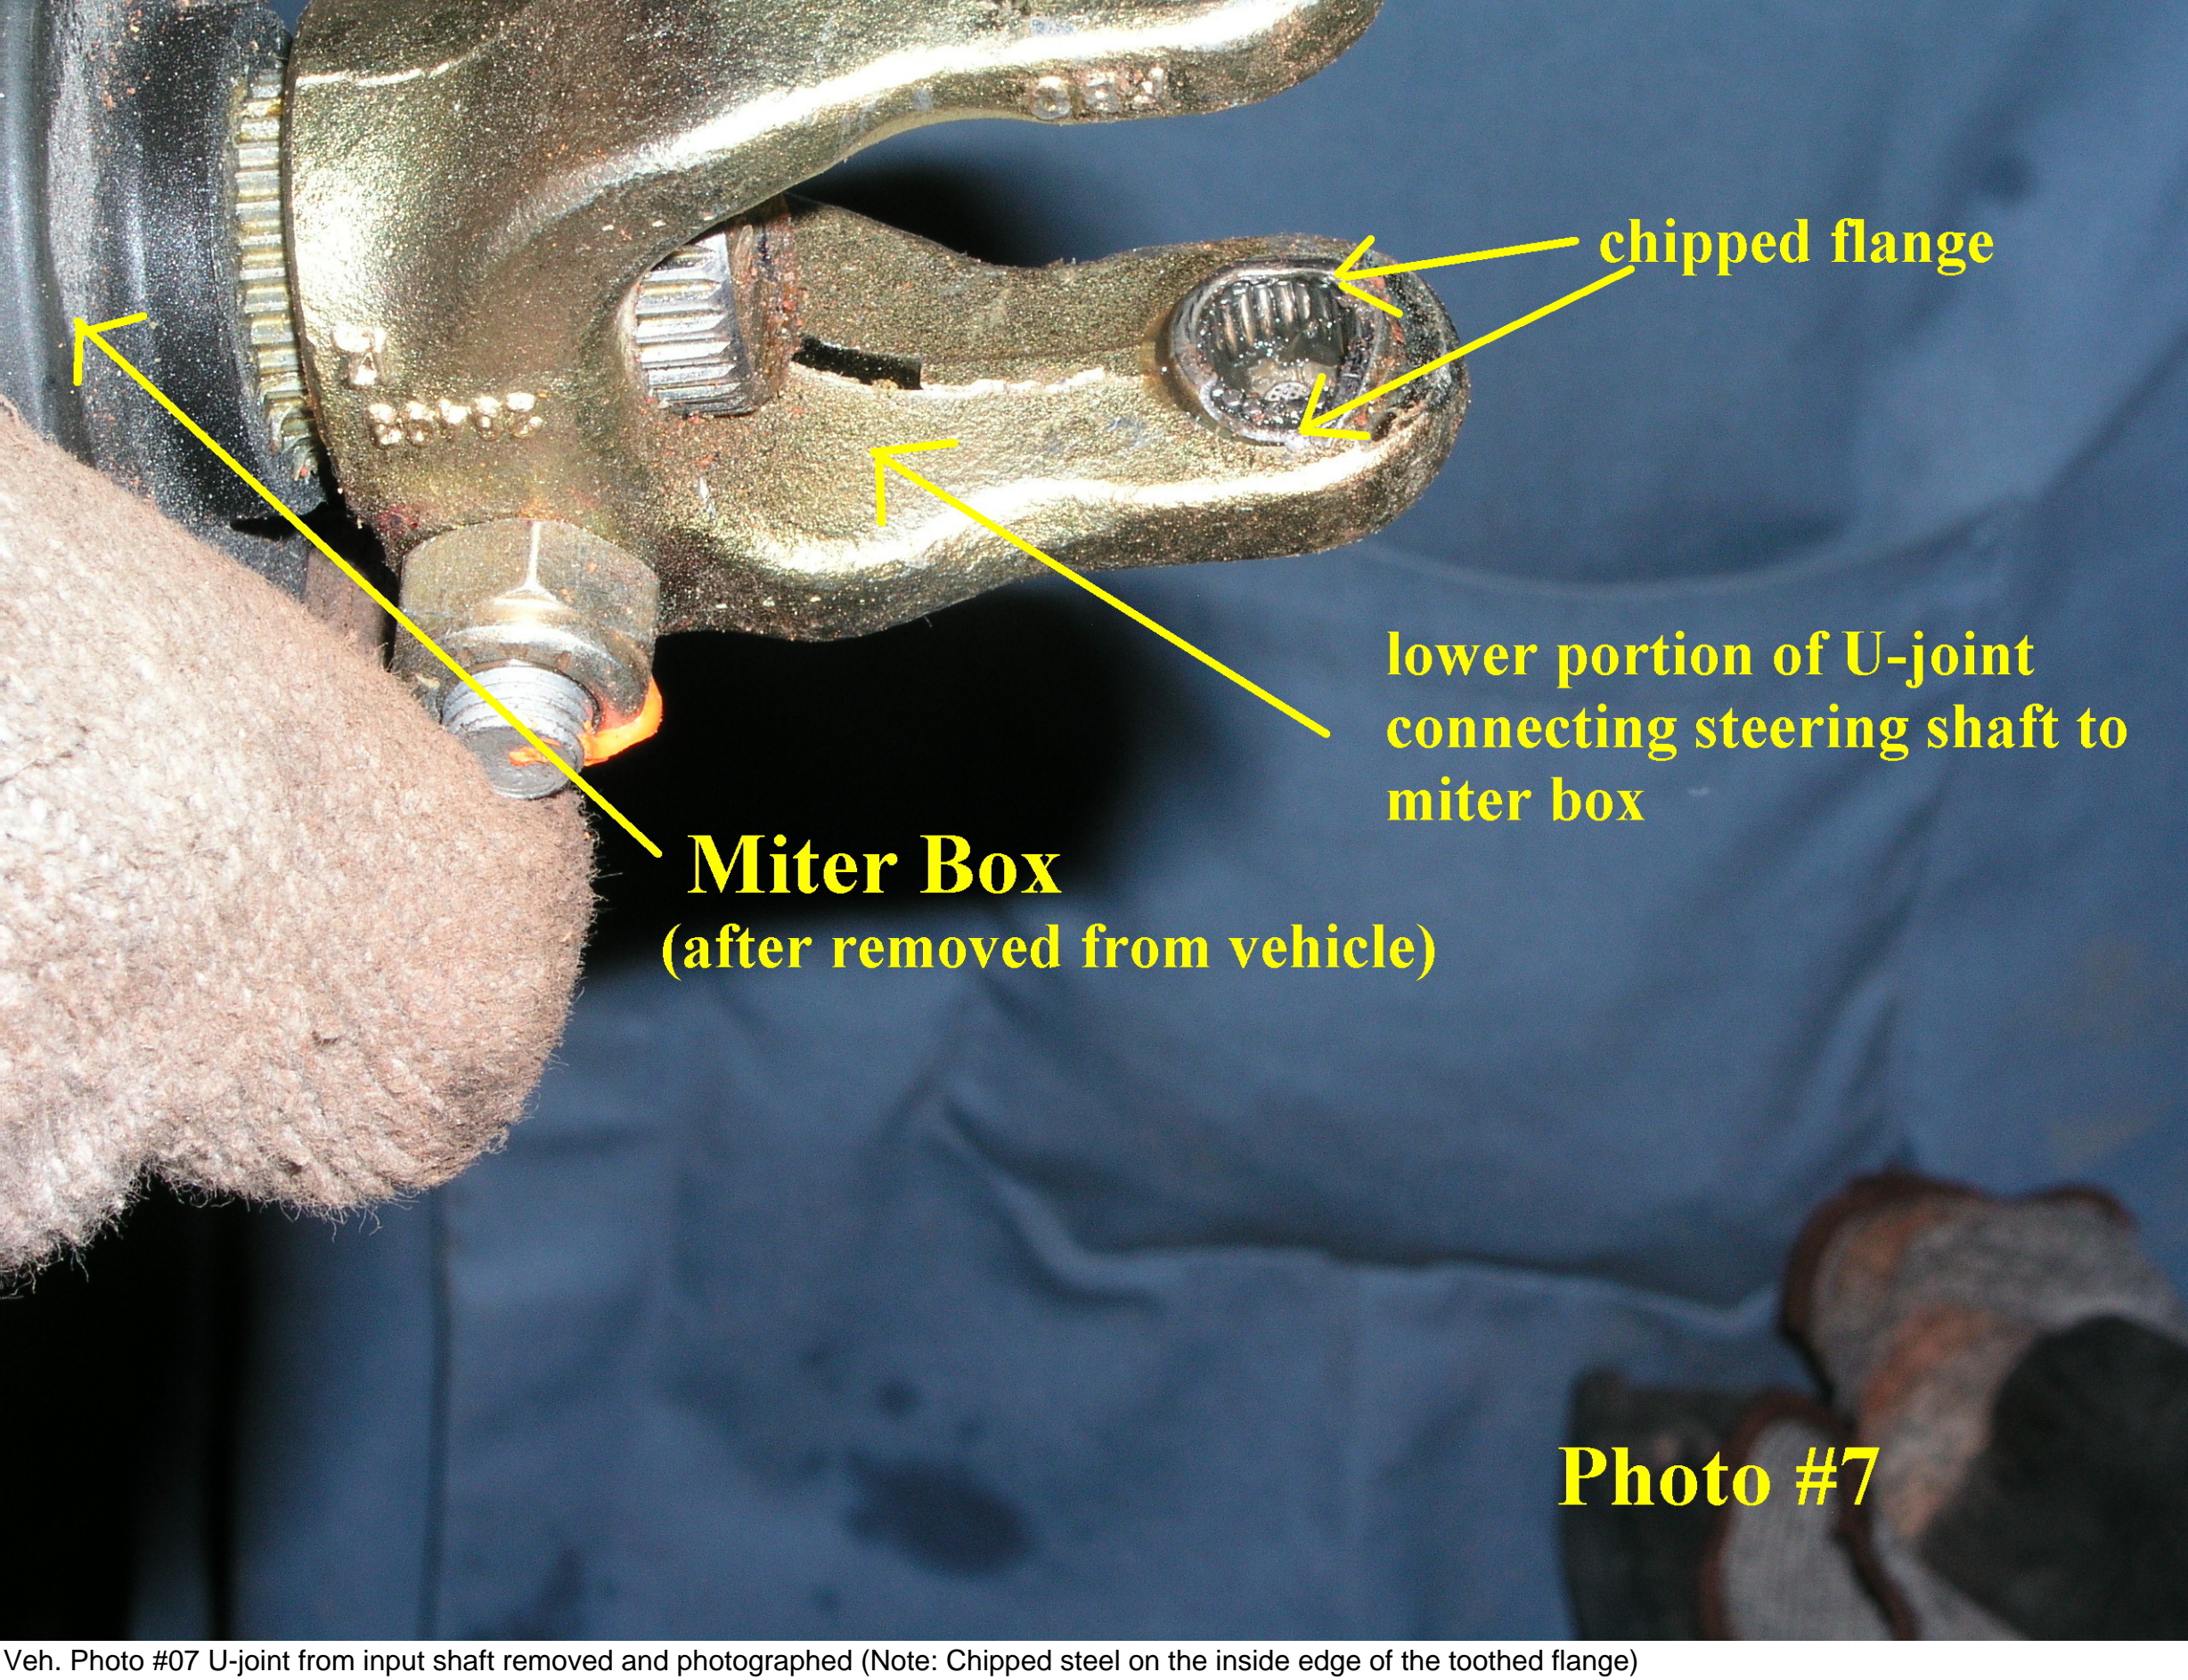
Photo #7

chipped flange

lower portion of U-joint
connecting steering shaft to
miter box

Miter Box
(after removed from vehicle)

Veh. Photo #07 U-joint from input shaft removed and photographed (Note: Chipped steel on the inside edge of the toothed flange)
